# **Bridgeton Landfill, LLC**

## **Weekly Data Submittal**

**Week of October 16, 2016 – October 22, 2016**

**Required by Section 52.F of Agreed Order, Case No. 13SL-CC01088  
Effective May 13, 2013**

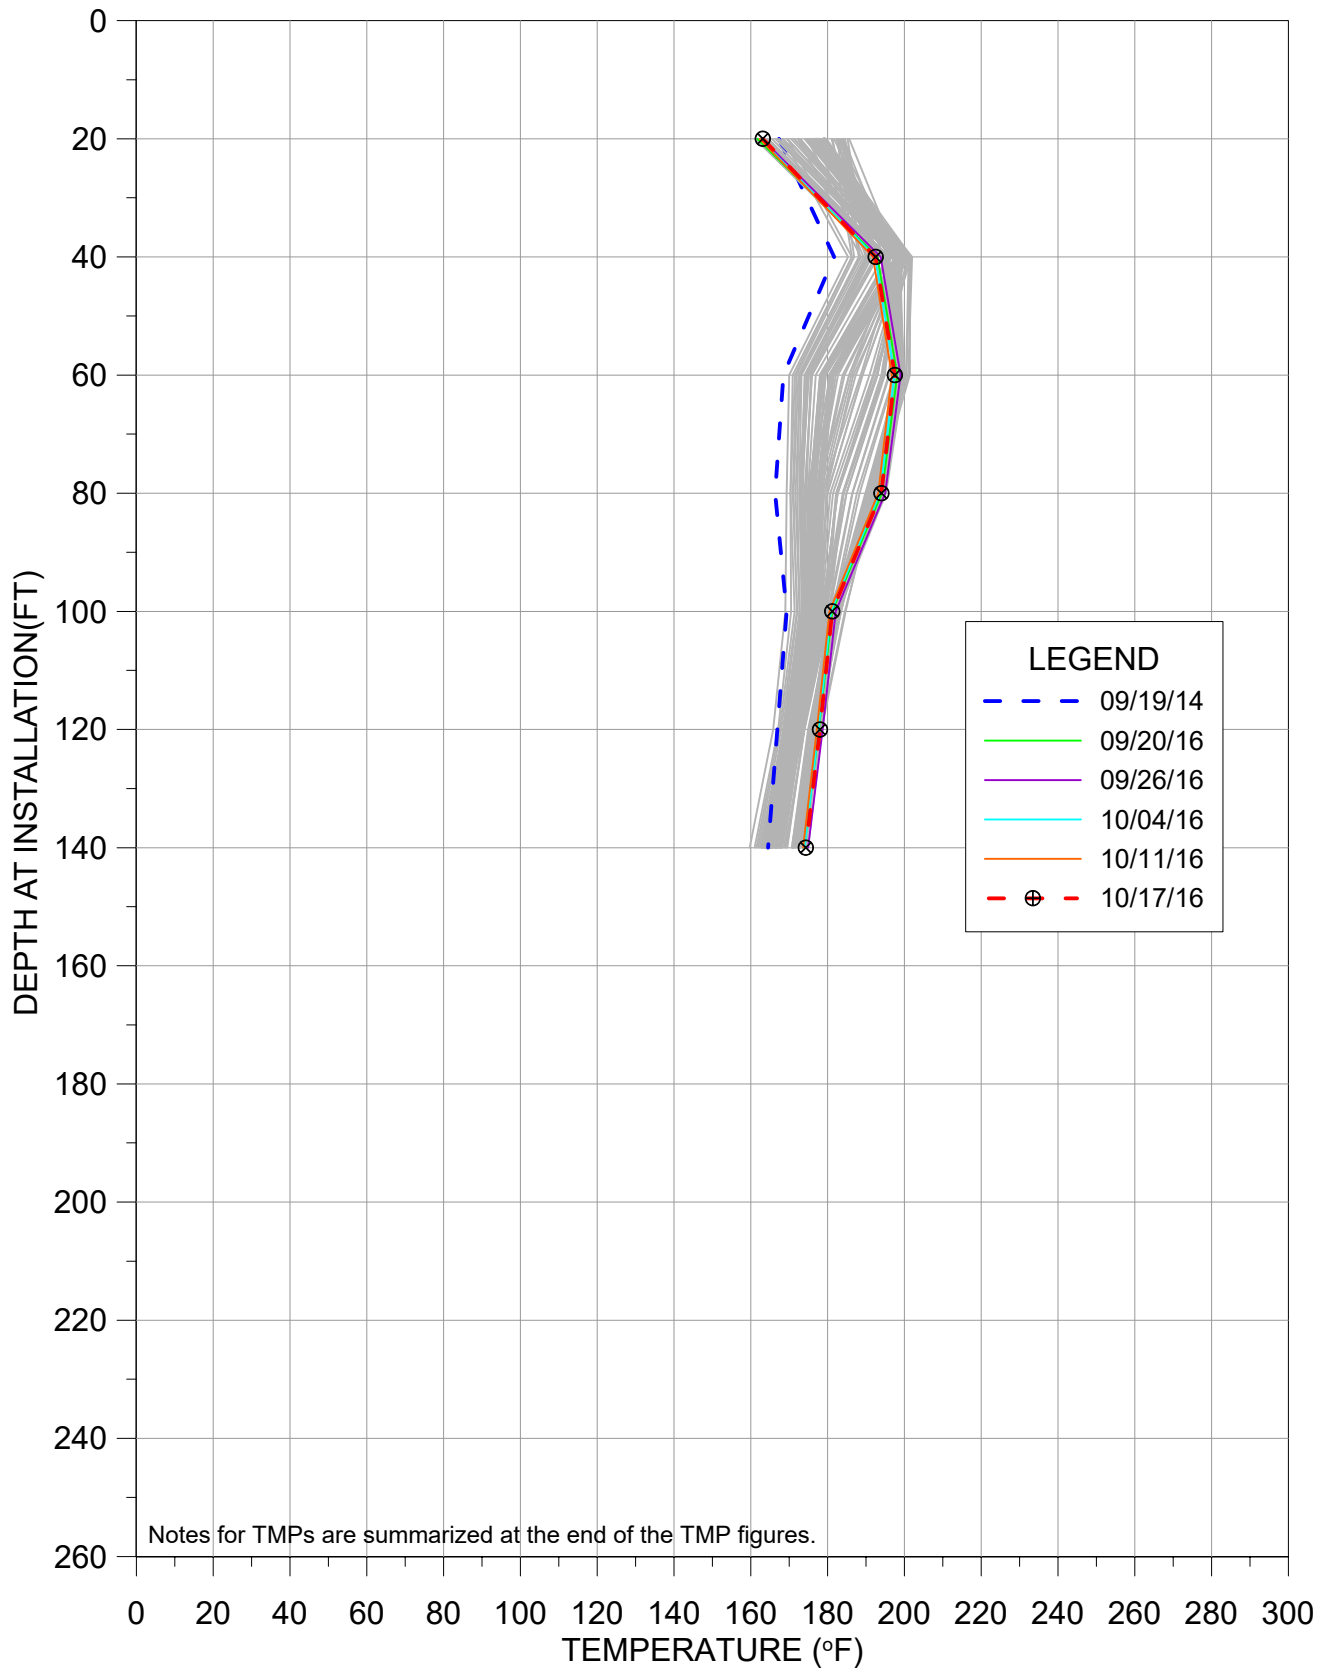
# TMP-14R

1. Due to the connectivity test results by Feezor Engineering on TMP-14 (see note above), TMP-14R is added to this reporting data set as of 3/7/2016.

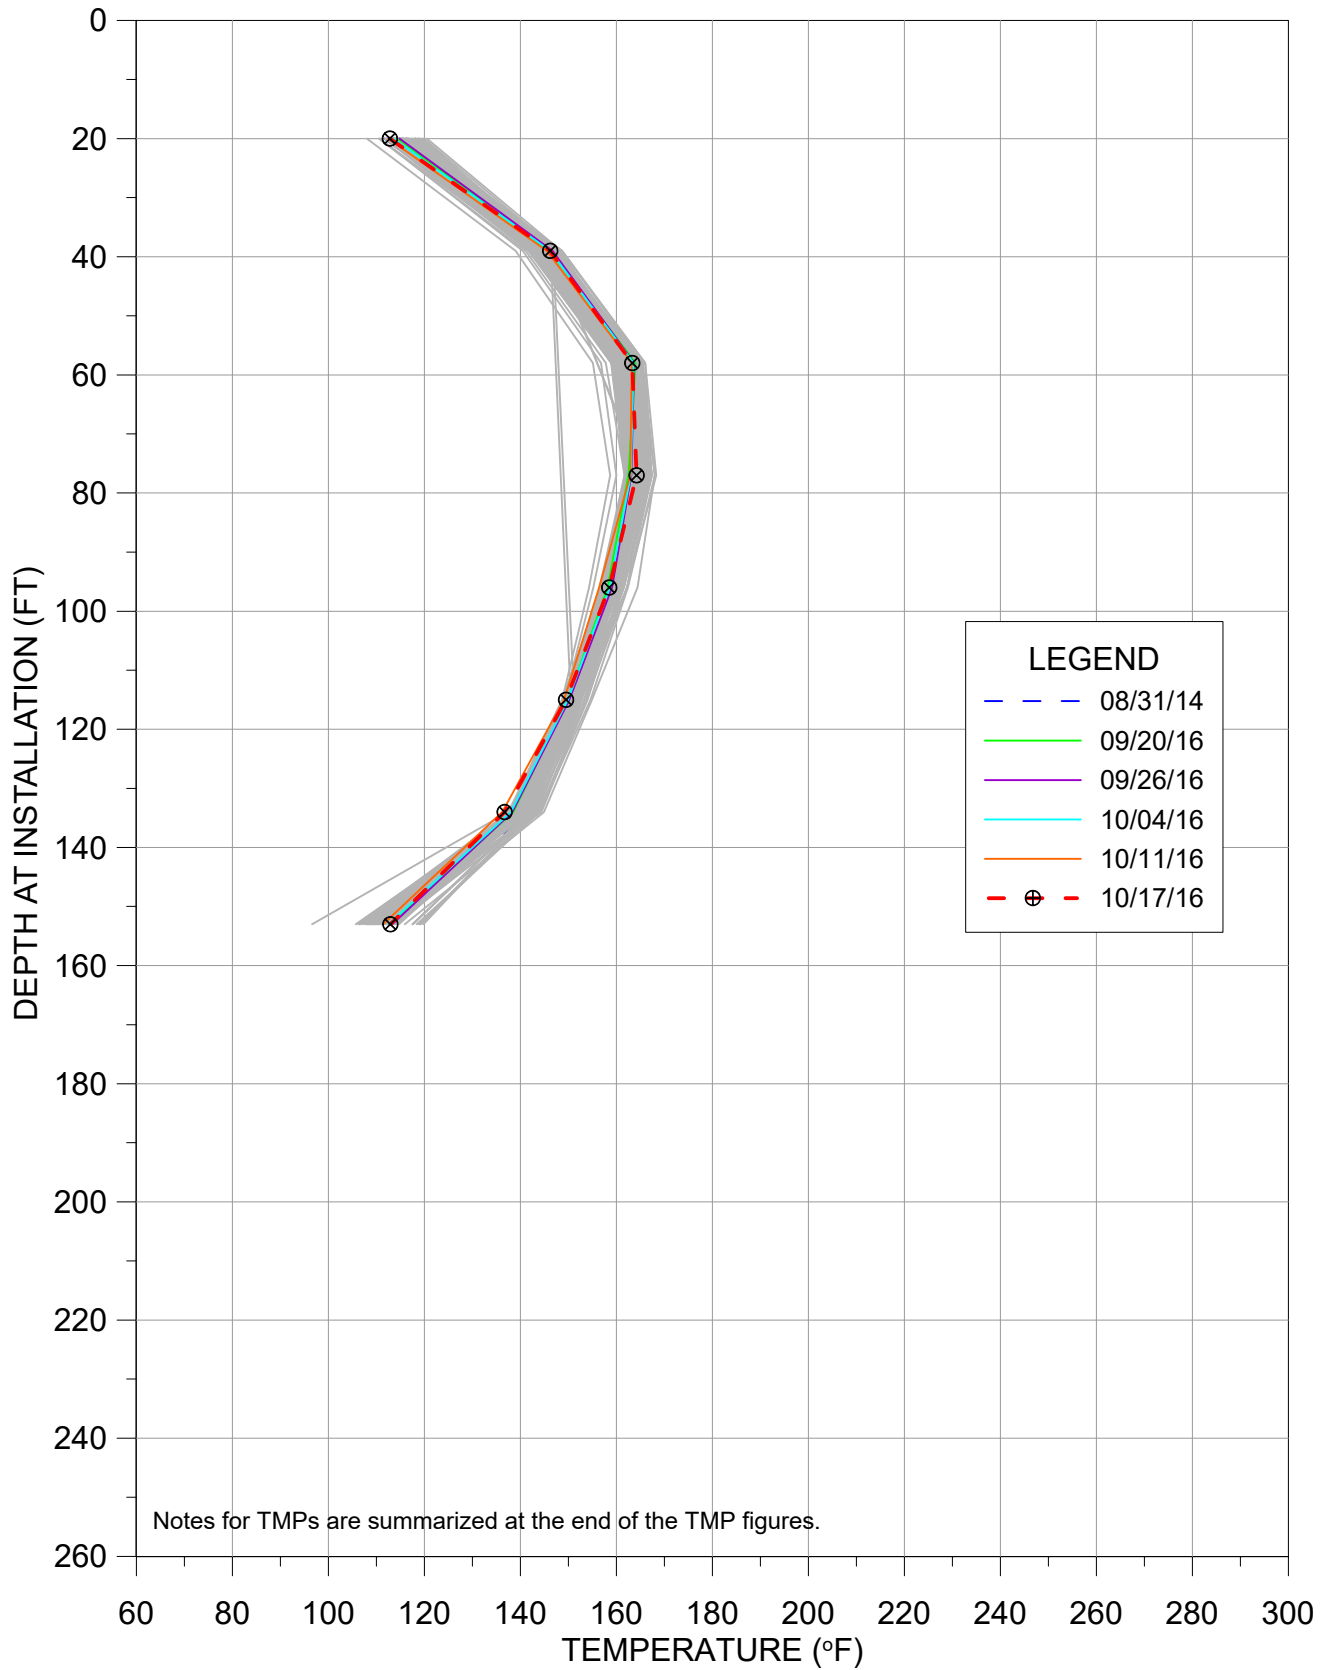
# TMP-16

1. A connectivity test conducted by Feezor Engineering showed that the units on TMP-16 may not be reliable since 9/9/2015. Further testing at the end of September 2015 showed possible connectivity on some of the units.
2. The unit at 153 ft depth had a low resistance reading and unreliable temperature since 12/21/2015.

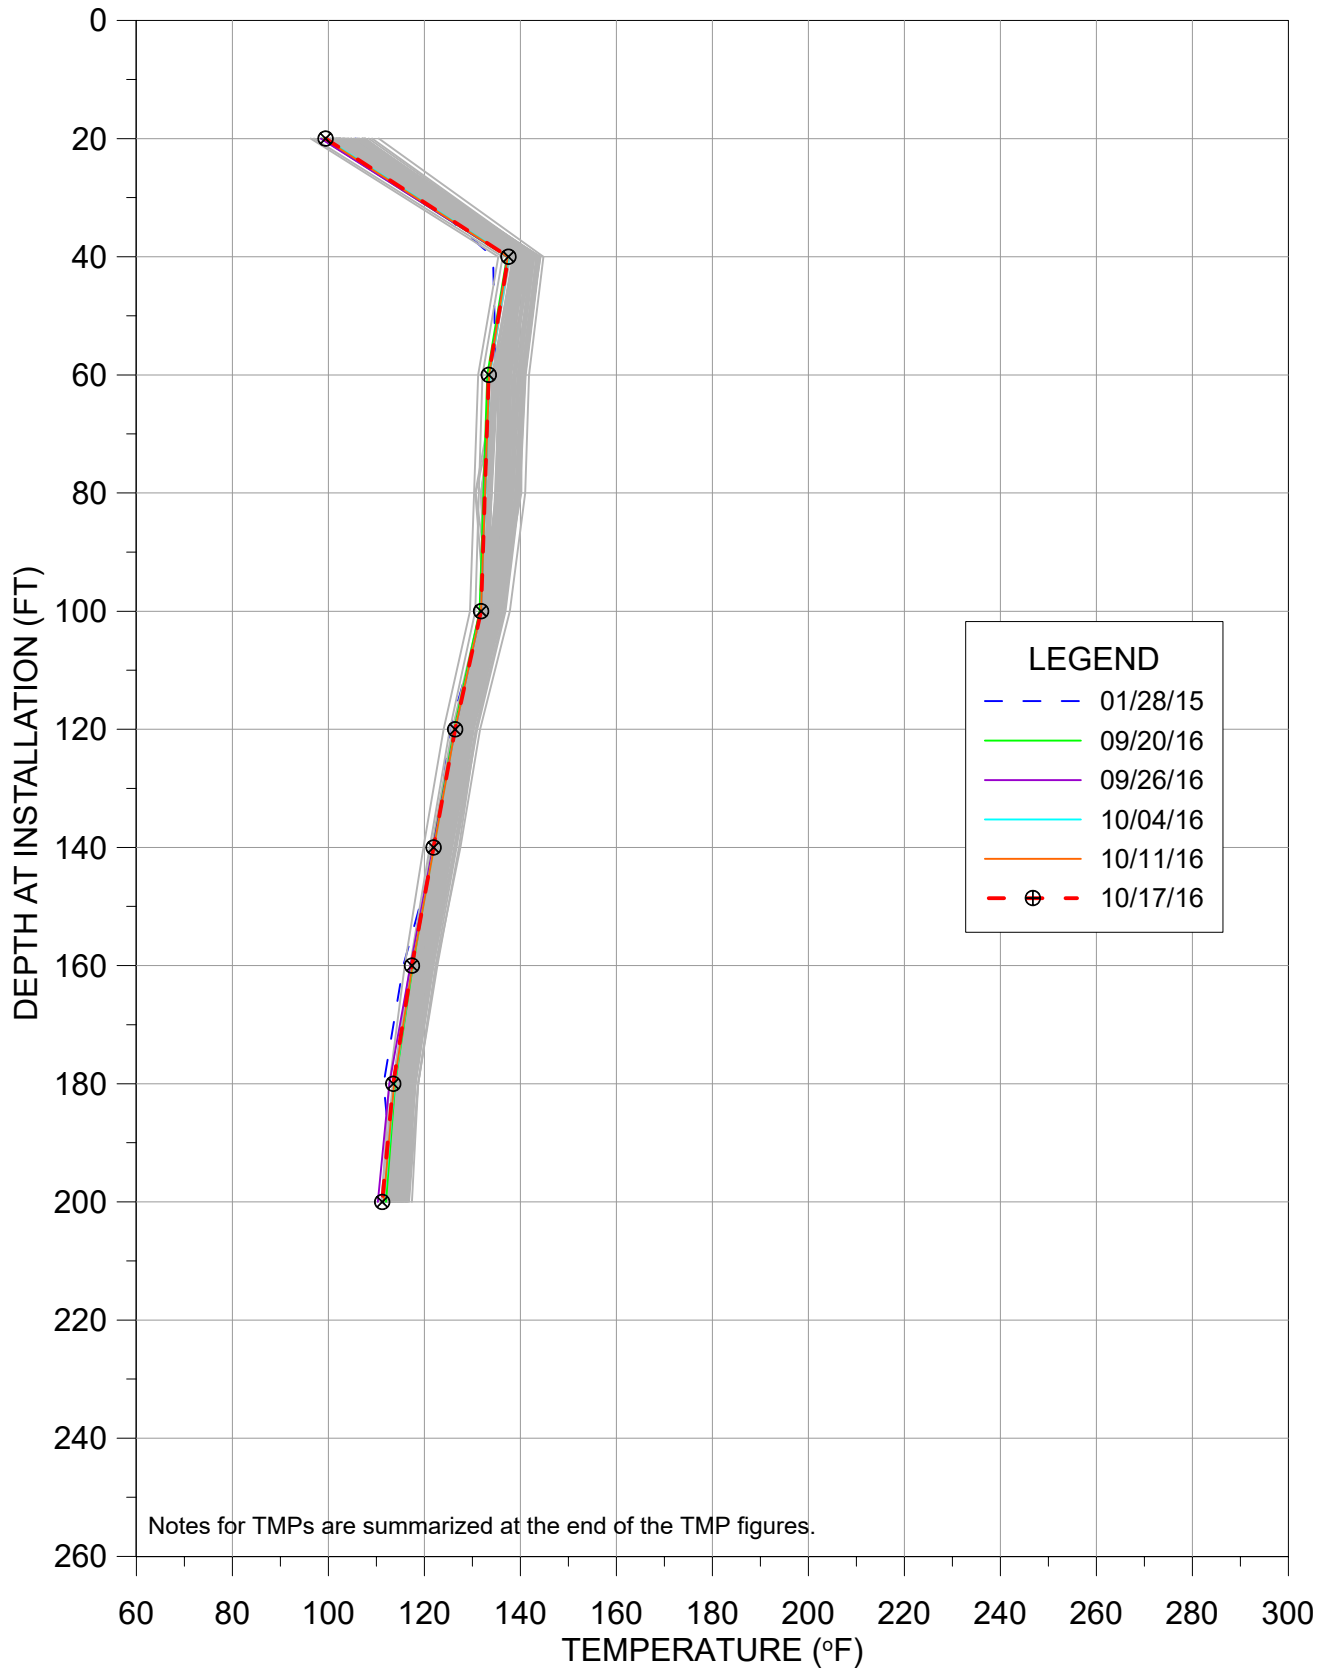
# TMP-28

1. The unit at 217 ft depth has had no resistance or temperature readings since installation.
2. The unit at 80 ft depth had a resistance drop and an unreasonable temperature decrease on 6/1/2016. The temperature has since fluctuated and is determined to be unreliable.

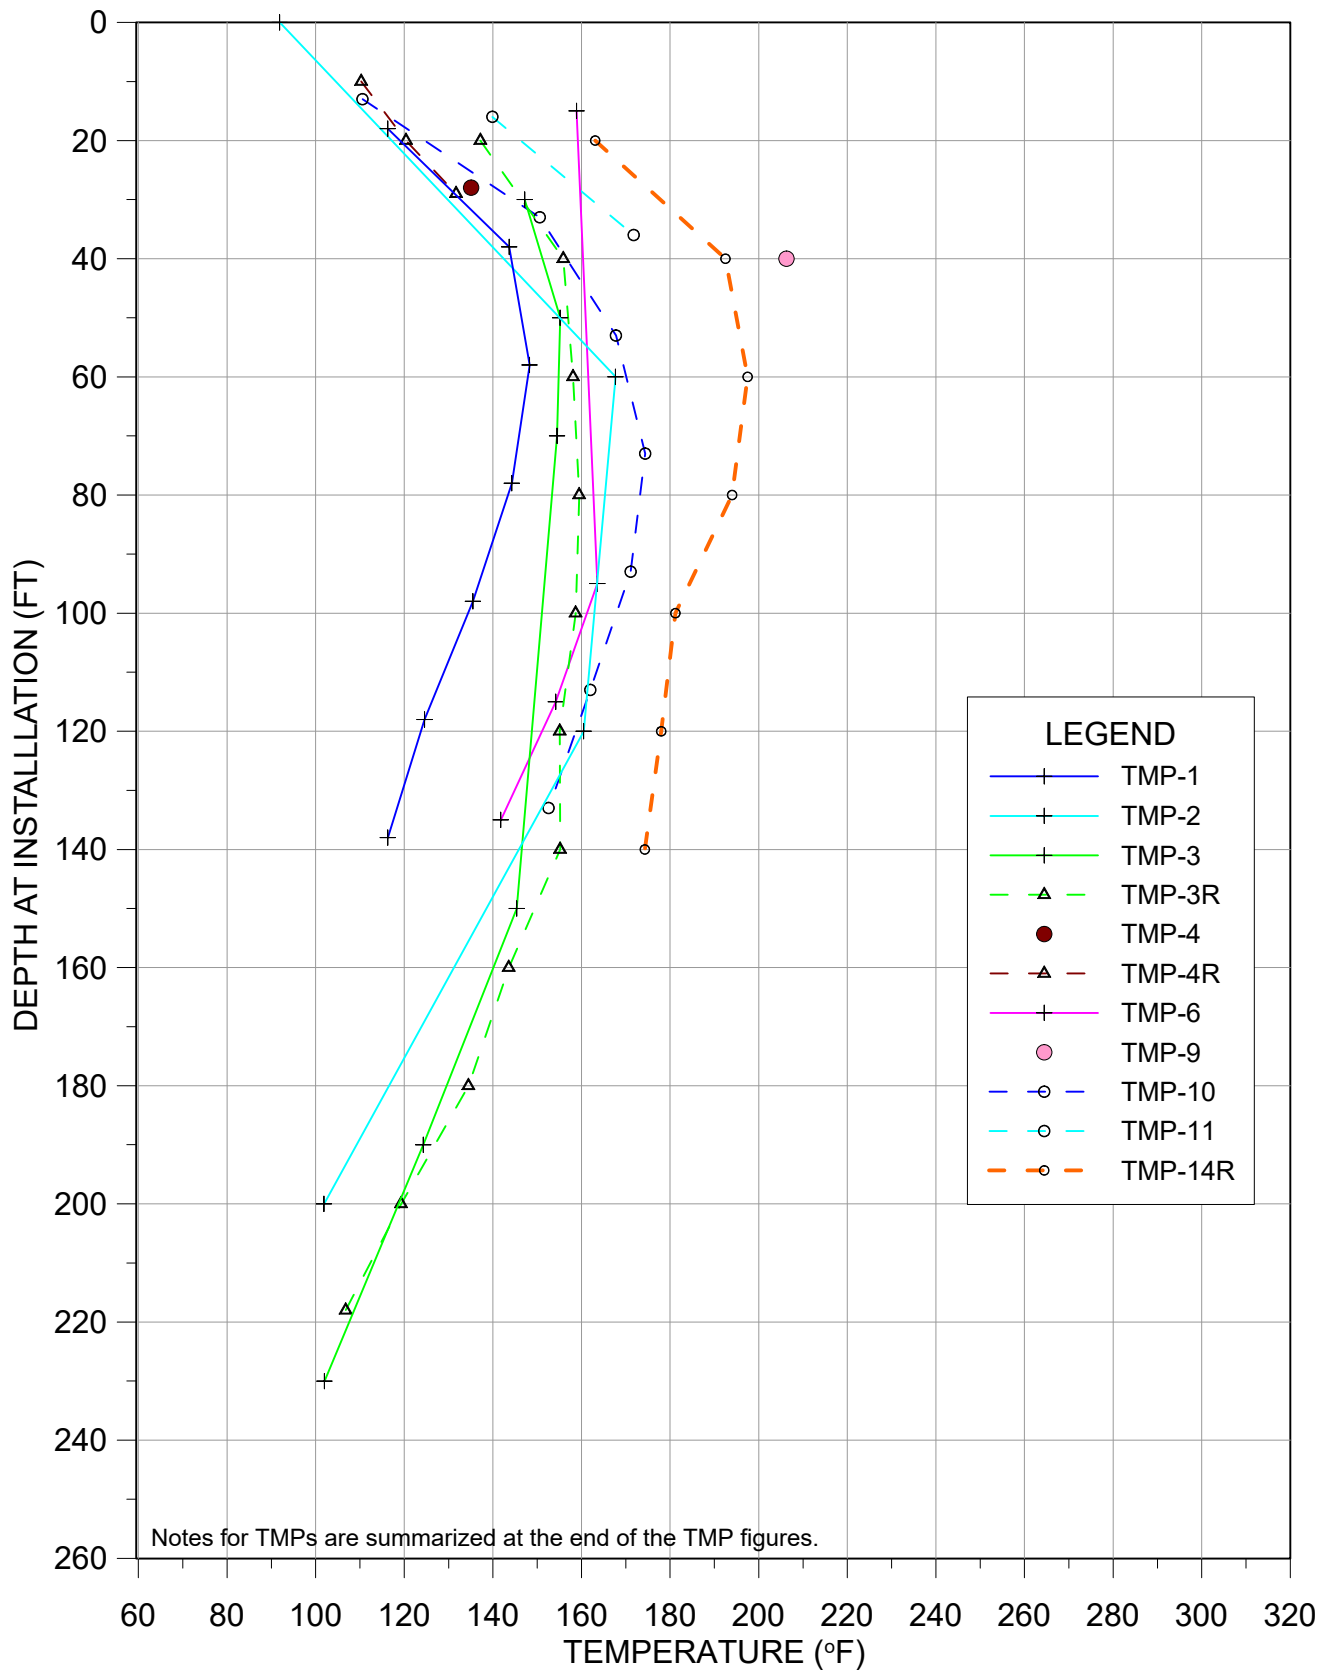
10/17/2016

1. There were no reliable temperature readings for TMP-13 since 3/19/2014.
2. There were no reliable temperature readings for TMP-7R, as determined by the connectivity test on 4/11/2014.
3. There were no reliable temperature readings for TMP-5 since 11/5/2014.
4. There were no reliable temperature readings for TMP-12 since 9/28/2015.
5. There were no reliable temperature readings for TMP-8 since 9/9/2015.
6. There were no reliable temperature readings for TMP-14, confirmed since 3/7/2016.

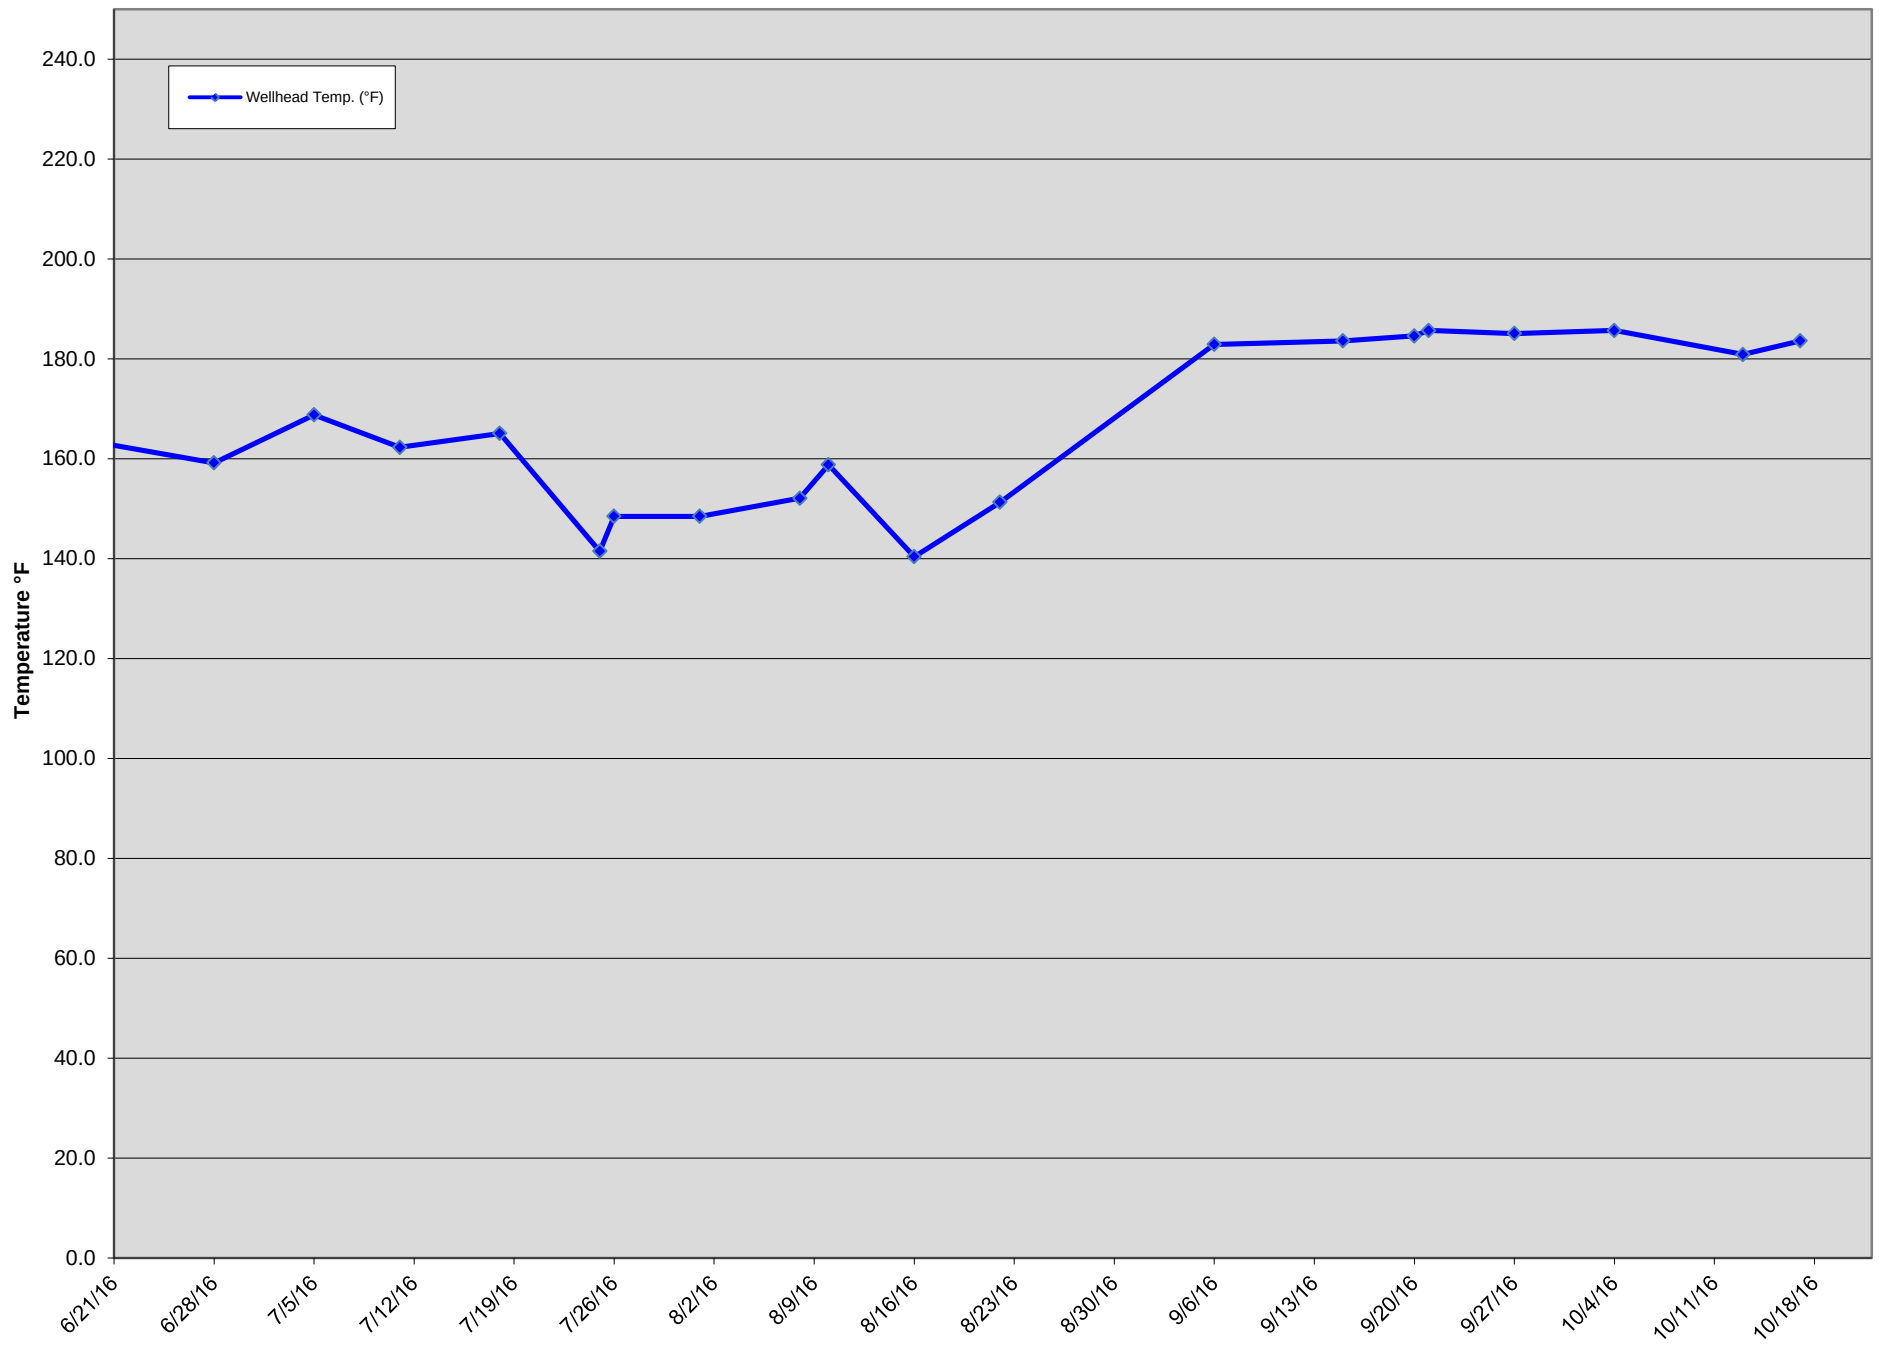
## GIW-1 Wellhead Temperatures

As part of the HES, there are currently cooling water circulation loops installed in twelve Gas Interceptor Wells (GIWs) (GIW-02 through GIW-13). The remaining well (GIW-01) had a measured gas temperature within its historical operating limits.
