# **Bridgeton Landfill, LLC**

## **Weekly Data Submittal**

**Week of December 24, 2017 – December 30, 2017**

**Required by Section 52.F of Agreed Order, Case No. 13SL-CC01088  
Effective May 13, 2013**

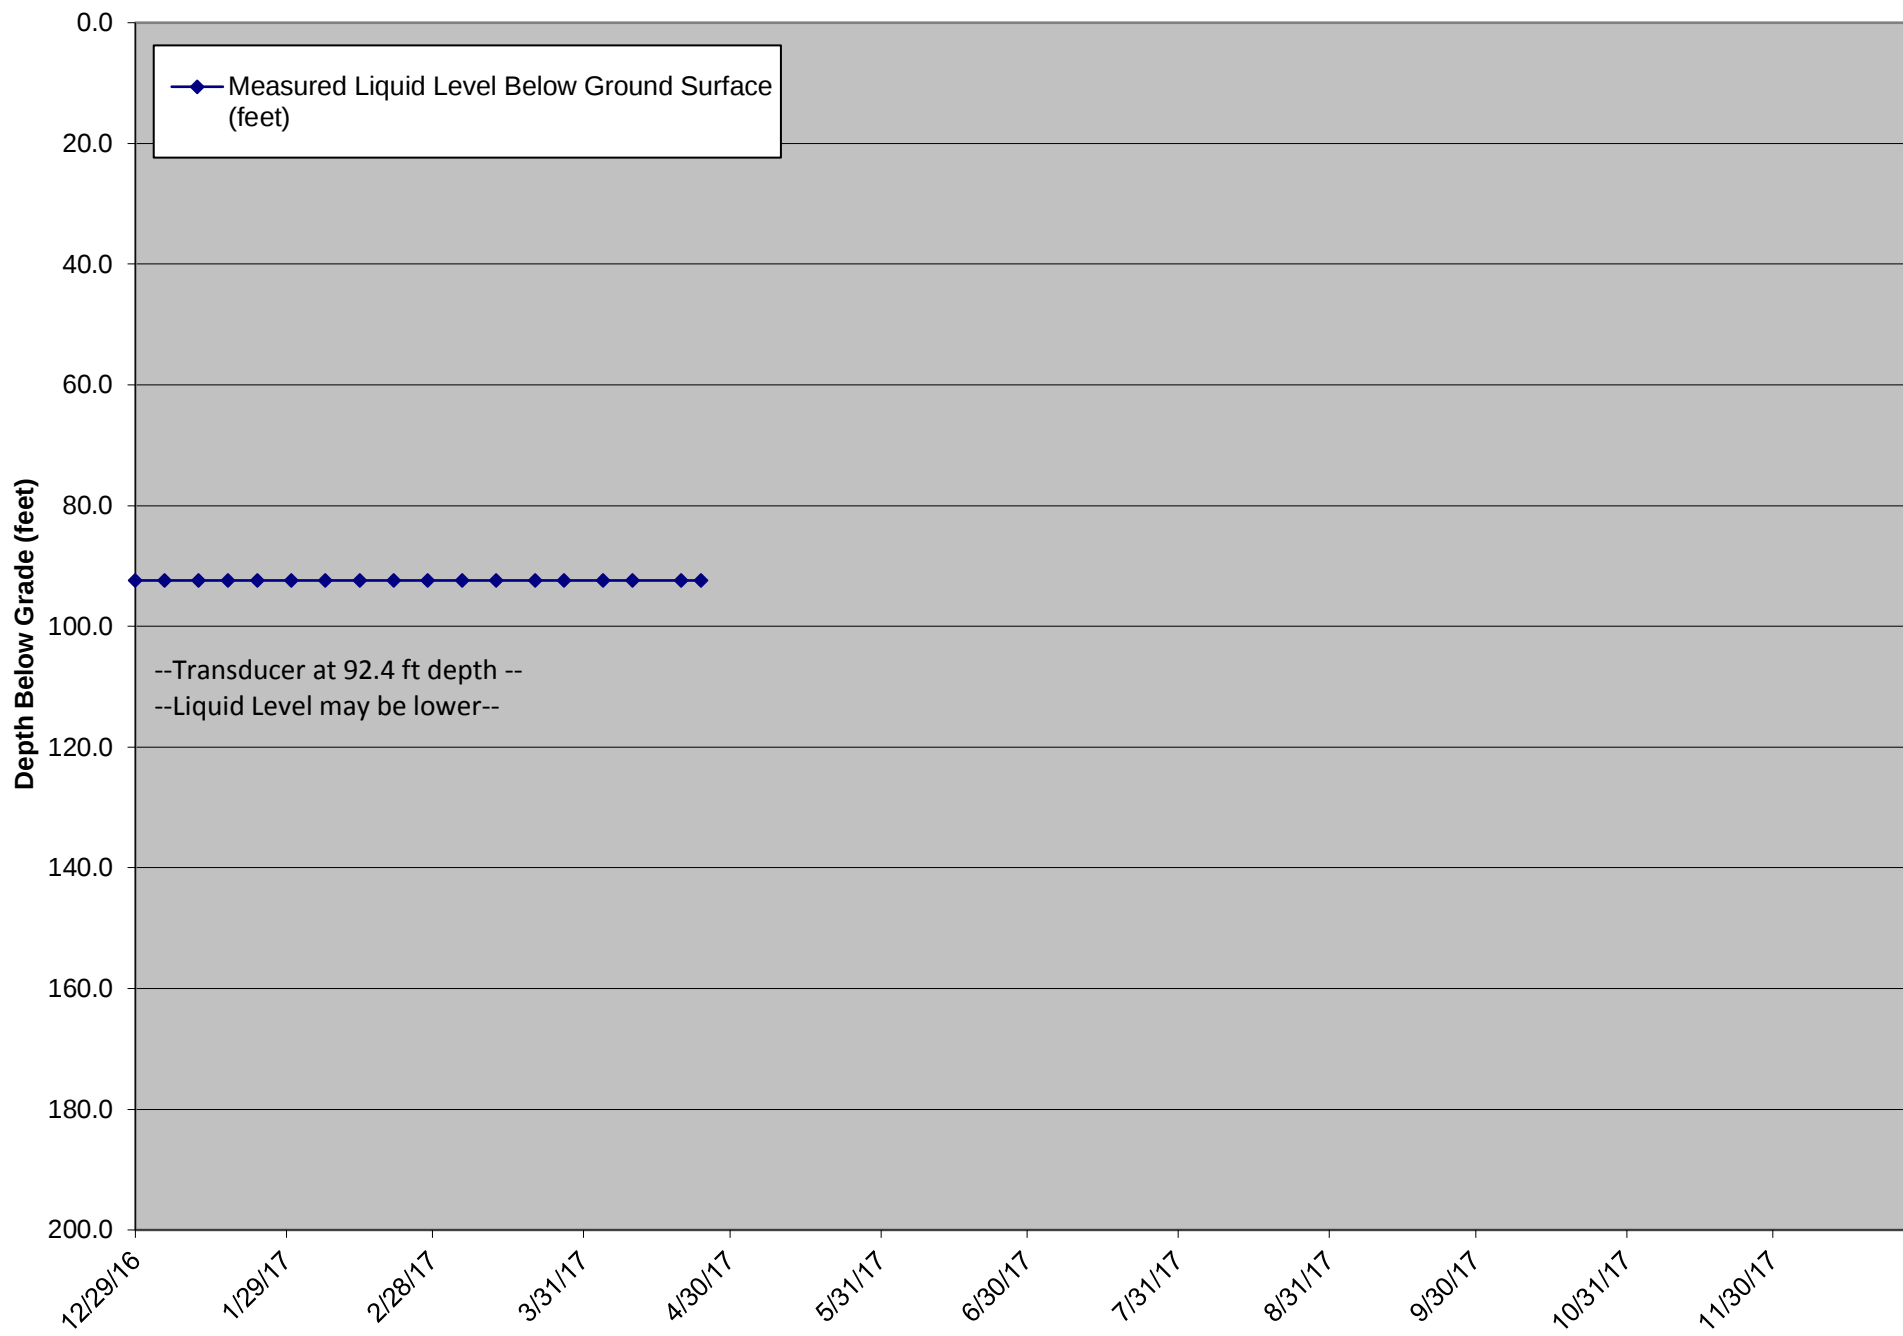
# LCS-1D Liquid Level Below Ground Surface

The downhole discharge piping for LCS-1D requires replacement. Pump and level sensor replacement was postponed due to windy conditions. Pump and level sensor replacement will take place in January 2018 pending weather conditions and contractor availability.

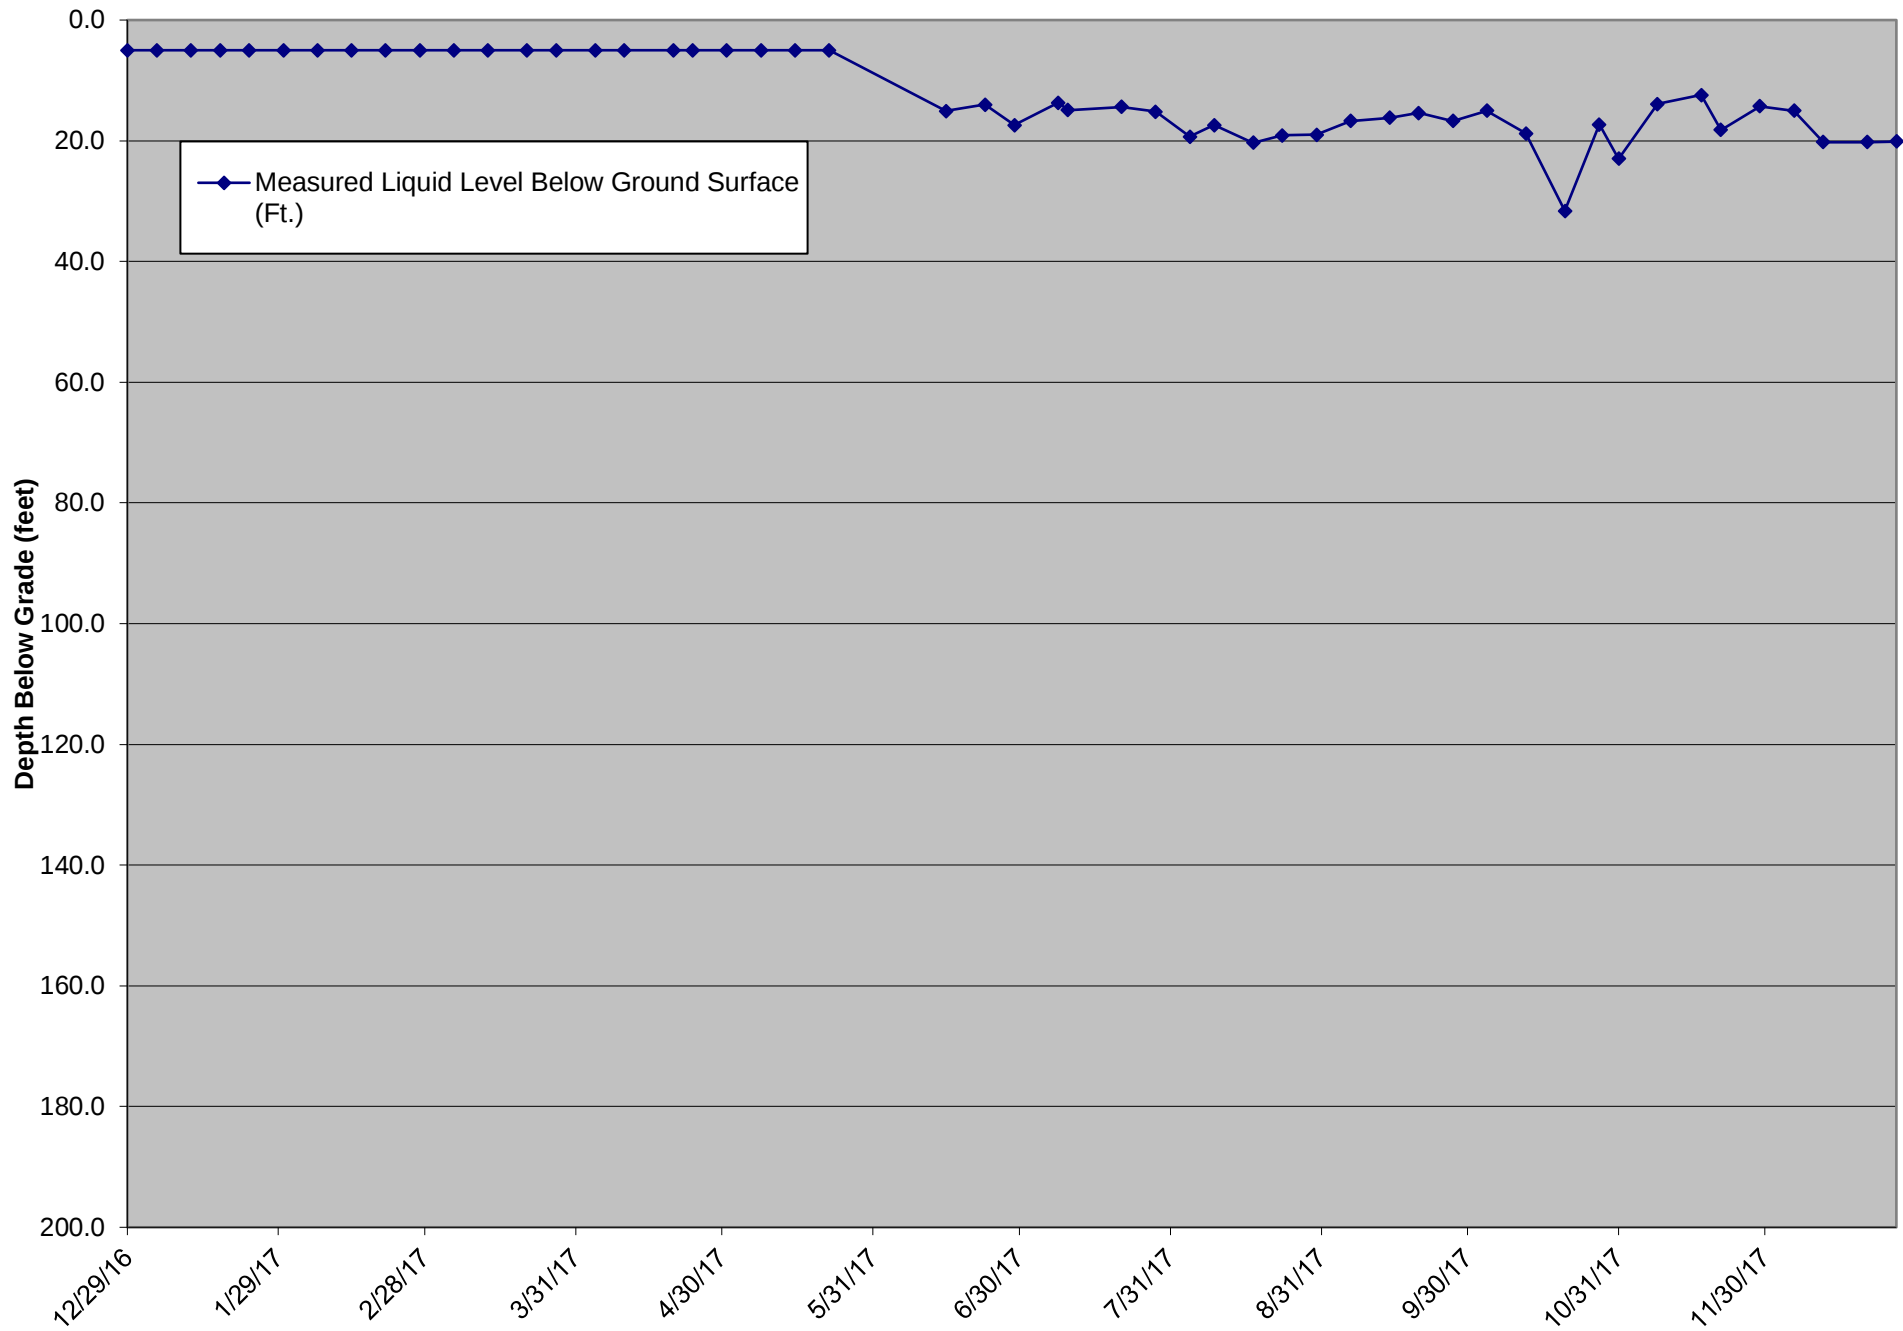
LCS-3D Liquid Level Below Ground Surface

The Blackhawk pneumatic pumps in LCS-3D were non-operational during the weekly reporting period. The casing on LCS-3D will be extended and the line sets for the Blackhawk pumps will be replaced as part of the east fill project. Liquid level was measured manually.

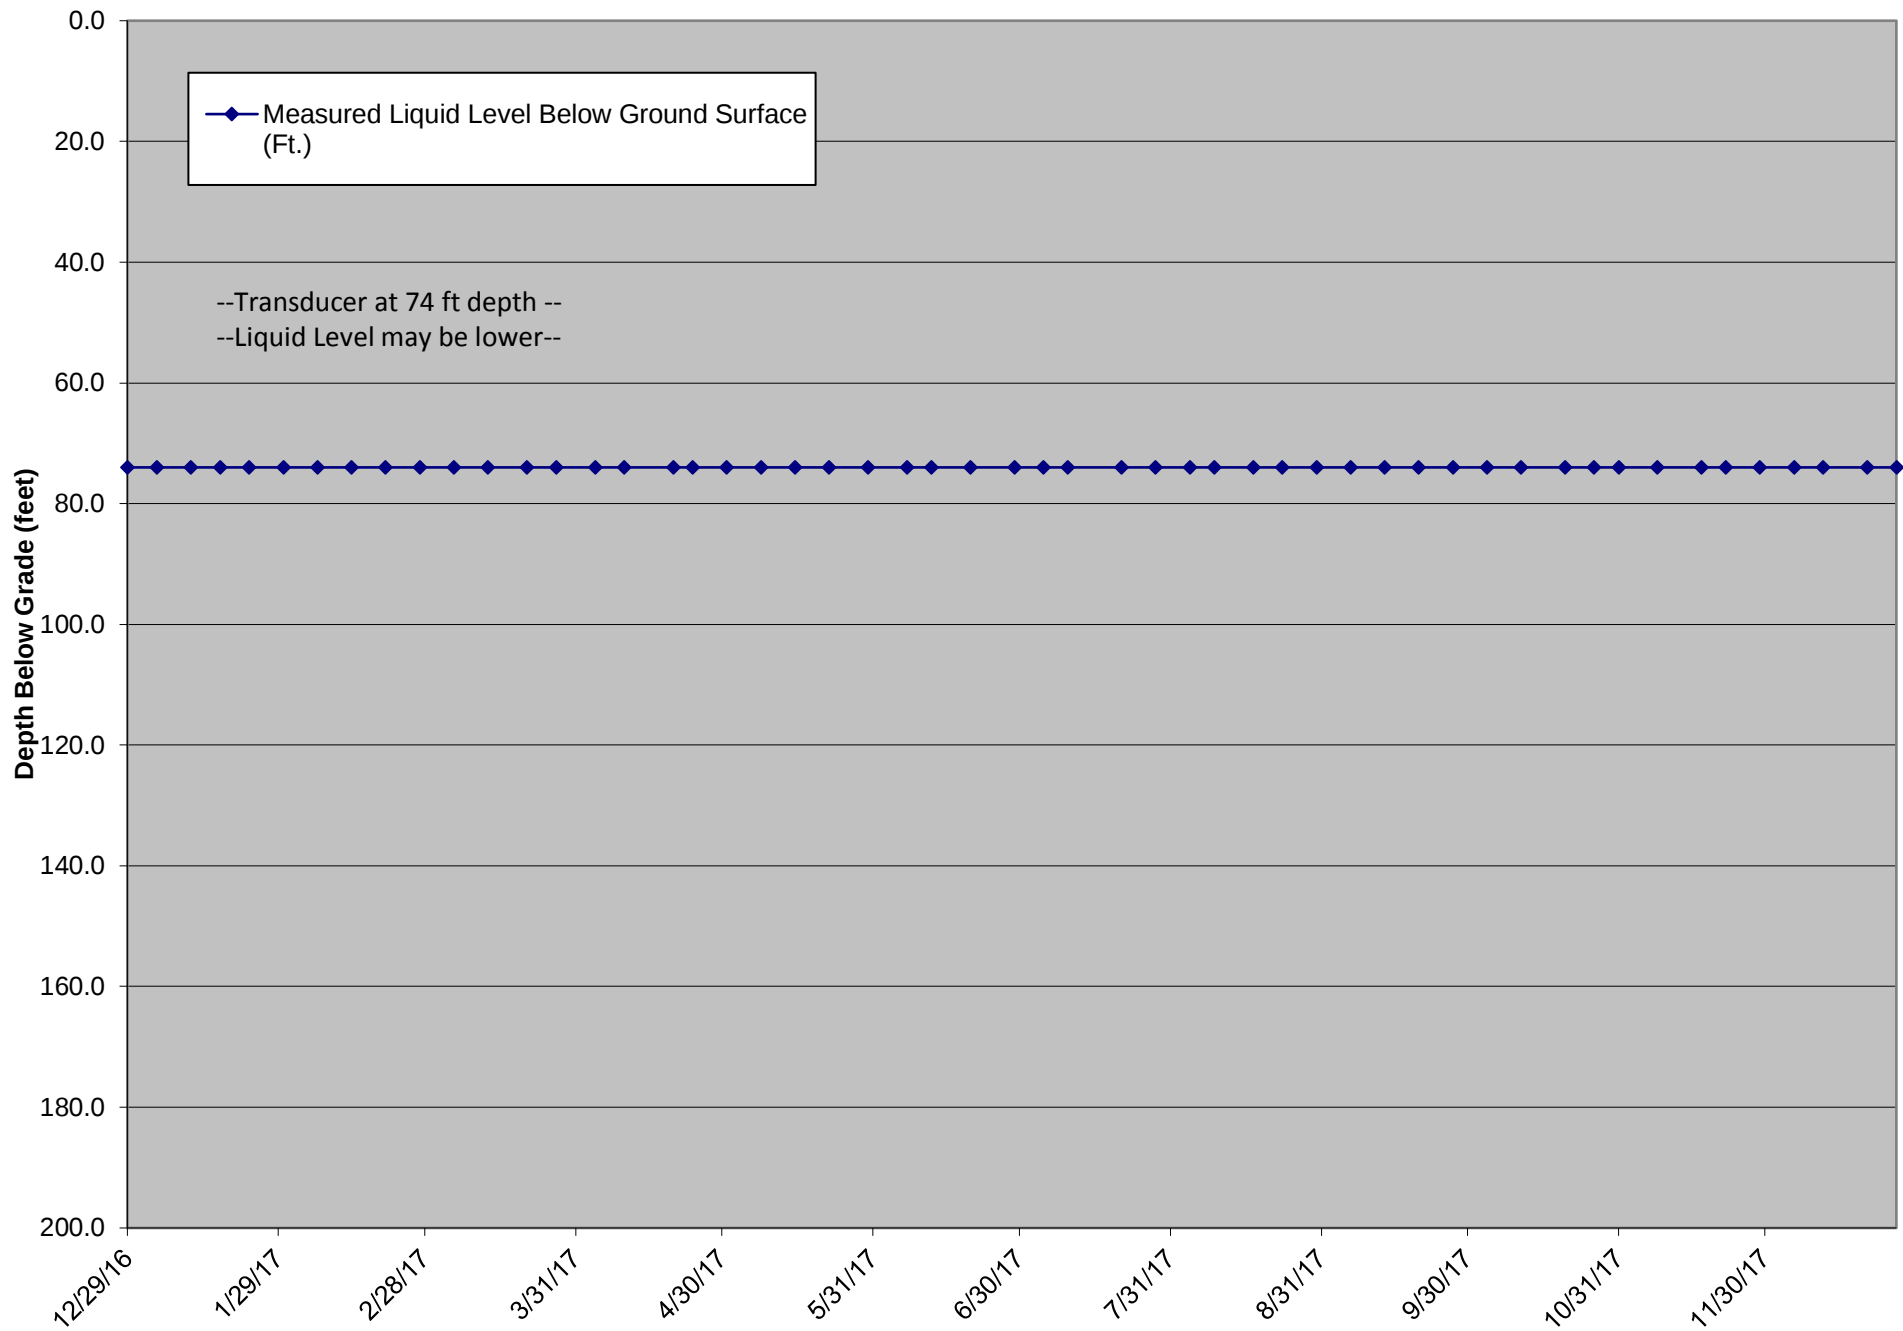
# LCS-4B Liquid Level Below Ground Surface

The level sensor in LCS-4B is currently operational and responsive. Liquid level was not recorded by the level sensor during the weekly reporting period. LCS-4B is equipped with a flow meter that displayed no flow during the weekly reporting period. Therefore, it can be concluded that the liquid level was below the bottom of the pump and level sensor in LCS-4B.

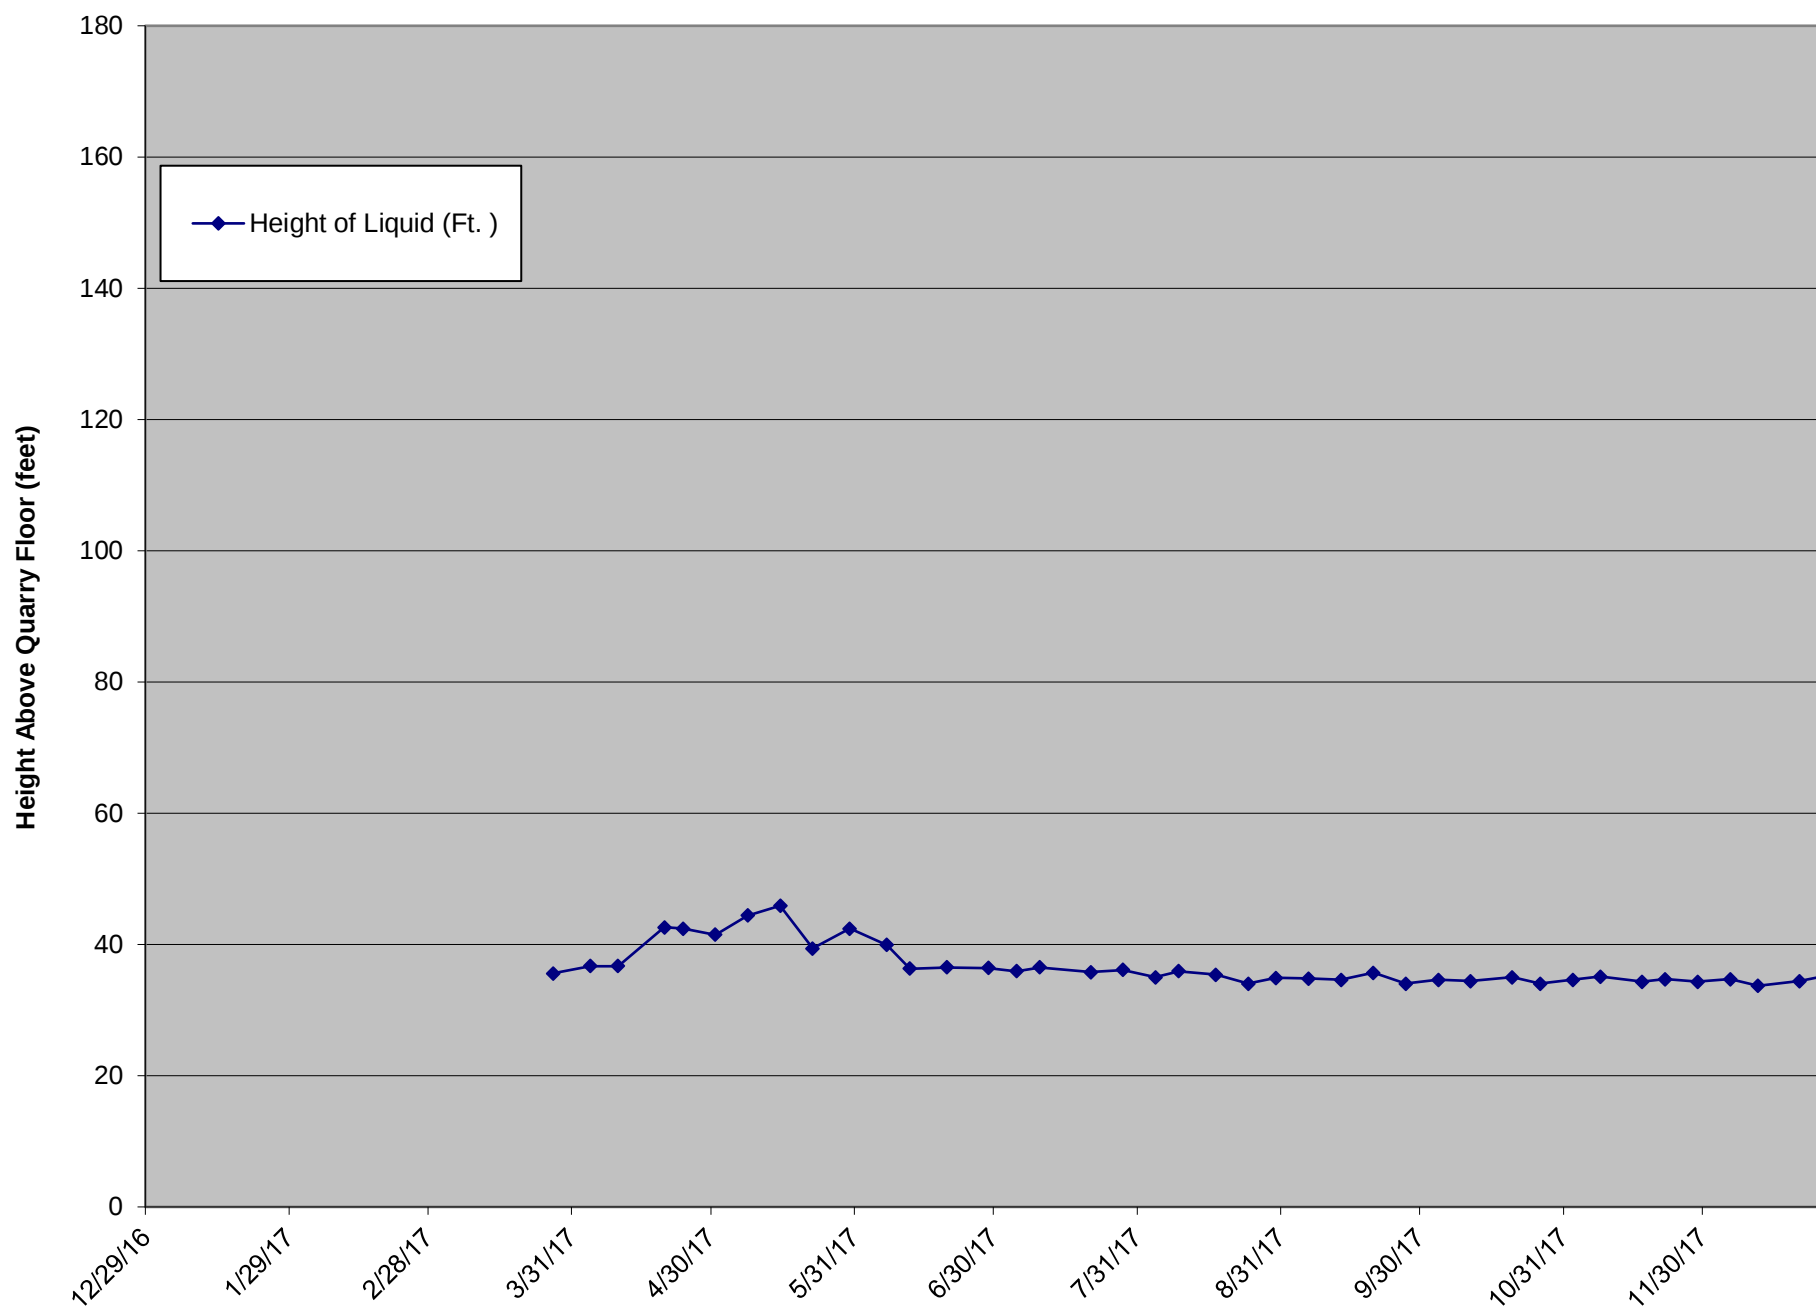
LCS-5B Liquid Level Above Quarry Floor

LCS-5B and LCS-6B were fully operational during the weekly reporting period.

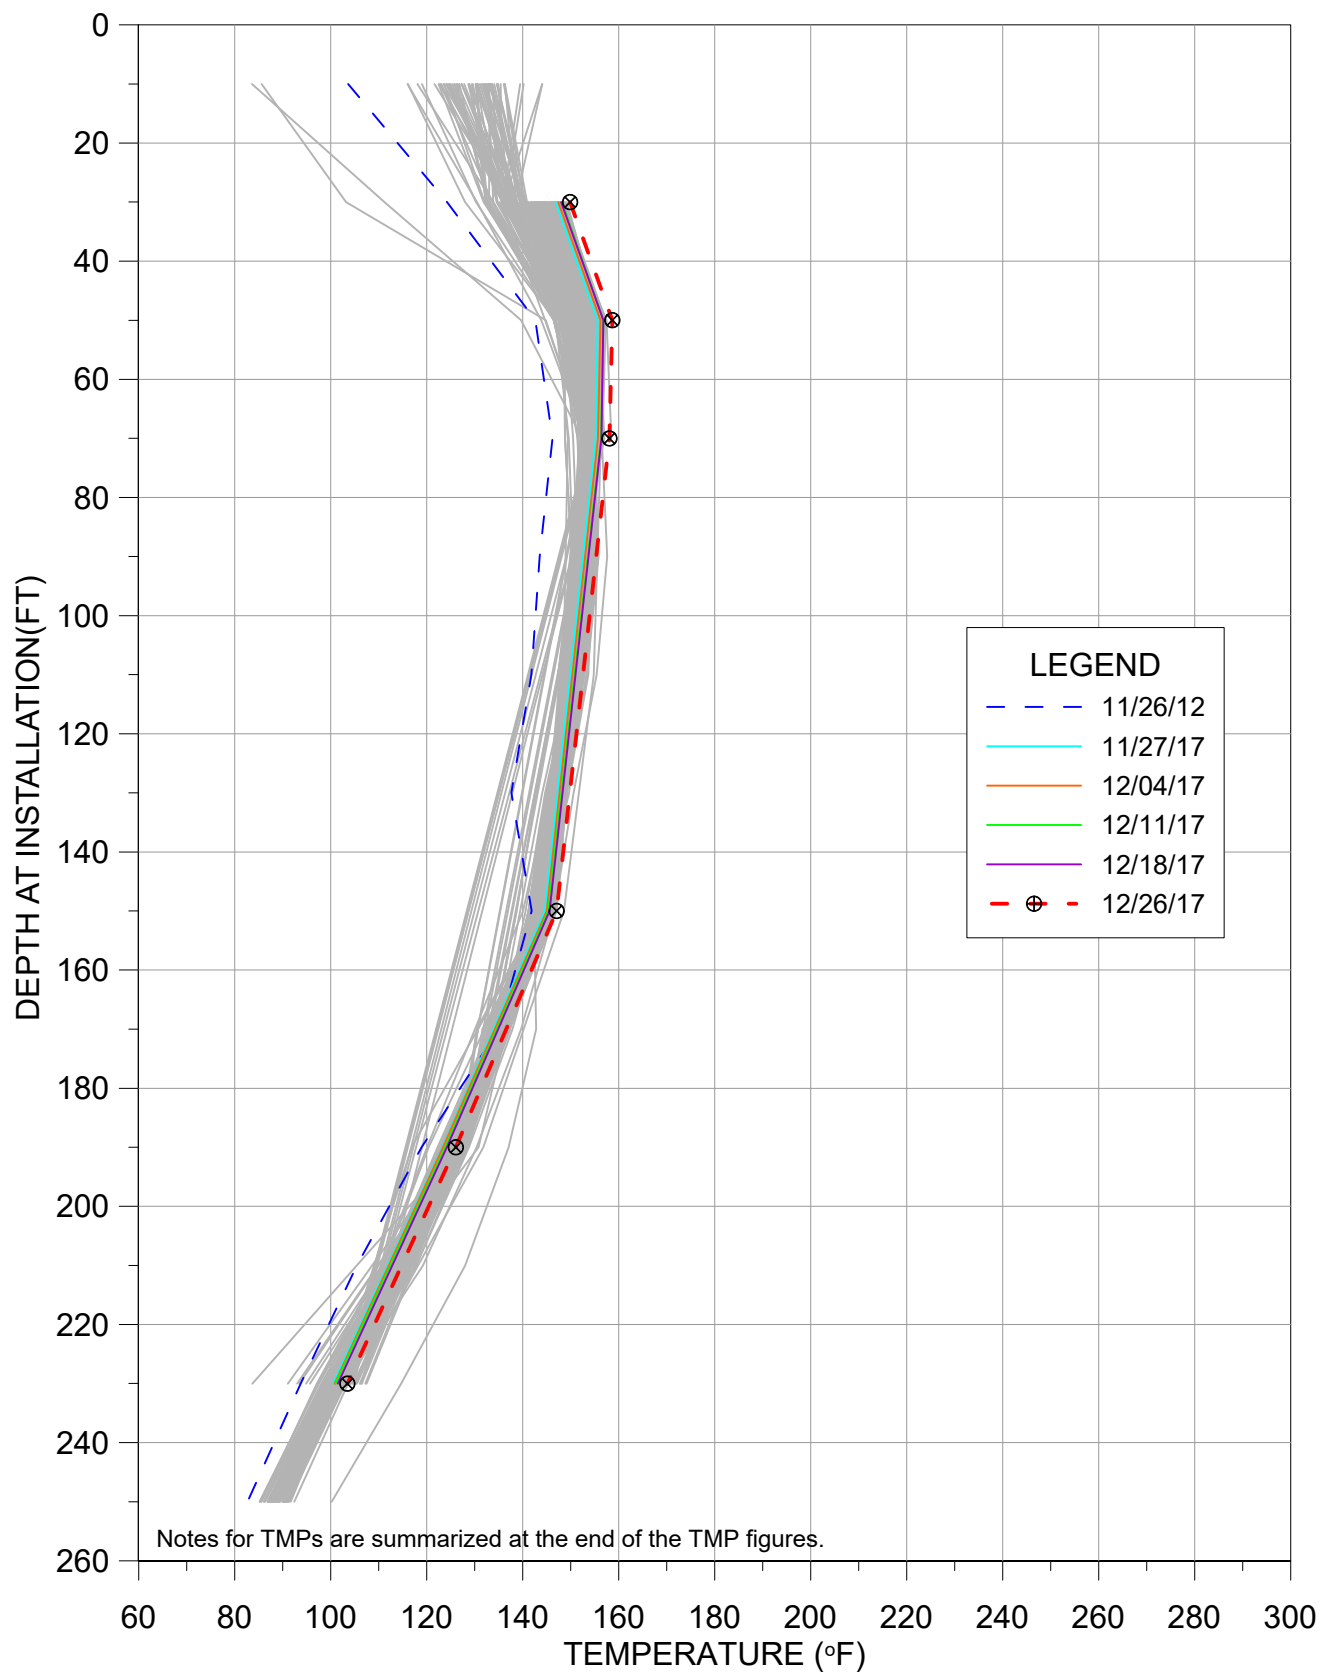
# TMP-3

1. No reliable temperature readings have been obtained at 170 ft depth since 1/29/2014, except on 3/13/2014.
2. The connectivity tests on 4/11/2014 conducted by CEC showed that units at 10, 90, 130, 210 and 250 ft depths are no longer reliable.
3. The connectivity tests on 10/28/2014 conducted by Feezor Engineering showed that units at 10, 90, 110, 130, 210 and 250 ft depths are not reliable.

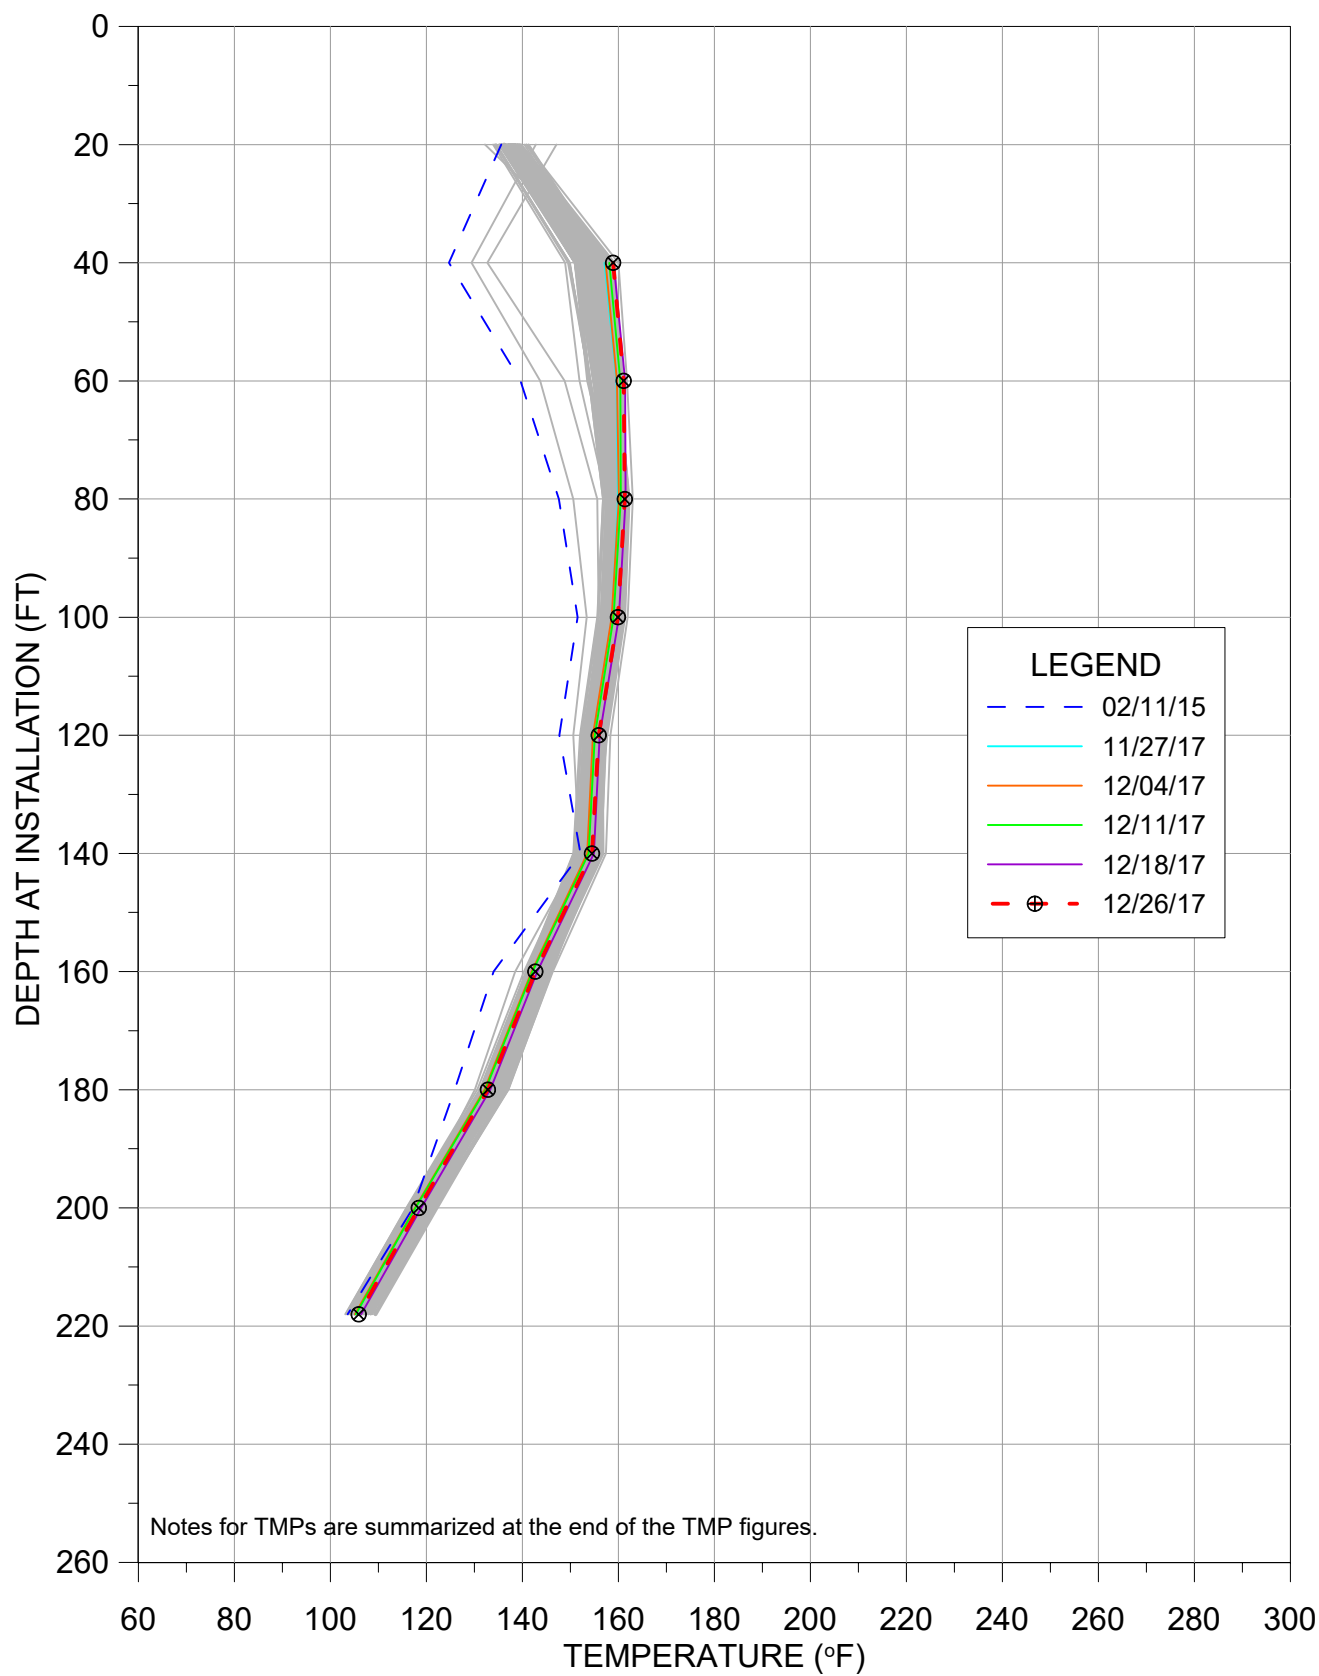
# TMP-3R

1. The unit at 20 ft depth had a fluctuating resistance since 9/25/2017. Therefore the temperature is determined to be unreliable.

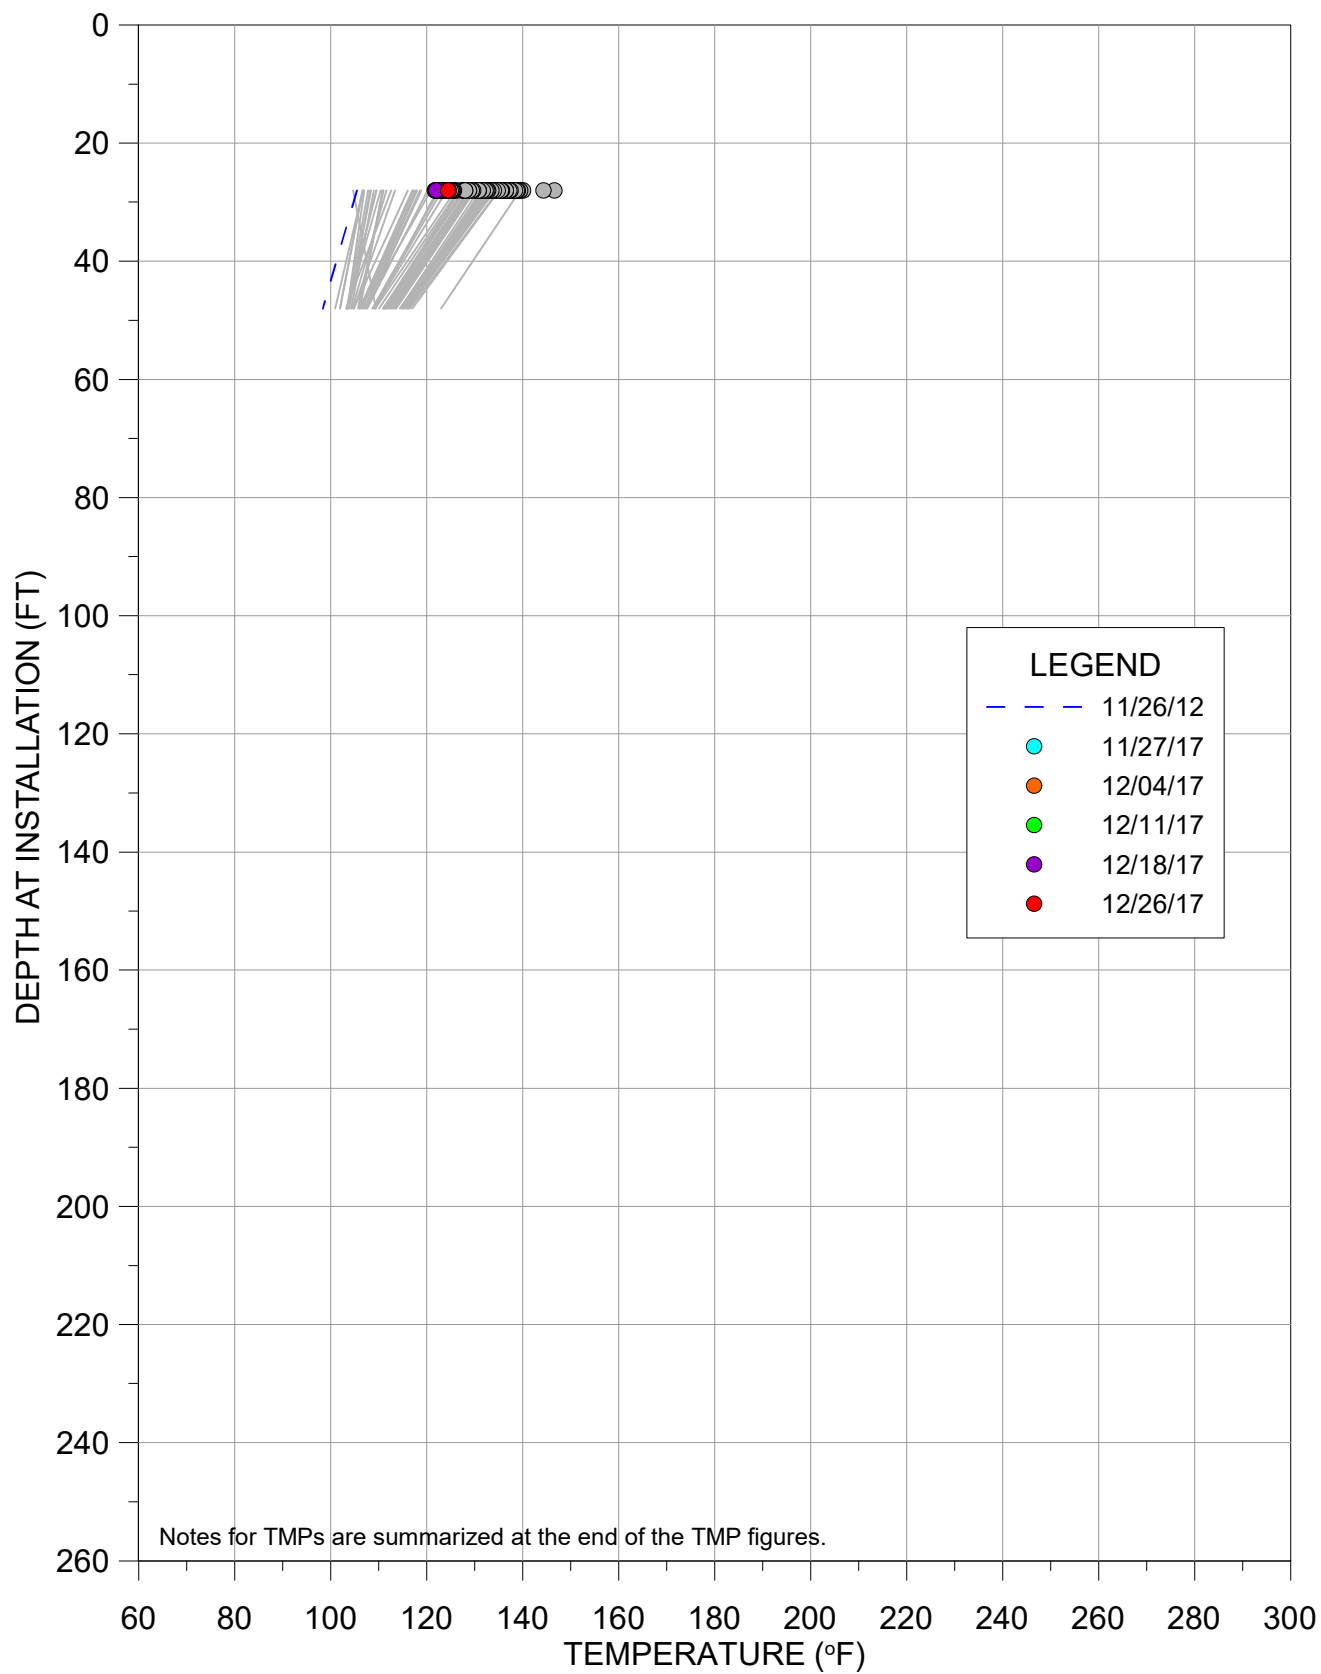
# TMP-4

1. The connectivity tests on 4/11/2014 conducted by CEC showed that the unit at 48 ft depth is no longer reliable.

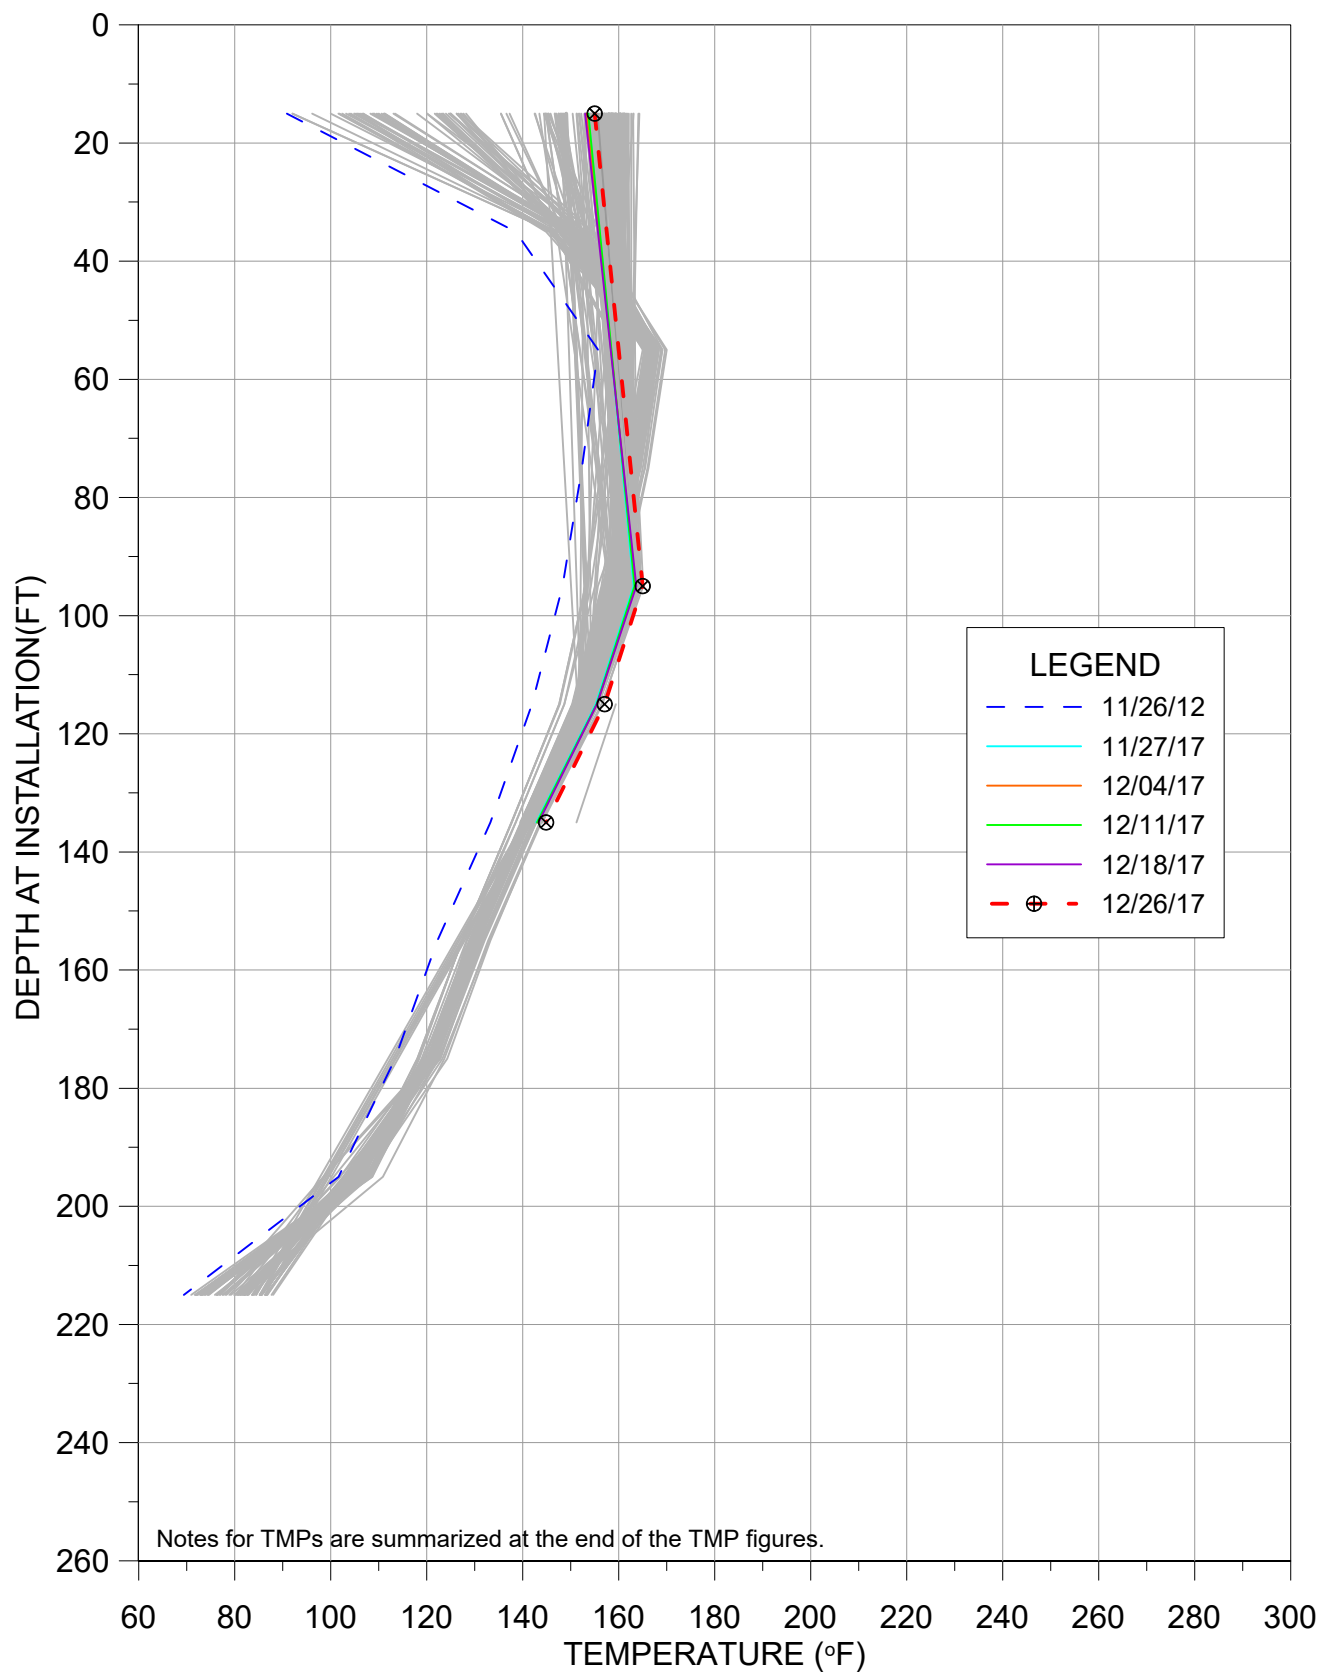
# TMP-6

1. The connectivity tests on 4/11/2014 conducted by CEC showed that units at 35, 55, 75, 155, 175, and 195 ft depths are no longer reliable.
2. No reliable temperature readings have been obtained at the unit at 215 ft depth since 6/13/2014.

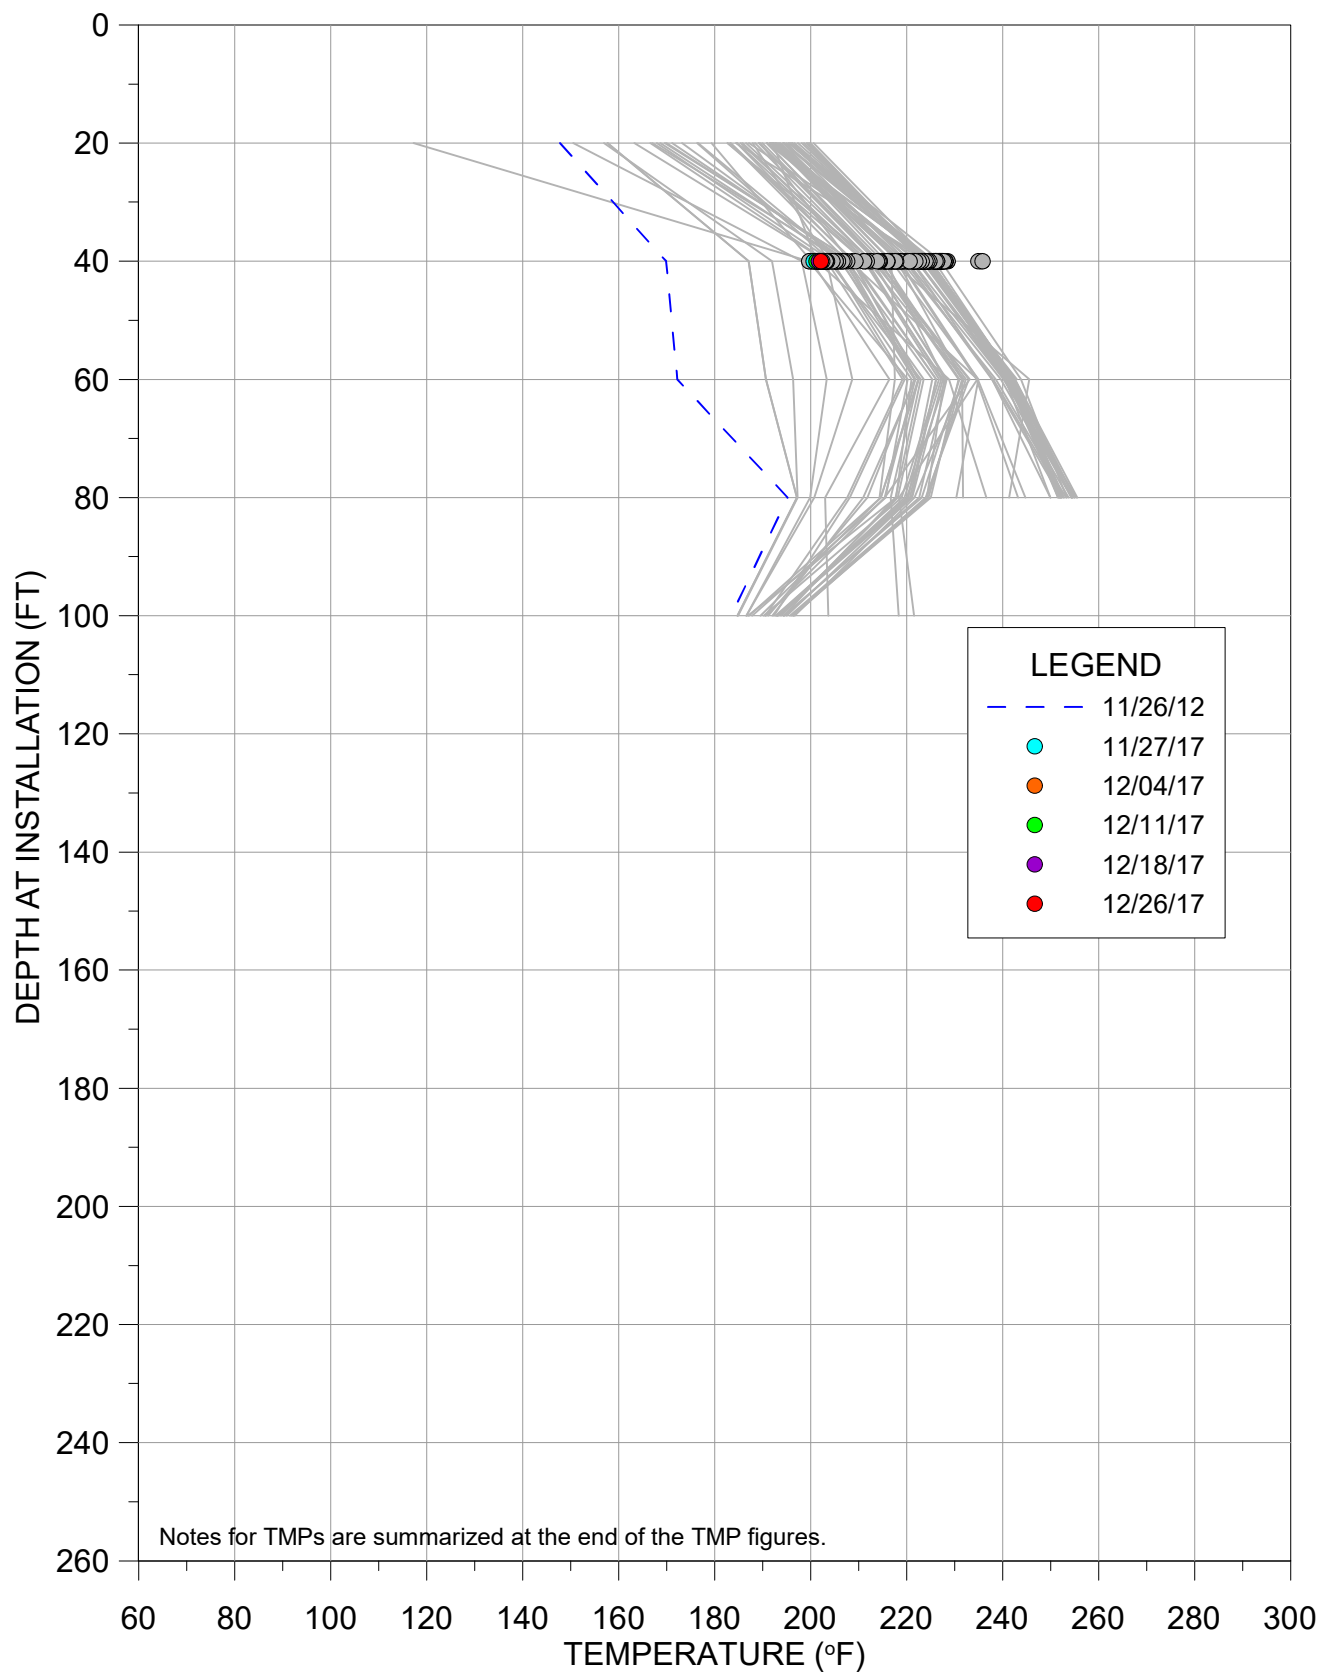
# TMP-9

1. Unit at 100 ft depth had an inaccurate temperature reading on 8/1/2013 and no reading since 8/6/2013.
2. The connectivity tests on 4/11/2014 conducted by CEC showed that units at 20, 60, 80, and 100 ft depths are no longer reliable.
