# **Bridgeton Landfill, LLC**

## **Weekly Data Submittal**

**Week of December 24, 2017 – December 30, 2017**

**Required by Section 52.F of Agreed Order, Case No. 13SL-CC01088  
Effective May 13, 2013**

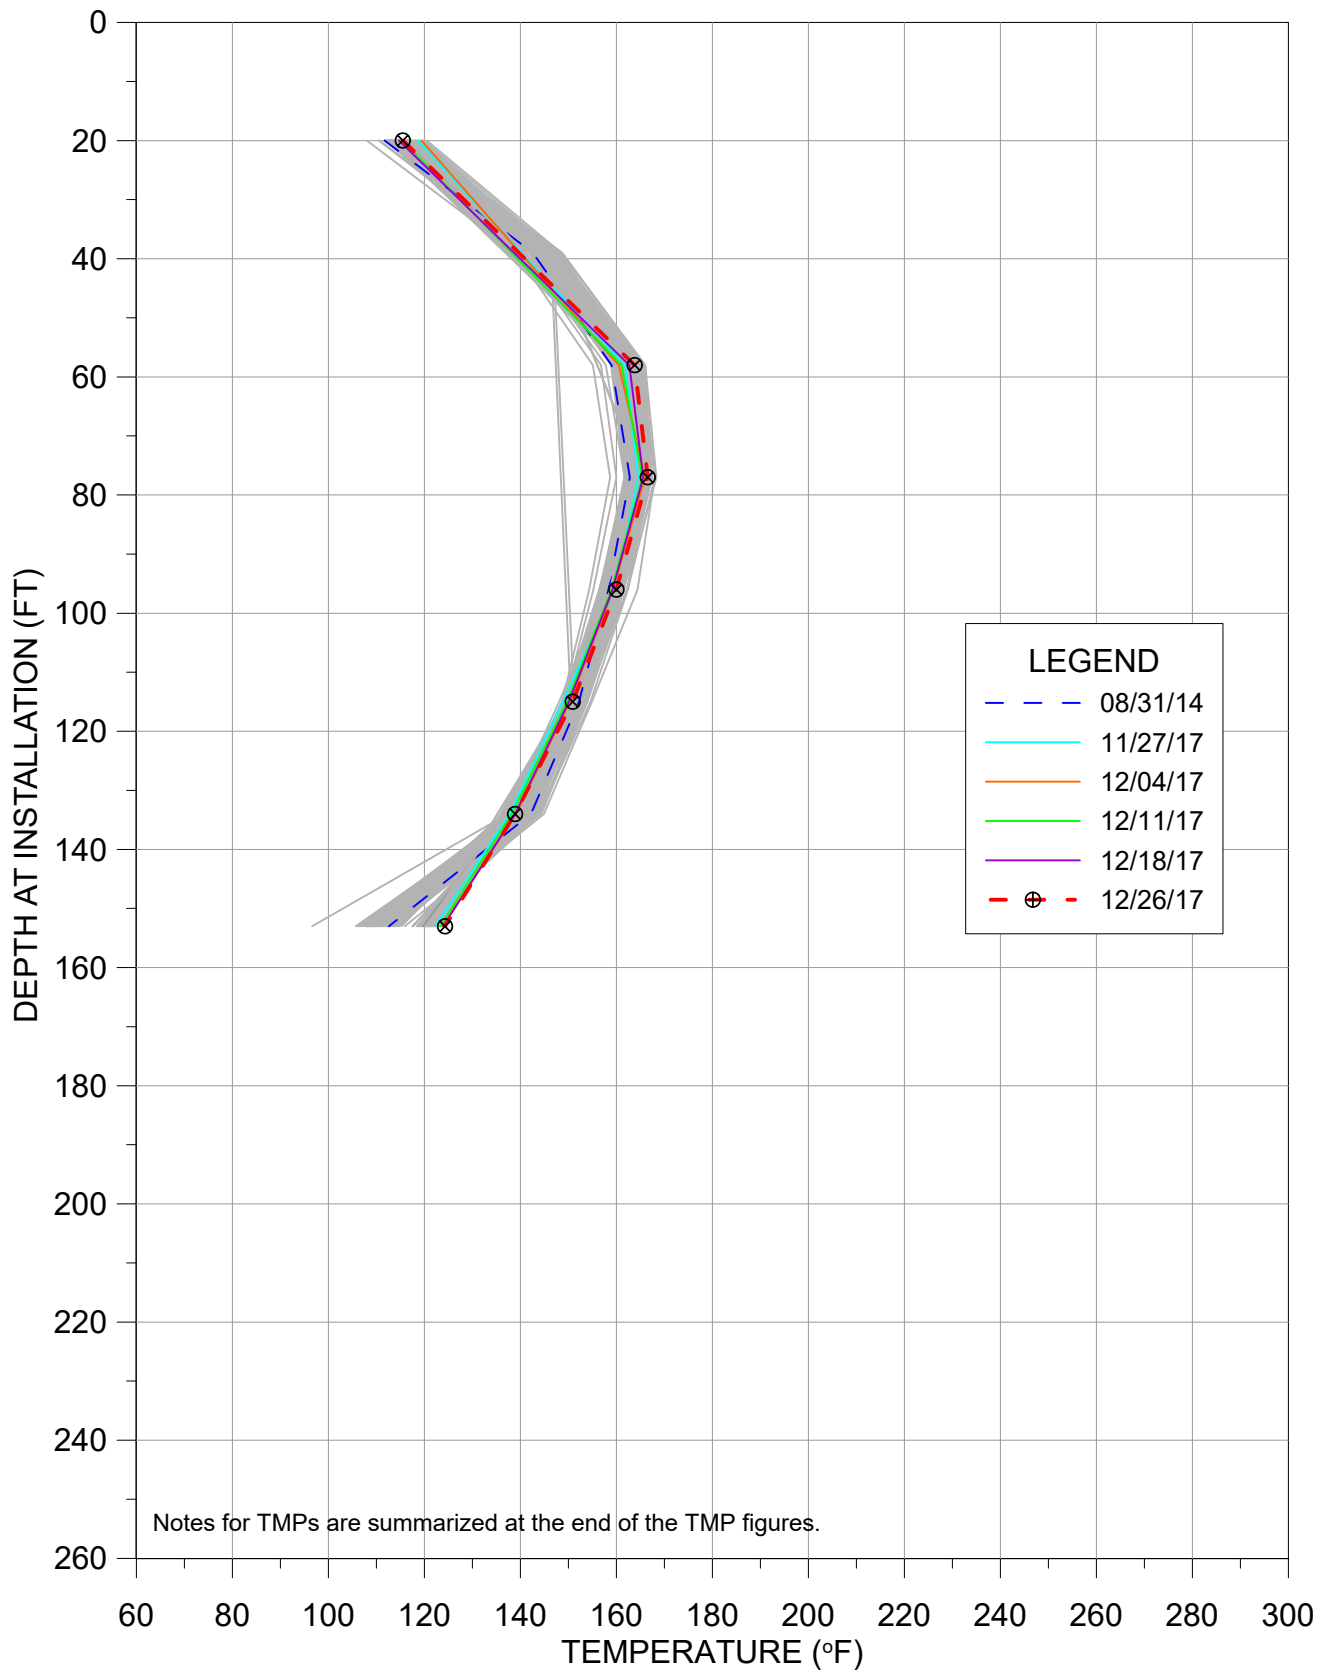
# TMP-16

1. A connectivity test conducted by Feezor Engineering showed that the units on TMP-16 may not be reliable since 9/9/2015. Further testing at the end of September 2015 showed possible connectivity on some of the units.
2. The unit at 153 ft depth had a low resistance reading and unreliable temperature since 12/21/2015.

3. The unit at 39 ft depth had a higher than acceptable resistance reading and unreliable temperature between beginning on 2/7/17. Unit resumed normal resistance on 3/28/17 but is still considered unreliable as no repairs were done to reducer the resistance. NOTE REVISED-10/13/17

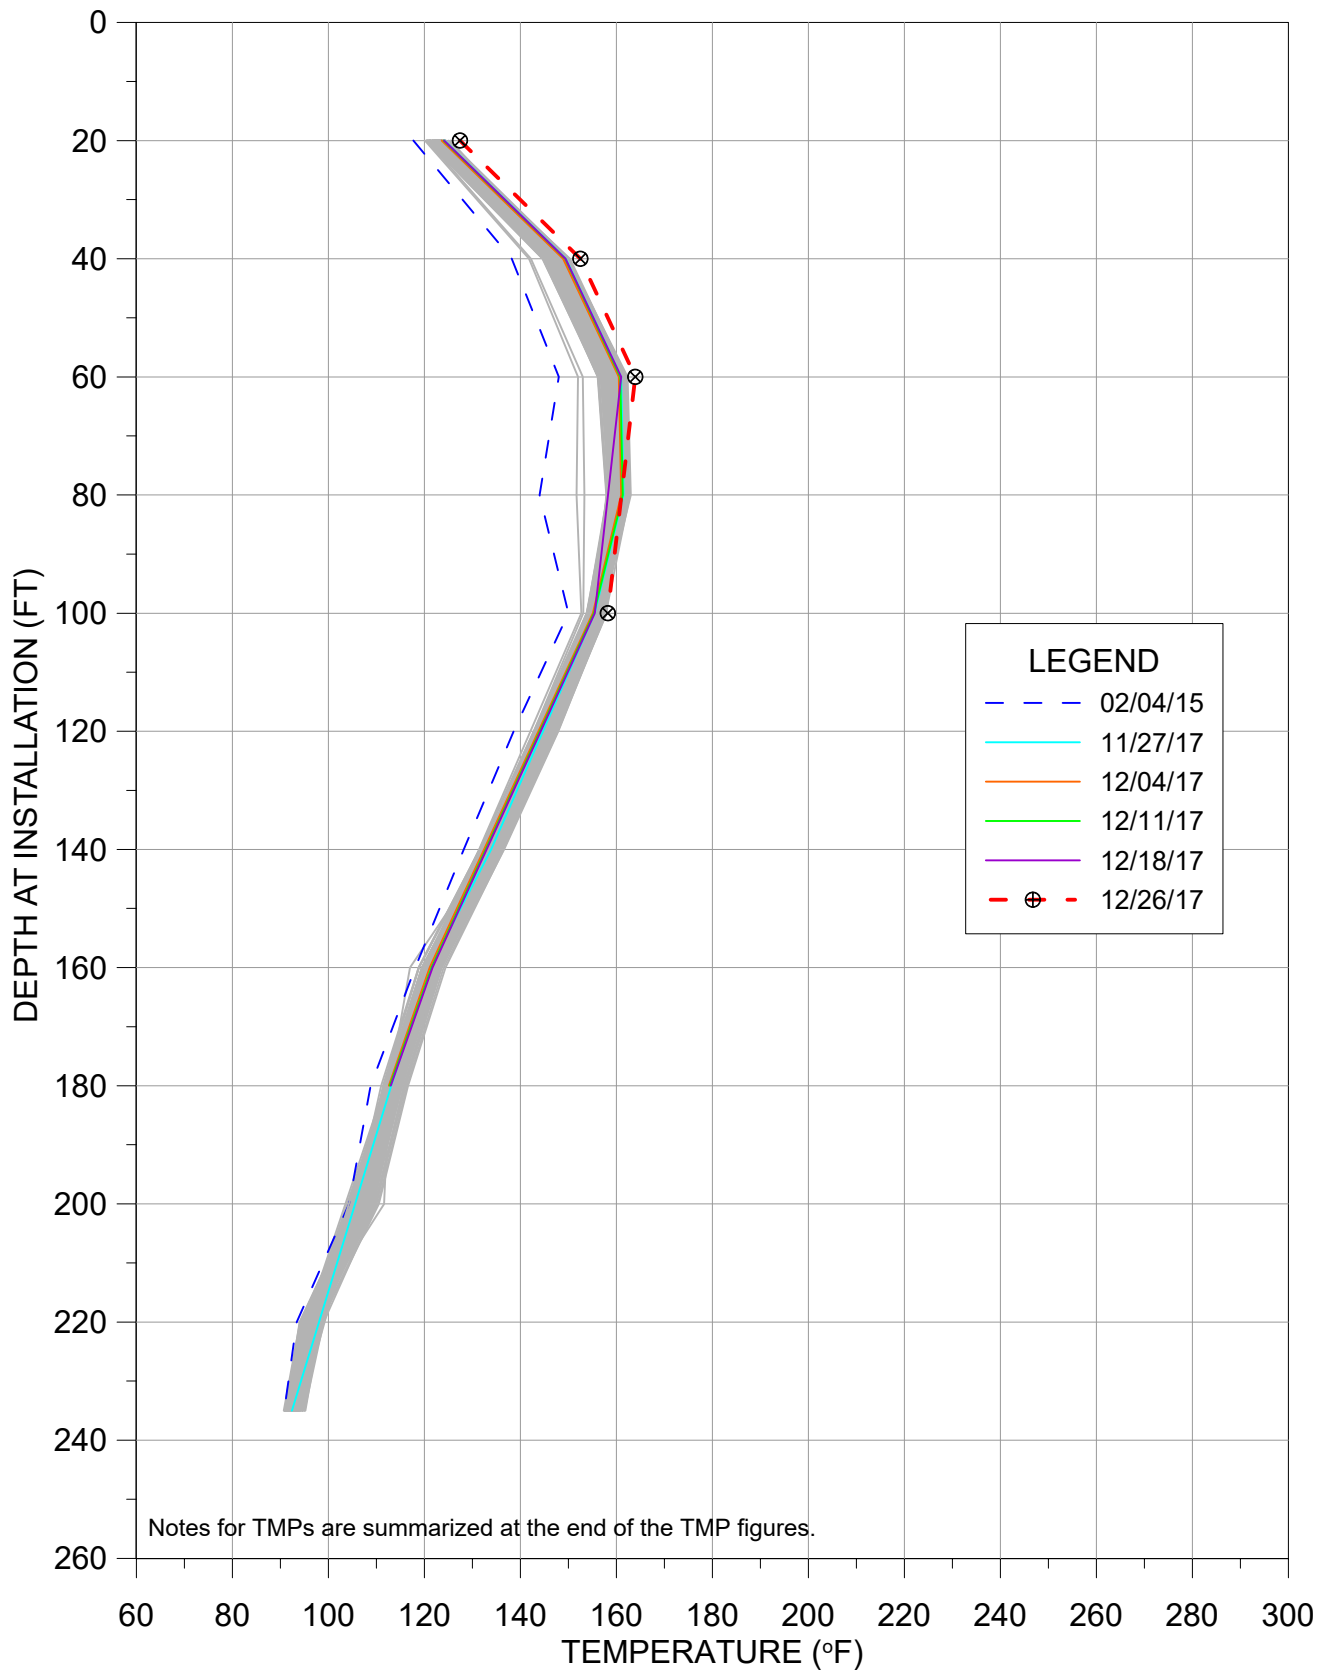
# TMP-25

1. The unit at 200 ft provided an apparent anomalous reading on 3/28/2017. Subsequent readings on 4/4/2017 showed the unit to have failed (see below). The unit is no longer working and the reading of 3/28/2017 was likely unreliable.

2. The unit at 200 ft depth had a resistance reading greater 4000 ohms on 4/4/2017. A connectivity test conducted by Feezor Engineering on 4/7/2017 showed that this unit also had cross-connectivity. The unit is therefore determined to be no longer working as of the 4/4/2017 reading.

3. The unit at 120 feet had a higher than acceptable limit on 7/10/2017. Also, a connectivity test conducted by Feezor Engineering on 4/7/2017 showed that this unit may be unreliable. Therefore, this unit is determined to be unreliable.

4. The unit at 220 ft has been reported as unable to attain a reading of any kind since 6/19/17. The unit is considered to be on no longer working as of that date.

5. The unit at 235 ft resistance reading was reported to be fluctuating on 11/20/2017, on 12/4/2017 no resistance reading was able to be obtained. This unit is determined to be unreliable as of 12/4/2017.

6. The unit at 140 ft had no reading for temperature or resistivity since 11/27/2017.
7. The unit at 80 ft had fluctuating **had no reliable temperature reading since 12/18/2017.**

8. **The units at 160 ft and 180 ft had no reading for temperature or resistivity on 12/26/2017.**

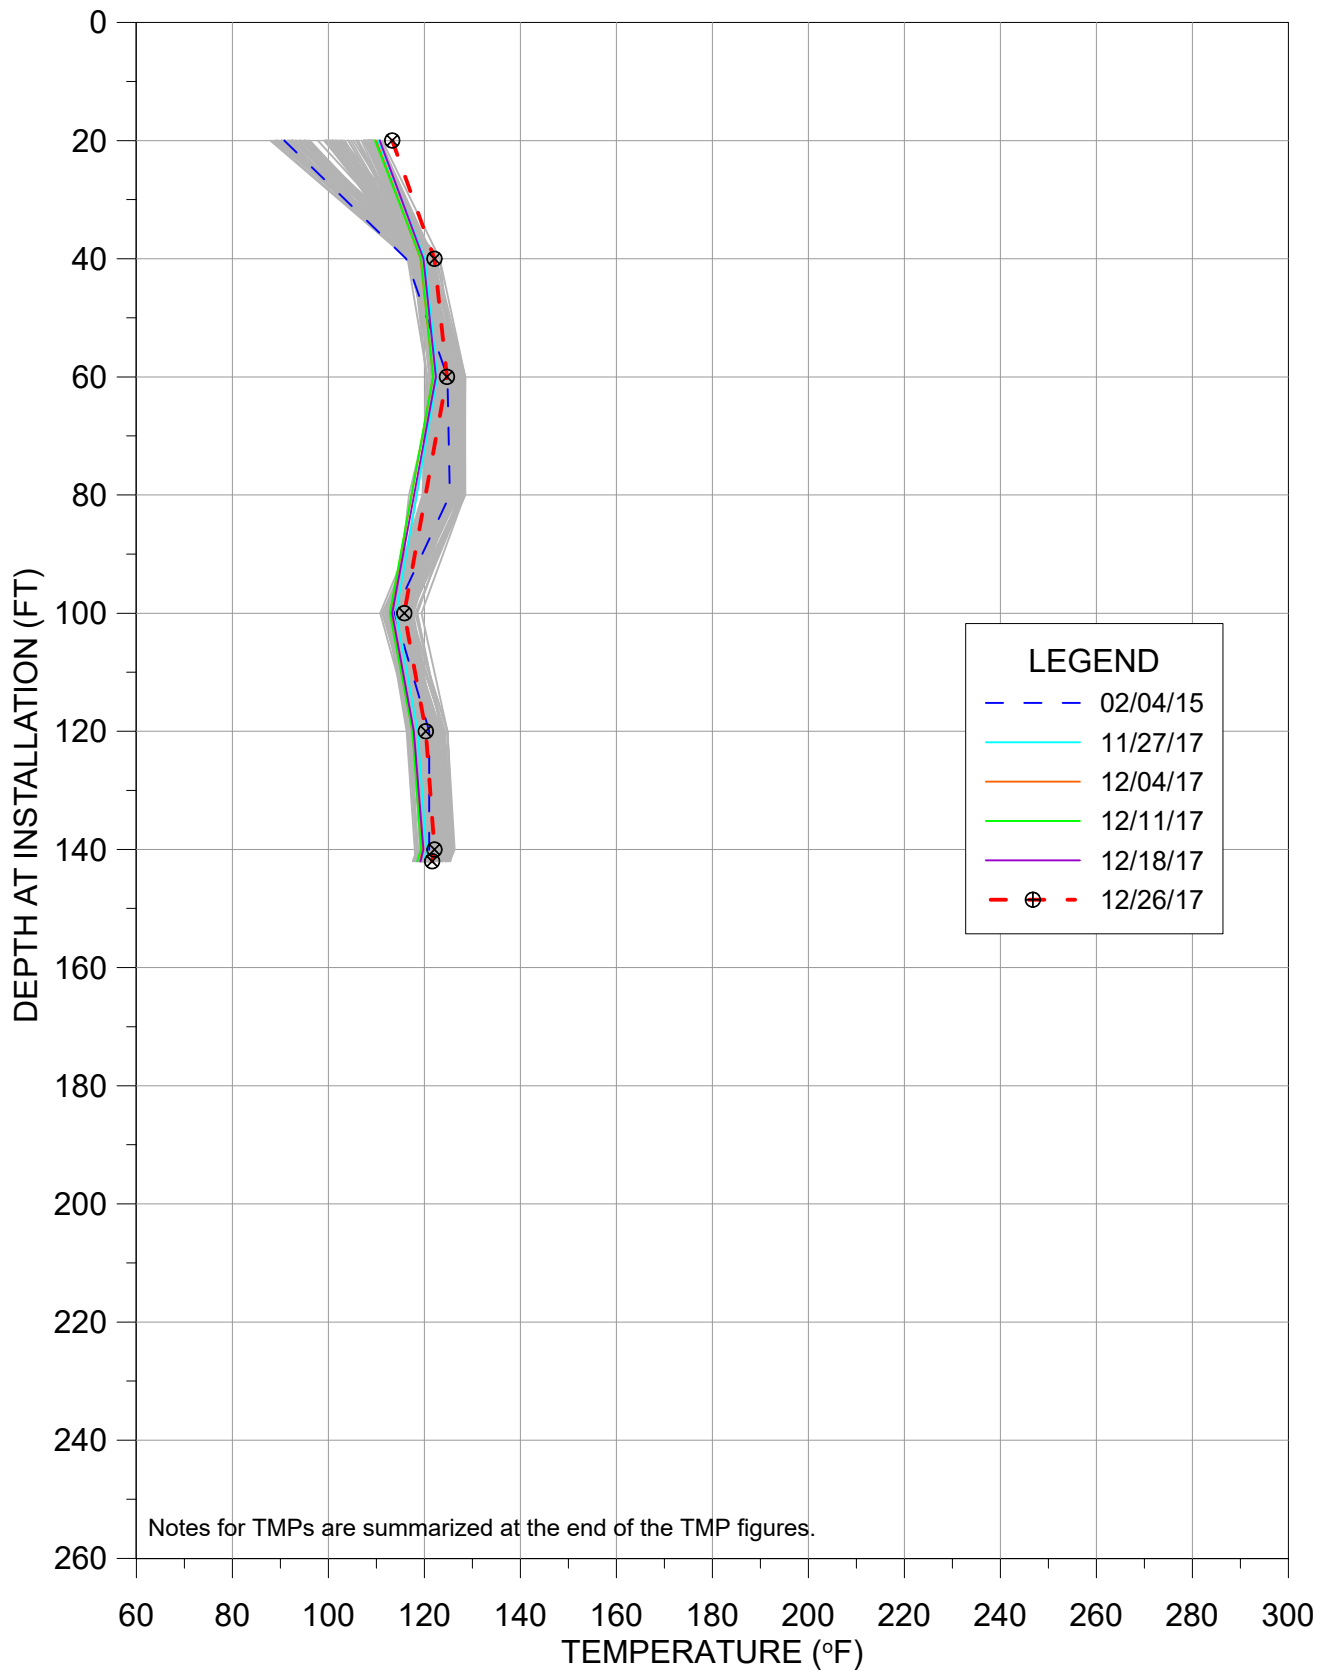
# TMP-26

1. Resistance on unit at 80 ft dropped 12.9 ohms (11/06/2017) and subsequent resistance reading continue to be low. Upon further investigation by Feezor Engineering, this unit is determined to be unreliable.

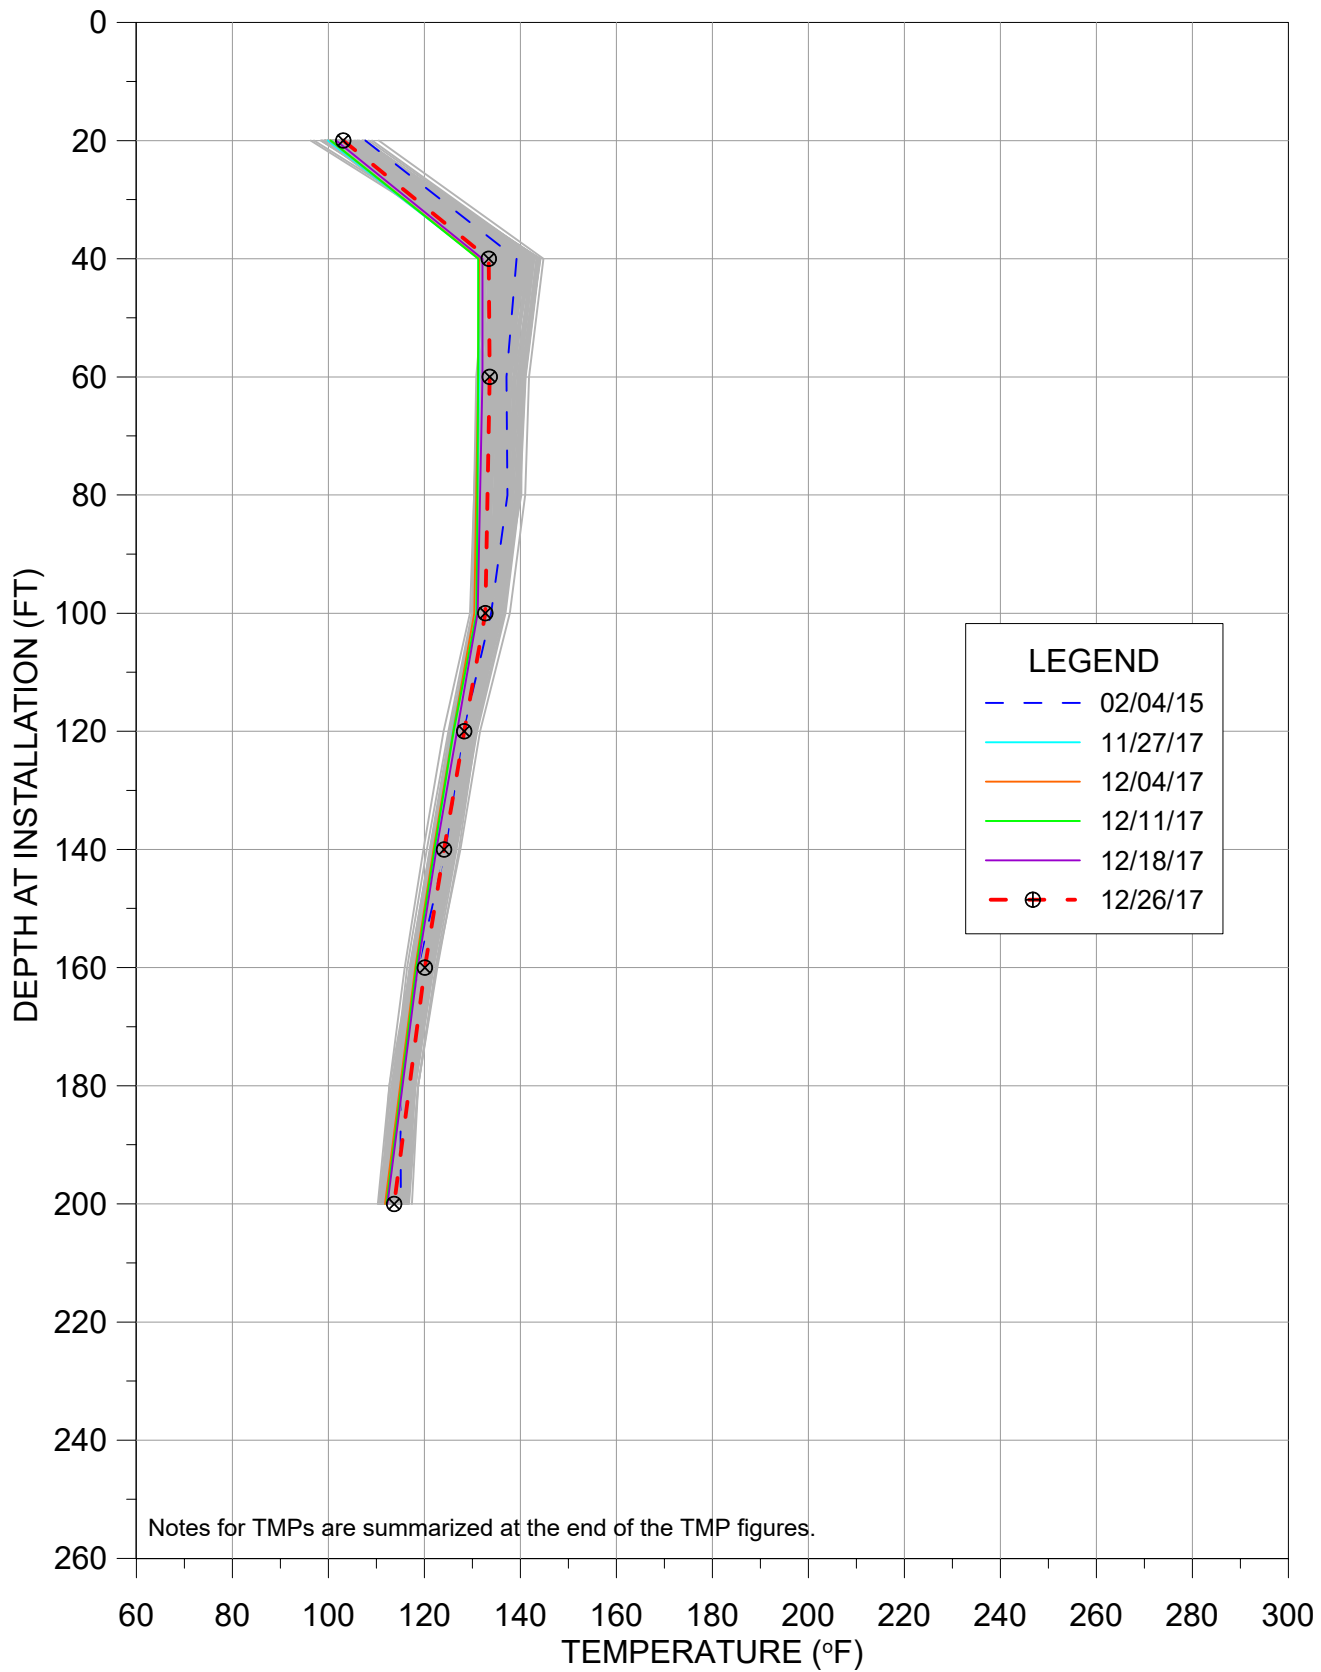
# TMP-28

1. The unit at 217 ft depth has had no resistance or temperature readings since installation.
2. The unit at 80 ft depth had a resistance drop and an unreasonable temperature decrease on 6/1/2016. The temperature has since fluctuated and is determined to be unreliable.
3. The unit at 180 feet has had a higher than acceptable limit since 3/28/2017 and is therefore determined to be unreliable as of the 4/4/2017 reading.

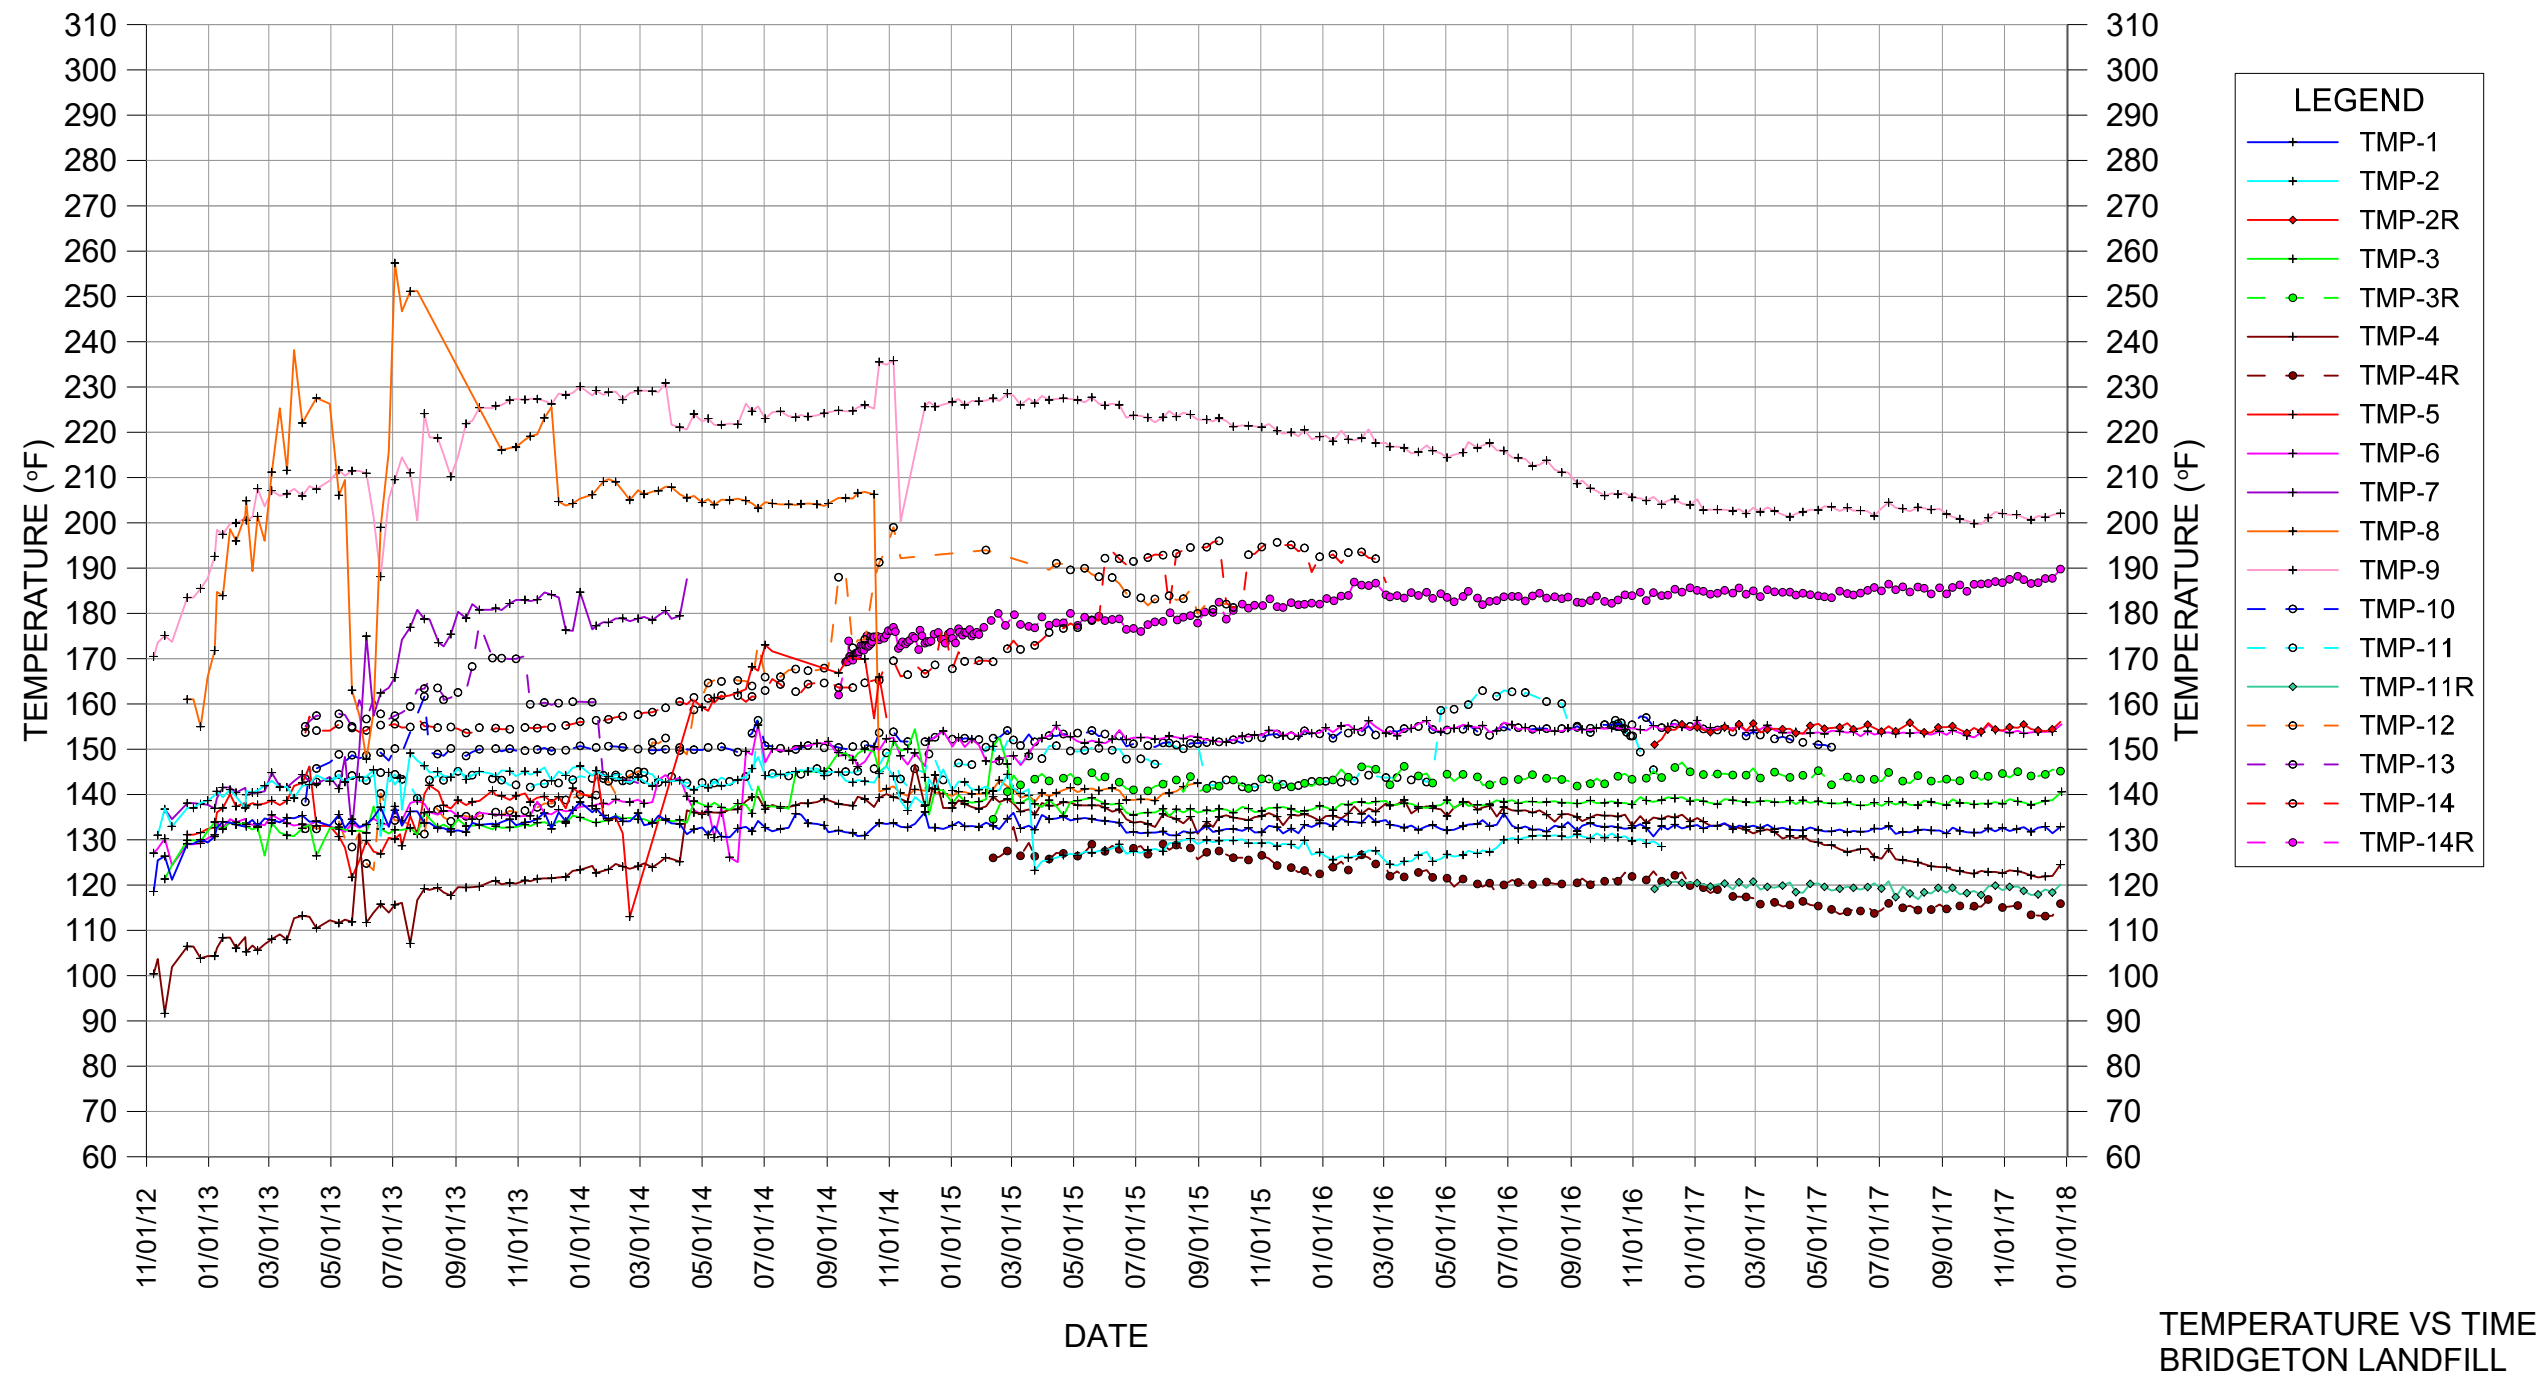
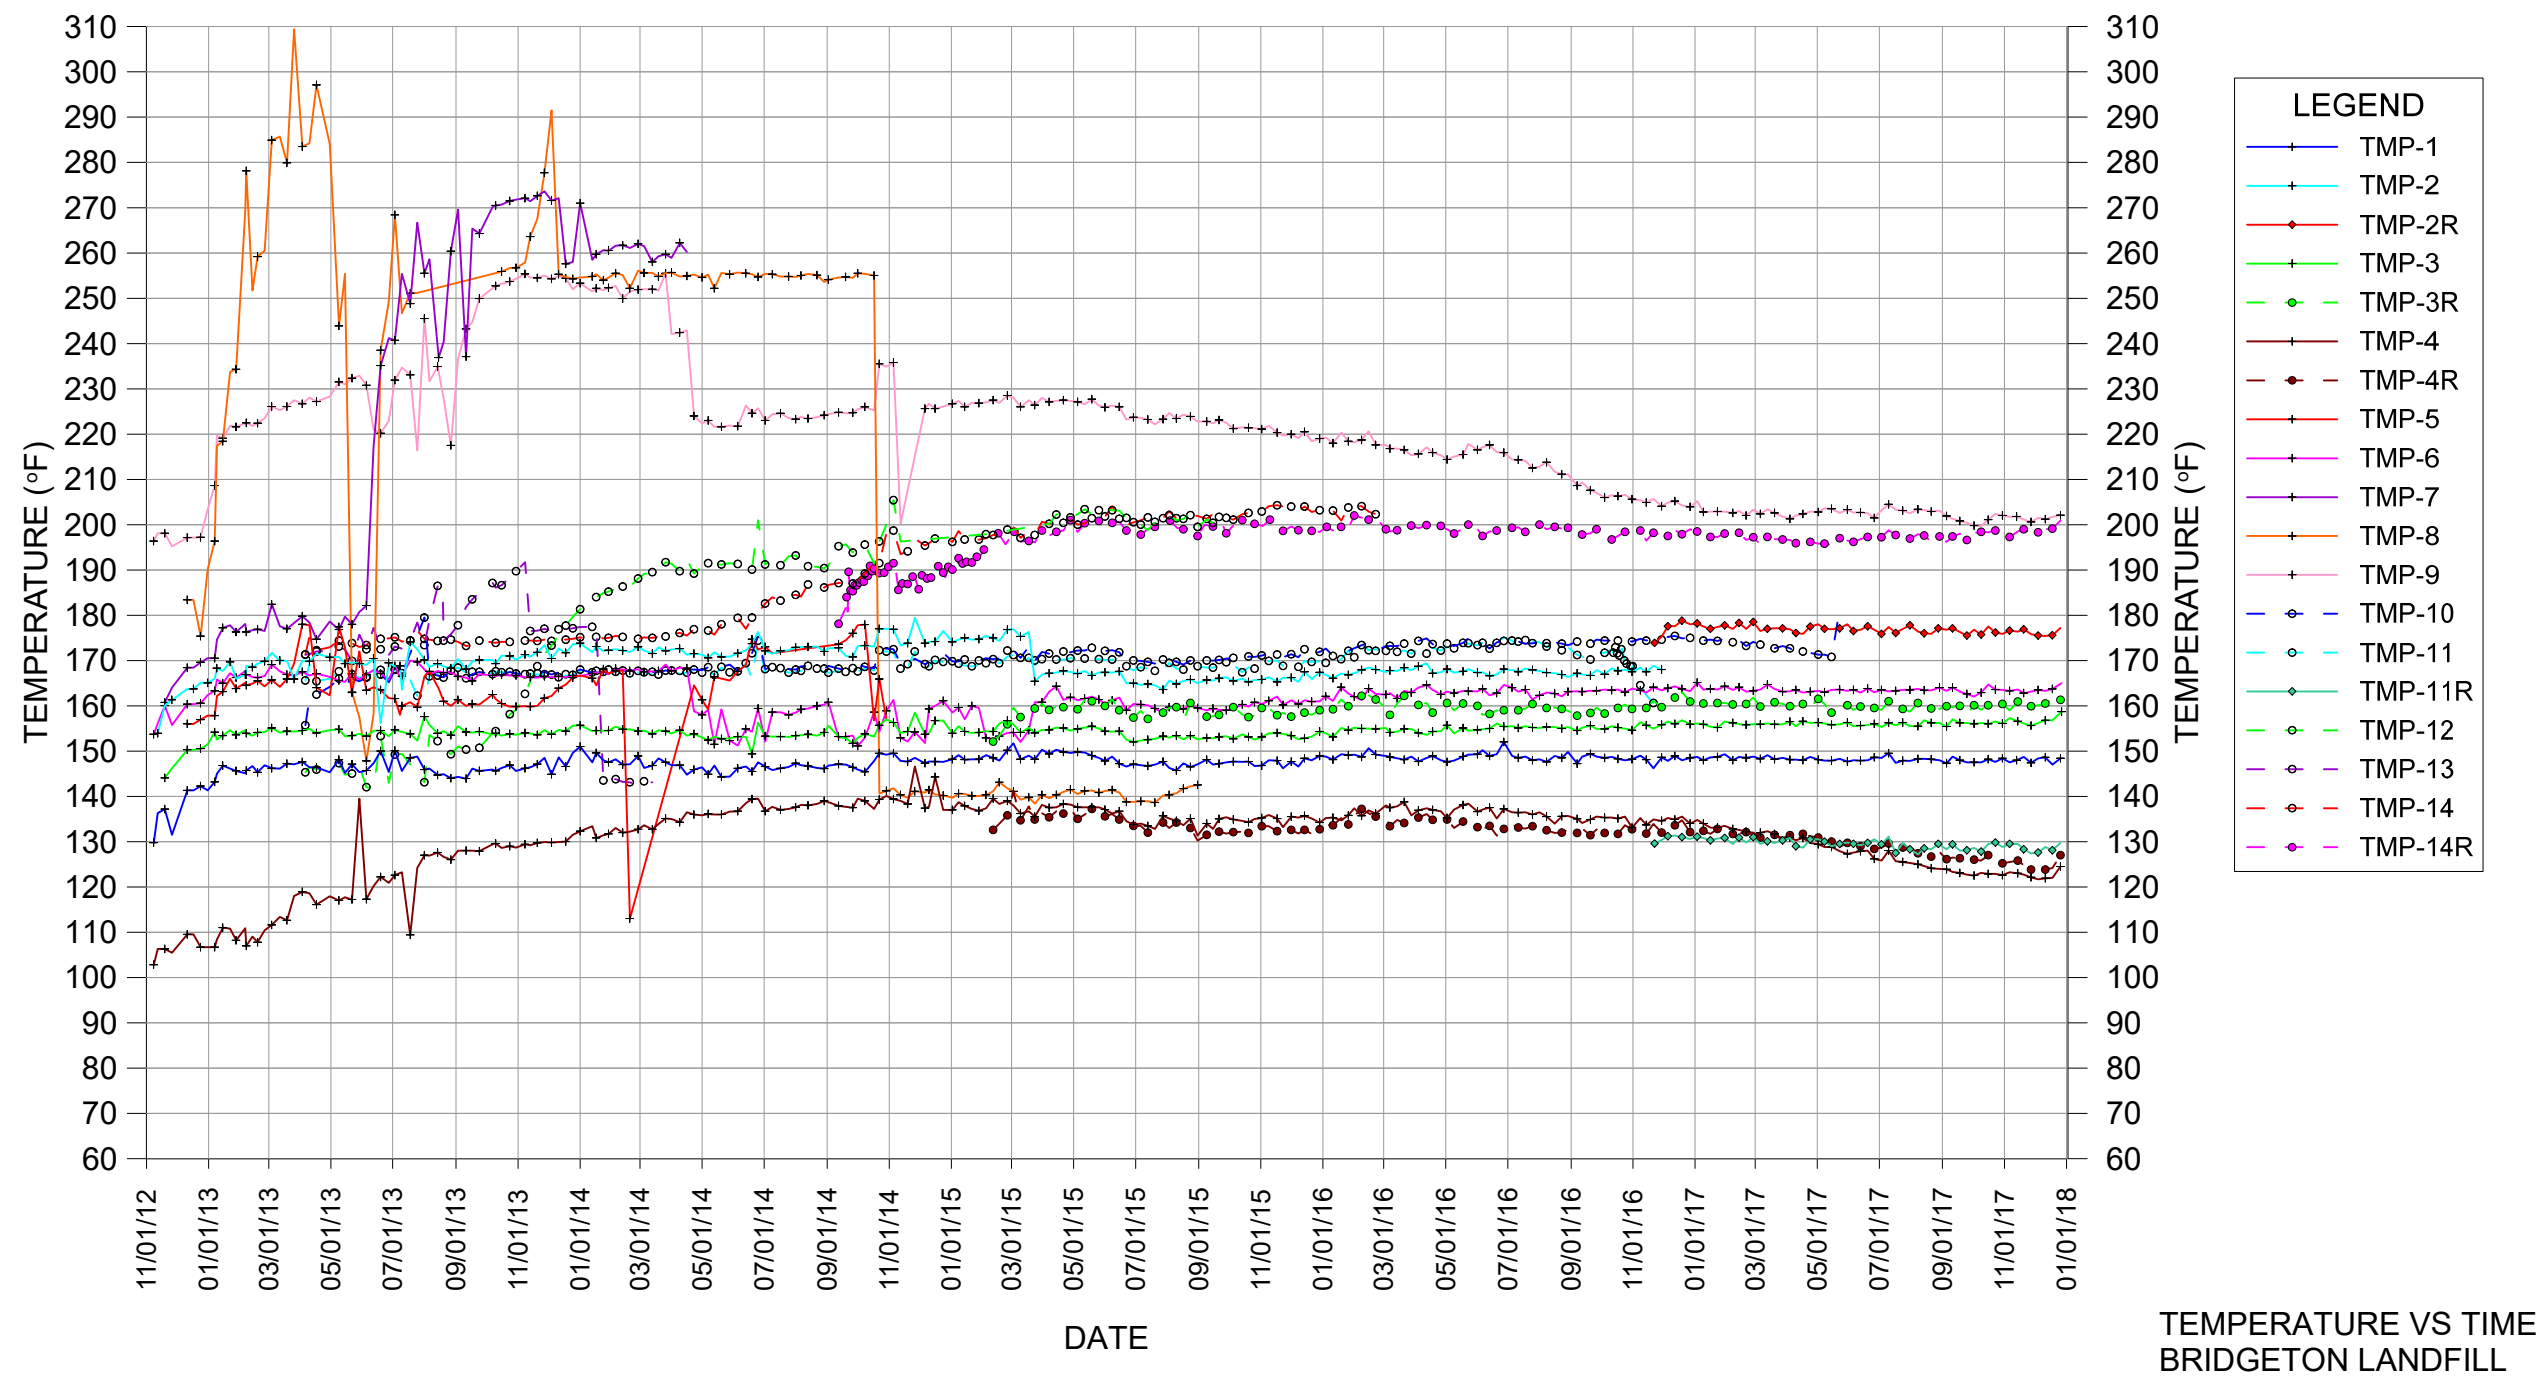
Note virtually all TMPs units exhibit an increase in temperature reading this week. The apparent increase affected all individual thermocouples at the TMPs. There is no phenomena within the landfill mass that would account for the nearly uniform rise in temperature of all TMPs at the same time. Therefore, it is likely that the uniform rise is attributable to a weather or equipment issue. Therefore, the readings of 12/26/12 should not be interpreted as indicative of an actual rise of temperature in the waste. Readings from the upcoming weeks will be used to further evaluate this occurrence.

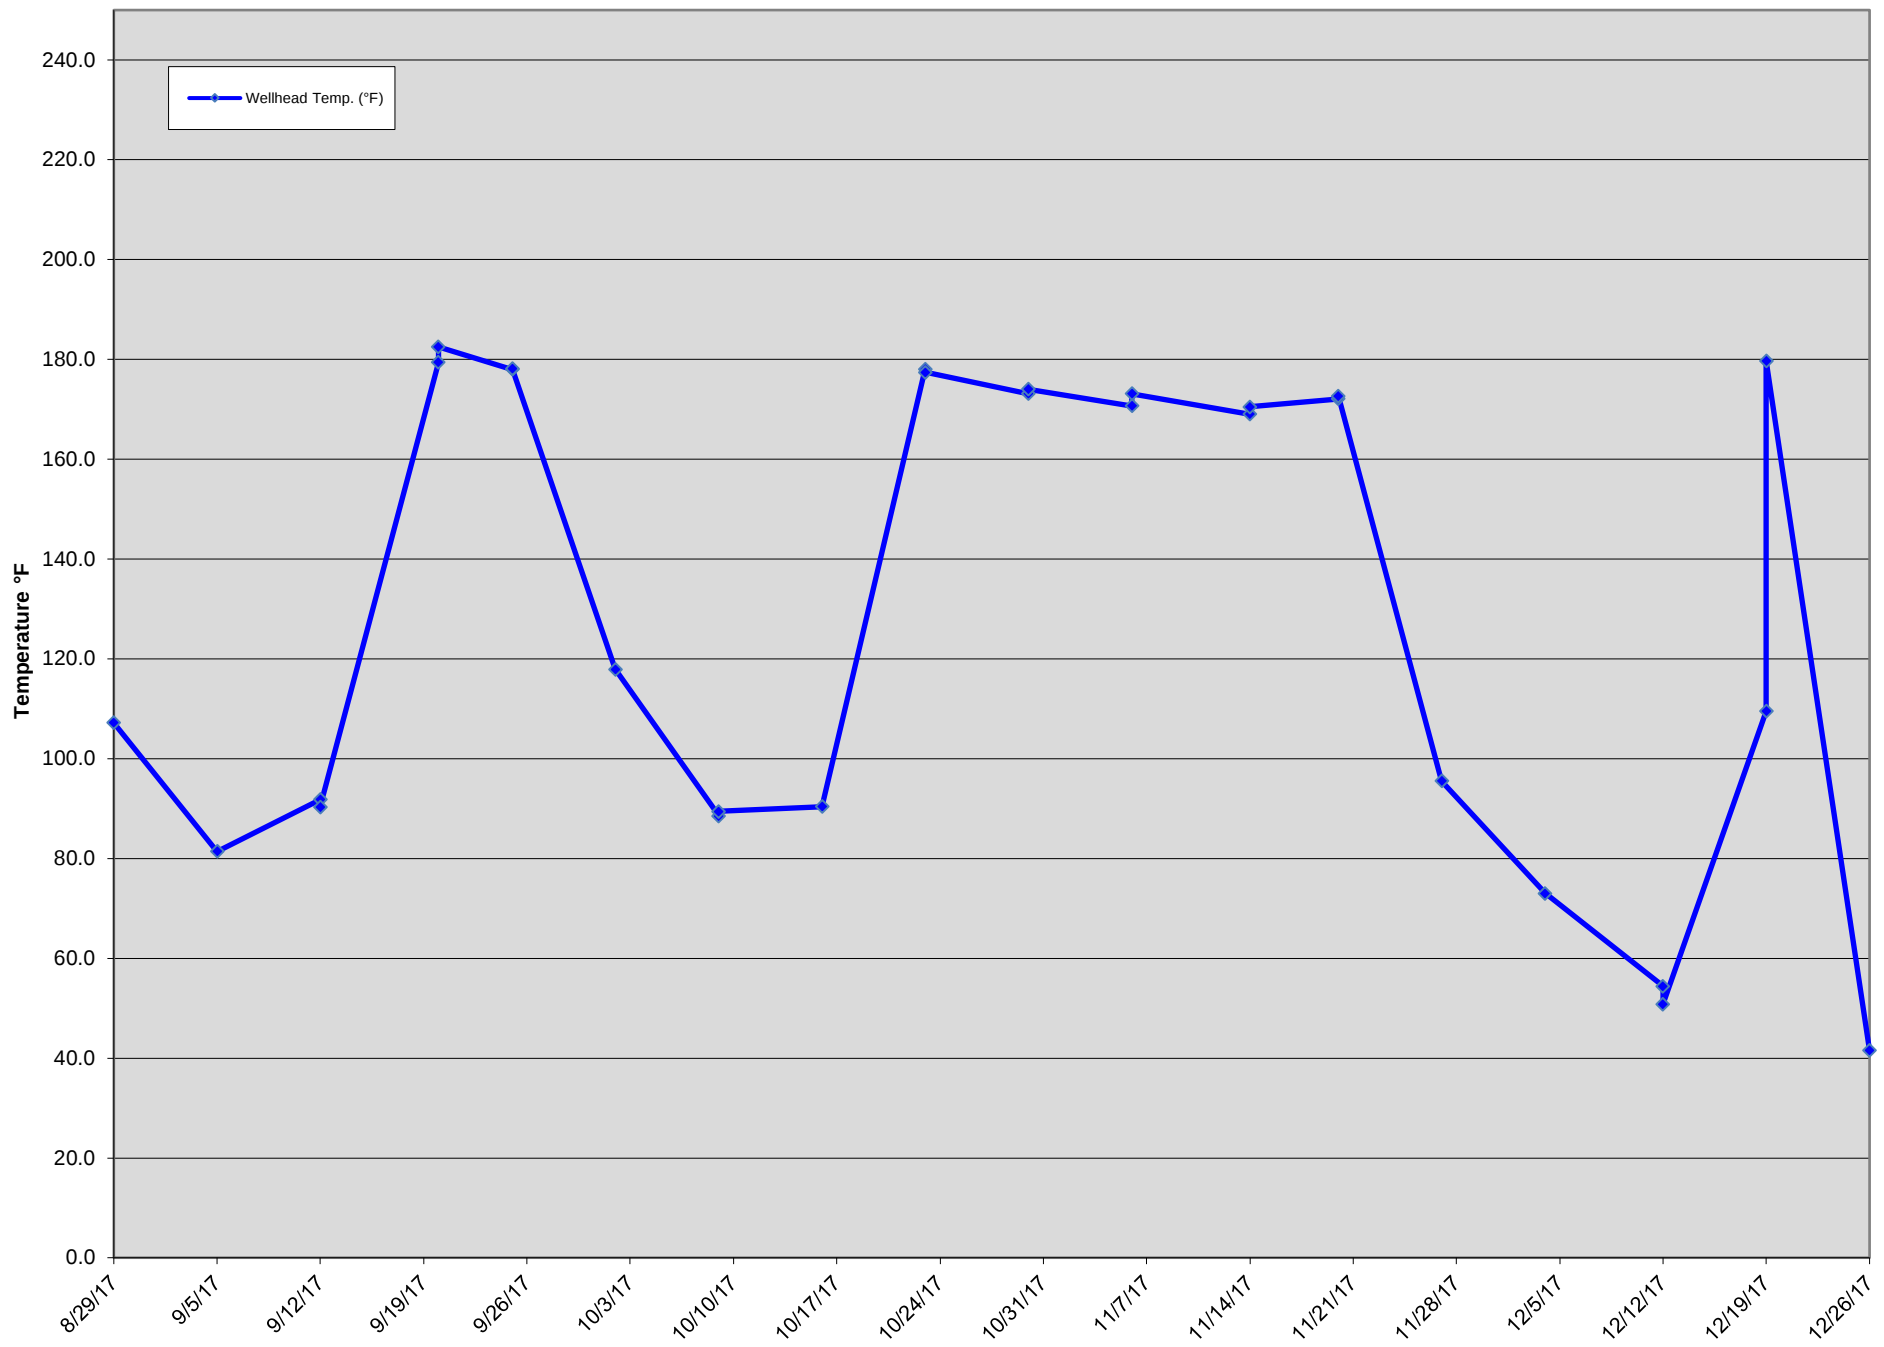
GIW-1 Wellhead Temperatures

As part of the HES, there are currently cooling water circulation loops installed in twelve Gas Interceptor Wells (GIWs) (GIW-02 through GIW-13). The remaining well (GIW-01) had a measured gas temperature within its historical operating limits.
