# **Bridgeton Landfill, LLC**

## **Weekly Data Submittal**

**Week of January 28, 2018 – February 3, 2018**

**Required by Section 52.F of Agreed Order, Case No. 13SL-CC01088  
Effective May 13, 2013**

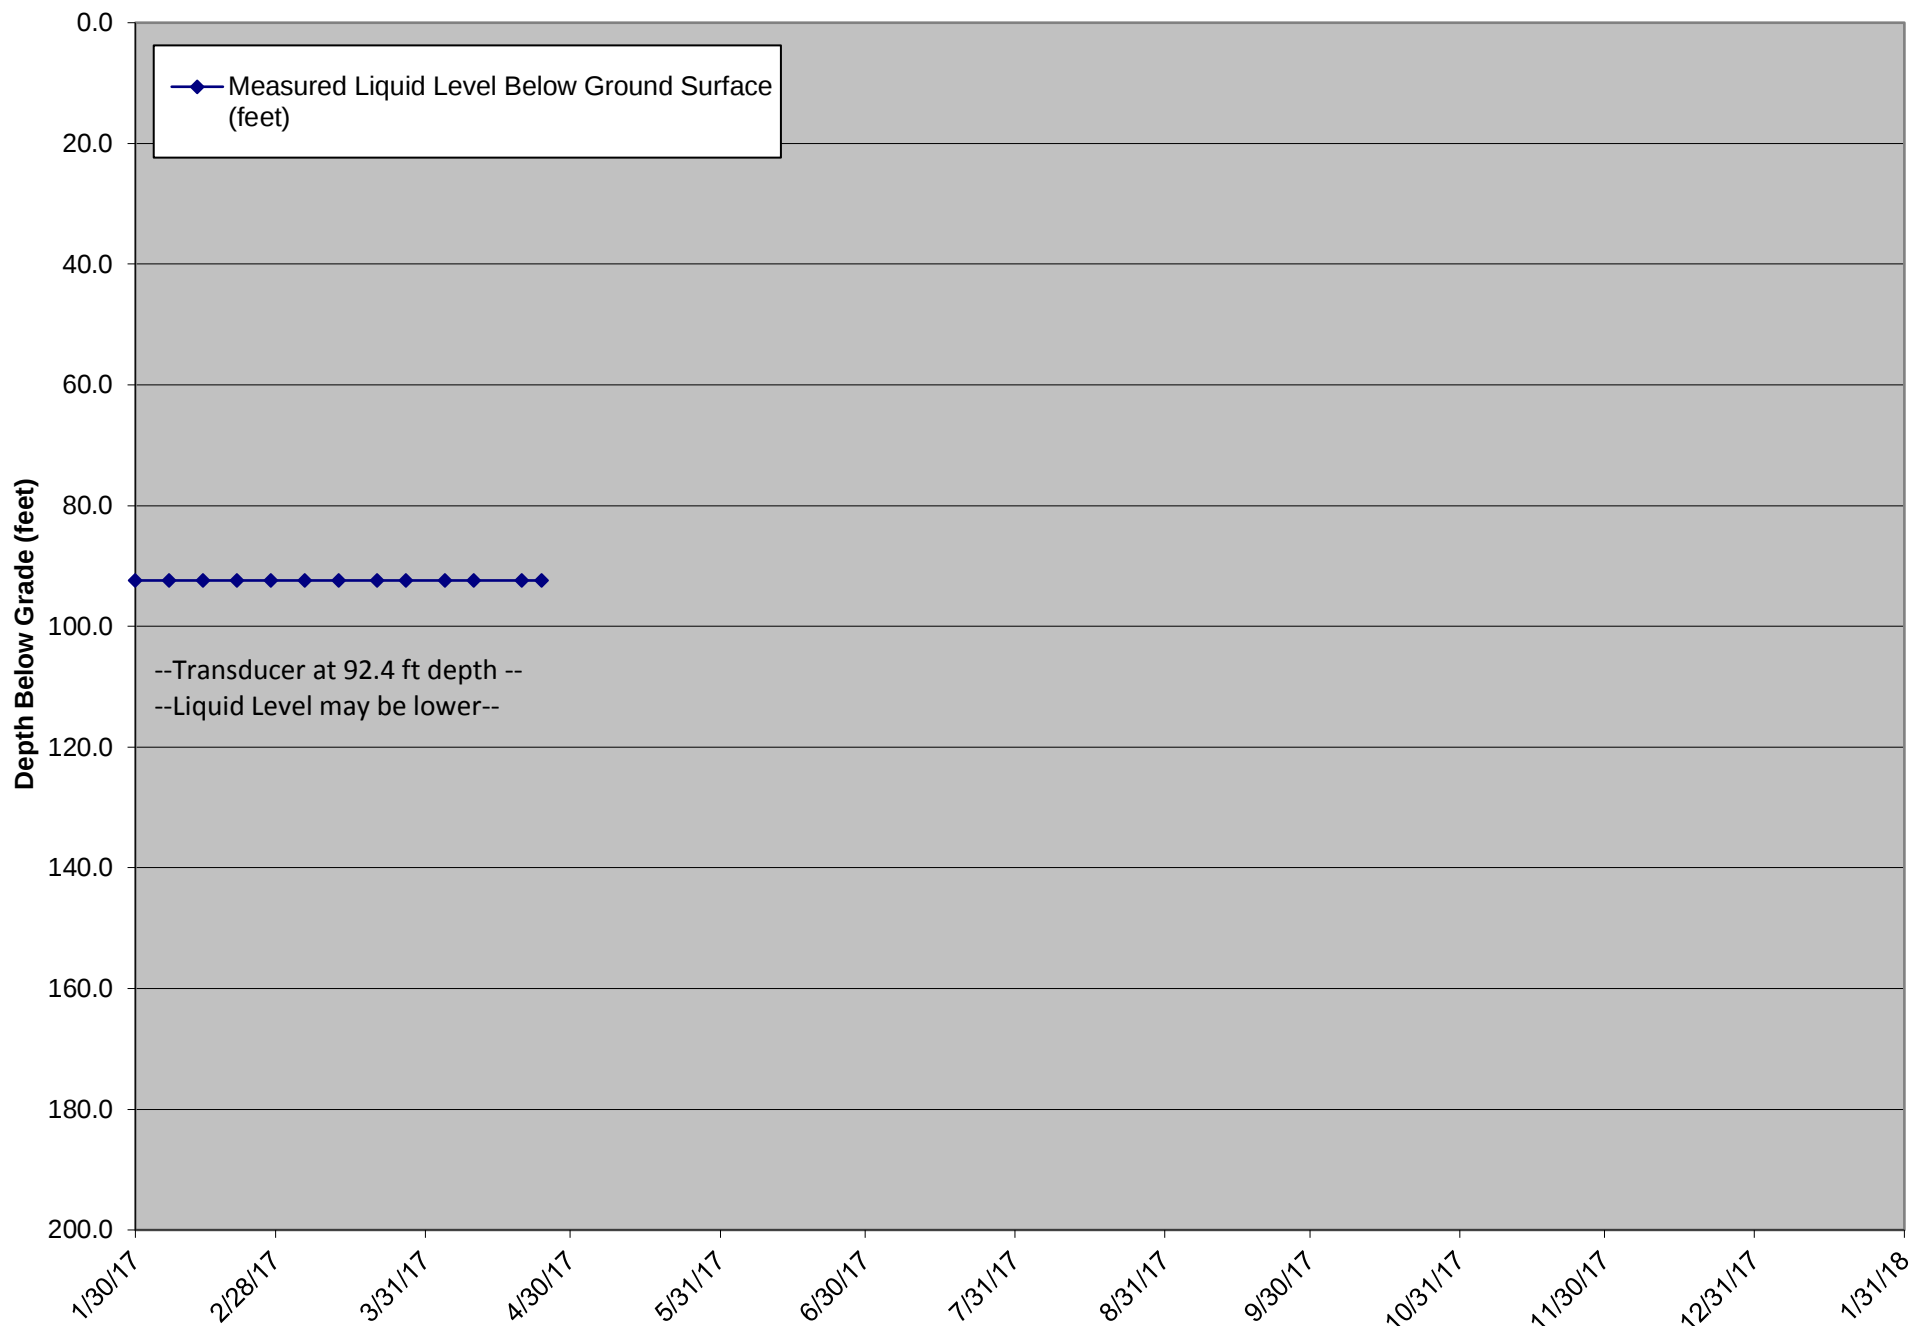
# LCS-1D Liquid Level Below Ground Surface

The downhole discharge piping for LCS-1D requires replacement. Pump and level sensor replacement is scheduled for the week of 2/5/18 pending suitable weather conditions.

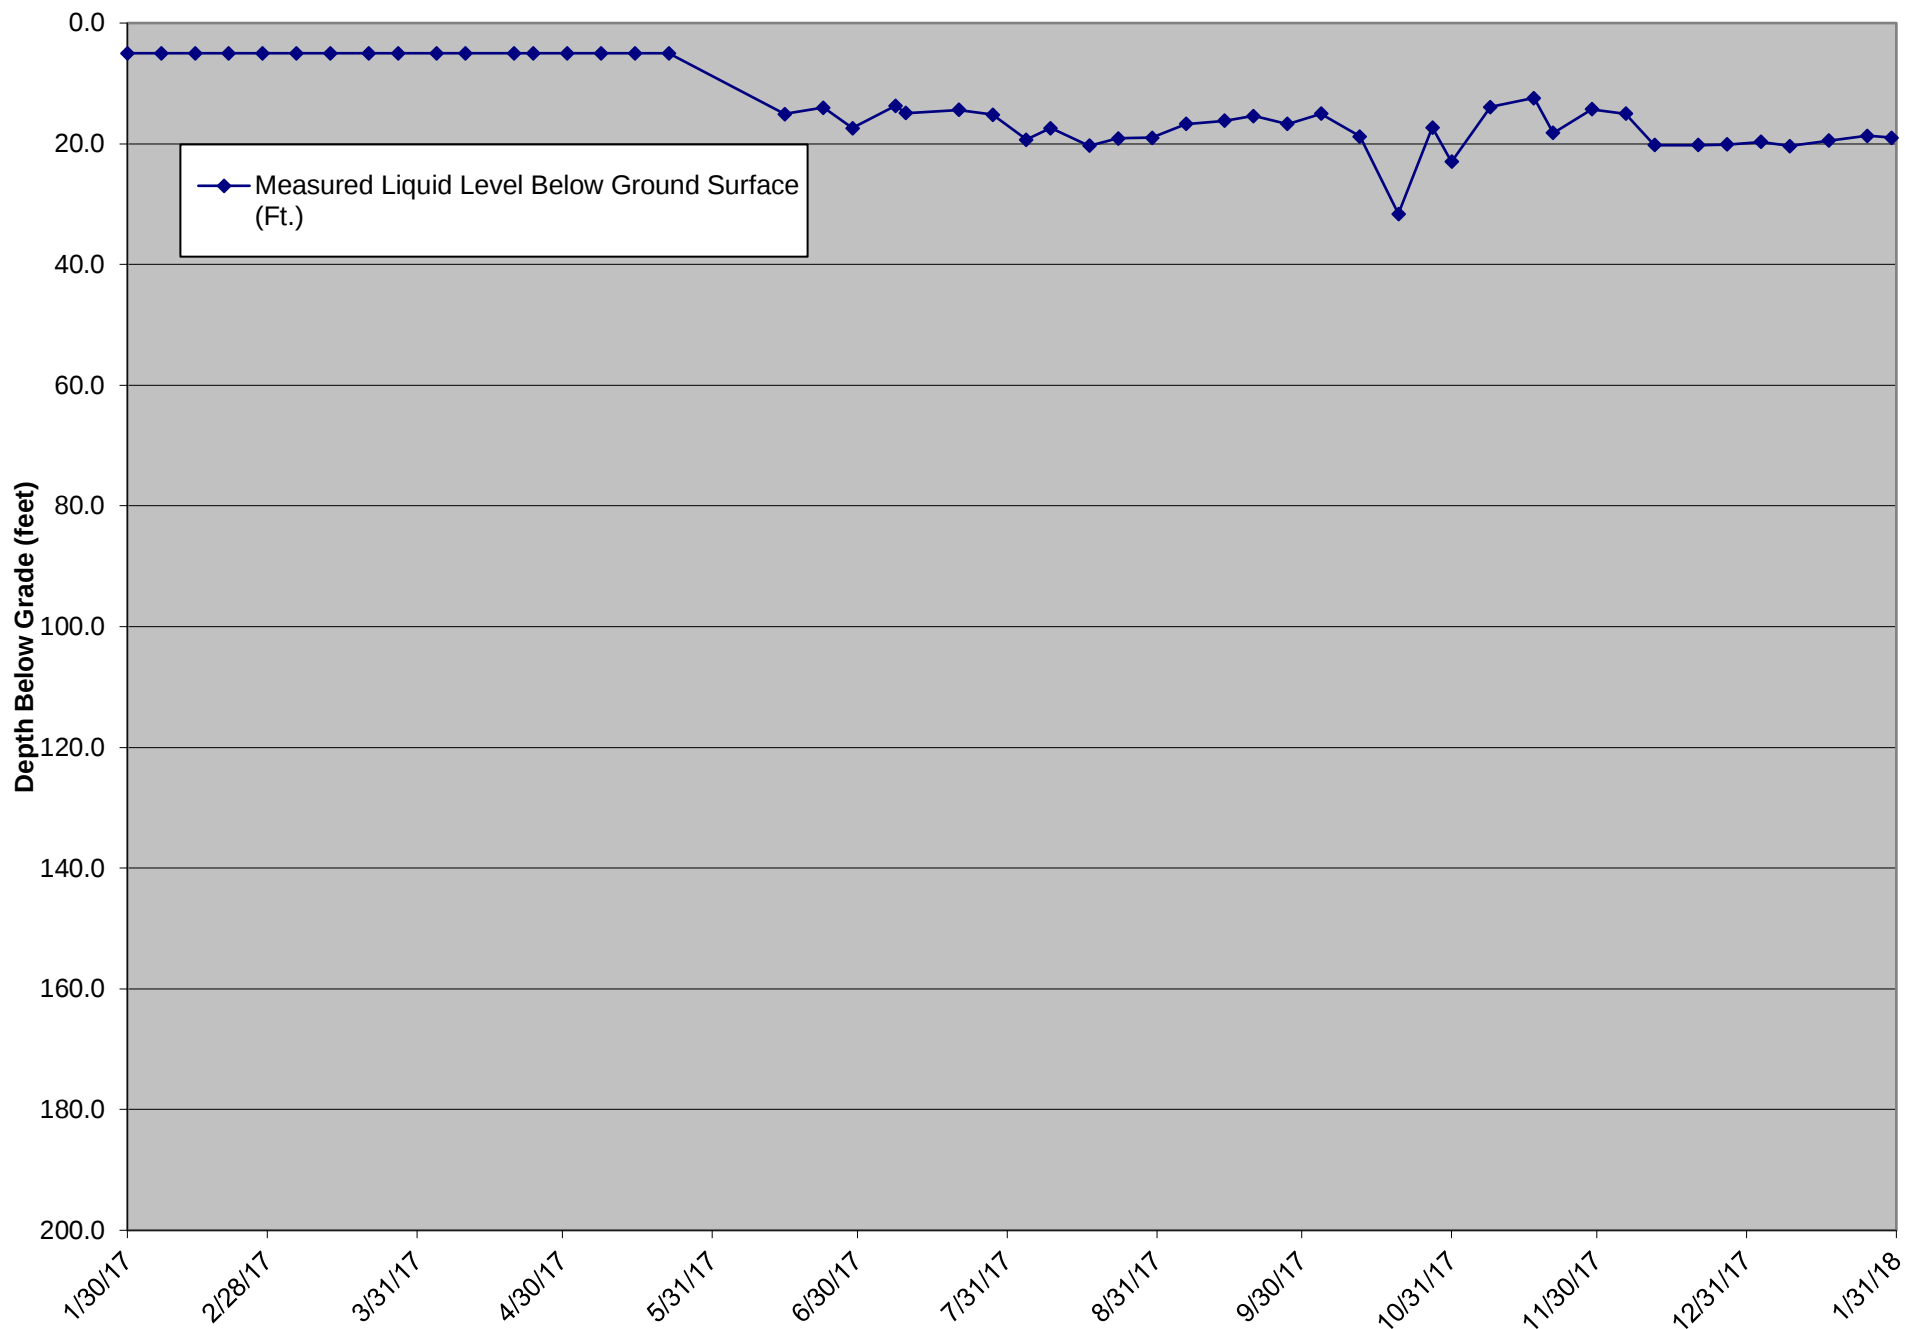
LCS-3D Liquid Level Below Ground Surface

The Blackhawk pneumatic pumps in LCS-3D were non-operational during the weekly reporting period. The casing on LCS-3D will be extended and the line sets for the Blackhawk pumps will be replaced as part of the east fill project. Liquid level was measured manually.

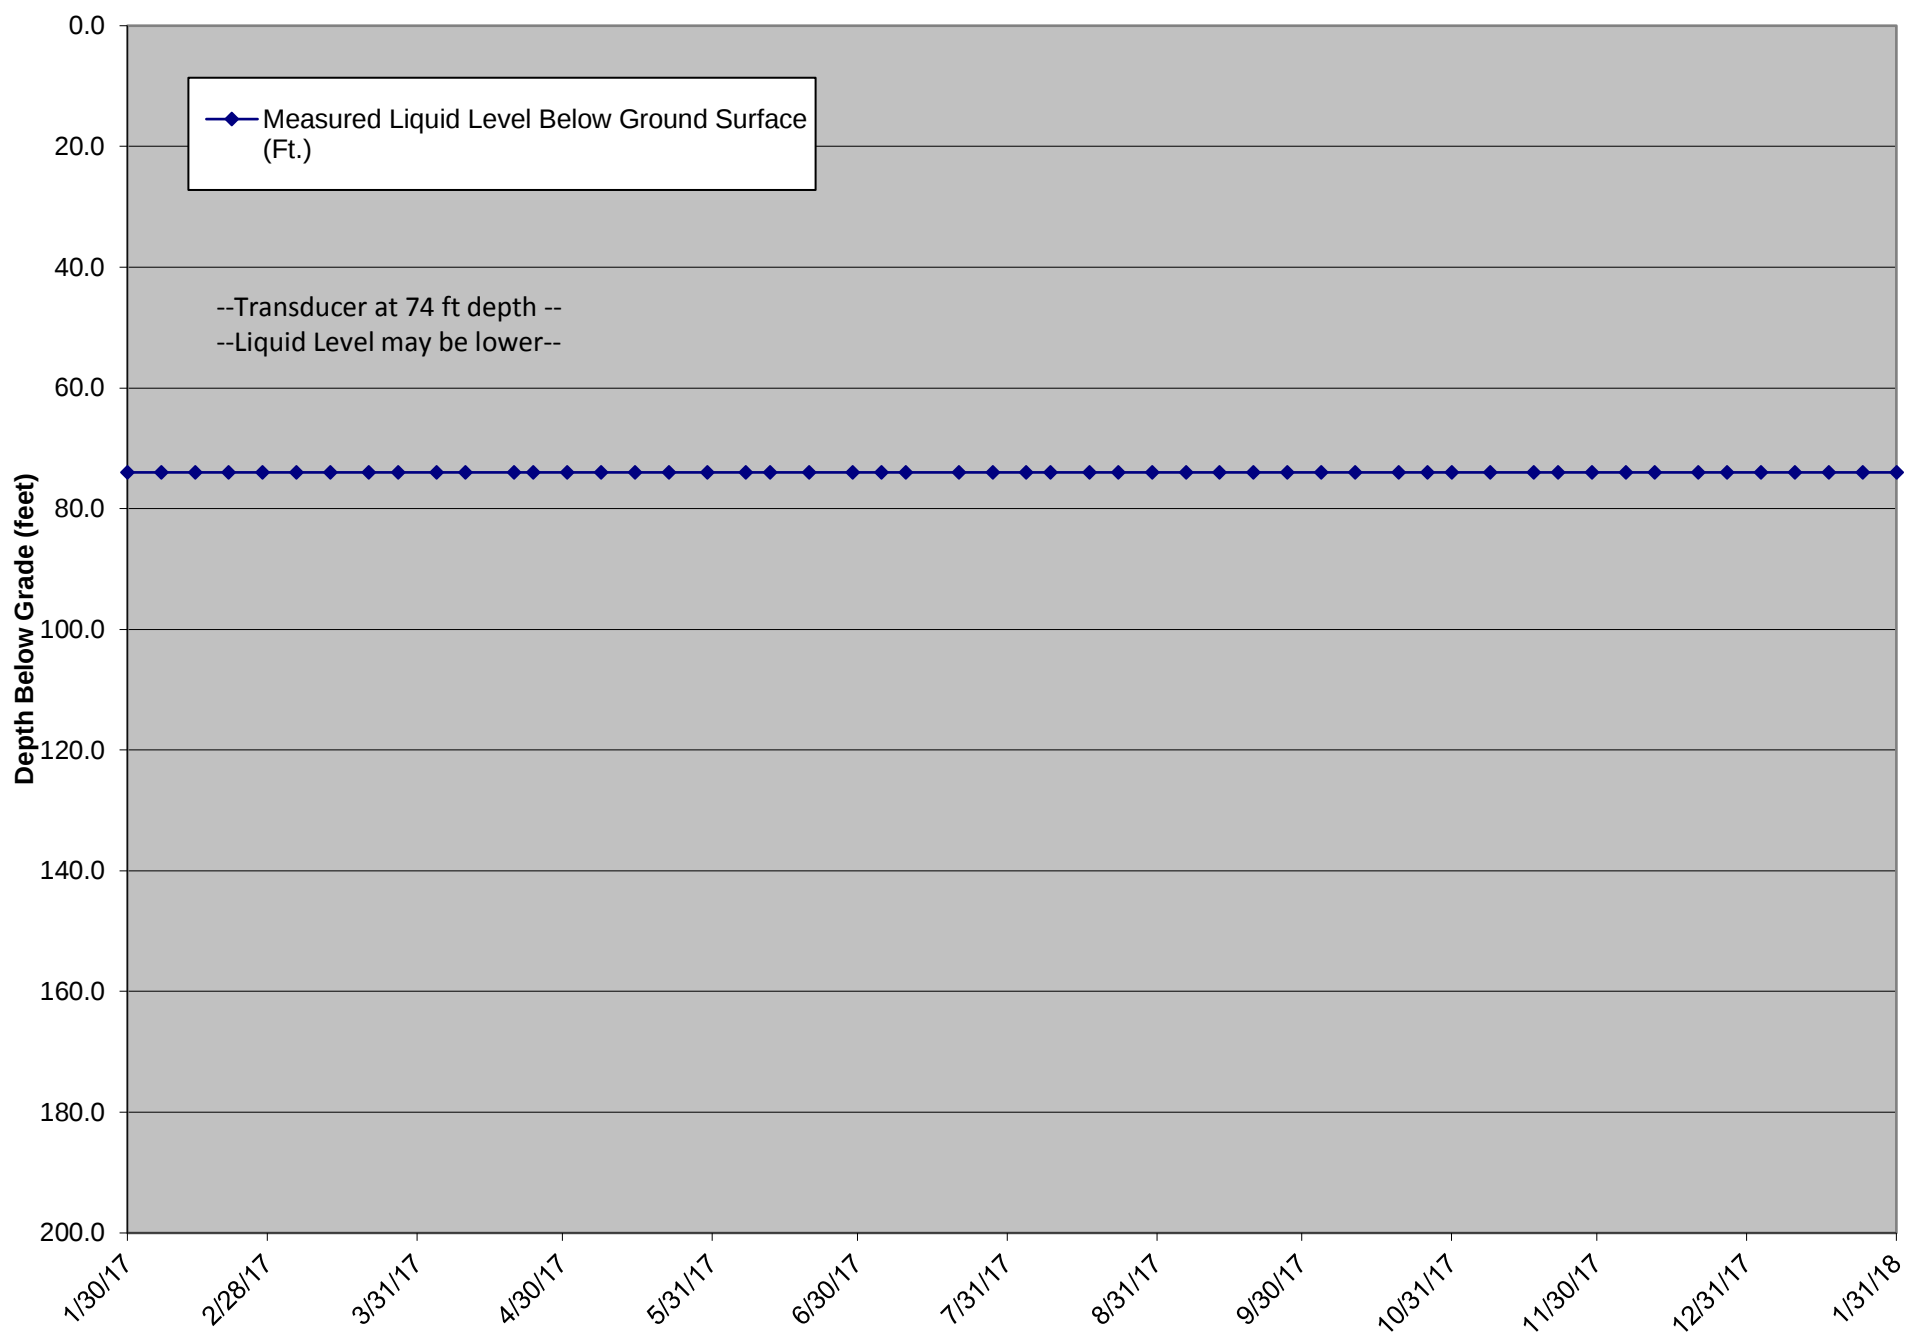
# LCS-4B Liquid Level Below Ground Surface

The level sensor in LCS-4B is currently operational and responsive. Liquid level was not recorded by the level sensor during the weekly reporting period. LCS-4B is equipped with a flow meter that displayed no flow during the weekly reporting period. Therefore, it can be concluded that the liquid level was below the bottom of the pump and level sensor in LCS-4B.

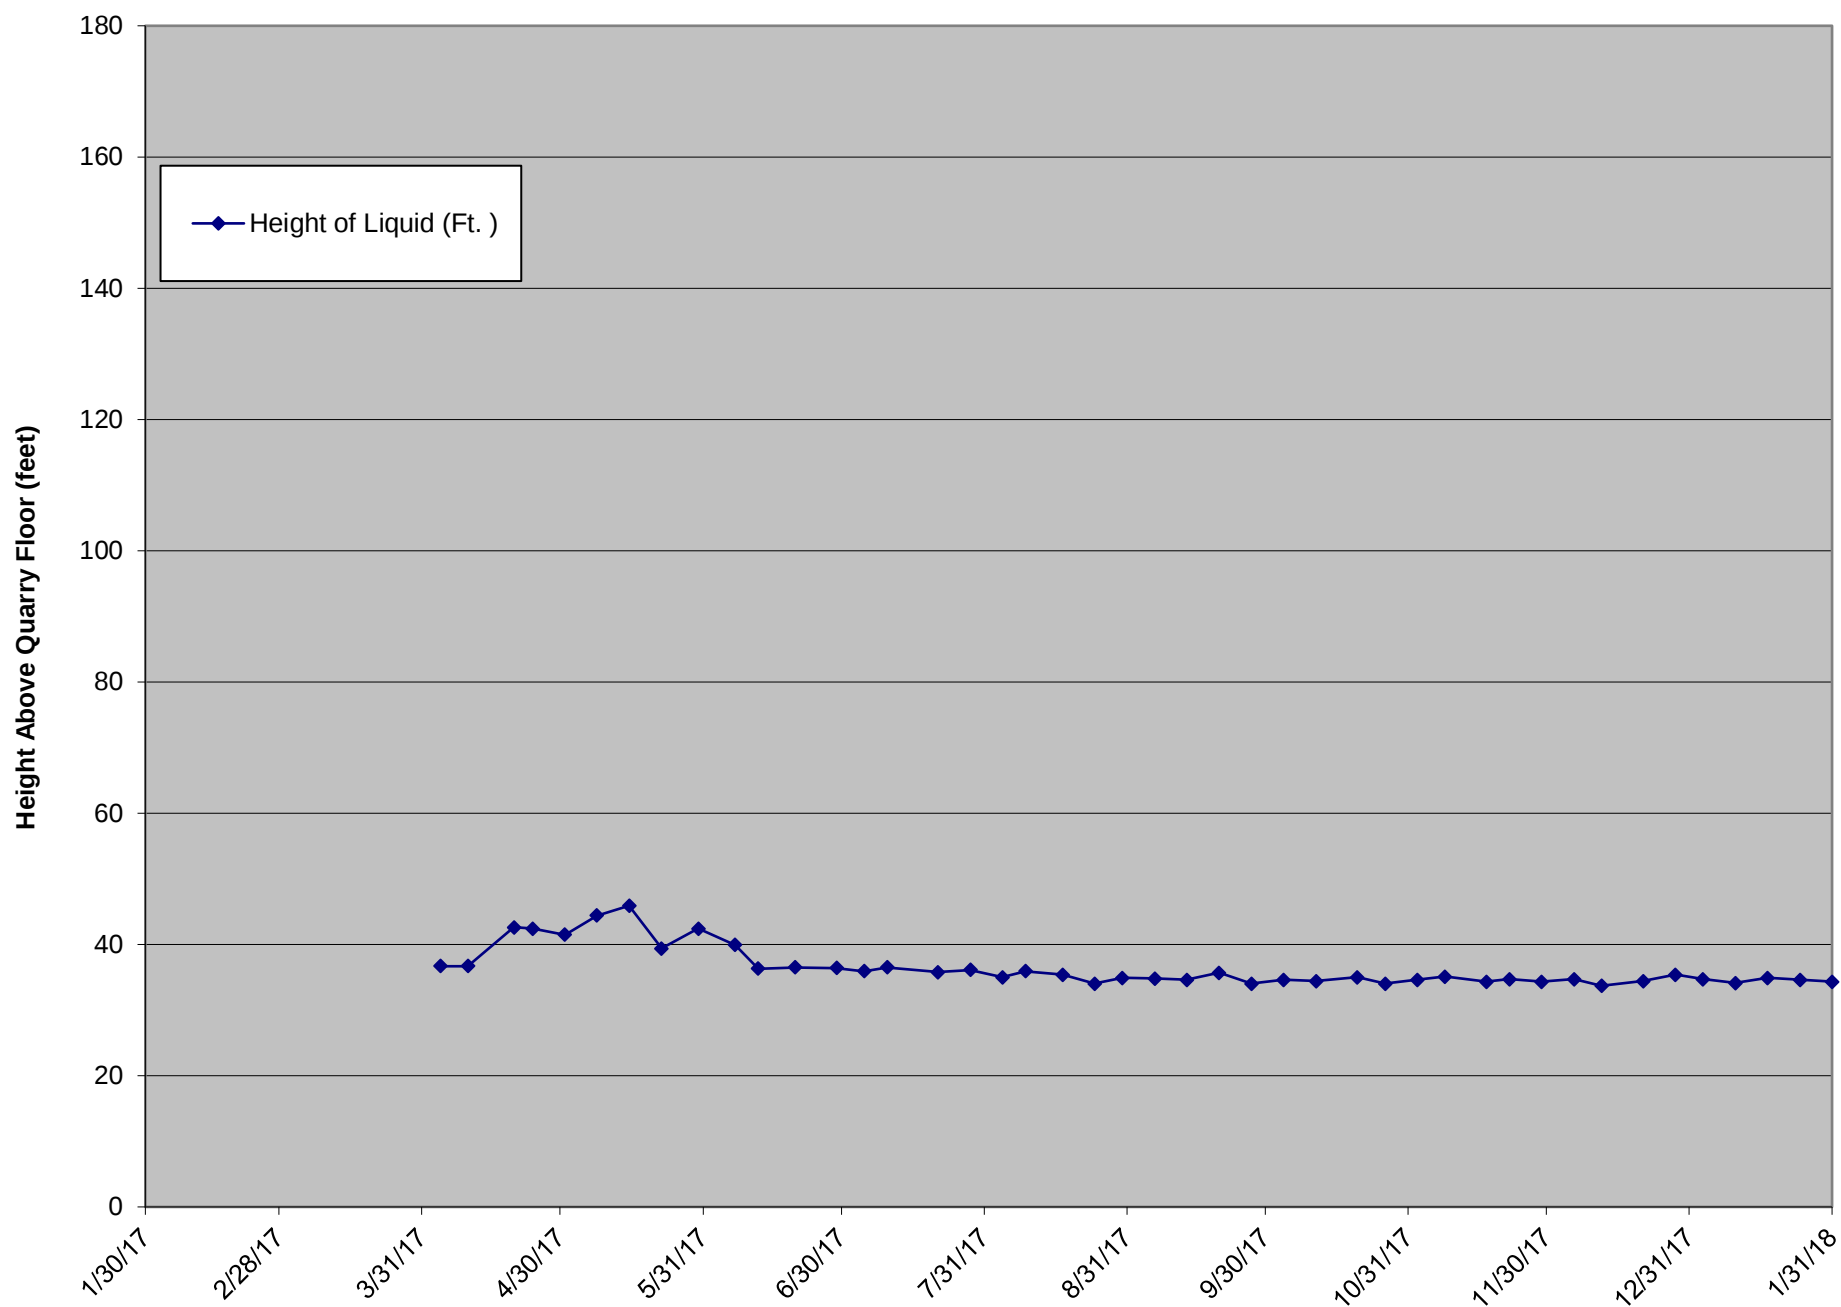
LCS-5B Liquid Level Above Quarry Floor

LCS-5B and LCS-6B were fully operational during the weekly reporting period.

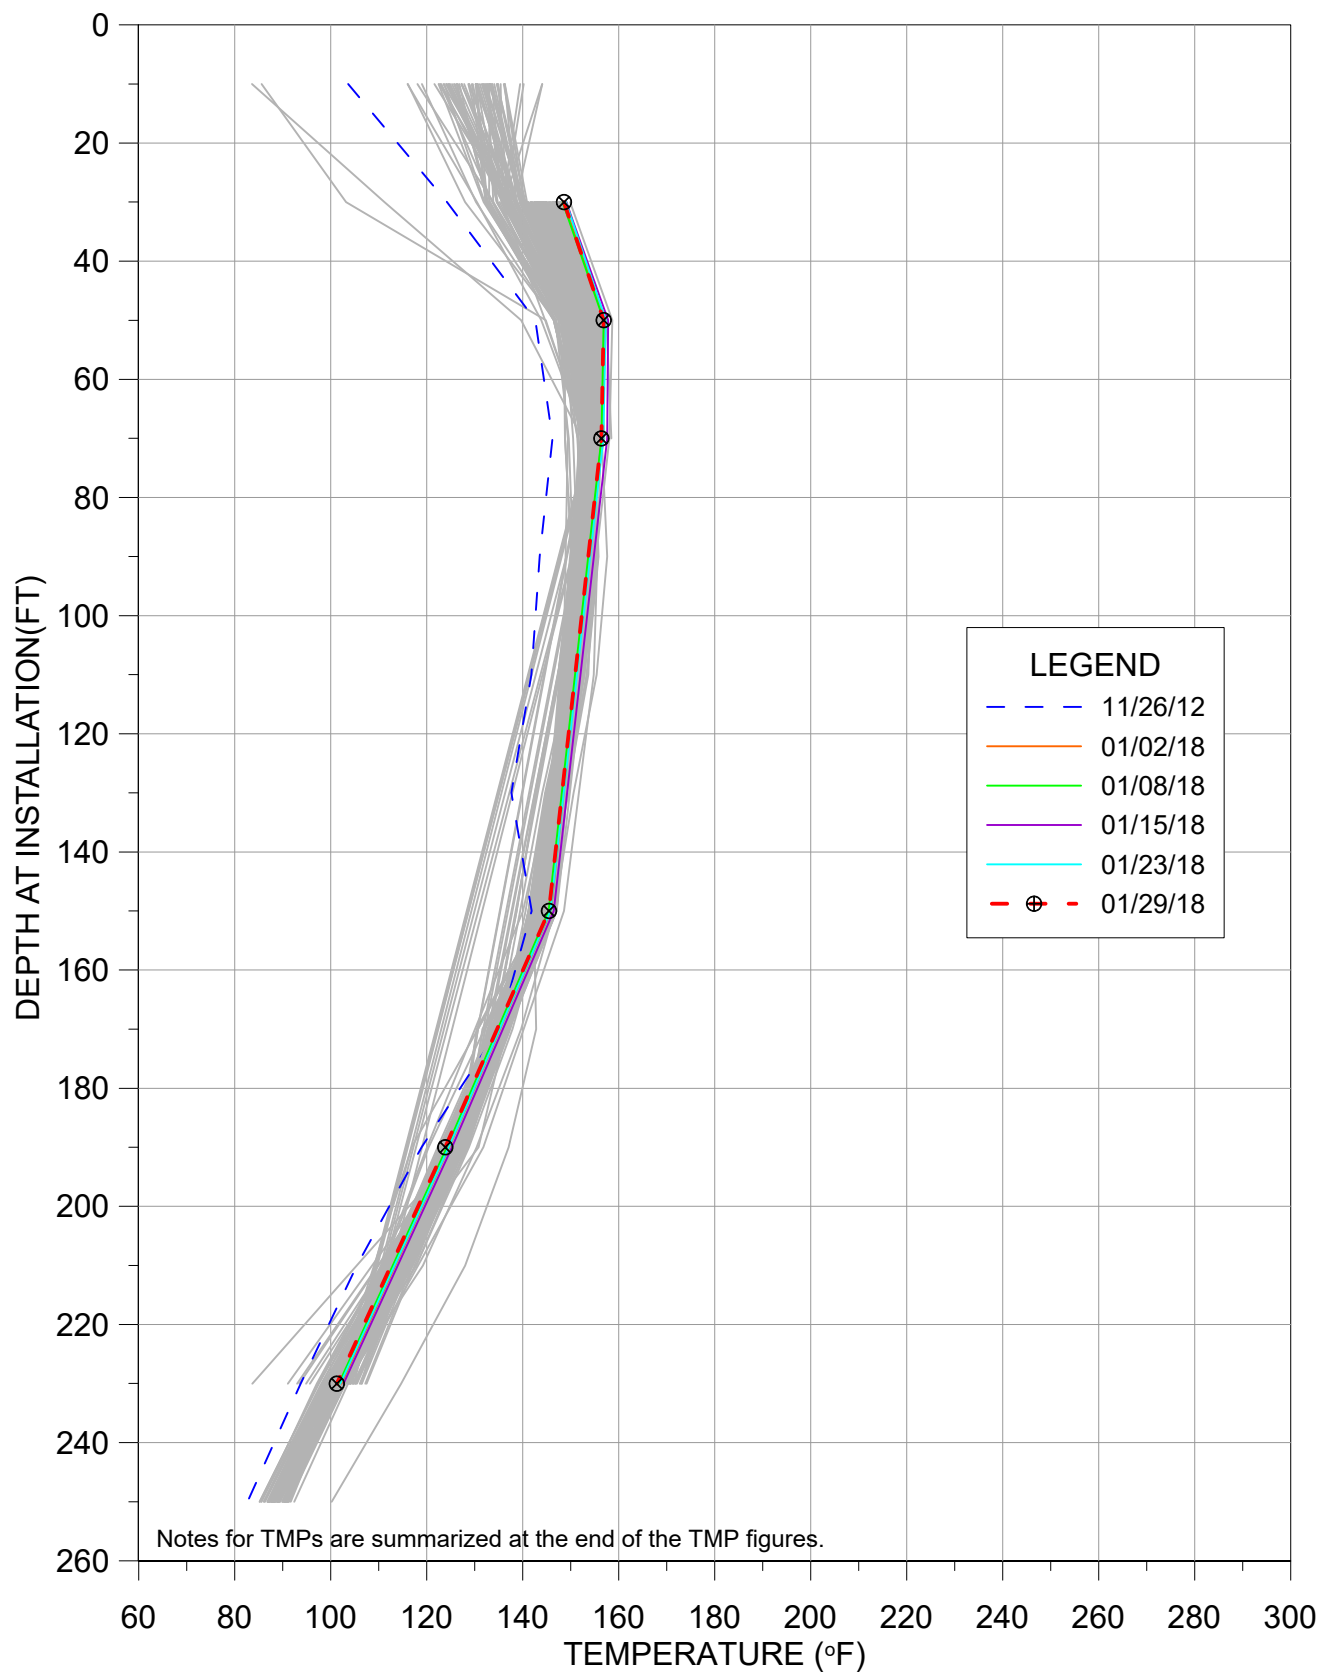
# TMP-3

1. No reliable temperature readings have been obtained at 170 ft depth since 1/29/2014, except on 3/13/2014.
2. The connectivity tests on 4/11/2014 conducted by CEC showed that units at 10, 90, 130, 210 and 250 ft depths are no longer reliable.
3. The connectivity tests on 10/28/2014 conducted by Feezor Engineering showed that units at 10, 90, 110, 130, 210 and 250 ft depths are not reliable.

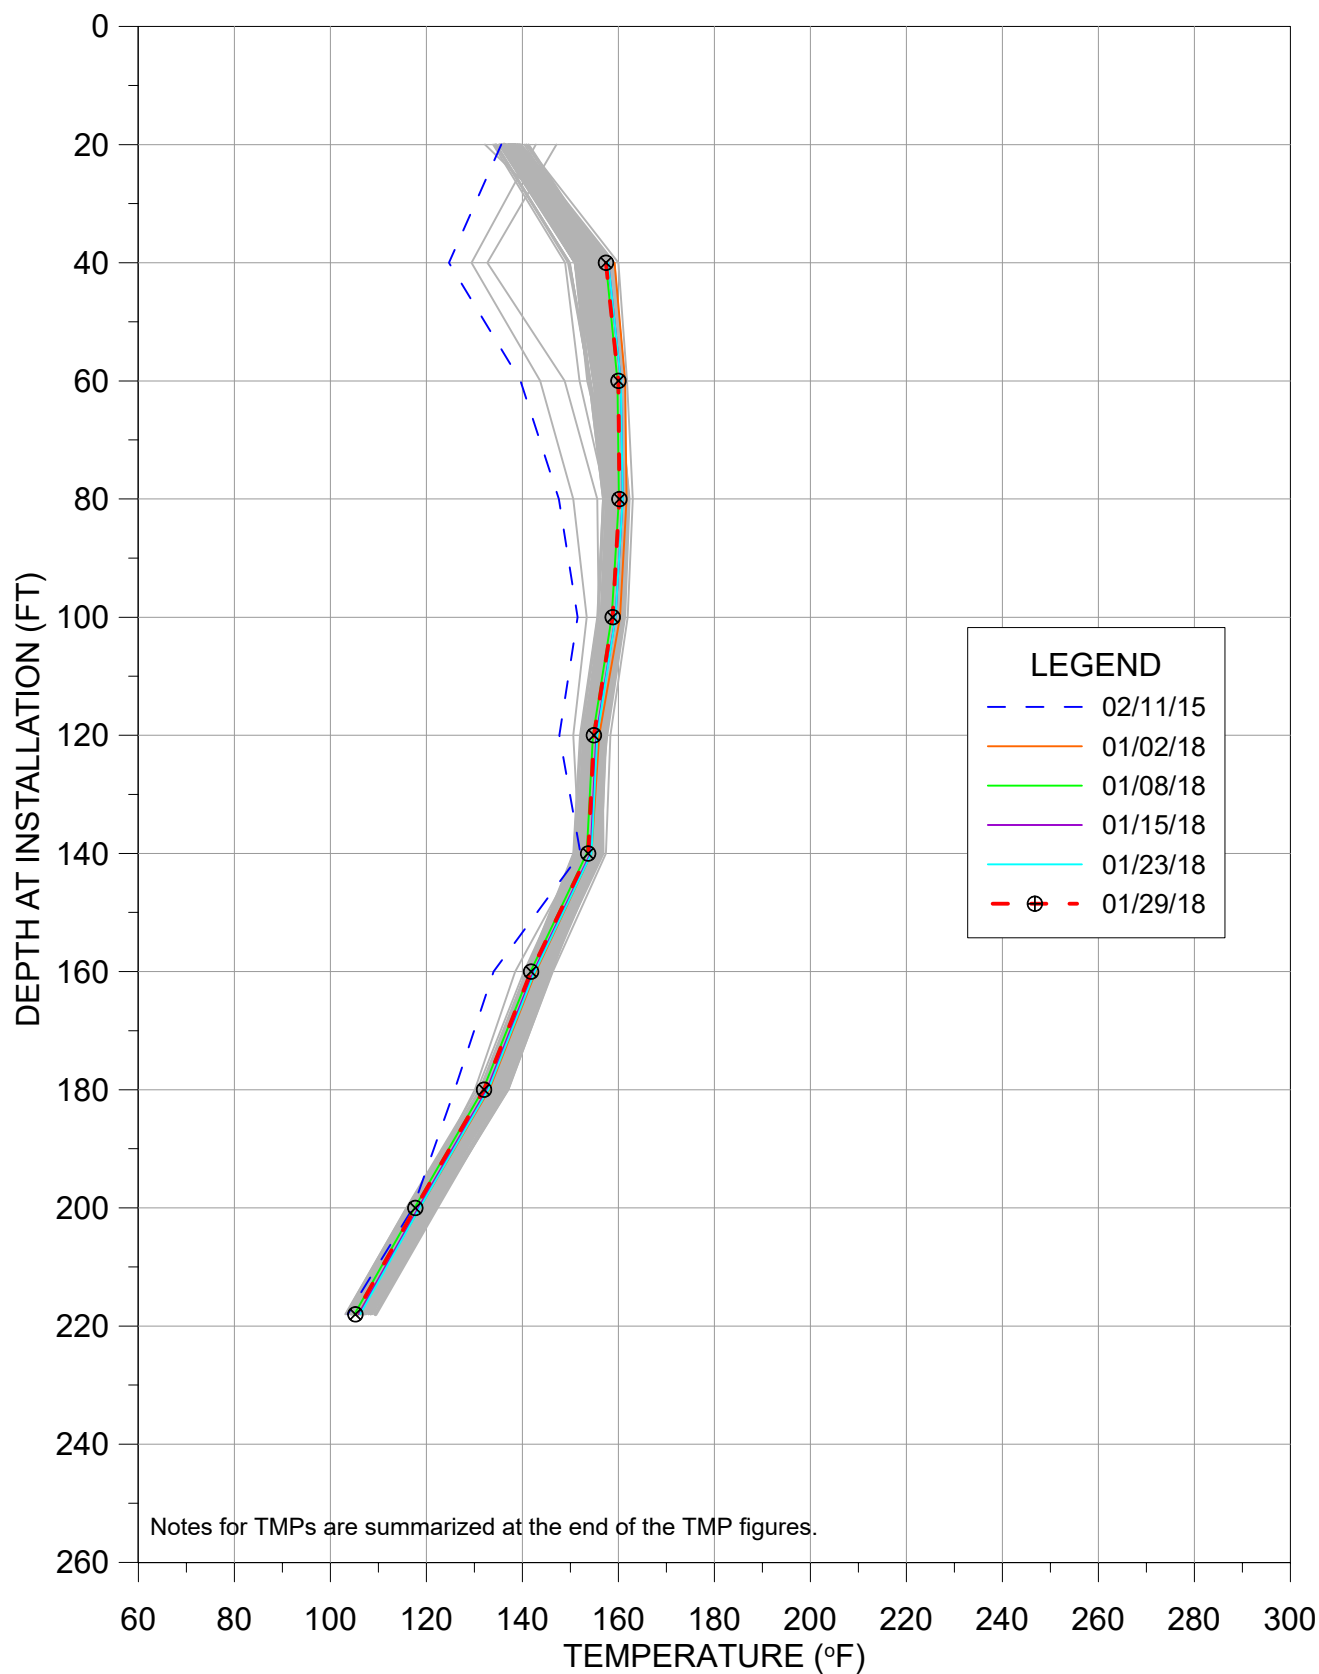
# TMP-3R

1. The unit at 20 ft depth had a fluctuating resistance since 9/25/2017. Therefore the temperature is determined to be unreliable.

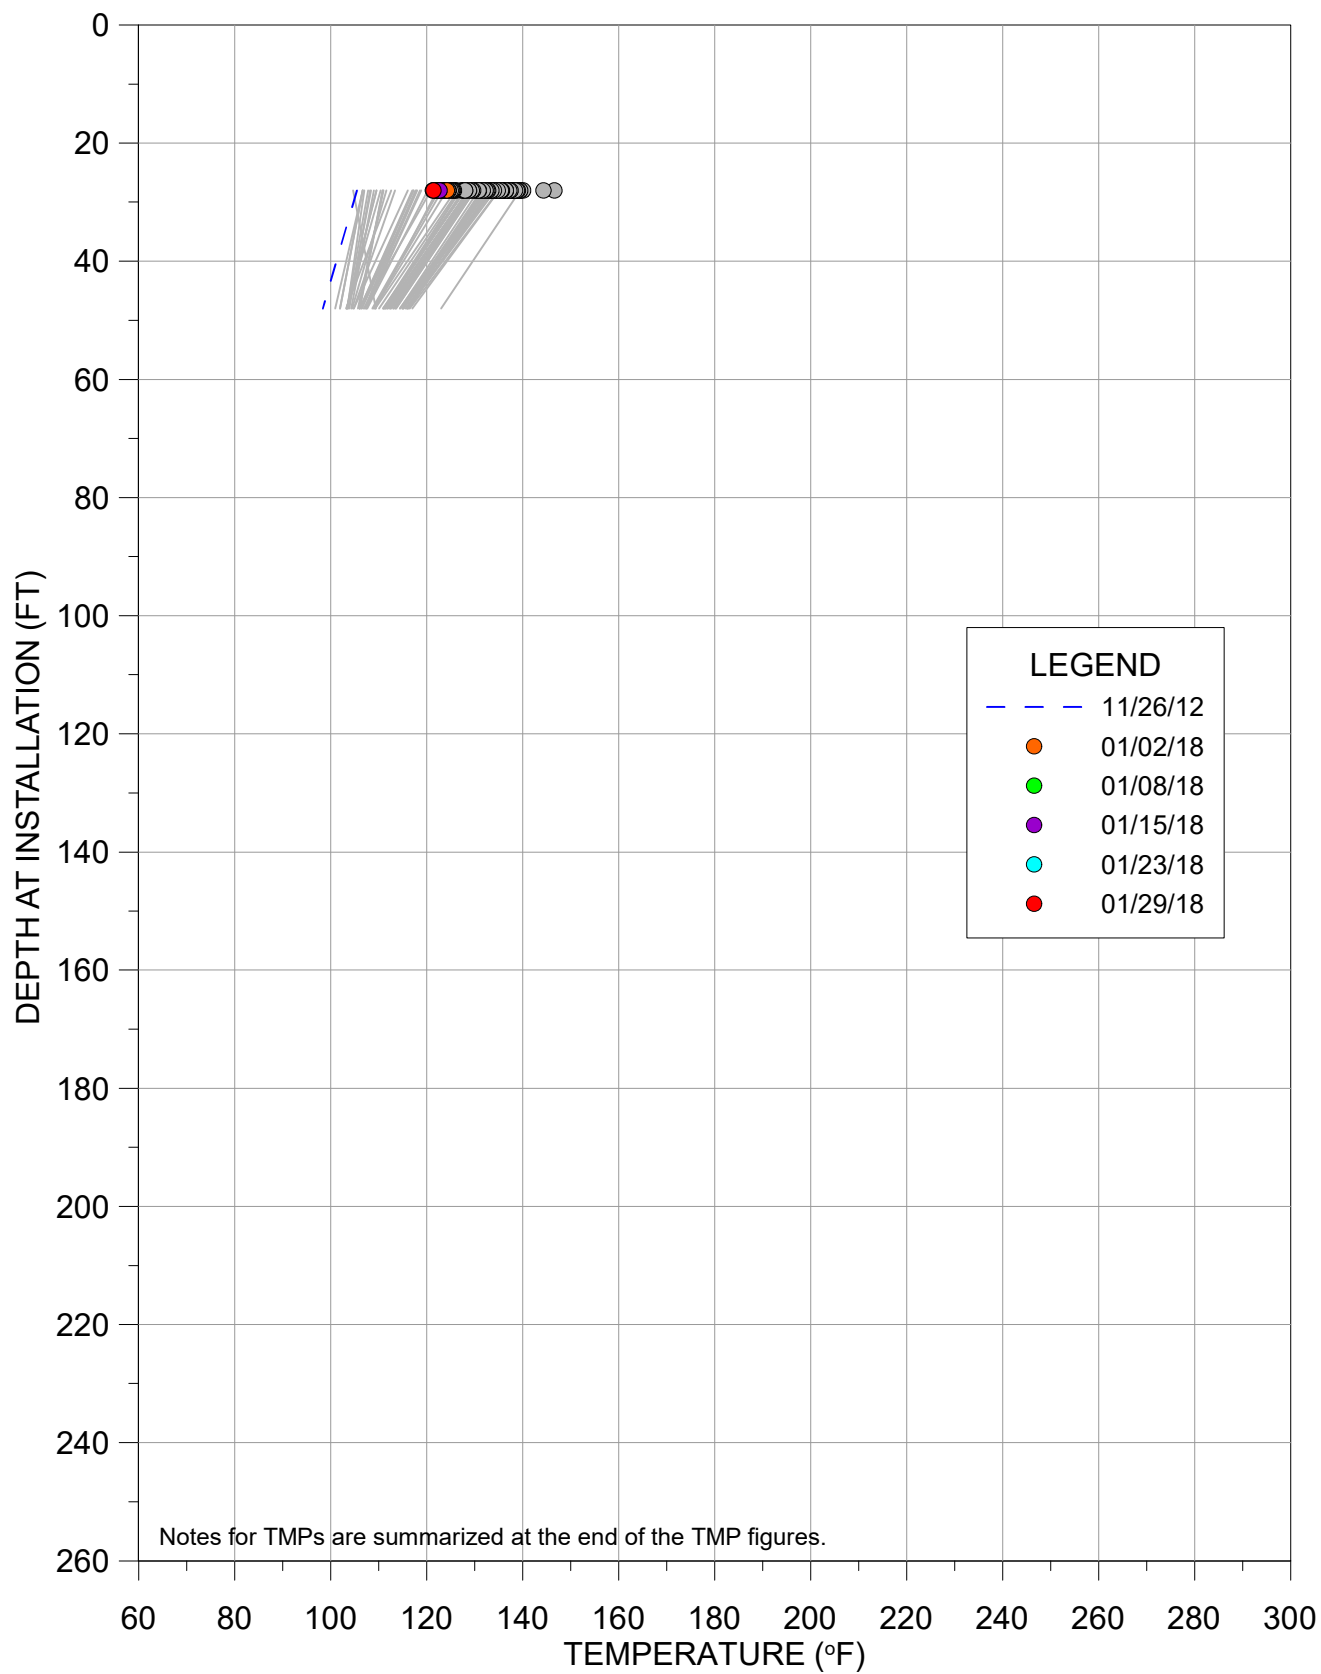
# TMP-4

1. The connectivity tests on 4/11/2014 conducted by CEC showed that the unit at 48 ft depth is no longer reliable.

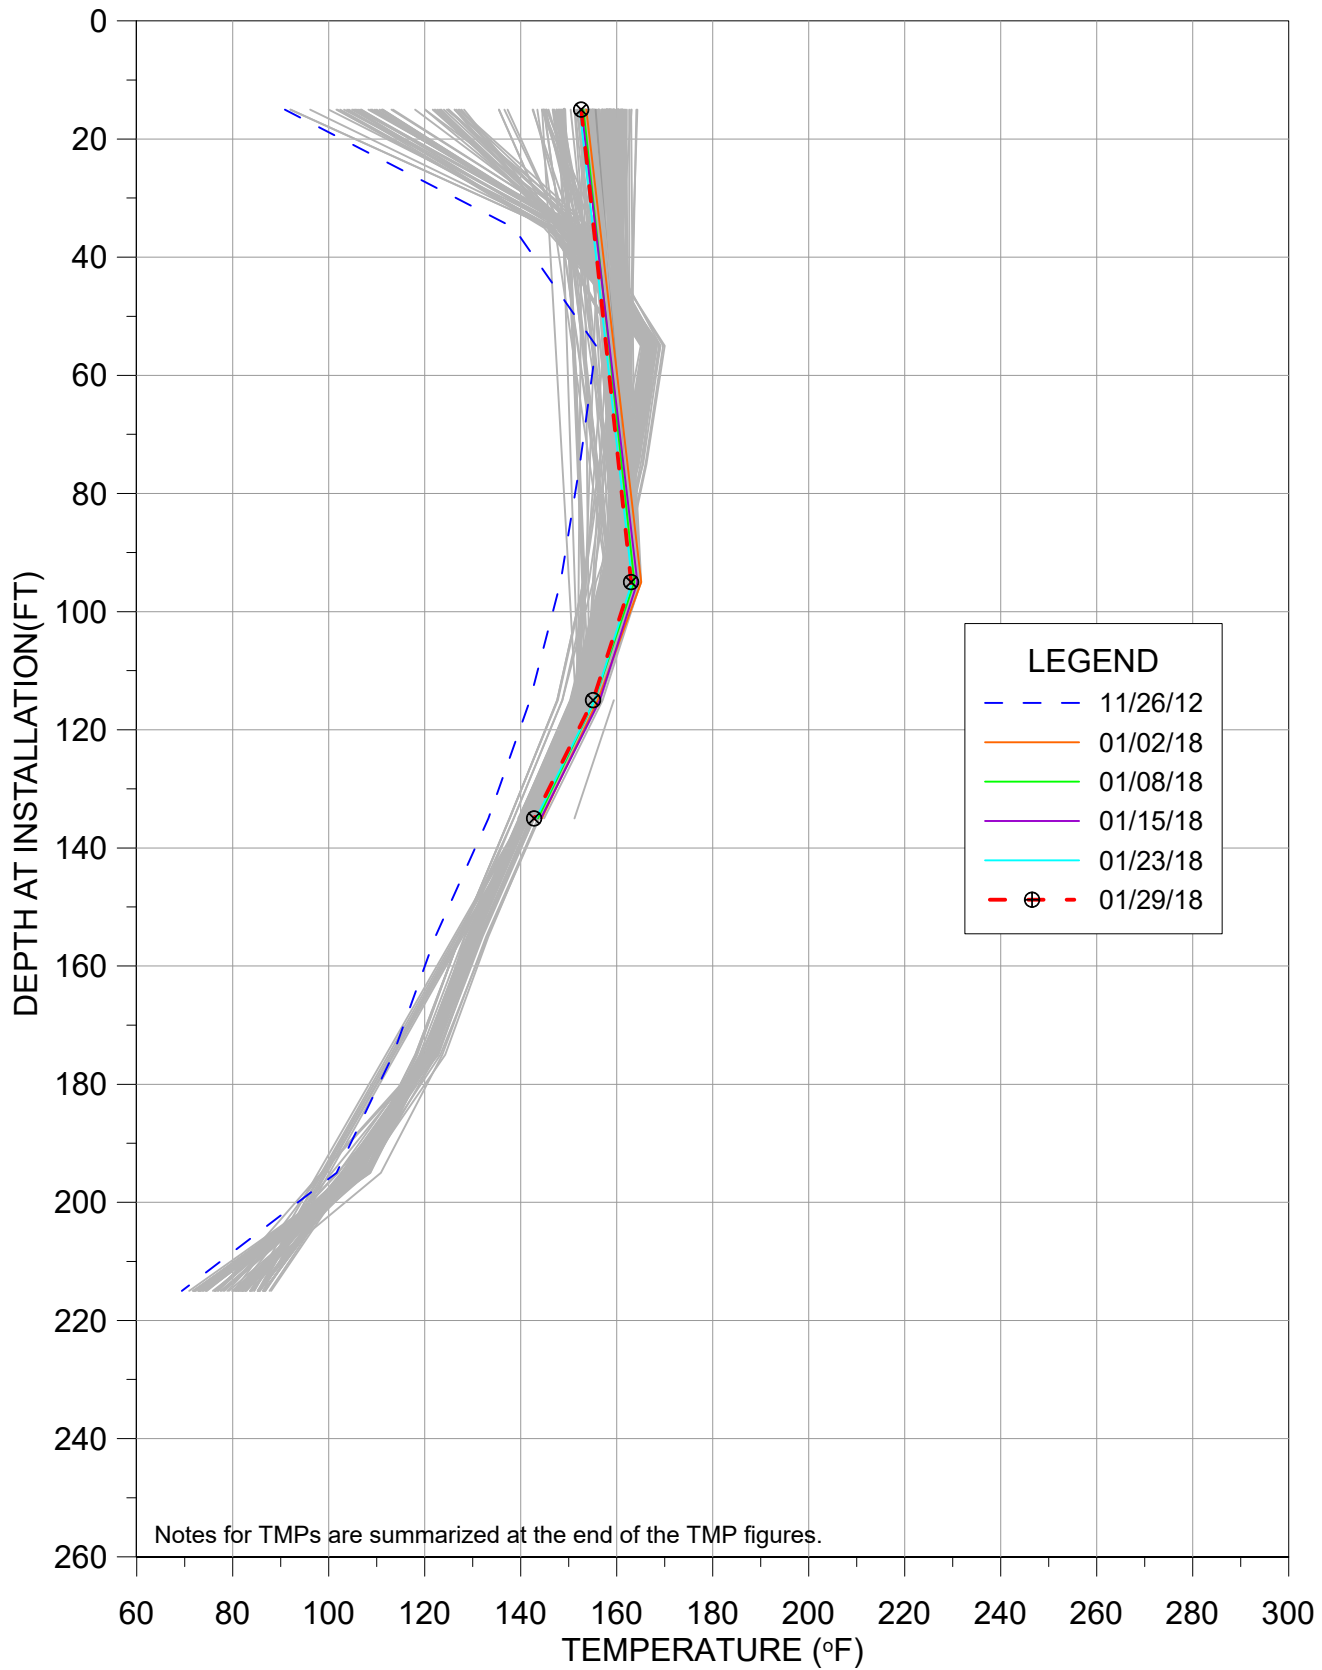
# TMP-6

1. The connectivity tests on 4/11/2014 conducted by CEC showed that units at 35, 55, 75, 155, 175, and 195 ft depths are no longer reliable.
2. No reliable temperature readings have been obtained at the unit at 215 ft depth since 6/13/2014.

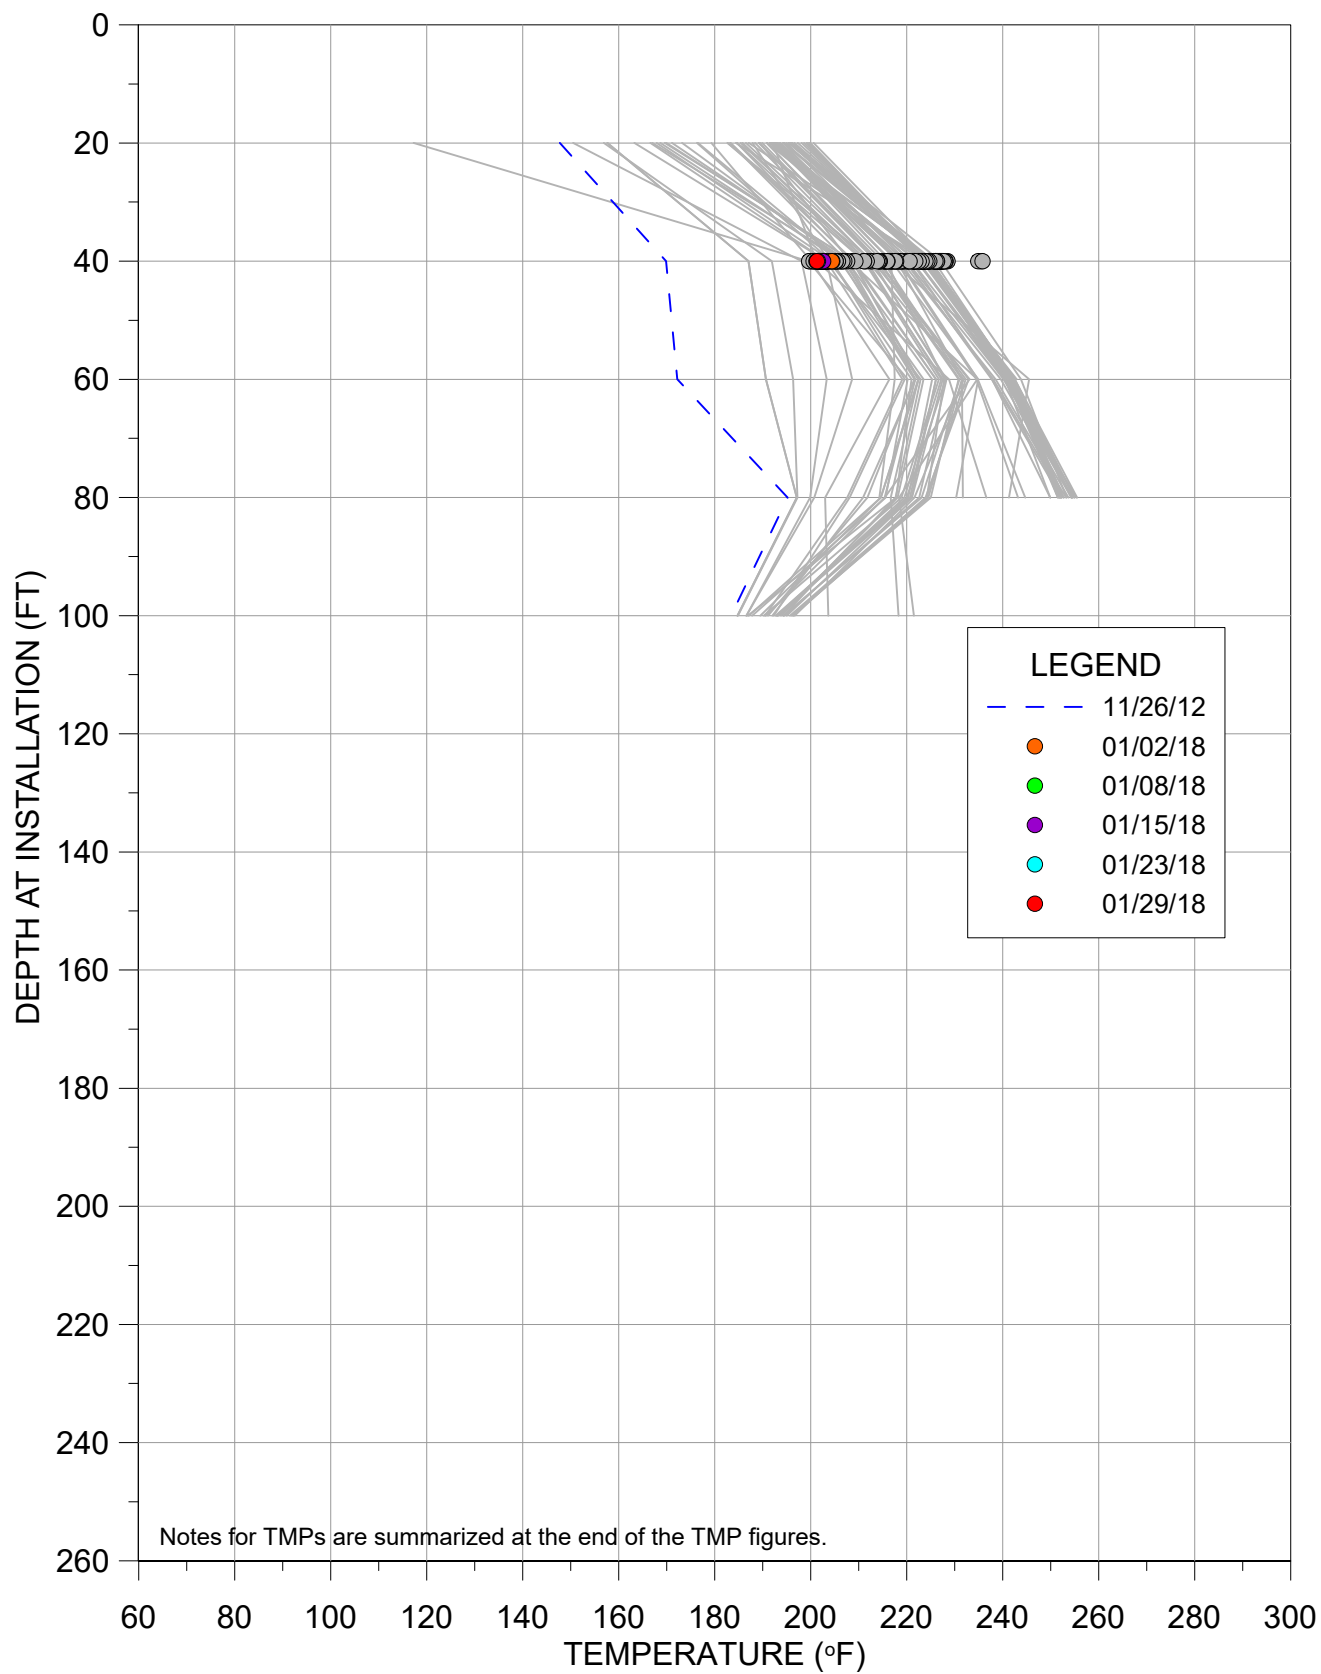
# TMP-9

1. Unit at 100 ft depth had an inaccurate temperature reading on 8/1/2013 and no reading since 8/6/2013.
2. The connectivity tests on 4/11/2014 conducted by CEC showed that units at 20, 60, 80, and 100 ft depths are no longer reliable.
