# **Bridgeton Landfill, LLC**

## **Weekly Data Submittal**

**Week of January 28, 2018 – February 3, 2018**

**Required by Section 52.F of Agreed Order, Case No. 13SL-CC01088  
Effective May 13, 2013**

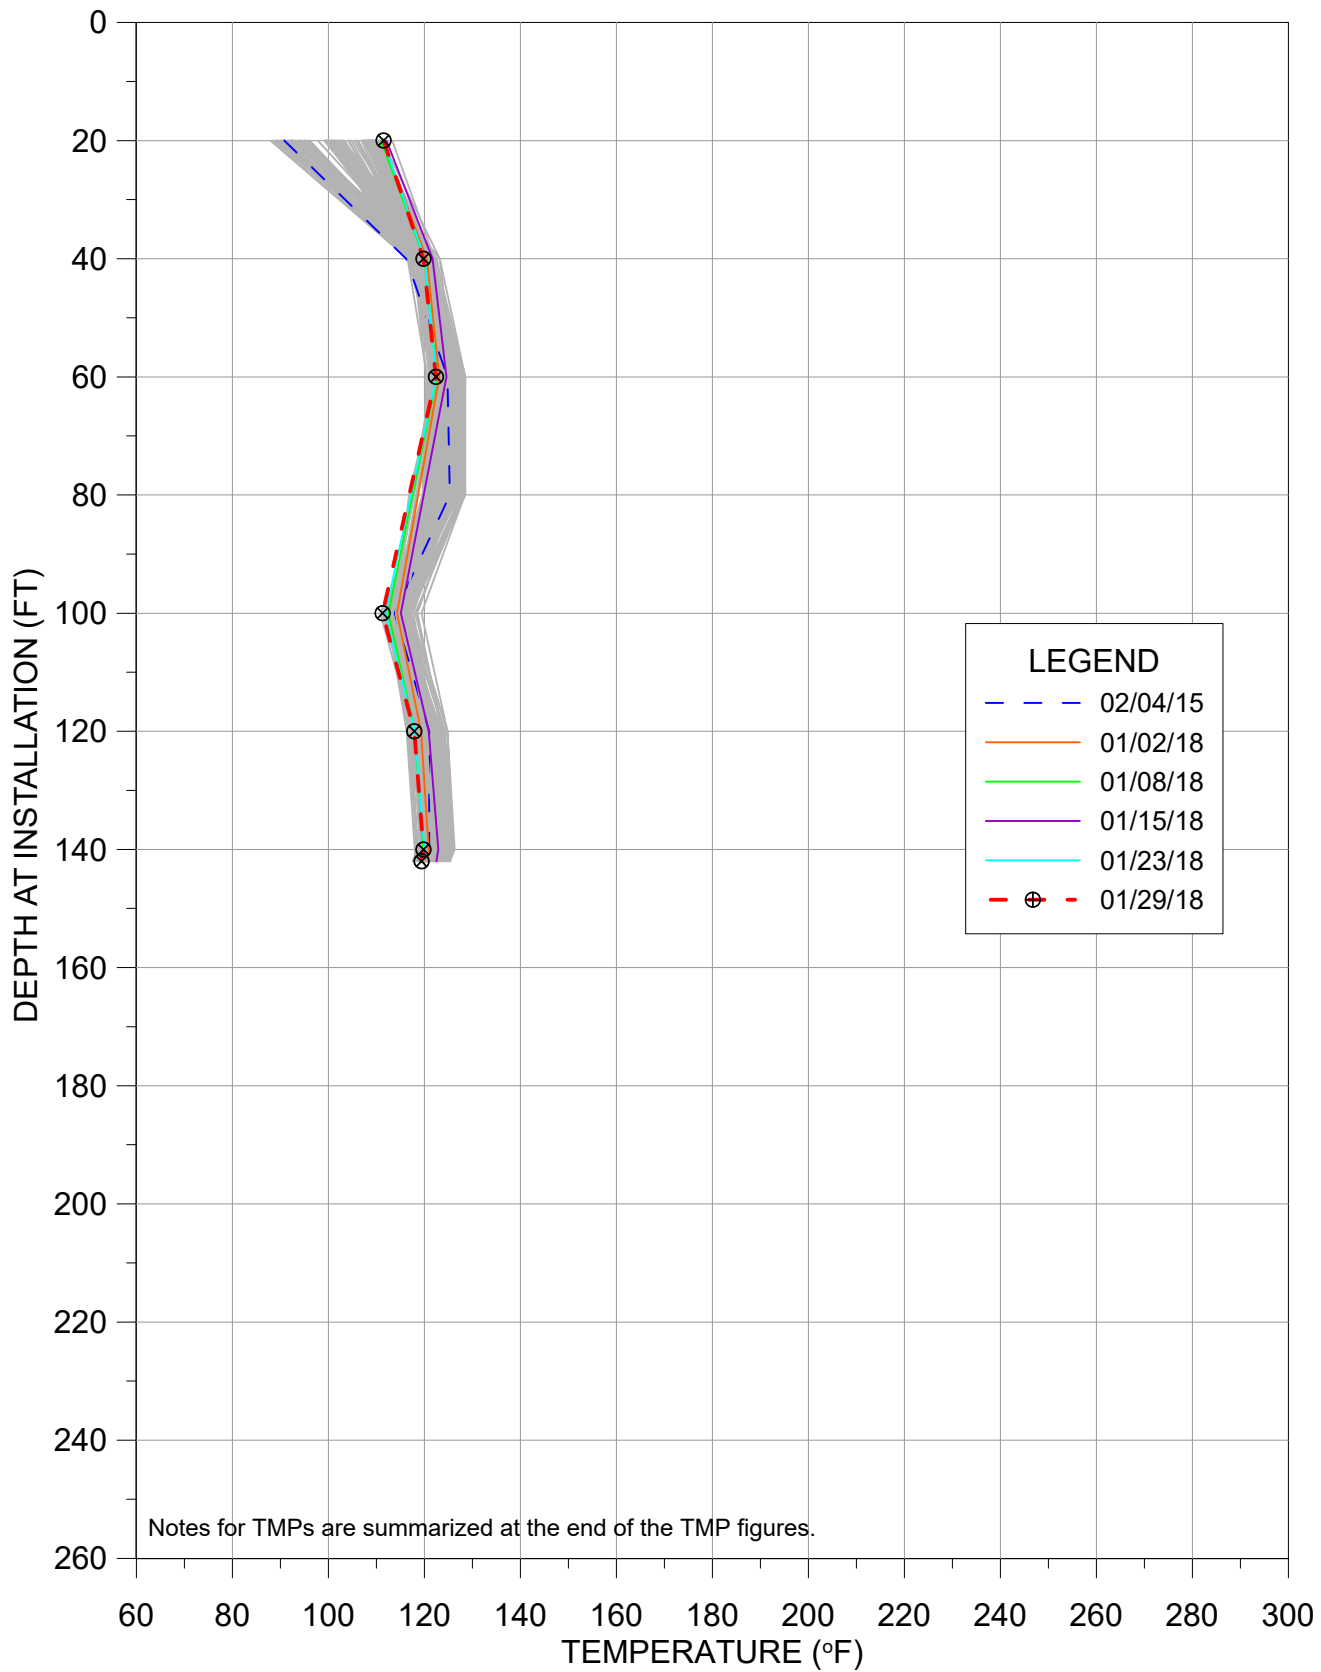
# TMP-26

1. Resistance on unit at 80 ft dropped 12.9 ohms (11/06/2017) and subsequent resistance reading continue to be low. Upon further investigation by Feezor Engineering, this unit is determined to be unreliable.

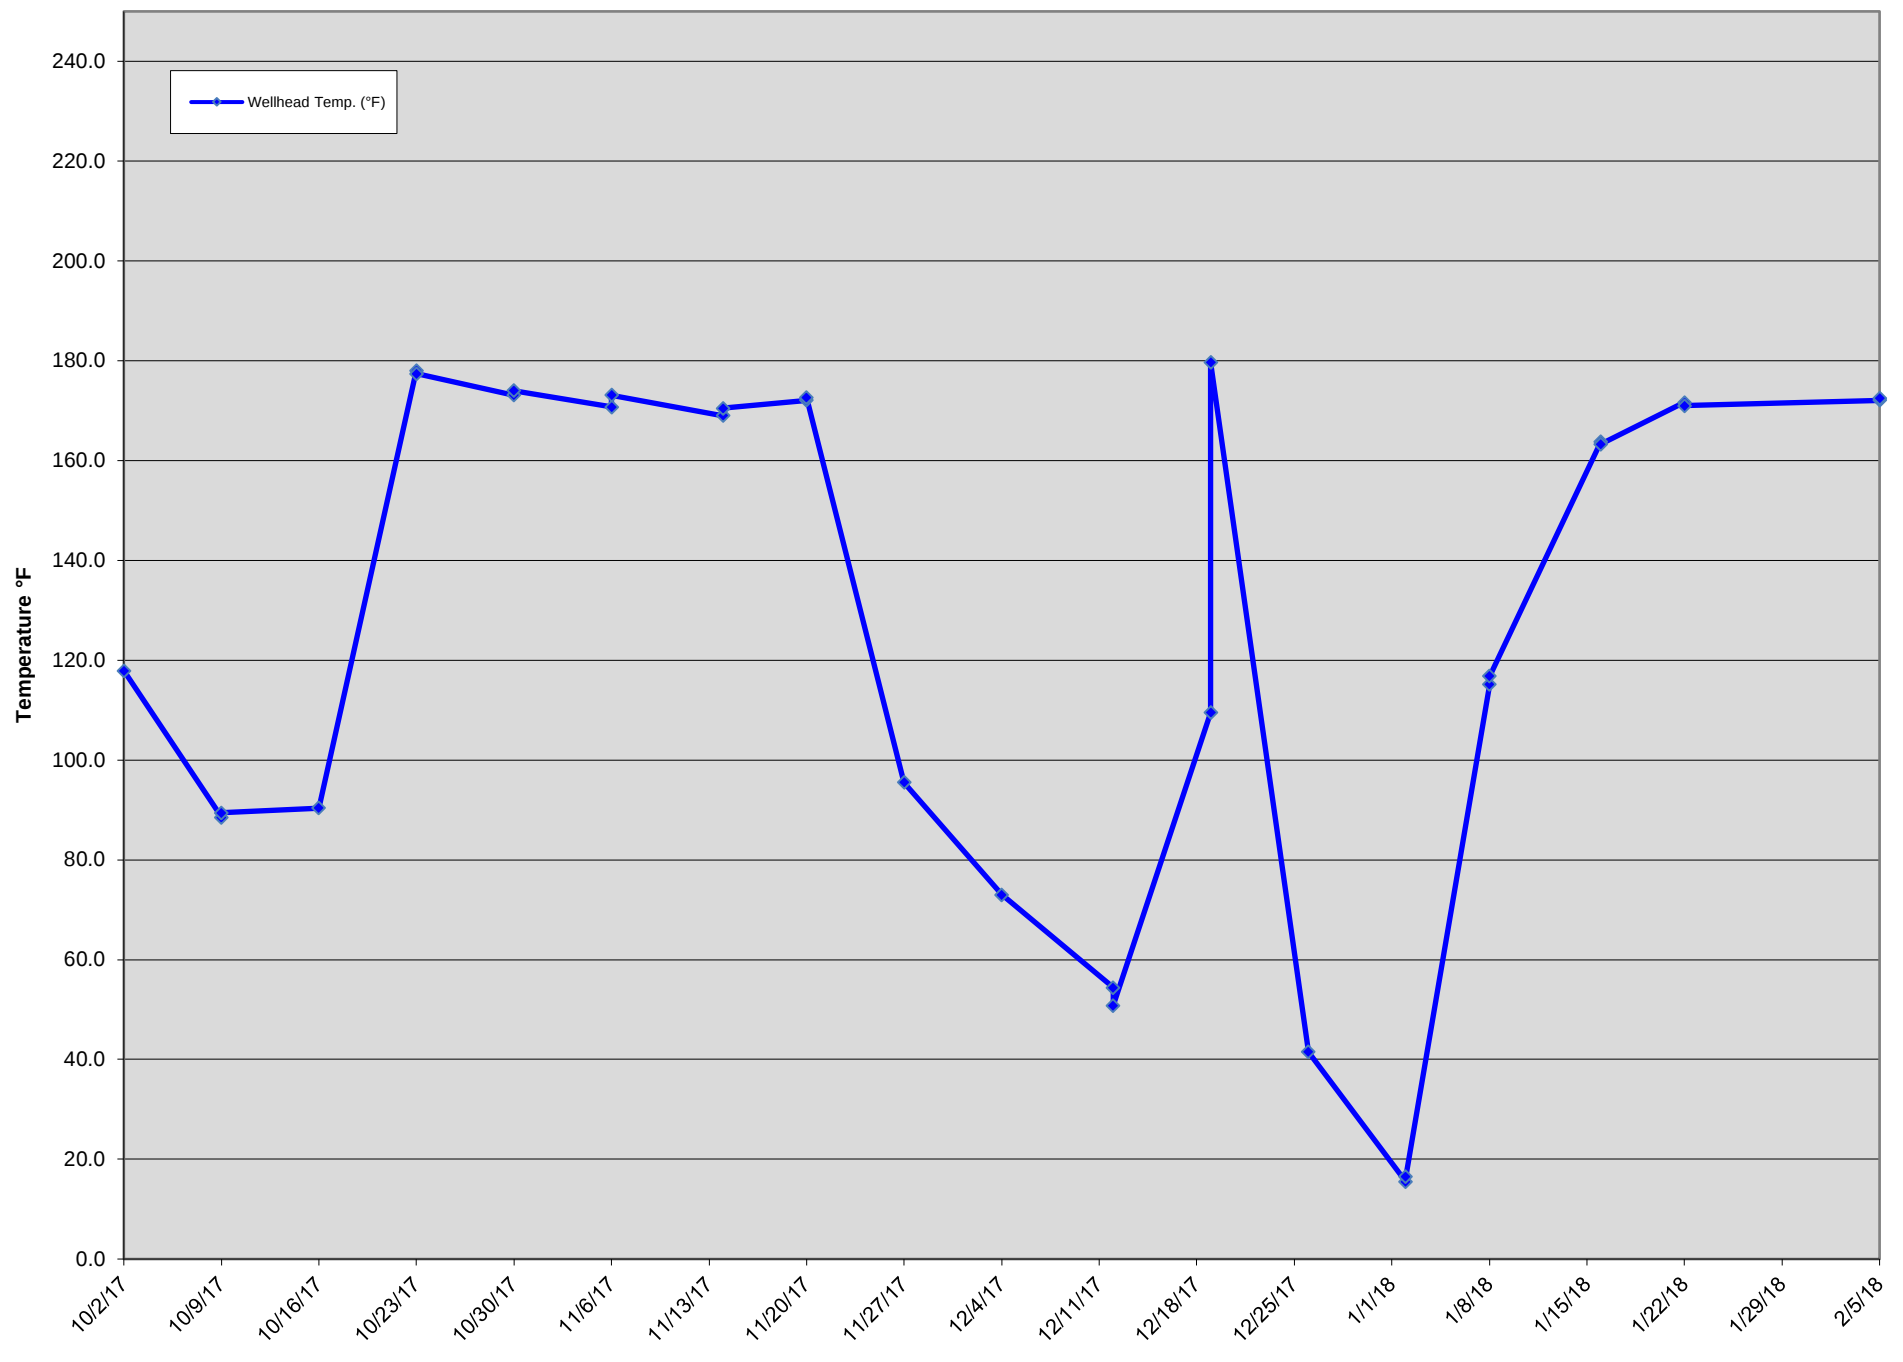
GIW-1 Wellhead Temperatures

As part of the HES, there are currently cooling water circulation loops installed in twelve Gas Interceptor Wells (GIWs) (GIW-02 through GIW-13). The remaining well (GIW-01) had a measured gas temperature within its historical operating limits.
