Bridgeton Landfill, LLC

Weekly Data Submittal

Week of February 18, 2018 – February 24, 2018

**Required by Section 52.F of Agreed Order, Case No. 13SL-CC01088
Effective May 13, 2013**

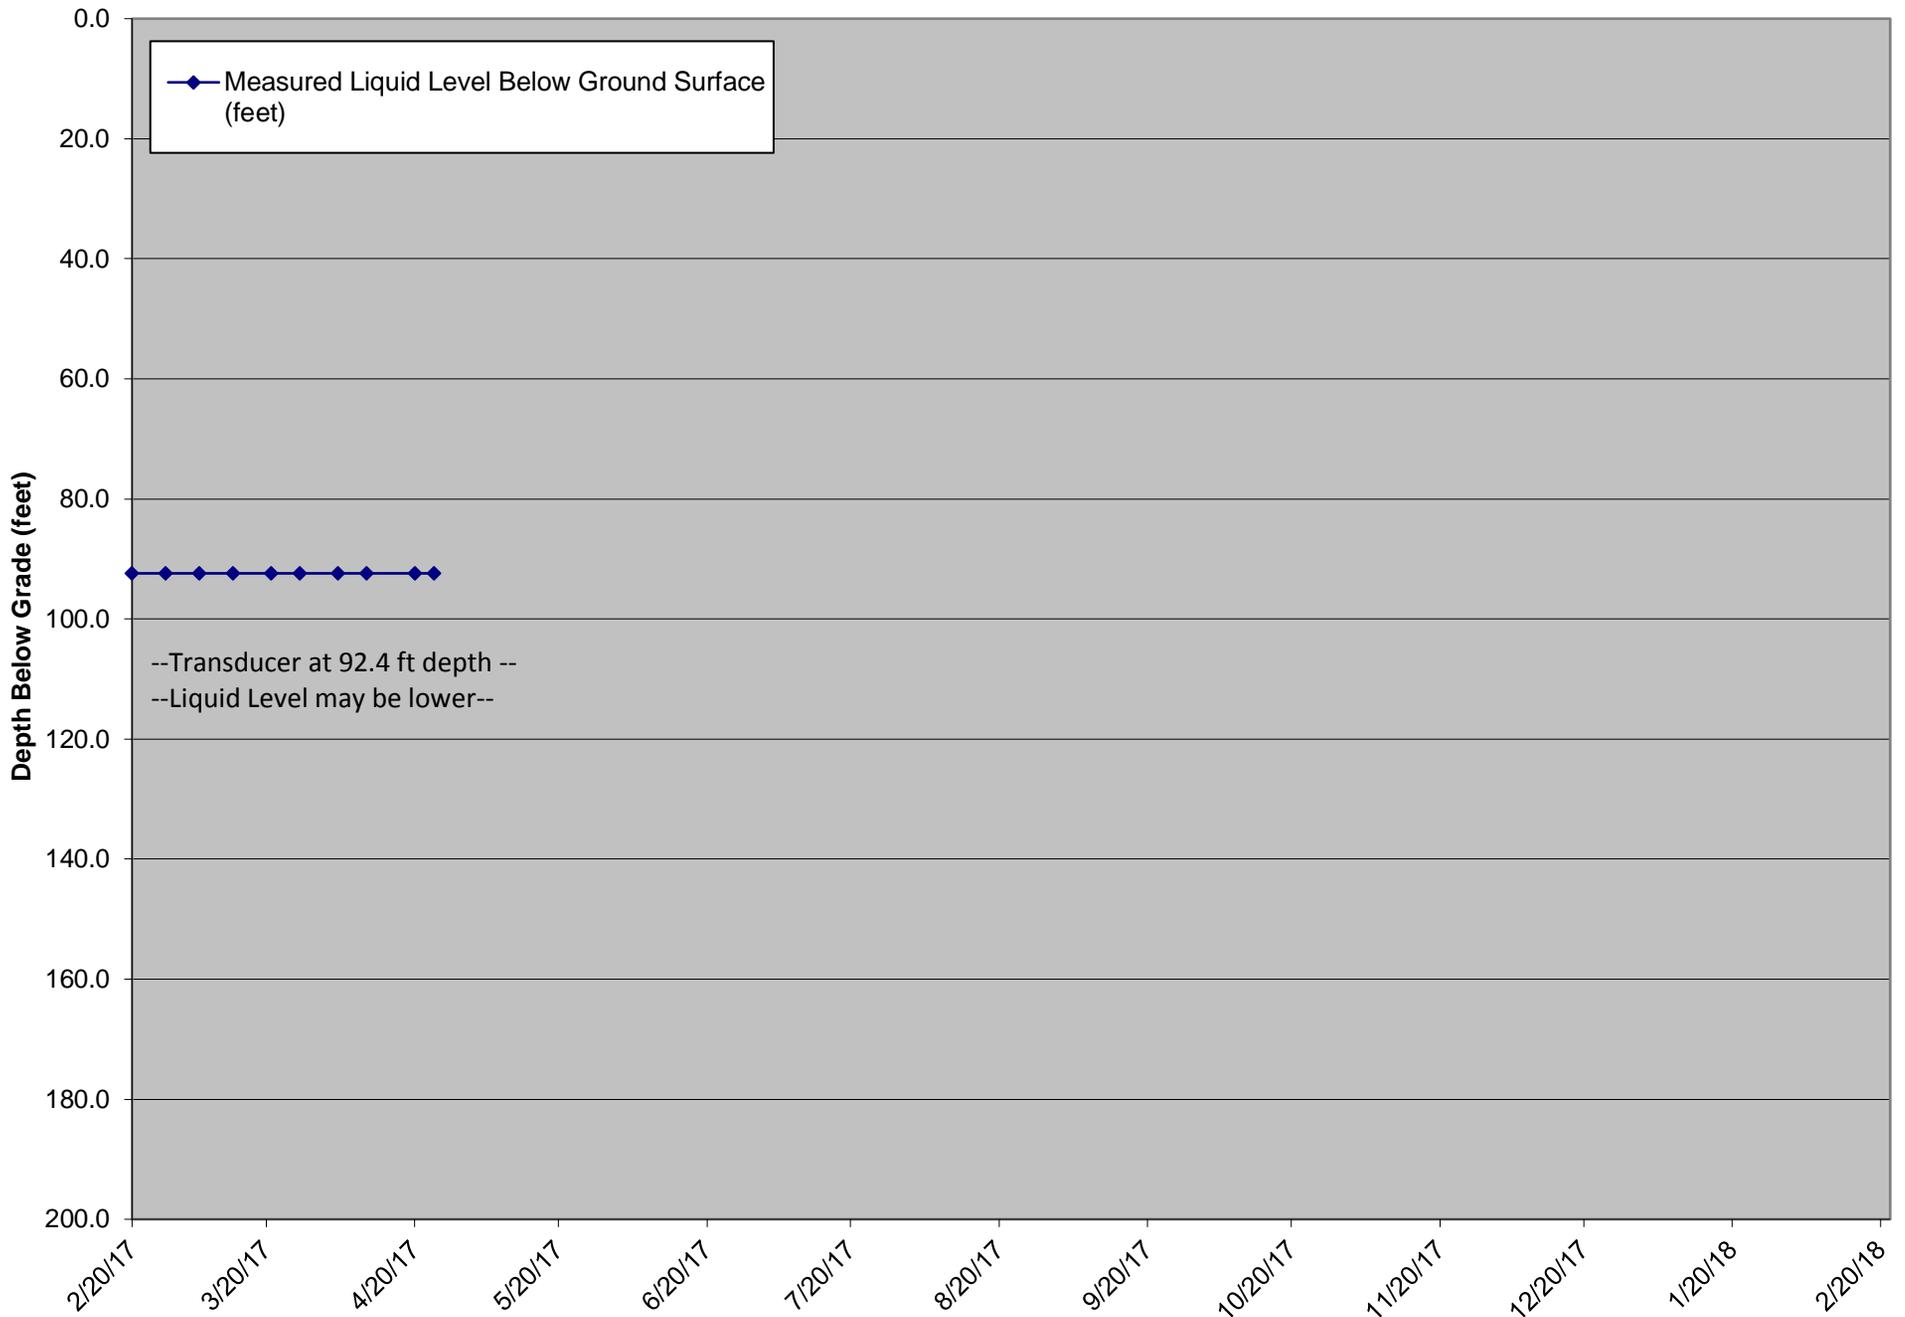
LCS-1D Liquid Level Below Ground Surface

Downhole discharge piping and the pump for LCS-1D was replaced the week of 2/5/18. Pump was non-operational after startup activities. Pump replacement is pending parts arrival.

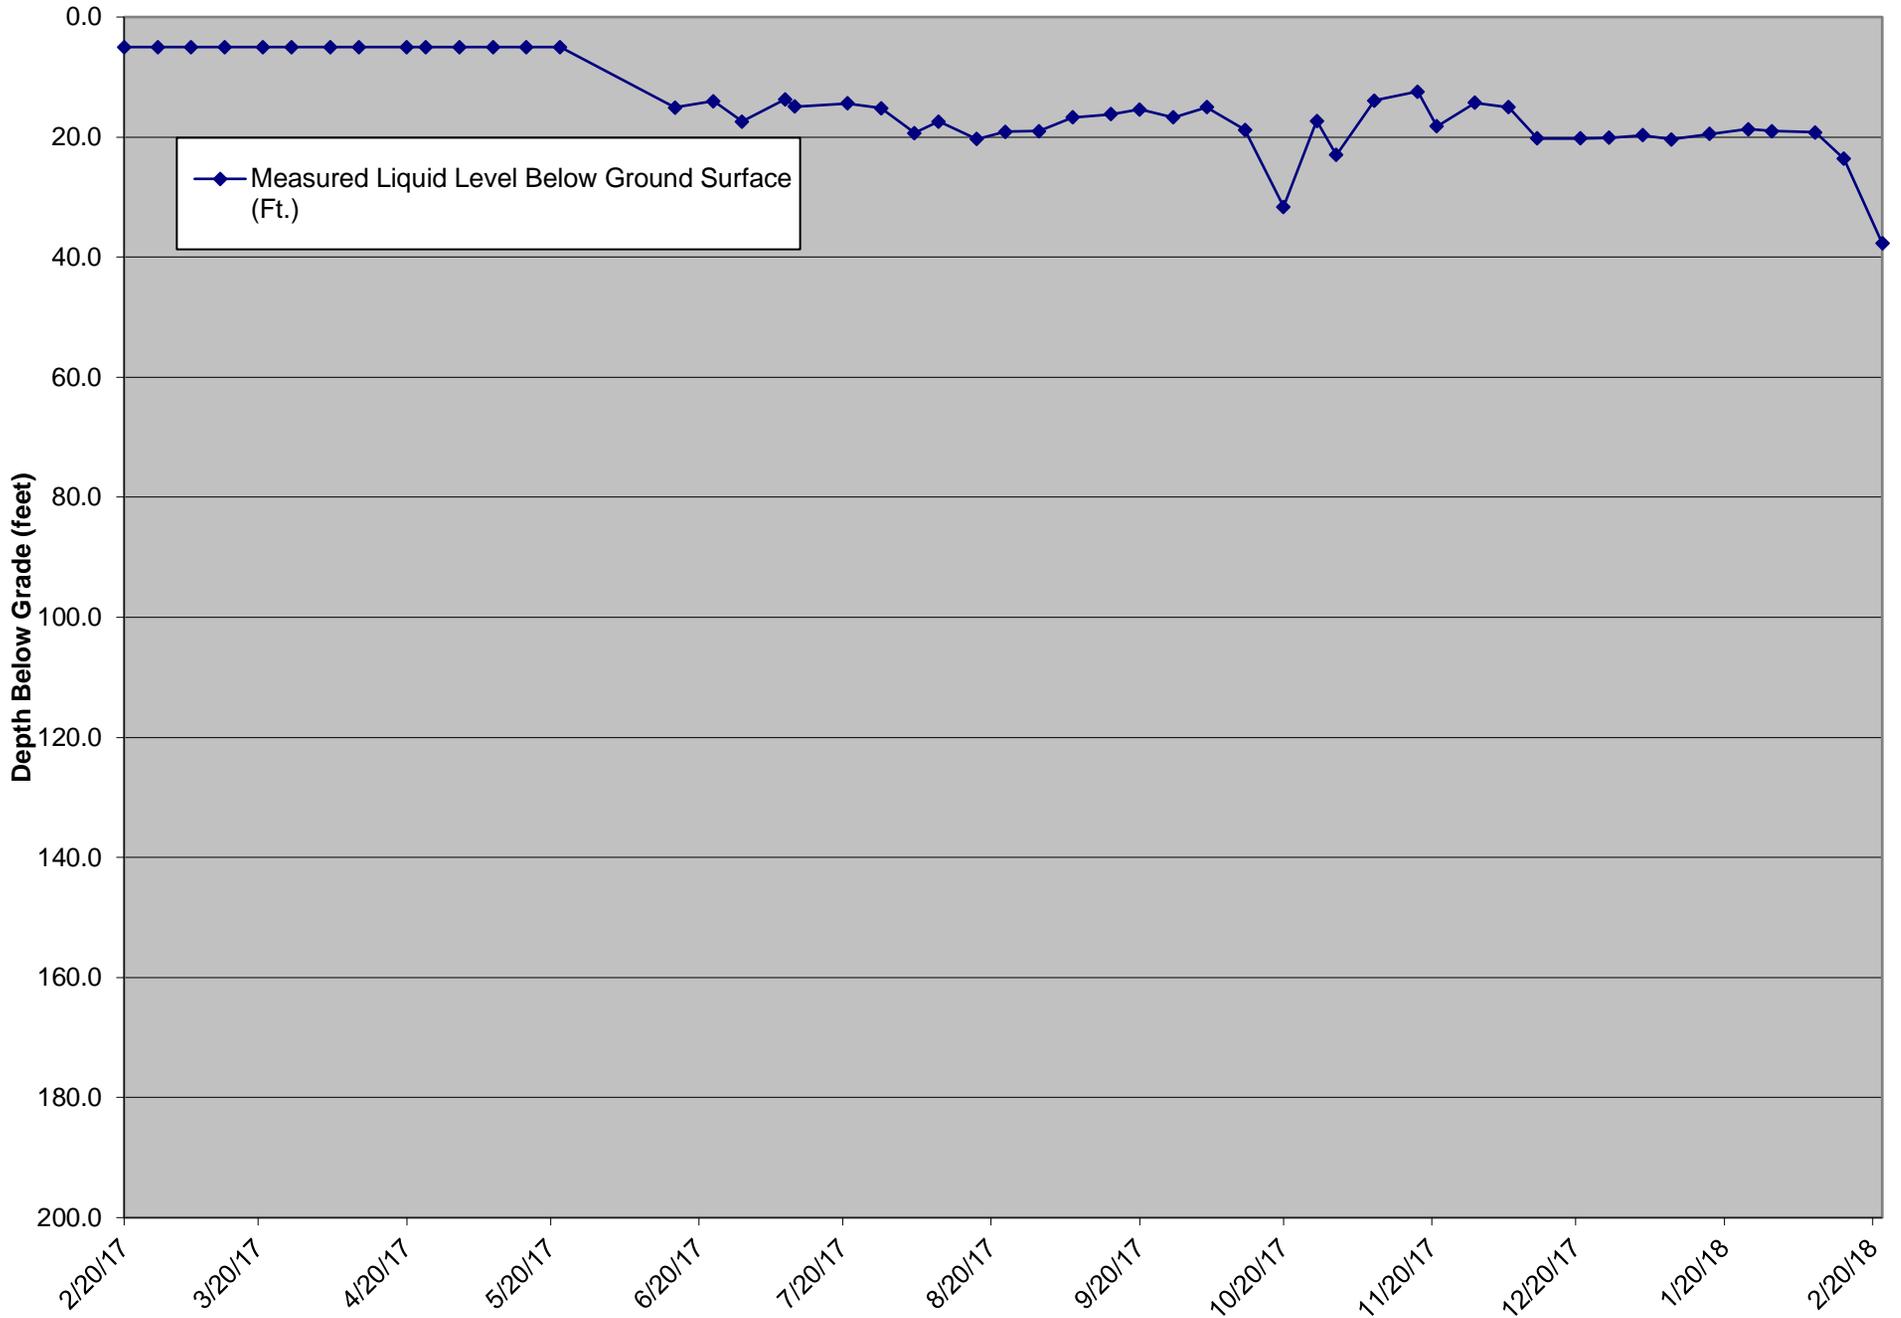
LCS-3D Liquid Level Below Ground Surface

The Blackhawk pneumatic pumps in LCS-3D were replaced with a QED AP-4 pneumatic pump on 2/15/18. Liquid level was measured manually.

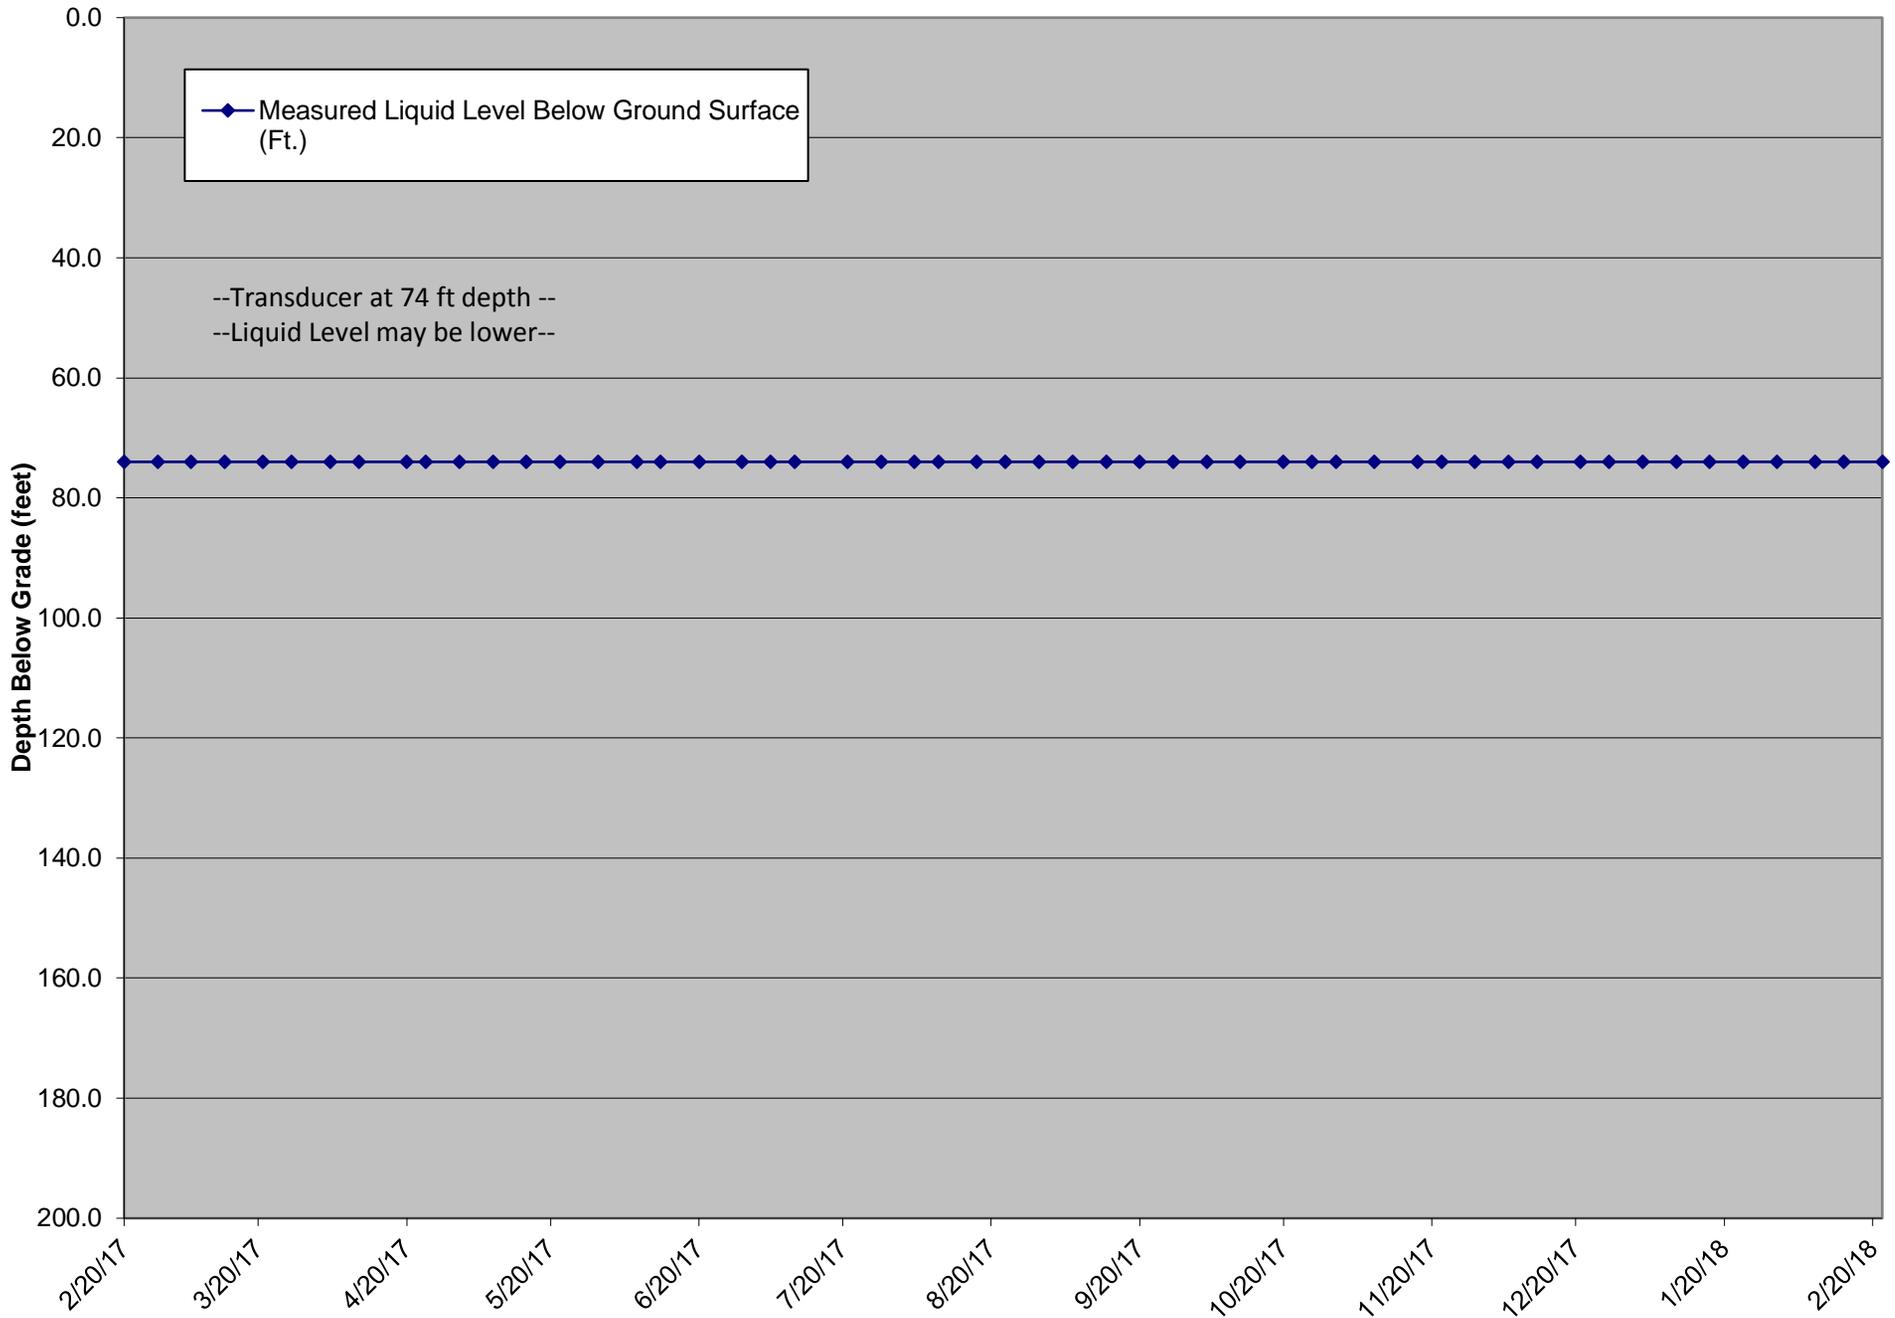
LCS-4B Liquid Level Below Ground Surface

The level sensor in LCS-4B is currently operational and responsive. Liquid level was not recorded by the level sensor during the weekly reporting period. LCS-4B is equipped with a flow meter that displayed no flow during the weekly reporting period. Therefore, it can be concluded that the liquid level was below the bottom of the pump and level sensor in LCS-4B.

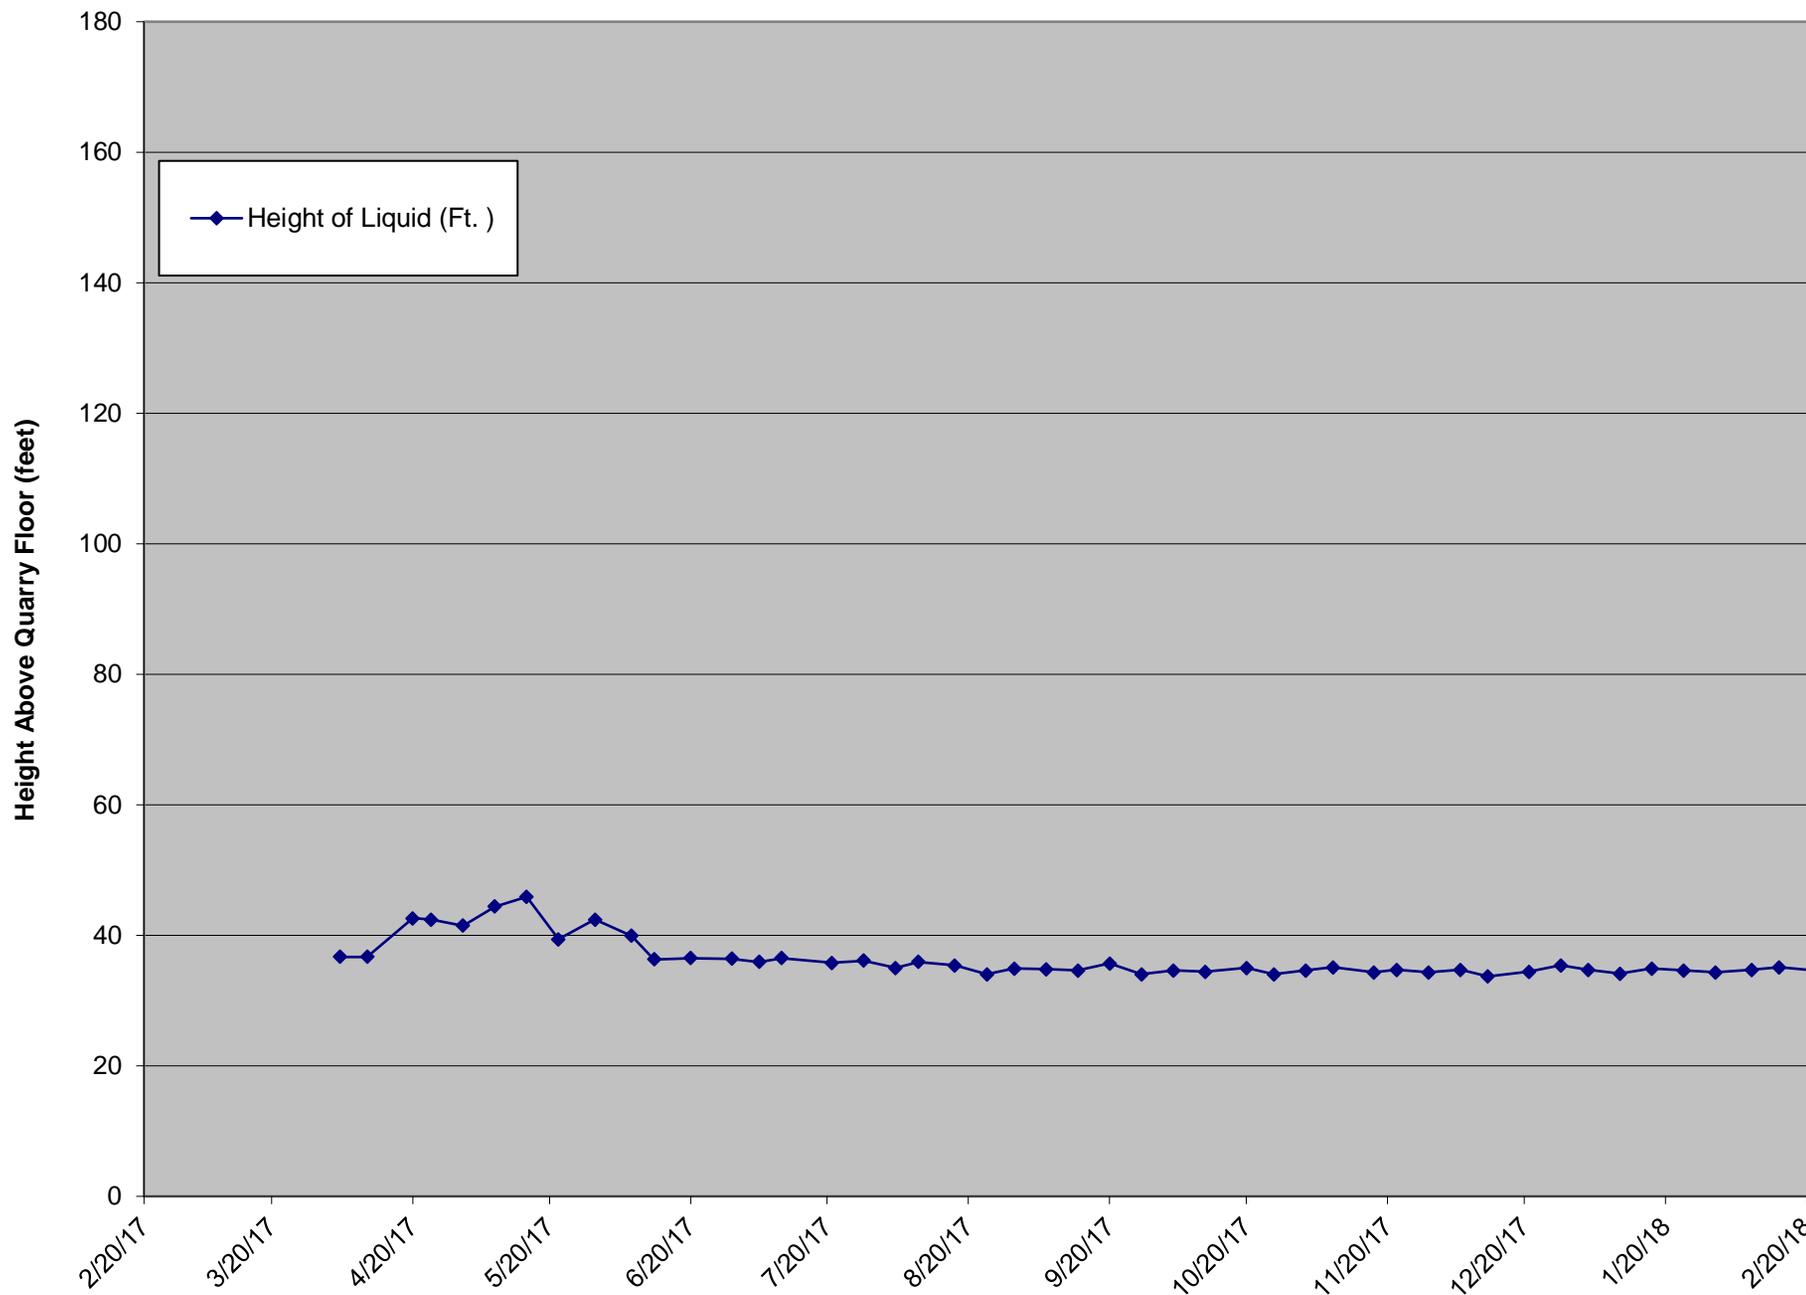
LCS-5B Liquid Level Above Quarry Floor

LCS-5B and LCS-6B were fully operational during the weekly reporting period.

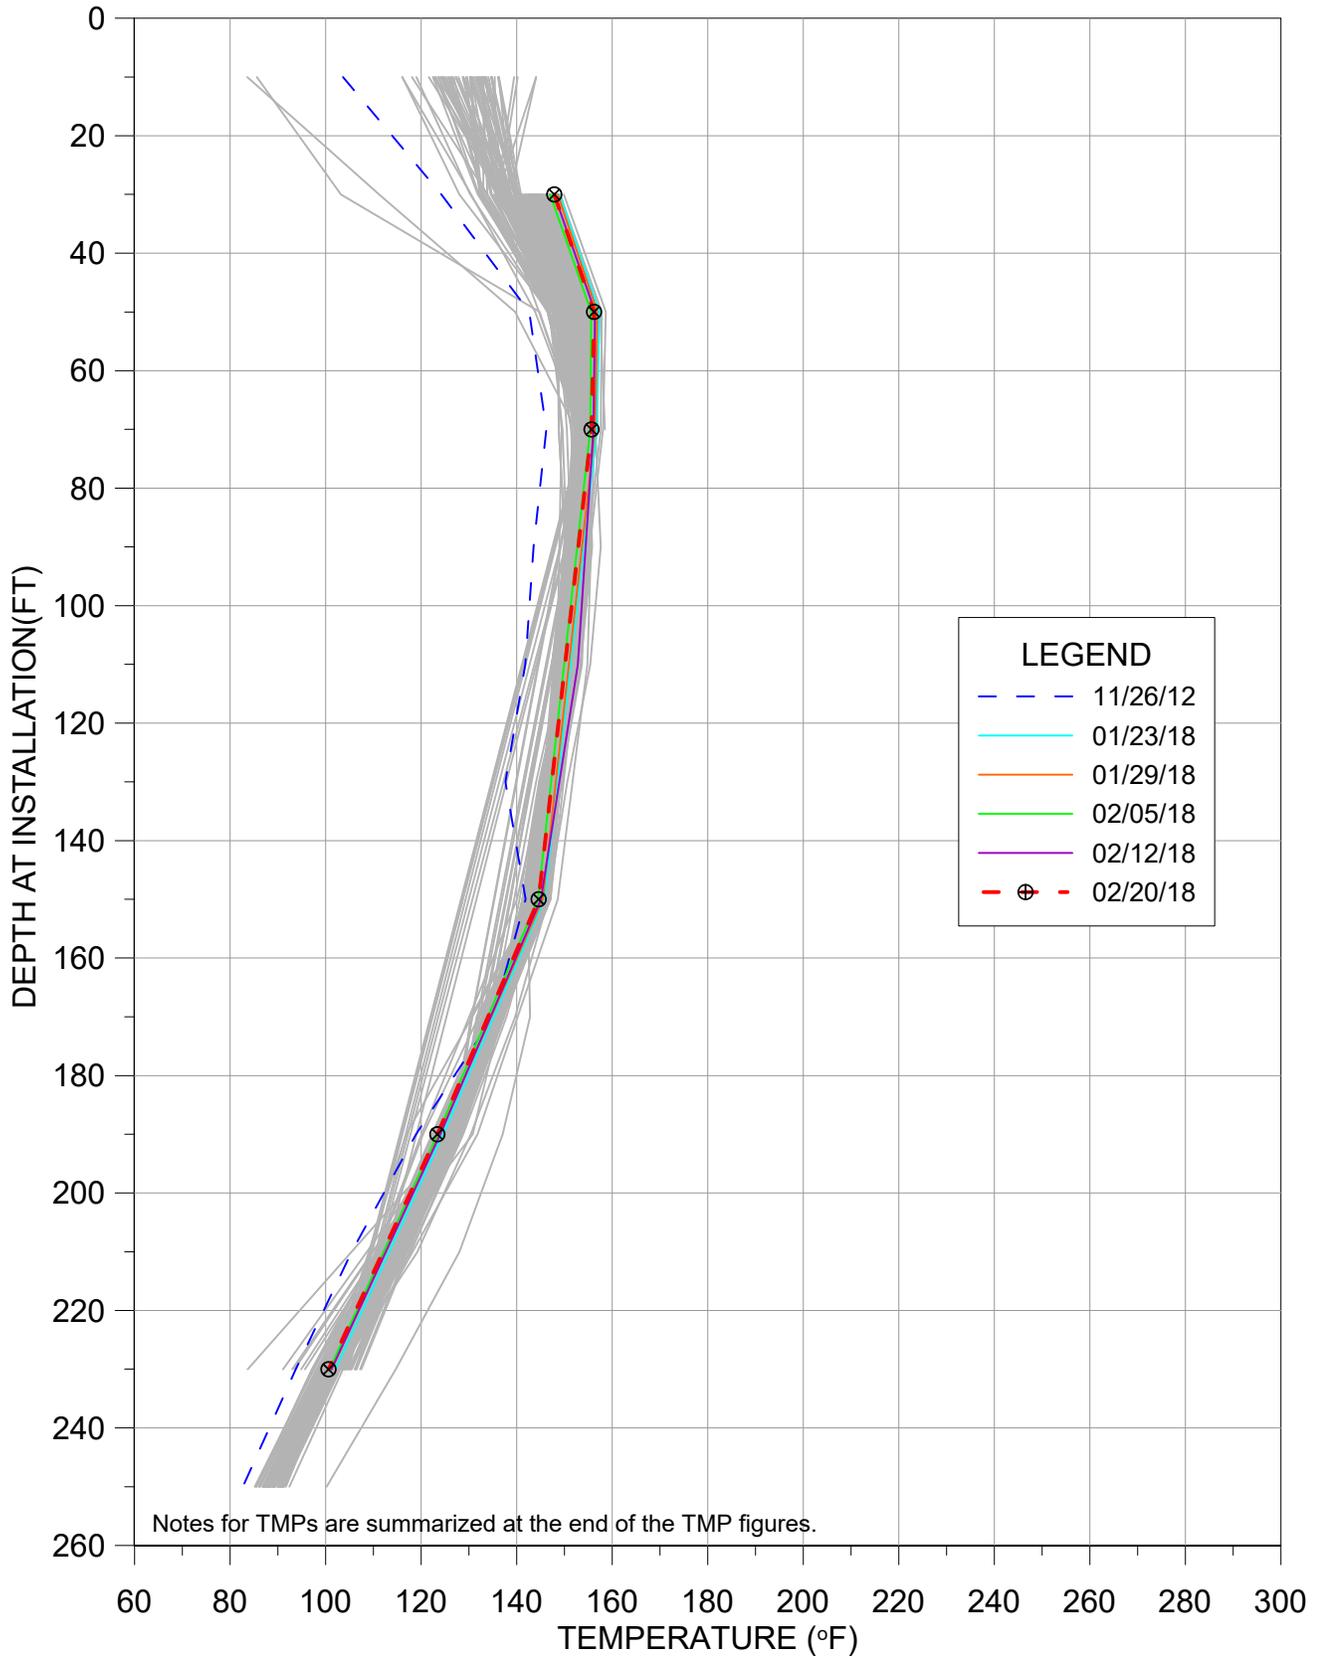
TMP-3

1. No reliable temperature readings have been obtained at 170 ft depth since 1/29/2014, except on 3/13/2014.
2. The connectivity tests on 4/11/2014 conducted by CEC showed that units at 10, 90, 130, 210 and 250 ft depths are no longer reliable.
3. The connectivity tests on 10/28/2014 conducted by Feezor Engineering showed that units at 10, 90, 110, 130, 210 and 250 ft depths are not reliable.

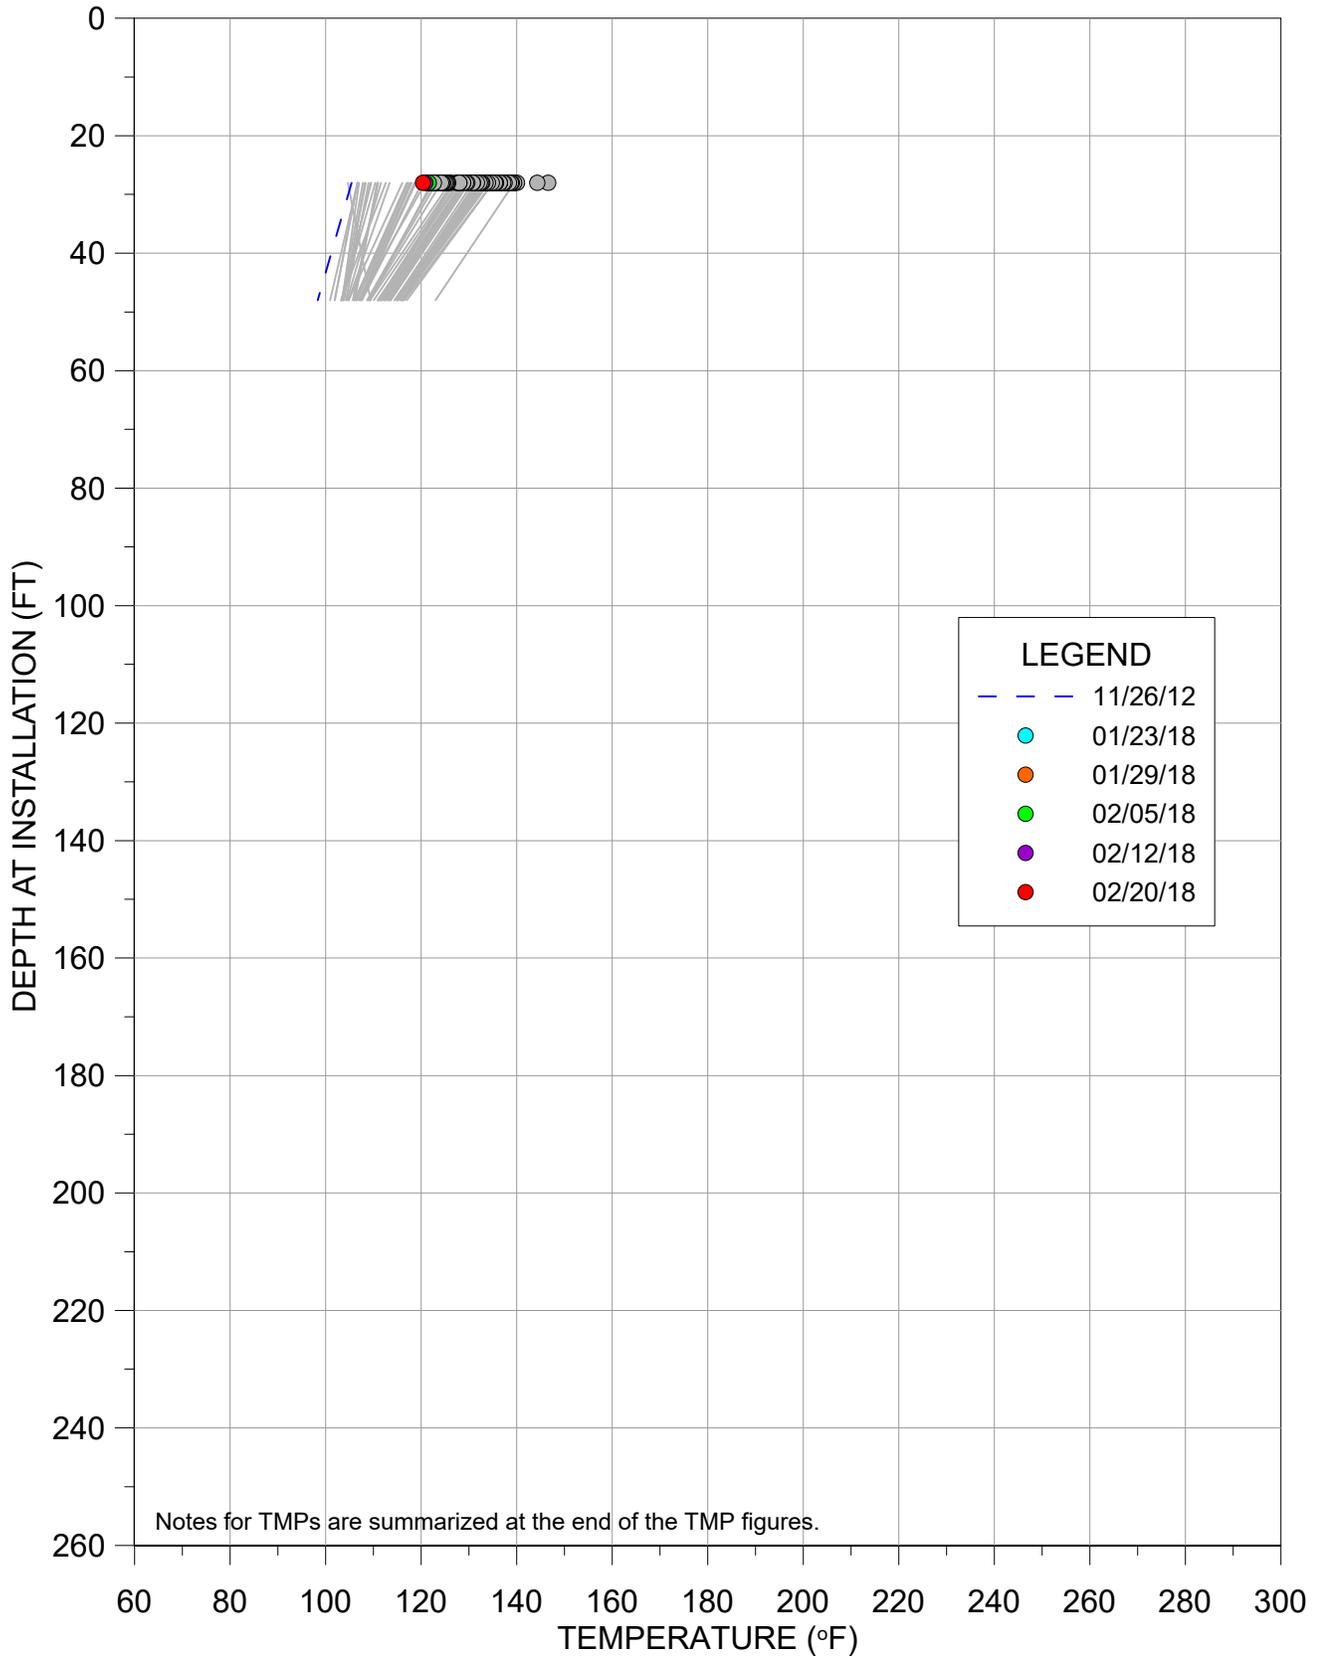
TMP-4

1. The connectivity tests on 4/11/2014 conducted by CEC showed that the unit at 48 ft depth is no longer reliable.

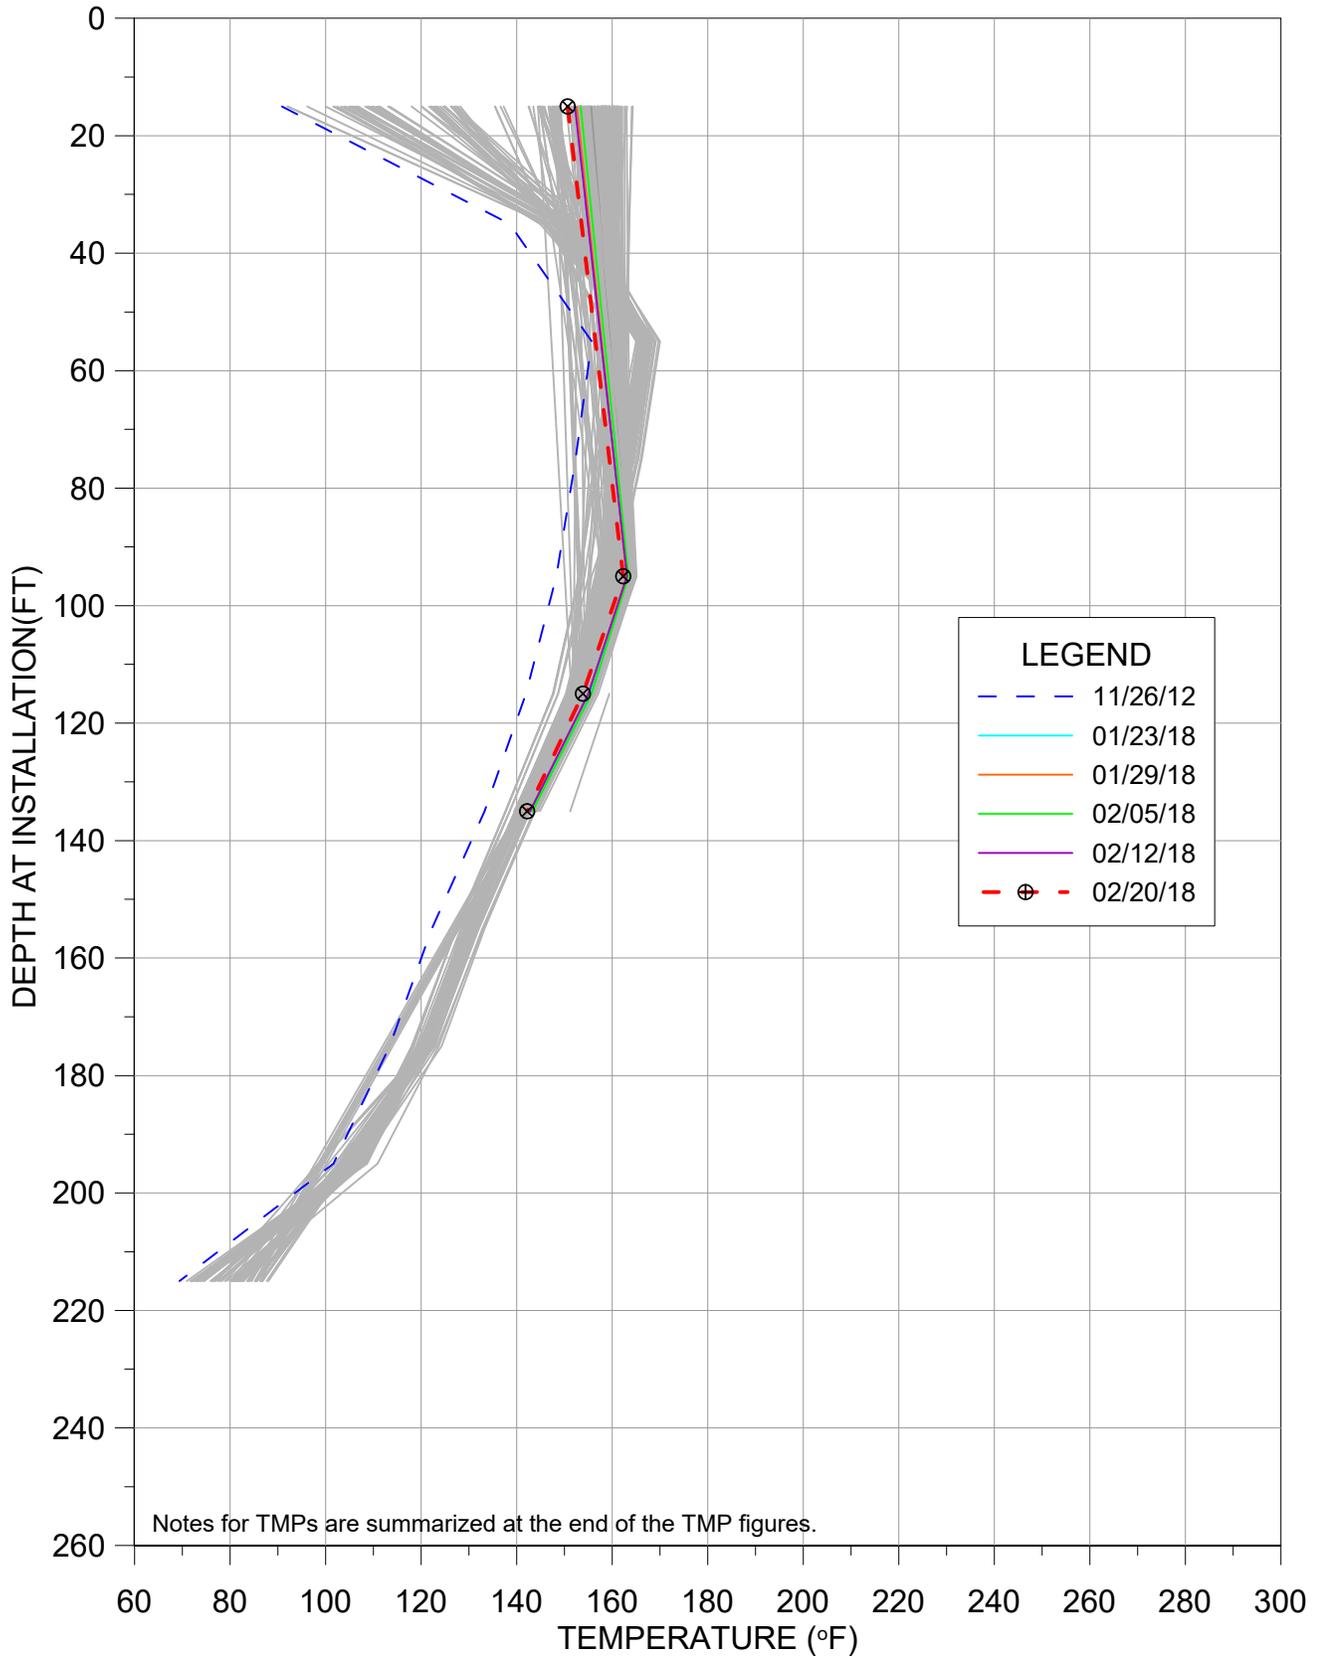
TMP-6

1. The connectivity tests on 4/11/2014 conducted by CEC showed that units at 35, 55, 75, 155, 175, and 195 ft depths are no longer reliable.
2. No reliable temperature readings have been obtained at the unit at 215 ft depth since 6/13/2014.

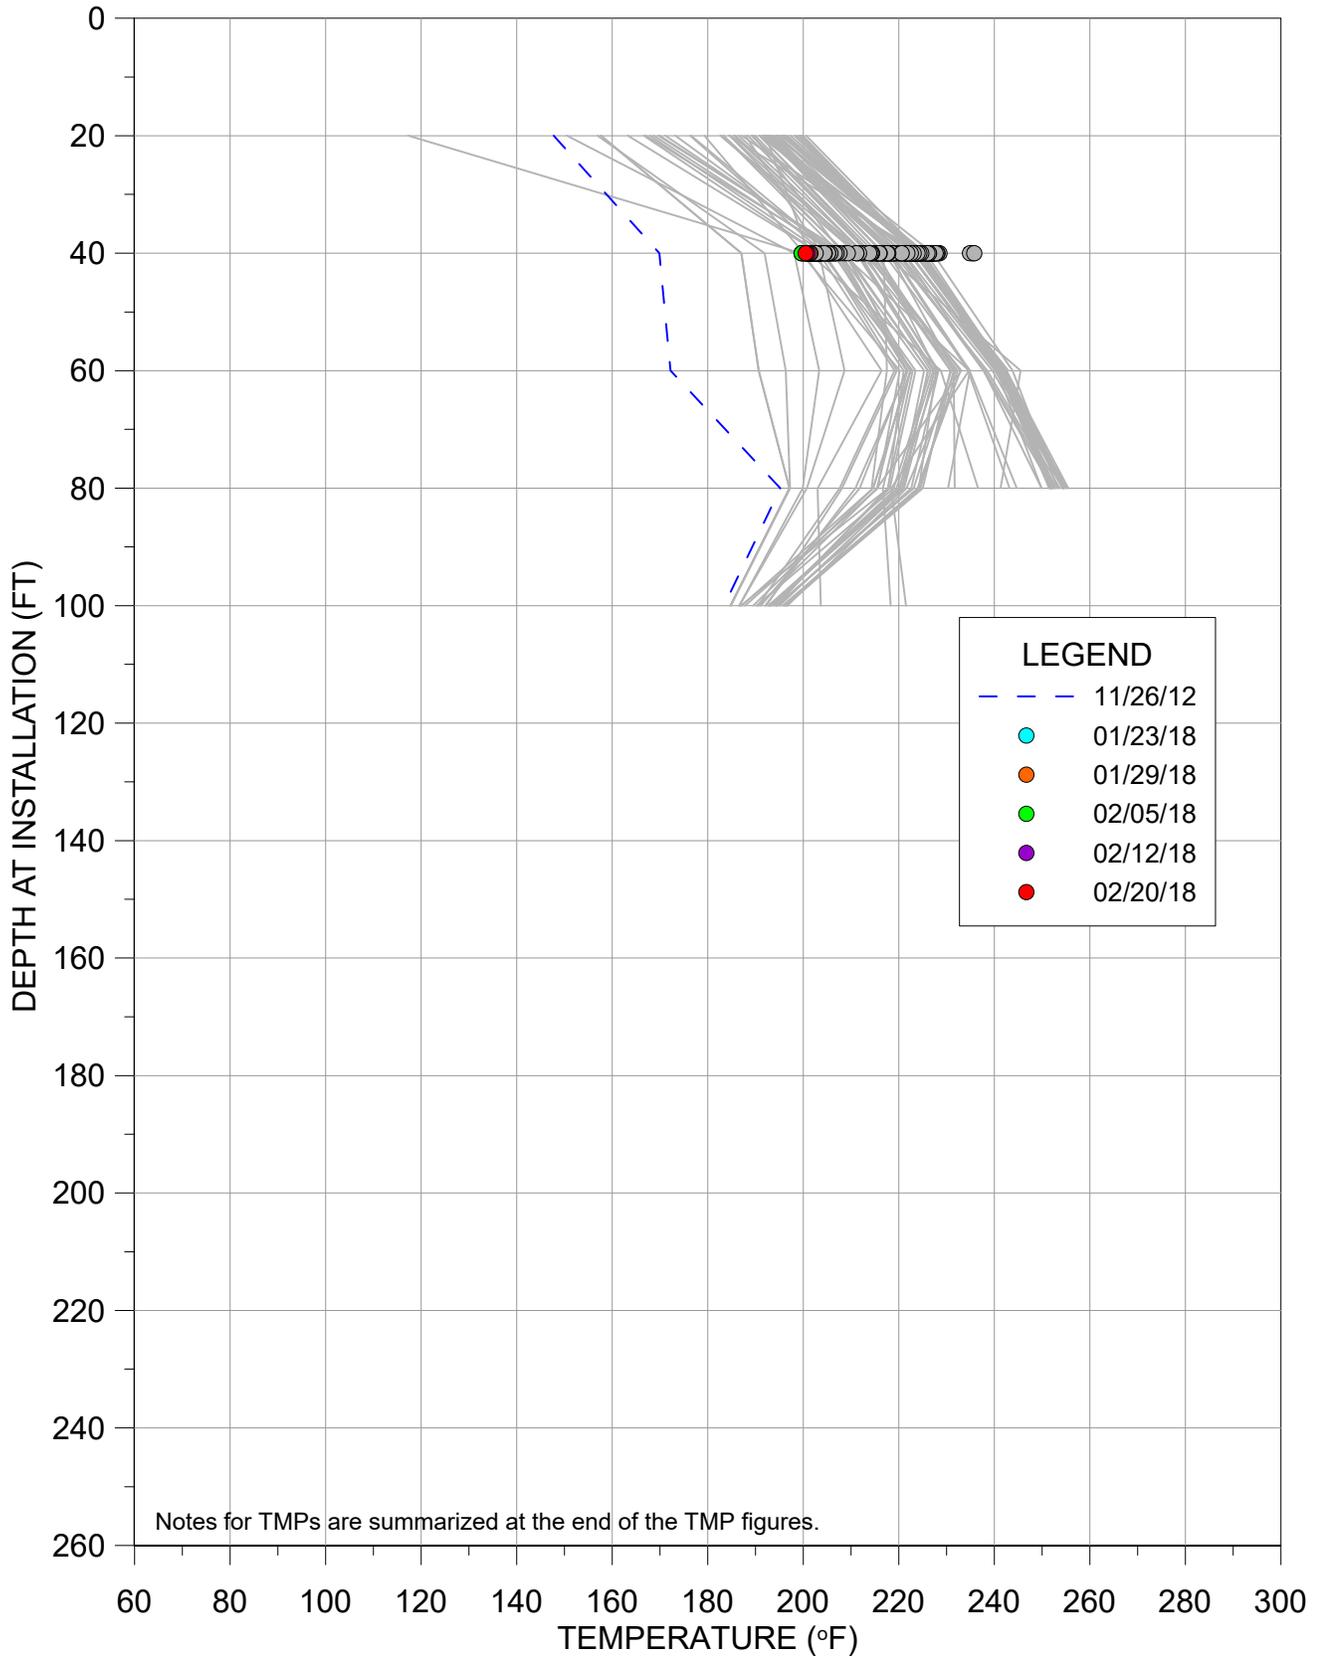
TMP-9

1. Unit at 100 ft depth had an inaccurate temperature reading on 8/1/2013 and no reading since 8/6/2013.
2. The connectivity tests on 4/11/2014 conducted by CEC showed that units at 20, 60, 80, and 100 ft depths are no longer reliable.

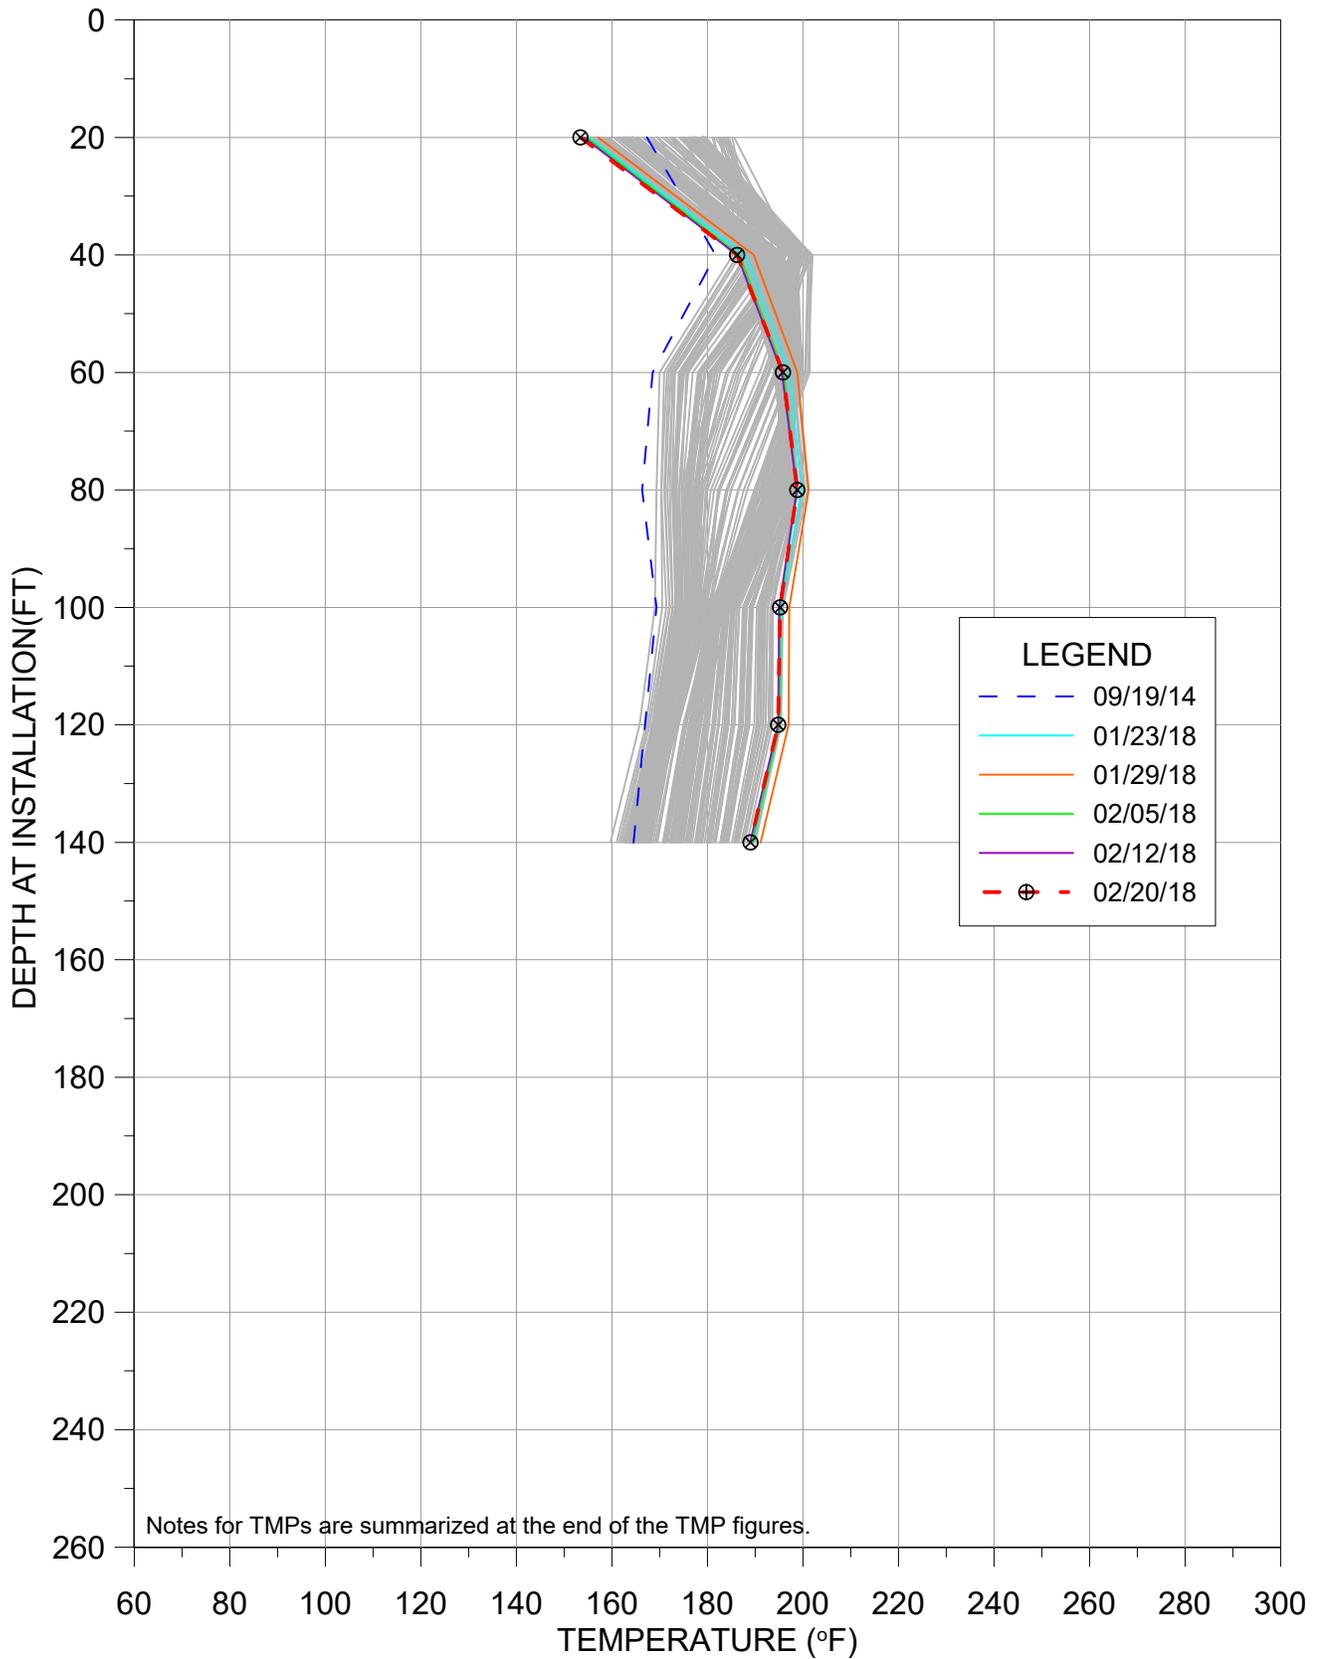
1. Due to the connectivity test results by Feezor Engineering on TMP-14 (see note above), TMP-14R is added to this reporting data set as of 3/7/2016.
