Bridgeton Landfill, LLC

Weekly Data Submittal

Week of February 18, 2018 – February 24, 2018

**Required by Section 52.F of Agreed Order, Case No. 13SL-CC01088
Effective May 13, 2013**

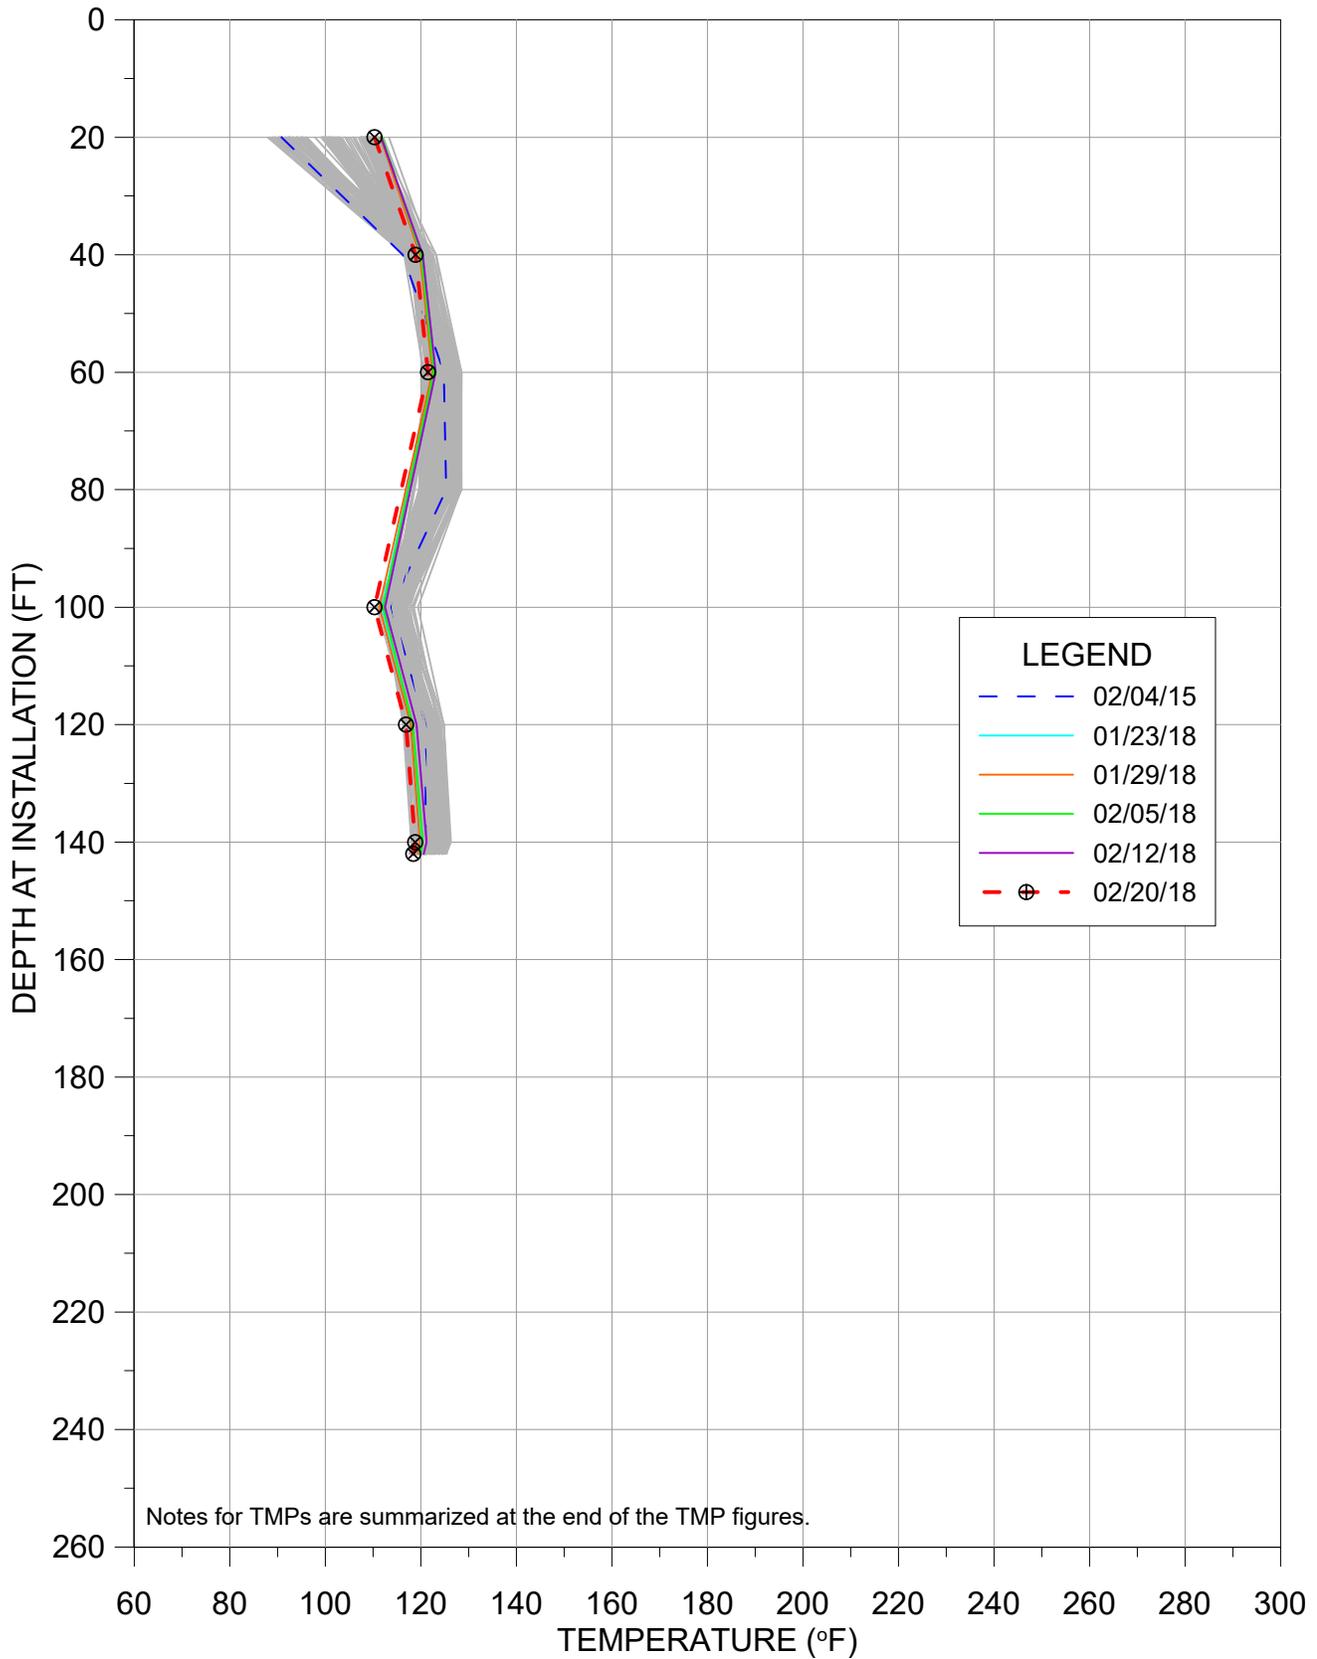
TMP-26

1. Resistance on unit at 80 ft dropped 12.9 ohms (11/06/2017) and subsequent resistance reading continue to be low. Upon further investigation by Feezor Engineering, this unit is determined to be unreliable.

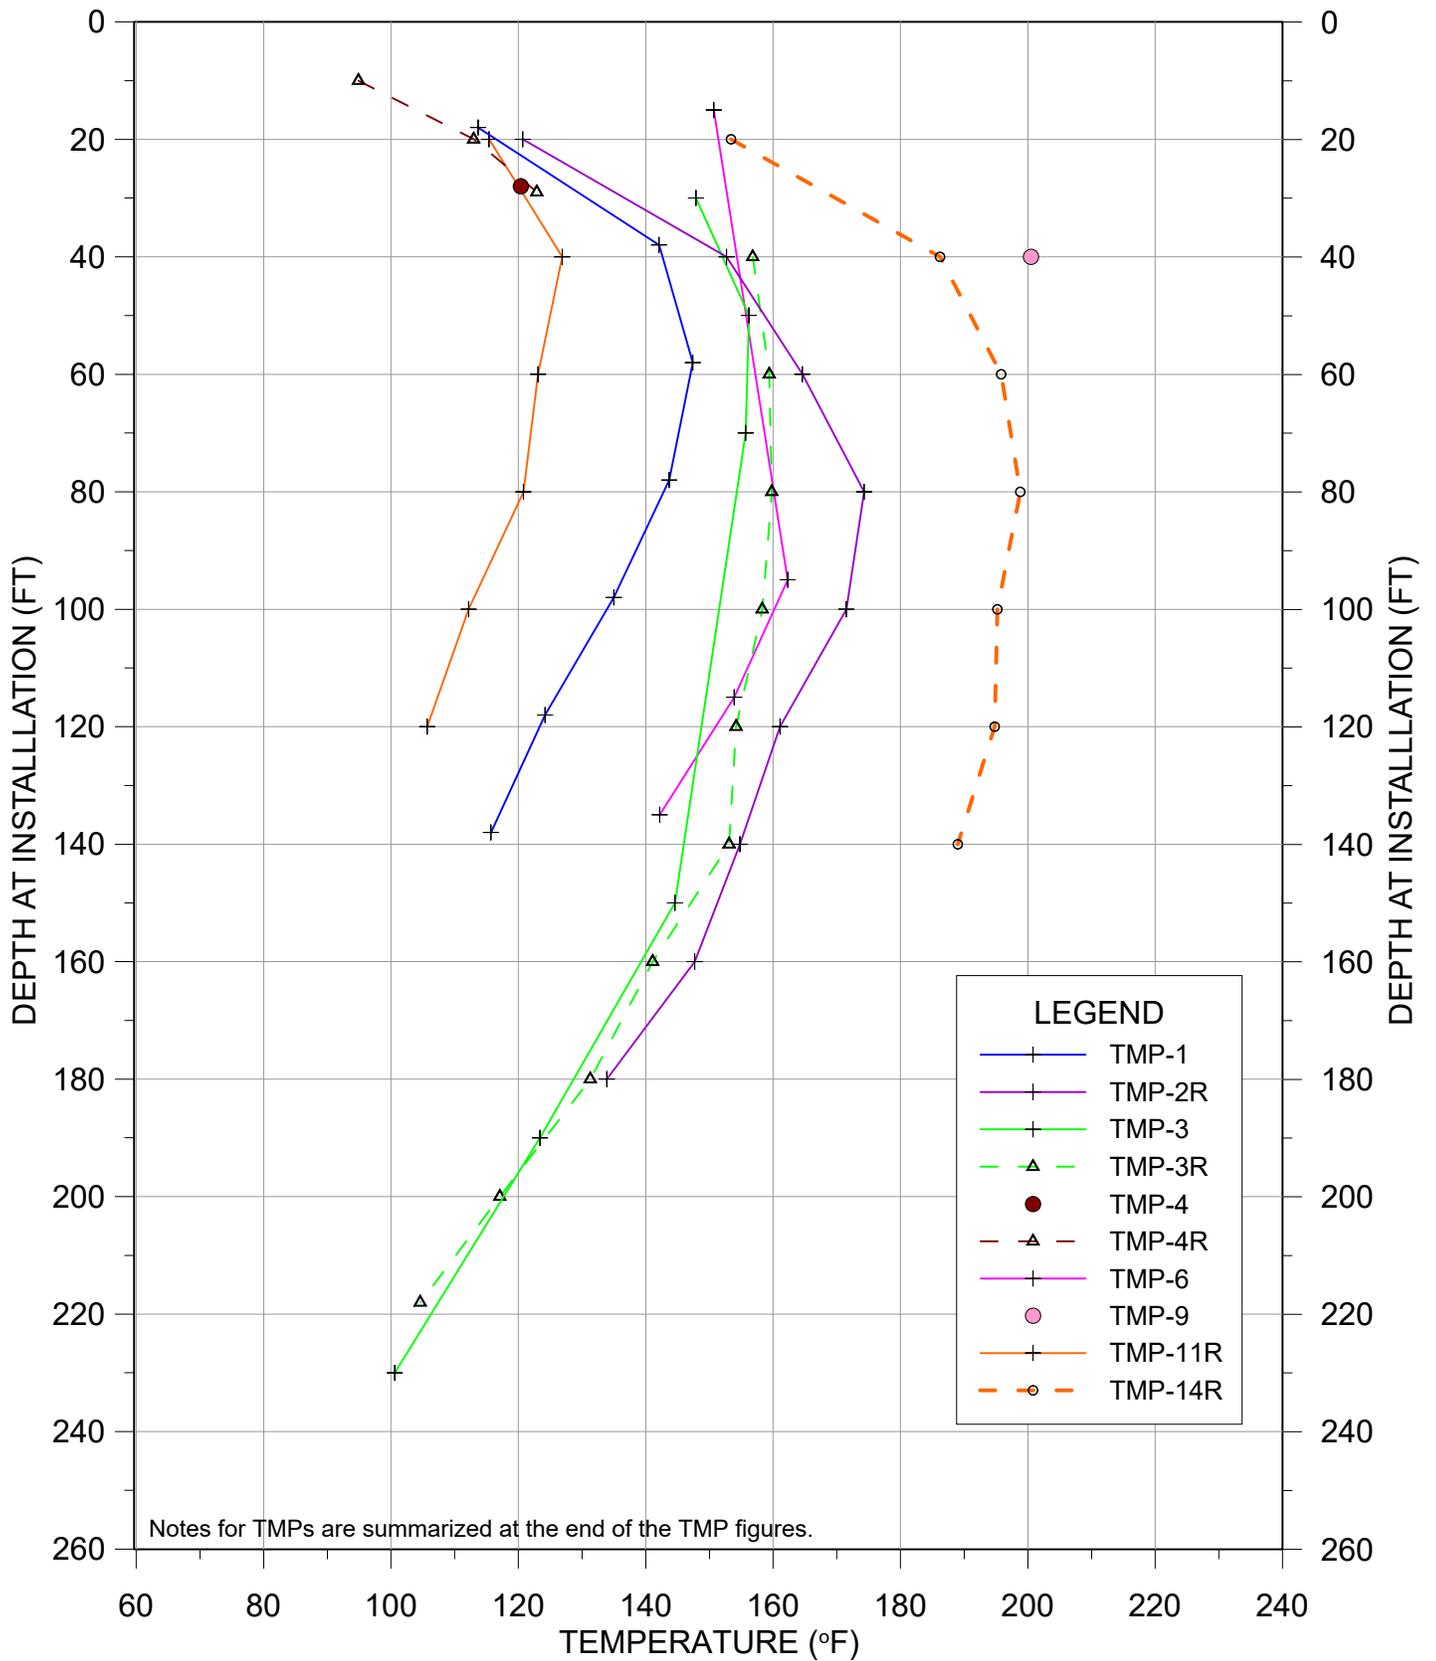
TEMPERATURE VS DEPTH
BRIDGETON LANDFILL

1. There were no reliable temperature readings for TMP-13 since 3/19/2014.
2. There were no reliable temperature readings for TMP-7R, as determined by the connectivity test on 4/11/2014.

3. There were no reliable temperature readings for TMP-5 since 11/5/2014.
4. There were no reliable temperature readings for TMP-12 since 9/28/2015.
5. There were no reliable temperature readings for TMP-8 since 9/9/2015.

6. There were no reliable temperature readings for TMP-14, confirmed since 3/7/2016.
7. There were no reliable temperature readings for TMP-11 as determined by the connectivity test on 11/23/2016.

8. TMP-2 has been replaced by TMP-2R and will no longer be monitored.
9. TMP-11 is no longer in service and will not be included in the presentation.
10. There were no reliable temperature readings for TMP-10 since 5/30/2017.

11. TMP-16, 25, and 28 have been replaced by TMP-16R, 25R, and 28R and will be no longer reported since 1/15/2018.

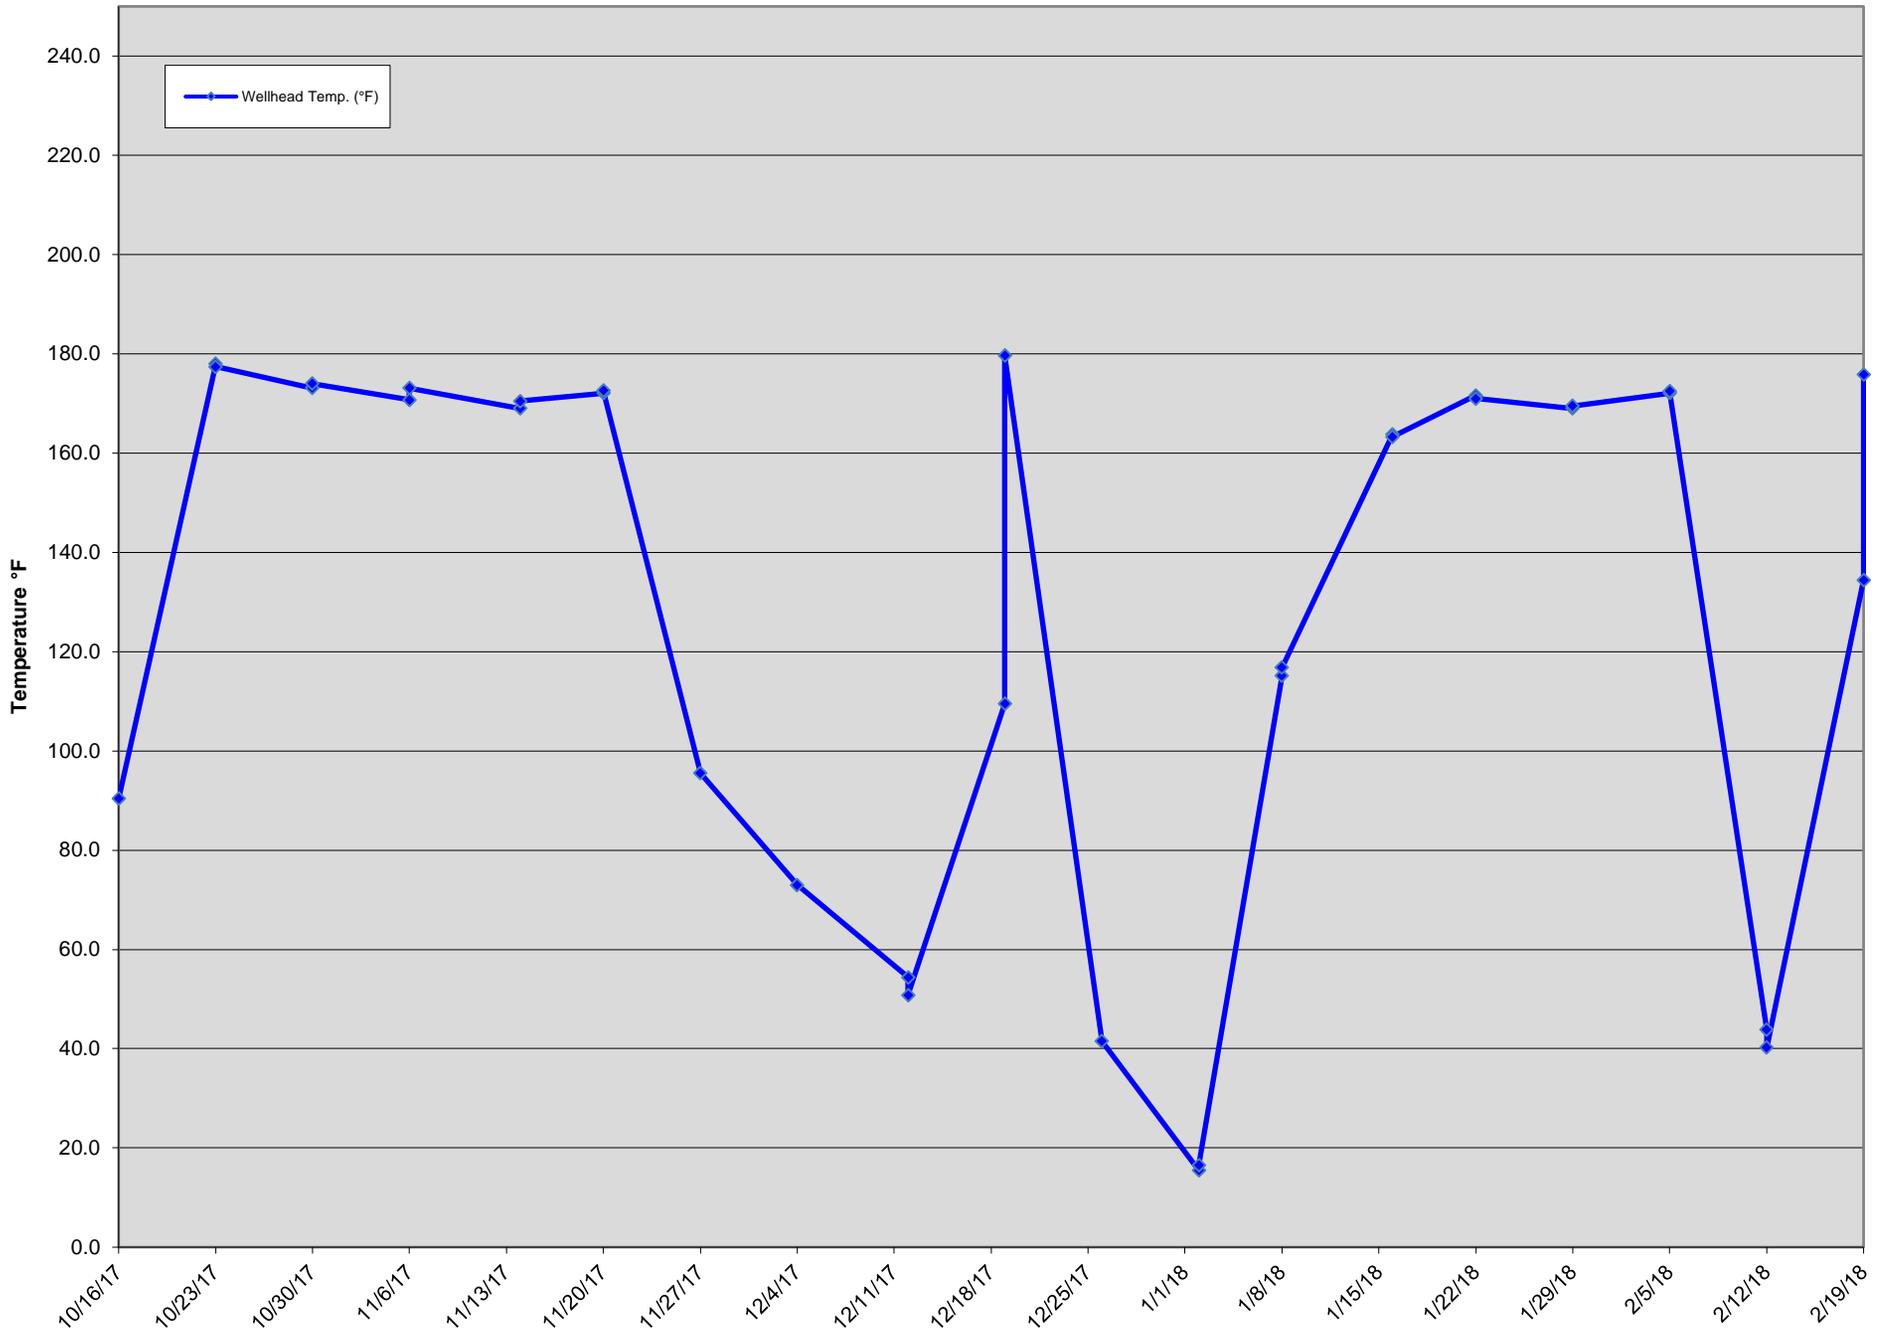
GIW-1 Wellhead Temperatures

As part of the HES, there are currently cooling water circulation loops installed in twelve Gas Interceptor Wells (GIWs) (GIW-02 through GIW-13). The remaining well (GIW-01) had a measured gas temperature within its historical operating limits.
