# **Bridgeton Landfill, LLC**

## **Weekly Data Submittal**

**Week of February 25, 2018 – March 3, 2018**

**Required by Section 52.F of Agreed Order, Case No. 13SL-CC01088  
Effective May 13, 2013**

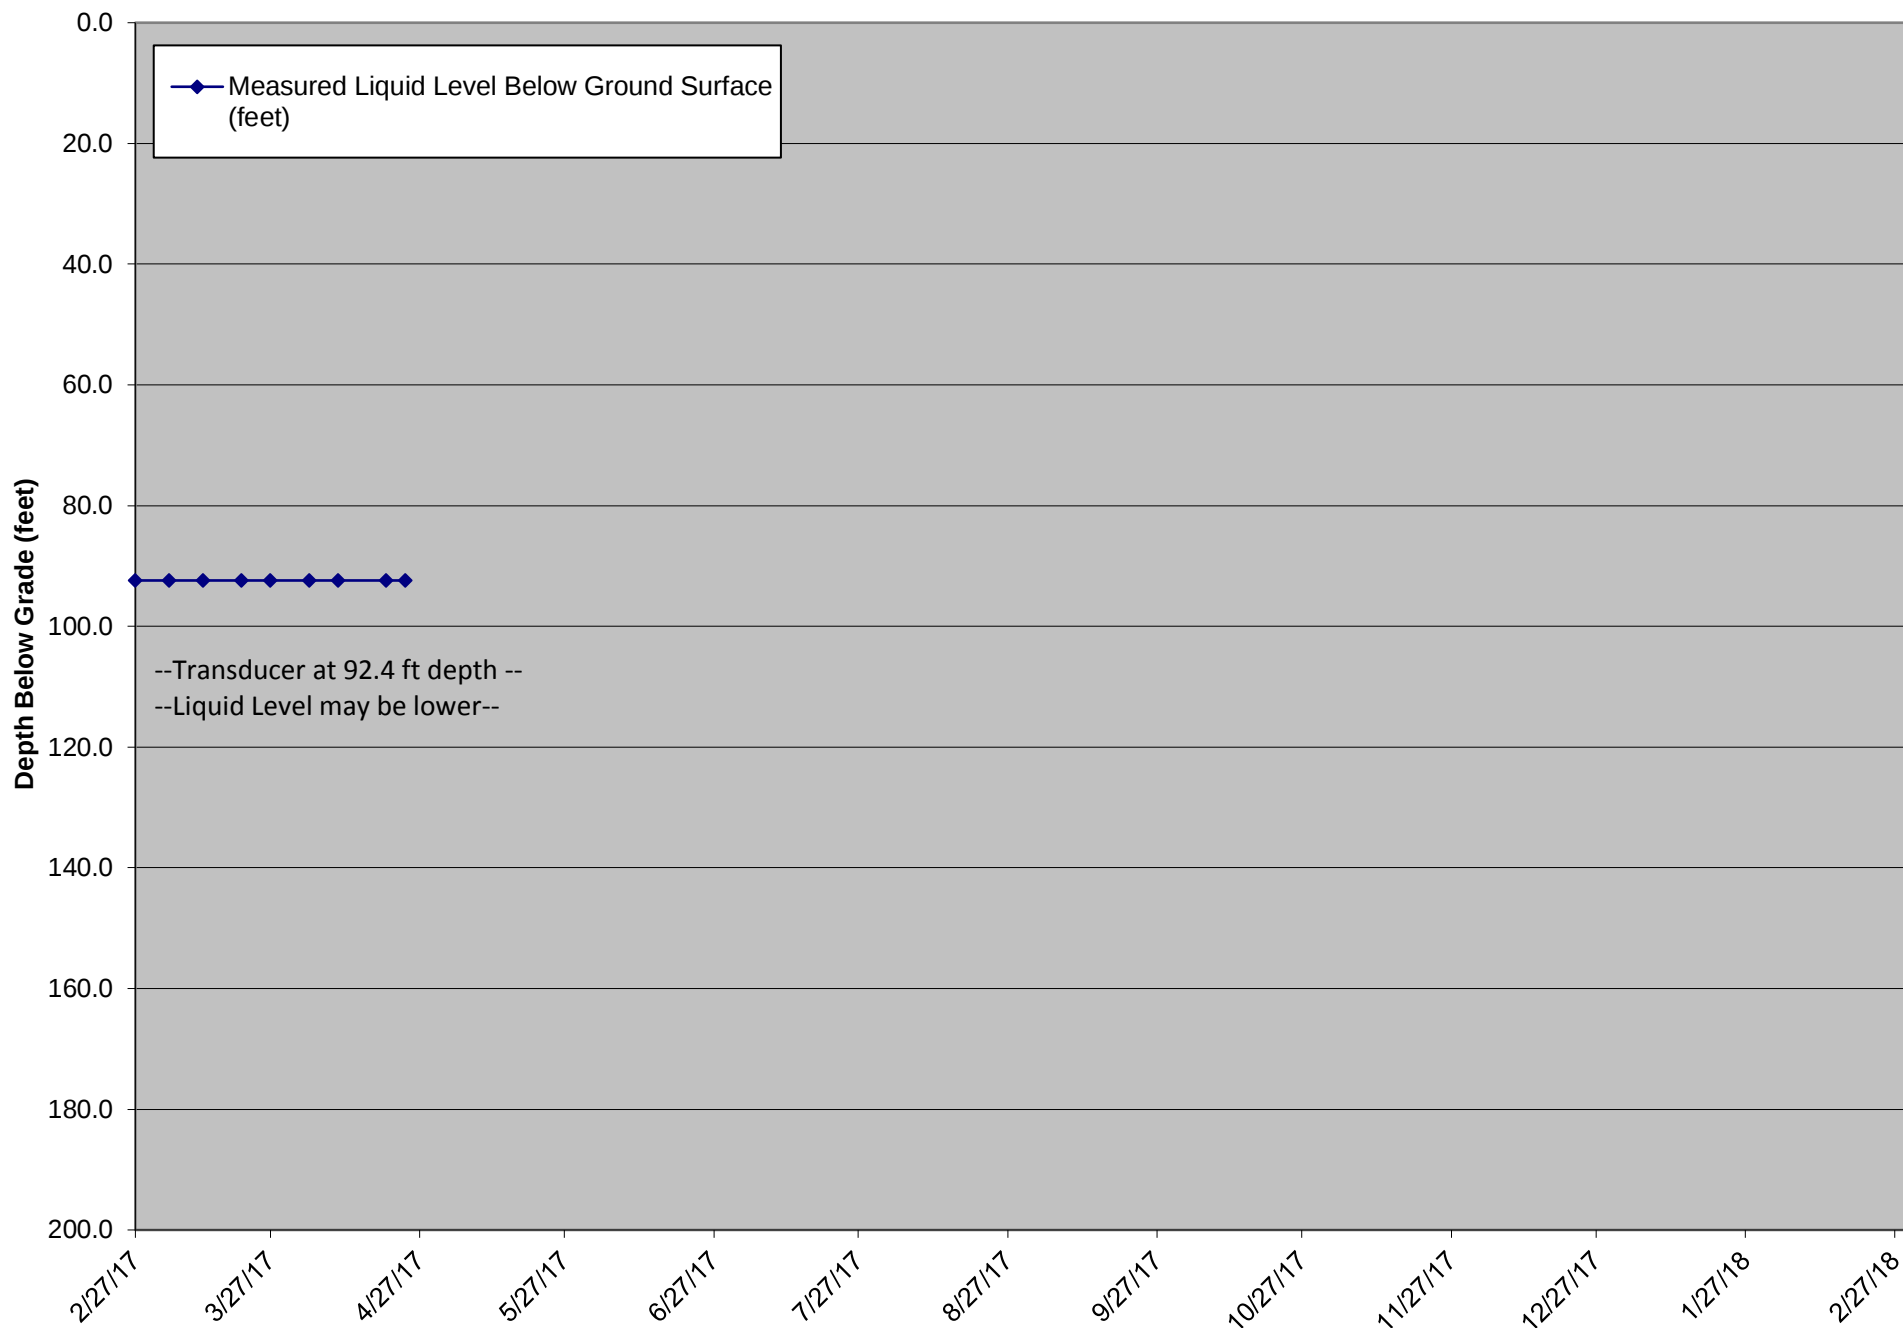
# LCS-1D Liquid Level Below Ground Surface

Downhole discharge piping and the pump for LCS-1D was replaced the week of 2/5/18. Pump was non-operational after startup activities. Pump replacement is pending parts arrival.

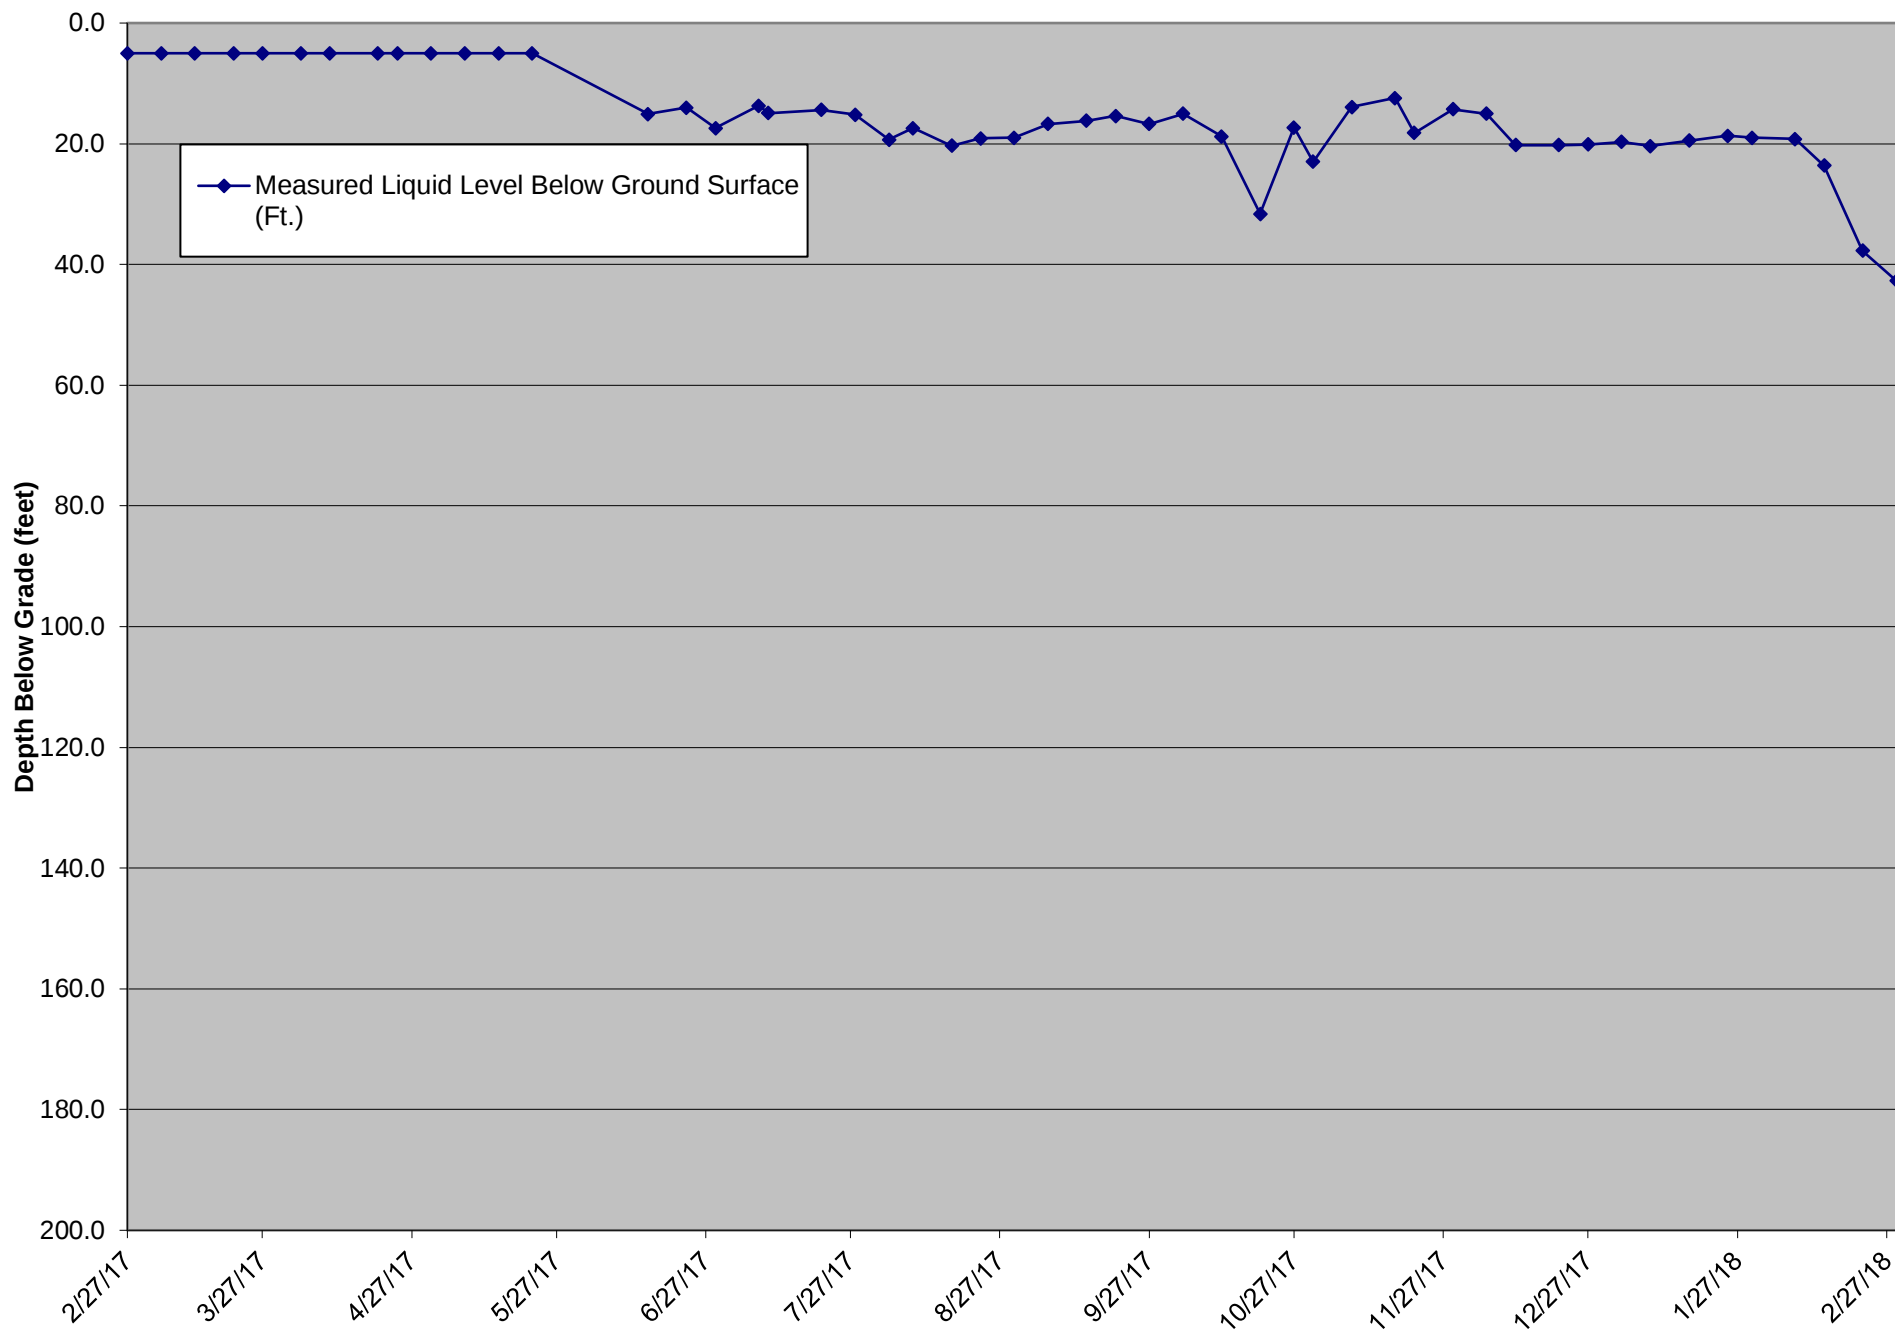
LCS-3D Liquid Level Below Ground Surface

The Blackhawk pneumatic pumps in LCS-3D were replaced with a QED AP-4 pneumatic pump on 2/15/18. Liquid level was measured manually.

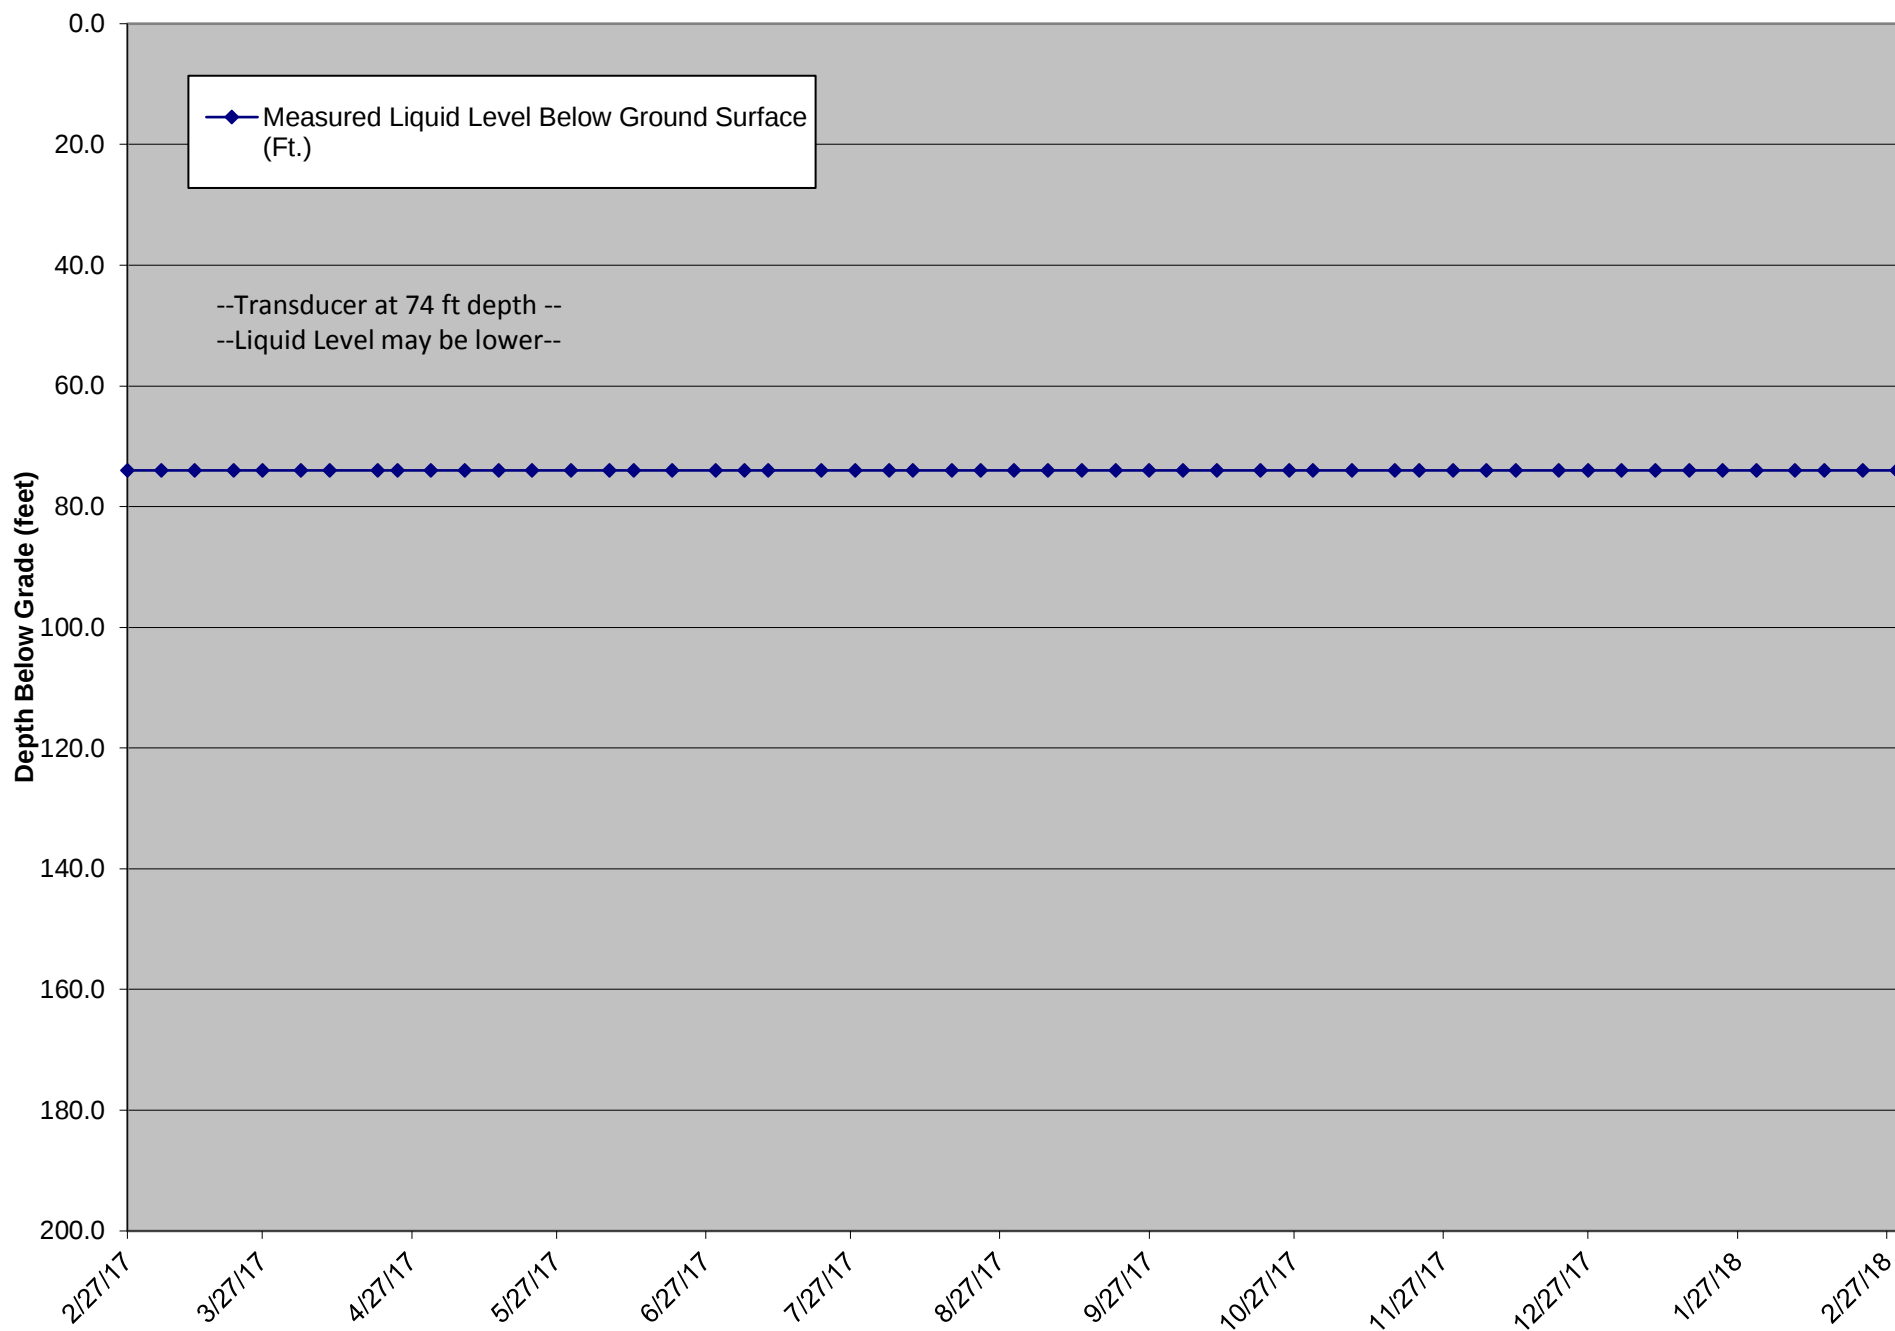
# LCS-4B Liquid Level Below Ground Surface

The level sensor in LCS-4B is currently operational and responsive. Liquid level was not recorded by the level sensor during the weekly reporting period. LCS-4B is equipped with a flow meter that displayed no flow during the weekly reporting period. Therefore, it can be concluded that the liquid level was below the bottom of the pump and level sensor in LCS-4B.

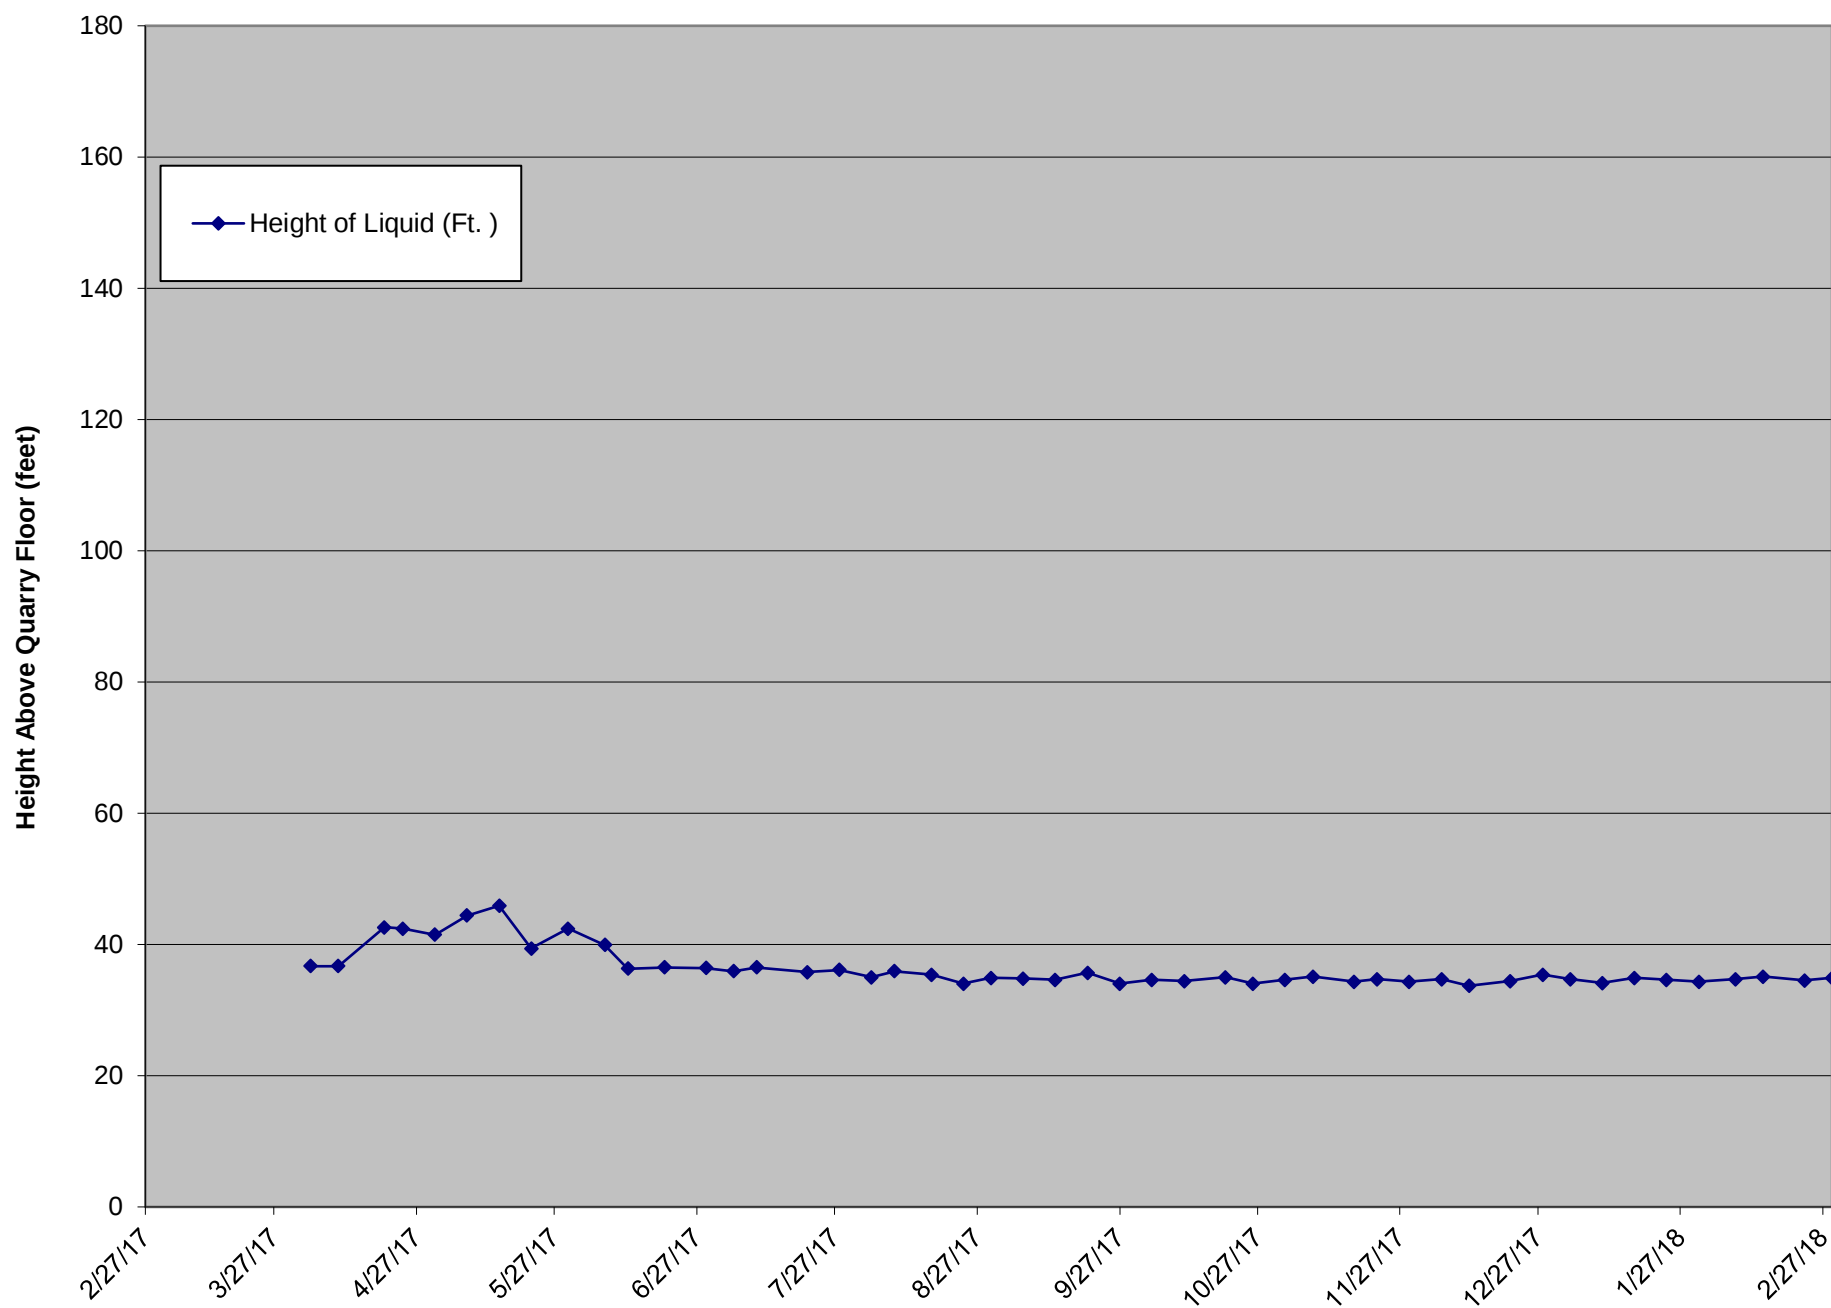
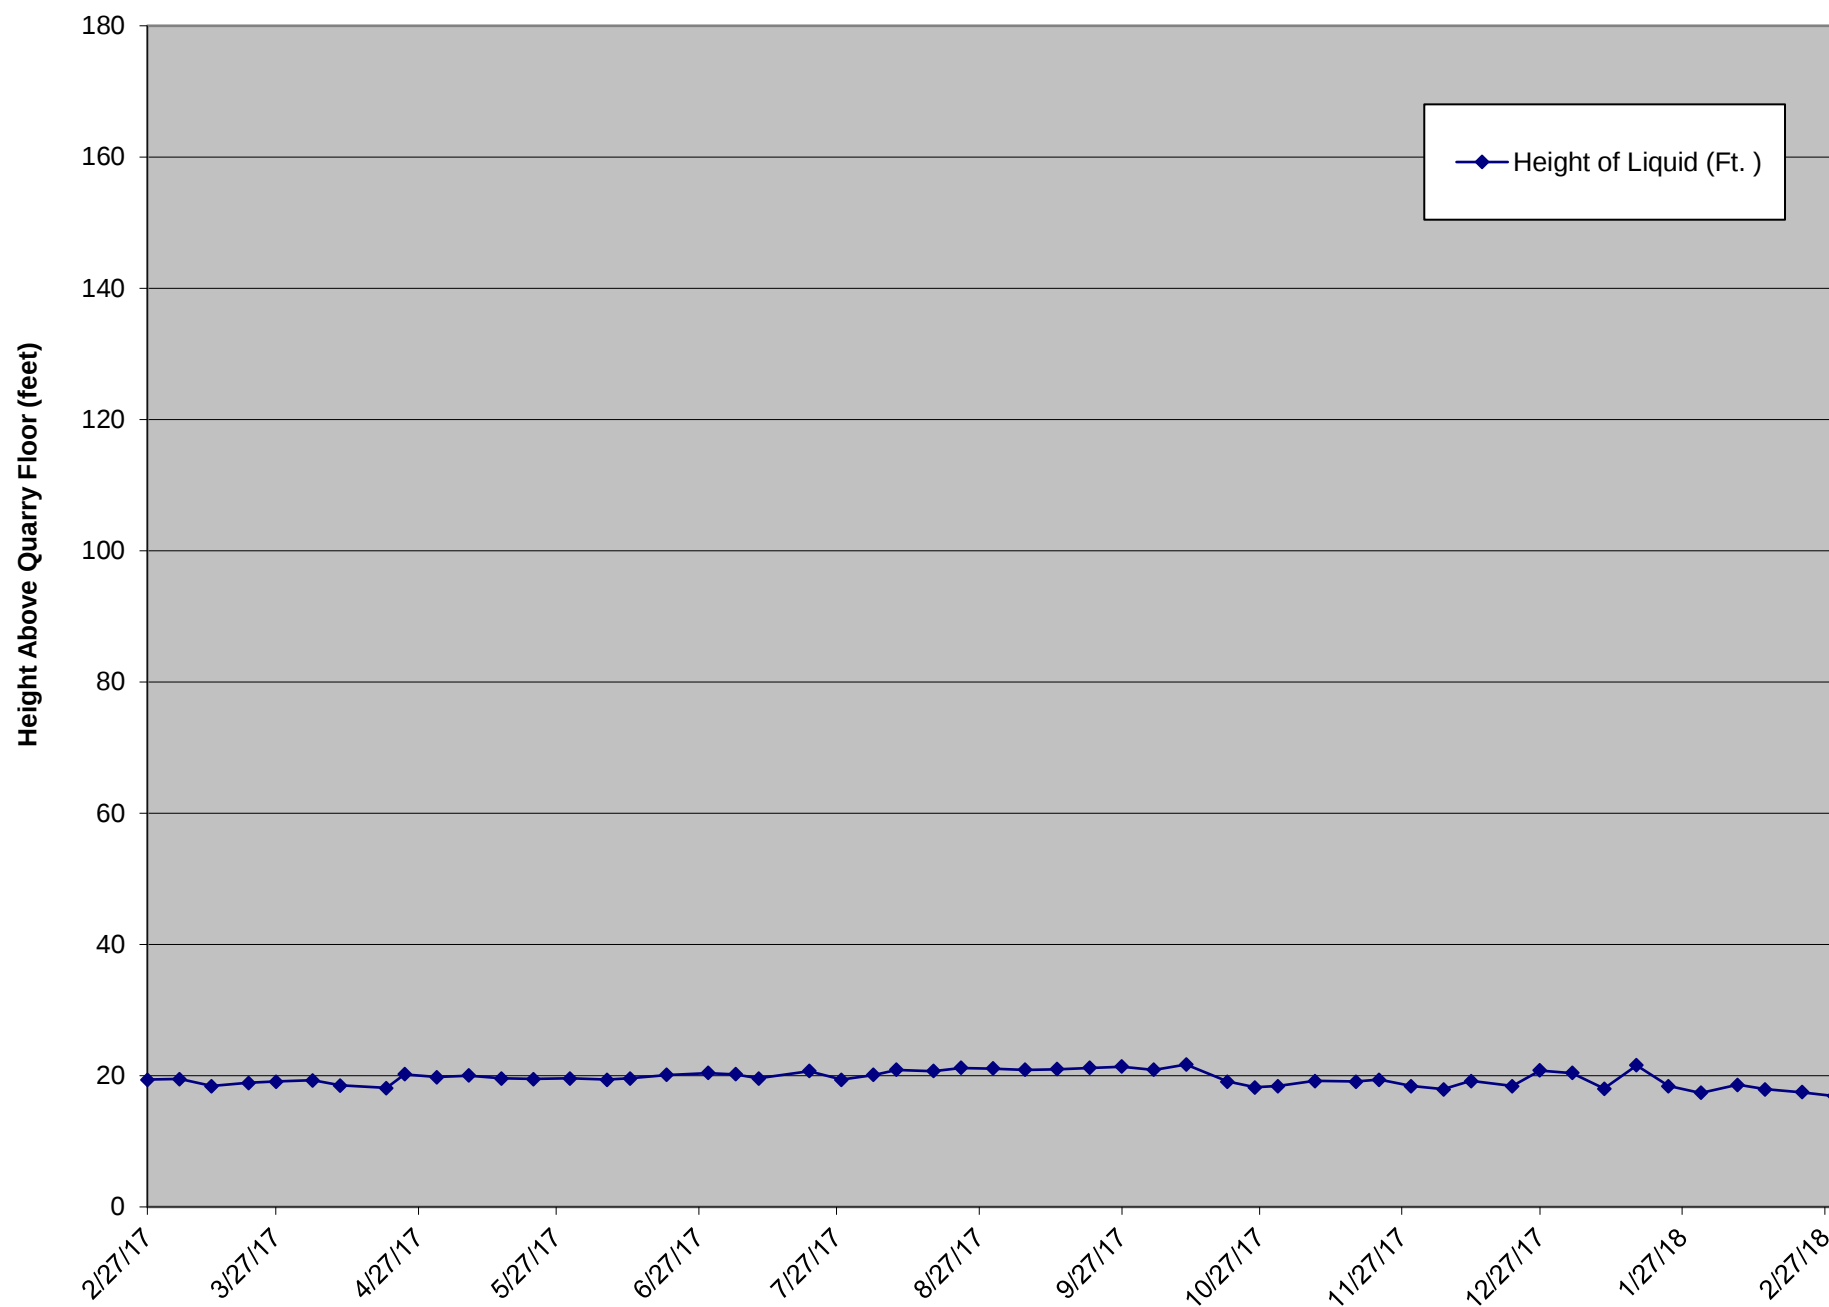
LCS-5B and LCS-6B were fully operational during the weekly reporting period.

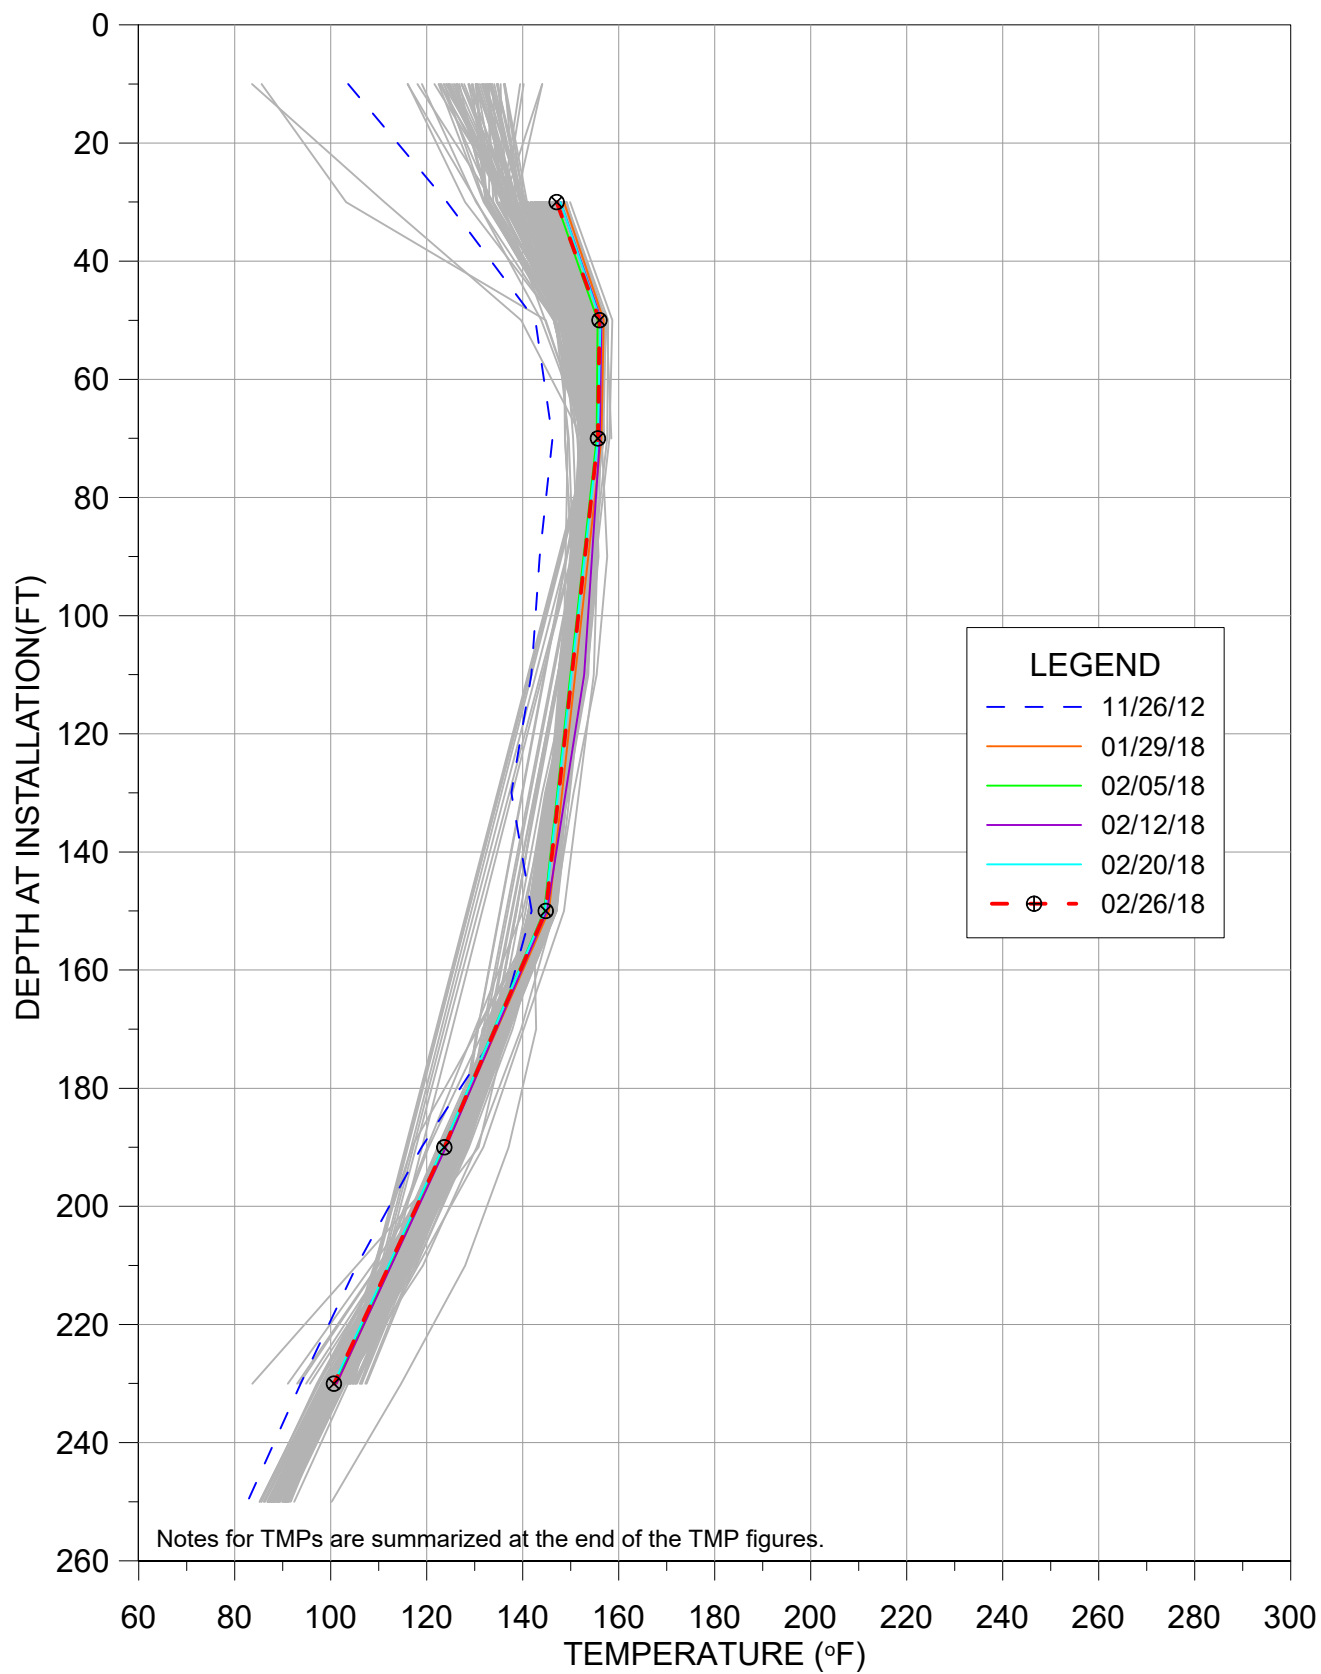
# TMP-3

1. No reliable temperature readings have been obtained at 170 ft depth since 1/29/2014, except on 3/13/2014.
2. The connectivity tests on 4/11/2014 conducted by CEC showed that units at 10, 90, 130, 210 and 250 ft depths are no longer reliable.
3. The connectivity tests on 10/28/2014 conducted by Feezor Engineering showed that units at 10, 90, 110, 130, 210 and 250 ft depths are not reliable.

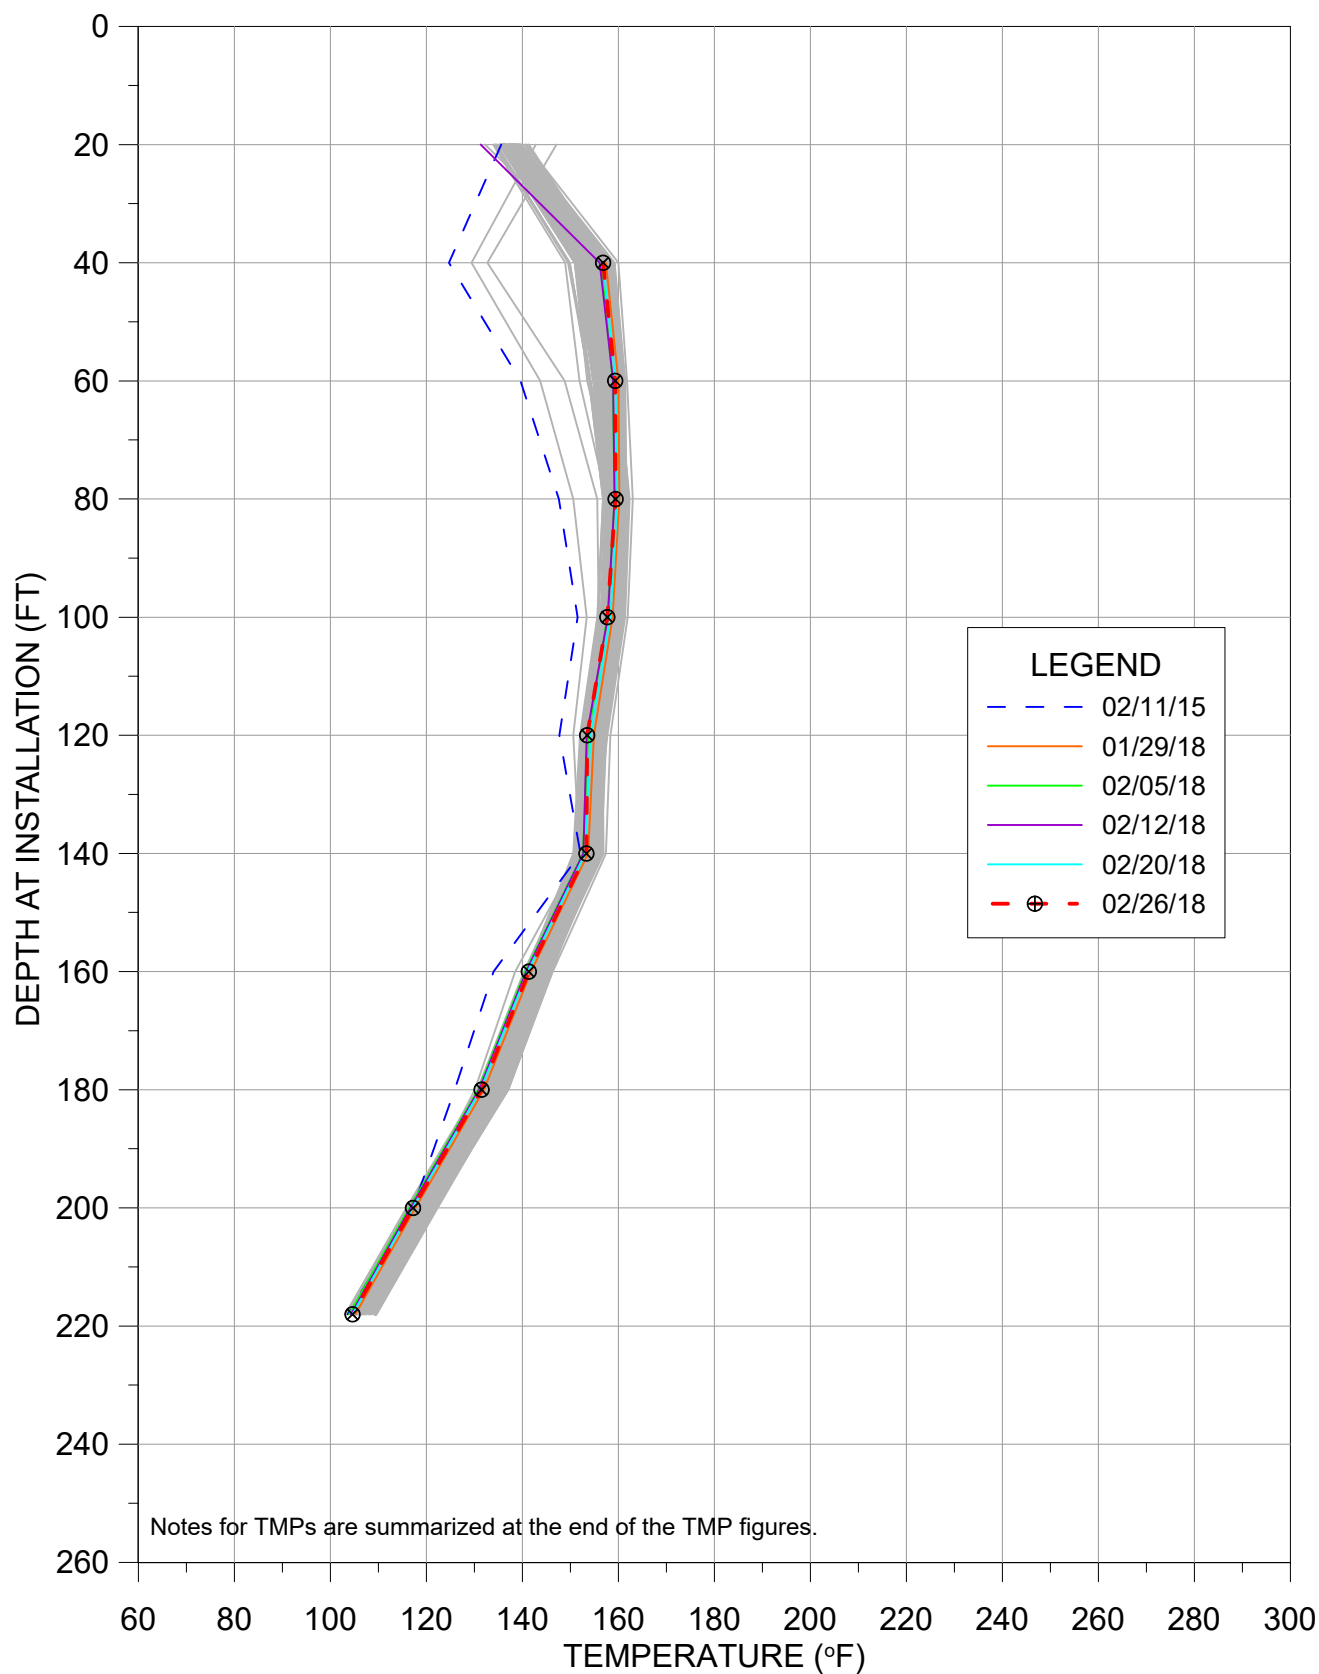
# TMP-3R

1. The unit at 20 ft depth had a fluctuating resistance since 9/25/2017. Therefore the temperature is determined to be unreliable.

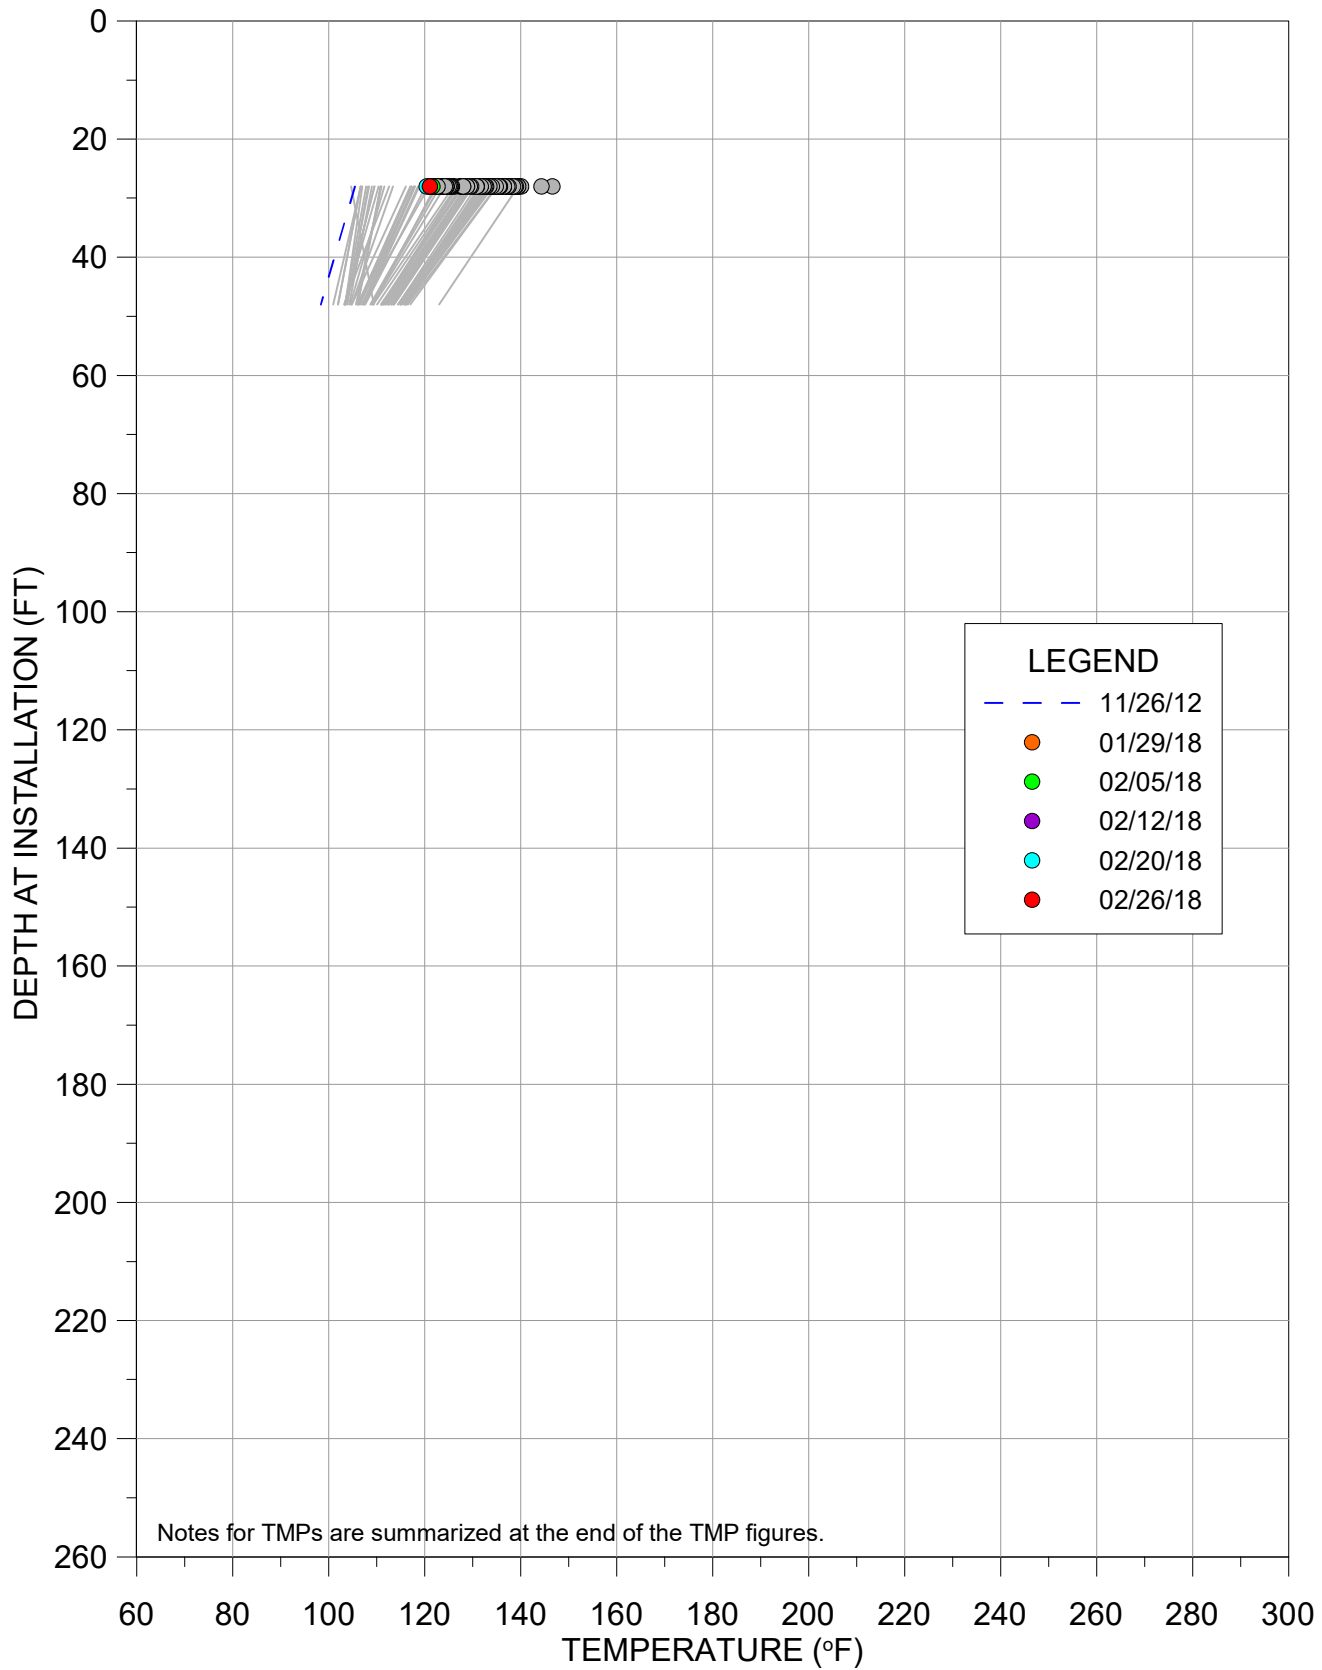
# TMP-4

1. The connectivity tests on 4/11/2014 conducted by CEC showed that the unit at 48 ft depth is no longer reliable.

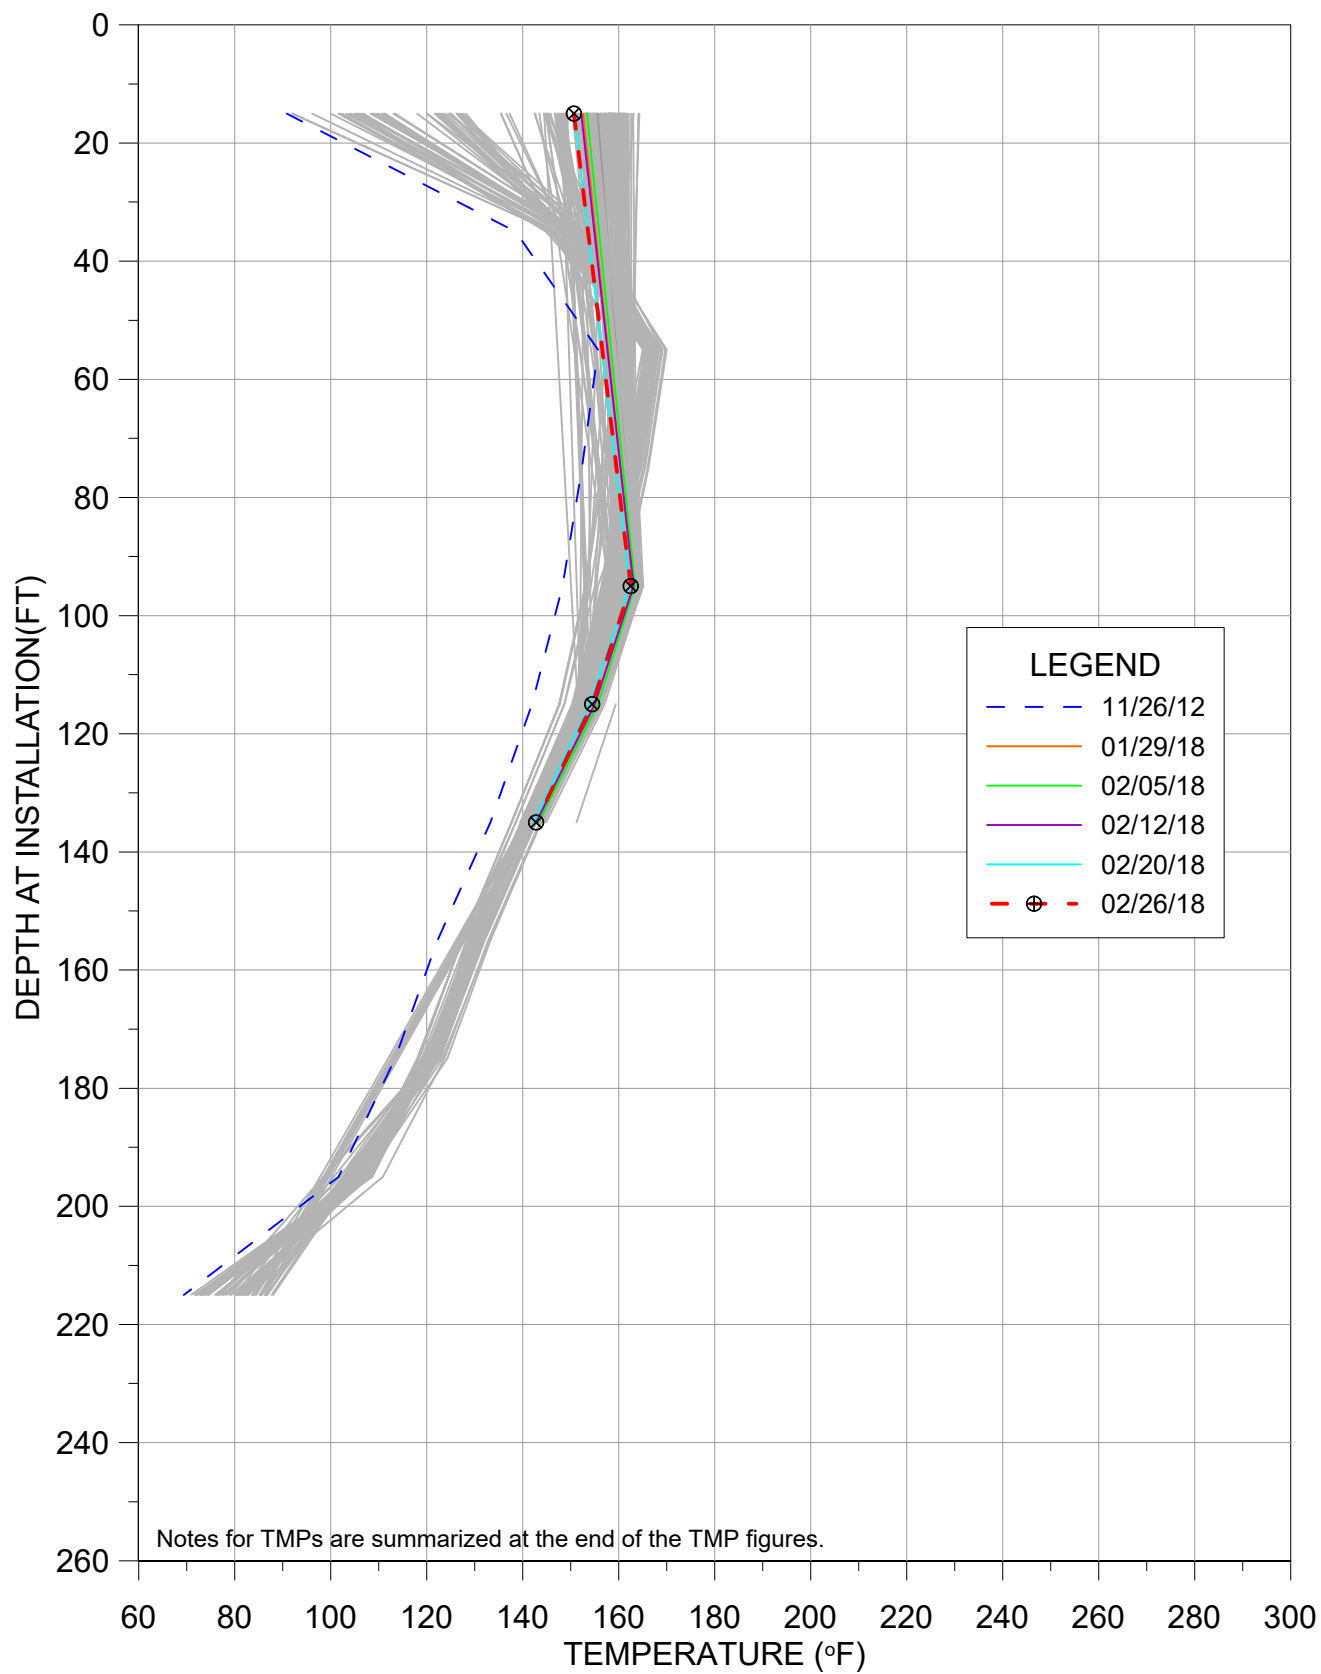
# TMP-6

1. The connectivity tests on 4/11/2014 conducted by CEC showed that units at 35, 55, 75, 155, 175, and 195 ft depths are no longer reliable.
2. No reliable temperature readings have been obtained at the unit at 215 ft depth since 6/13/2014.
