# **Bridgeton Landfill, LLC**

## **Weekly Data Submittal**

**Week of February 25, 2018 – March 3, 2018**

**Required by Section 52.F of Agreed Order, Case No. 13SL-CC01088  
Effective May 13, 2013**

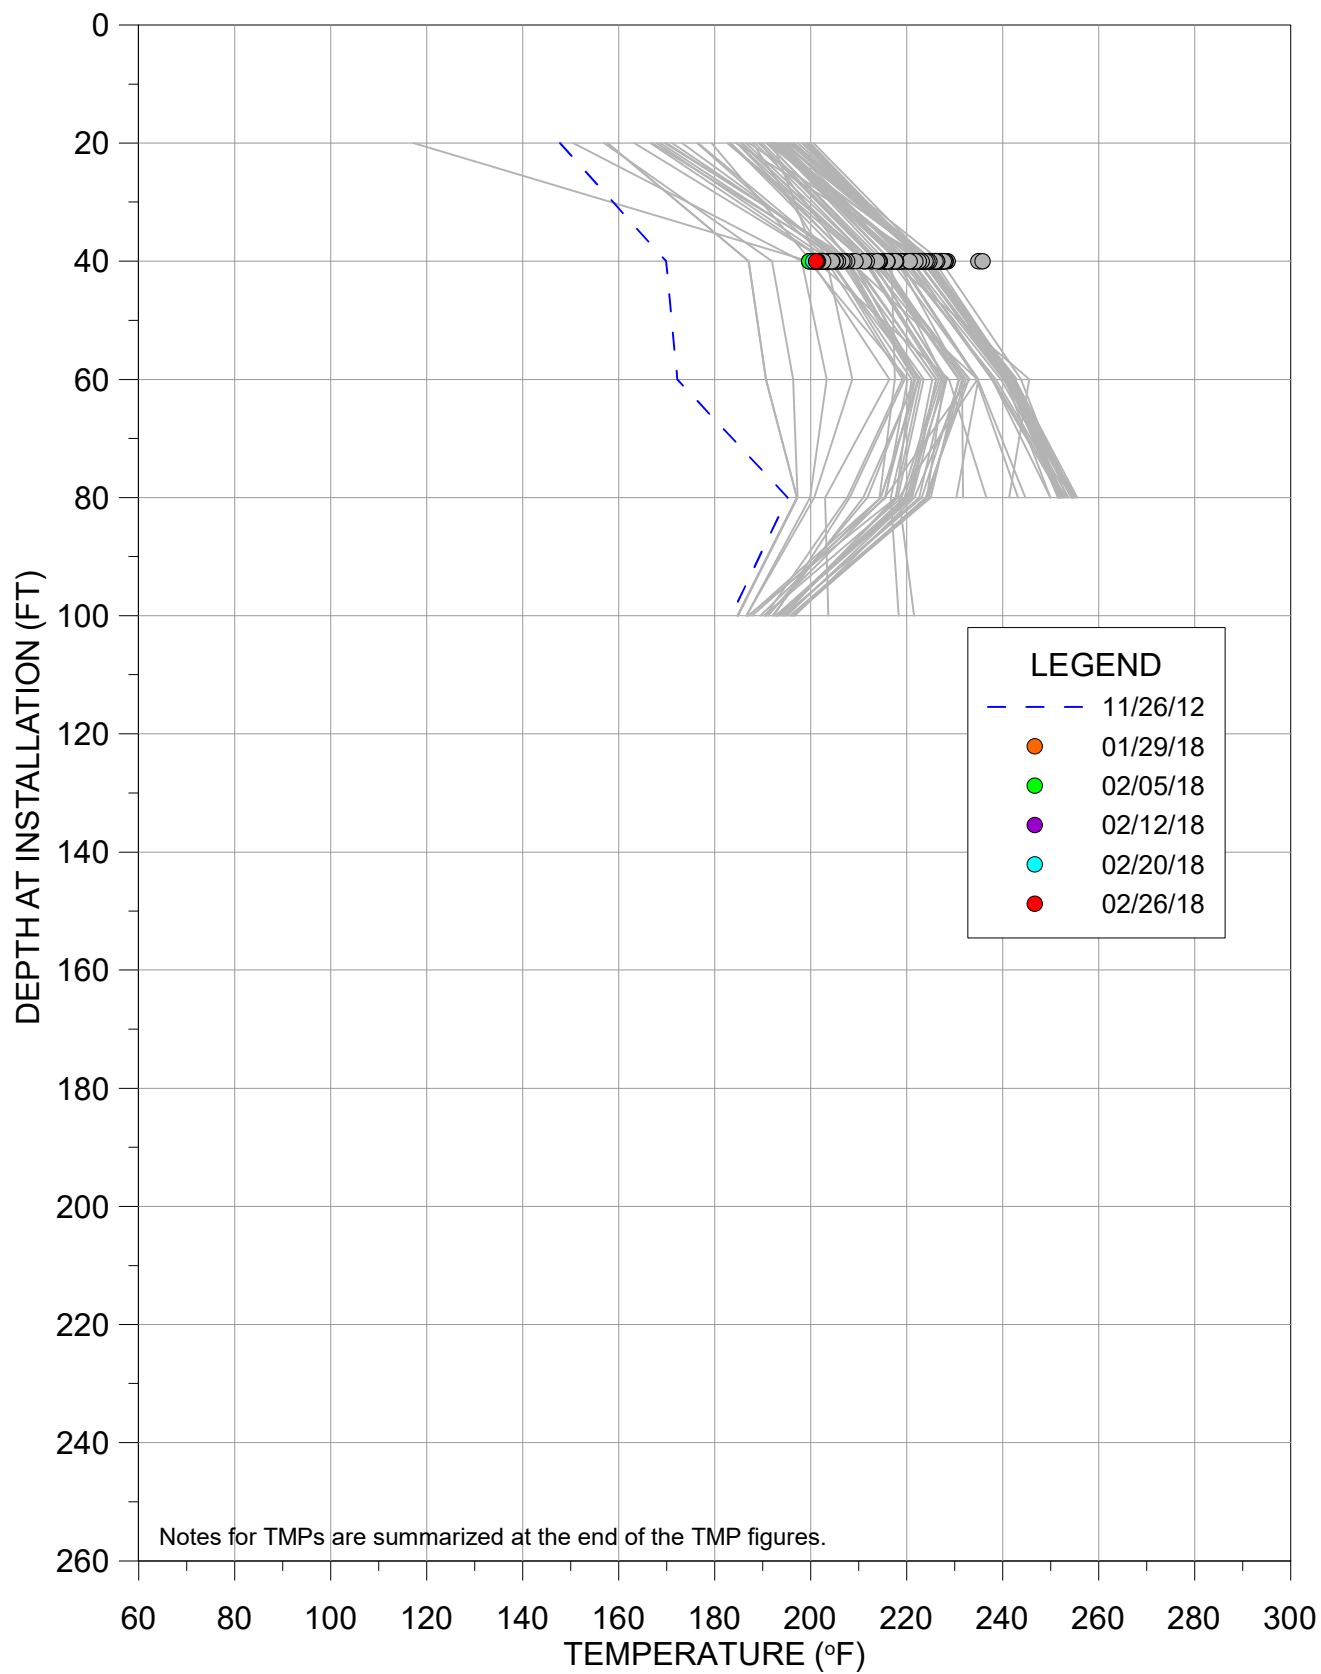
# TMP-9

1. Unit at 100 ft depth had an inaccurate temperature reading on 8/1/2013 and no reading since 8/6/2013.
2. The connectivity tests on 4/11/2014 conducted by CEC showed that units at 20, 60, 80, and 100 ft depths are no longer reliable.

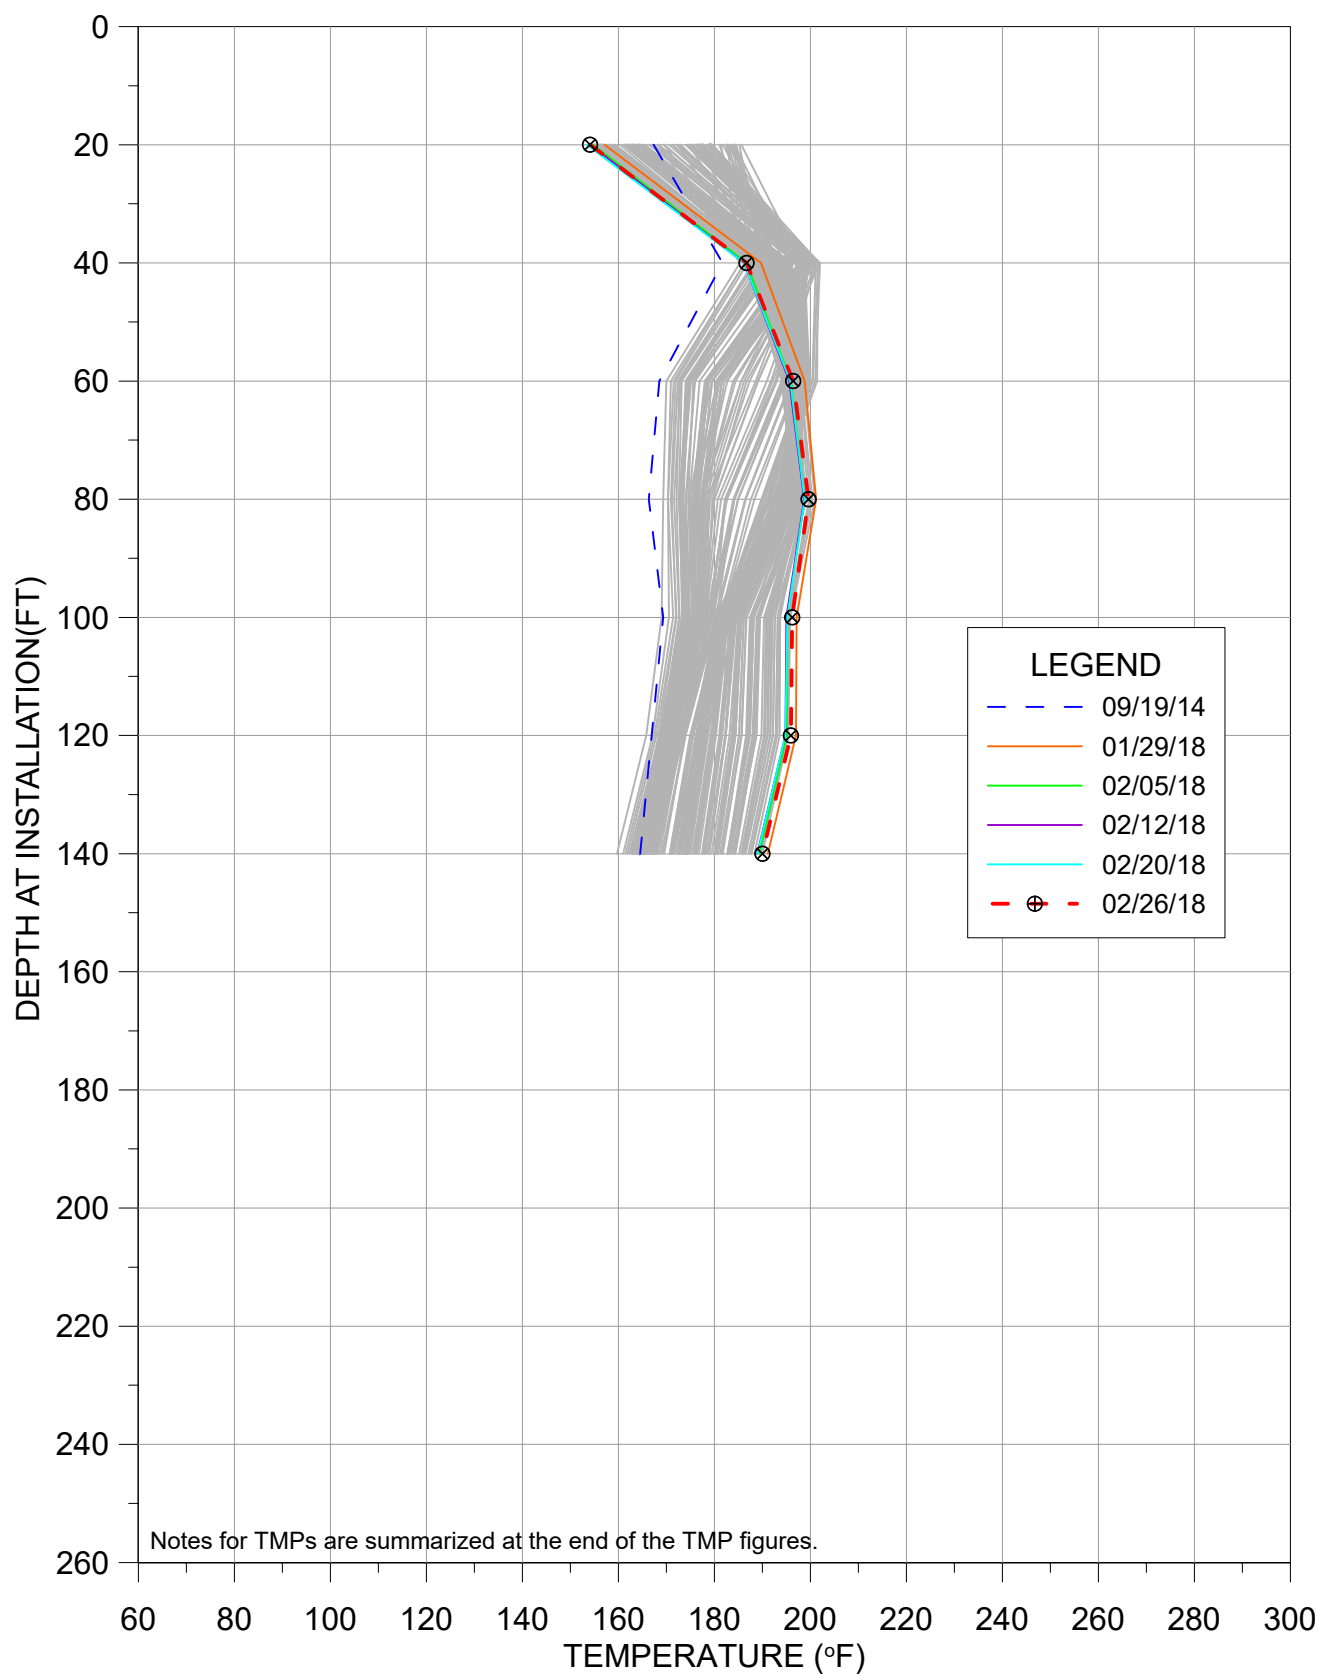
# TMP-14R

1. Due to the connectivity test results by Feezor Engineering on TMP-14 (see note above), TMP-14R is added to this reporting data set as of 3/7/2016.

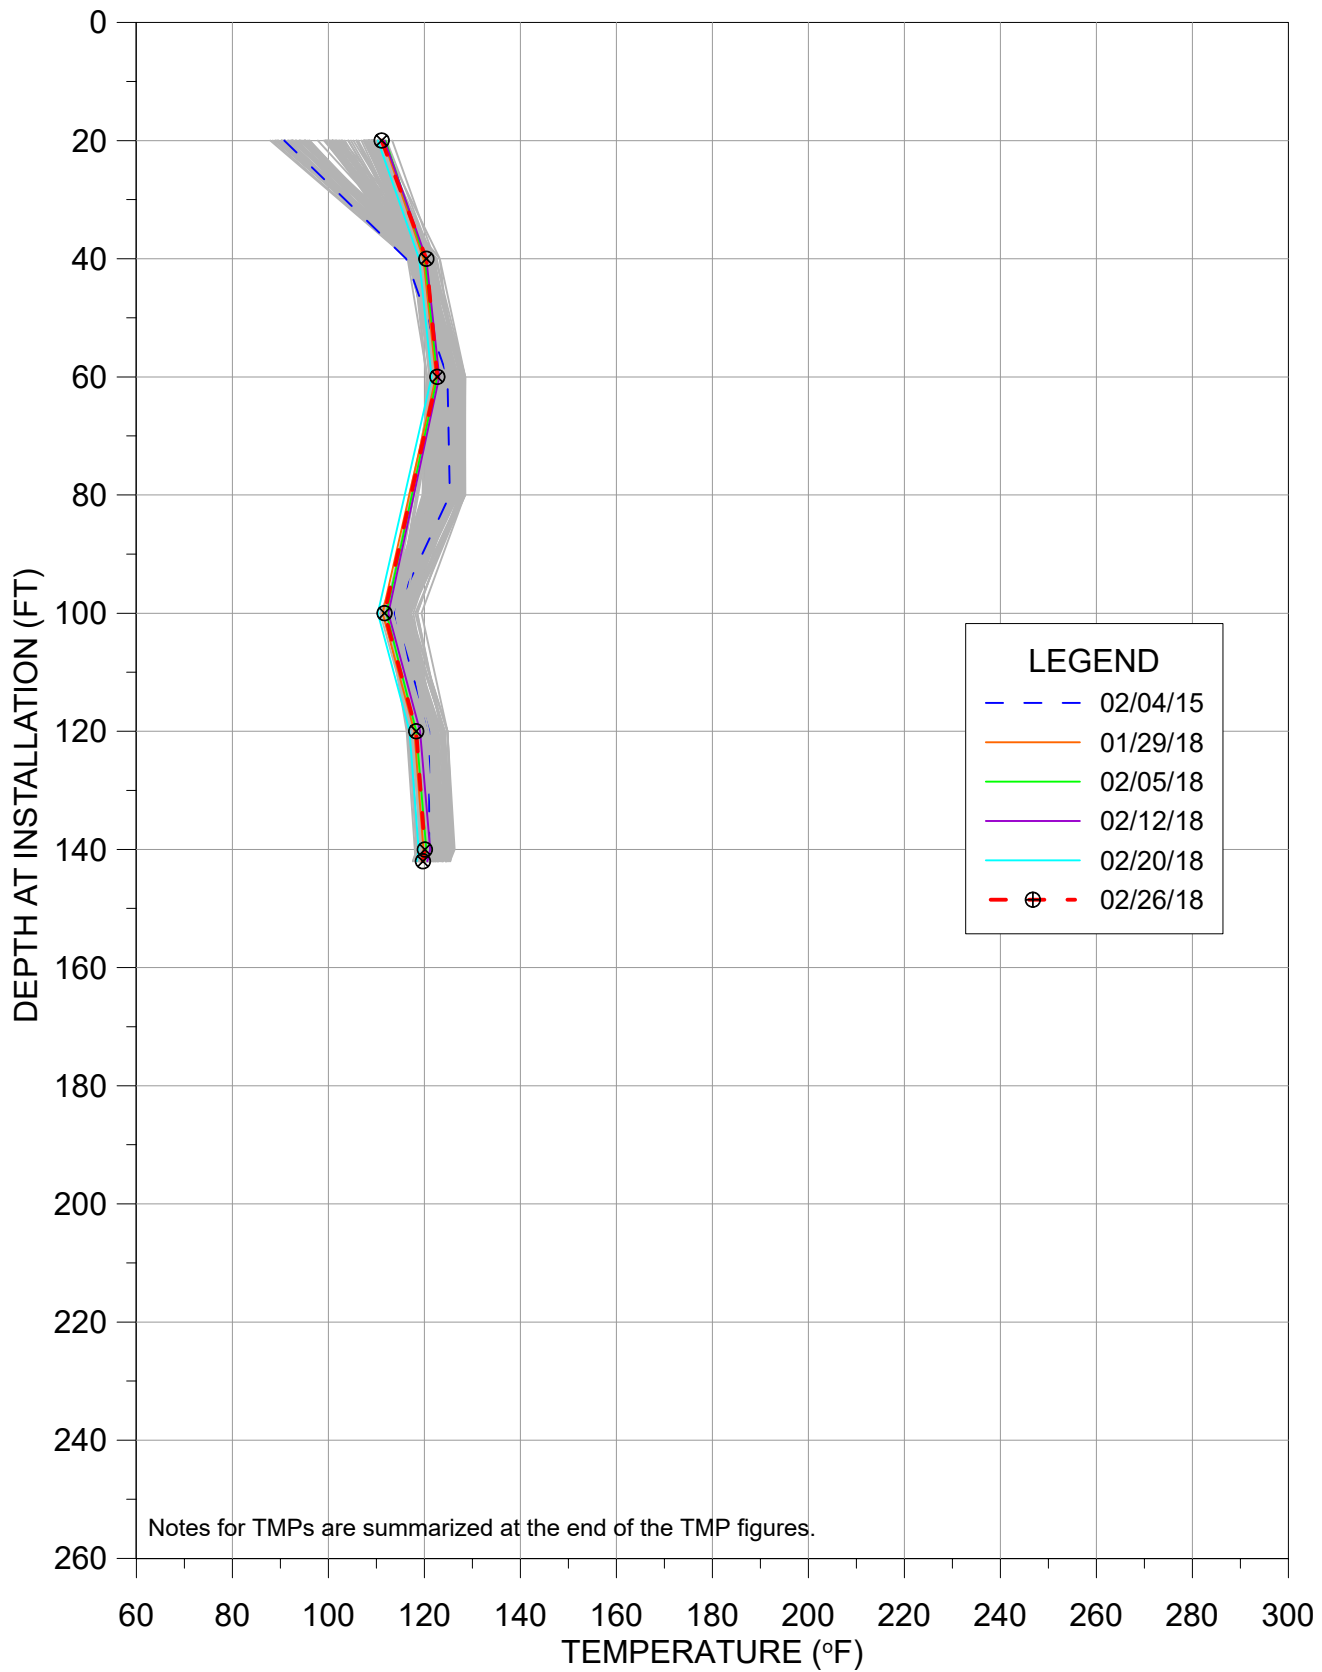
# TMP-26

1. Resistance on unit at 80 ft dropped 12.9 ohms (11/06/2017) and subsequent resistance reading continue to be low. Upon further investigation by Feezor Engineering, this unit is determined to be unreliable.

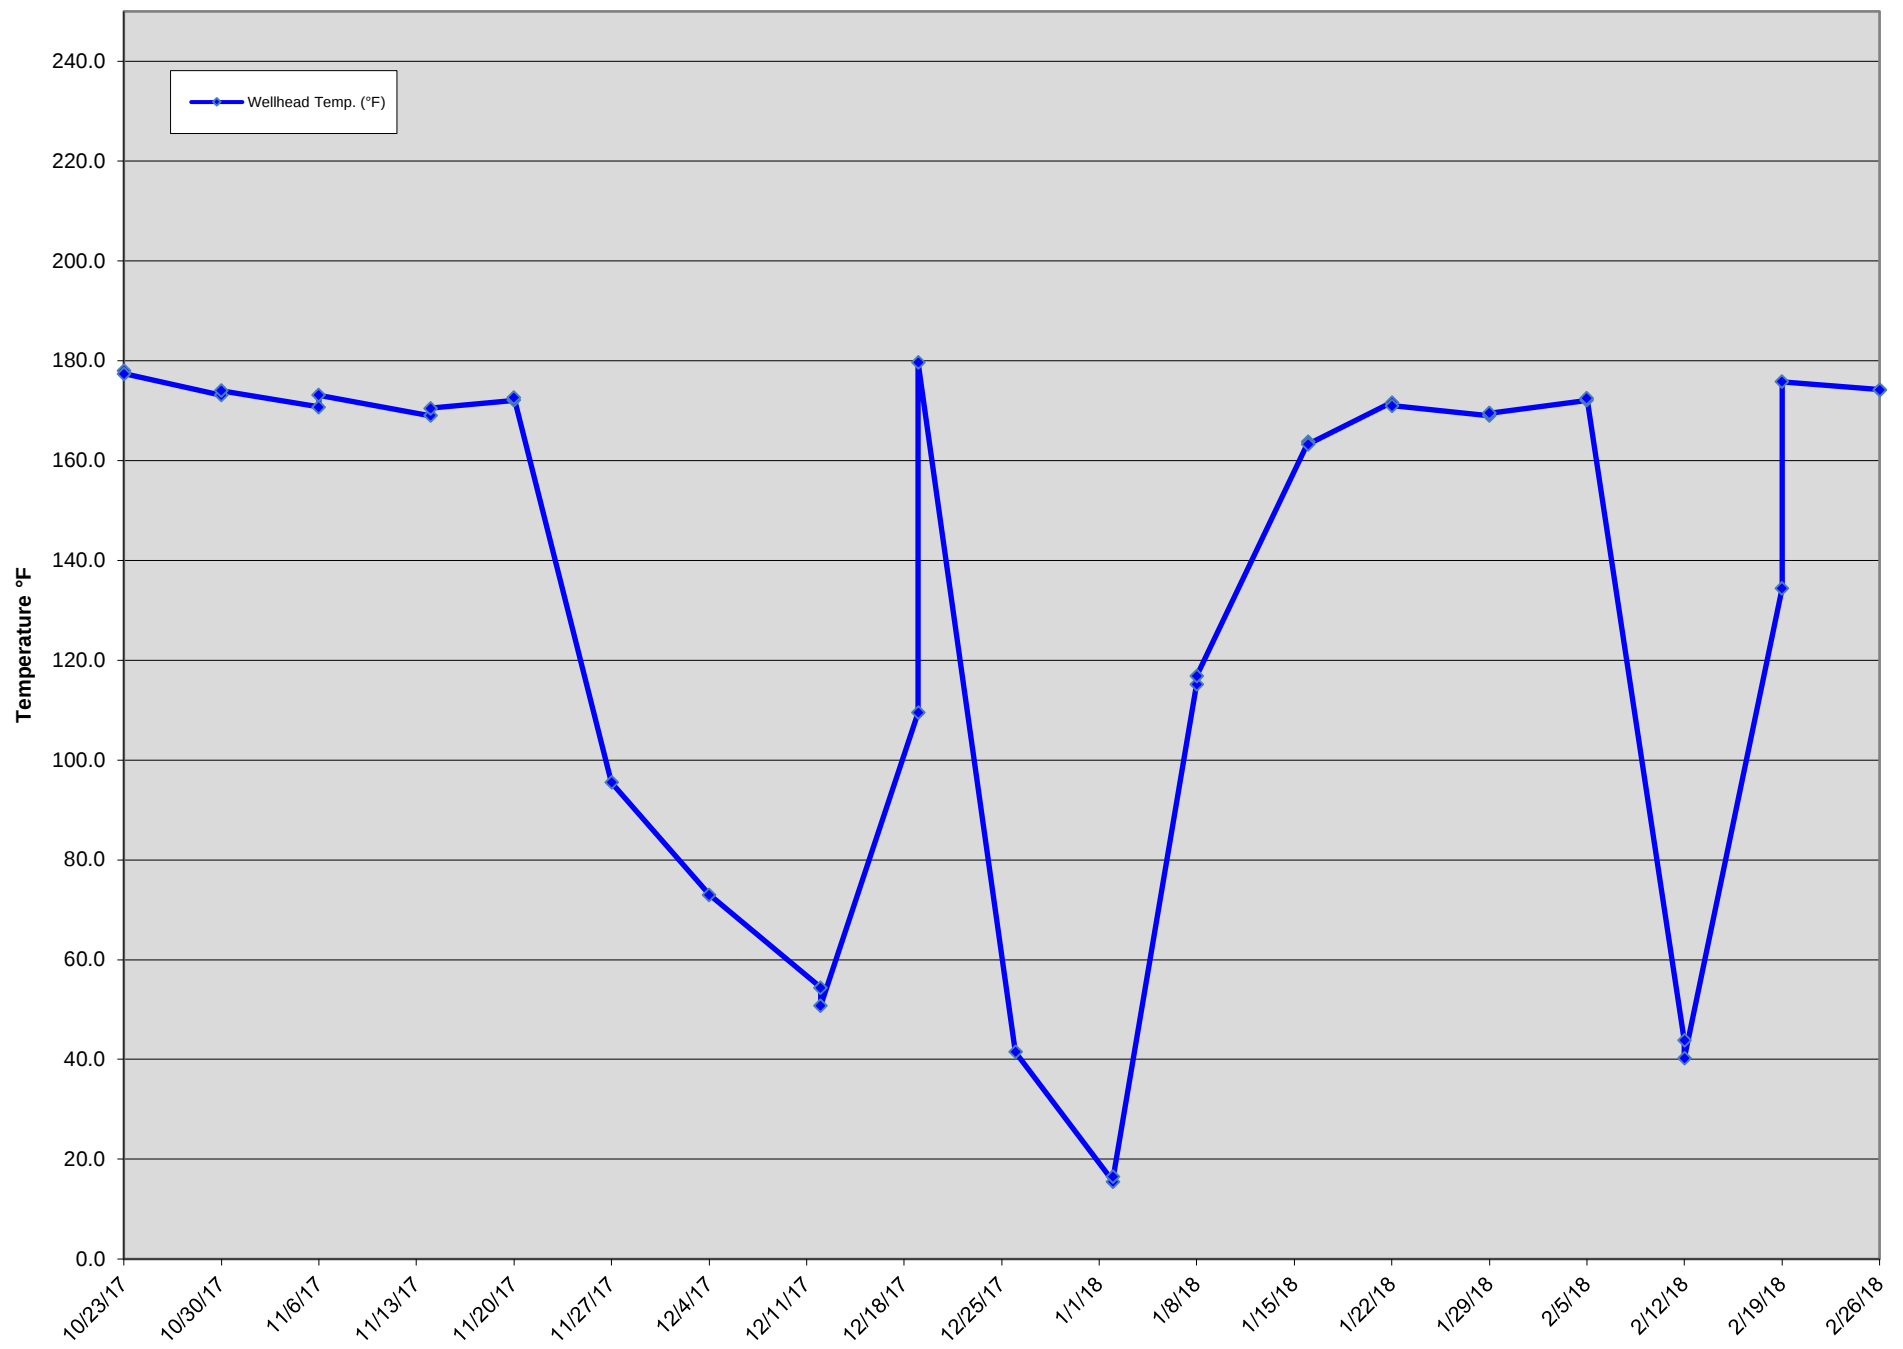
GIW-1 Wellhead Temperatures

As part of the HES, there are currently cooling water circulation loops installed in twelve Gas Interceptor Wells (GIWs) (GIW-02 through GIW-13). The remaining well (GIW-01) had a measured gas temperature within its historical operating limits.
