# **Bridgeton Landfill, LLC**

## **Weekly Data Submittal**

**Week of April 1, 2018 – April 7, 2018**

**Required by Section 52.F of Agreed Order, Case No. 13SL-CC01088  
Effective May 13, 2013**

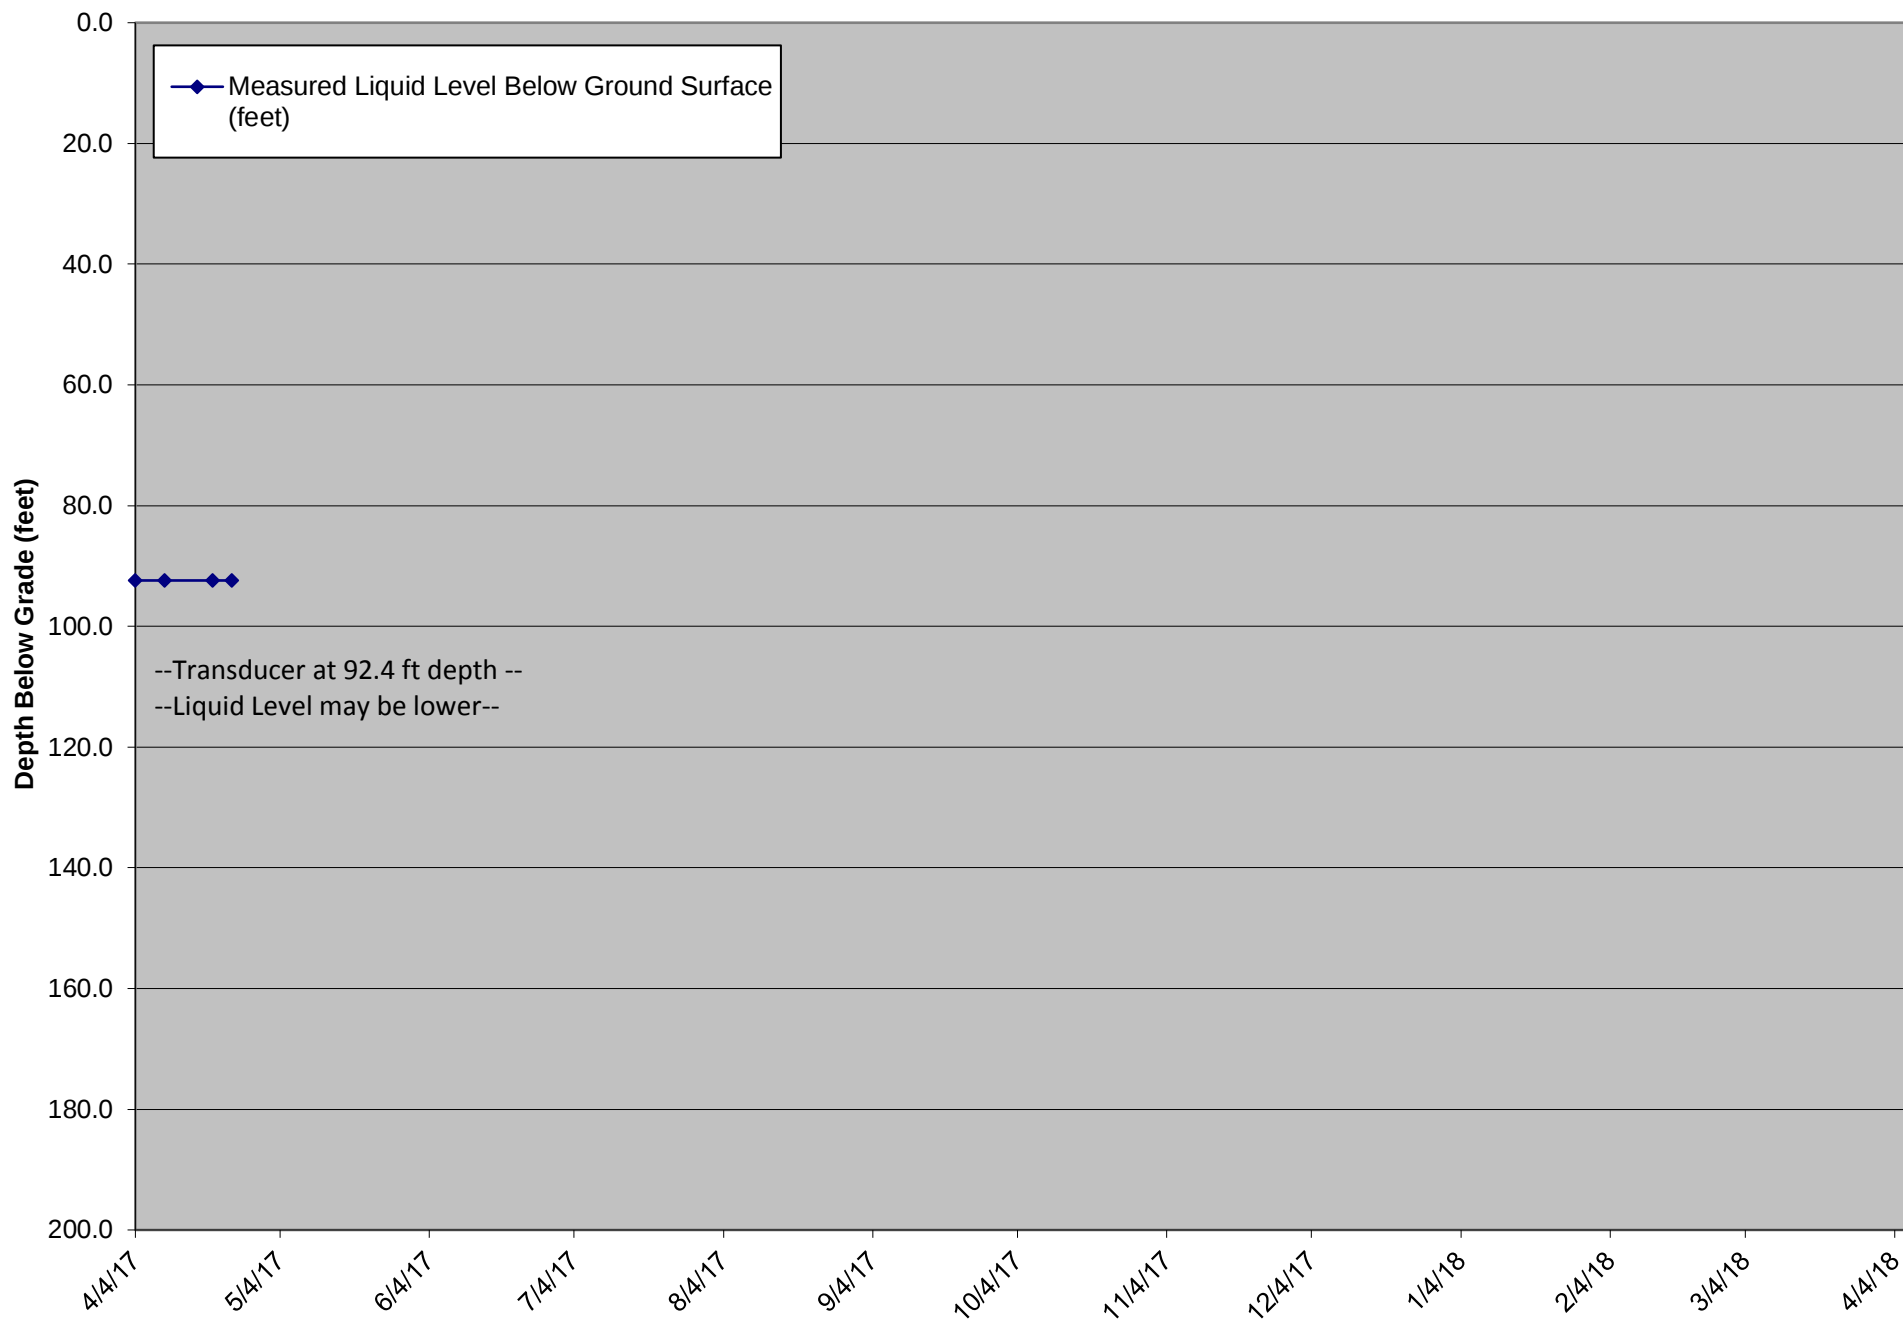
# LCS-1D Liquid Level Below Ground Surface

Downhole discharge piping and the pump for LCS-1D was replaced the week of 2/5/18. Pump was non-operational after startup activities. Pump replacement is scheduled for the week of 4/16/18 pending suitable weather conditions.

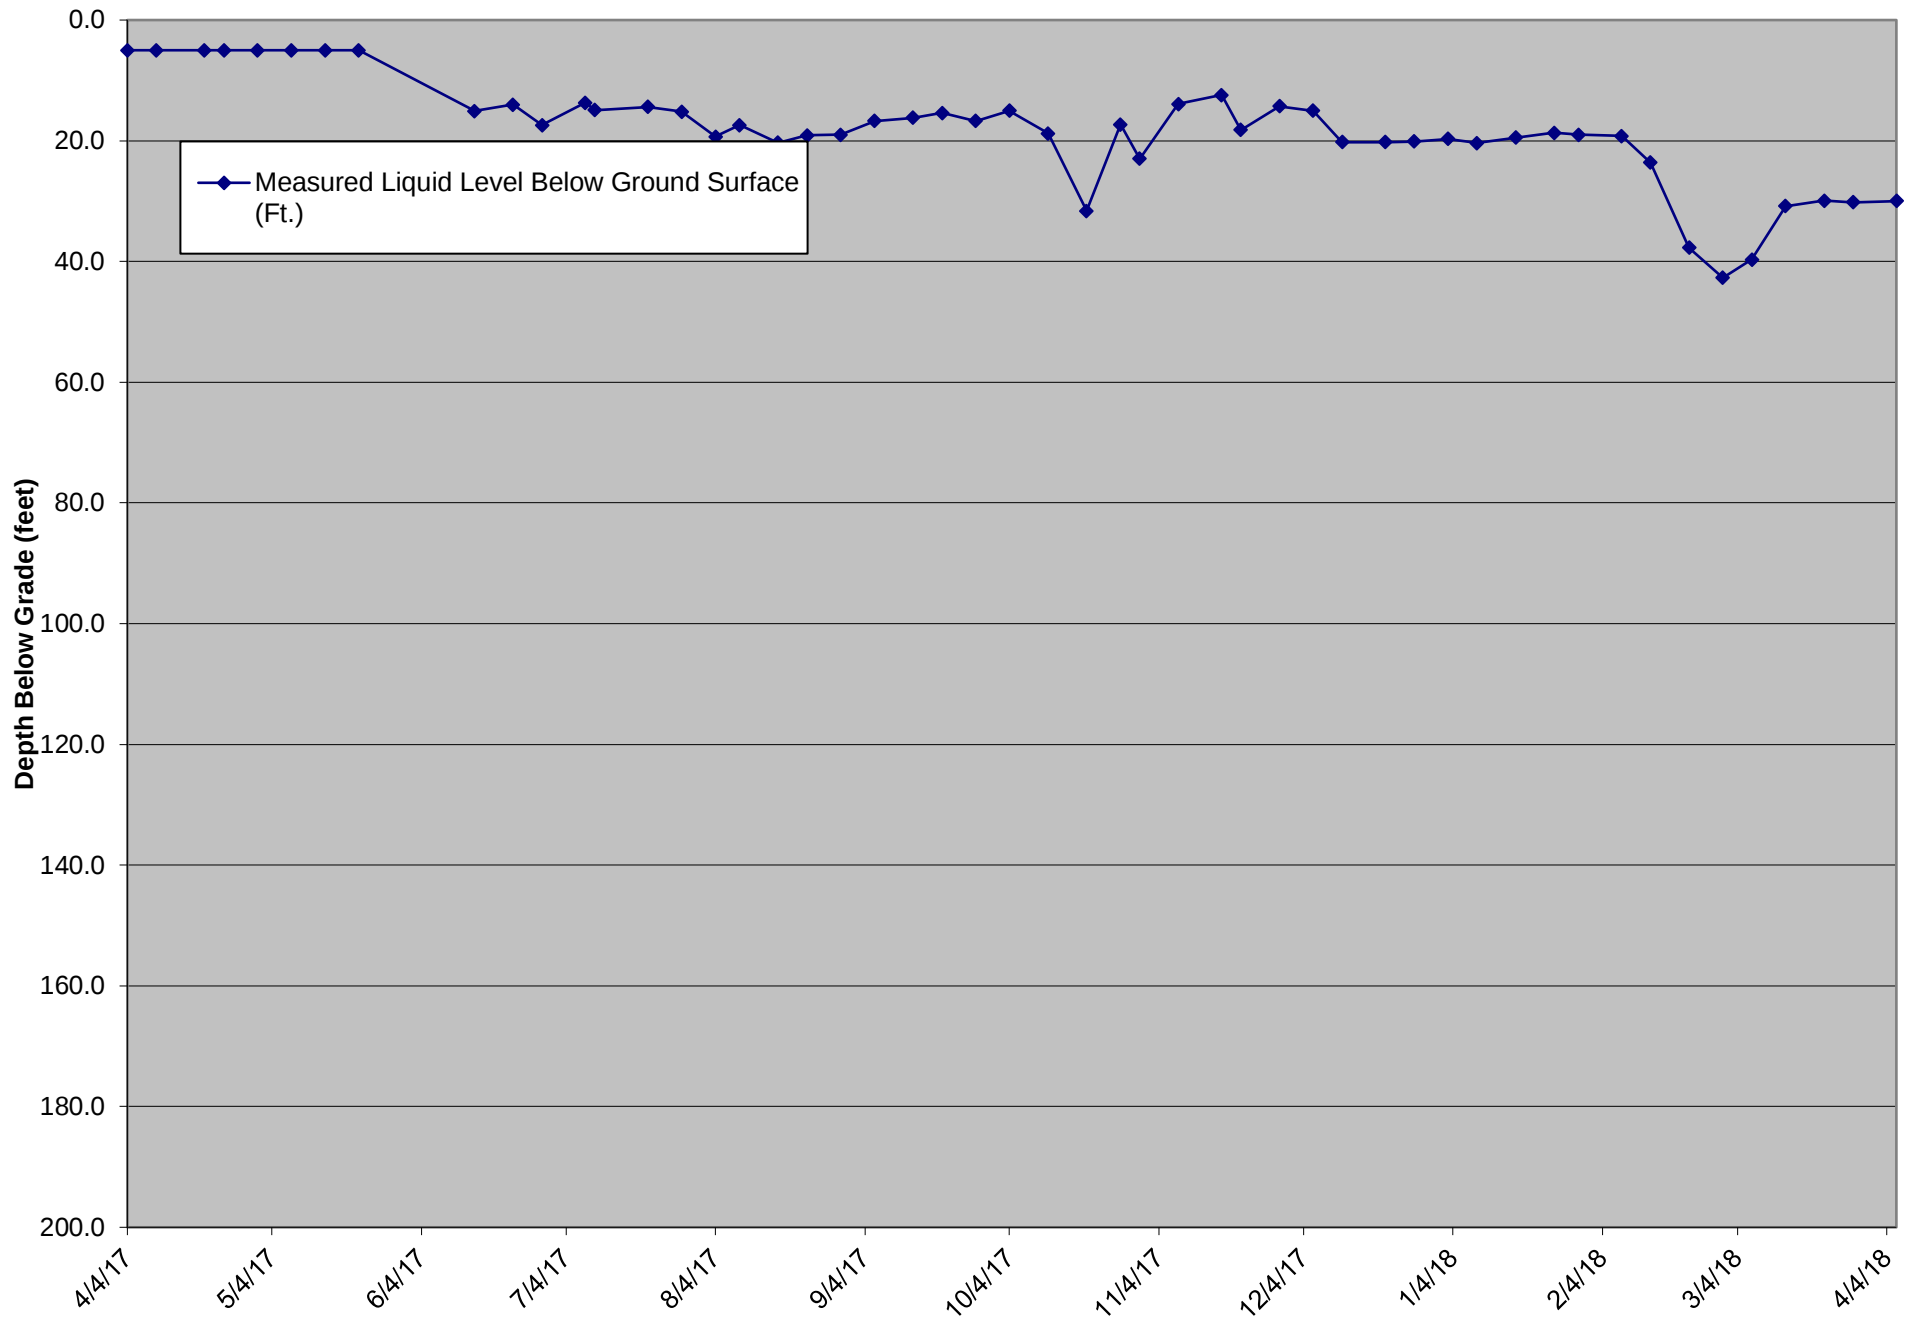
LCS-3D Liquid Level Below Ground Surface

The Blackhawk pneumatic pumps in LCS-3D were replaced with a QED AP-4 pneumatic pump on 2/15/18. Liquid level was measured manually.

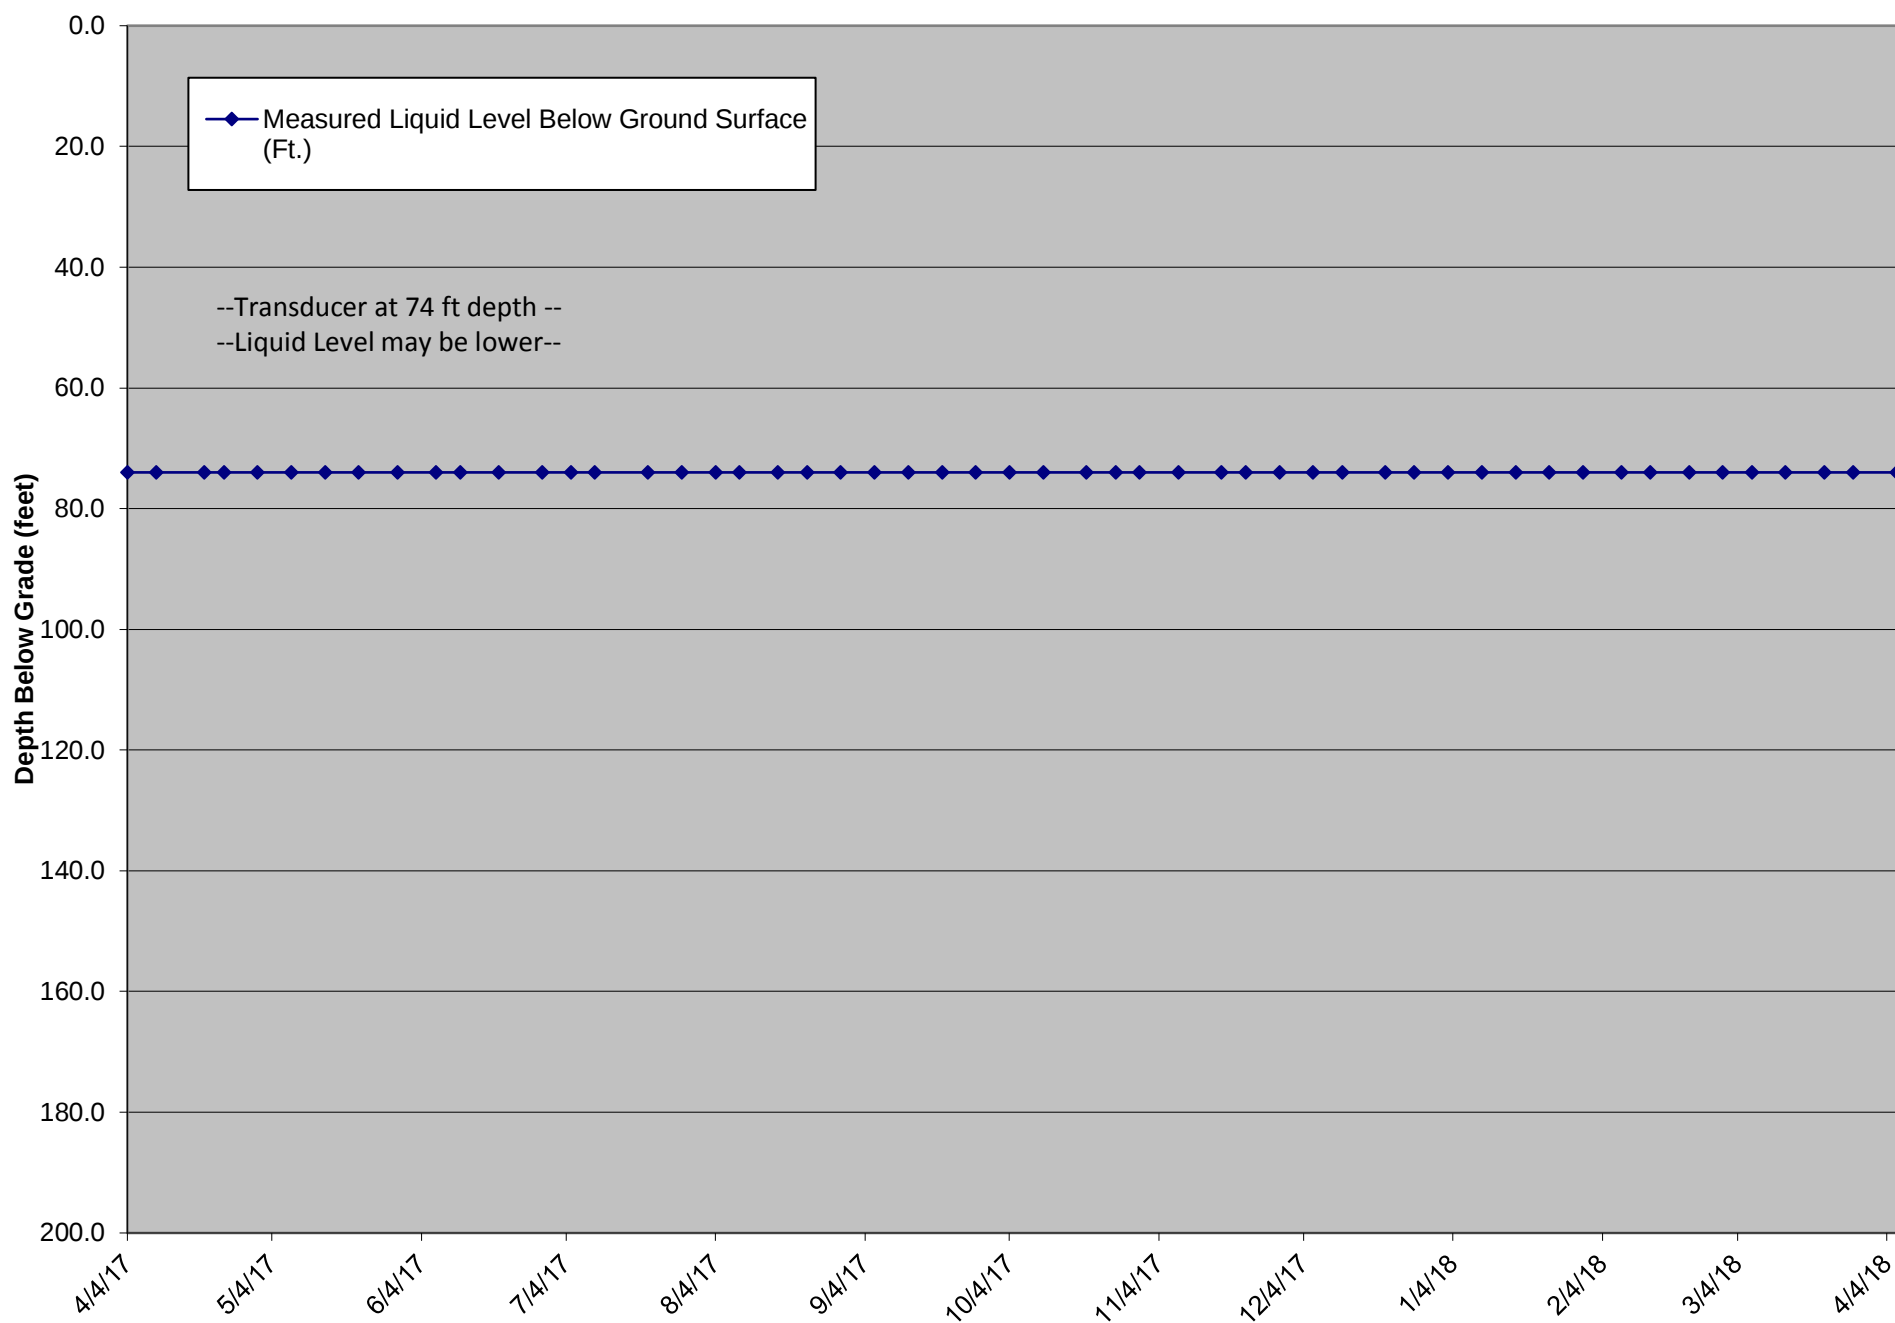
# LCS-4B Liquid Level Below Ground Surface

The level sensor in LCS-4B is currently operational and responsive. Liquid level was not recorded by the level sensor during the weekly reporting period. LCS-4B is equipped with a flow meter that displayed no flow during the weekly reporting period. Therefore, it can be concluded that the liquid level was below the bottom of the pump and level sensor in LCS-4B.

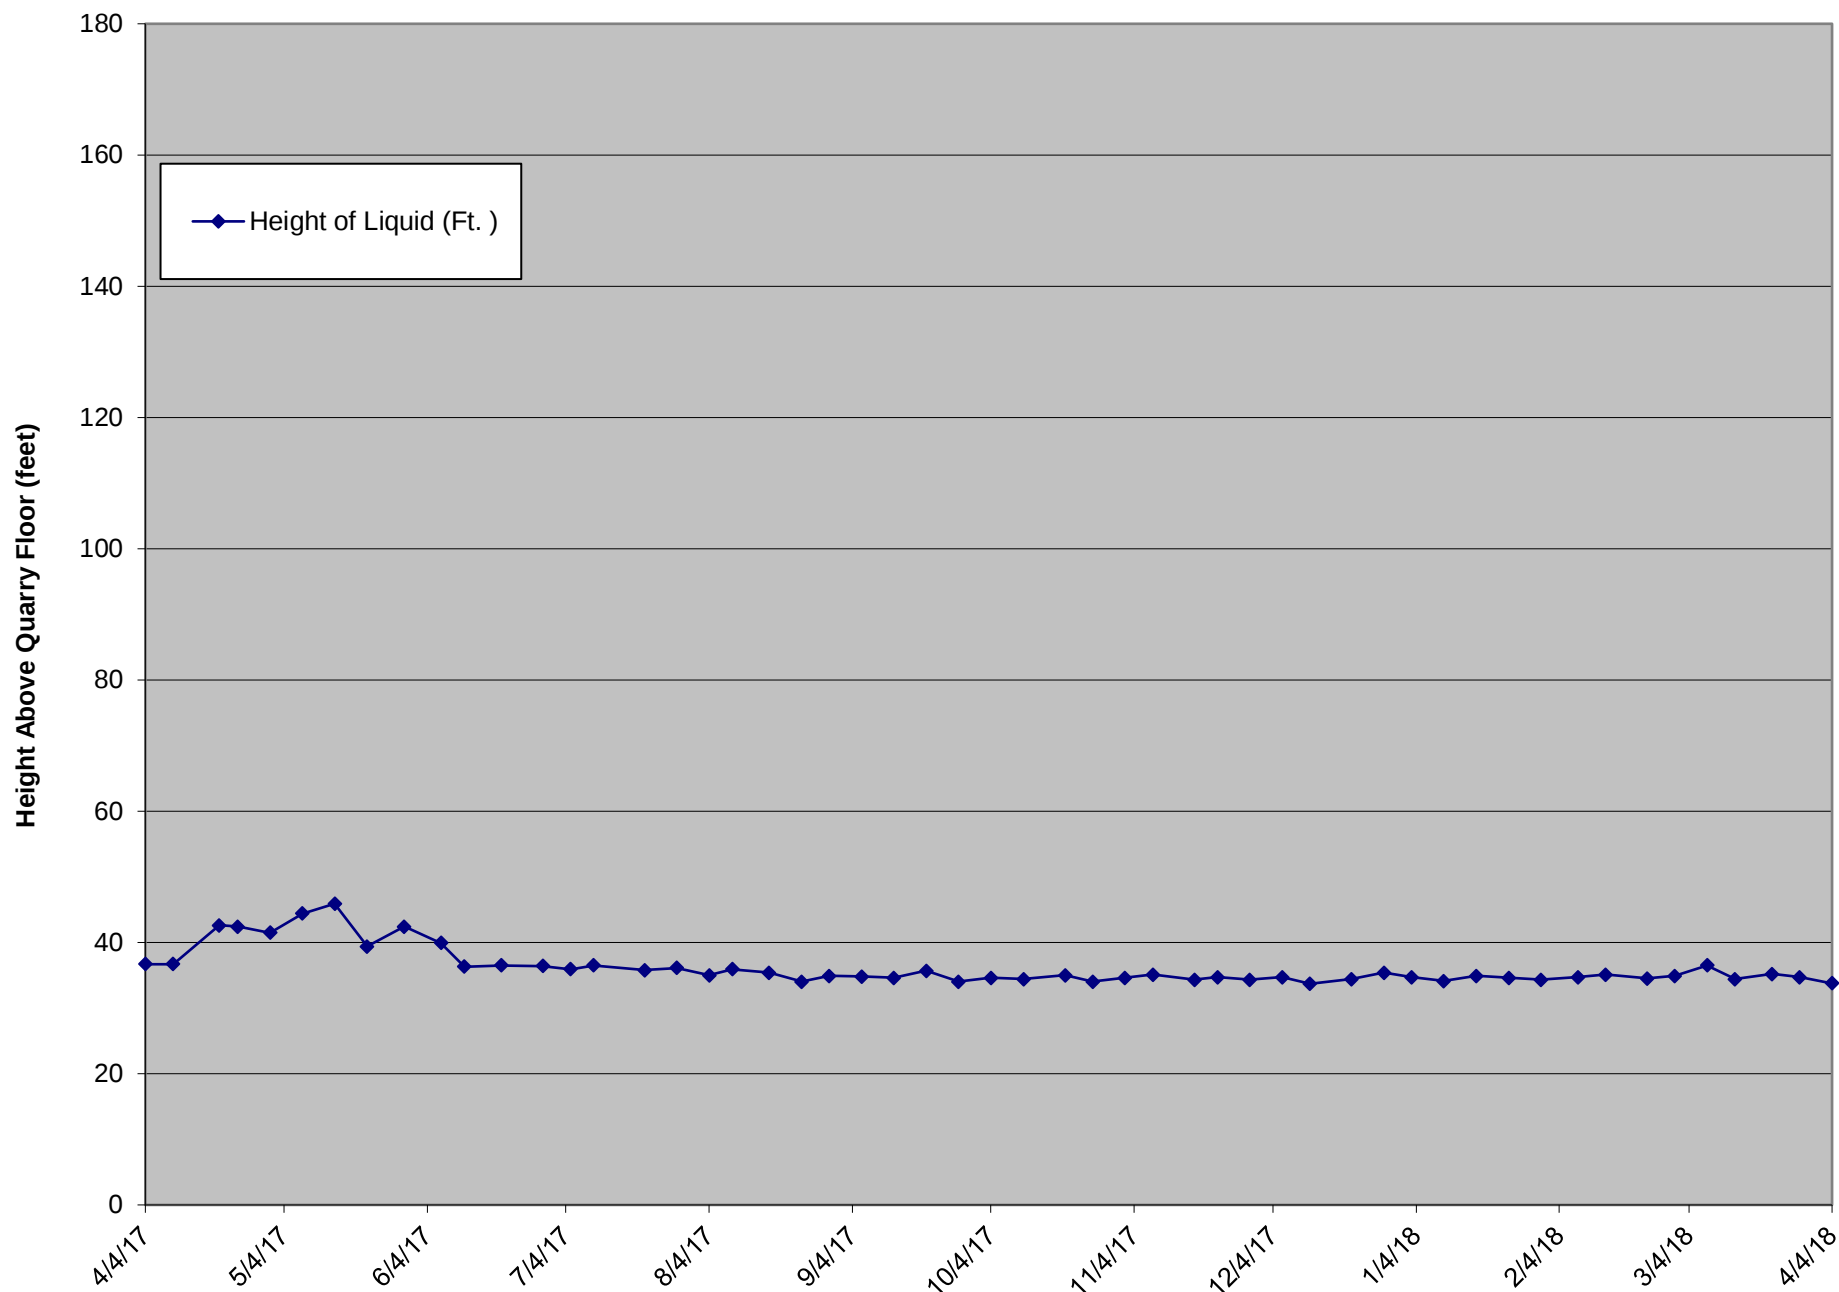
LCS-5B Liquid Level Above Quarry Floor

LCS-5B was fully operational during the weekly reporting period.

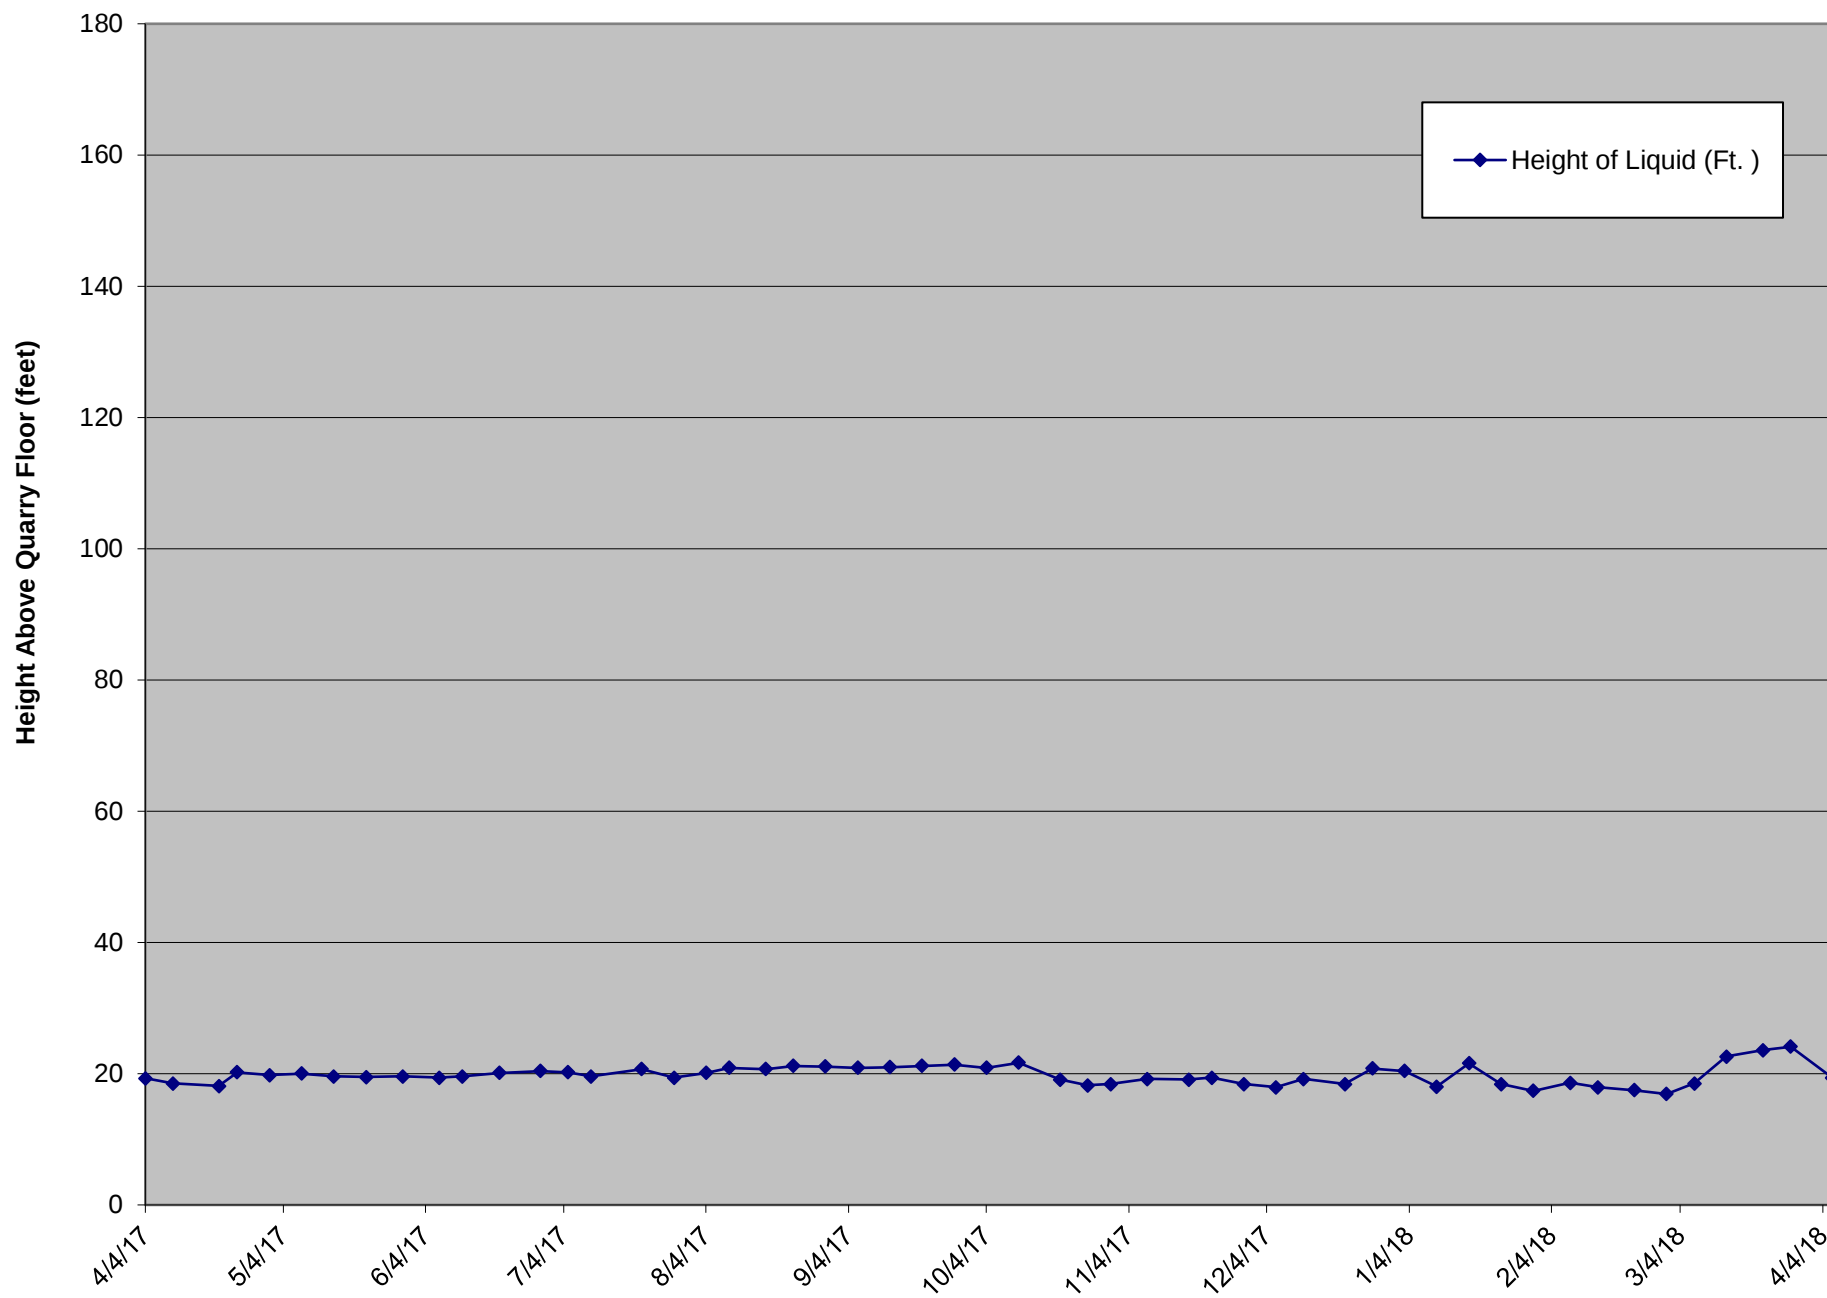
LCS-6B Liquid Level Above Quarry Floor

The pump in LCS-6B was observed to be non-operational on 3/9/18 and was replaced on 4/6/18. LCS-6B was fully operational as of 4/6/18.

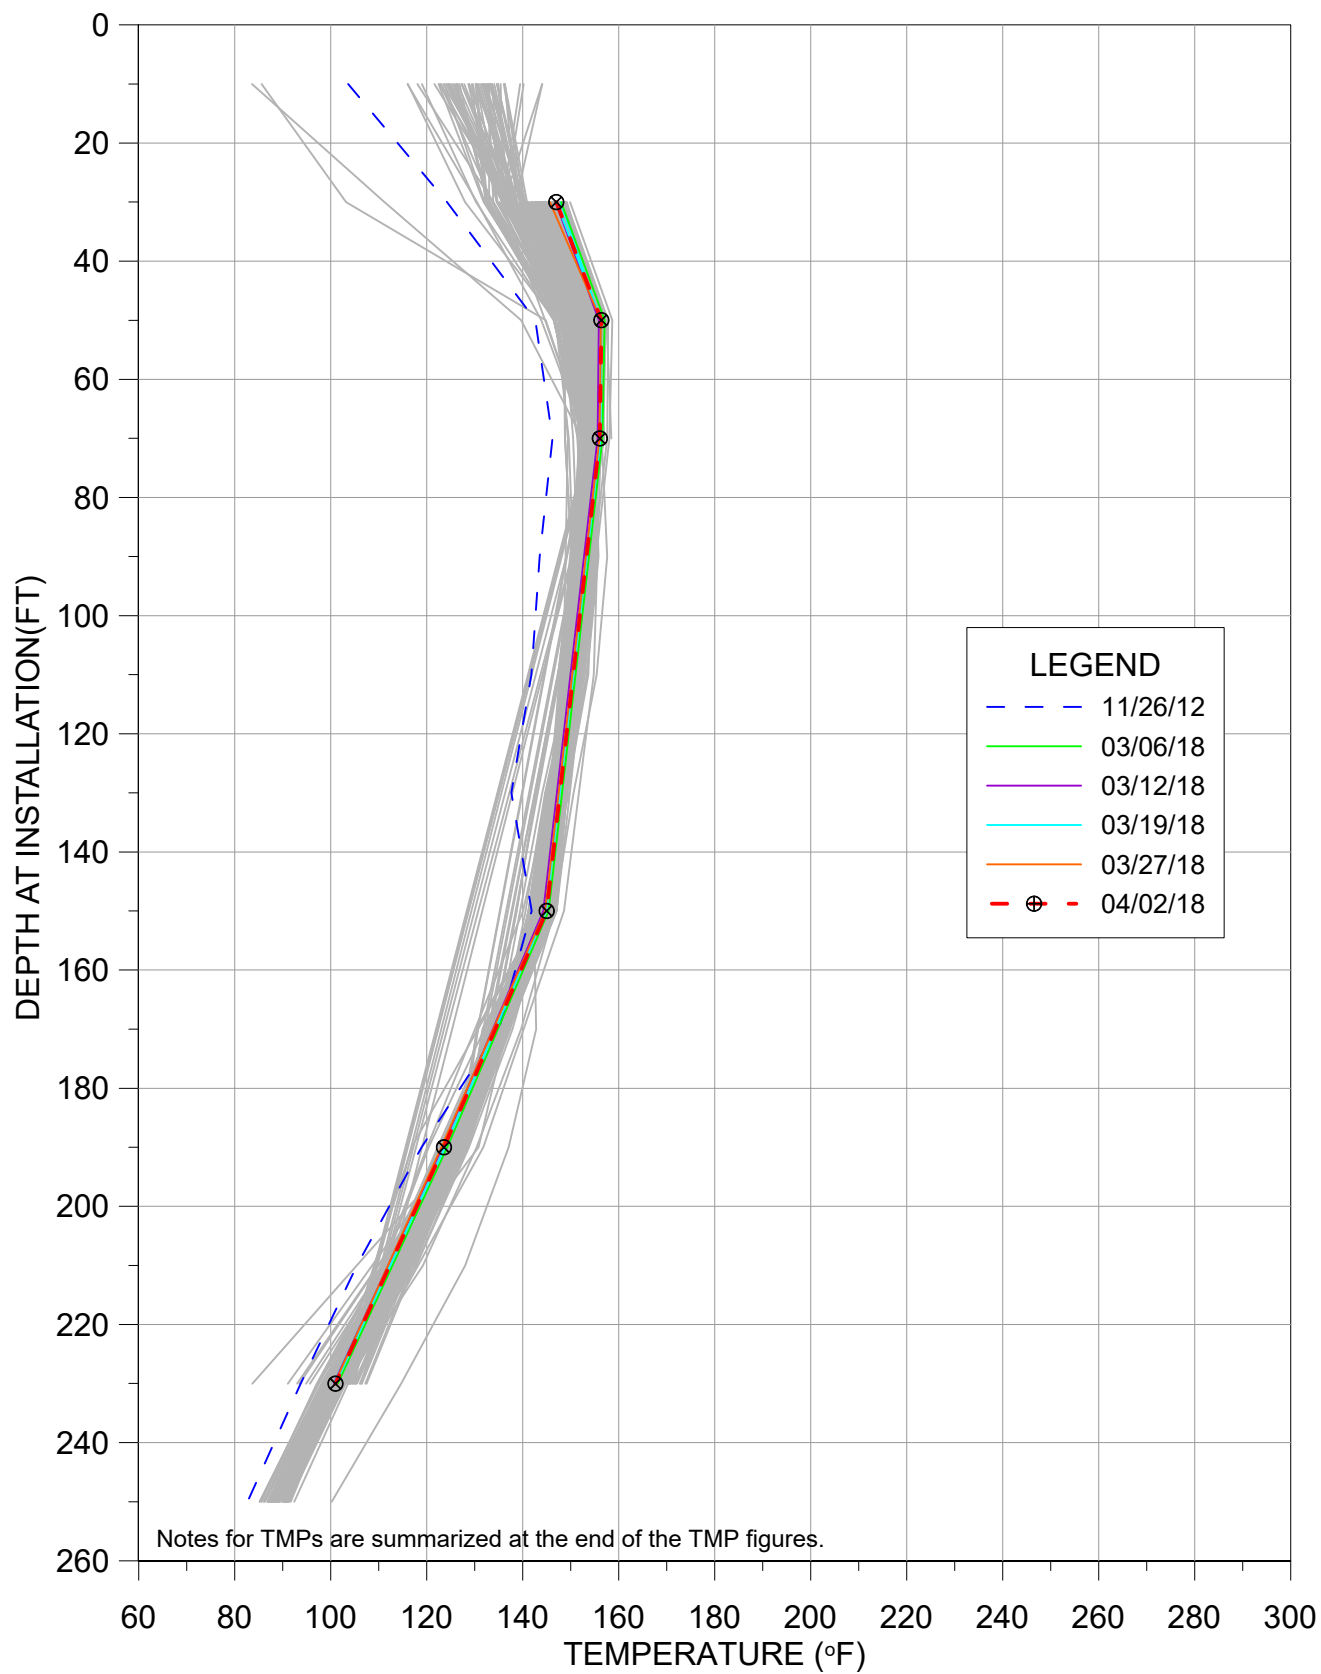
# TMP-3

1. No reliable temperature readings have been obtained at 170 ft depth since 1/29/2014, except on 3/13/2014.
2. The connectivity tests on 4/11/2014 conducted by CEC showed that units at 10, 90, 130, 210 and 250 ft depths are no longer reliable.
3. The connectivity tests on 10/28/2014 conducted by Feezor Engineering showed that units at 10, 90, 110, 130, 210 and 250 ft depths are not reliable.

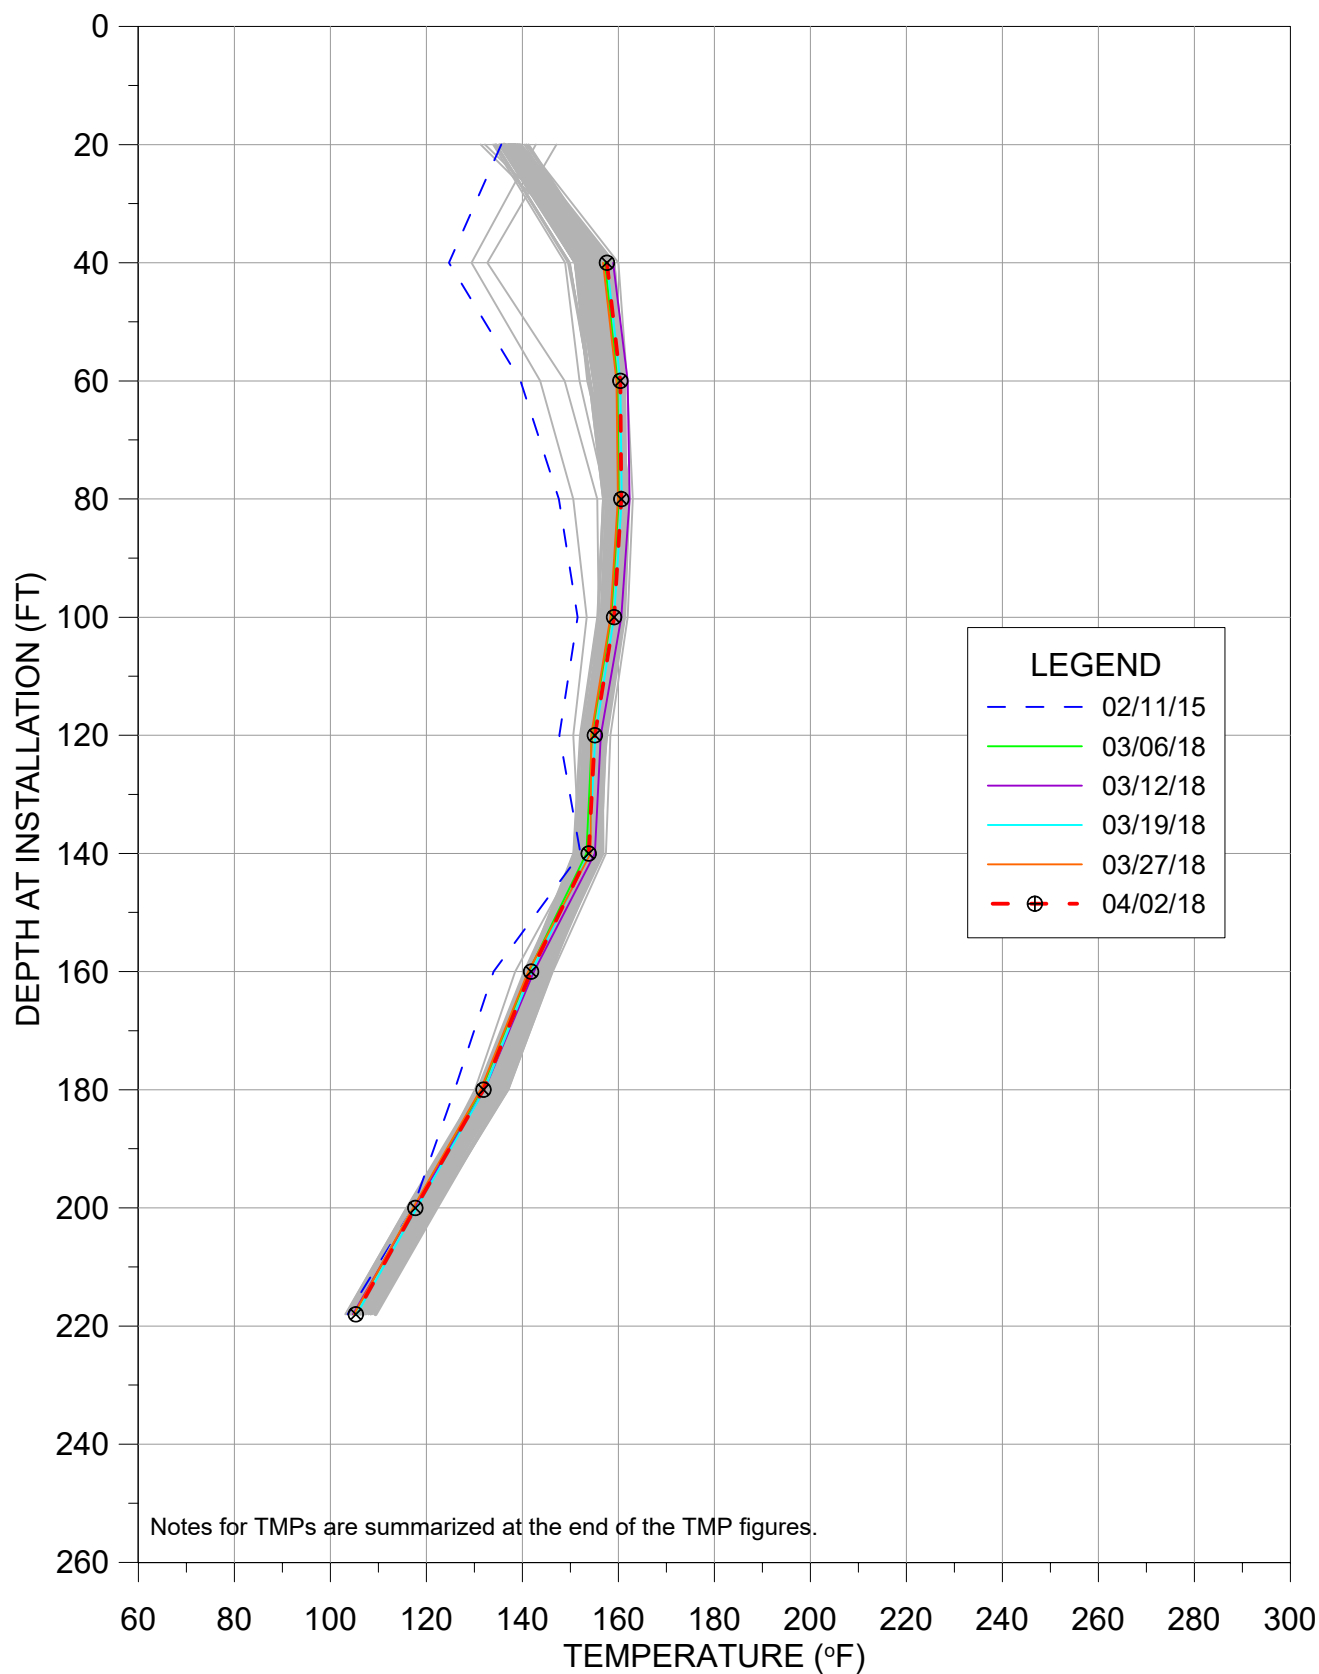
# TMP-3R

1. The unit at 20 ft depth had a fluctuating resistance since 9/25/2017. Therefore the temperature is determined to be unreliable.

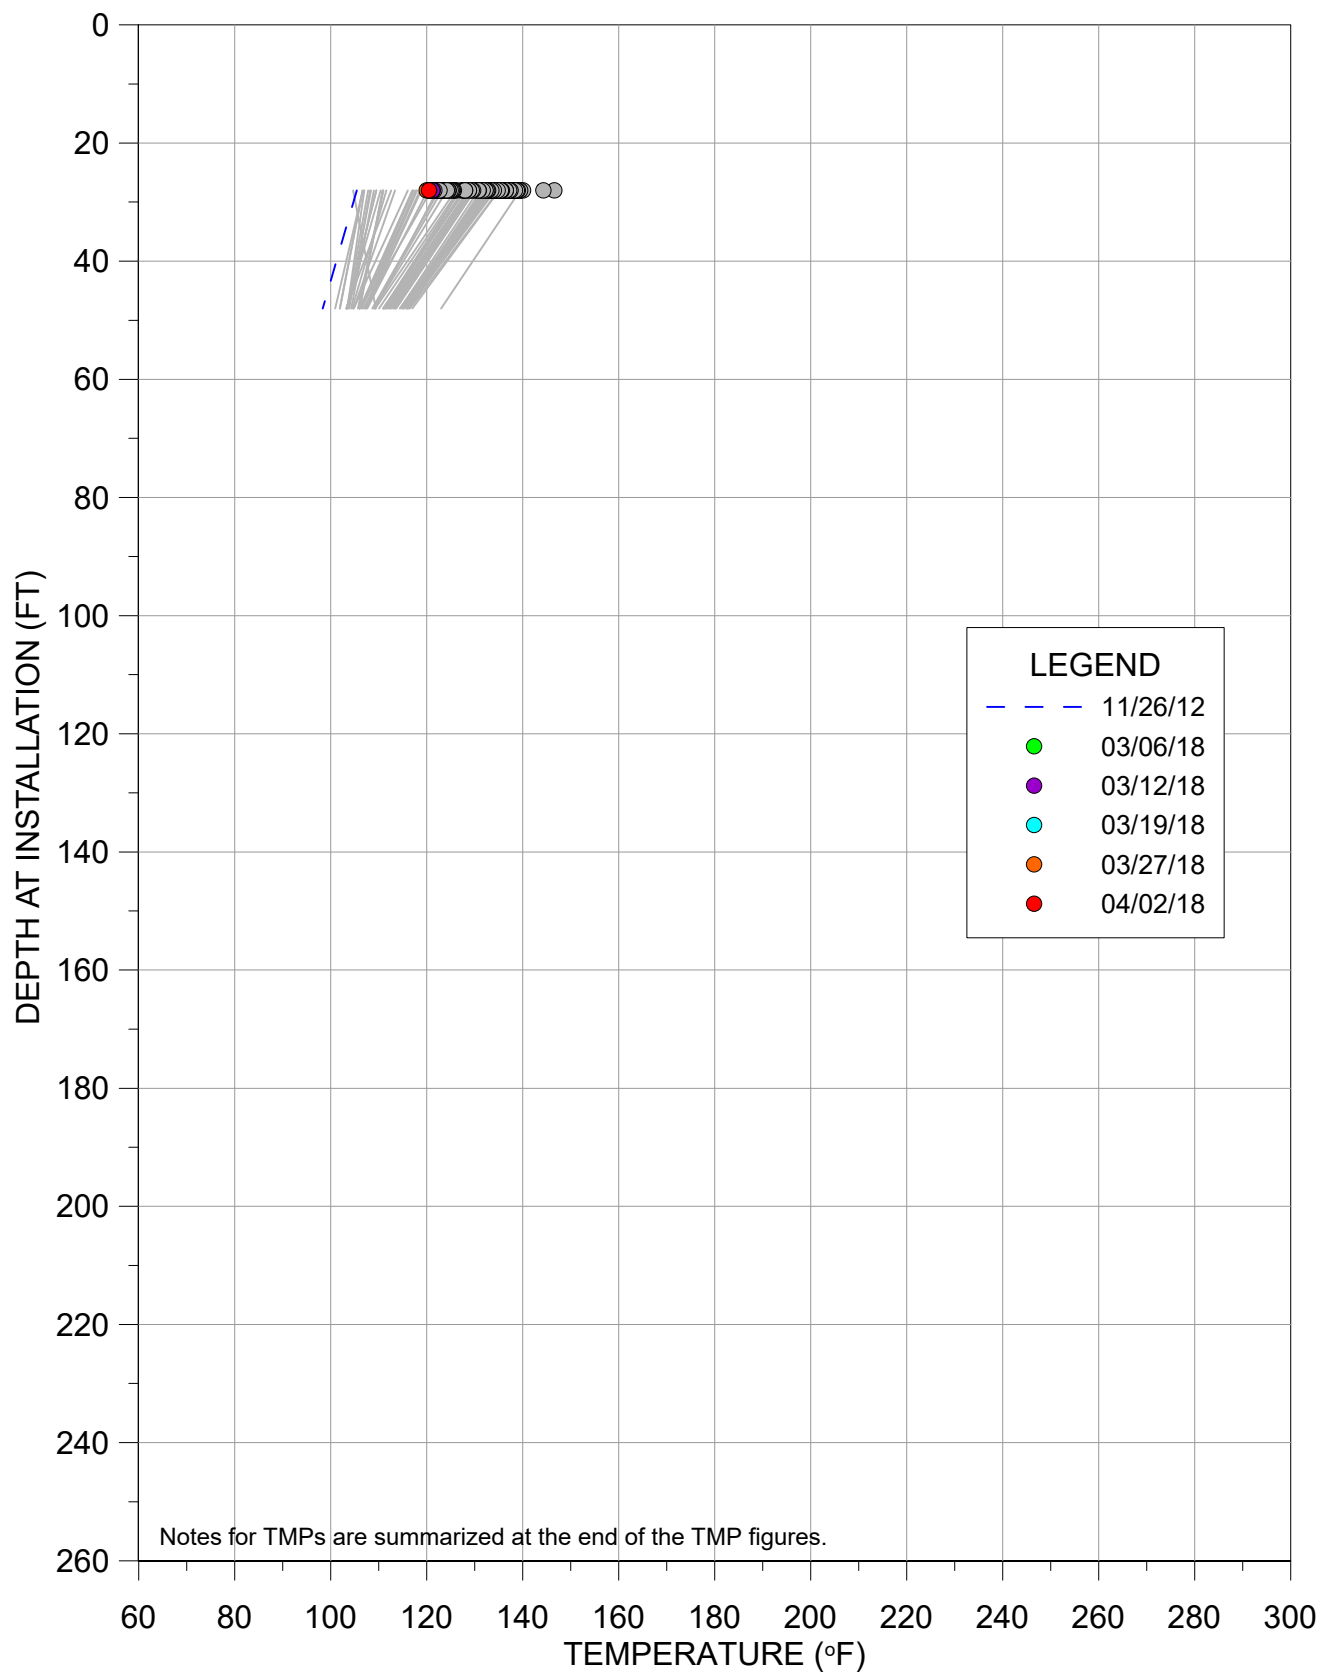
# TMP-4

1. The connectivity tests on 4/11/2014 conducted by CEC showed that the unit at 48 ft depth is no longer reliable.

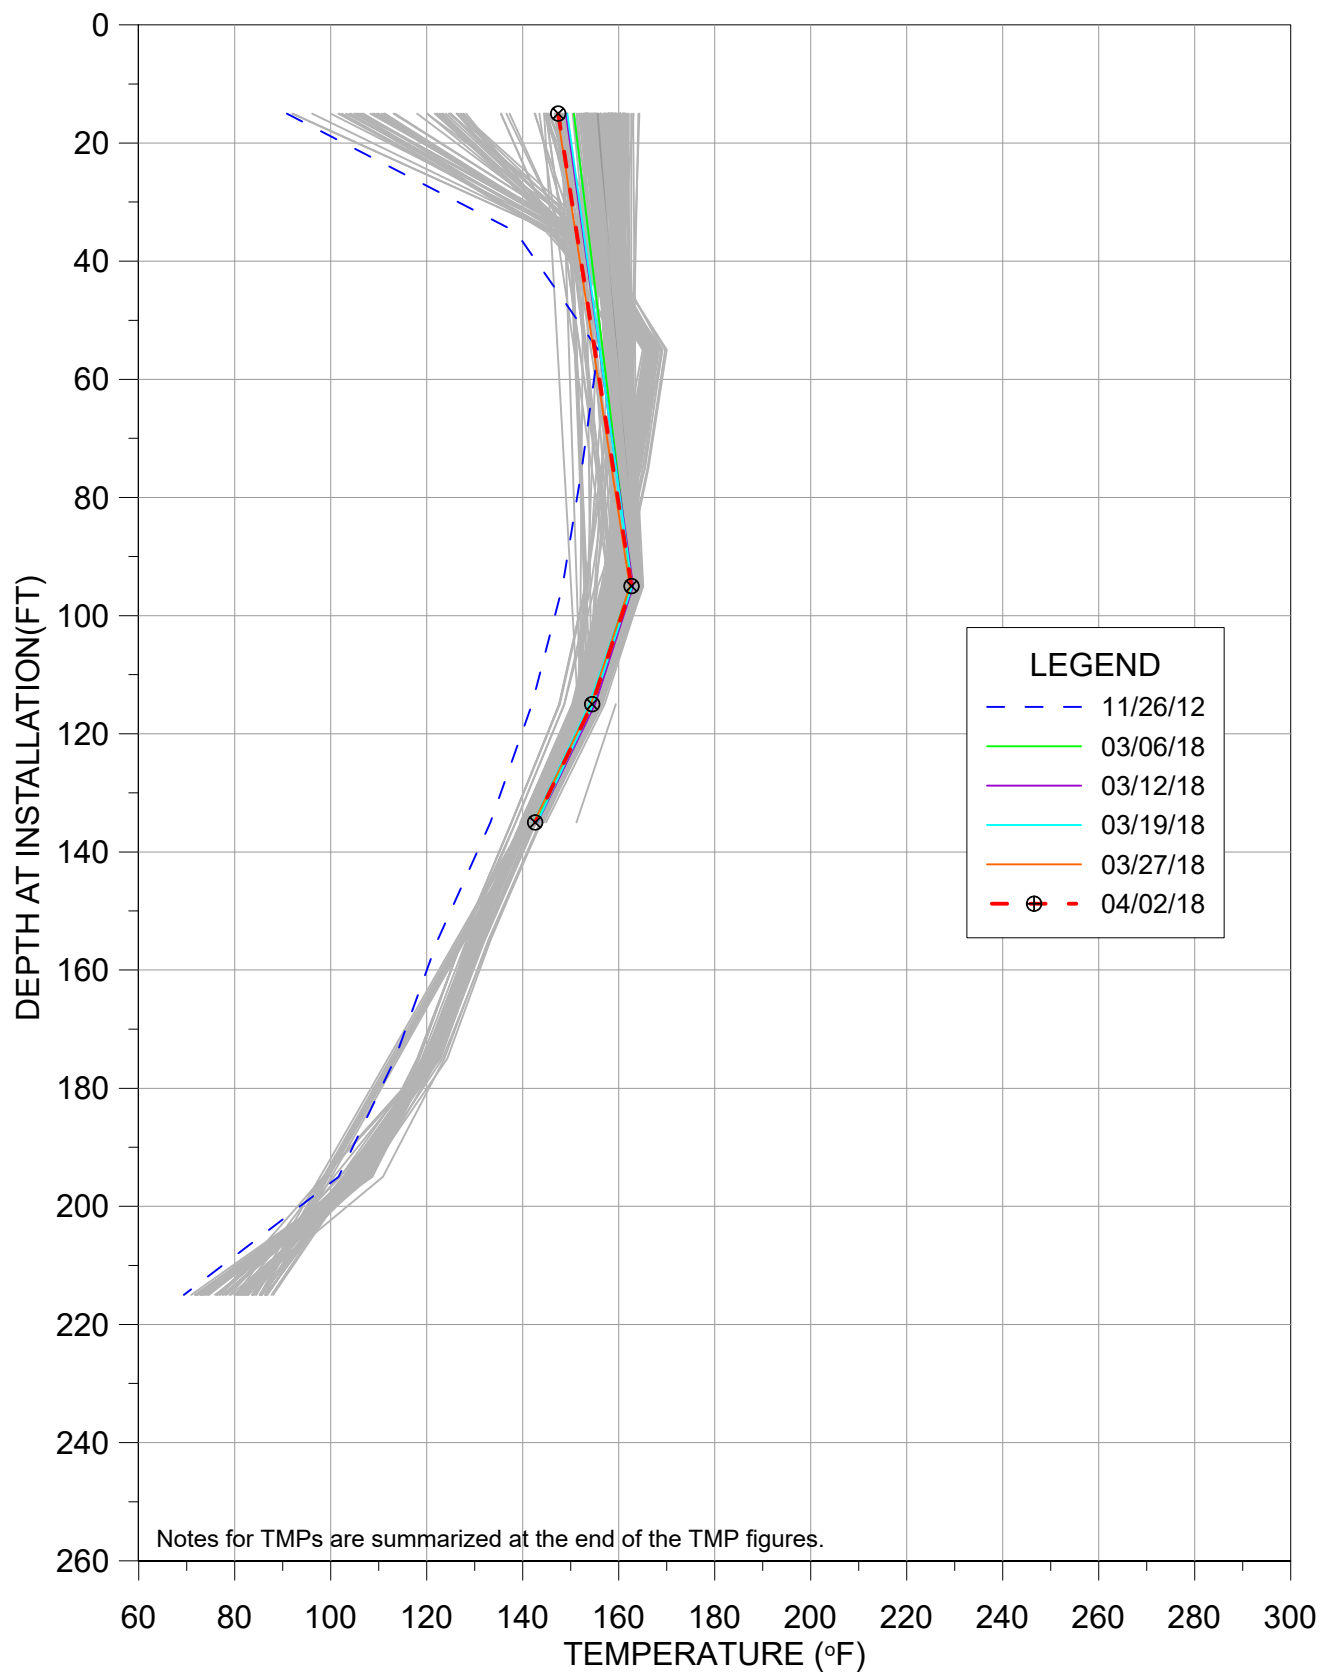
# TMP-6

1. The connectivity tests on 4/11/2014 conducted by CEC showed that units at 35, 55, 75, 155, 175, and 195 ft depths are no longer reliable.
2. No reliable temperature readings have been obtained at the unit at 215 ft depth since 6/13/2014.
