# **Bridgeton Landfill, LLC**

## **Weekly Data Submittal**

**Week of April 1, 2018 – April 7, 2018**

**Required by Section 52.F of Agreed Order, Case No. 13SL-CC01088  
Effective May 13, 2013**

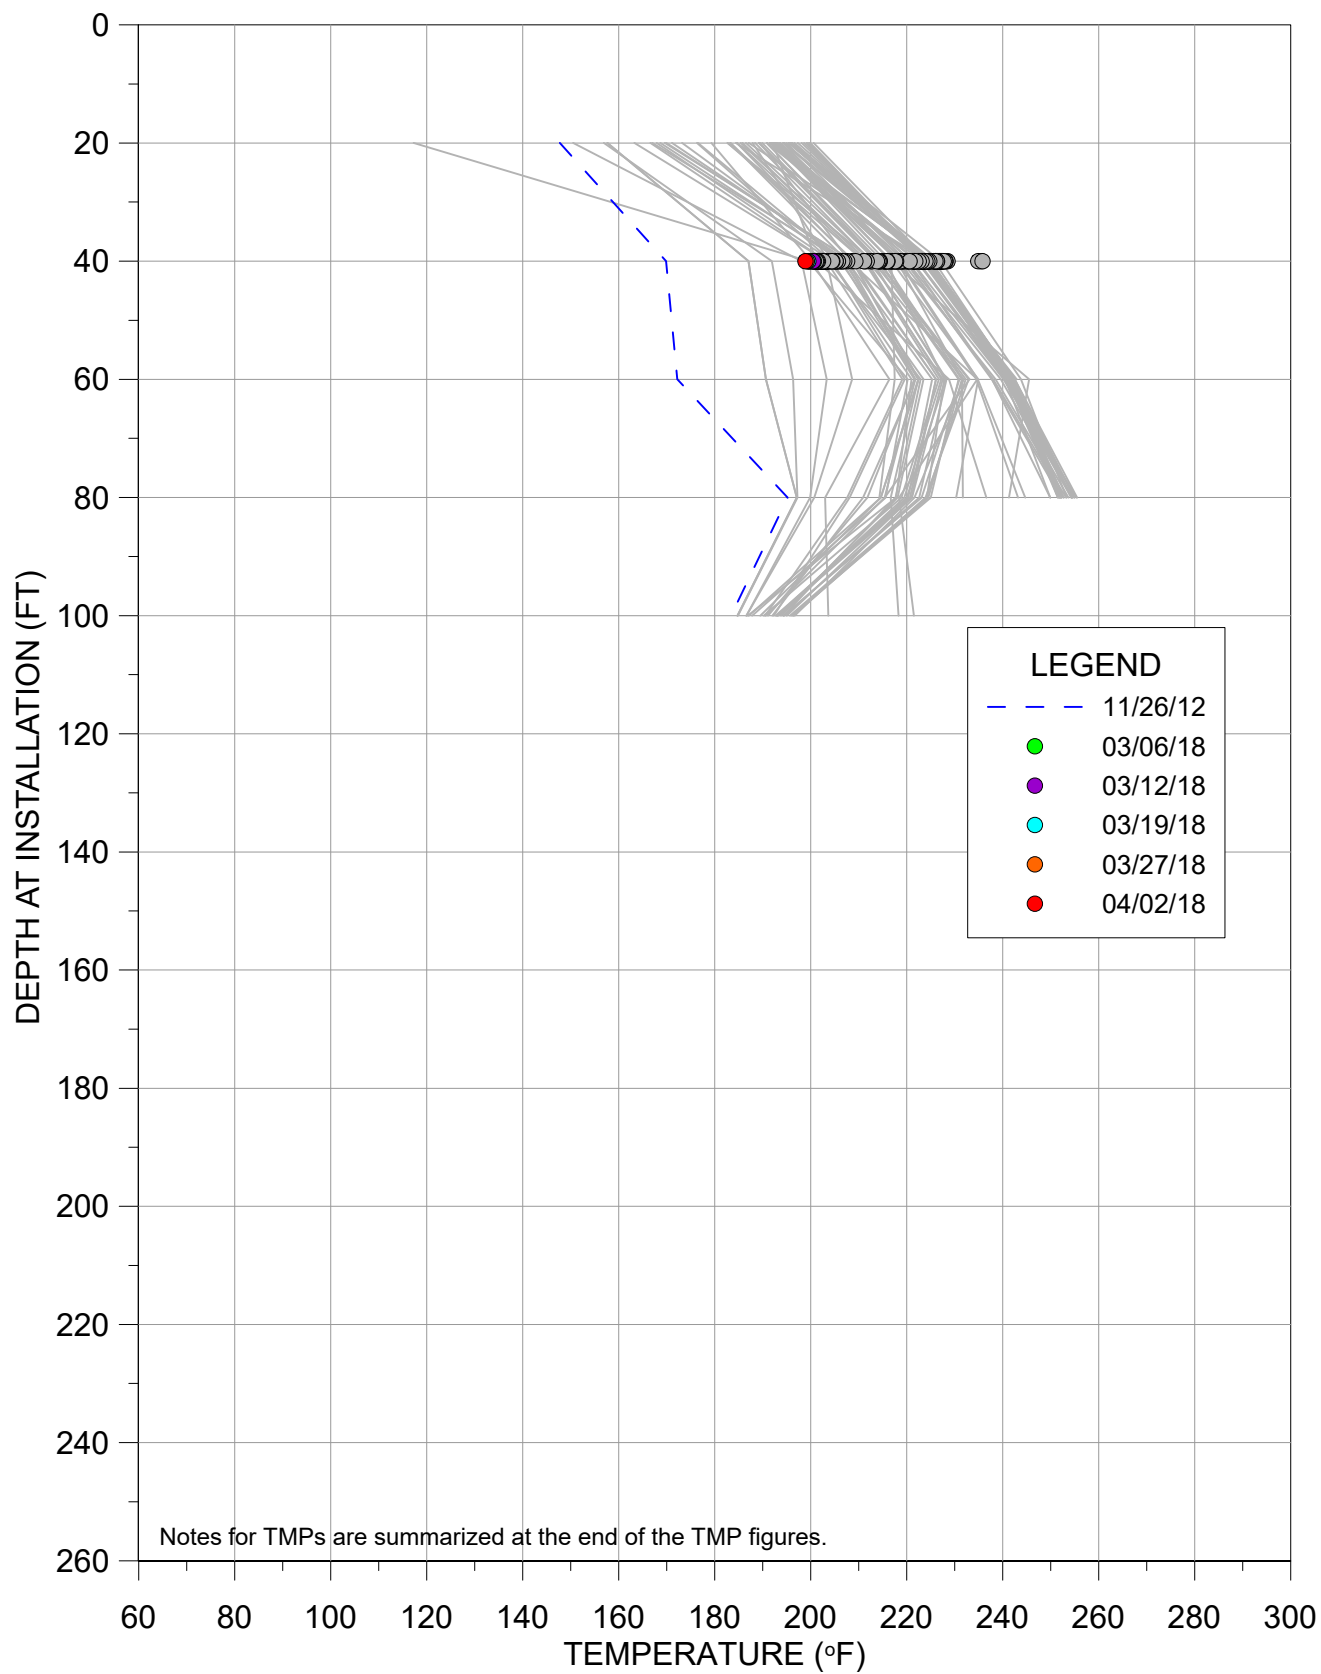
# TMP-9

1. Unit at 100 ft depth had an inaccurate temperature reading on 8/1/2013 and no reading since 8/6/2013.
2. The connectivity tests on 4/11/2014 conducted by CEC showed that units at 20, 60, 80, and 100 ft depths are no longer reliable.

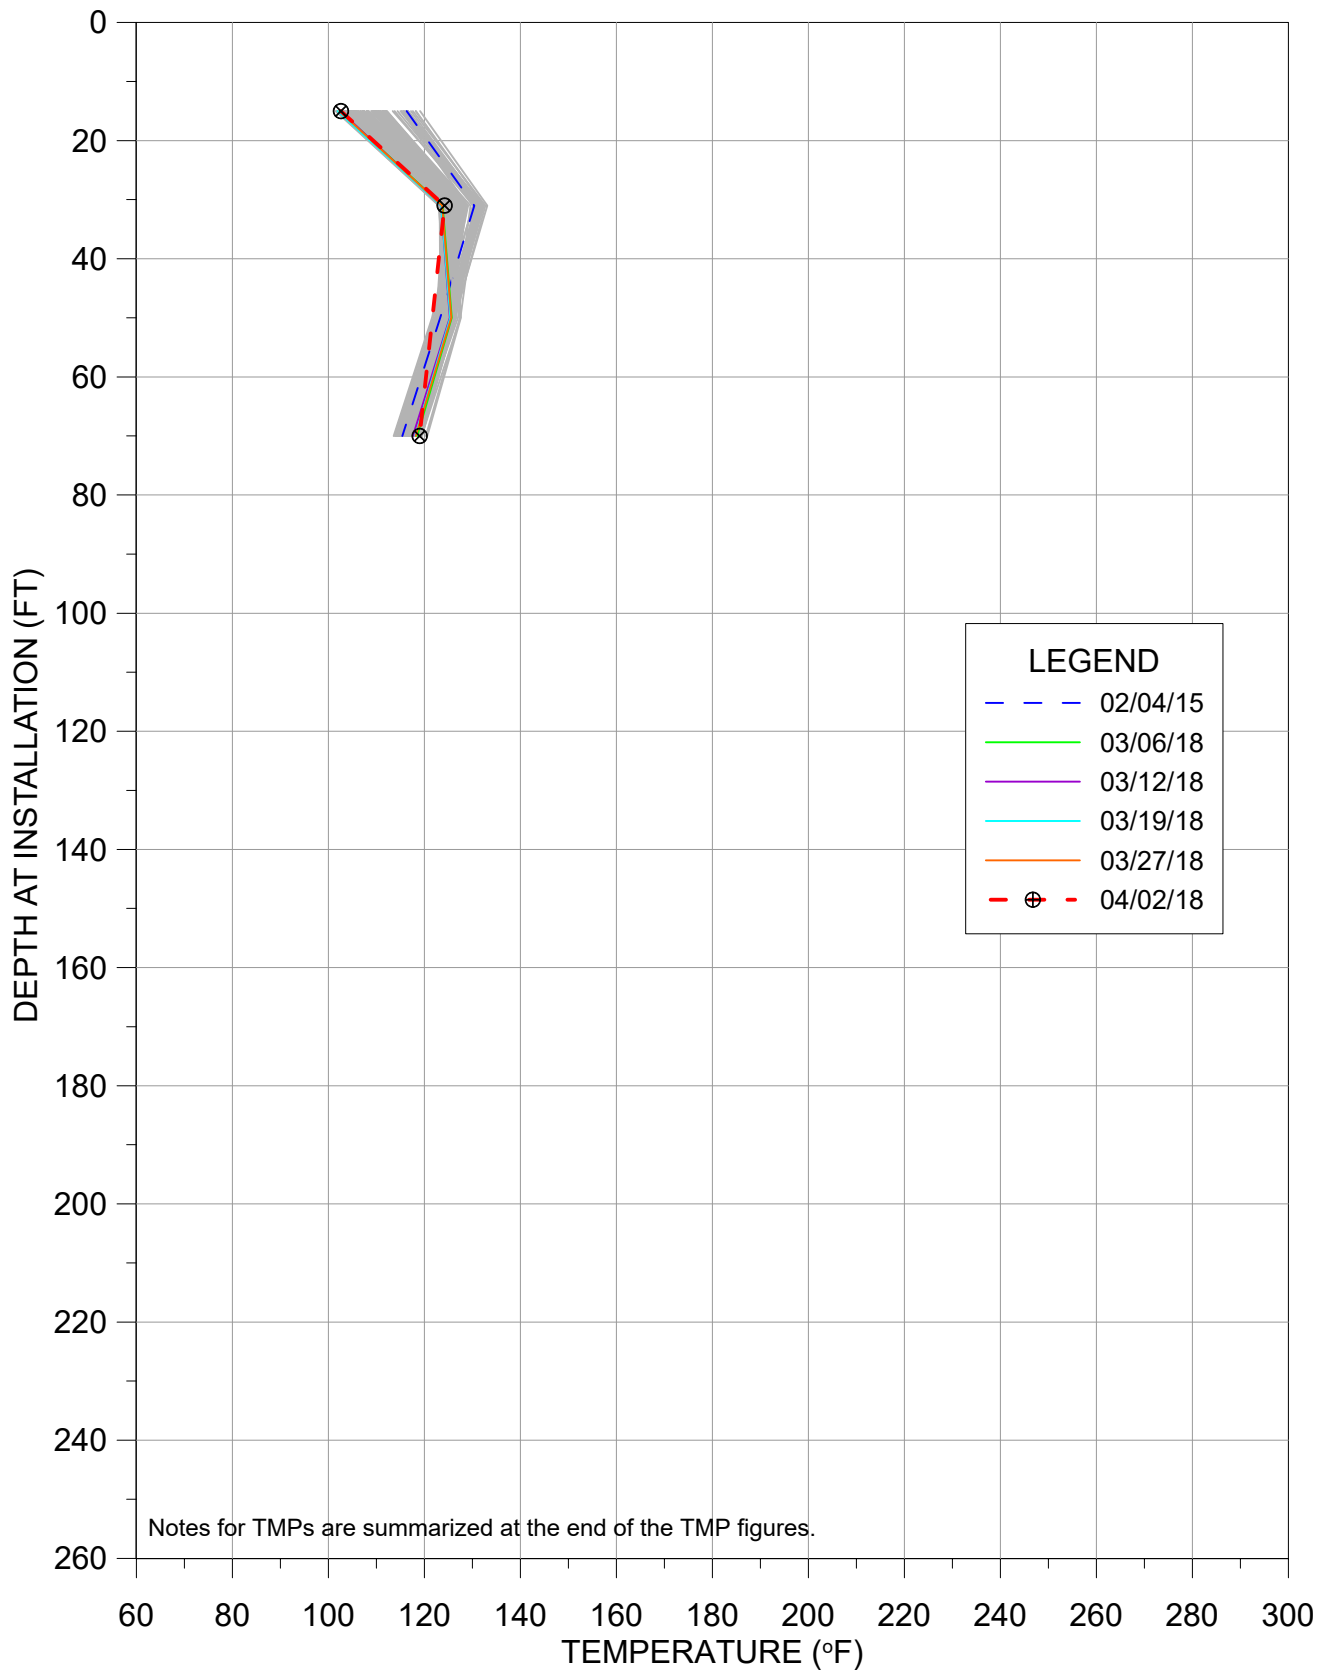
# TMP-22

1. **No temperature reading could be obtained and resistivity was fluctuating at the unit at 50 ft depth on 4/2/2018.**

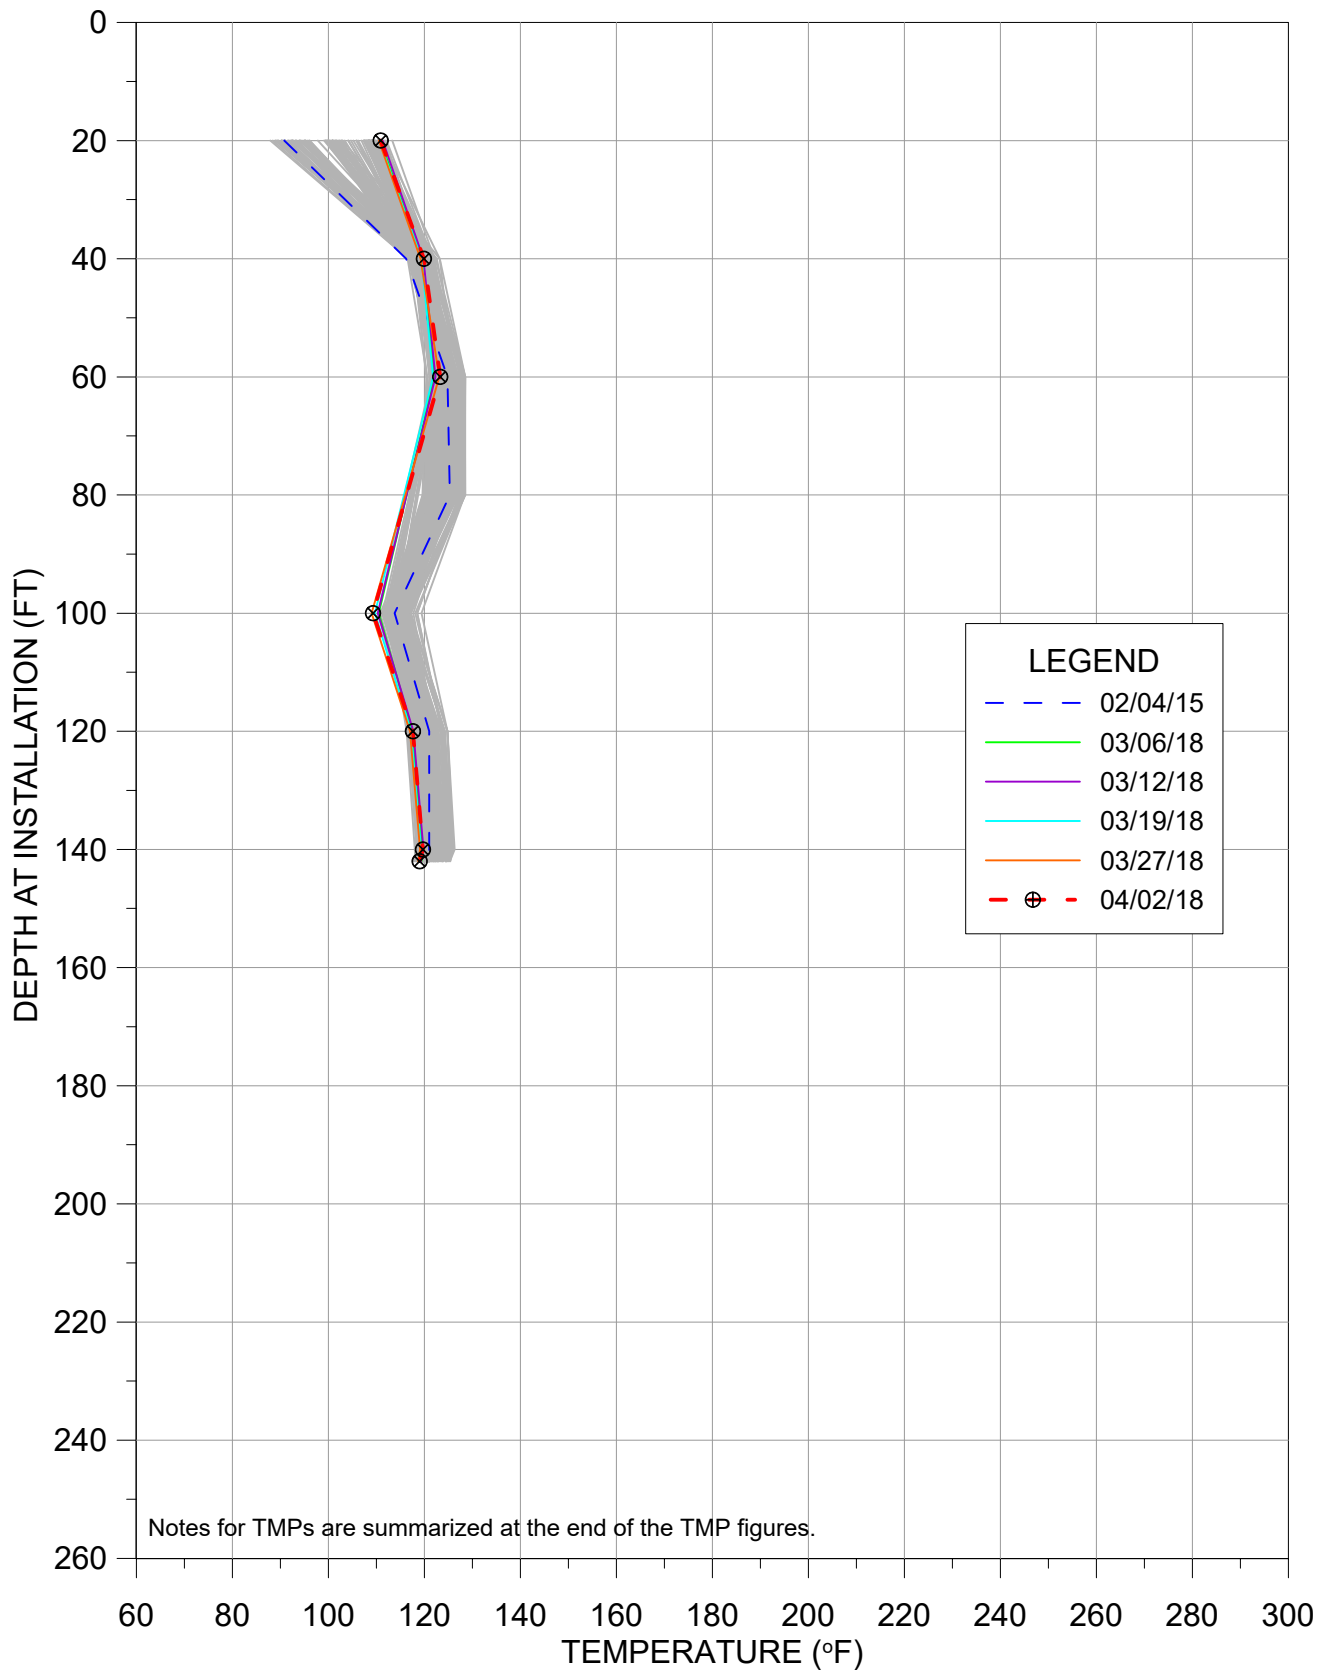
# TMP-26

1. Resistance on unit at 80 ft dropped 12.9 ohms (11/06/2017) and subsequent resistance reading continue to be low. Upon further investigation by Feezor Engineering, this unit is determined to be unreliable.

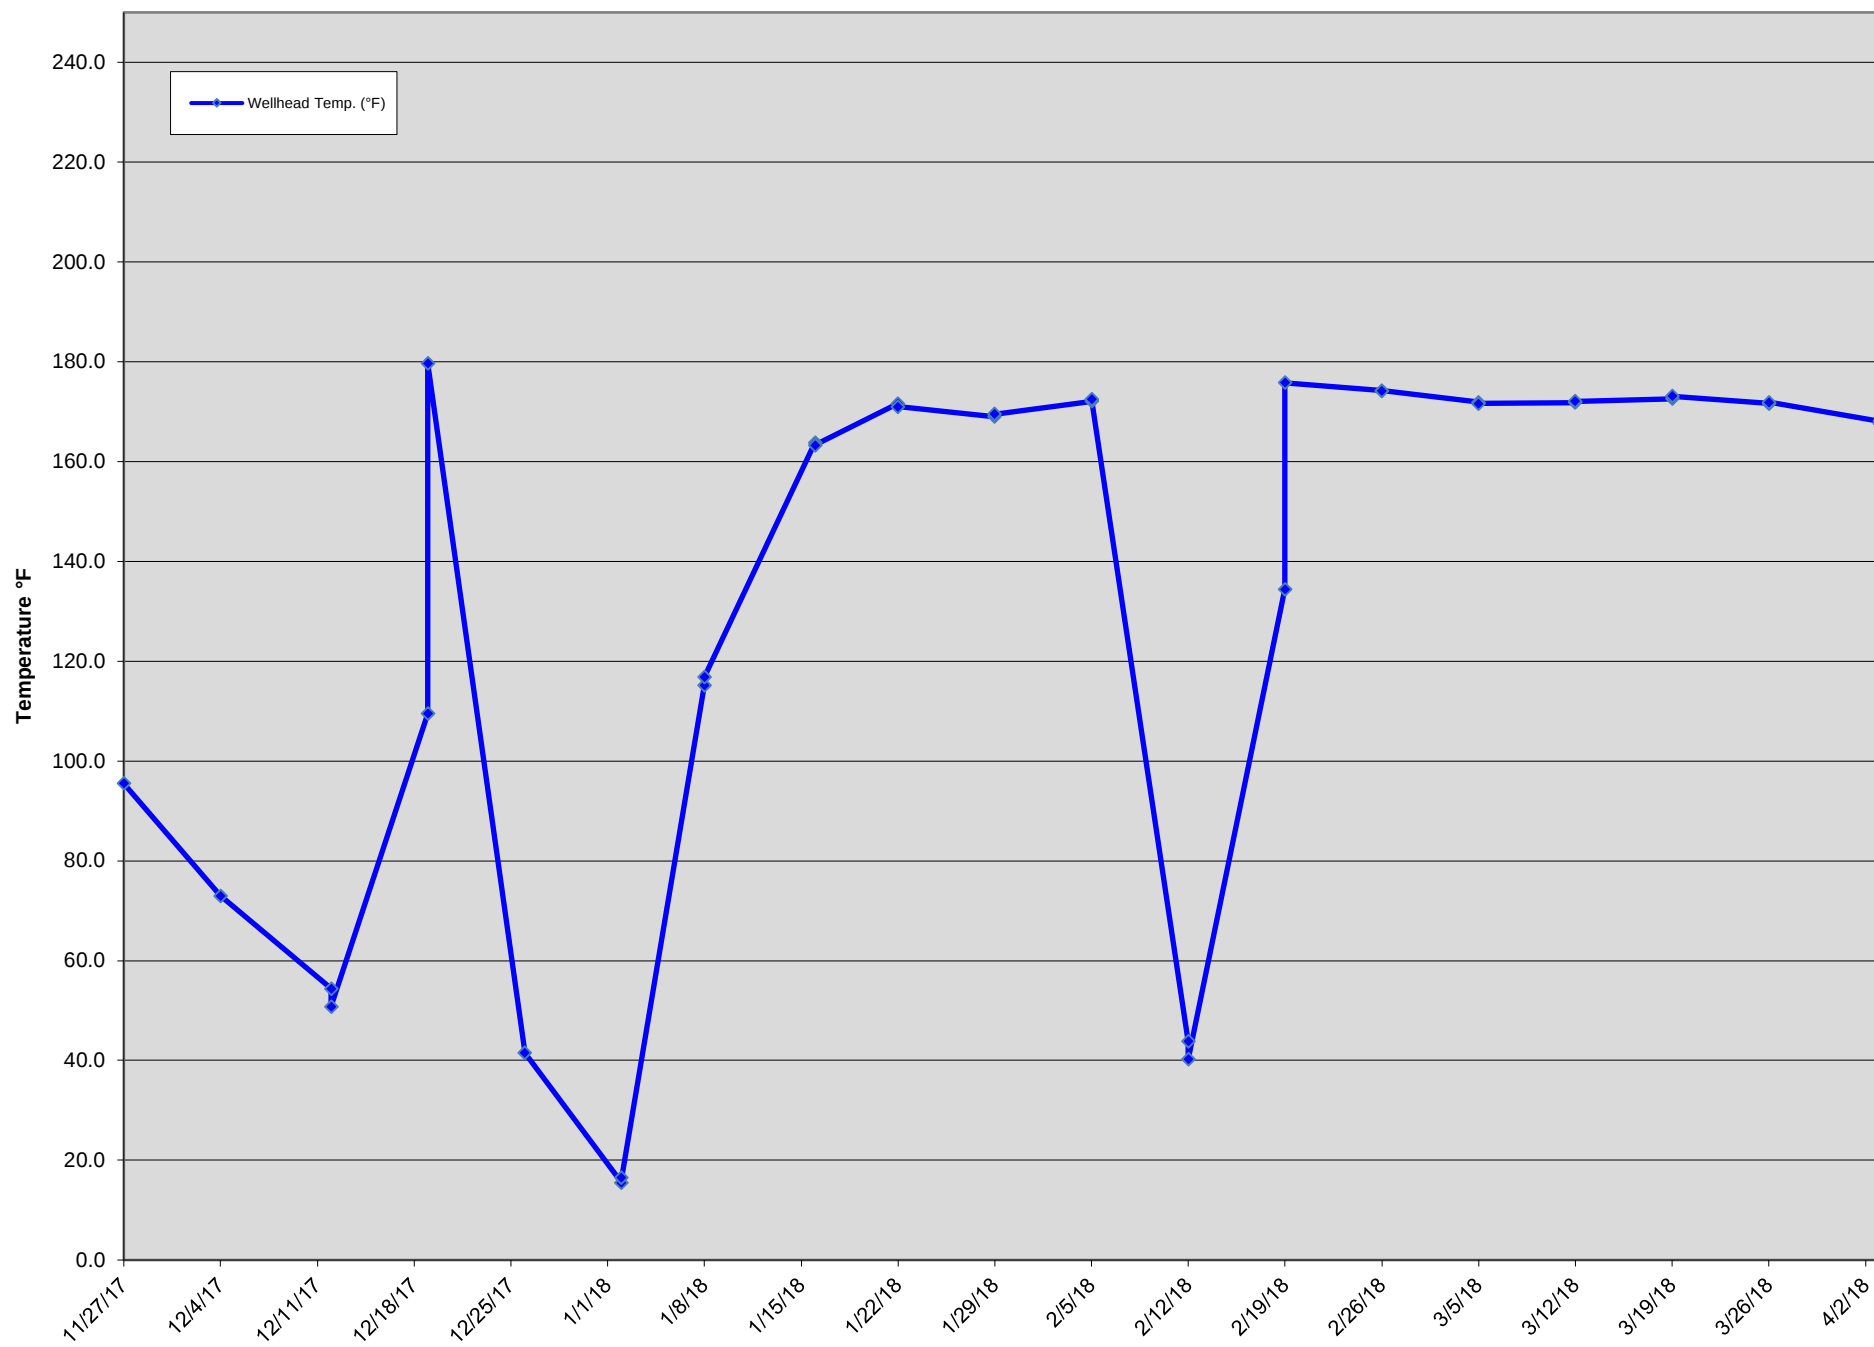
GIW-1 Wellhead Temperatures

As part of the HES, there are currently cooling water circulation loops installed in twelve Gas Interceptor Wells (GIWs) (GIW-02 through GIW-13). The remaining well (GIW-01) had a measured gas temperature within its historical operating limits.
