Bridgeton Landfill, LLC

Weekly Data Submittal

Week of May 6, 2018 – May 12, 2018

**Required by Section 52.F of Agreed Order, Case No. 13SL-CC01088
Effective May 13, 2013**

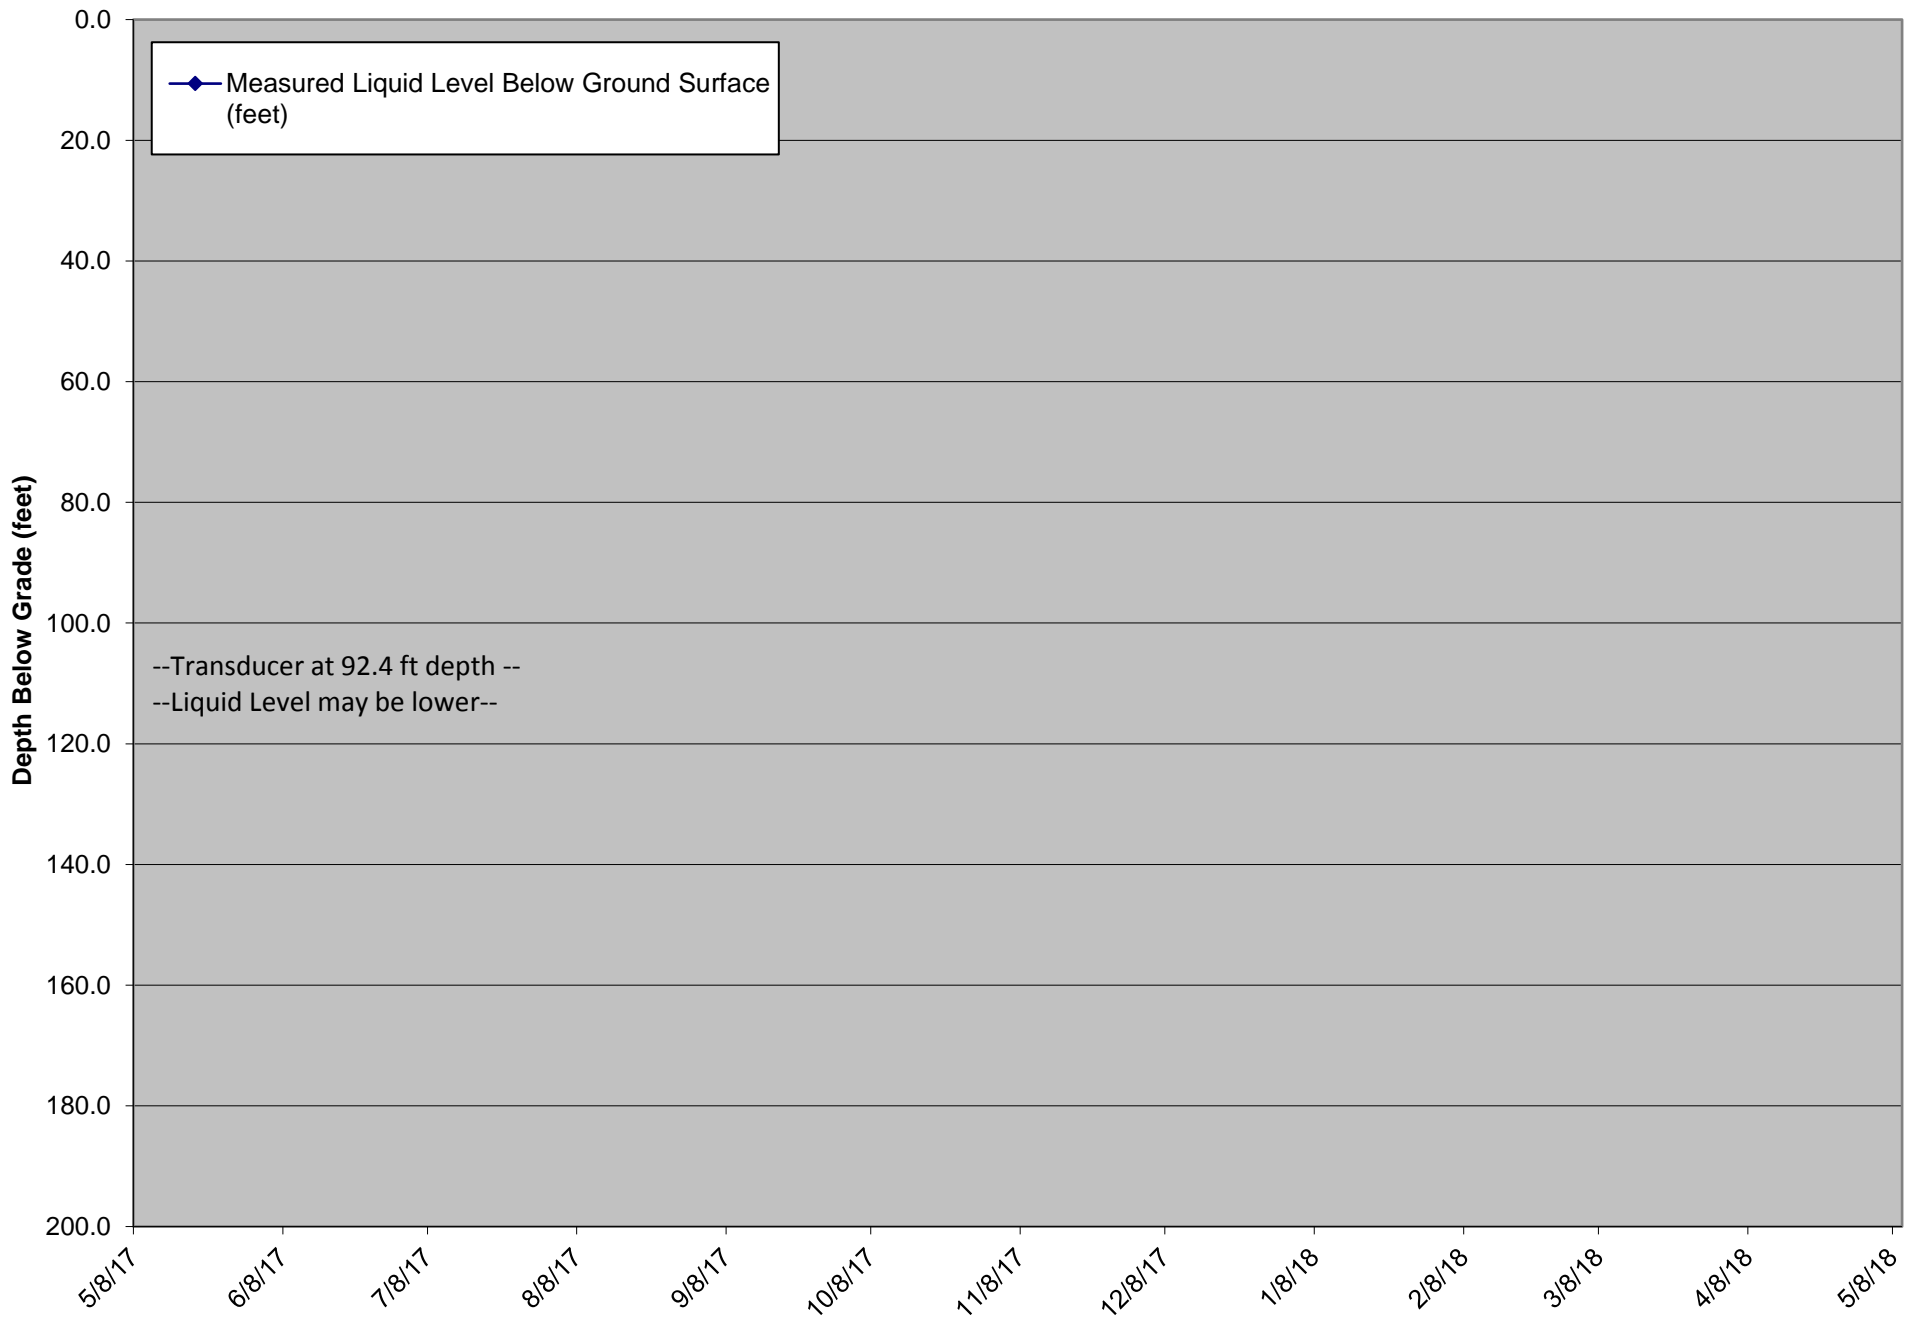
LCS-1D Liquid Level Below Ground Surface

Downhole discharge piping and the pump for LCS-1D was replaced the week of 2/5/18. Pump was non-operational after startup activities. Pump replacement was attempted the week of 4/30/18 and was unsuccessful. Further options are being evaluated.

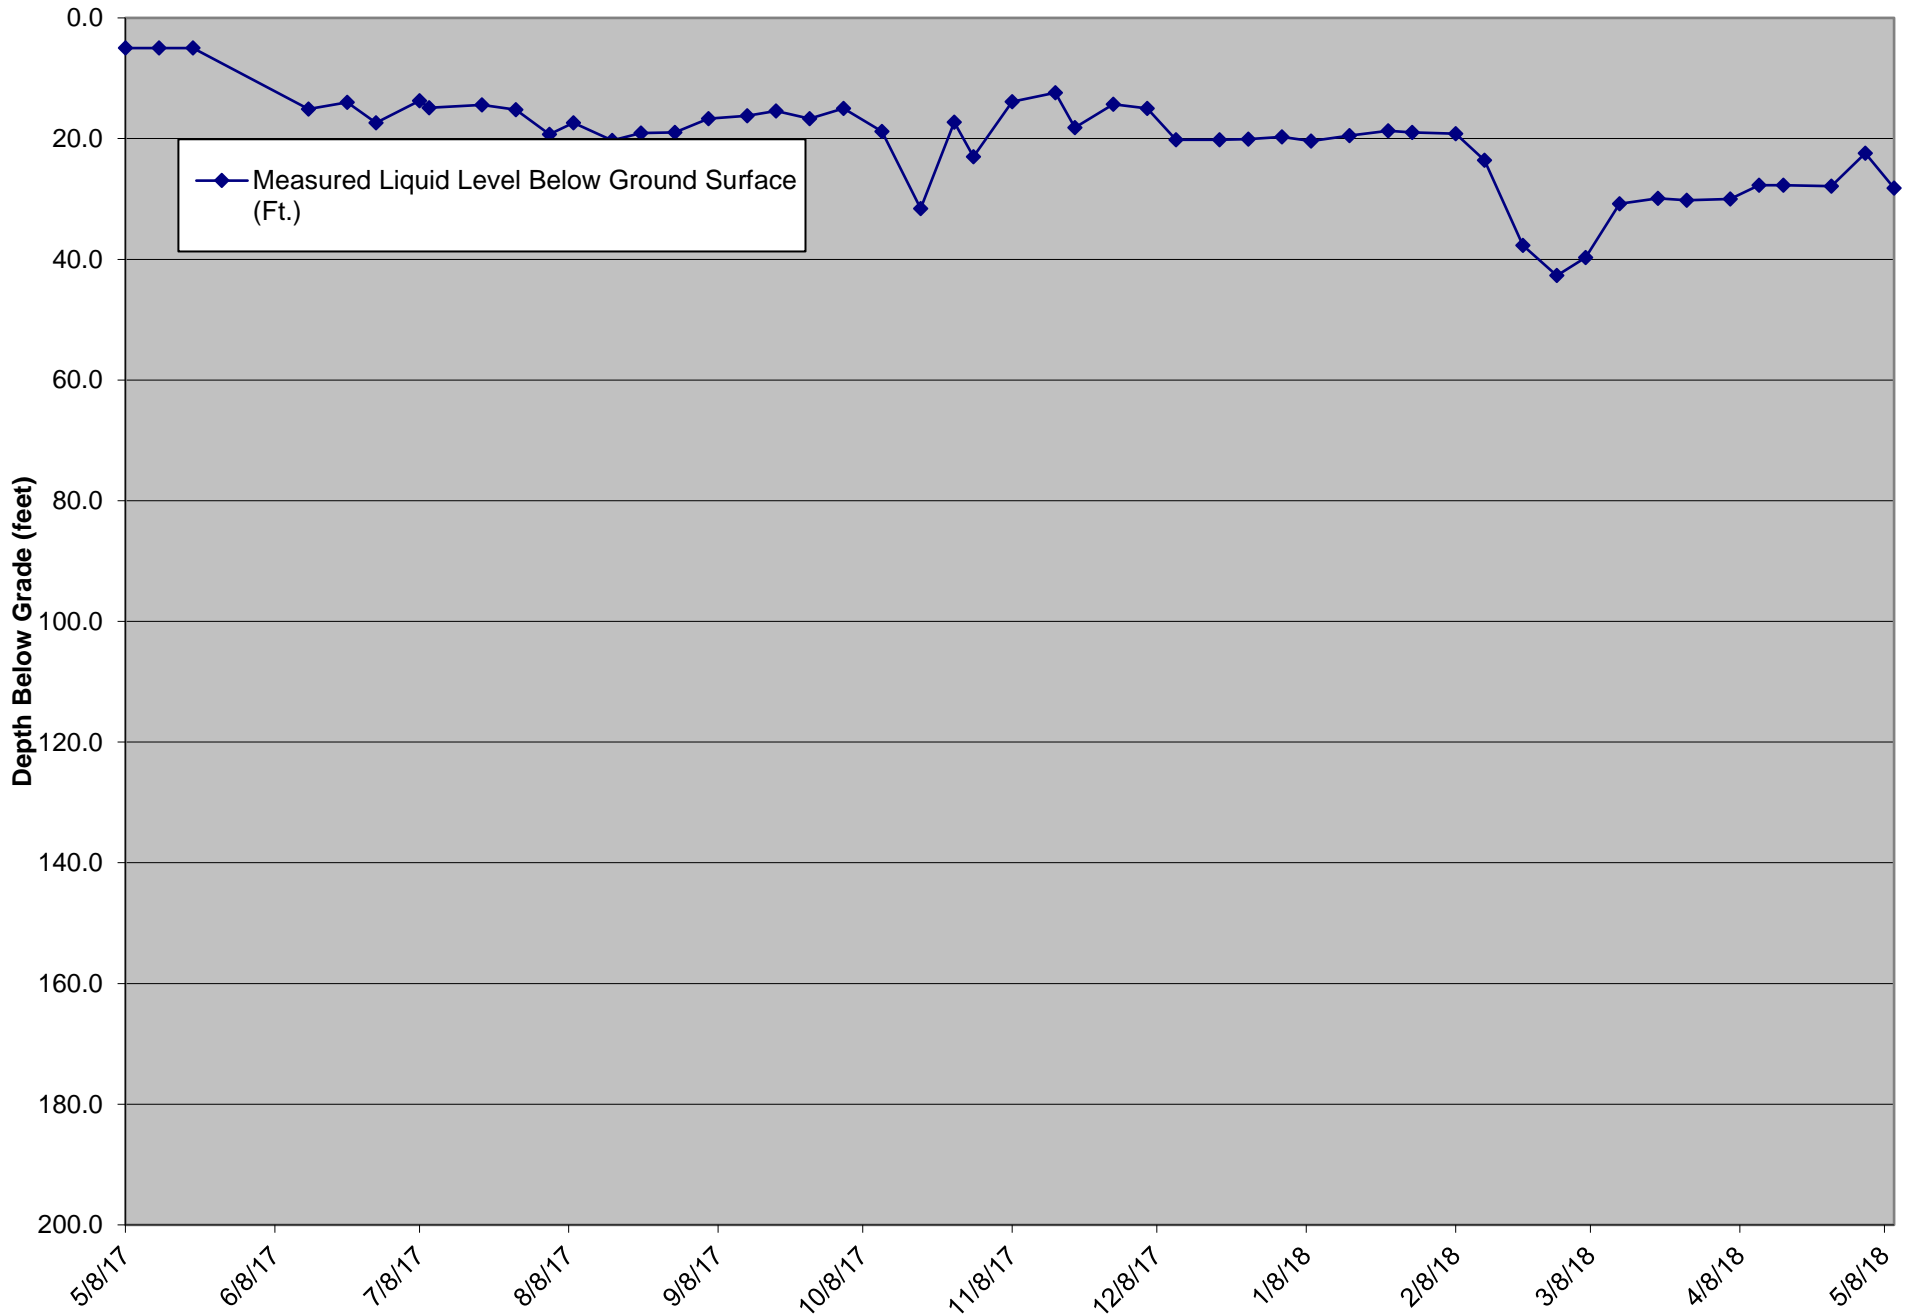
LCS-3D Liquid Level Below Ground Surface

The QED AP-4 at LCS-3D pneumatic pump was non-operational during the weekly reporting period. Liquid level was measured manually.

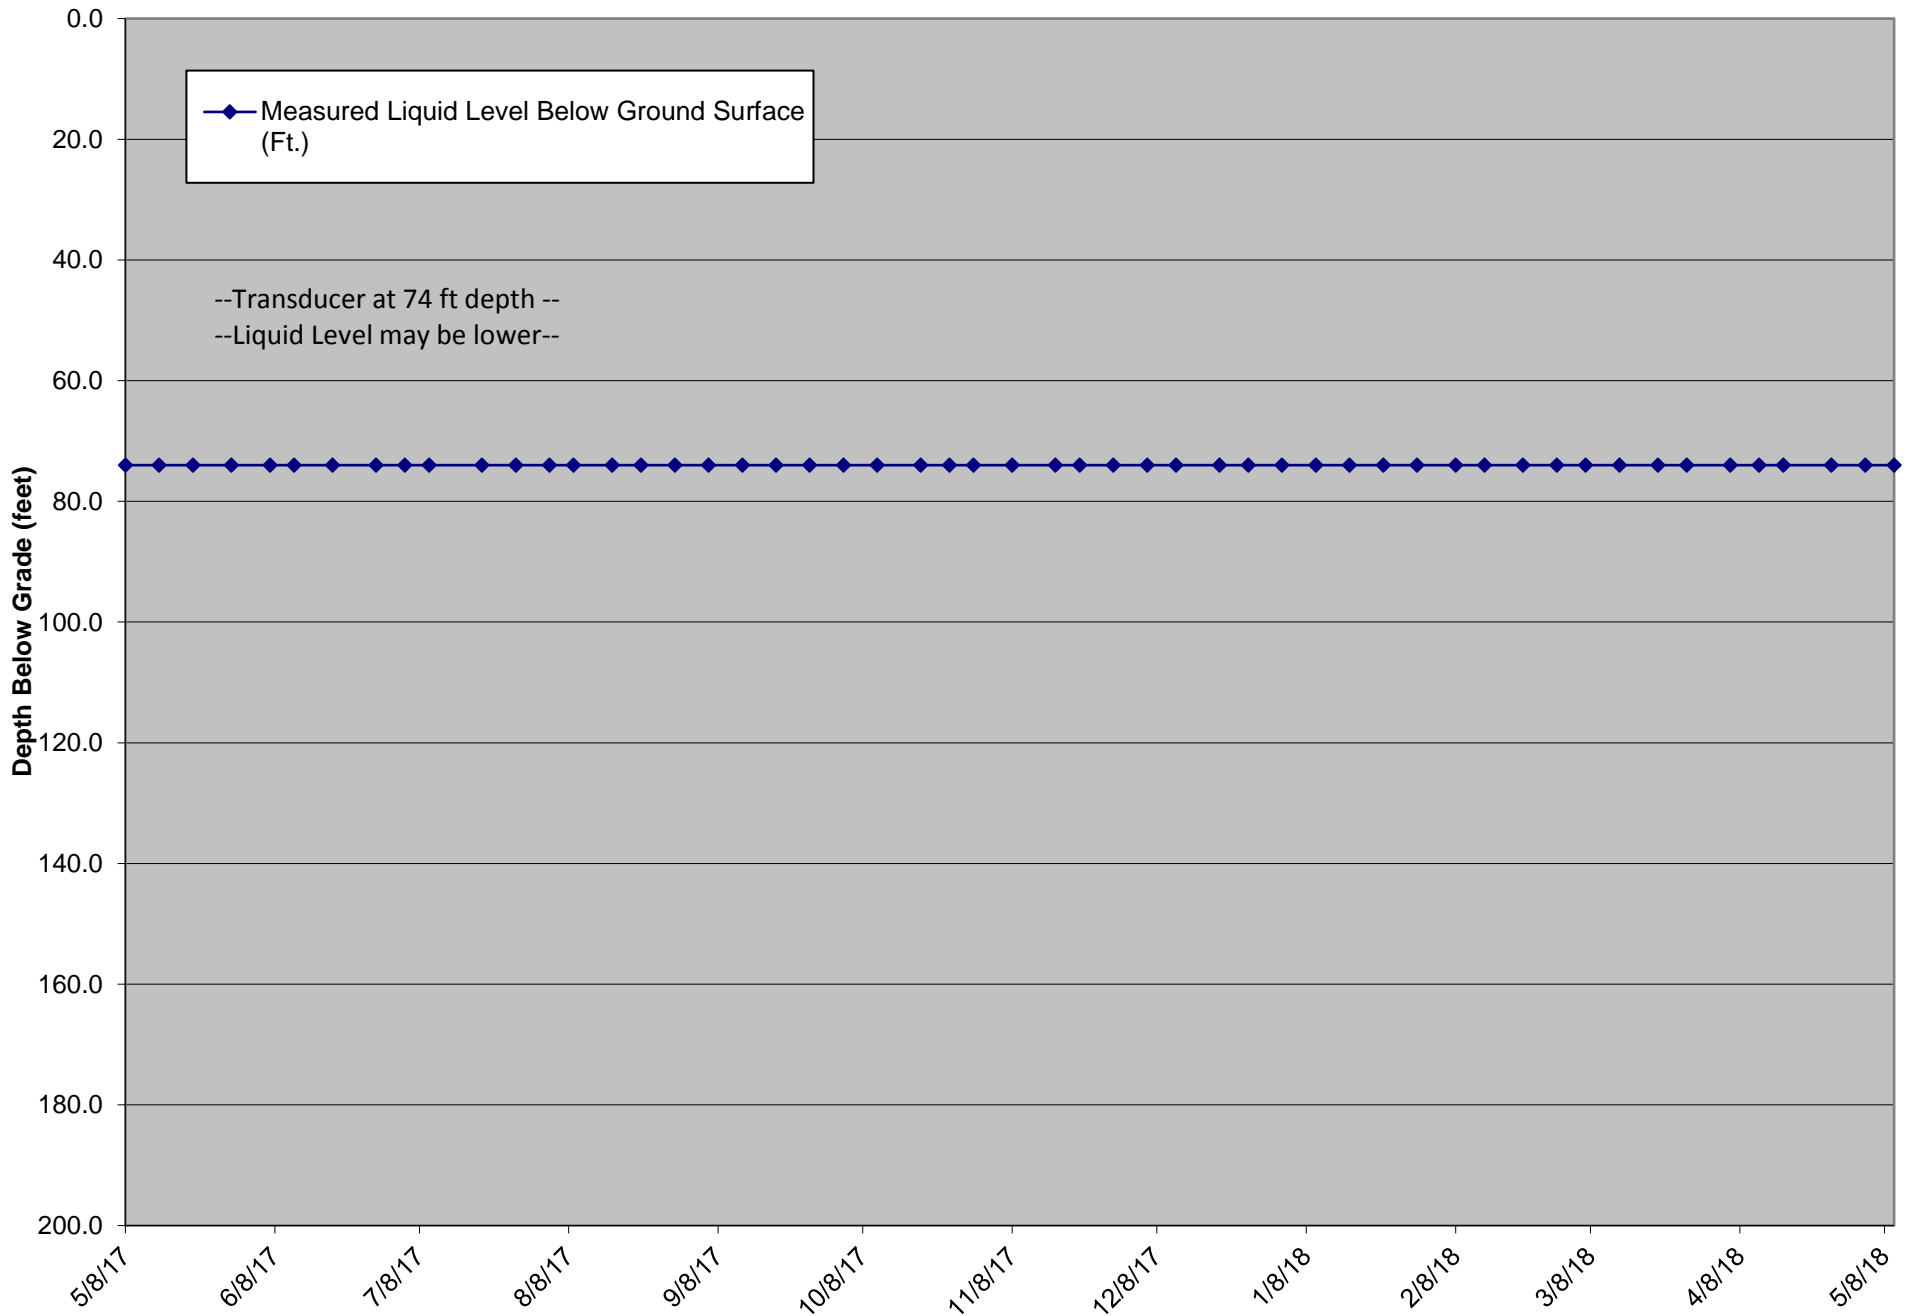
LCS-4B Liquid Level Below Ground Surface

The level sensor in LCS-4B is currently operational and responsive. Liquid level was not recorded by the level sensor during the weekly reporting period. LCS-4B is equipped with a flow meter that displayed no flow during the weekly reporting period. Therefore, it can be concluded that the liquid level was below the bottom of the pump and level sensor in LCS-4B.

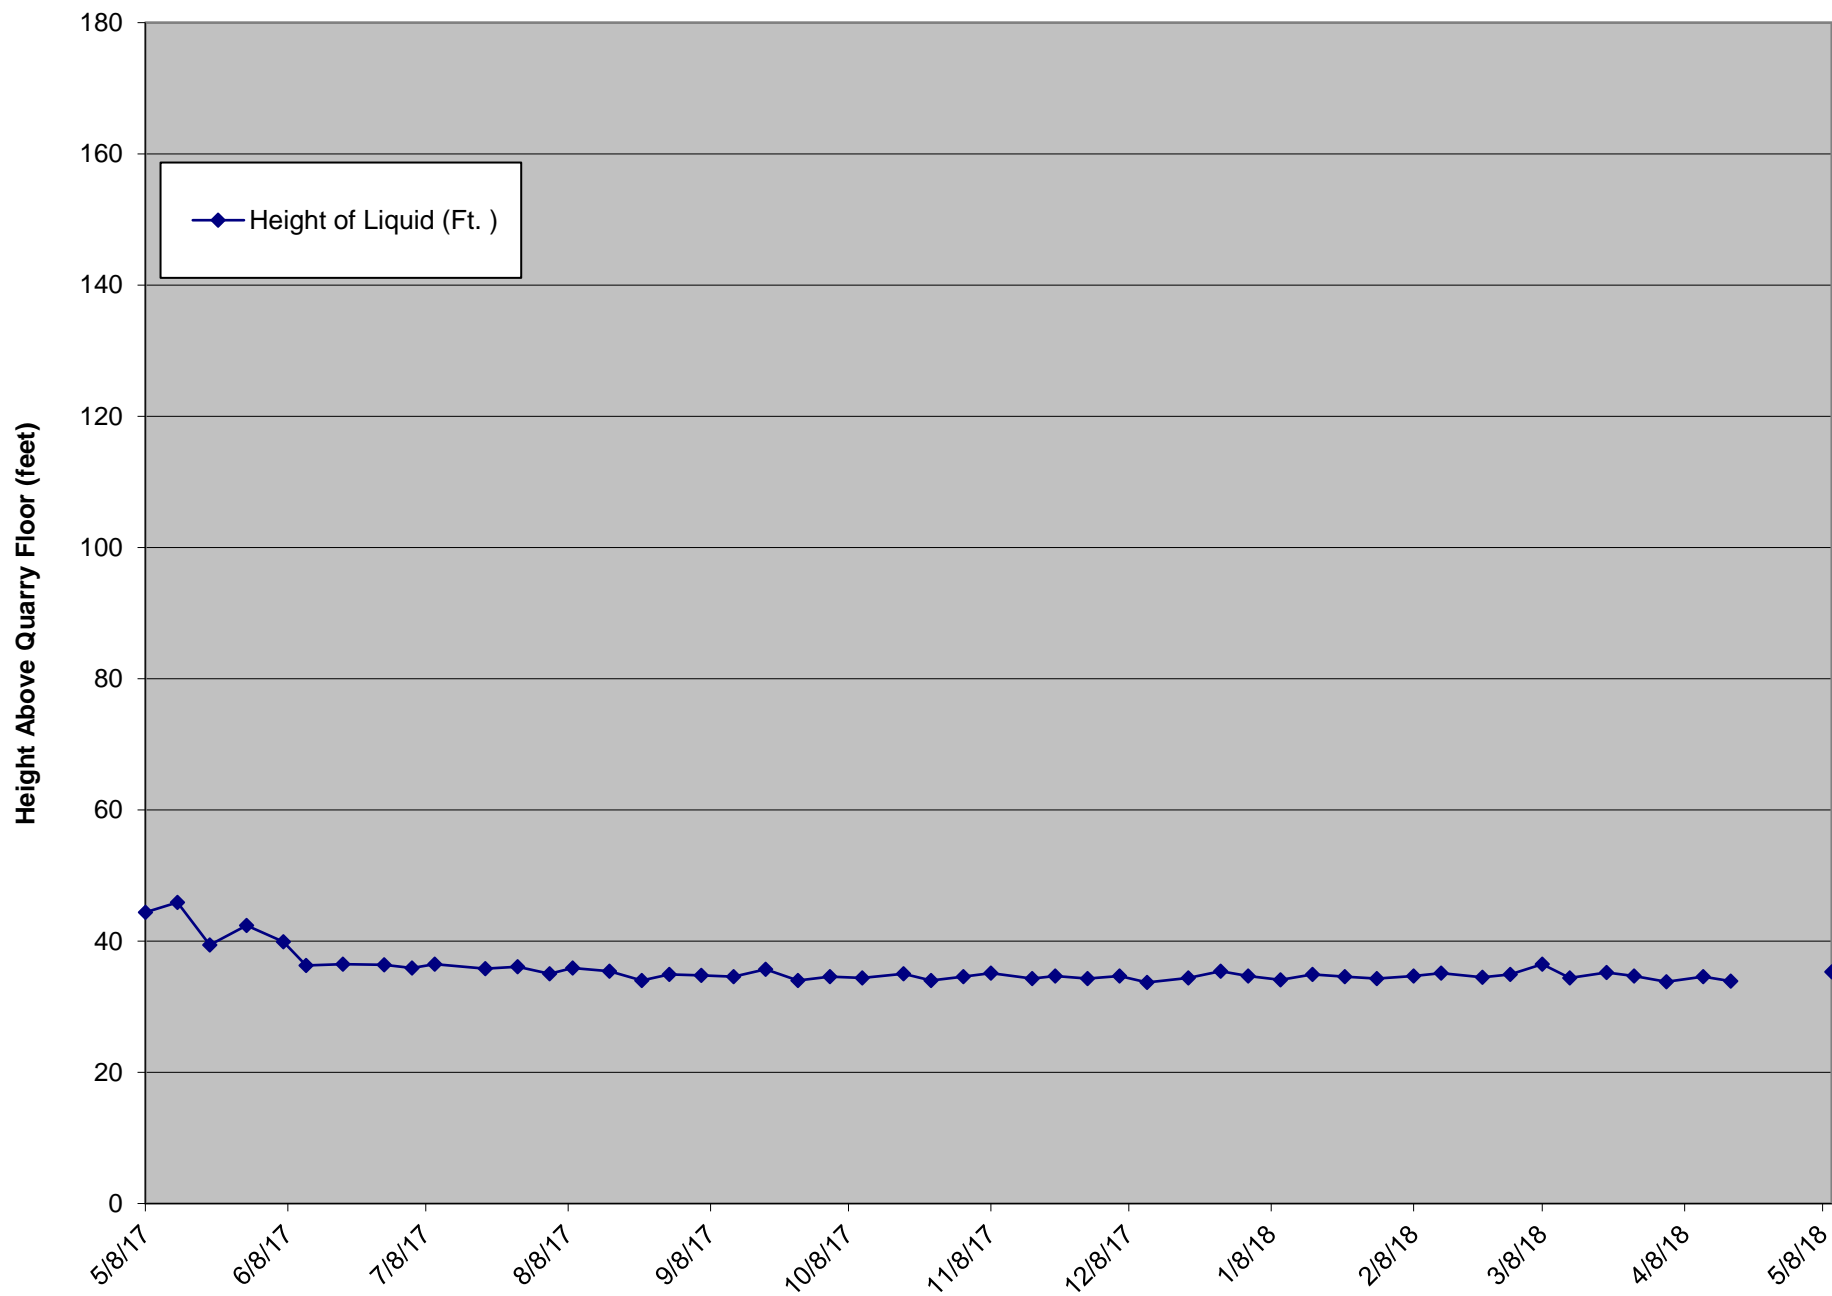
LCS-5B Liquid Level Above Quarry Floor

The pump, motor, and transducer were replaced on LCS-5B on 5/7/18. LCS-5B became fully operational on 5/7/18.

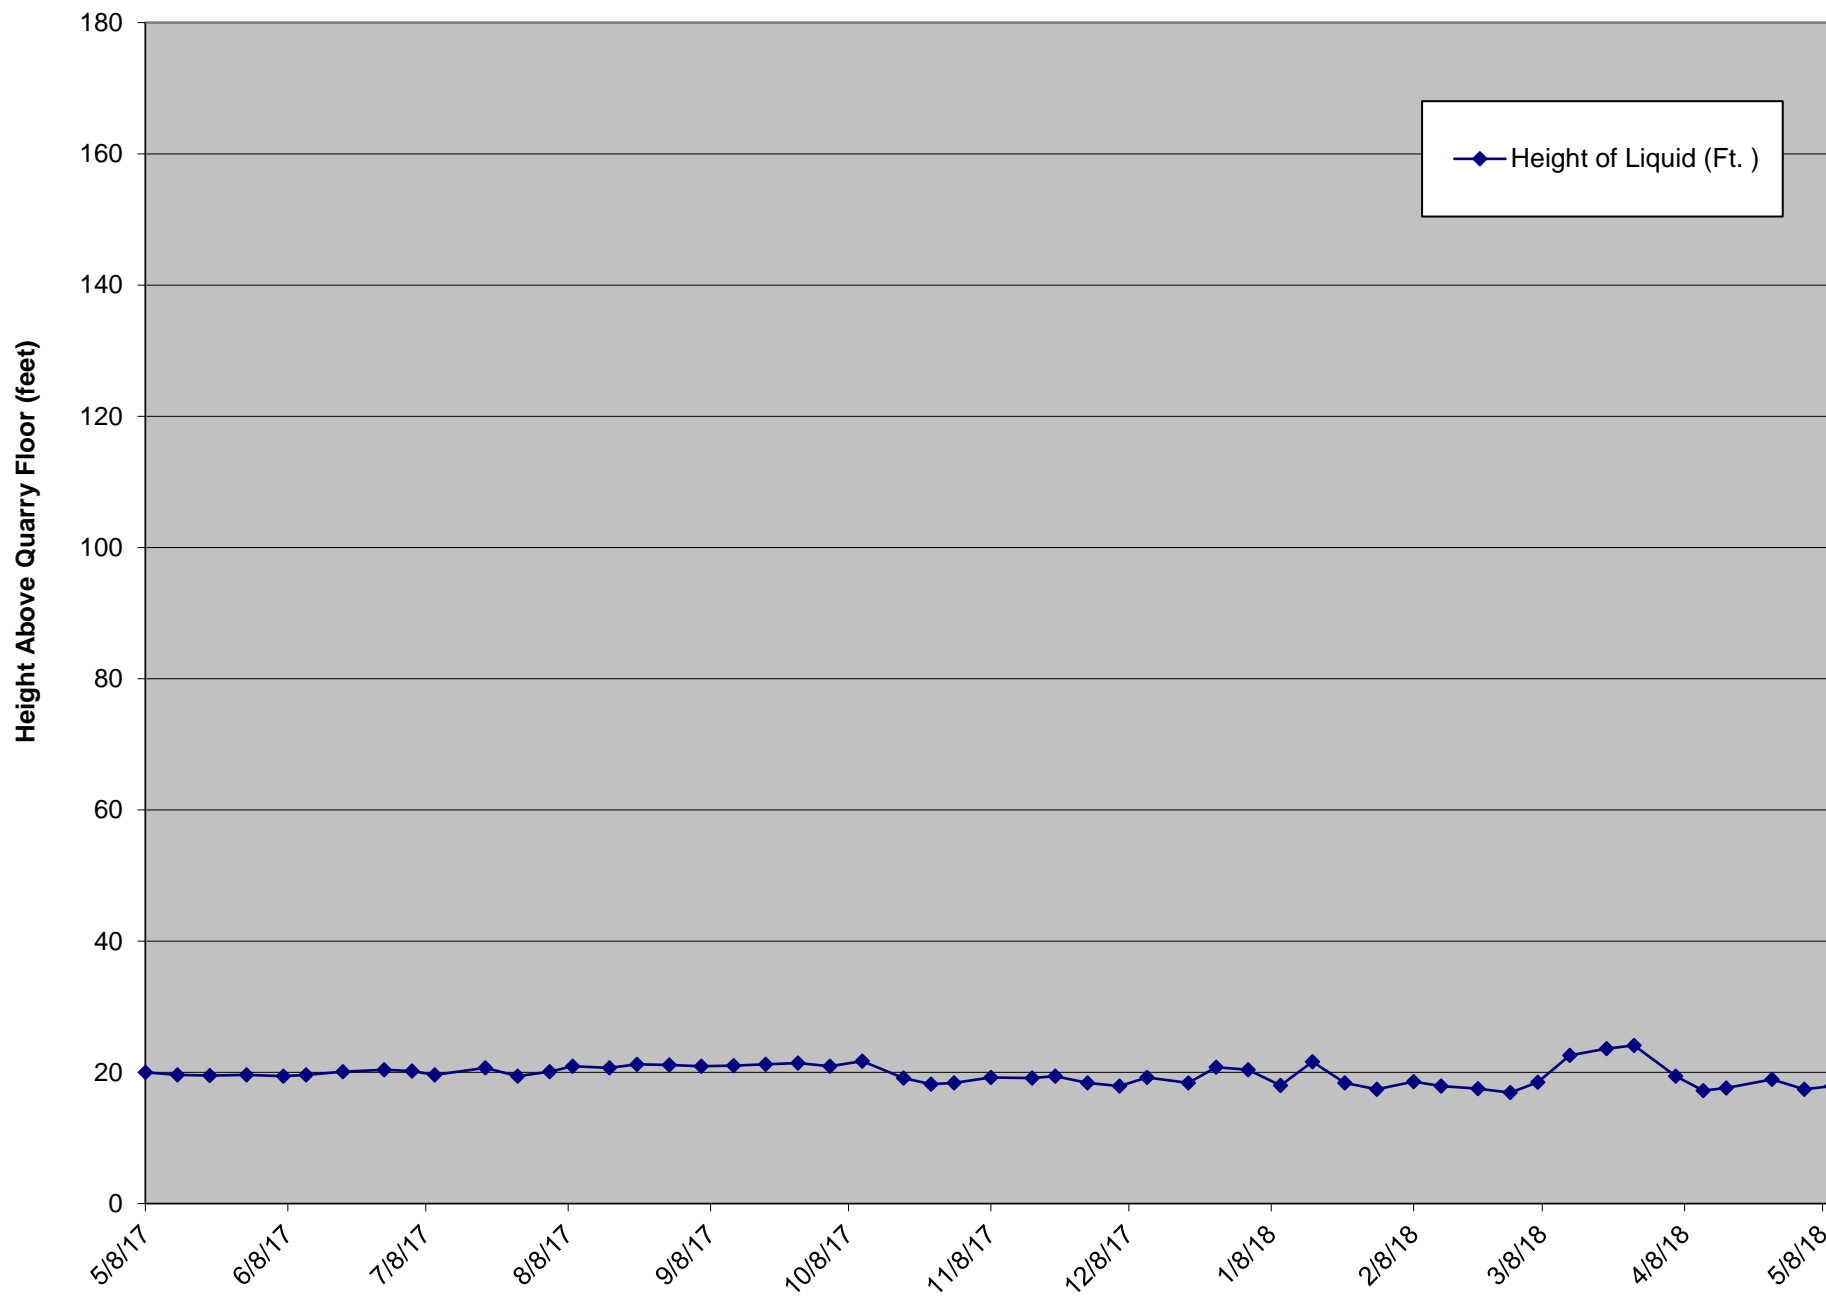
LCS-6B Liquid Level Above Quarry Floor

LCS-6B was fully operational during the weekly reporting period.

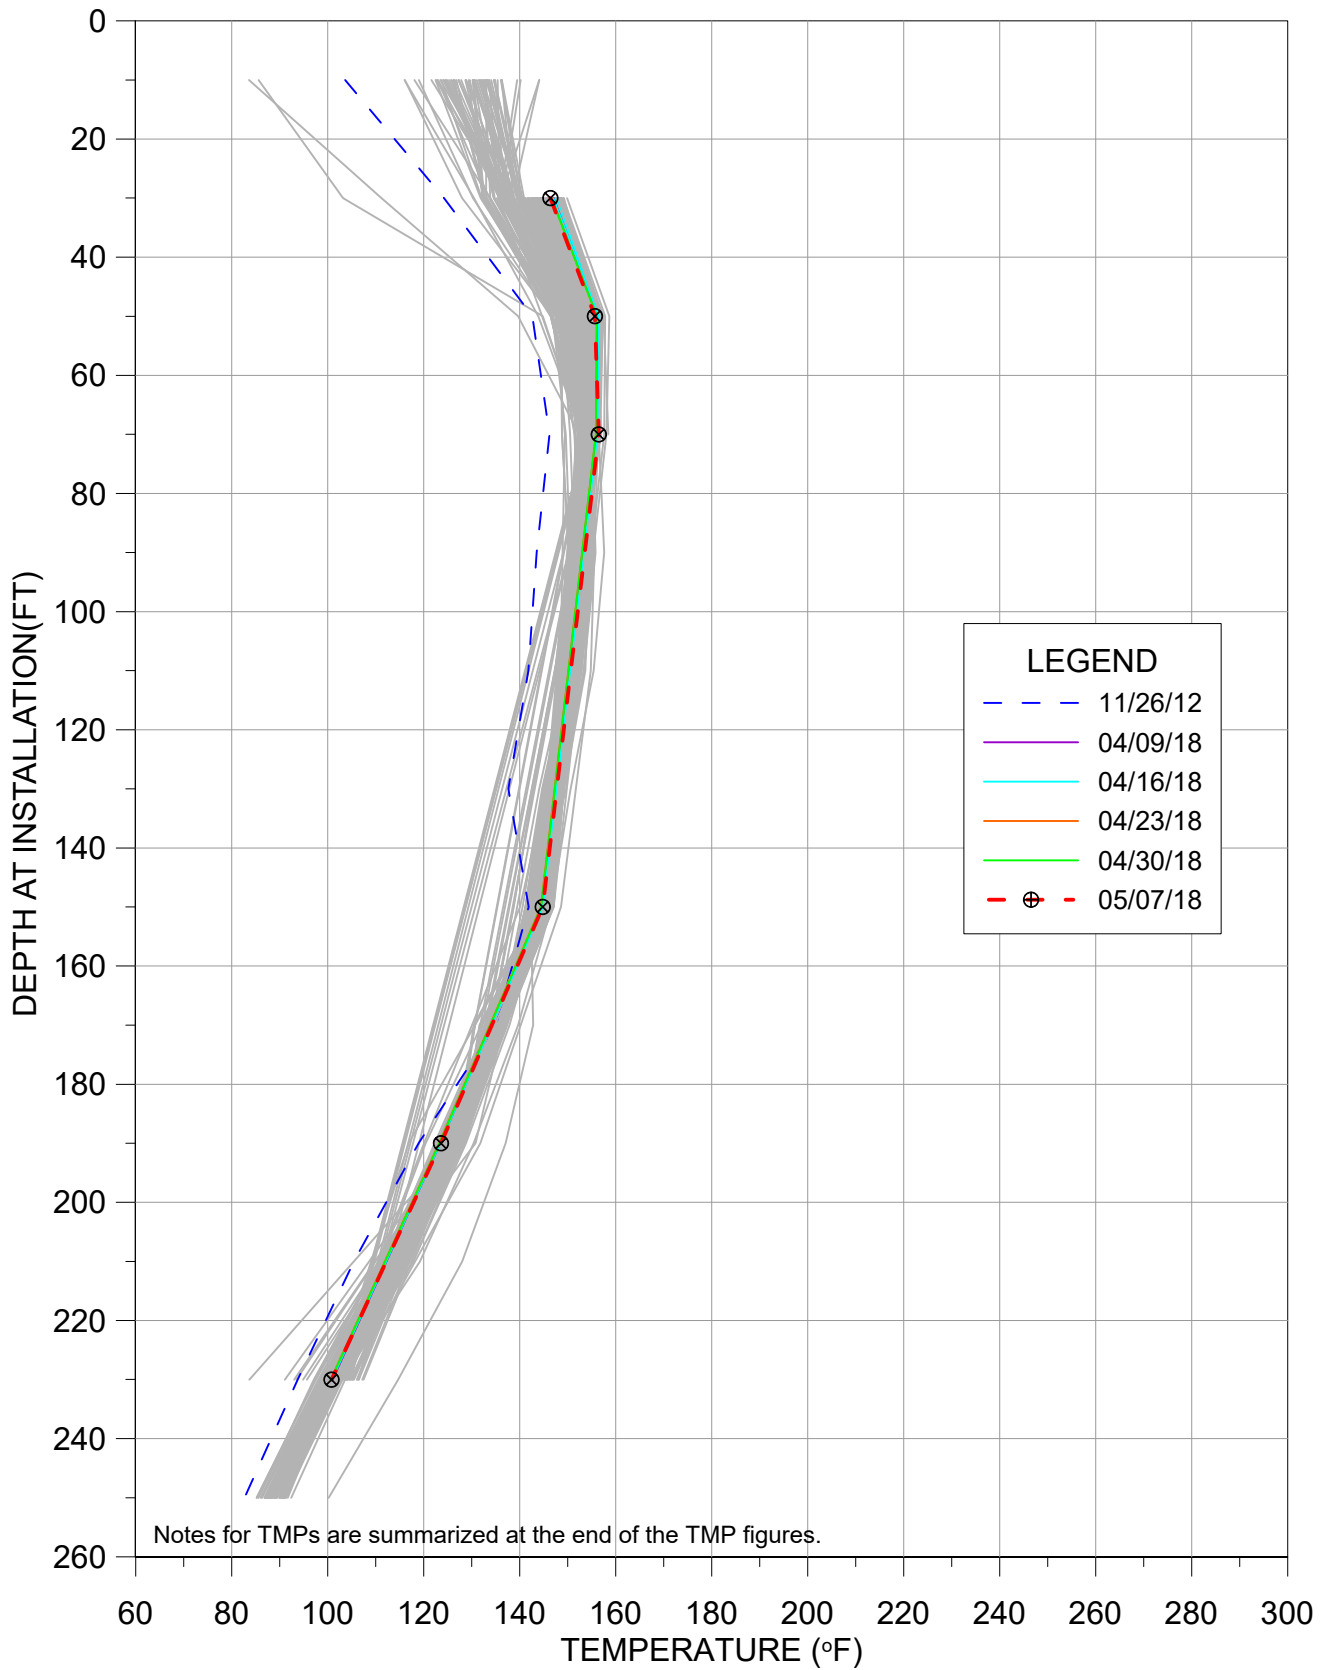
TMP-3

1. No reliable temperature readings have been obtained at 170 ft depth since 1/29/2014, except on 3/13/2014.
2. The connectivity tests on 4/11/2014 conducted by CEC showed that units at 10, 90, 130, 210 and 250 ft depths are no longer reliable.
3. The connectivity tests on 10/28/2014 conducted by Feezor Engineering showed that units at 10, 90, 110, 130, 210 and 250 ft depths are not reliable.

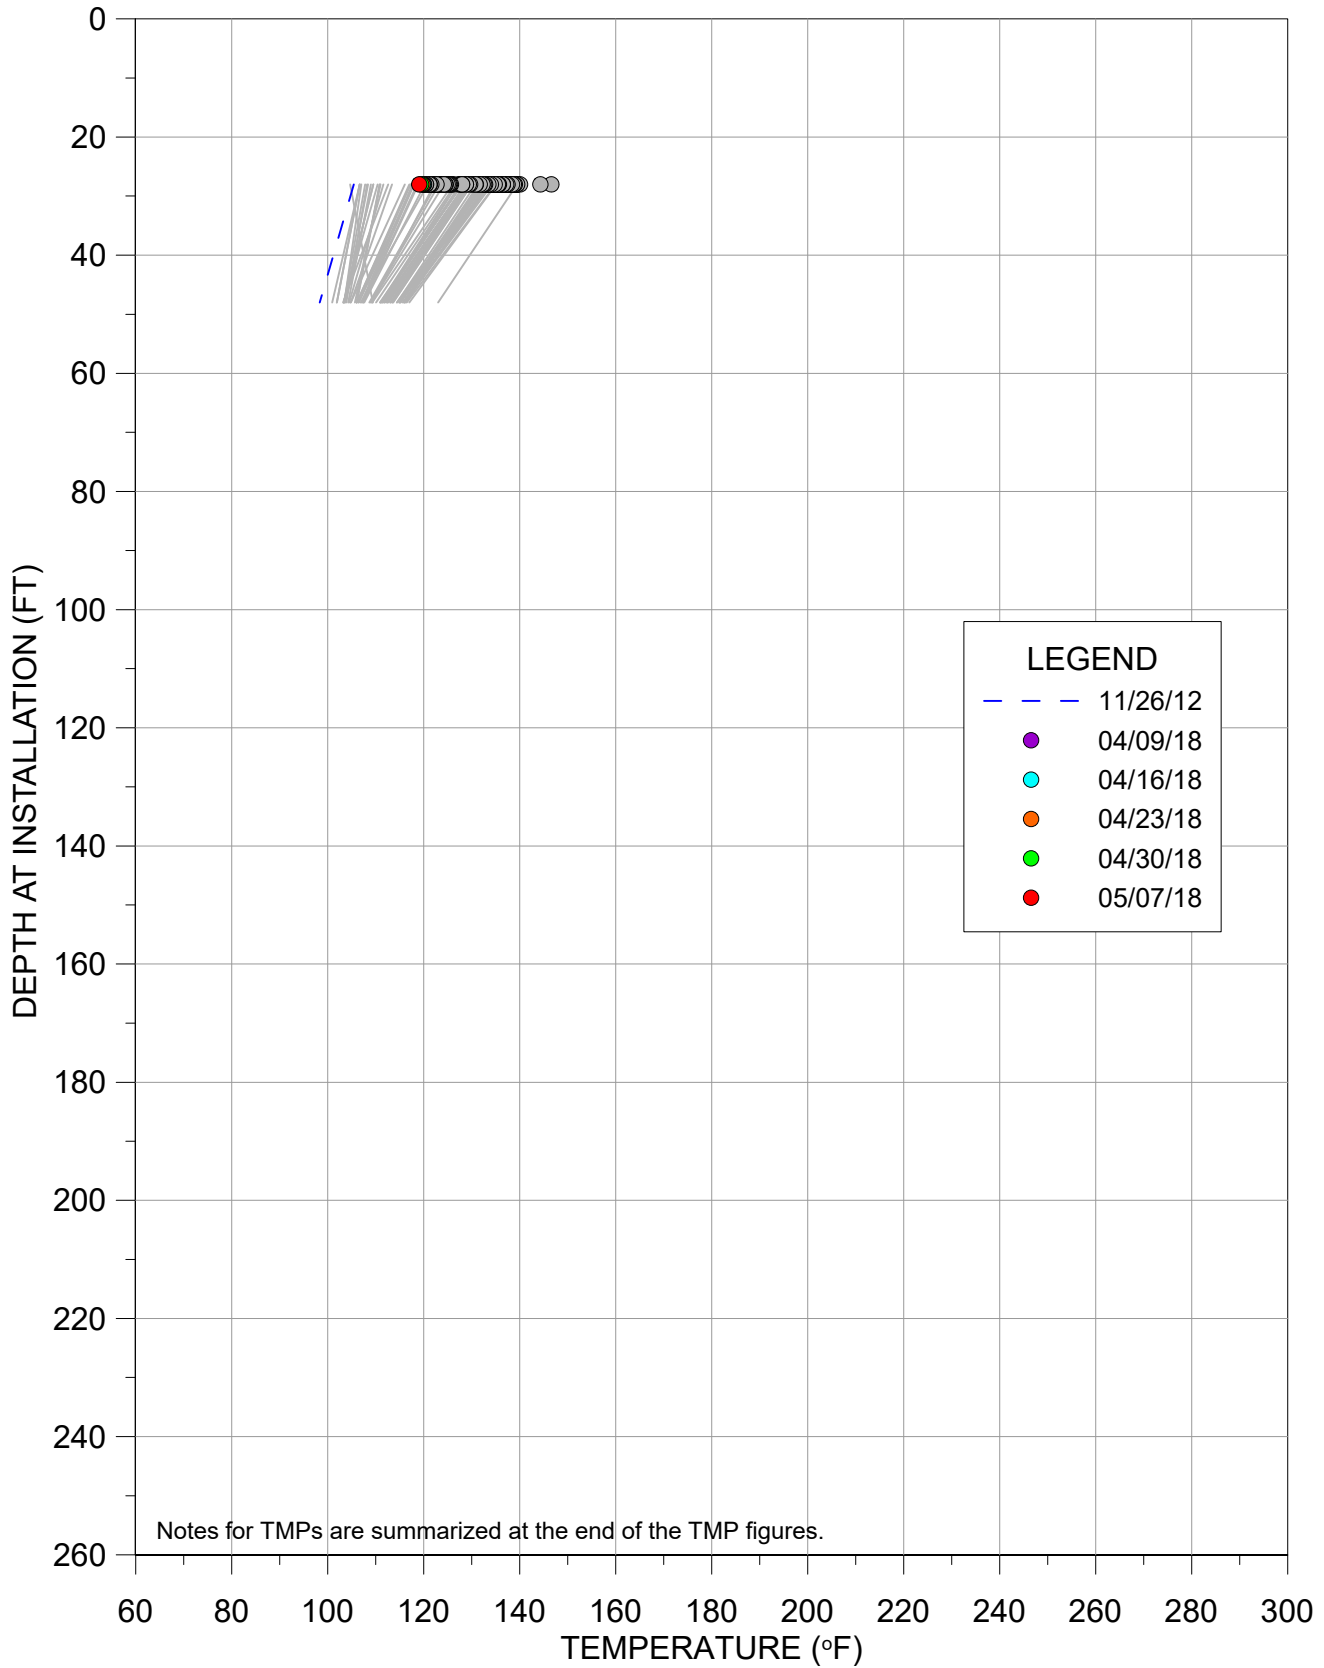
TMP-4

1. The connectivity tests on 4/11/2014 conducted by CEC showed that the unit at 48 ft depth is no longer reliable.

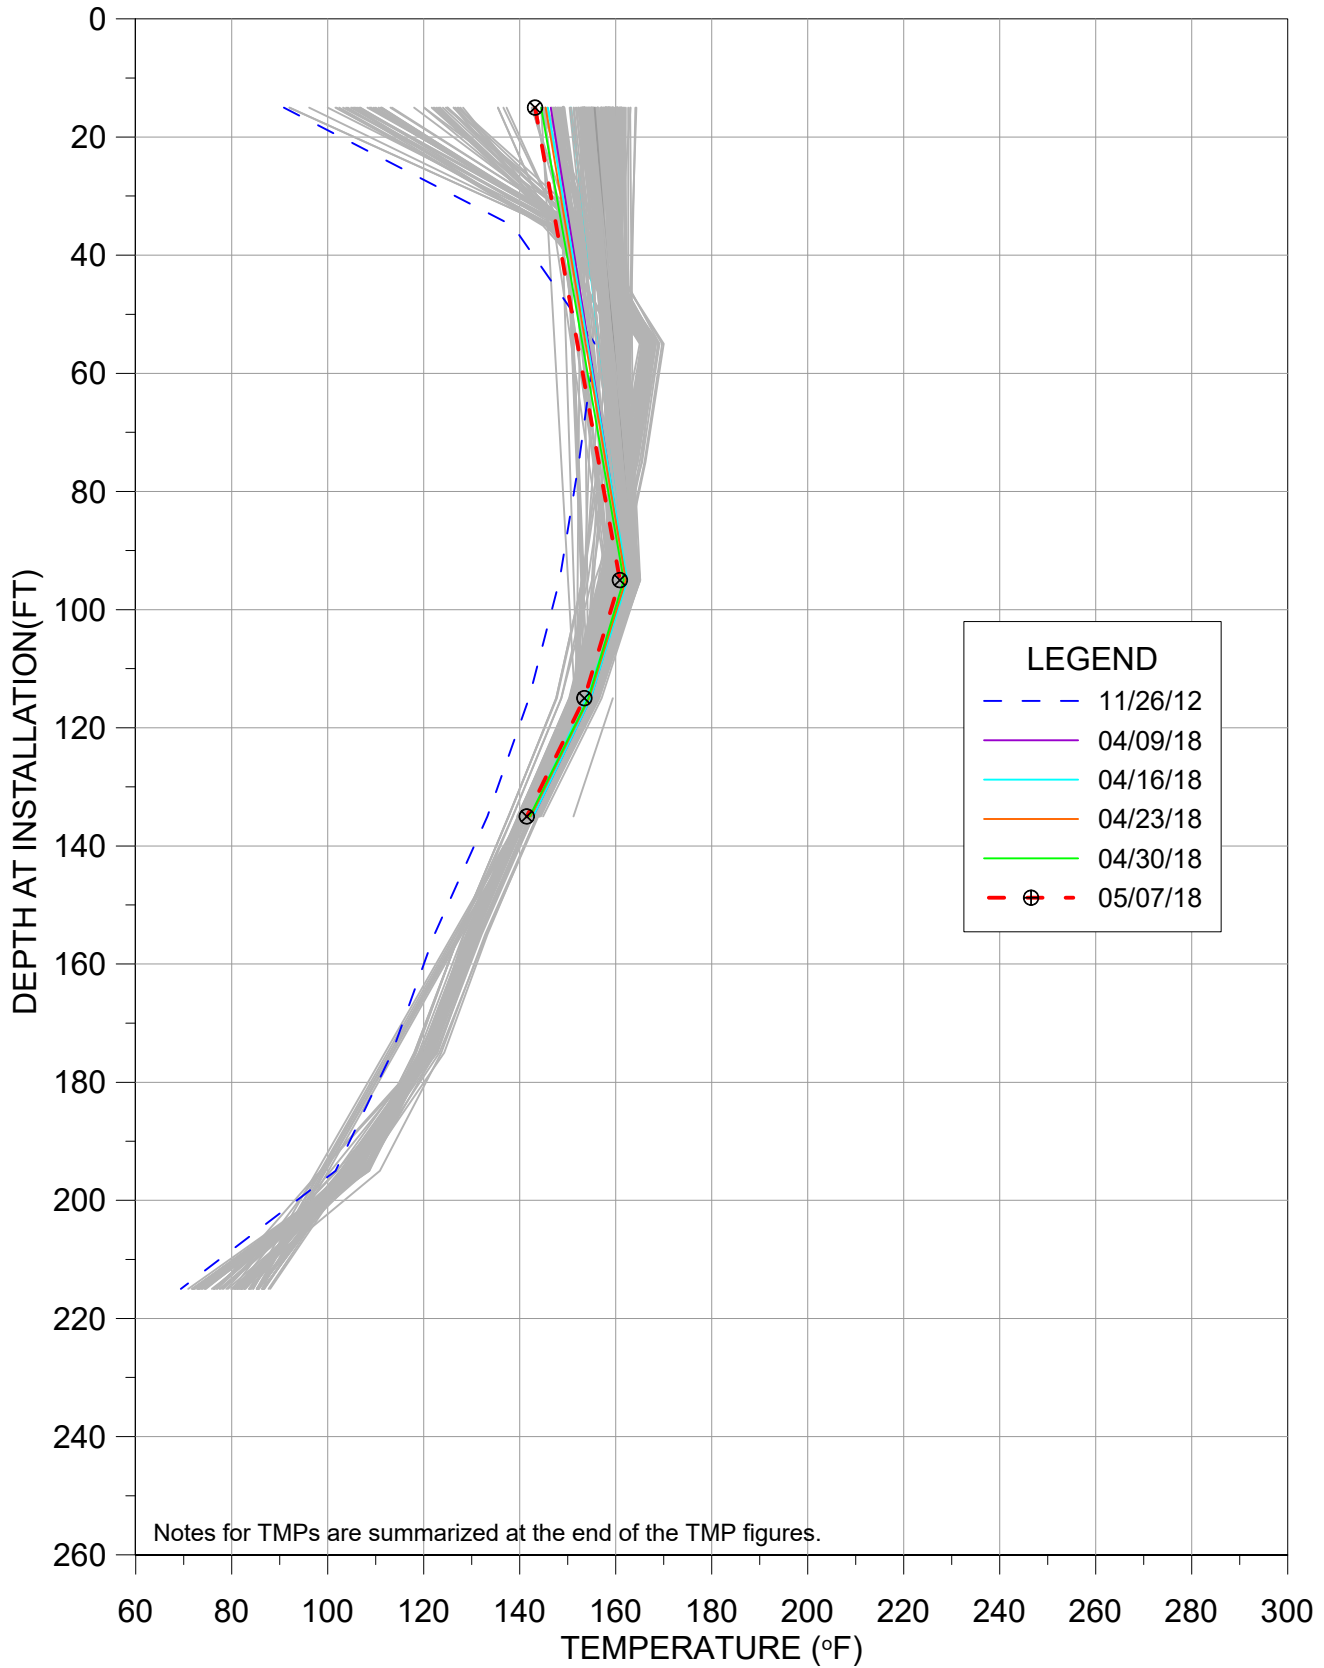
TMP-6

1. The connectivity tests on 4/11/2014 conducted by CEC showed that units at 35, 55, 75, 155, 175, and 195 ft depths are no longer reliable.
2. No reliable temperature readings have been obtained at the unit at 215 ft depth since 6/13/2014.

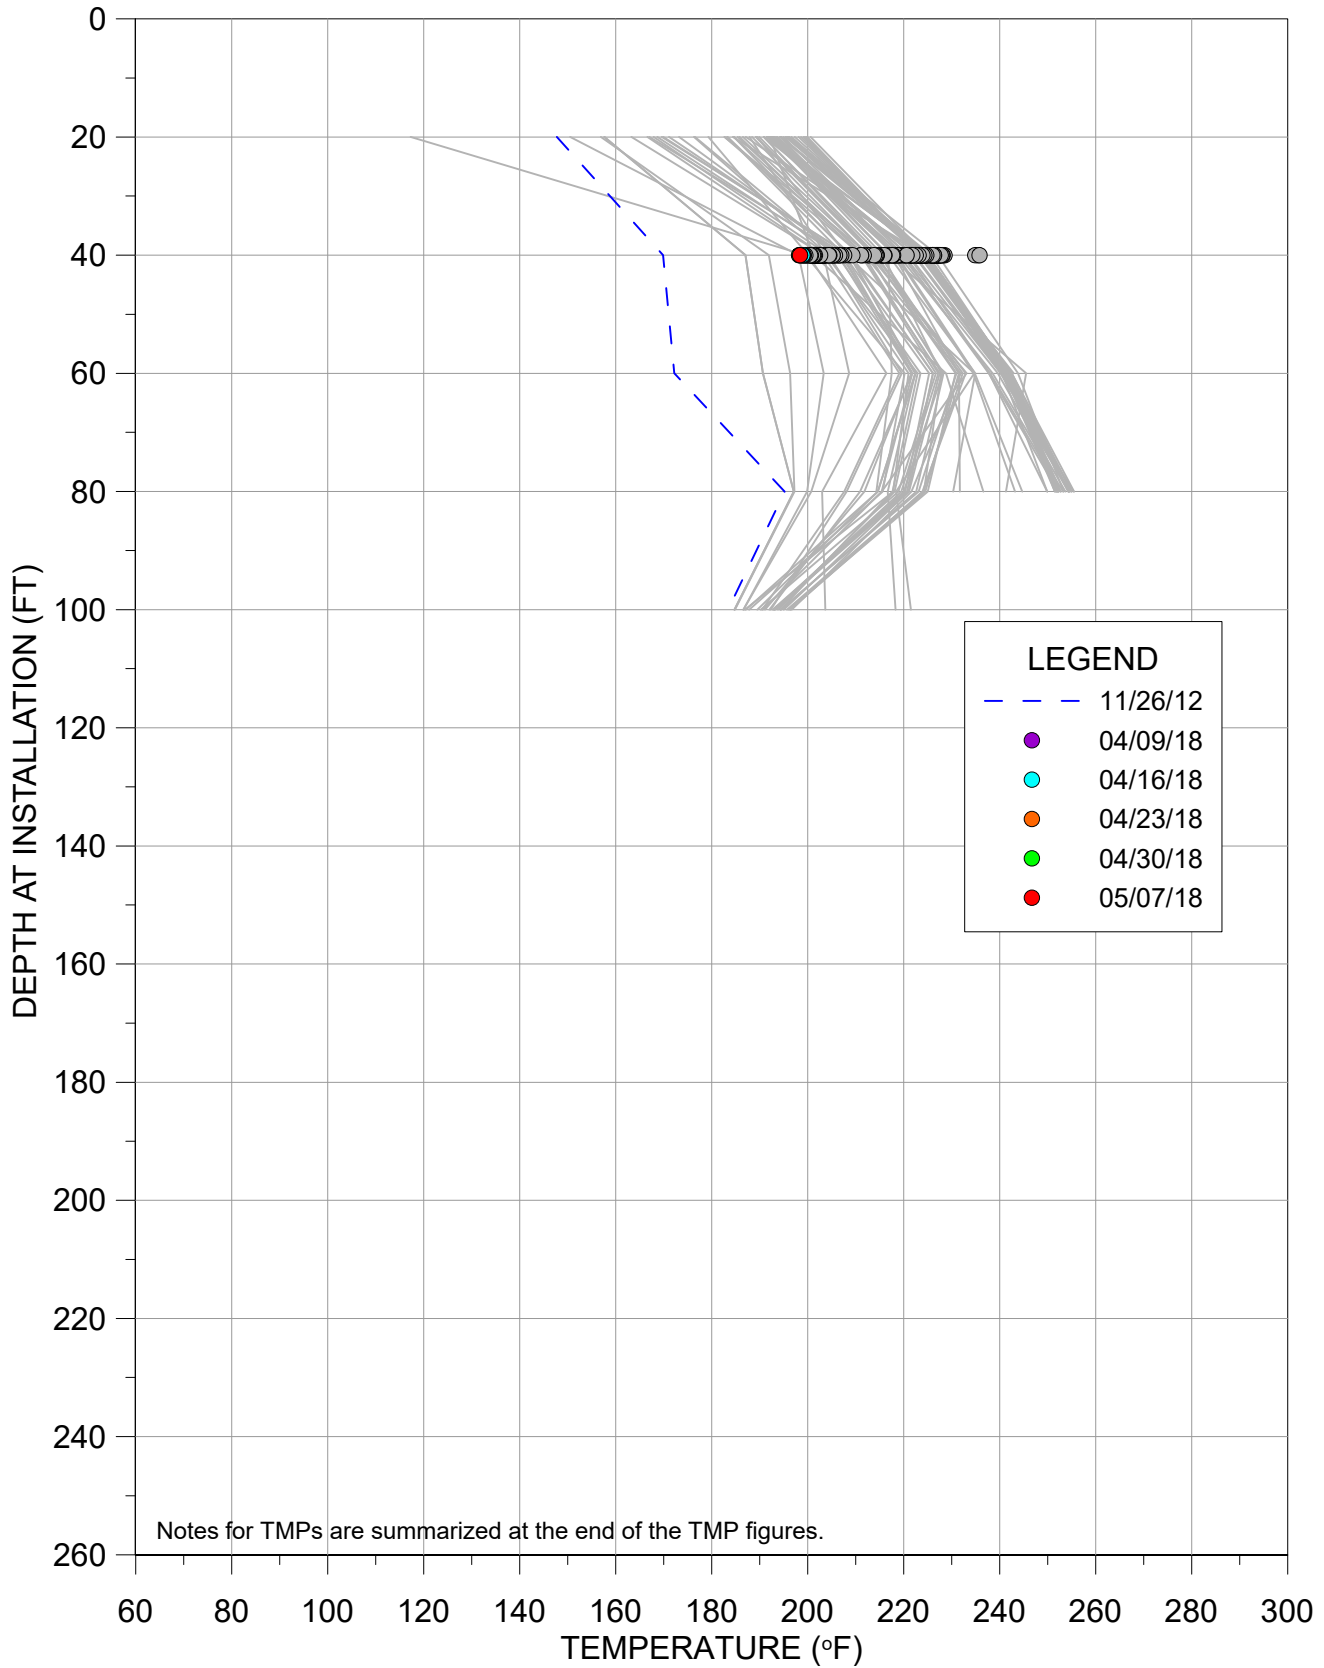
TMP-9

1. Unit at 100 ft depth had an inaccurate temperature reading on 8/1/2013 and no reading since 8/6/2013.
2. The connectivity tests on 4/11/2014 conducted by CEC showed that units at 20, 60, 80, and 100 ft depths are no longer reliable.
