Bridgeton Landfill, LLC

Weekly Data Submittal

Week of May 6, 2018 – May 12, 2018

**Required by Section 52.F of Agreed Order, Case No. 13SL-CC01088
Effective May 13, 2013**

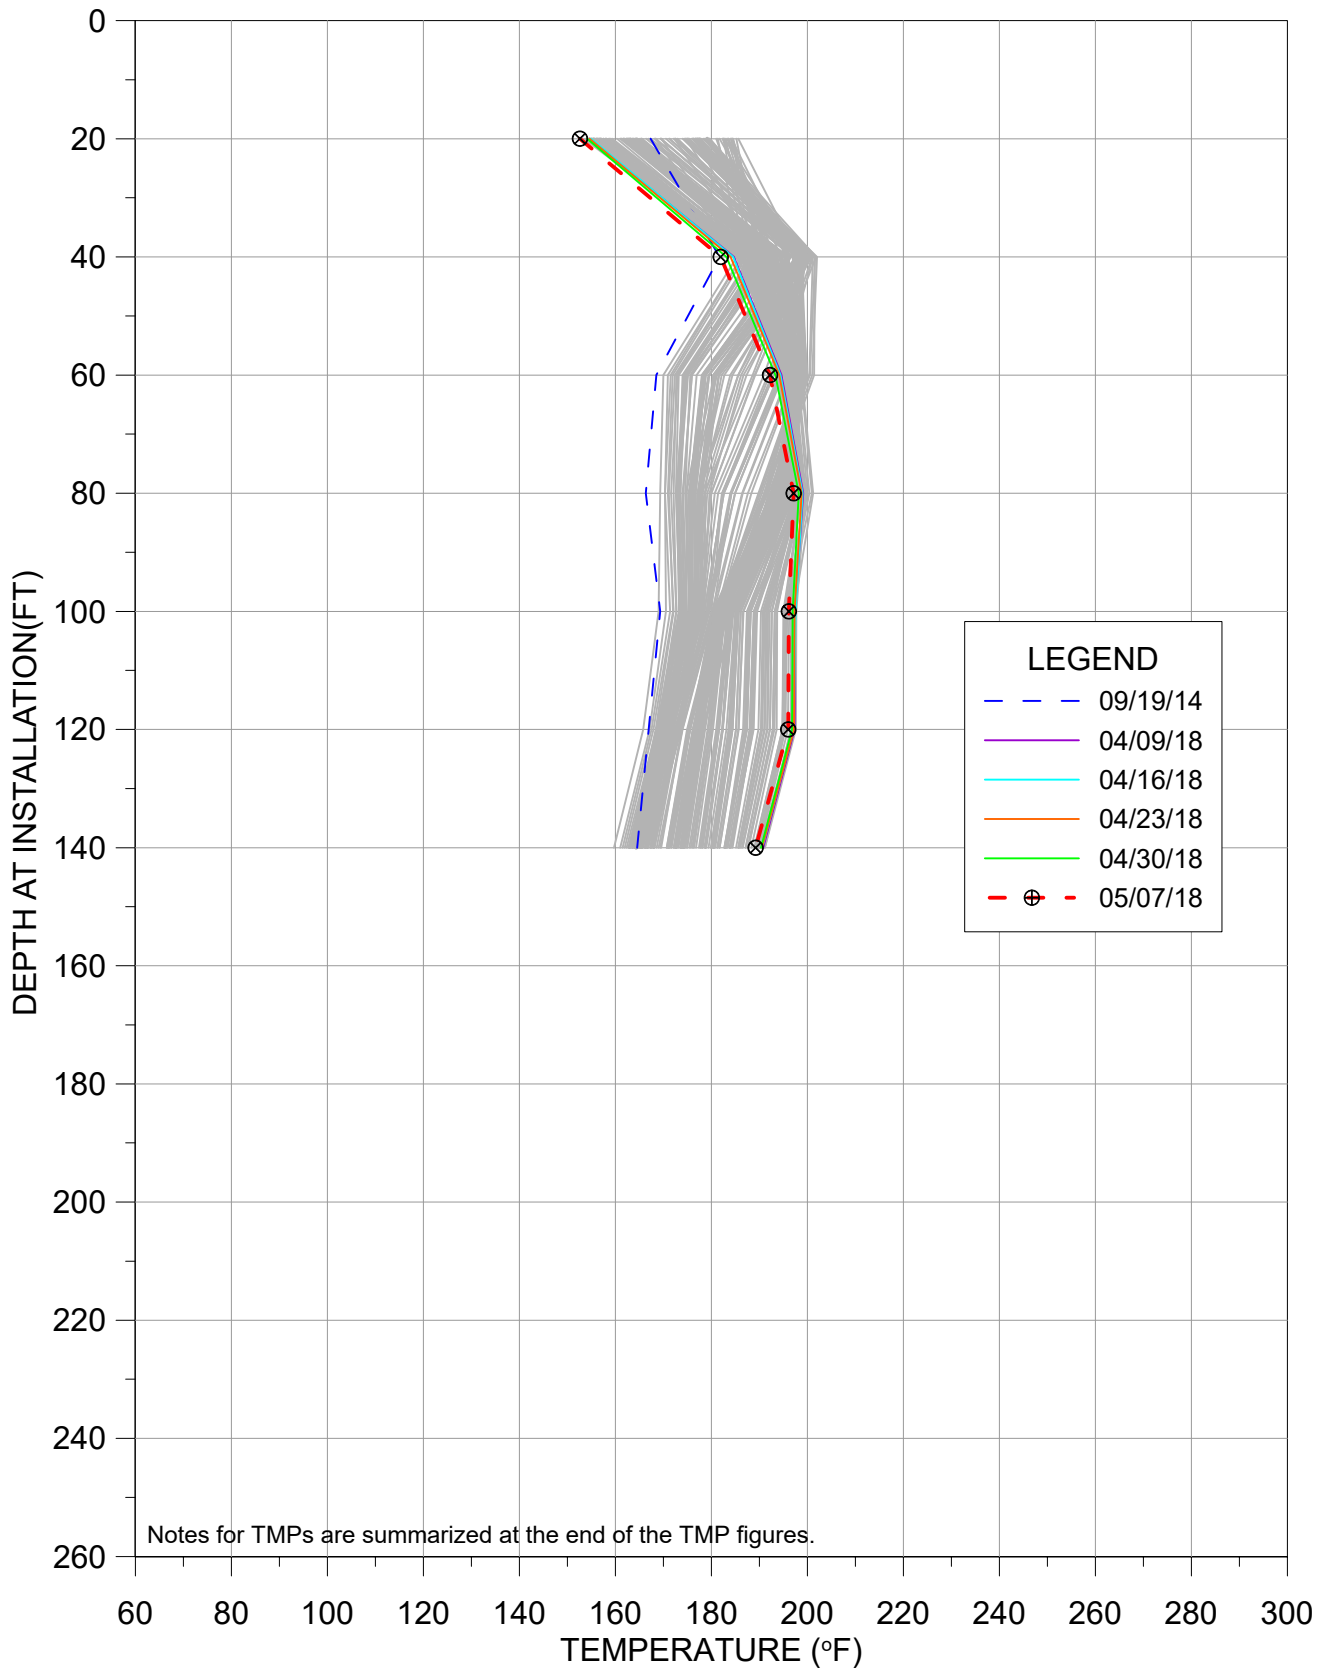
1. Due to the connectivity test results by Feezor Engineering on TMP-14 (see note above), TMP-14R is added to this reporting data set as of 3/7/2016.

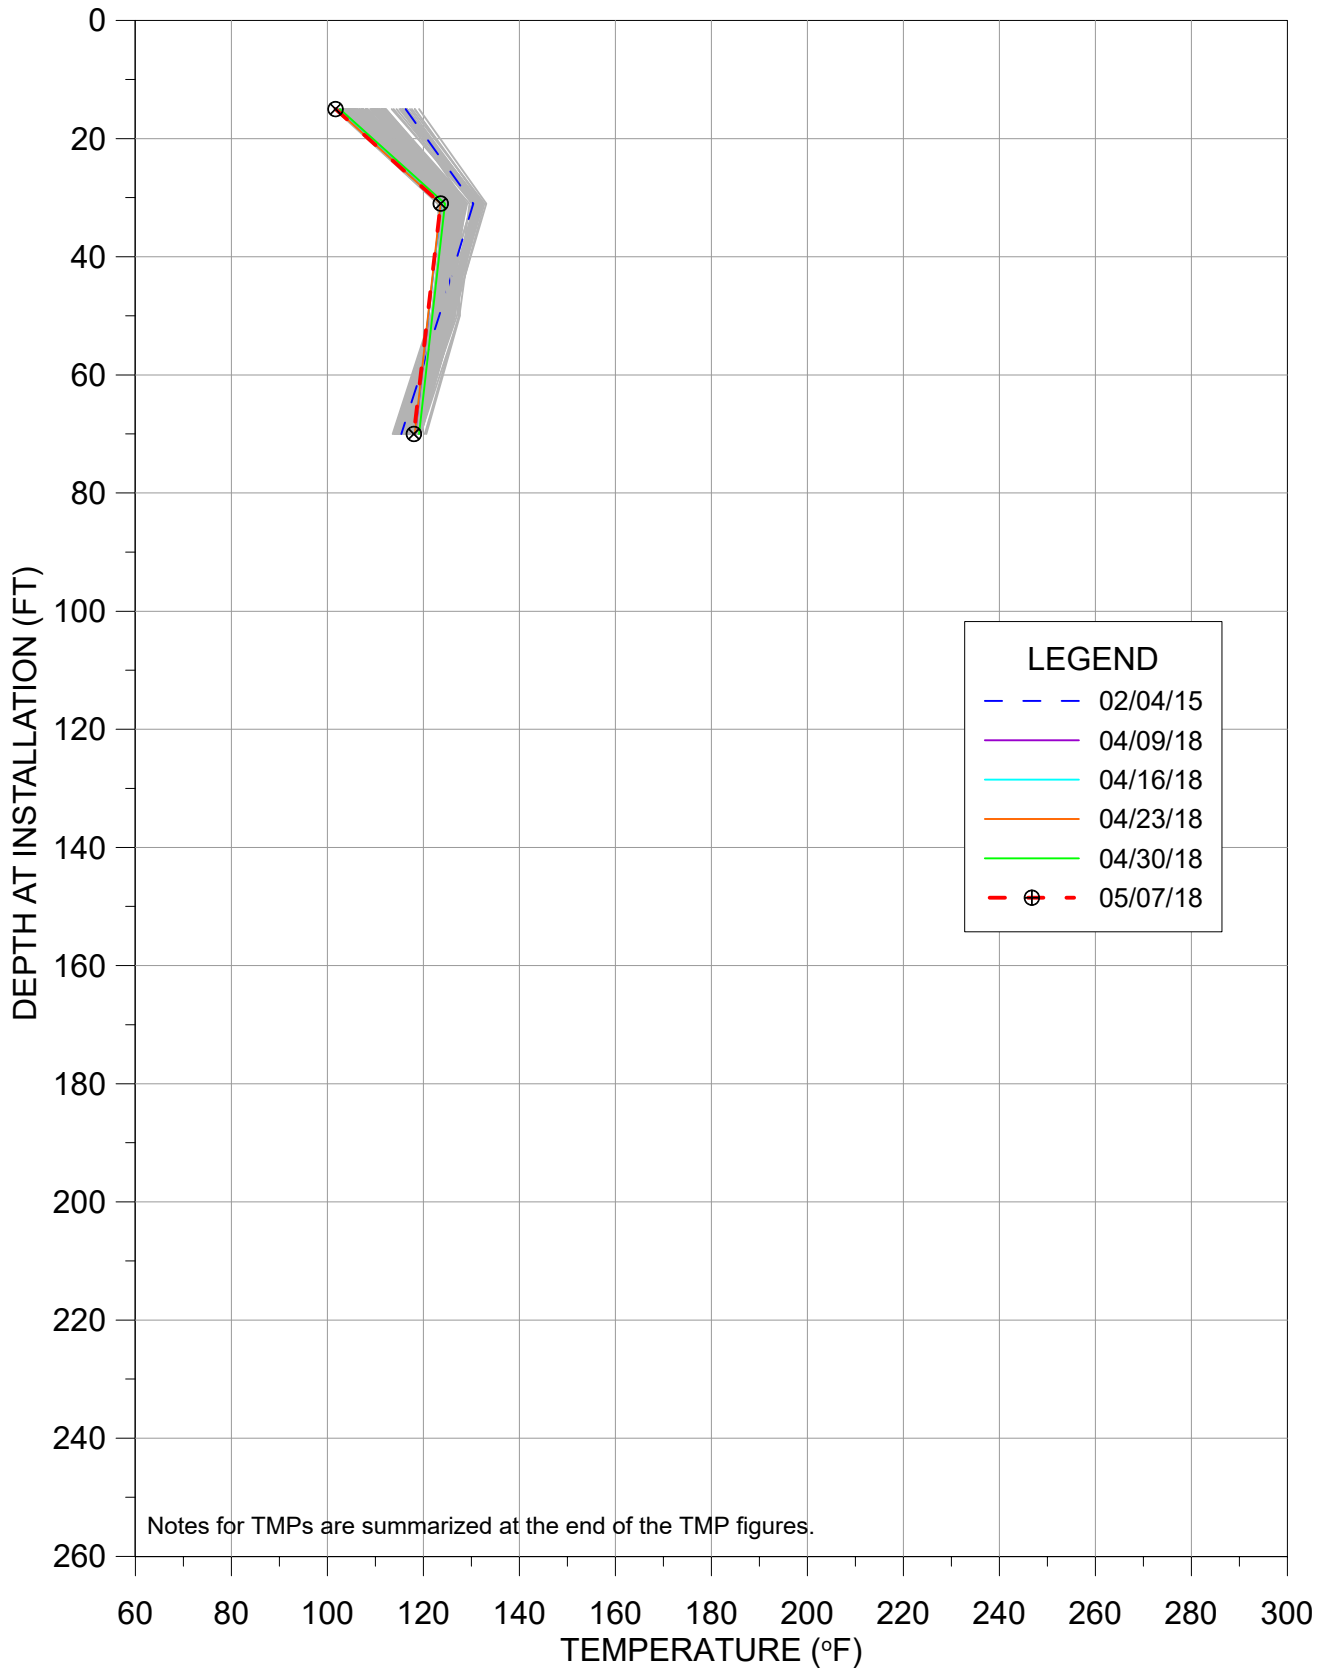
TMP-22

1. No temperature reading could be obtained and resistivity was fluctuating at the unit at 50 ft depth since 4/2/2018.

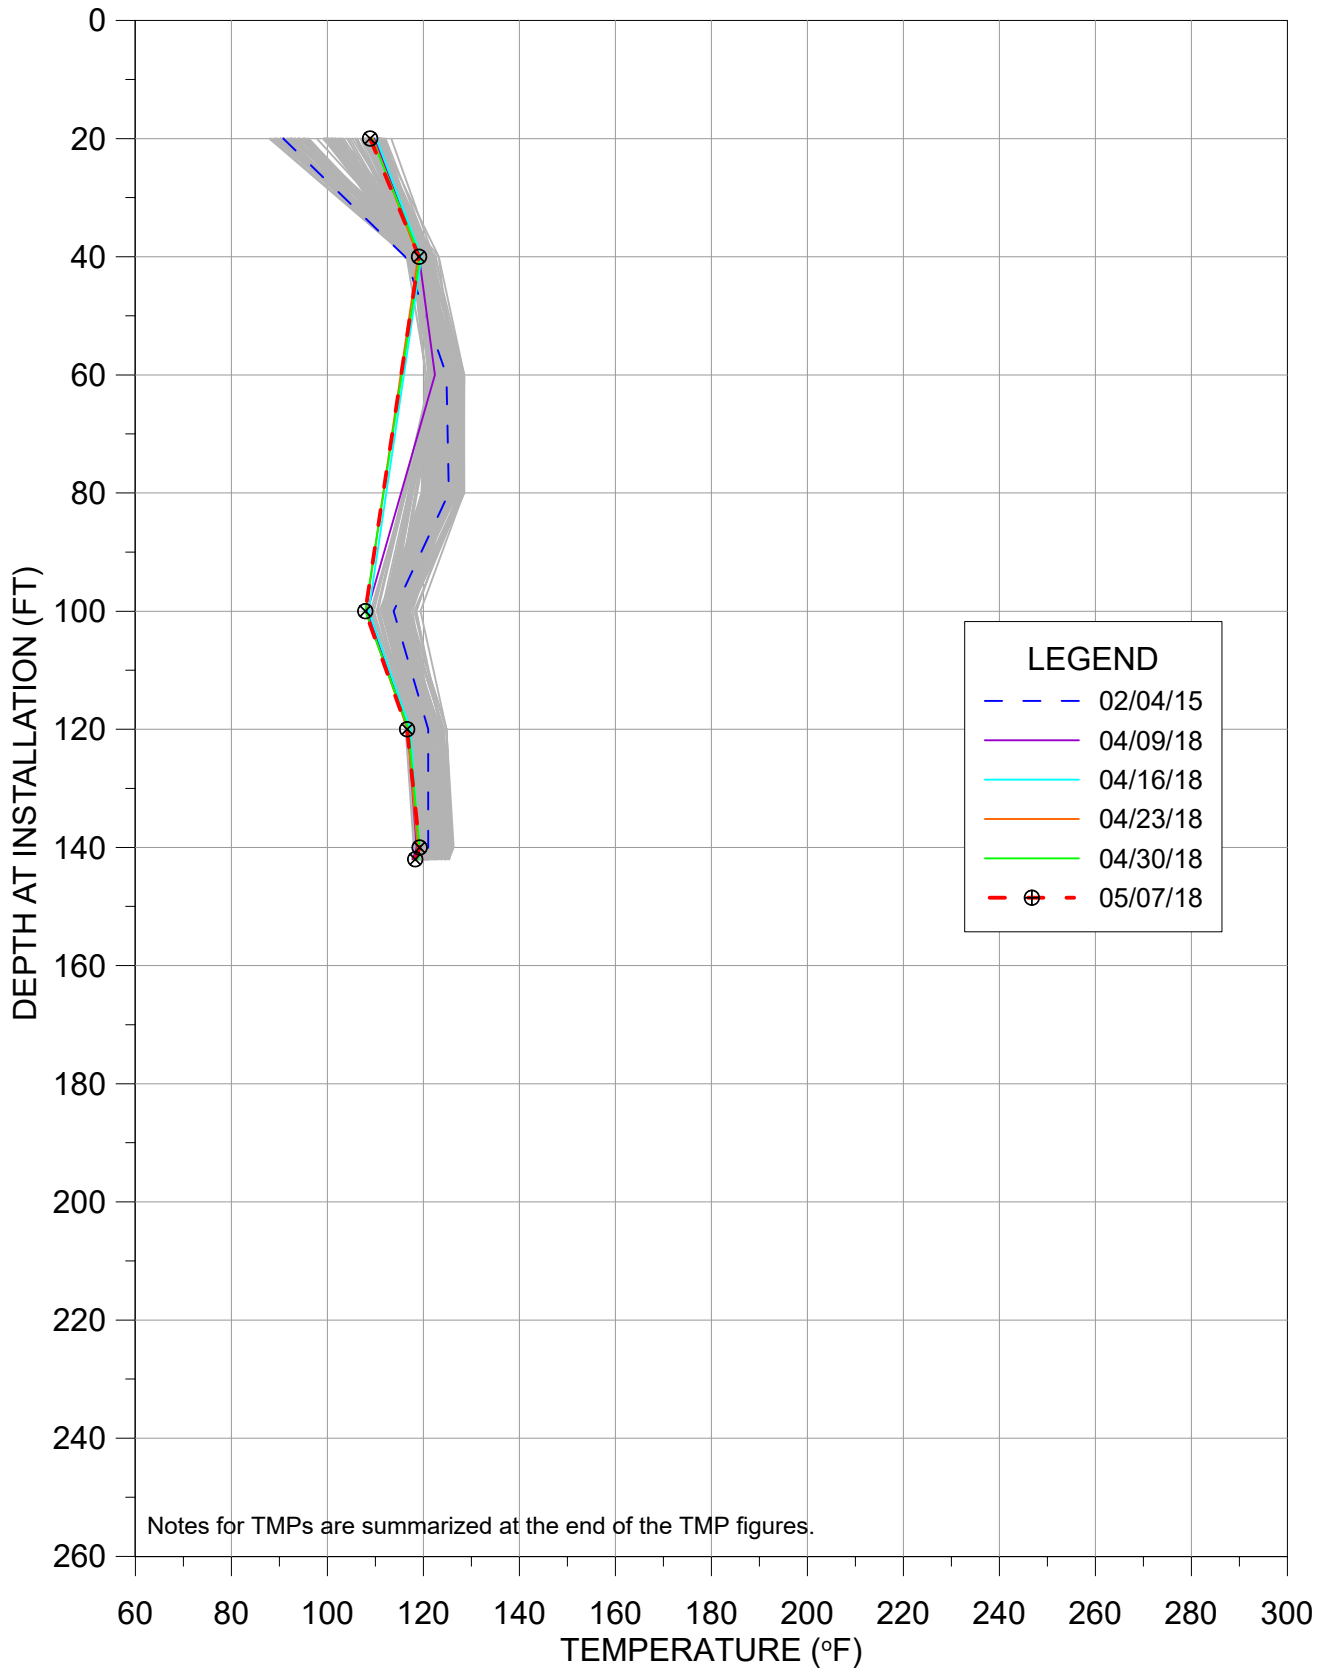
TMP-26

1. Resistance on unit at 80 ft dropped 12.9 ohms (11/06/2017) and subsequent resistance reading continue to be low. Upon further investigation by Feezor Engineering, this unit is determined to be unreliable.
2. No temperature reading could be obtained and resistivity was fluctuating at the unit at 60 ft depth since 4/16/2018.

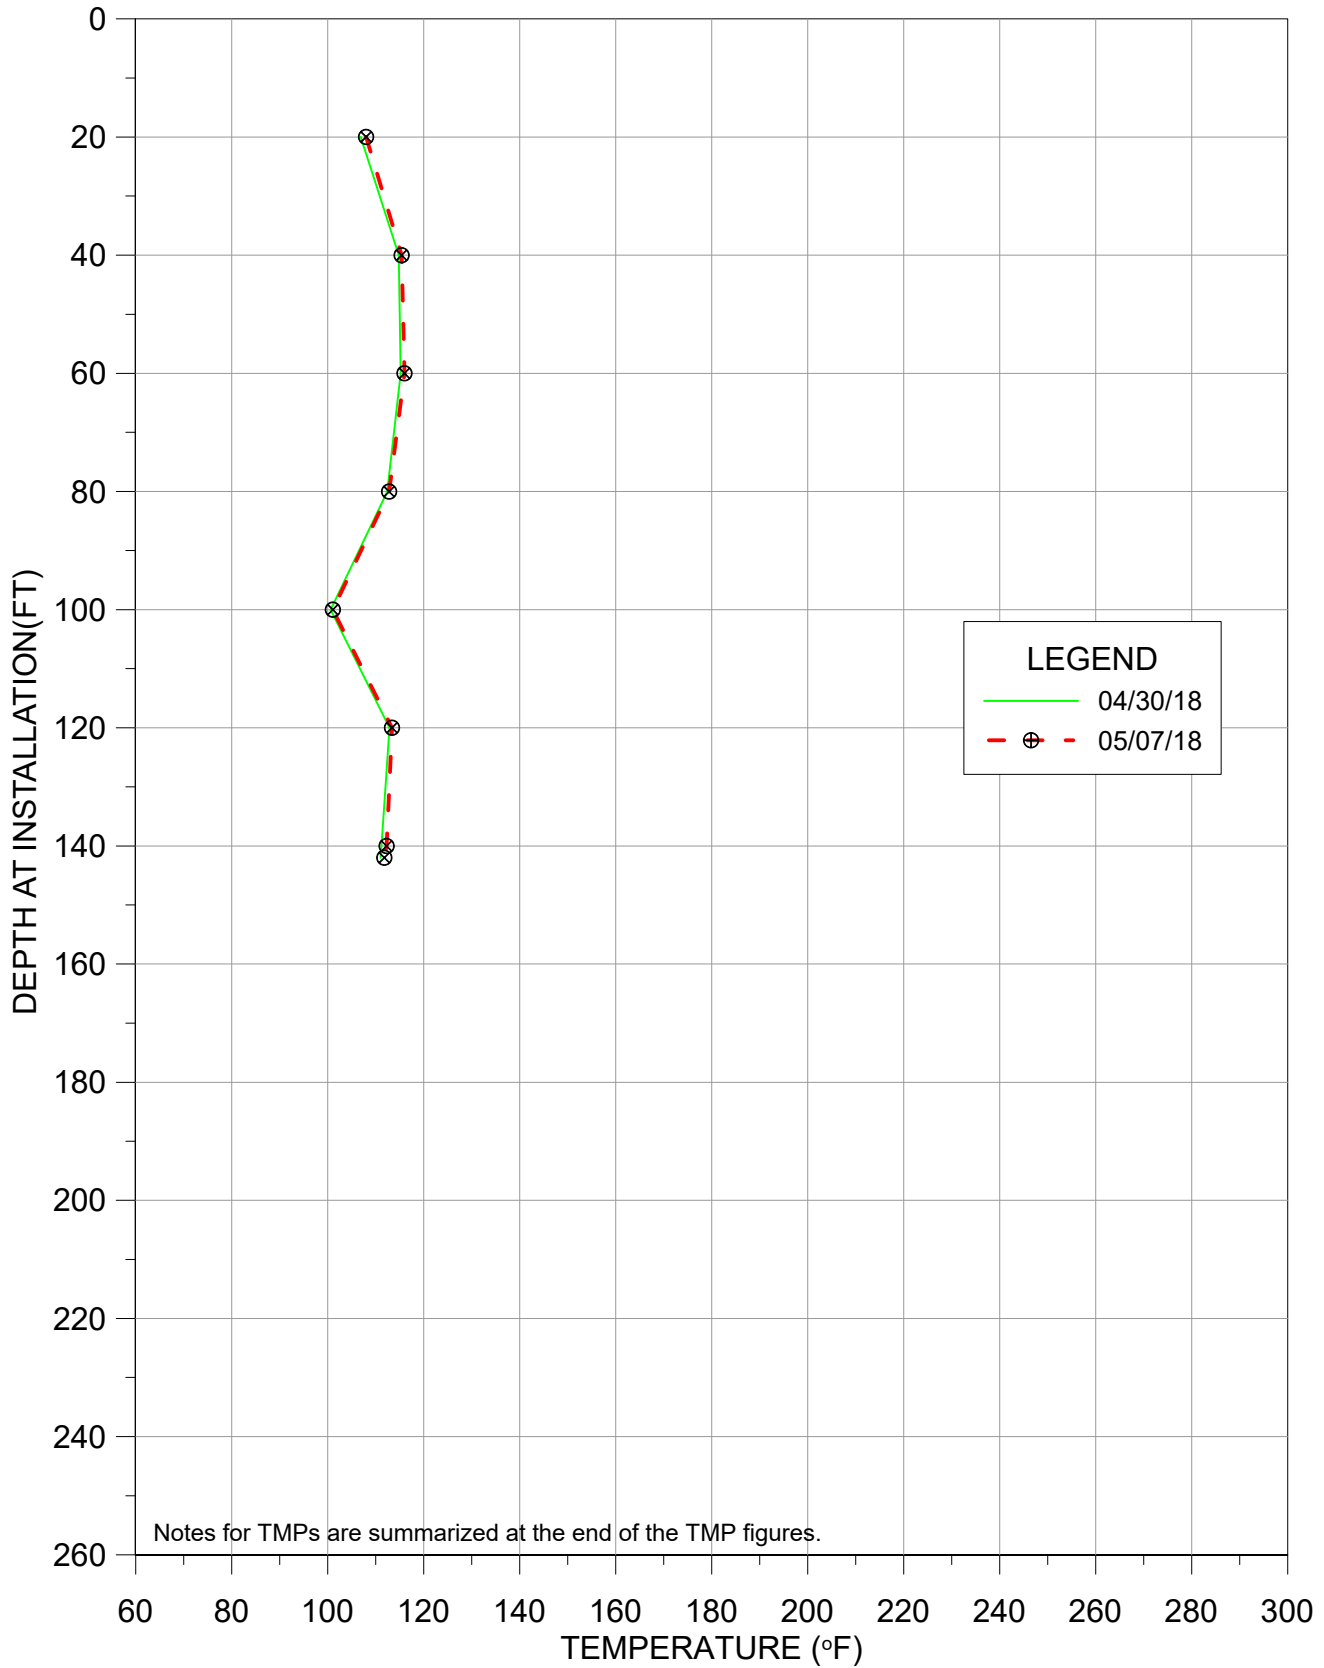
1. TMP-26R may still be equilibrating.

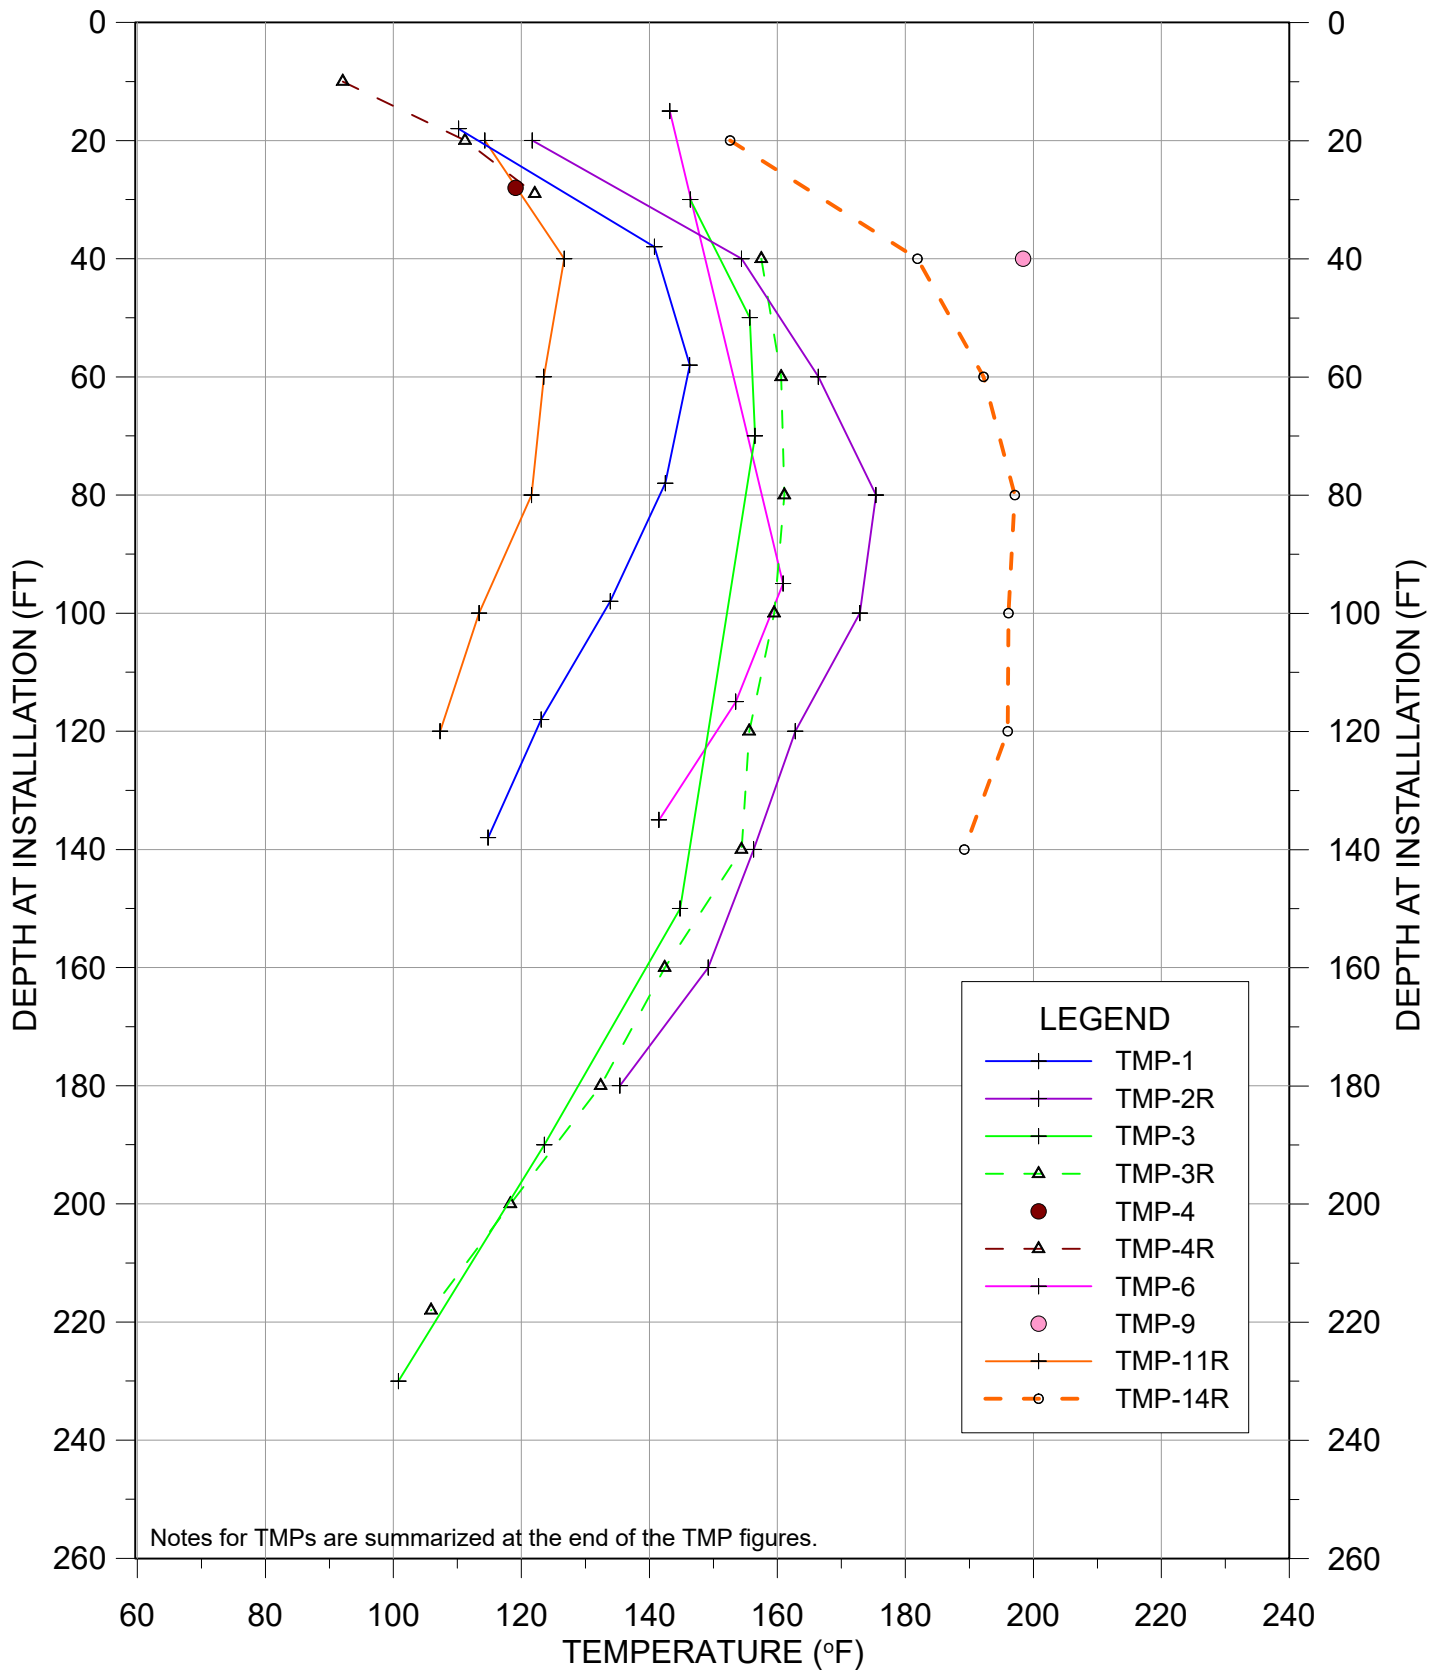
5/7/2018

TMP vs DEPTH and TMP vs ELEVATION (for **5/07/18**):

1. There were no reliable temperature readings for TMP-13 since 3/19/2014.
2. There were no reliable temperature readings for TMP-7R, as determined by the connectivity test on 4/11/2014.

3. There were no reliable temperature readings for TMP-5 since 11/5/2014.
4. There were no reliable temperature readings for TMP-12 since 9/28/2015.
5. There were no reliable temperature readings for TMP-8 since 9/9/2015.

6. There were no reliable temperature readings for TMP-14, confirmed since 3/7/2016.
7. There were no reliable temperature readings for TMP-11 as determined by the connectivity test on 11/23/2016.

8. TMP-2 has been replaced by TMP-2R and will no longer be monitored.
9. TMP-11 is no longer in service and will not be included in the presentation.
10. There were no reliable temperature readings for TMP-10 since 5/30/2017.

11. TMP-16, 25, and 28 have been replaced by TMP-16R, 25R, and 28R and will be no longer reported since 1/15/2018.

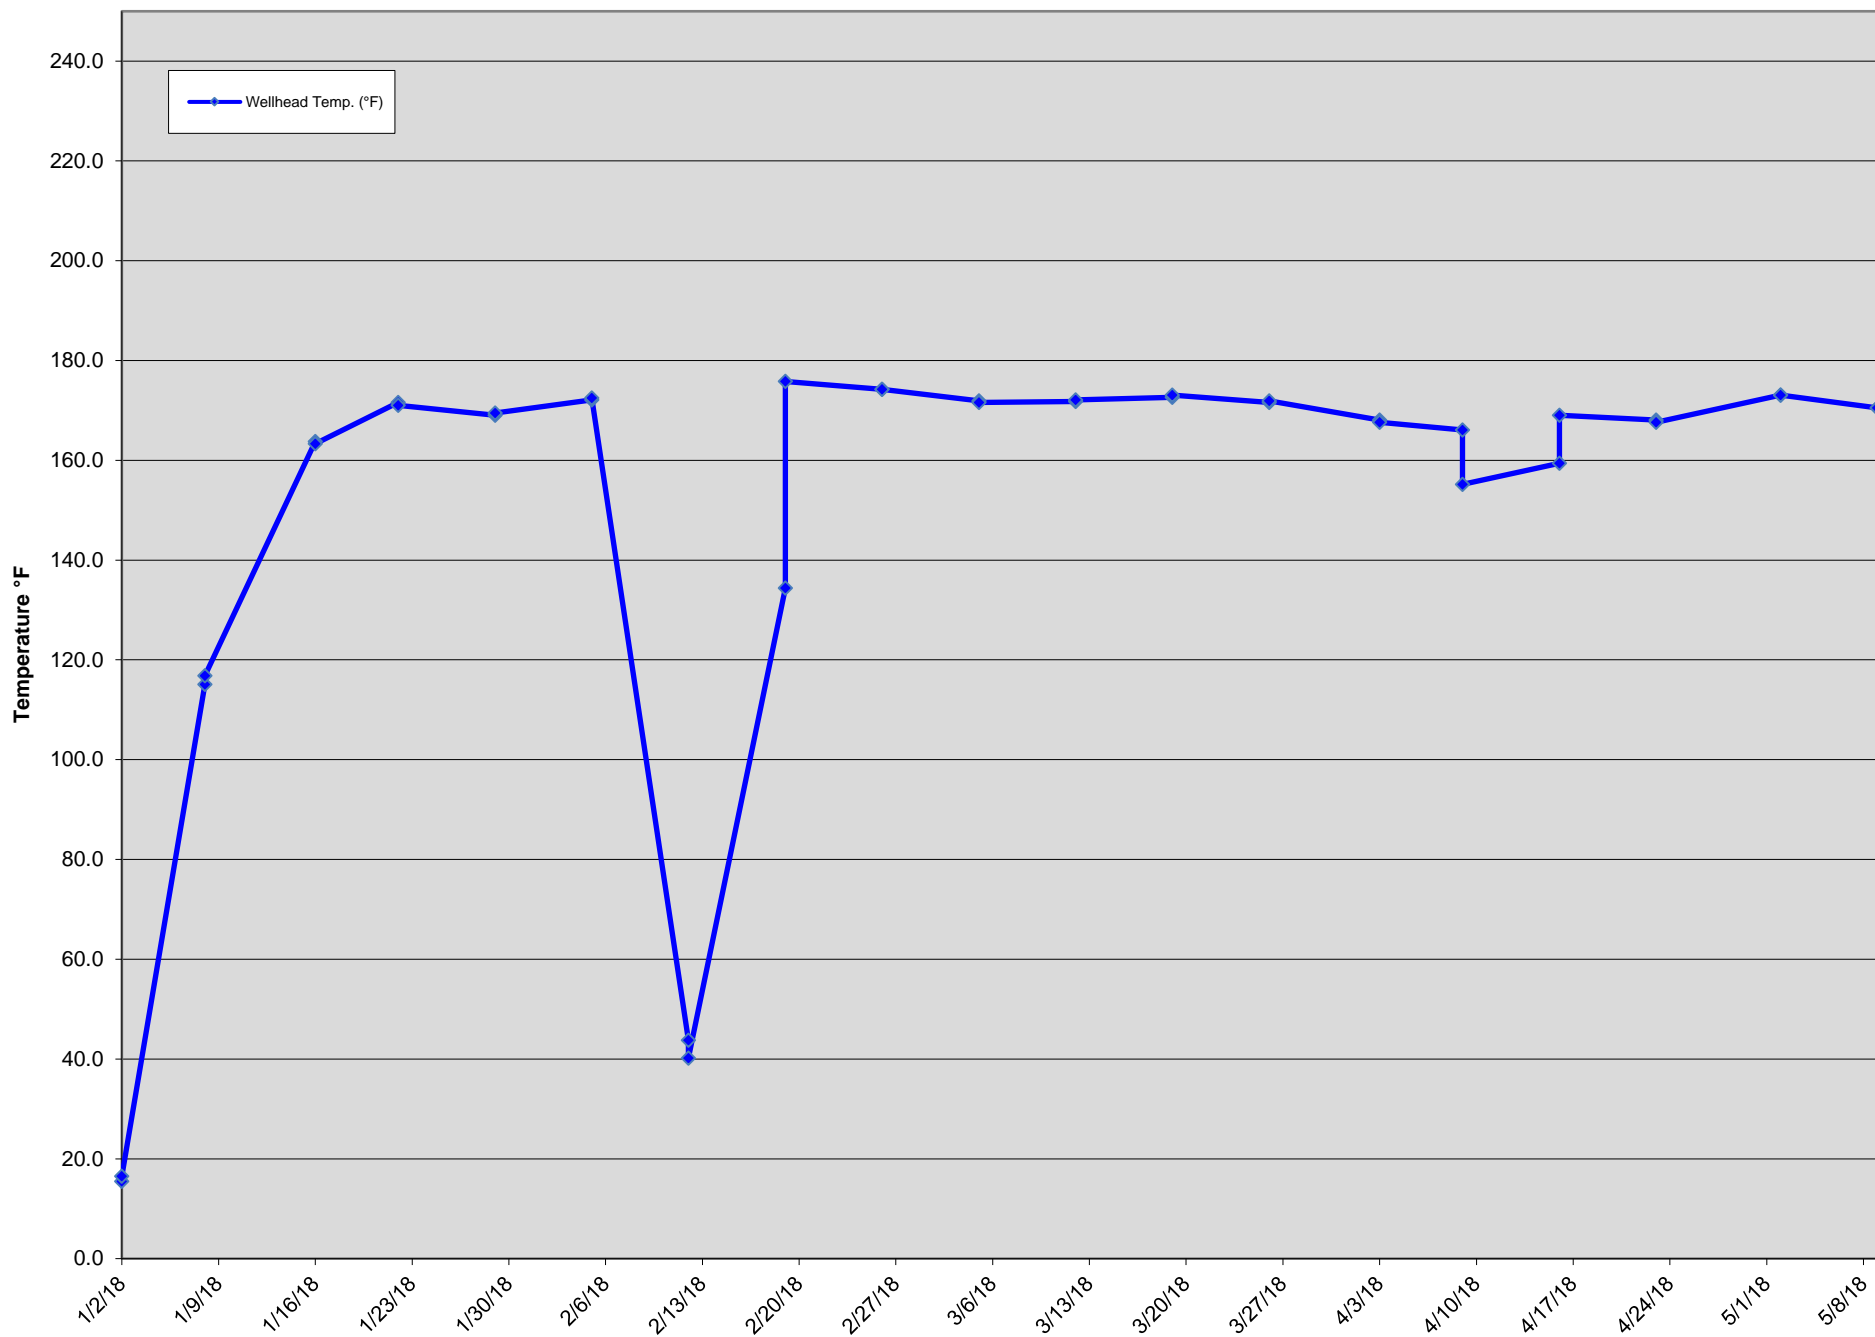
GIW-1 Wellhead Temperatures

As part of the HES, there are currently cooling water circulation loops installed in twelve Gas Interceptor Wells (GIWs) (GIW-02 through GIW-13). The remaining well (GIW-01) had a measured gas temperature within its historical operating limits.
