# **Bridgeton Landfill, LLC**

## **Weekly Data Submittal**

**Week of May 20, 2018 – May 26, 2018**

**Required by Section 52.F of Agreed Order, Case No. 13SL-CC01088  
Effective May 13, 2013**

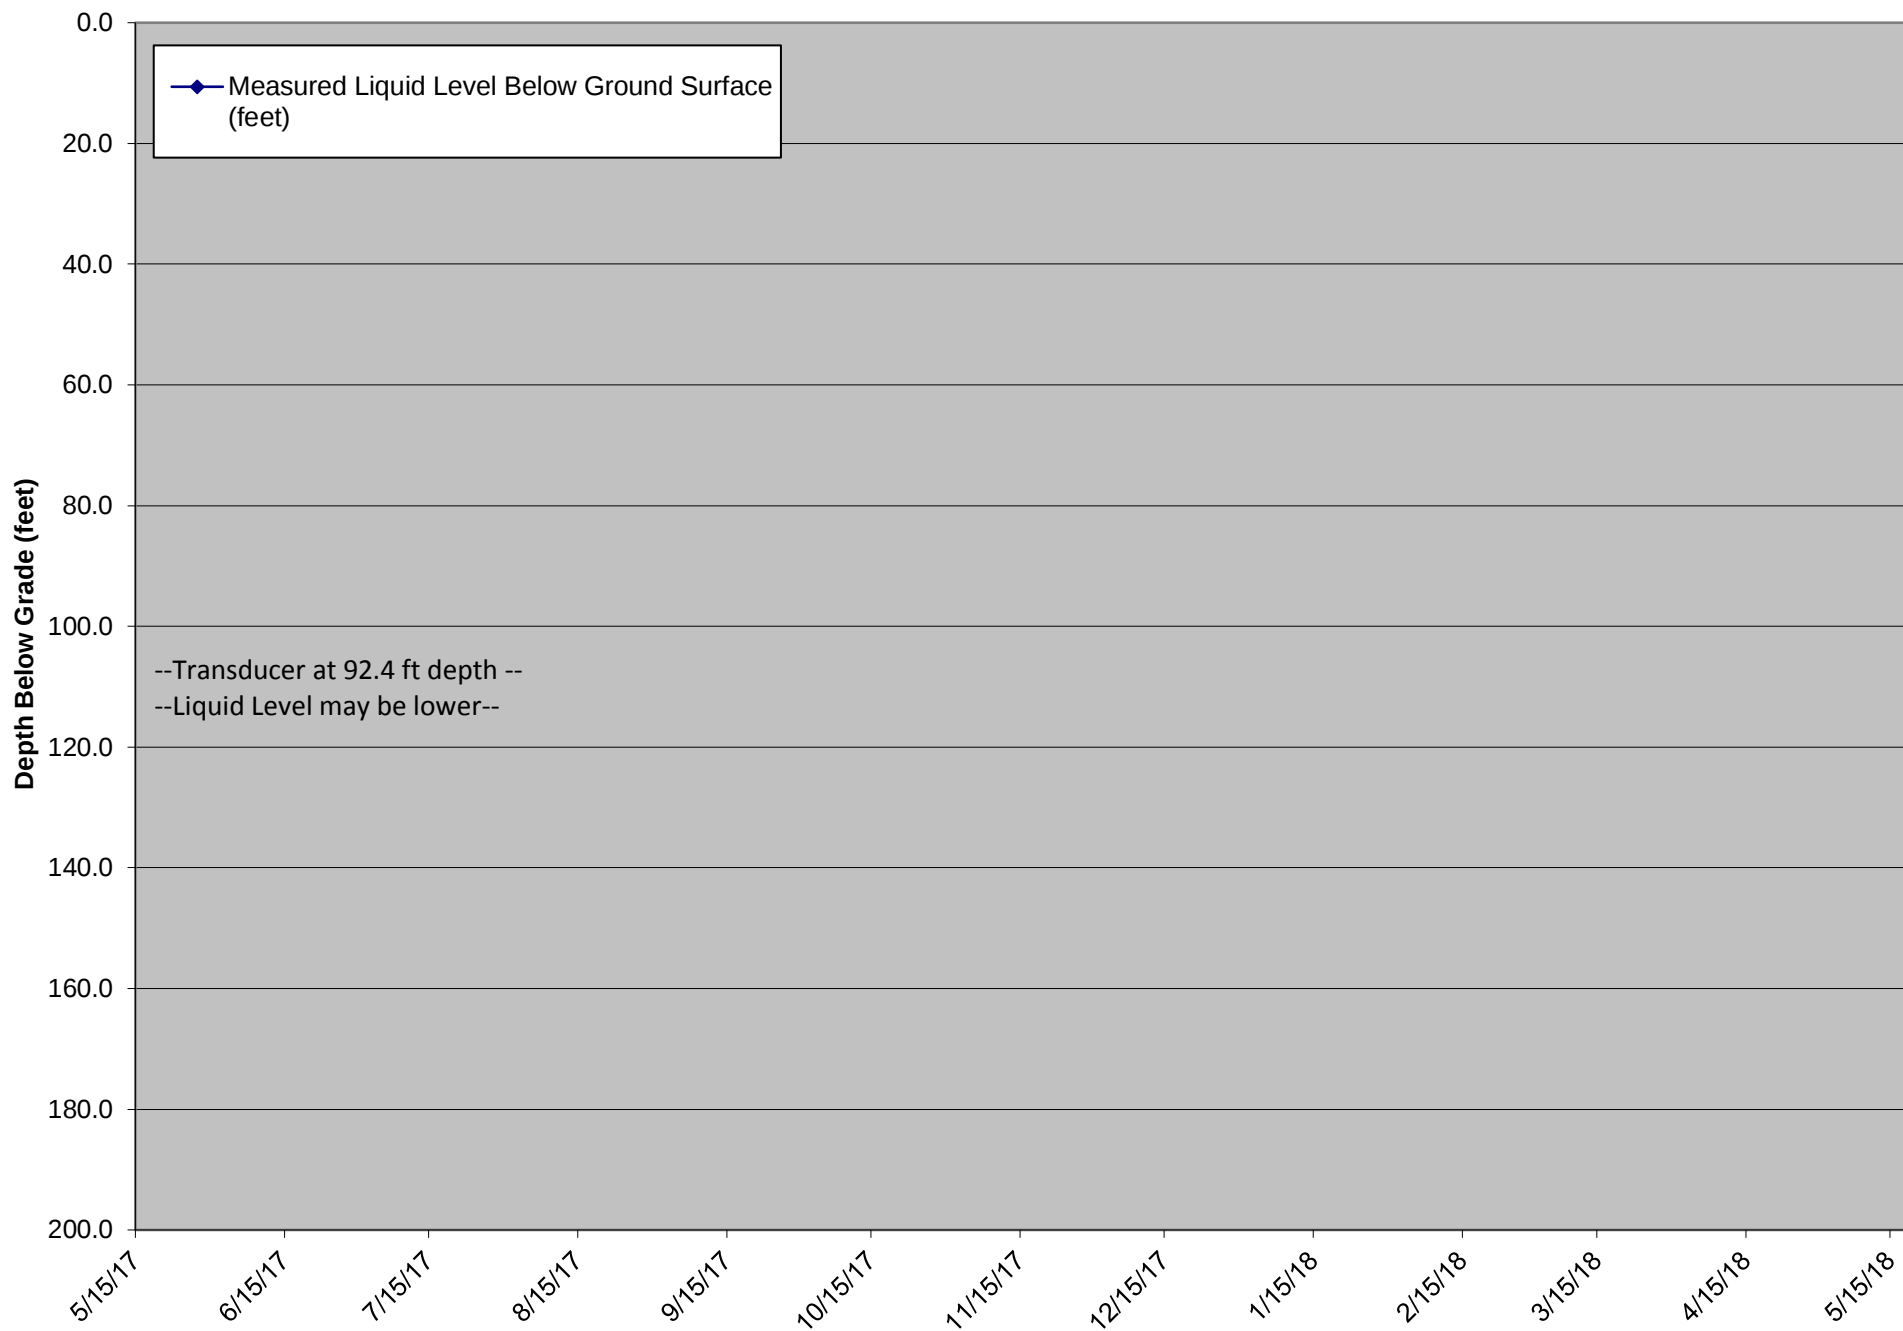
# LCS-1D Liquid Level Below Ground Surface

Downhole discharge piping and the pump for LCS-1D was replaced the week of 2/5/18. Pump was non-operational after startup activities. Pump replacement was attempted the week of 4/30/18 and was unsuccessful. Further options are being evaluated.

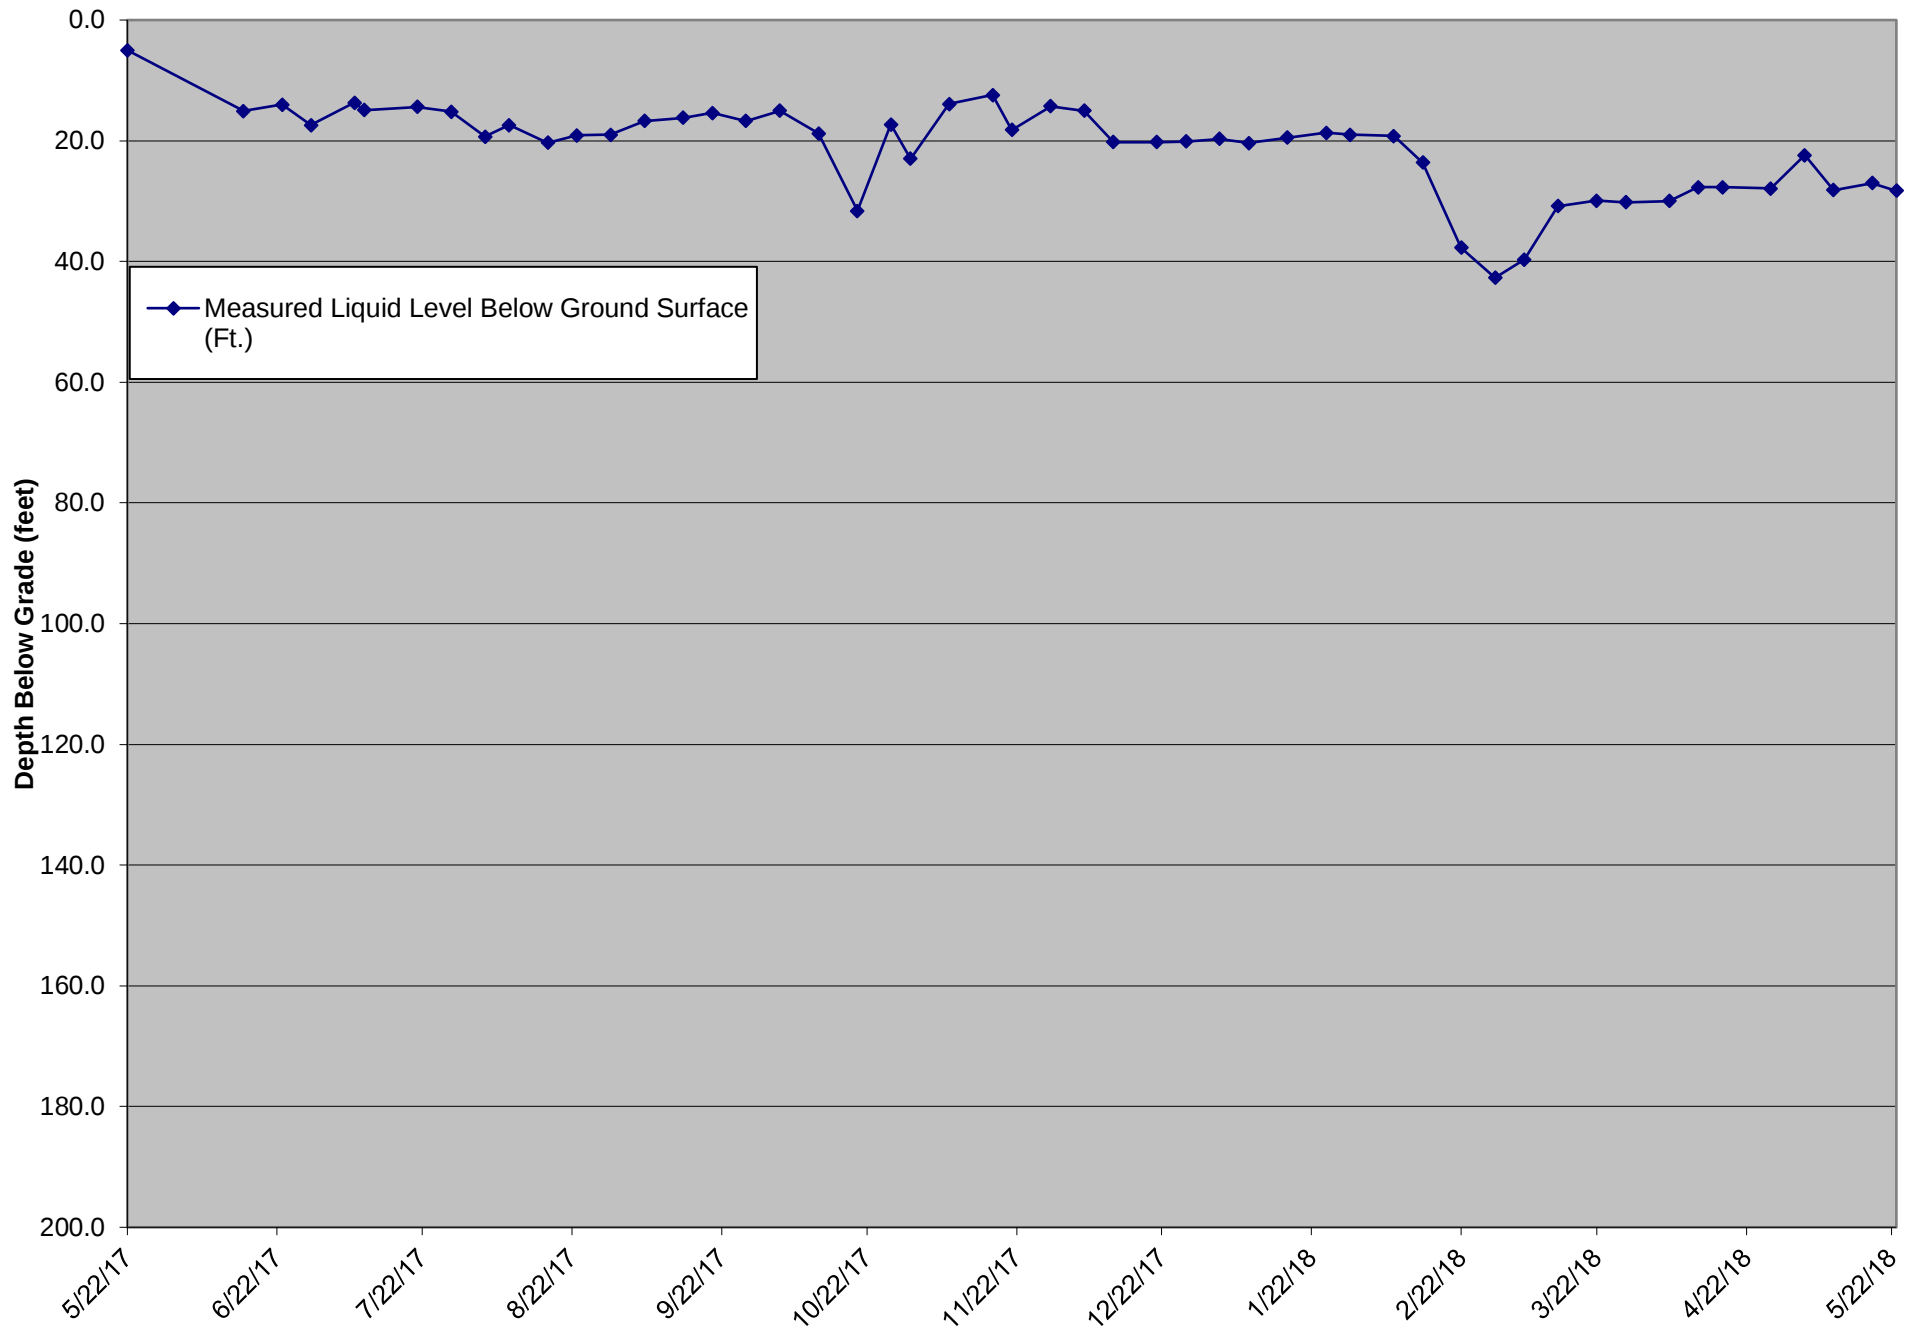
LCS-3D Liquid Level Below Ground Surface

The QED AP-4 pneumatic pump in LCS-3D was non-operational during the weekly reporting period. Liquid level was measured manually.

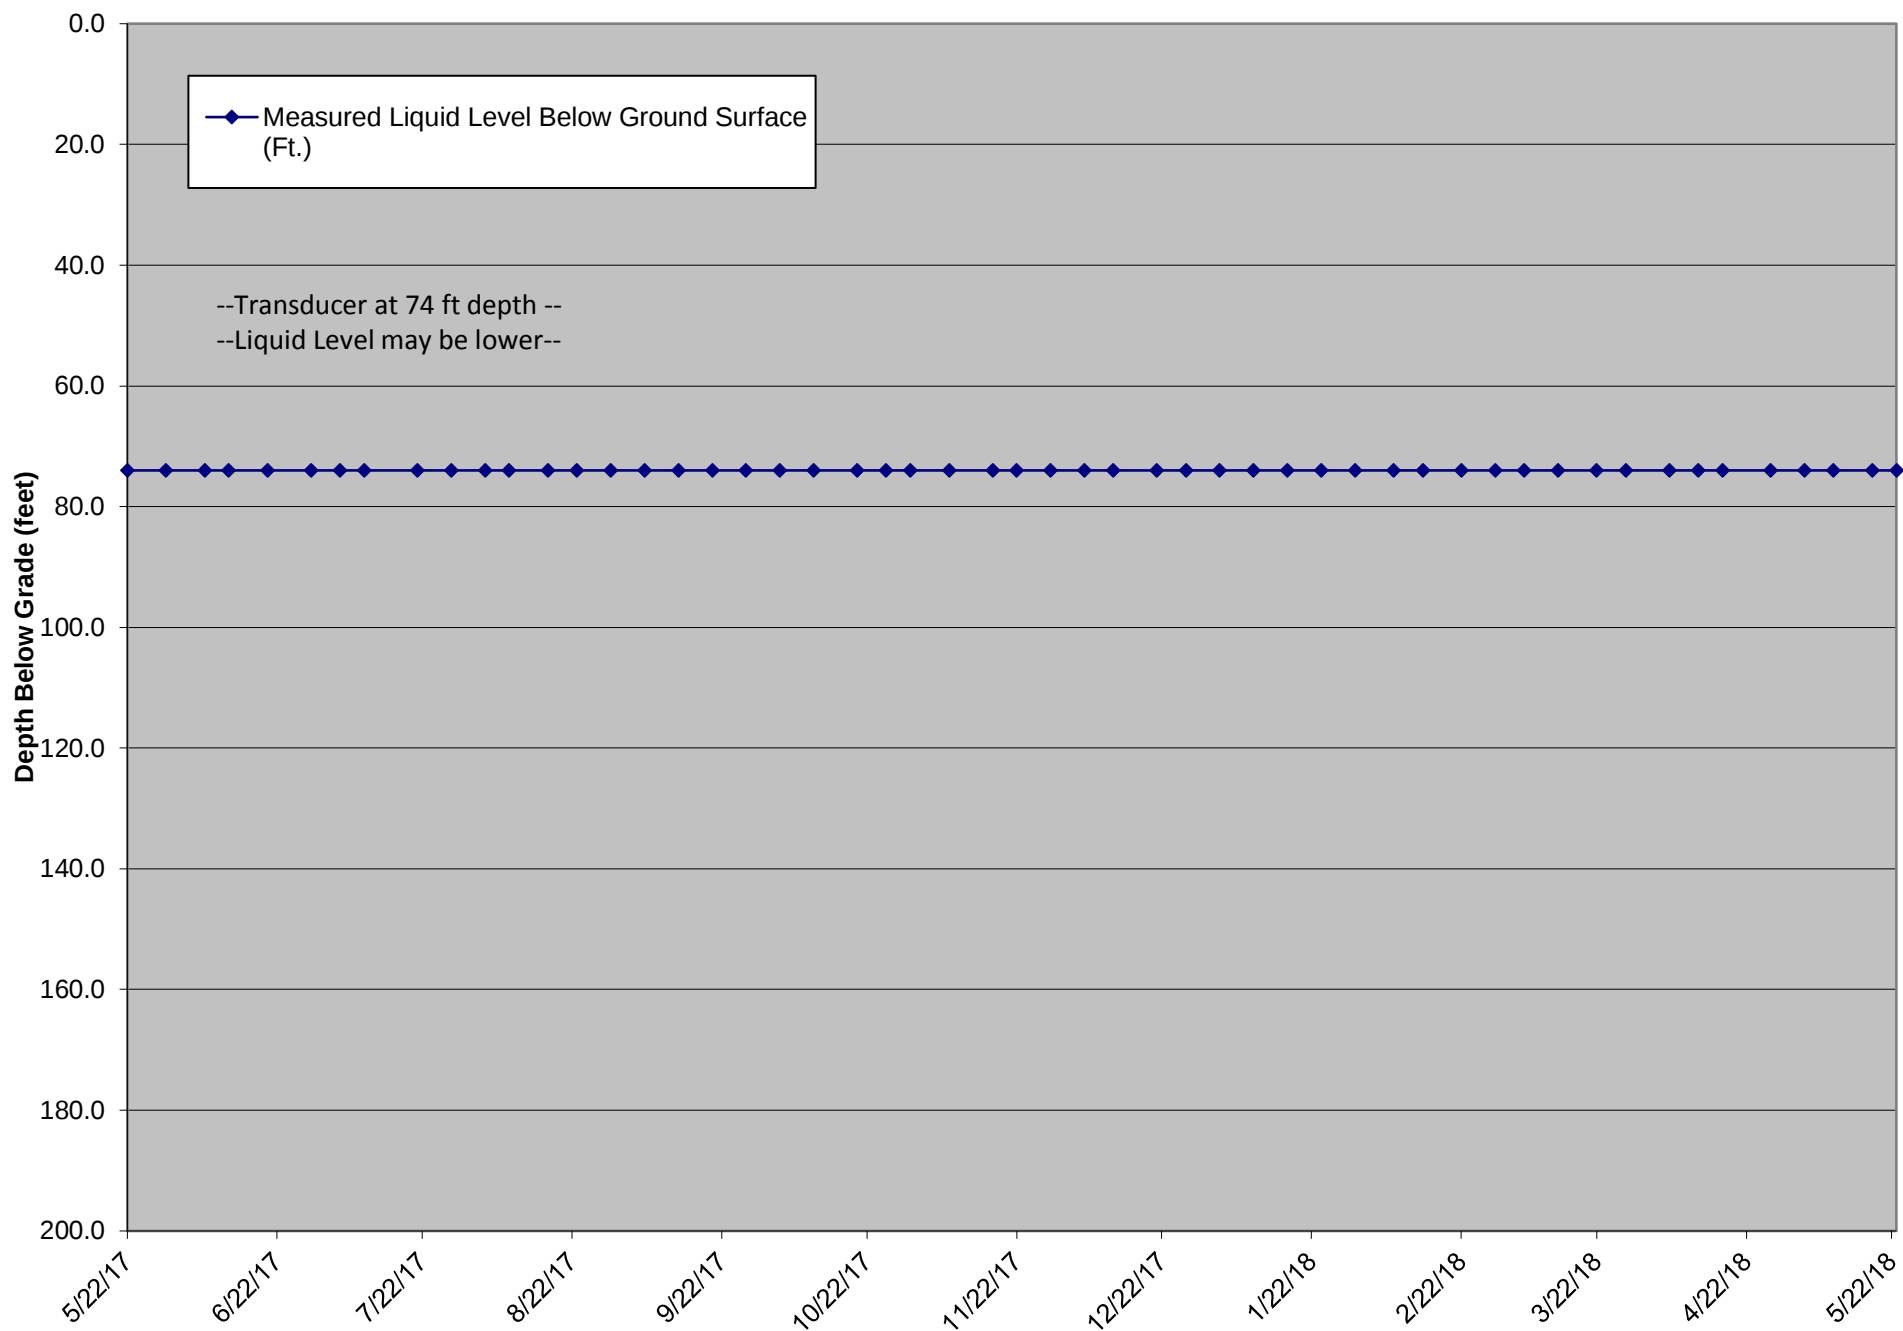
# LCS-4B Liquid Level Below Ground Surface

The level sensor in LCS-4B is currently operational and responsive. Liquid level was not recorded by the level sensor during the weekly reporting period. LCS-4B is equipped with a flow meter that displayed no flow during the weekly reporting period. Therefore, it can be concluded that the liquid level was below the bottom of the pump and level sensor in LCS-4B.

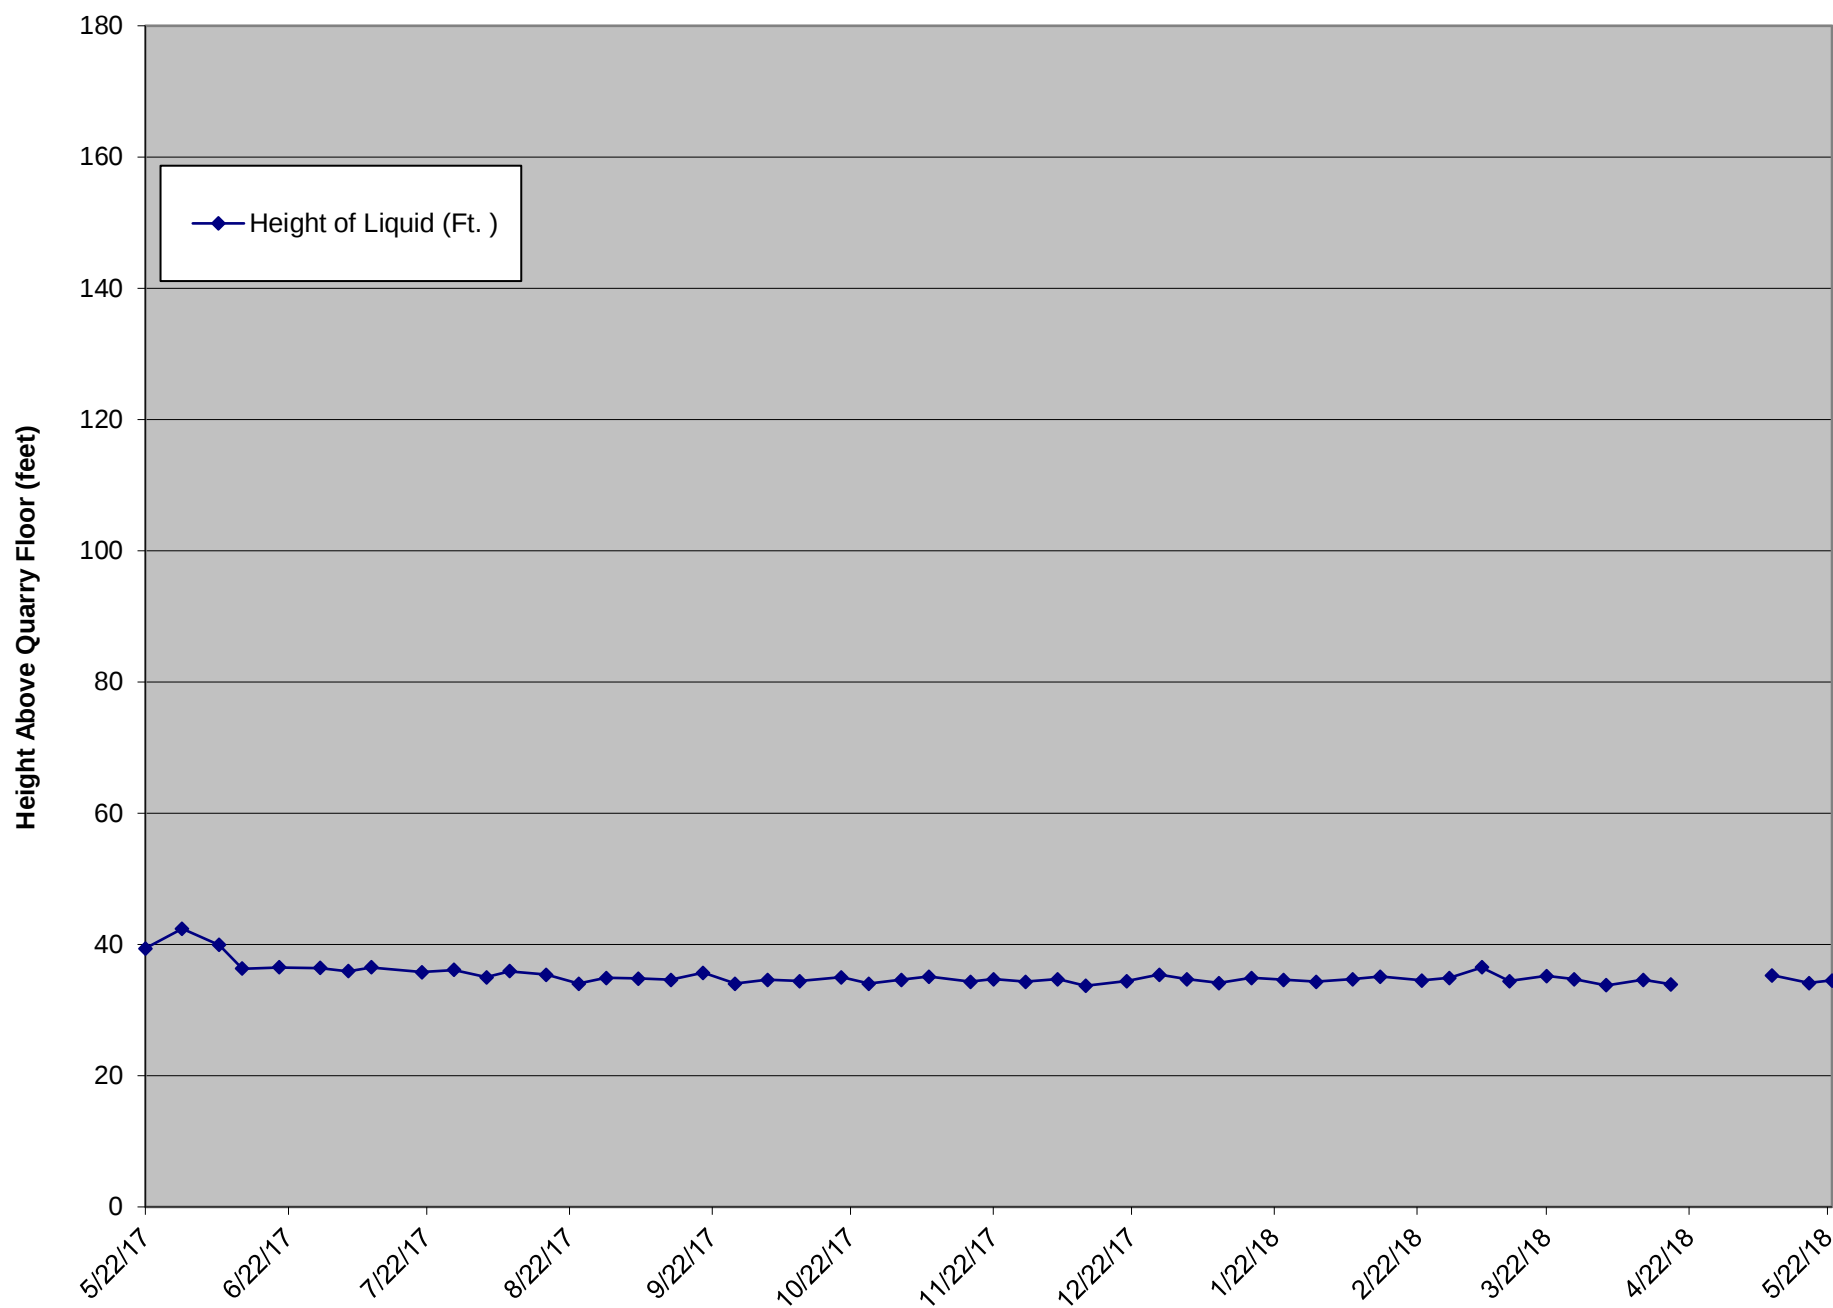
LCS-5B Liquid Level Above Quarry Floor

LCS-5B and LCS-6B were fully operational during the weekly reporting period.

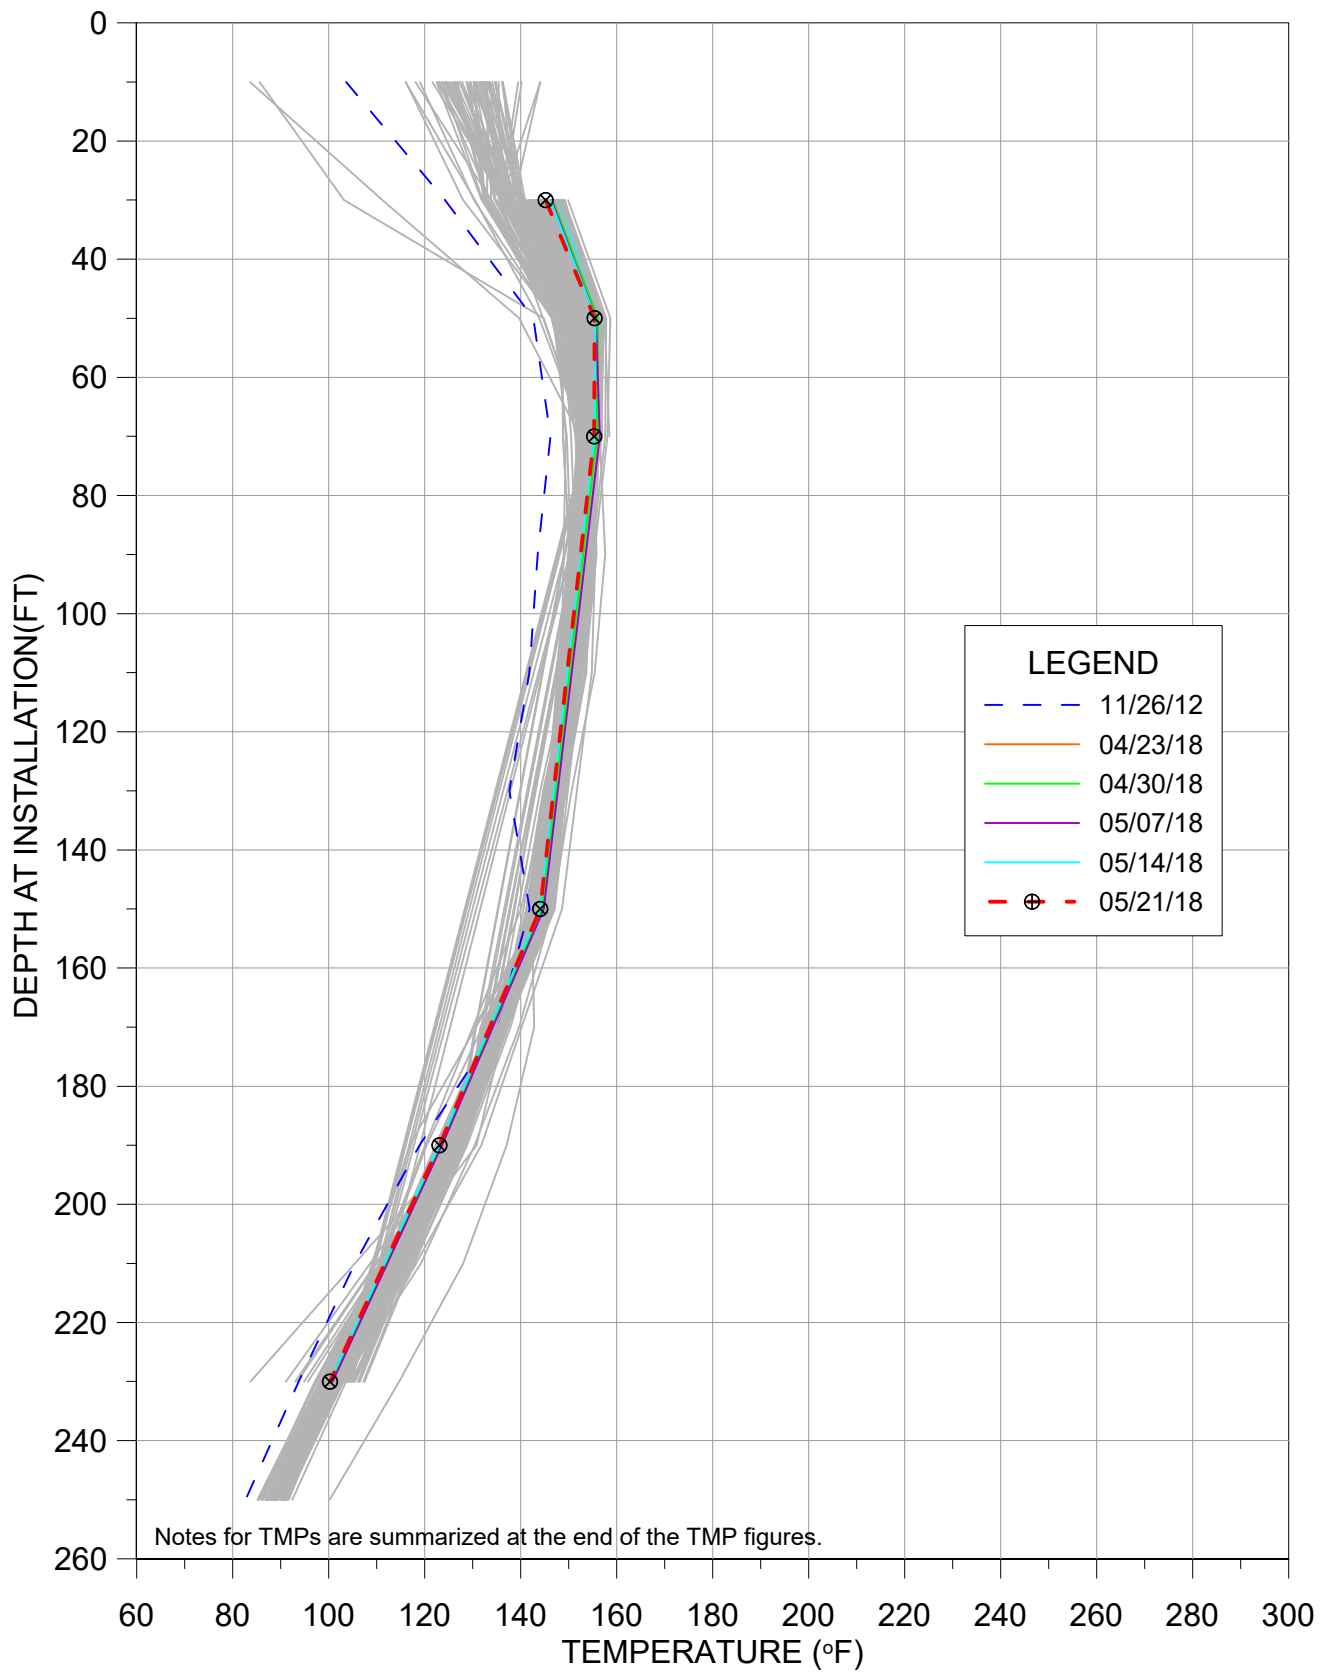
# TMP-3

1. No reliable temperature readings have been obtained at 170 ft depth since 1/29/2014, except on 3/13/2014.
2. The connectivity tests on 4/11/2014 conducted by CEC showed that units at 10, 90, 130, 210 and 250 ft depths are no longer reliable.
3. The connectivity tests on 10/28/2014 conducted by Feezor Engineering showed that units at 10, 90, 110, 130, 210 and 250 ft depths are not reliable.

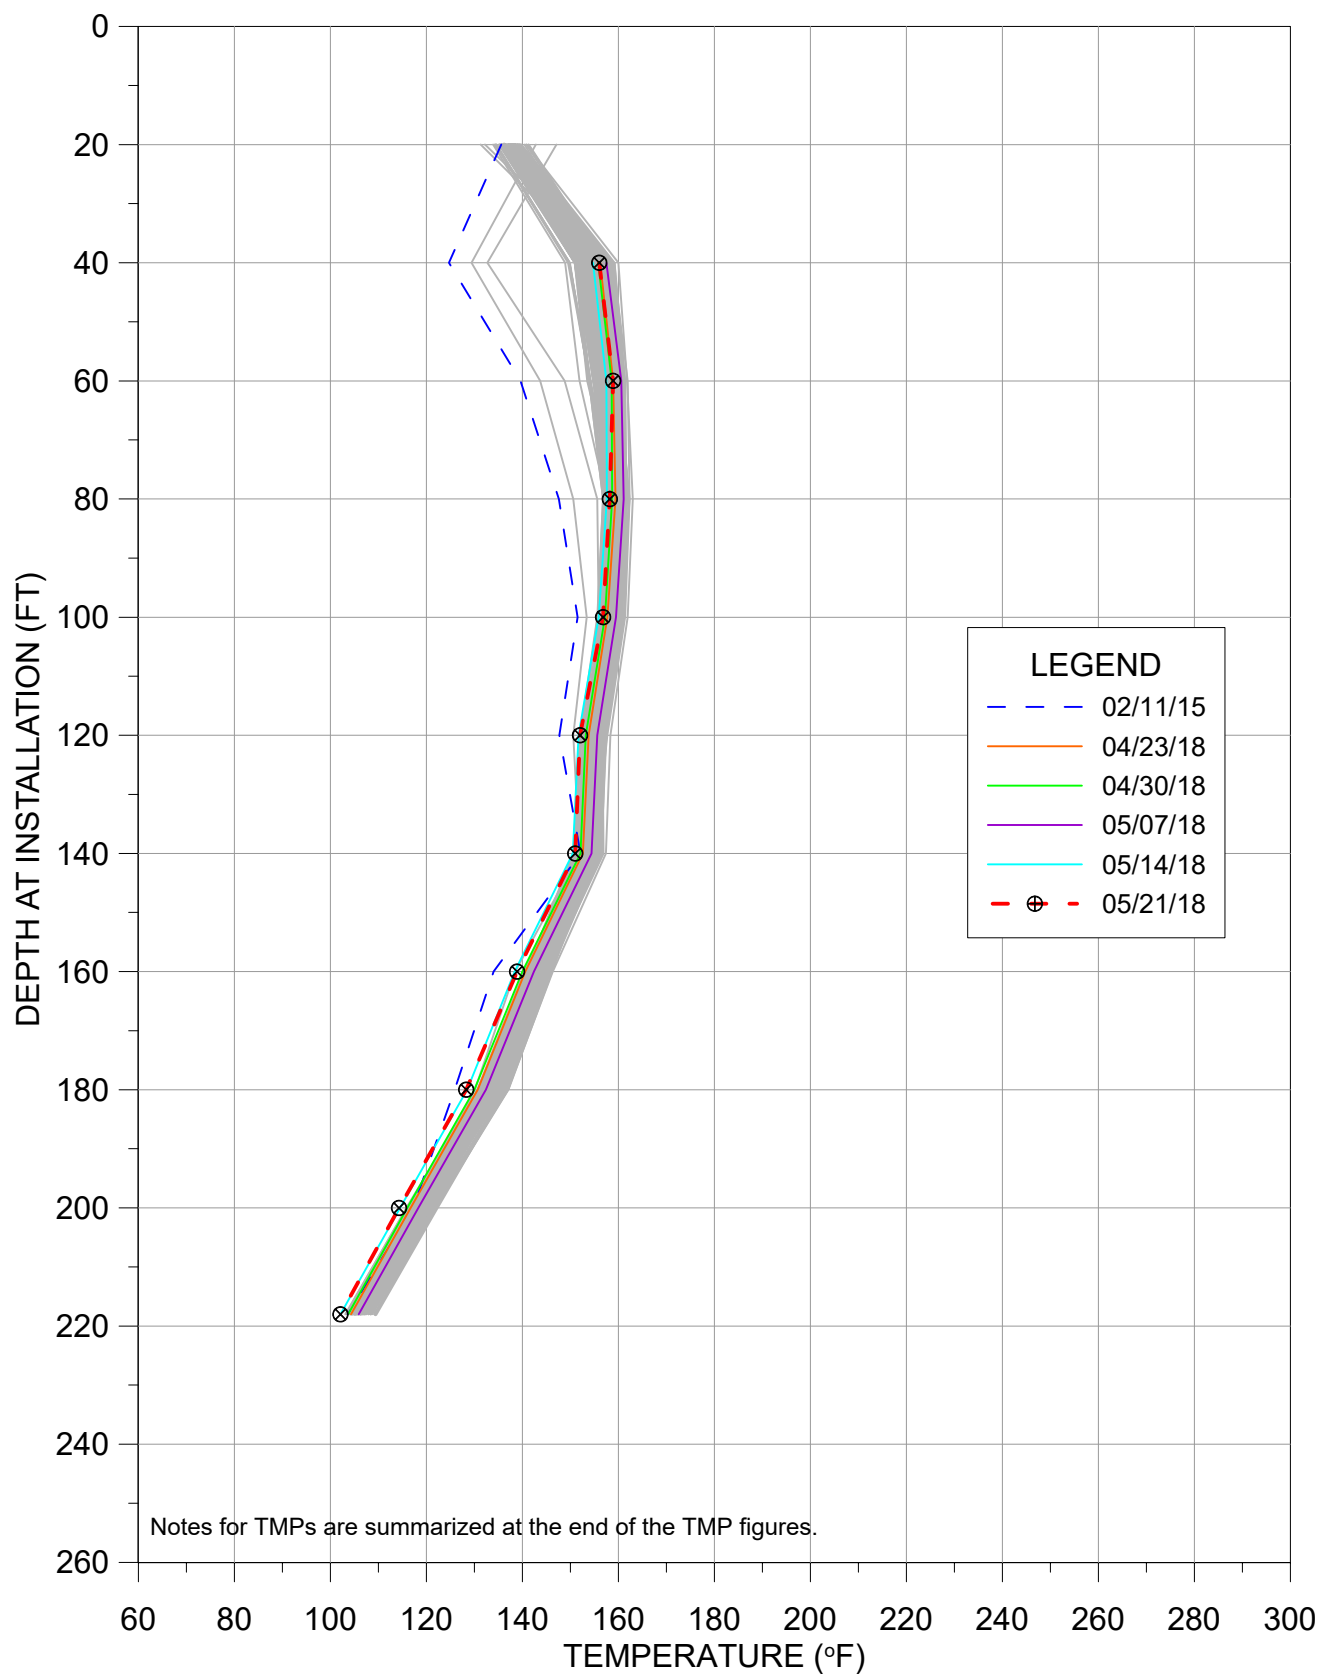
# TMP-3R

1. The unit at 20 ft depth had a fluctuating resistance since 9/25/2017. Therefore the temperature is determined to be unreliable.

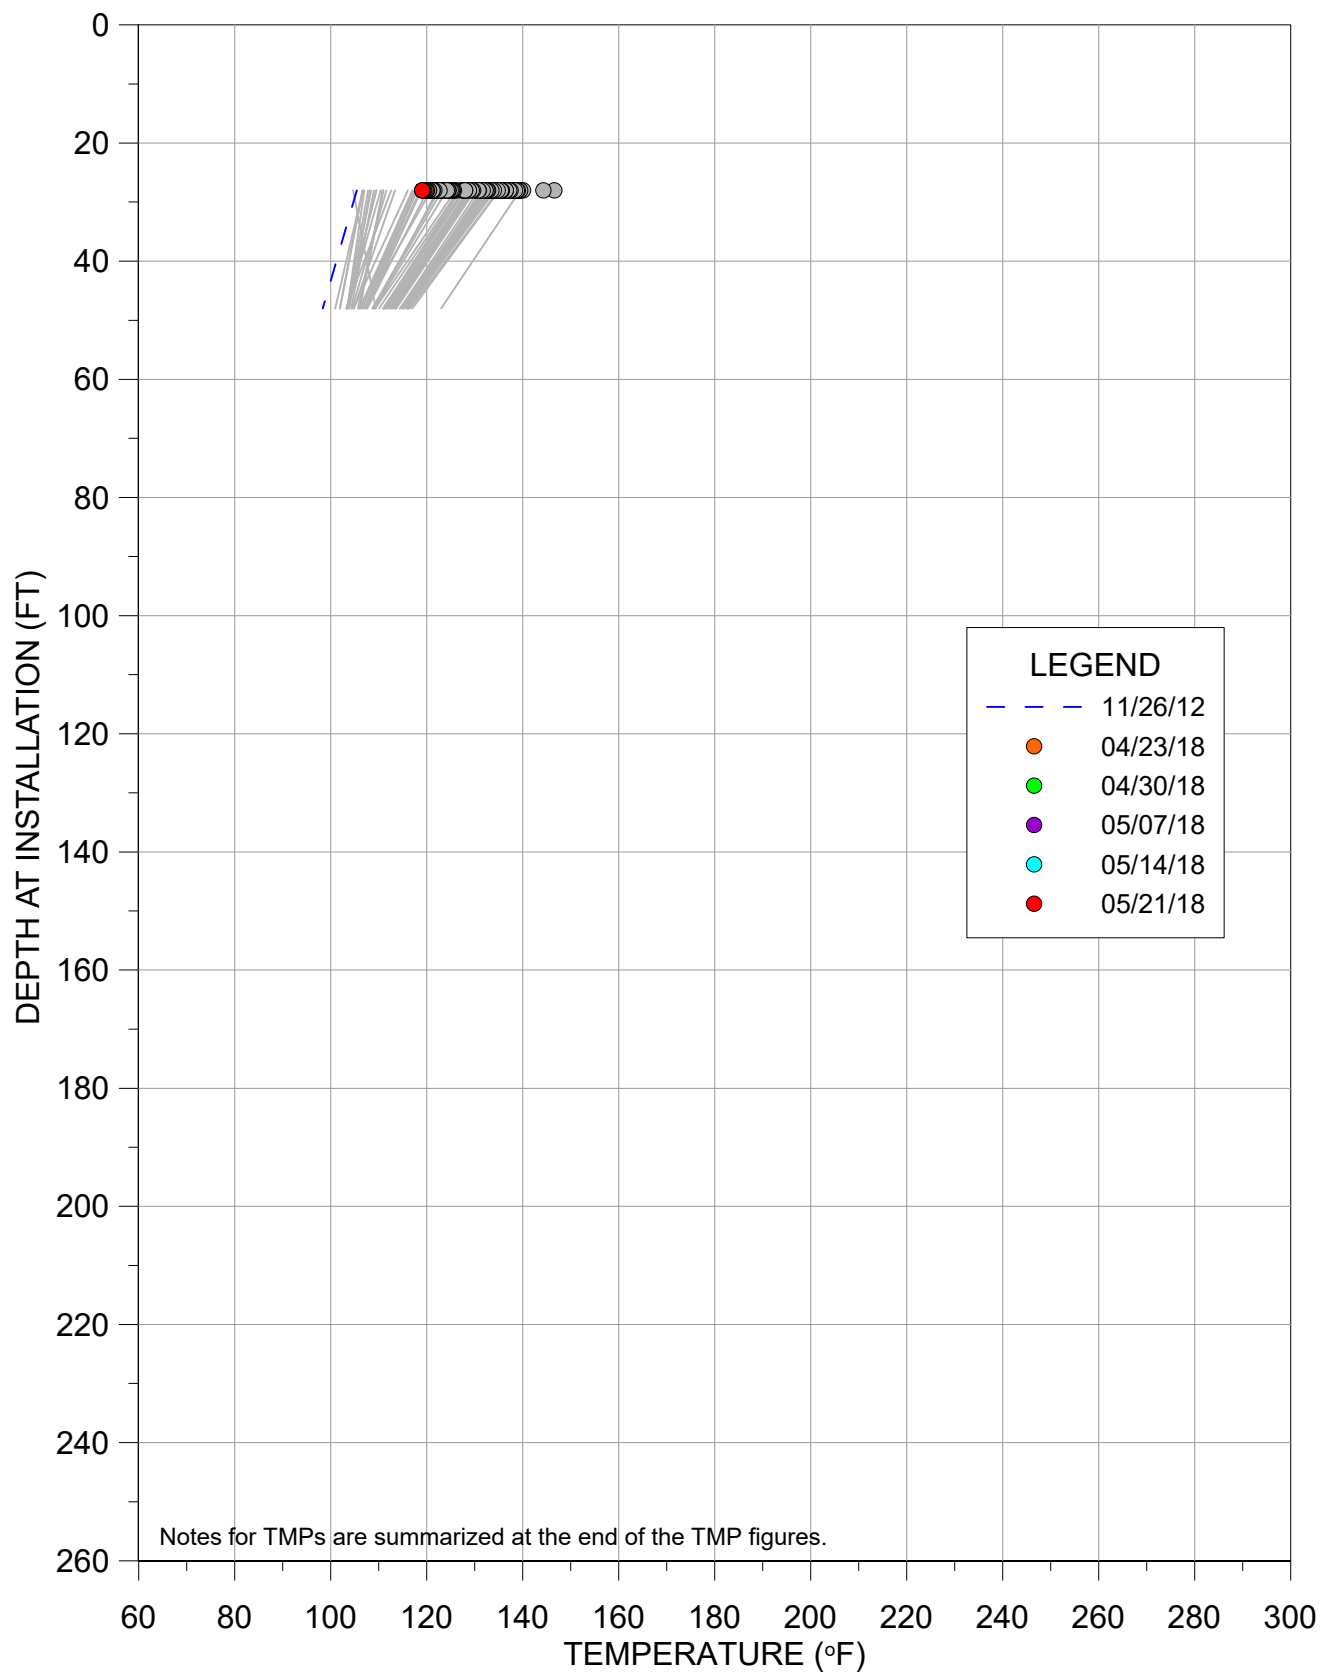
# TMP-4

1. The connectivity tests on 4/11/2014 conducted by CEC showed that the unit at 48 ft depth is no longer reliable.

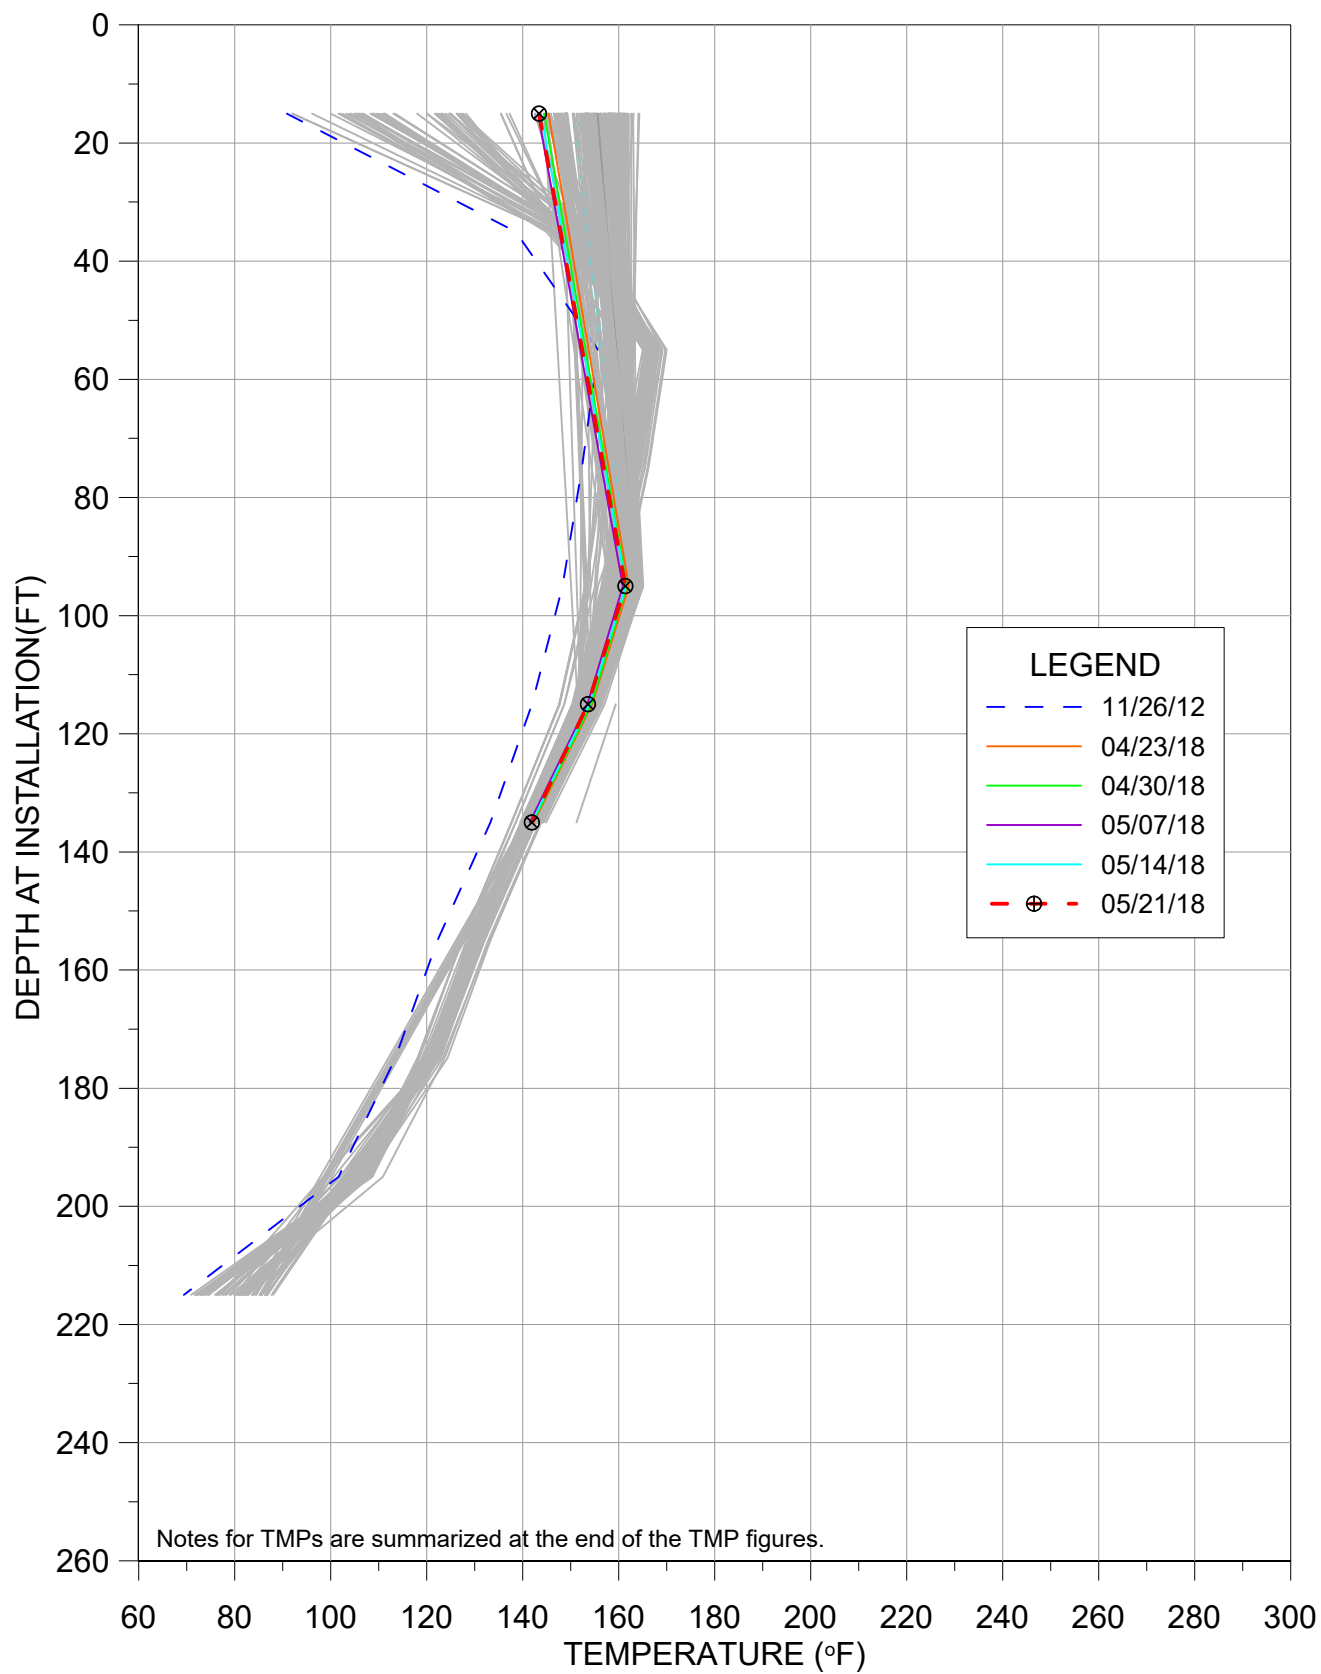
# TMP-6

1. The connectivity tests on 4/11/2014 conducted by CEC showed that units at 35, 55, 75, 155, 175, and 195 ft depths are no longer reliable.
2. No reliable temperature readings have been obtained at the unit at 215 ft depth since 6/13/2014.

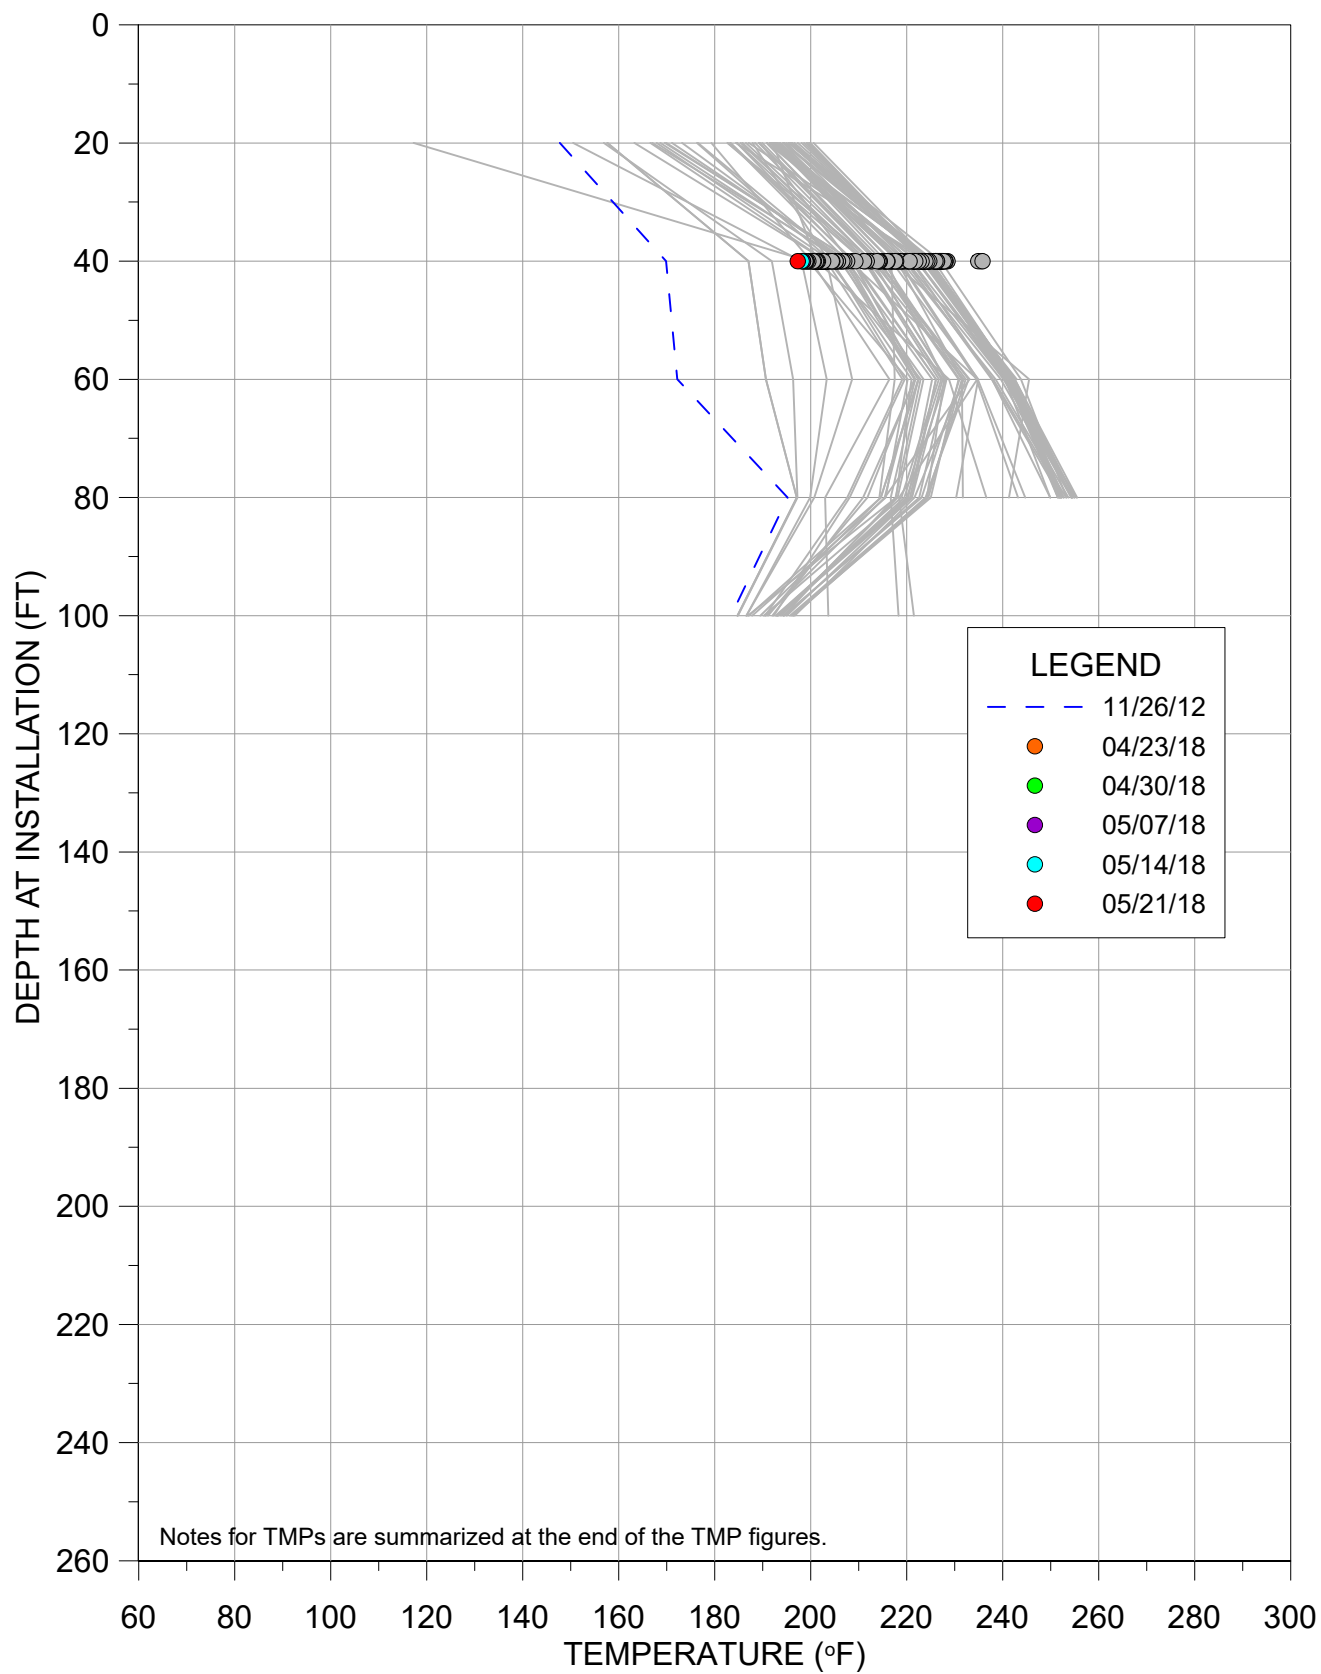
# TMP-9

1. Unit at 100 ft depth had an inaccurate temperature reading on 8/1/2013 and no reading since 8/6/2013.
2. The connectivity tests on 4/11/2014 conducted by CEC showed that units at 20, 60, 80, and 100 ft depths are no longer reliable.
