# **Bridgeton Landfill, LLC**

## **Weekly Data Submittal**

**Week of May 20, 2018 – May 26, 2018**

**Required by Section 52.F of Agreed Order, Case No. 13SL-CC01088  
Effective May 13, 2013**

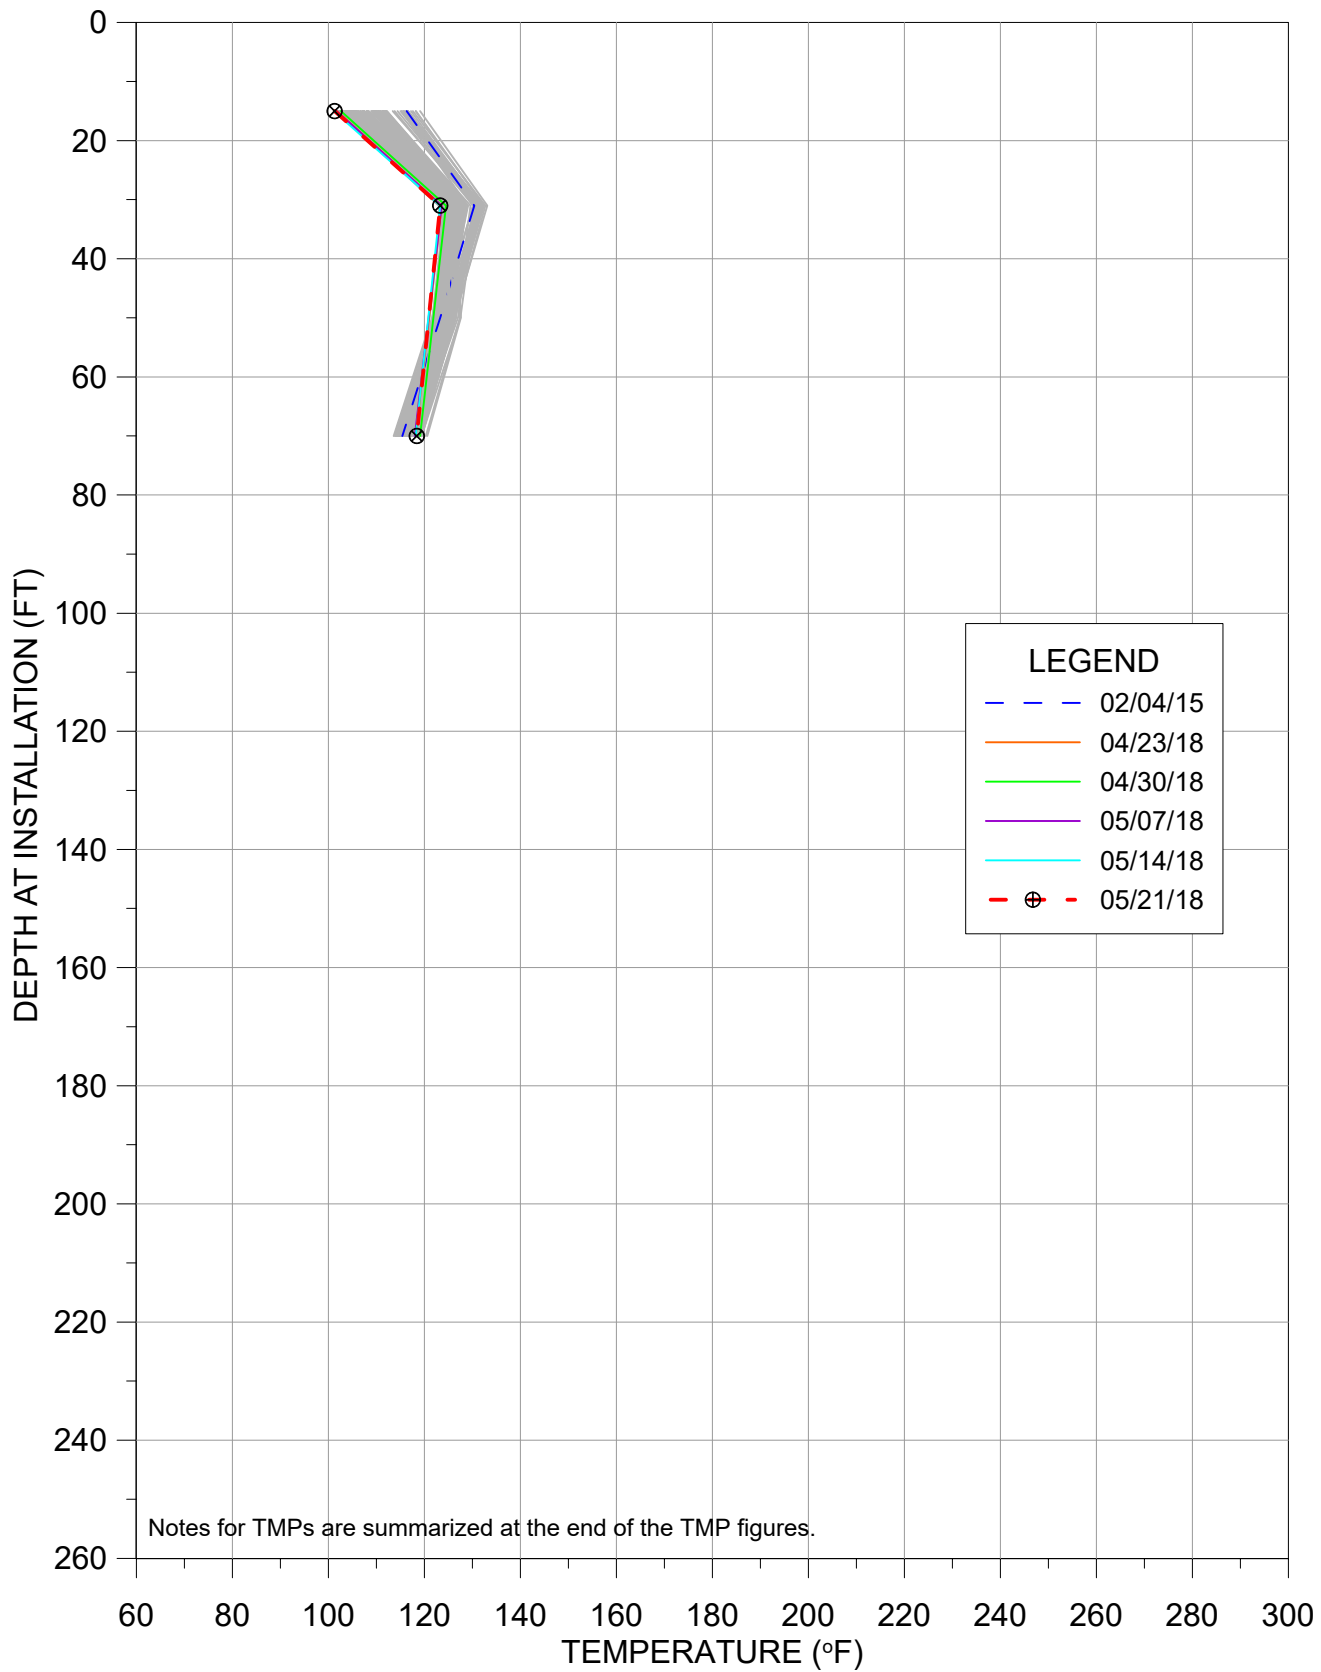
# TMP-22

1. No temperature reading could be obtained and resistivity was fluctuating at the unit at 50 ft depth since 4/2/2018.

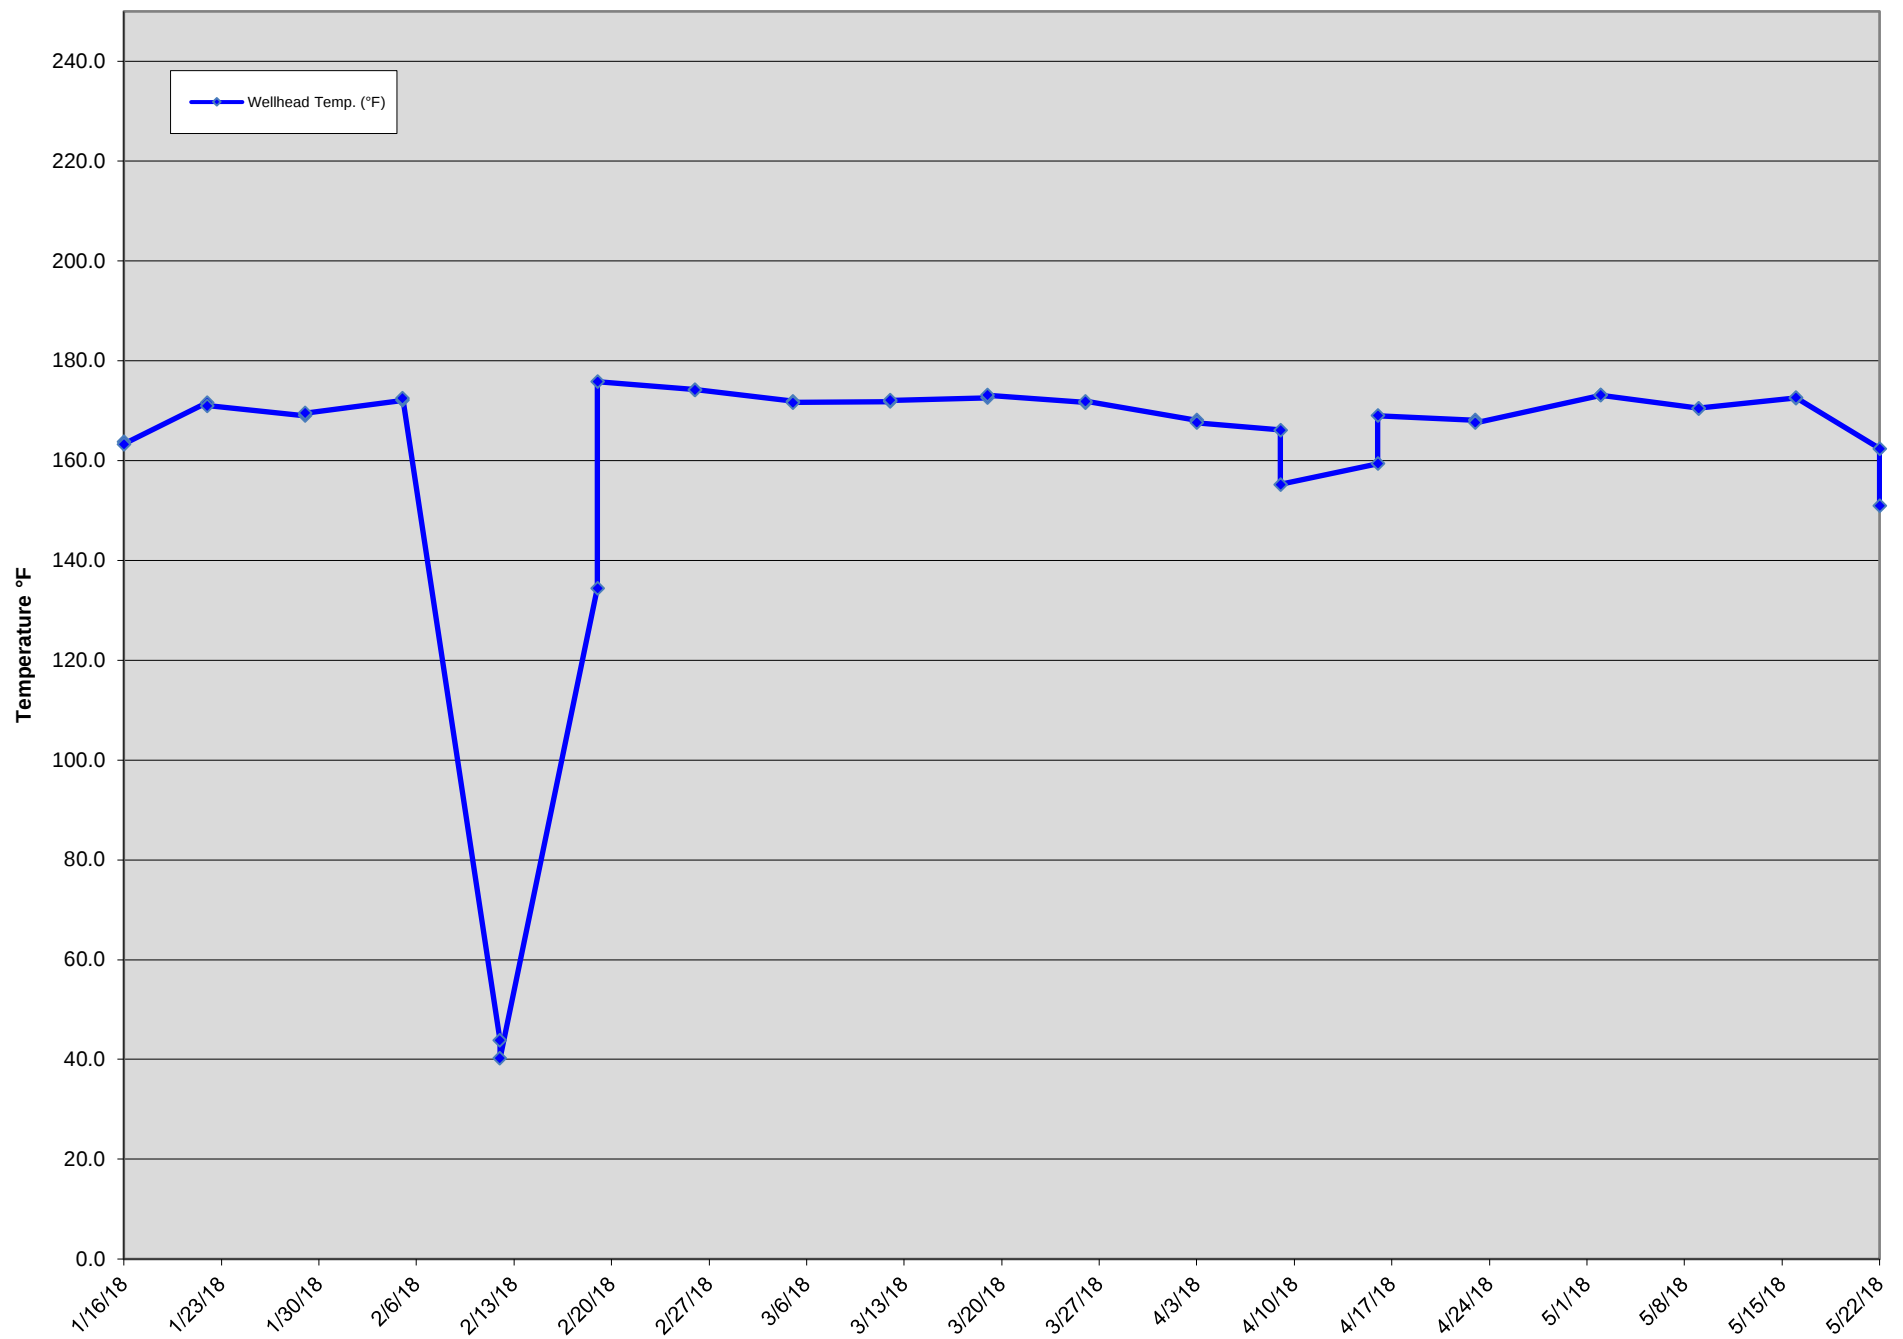
GIW-1 Wellhead Temperatures

As part of the HES, there are currently cooling water circulation loops installed in twelve Gas Interceptor Wells (GIWs) (GIW-02 through GIW-13). The remaining well (GIW-01) had a measured gas temperature within its historical operating limits.
