# **Bridgeton Landfill, LLC**

## **Weekly Data Submittal**

**Week of May 27, 2018 – June 02, 2018**

**Required by Section 52.F of Agreed Order, Case No. 13SL-CC01088  
Effective May 13, 2013**

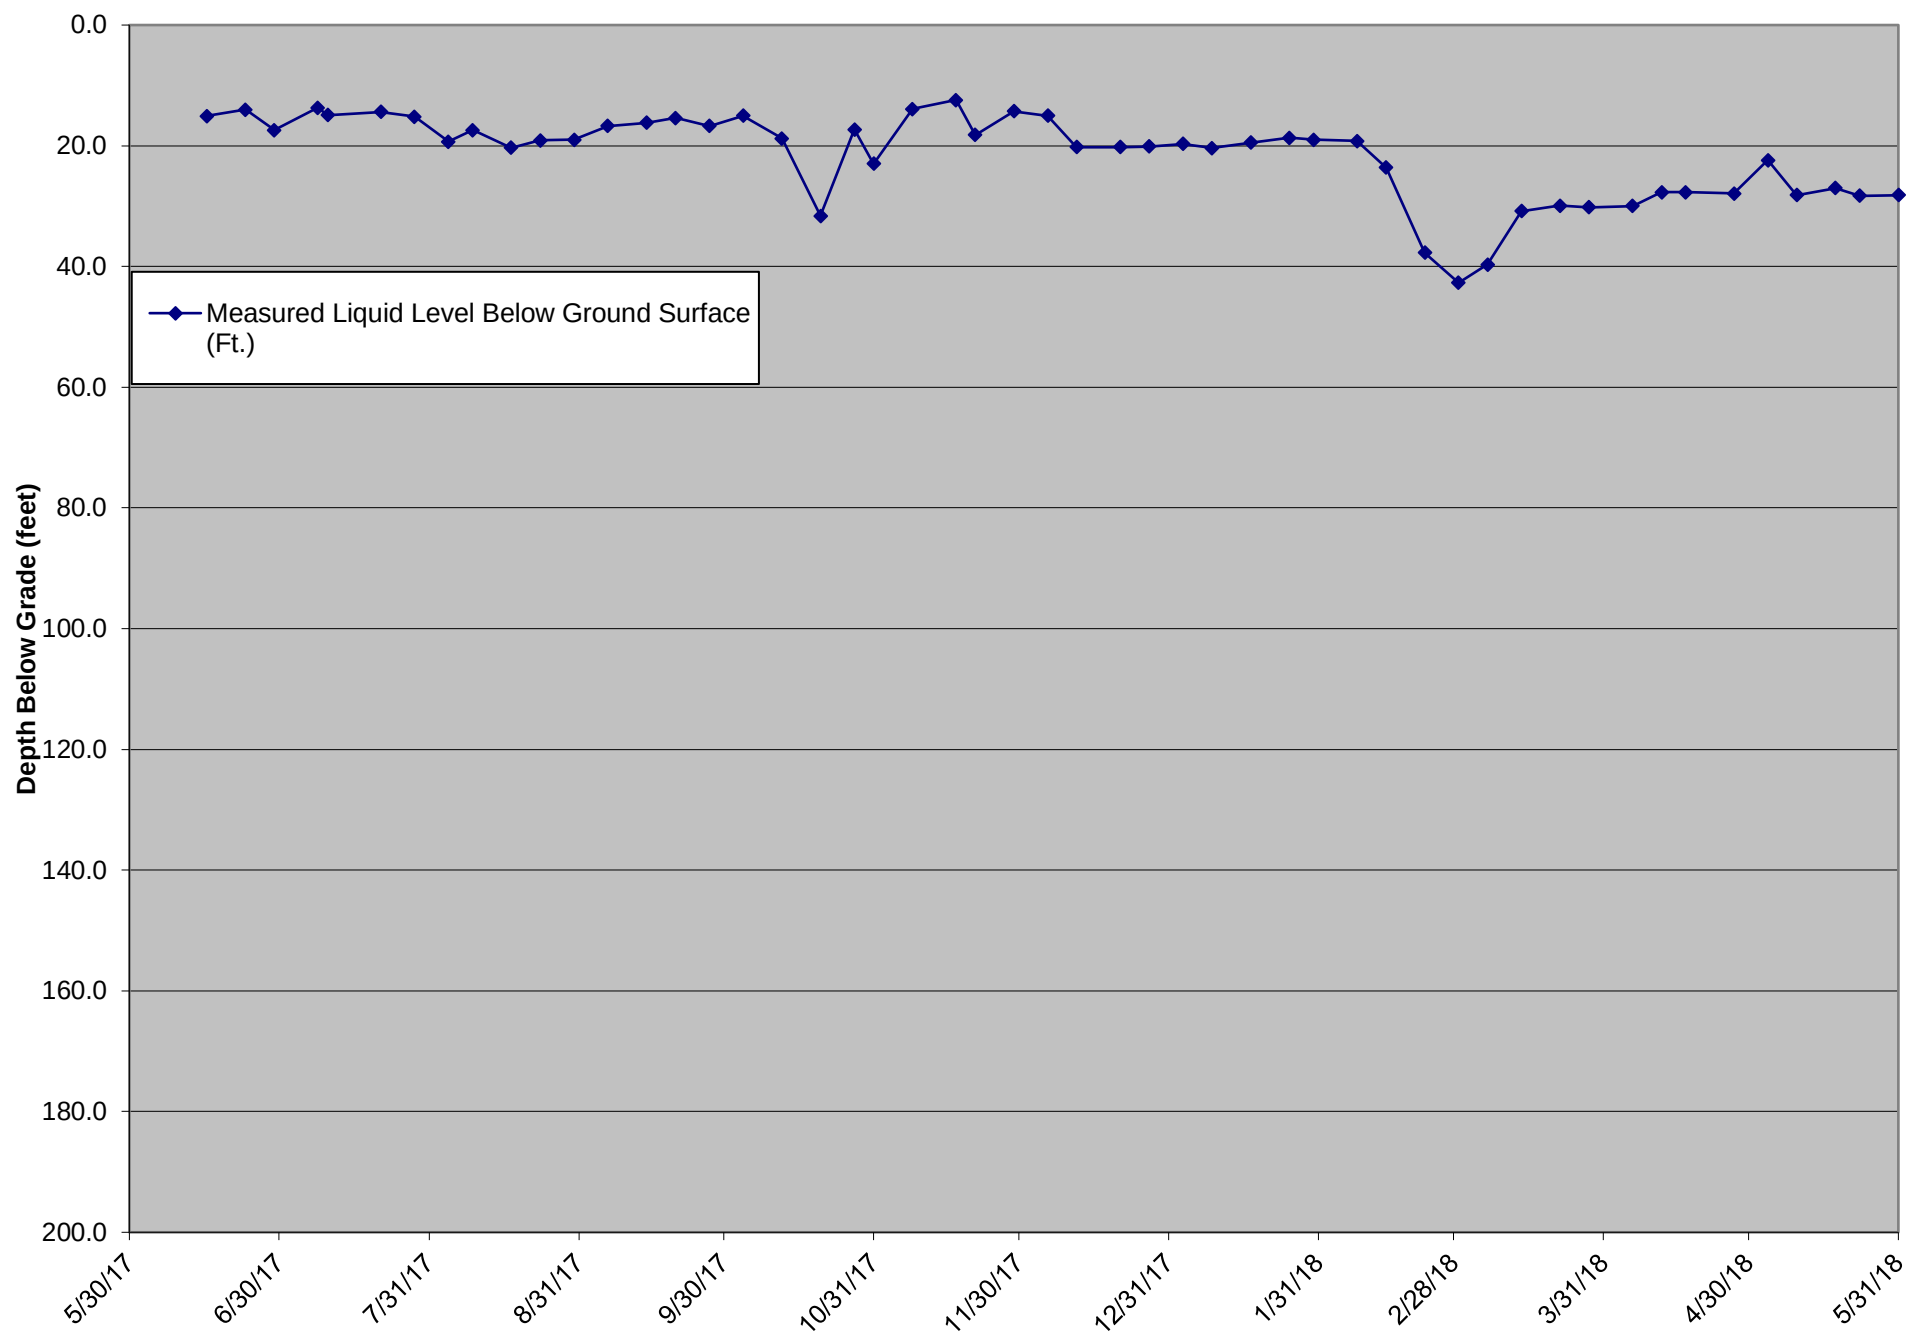
LCS-3D Liquid Level Below Ground Surface

The QED AP-4 pneumatic pump in LCS-3D was non-operational during the weekly reporting period. Liquid level was measured manually.

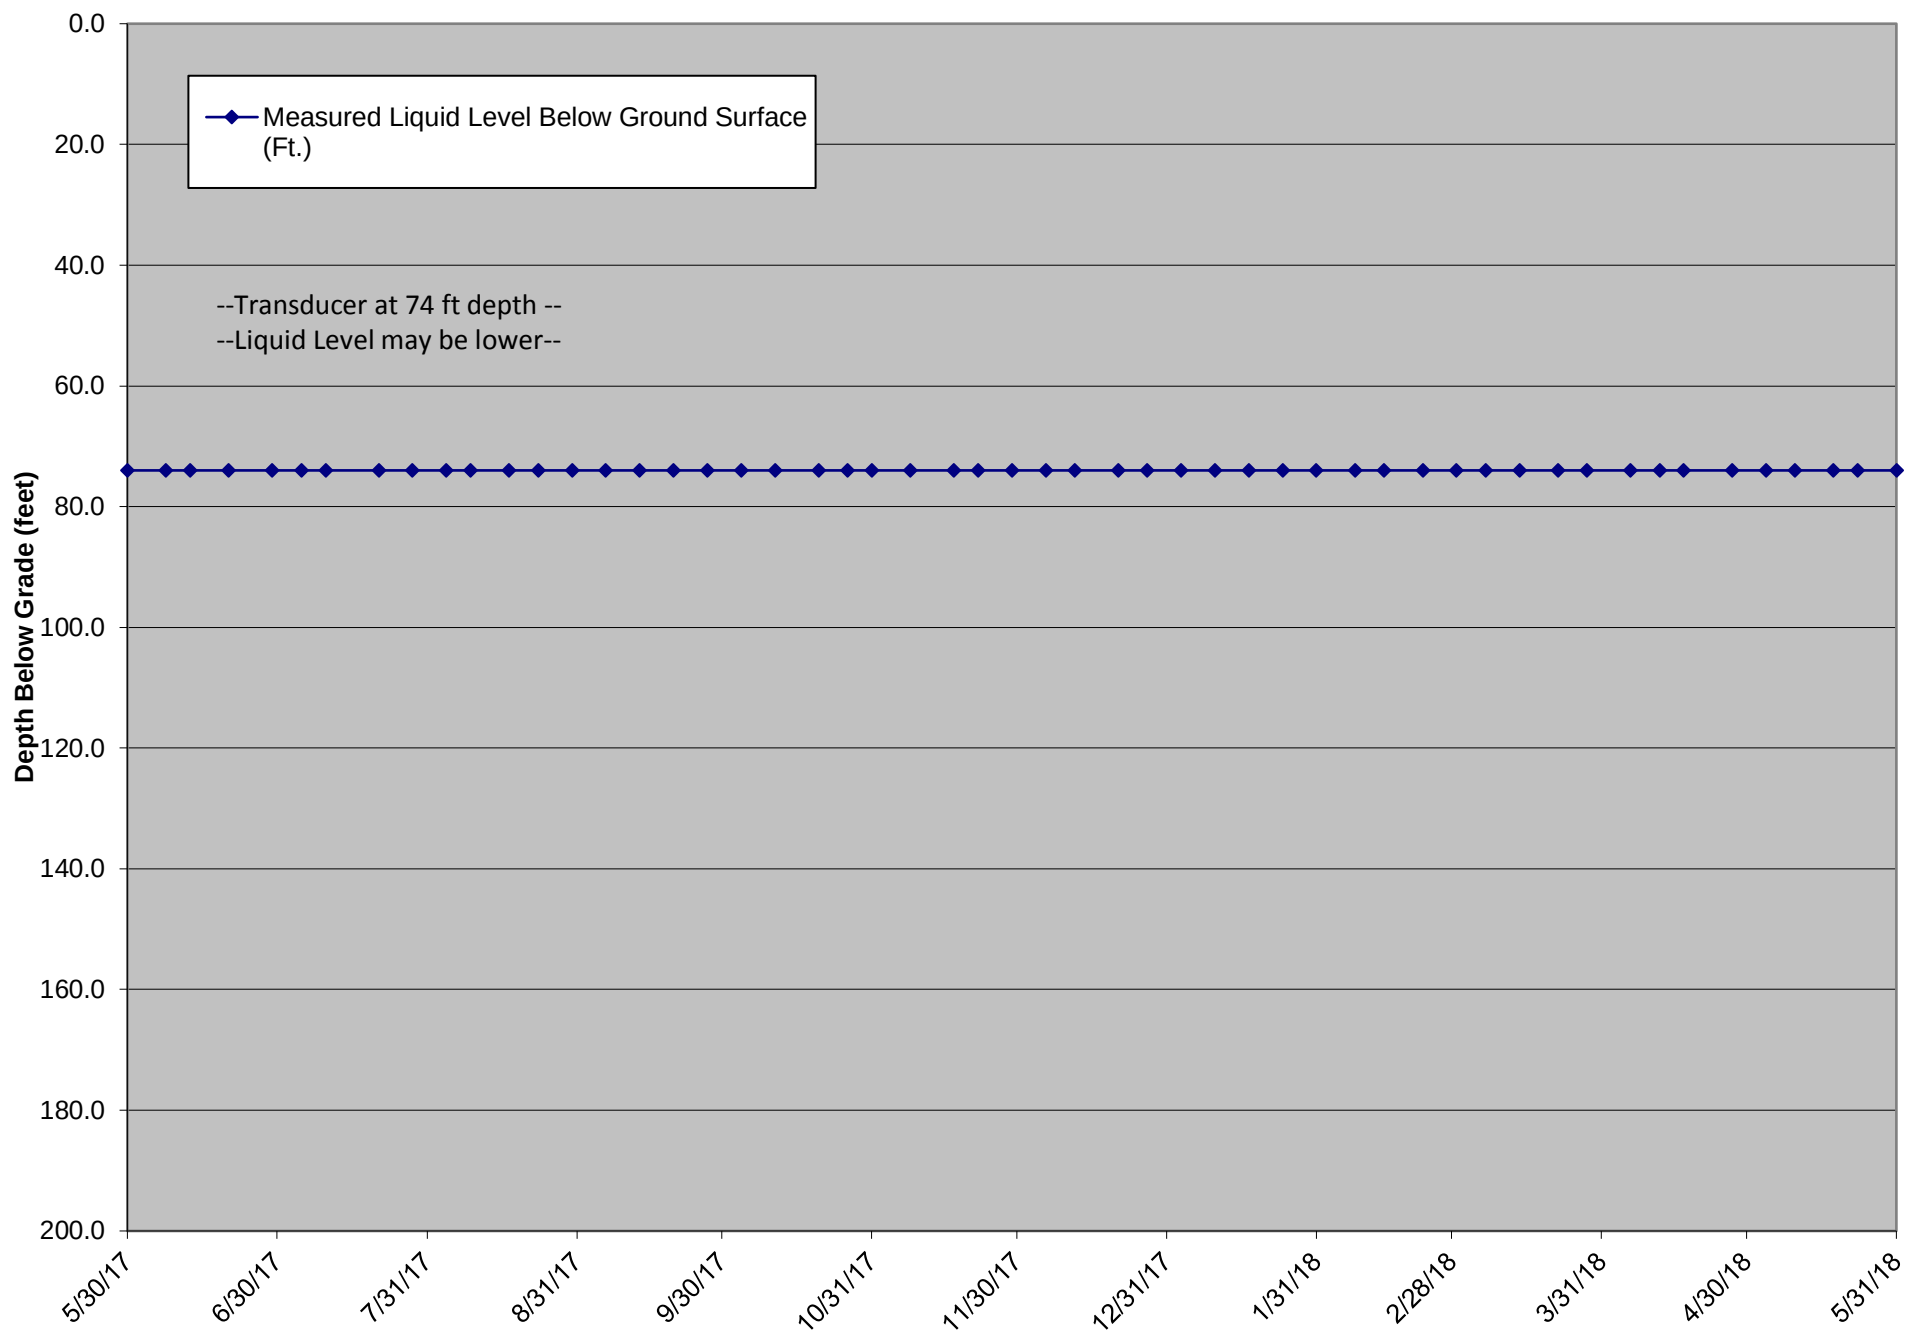
# LCS-4B Liquid Level Below Ground Surface

The level sensor in LCS-4B is currently operational and responsive. Liquid level was not recorded by the level sensor during the weekly reporting period. LCS-4B is equipped with a flow meter that displayed no flow during the weekly reporting period. Therefore, it can be concluded that the liquid level was below the bottom of the pump and level sensor in LCS-4B.

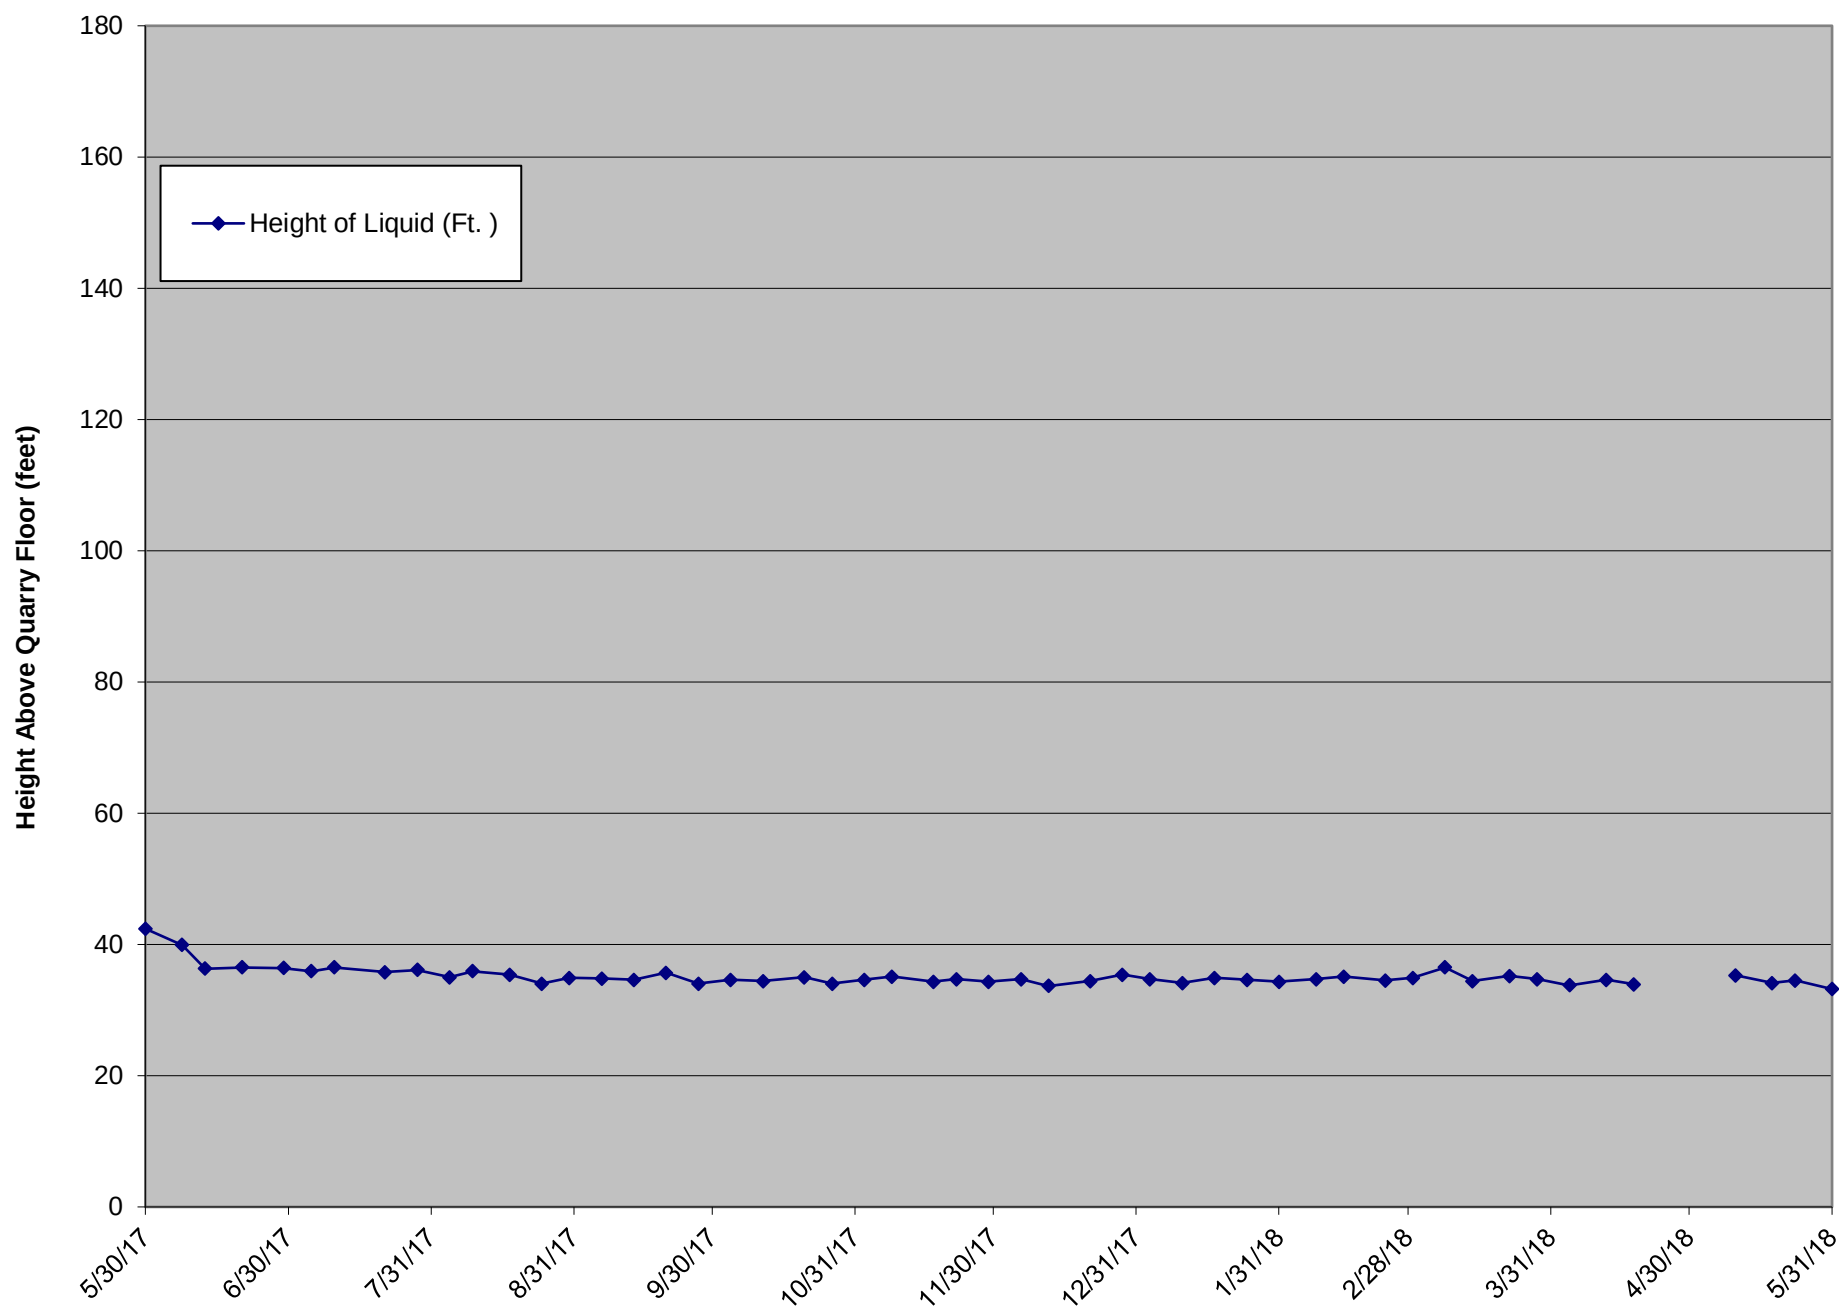
LCS-5B Liquid Level Above Quarry Floor

LCS-5B and LCS-6B were fully operational during the weekly reporting period.

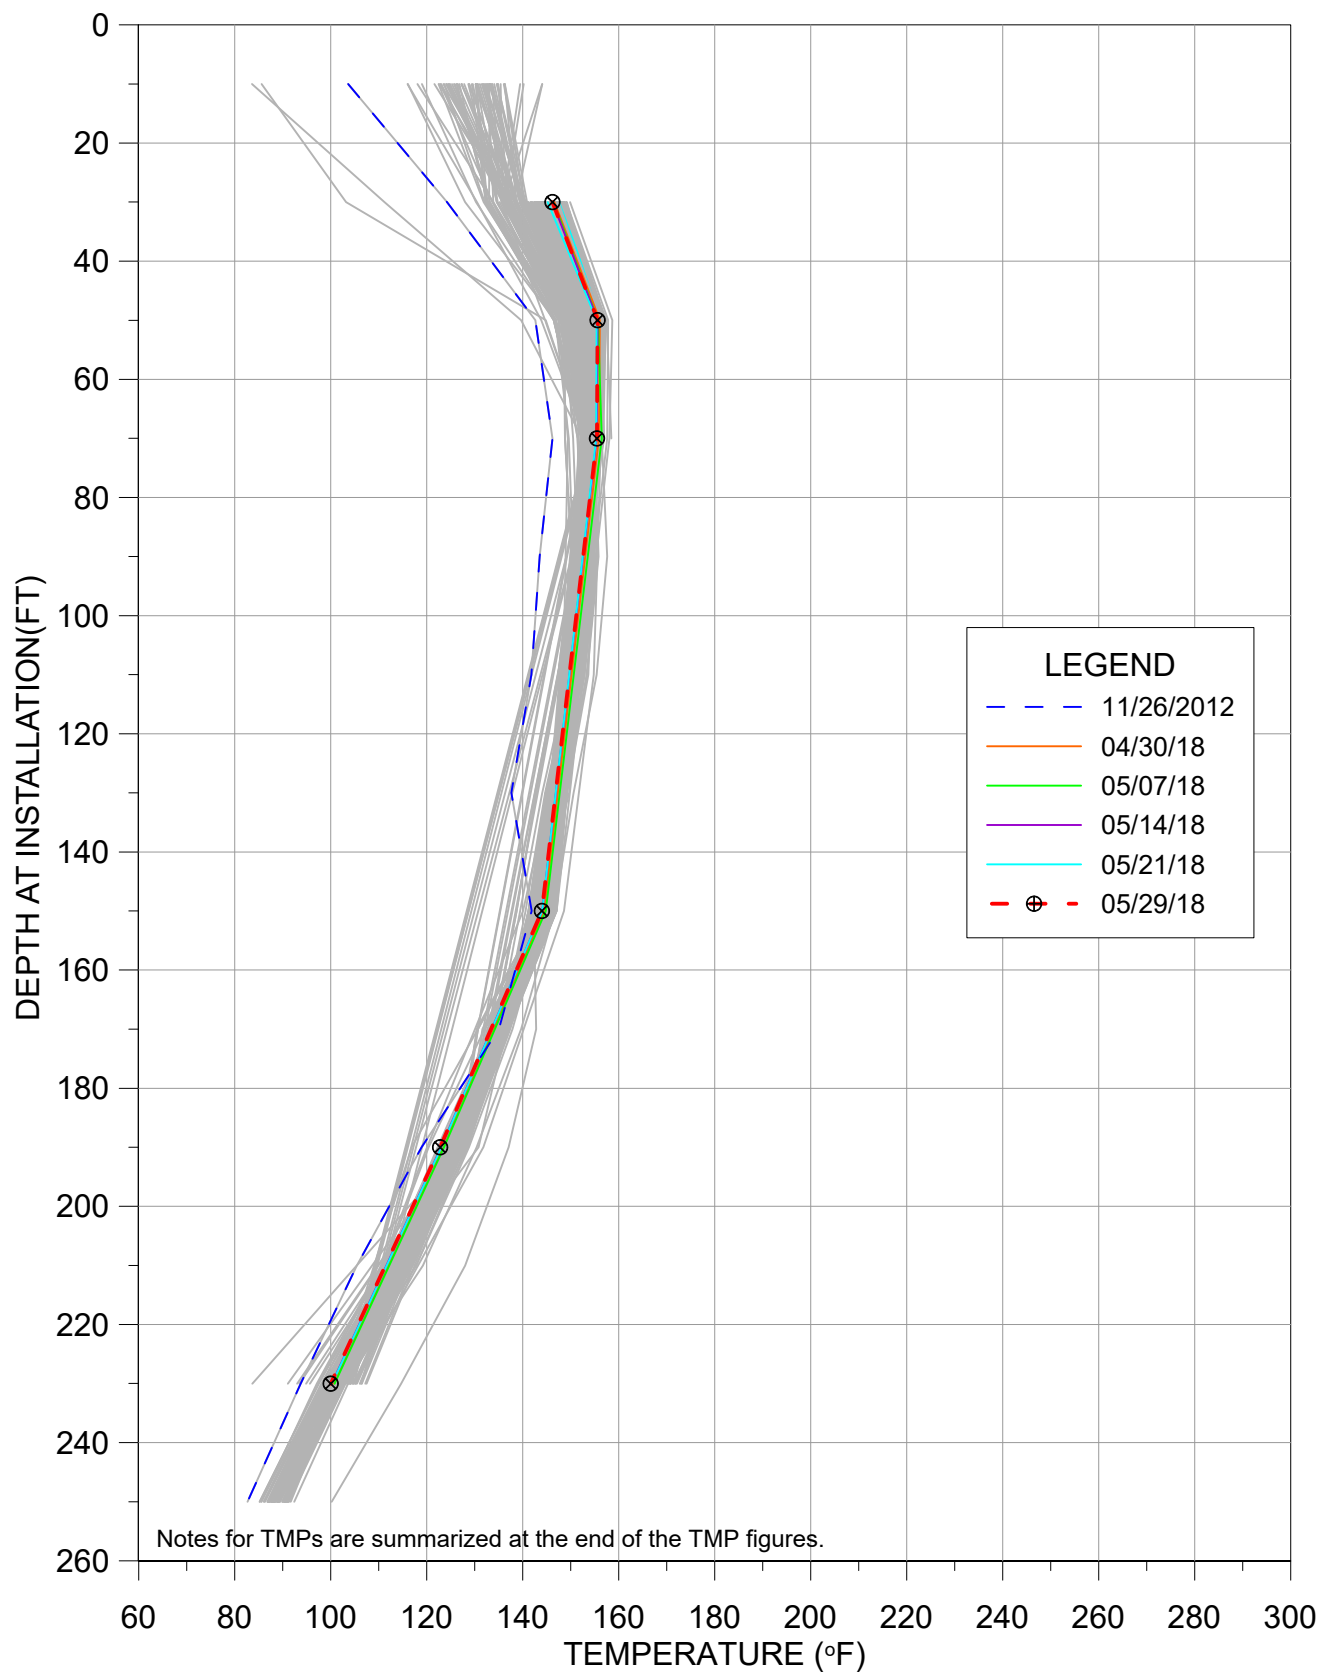
# TMP-3

1. No reliable temperature readings have been obtained at 170 ft depth since 1/29/2014, except on 3/13/2014.
2. The connectivity tests on 4/11/2014 conducted by CEC showed that units at 10, 90, 130, 210 and 250 ft depths are no longer reliable.
3. The connectivity tests on 10/28/2014 conducted by Feezor Engineering showed that units at 10, 90, 110, 130, 210 and 250 ft depths are not reliable.

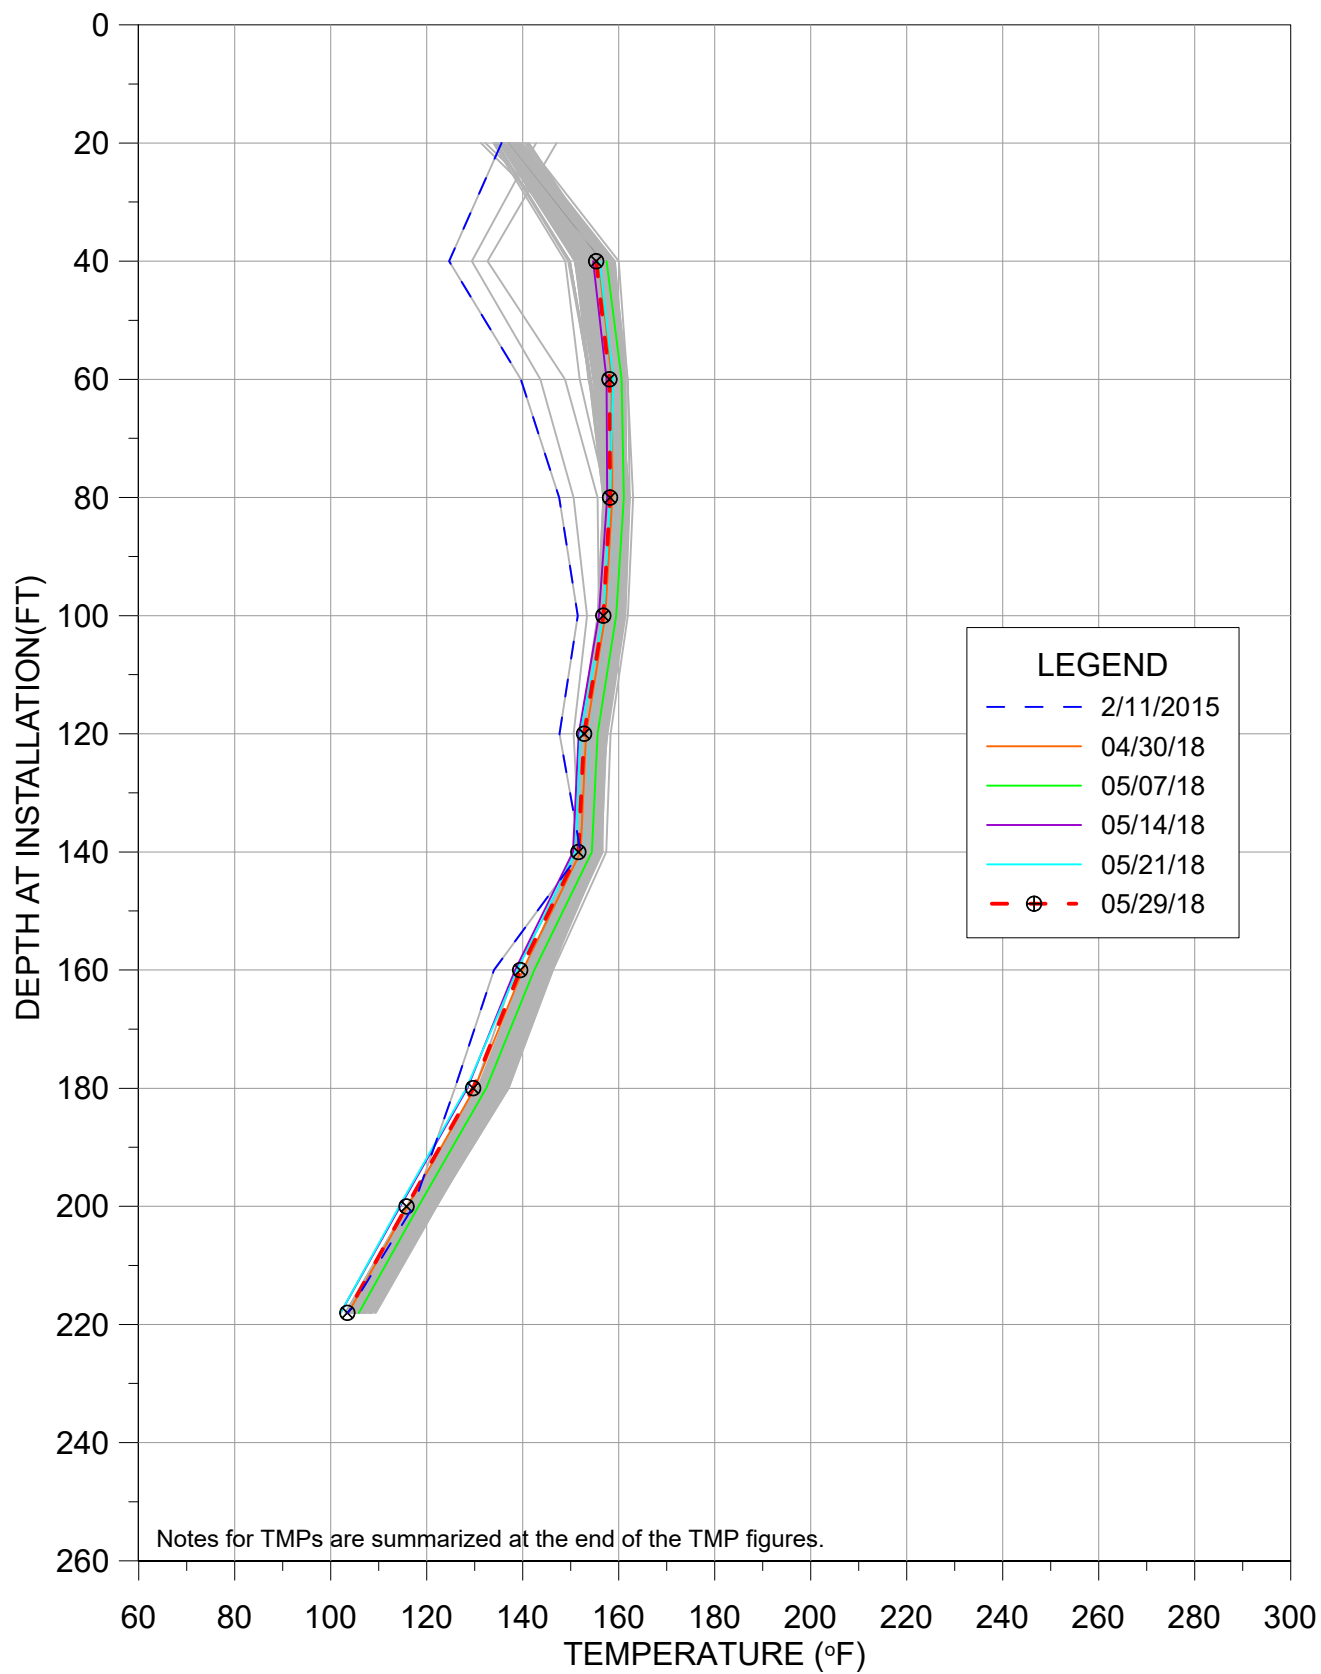
# TMP-3R

1. The unit at 20 ft depth had a fluctuating resistance since 9/25/2017. Therefore the temperature is determined to be unreliable.

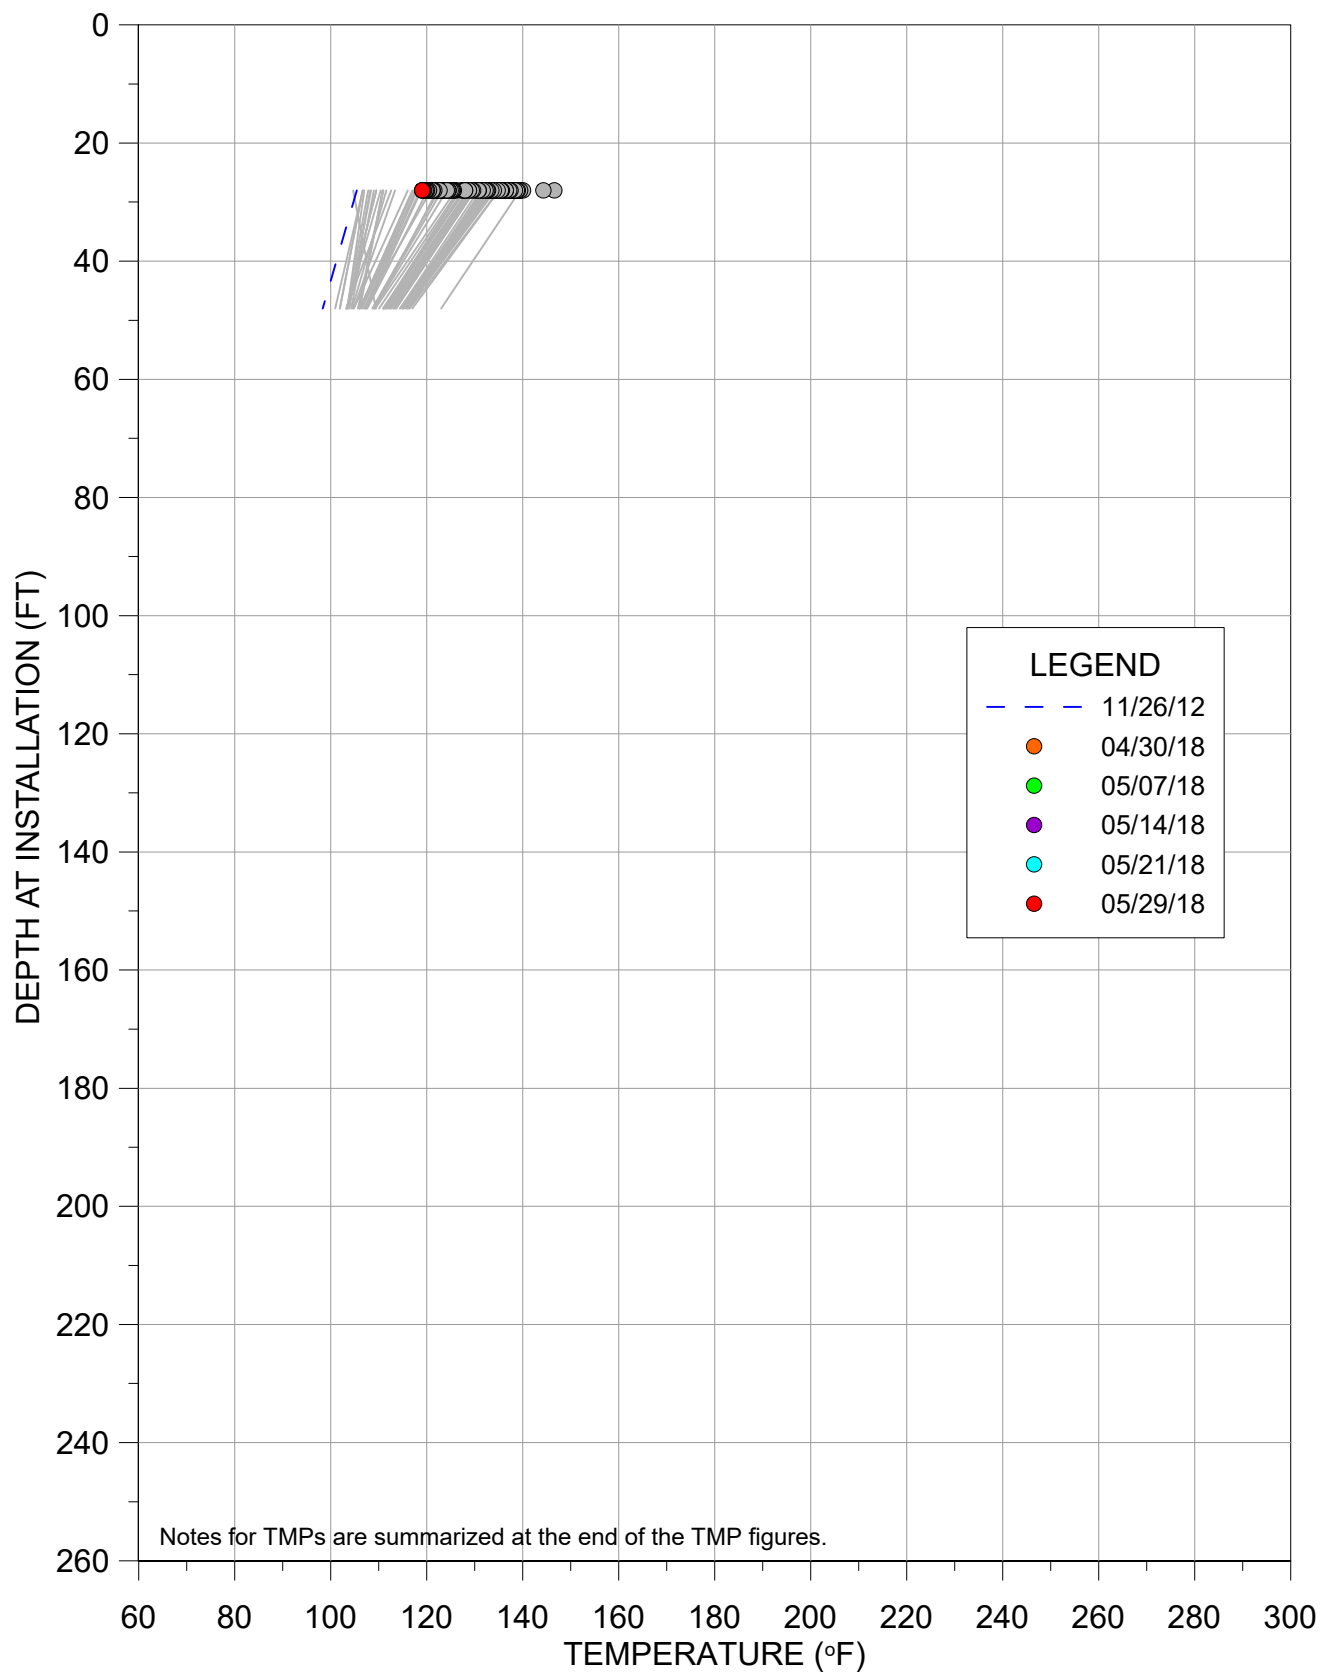
# TMP-4

1. The connectivity tests on 4/11/2014 conducted by CEC showed that the unit at 48 ft depth is no longer reliable.

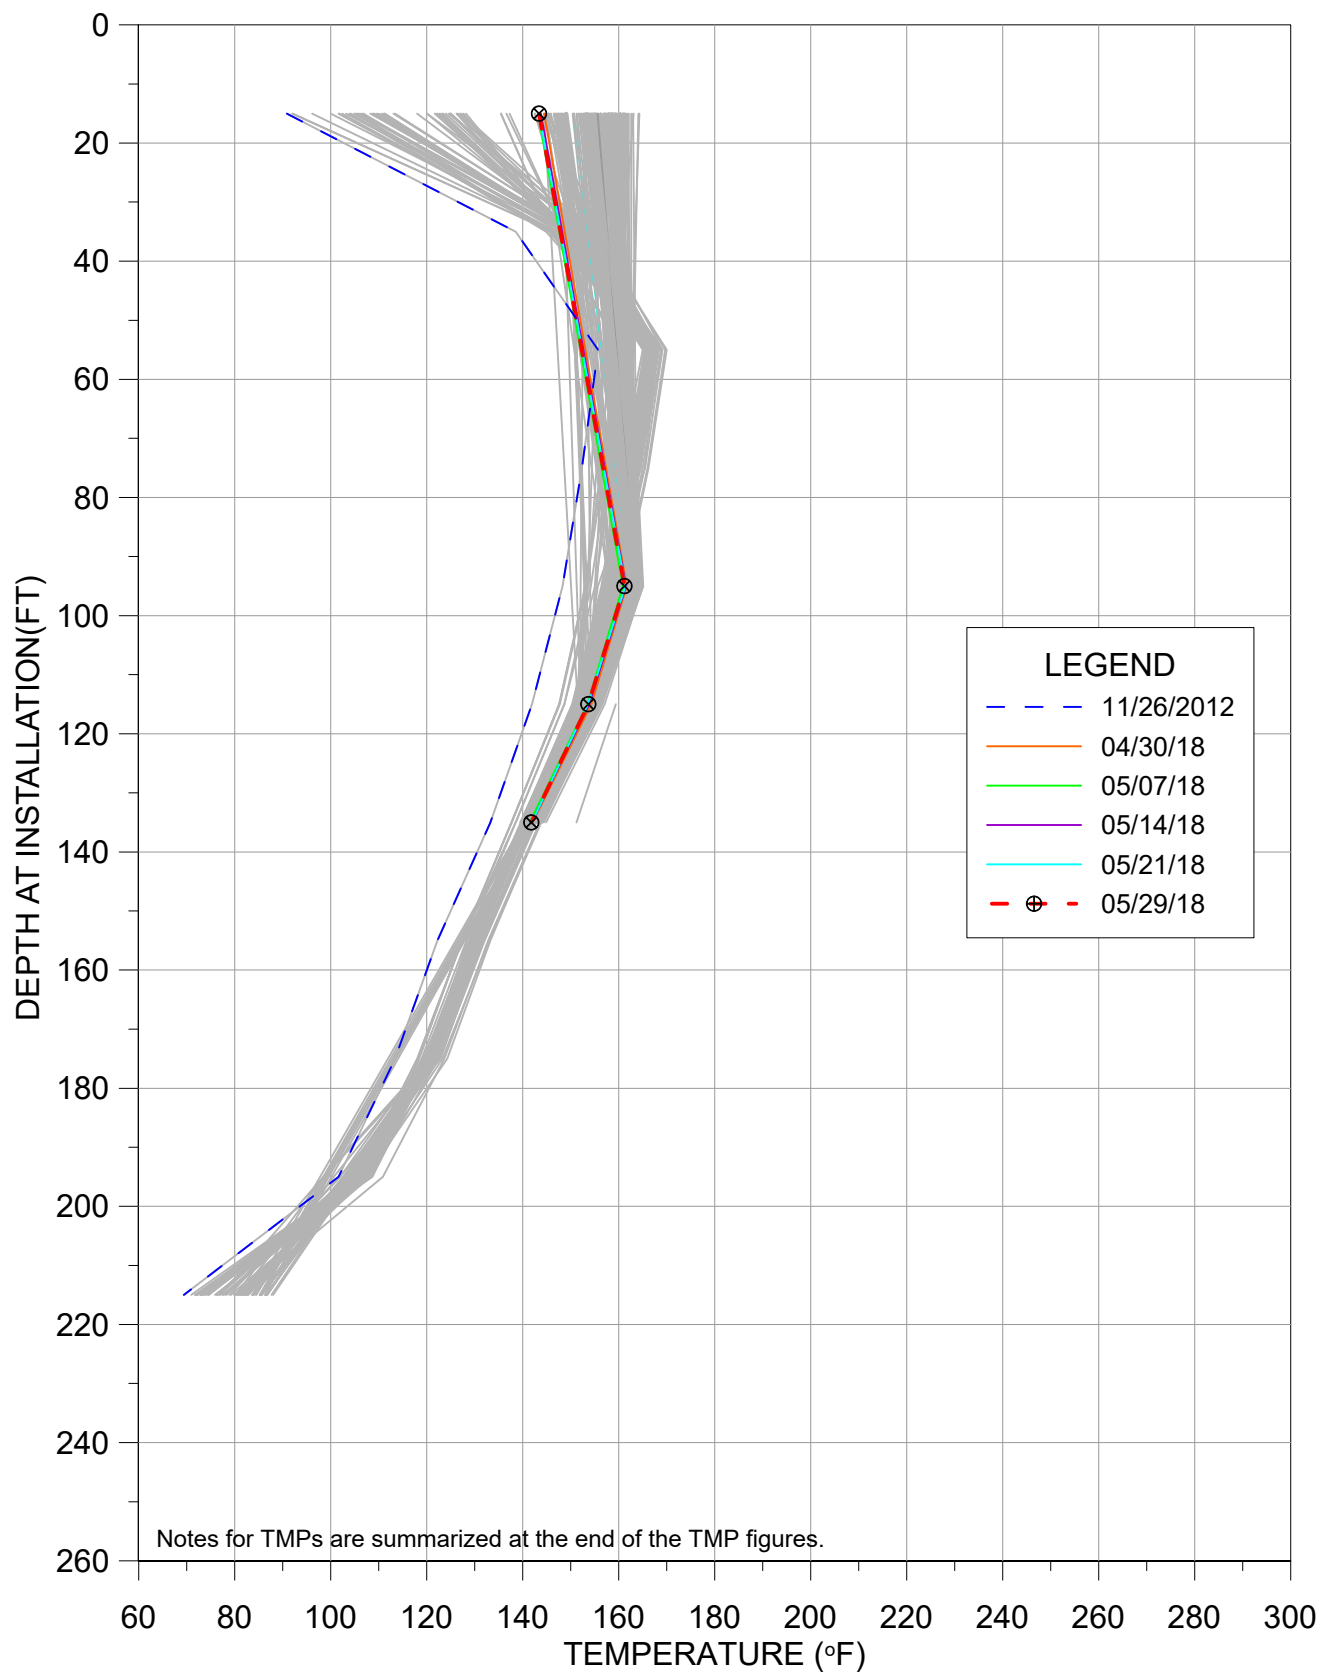
# TMP-6

1. The connectivity tests on 4/11/2014 conducted by CEC showed that units at 35, 55, 75, 155, 175, and 195 ft depths are no longer reliable.
2. No reliable temperature readings have been obtained at the unit at 215 ft depth since 6/13/2014.

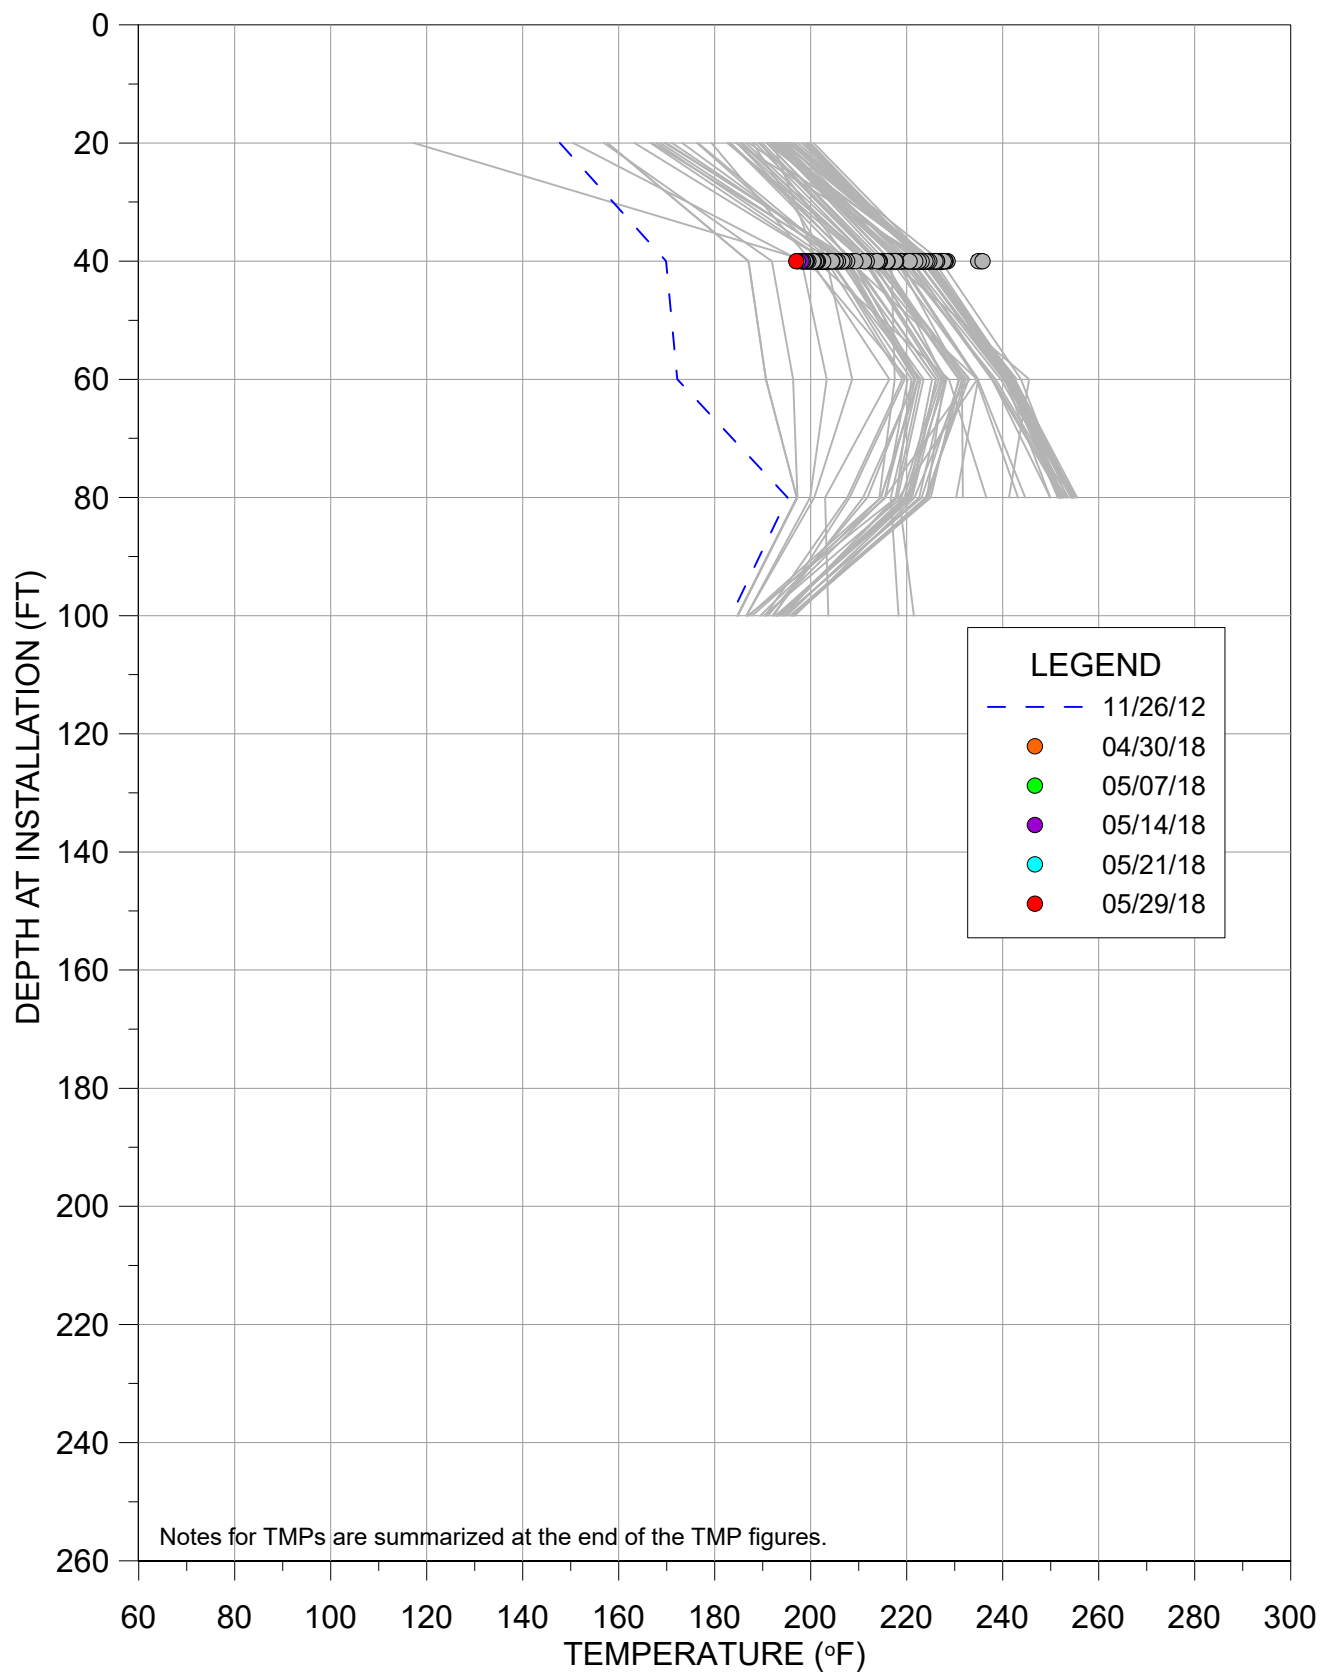
# TMP-9

1. Unit at 100 ft depth had an inaccurate temperature reading on 8/1/2013 and no reading since 8/6/2013.
2. The connectivity tests on 4/11/2014 conducted by CEC showed that units at 20, 60, 80, and 100 ft depths are no longer reliable.

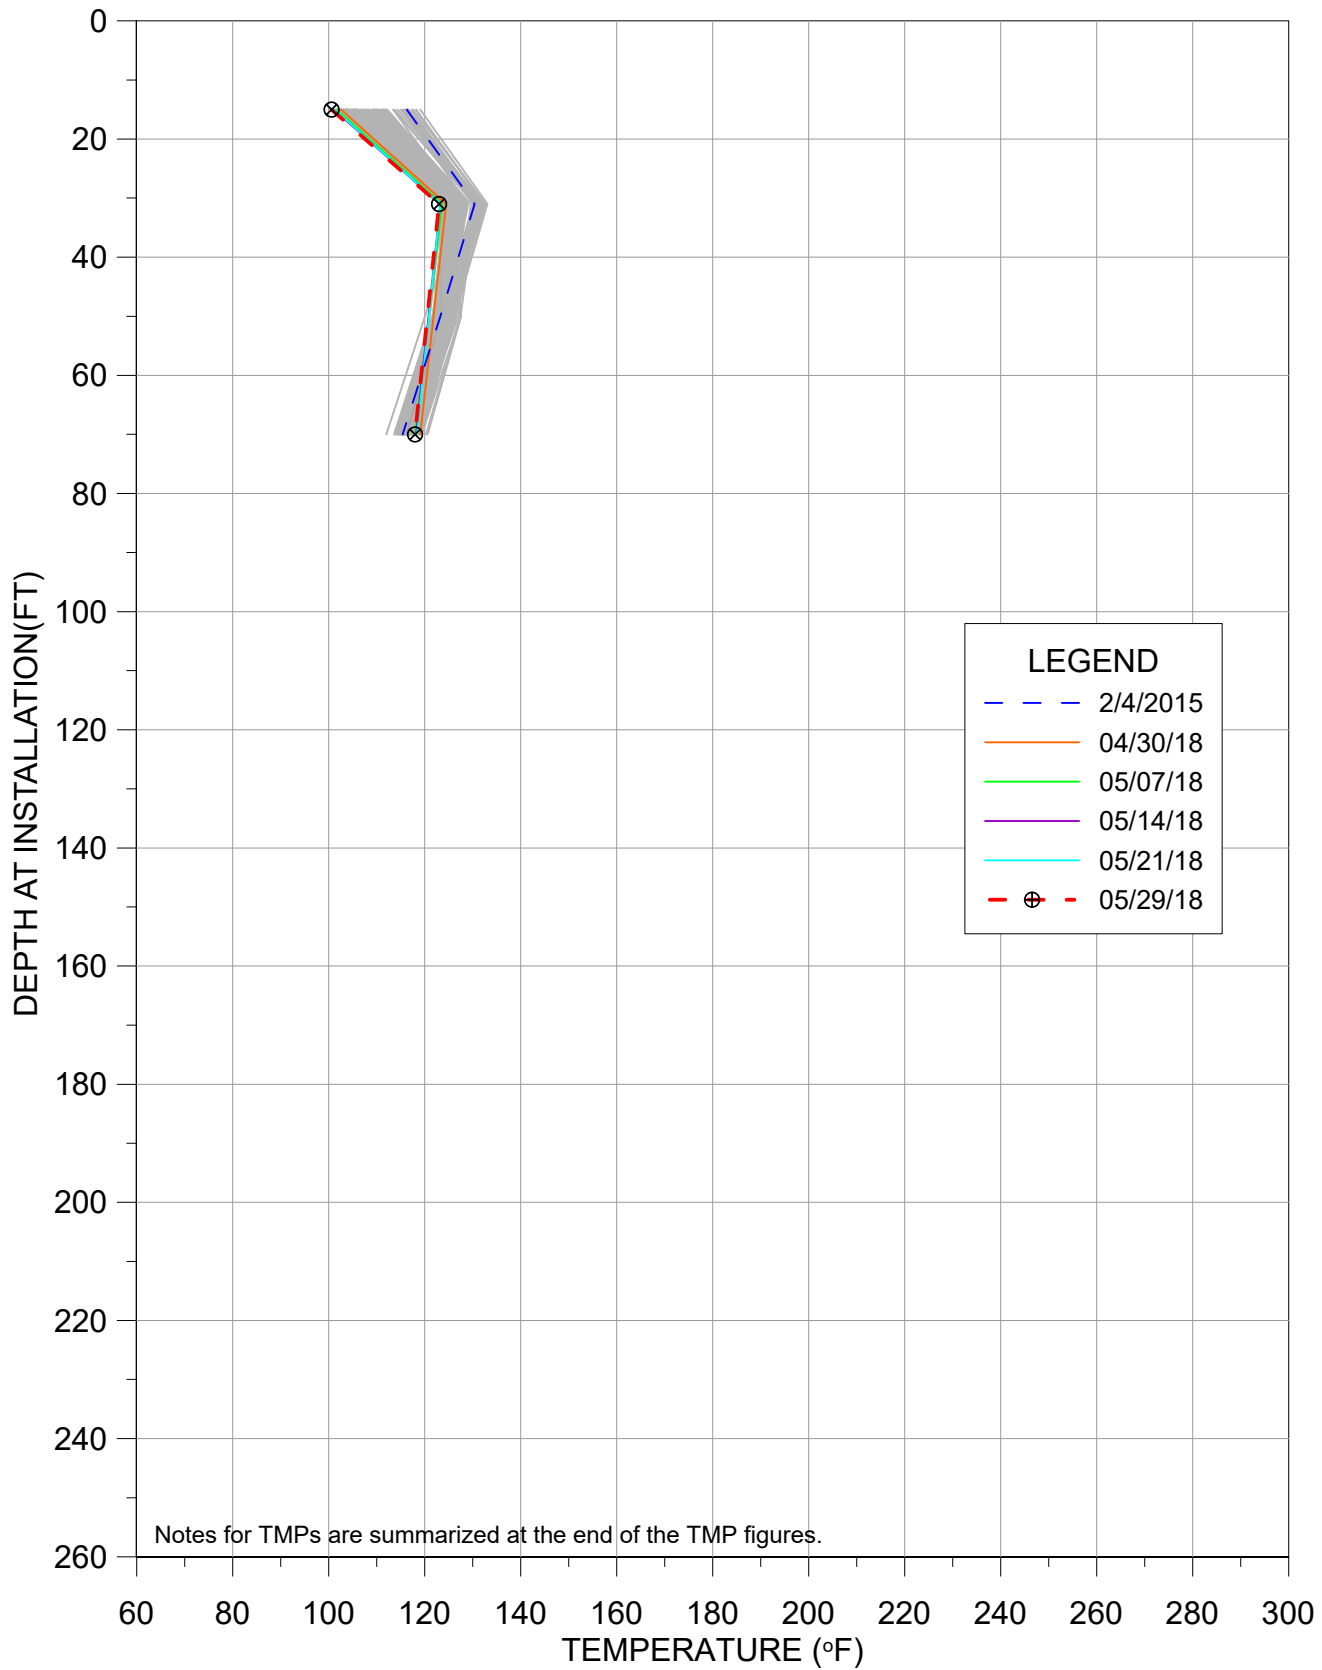
# TMP-22

1. No temperature reading could be obtained and resistivity was fluctuating at the unit at 50 ft depth since 4/2/2018.
