# **Bridgeton Landfill, LLC**

## **Weekly Data Submittal**

**Week of May 27, 2018 – June 02, 2018**

**Required by Section 52.F of Agreed Order, Case No. 13SL-CC01088  
Effective May 13, 2013**

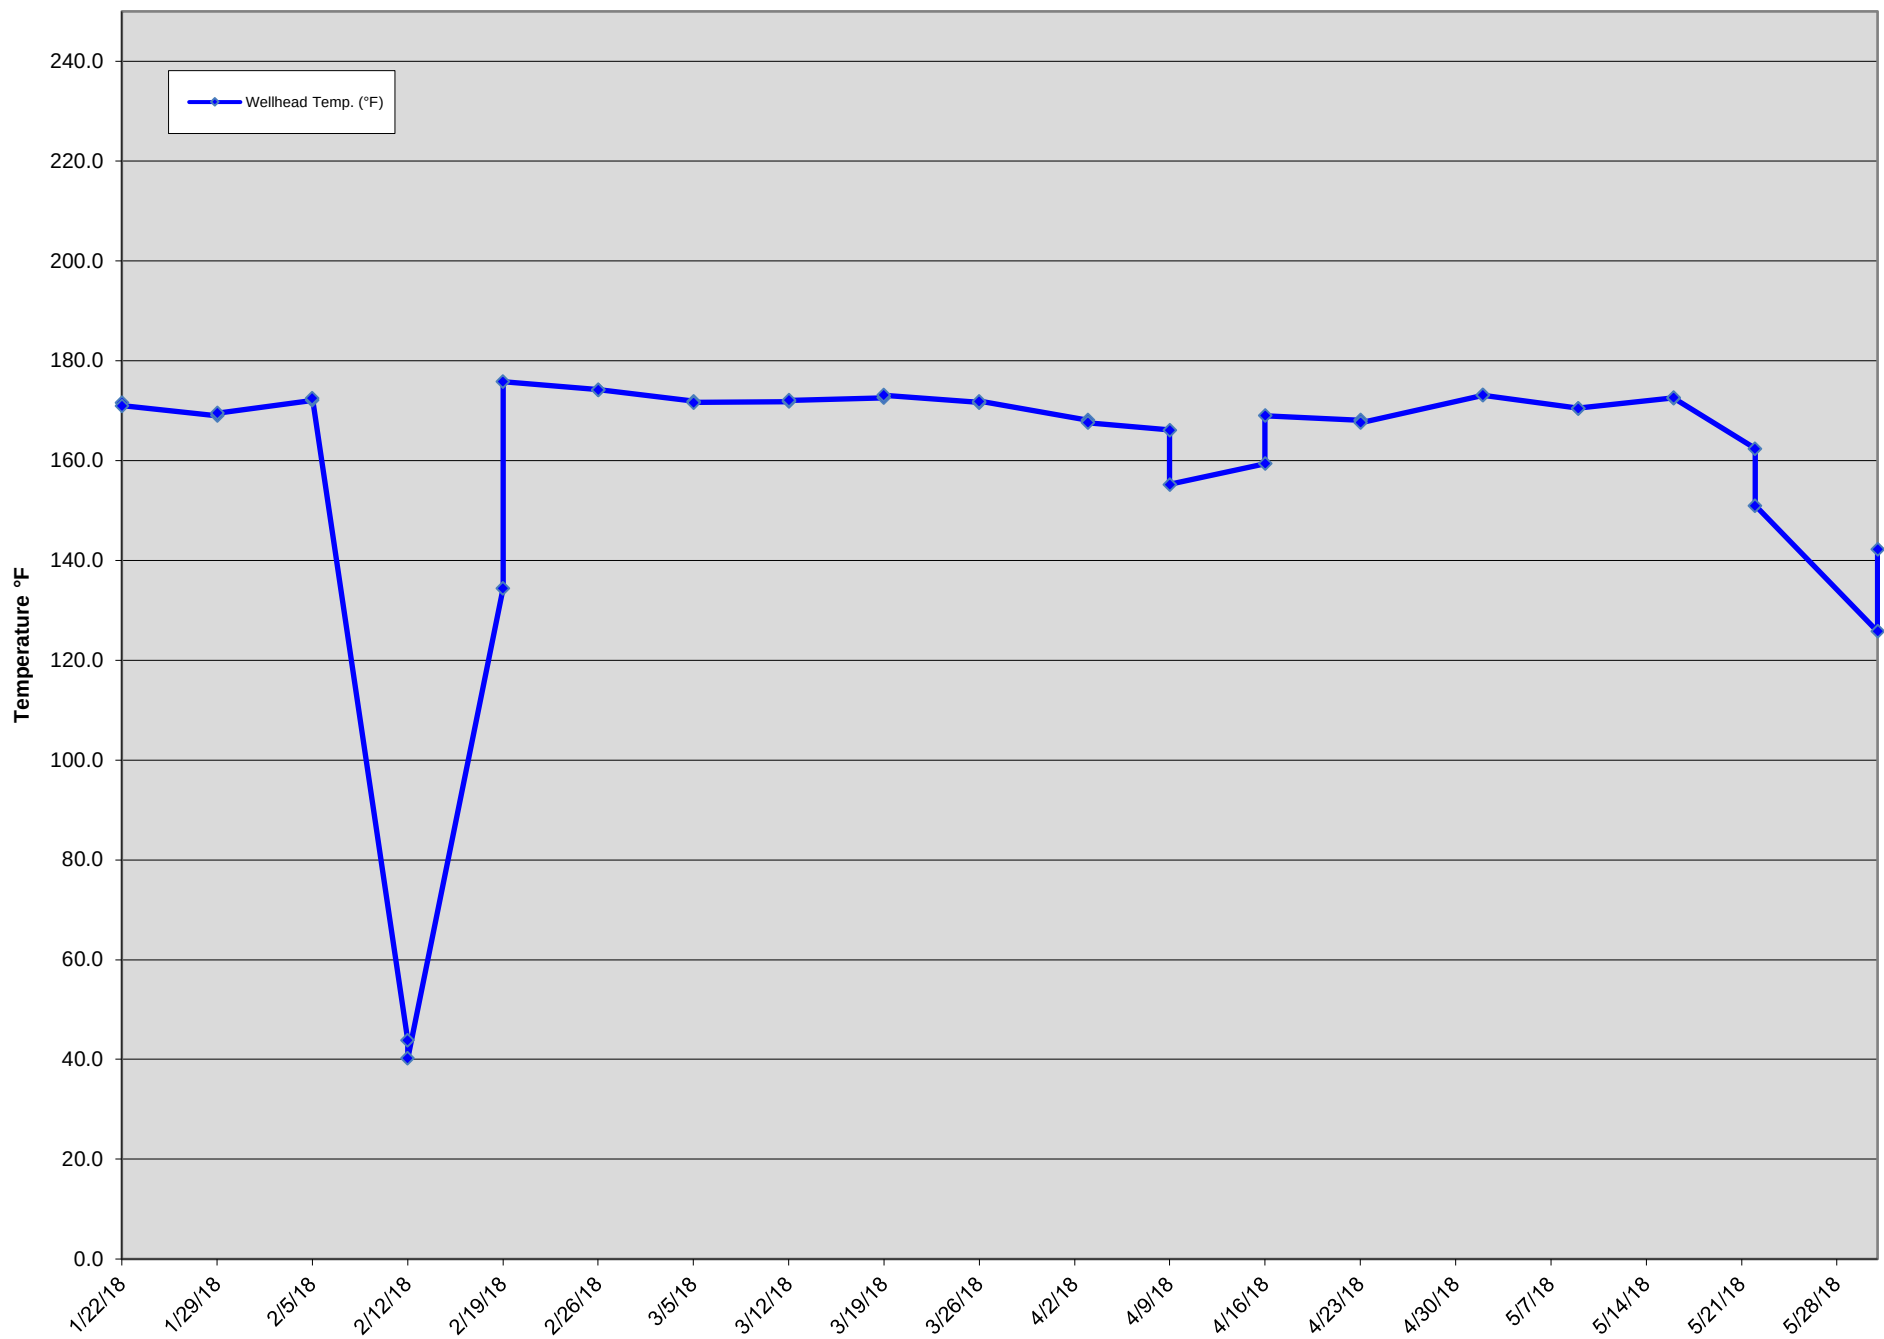
GIW-1 Wellhead Temperatures

As part of the HES, there are currently cooling water circulation loops installed in twelve Gas Interceptor Wells (GIWs) (GIW-02 through GIW-13). The remaining well (GIW-01) had a measured gas temperature within its historical operating limits.
