# **Bridgeton Landfill, LLC**

## **Weekly Data Submittal**

**Week of June 03, 2018 – June 09, 2018**

**Required by Section 52.F of Agreed Order, Case No. 13SL-CC01088  
Effective May 13, 2013**

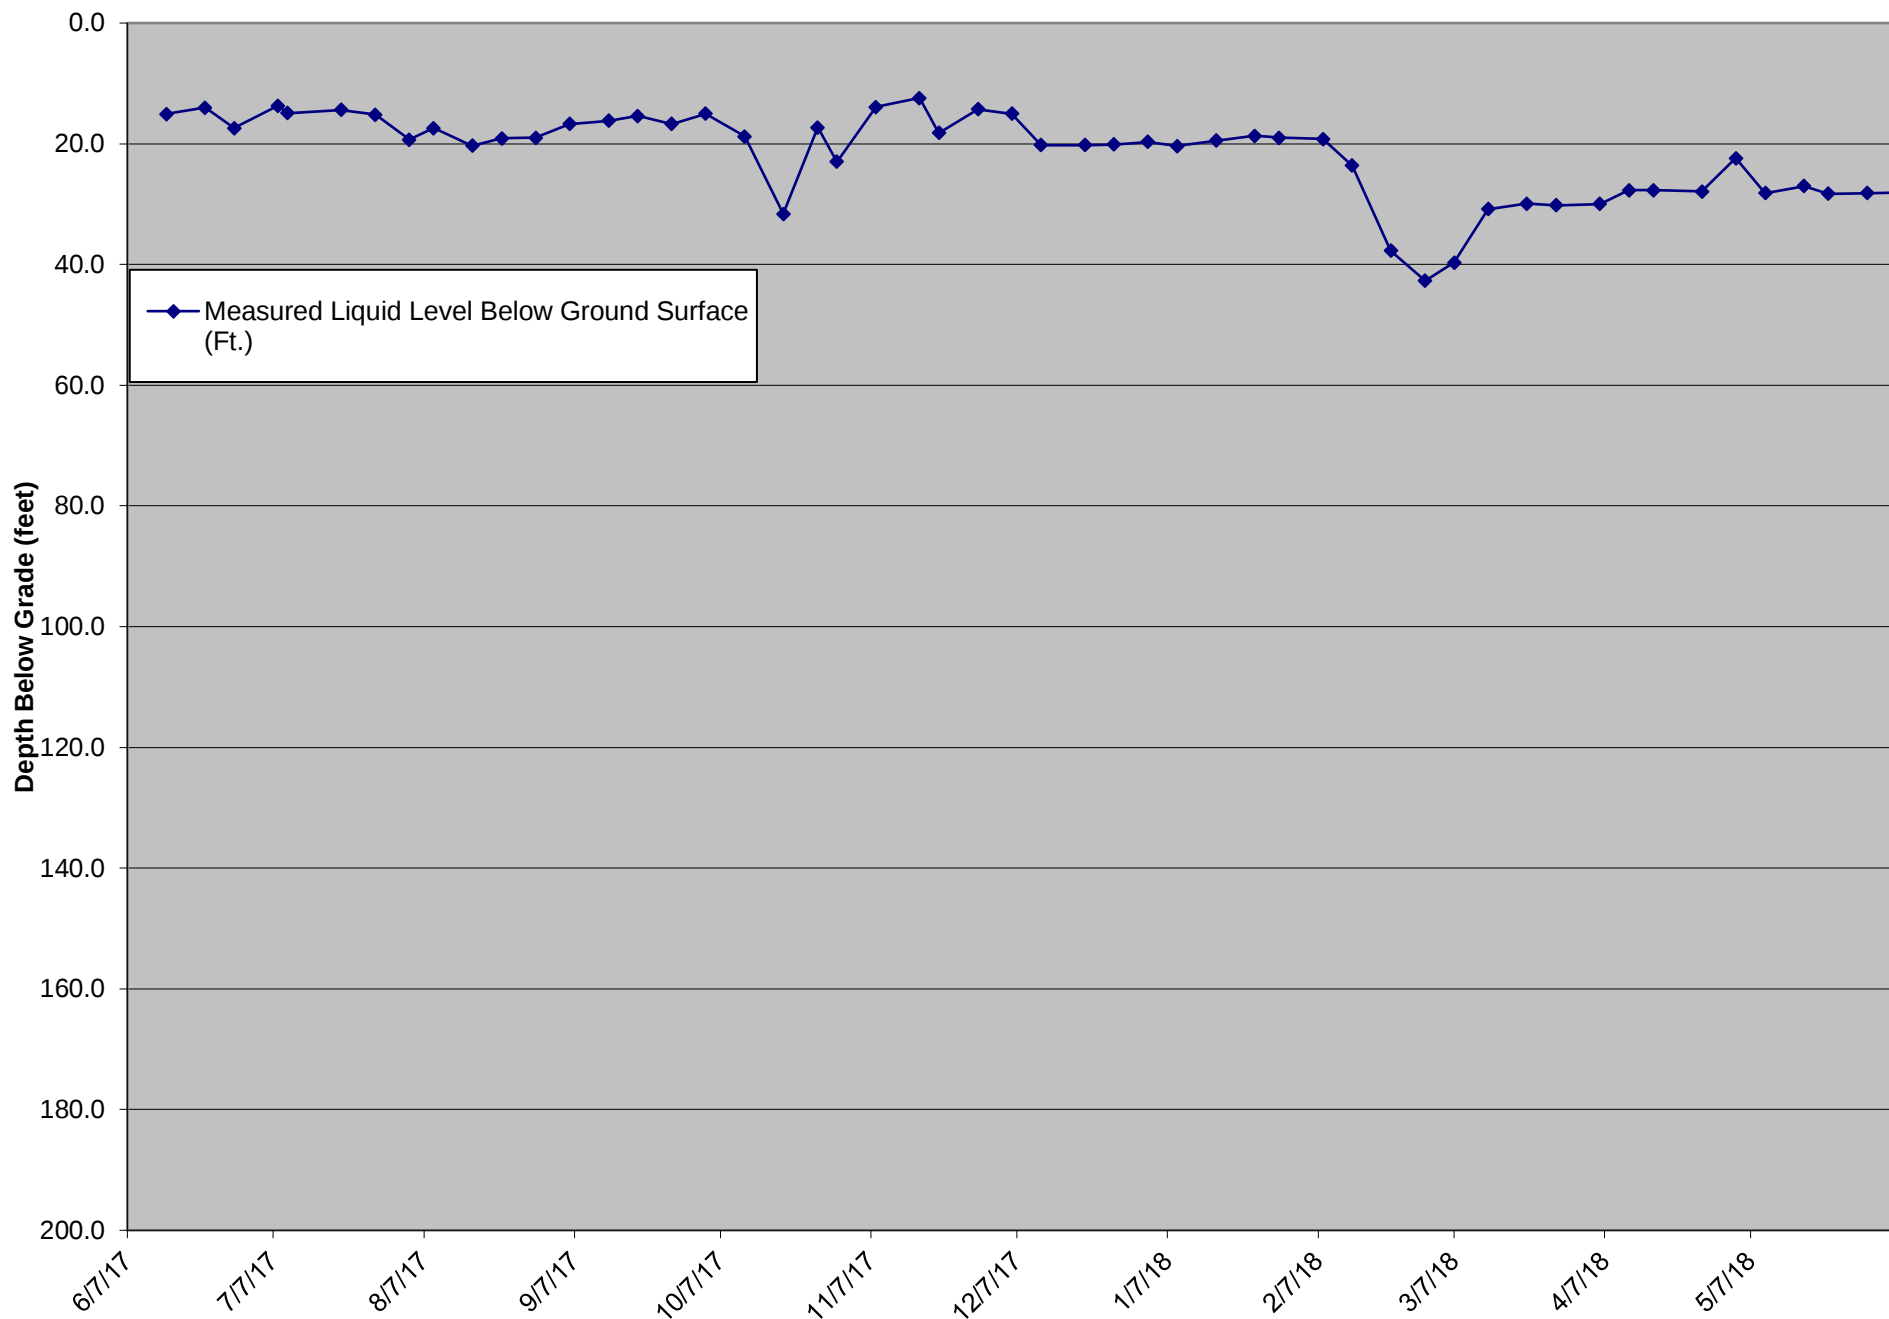
LCS-3D Liquid Level Below Ground Surface

The QED AP-4 pneumatic pump in LCS-3D was non-operational during the weekly reporting period. Liquid level was measured manually.

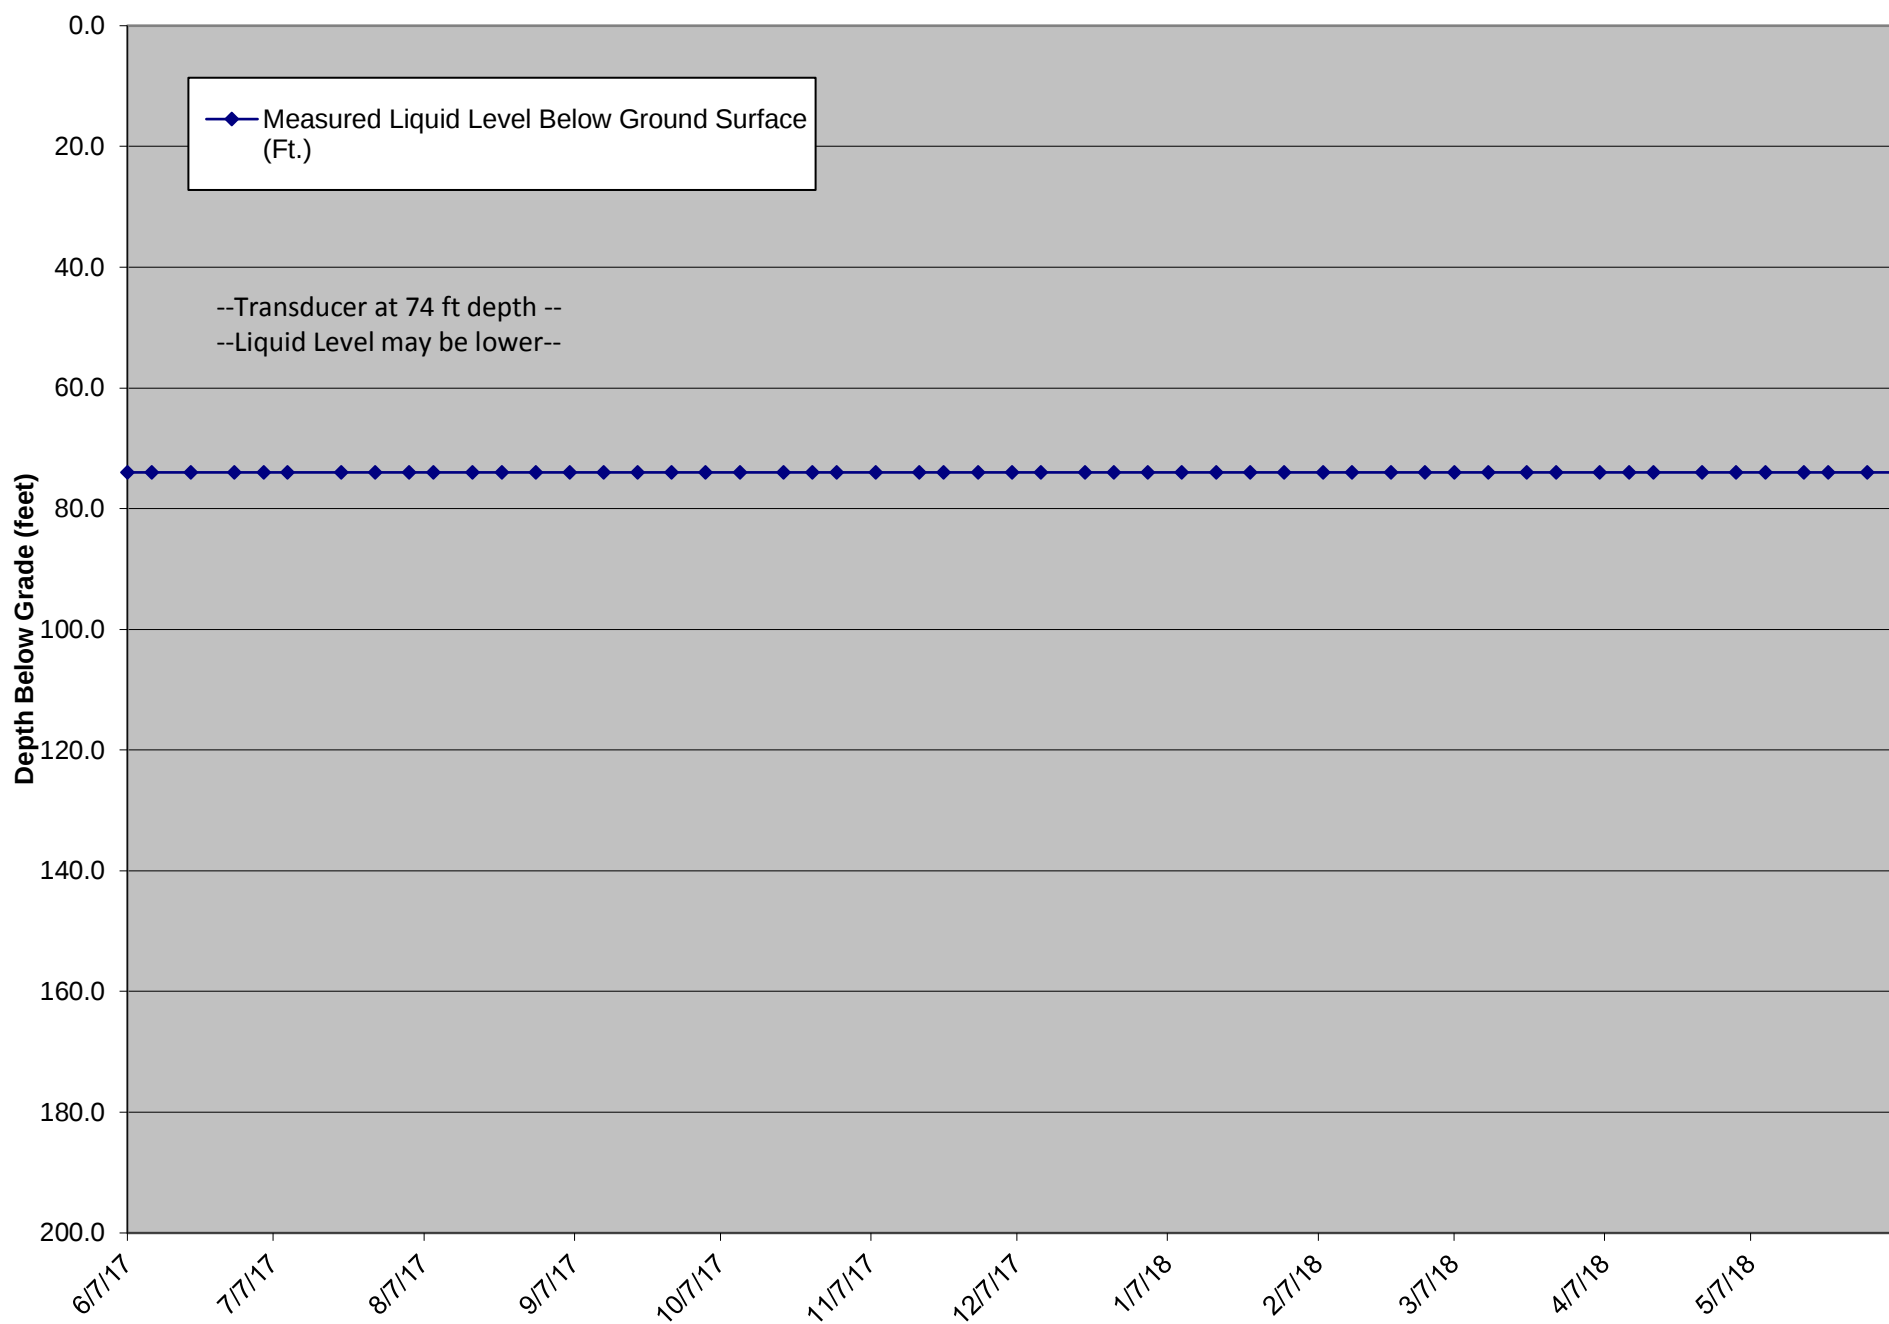
# LCS-4B Liquid Level Below Ground Surface

The level sensor in LCS-4B is currently operational and responsive. Liquid level was not recorded by the level sensor during the weekly reporting period. LCS-4B is equipped with a flow meter that displayed no flow during the weekly reporting period. Therefore, it can be concluded that the liquid level was below the bottom of the pump and level sensor in LCS-4B.

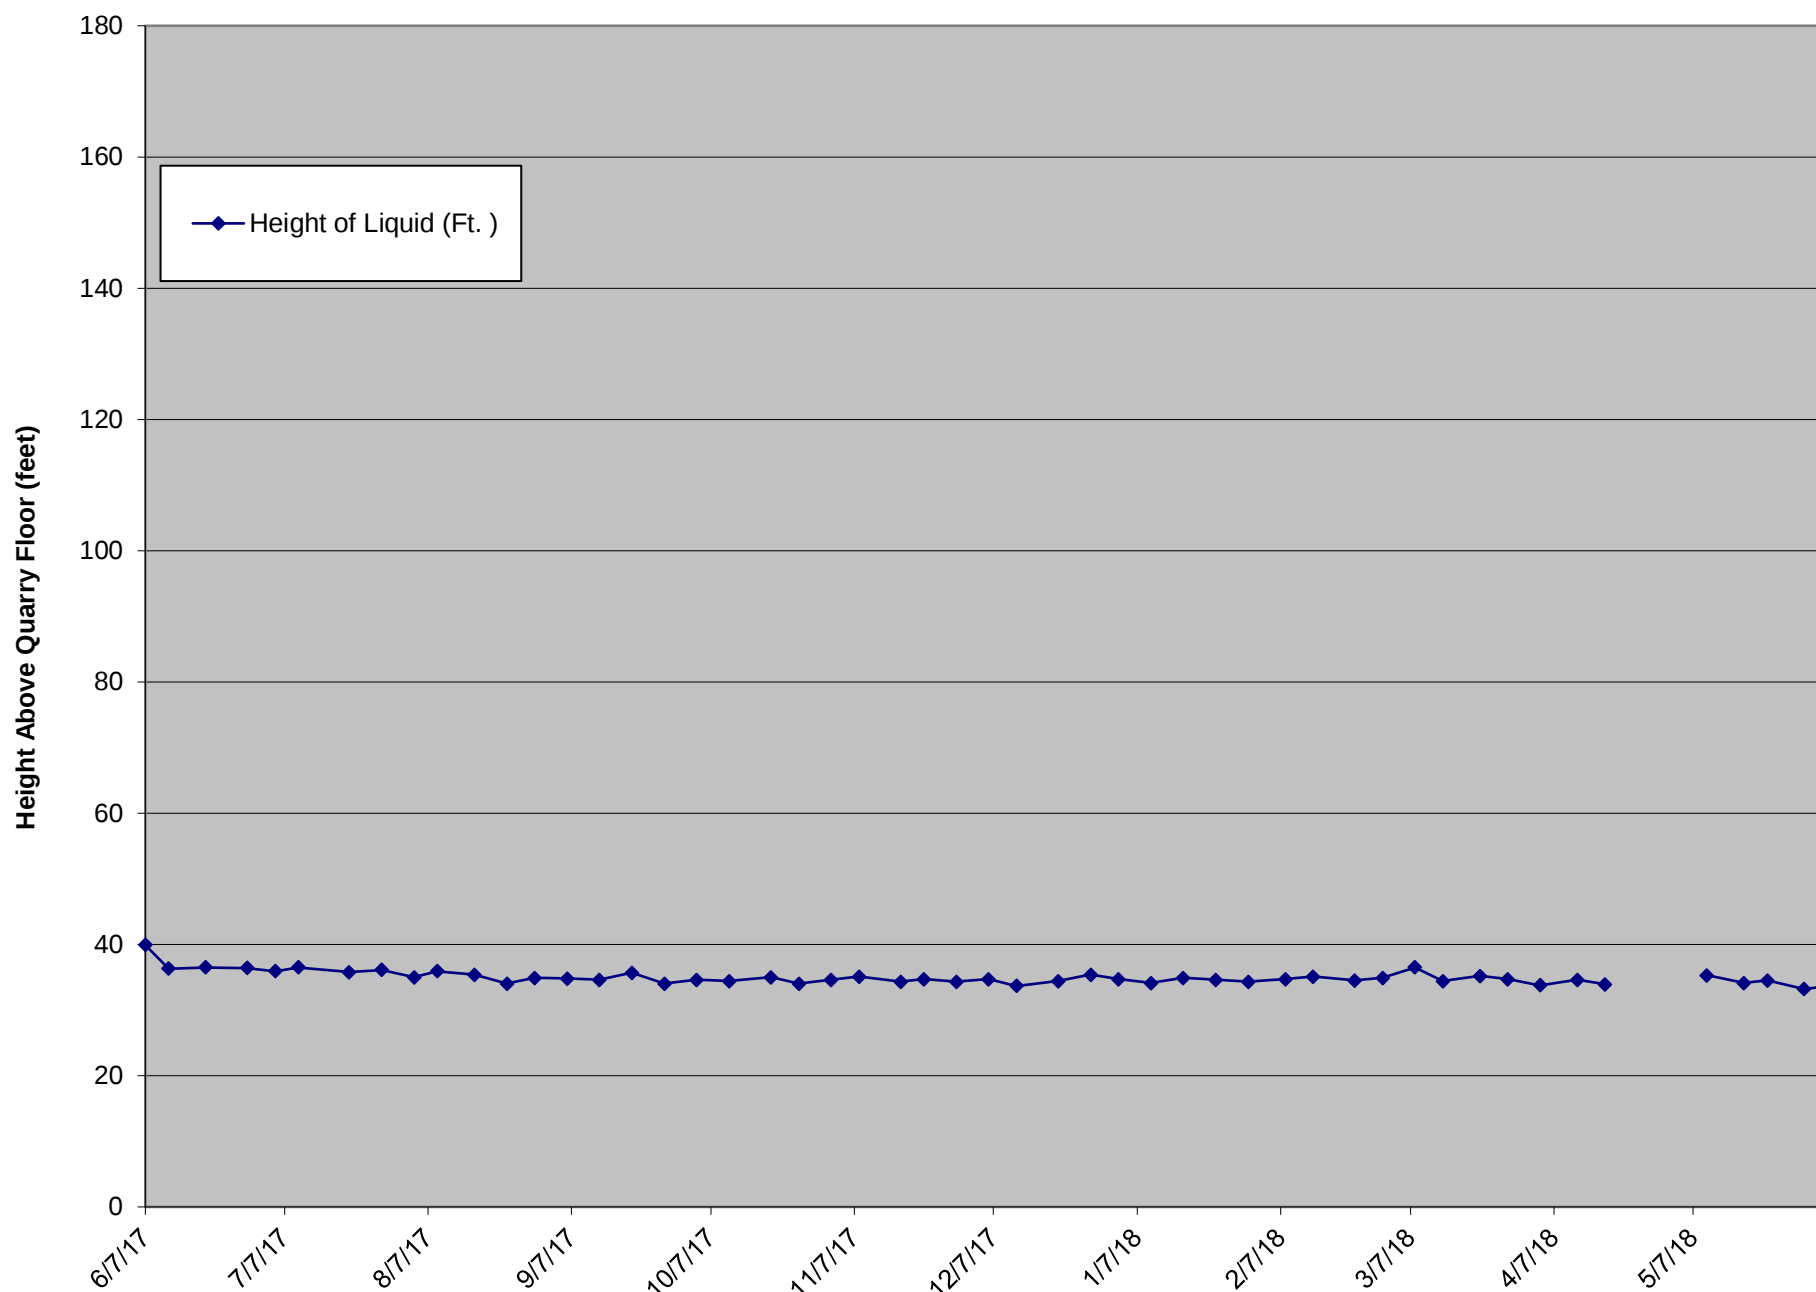
LCS-5B Liquid Level Above Quarry Floor

LCS-5B and LCS-6B were fully operational during the weekly reporting period.

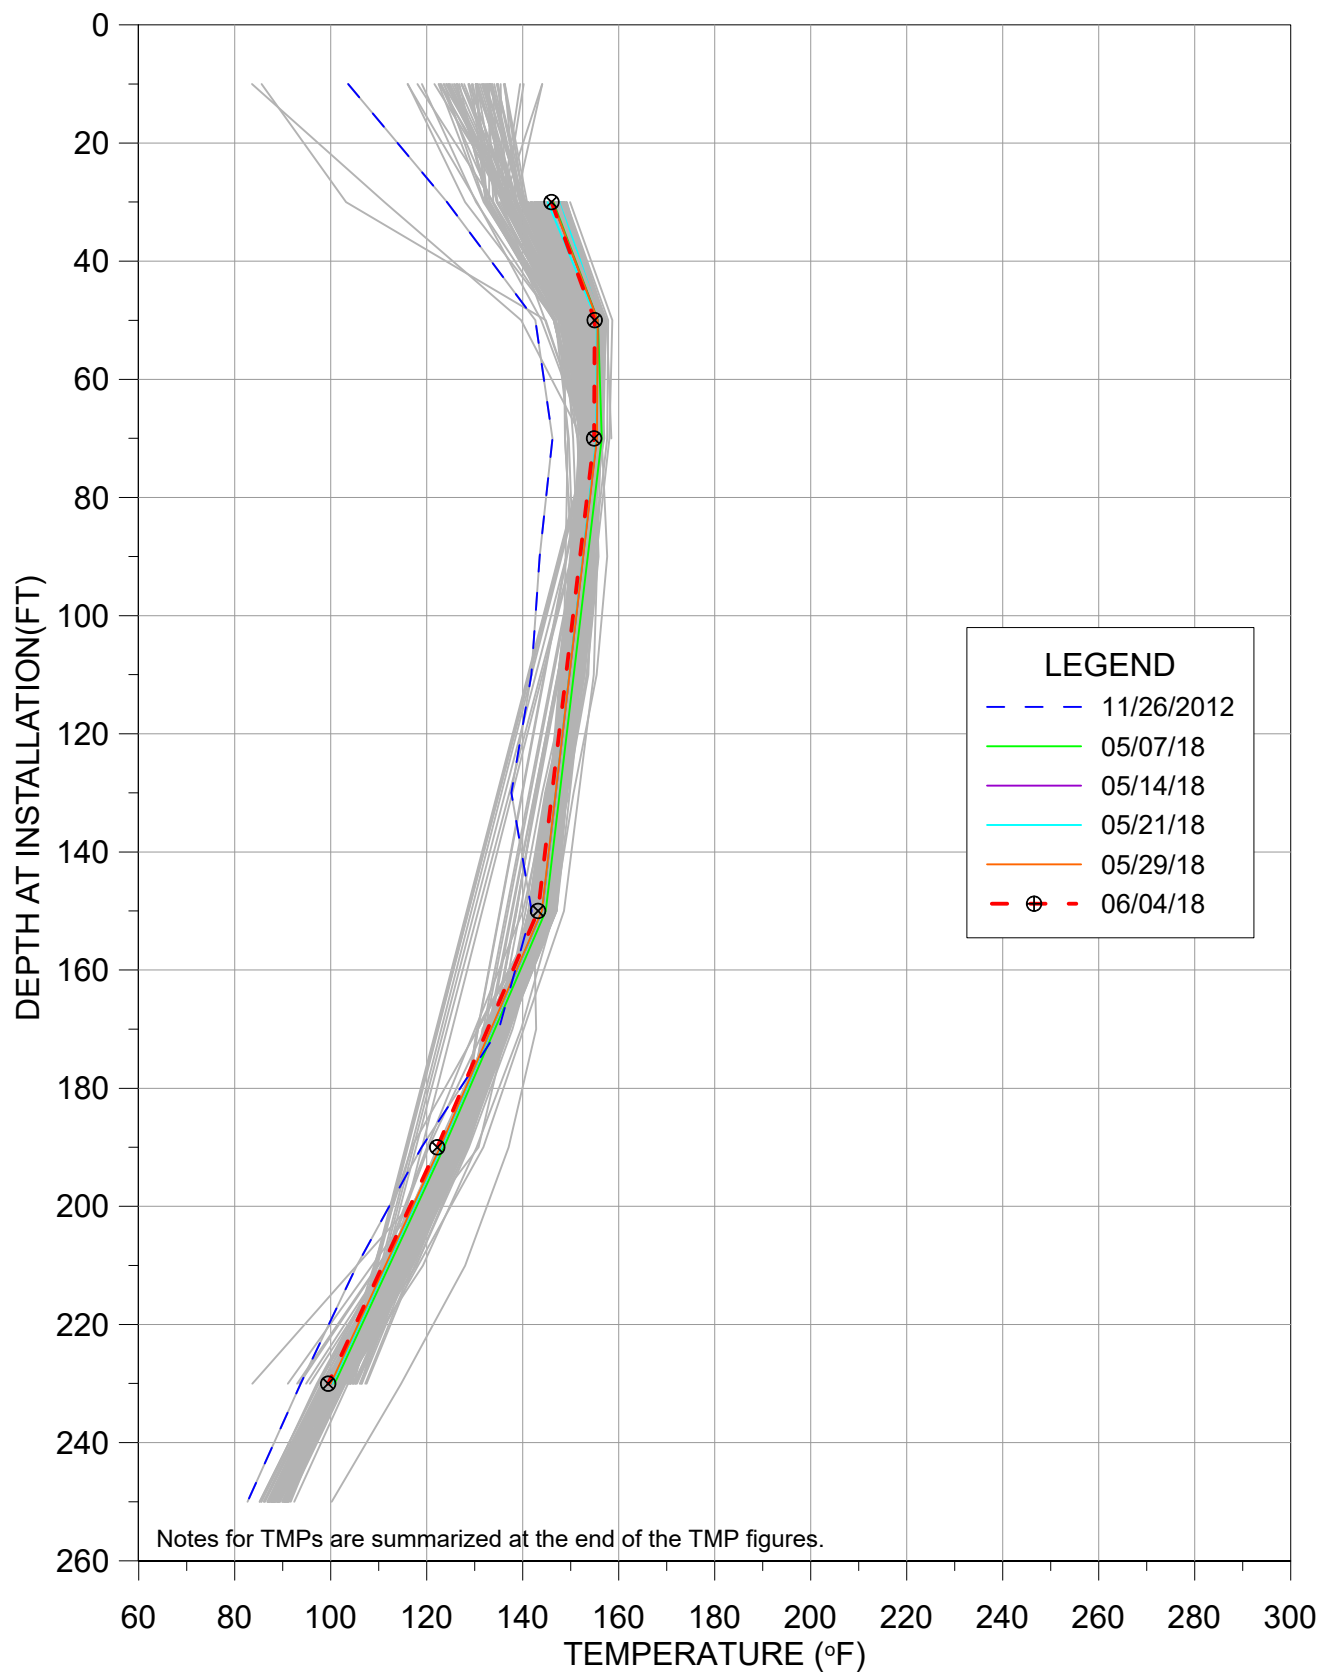
# TMP-3

1. No reliable temperature readings have been obtained at 170 ft depth since 1/29/2014, except on 3/13/2014.
2. The connectivity tests on 4/11/2014 conducted by CEC showed that units at 10, 90, 130, 210 and 250 ft depths are no longer reliable.
3. The connectivity tests on 10/28/2014 conducted by Feezor Engineering showed that units at 10, 90, 110, 130, 210 and 250 ft depths are not reliable.

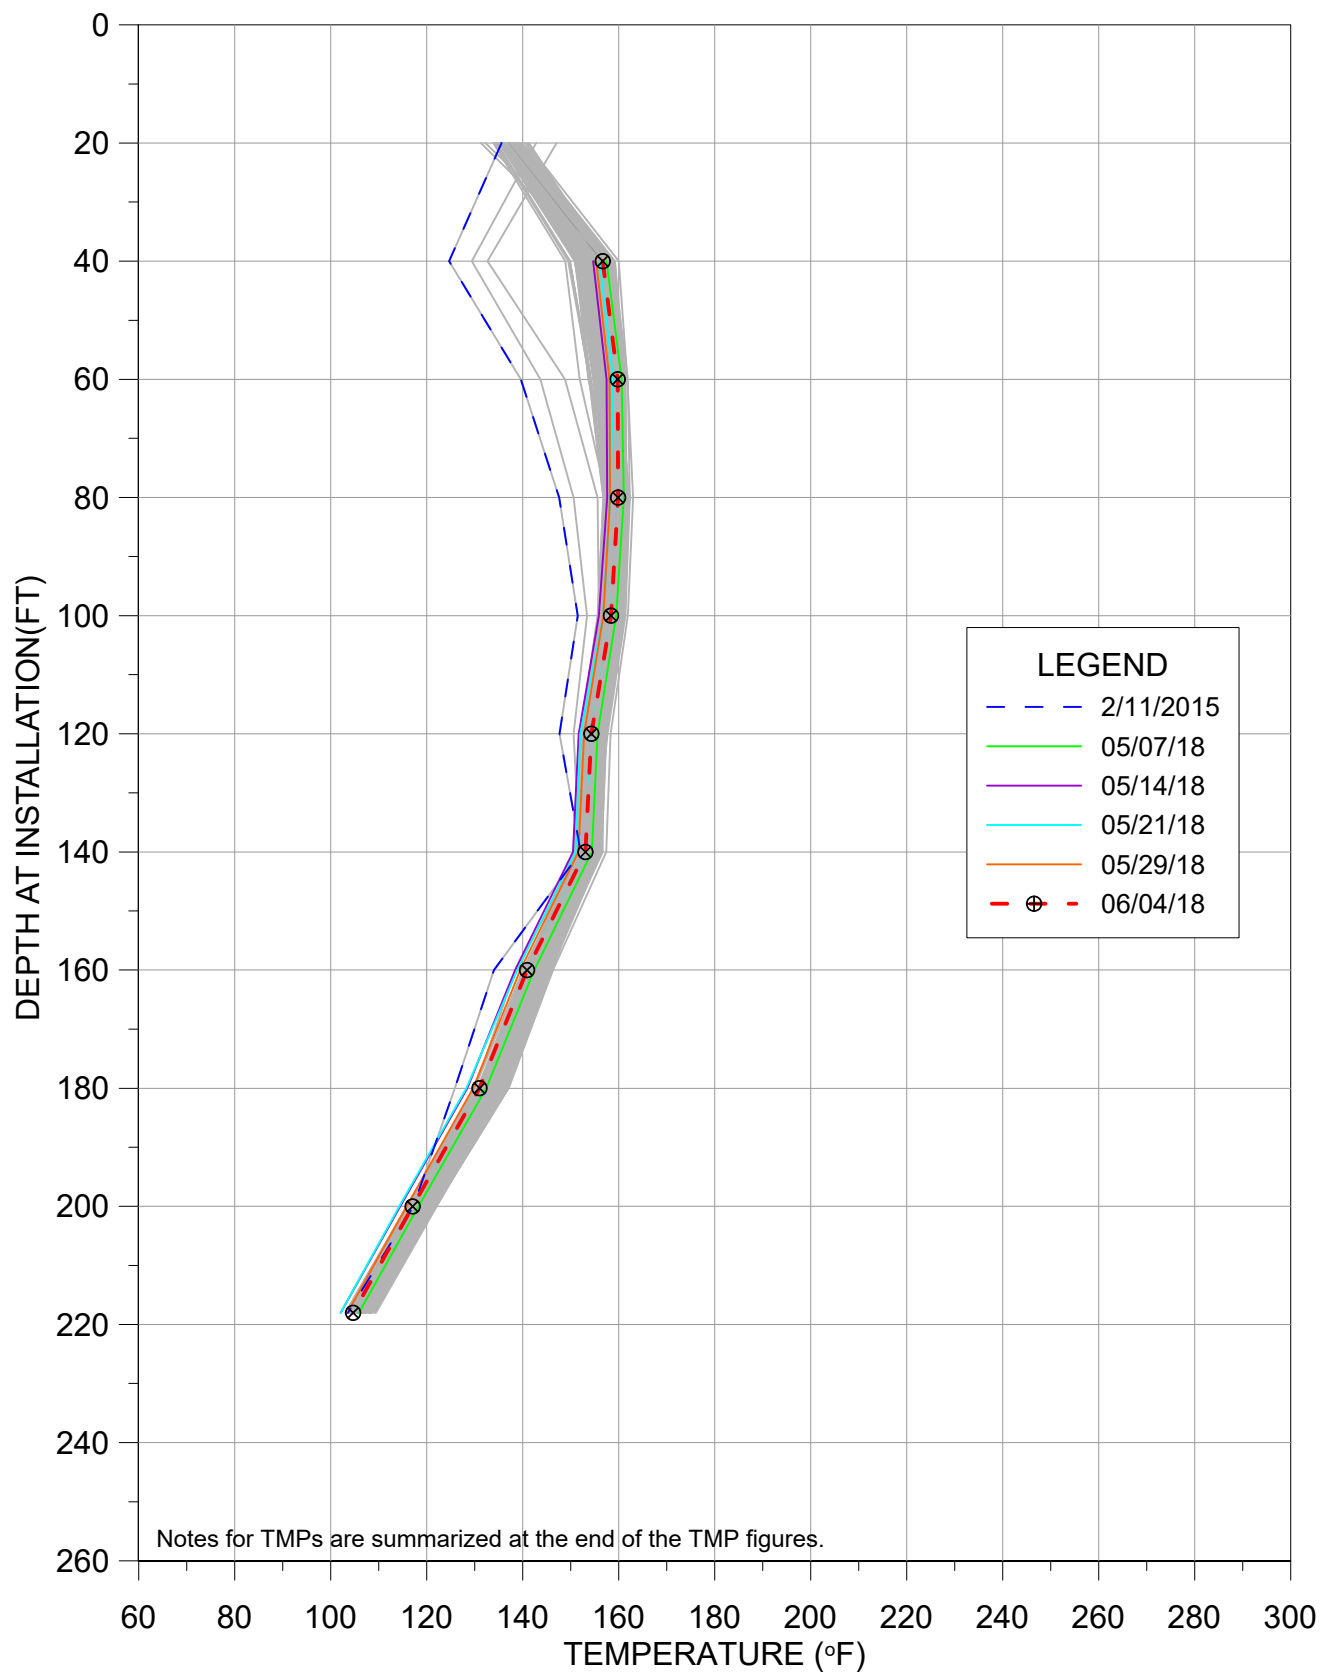
# TMP-3R

1. The unit at 20 ft depth had a fluctuating resistance since 9/25/2017. Therefore the temperature is determined to be unreliable.

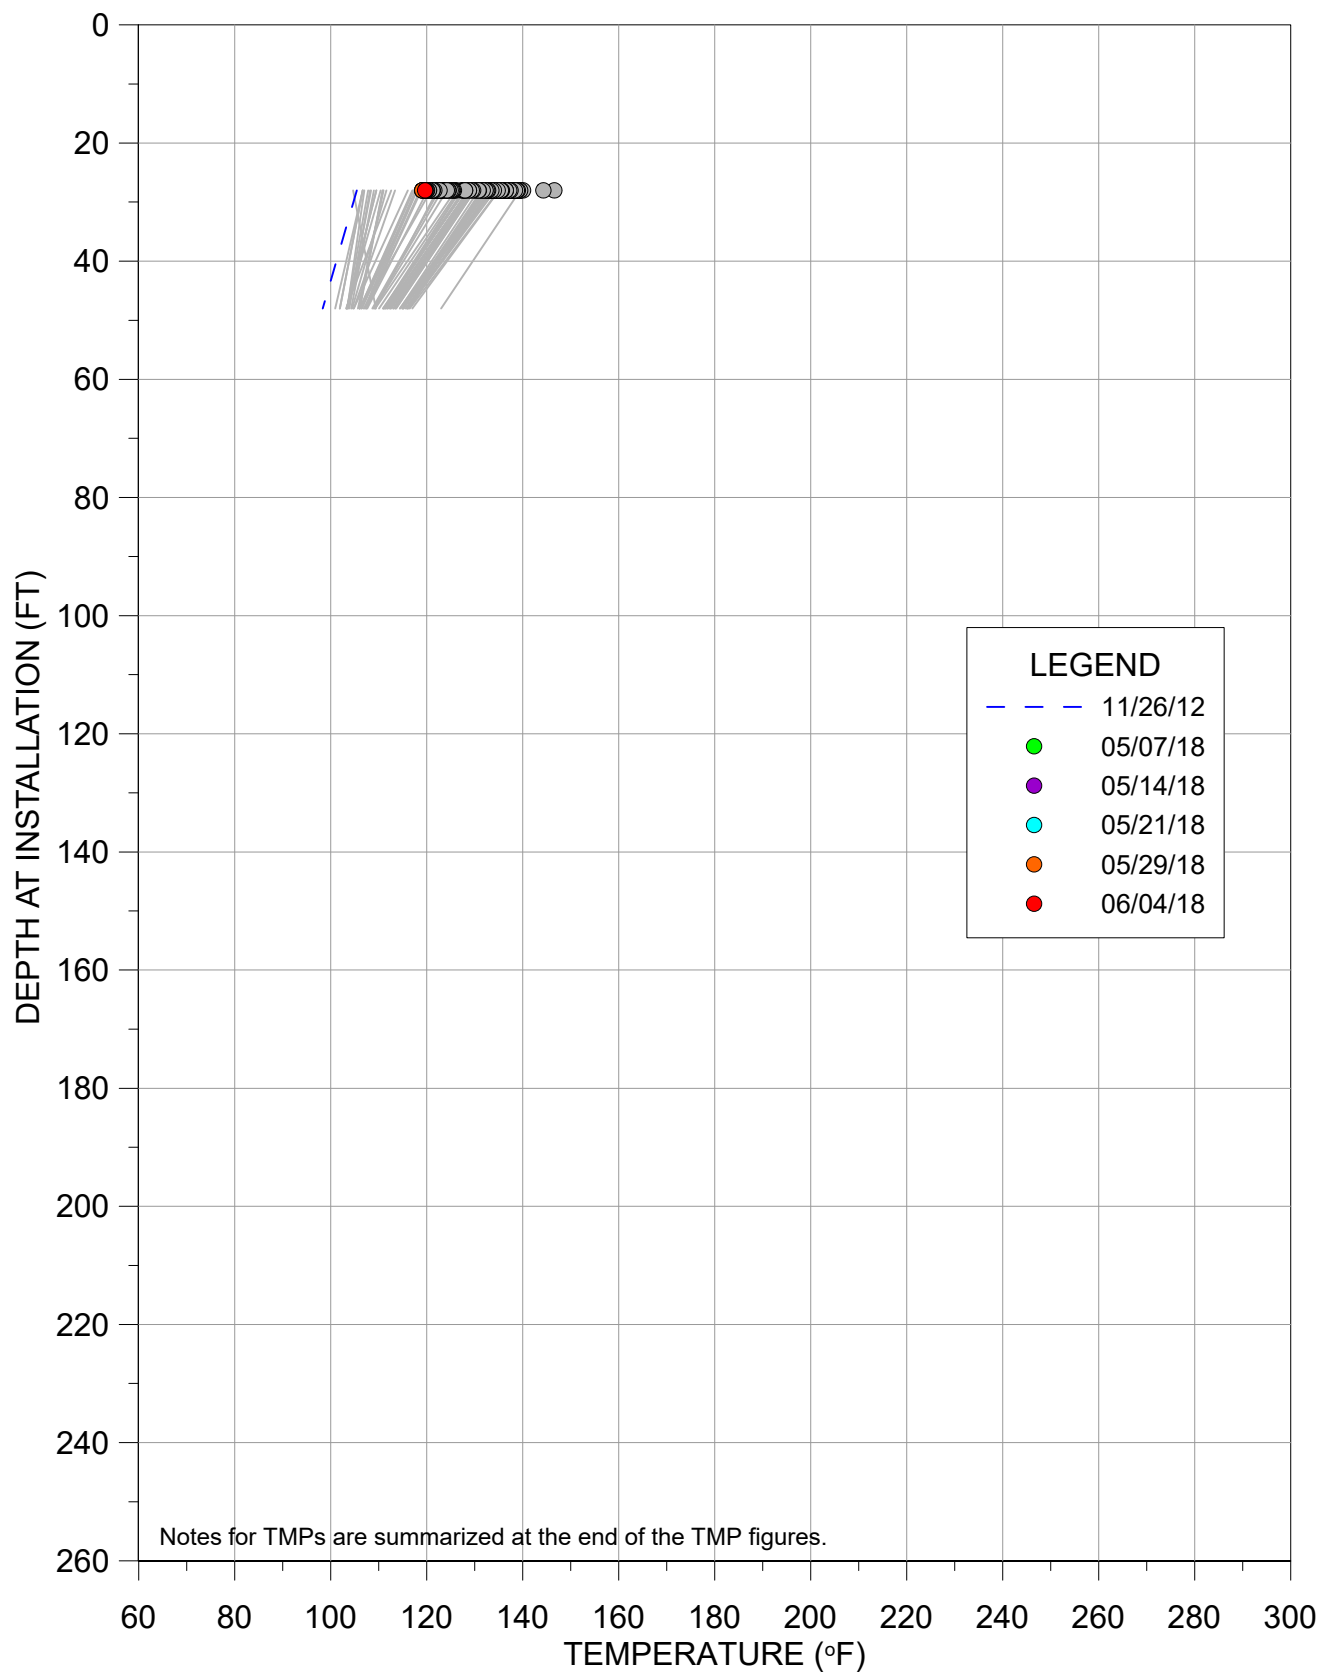
# TMP-4

1. The connectivity tests on 4/11/2014 conducted by CEC showed that the unit at 48 ft depth is no longer reliable.

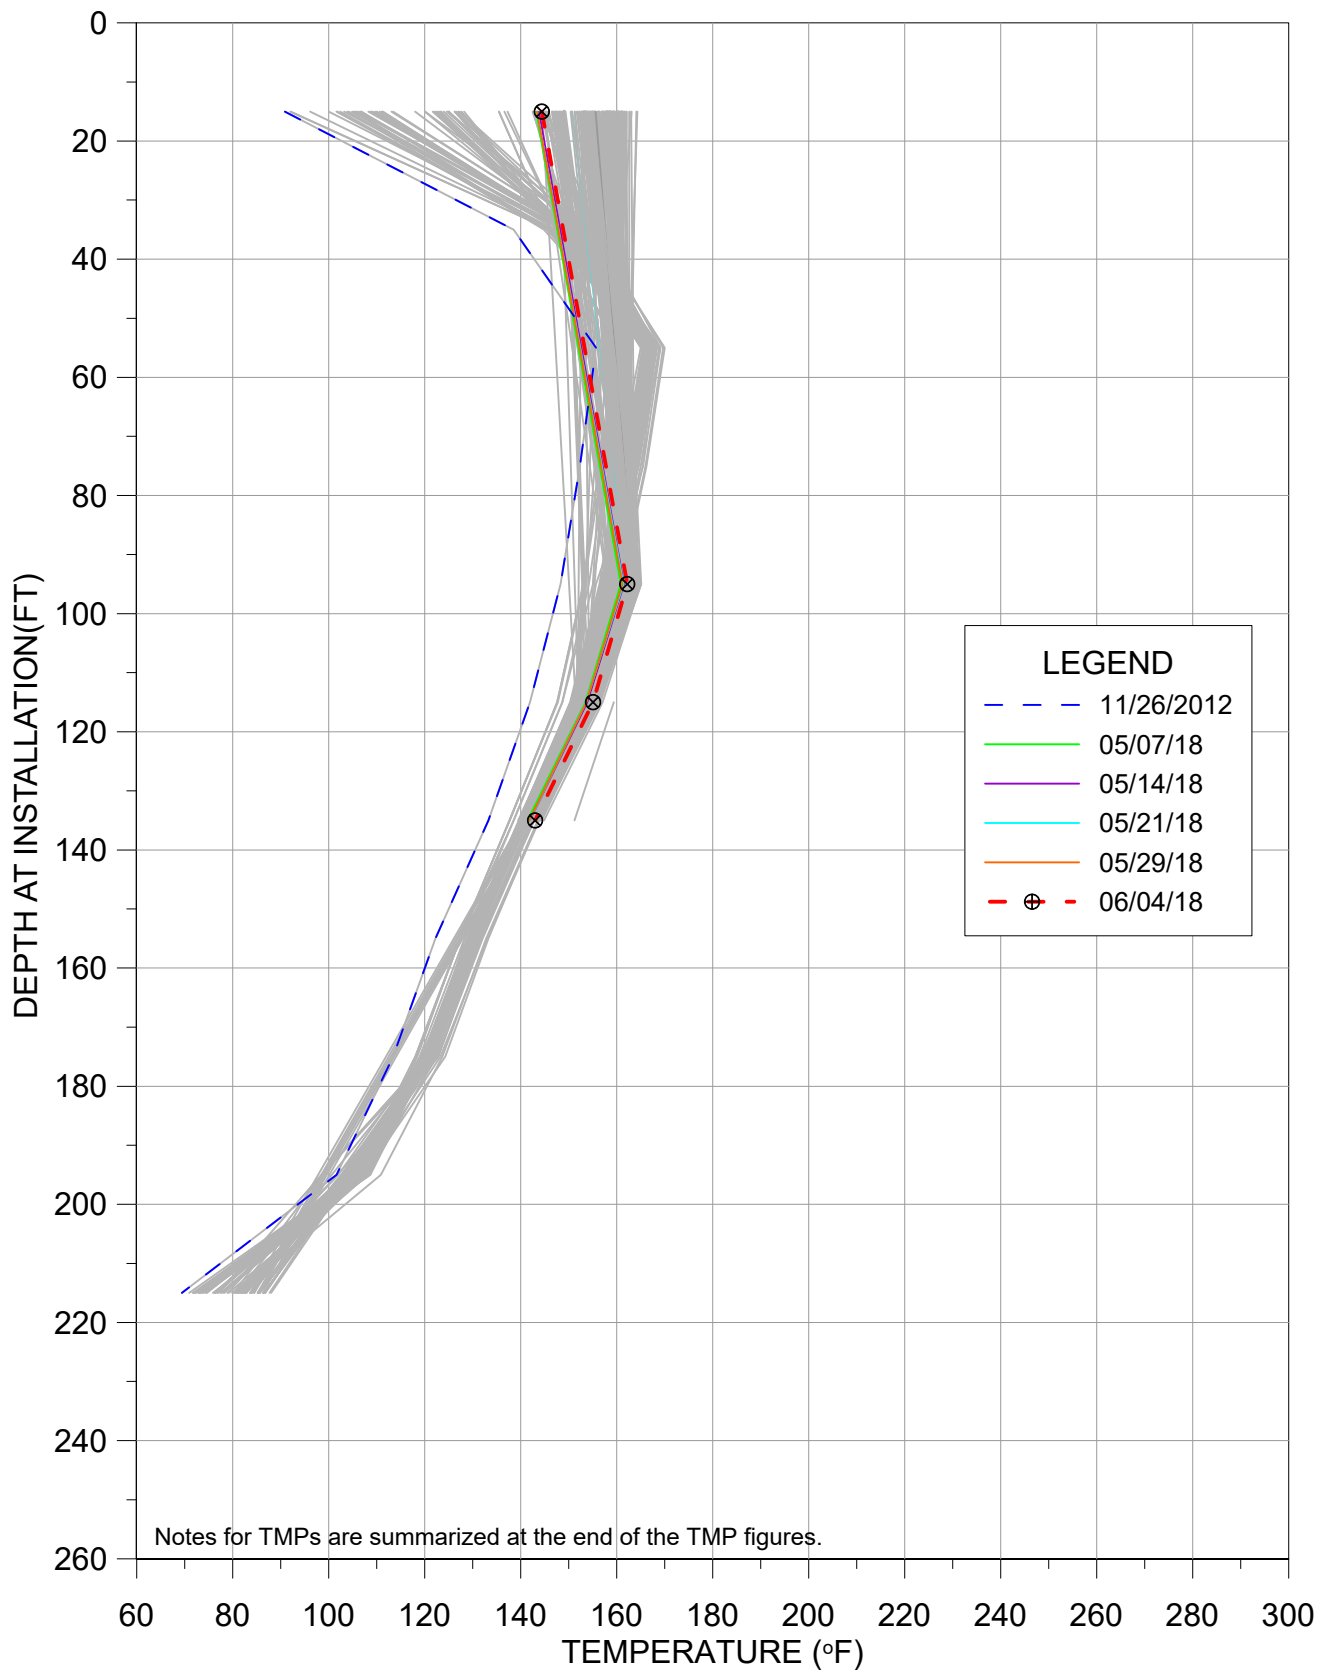
# TMP-6

1. The connectivity tests on 4/11/2014 conducted by CEC showed that units at 35, 55, 75, 155, 175, and 195 ft depths are no longer reliable.
2. No reliable temperature readings have been obtained at the unit at 215 ft depth since 6/13/2014.

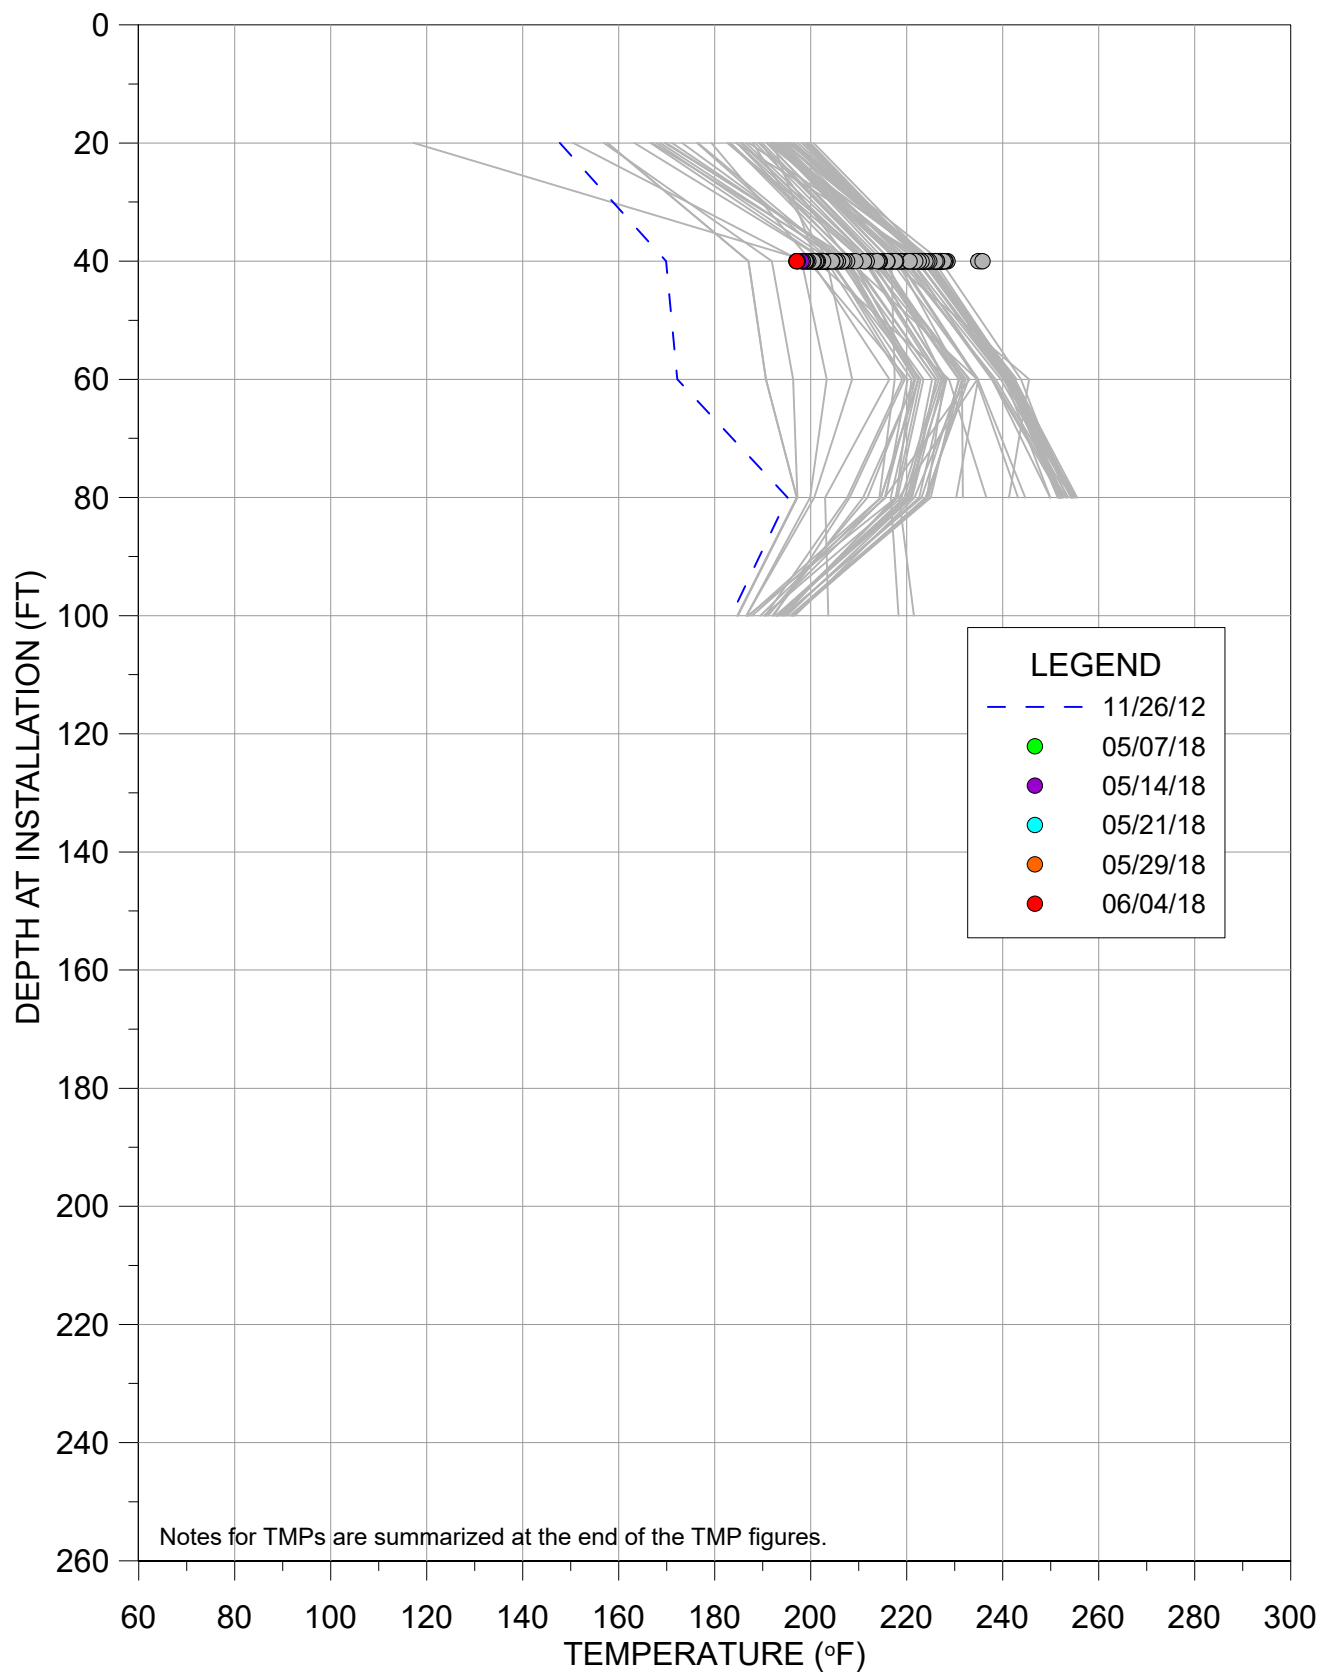
# TMP-9

1. Unit at 100 ft depth had an inaccurate temperature reading on 8/1/2013 and no reading since 8/6/2013.
2. The connectivity tests on 4/11/2014 conducted by CEC showed that units at 20, 60, 80, and 100 ft depths are no longer reliable.

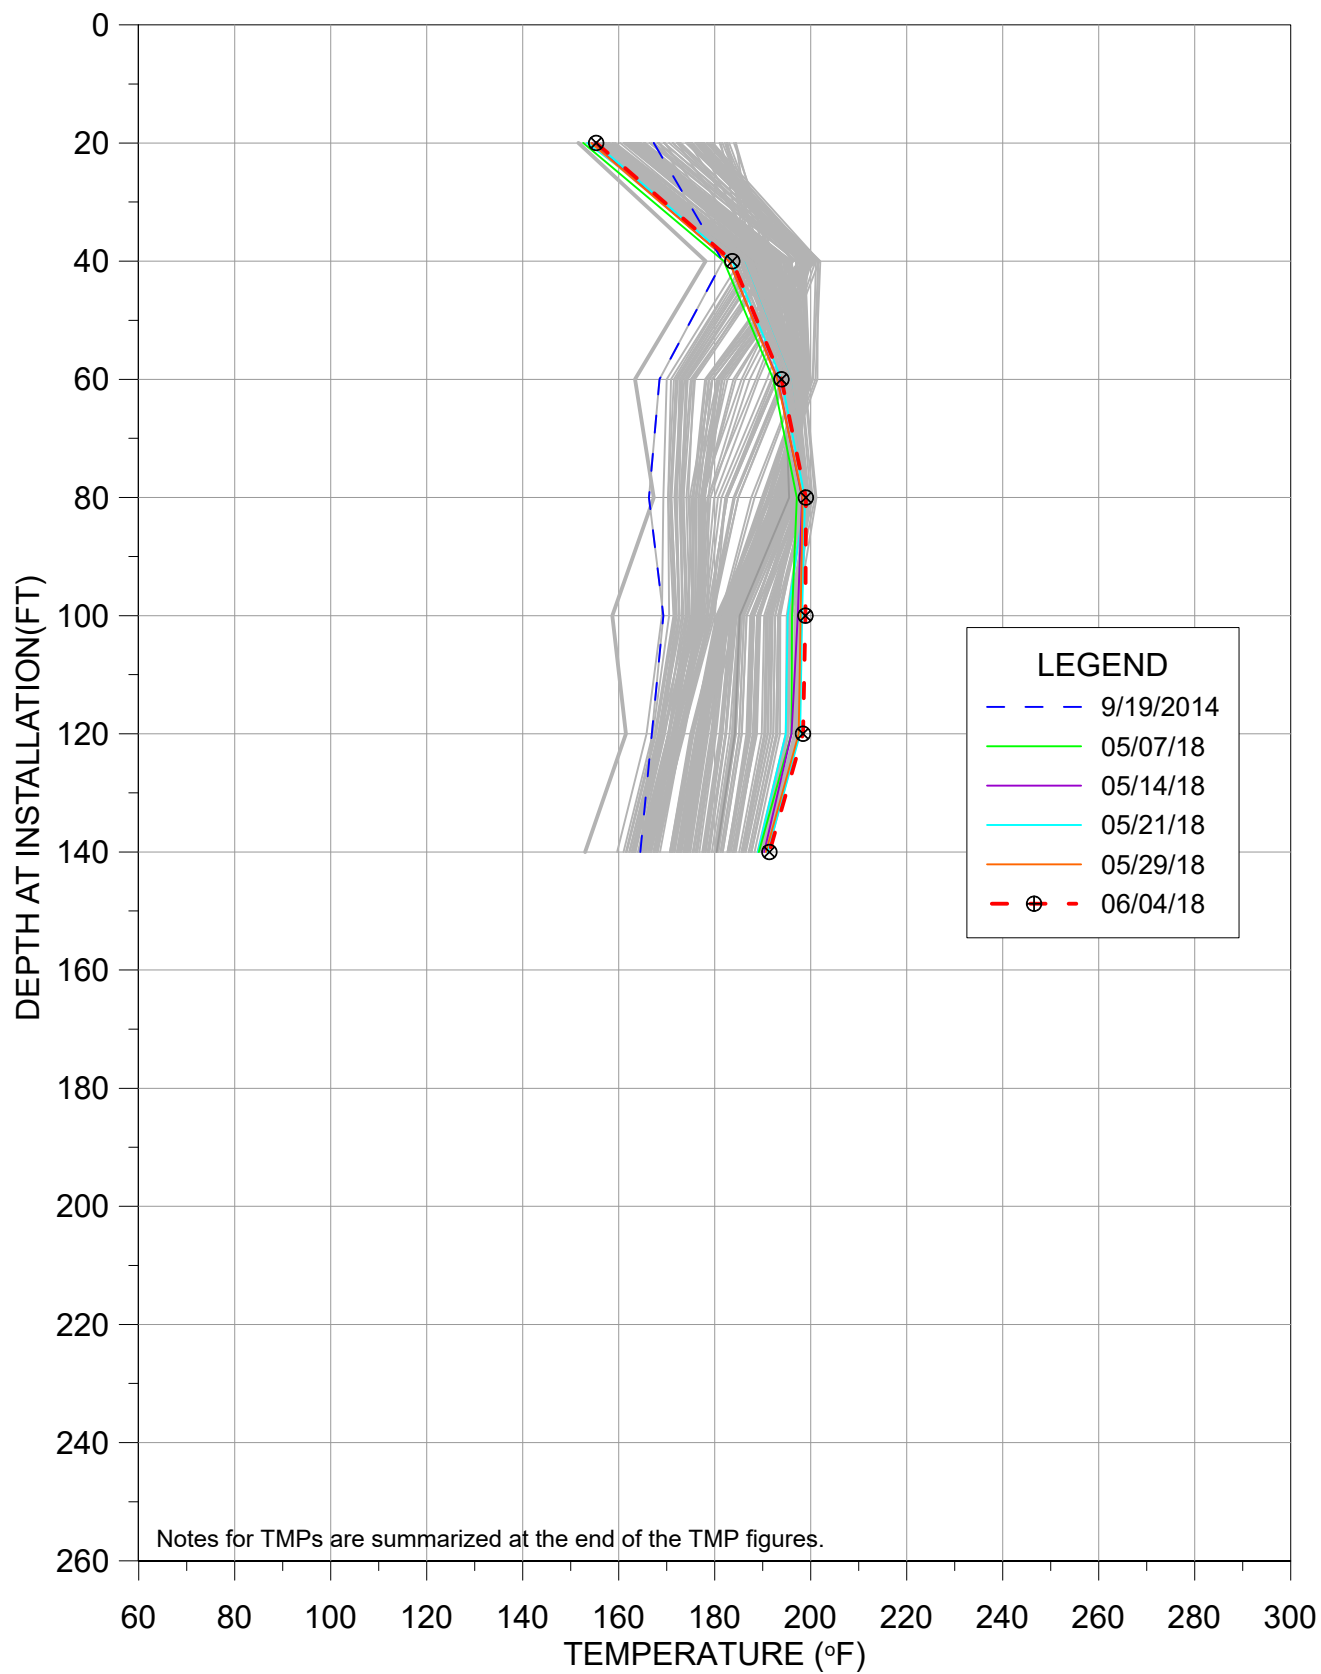
# TMP-14R

1. Due to the connectivity test results by Feezor Engineering on TMP-14 (see note above), TMP-14R is added to this reporting data set as of 3/7/2016.
