# **Bridgeton Landfill, LLC**

## **Weekly Data Submittal**

**Week of June 03, 2018 – June 09, 2018**

**Required by Section 52.F of Agreed Order, Case No. 13SL-CC01088  
Effective May 13, 2013**

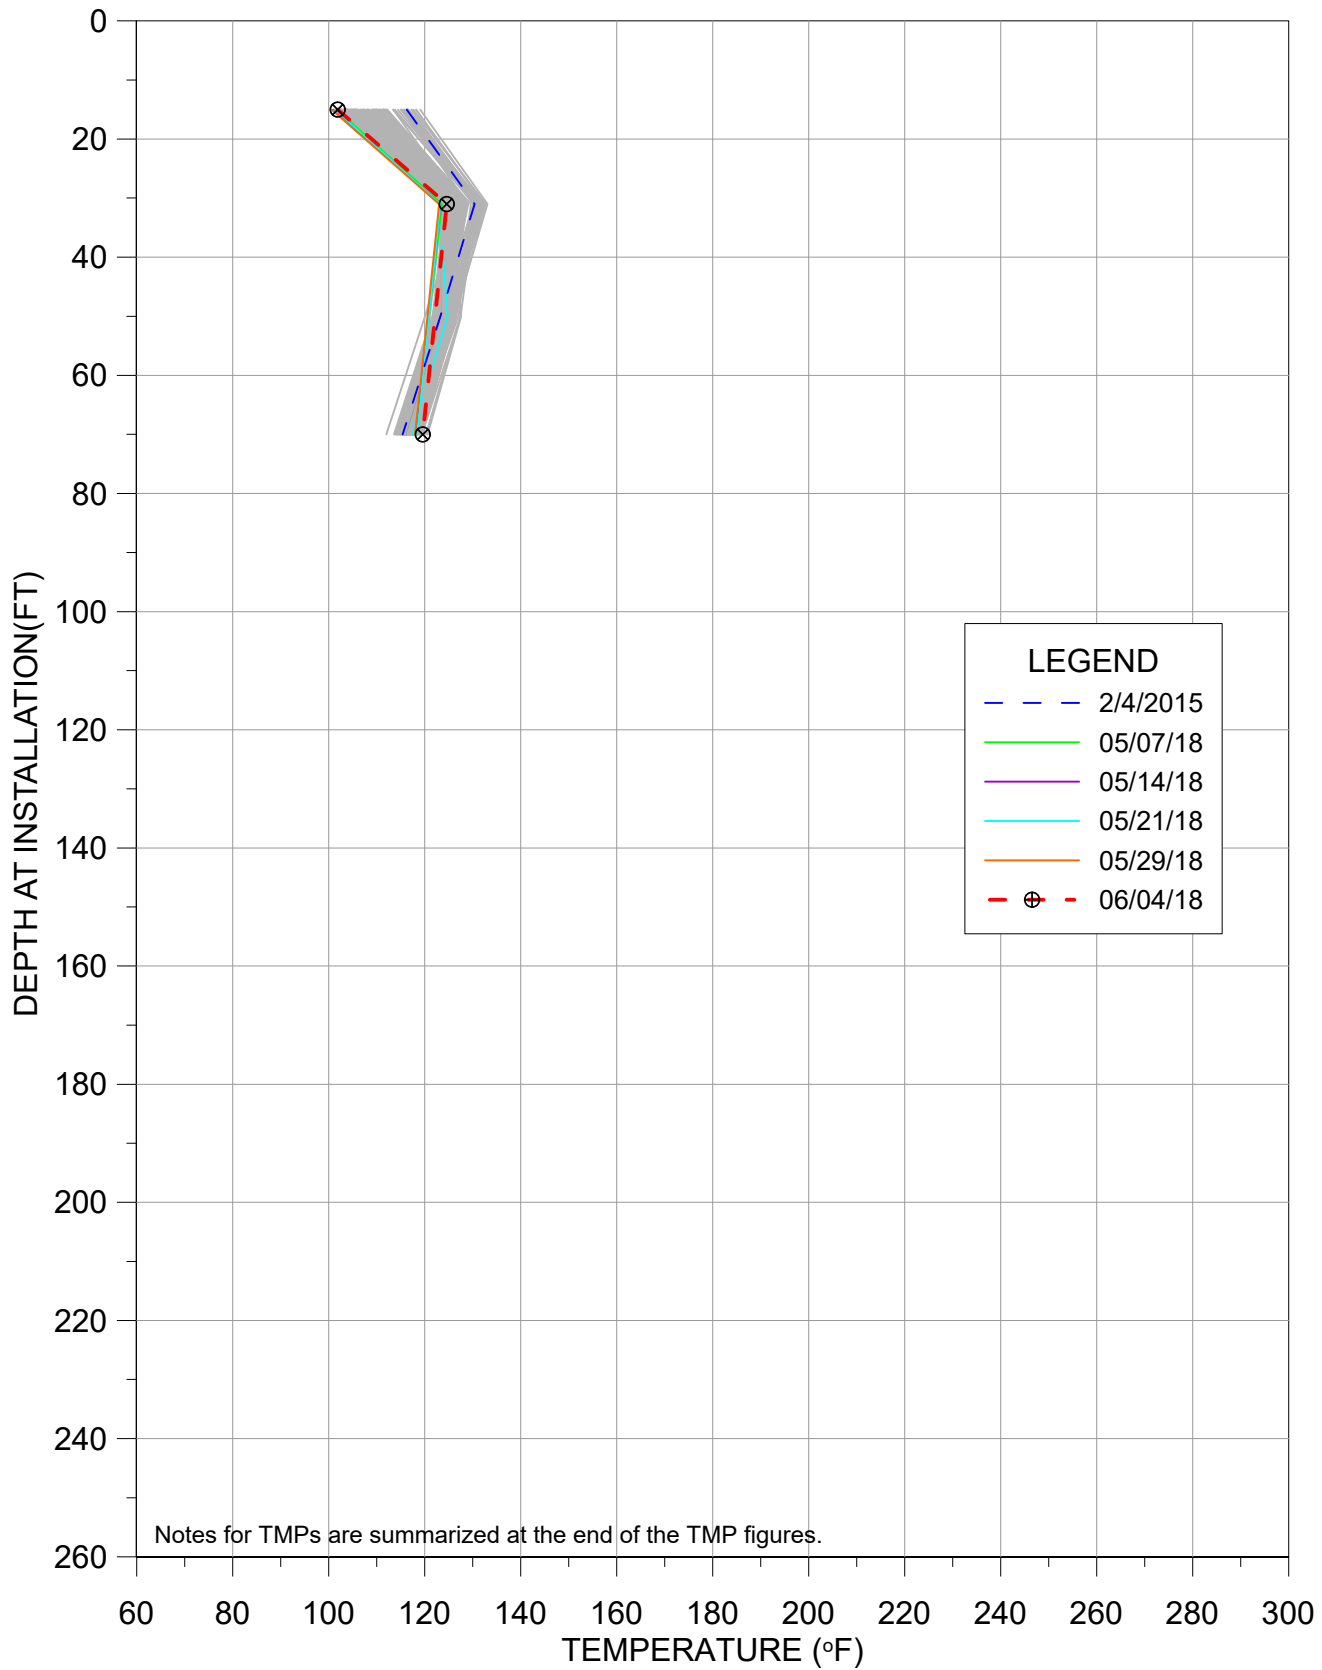
# TMP-22

1. No temperature reading could be obtained and resistivity was fluctuating at the unit at 50 ft depth since 4/2/2018.

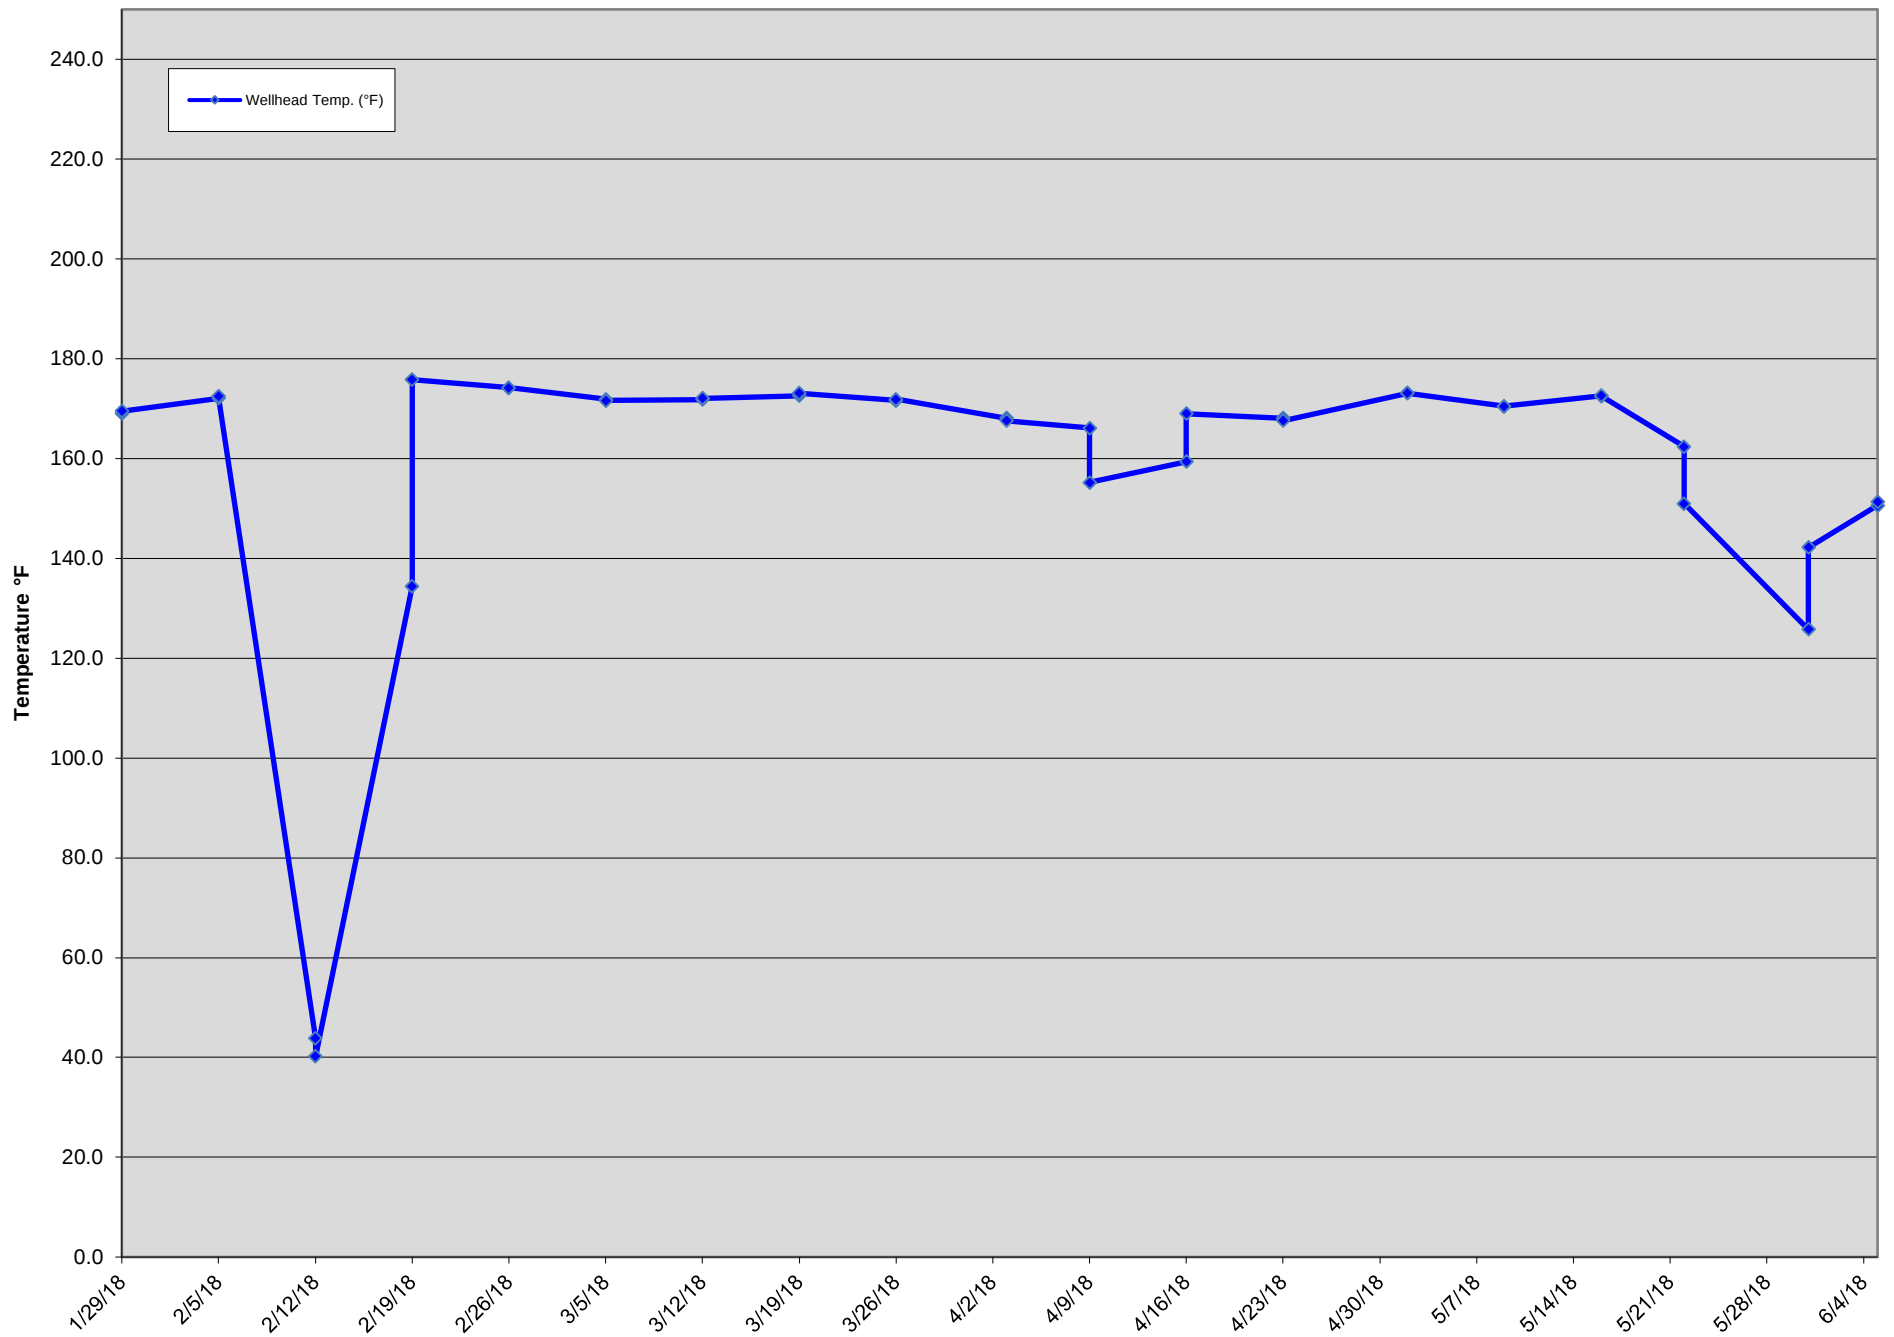
GIW-1 Wellhead Temperatures

As part of the HES, there are currently cooling water circulation loops installed in twelve Gas Interceptor Wells (GIWs) (GIW-02 through GIW-13). The remaining well (GIW-01) had a measured gas temperature within its historical operating limits.
