# **Bridgeton Landfill, LLC**

## **Weekly Data Submittal**

**Week of October 29, 2017 – November 4, 2017**

**Required by Section 52.F of Agreed Order, Case No. 13SL-CC01088  
Effective May 13, 2013**

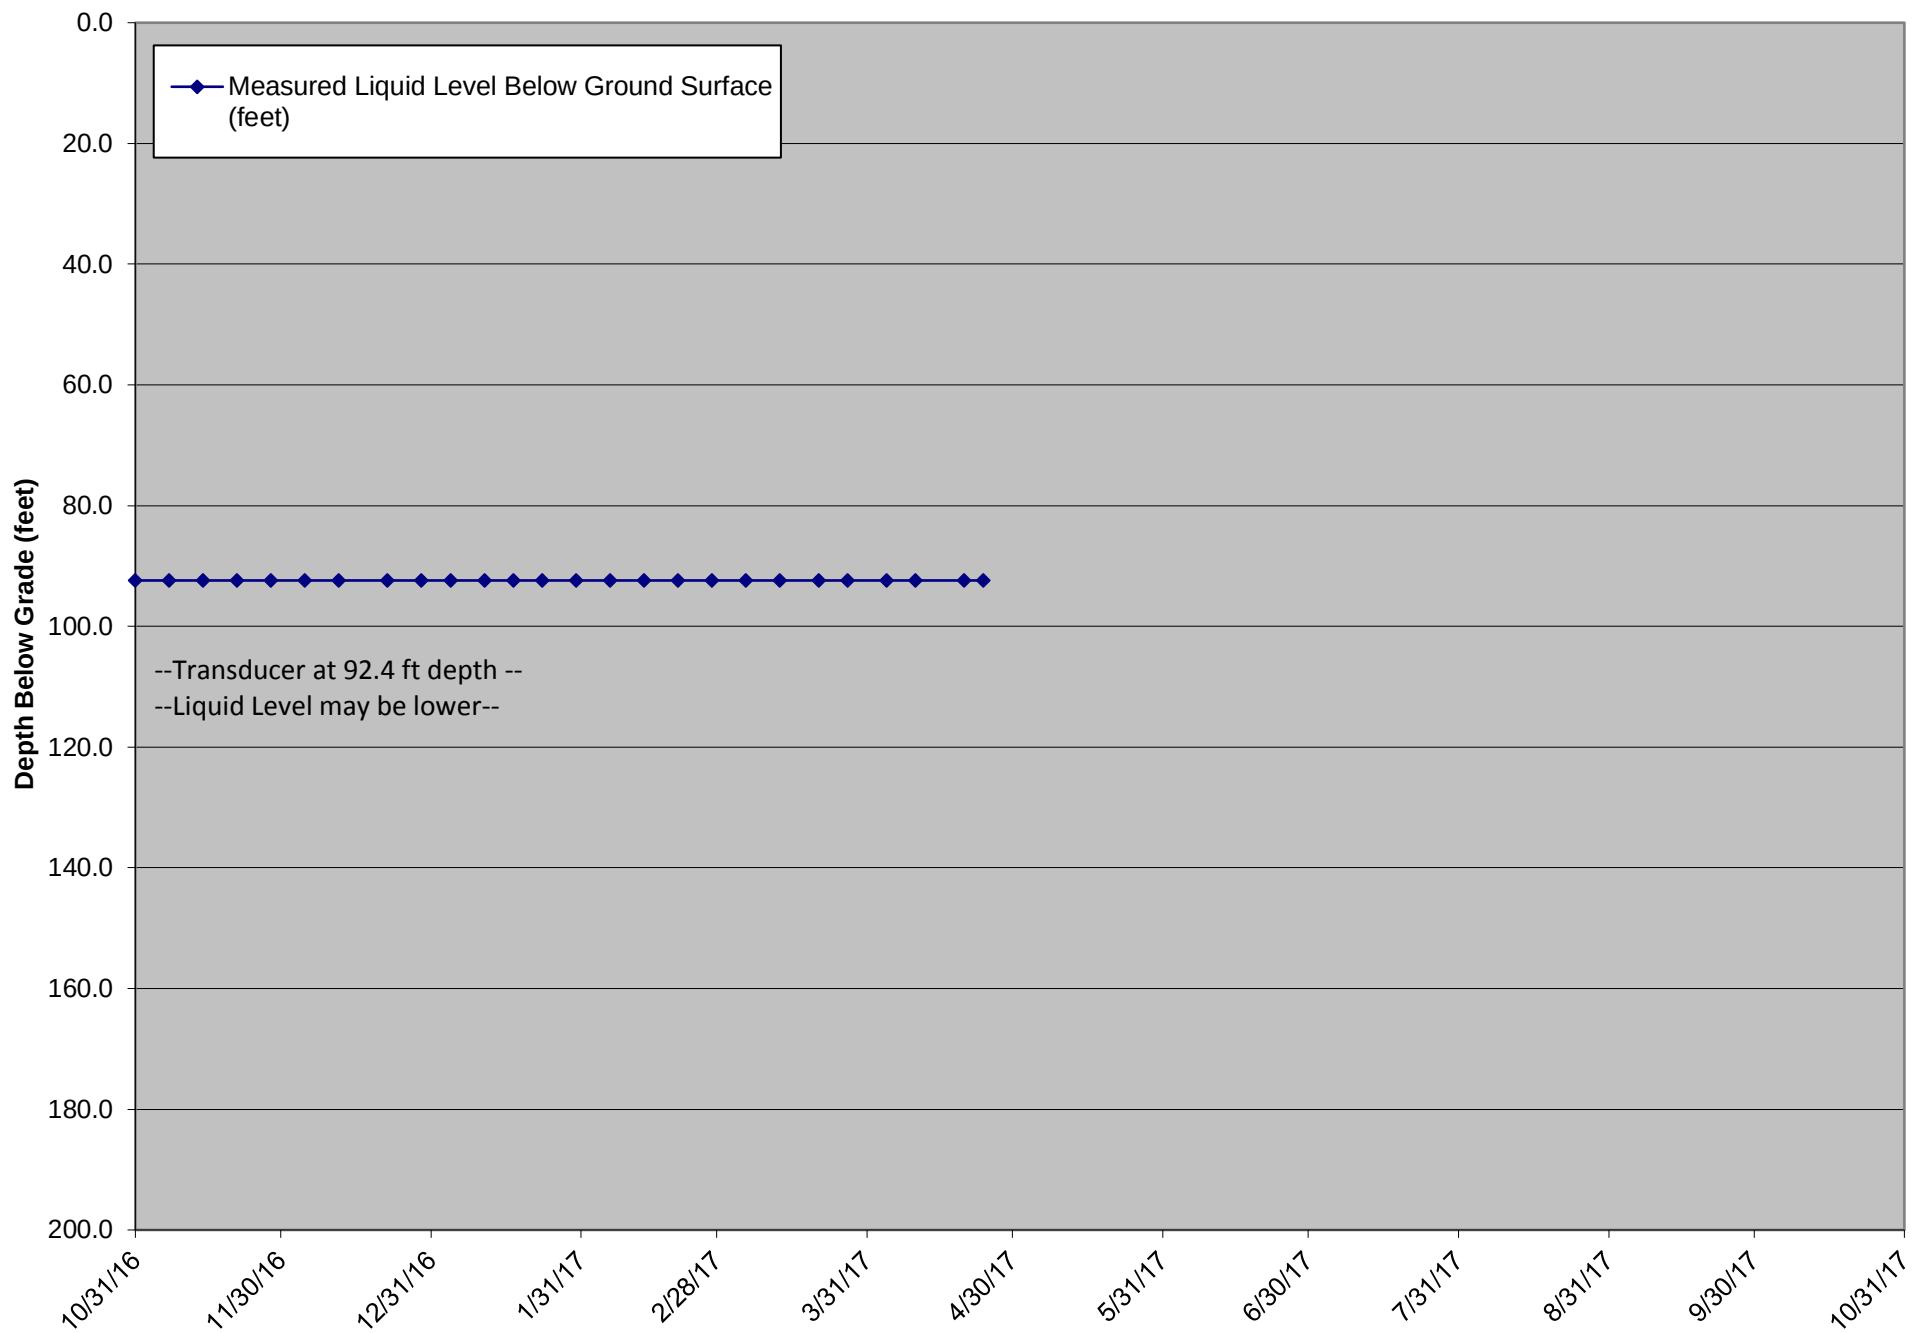
# LCS-1D Liquid Level Below Ground Surface

The downhole discharge piping for LCS-1D requires replacement. Pump and level sensor replacement are pending arrival of stainless steel piping.

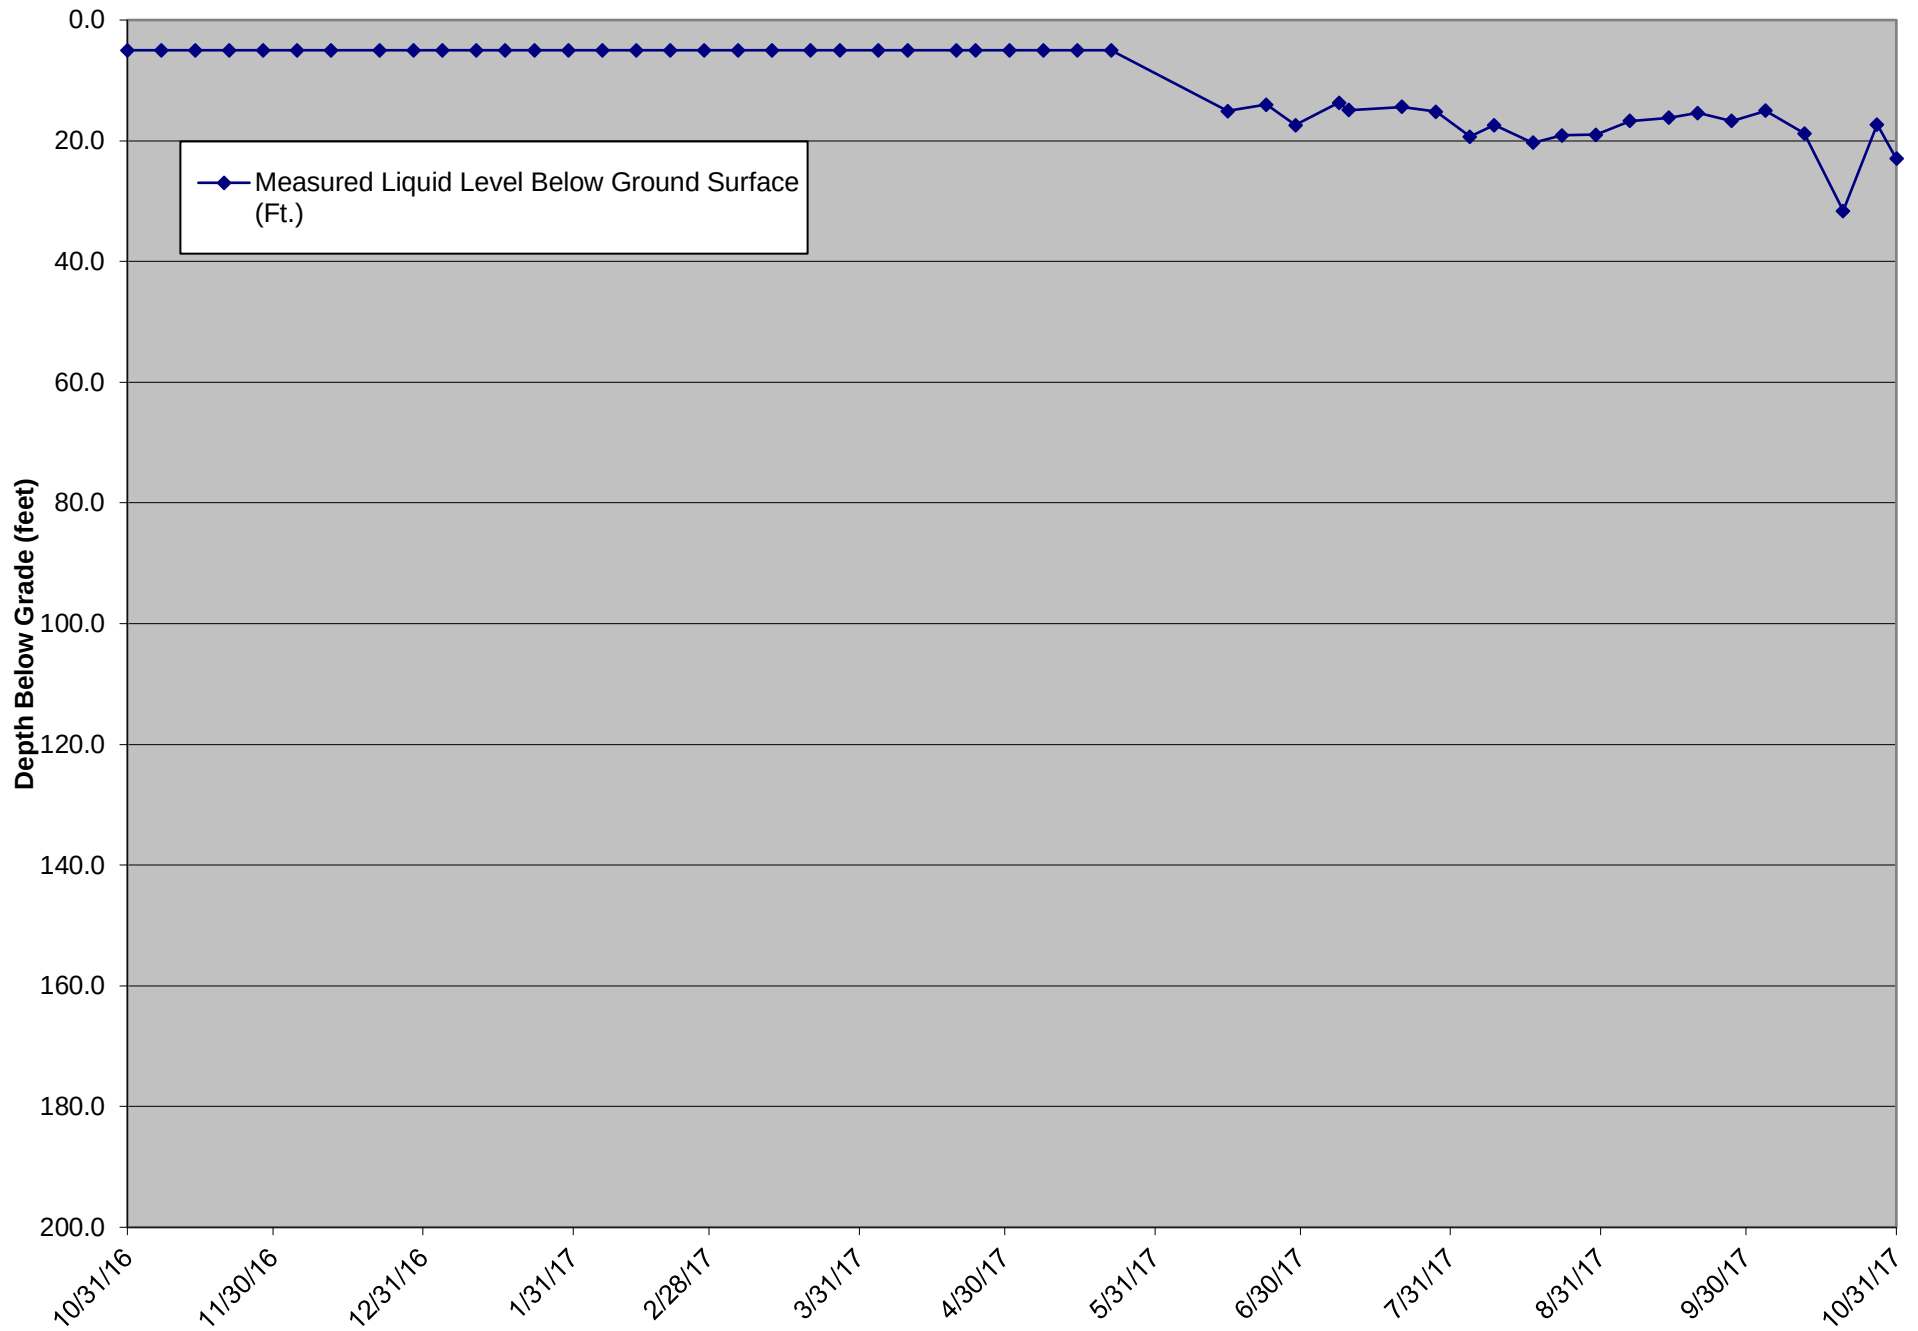
LCS-3D Liquid Level Below Ground Surface

Two Blackhawk pneumatic pumps were installed in LCS-3D on 6/13/2017. Blackhawk pumps do not require a level sensor. Liquid level was measured manually.

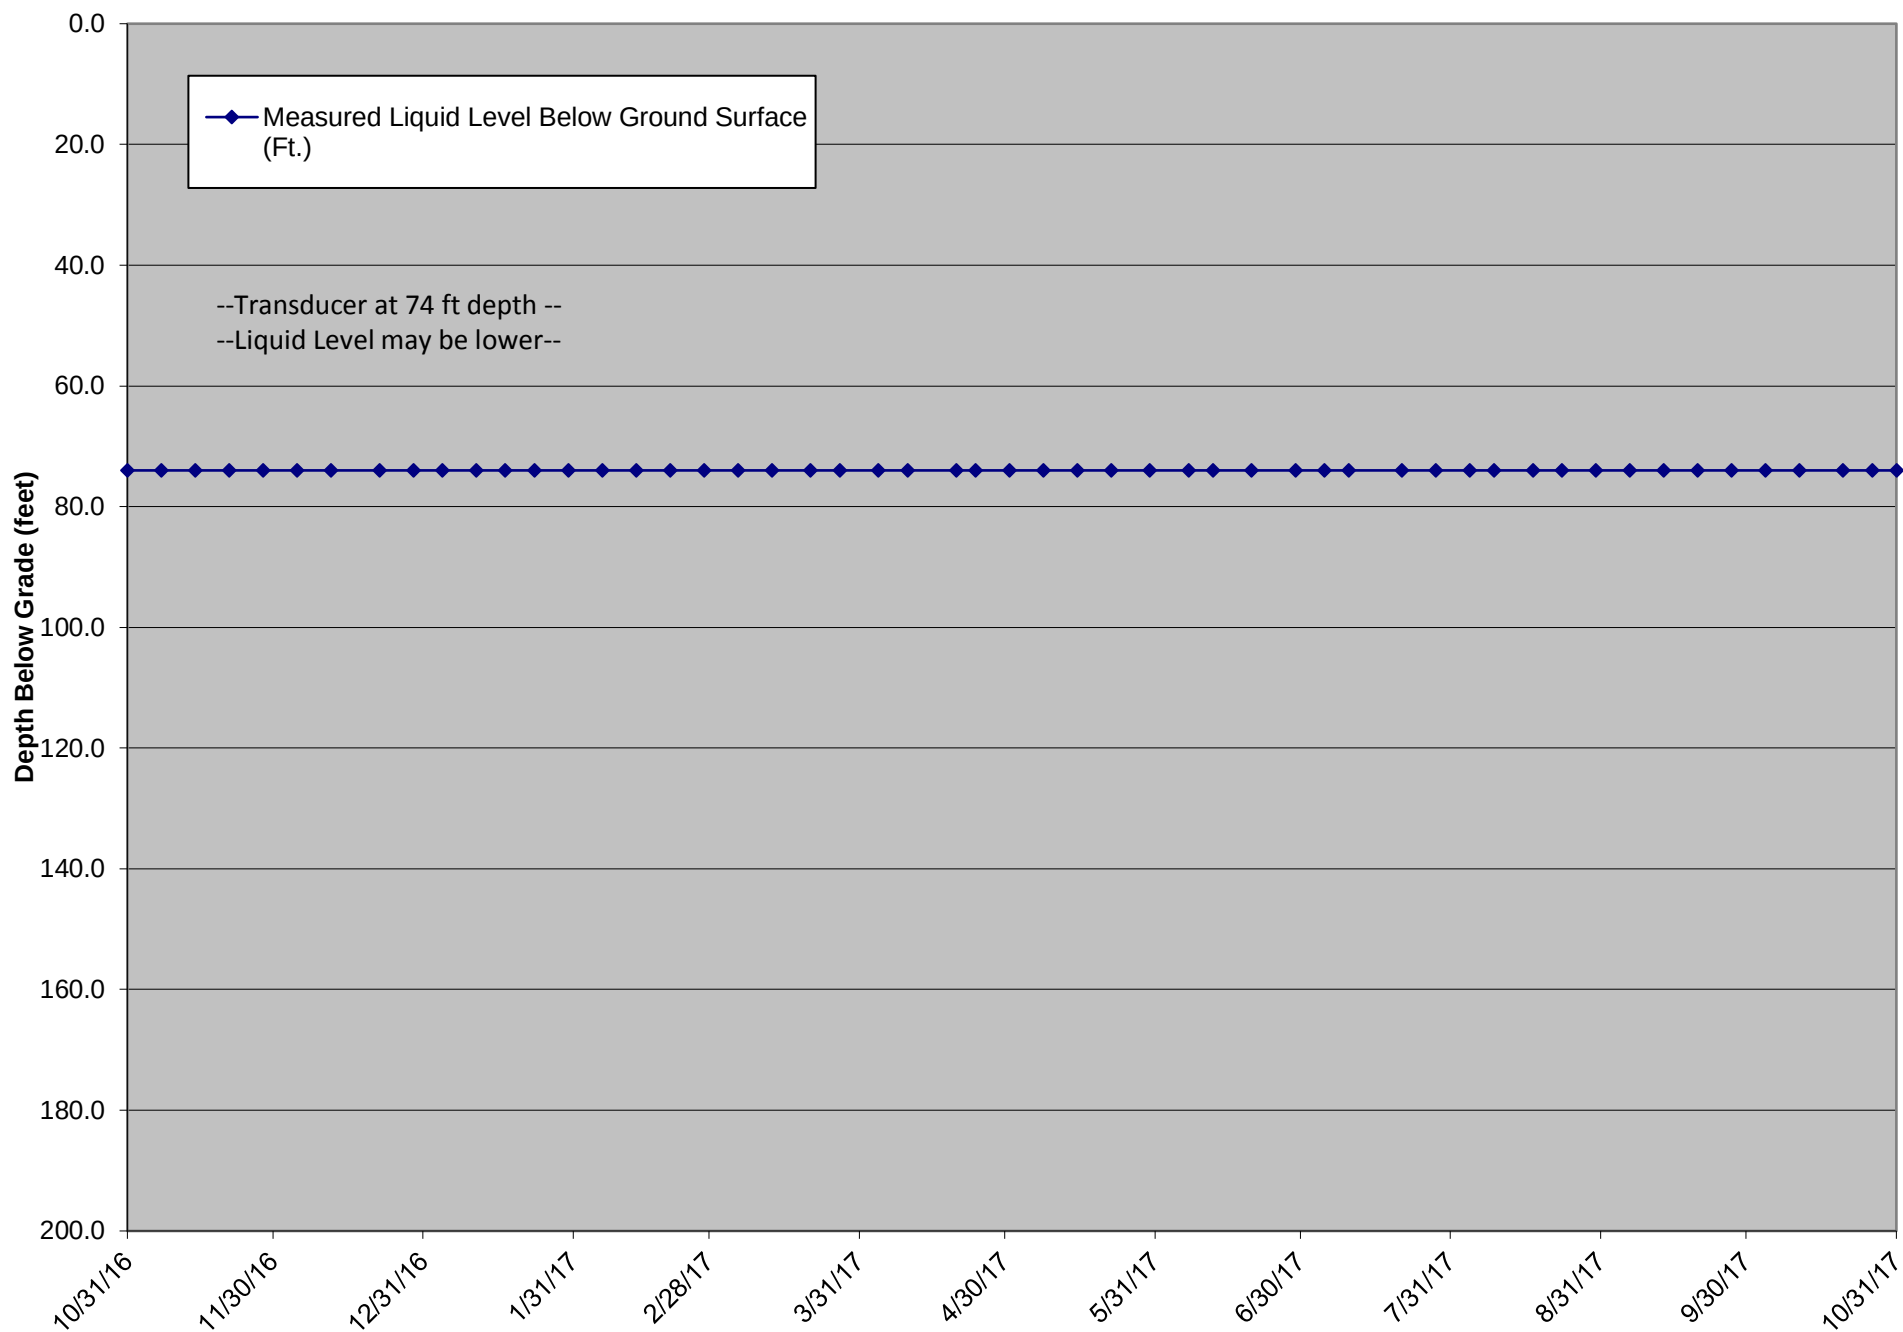
# LCS-4B Liquid Level Below Ground Surface

The level sensor in LCS-4B is currently operational and responsive. Liquid level was not recorded by the level sensor during the weekly reporting period. LCS-4B is equipped with a flow meter that displayed no flow during the weekly reporting period. Therefore, it can be concluded that the liquid level was below the bottom of the pump and level sensor in LCS-4B.

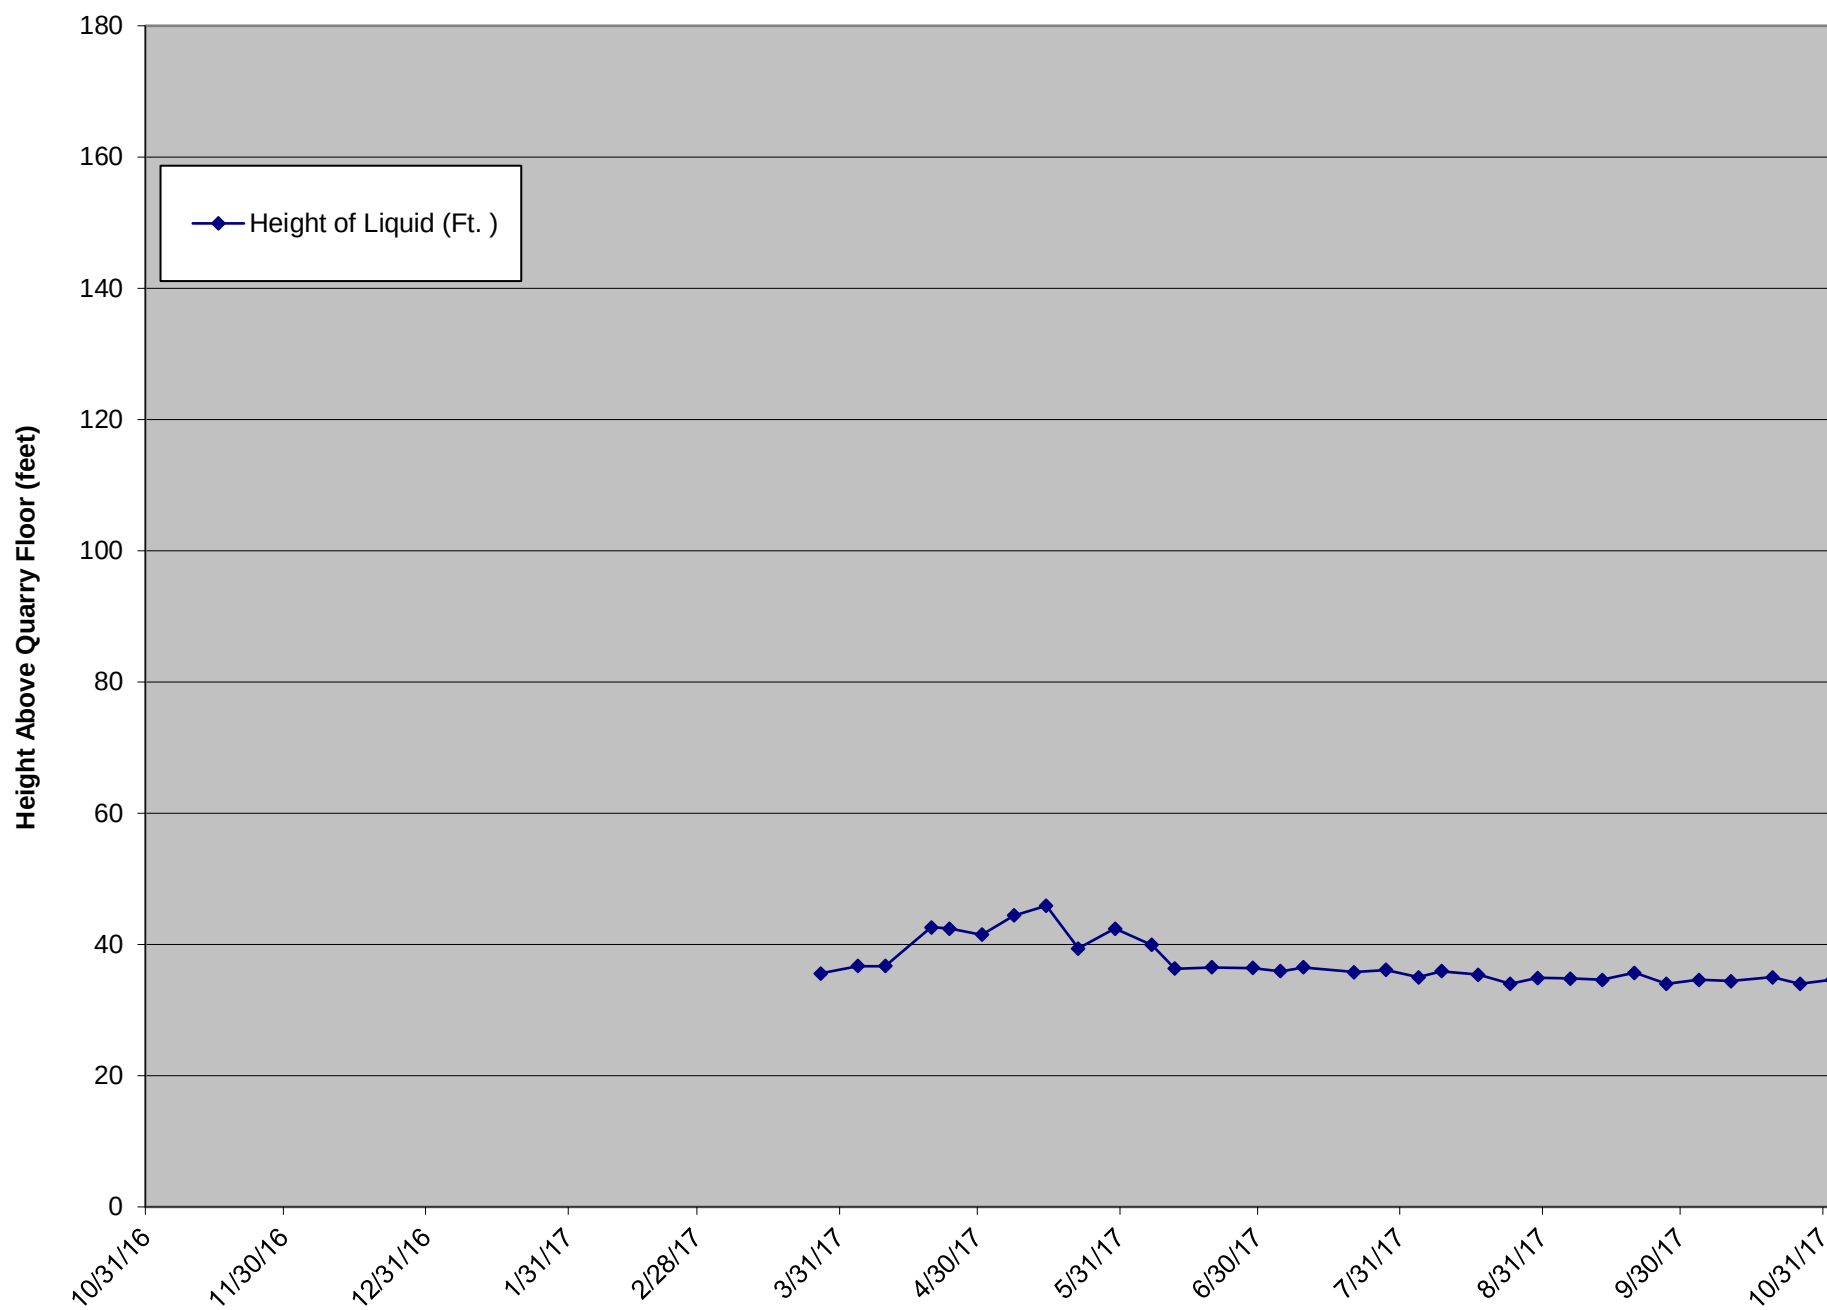
LCS-5B Liquid Level Above Quarry Floor

The level sensor on LCS-5B was non-operational on 10/27/17. The level sensor was replaced and LCS-5B became fully operational again on 11/2/17.

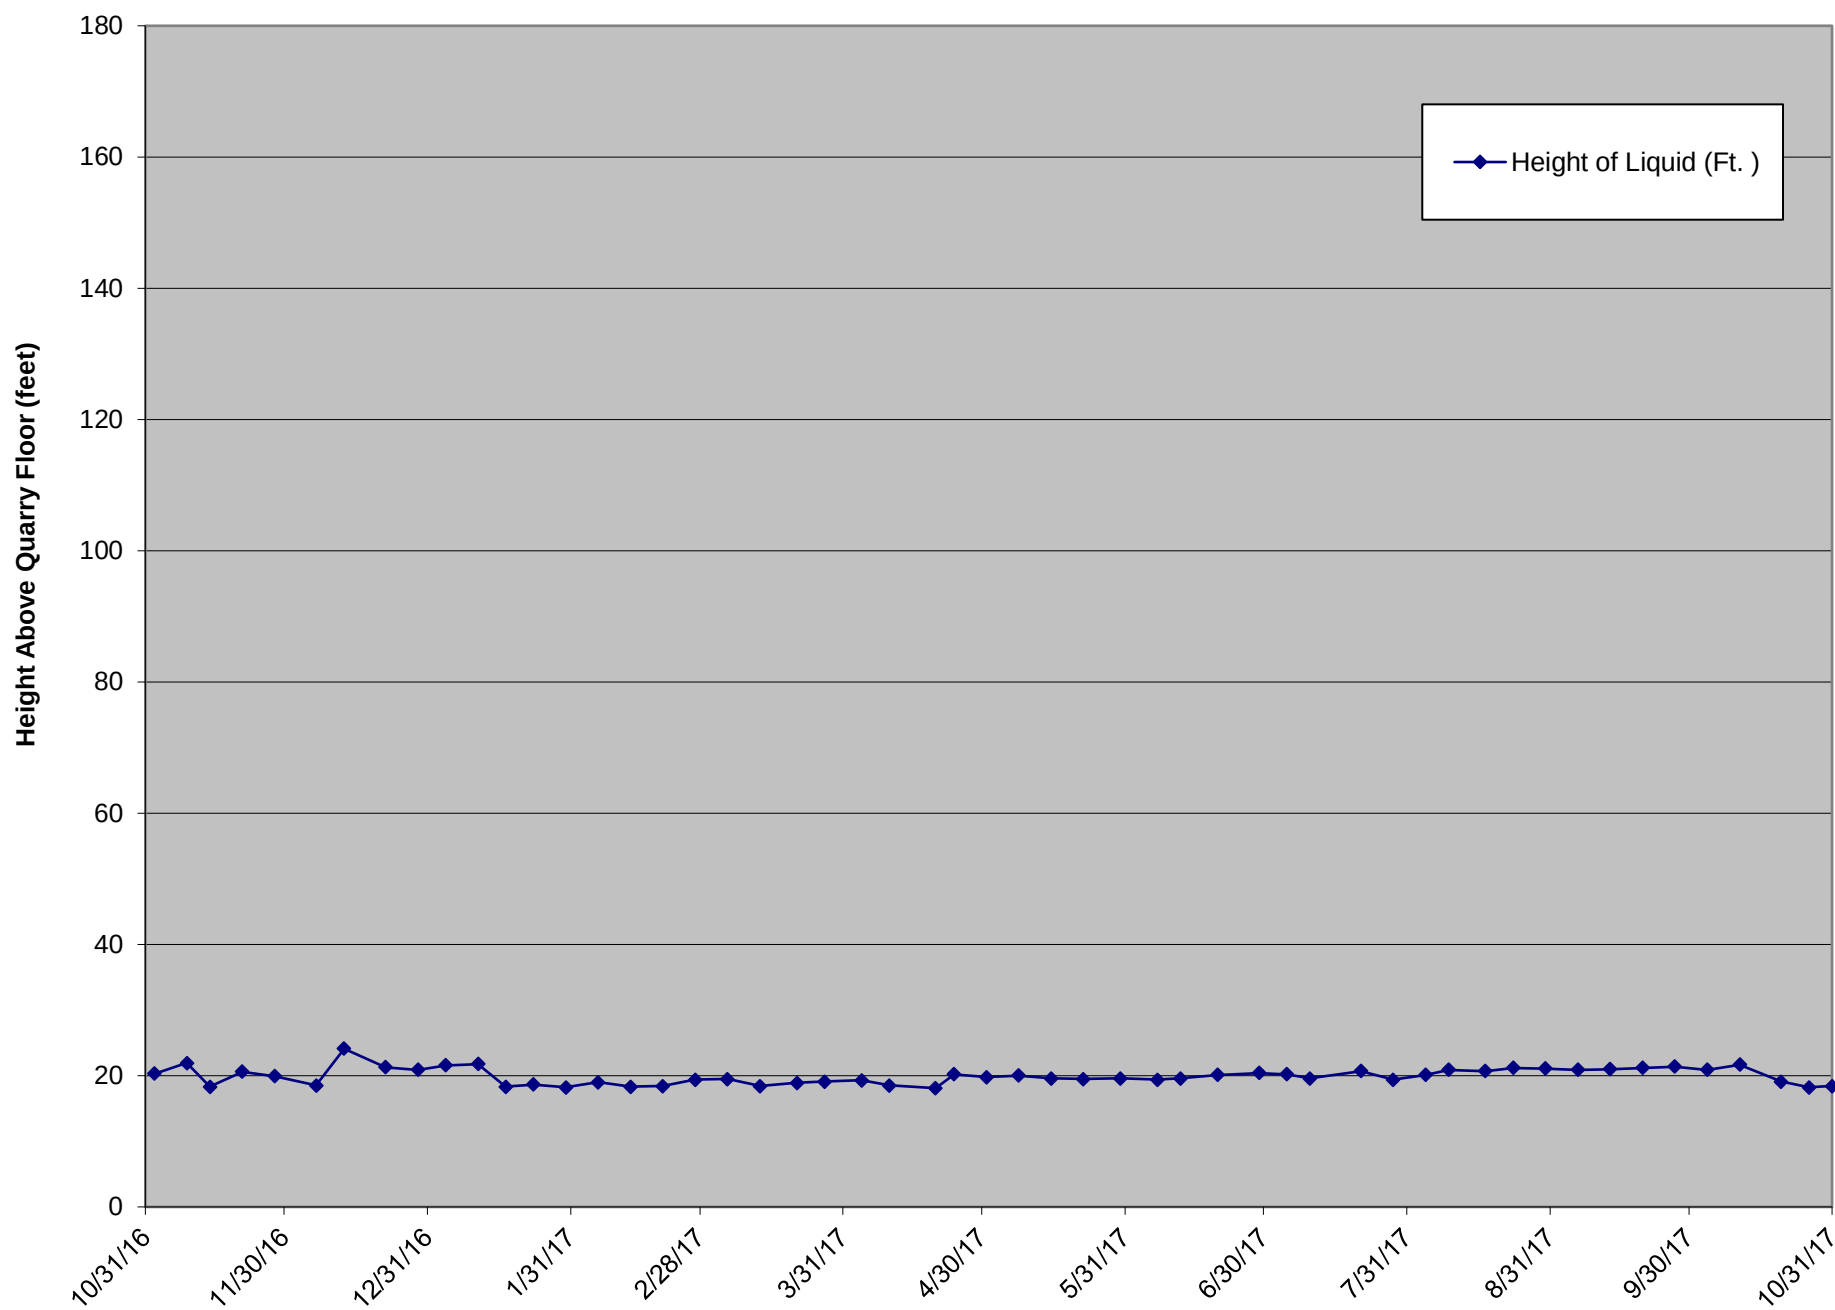
LCS-6B Liquid Level Above Quarry Floor

LCS-6B was fully operational during the weekly reporting period.

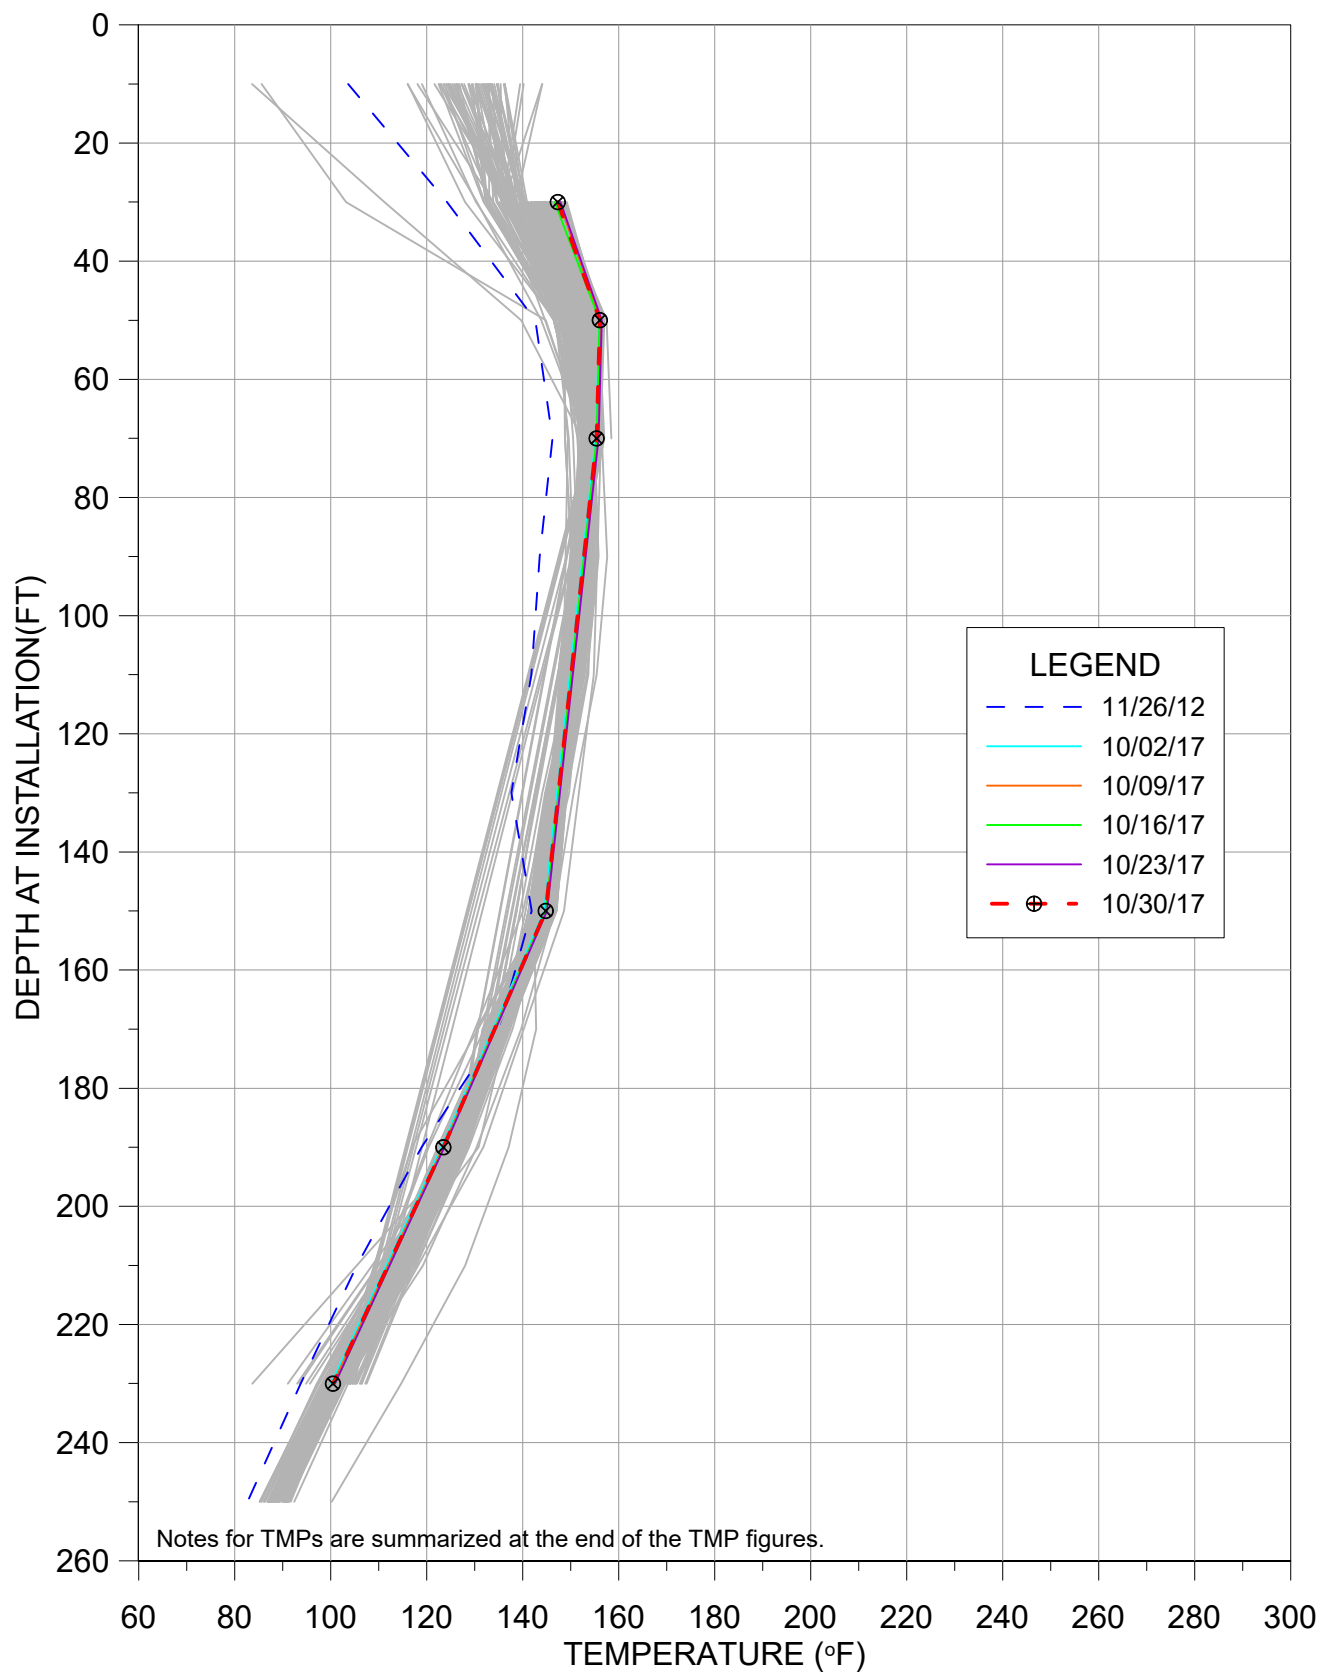
# TMP-3

1. No reliable temperature readings have been obtained at 170 ft depth since 1/29/2014, except on 3/13/2014.
2. The connectivity tests on 4/11/2014 conducted by CEC showed that units at 10, 90, 130, 210 and 250 ft depths are no longer reliable.
3. The connectivity tests on 10/28/2014 conducted by Feezor Engineering showed that units at 10, 90, 110, 130, 210 and 250 ft depths are not reliable.

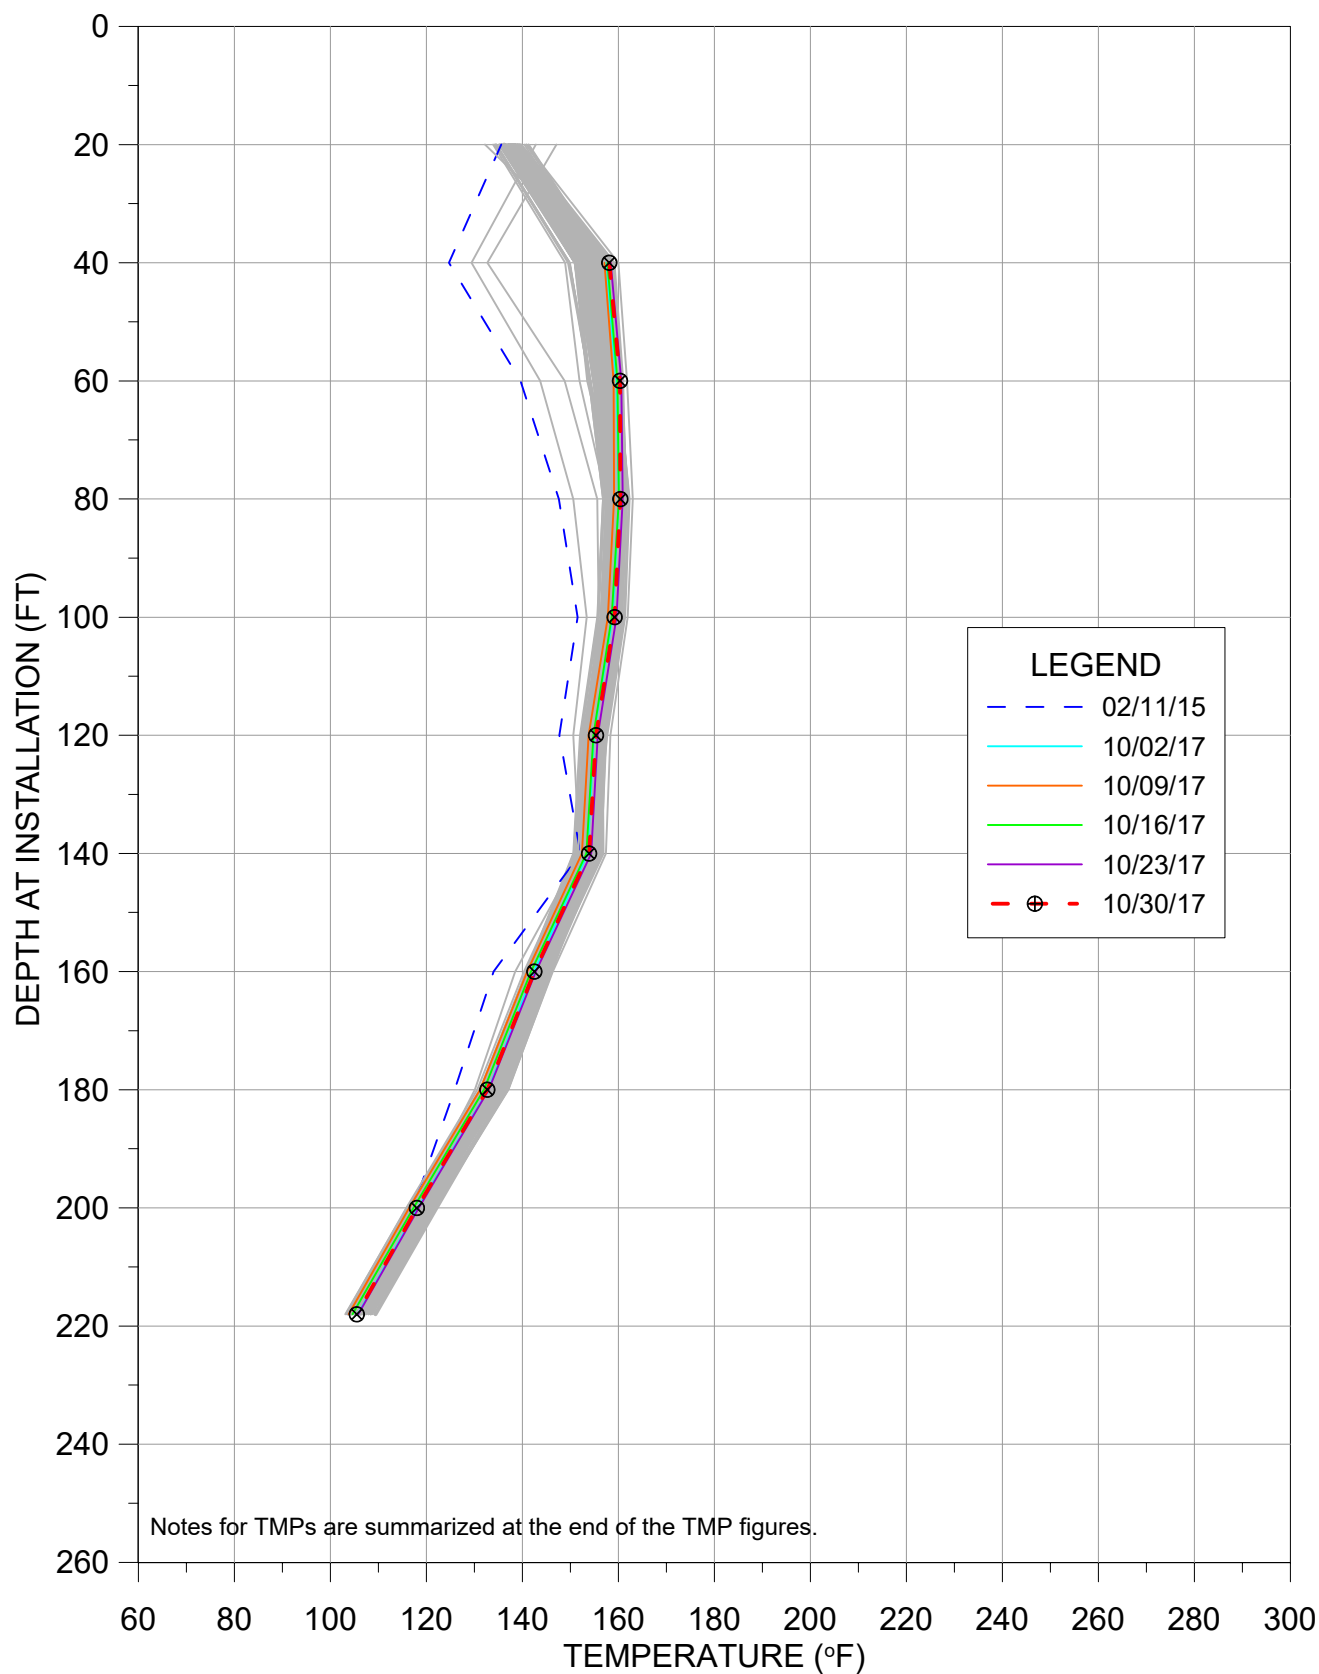
# TMP-3R

1. The unit at 20 ft depth had a fluctuating resistance since 9/25/2017. Therefore the temperature is determined to be unreliable.

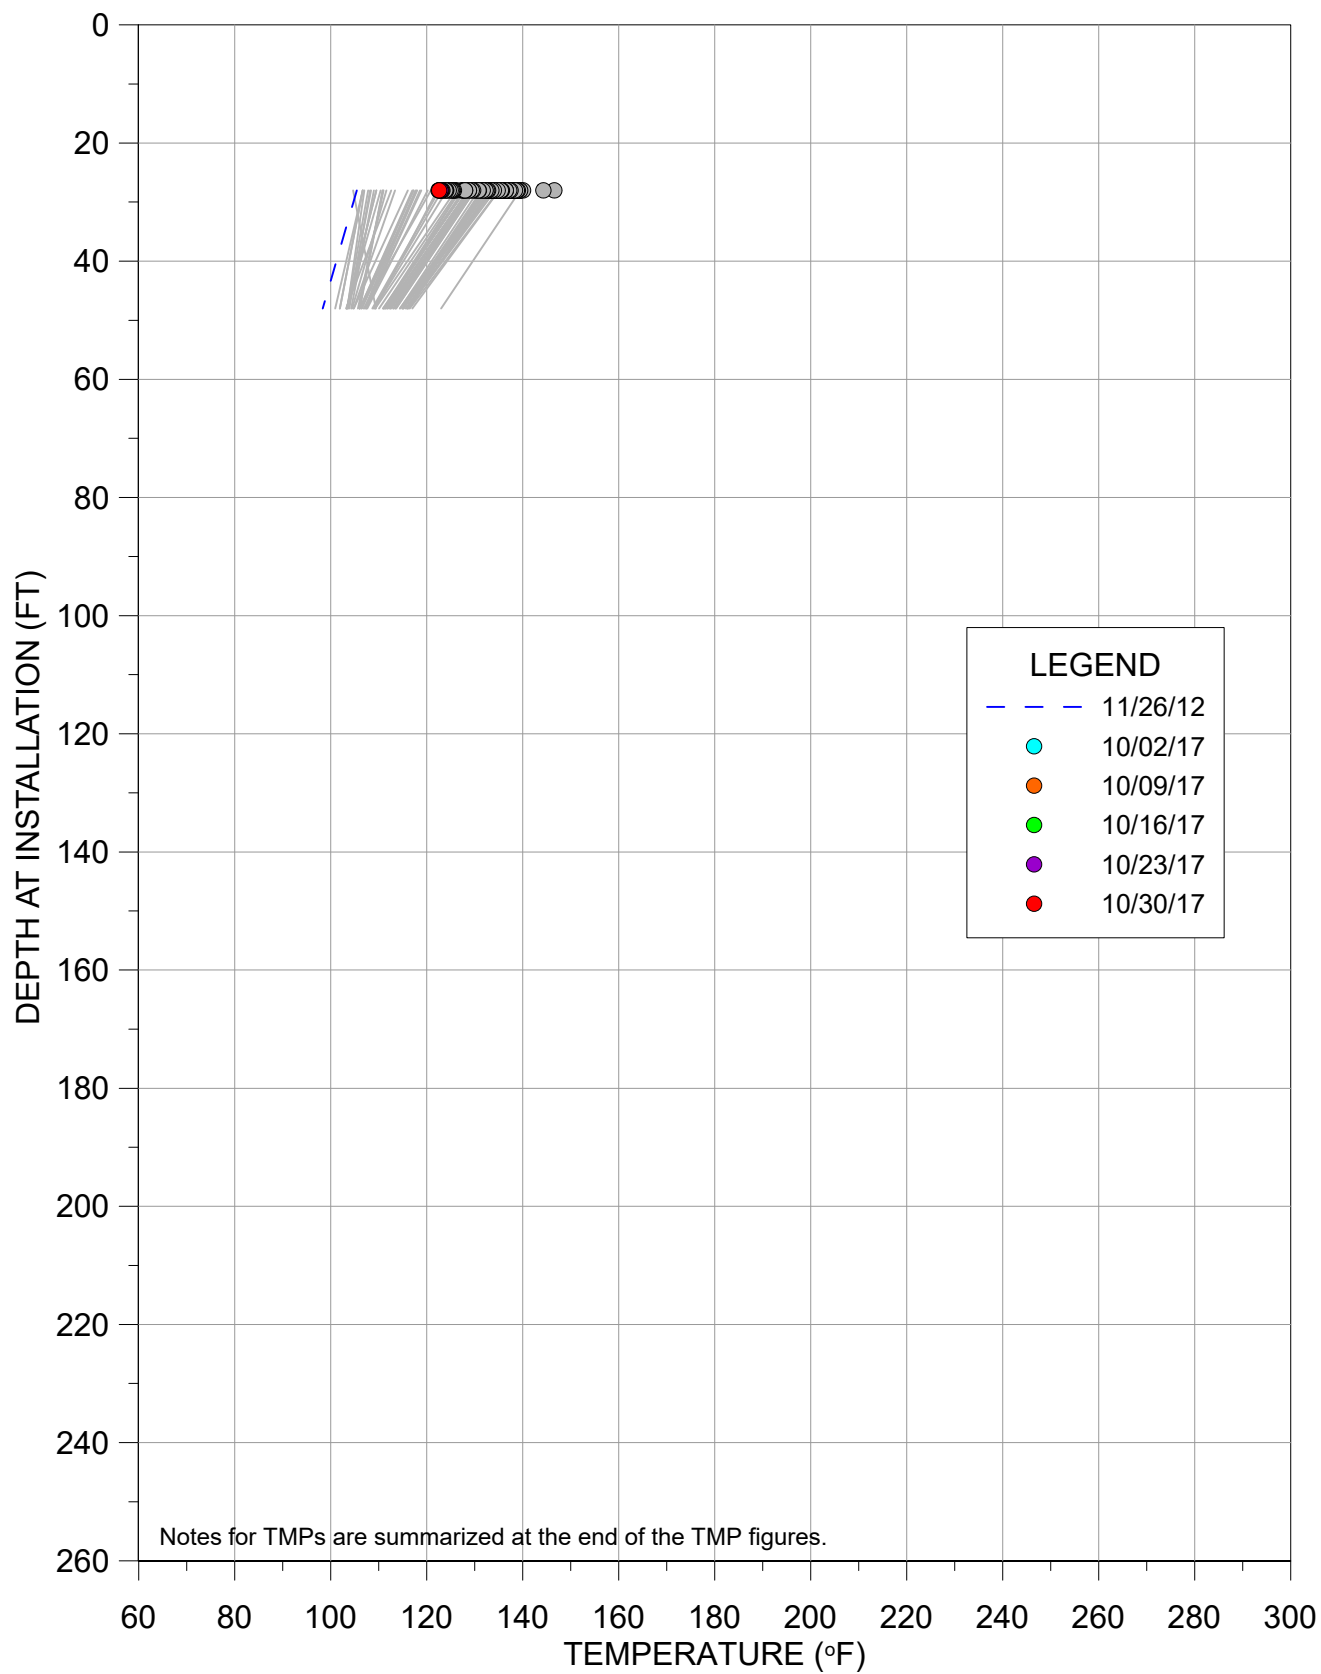
# TMP-4

1. The connectivity tests on 4/11/2014 conducted by CEC showed that the unit at 48 ft depth is no longer reliable.

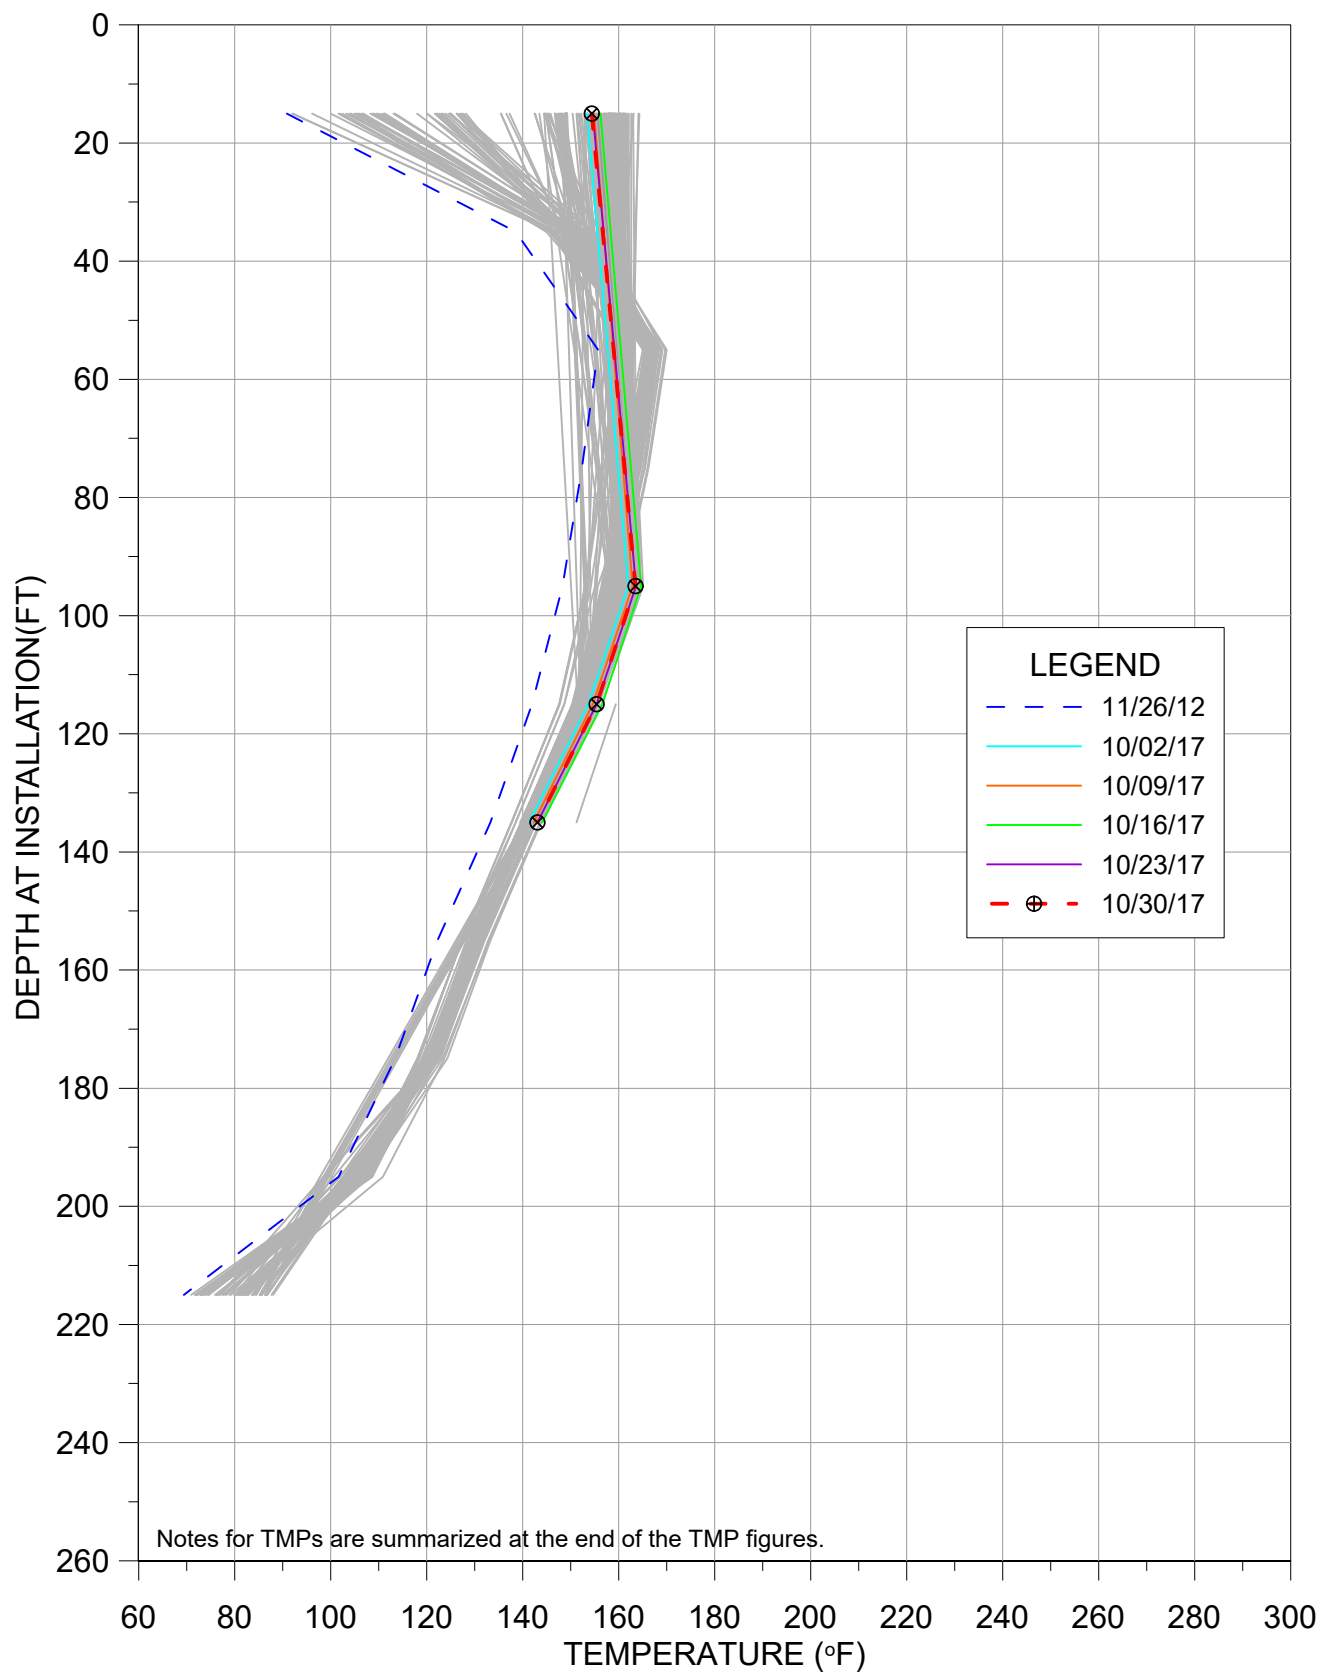
# TMP-6

1. The connectivity tests on 4/11/2014 conducted by CEC showed that units at 35, 55, 75, 155, 175, and 195 ft depths are no longer reliable.
2. No reliable temperature readings have been obtained at the unit at 215 ft depth since 6/13/2014.
