# **Bridgeton Landfill, LLC**

## **Weekly Data Submittal**

**Week of October 29, 2017 – November 4, 2017**

**Required by Section 52.F of Agreed Order, Case No. 13SL-CC01088  
Effective May 13, 2013**

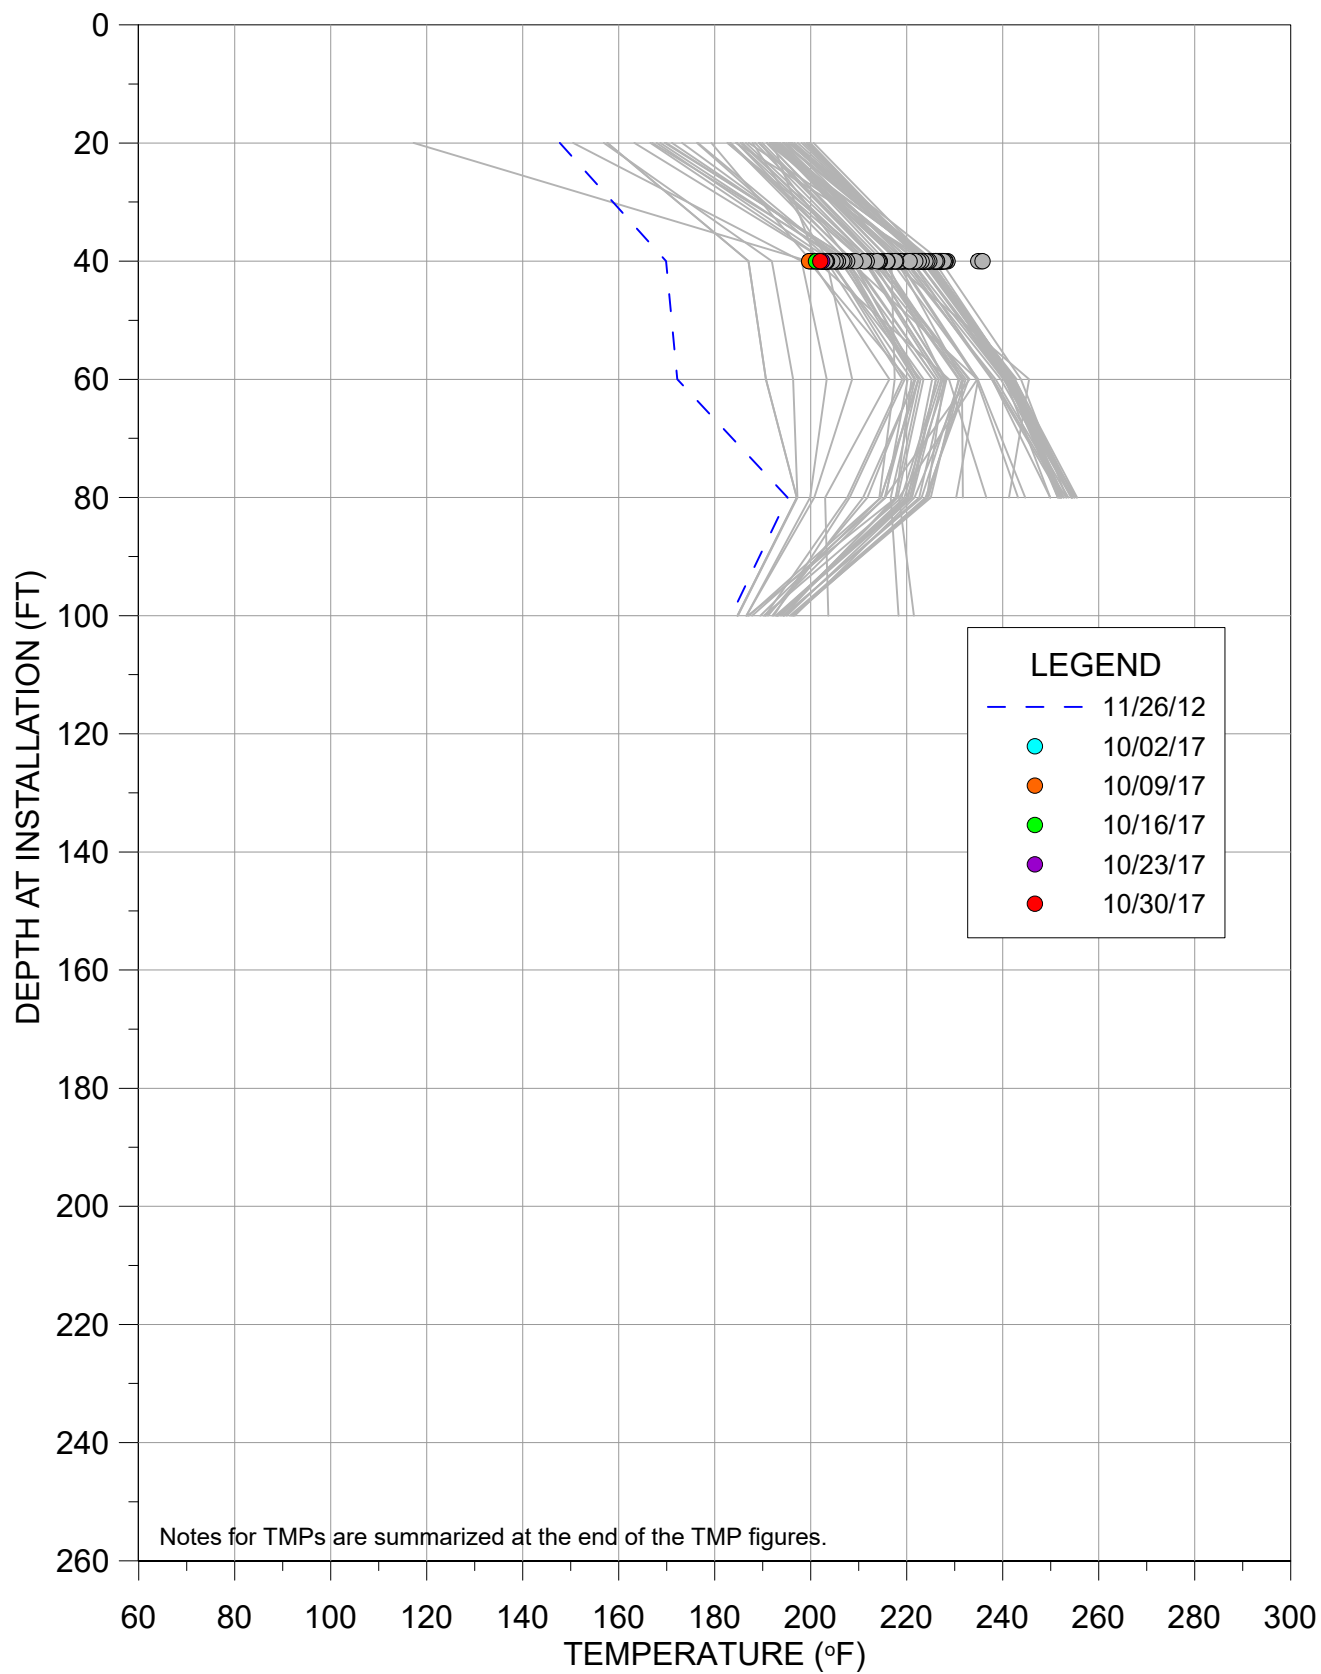
# TMP-9

1. Unit at 100 ft depth had an inaccurate temperature reading on 8/1/2013 and no reading since 8/6/2013.
2. The connectivity tests on 4/11/2014 conducted by CEC showed that units at 20, 60, 80, and 100 ft depths are no longer reliable.

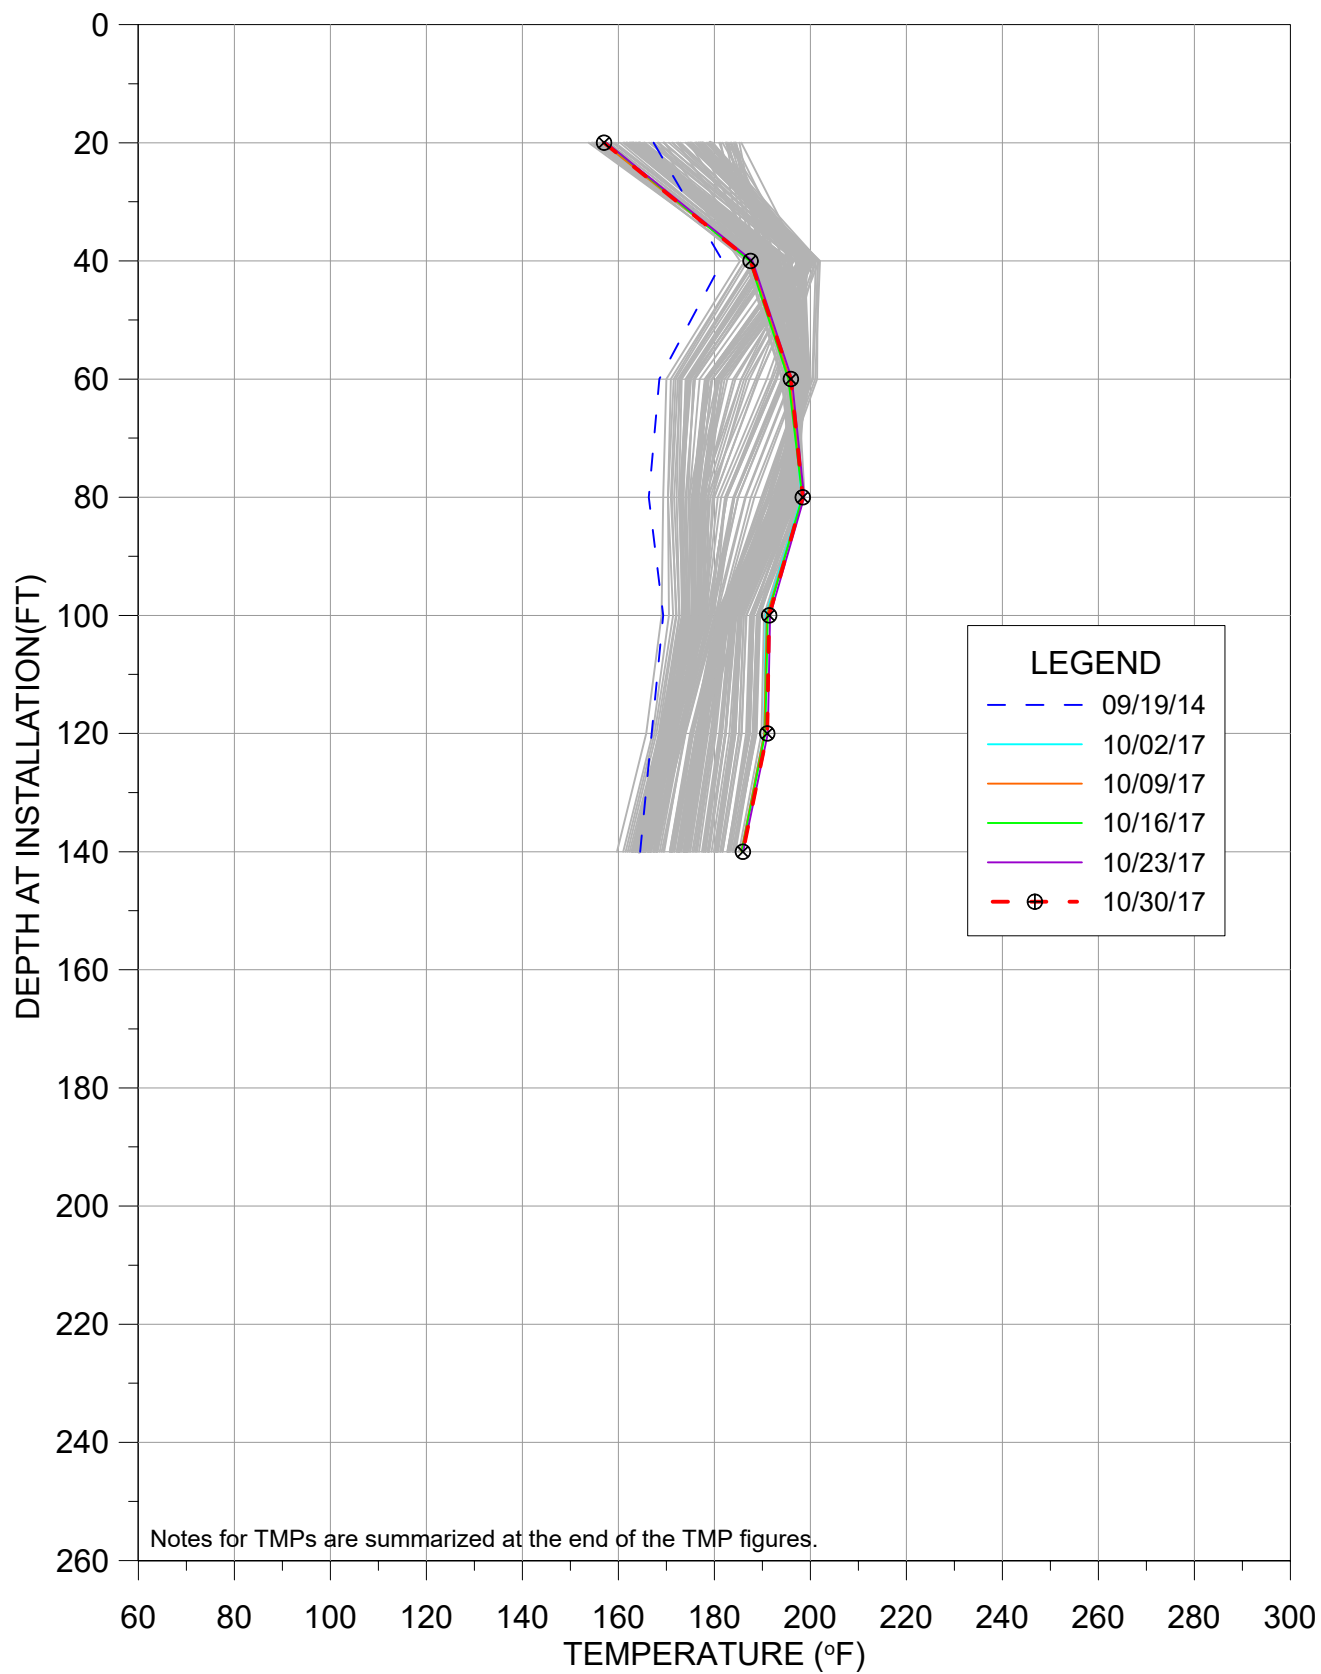
# TMP-14R

1. Due to the connectivity test results by Feezor Engineering on TMP-14 (see note above), TMP-14R is added to this reporting data set as of 3/7/2016.

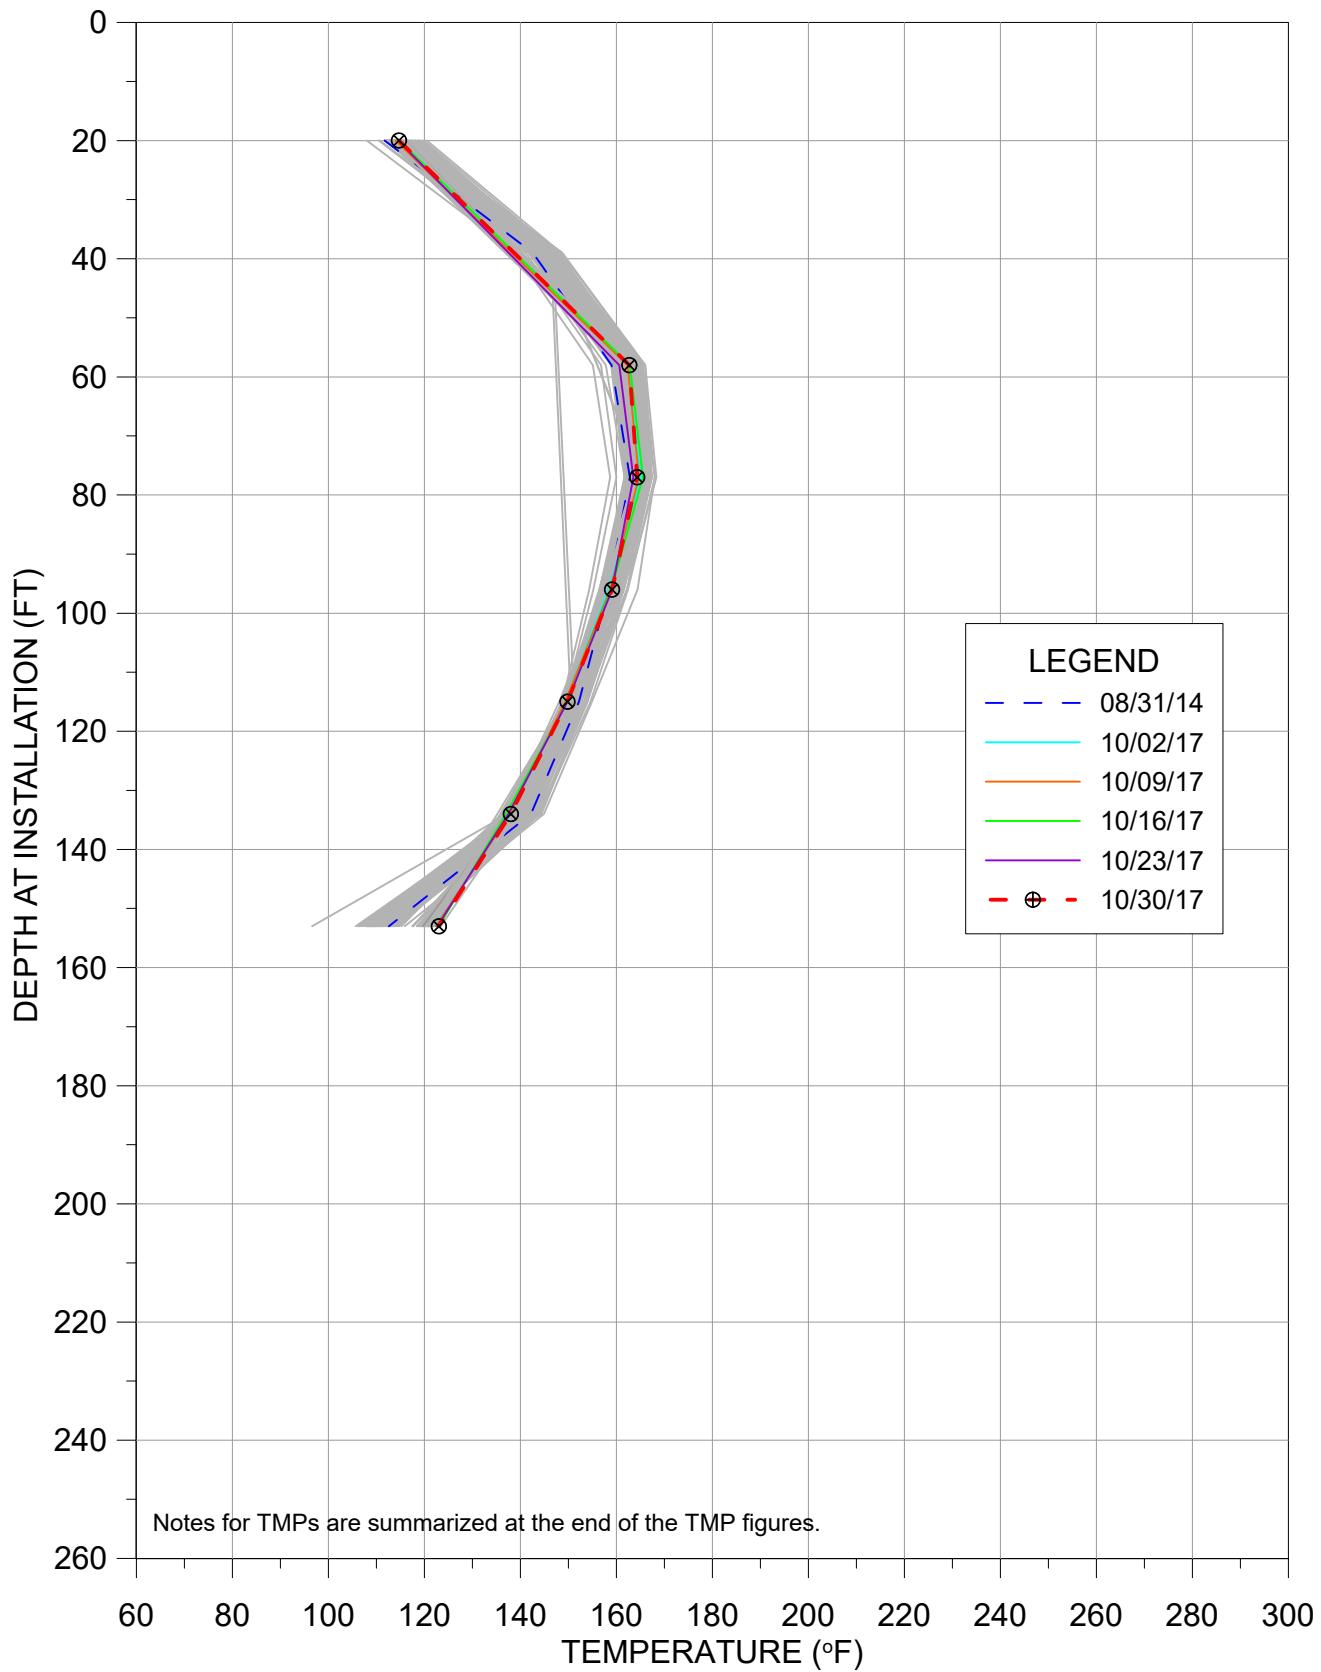
# TMP-16

1. A connectivity test conducted by Feezor Engineering showed that the units on TMP-16 may not be reliable since 9/9/2015. Further testing at the end of September 2015 showed possible connectivity on some of the units.
2. The unit at 153 ft depth had a low resistance reading and unreliable temperature since 12/21/2015.

3. The unit at 39 ft depth had a higher than acceptable resistance reading and unreliable temperature between beginning on 2/7/17. Unit resumed normal resistance on 3/28/17 but is still considered unreliable as no repairs were done to reducer the resistance. NOTE REVISED- 10/13/17

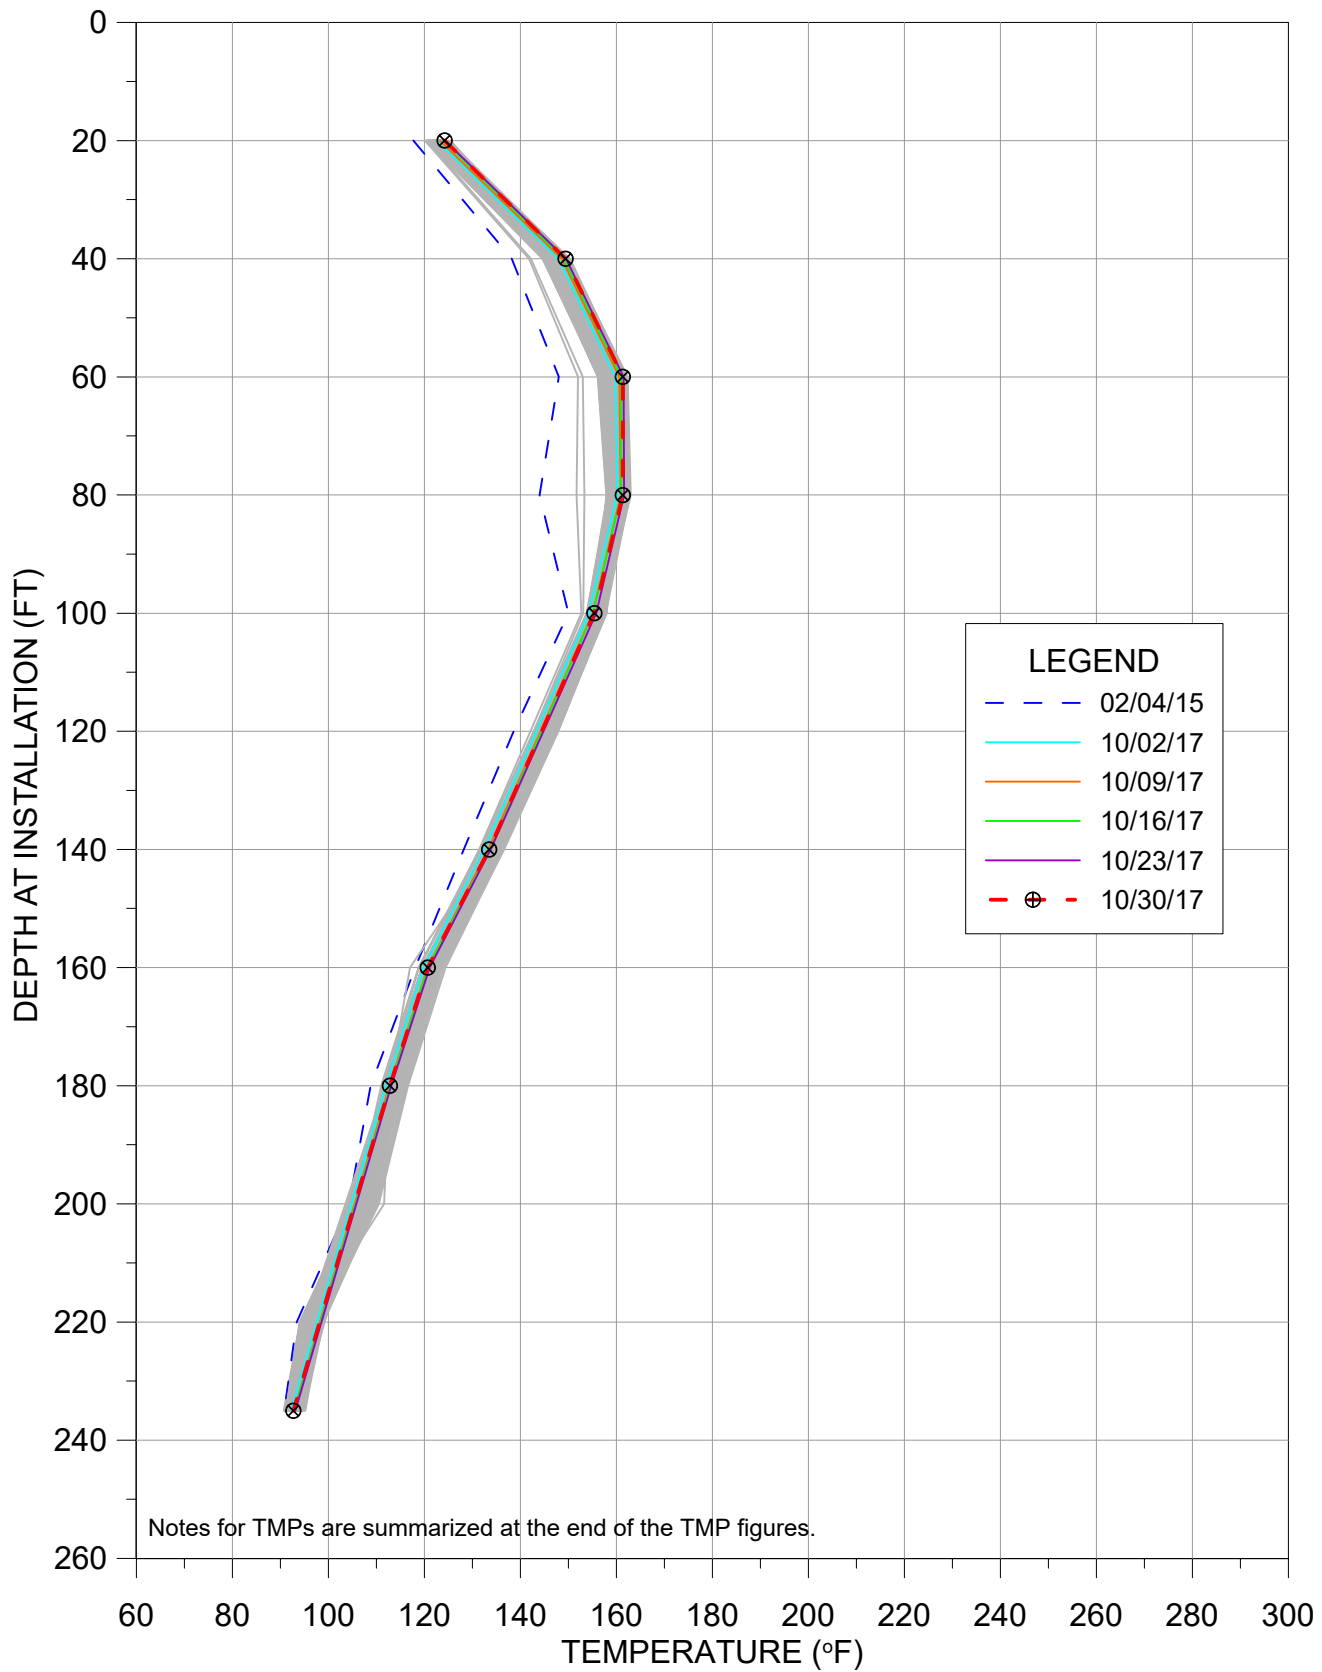
# TMP-25

1. The unit at 200 ft provided an apparent anomalous reading on 3/28/2017. Subsequent readings on 4/4/2017 showed the unit to have failed (see below). The unit is no longer working and the reading of 3/28/2017 was likely unreliable.

2. The unit at 200 ft depth had a resistance reading greater 4000 ohms on 4/4/2017. A connectivity test conducted by Feezor Engineering on 4/7/2017 showed that this unit also had cross-connectivity. The unit is therefore determined to be no longer working as of the 4/4/2017 reading.

3. The unit at 120 feet had a higher than acceptable limit on 7/10/2017. Also, a connectivity test conducted by Feezor Engineering on 4/7/2017 showed that this unit may be unreliable. Therefore, this unit is determined to be unreliable.

4. The unit at 220 ft has been reported as unable to attain a reading of any kind since June 19, 2017. The unit is considered to be on no longer working as of that date.

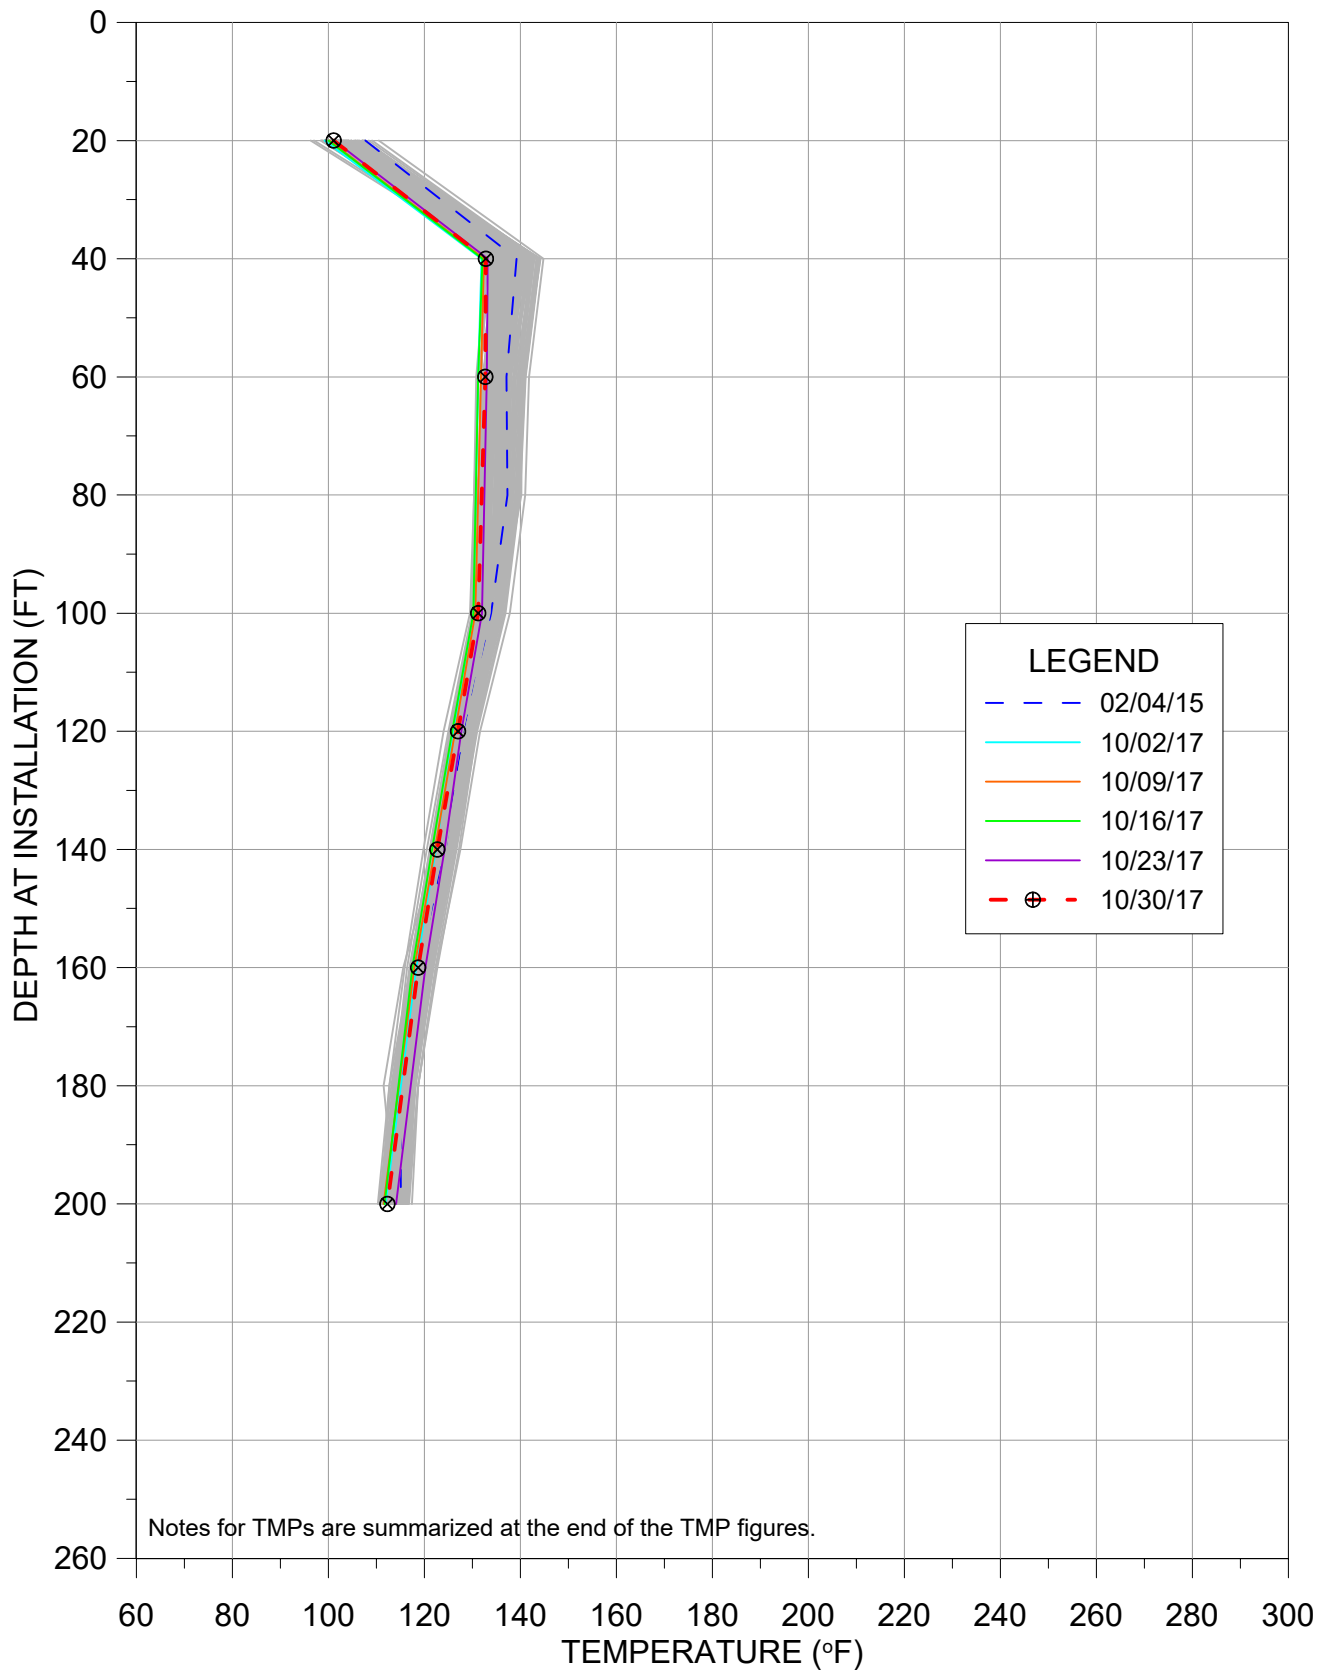
# TMP-28

1. The unit at 217 ft depth has had no resistance or temperature readings since installation.
2. The unit at 80 ft depth had a resistance drop and an unreasonable temperature decrease on 6/1/2016. The temperature has since fluctuated and is determined to be unreliable.
3. The unit at 180 feet has had a higher than acceptable limit since 3/28/2017 and is therefore determined to be unreliable as of the 4/4/2017 reading.

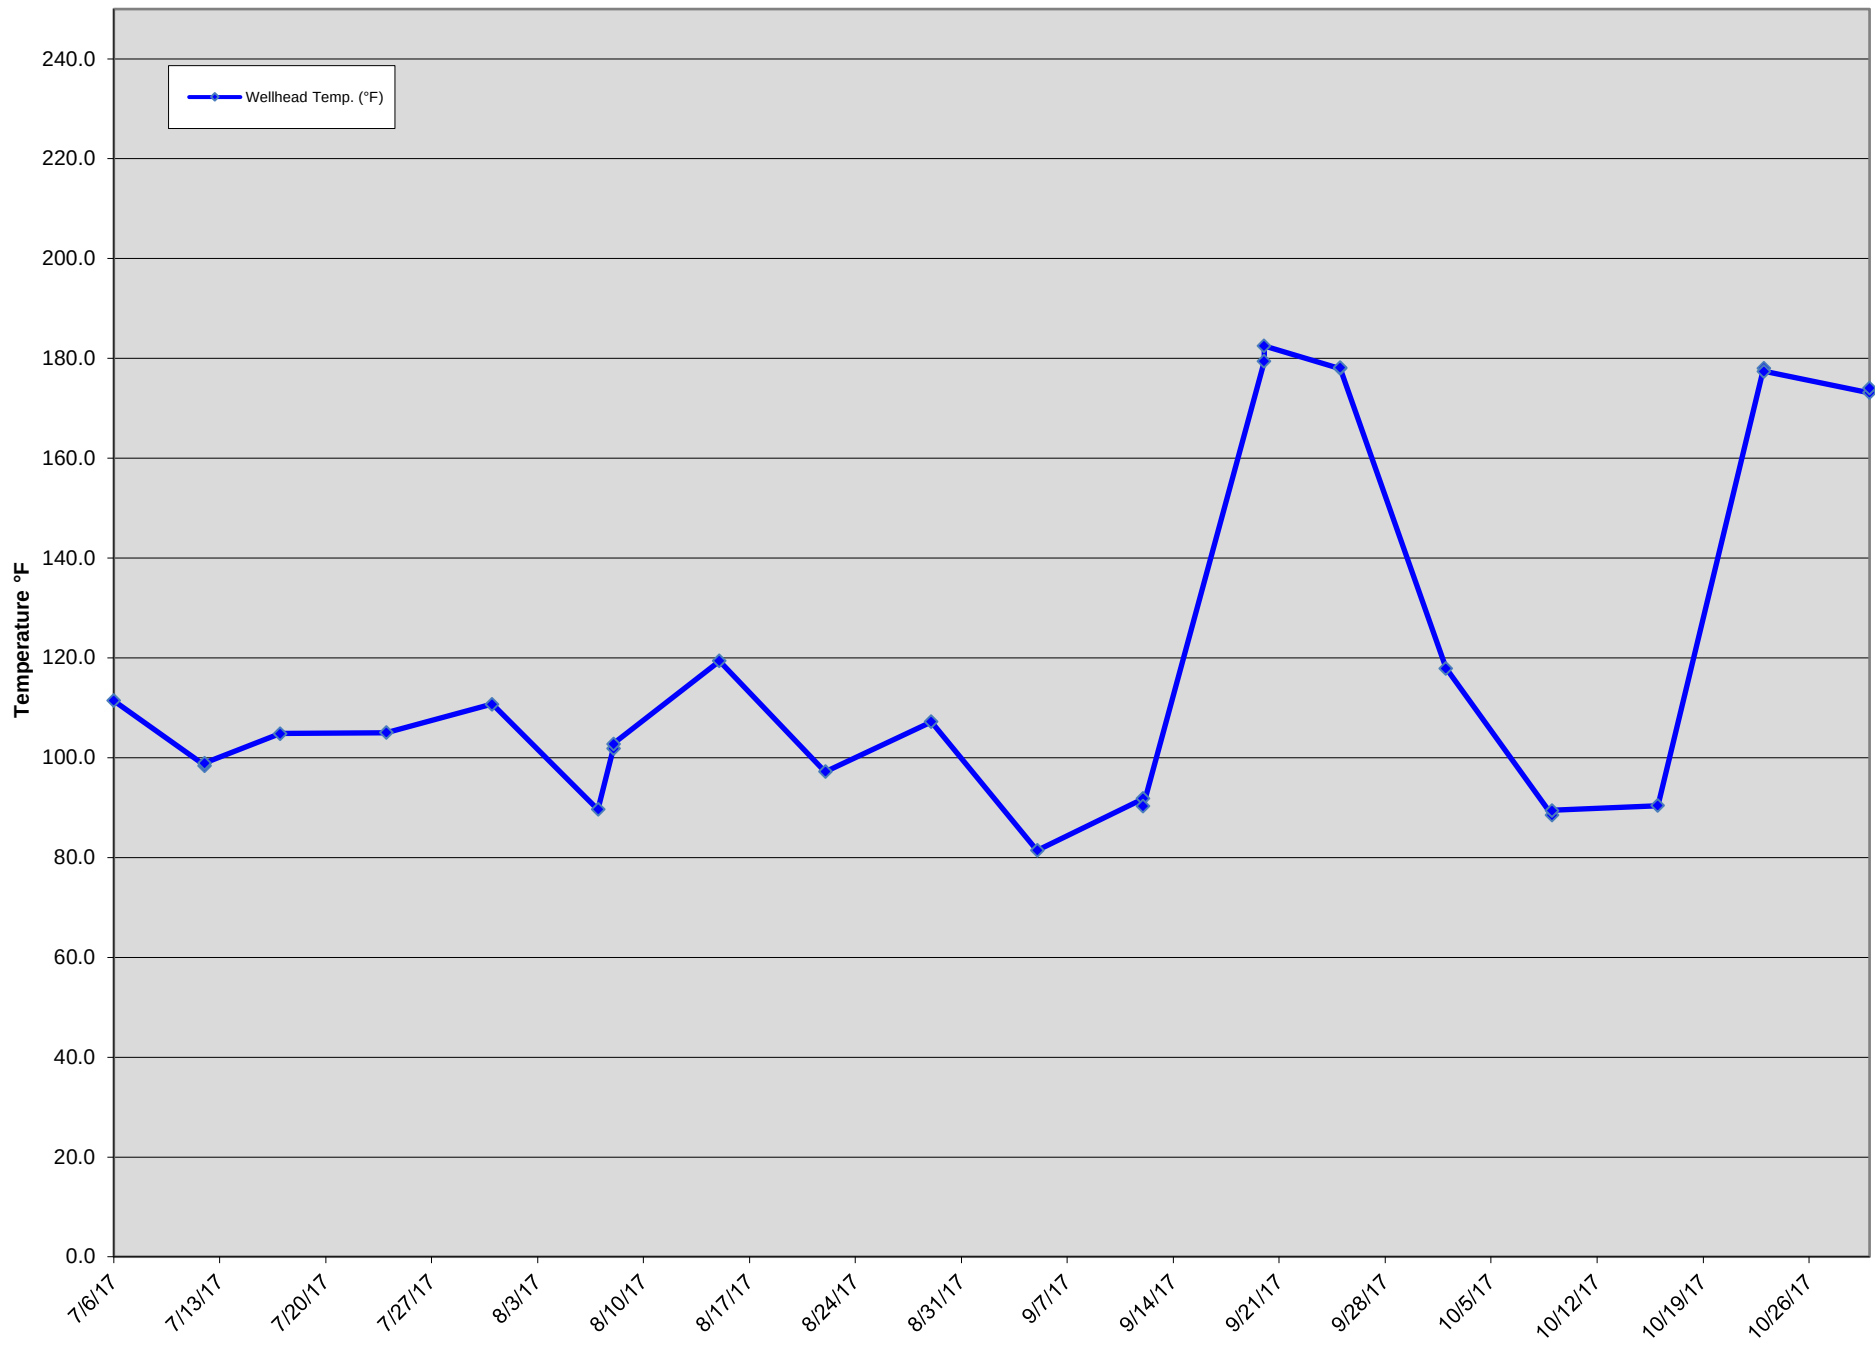
GIW-1 Wellhead Temperatures

As part of the HES, there are currently cooling water circulation loops installed in twelve Gas Interceptor Wells (GIWs) (GIW-02 through GIW-13). The remaining well (GIW-01) had a measured gas temperature within its historical operating limits.
