**YEAR 3 HEAT EXTRACTION BARRIER
PERFORMANCE REPORT**

BRIDGETON LANDFILL

BRIDGETON, ST. LOUIS COUNTY, MISSOURI

October 11, 2019

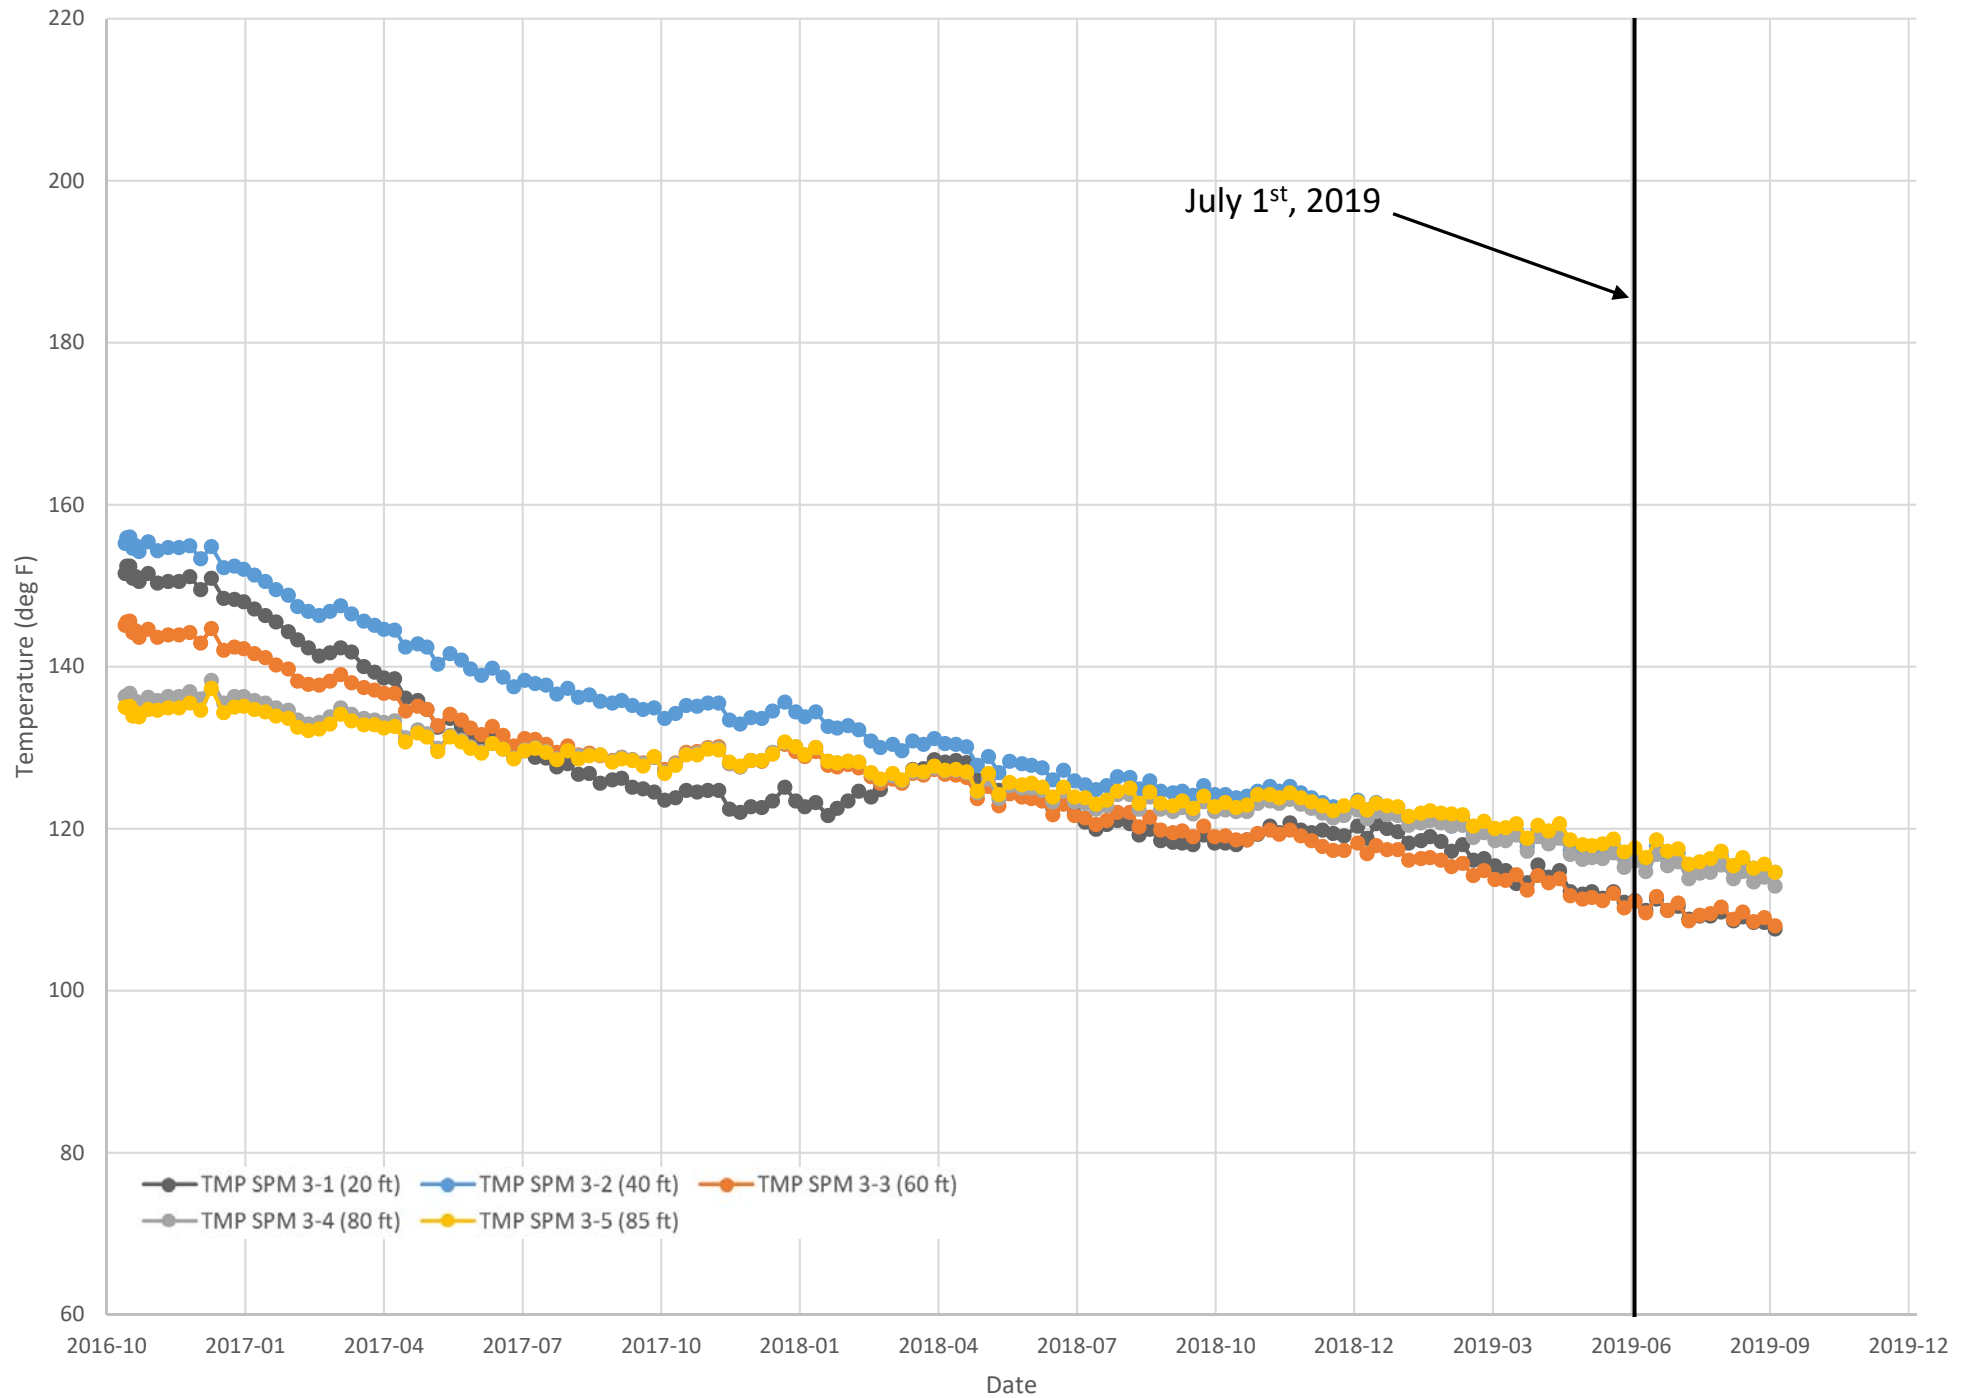
TMP SPM-3

On March 11, 2019, it was observed that HEW-4 was not able to accommodate a six (6) gallon per minute flow that was deemed optimal. Flow continued to decrease until it ceased on July 22, 2019. Two separate field investigations (on July 31, 2019 and August 13, 2019) have determined that a constriction in HEW-4 exists between 90-95 feet below ground level.

Temperature measurement results for adjacent SPM-TMPs were evaluated to determine if there is evidence of thermal rebound. TMP-SPM-3 is the closest TMP to HEW-4 (approximately 25 feet away). Time series per TMP thermocouple graphs are provided in **Appendix G** for TMP-SMP-2 and TMP-SPM-3. The TMP-SPM-3 graph depicts stable subsurface temperatures north of the HEB despite the zero-flow condition beginning July 2019 at HEW-4. The graph for TMP-SPM-2 (approximately 45 ft south of HEW-4) also depicts generally downward trends since July 2019 for most of the individual probes.

Thermal modeling will be conducted for the inoperable HEW-4 unit. The report of the thermal modeling analysis is expected to be submitted to the USEPA and MDNR by January 31st, 2020.
