Bridgeton Landfill, LLC

Weekly Data Submittal

Week of June 10, 2018 – June 16, 2018

**Required by Section 52.F of Agreed Order, Case No. 13SL-CC01088
Effective May 13, 2013**

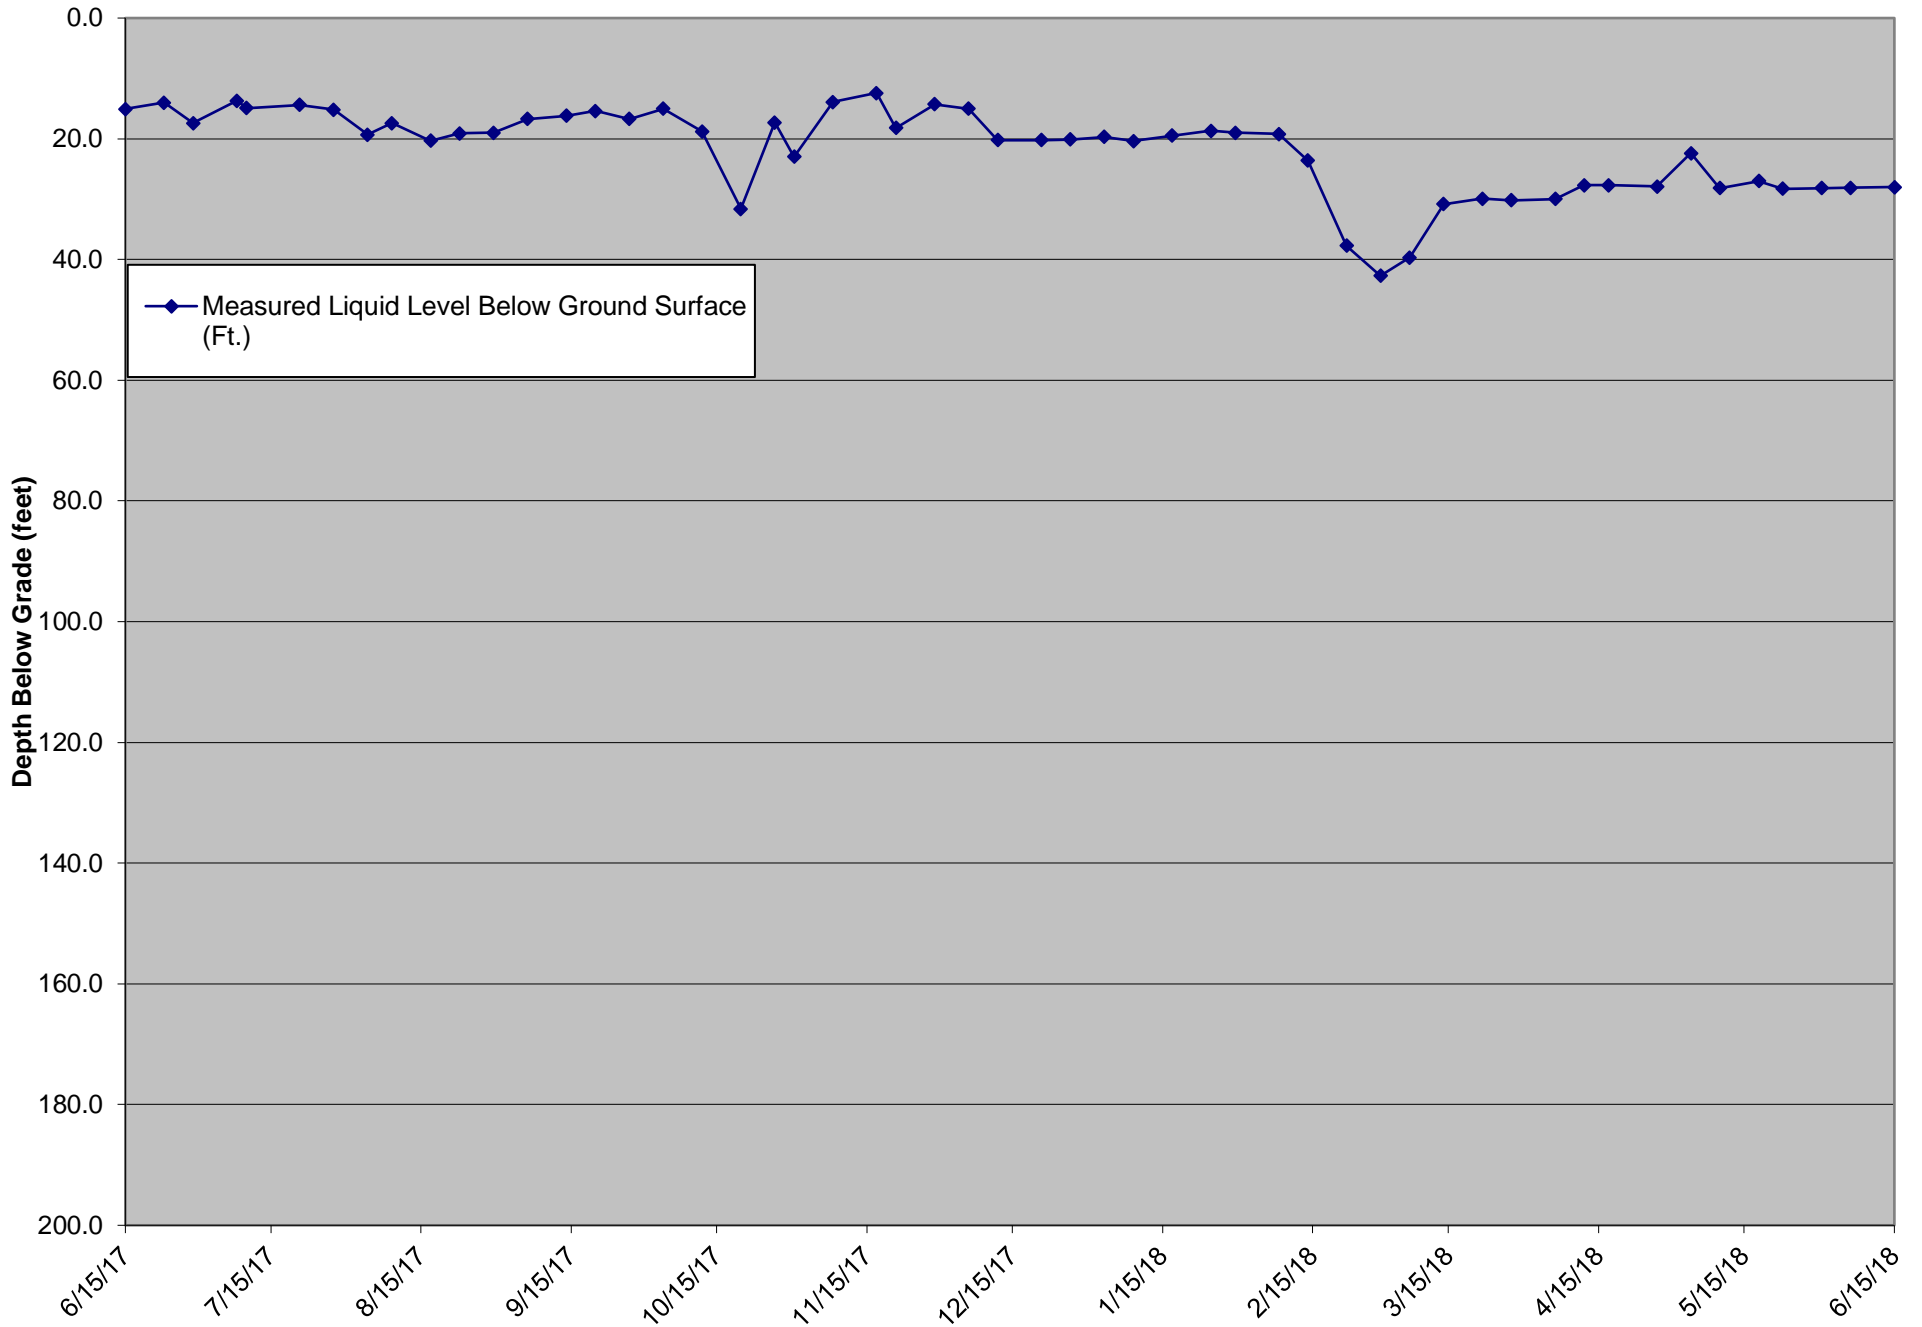
LCS-3D Liquid Level Below Ground Surface

The QED AP-4 pneumatic pump in LCS-3D was non-operational during the weekly reporting period. Liquid level was measured manually.

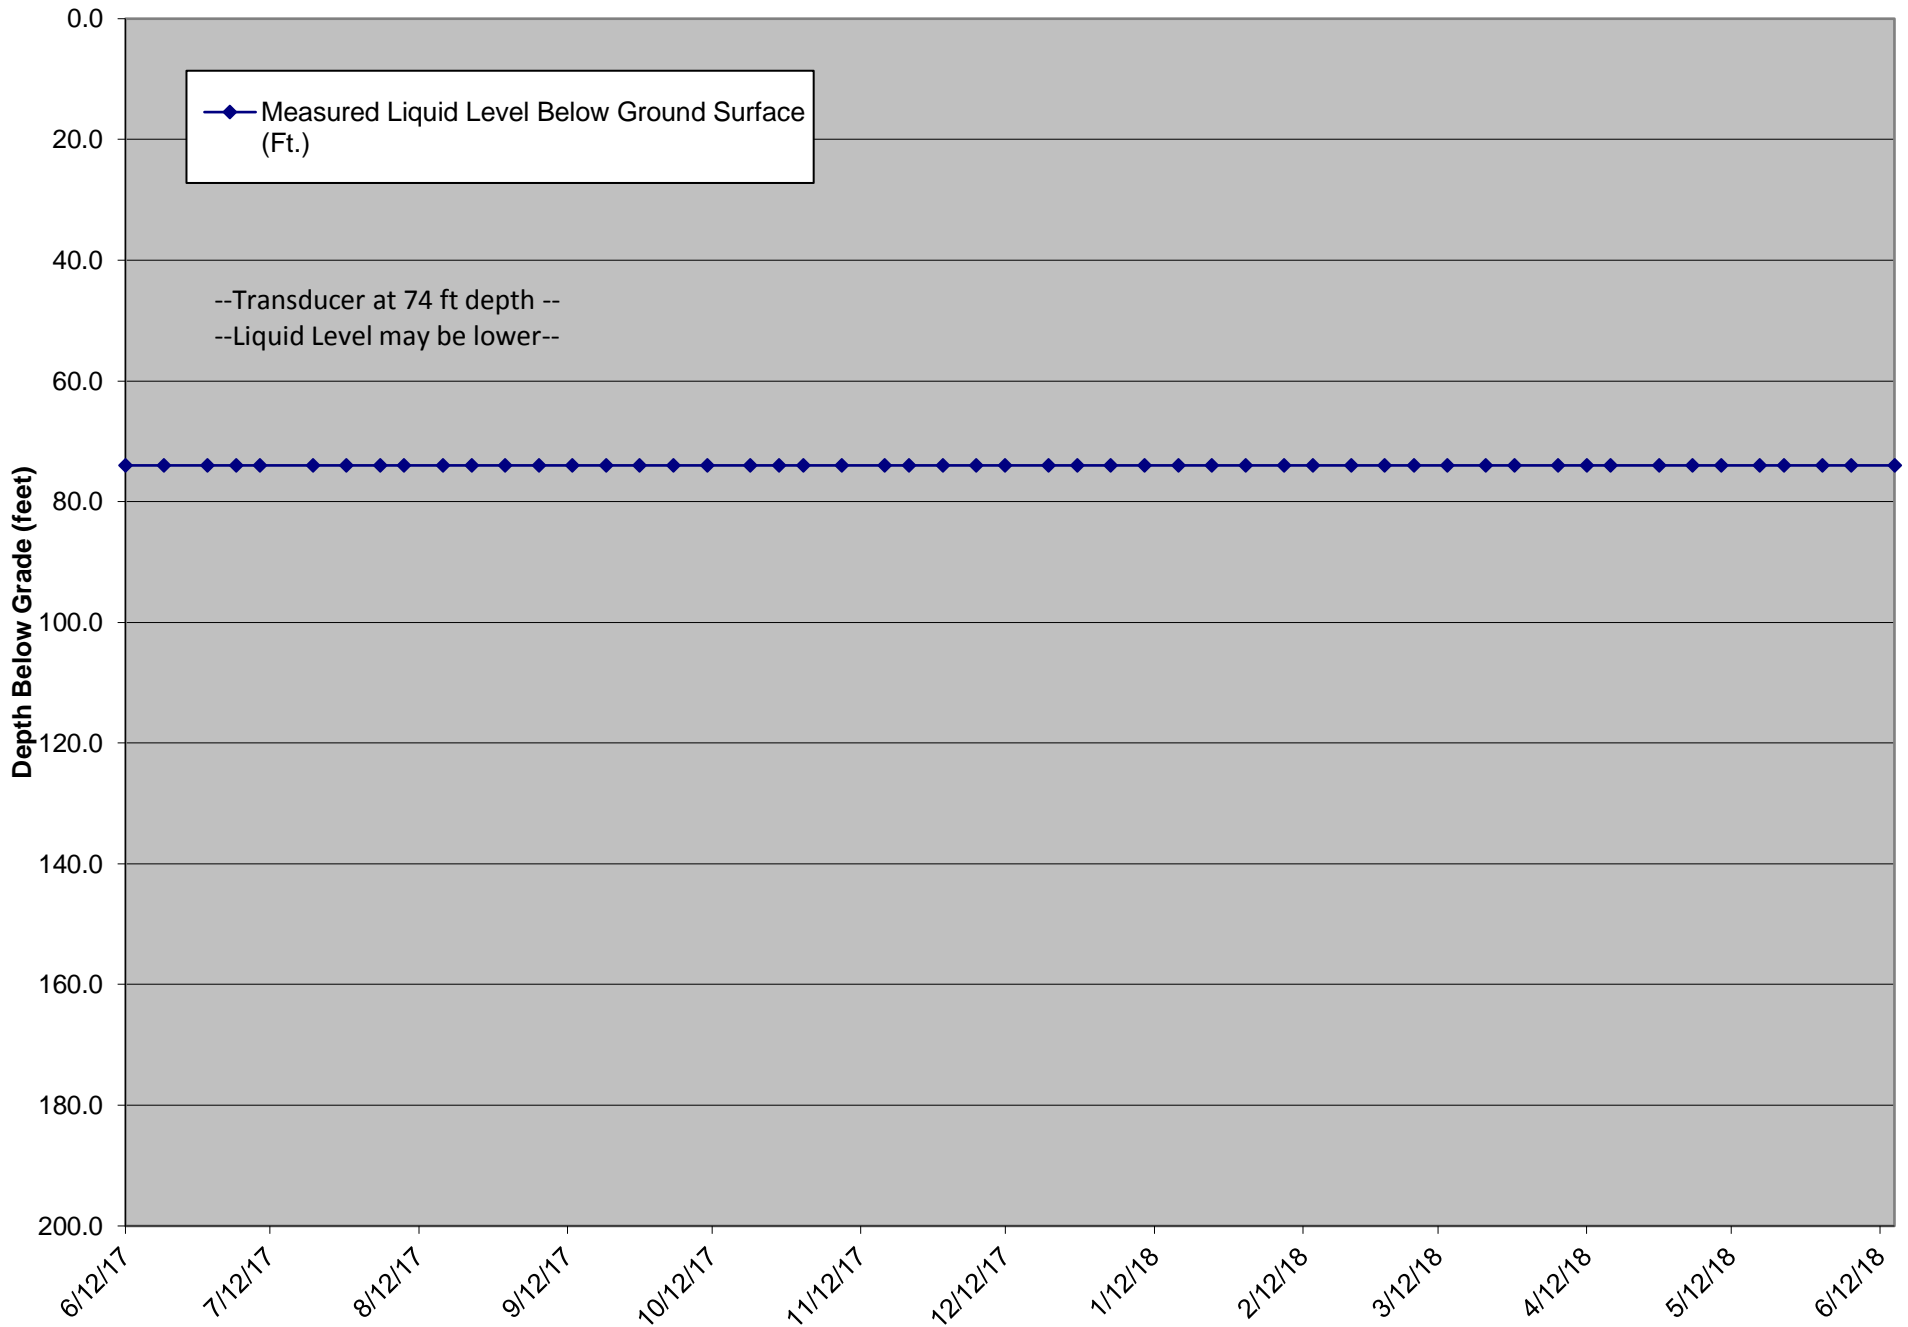
LCS-4B Liquid Level Below Ground Surface

The level sensor in LCS-4B is currently operational and responsive. Liquid level was not recorded by the level sensor during the weekly reporting period. LCS-4B is equipped with a flow meter that displayed no flow during the weekly reporting period. Therefore, it can be concluded that the liquid level was below the bottom of the pump and level sensor in LCS-4B.

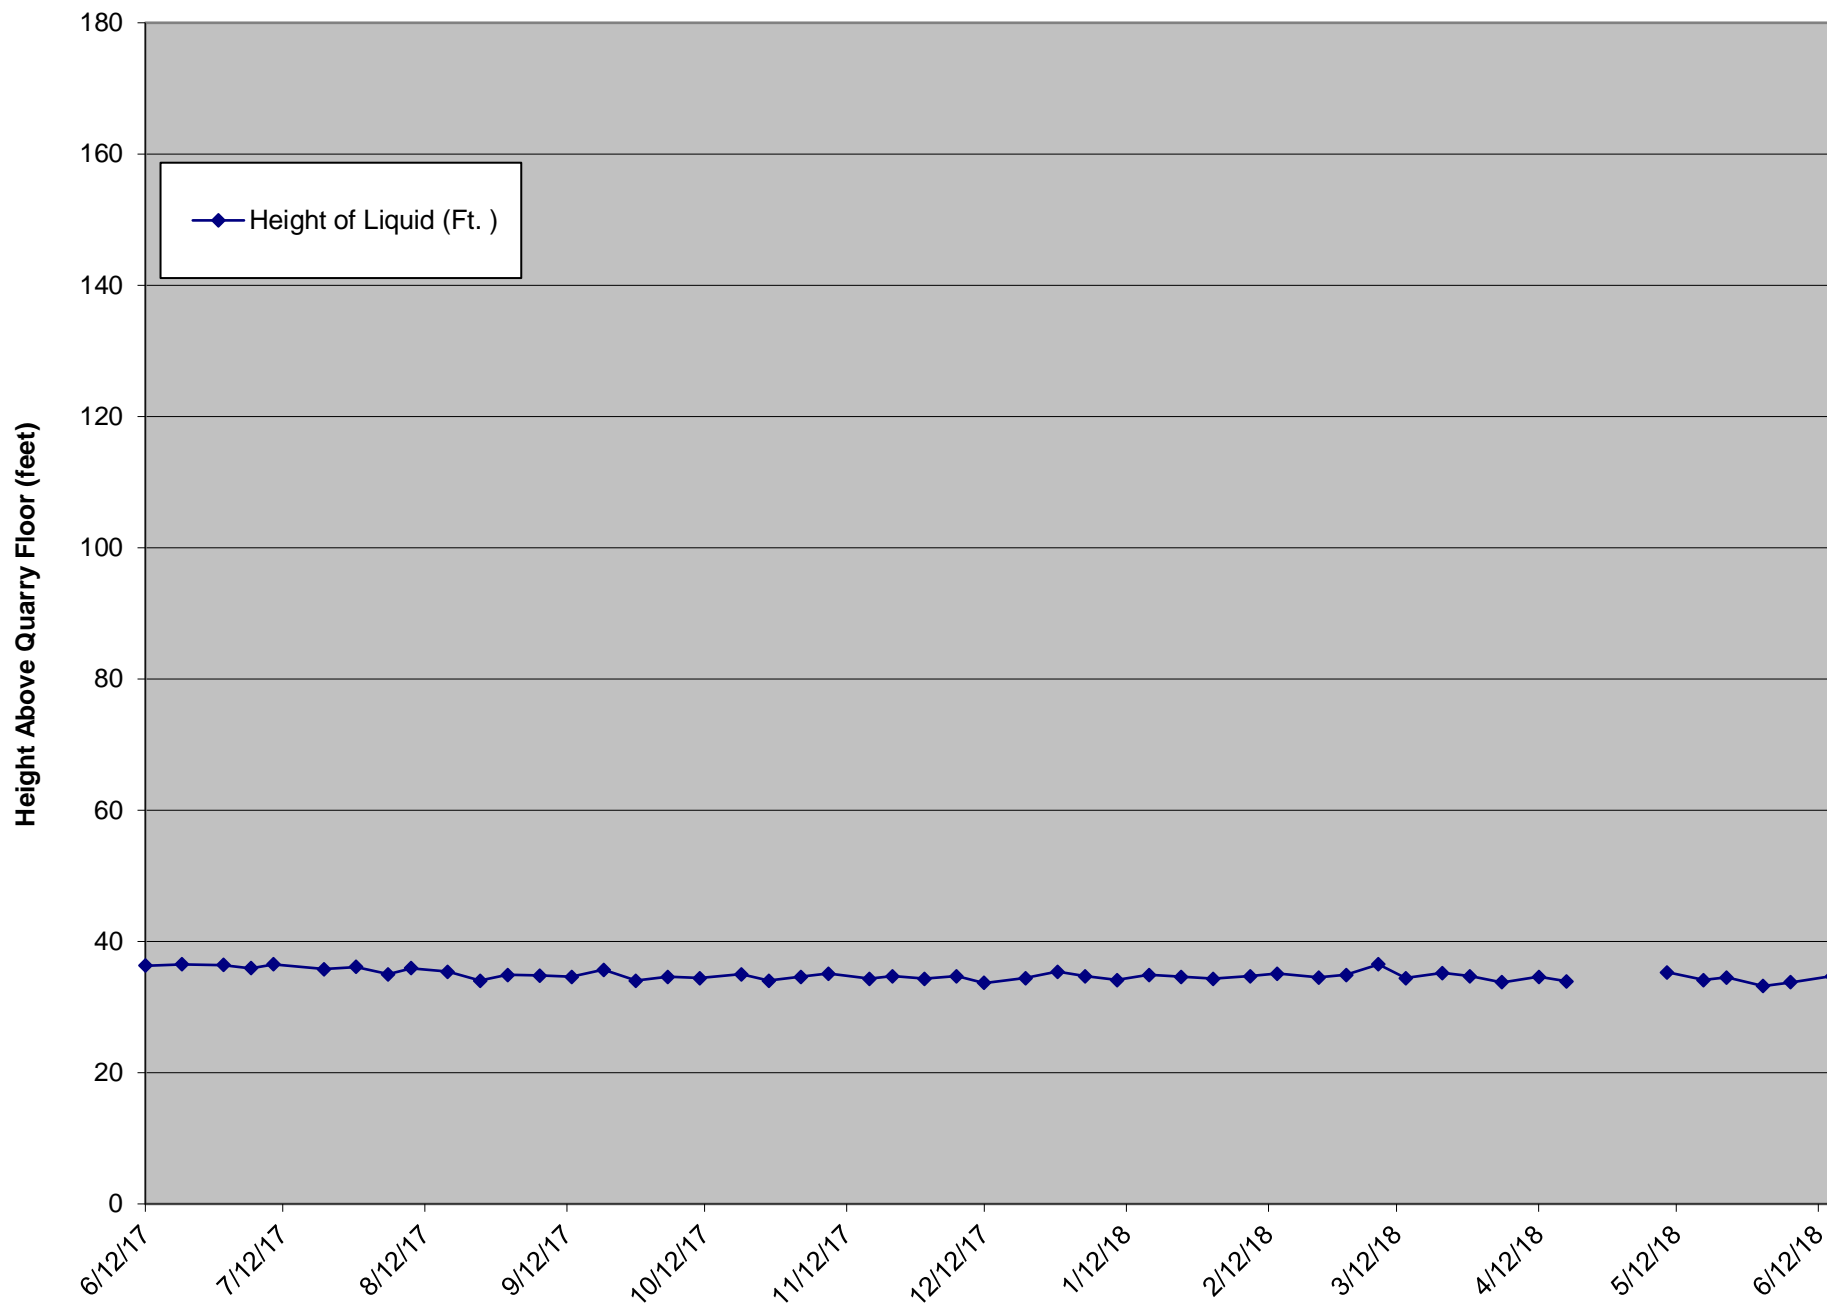
LCS-5B Liquid Level Above Quarry Floor

LCS-5B and LCS-6B were fully operational during the weekly reporting period.

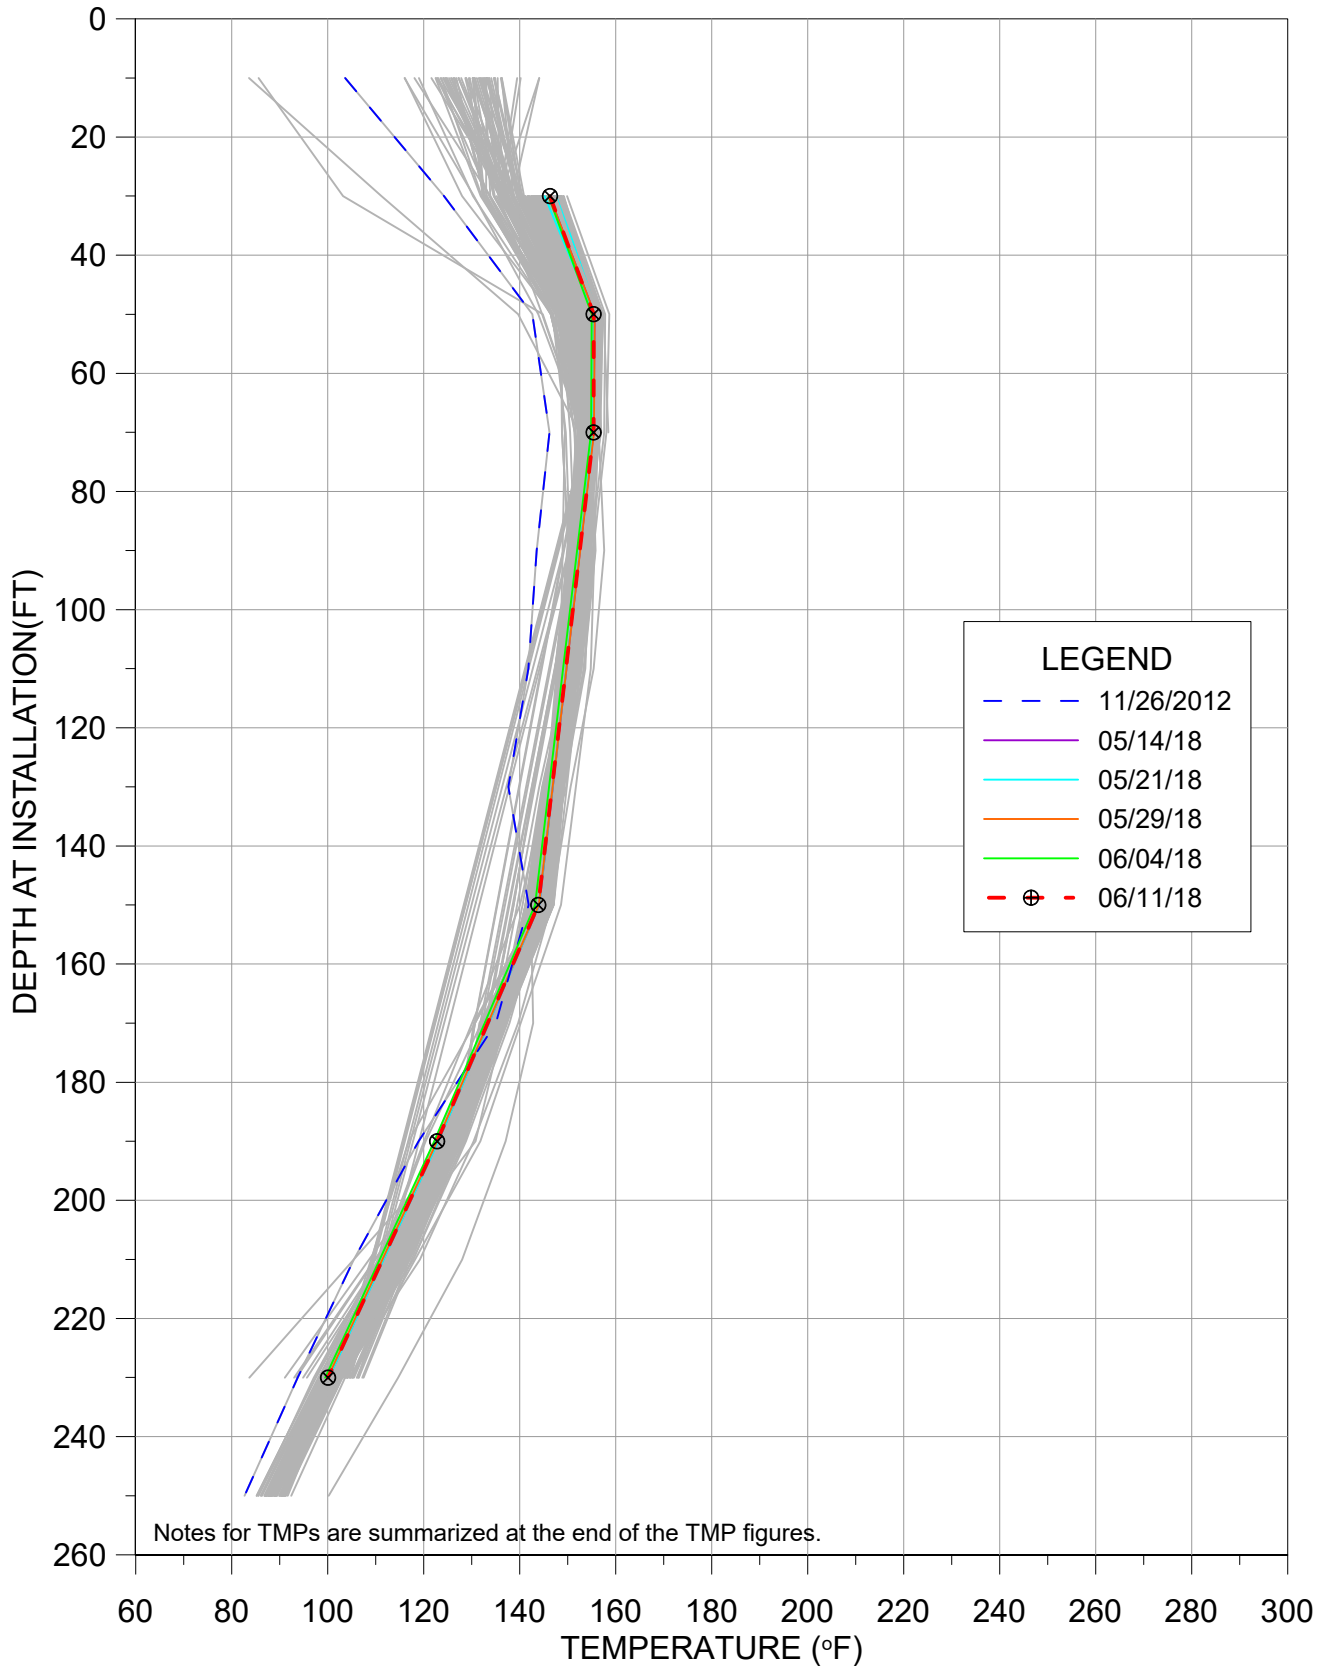
TMP-3

1. No reliable temperature readings have been obtained at 170 ft depth since 1/29/2014, except on 3/13/2014.
2. The connectivity tests on 4/11/2014 conducted by CEC showed that units at 10, 90, 130, 210 and 250 ft depths are no longer reliable.
3. The connectivity tests on 10/28/2014 conducted by Feezor Engineering showed that units at 10, 90, 110, 130, 210 and 250 ft depths are not reliable.

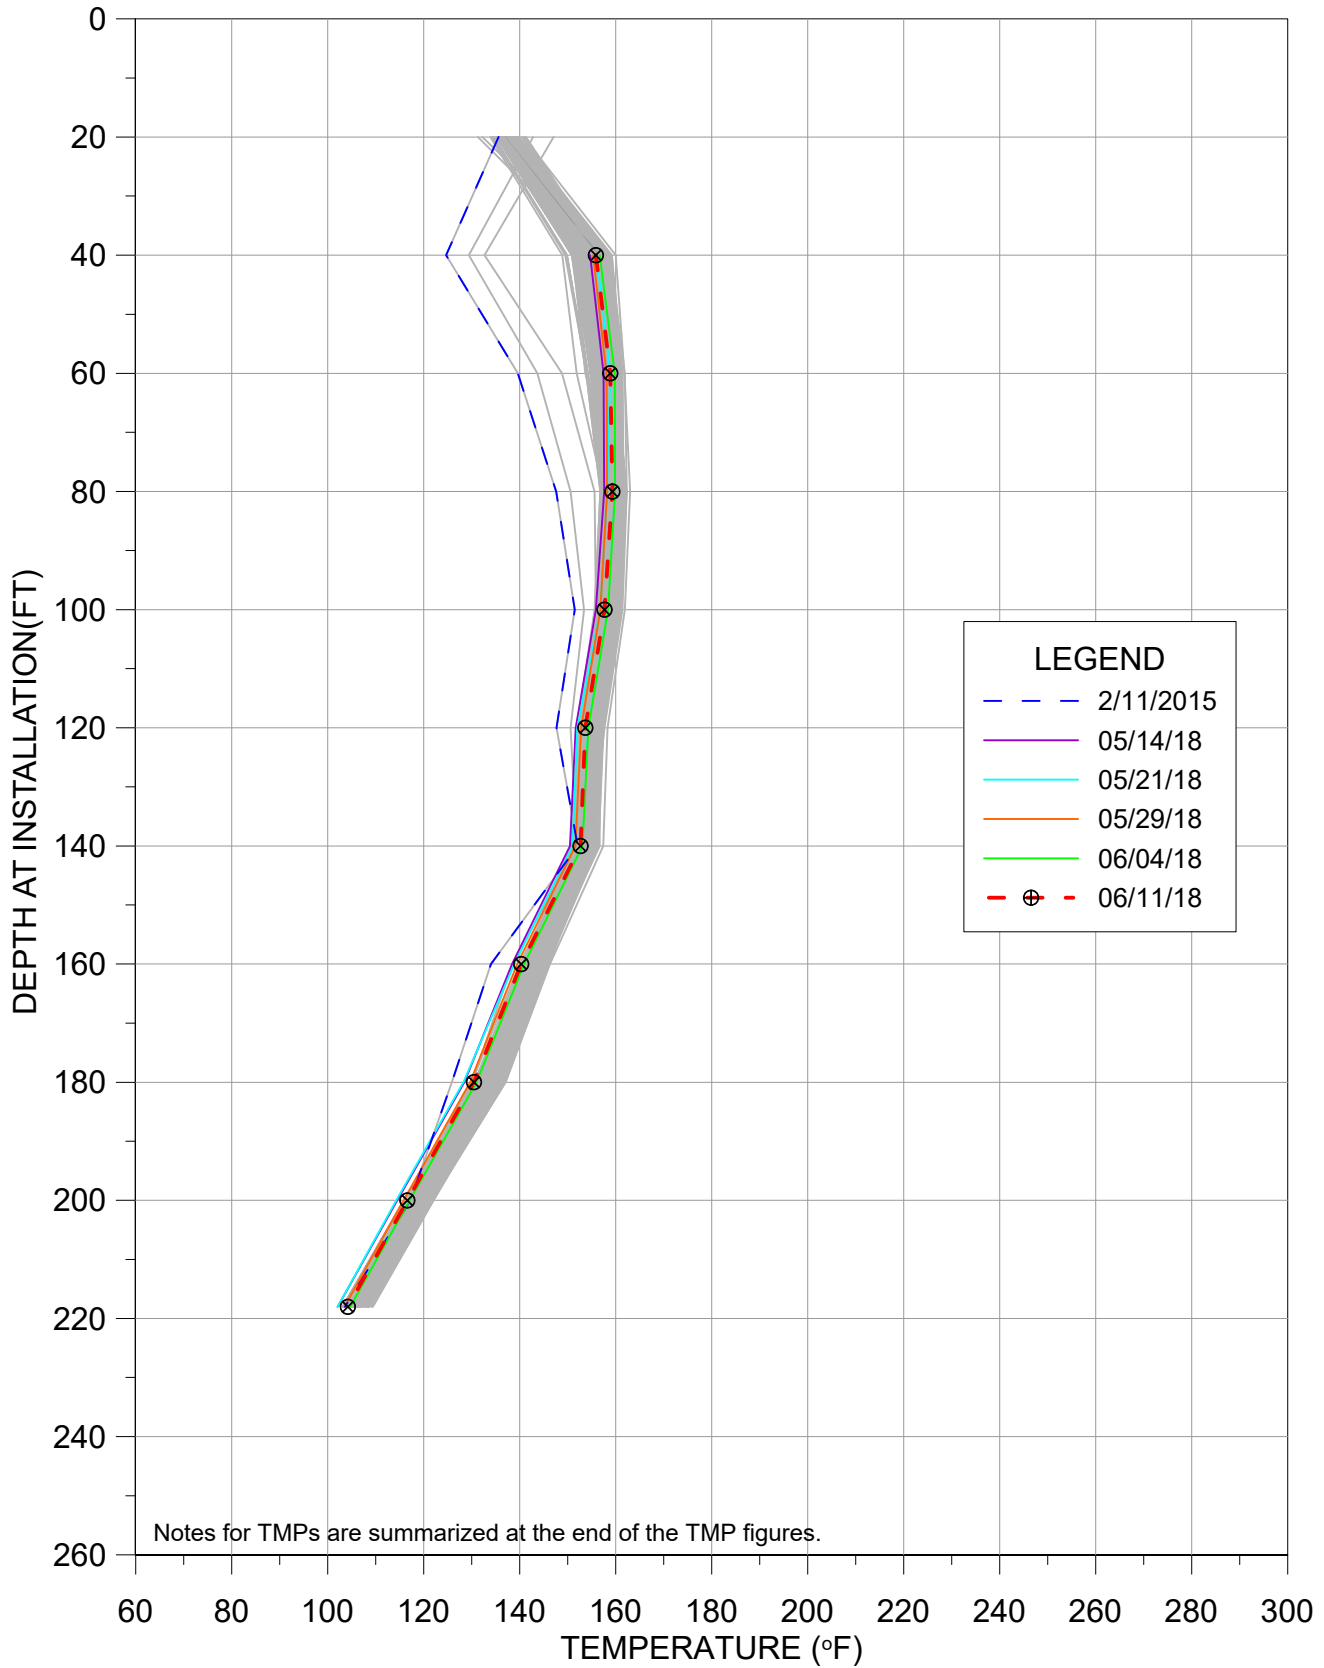
TMP-3R

1. The unit at 20 ft depth had a fluctuating resistance since 9/25/2017. Therefore the temperature is determined to be unreliable.

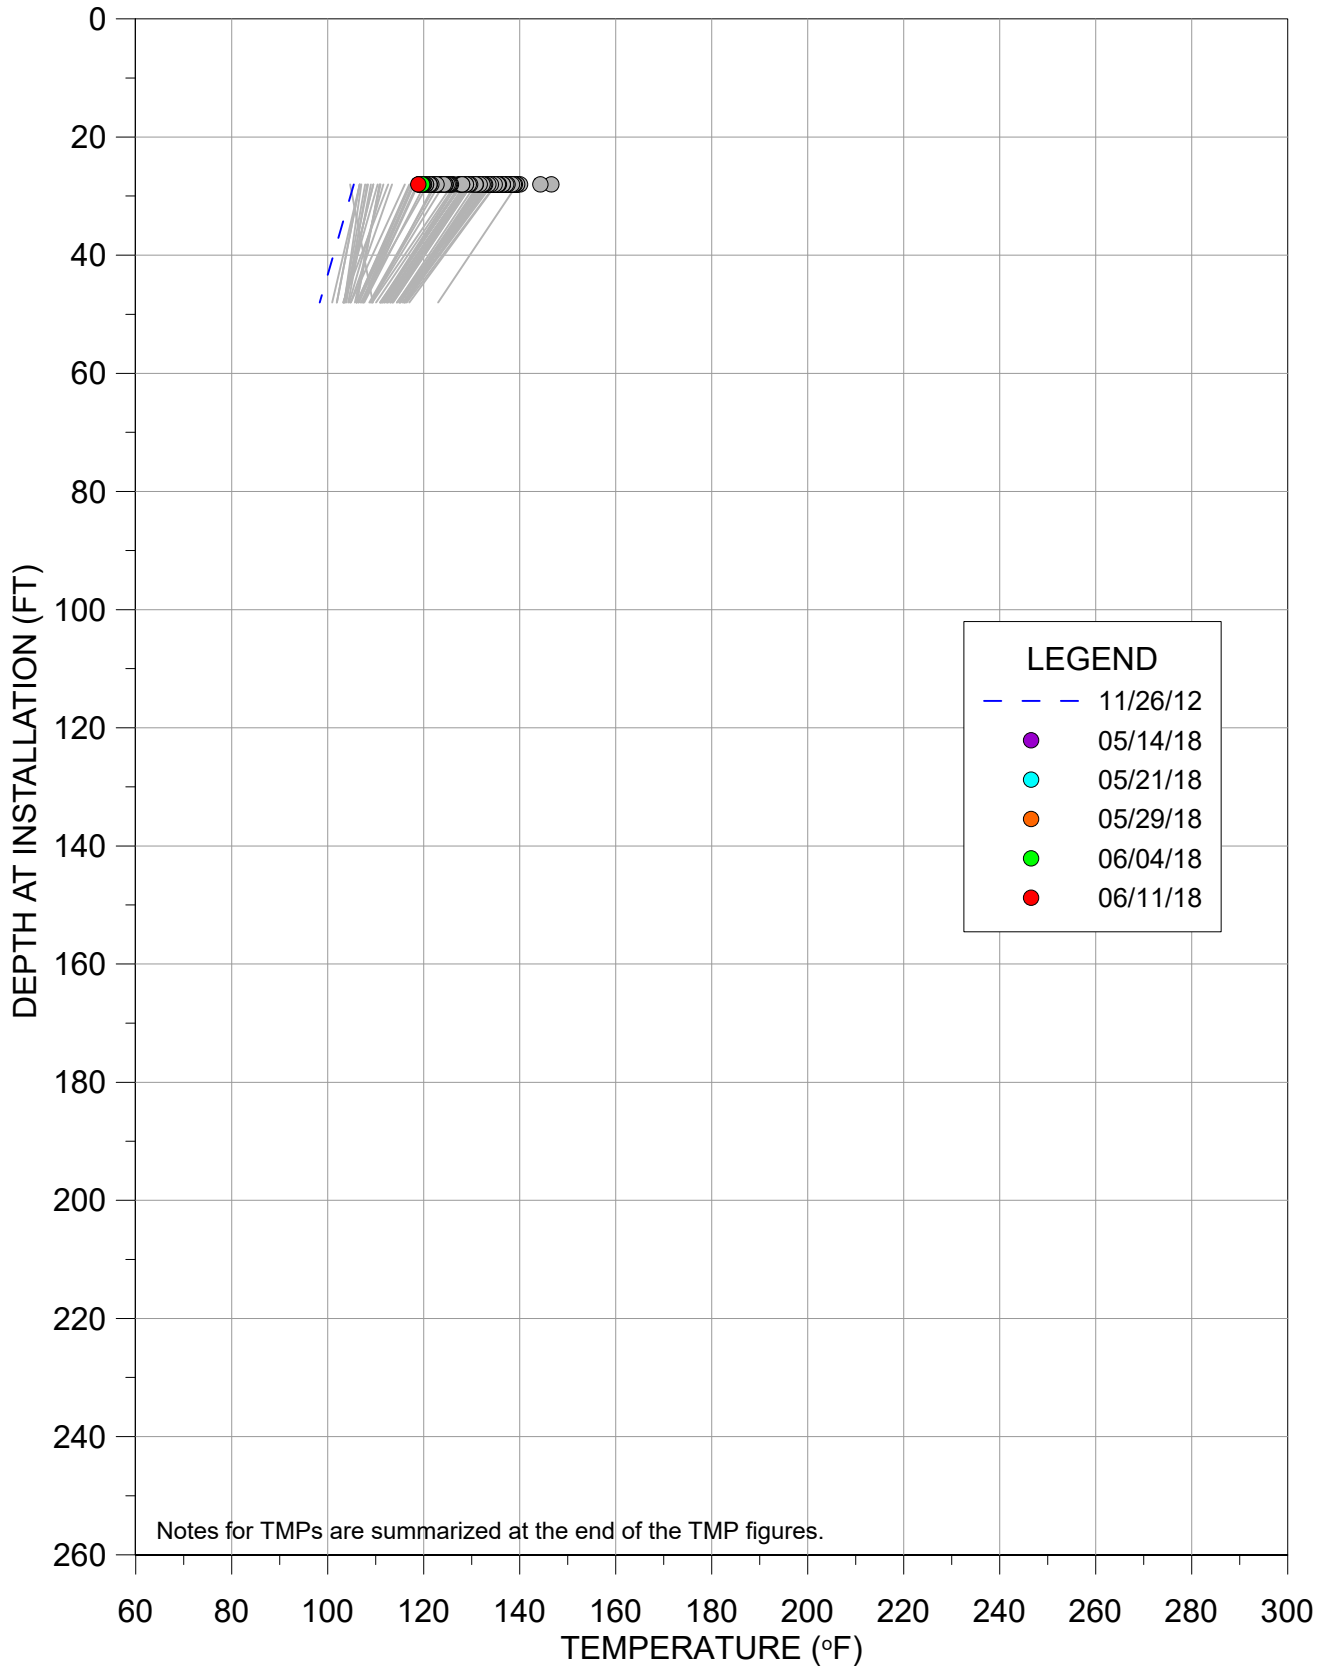
TMP-4

1. The connectivity tests on 4/11/2014 conducted by CEC showed that the unit at 48 ft depth is no longer reliable.

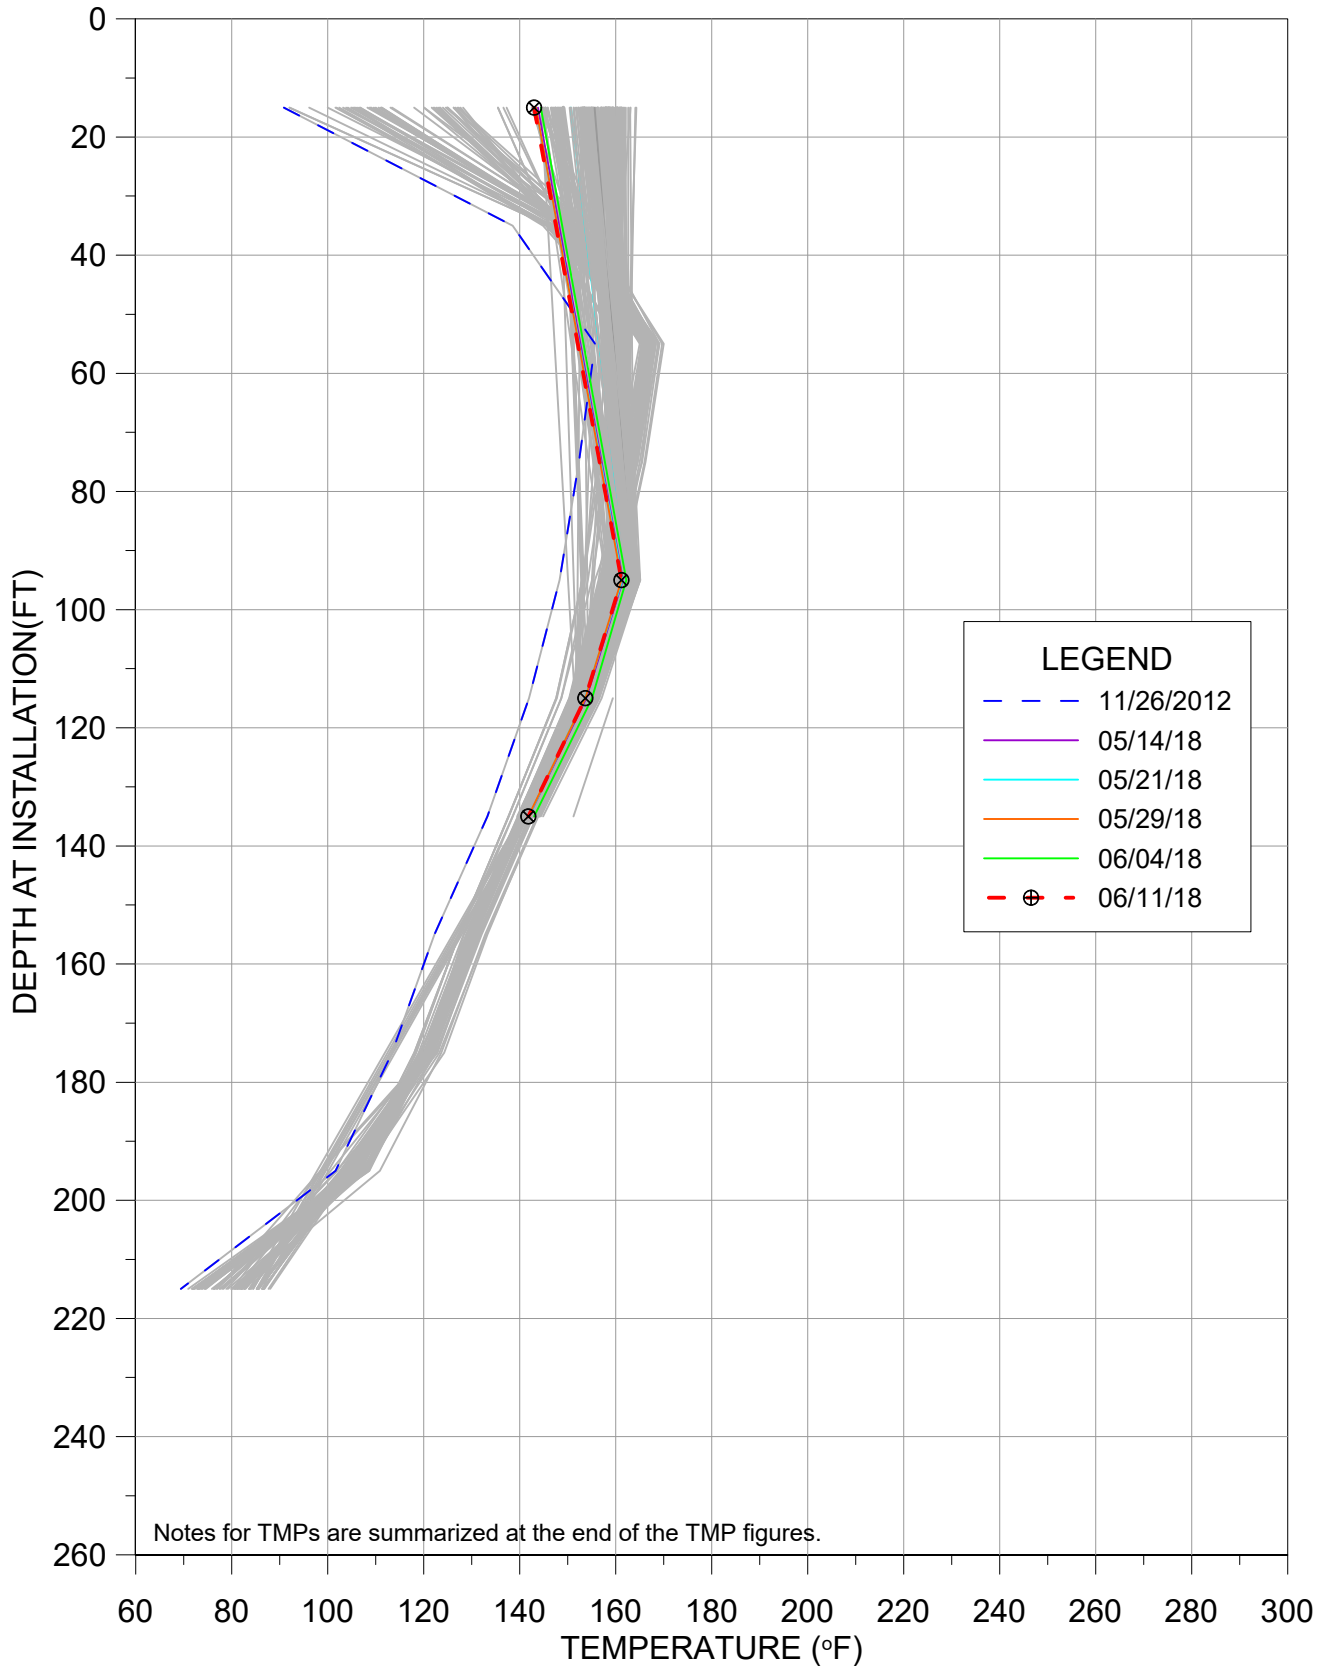
TMP-6

1. The connectivity tests on 4/11/2014 conducted by CEC showed that units at 35, 55, 75, 155, 175, and 195 ft depths are no longer reliable.
2. No reliable temperature readings have been obtained at the unit at 215 ft depth since 6/13/2014.

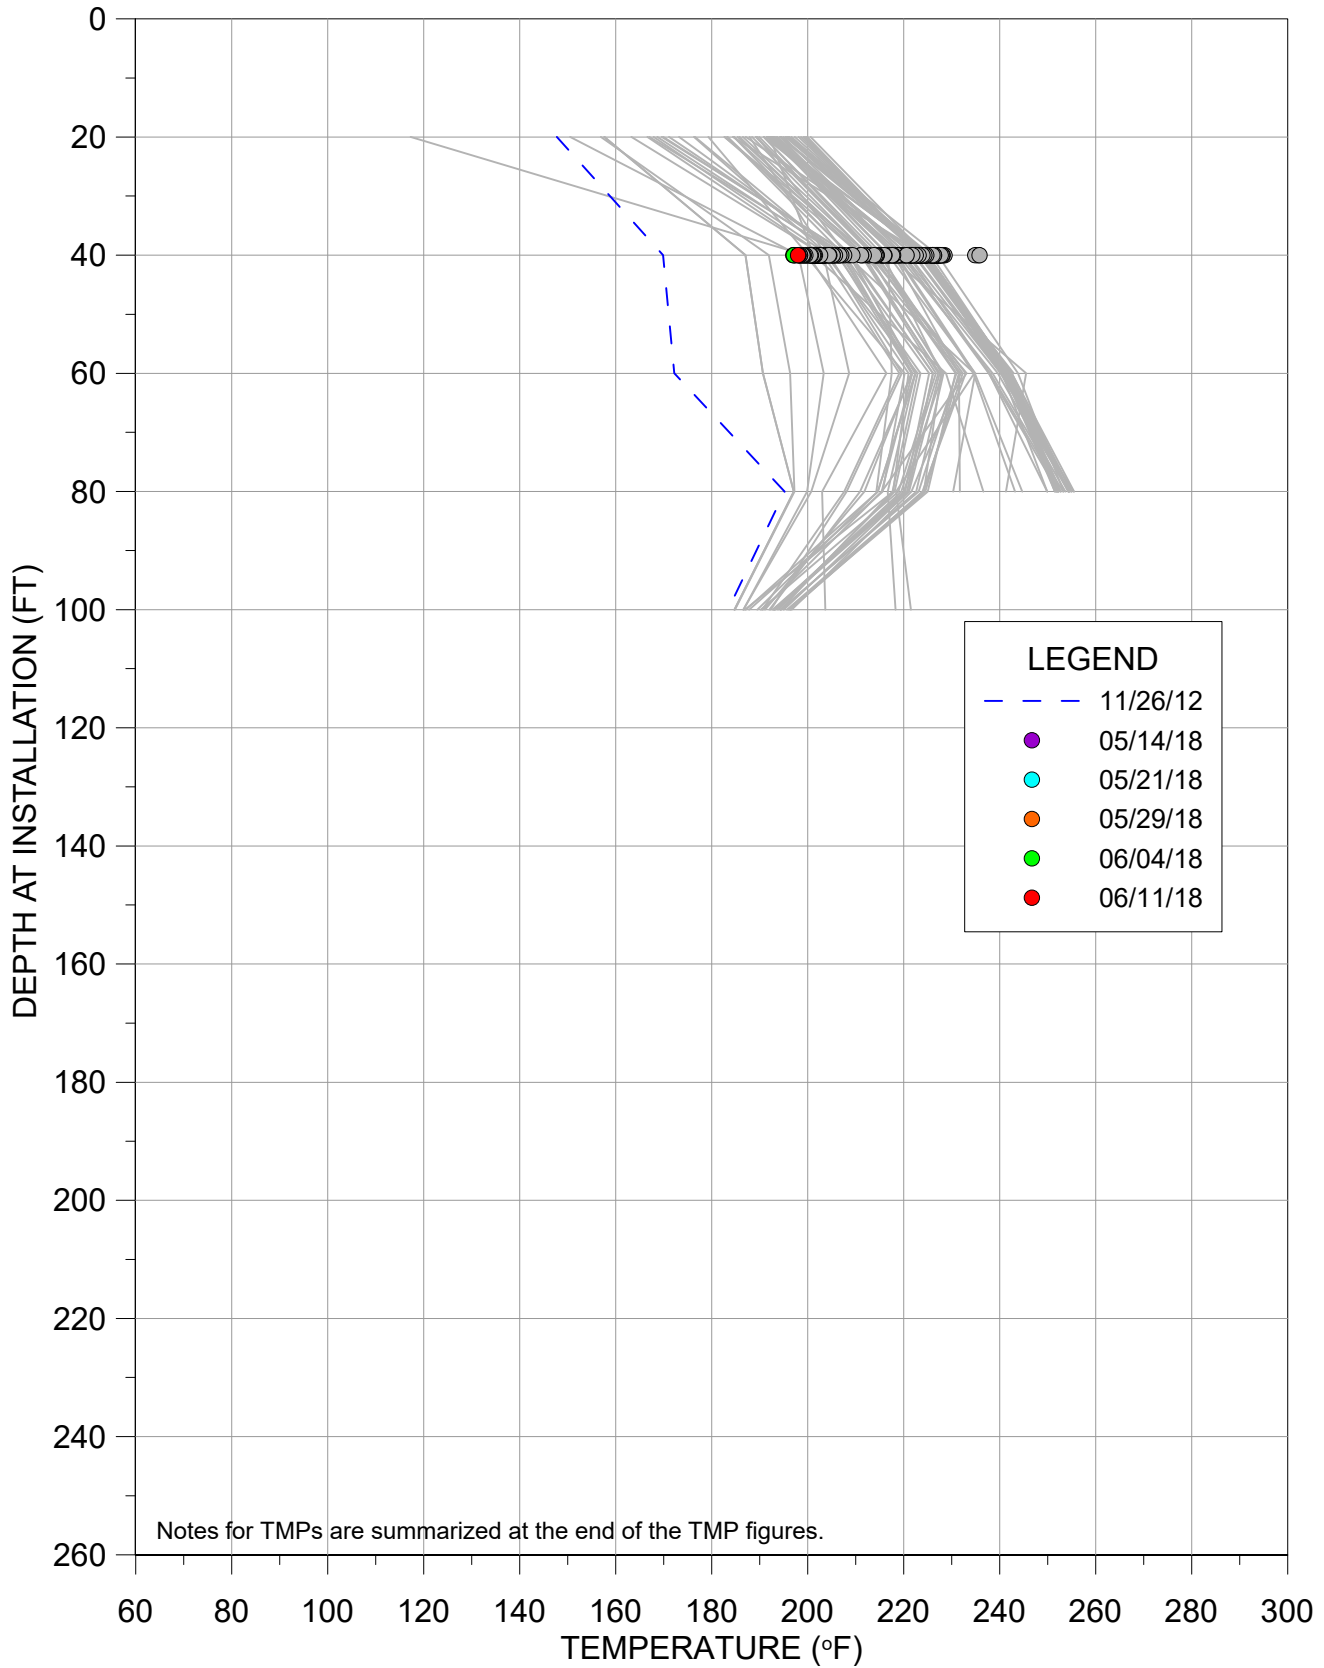
TMP-9

1. Unit at 100 ft depth had an inaccurate temperature reading on 8/1/2013 and no reading since 8/6/2013.
2. The connectivity tests on 4/11/2014 conducted by CEC showed that units at 20, 60, 80, and 100 ft depths are no longer reliable.

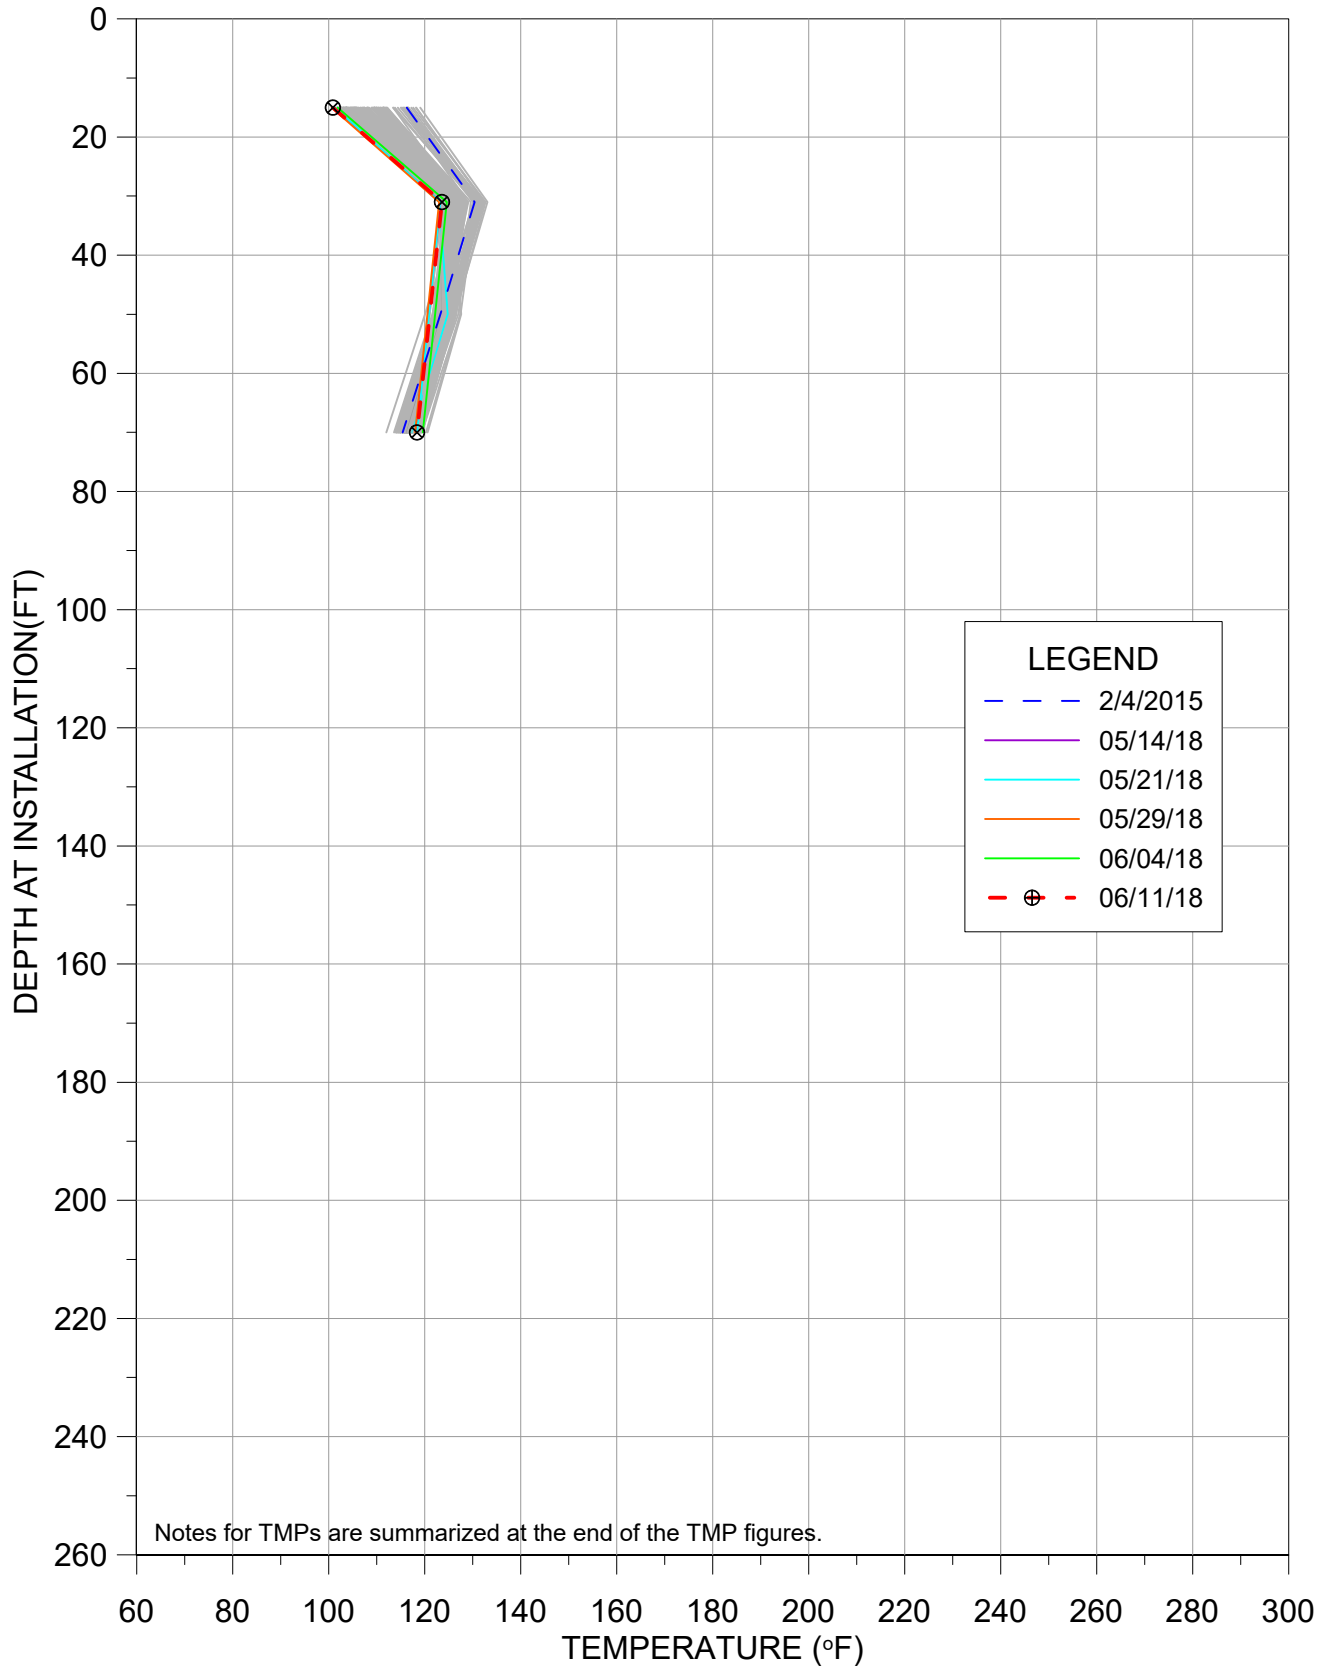
TMP-22

1. No temperature reading could be obtained and resistivity was fluctuating at the unit at 50 ft depth since 4/2/2018.
