Bridgeton Landfill, LLC

Weekly Data Submittal

Week of June 10, 2018 – June 16, 2018

**Required by Section 52.F of Agreed Order, Case No. 13SL-CC01088
Effective May 13, 2013**

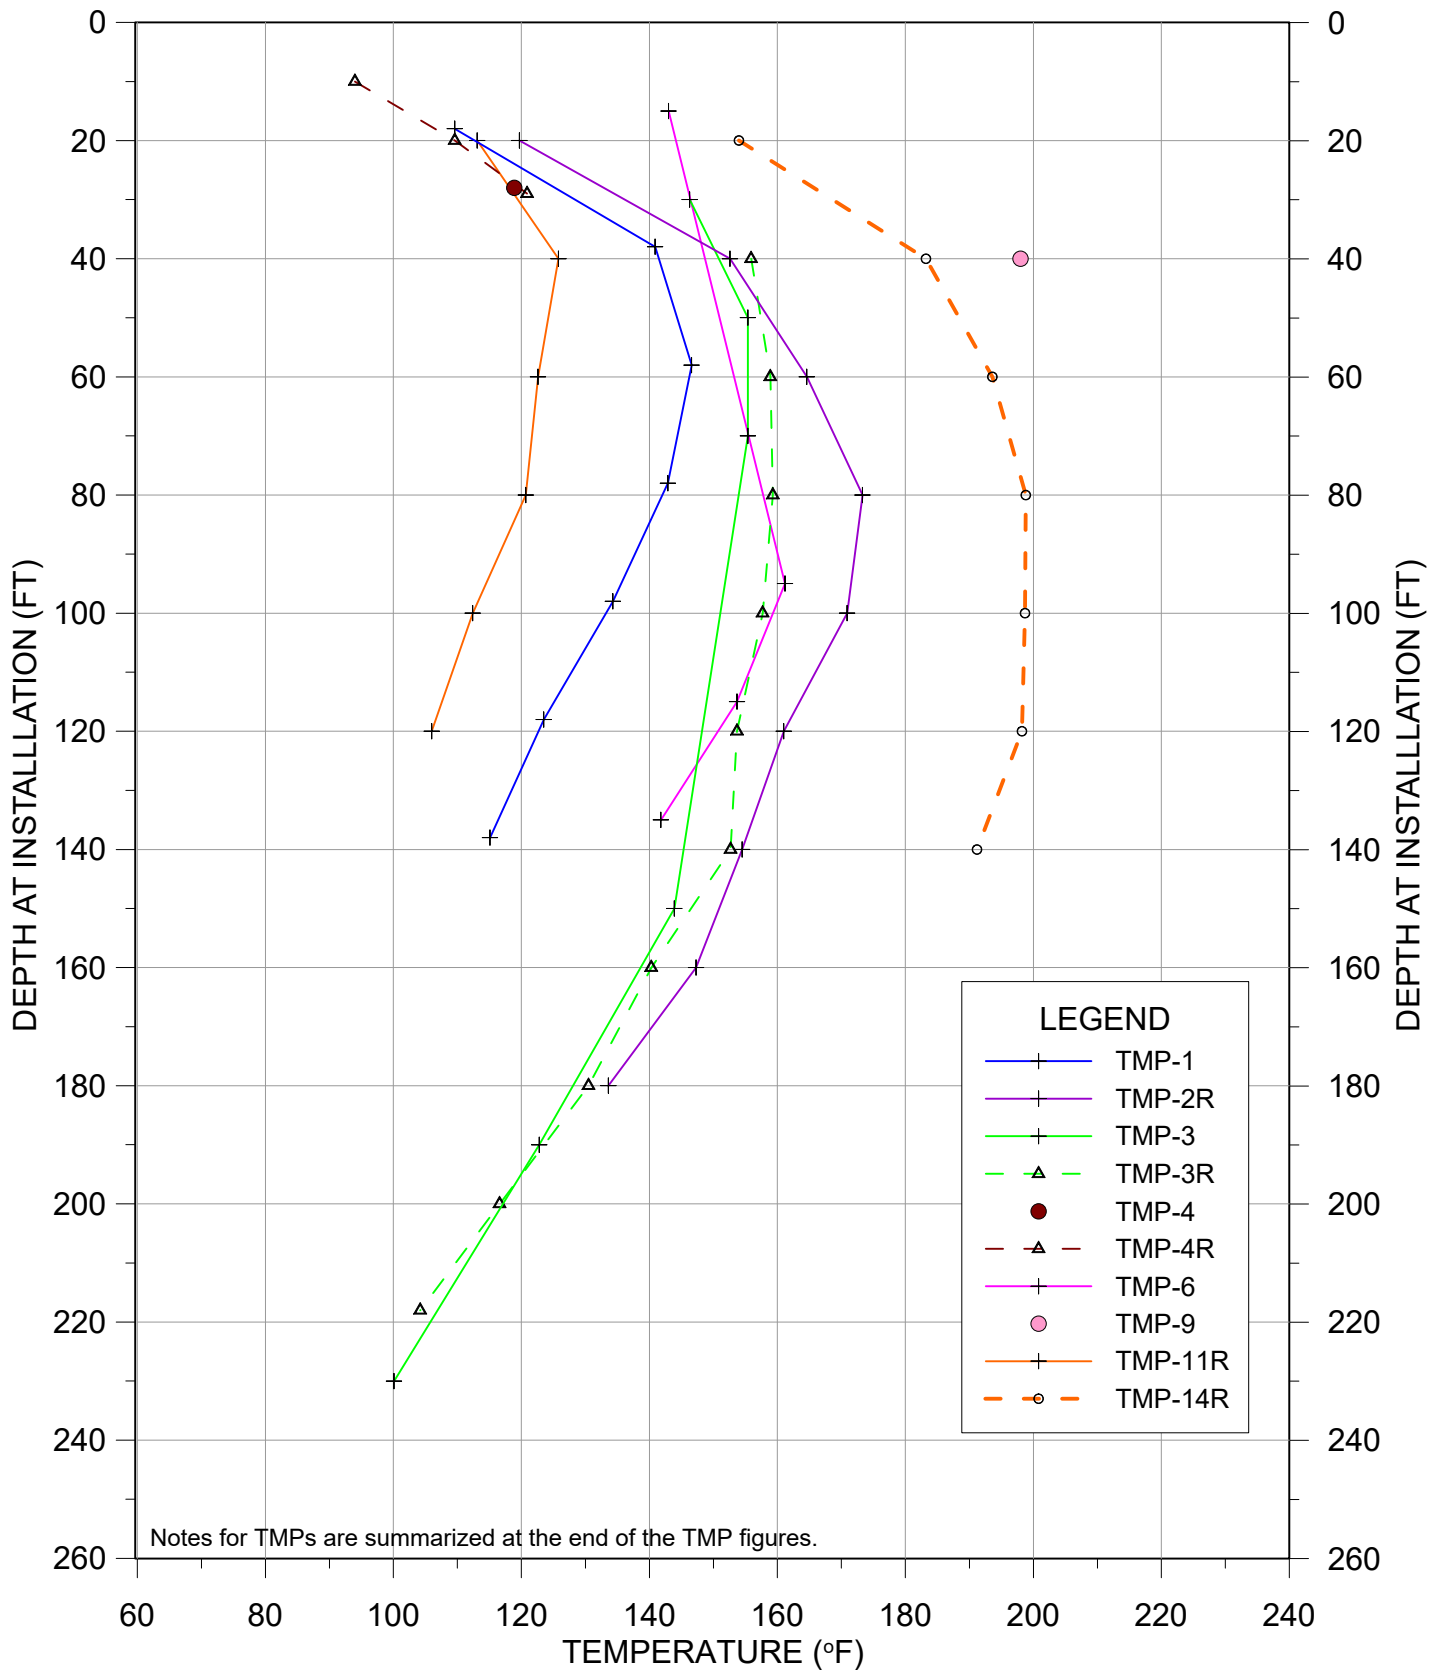
6/11/2018

TMP vs DEPTH and TMP vs ELEVATION (for **6/11/18**):

1. There were no reliable temperature readings for TMP-13 since 3/19/2014.
2. There were no reliable temperature readings for TMP-7R, as determined by the connectivity test on 4/11/2014.

3. There were no reliable temperature readings for TMP-5 since 11/5/2014.
4. There were no reliable temperature readings for TMP-12 since 9/28/2015.
5. There were no reliable temperature readings for TMP-8 since 9/9/2015.

6. There were no reliable temperature readings for TMP-14, confirmed since 3/7/2016.
7. There were no reliable temperature readings for TMP-11 as determined by the connectivity test on 11/23/2016.

8. TMP-2 has been replaced by TMP-2R and will no longer be monitored.
9. TMP-11 is no longer in service and will not be included in the presentation.
10. There were no reliable temperature readings for TMP-10 since 5/30/2017.

11. TMP-16, 25, and 28 have been replaced by TMP-16R, 25R, and 28R and will be no longer reported since 1/15/2018.
12. TMP-26 has been replaced by TMP-26R and will be no longer reported since 5/21/2018.

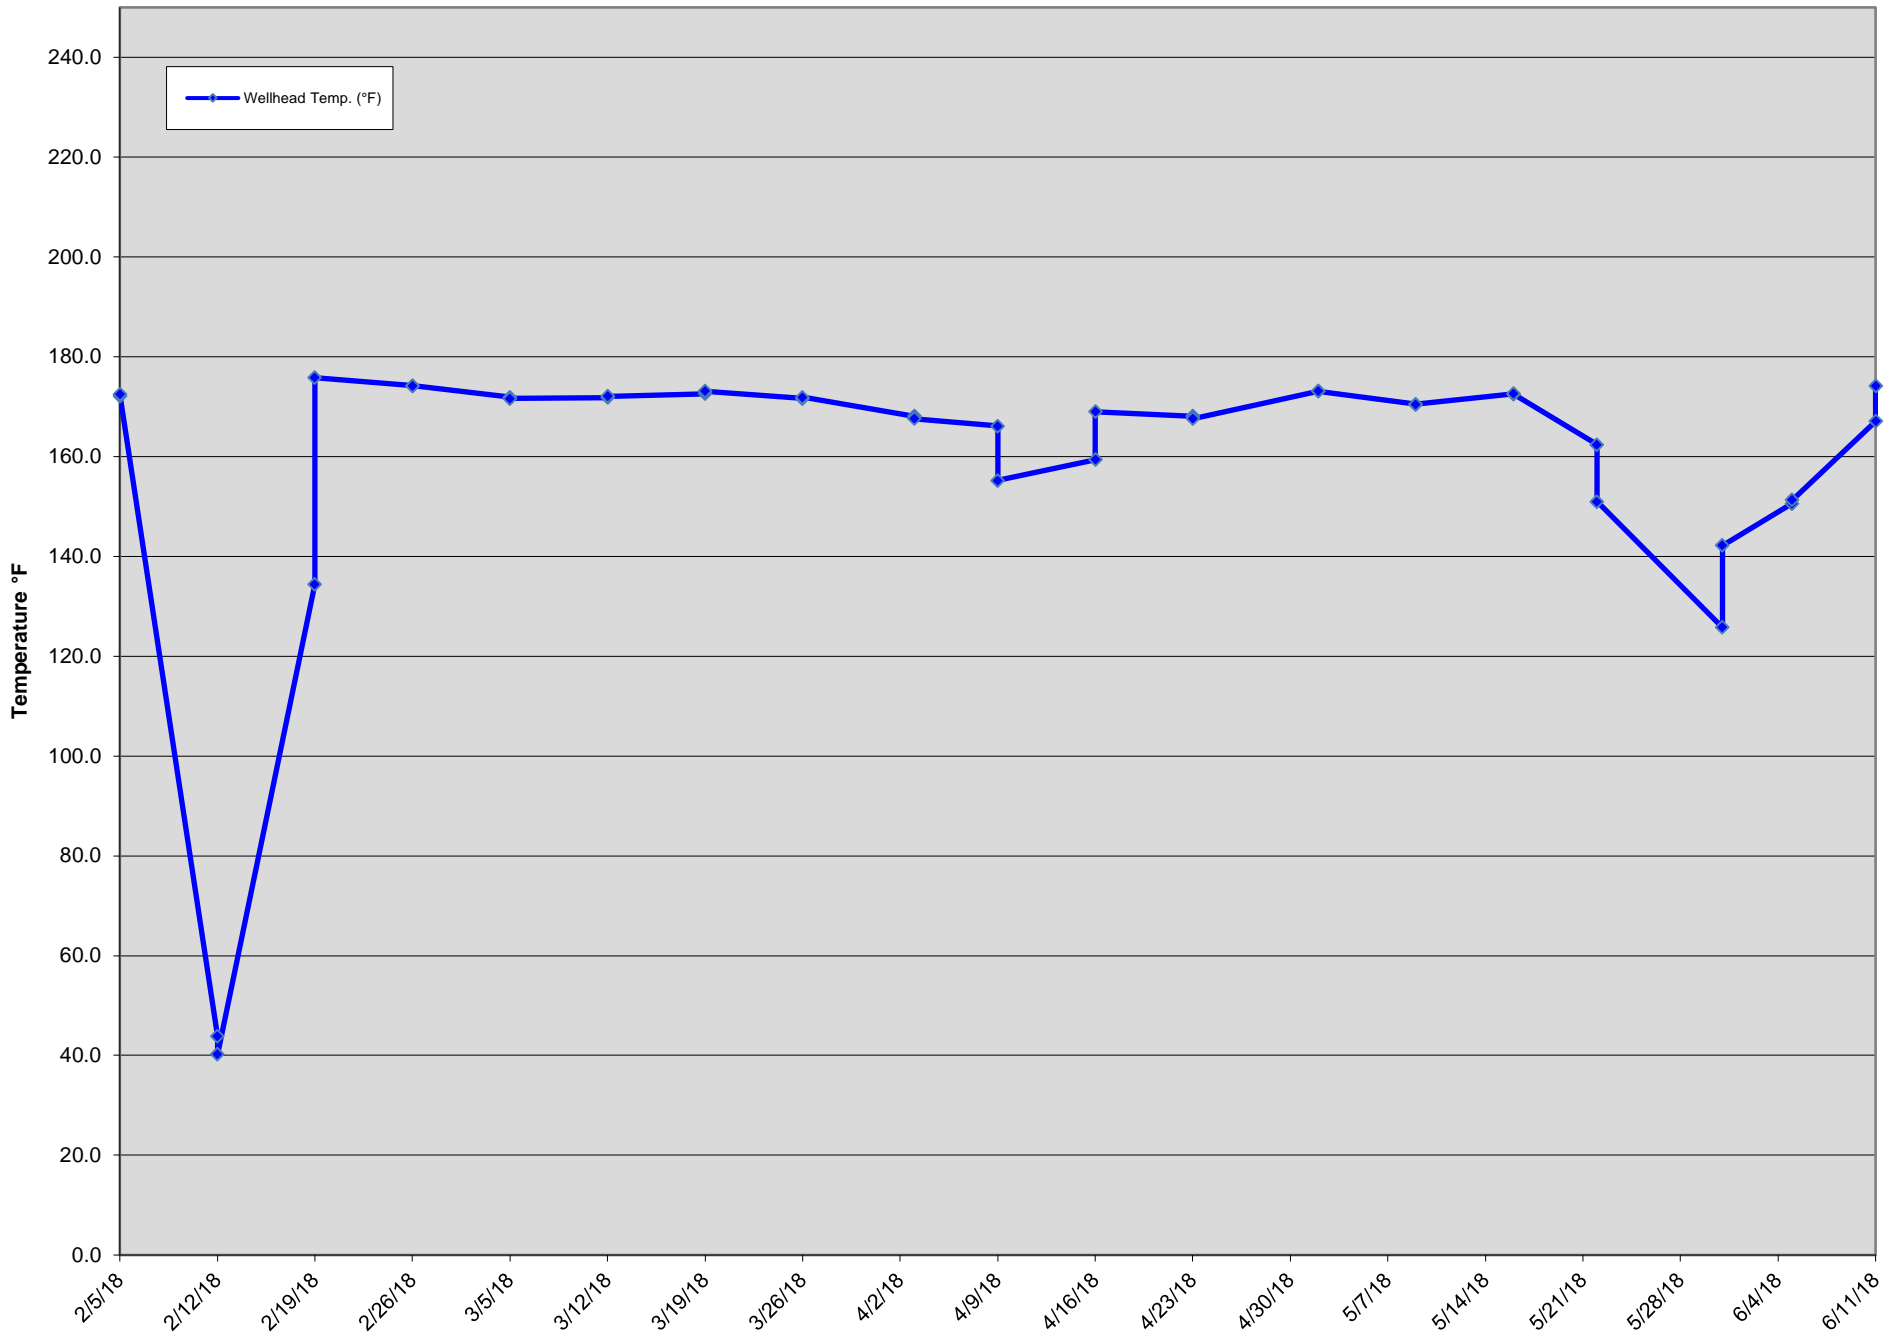
GIW-1 Wellhead Temperatures

As part of the HES, there are currently cooling water circulation loops installed in twelve Gas Interceptor Wells (GIWs) (GIW-02 through GIW-13). The remaining well (GIW-01) had a measured gas temperature within its historical operating limits.
