Bridgeton Landfill, LLC

Weekly Data Submittal

Week of June 17, 2018 – June 23, 2018

**Required by Section 52.F of Agreed Order, Case No. 13SL-CC01088
Effective May 13, 2013**

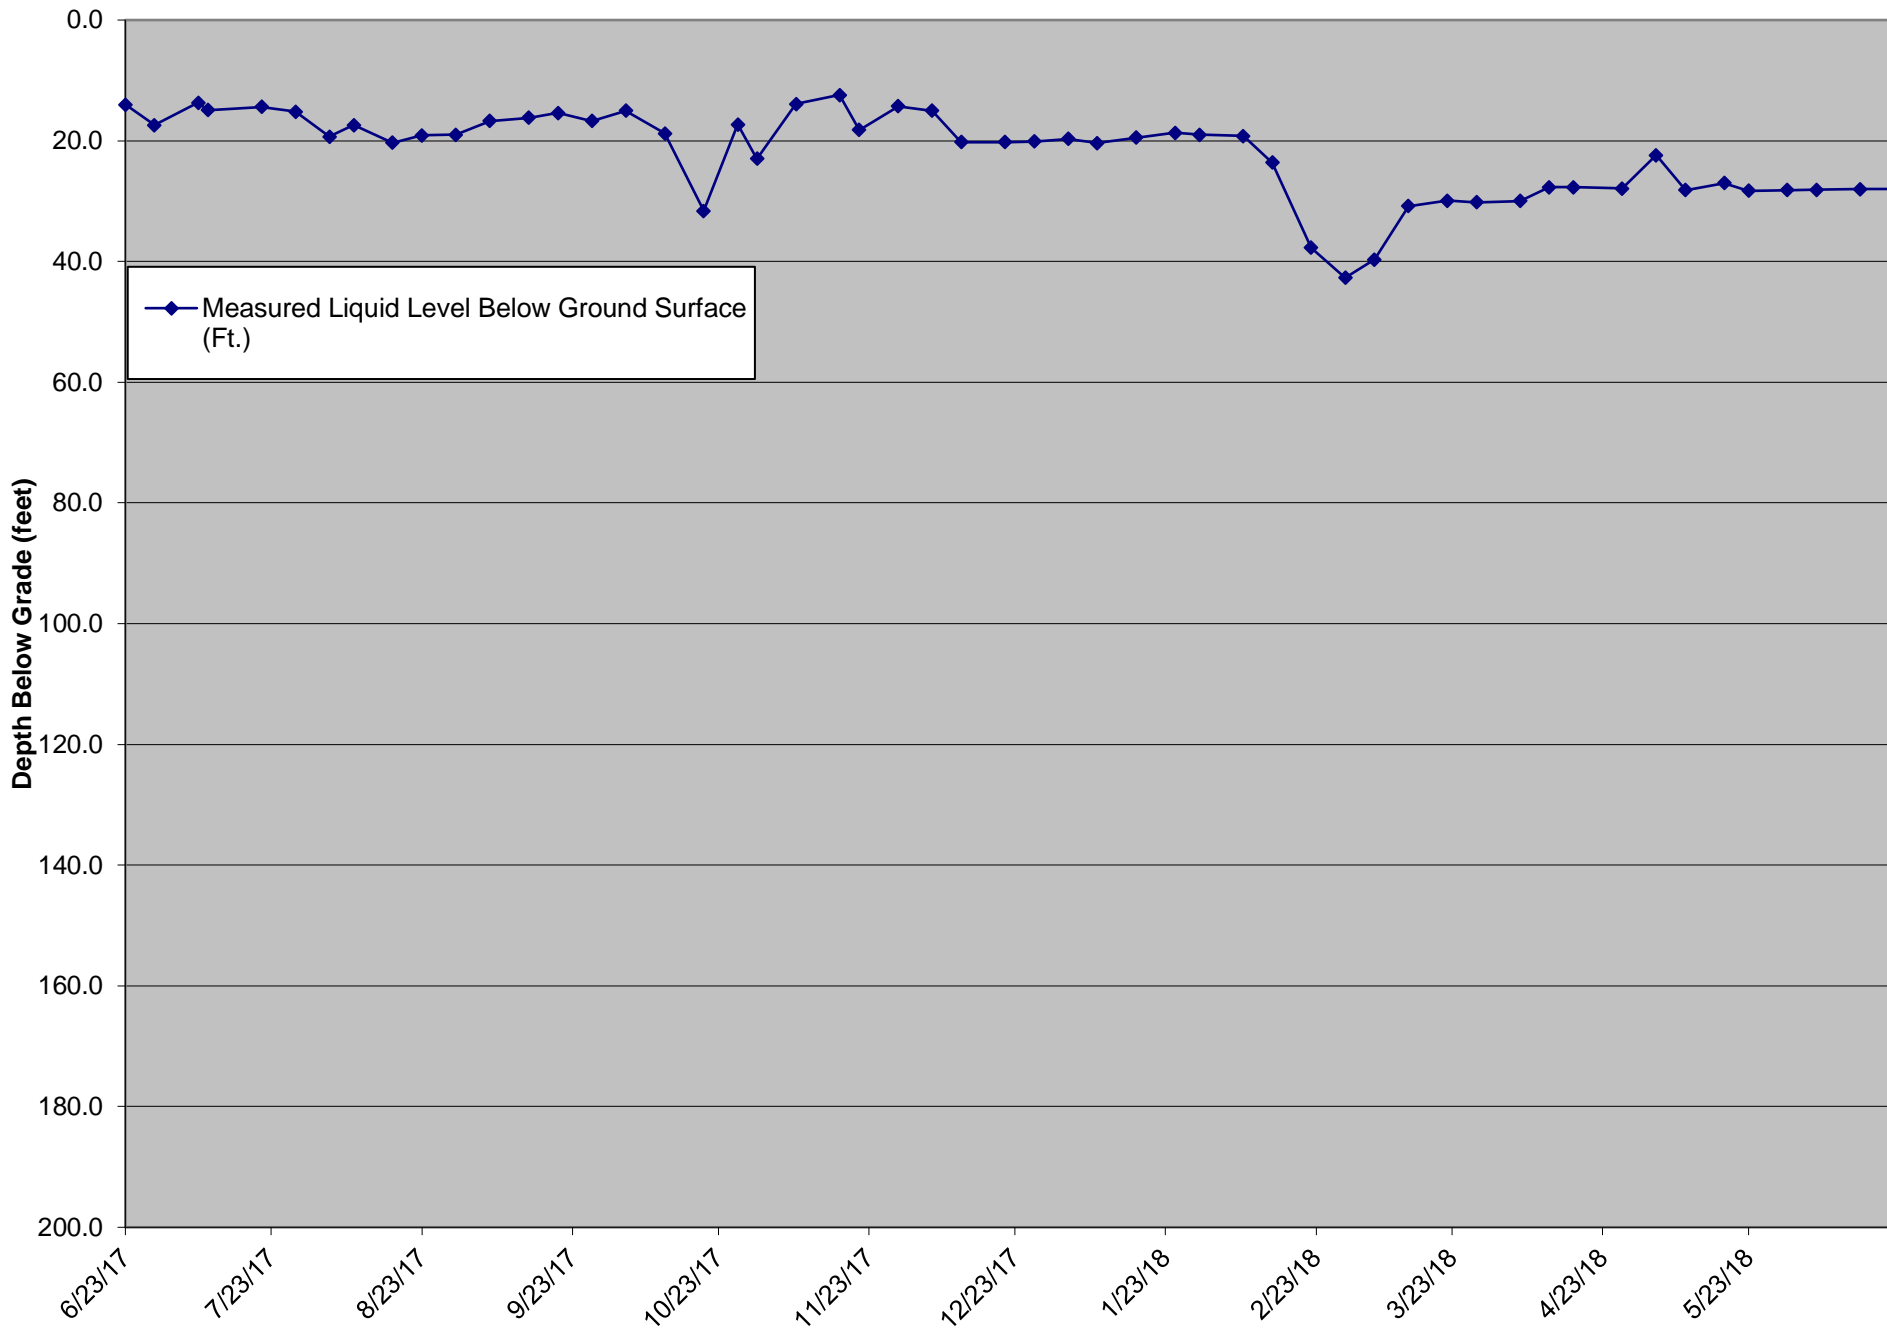
LCS-3D Liquid Level Below Ground Surface

The QED AP-4 pneumatic pump in LCS-3D was non-operational during the weekly reporting period. Liquid level was measured manually.

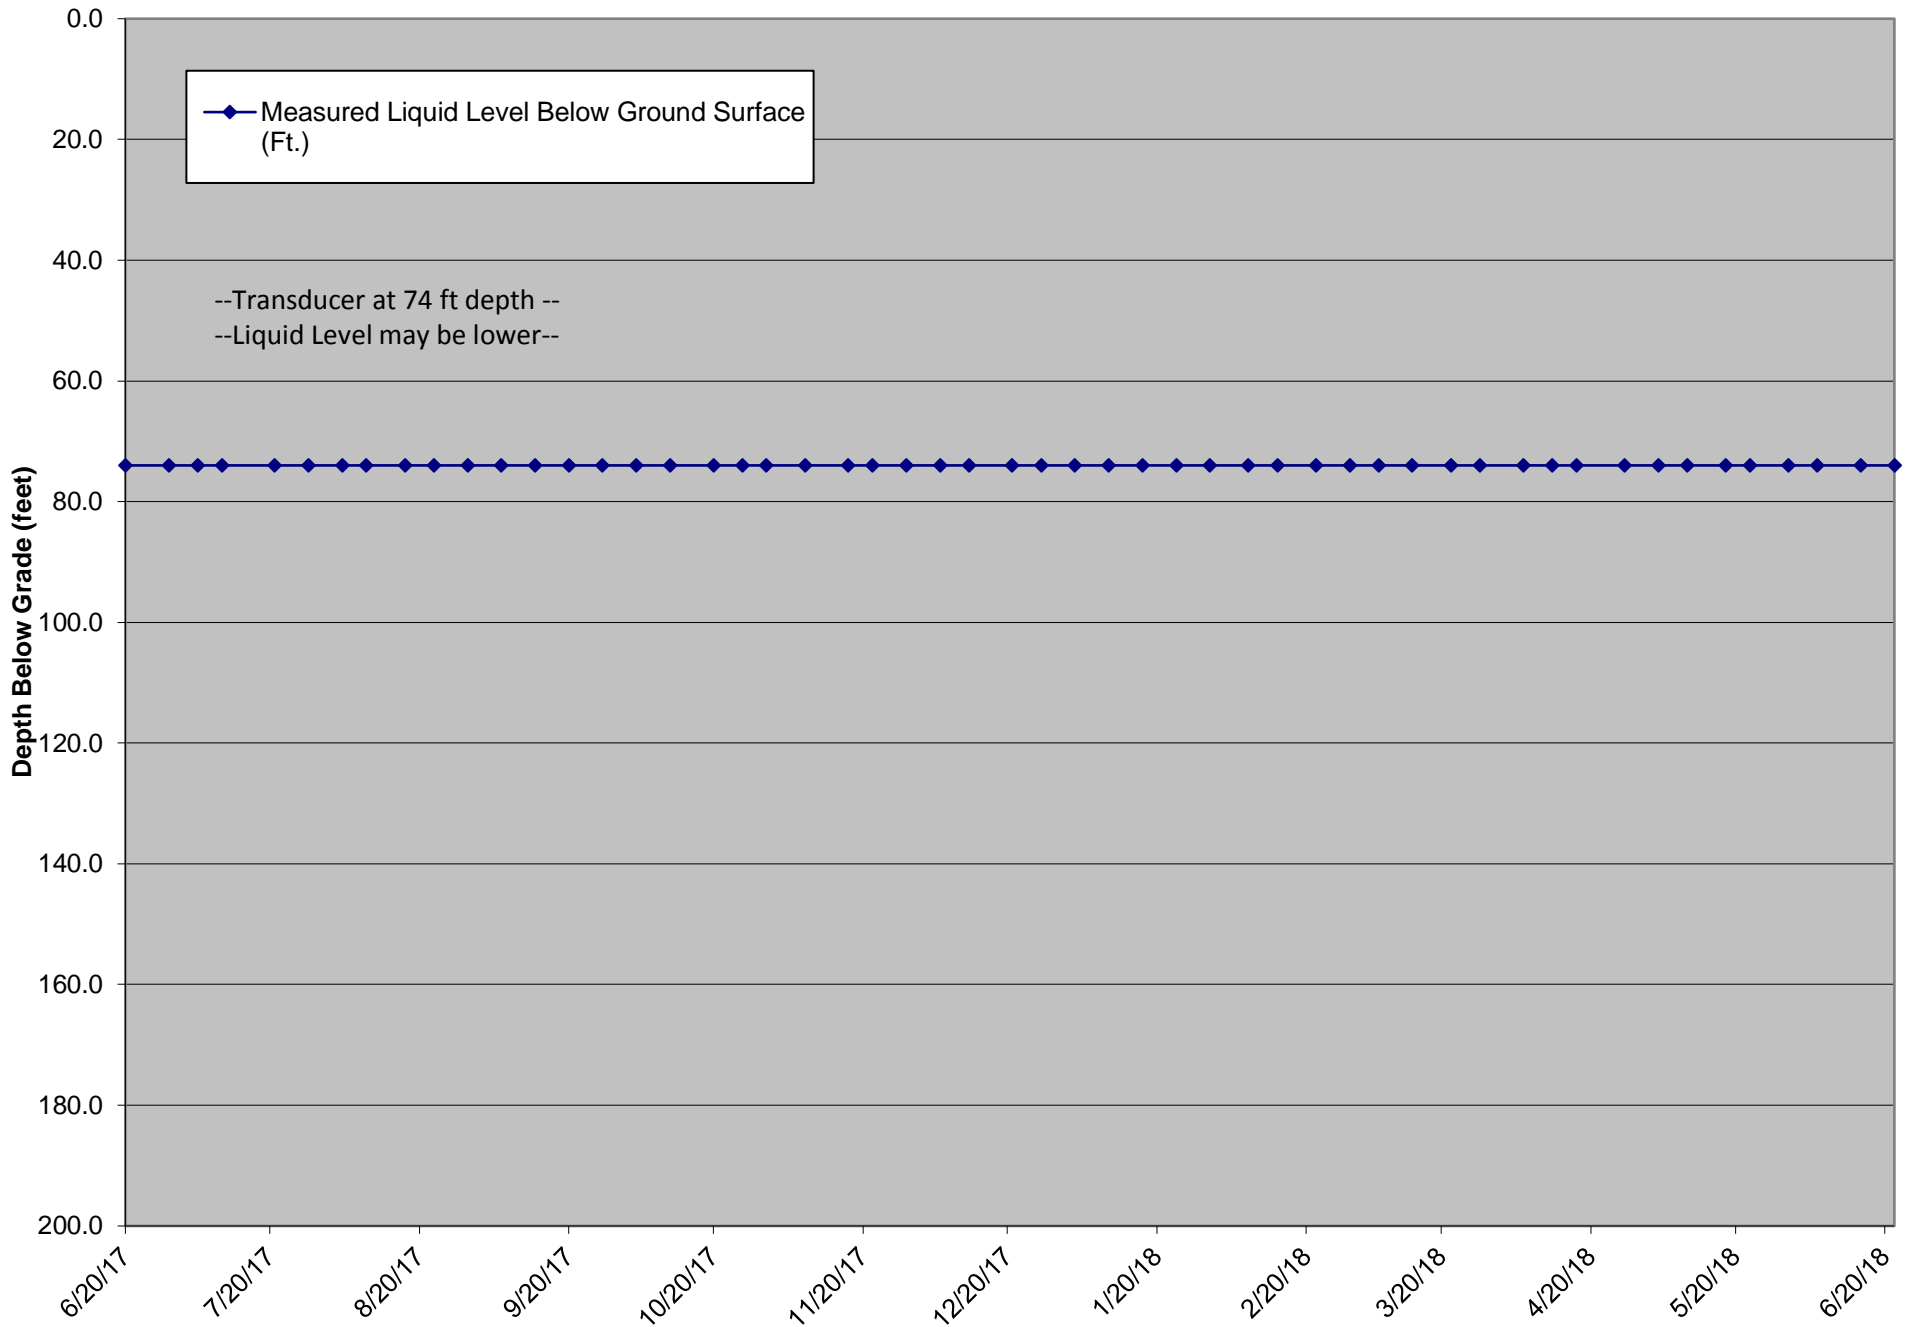
LCS-4B Liquid Level Below Ground Surface

The level sensor in LCS-4B is currently operational and responsive. Liquid level was not recorded by the level sensor during the weekly reporting period. LCS-4B is equipped with a flow meter that displayed no flow during the weekly reporting period. Therefore, it can be concluded that the liquid level was below the bottom of the pump and level sensor in LCS-4B.

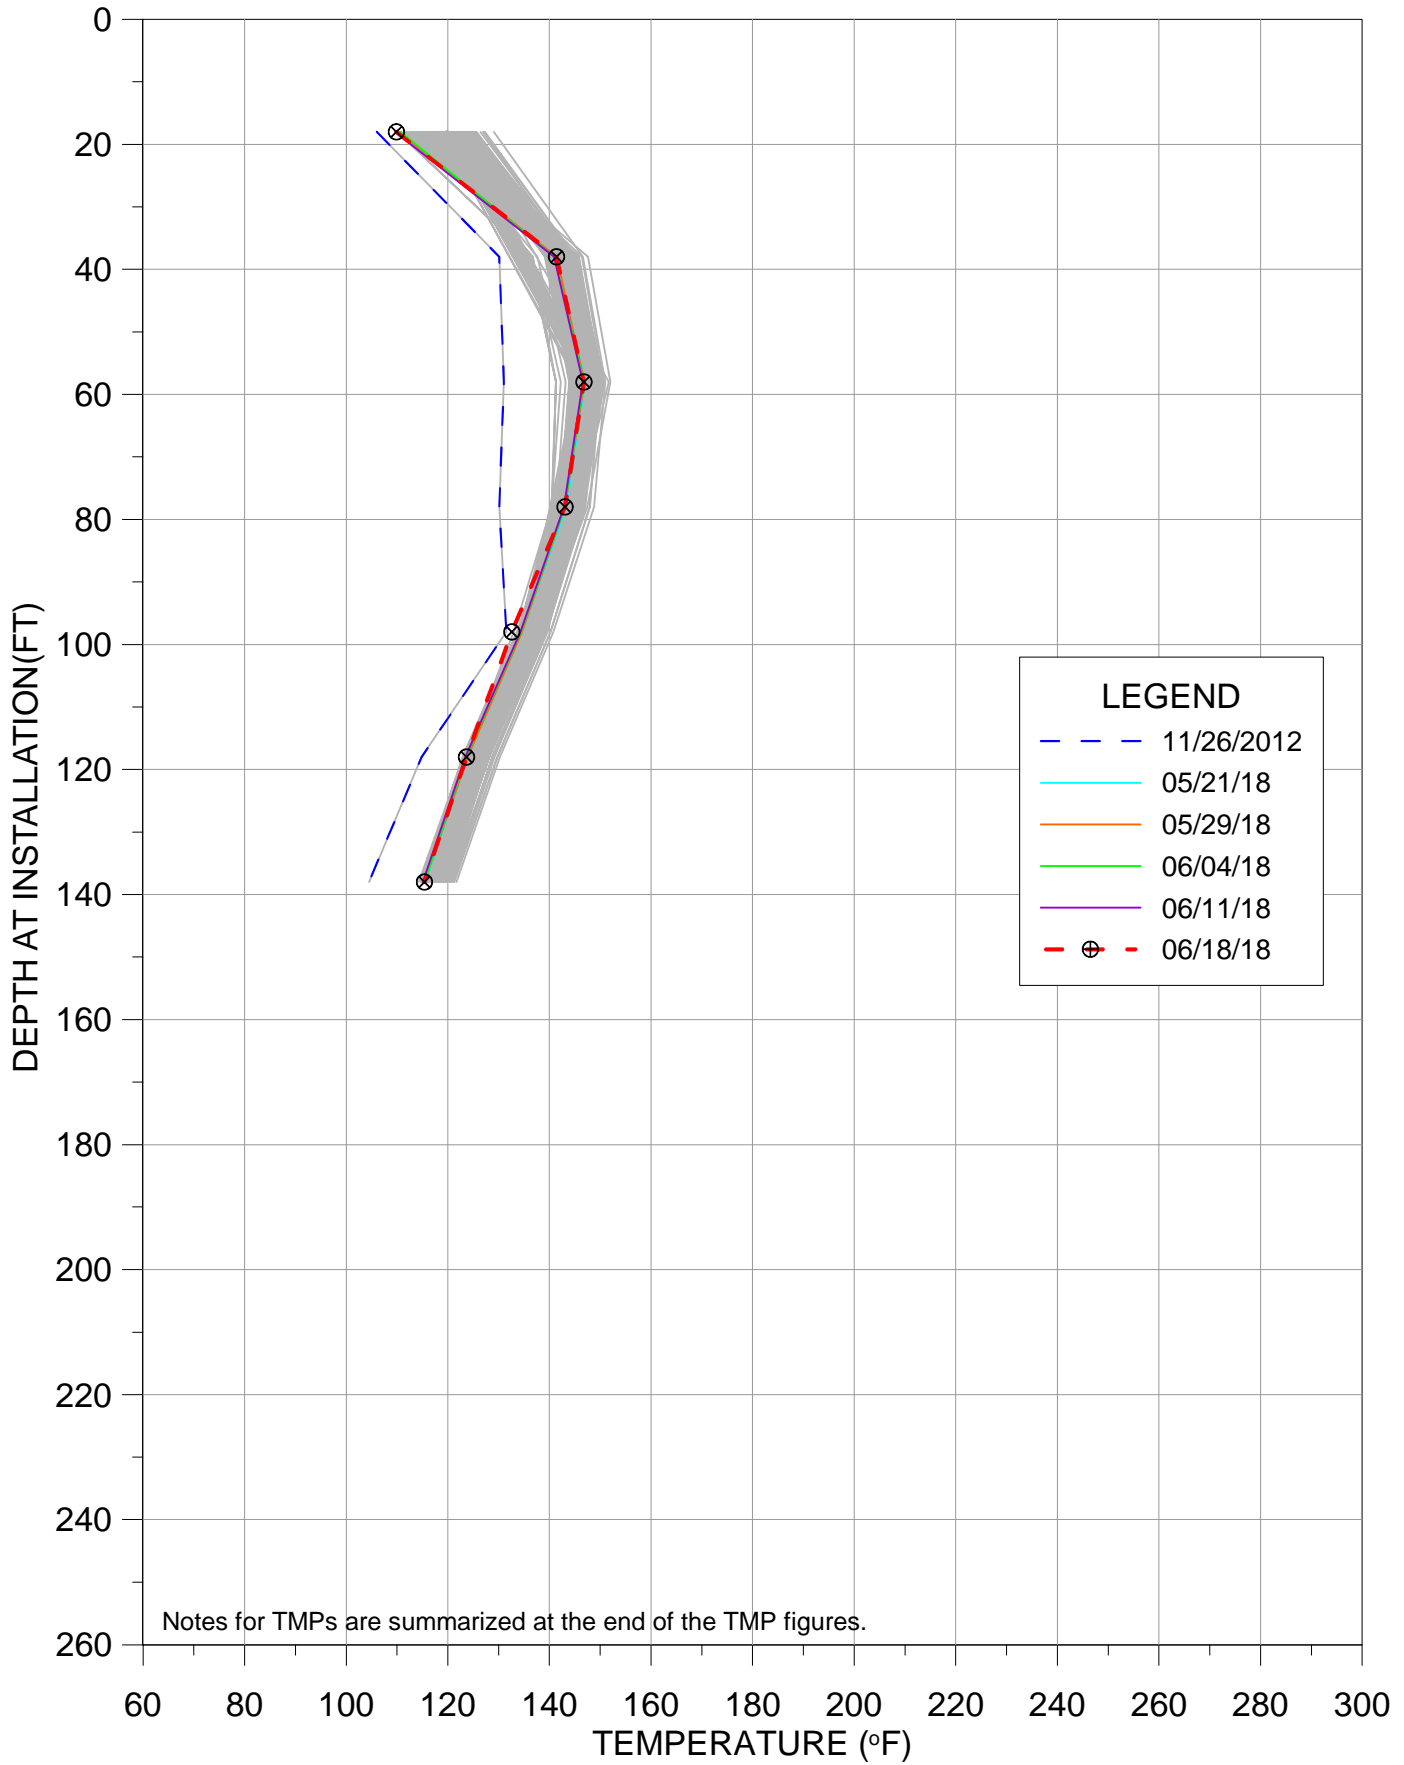
TMP-1

TMP-1: NONE

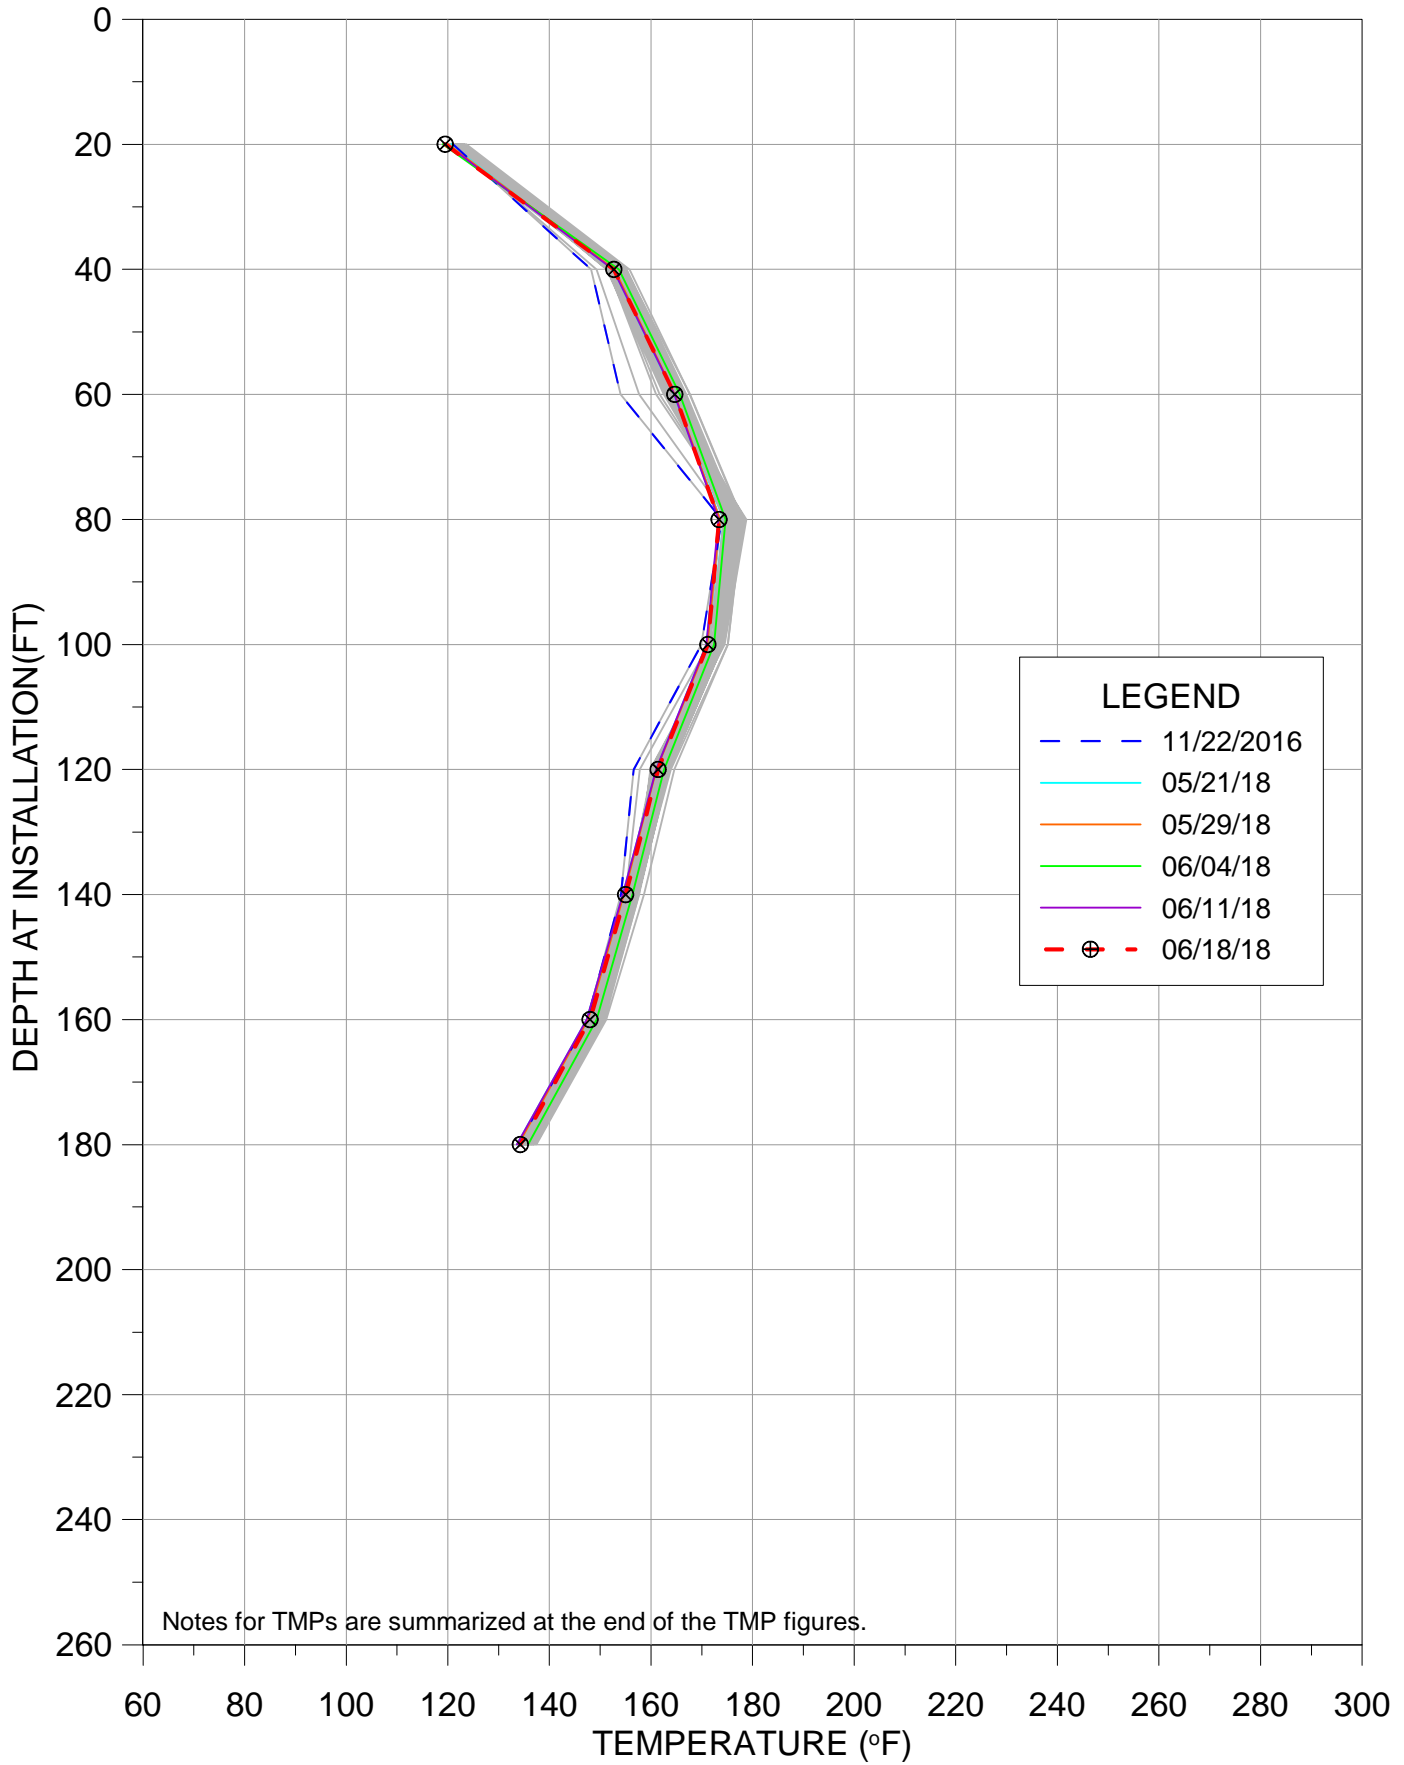
TMP-2R

1. Data reported on 11/29/2016 was inadvertently left as the 11/22/2016 data. This was corrected on 12/5/2016 reading submittal.

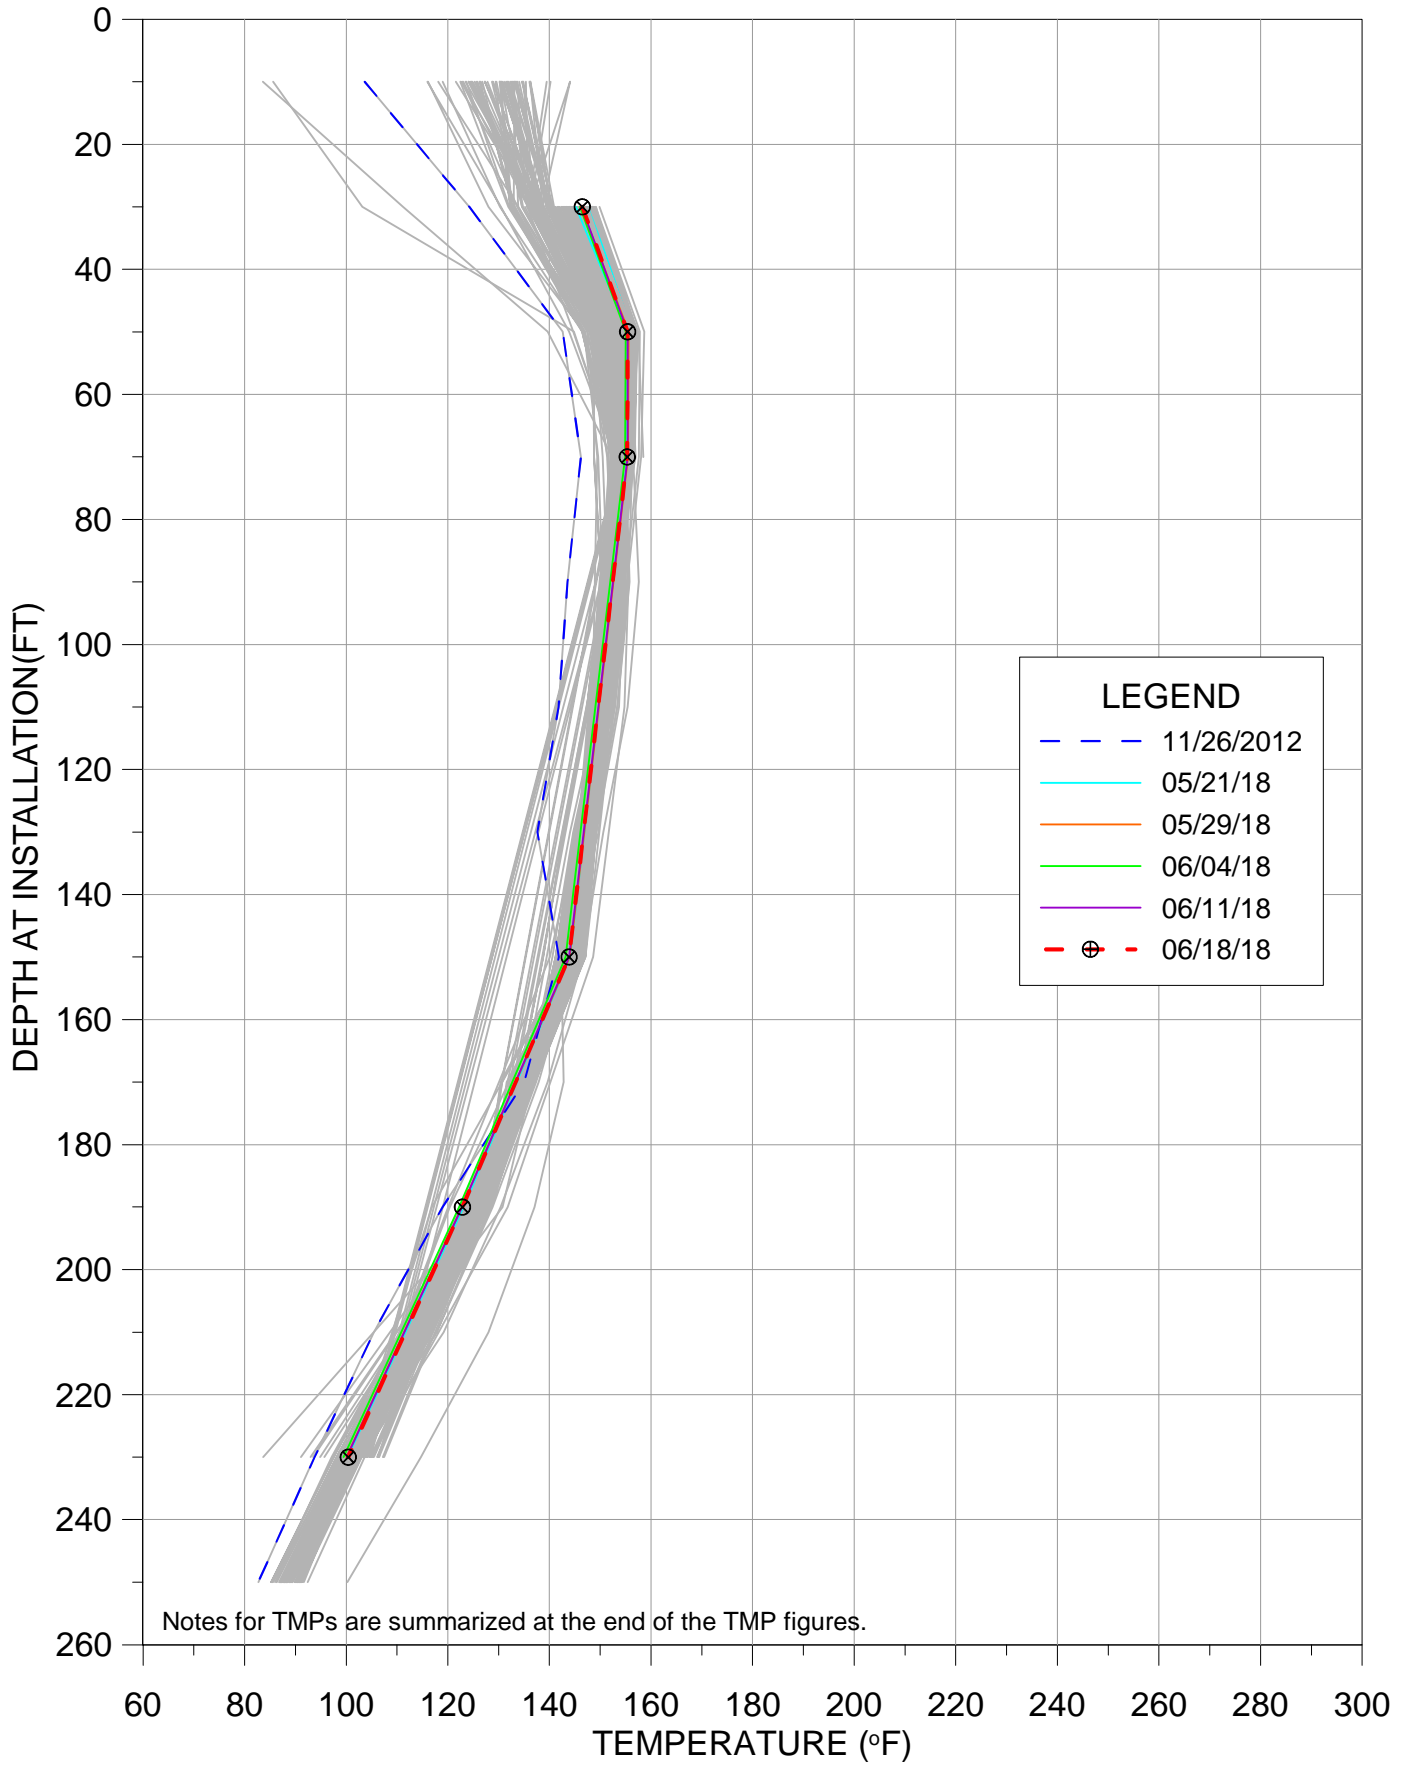
TMP-3

1. No reliable temperature readings have been obtained at 170 ft depth since 1/29/2014, except on 3/13/2014.
2. The connectivity tests on 4/11/2014 conducted by CEC showed that units at 10, 90, 130, 210 and 250 ft depths are no longer reliable.
3. The connectivity tests on 10/28/2014 conducted by Feezor Engineering showed that units at 10, 90, 110, 130, 210 and 250 ft depths are not reliable.

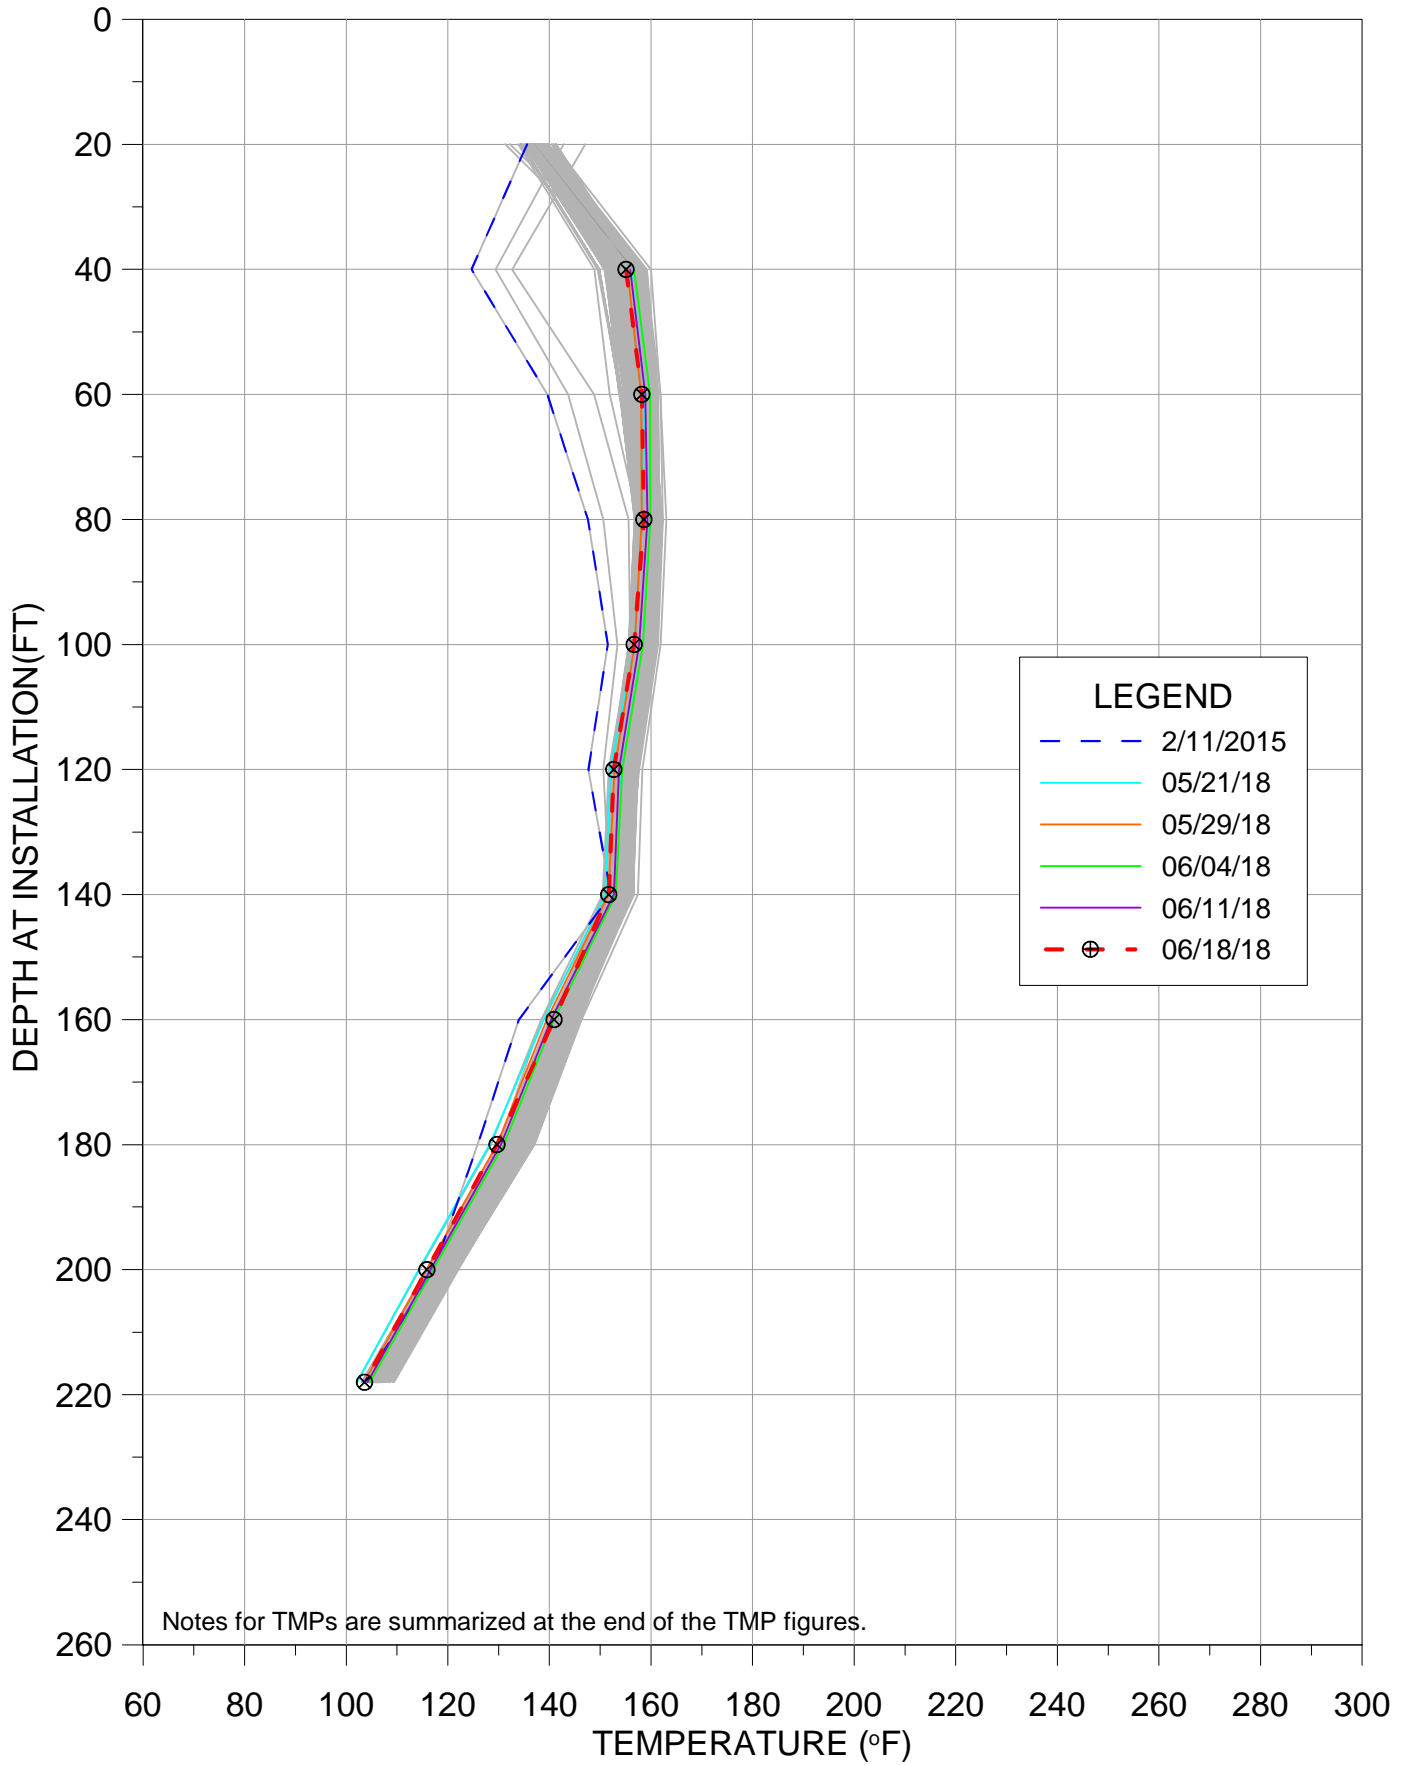
TMP-3R

1. The unit at 20 ft depth had a fluctuating resistance since 9/25/2017. Therefore the temperature is determined to be unreliable.

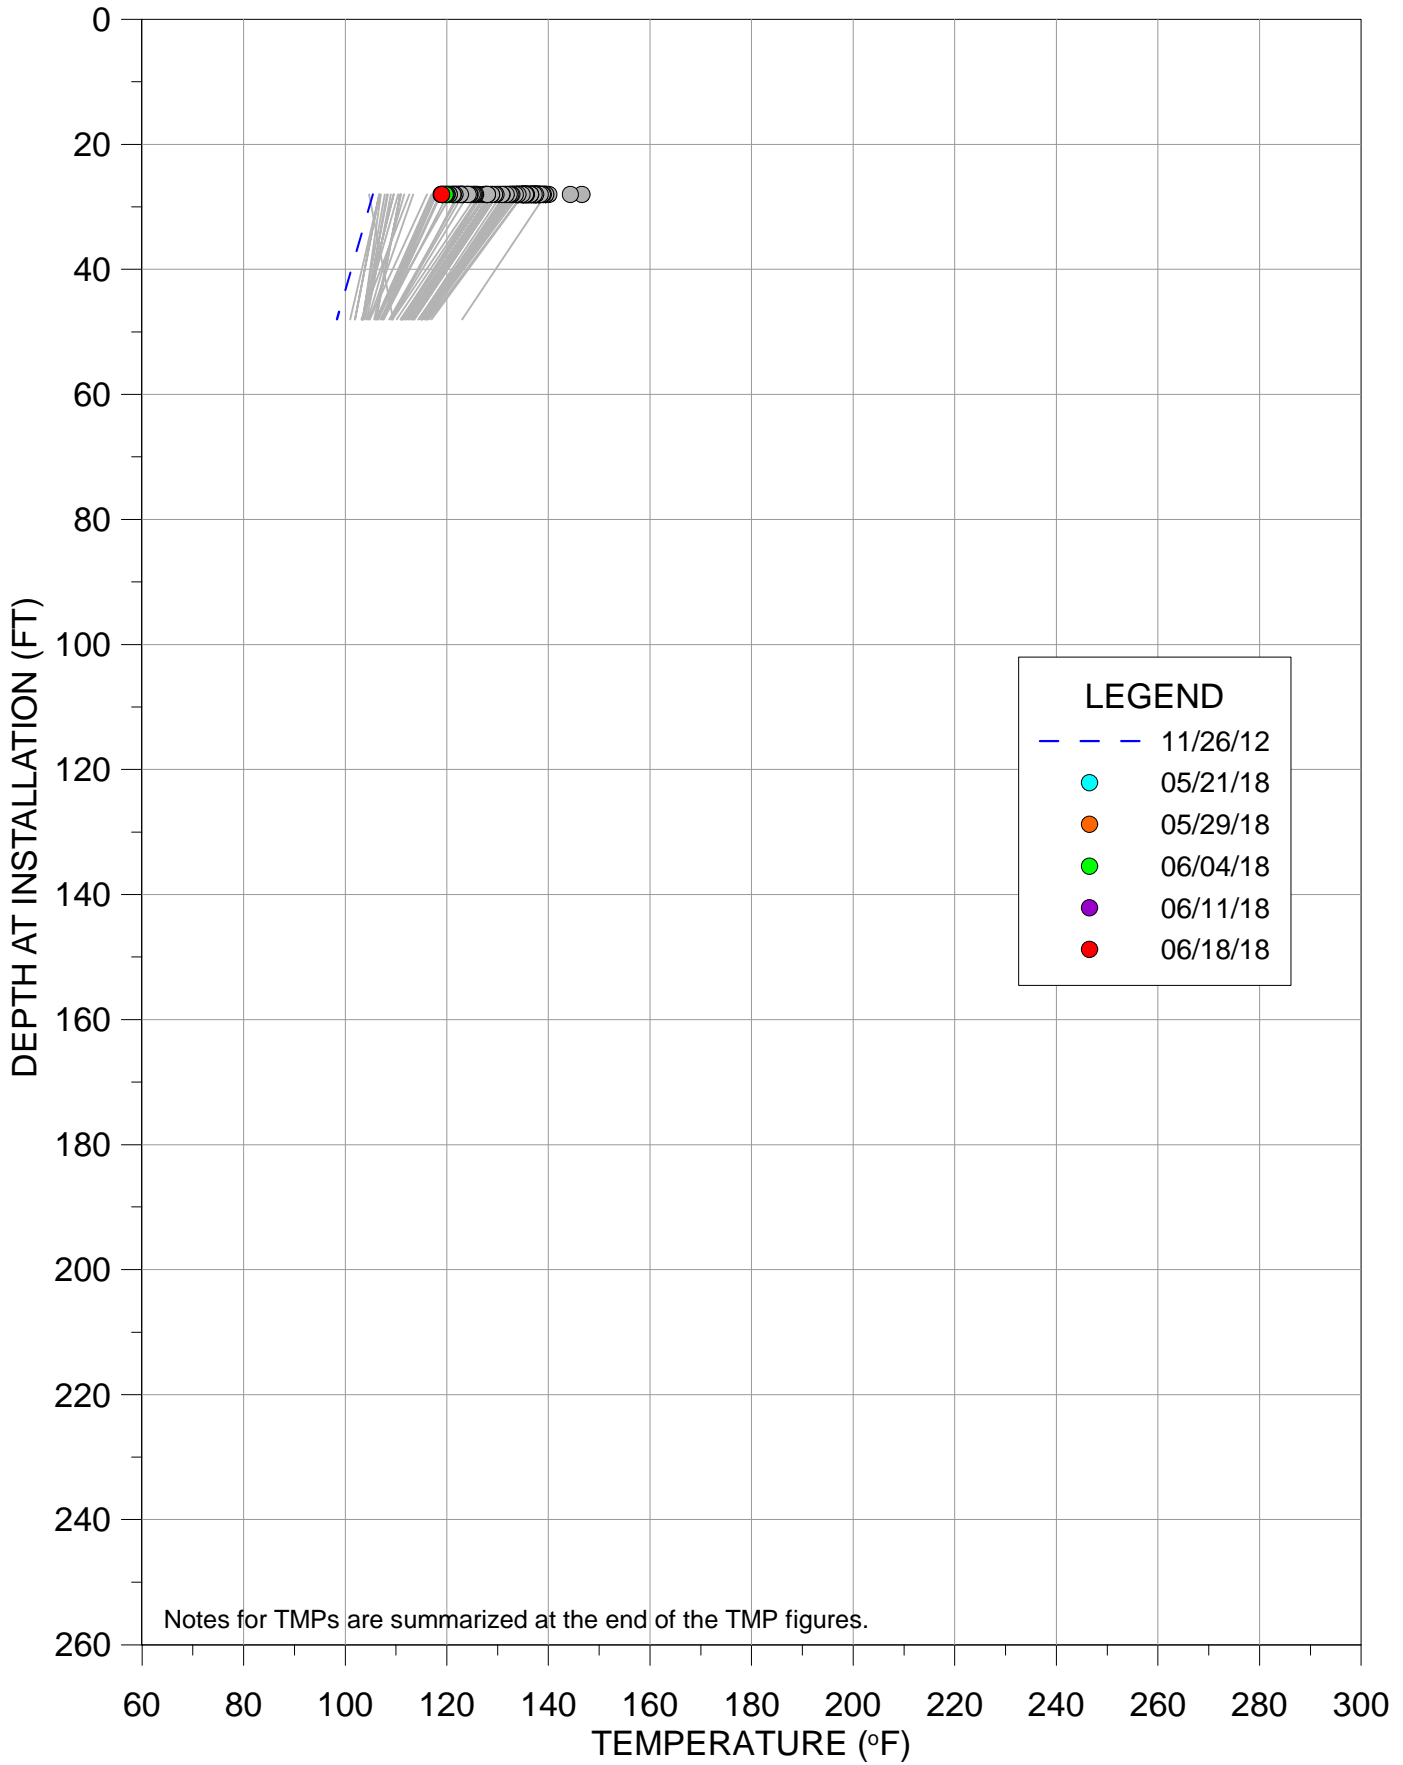
TMP-4

1. The connectivity tests on 4/11/2014 conducted by CEC showed that the unit at 48 ft depth is no longer reliable.

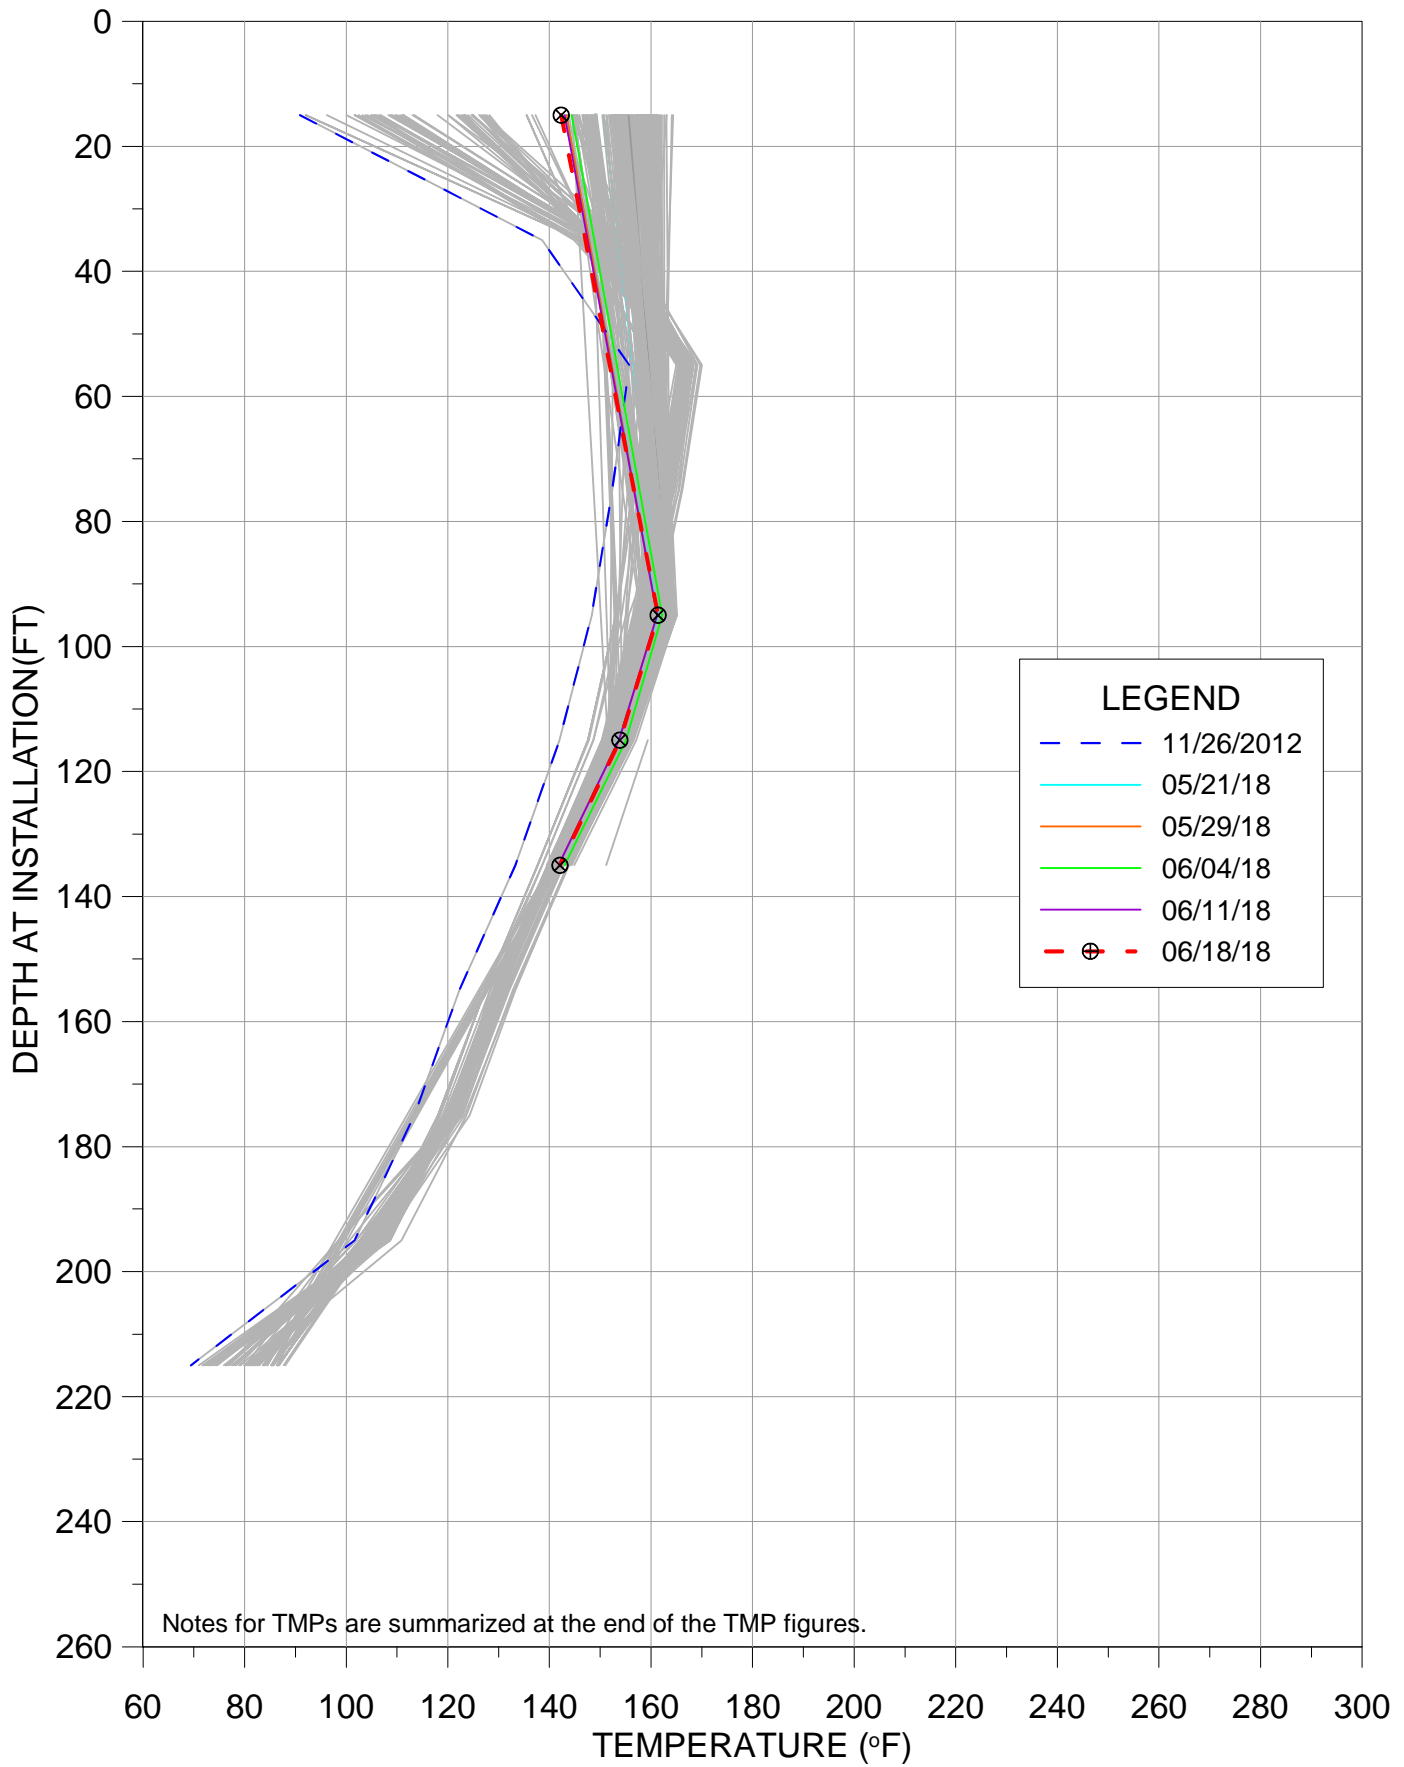
TMP-6

1. The connectivity tests on 4/11/2014 conducted by CEC showed that units at 35, 55, 75, 155, 175, and 195 ft depths are no longer reliable.
2. No reliable temperature readings have been obtained at the unit at 215 ft depth since 6/13/2014.

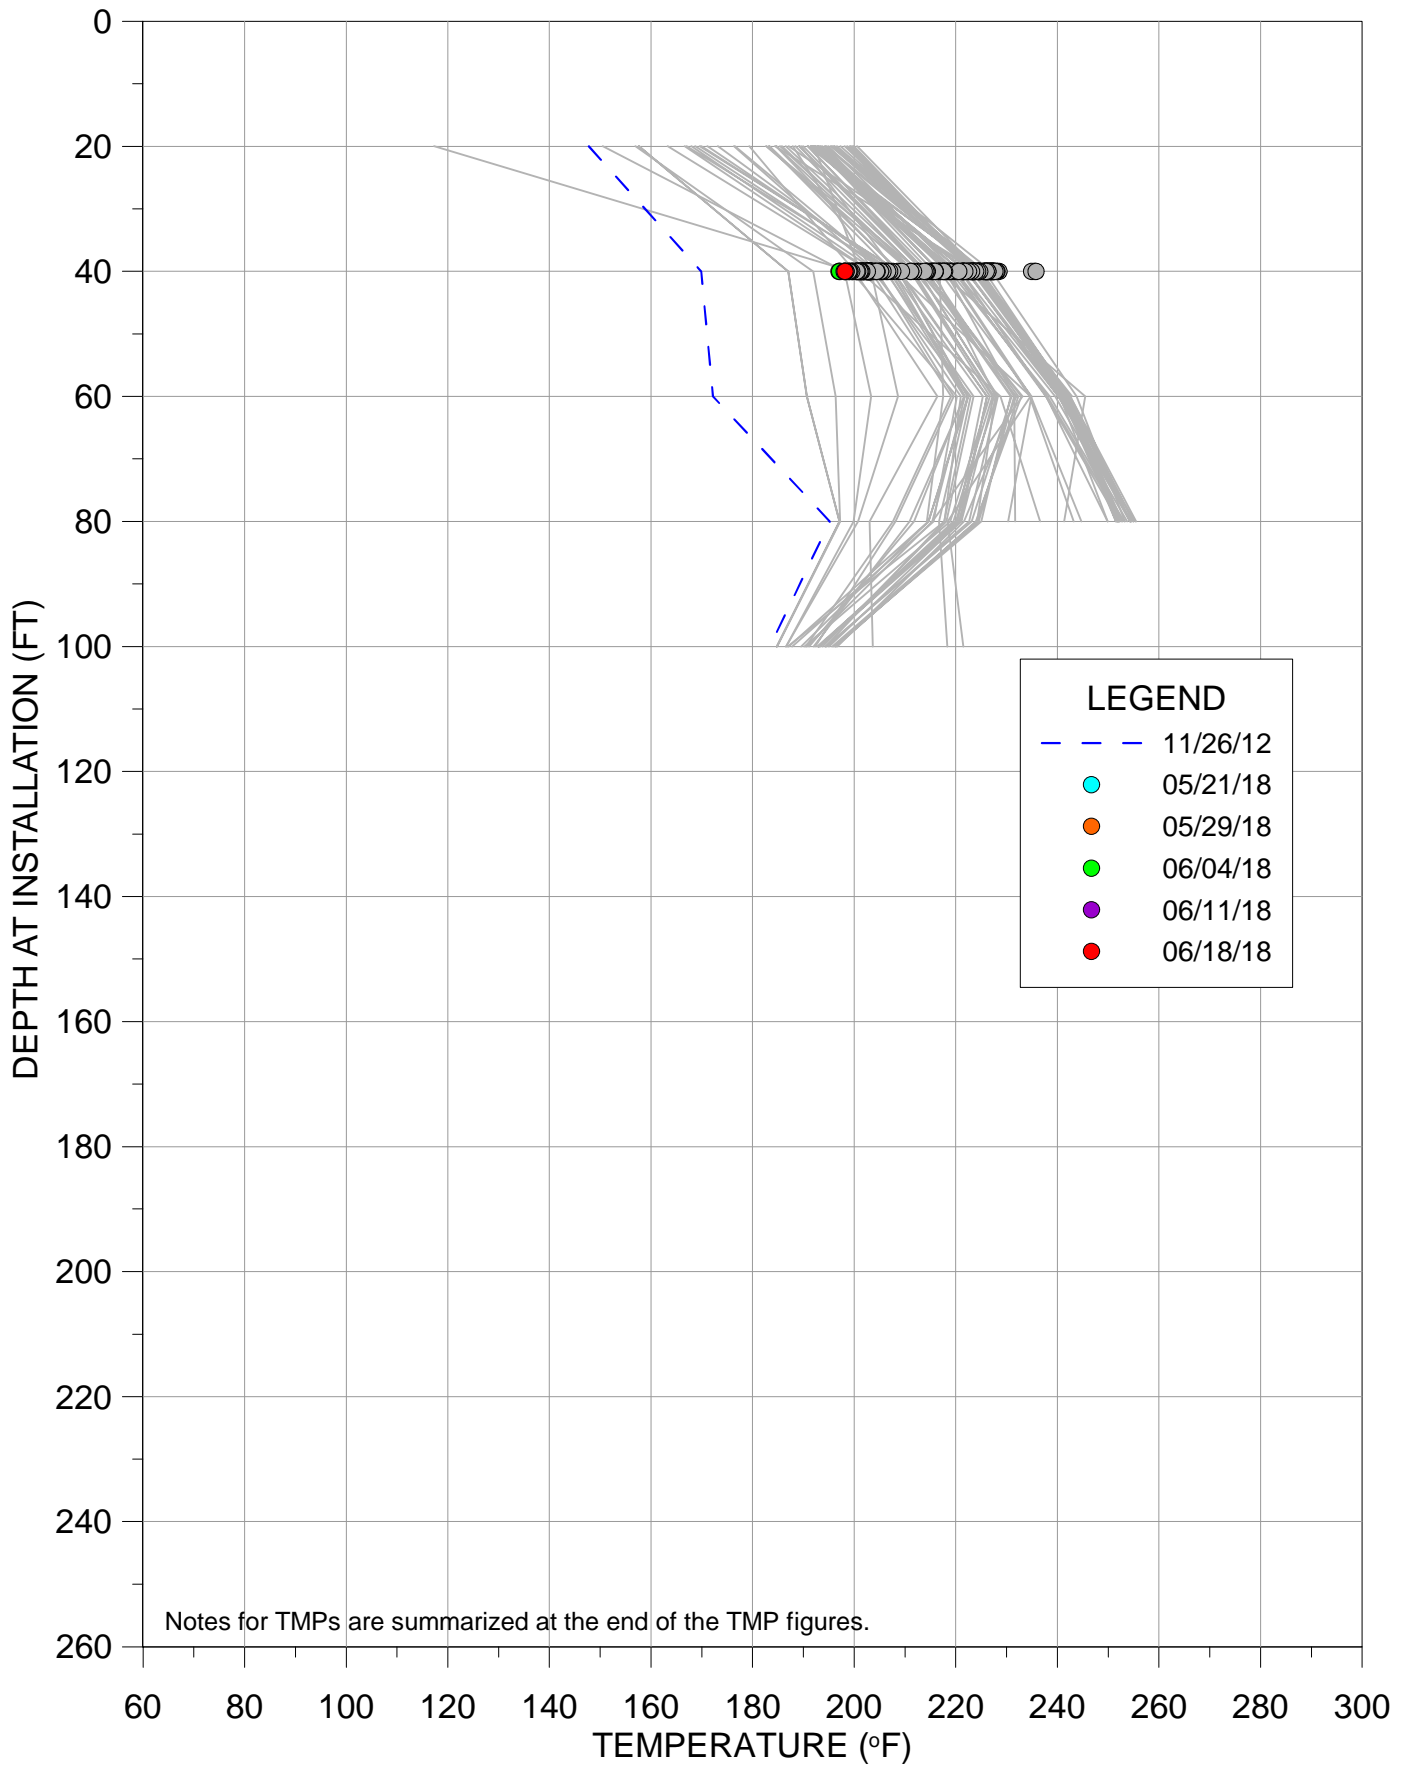
TMP-9

1. Unit at 100 ft depth had an inaccurate temperature reading on 8/1/2013 and no reading since 8/6/2013.
2. The connectivity tests on 4/11/2014 conducted by CEC showed that units at 20, 60, 80, and 100 ft depths are no longer reliable.
