Bridgeton Landfill, LLC

Weekly Data Submittal

Week of June 17, 2018 – June 23, 2018

**Required by Section 52.F of Agreed Order, Case No. 13SL-CC01088
Effective May 13, 2013**

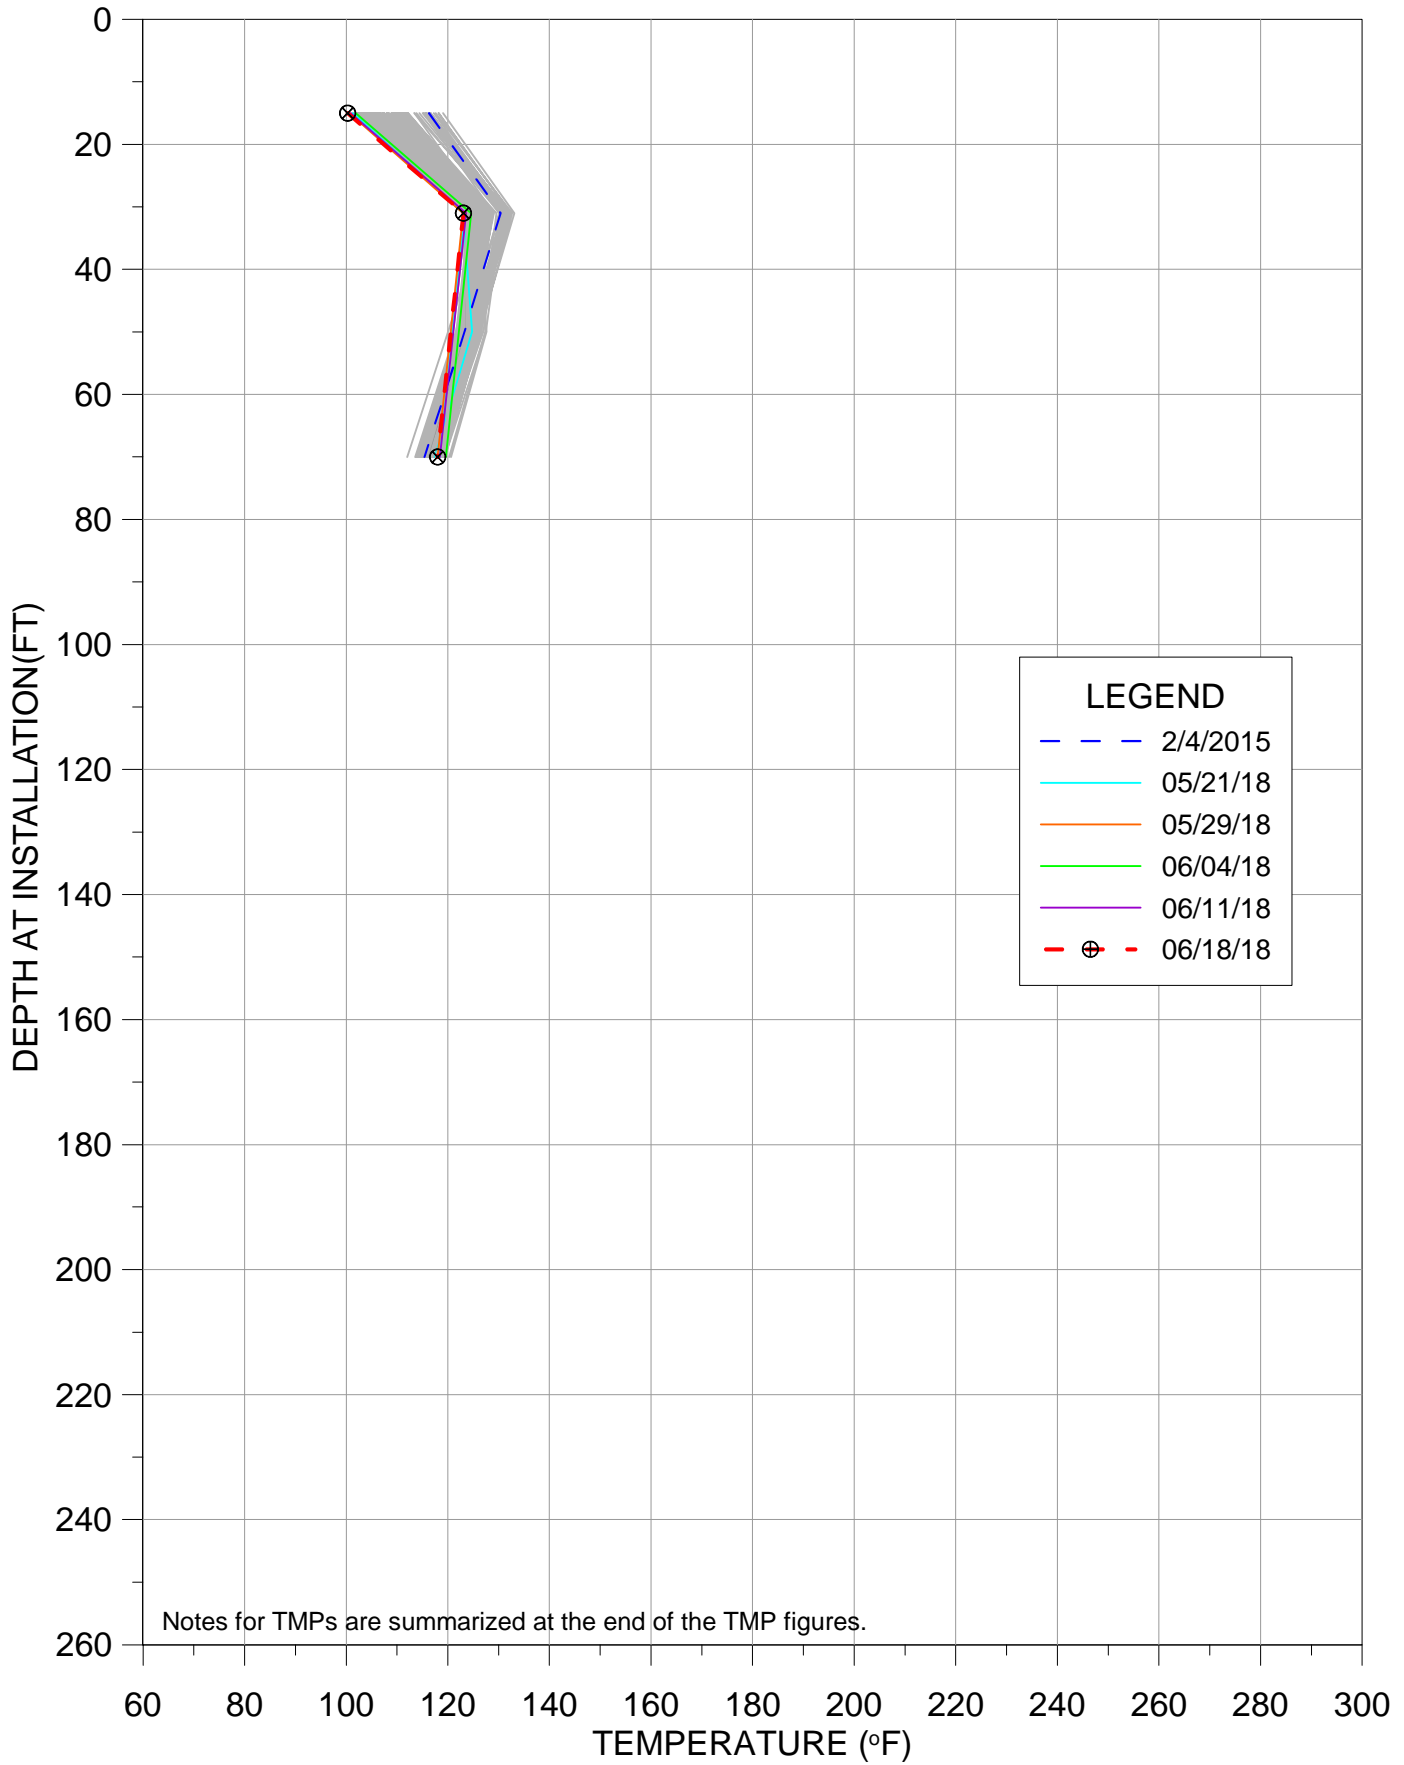
TMP-22

1. No temperature reading could be obtained and resistivity was fluctuating at the unit at 50 ft depth since 4/2/2018.

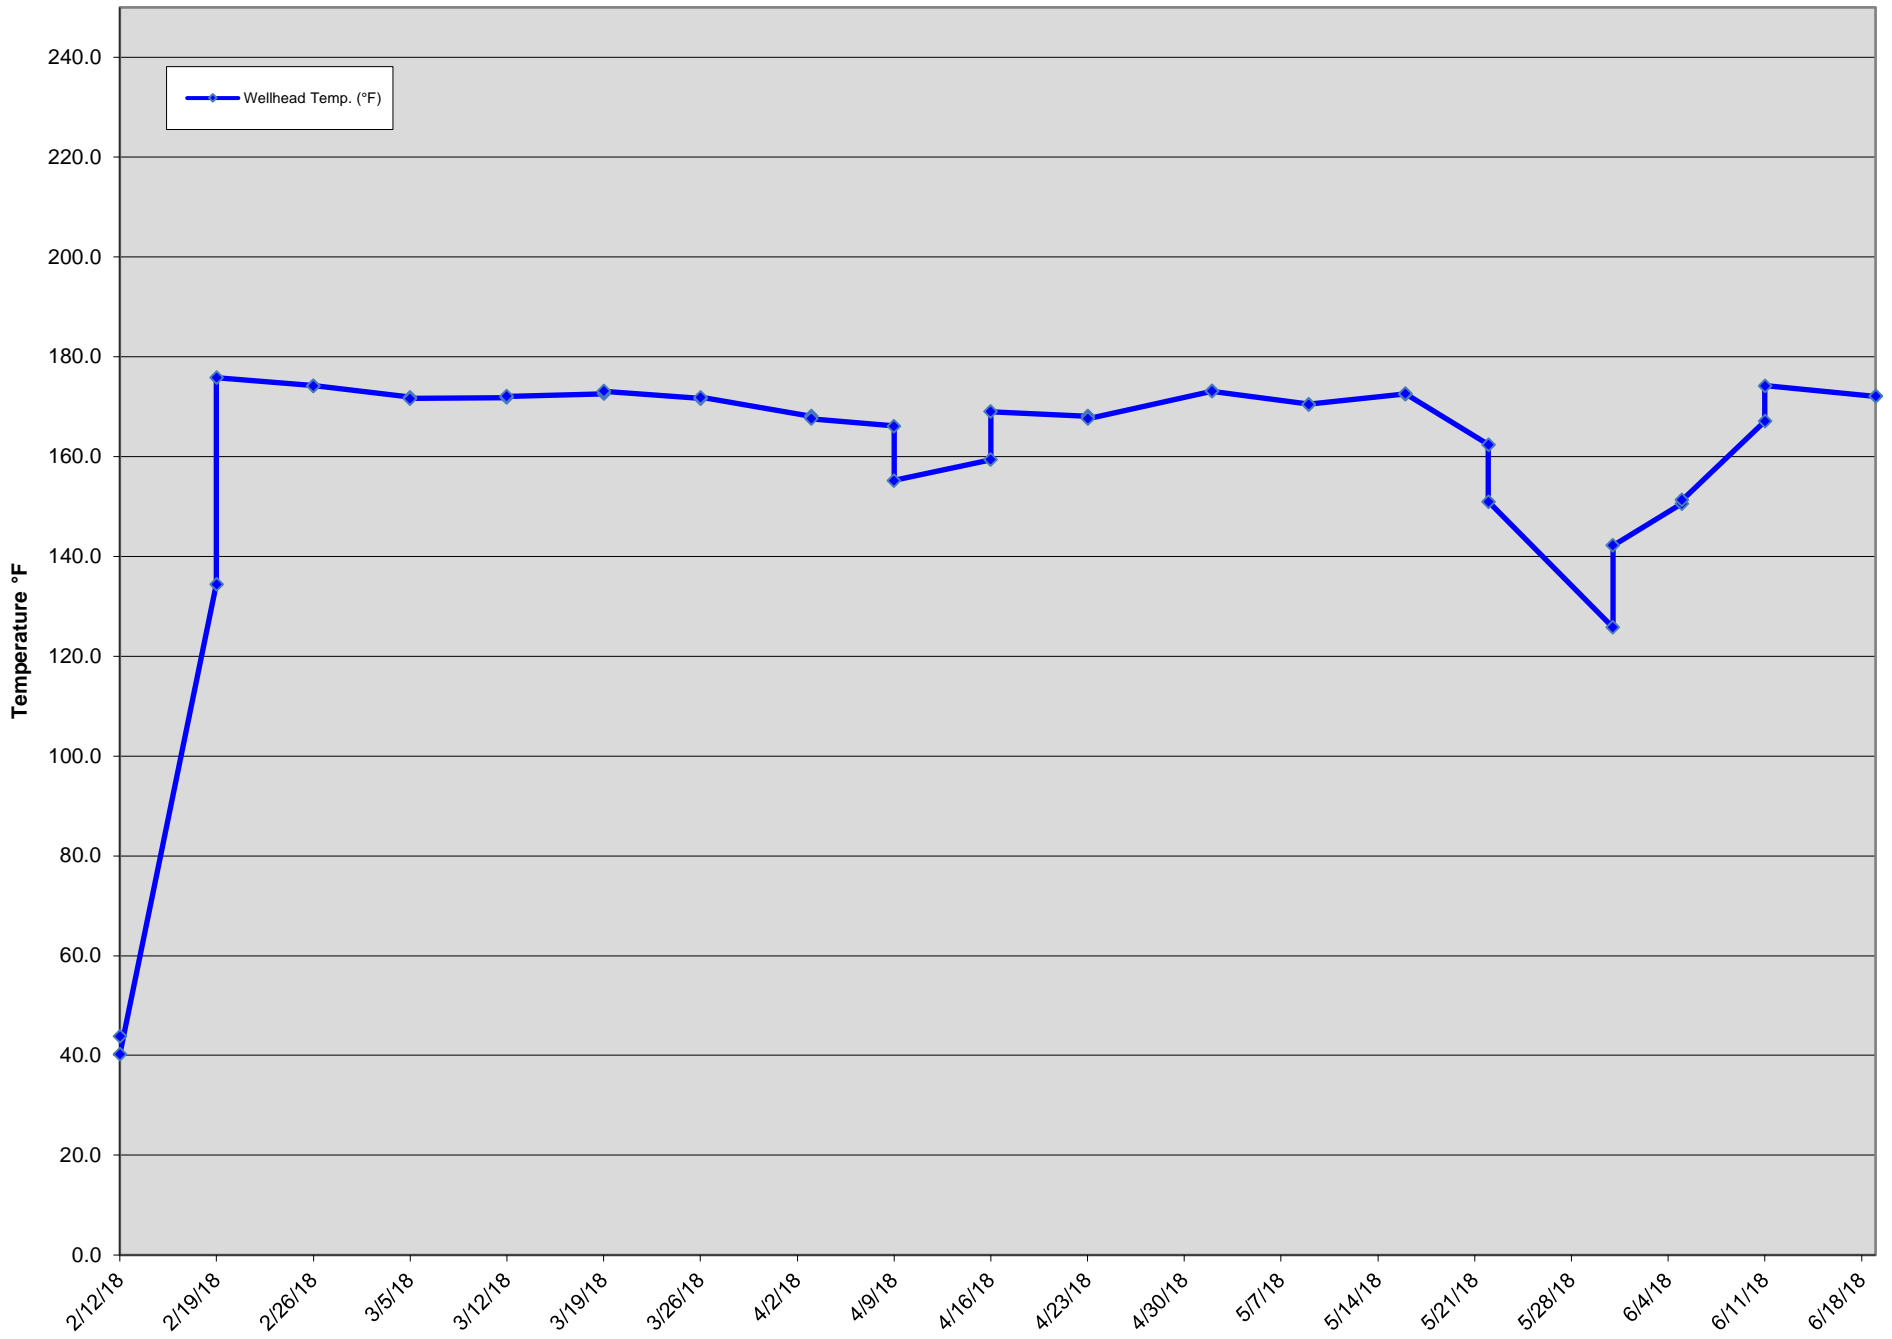
GIW-1 Wellhead Temperatures

As part of the HES, there are currently cooling water circulation loops installed in twelve Gas Interceptor Wells (GIWs) (GIW-02 through GIW-13). The remaining well (GIW-01) had a measured gas temperature within its historical operating limits.
