Bridgeton Landfill, LLC

Weekly Data Submittal

Week of June 24, 2018 – June 30, 2018

**Required by Section IX.33.g of Final Consent Judgment, Case No. 13SL-
CC01088-01
Effective June 29, 2018**

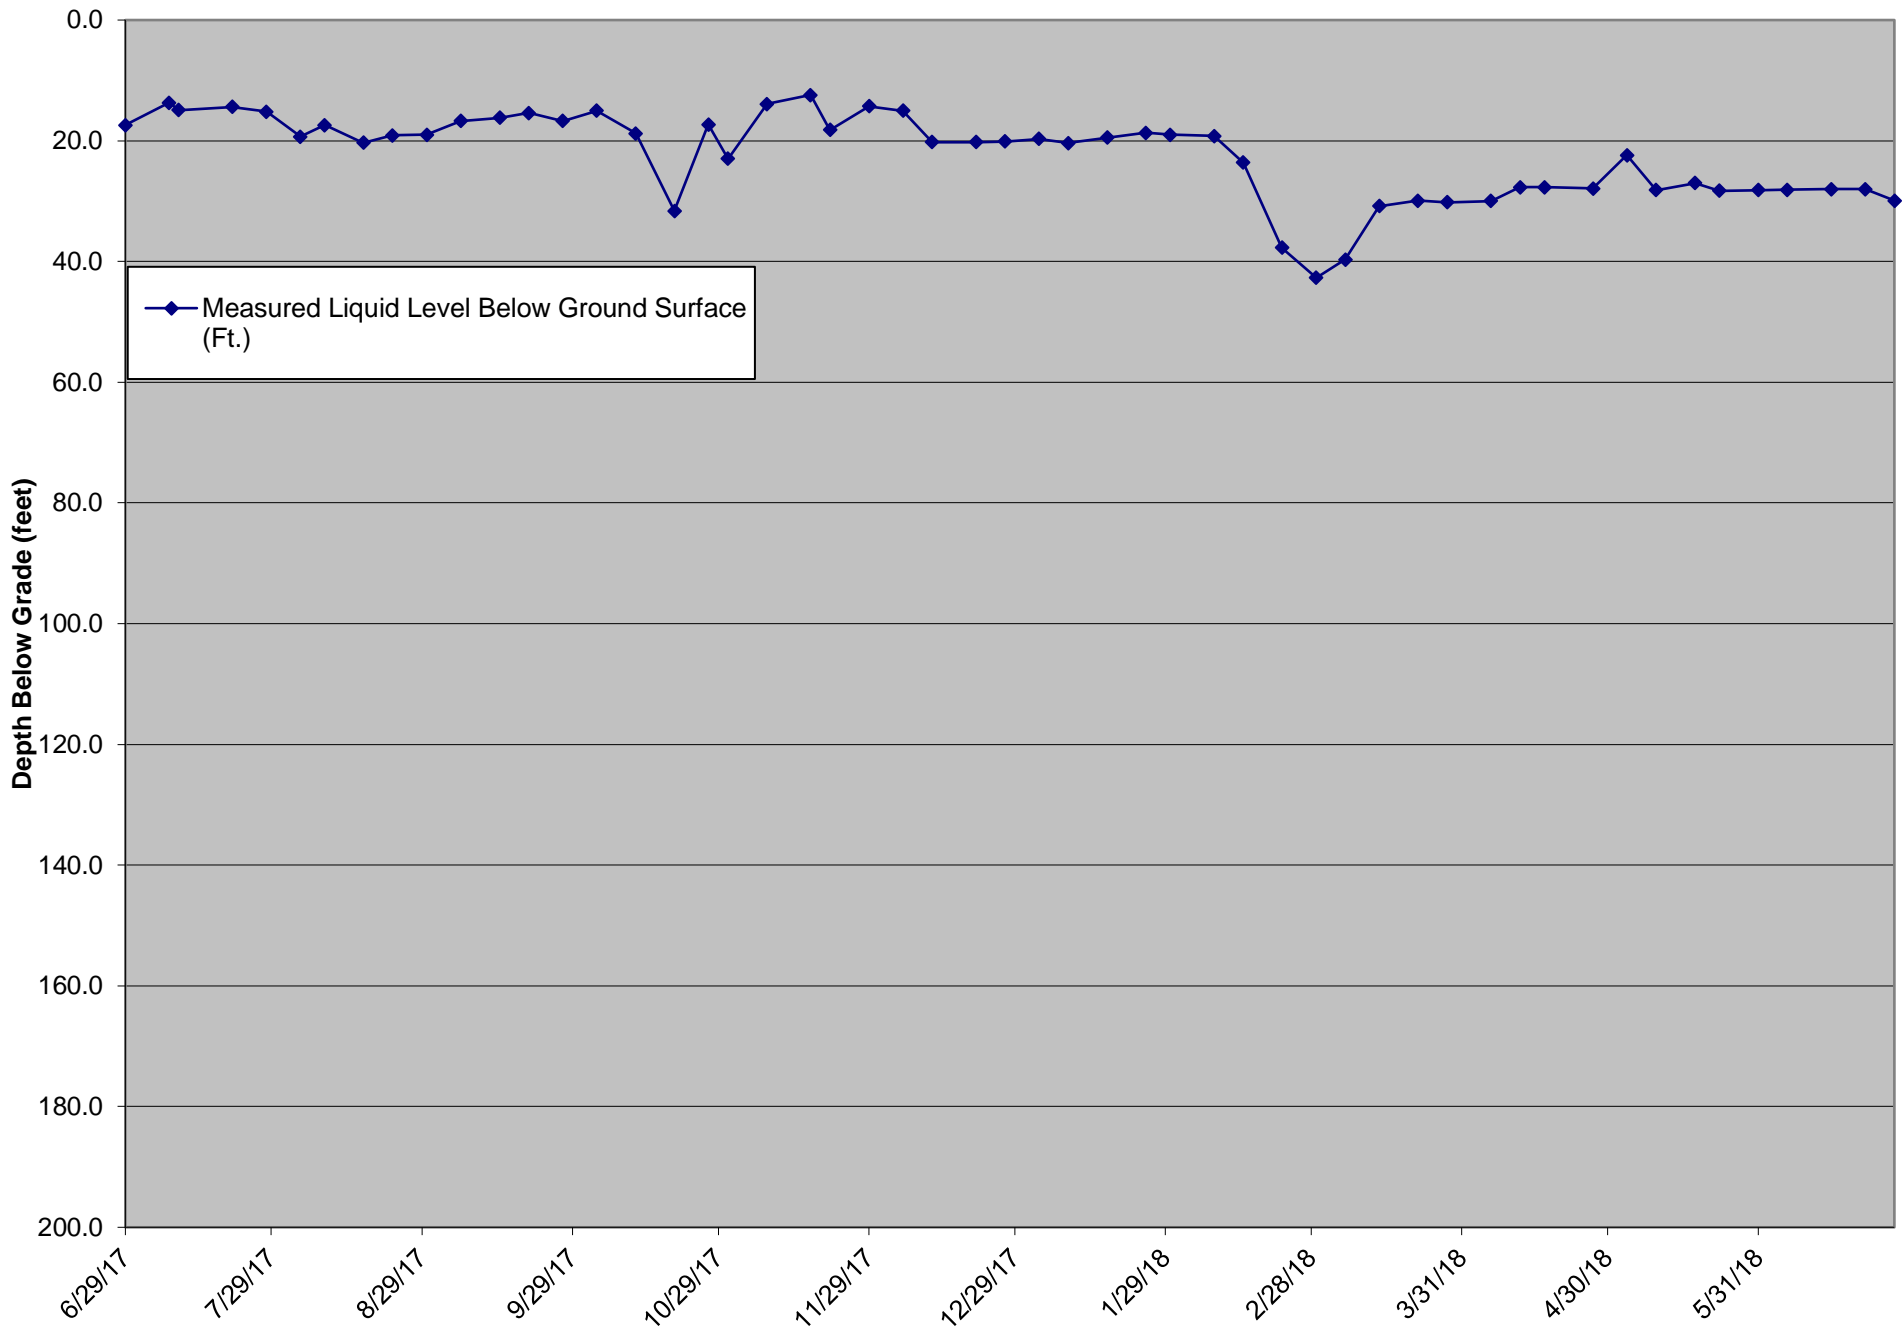
LCS-3D Liquid Level Below Ground Surface

The QED AP-4 pneumatic pump in LCS-3D was non-operational during the weekly reporting period. Liquid level was measured manually.

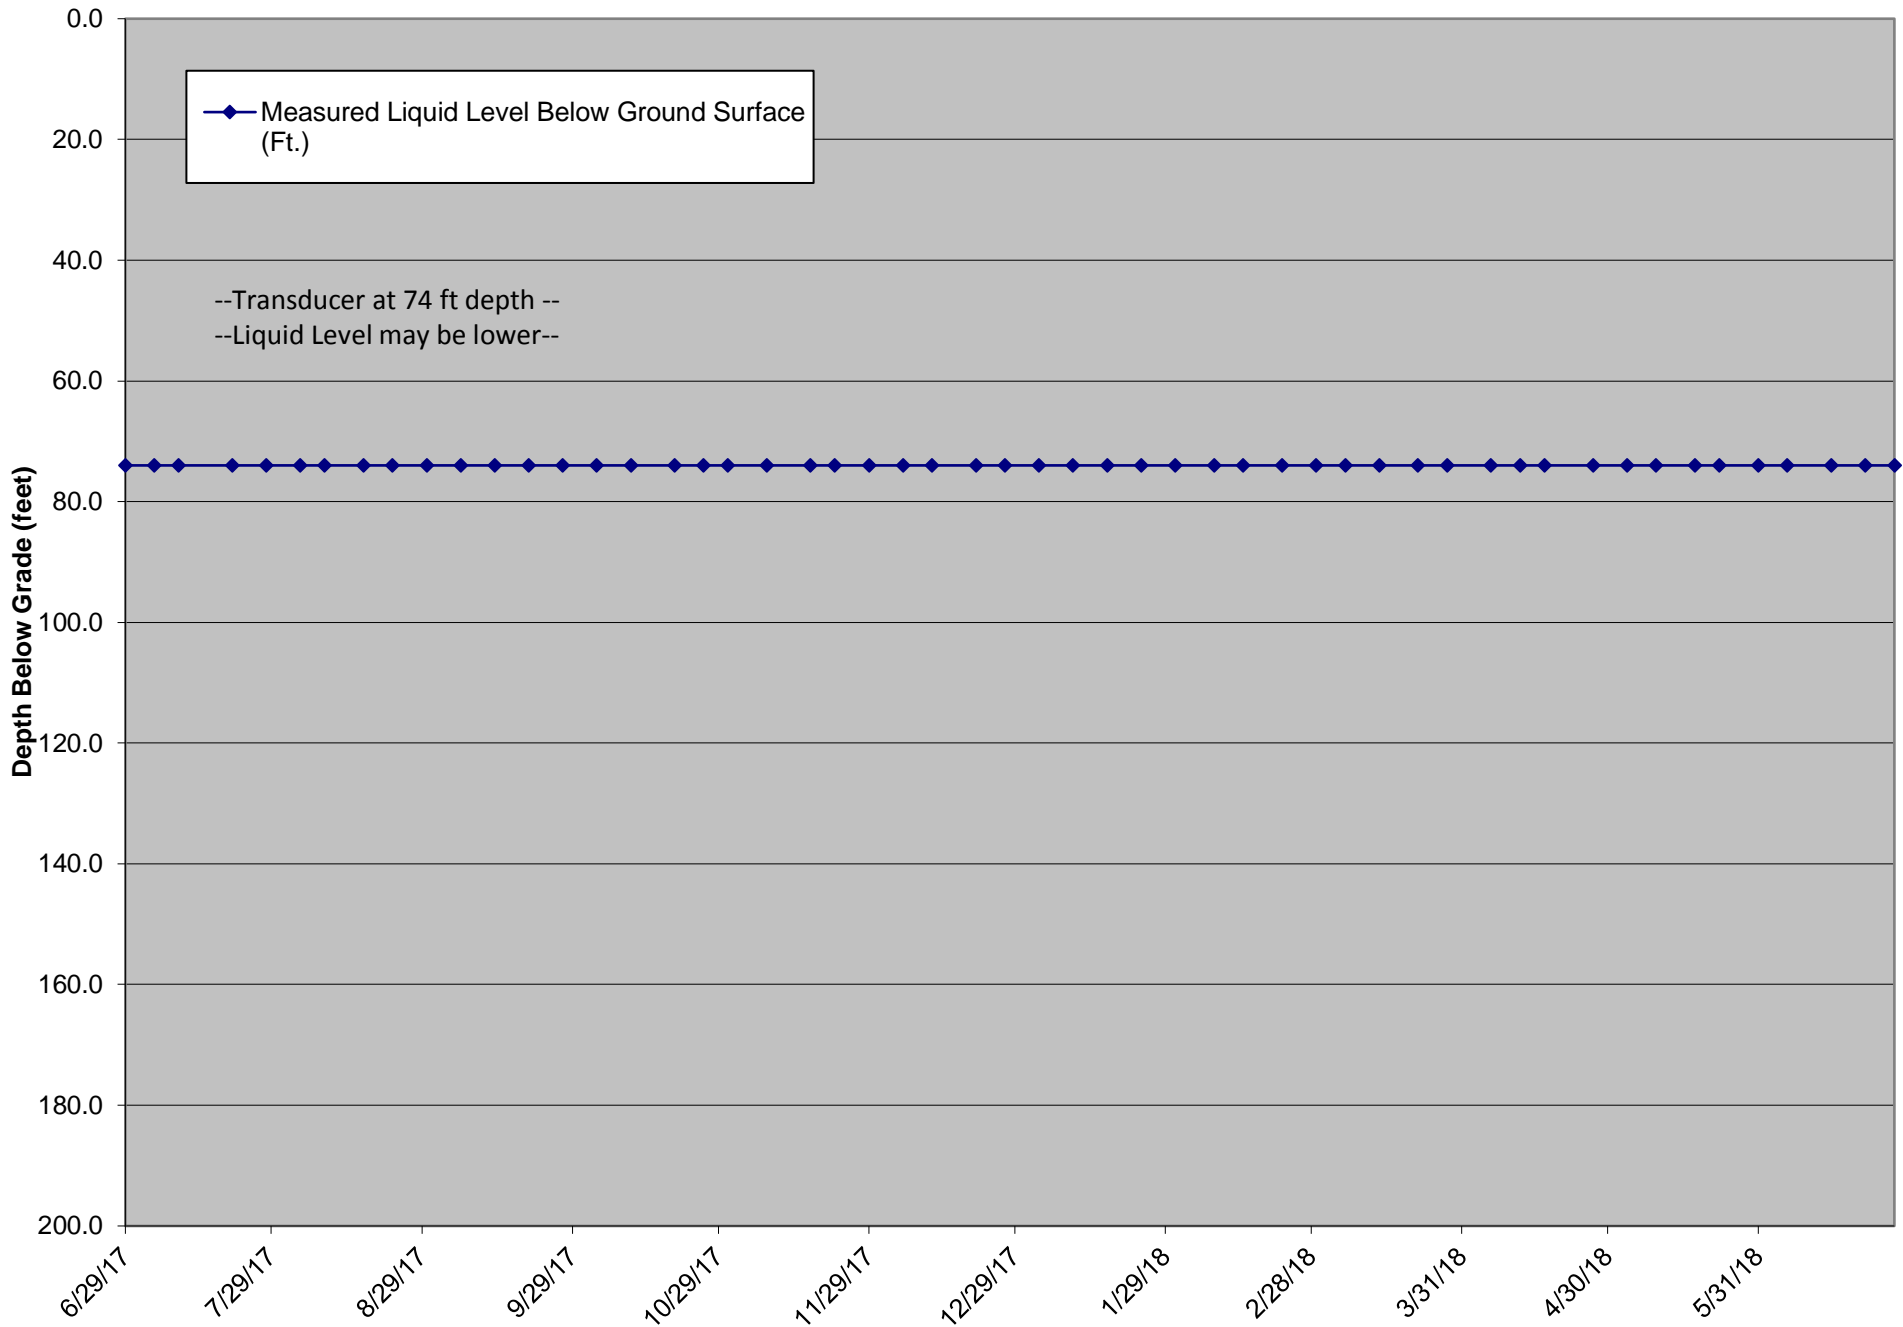
LCS-4B Liquid Level Below Ground Surface

The level sensor in LCS-4B is currently operational and responsive. Liquid level was not recorded by the level sensor during the weekly reporting period. LCS-4B is equipped with a flow meter that displayed no flow during the weekly reporting period. Therefore, it can be concluded that the liquid level was below the bottom of the pump and level sensor in LCS-4B.

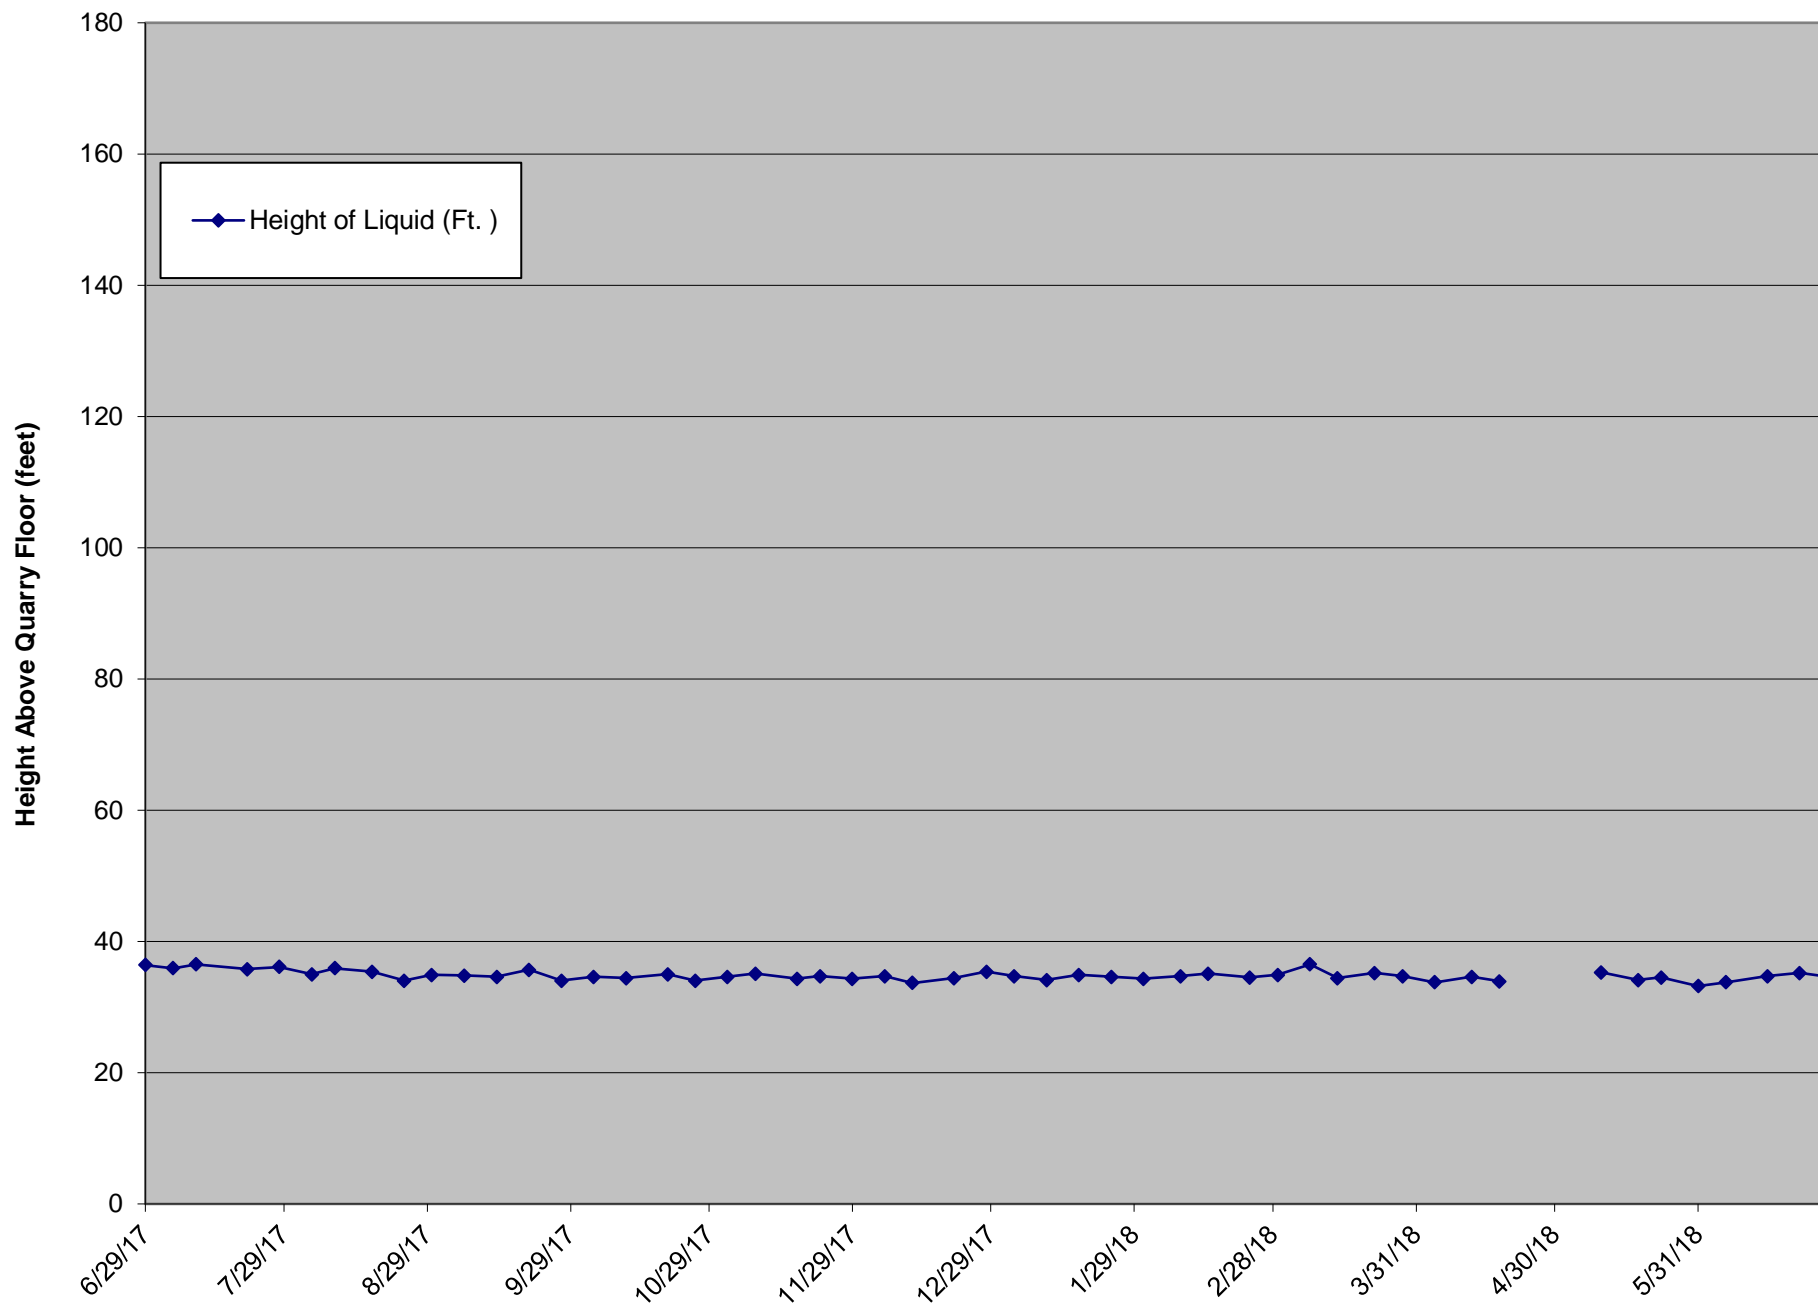
LCS-5B Liquid Level Above Quarry Floor

LCS-5B and LCS-6B were fully operational during the weekly reporting period.

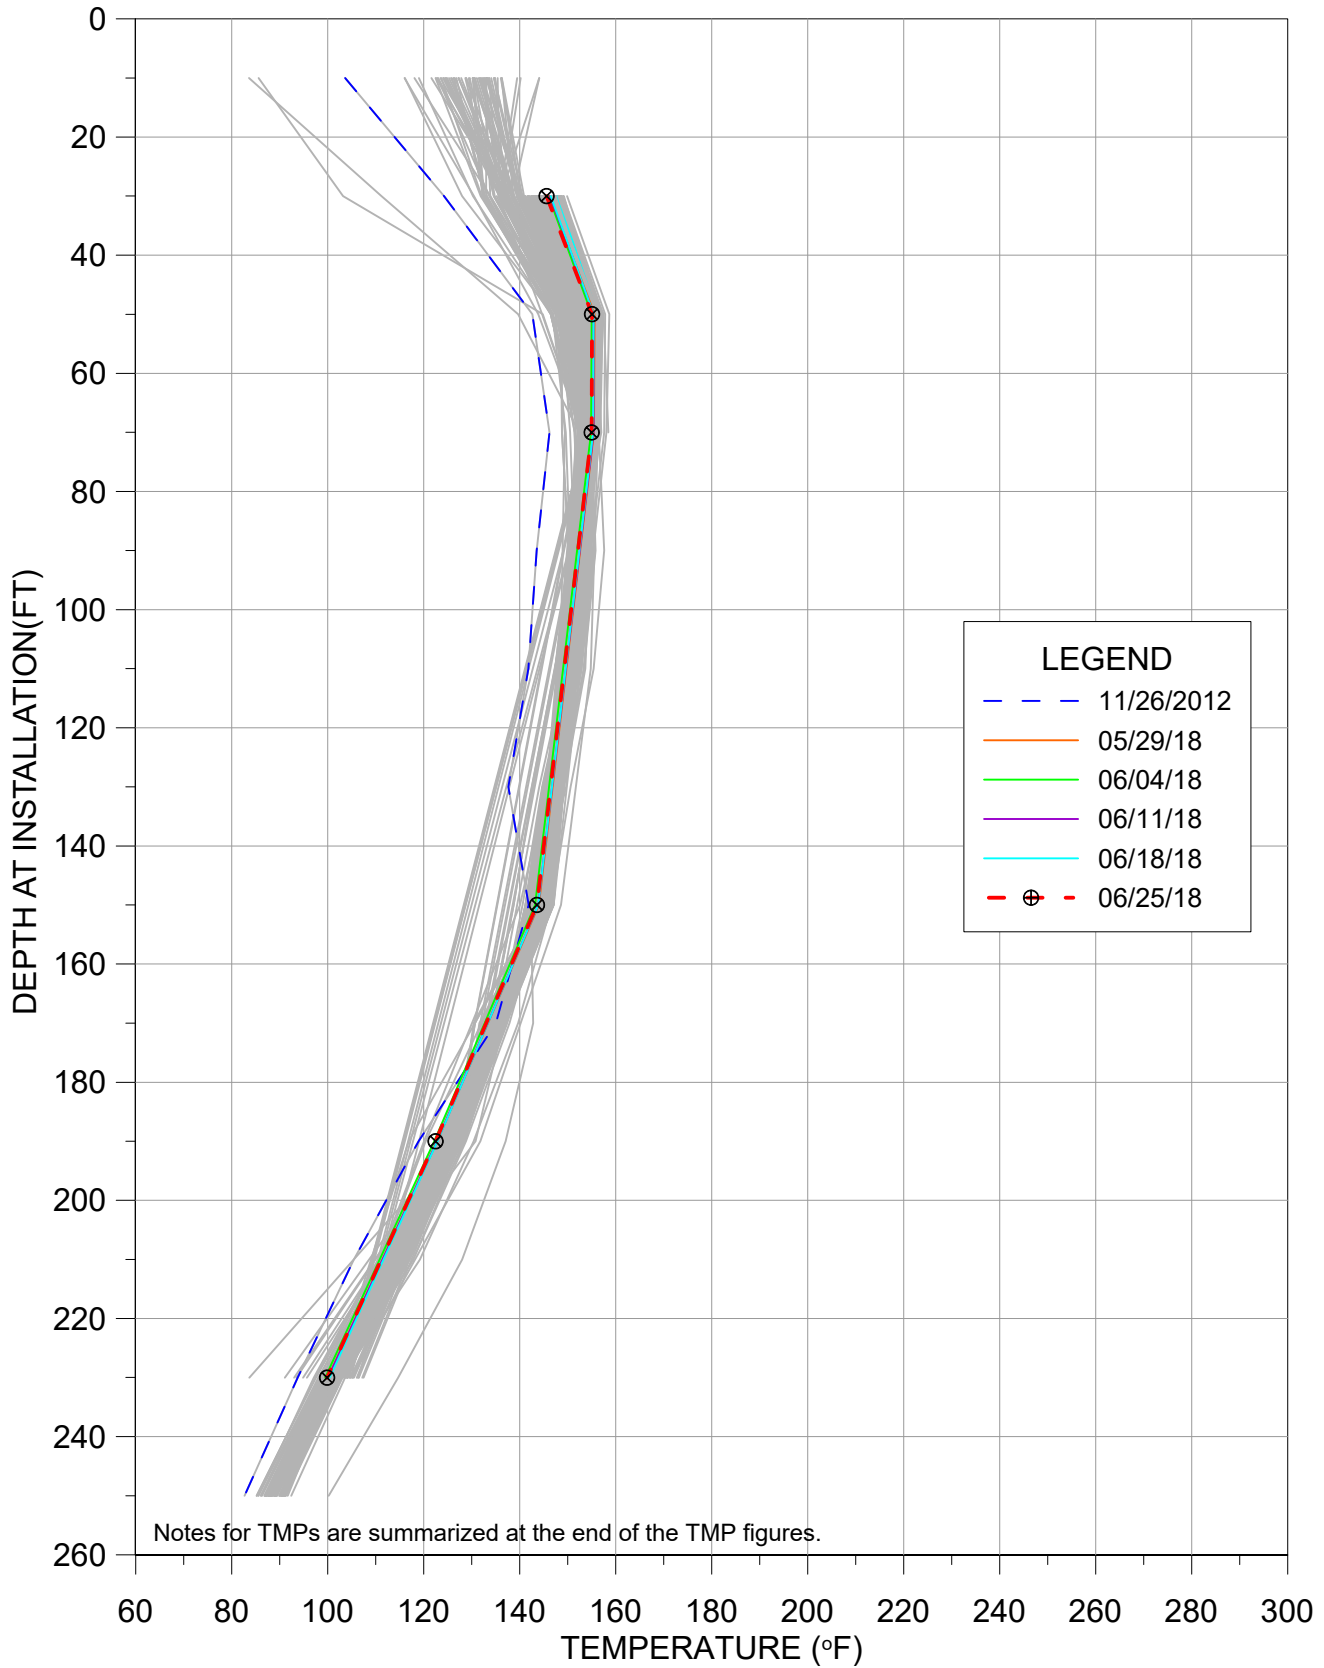
TMP-3

1. No reliable temperature readings have been obtained at 170 ft depth since 1/29/2014, except on 3/13/2014.
2. The connectivity tests on 4/11/2014 conducted by CEC showed that units at 10, 90, 130, 210 and 250 ft depths are no longer reliable.
3. The connectivity tests on 10/28/2014 conducted by Feezor Engineering showed that units at 10, 90, 110, 130, 210 and 250 ft depths are not reliable.

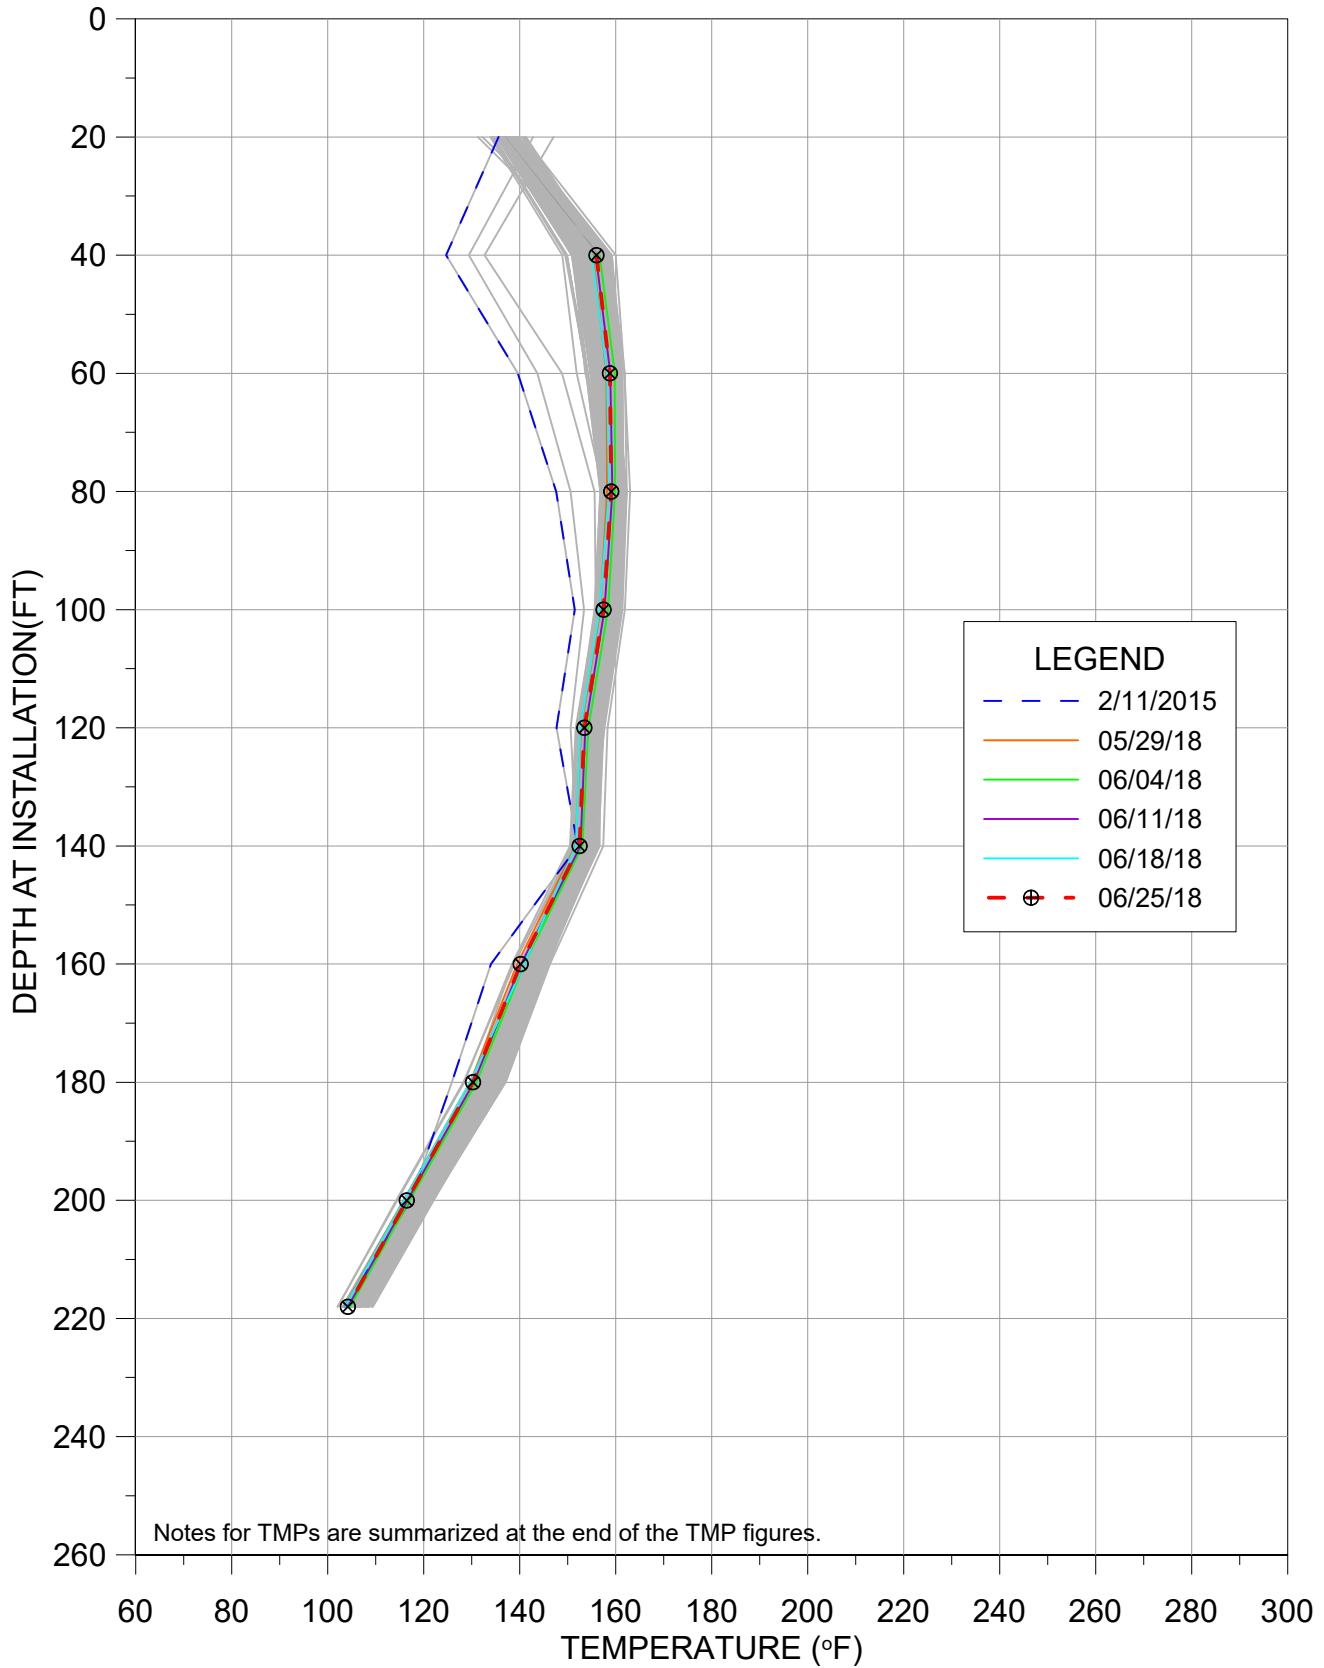
TMP-3R

1. The unit at 20 ft depth had a fluctuating resistance since 9/25/2017. Therefore the temperature is determined to be unreliable.

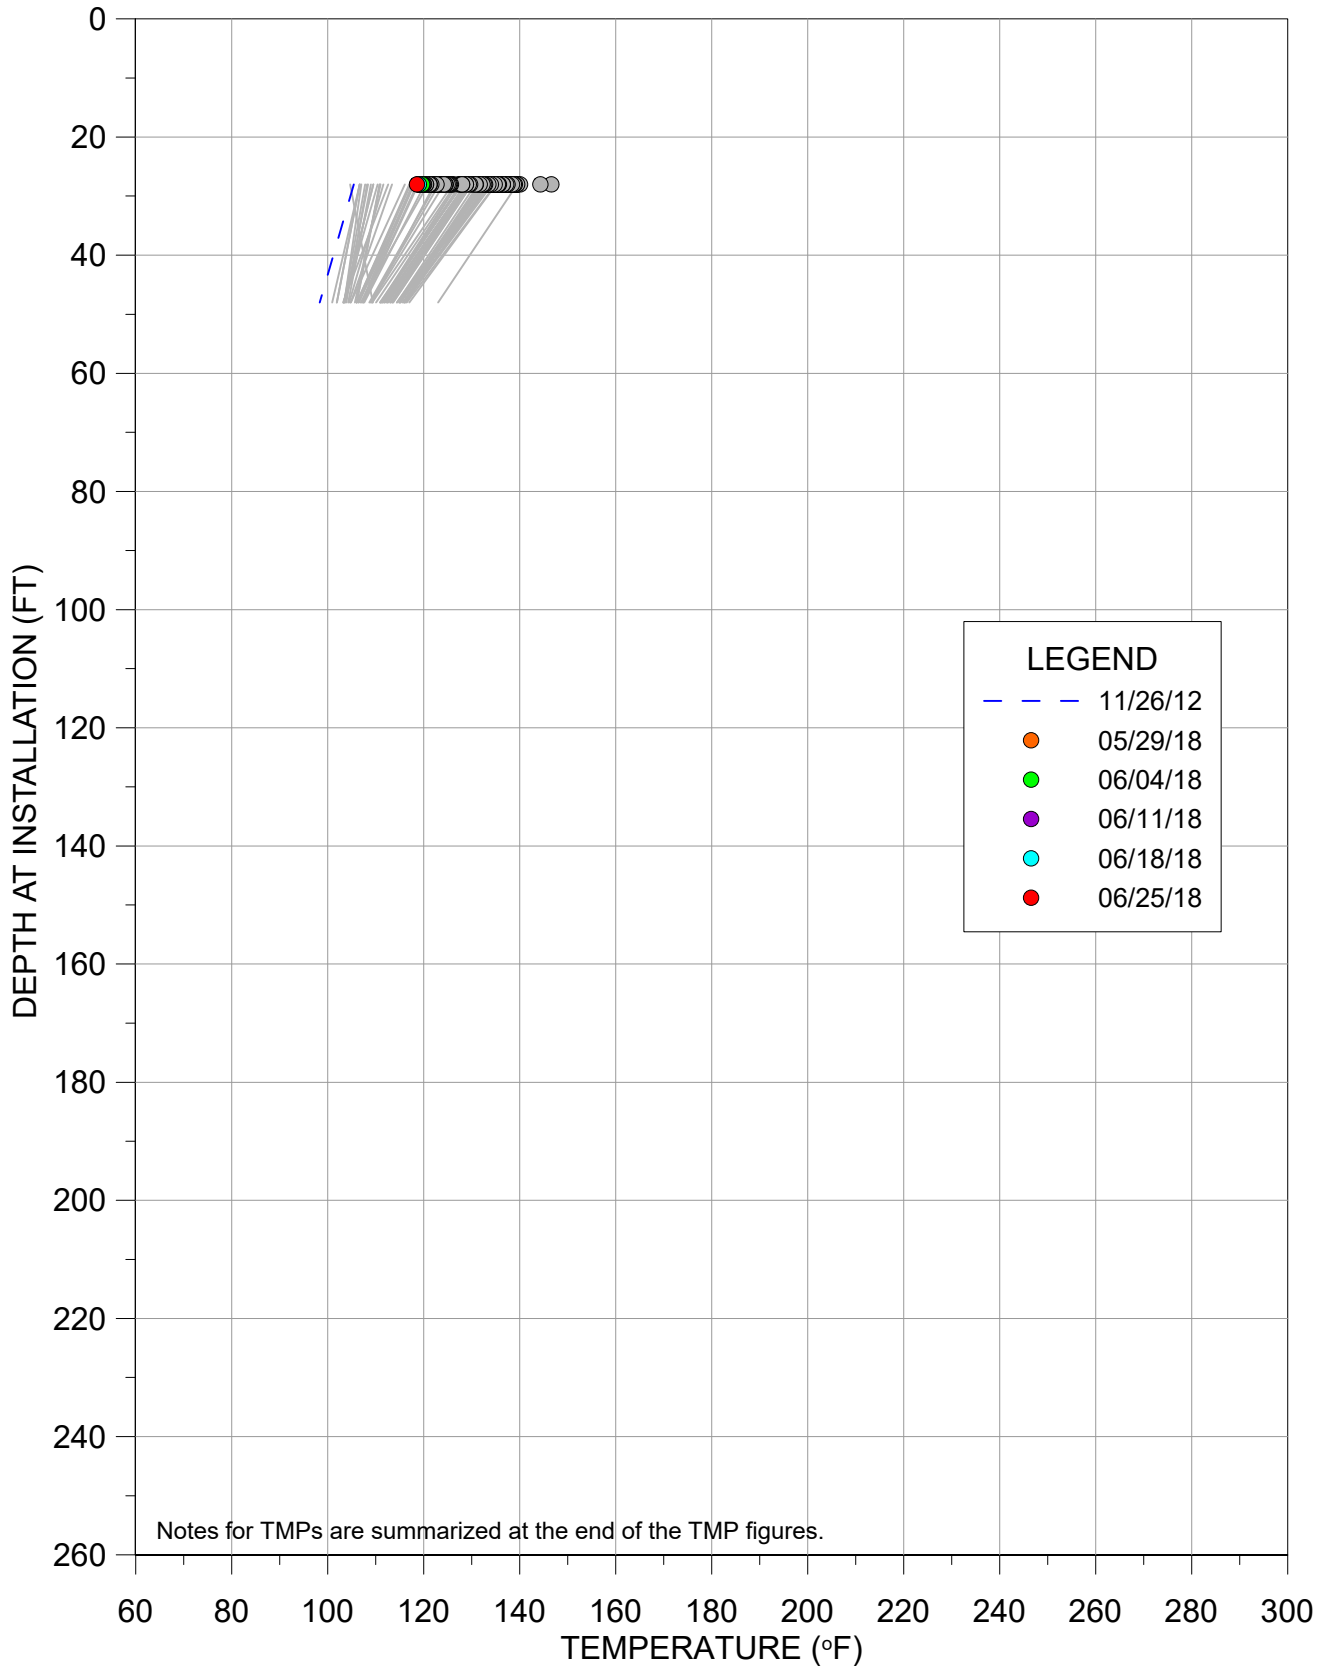
TMP-4

1. The connectivity tests on 4/11/2014 conducted by CEC showed that the unit at 48 ft depth is no longer reliable.

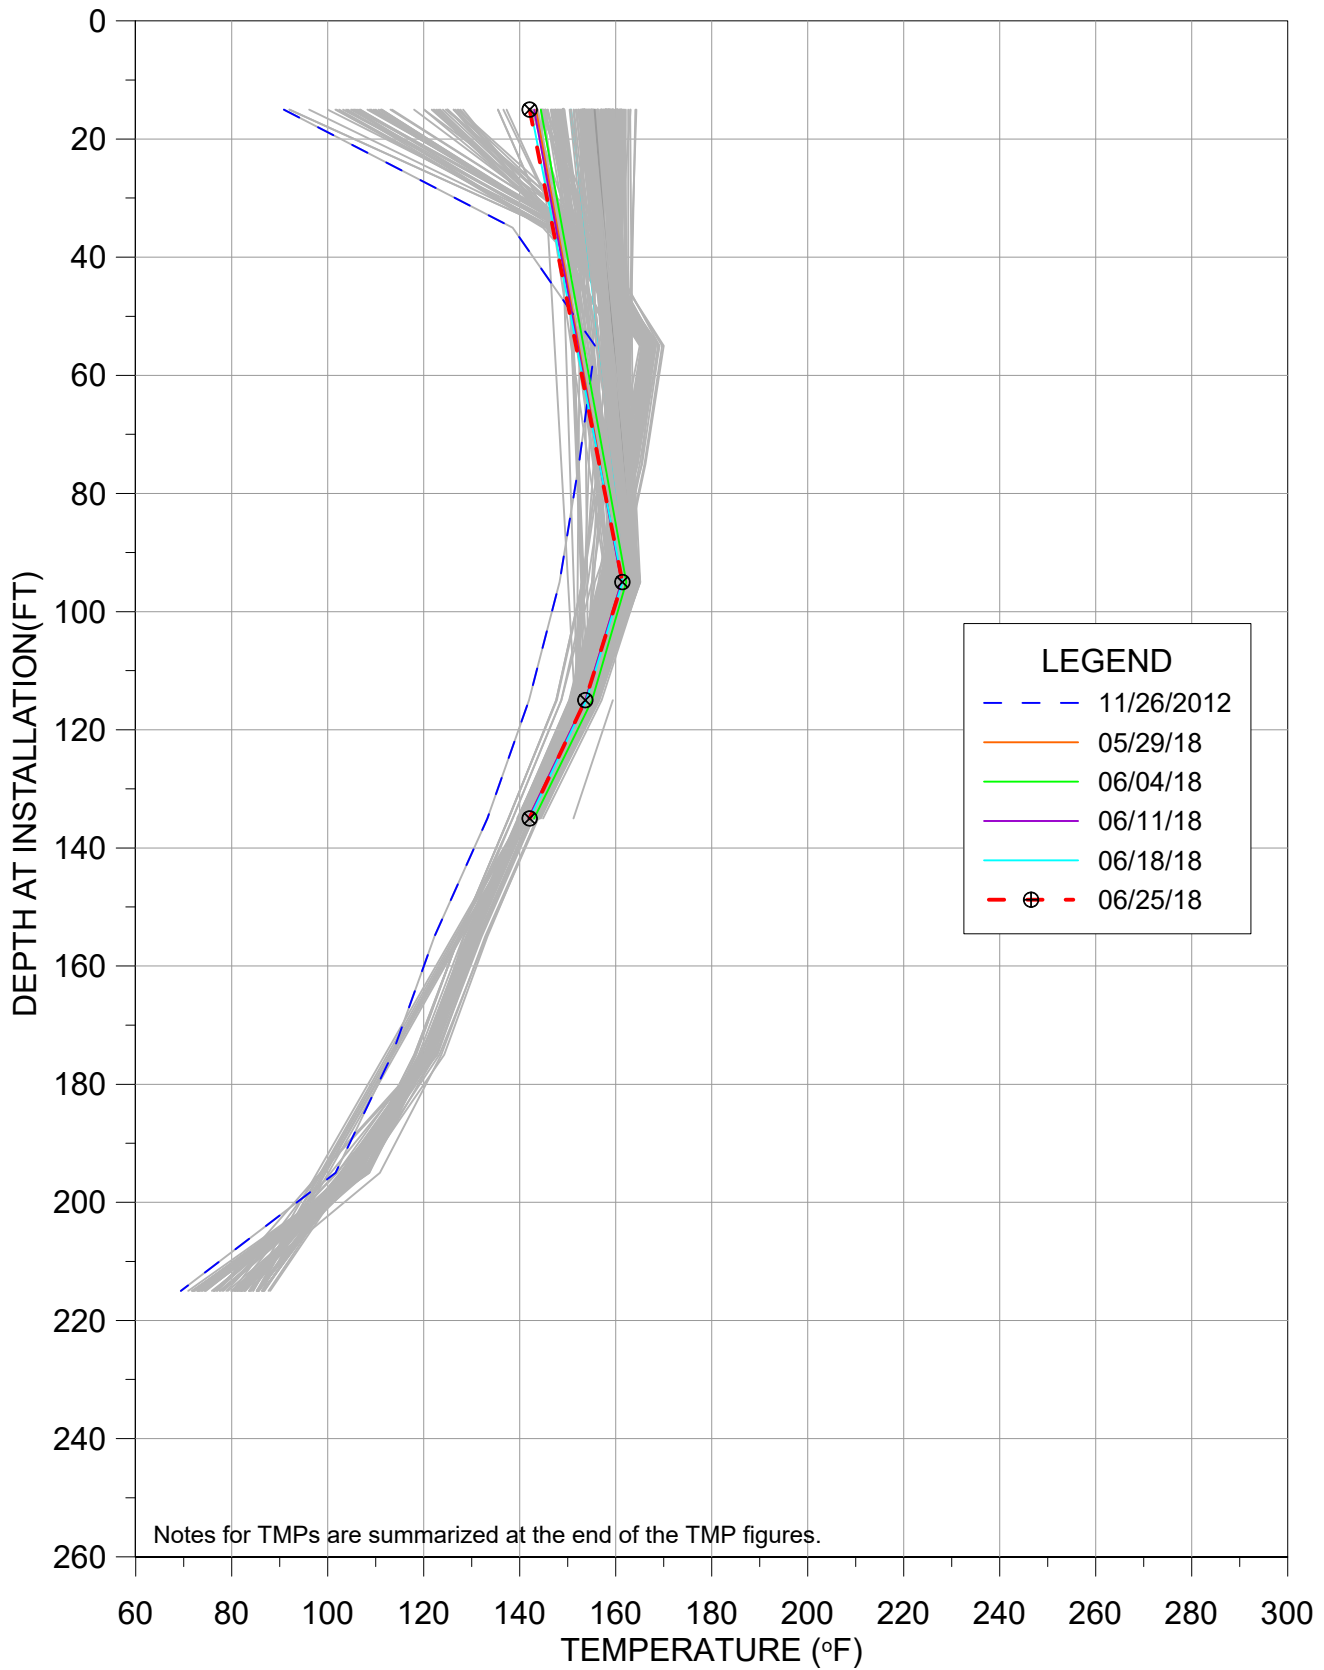
TMP-6

1. The connectivity tests on 4/11/2014 conducted by CEC showed that units at 35, 55, 75, 155, 175, and 195 ft depths are no longer reliable.
2. No reliable temperature readings have been obtained at the unit at 215 ft depth since 6/13/2014.

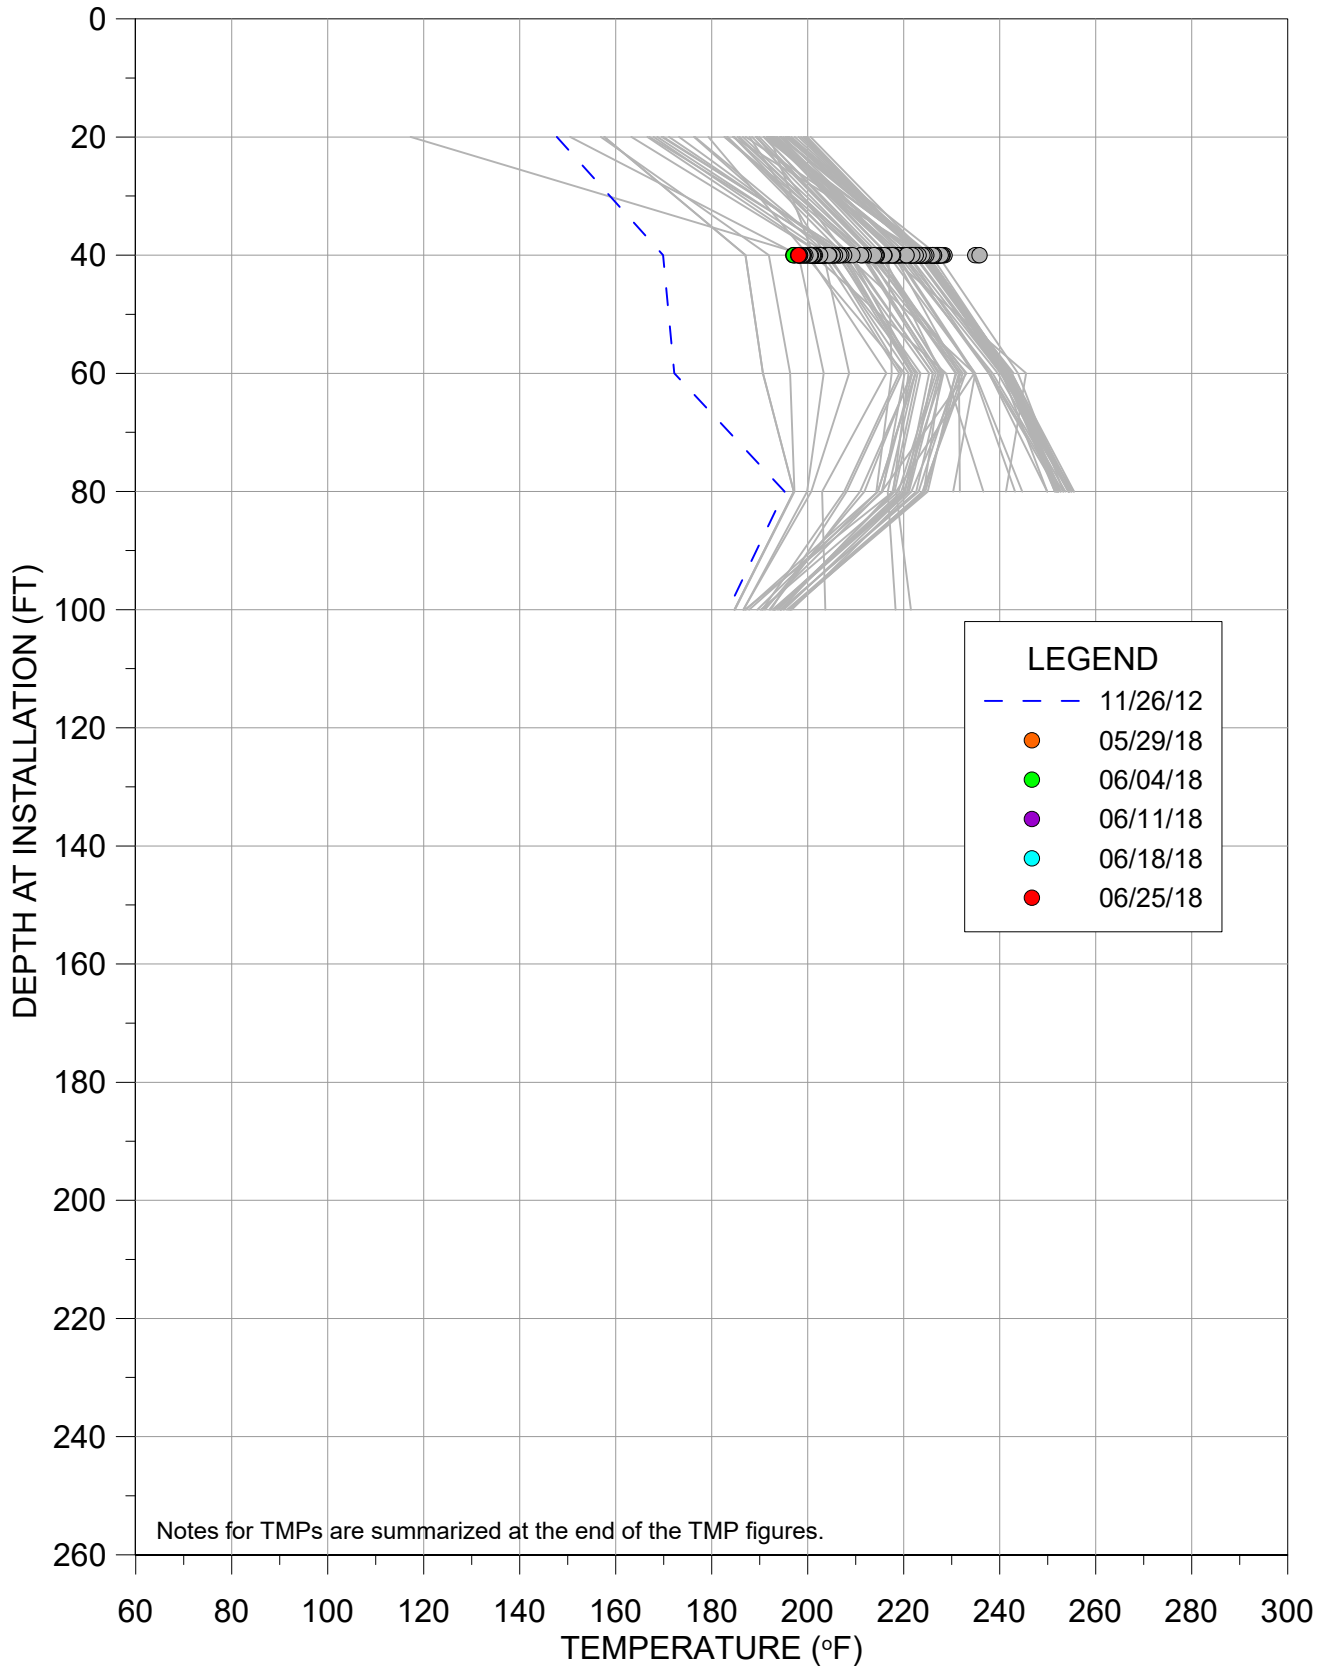
TMP-9

1. Unit at 100 ft depth had an inaccurate temperature reading on 8/1/2013 and no reading since 8/6/2013.
2. The connectivity tests on 4/11/2014 conducted by CEC showed that units at 20, 60, 80, and 100 ft depths are no longer reliable.

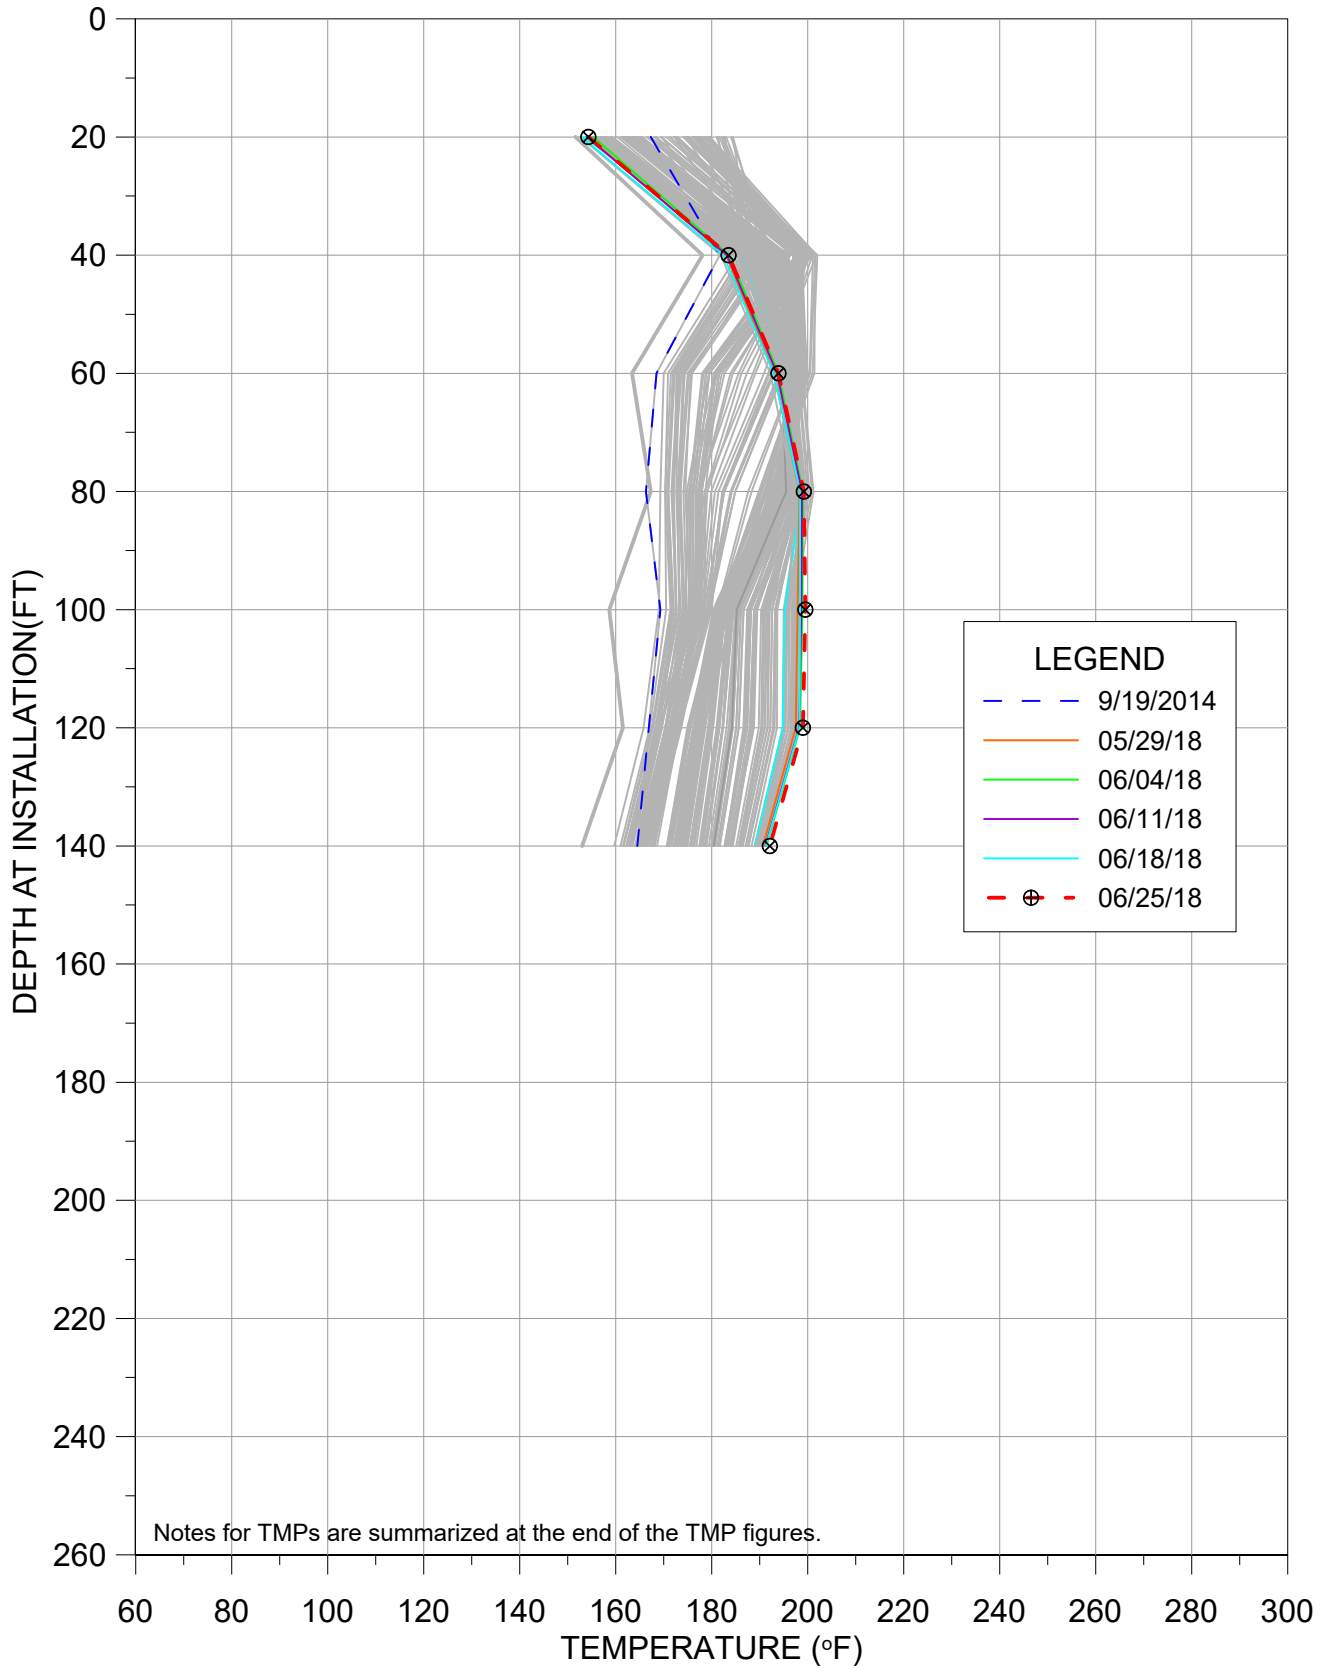
1. Due to the connectivity test results by Feezor Engineering on TMP-14 (see note above), TMP-14R is added to this reporting data set as of 3/7/2016.
