Bridgeton Landfill, LLC

Weekly Data Submittal

Week of June 24, 2018 – June 30, 2018

**Required by Section IX.33.g of Final Consent Judgment, Case No. 13SL-
CC01088-01
Effective June 29, 2018**

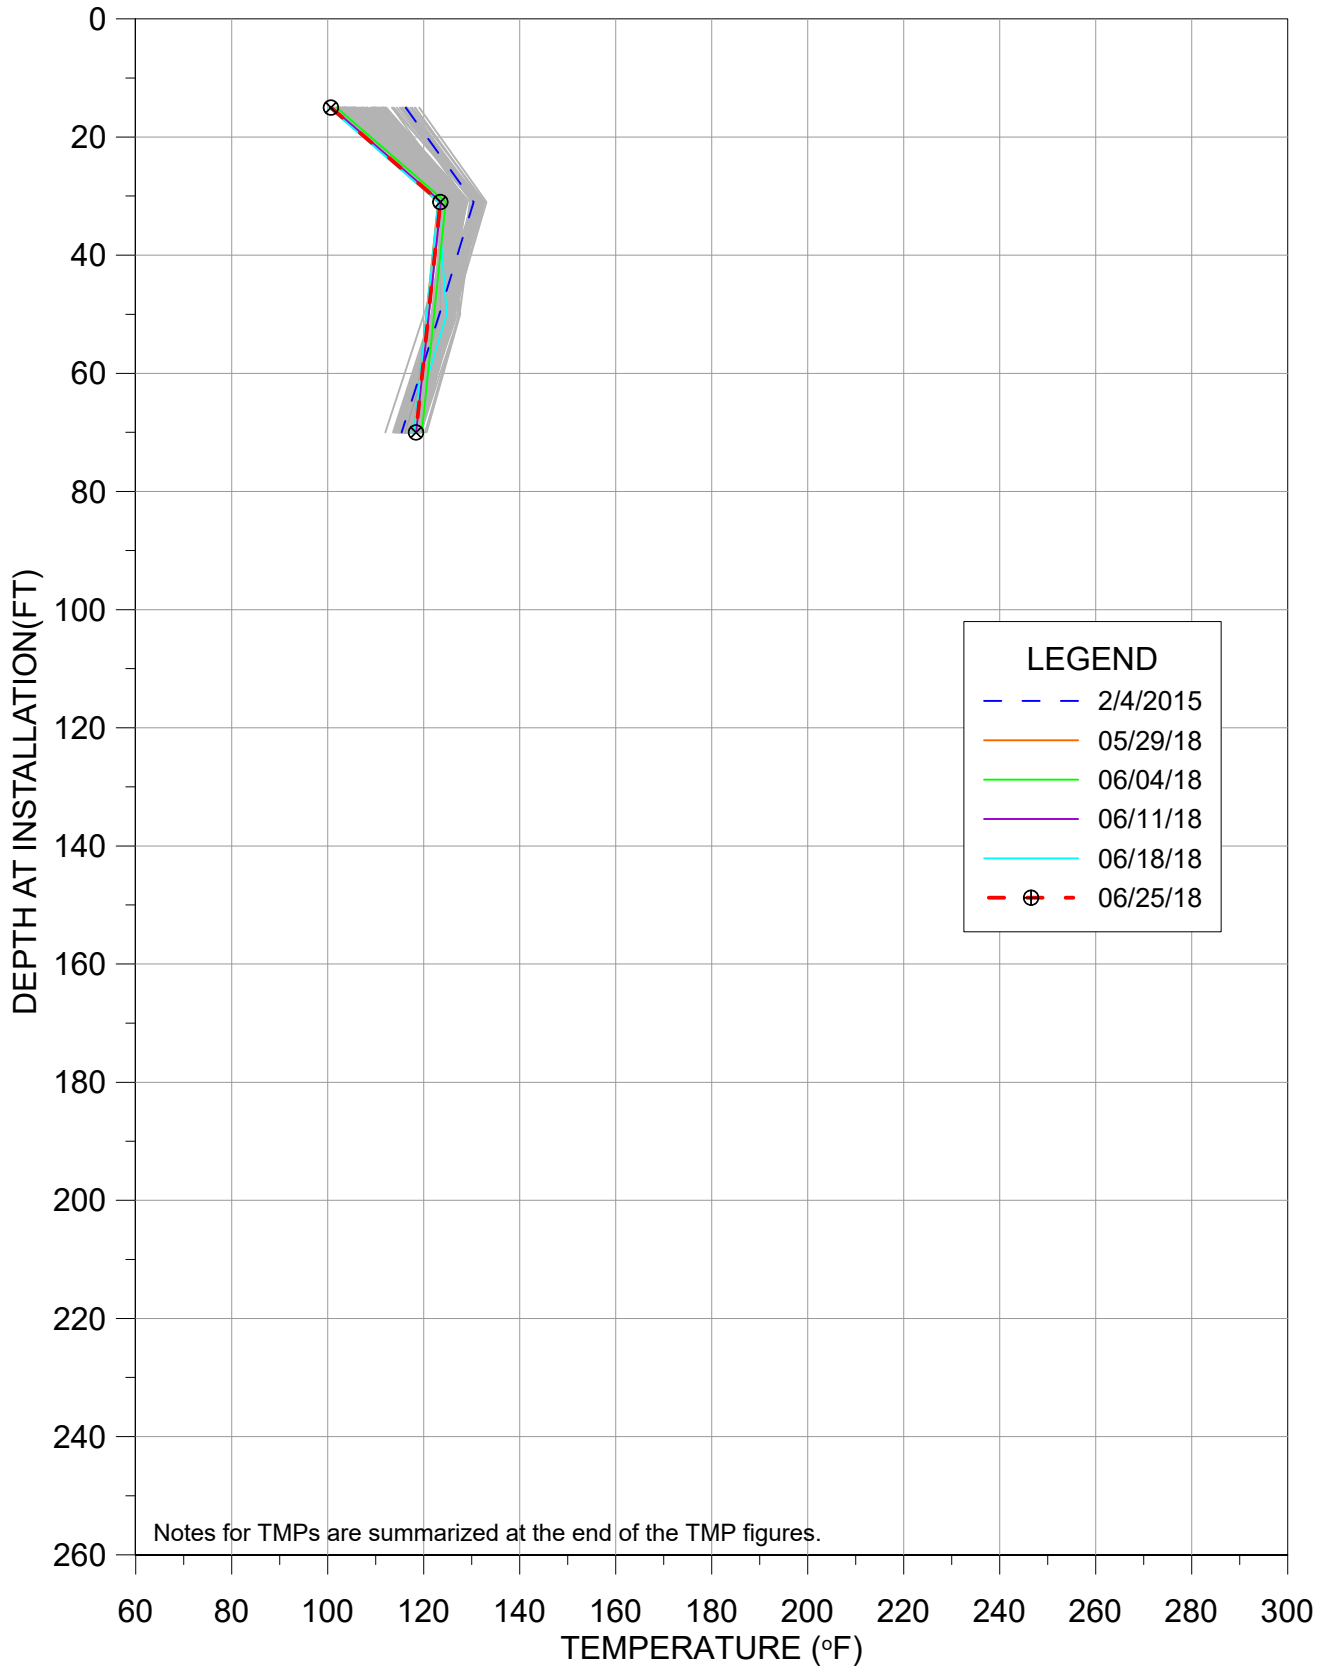
TMP-22

1. No temperature reading could be obtained and resistivity was fluctuating at the unit at 50 ft depth since 4/2/2018.

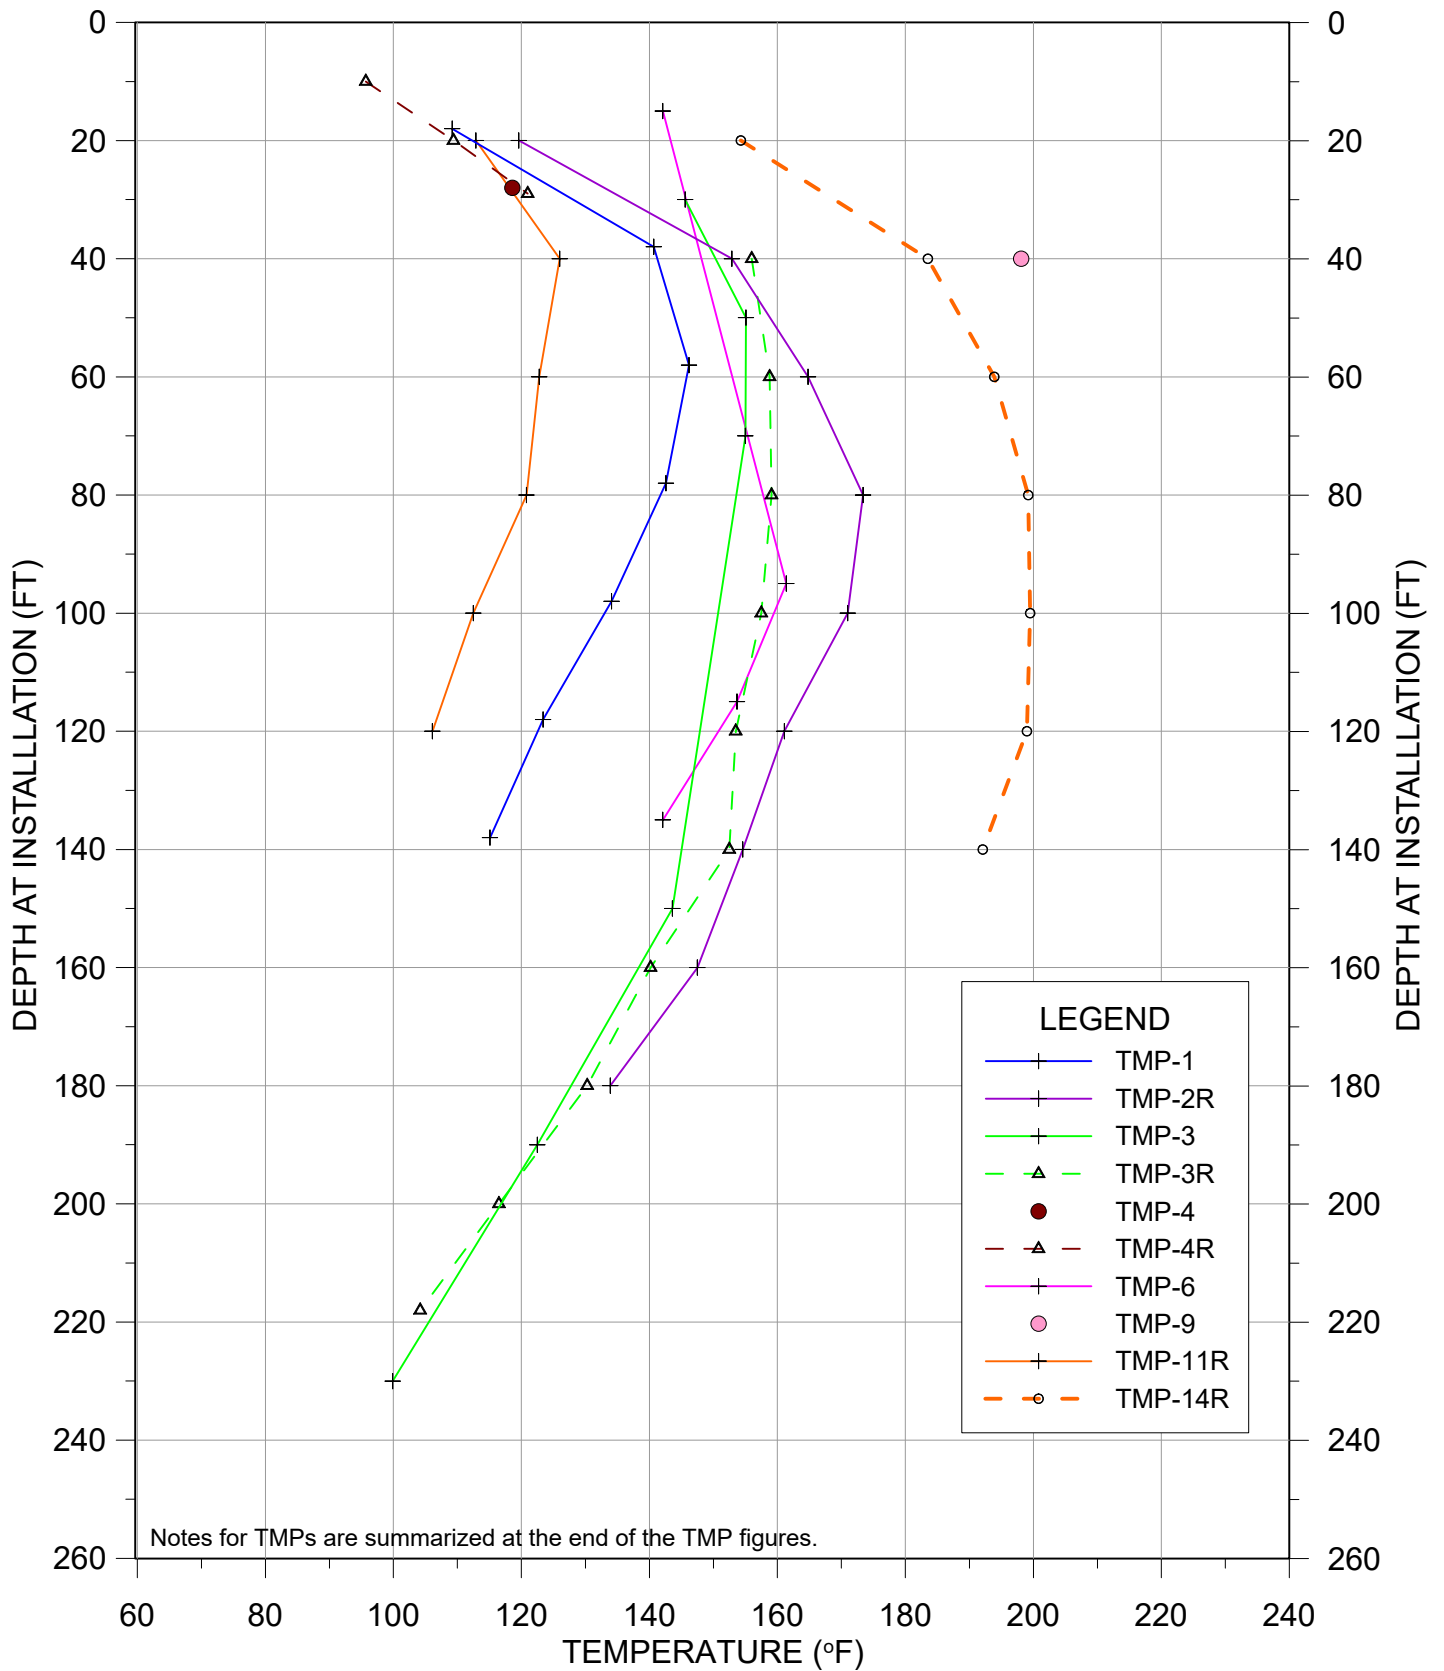
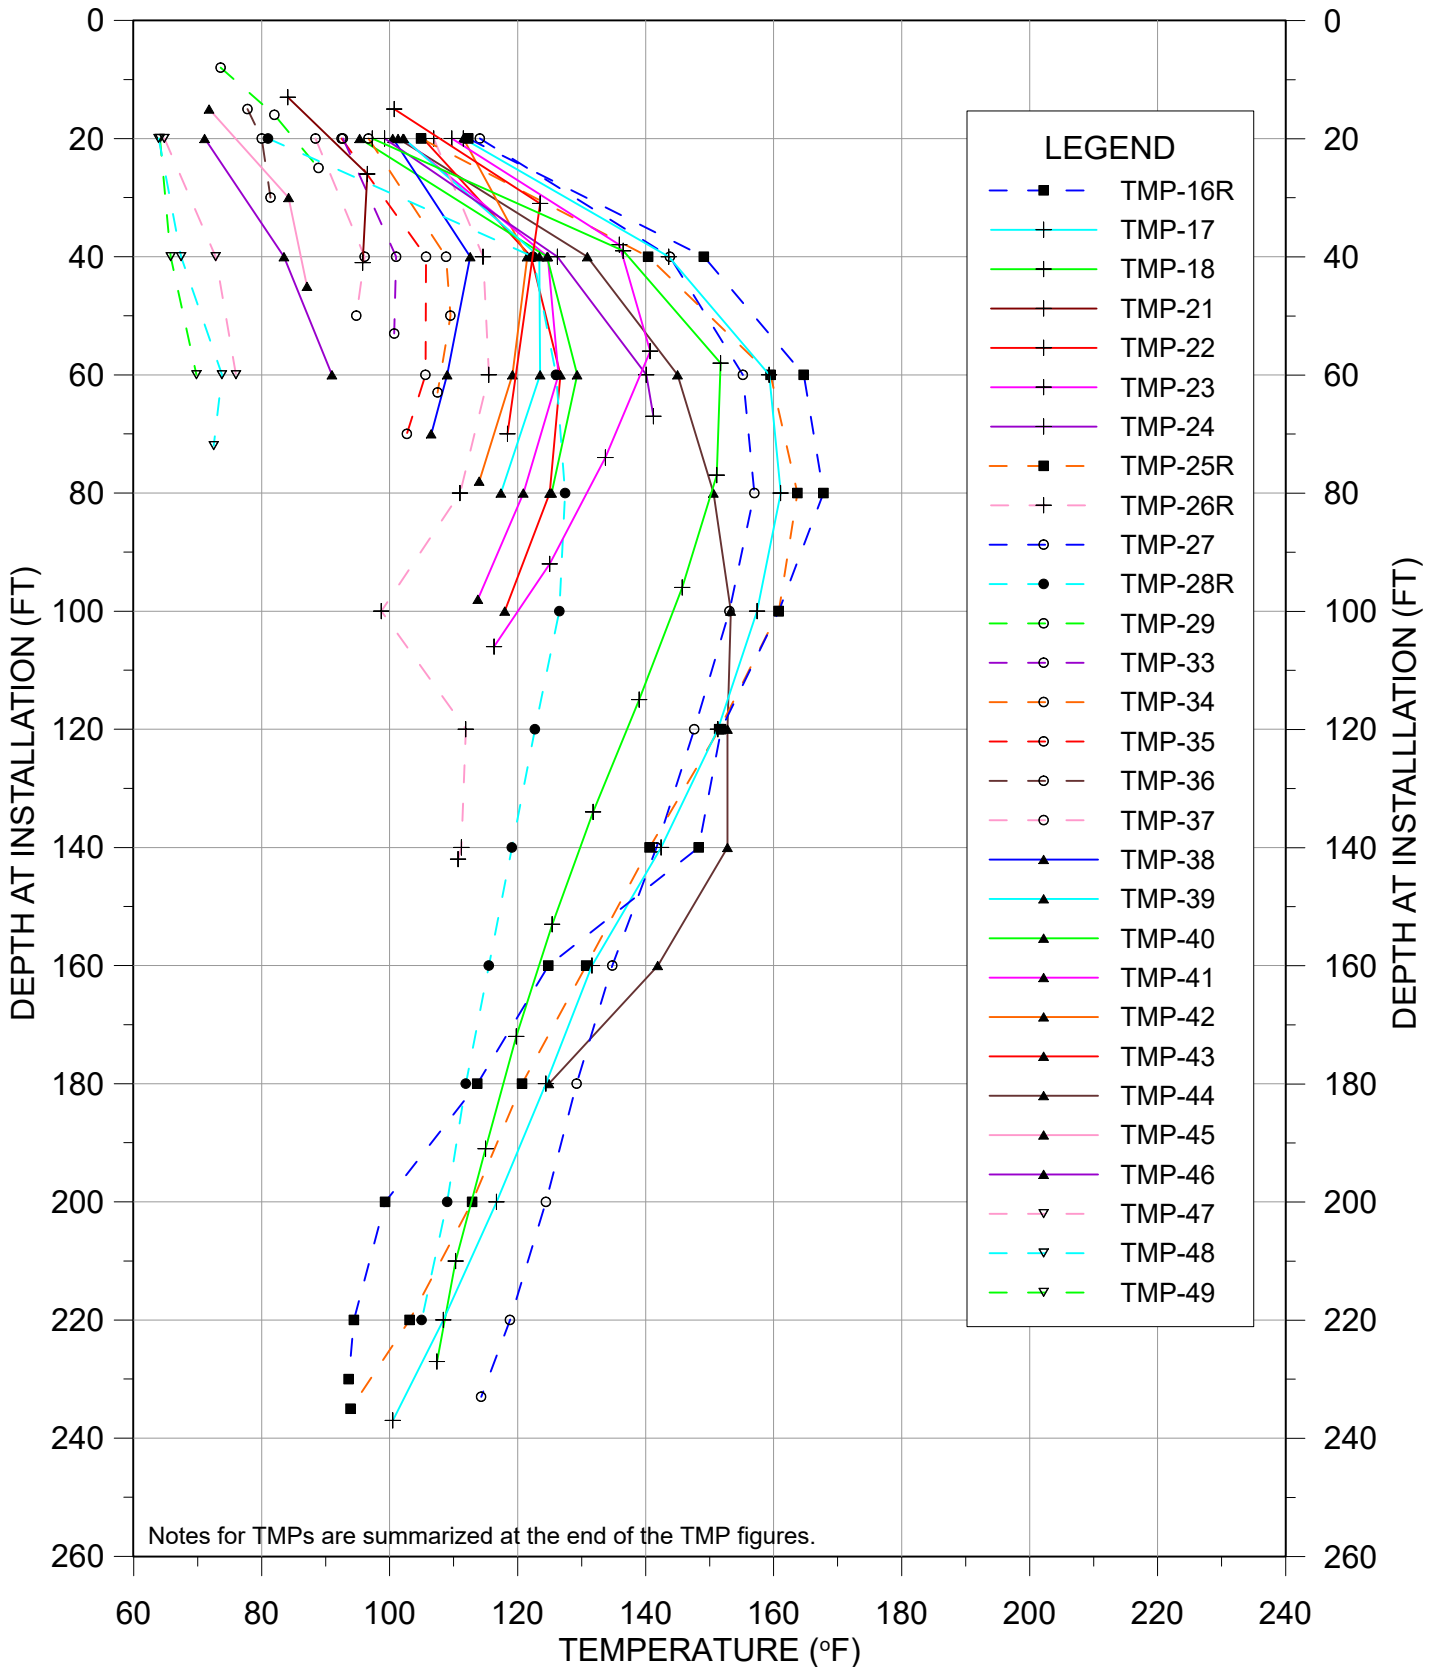
TEMPERATURE VS DEPTH
BRIDGETON LANDFILL

1. There were no reliable temperature readings for TMP-13 since 3/19/2014.
2. There were no reliable temperature readings for TMP-7R, as determined by the connectivity test on 4/11/2014.

3. There were no reliable temperature readings for TMP-5 since 11/5/2014.
4. There were no reliable temperature readings for TMP-12 since 9/28/2015.
5. There were no reliable temperature readings for TMP-8 since 9/9/2015.

6. There were no reliable temperature readings for TMP-14, confirmed since 3/7/2016.
7. There were no reliable temperature readings for TMP-11 as determined by the connectivity test on 11/23/2016.

8. TMP-2 has been replaced by TMP-2R and will no longer be monitored.
9. TMP-11 is no longer in service and will not be included in the presentation.
10. There were no reliable temperature readings for TMP-10 since 5/30/2017.

11. TMP-16, 25, and 28 have been replaced by TMP-16R, 25R, and 28R and will be no longer reported since 1/15/2018.
12. TMP-26 has been replaced by TMP-26R and will be no longer reported since 5/21/2018.

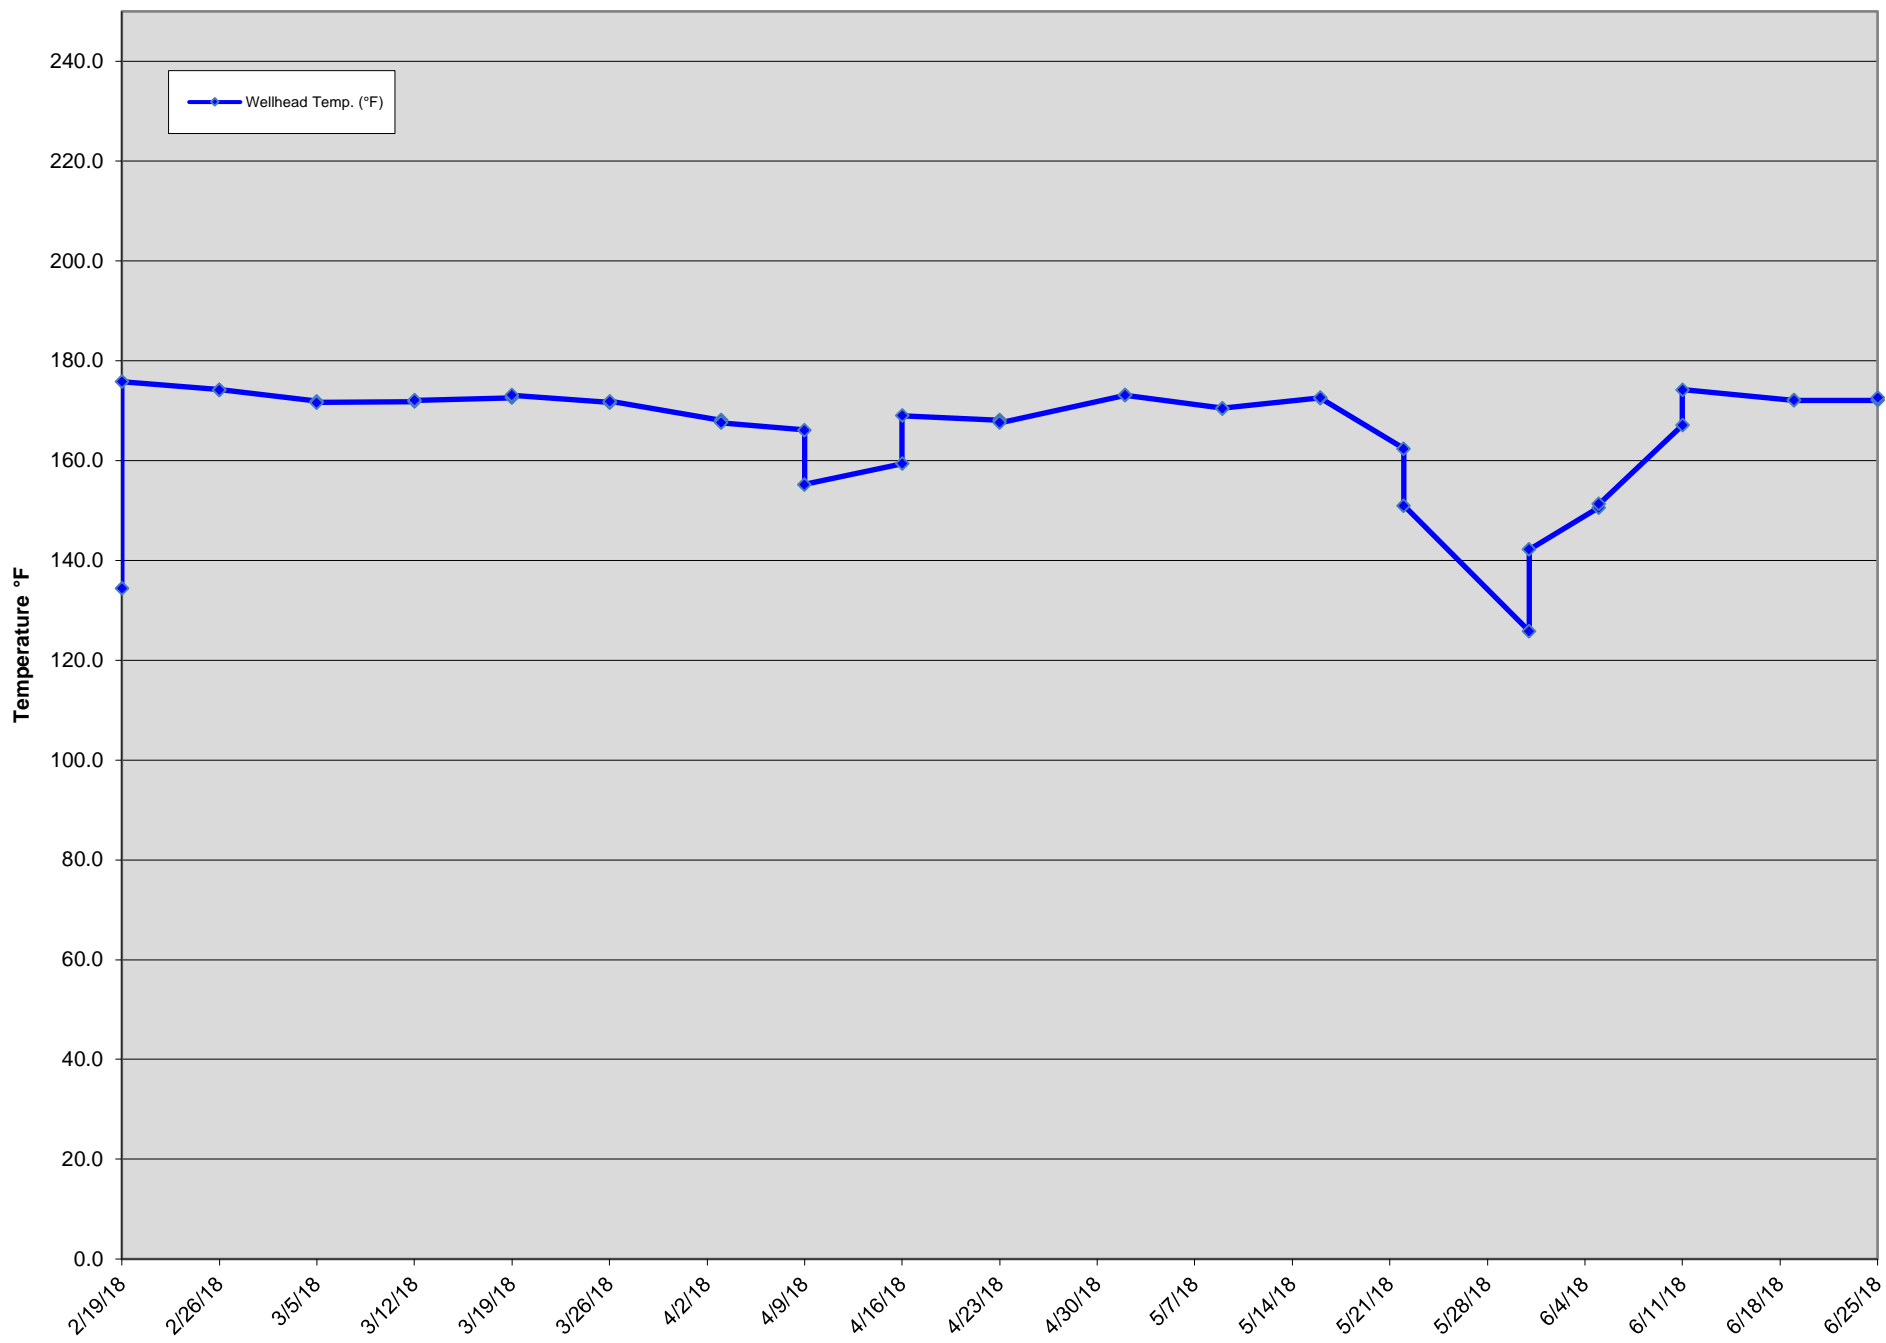
GIW-1 Wellhead Temperatures

As part of the HES, there are currently cooling water circulation loops installed in twelve Gas Interceptor Wells (GIWs) (GIW-02 through GIW-13). The remaining well (GIW-01) had a measured gas temperature within its historical operating limits.
