# **Bridgeton Landfill, LLC**

## **Weekly Data Submittal**

**Week of October 1, 2017 – October 7, 2017**

**Required by Section 52.F of Agreed Order, Case No. 13SL-CC01088  
Effective May 13, 2013**

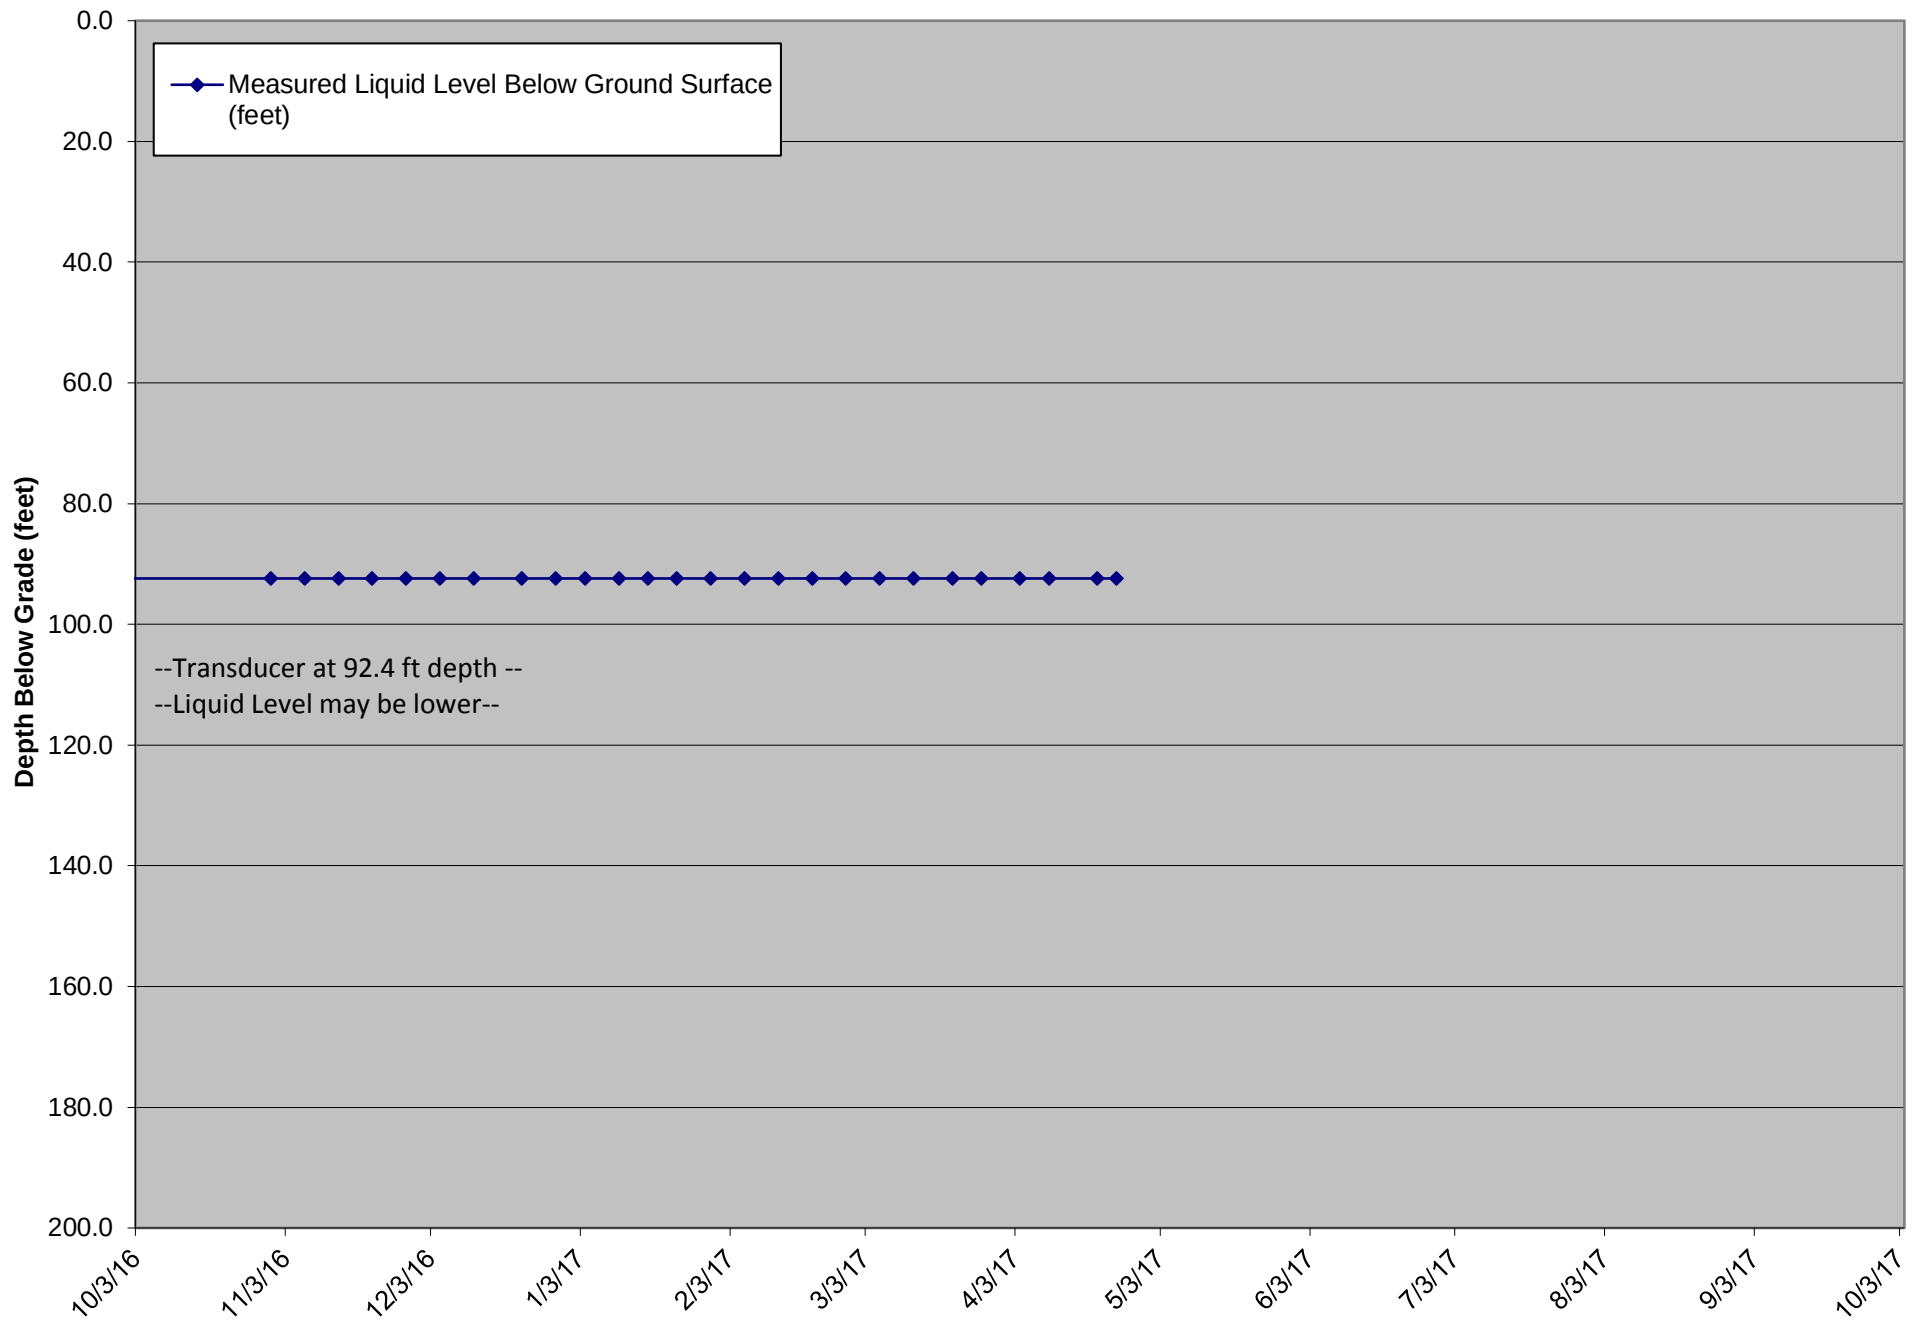
# LCS-1D Liquid Level Below Ground Surface

Bridgeton Landfill is currently troubleshooting the pump in LCS-1D. Level sensor replacement is pending while awaiting parts arrival.

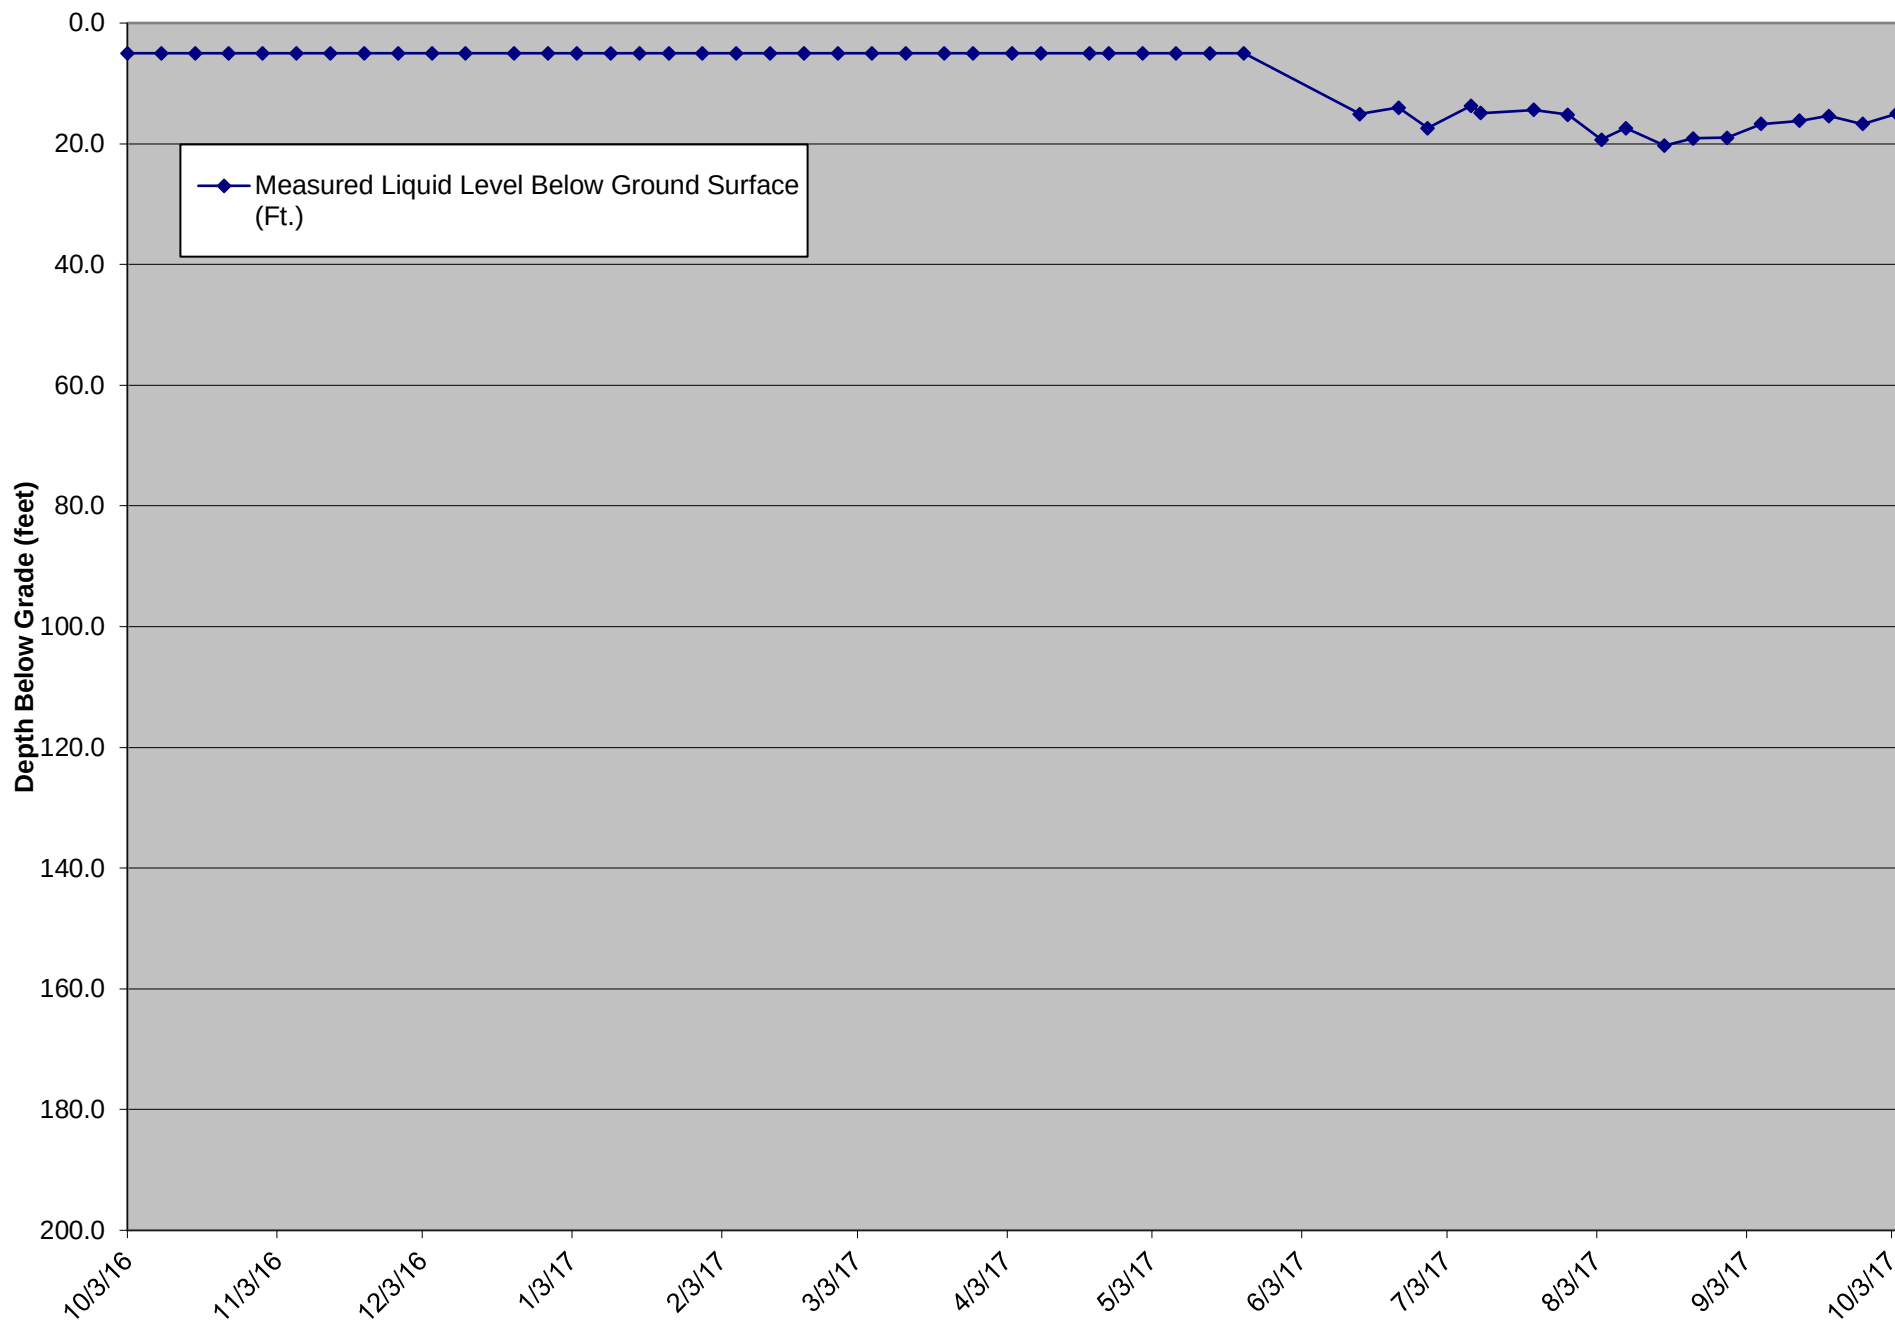
LCS-3D Liquid Level Below Ground Surface

Two Blackhawk pneumatic pumps were installed in LCS-3D on 6/13/2017. Blackhawk pumps do not require a level sensor. Liquid level was measured manually.

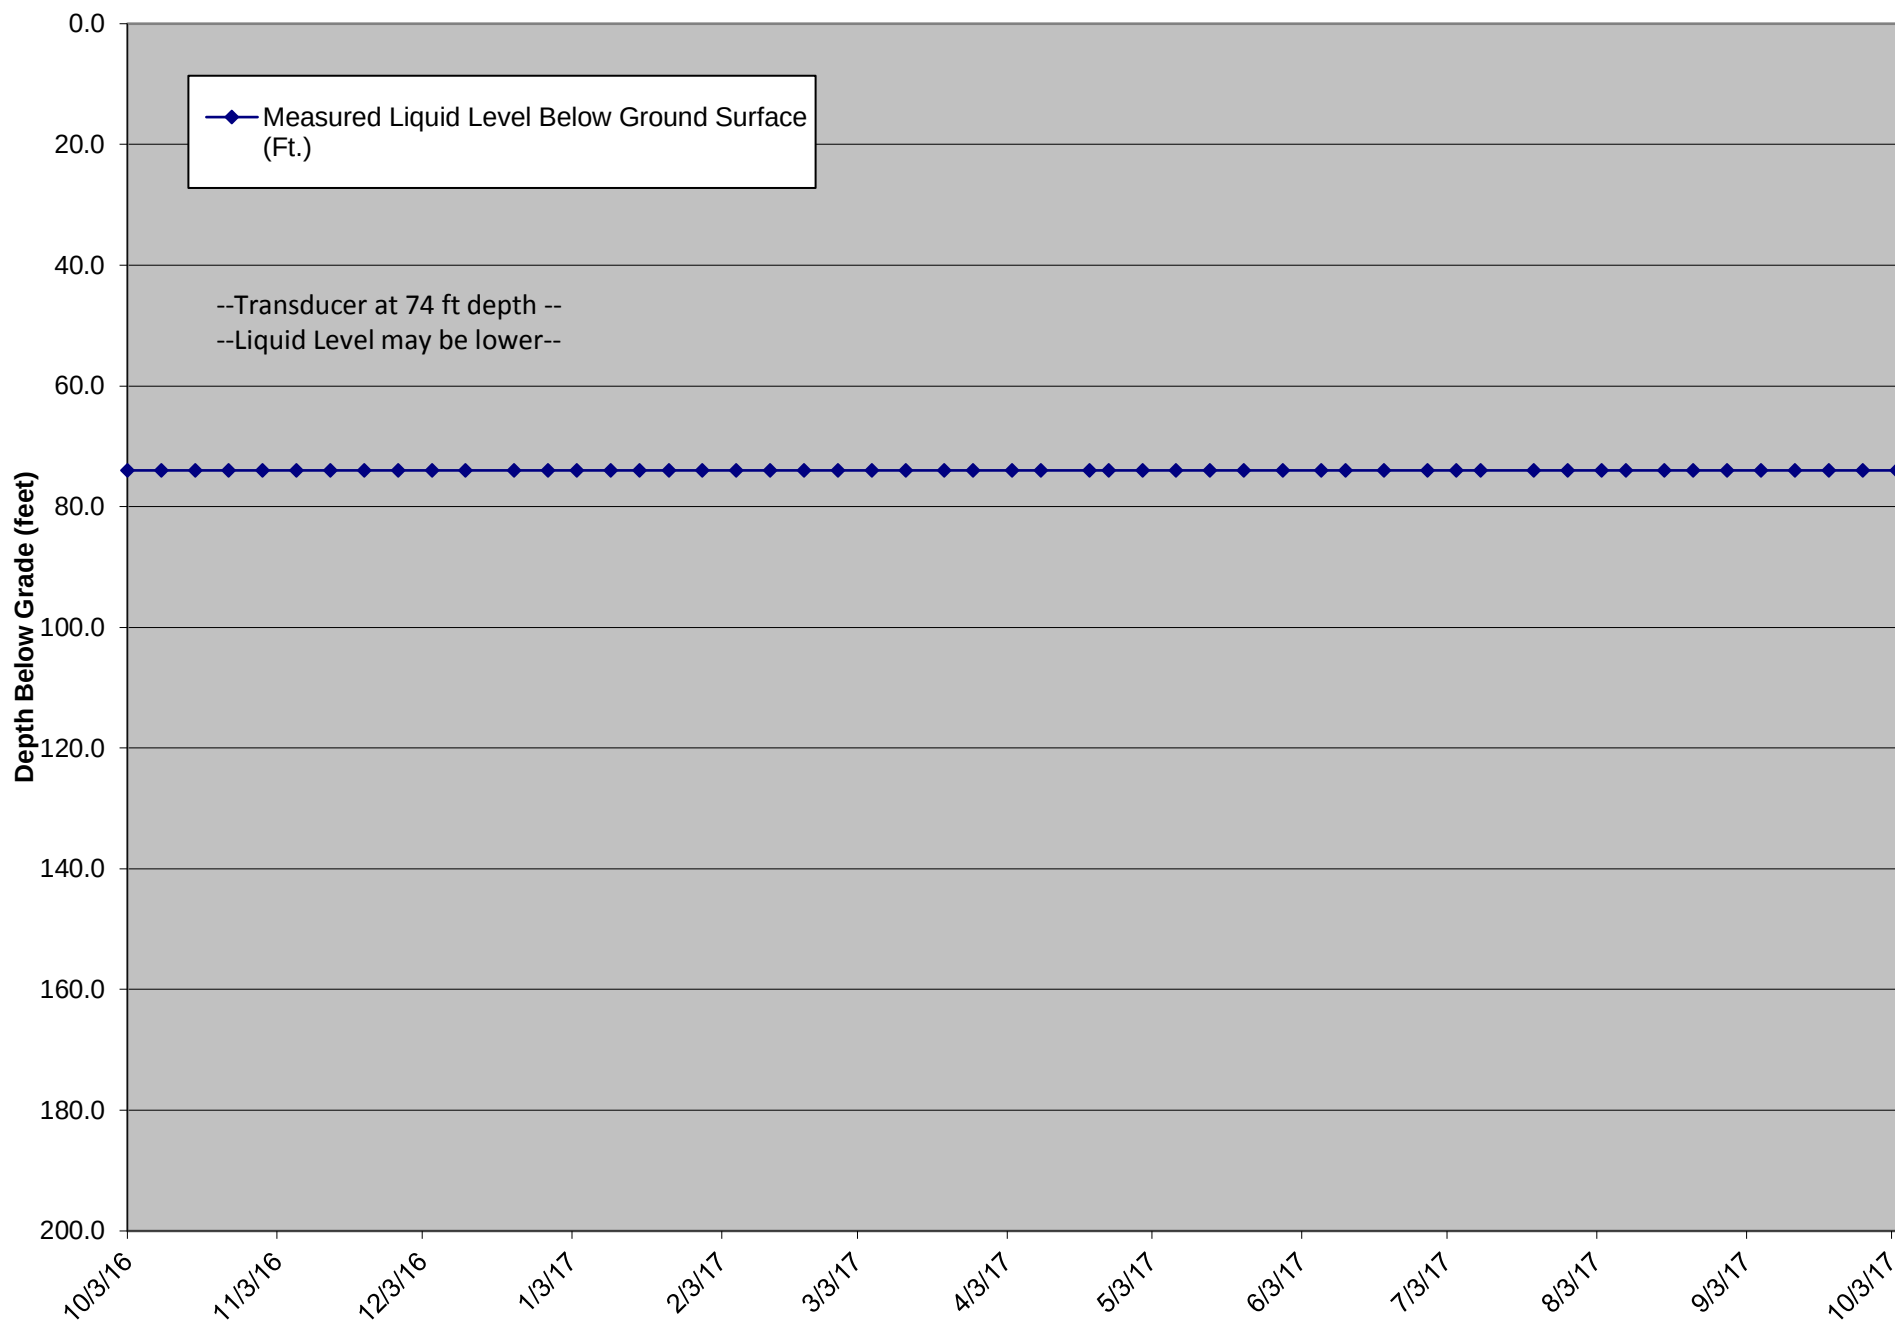
# LCS-4B Liquid Level Below Ground Surface

The level sensor in LCS-4B is currently operational and responsive. Liquid level was not recorded by the level sensor during the weekly reporting period. LCS-4B is equipped with a flow meter that displayed no flow during the weekly reporting period. Therefore, it can be concluded that the liquid level was below the bottom of the pump and level sensor in LCS-4B.

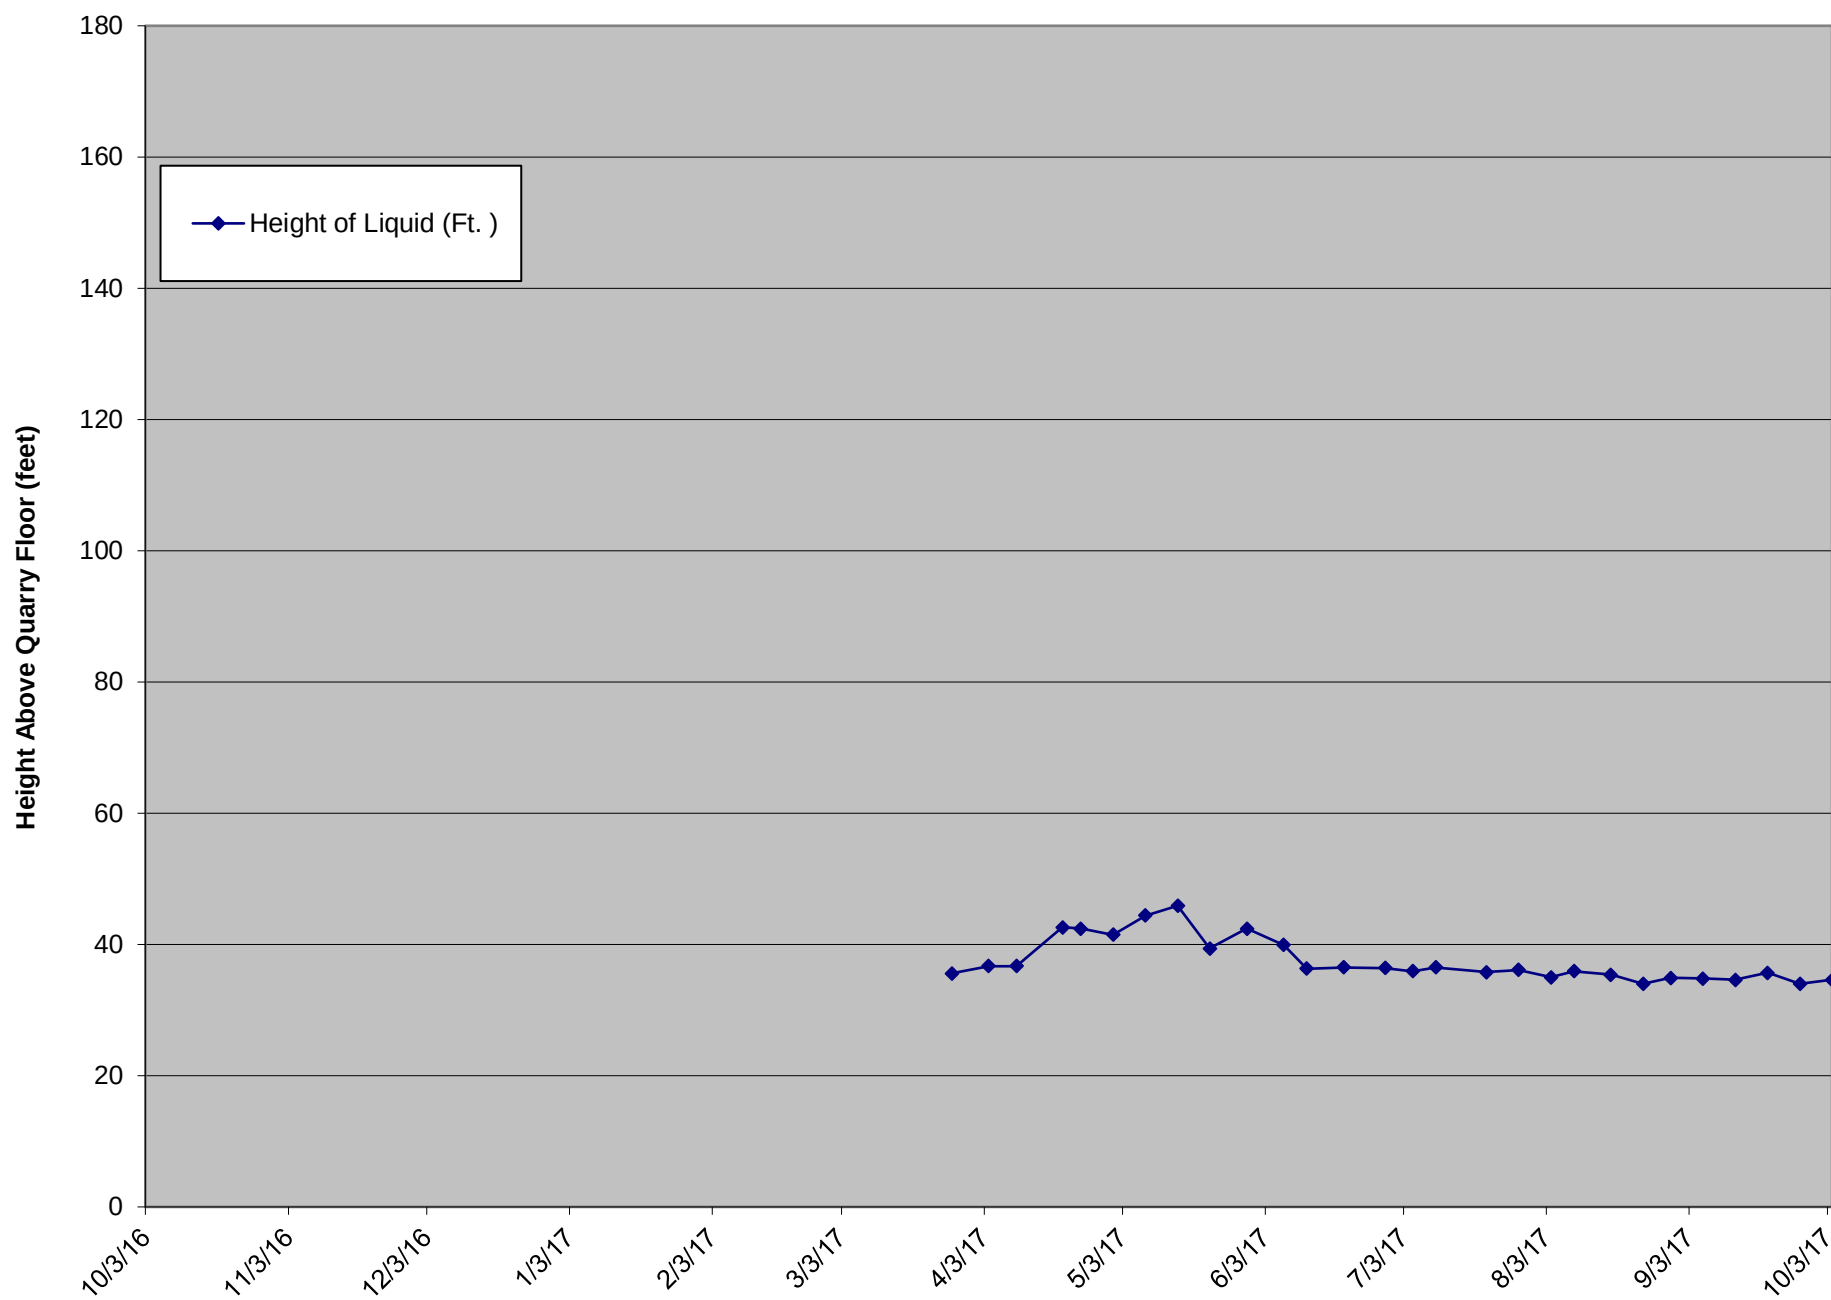
LCS-5B Liquid Level Above Quarry Floor

LCS-5B and LCS-6B were fully operational during the weekly reporting period.

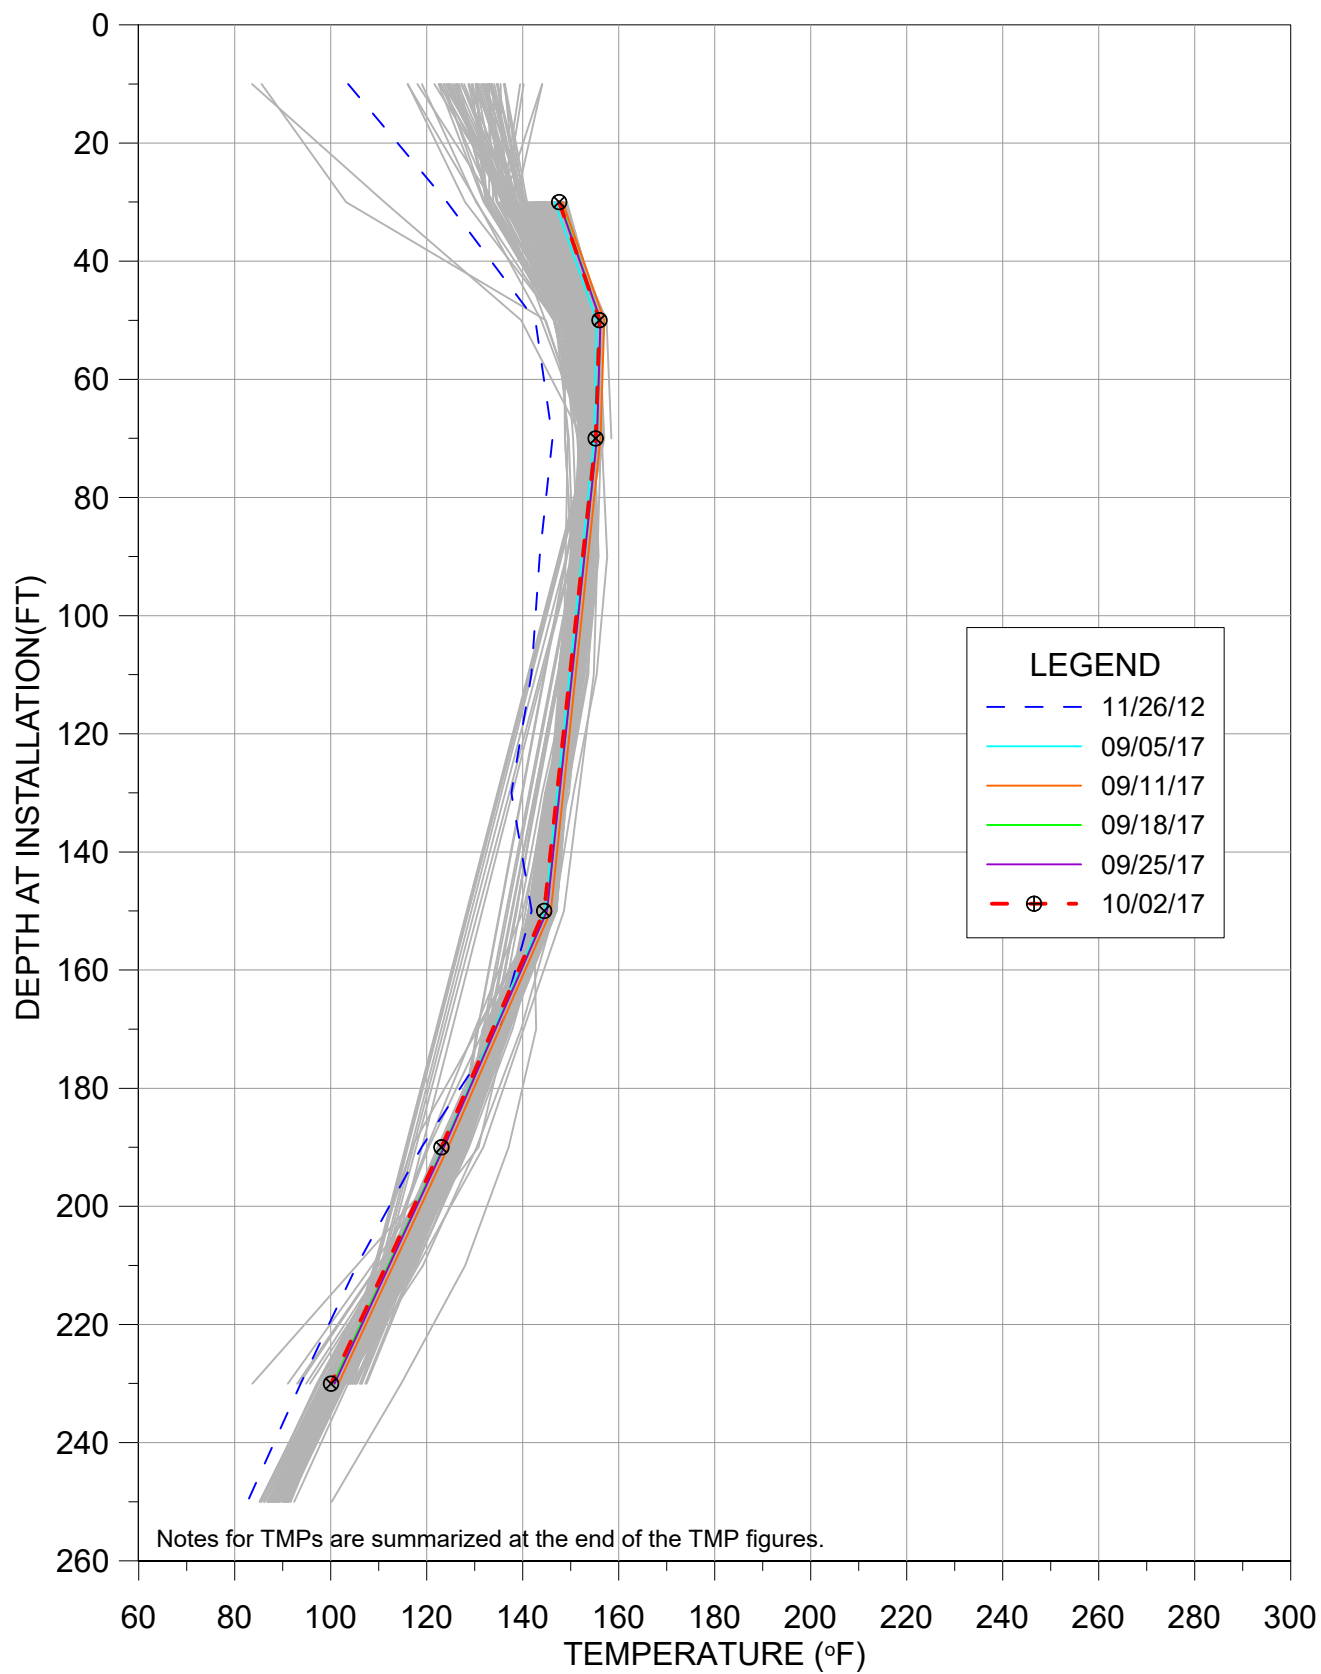
# TMP-3

1. No reliable temperature readings have been obtained at 170 ft depth since 1/29/2014, except on 3/13/2014.
2. The connectivity tests on 4/11/2014 conducted by CEC showed that units at 10, 90, 130, 210 and 250 ft depths are no longer reliable.
3. The connectivity tests on 10/28/2014 conducted by Feezor Engineering showed that units at 10, 90, 110, 130, 210 and 250 ft depths are not reliable.

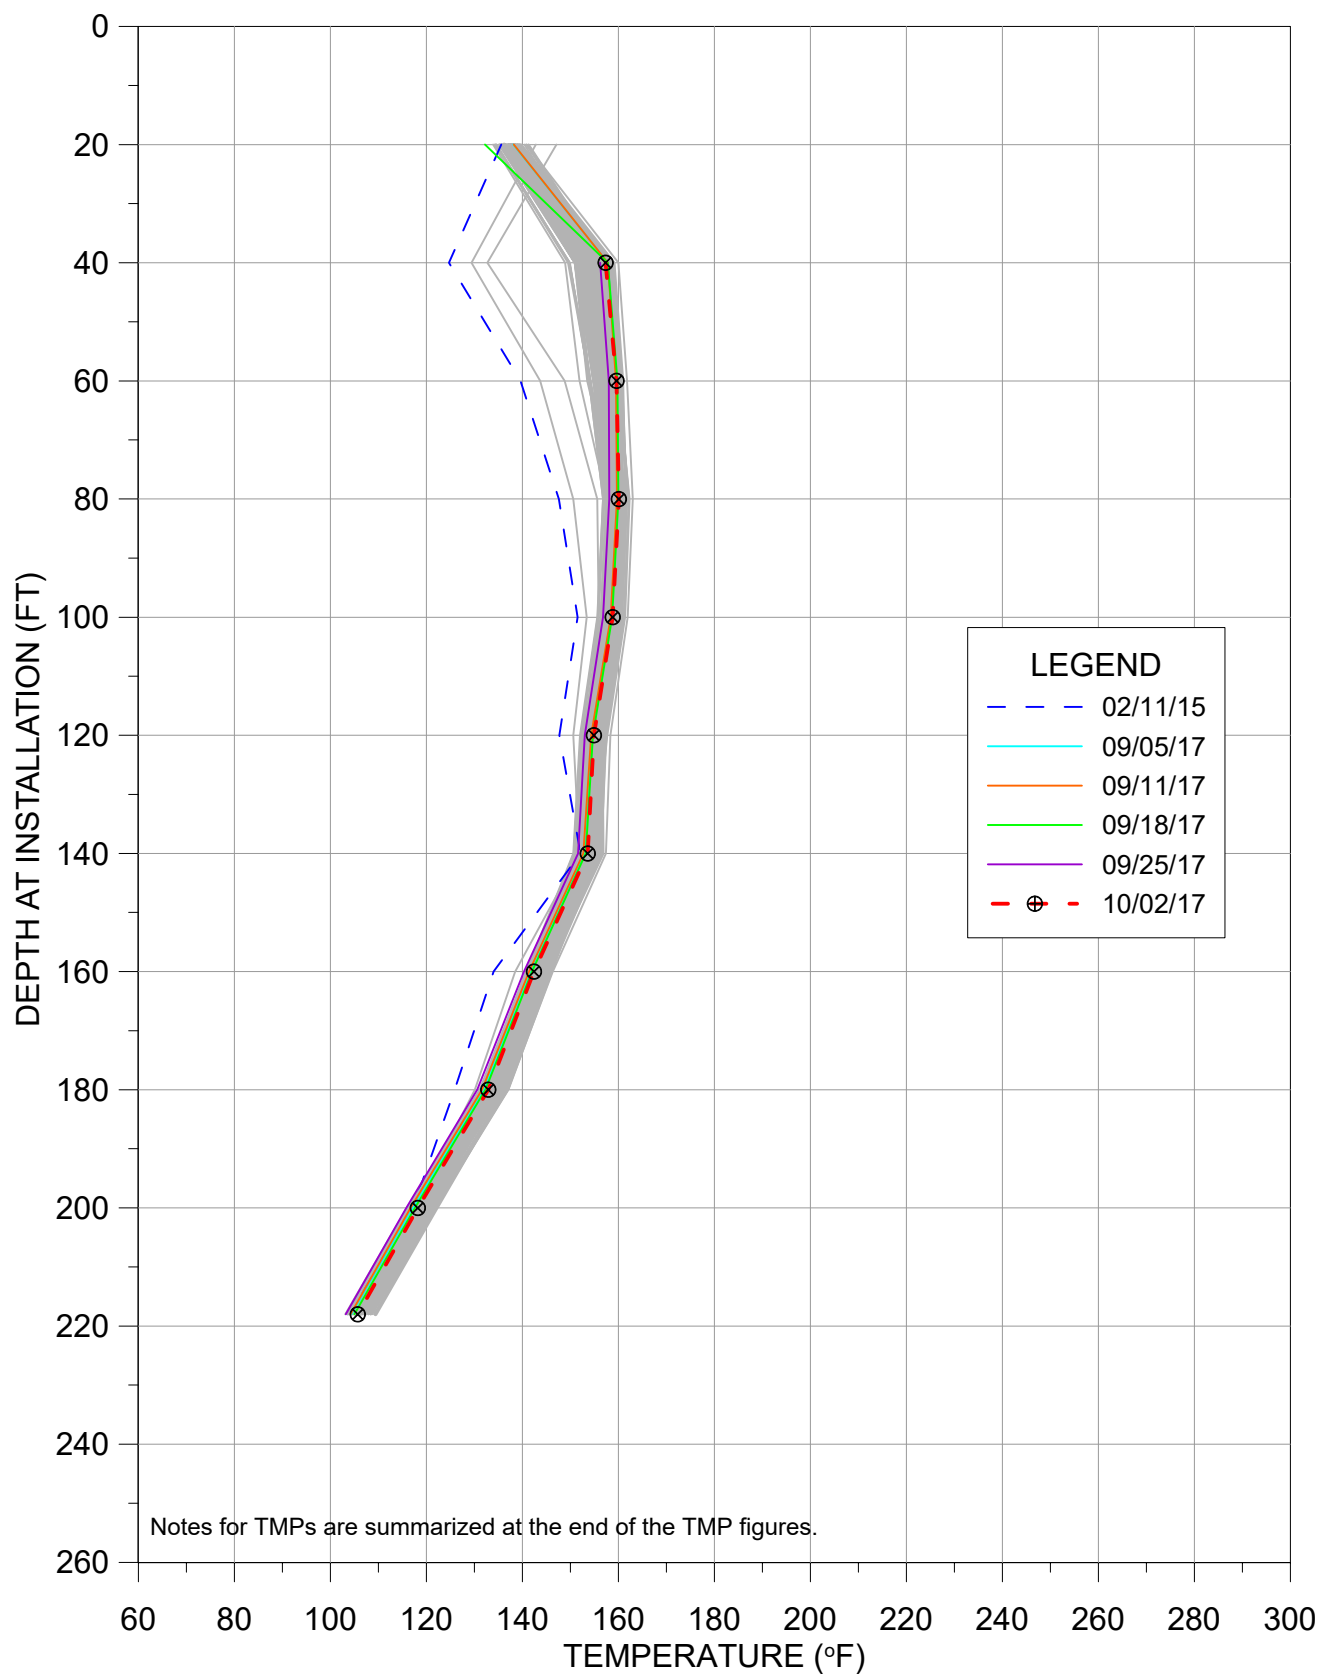
# TMP-3R

1. The unit at 20 ft depth had a fluctuating resistance **since** 9/25/2017. Therefore the temperature is determined to be unreliable.

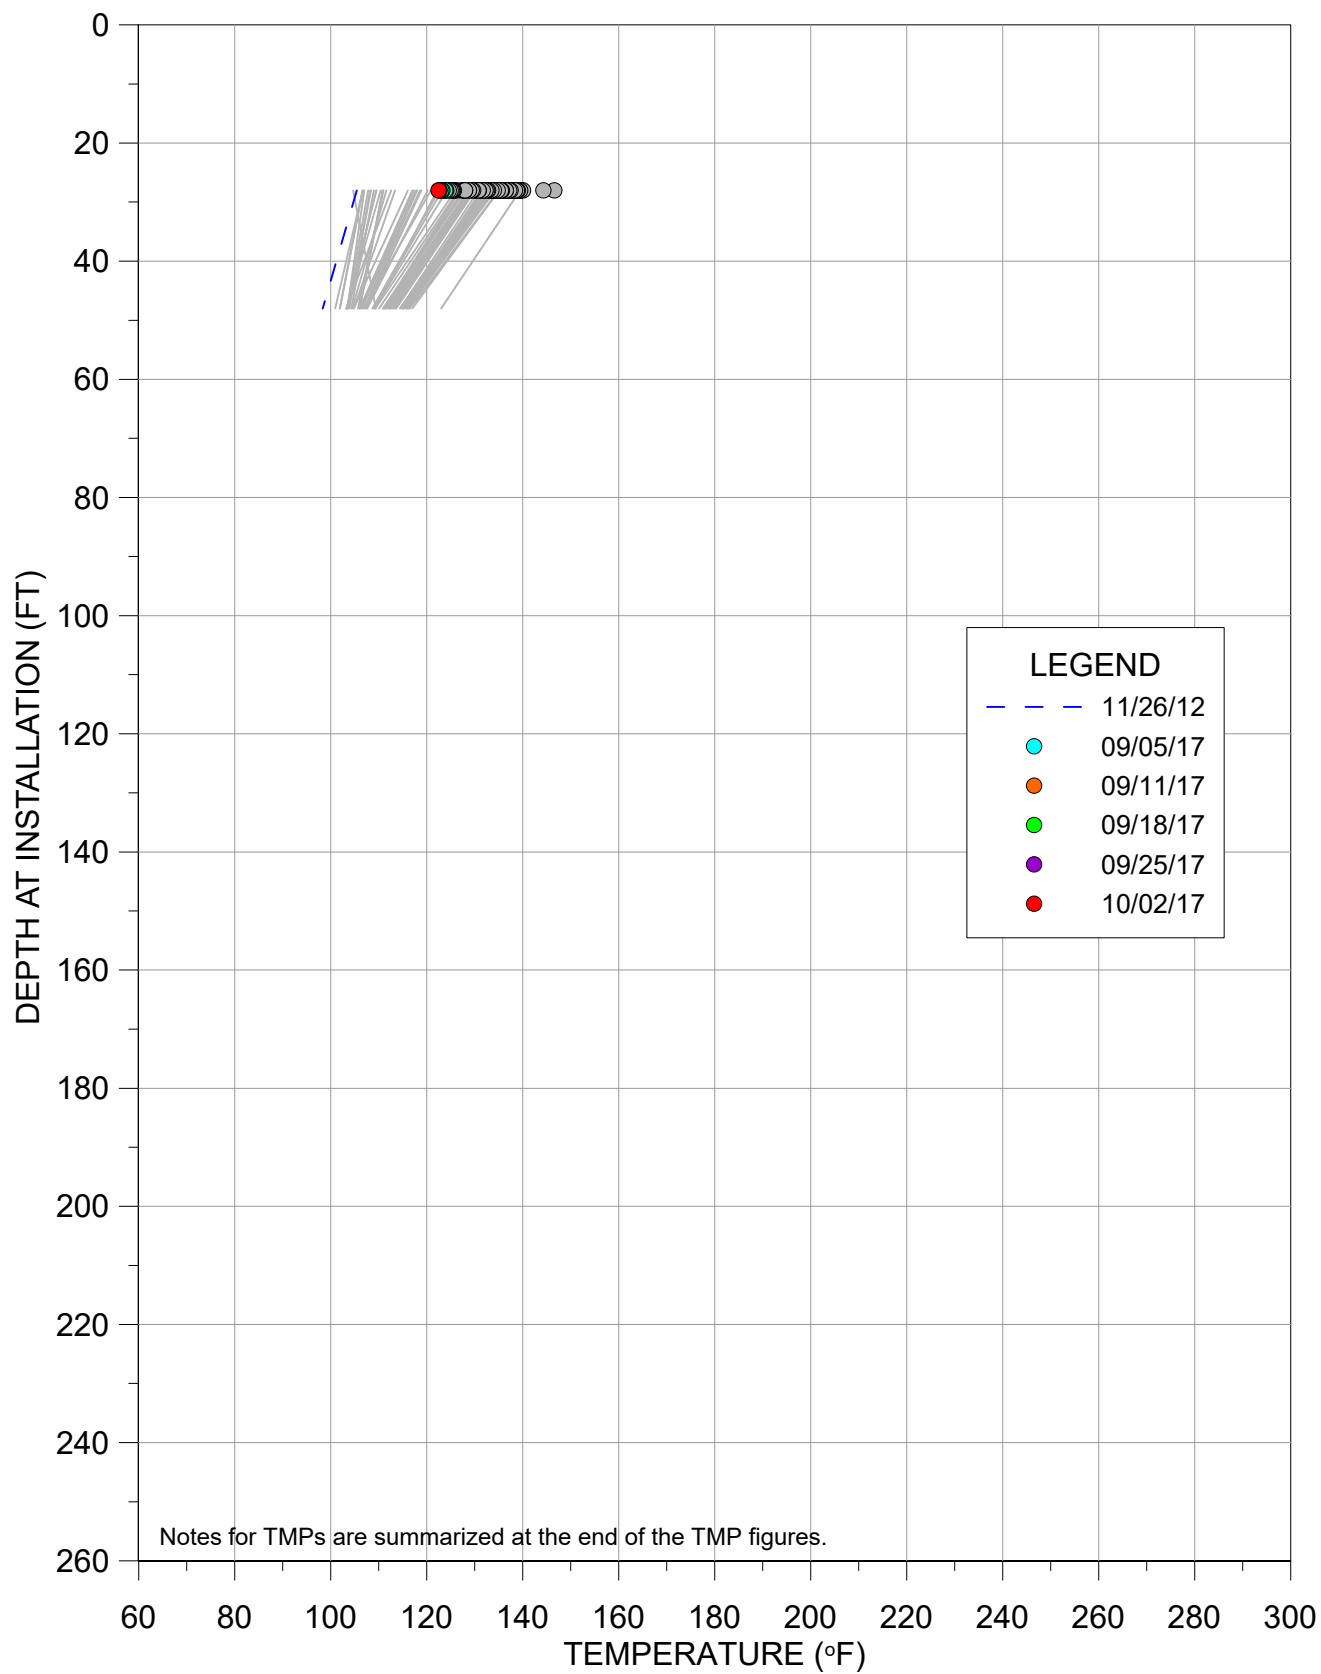
# TMP-4

1. The connectivity tests on 4/11/2014 conducted by CEC showed that the unit at 48 ft depth is no longer reliable.

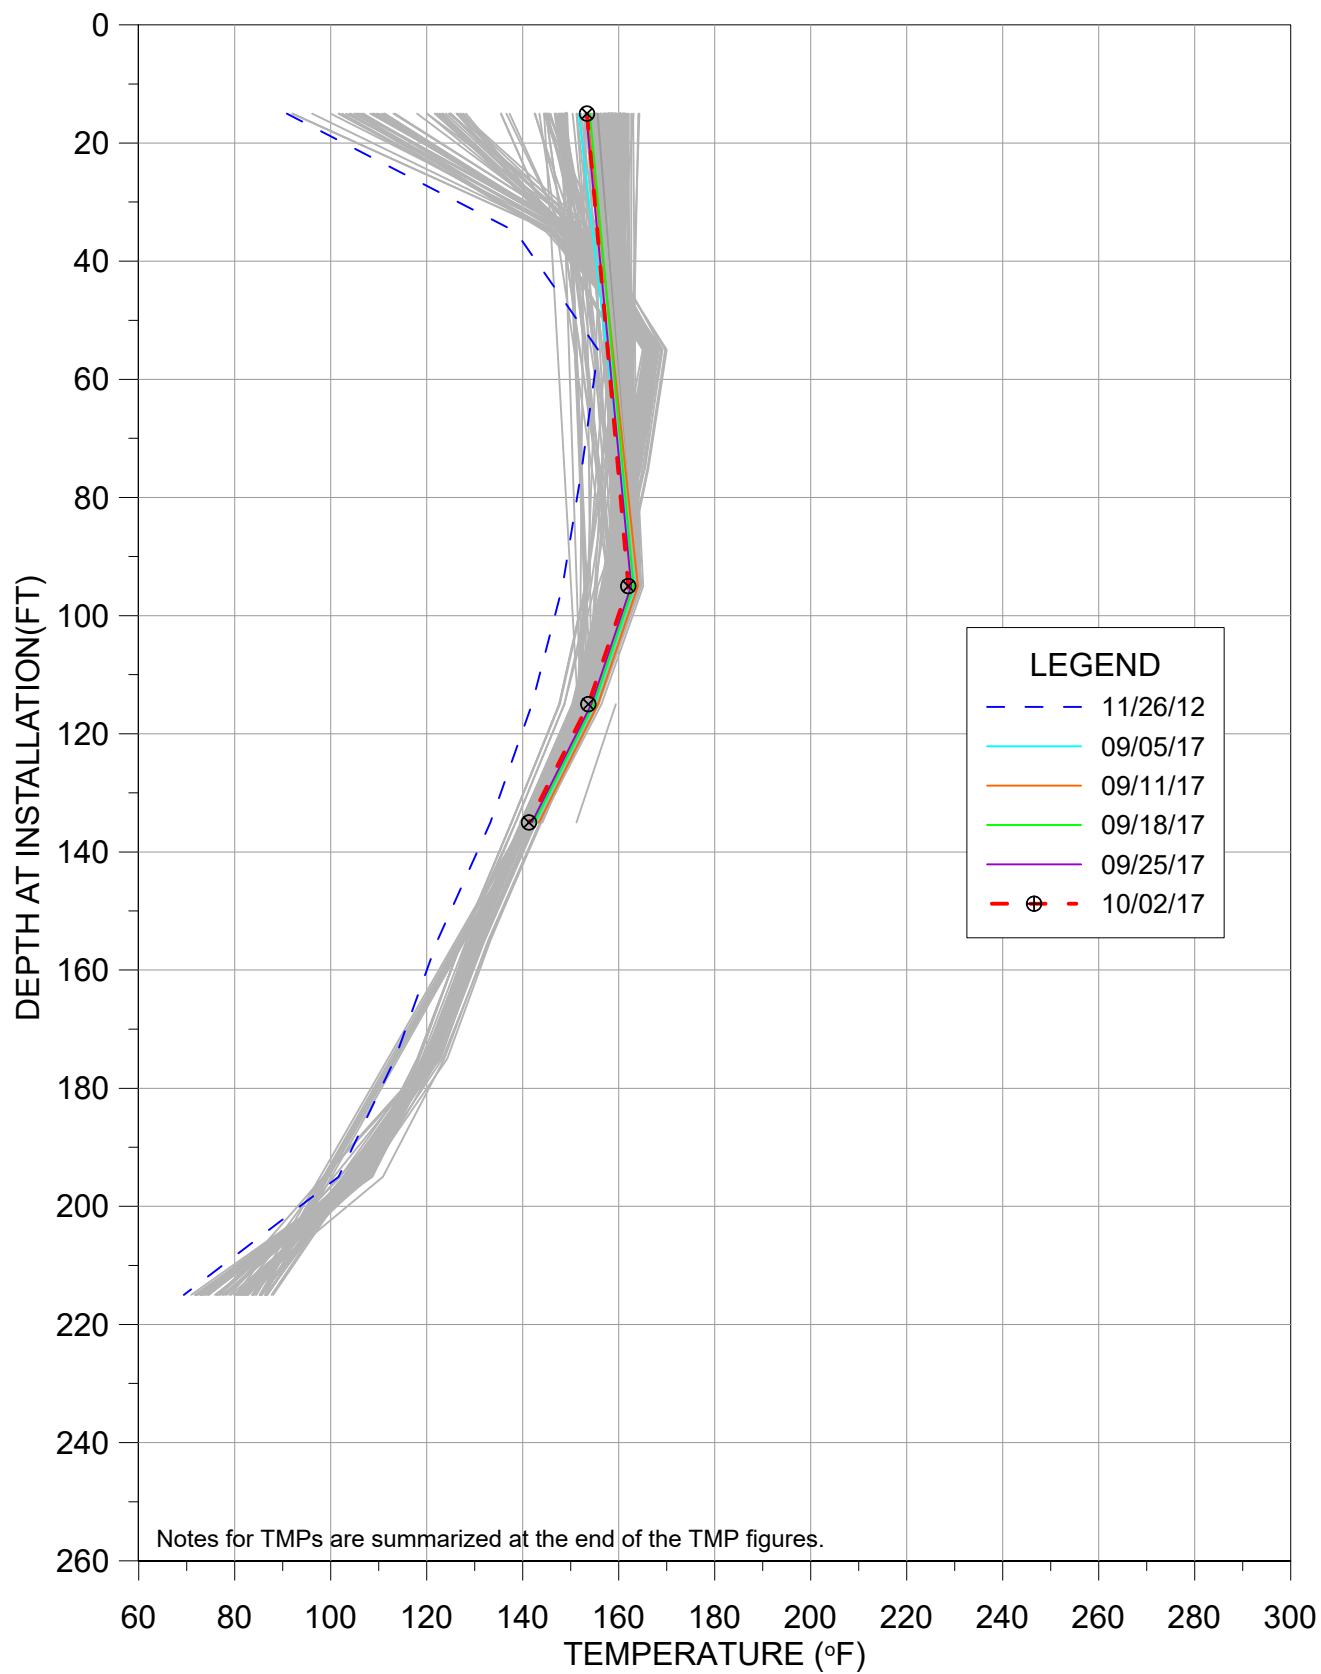
# TMP-6

1. The connectivity tests on 4/11/2014 conducted by CEC showed that units at 35, 55, 75, 155, 175, and 195 ft depths are no longer reliable.
2. No reliable temperature readings have been obtained at the unit at 215 ft depth since 6/13/2014.

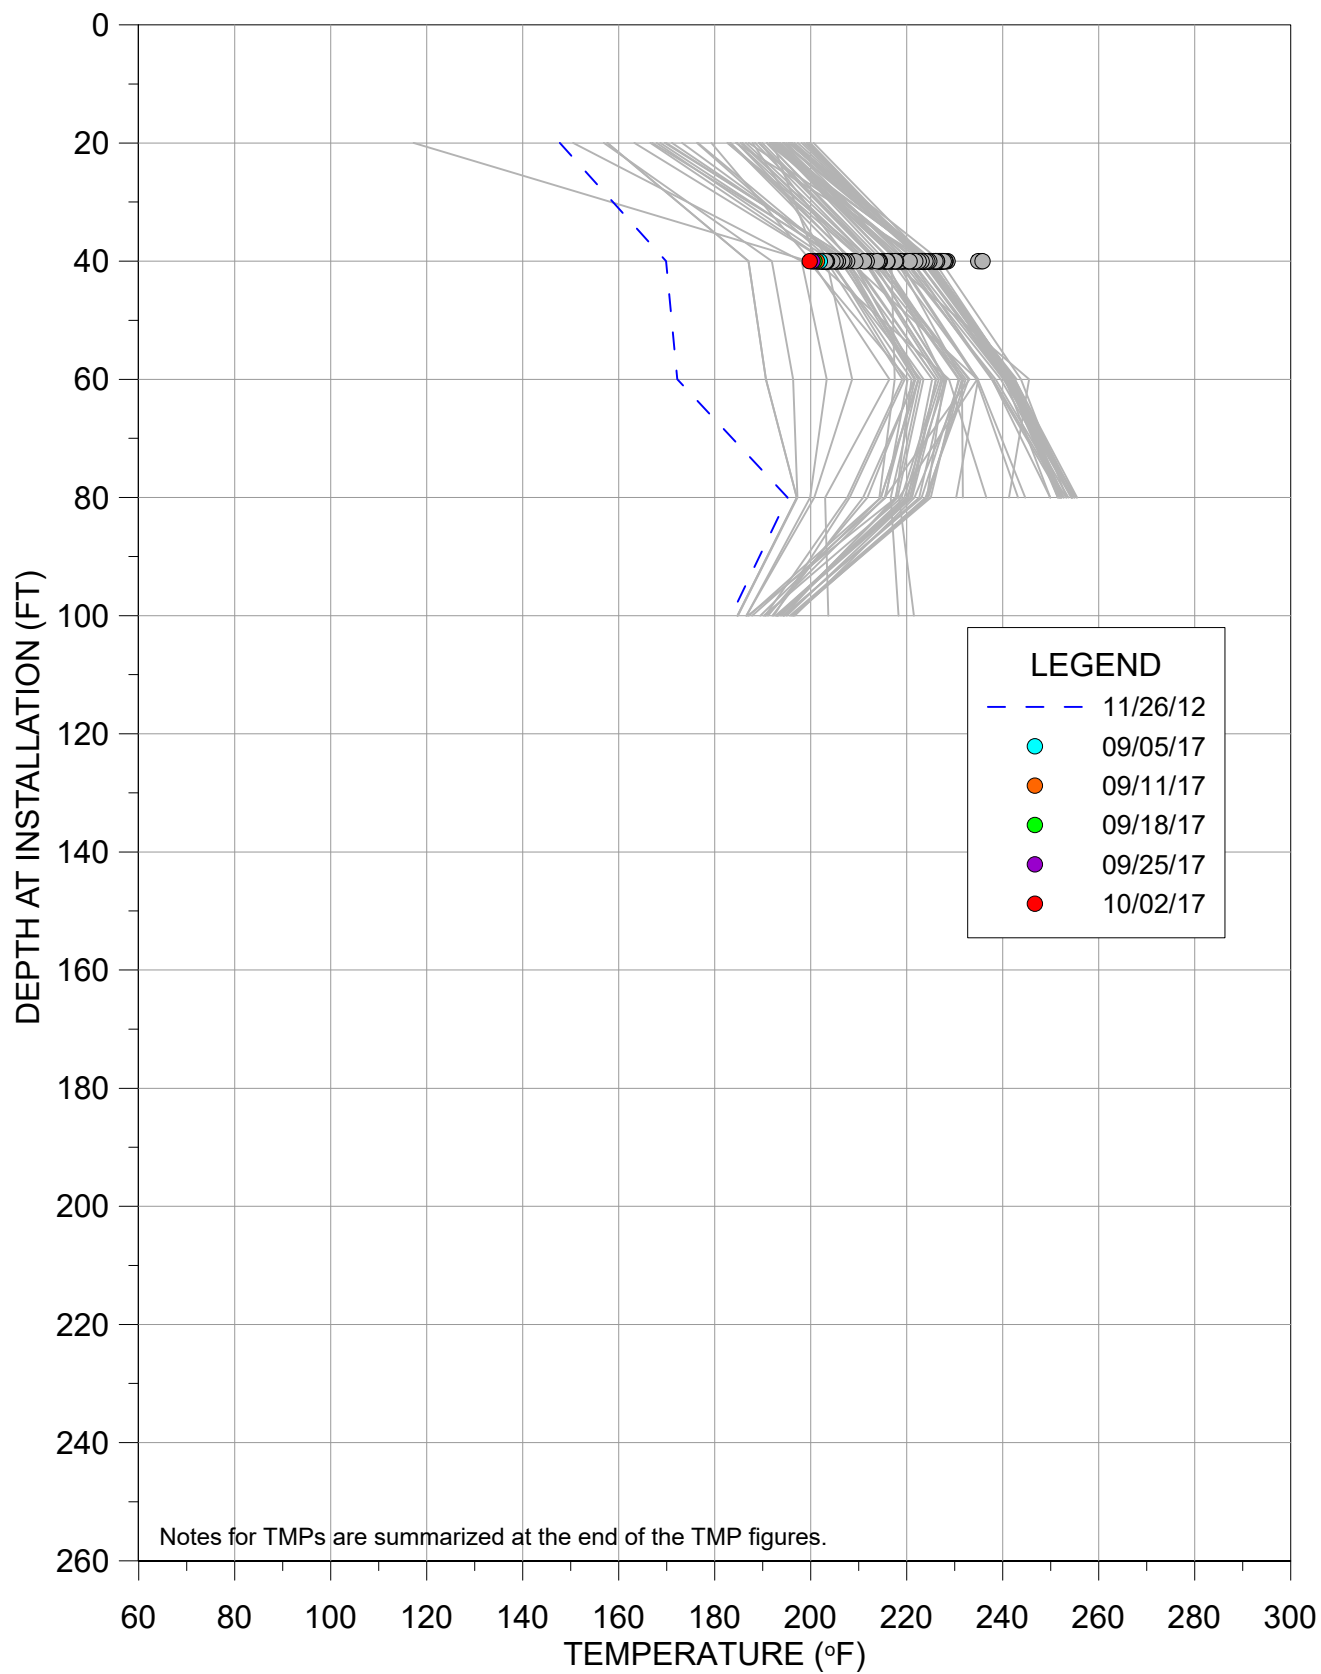
# TMP-9

1. Unit at 100 ft depth had an inaccurate temperature reading on 8/1/2013 and no reading since 8/6/2013.
2. The connectivity tests on 4/11/2014 conducted by CEC showed that units at 20, 60, 80, and 100 ft depths are no longer reliable.
