# **Bridgeton Landfill, LLC**

## **Weekly Data Submittal**

**Week of October 1, 2017 – October 7, 2017**

**Required by Section 52.F of Agreed Order, Case No. 13SL-CC01088  
Effective May 13, 2013**

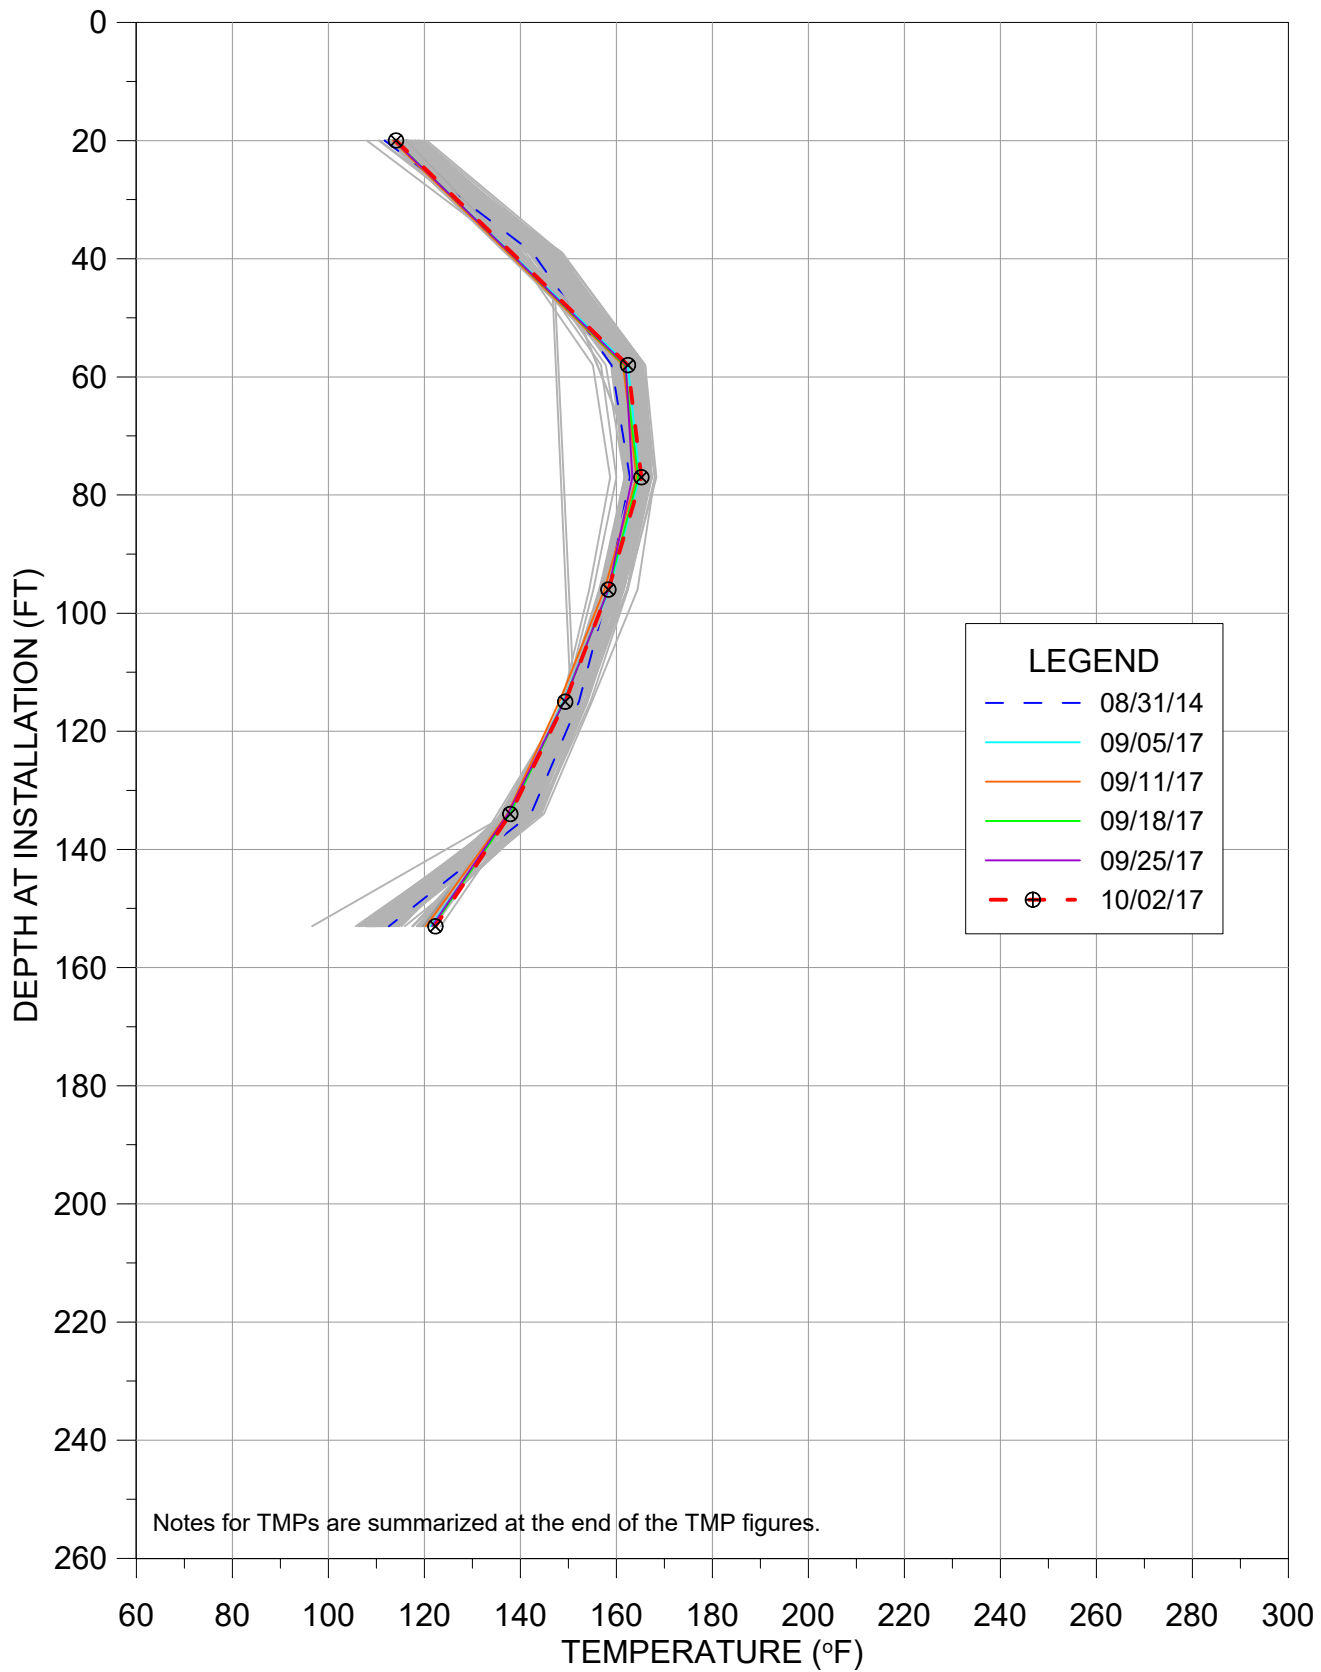
# TMP-16

1. A connectivity test conducted by Feezor Engineering showed that the units on TMP-16 may not be reliable since 9/9/2015. Further testing at the end of September 2015 showed possible connectivity on some of the units.
2. The unit at 153 ft depth had a low resistance reading and unreliable temperature since 12/21/2015.

3. The unit at 39 ft depth had a higher than acceptable resistance reading and unreliable temperature between beginning on 2/7/17. **Unit resumed normal resistance on 3/28/17 but is still considered unreliable as no repairs were done to reduce the resistance. NOTE REVISED- 10/13/17**

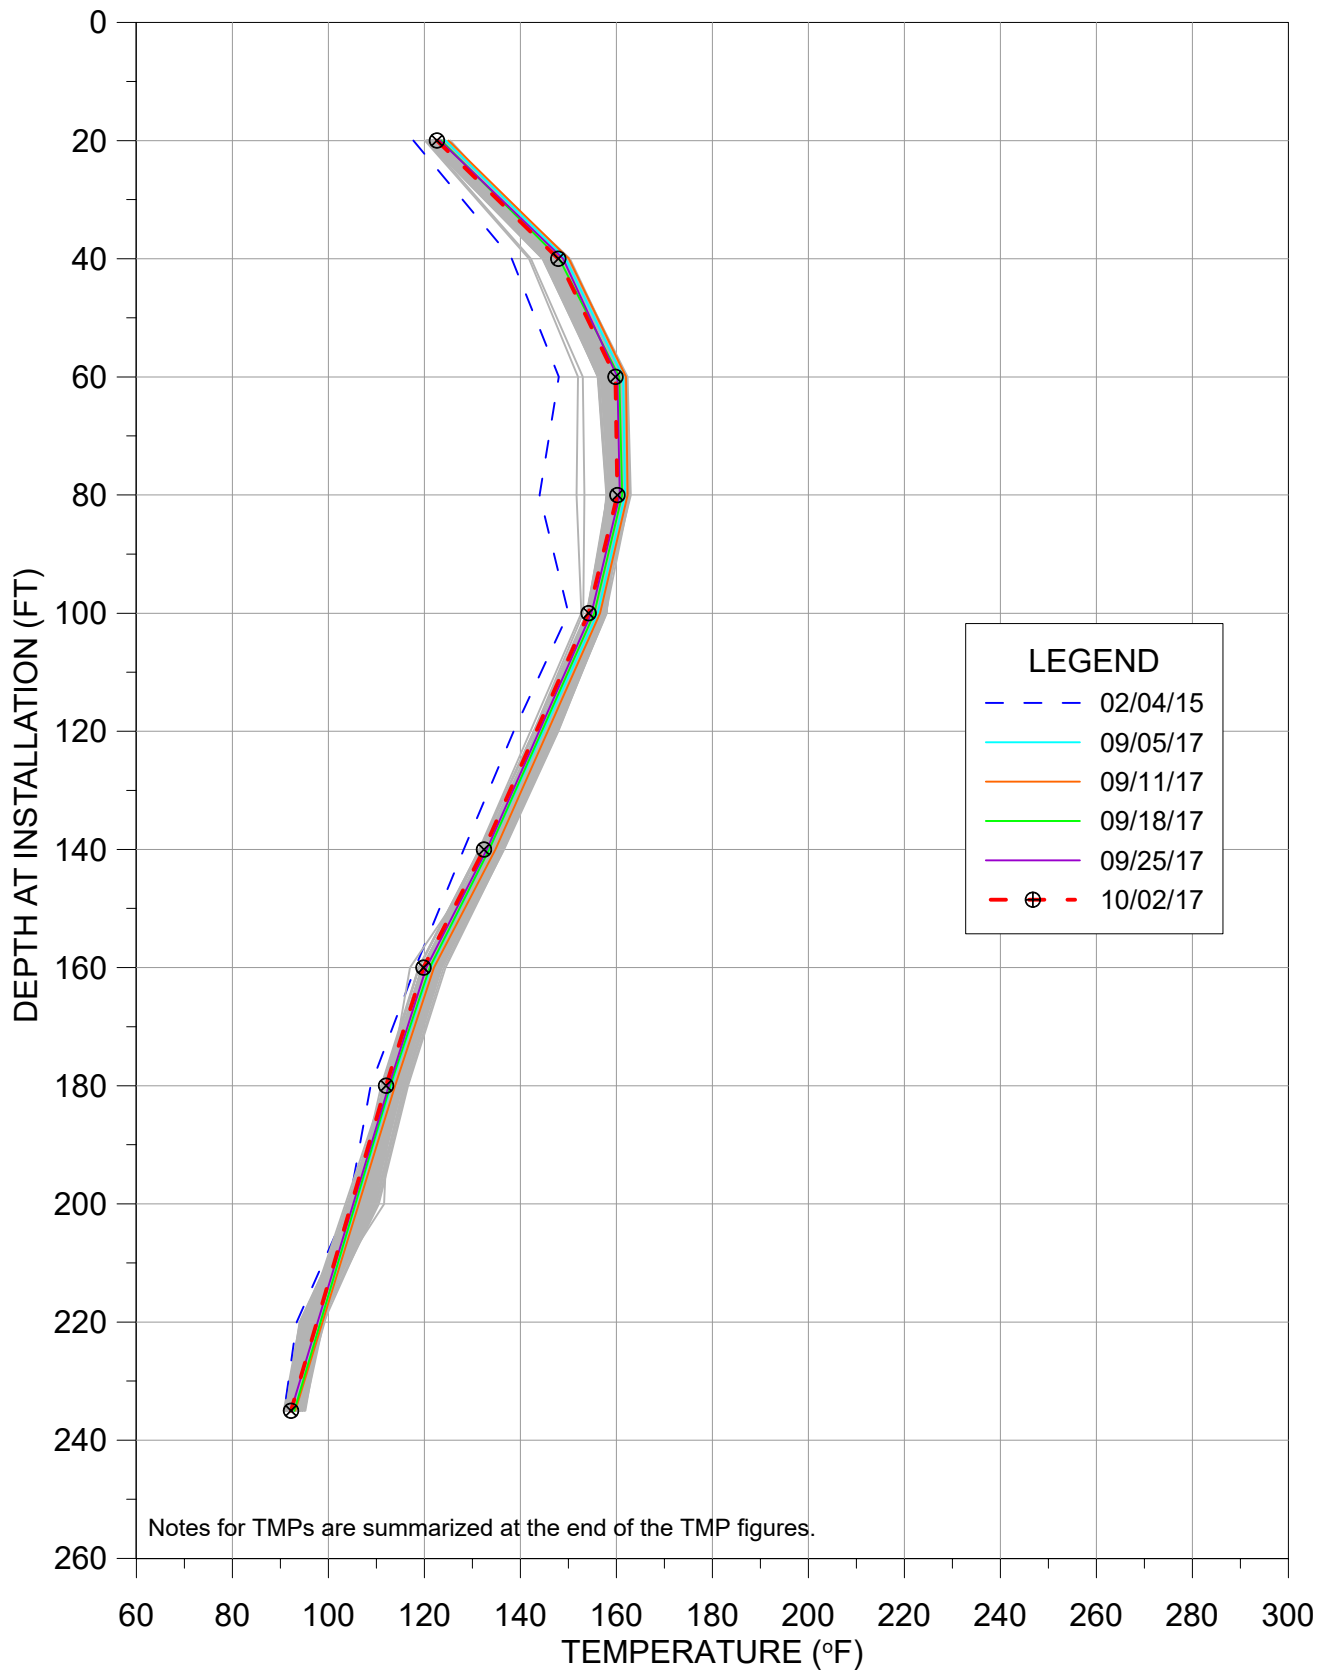
# TMP-25

1. The unit at 200 ft provided an apparent anomalous reading on 3/28/2017. Subsequent readings on 4/4/2017 showed the unit to have failed (see below). The unit is no longer working and the reading of 3/28/2017 was likely unreliable.

2. The unit at 200 ft depth had a resistance reading greater 4000 ohms on 4/4/2017. A connectivity test conducted by Feezor Engineering on 4/7/2017 showed that this unit also had cross-connectivity. The unit is therefore determined to be no longer working as of the 4/4/2017 reading.

3. The unit at 120 feet had a higher than acceptable limit on 7/10/2017. Also, a connectivity test conducted by Feezor Engineering on 4/7/2017 showed that this unit may be unreliable. Therefore, this unit is determined to be unreliable.

4. The unit at 220 ft has been reported as unable to attain a reading of any kind since June 19, 2017. The unit is considered to be on no longer working as of that date.

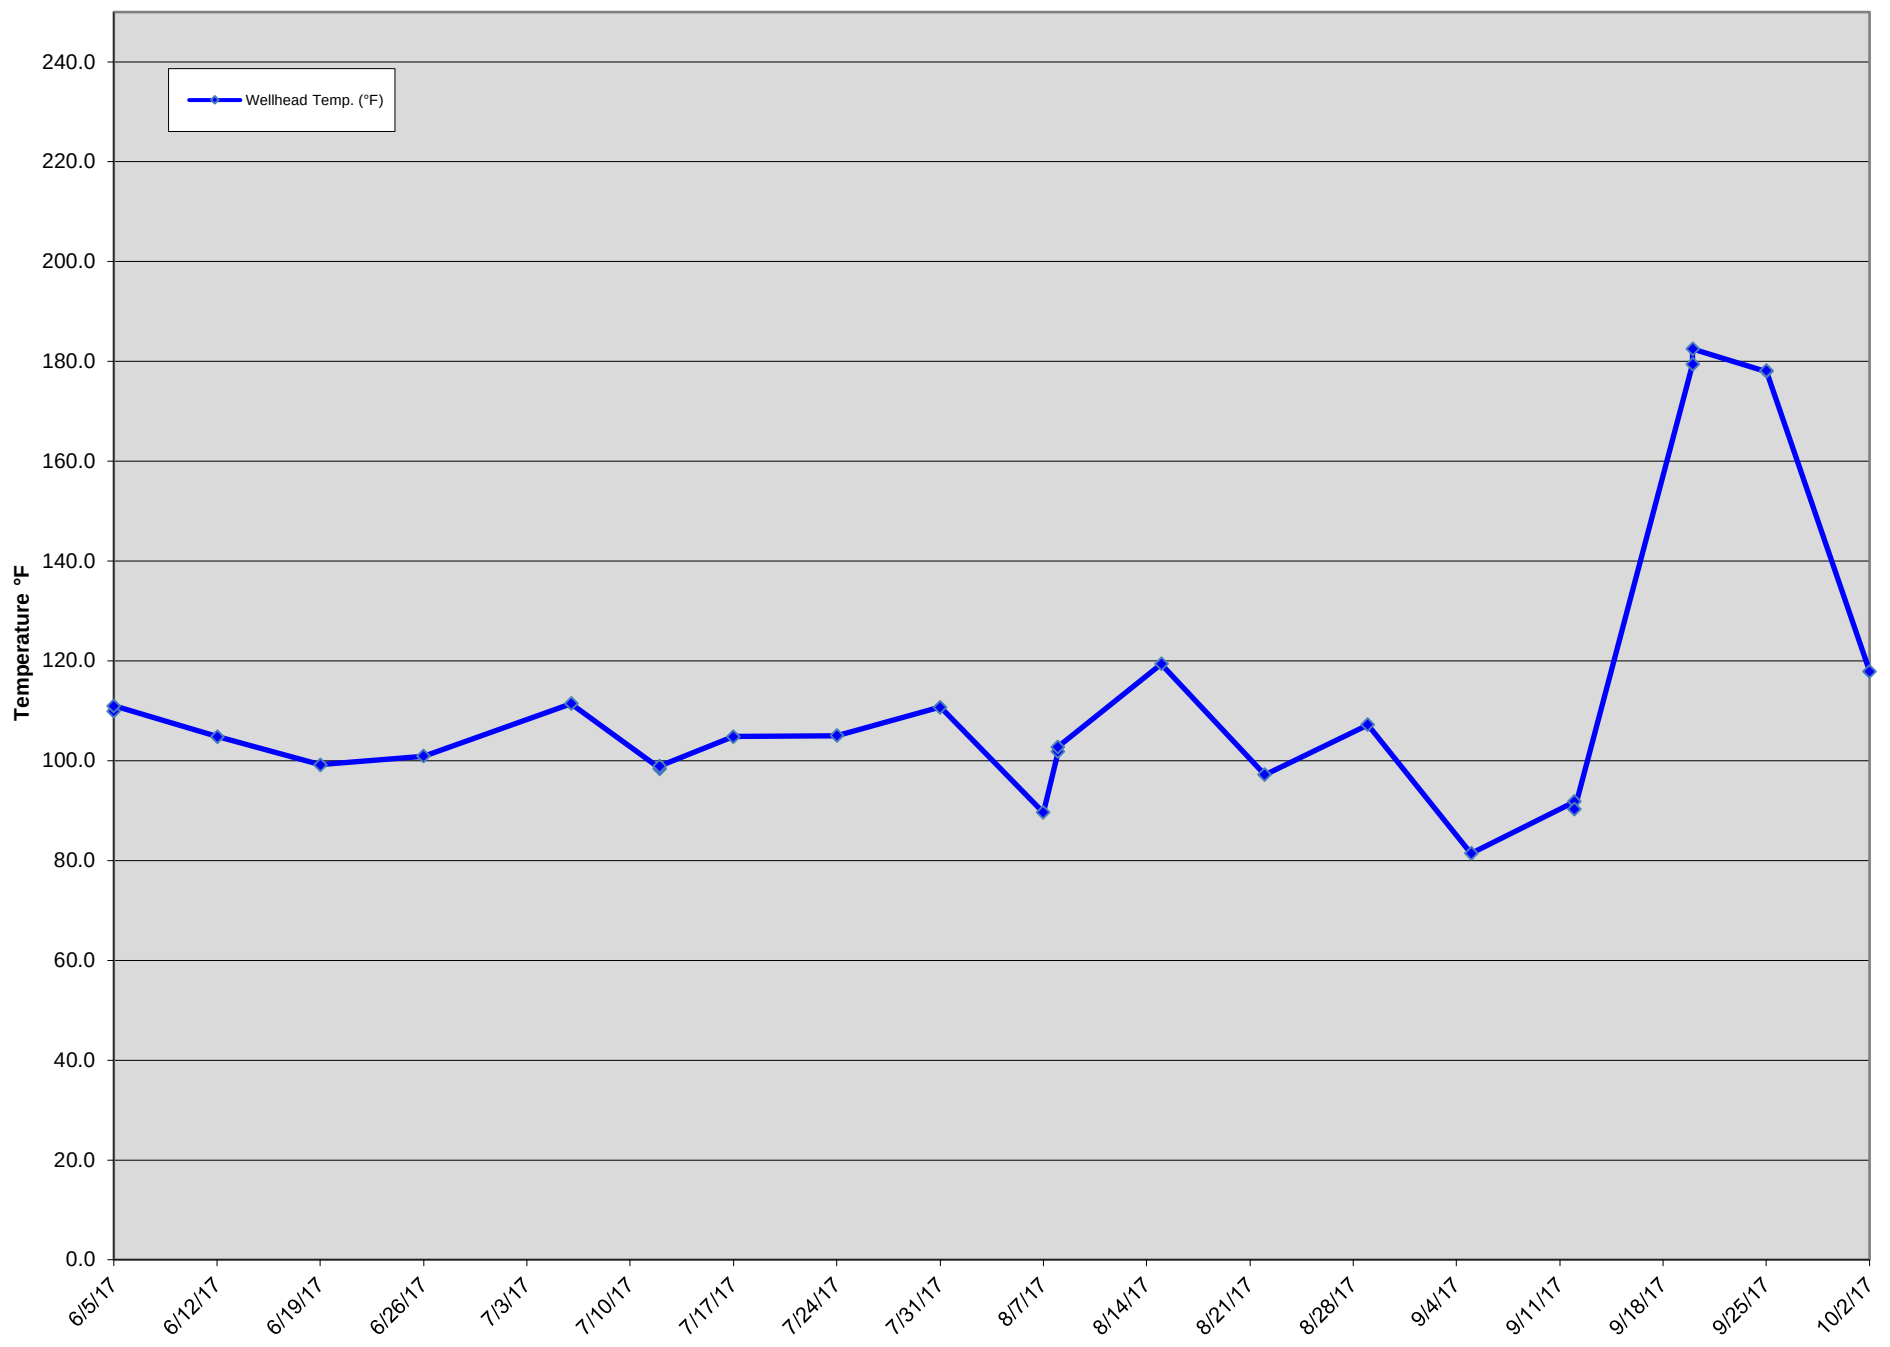
## GIW-1 Wellhead Temperatures

As part of the HES, there are currently cooling water circulation loops installed in twelve Gas Interceptor Wells (GIWs) (GIW-02 through GIW-13). The remaining well (GIW-01) had a measured gas temperature within its historical operating limits.
