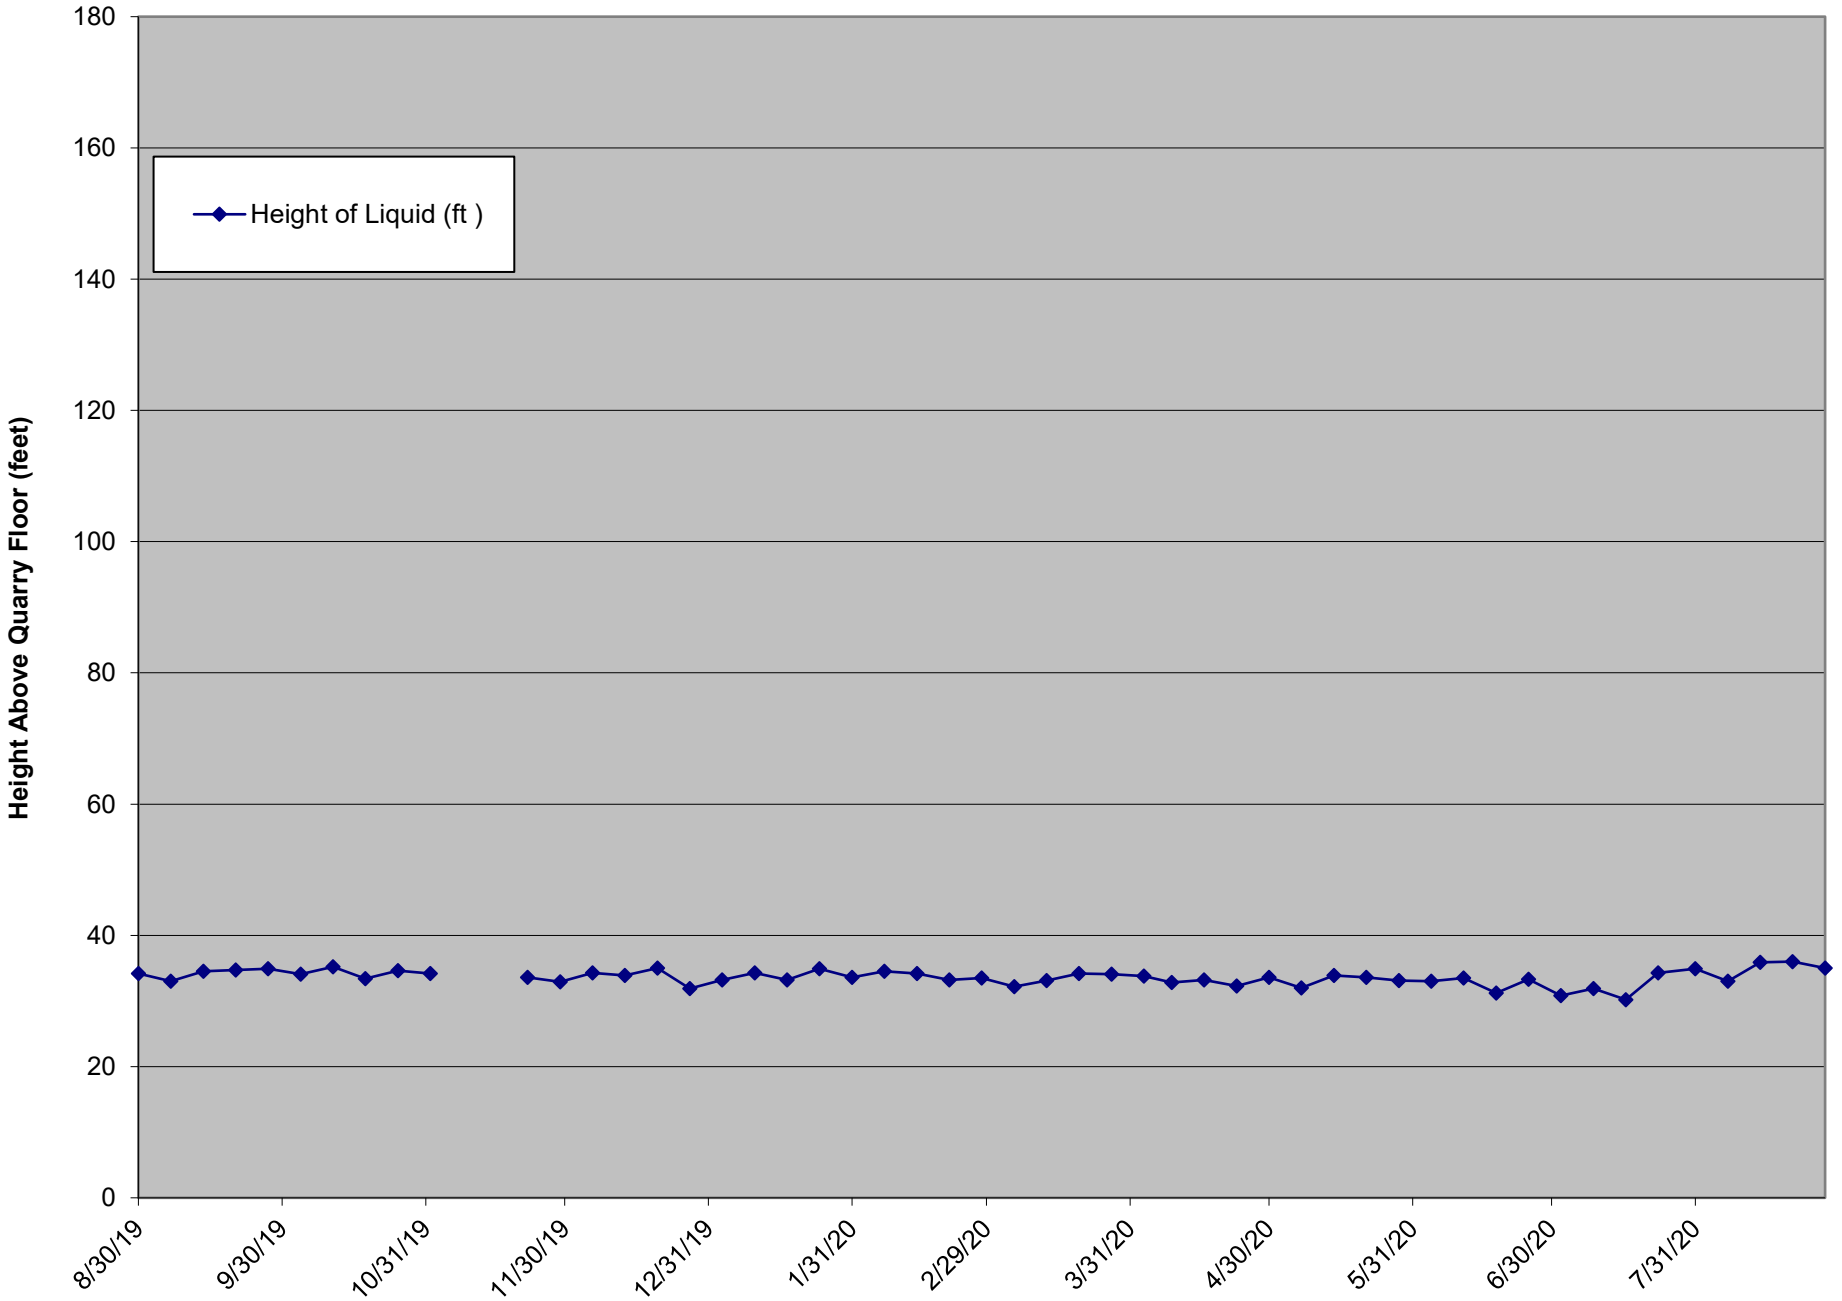
LCS-5B Liquid Level Above Quarry Floor

LCS- 5B	11/8/19		21.9	235.3		235.30	N	Dedicated Transducer	The transducer was observed to be non-operational on 11/6/19. Transducer replacement is scheduled on 11/13/19.
LCS- 5B	11/15/19		21.9	235.3		235.30	N	Dedicated Transducer	The transducer was observed to be non-operational on 11/6/19 and was replaced on 11/13/19. After transducer replacement, pump was non-operational due to suspected frozen forcemain section. Troubleshooting will continue the week of 11/18/19.
LCS- 5B	11/22/19	11.7	21.9	235.3	33.6	268.90	Y	Dedicated Transducer	The transducer was observed to be non-operational on 11/6/19 and was replaced on 11/13/19. After transducer replacement, pump was non-operational due to suspected frozen forcemain section. The pump and motor were replaced on 11/19/19 and LCS-5B became fully operational.
LCS- 5B	11/29/19	11.0	21.9	235.3	32.9	268.20	Y	Dedicated Transducer	
LCS- 5B	12/6/19	12.4	21.9	235.3	34.3	269.60	Y	Dedicated Transducer

*The transducer in LCS-5B was down from 11/6/19 to 11/19/19.

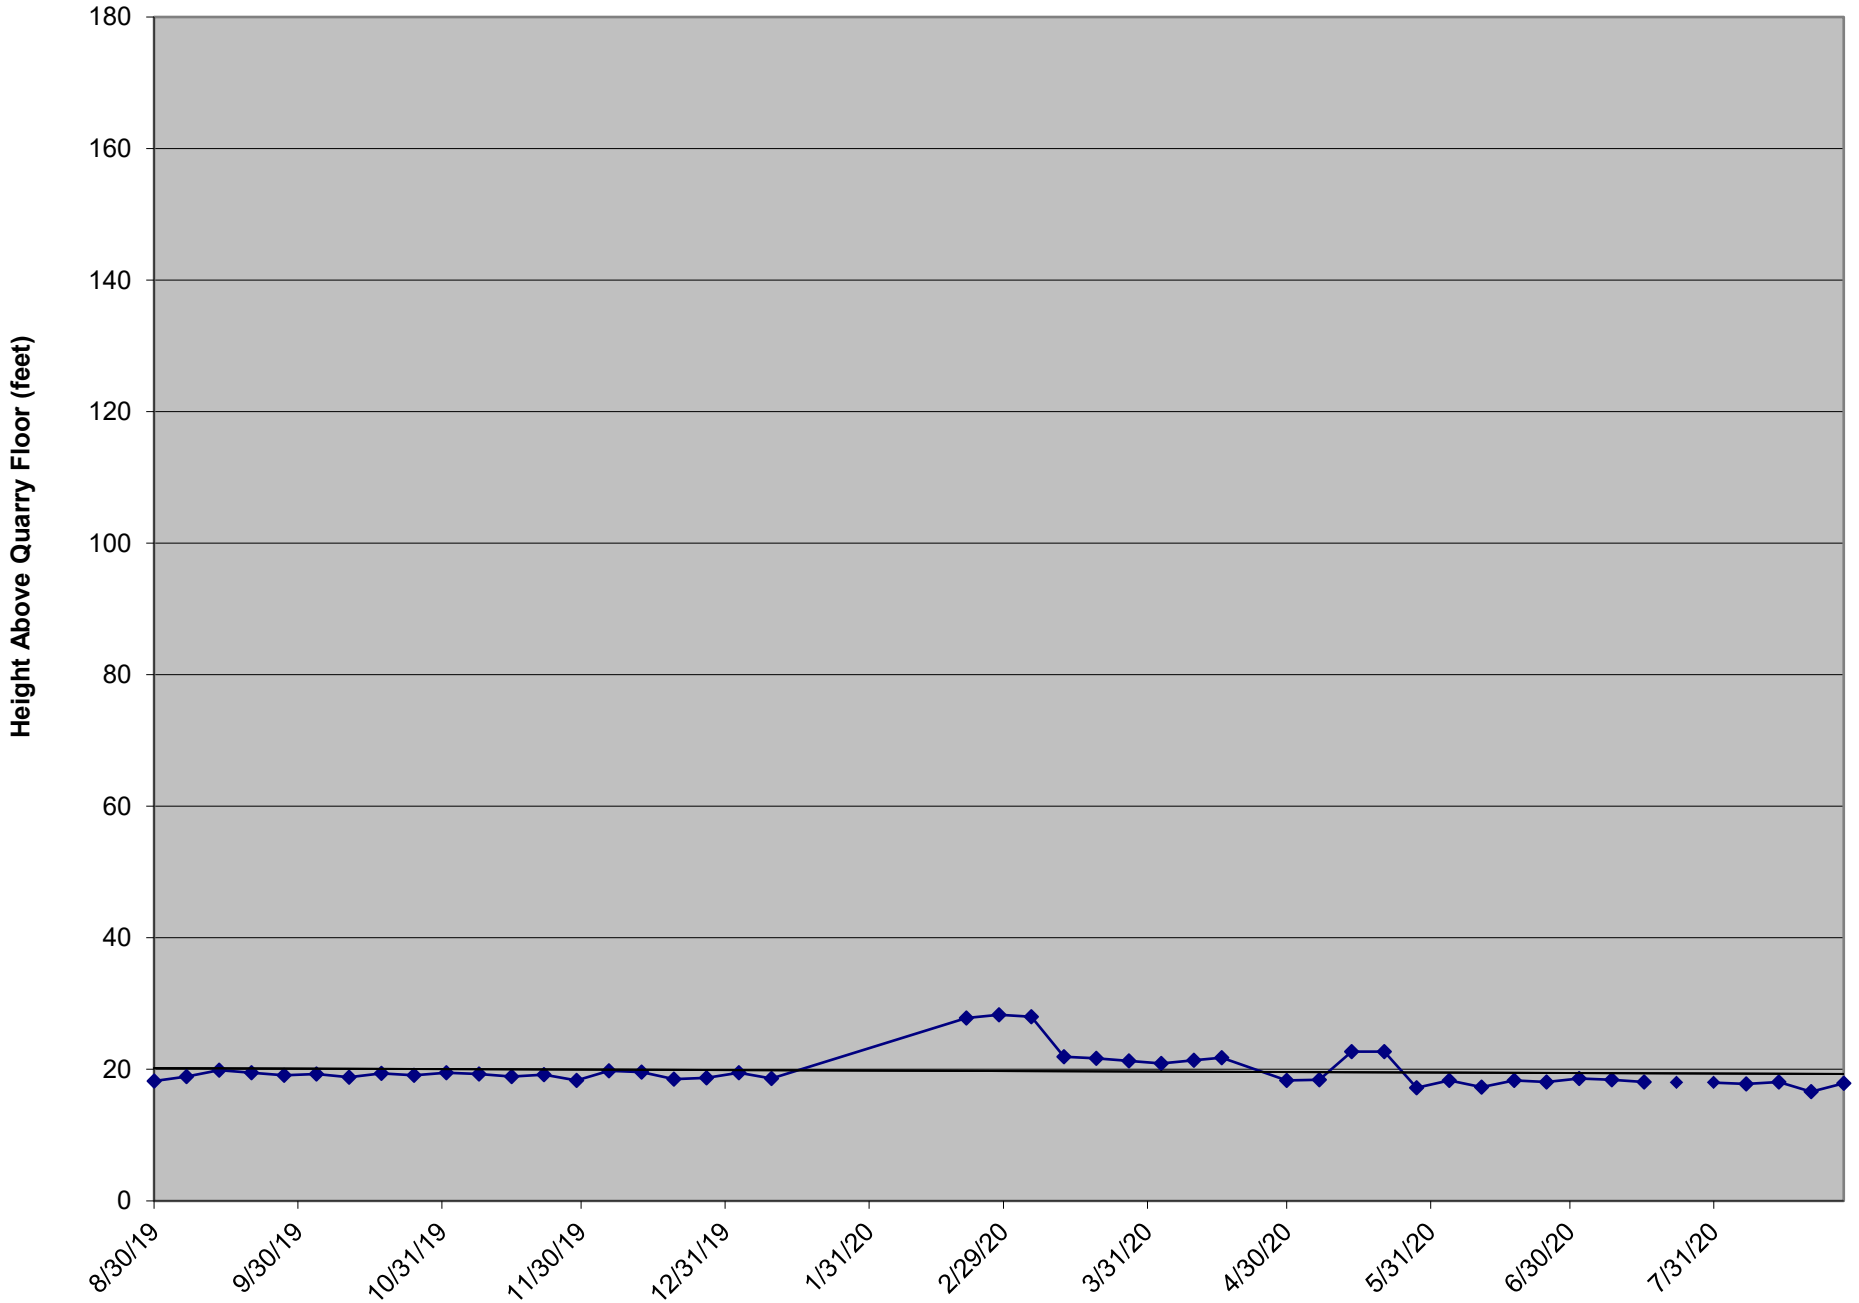
LCS-6B Liquid Level Above Quarry Floor

LCS- 6B	11/8/19	9.9	9.4	429.52	19.3	448.82	Y	Dedicated Transducer	
LCS- 6B	11/15/19	9.5	9.4	429.52	18.9	448.42	Y	Dedicated Transducer	
LCS- 6B	11/22/19	9.8	9.4	429.52	19.2	448.72	Y	Dedicated Transducer	
LCS- 6B	11/29/19	8.9	9.4	429.52	18.3	447.82	Y	Dedicated Transducer	
LCS- 6B	12/6/19	10.4	9.4	429.52	19.8	449.32	Y	Dedicated Transducer	
LCS- 6B	12/13/19	10.2	9.4	429.52	19.6	449.12	Y	Dedicated Transducer	
LCS- 6B	12/20/19	9.1	9.4	429.52	18.5	448.02	Y	Dedicated Transducer	
LCS- 6B	12/27/19	9.3	9.4	429.52	18.7	448.22	Y	Dedicated Transducer	
LCS- 6B	1/3/20	10.1	9.4	429.52	19.5	449.02	Y	Dedicated Transducer	
LCS- 6B	1/10/20	9.2	9.4	429.52	18.6	448.12	Y	Dedicated Transducer	
LCS- 6B	1/17/20		9.4	429.52			N	Dedicated Transducer	The LCS-6B transducer was observed to be non-operational on 1/13/20. Transducer replacement is pending replacement parts arrival.
LCS- 6B	1/24/20		9.4	429.52			N	Dedicated Transducer	The LCS-6B transducer was observed to be non-operational on 1/13/20. Transducer replacement is pending replacement parts arrival.

LCS- 6B	1/31/20		9.4	429.52			N	Dedicated Transducer	The LCS-6B transducer was observed to be non-operational on 1/13/20. Transducer replacement is pending replacement parts arrival.
LCS- 6B	2/7/20		9.4	429.52			N	Dedicated Transducer	The LCS-6B transducer was observed to be non-operational on 1/13/20. Transducer replacement is pending replacement parts arrival.
LCS- 6B	2/14/20		9.4	429.52			N	Dedicated Transducer	The LCS-6B transducer was observed to be non-operational on 1/13/20. Transducer replacement is pending replacement parts arrival.
LCS- 6B	2/21/20	N/A	N/A	429.52	27.8	457.32	N	Heron Dipper T	The LCS-6B transducer was observed to be non-operational on 1/13/20. Transducer replacement is pending replacement parts arrival. Liquid level was measured manually.
LCS- 6B	2/28/20	N/A	N/A	429.52	28.3	457.82	N	Heron Dipper T	The LCS-6B transducer was observed to be non-operational on 1/13/20. Transducer replacement is tentatively scheduled the week of 3/9/20. Liquid level was measured manually.

LCS- 6B	3/6/20	N/A	N/A	429.52	28.0	457.52	N	Heron Dipper T	The LCS-6B transducer was observed to be non-operational on 1/13/20. Transducer replacement is scheduled for 3/11/20. Liquid level was measured manually.
LCS- 6B	3/13/20	12.5	9.4	429.52	21.9	451.42	Y	Dedicated Transducer	The LCS-6B transducer was replaced on 3/11/20 and the pump became fully operational. The LCS-6B pump was observed to be non-operational on 3/12/20. The LCS-6B pump was replaced on 3/13/20. LCS-6B became fully operational on 3/13/20.
LCS- 6B	3/20/20	12.3	9.4	429.52	21.7	451.22	Y	Dedicated Transducer	
LCS- 6B	3/27/20	11.9	9.4	429.52	21.3	450.82	Y	Dedicated Transducer	
LCS- 6B	4/3/20	11.5	9.4	429.52	20.9	450.42	Y	Dedicated Transducer	
LCS- 6B	4/10/20	12.0	9.4	429.52	21.4	450.92	Y	Dedicated Transducer	
LCS- 6B	4/16/20	12.4	9.4	429.52	21.8	451.32	Y	Dedicated Transducer	
LCS- 6B	4/23/20		9.4	429.52			Y	Dedicated Transducer	The LCS-6B VFD was observed to be non-operational on 4/23/20. The VFD was replaced on 4/23/20 and LCS-6B became fully operational. A level sensor reading was not collected during the weekly reporting period due to VFD communication loss with the site's SCADA system.

The transducer became non-operational on 1/13/20. Liquid level was measured manually on 2/21/20, 2/28/20 and 3/6/20. The transducer became operational on 3/13/20. The VFD was observed to be non-operational on 4/23/20, it was replaced on 4/23/20, however the level sensor reading was not taken due to VFD communication loss with SCADA.
