LCS-6B Liquid Level Above Quarry Floor

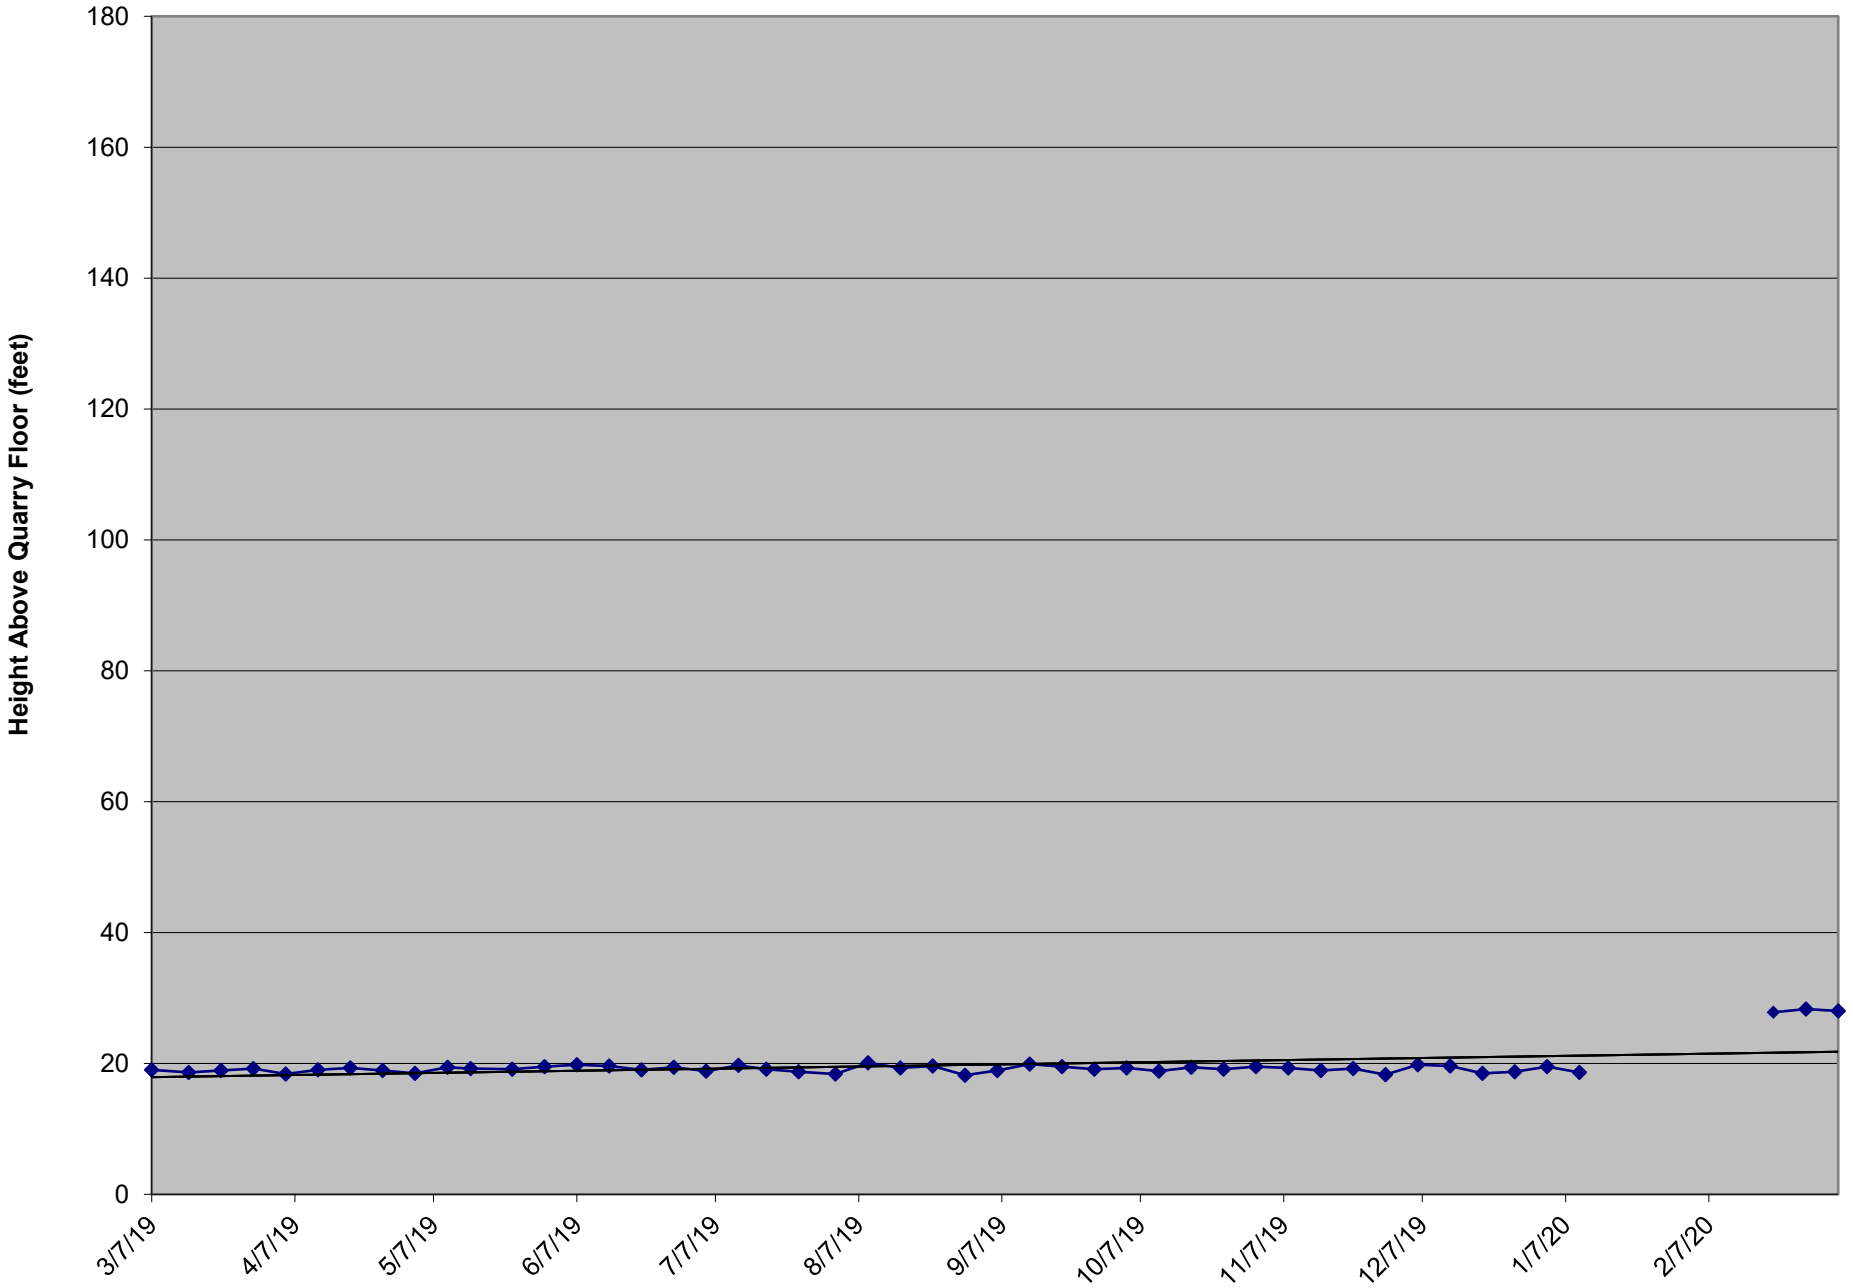
The transducer became non-operational on 1/13/20. Liquid level was measured manually on 2/21/20, 2/28/20 and 3/6/20.

LCS- 6B	2/7/20		9.4	429.52			N	Dedicated Transducer	The LCS-6B transducer was observed to be non-operational on 1/13/20. Transducer replacement is pending replacement parts arrival.
LCS- 6B	2/14/20		9.4	429.52			N	Dedicated Transducer	The LCS-6B transducer was observed to be non-operational on 1/13/20. Transducer replacement is pending replacement parts arrival.
LCS- 6B	2/21/20	N/A	N/A	429.52	27.8	457.32	N	Heron Dipper T	The LCS-6B transducer was observed to be non-operational on 1/13/20. Transducer replacement is pending replacement parts arrival. Liquid level was measured manually.
LCS- 6B	2/28/20	N/A	N/A	429.52	28.3	457.82	N	Heron Dipper T	The LCS-6B transducer was observed to be non-operational on 1/13/20. Transducer replacement is tentatively scheduled the week of 3/9/20. Liquid level was measured manually.
LCS- 6B	3/6/20	N/A	N/A	429.52	28.0	457.52	N	Heron Dipper T	The LCS-6B transducer was observed to be non-operational on 1/13/20. Transducer replacement is scheduled for 3/11/20. Liquid level was measured manually.

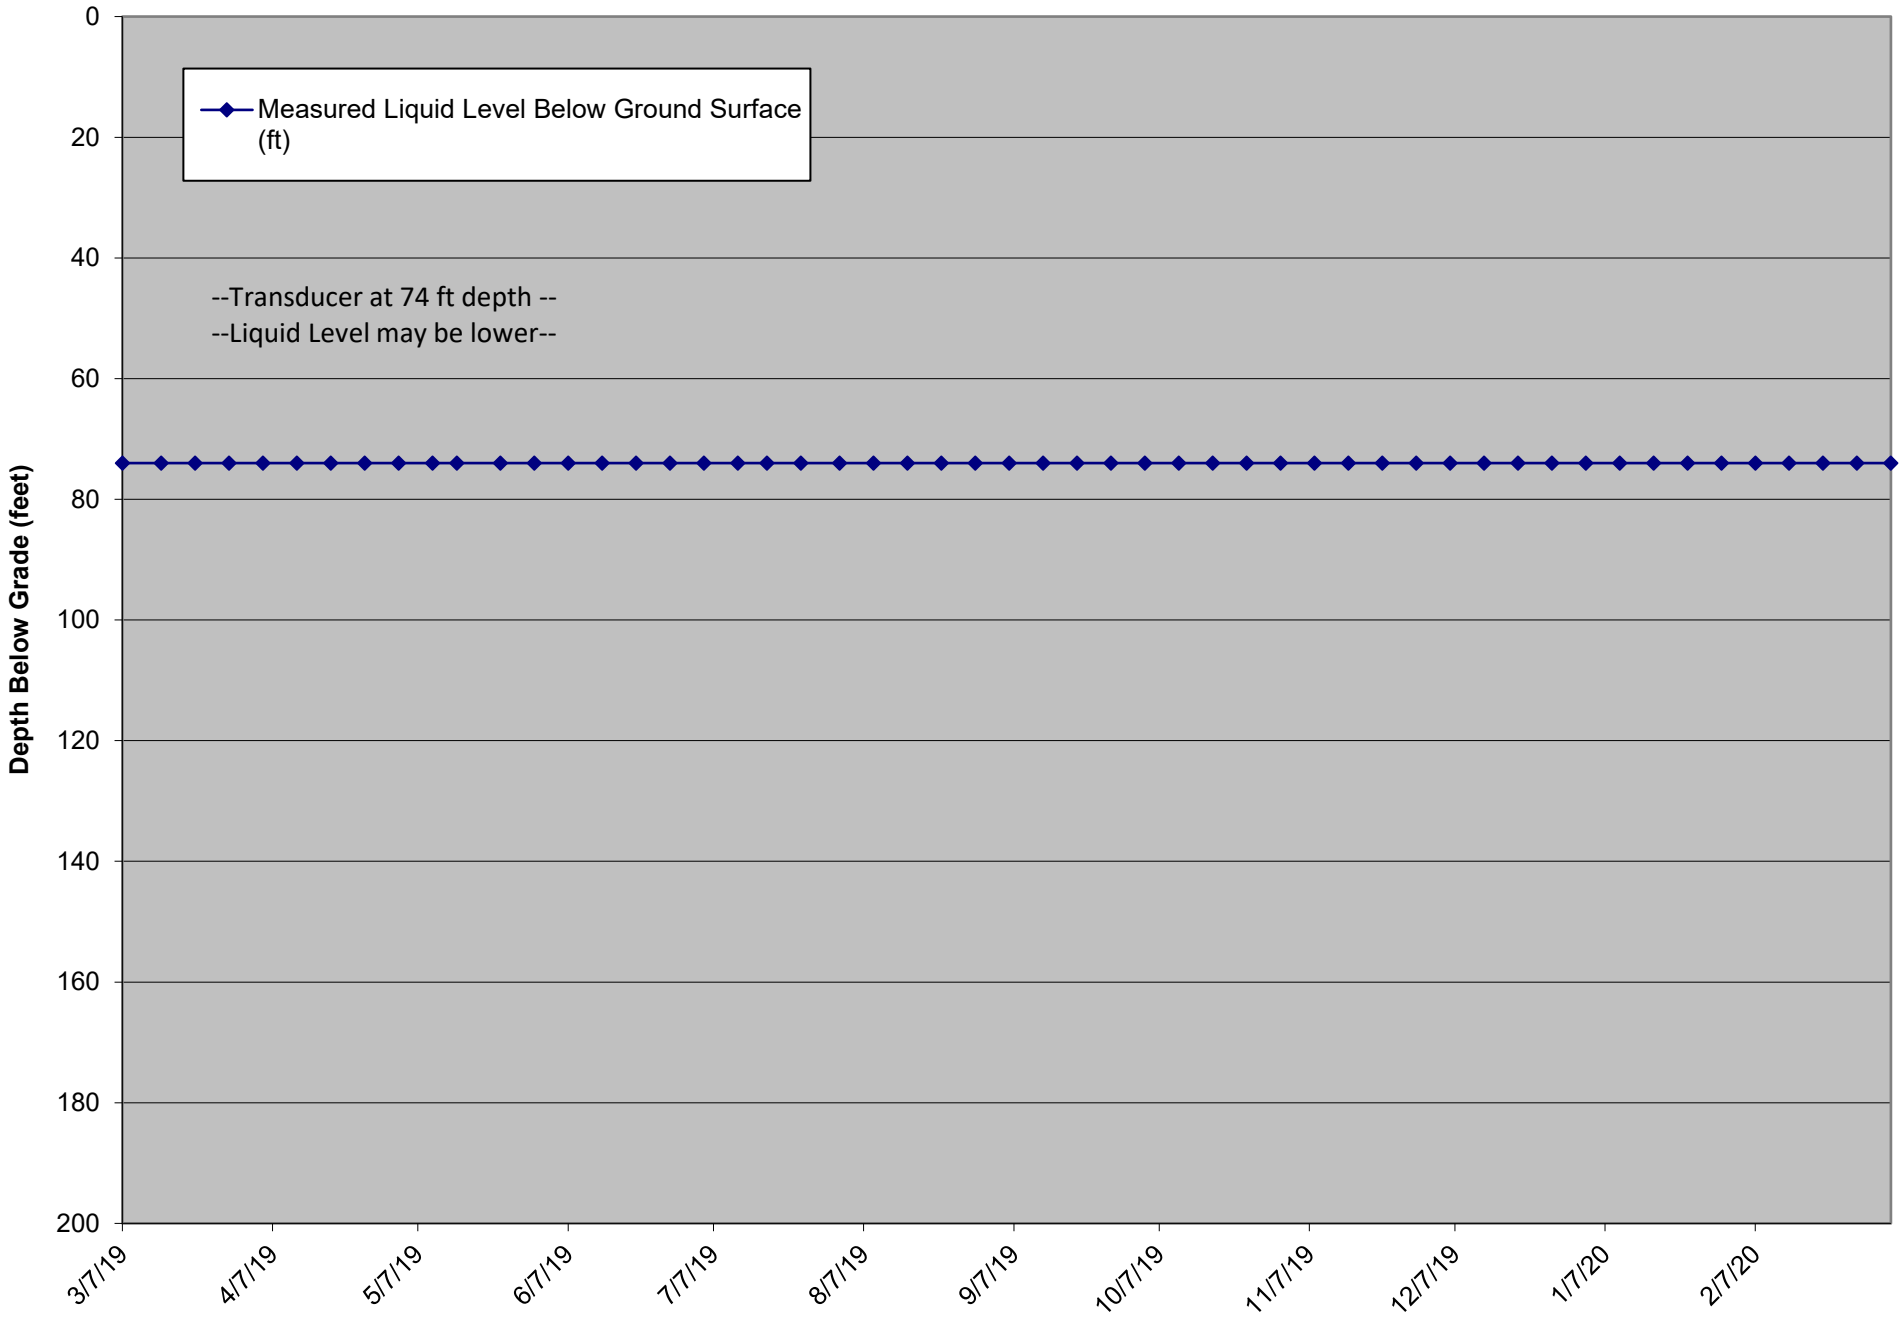
LCS-4B Liquid Level Below Ground Surface

LCS- 4B	1/24/20	74.0	81.0	244.00	Y	Dedicated Transducer	Pump operational, no flow detected, liquid level >74.0' BGS
LCS- 4B	1/31/20	74.0	81.0	244.00	Y	Dedicated Transducer	Pump operational, no flow detected, liquid level >74.0' BGS
LCS- 4B	2/7/20	74.0	81.0	244.00	Y	Dedicated Transducer	Pump operational, no flow detected, liquid level >74.0' BGS
LCS- 4B	2/14/20	74.0	81.0	244.00	Y	Dedicated Transducer	Pump operational, no flow detected, liquid level >74.0' BGS
LCS- 4B	2/21/20	74.0	81.0	244.00	Y	Dedicated Transducer	Pump operational, no flow detected, liquid level >74.0' BGS
LCS- 4B	2/28/20	74.0	81.0	244.00	Y	Dedicated Transducer	Pump operational, no flow detected, liquid level >74.0' BGS
LCS- 4B	3/6/20	74.0	81.0	244.00	Y	Dedicated Transducer	Pump operational, no flow detected, liquid level >74.0' BGS

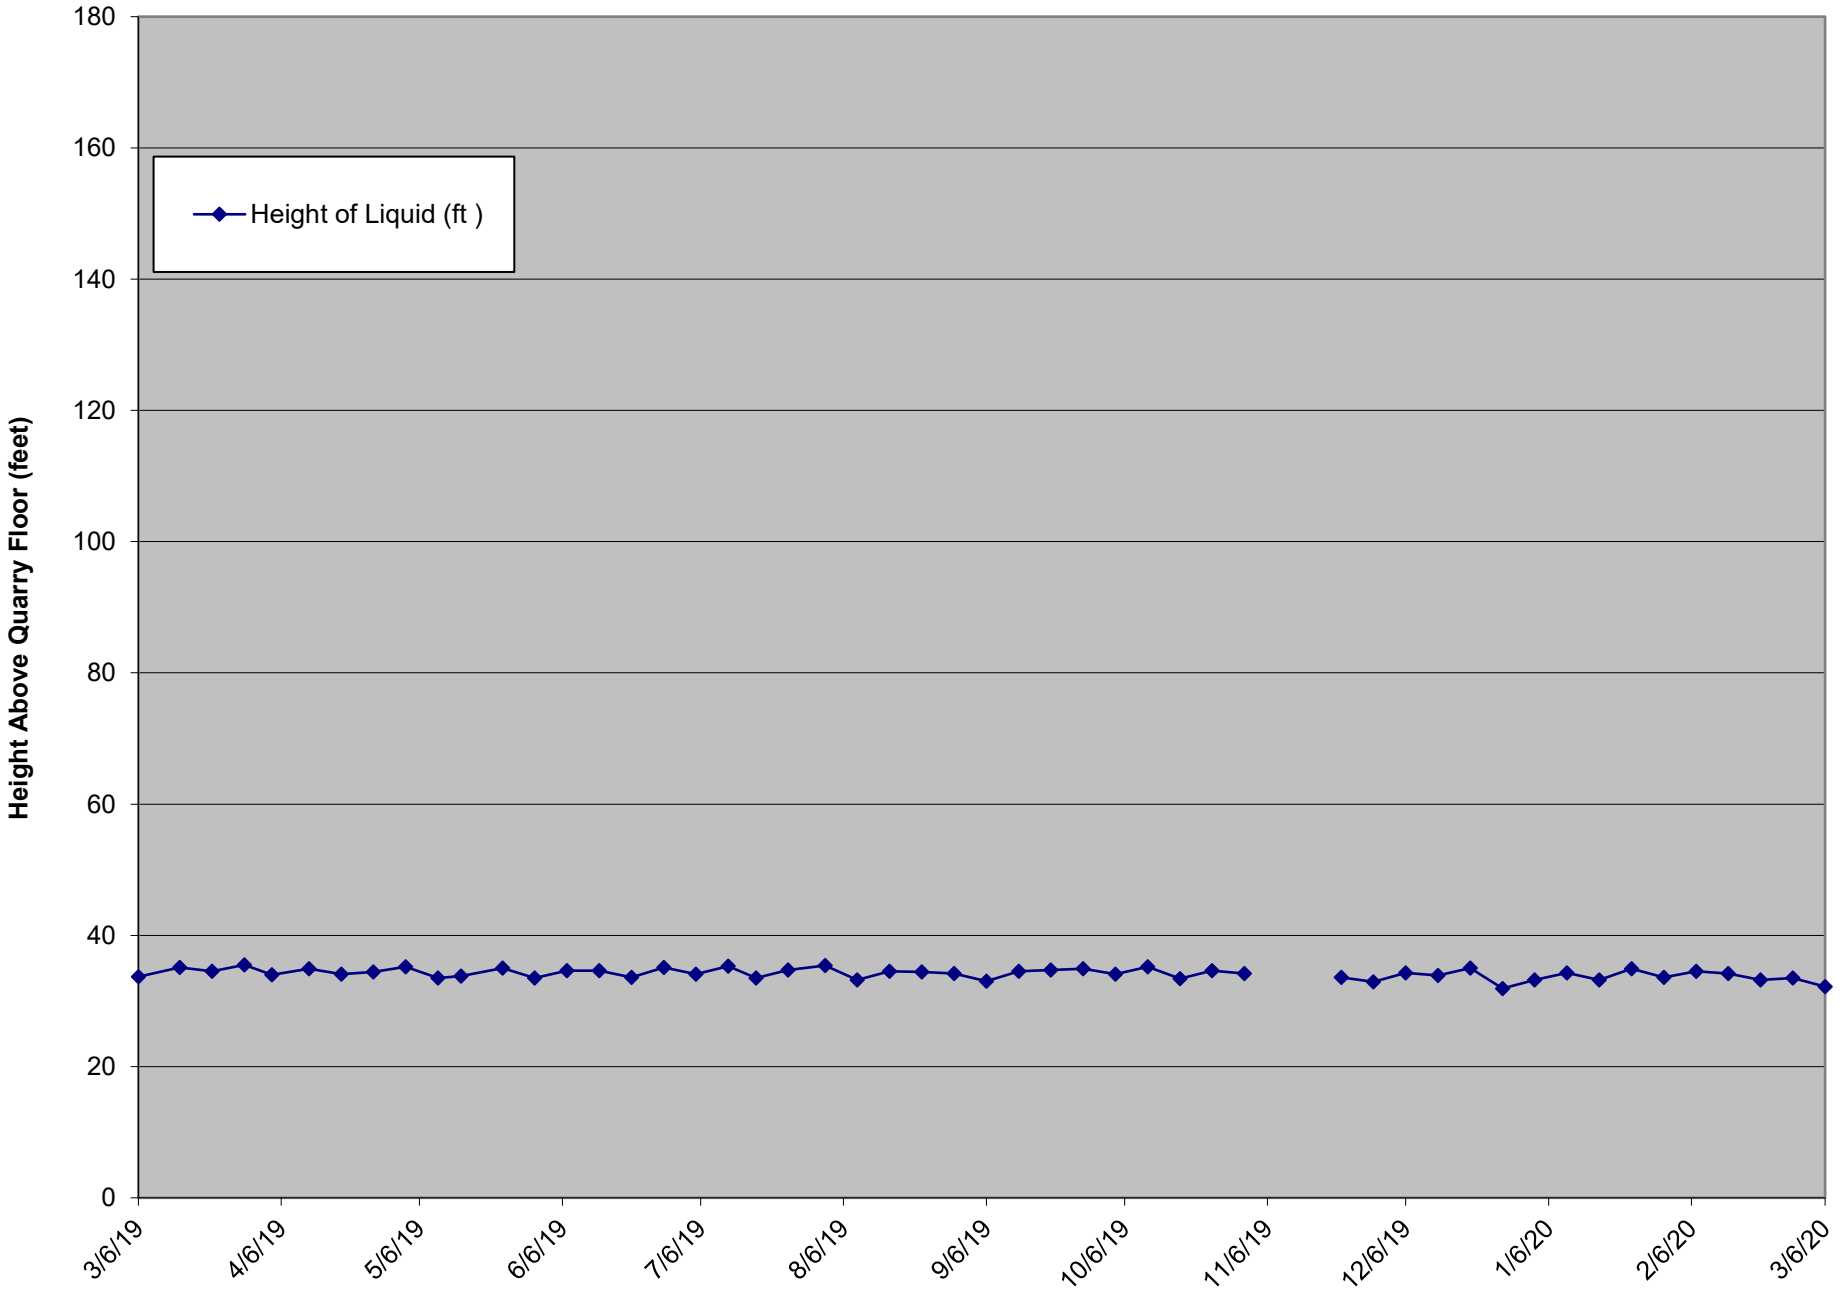
LCS-5B Liquid Level Above Quarry Floor

LCS- 5B	11/15/19		21.9	235.3		235.30	N	Dedicated Transducer	The transducer was observed to be non-operational on 11/6/19 and was replaced on 11/13/19. After transducer replacement, pump was non-operational due to suspected frozen forcemain section. Troubleshooting will continue the week of 11/18/19.
LCS- 5B	11/22/19	11.7	21.9	235.3	33.6	268.90	Y	Dedicated Transducer	The transducer was observed to be non-operational on 11/6/19 and was replaced on 11/13/19. After transducer replacement, pump was non-operational due to suspected frozen forcemain section. The pump and motor were replaced on 11/19/19 and LCS-5B became fully operational.
LCS- 5B	11/29/19	11.0	21.9	235.3	32.9	268.20	Y	Dedicated Transducer	
LCS- 5B	12/6/19	12.4	21.9	235.3	34.3	269.60	Y	Dedicated Transducer	
LCS- 5B	12/13/19	12.0	21.9	235.3	33.9	269.20	Y	Dedicated Transducer	
LCS- 5B	12/20/19	13.1	21.9	235.3	35.0	270.30	Y	Dedicated Transducer

*The transducer in LCS-5B was down from 11/6/19 to 11/19/19.
