LCS-6B Liquid Level Above Quarry Floor

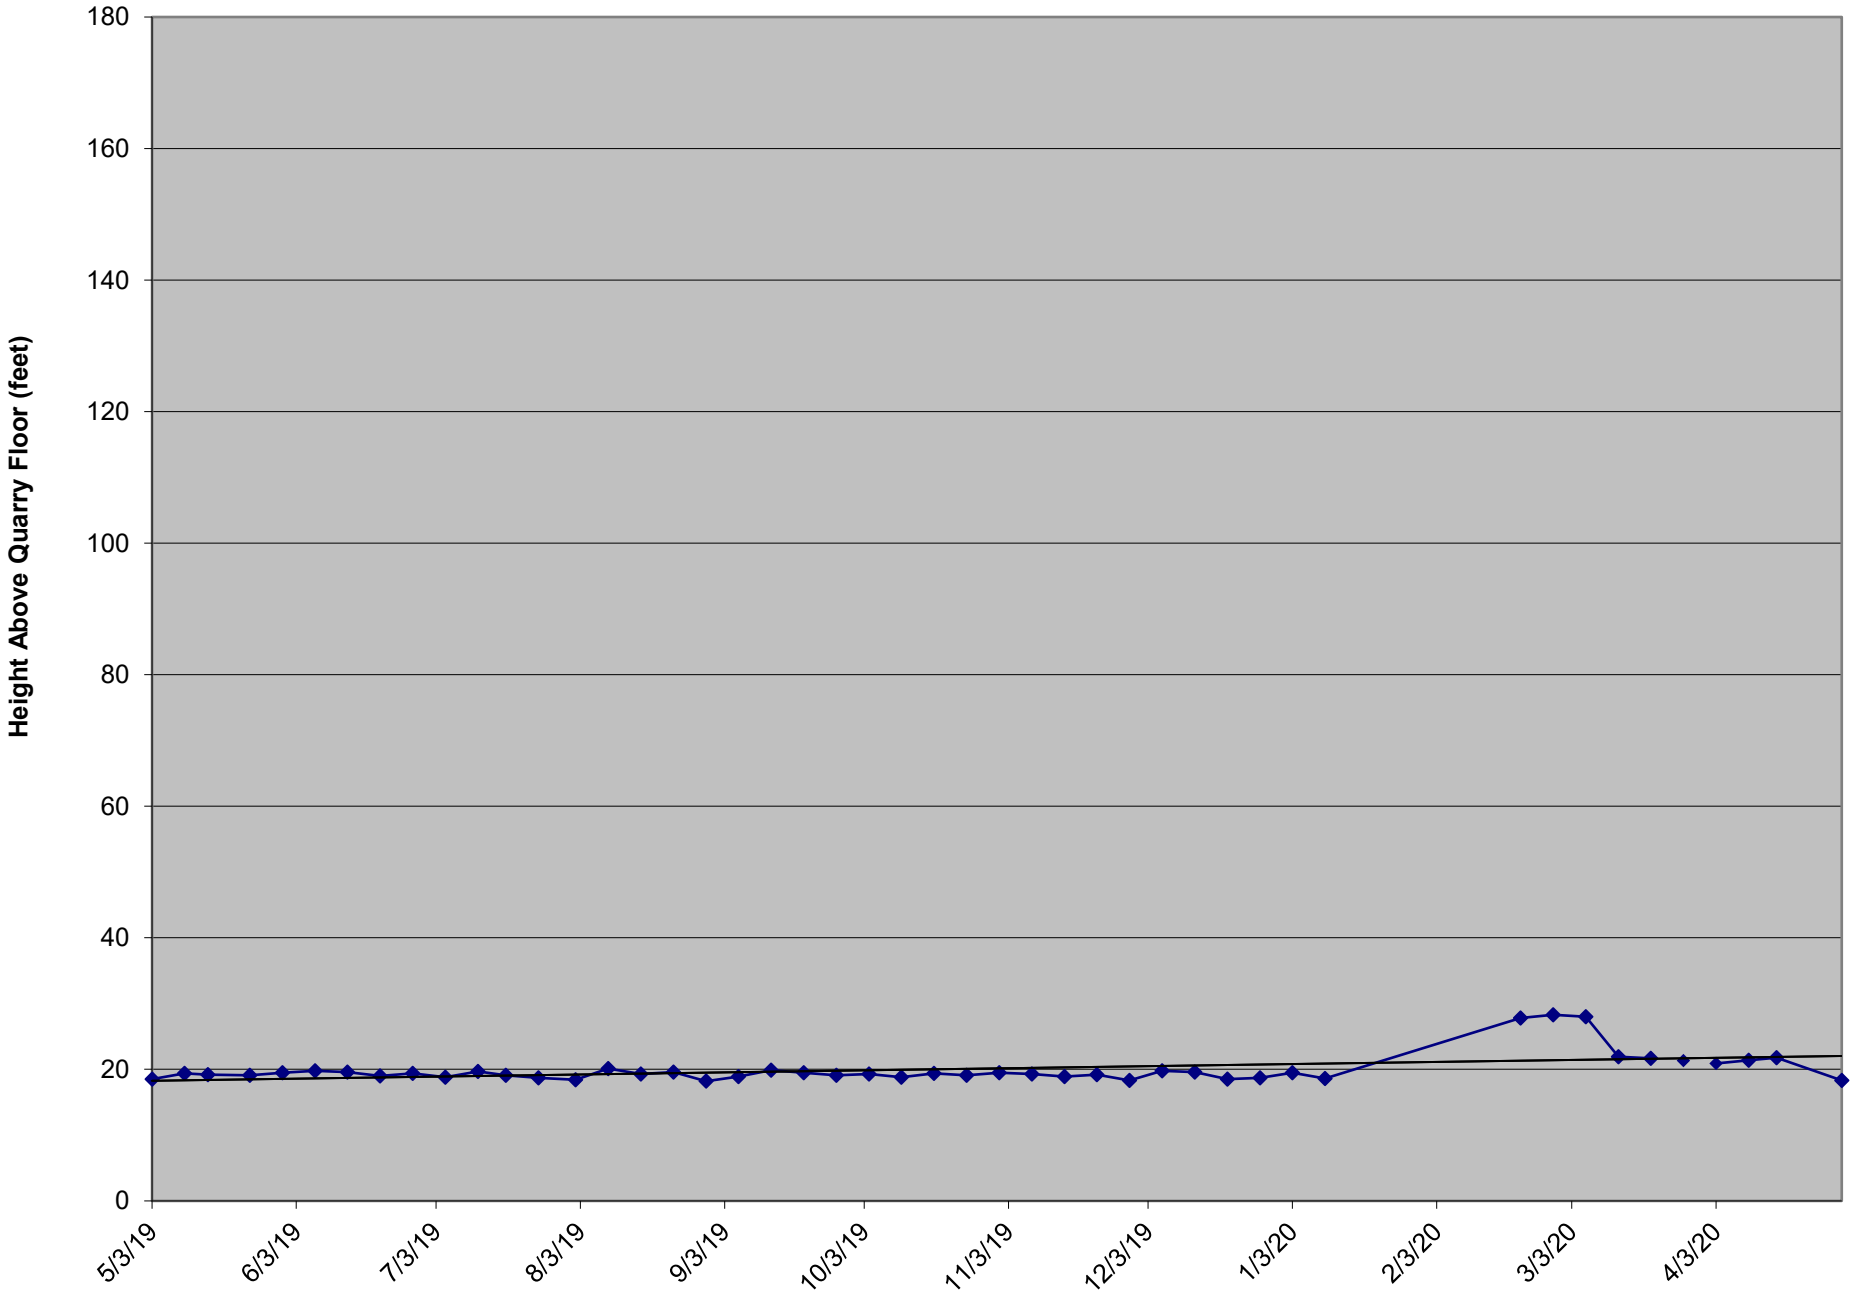
The transducer became non-operational on 1/13/20. Liquid level was measured manually on 2/21/20, 2/28/20 and 3/6/20. The transducer became operational on 3/13/20. The VFD was observed to be non-operational on 4/23/20, it was replaced on 4/23/20, however the level sensor reading was not taken due to VFD communication loss with SCADA.

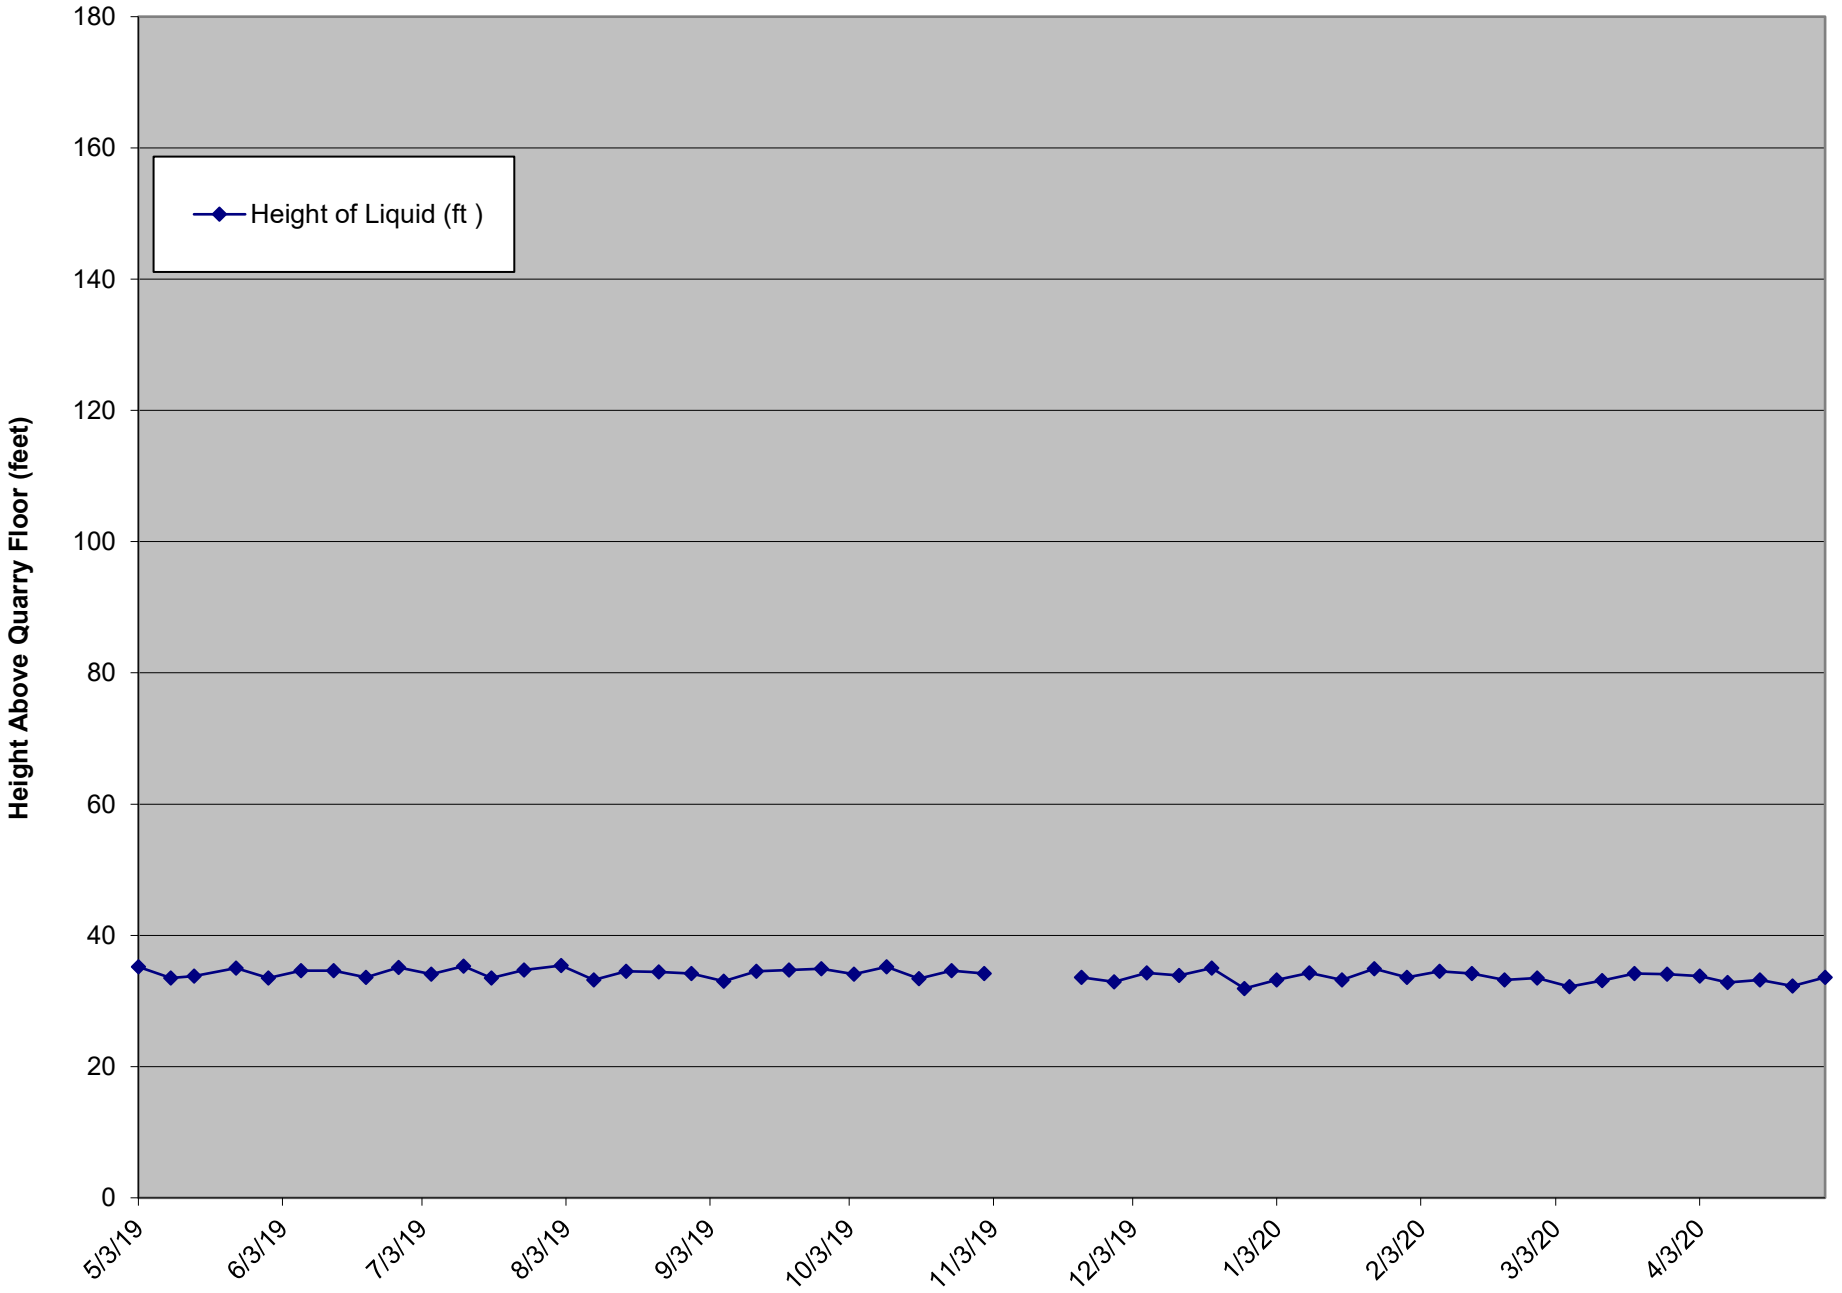
LCS-5B Liquid Level Above Quarry Floor

*The transducer in LCS-5B was down from 11/6/19 to 11/19/19.
