Bridgeton Landfill, LLC

Weekly Data Submittal

Week of February 21, 2021 – February 27, 2021

Required by Section IX.33.g of Final Consent Judgment, Case No. 13SL-CC01088-01 Effective June 29, 2018

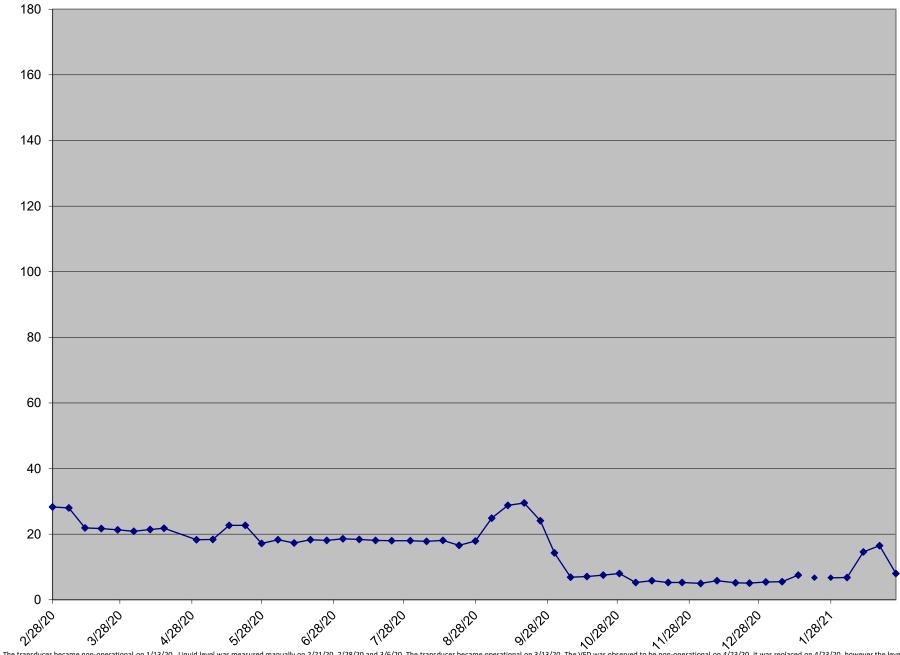
LCS-6B Liquid Level Above Quarry Floor

The transducer became non-operational on 1/13/20. Liquid level was measured manually on 2/21/20, 2/28/20 and 3/6/20. The transducer became operational on 3/13/20. The VFD was observed to be non-operational on 4/23/20, it was replaced on 4/23/20, however the level sensor reading was not taken due to VFD communication loss with SCADA. The LCS-6B pump was turned off on 8/31/20 for forcemain repairs leading to an increase in liquid level. The electric pump was converted to a pneumatic pump on 9/30/20.
