BRIDGETON LANDFILL, LLC.

**CONSTRUCTION QUALITY ASSURANCE
ACCEPTANCE REPORT**

2020 GCCS IMPROVEMENTS

BRIDGETON, ST. LOUIS COUNTY, MISSOURI

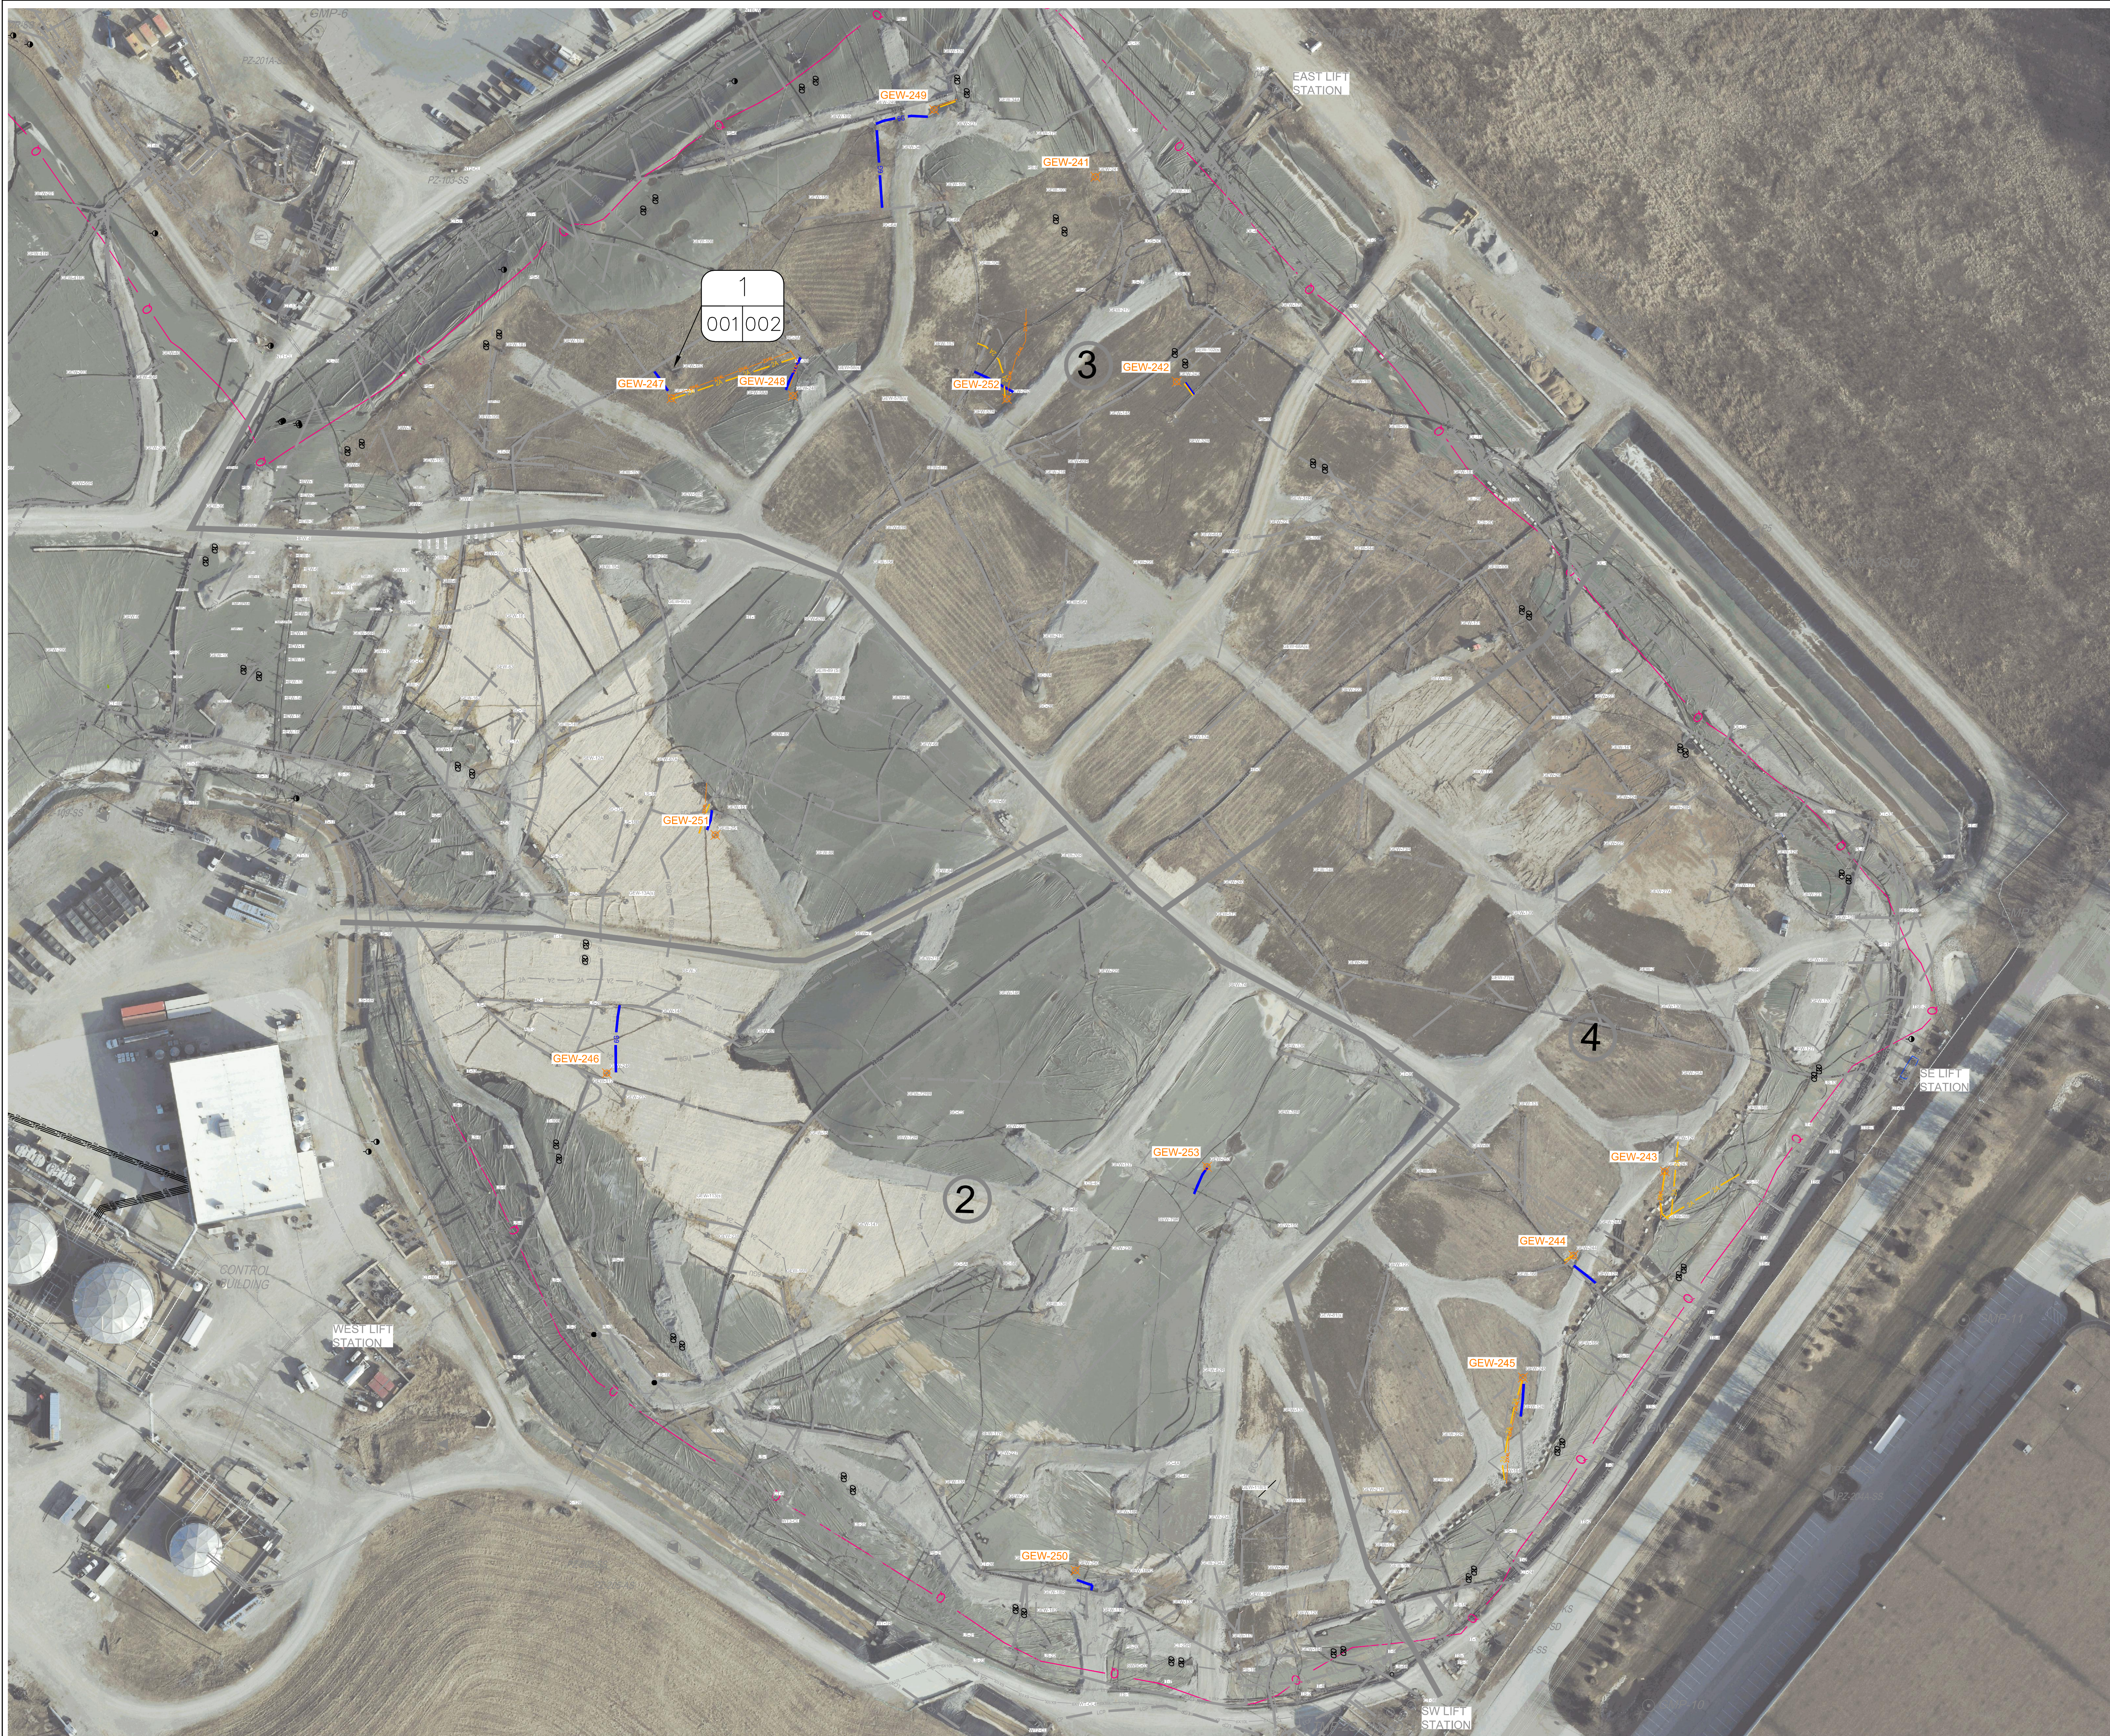
SOLID WASTE BOUNDARY
	QUARRY WALL
	GAS EXTRACTION WELL
	PERIMETER GAS EXTRACTION WELL
	SURFACE EXTRACTION WELL
	CONDENSATE SUMP
	PERIMETER GAS EXTRACTION WELL
	GAS INTERCEPTOR WELL
	GAS INTERCEPTOR WELL/HEAT EXTRACTION POINT
	GAS EXTRACTION WELL WITH 4" STINGER
	INSTALLED 2020 Q3 GAS EXTRACTION WELL
	INSTALLED HDPE LFG LATERAL (SIZE VARIES)
	INSTALLED 2" HDPE AIRLINE
	INSTALLED 2"x4" HDPE FORCEMAIN

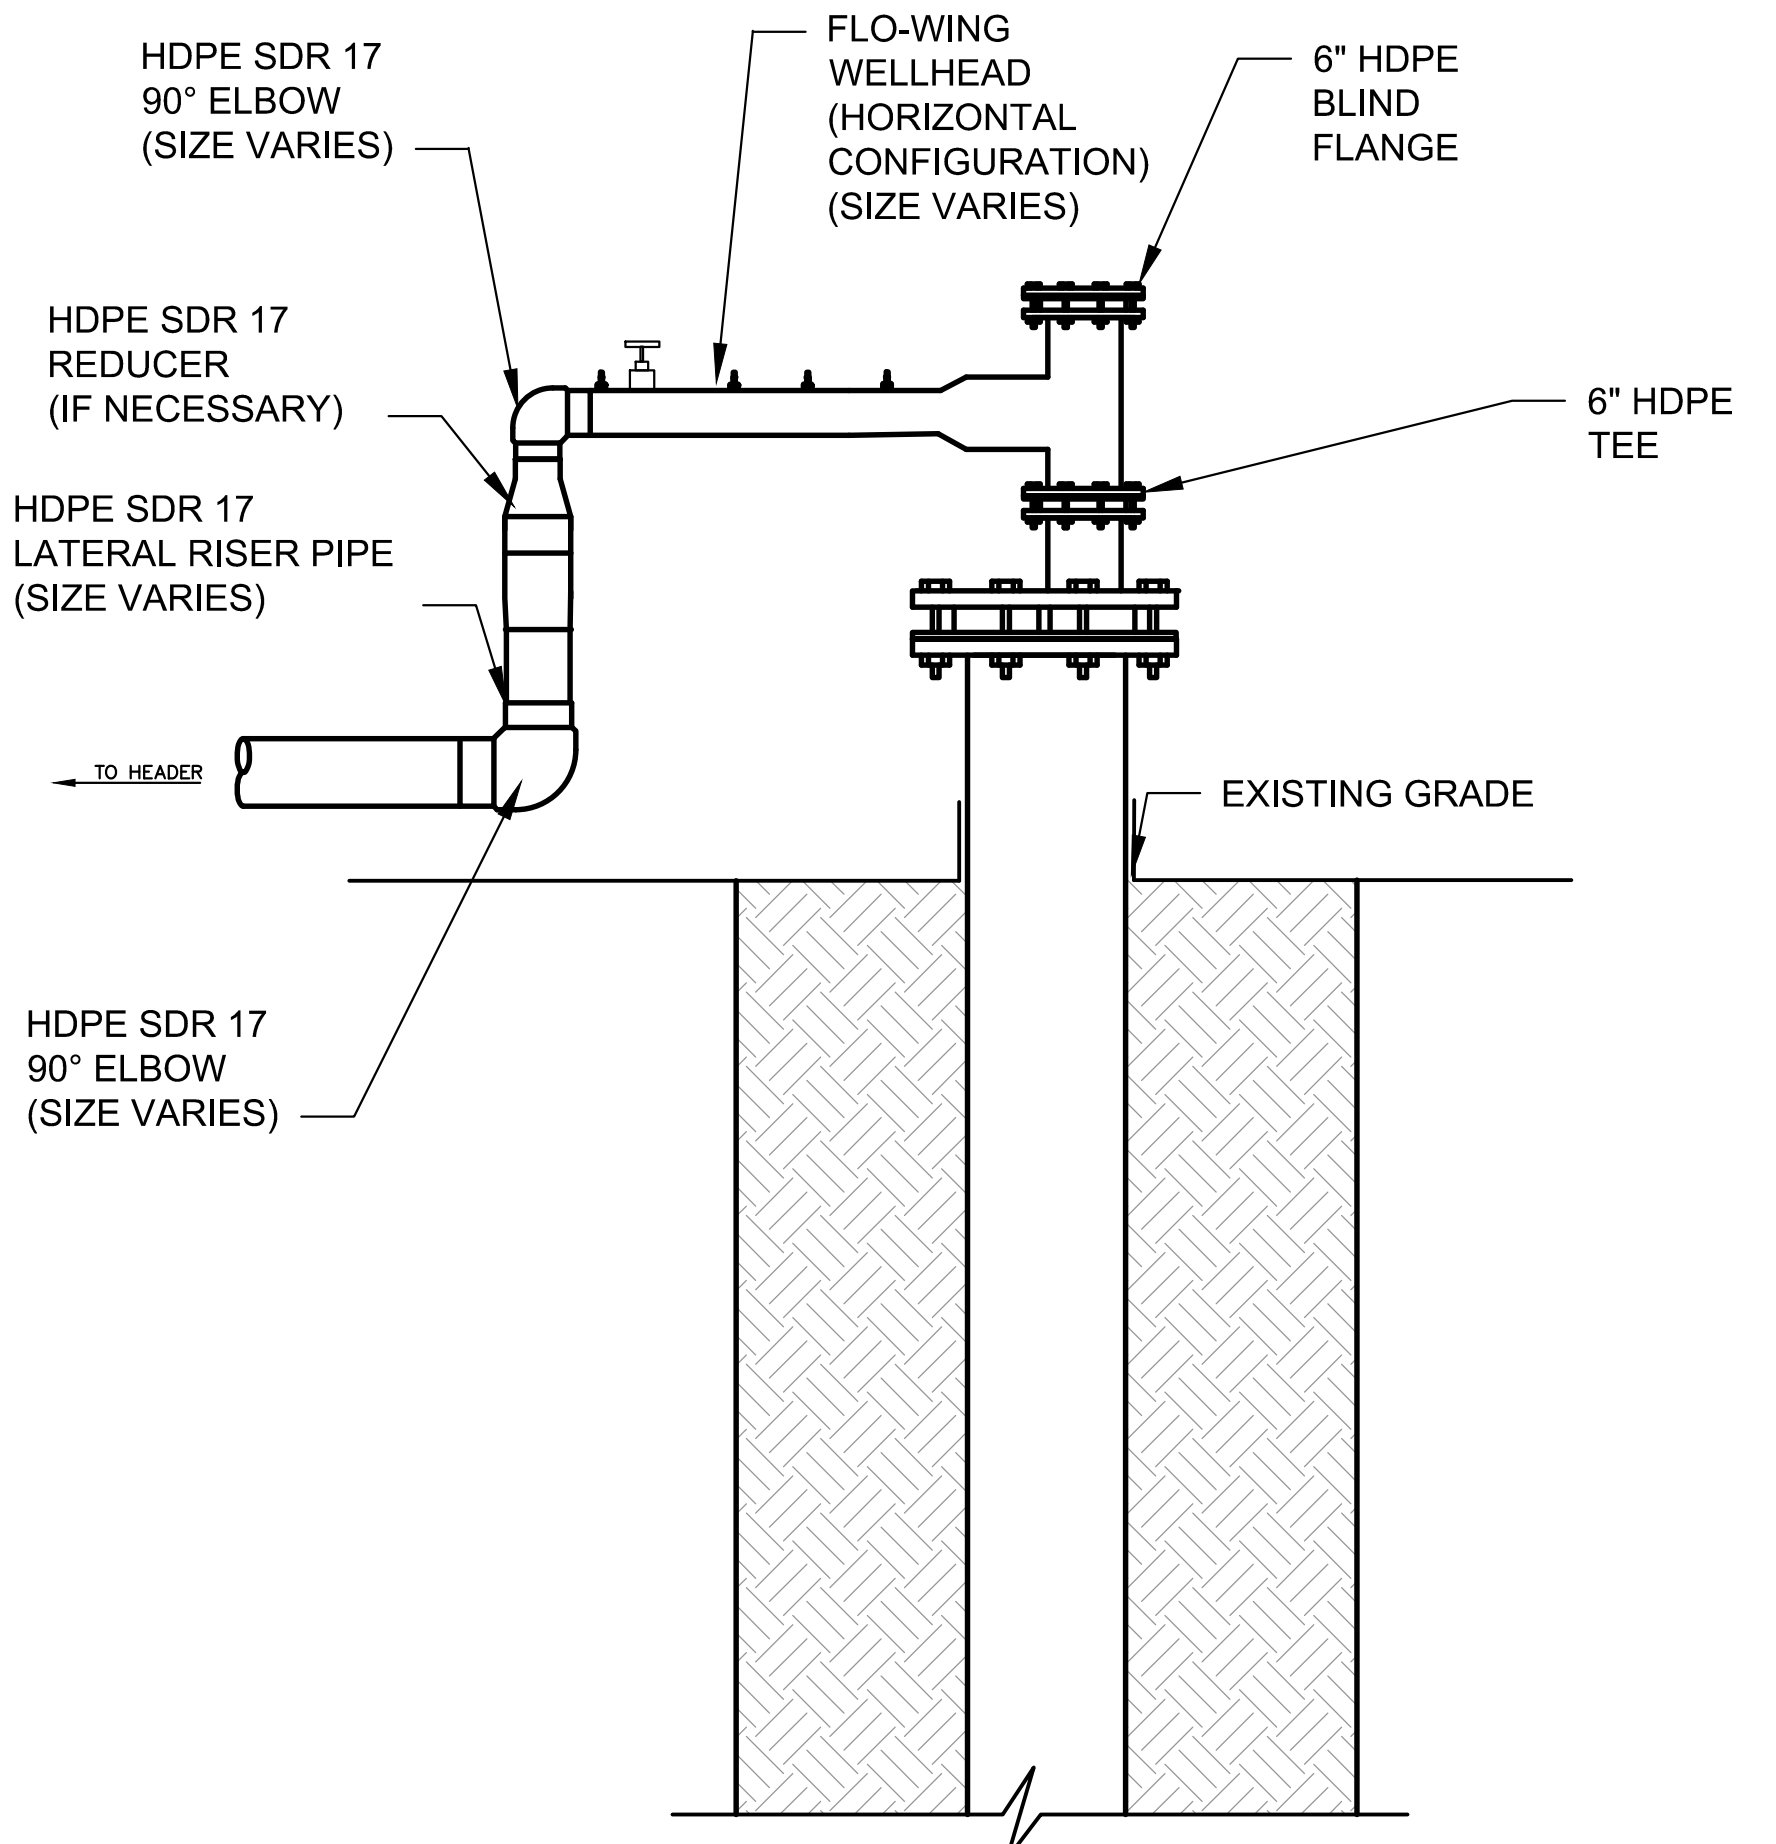
GEW WELLHEAD DETAIL 2
NOT TO SCALE 002 002

NOTES:
1. CONTRACTOR WILL INSTALL BRIDGETON LANDFILL TYPICAL WELLHEAD.

A six (6) inch diameter well head was installed and connected to the gas header system via lateral piping by Fusion Solutions Inc.

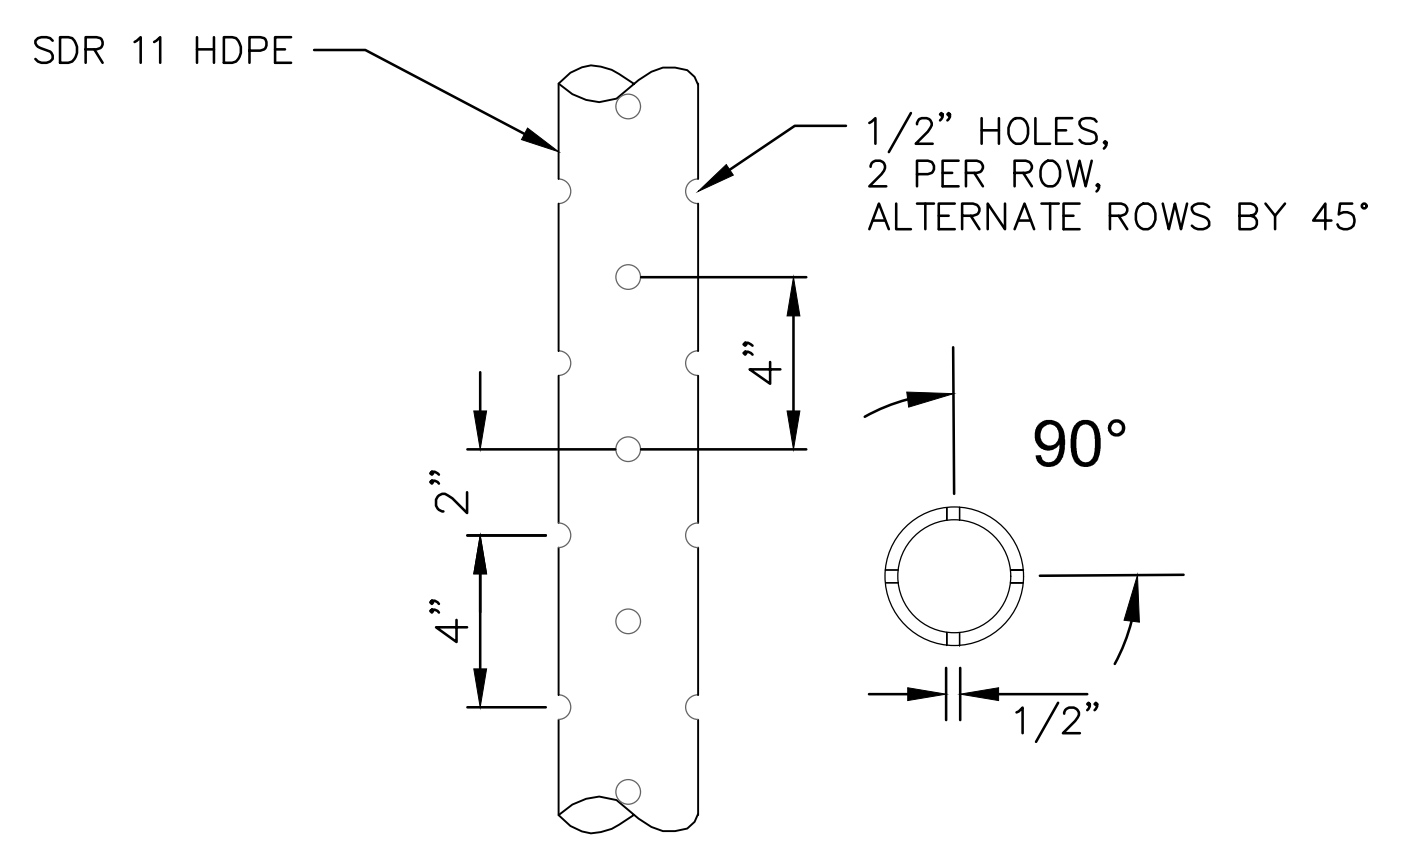
3 PERFORATED PIPE DETAIL
001 002 NOT TO SCALE

NOTES:
1. PERFORATIONS SPACED 90° APART HORIZONTALLY.
2. PERFORATIONS SPACED 4" APART VERTICALLY.
3. 90° AND 270° ROWS STAGGERED 2" BELOW 0° AND 180° ROWS.

Well piping consisted of 12" SDR-11 HDPE solid and perforated piping. The pipe sections were butt-fused together by Fusion Solutions. A low-pressure HDPE cap was installed at the bottom of each well casing and a pre-fabricated 12" flanged lid on the top of each well casing prior to installation.

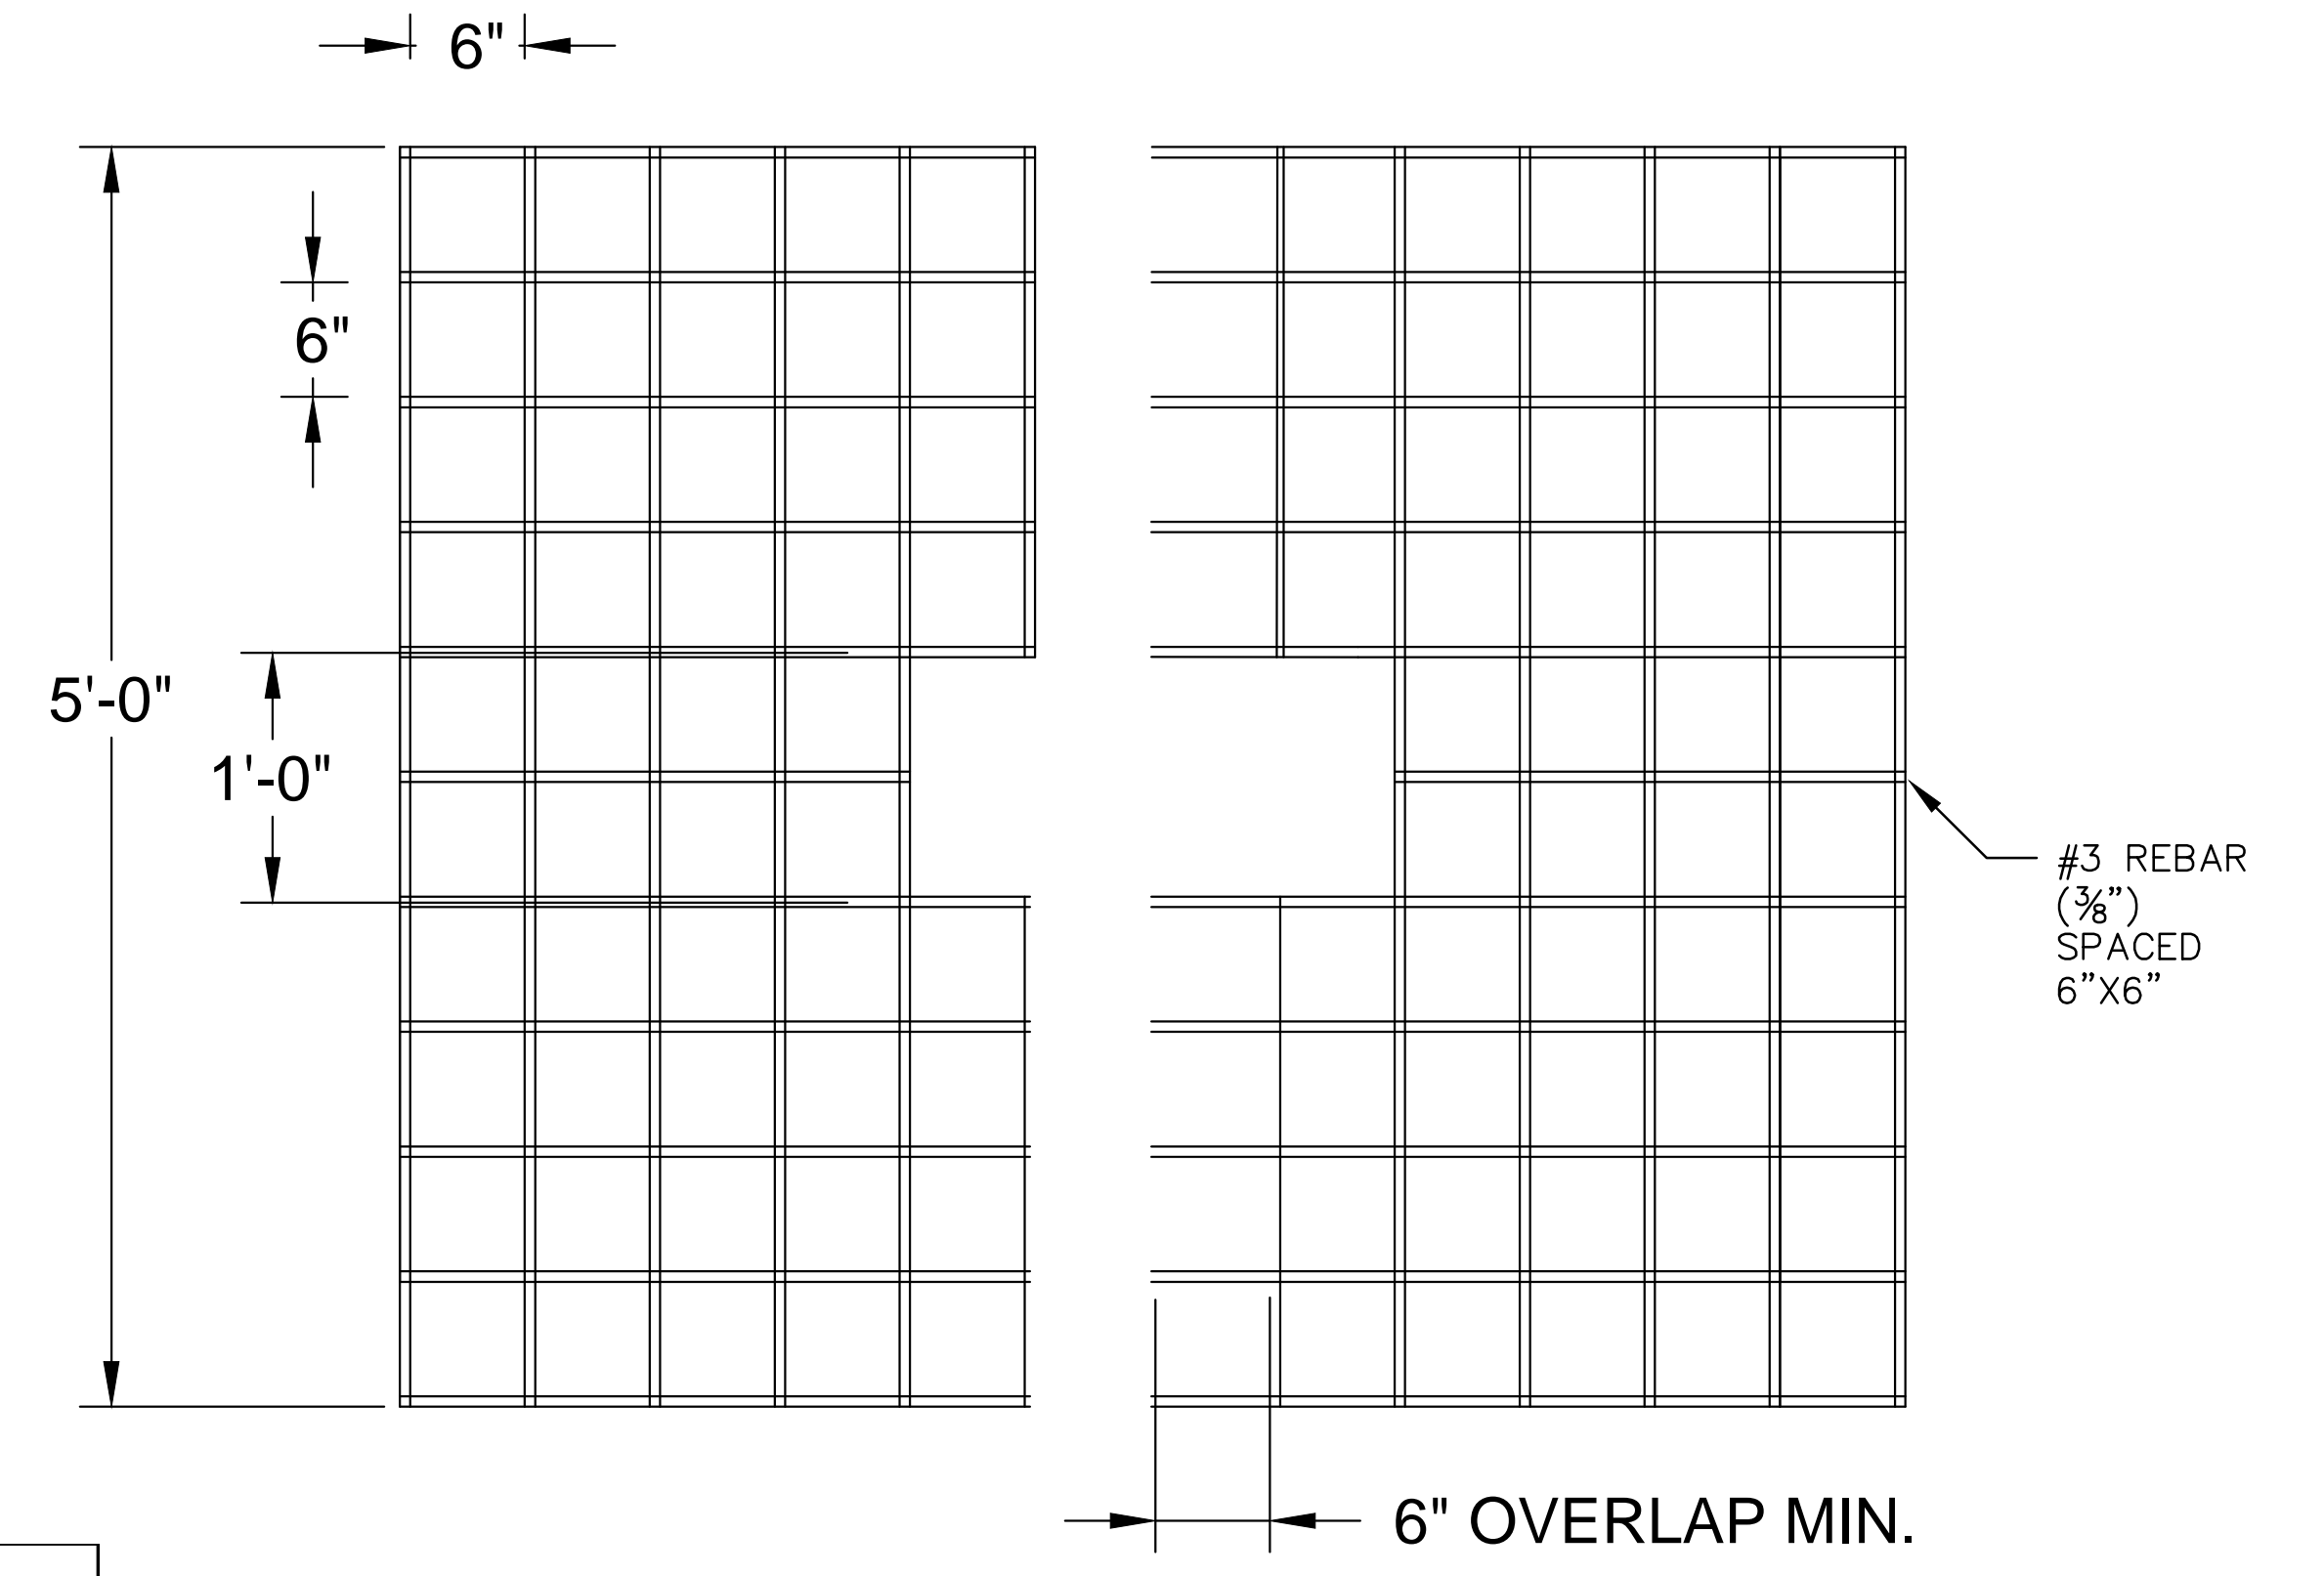
4 WELL BORE REINFORCEMENT GRATE
001 002 NOT TO SCALE

NOTES:
1. WELL BORE REINFORCEMENT GRATE INSTALLED APPR. 6" BELOW GRADE.

Prior to final backfill at surface, a permanent metal safety grate was installed a minimum 6" below final ground surface and the remainder of the area was backfilled with clean soil materials.
