Bridgeton Landfill, LLC

Weekly Data Submittal

Week of April 22, 2018 – April 28, 2018

Required by Section 52.F of Agreed Order, Case No. 13SL-CC01088
Effective May 13, 2013

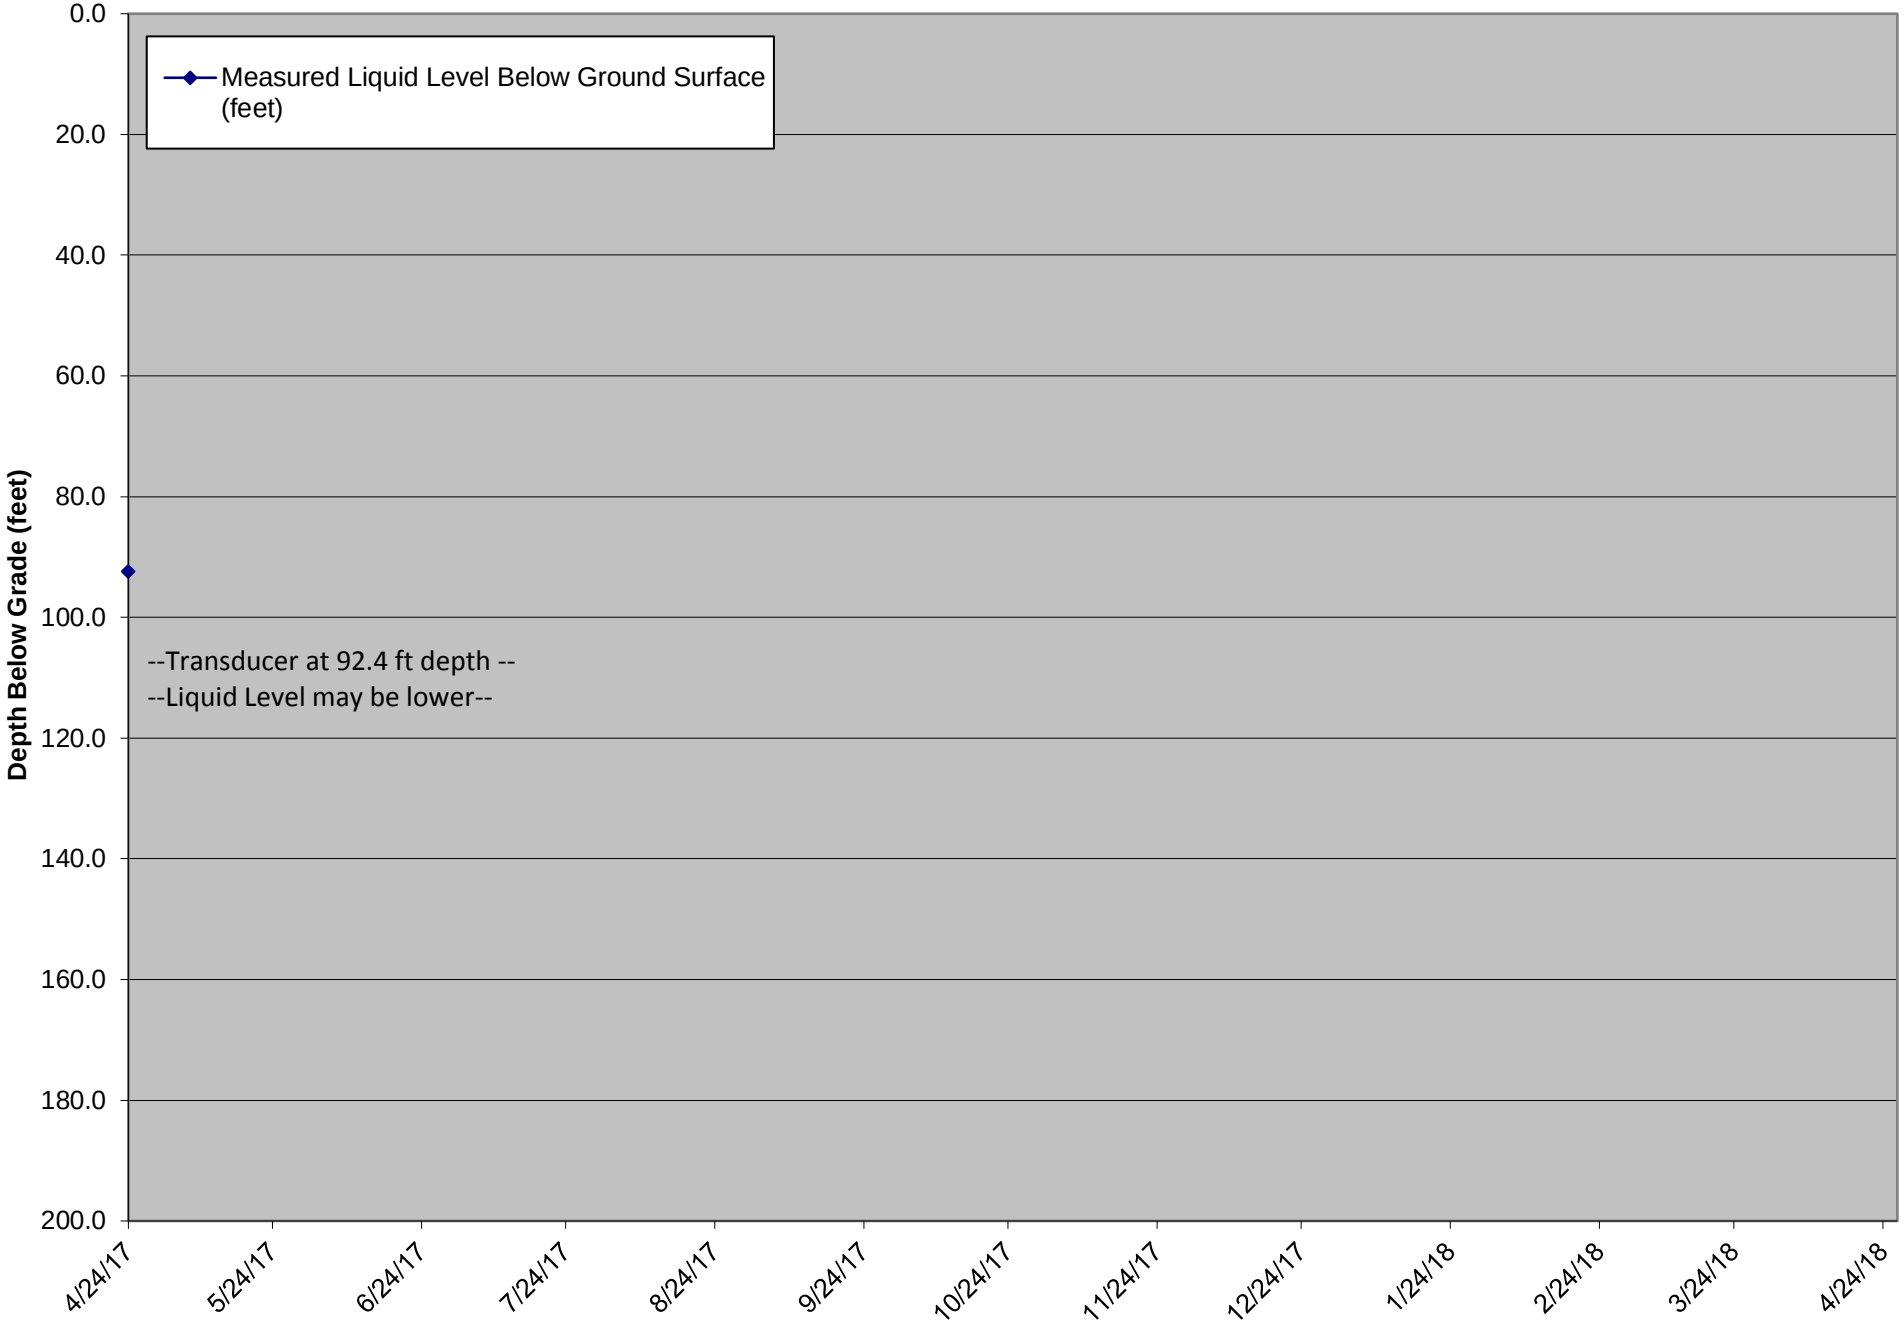
LCS-1D Liquid Level Below Ground Surface

Downhole discharge piping and the pump for LCS-1D was replaced the week of February 5, 2018. Pump was non-operational after startup activities. Pump replacement is scheduled for the week of April 30, 2018 pending suitable weather conditions.

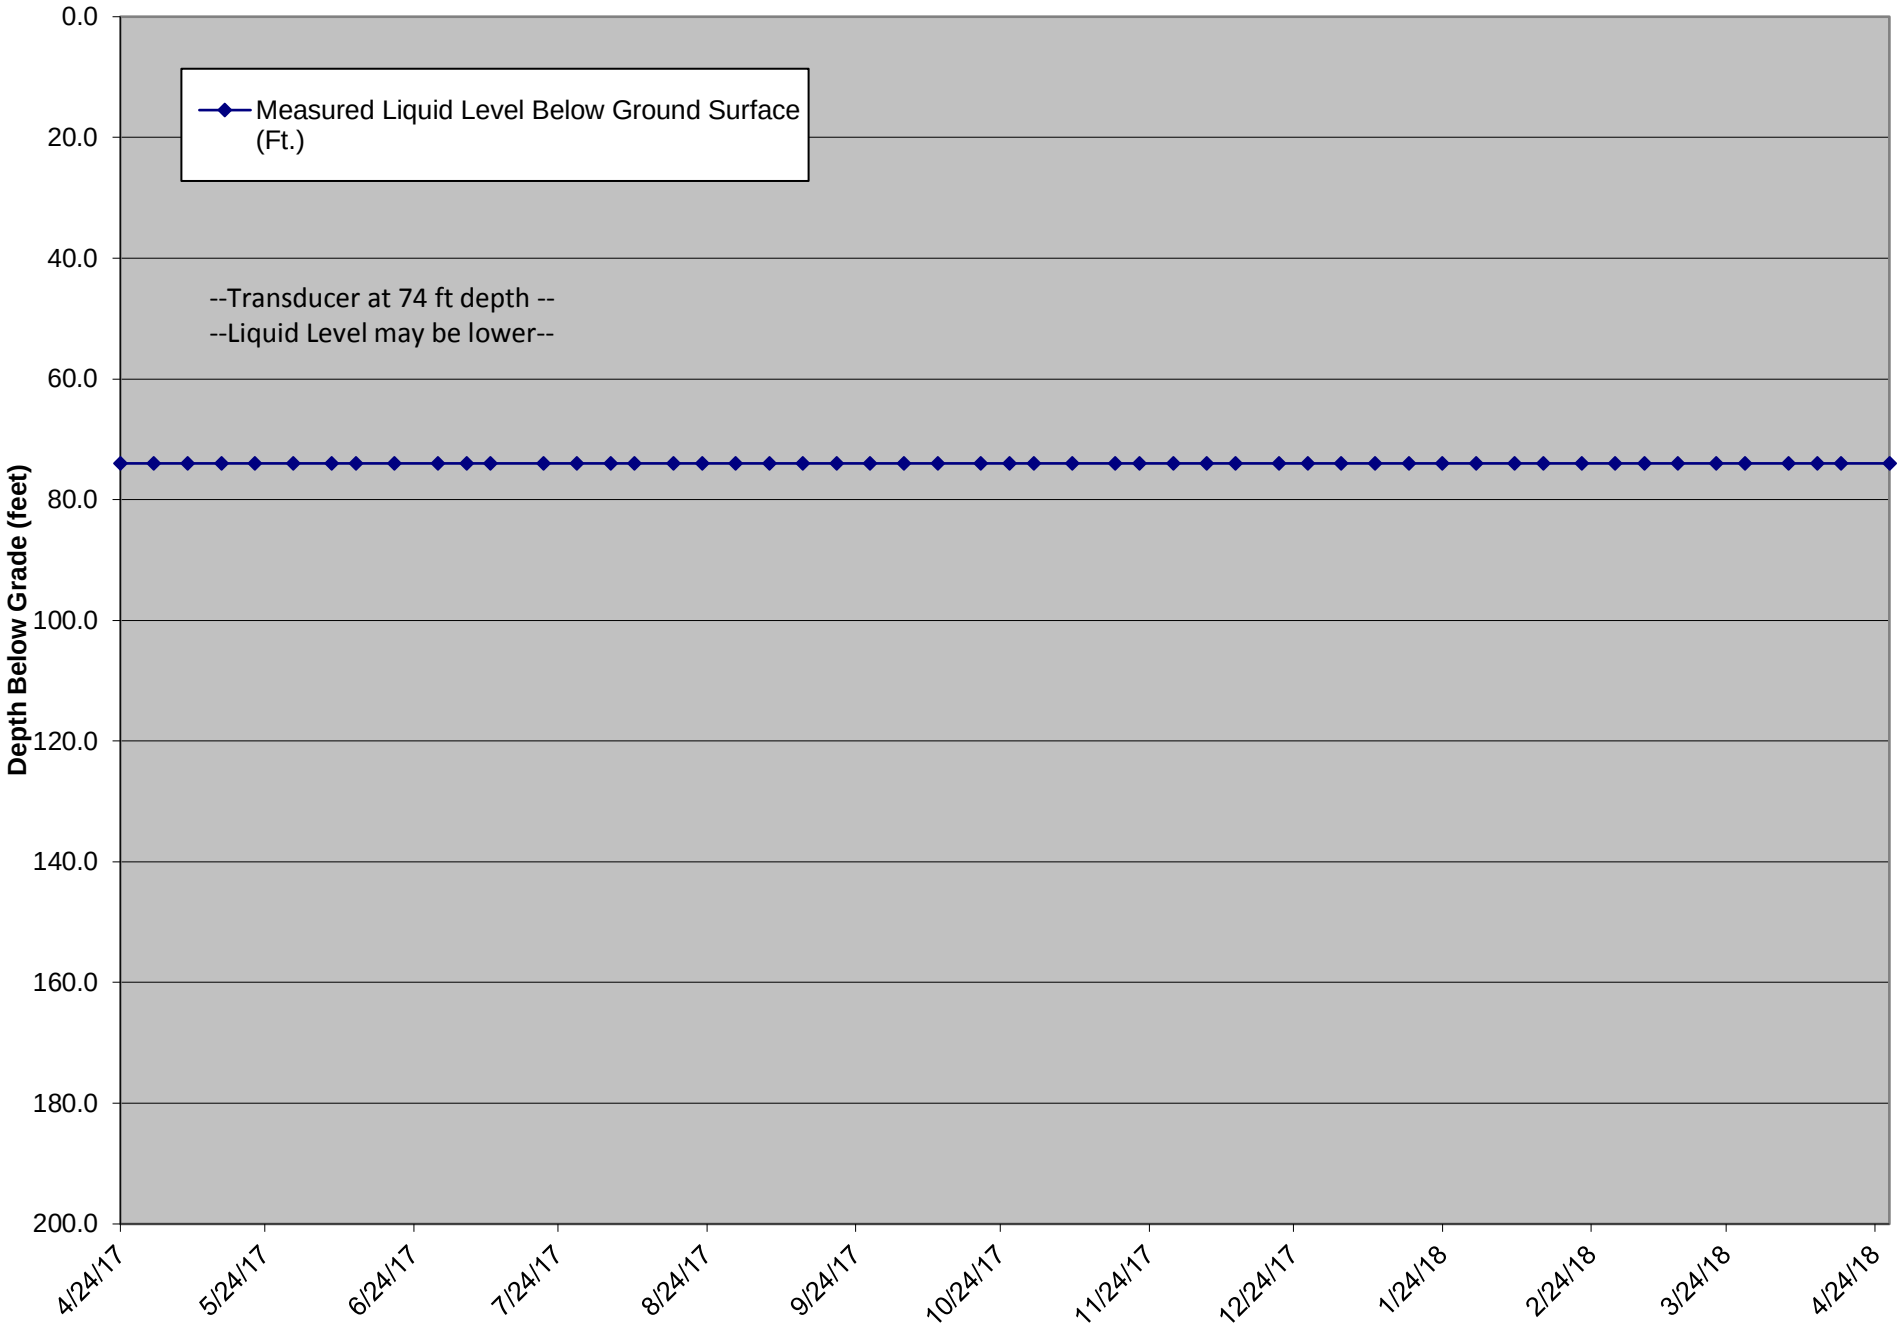
LCS-4B Liquid Level Below Ground Surface

The level sensor in LCS-4B is currently operational and responsive. Liquid level was not recorded by the level sensor during the weekly reporting period. LCS-4B is equipped with a flow meter that displayed no flow during the weekly reporting period. Therefore, it can be concluded that the liquid level was below the bottom of the pump and level sensor in LCS-4B.

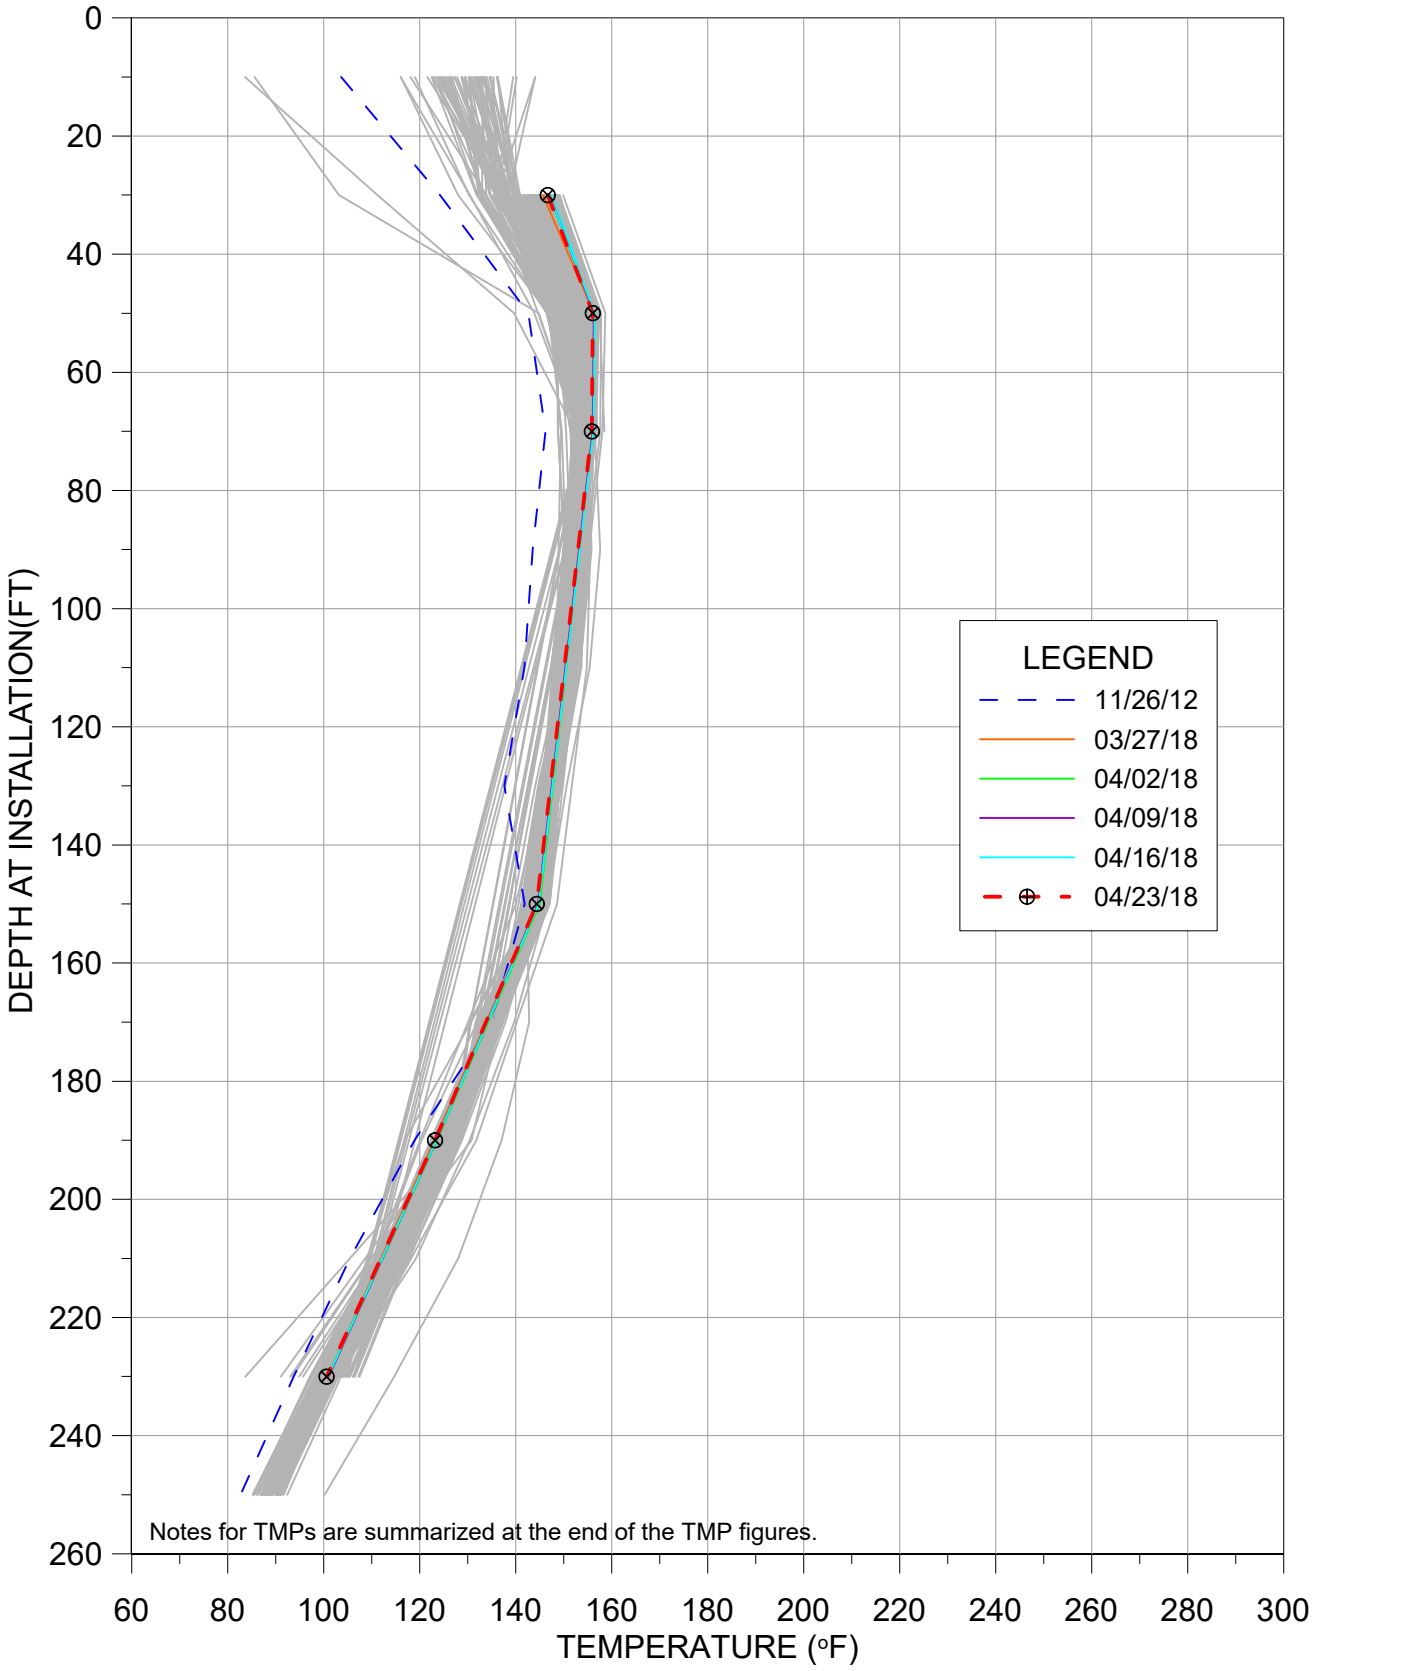
TMP-3

1. No reliable temperature readings have been obtained at 170 ft depth since 1/29/2014, except on 3/13/2014.
2. The connectivity tests on 4/11/2014 conducted by CEC showed that units at 10, 90, 130, 210 and 250 ft depths are no longer reliable.
3. The connectivity tests on 10/28/2014 conducted by Feezor Engineering showed that units at 10, 90, 110, 130, 210 and 250 ft depths are not reliable.

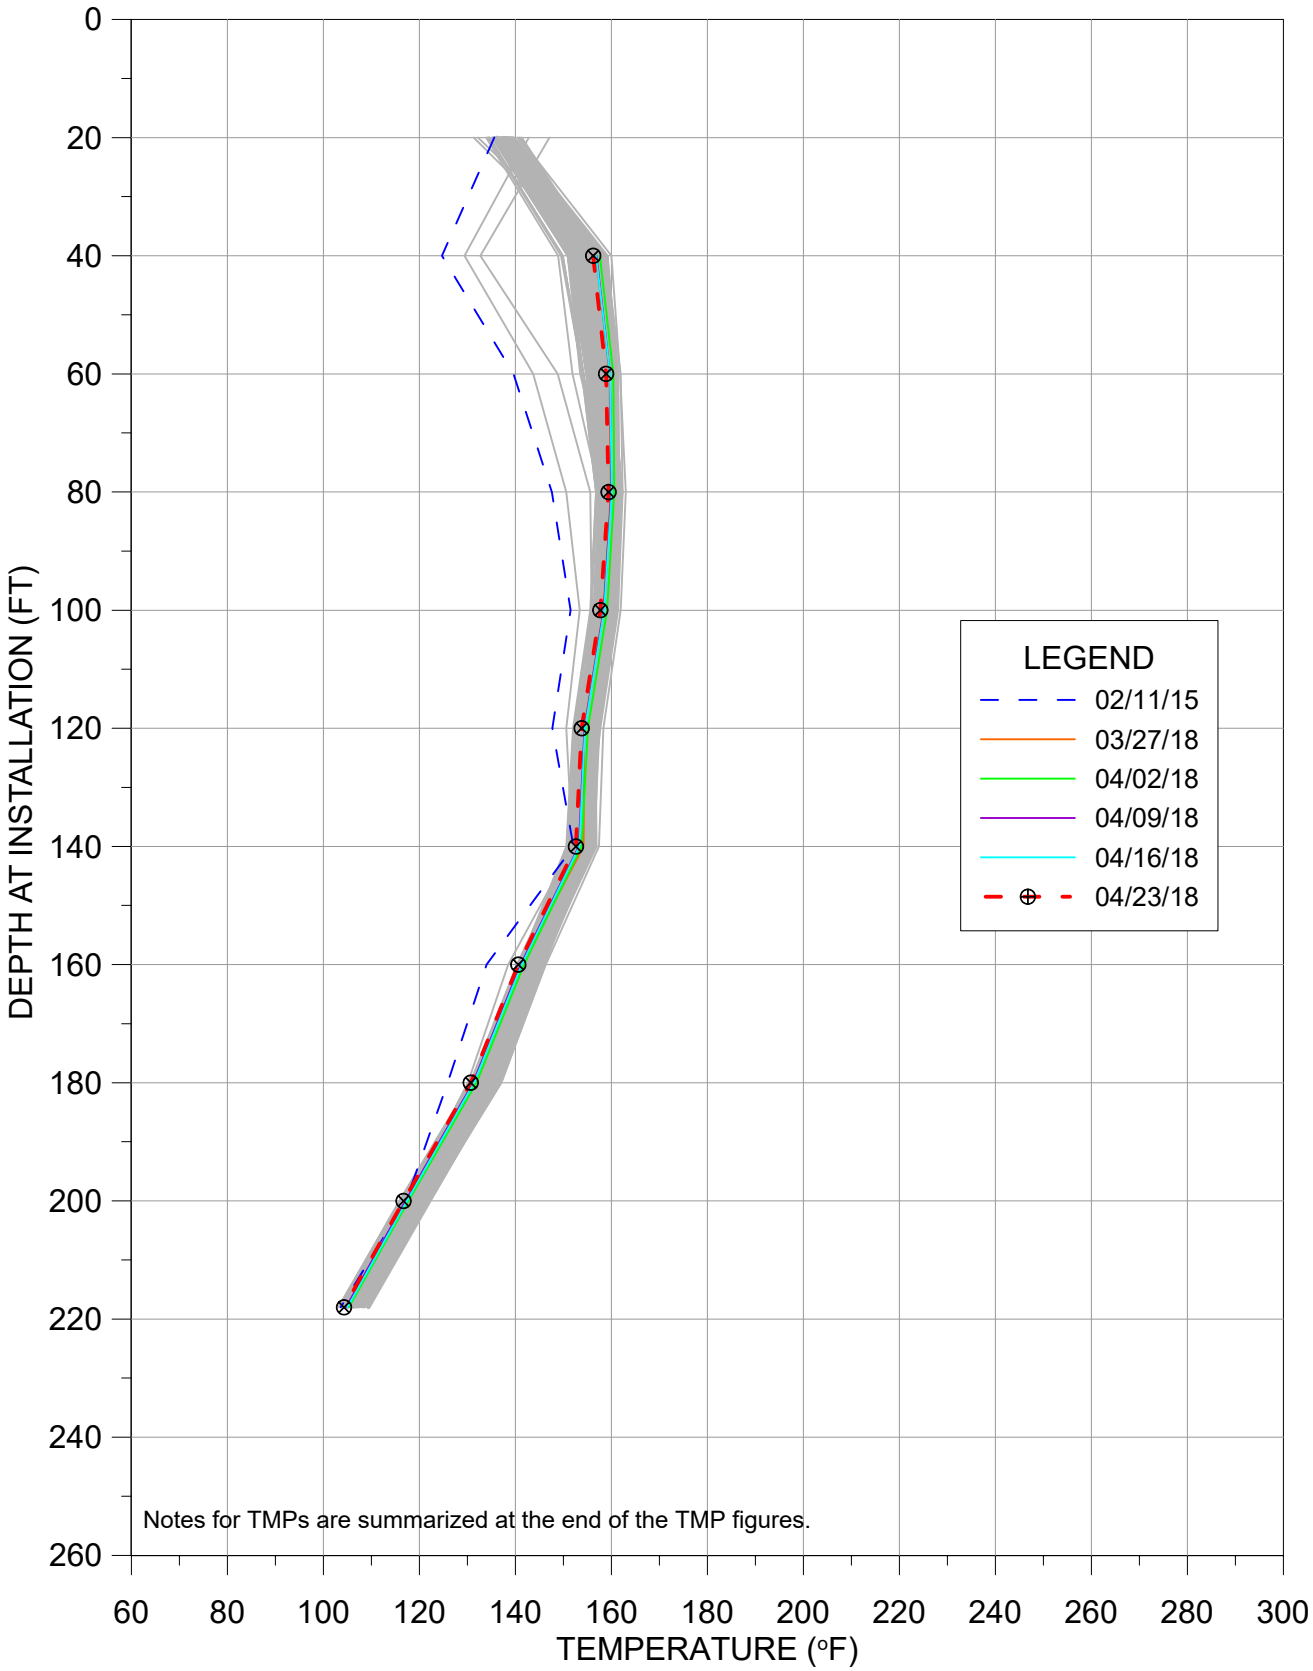
TMP-3R

1. The unit at 20 ft depth had a fluctuating resistance since 9/25/2017. Therefore the temperature is determined to be unreliable.

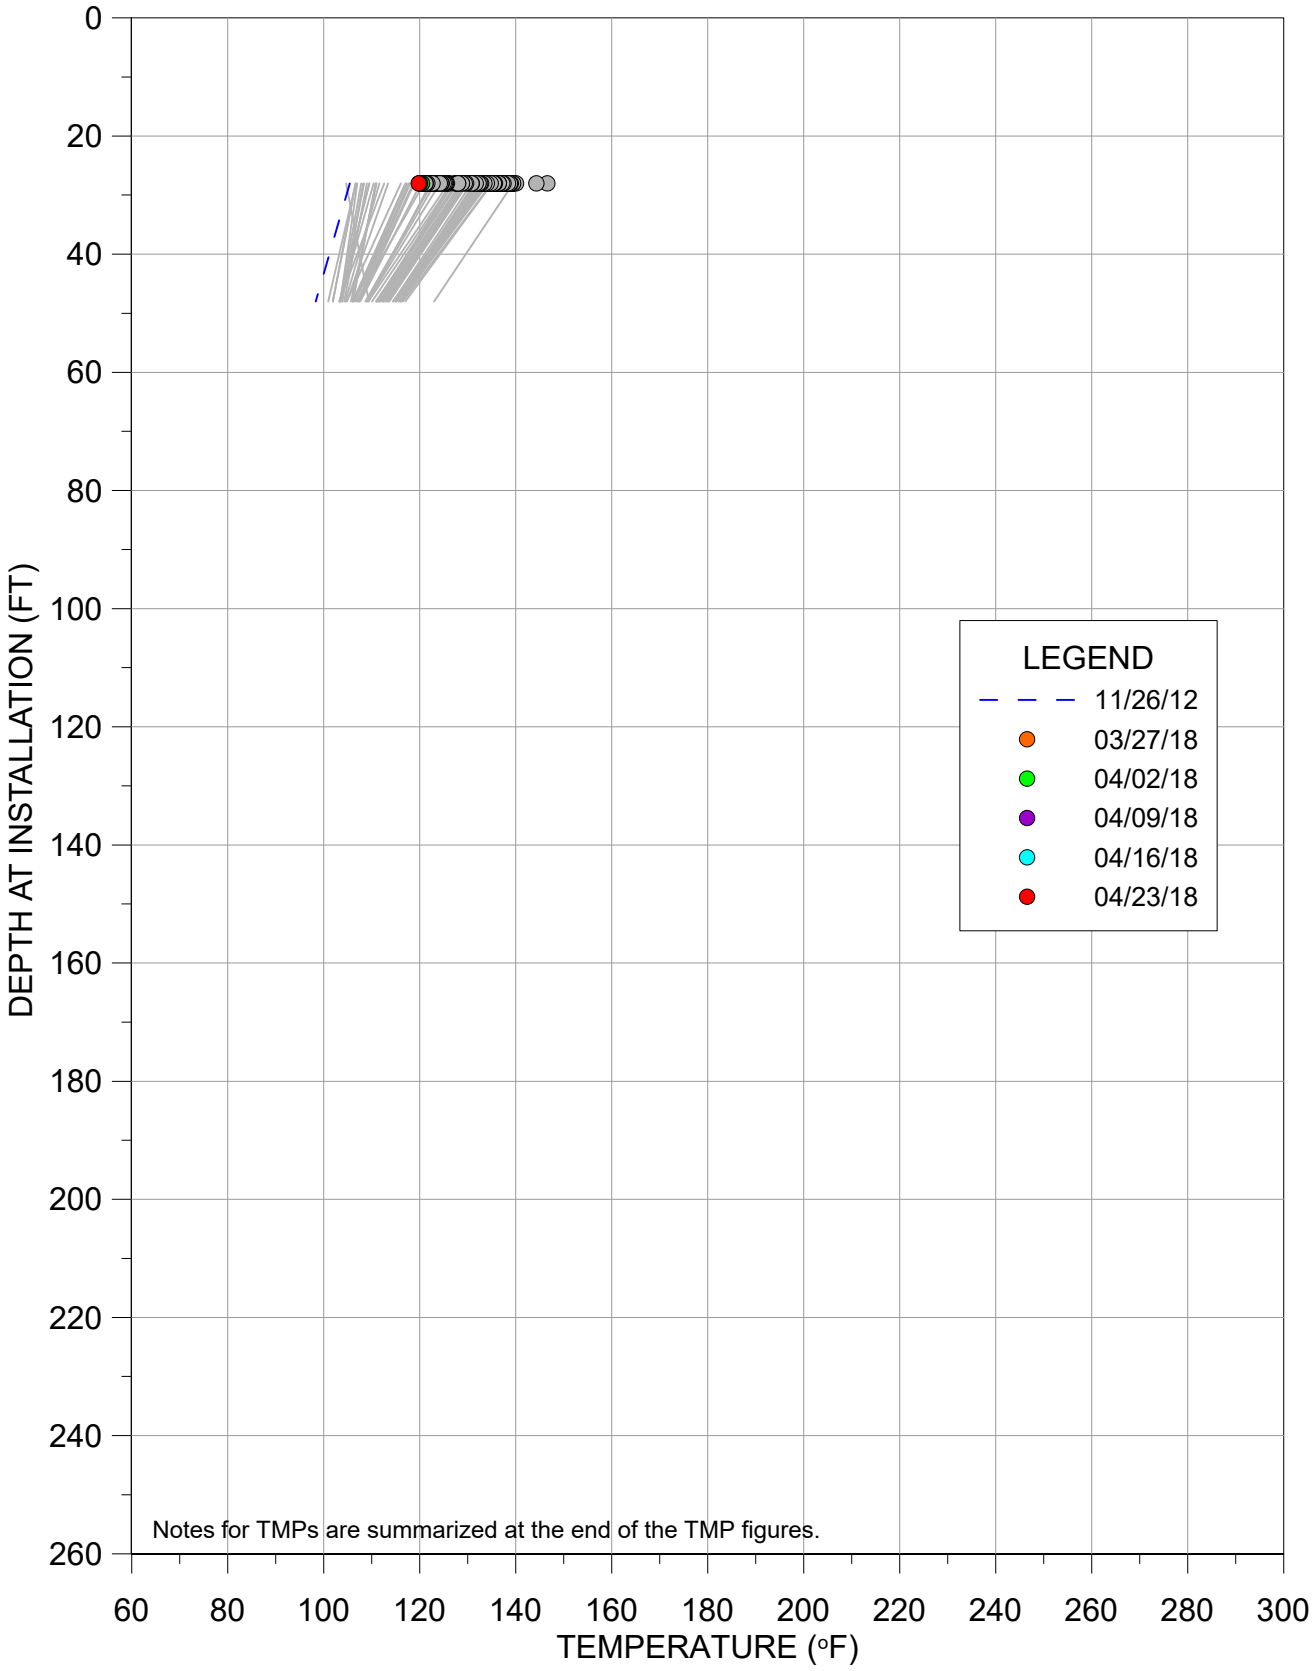
TMP-4

1. The connectivity tests on 4/11/2014 conducted by CEC showed that the unit at 48 ft depth is no longer reliable.

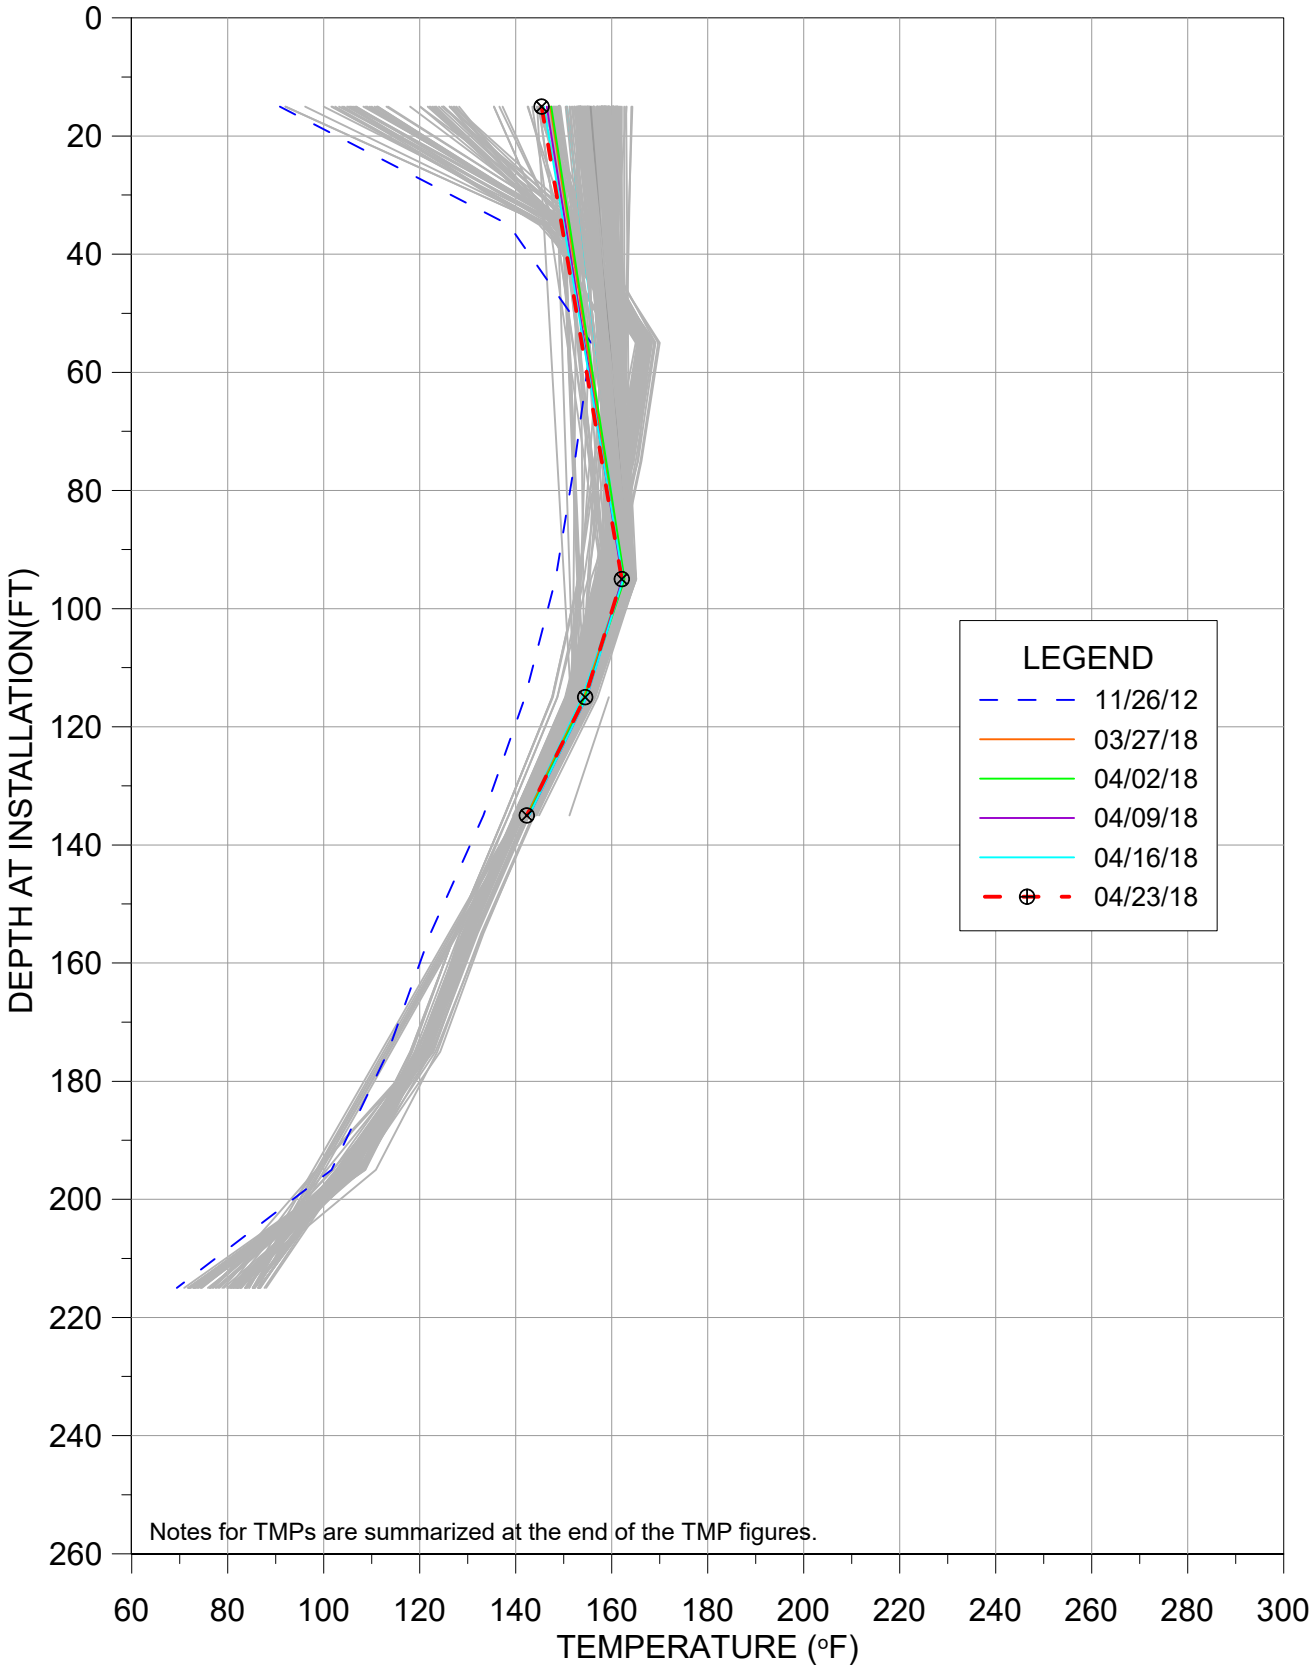
TMP-6

1. The connectivity tests on 4/11/2014 conducted by CEC showed that units at 35, 55, 75, 155, 175, and 195 ft depths are no longer reliable.
2. No reliable temperature readings have been obtained at the unit at 215 ft depth since 6/13/2014.

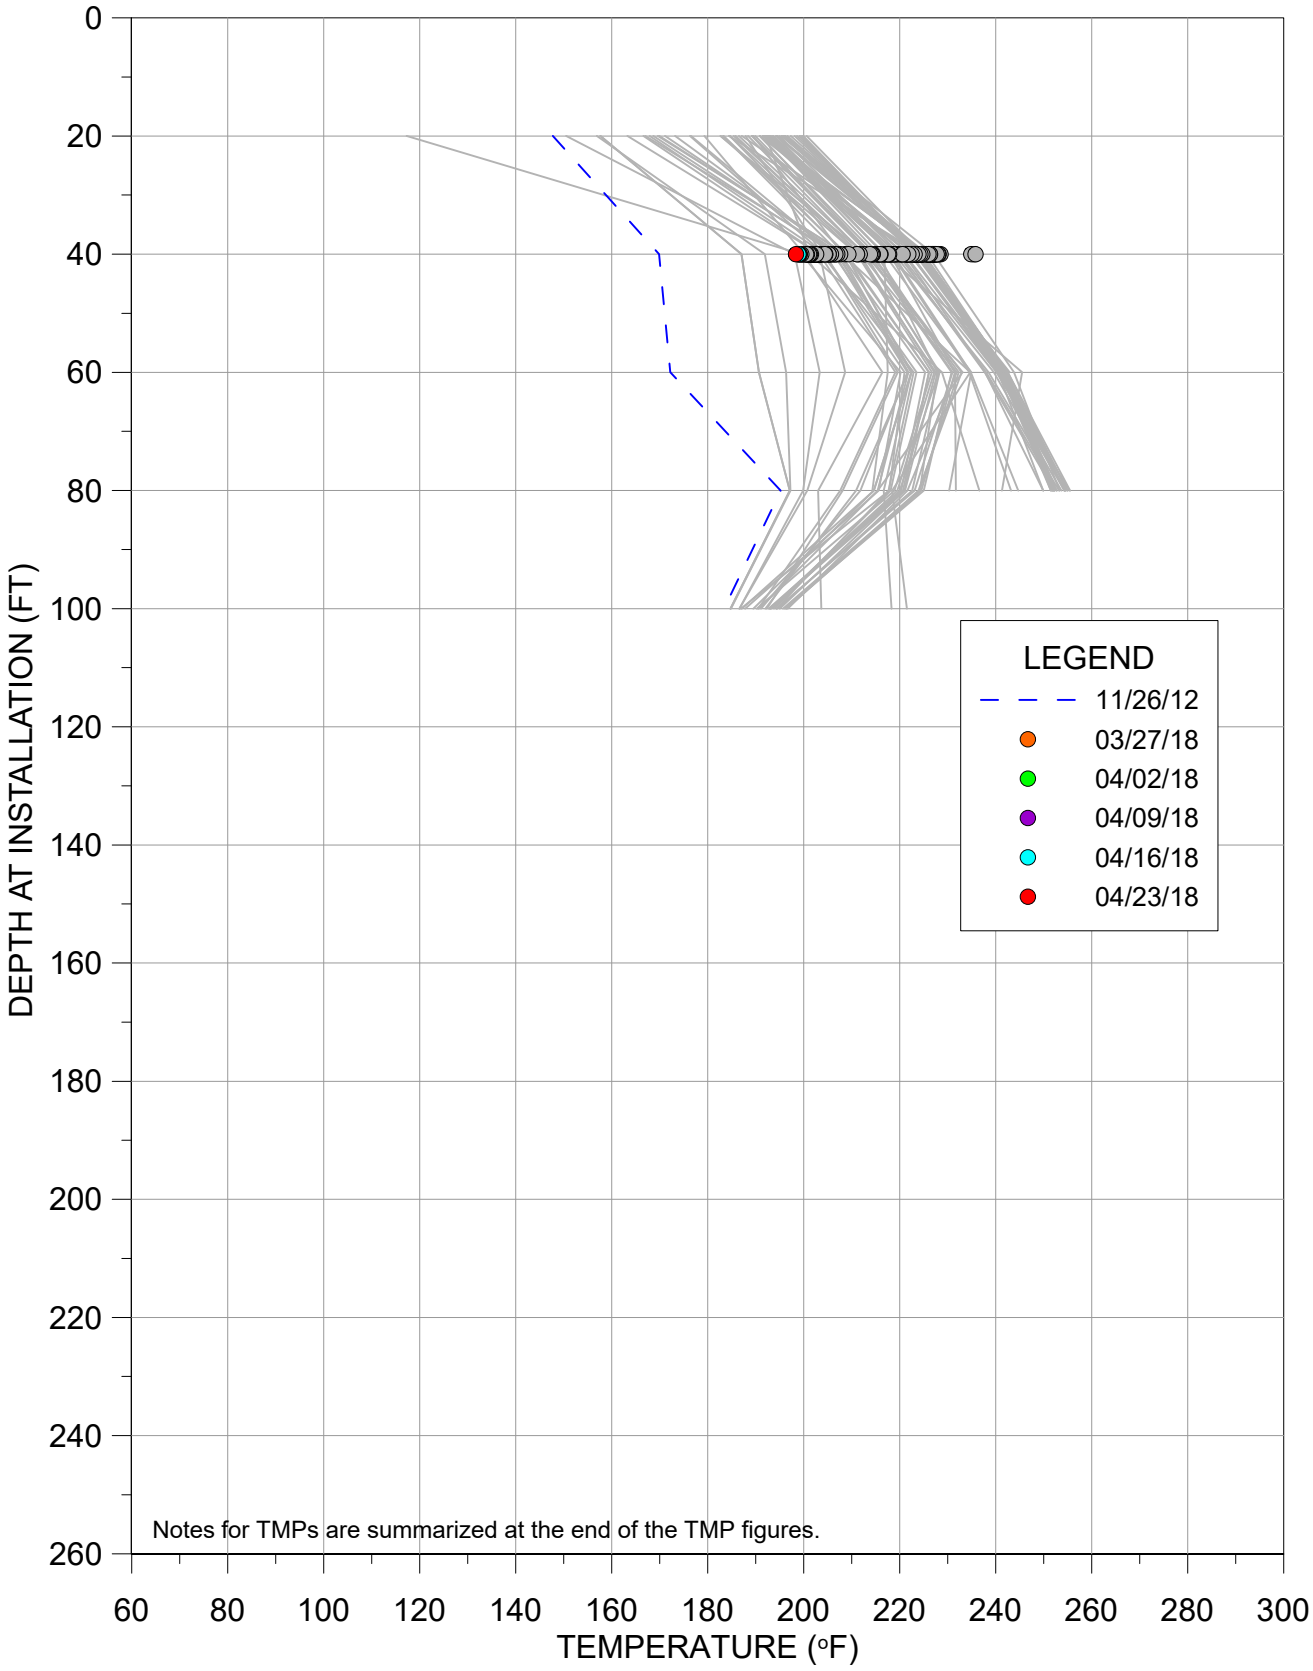
TMP-9

1. Unit at 100 ft depth had an inaccurate temperature reading on 8/1/2013 and no reading since 8/6/2013.
2. The connectivity tests on 4/11/2014 conducted by CEC showed that units at 20, 60, 80, and 100 ft depths are no longer reliable.

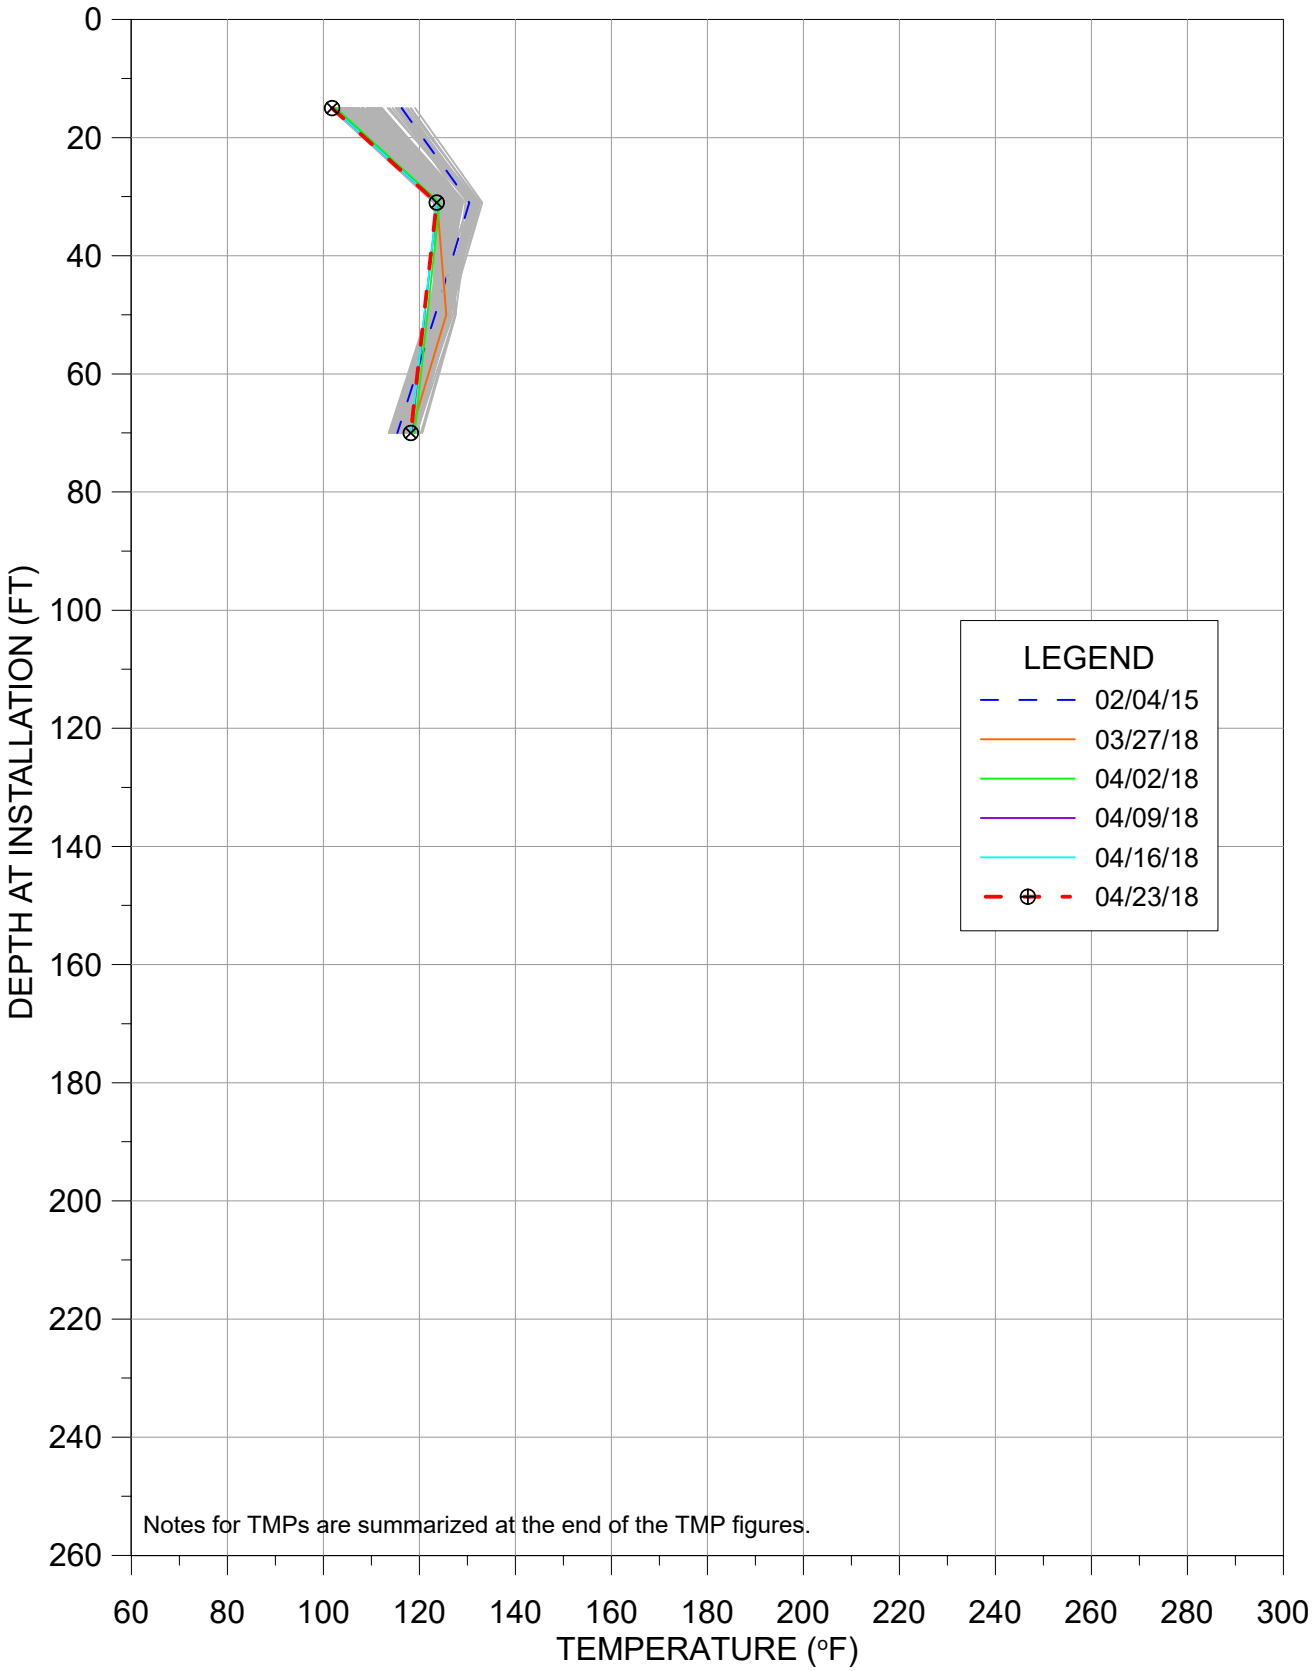
TMP-22

1. No temperature reading could be obtained and resistivity was fluctuating at the unit at 50 ft depth since 4/2/2018.

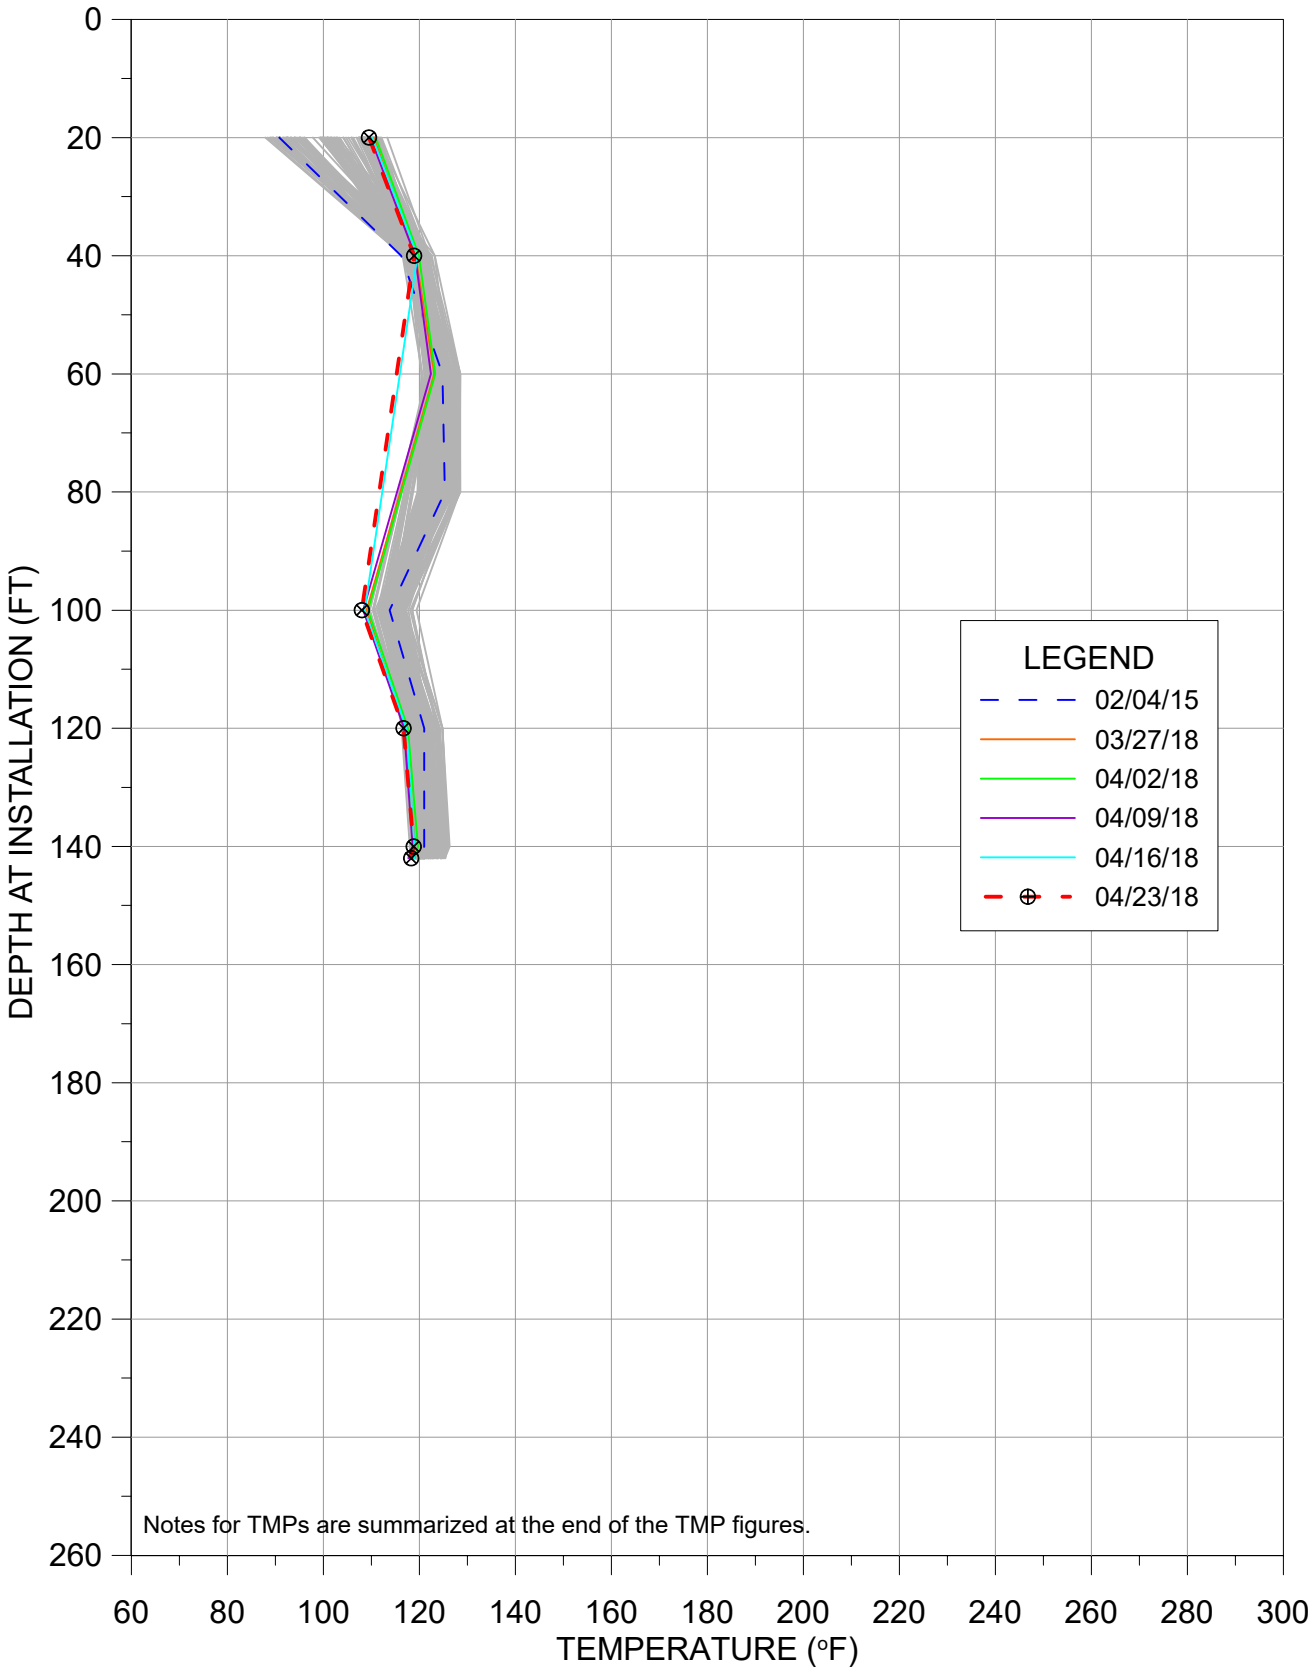
The thermocouple at 60’ in TMP-26 exhibited fluctuating resistivity and no temperature reading could be obtained during the week of April 15, 2018. This 60’ thermocouple is adjacent to the 80’ thermocouple, which has been unreliable since November 6, 2017. A replacement TMP (TMP-26R) was installed in the vicinity of TMP-26 on April 24, 2018. See the TMP Locations map for the location of TMP-26R.

1. Resistance on unit at 80 ft dropped 12.9 ohms (11/06/2017) and subsequent resistance reading continue to be low. Upon further investigation by Feezor Engineering, this unit is determined to be unreliable.
2. No temperature reading could be obtained and resistivity was fluctuating at the unit at 60 ft depth **since** 4/16/2018.
