Bridgeton Landfill, LLC

Weekly Data Submittal

Week of April 22, 2018 – April 28, 2018

Required by Section 52.F of Agreed Order, Case No. 13SL-CC01088
Effective May 13, 2013

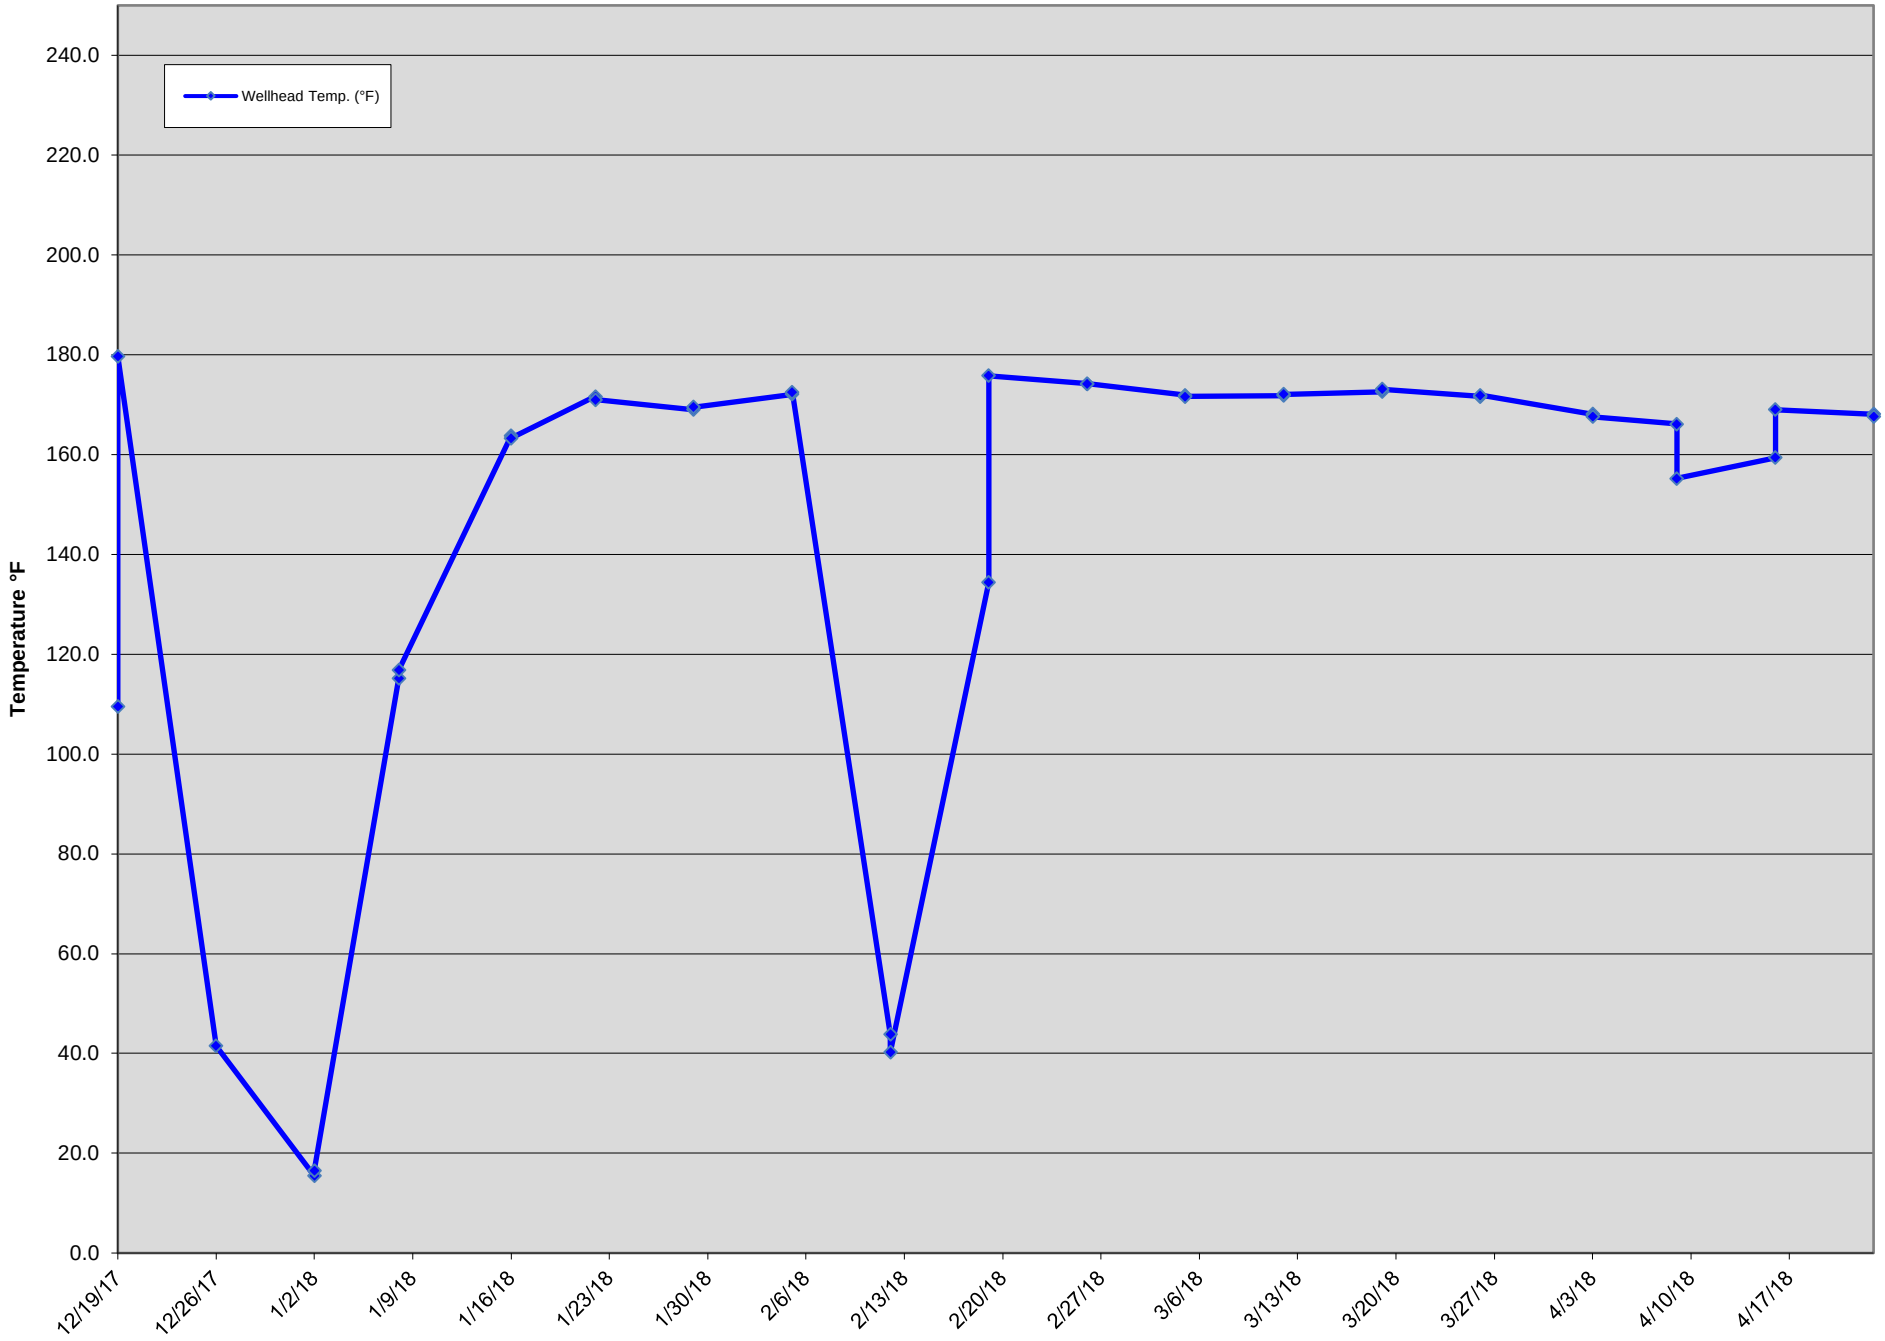
GIW-1 Wellhead Temperatures

As part of the HES, there are currently cooling water circulation loops installed in twelve Gas Interceptor Wells (GIWs) (GIW-02 through GIW-13). The remaining well (GIW-01) had a measured gas temperature within its historical operating limits.
