Bridgeton Landfill, LLC

Weekly Data Submittals

Required by Section 52.F of Agreed Order, Case No. 13SL-CC01088 Effective May 13, 2013

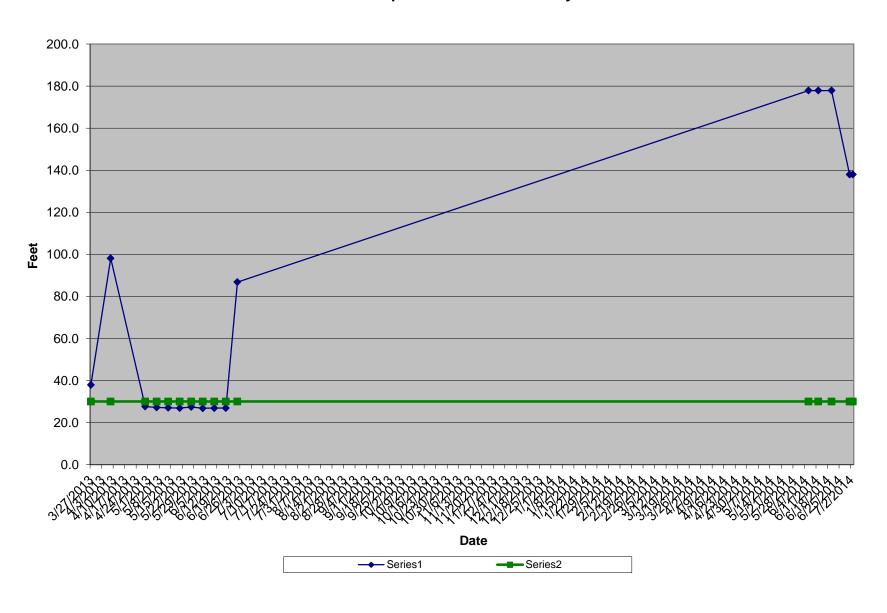
LCS-1D Liquid Level Above Quarry Floor

LCS-1D,-2D,-3D, and -5A were partially or fully operational during the weekly reporting period.

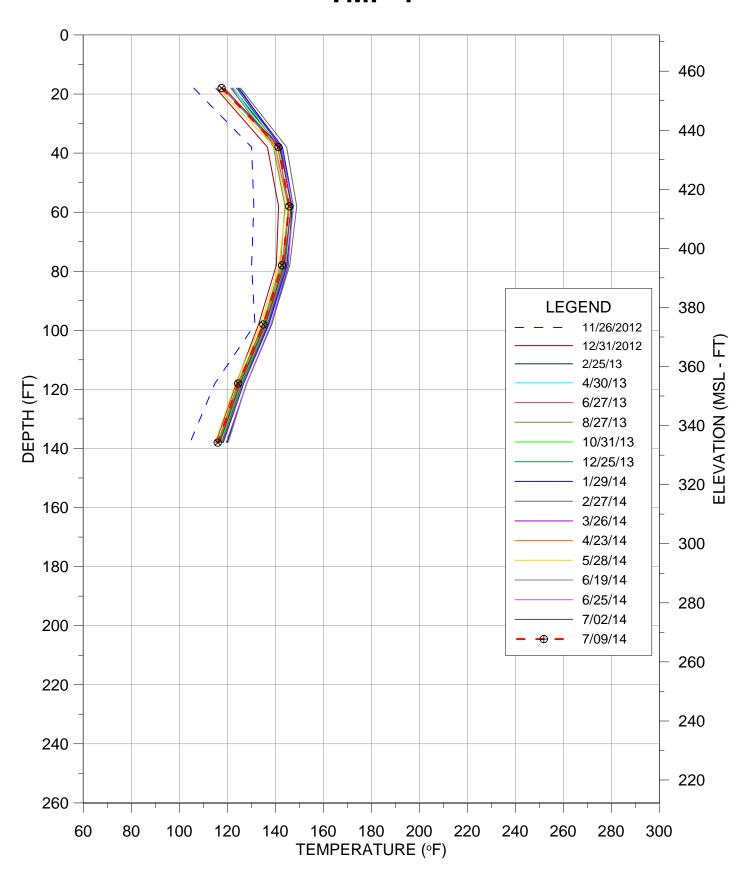
TMP-1

The following TMPs indicated consistent or lower temperature profiles to previous week(s): TMP-1, -2, -3, -4, -5, -6, -8, -9, -10, -11, and -12. Some intervals in TMP-14 increased in the latest reading.

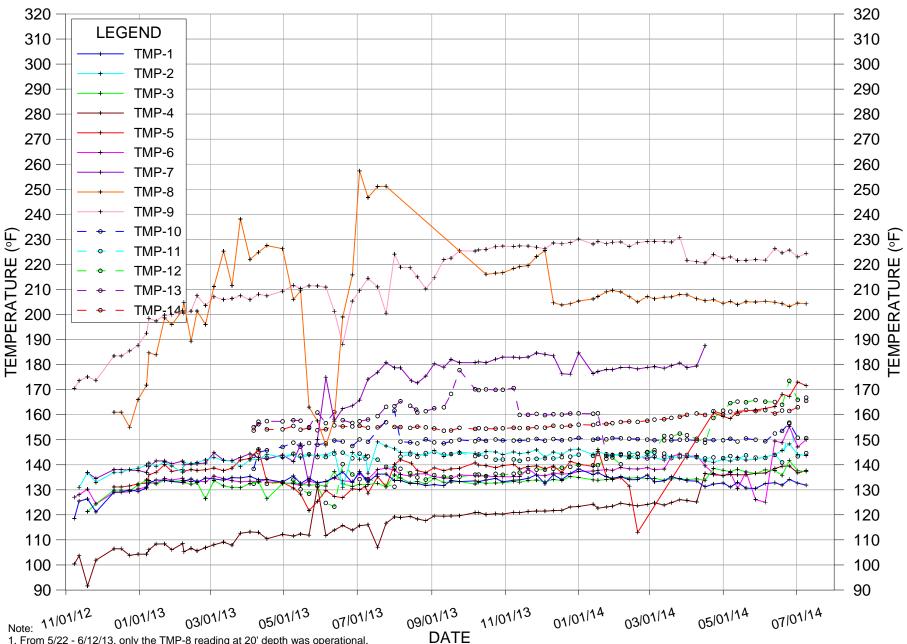
AVERAGE TEMPERATURES

1. From 5/22 - 6/12/13, only the TMP-8 reading at 20' depth was operational.

No valid readings were obtained for TMP-8 from 8/1 to 10/10/2013. Valid readings from 20' to 40' resumed on 10/16/2013.

- 2. A new OMEGA dial was installed at TMP-7R on 6/12/2013 enabling more vaild readings.
- 3. No valid readings were obtained for TMP-10 and TMP-12 on 7/18/2013 or 7/25/2013.
- 4. End terminals were replaced just prior to the 8/6/2013 readings with type T Omega connectors (part # SMPW-CC-T-M) on all TMPs except for TMP-8.

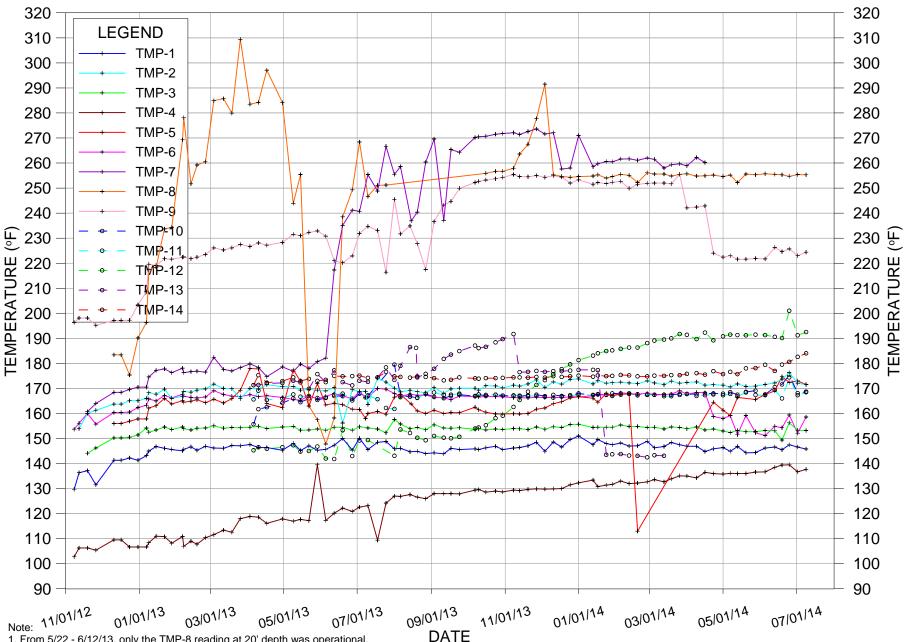
MAXIMUM TEMPERATURES

From 5/22 - 6/12/13, only the TMP-8 reading at 20' depth was operational.
 No valid readings were obtained for TMP-8 from 8/1 to 10/10/2013. Valid readings from 20' to 40' resumed on 10/16/2013.

- 2. A new OMEGA dial was installed at TMP-7R on 6/12/2013 enabling more vaild readings.
- 3. No valid readings were obtained for TMP-10 and TMP-12 on 7/18/2013 or 7/25/2013.
- 4. End terminals were replaced just prior to the 8/6/2013 readings with type T Omega connectors (part # SMPW-CC-T-M) on all TMPs except for TMP-8.

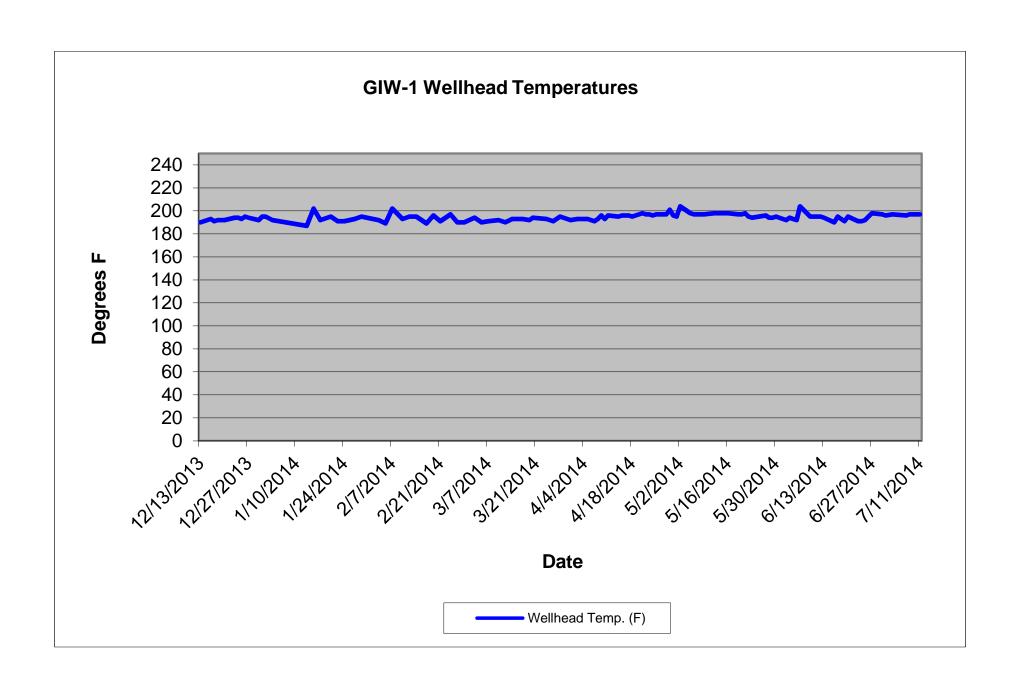
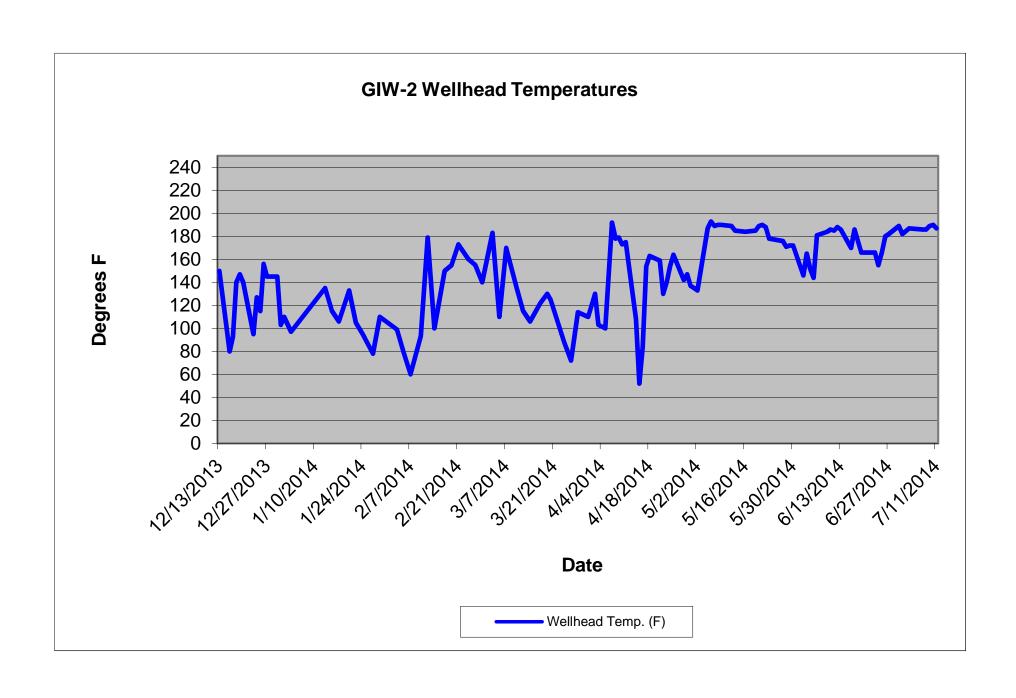
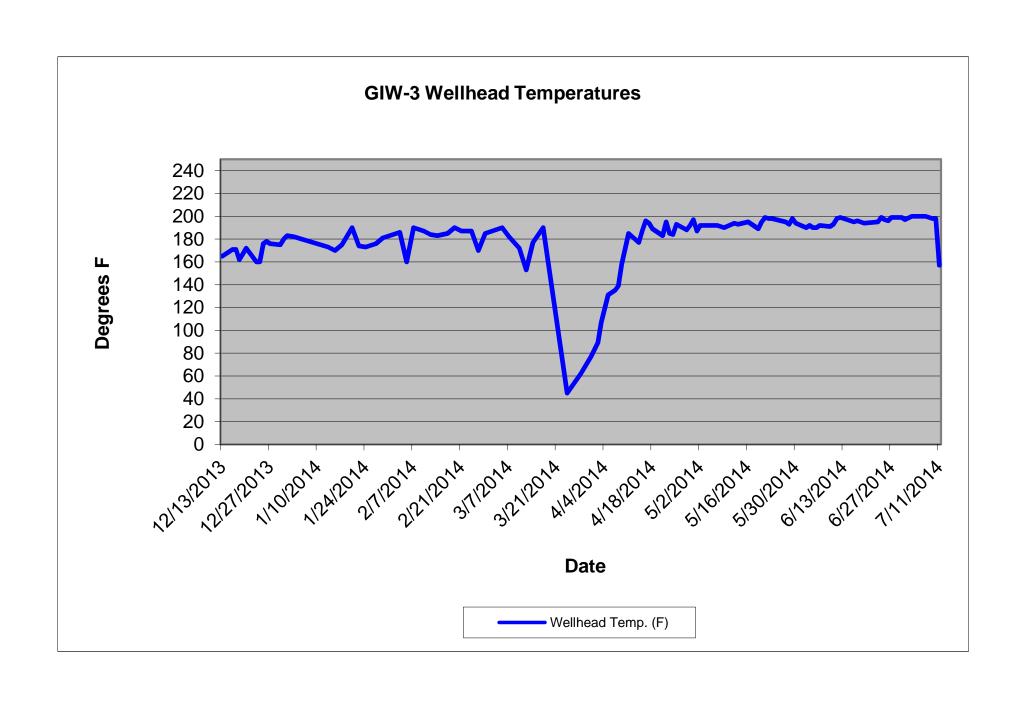
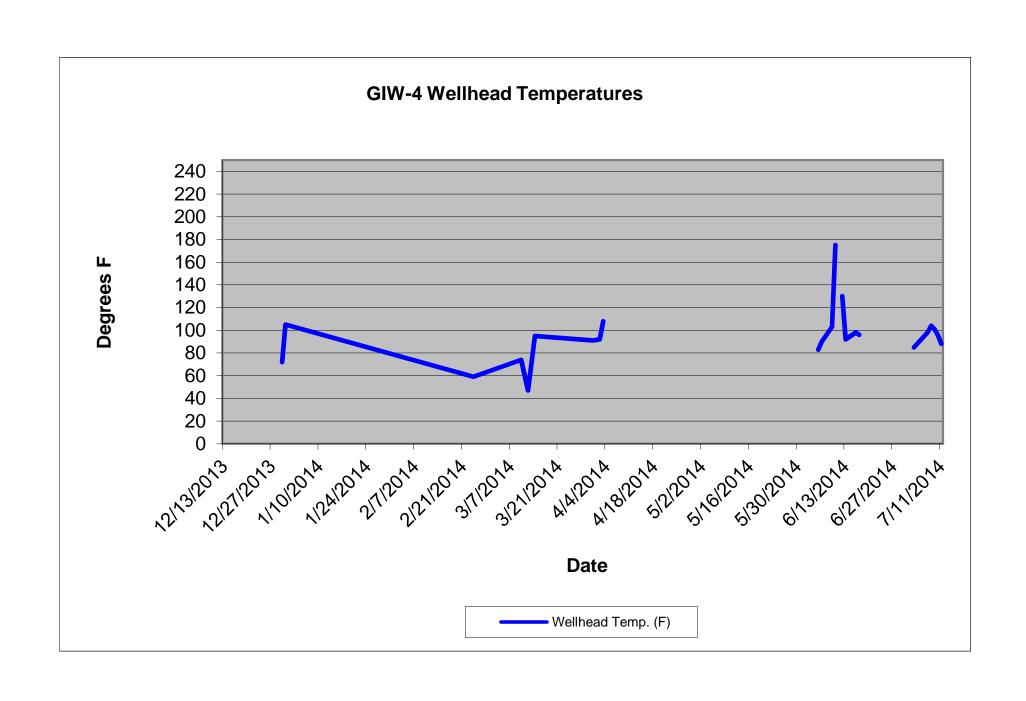
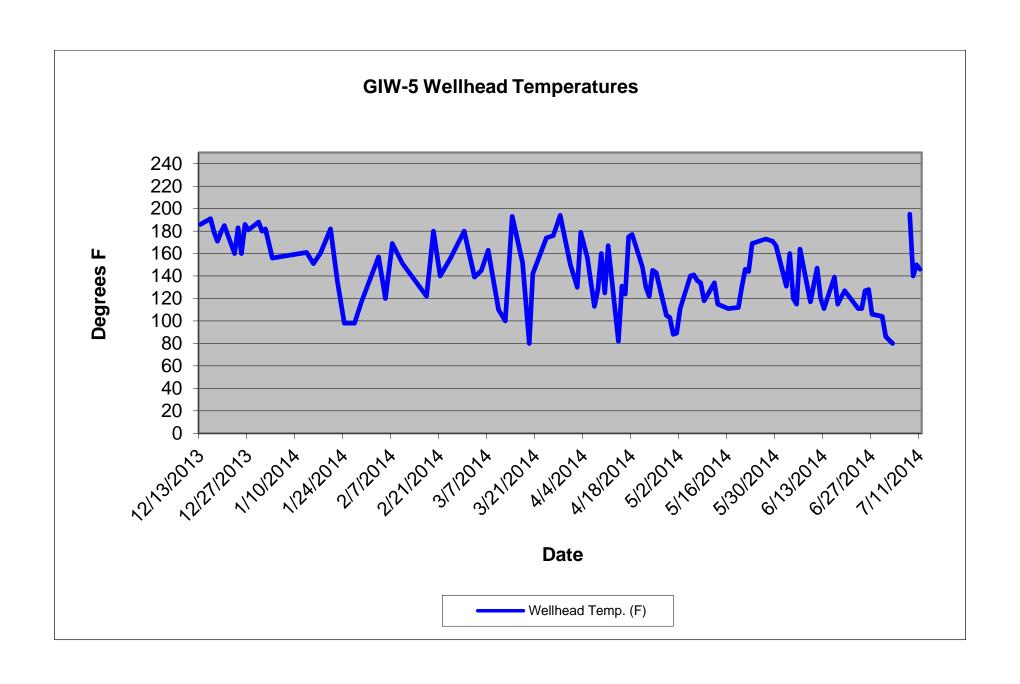
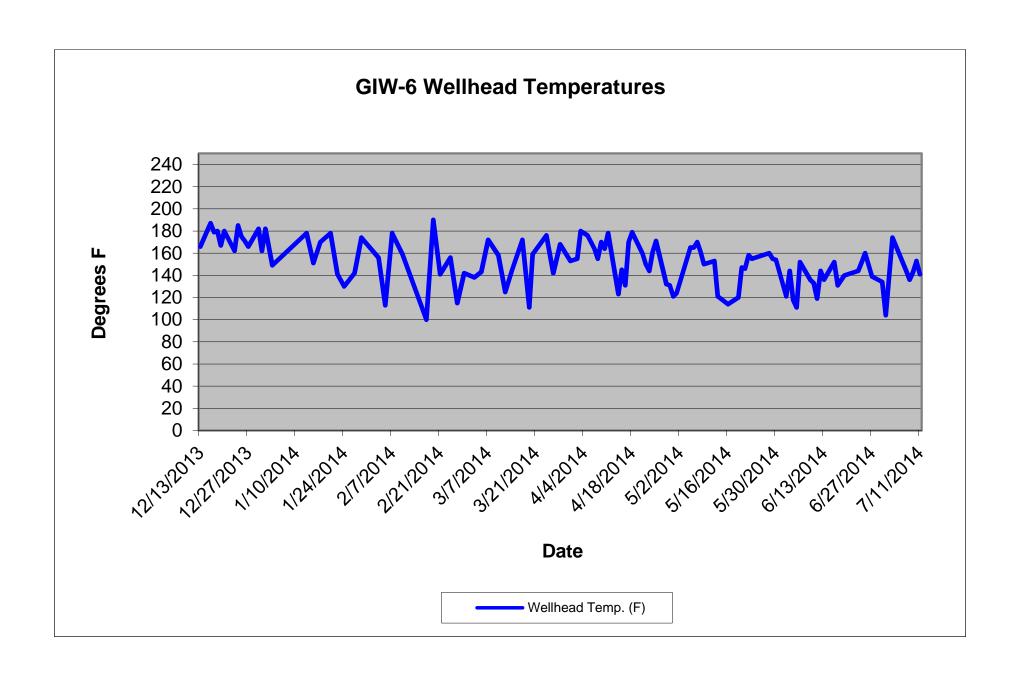
The fluctuation in wellhead gas temperatures can be attributed to variation in available vacuum, gas flow and ambient temperatures at the respective well.

Each gas interceptor well remained relatively consistent or lower with regards to gas wellhead temperatures previously measured at each location.

The water circulation cooling loop is currently installed in GIW-4.
