Bridgeton Landfill, LLC

Weekly Data Submittal

Week of April 04, 2021 – April 10, 2021

**Required by Section IX.33.g of Final Consent Judgment, Case No. 13SL-
CC01088-01
Effective June 29, 2018**

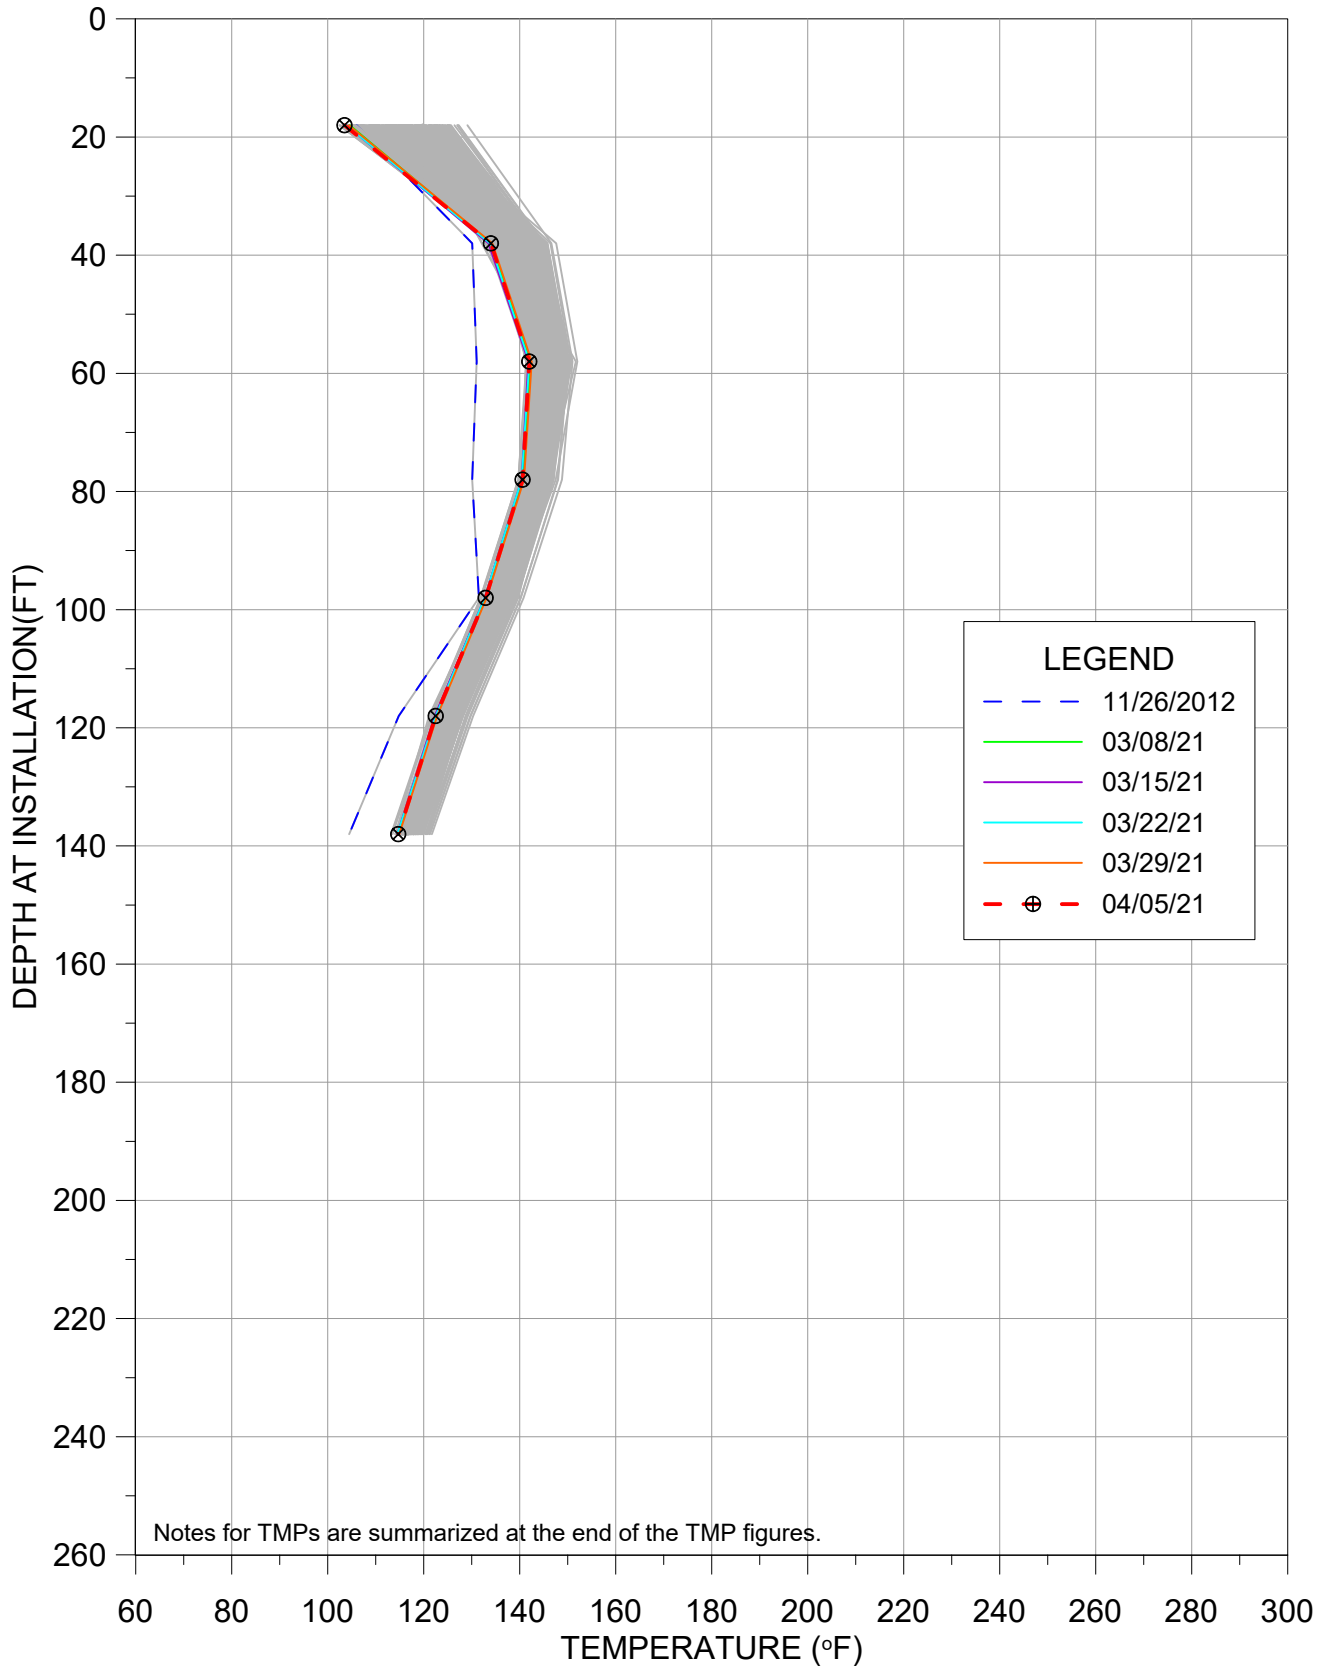
TMP-1

TMP-1: NONE

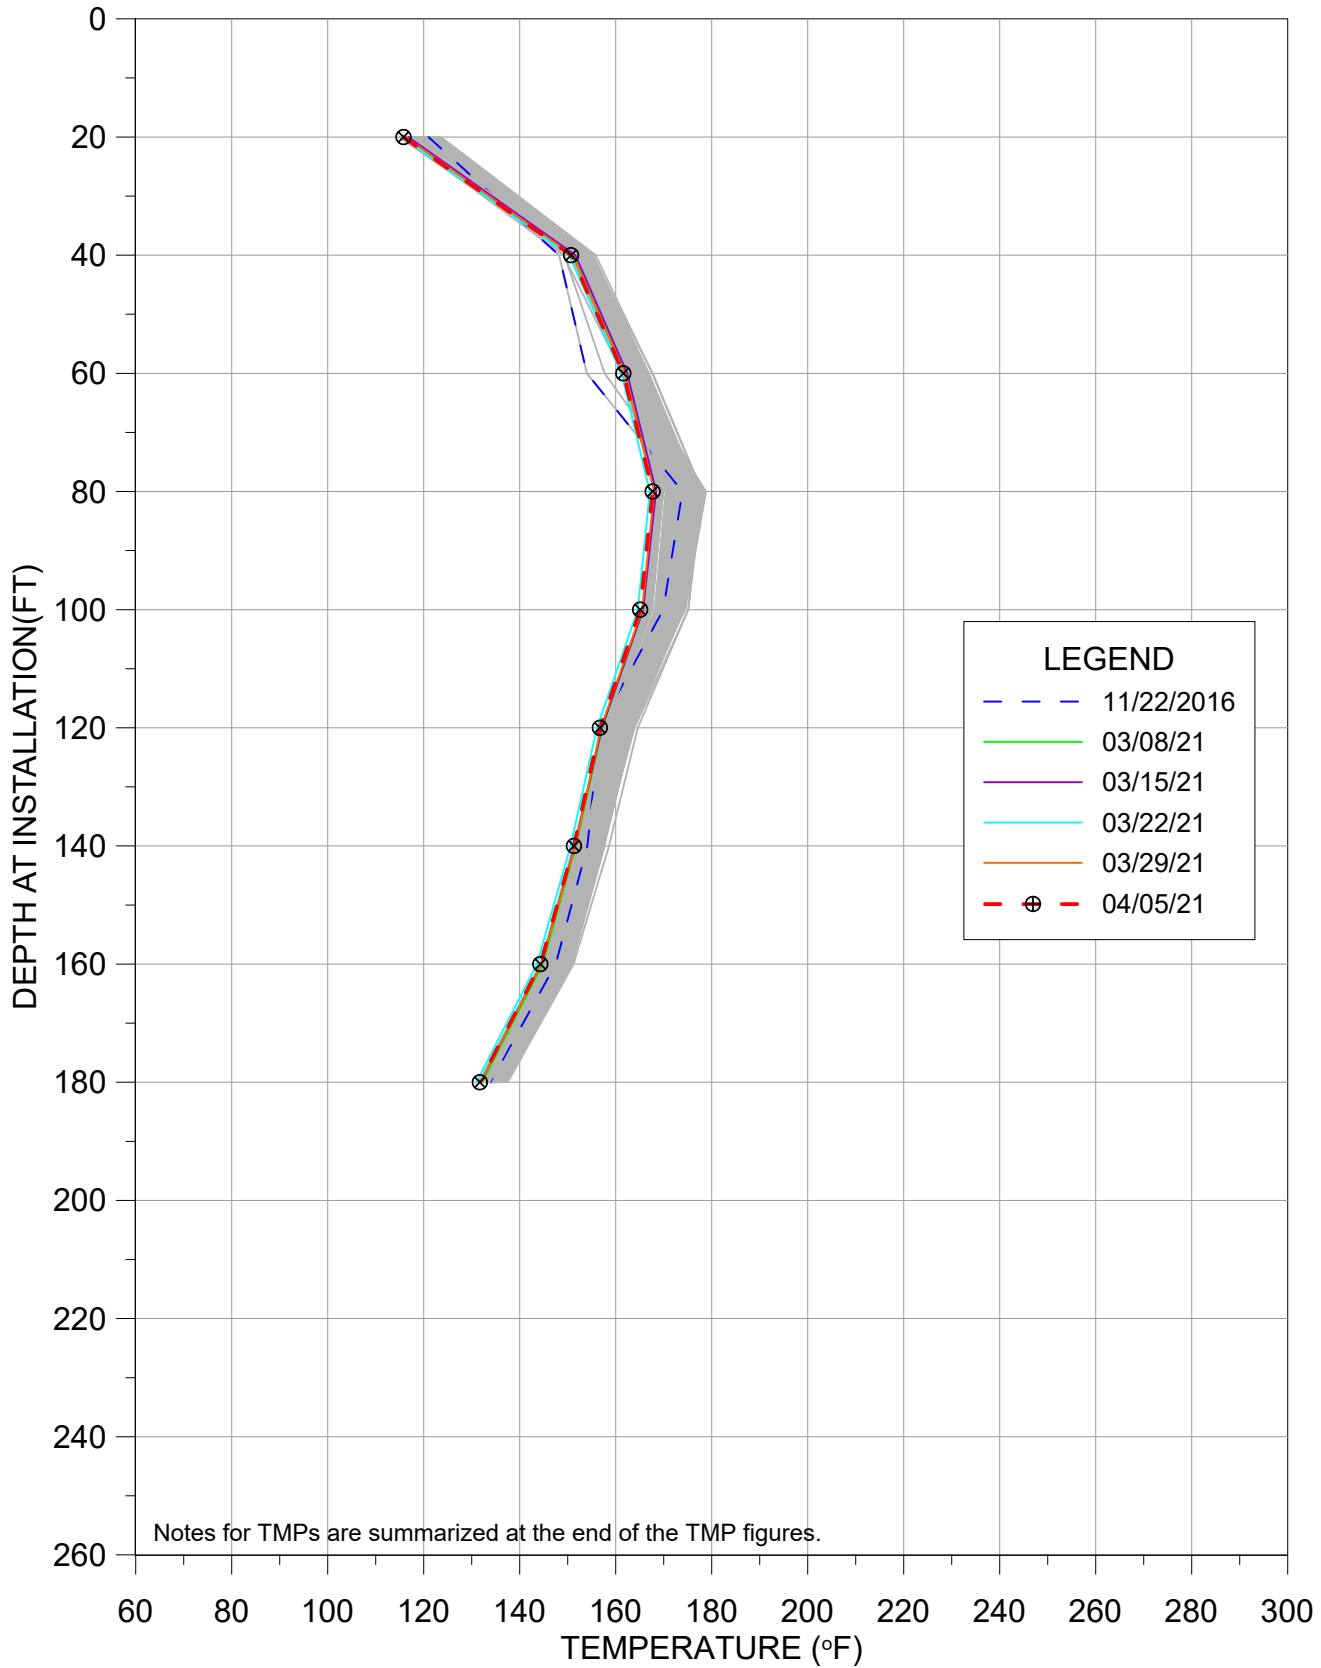
TMP-2R

1. Data reported on 11/29/2016 was inadvertently left as the 11/22/2016 data. This was corrected on 12/5/2016 reading submittal.

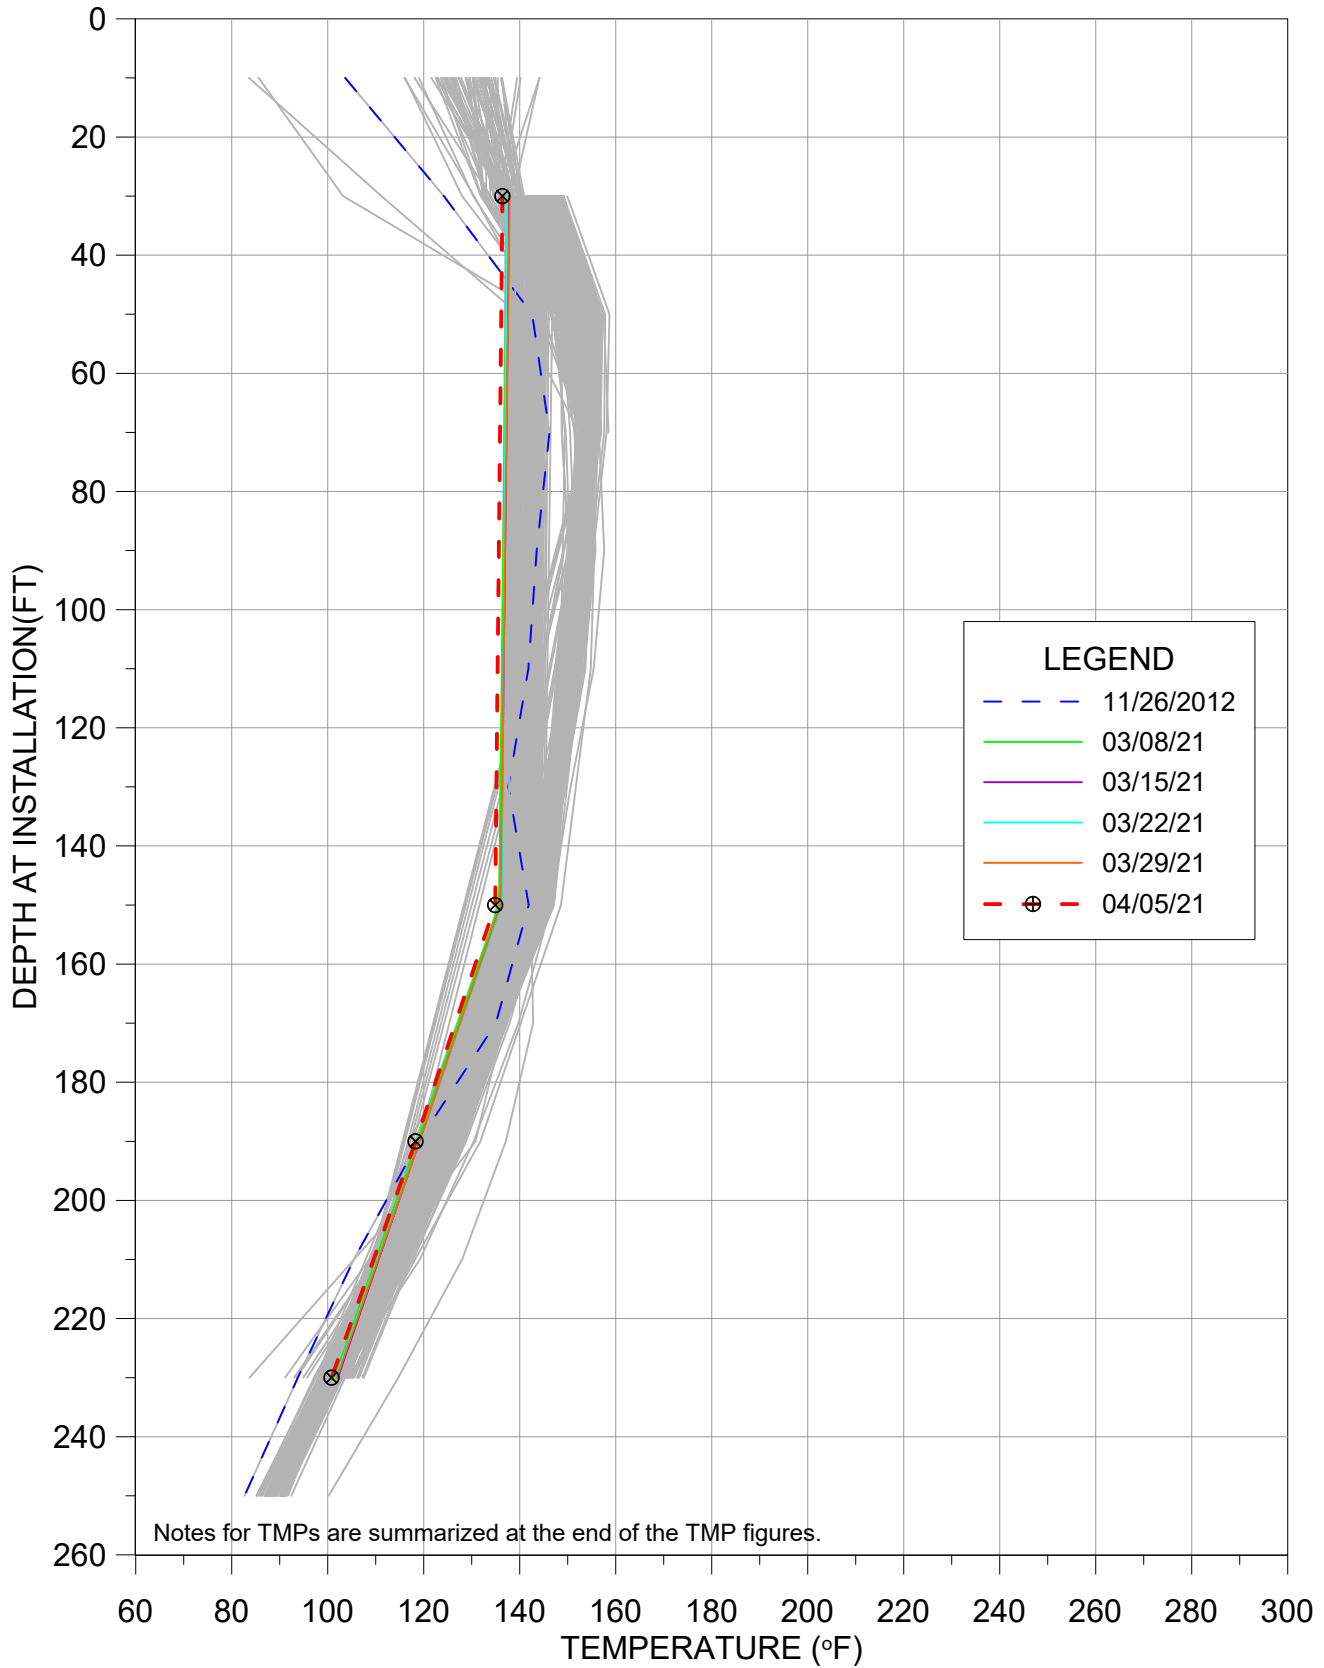
TMP-3

1. No reliable temperature readings have been obtained at 170 ft depth since 1/29/2014, except on 3/13/2014.
2. The connectivity tests on 4/11/2014 conducted by CEC showed that units at 10, 90, 130, 210 and 250 ft depths are no longer reliable.
3. The connectivity tests on 10/28/2014 conducted by Feezor Engineering showed that units at 10, 90, 110, 130, 210 and 250 ft depths are not reliable.
4. The unit at 50 ft depth was fluctuating resistance since 10/1/2018. Therefore the temperature is determined to be unreliable.
5. No temperature reading could be obtained at 70 ft depth since 10/22/2018.

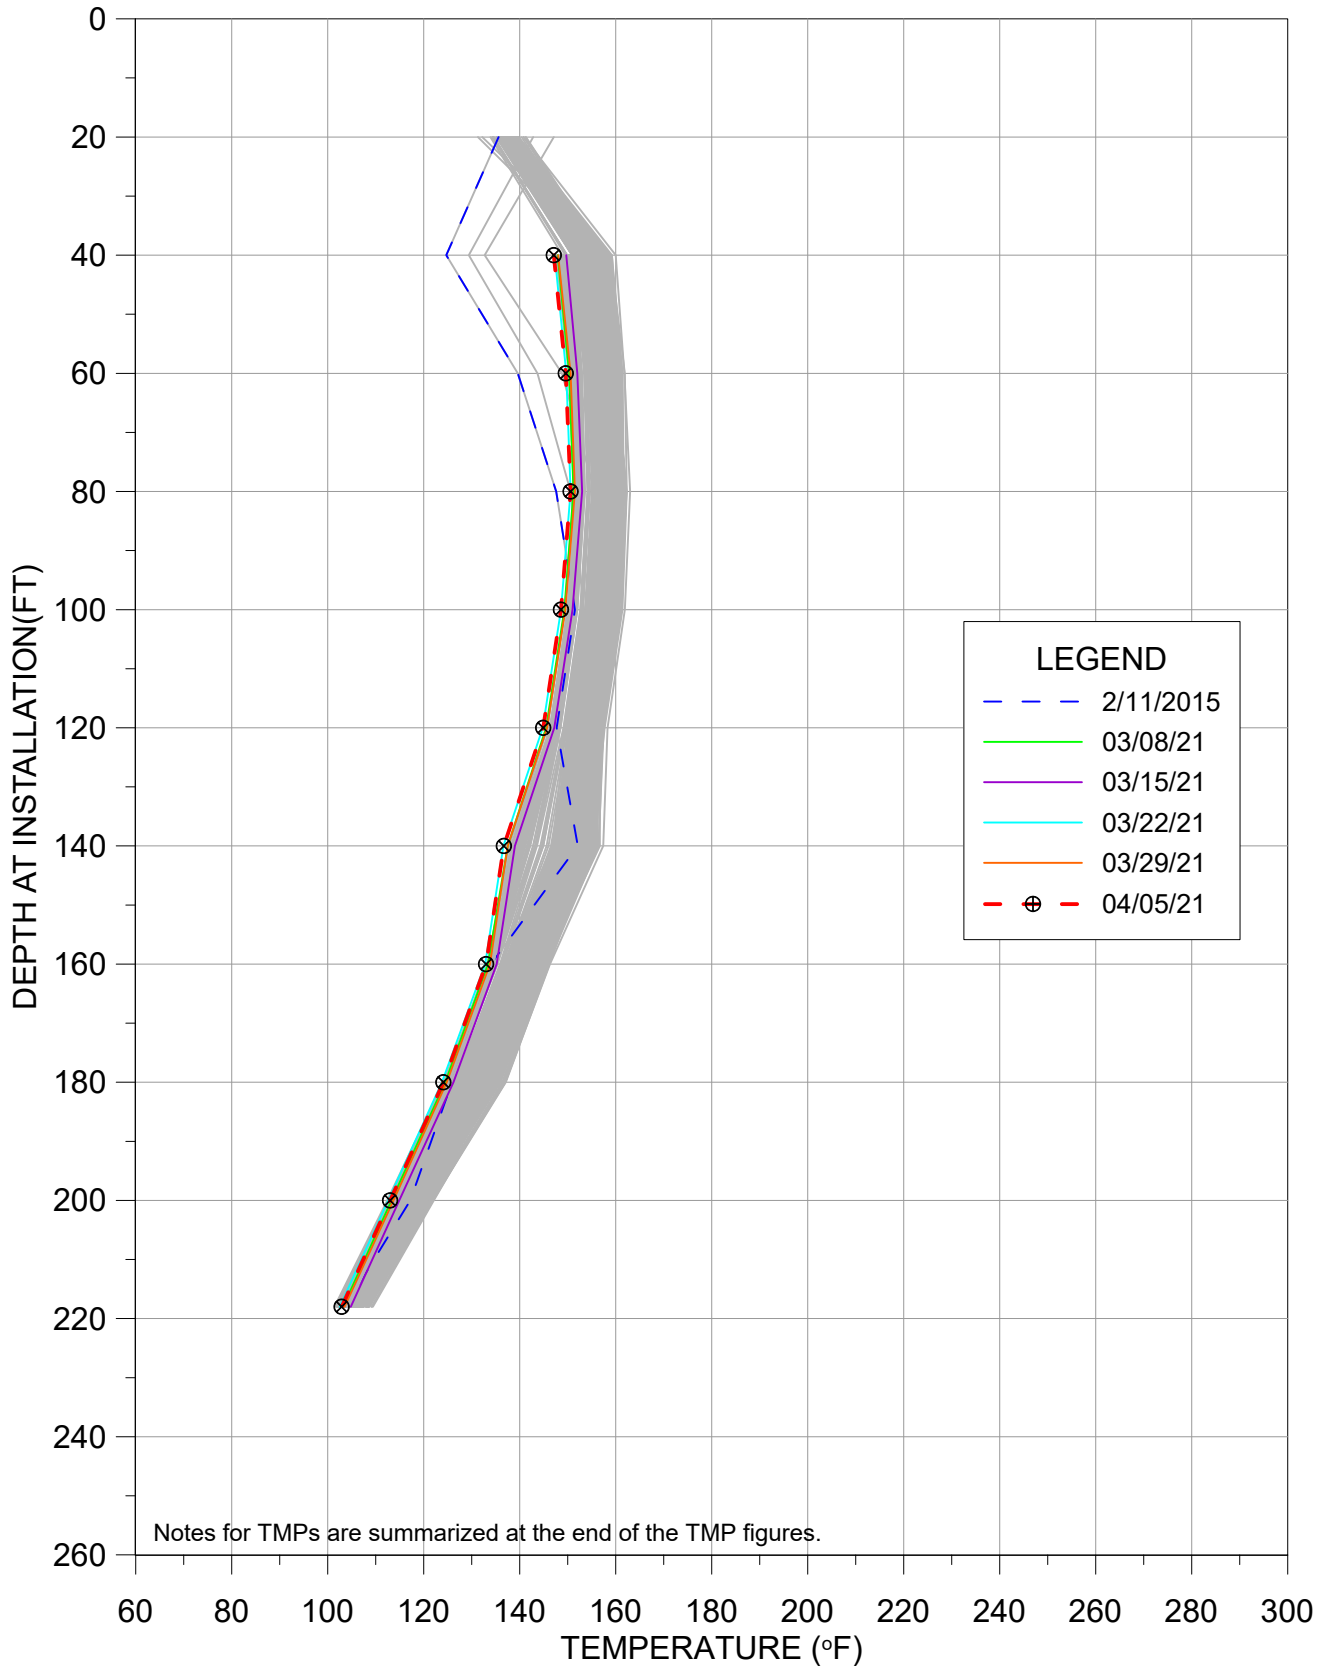
TMP-3R

1. The unit at 20 ft depth had a fluctuating resistance since 9/25/2017. Therefore the temperature is determined to be unreliable.

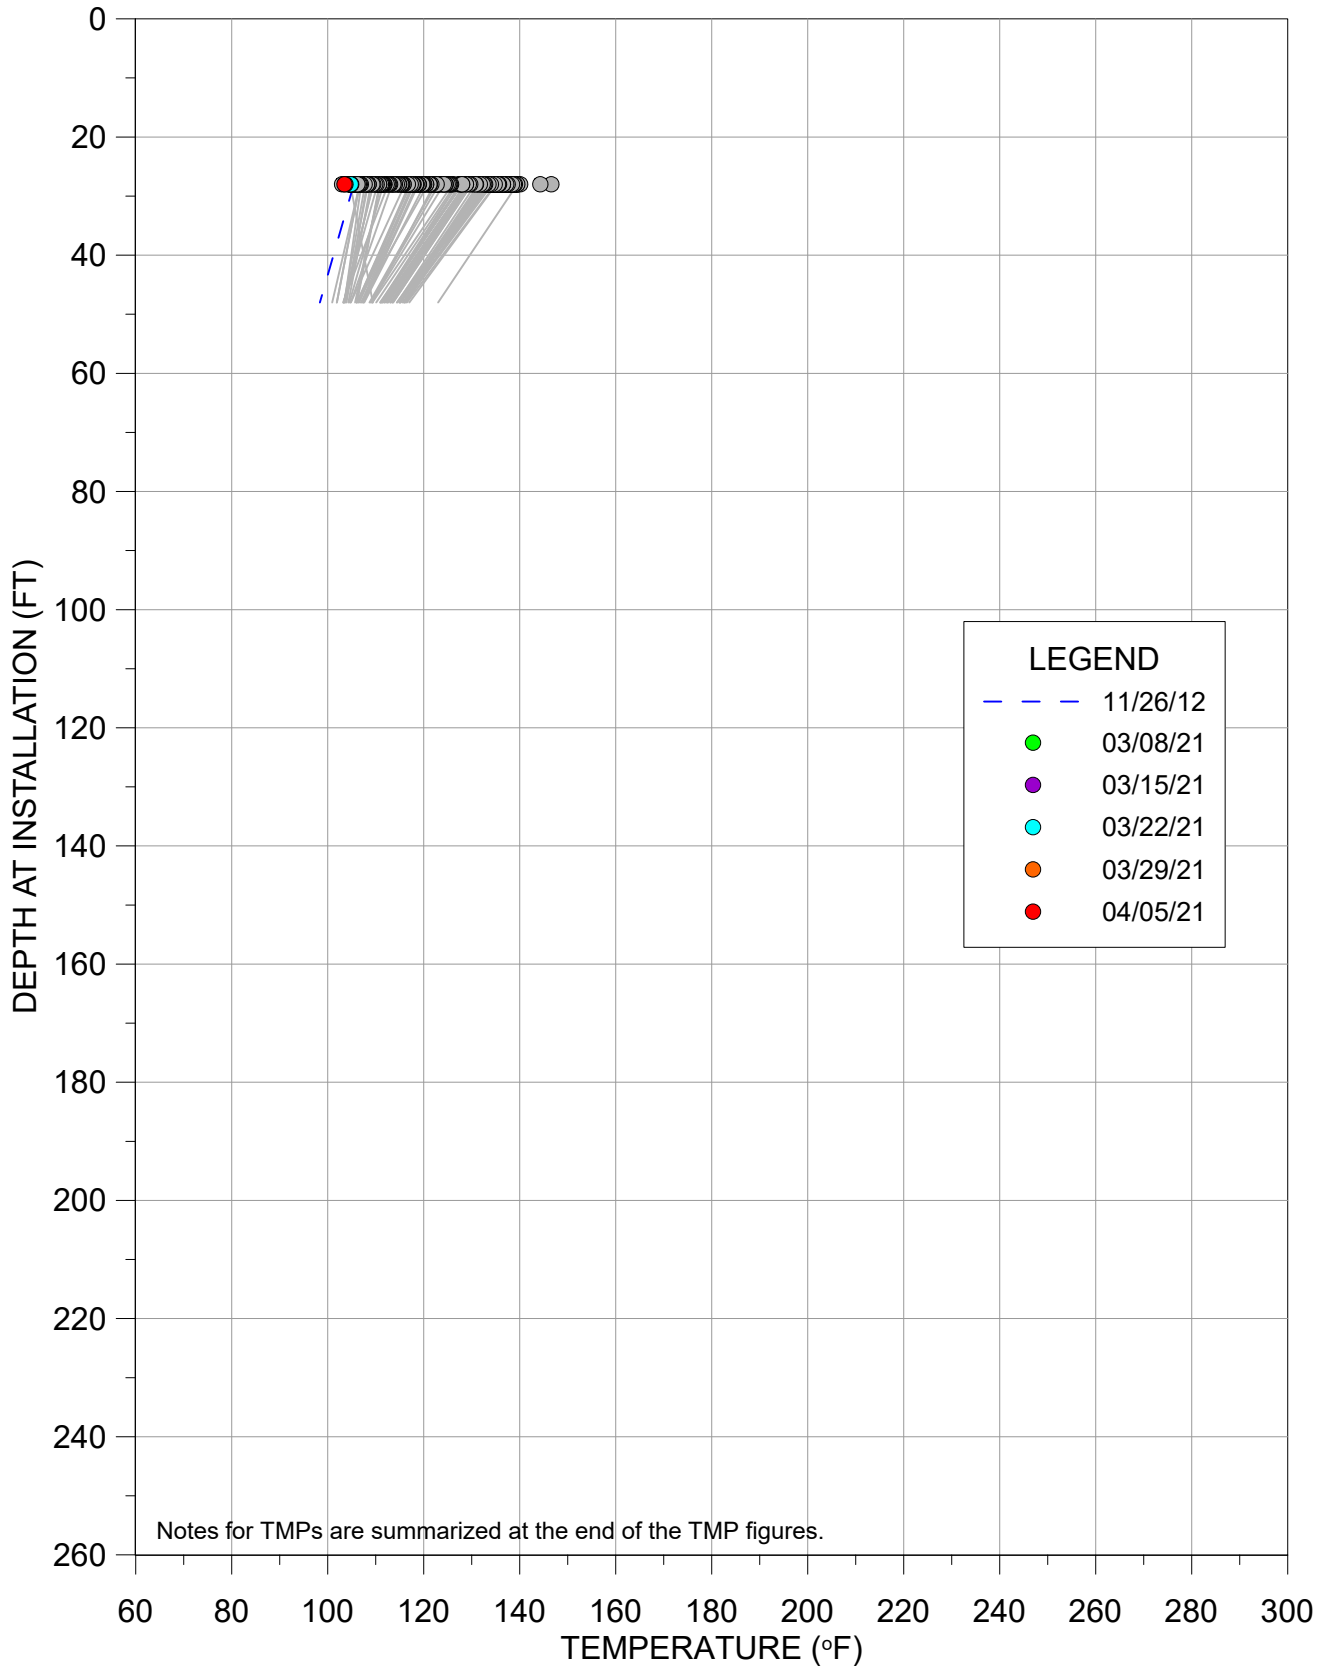
TMP-4

1. The connectivity tests on 4/11/2014 conducted by CEC showed that the unit at 48 ft depth is no longer reliable.

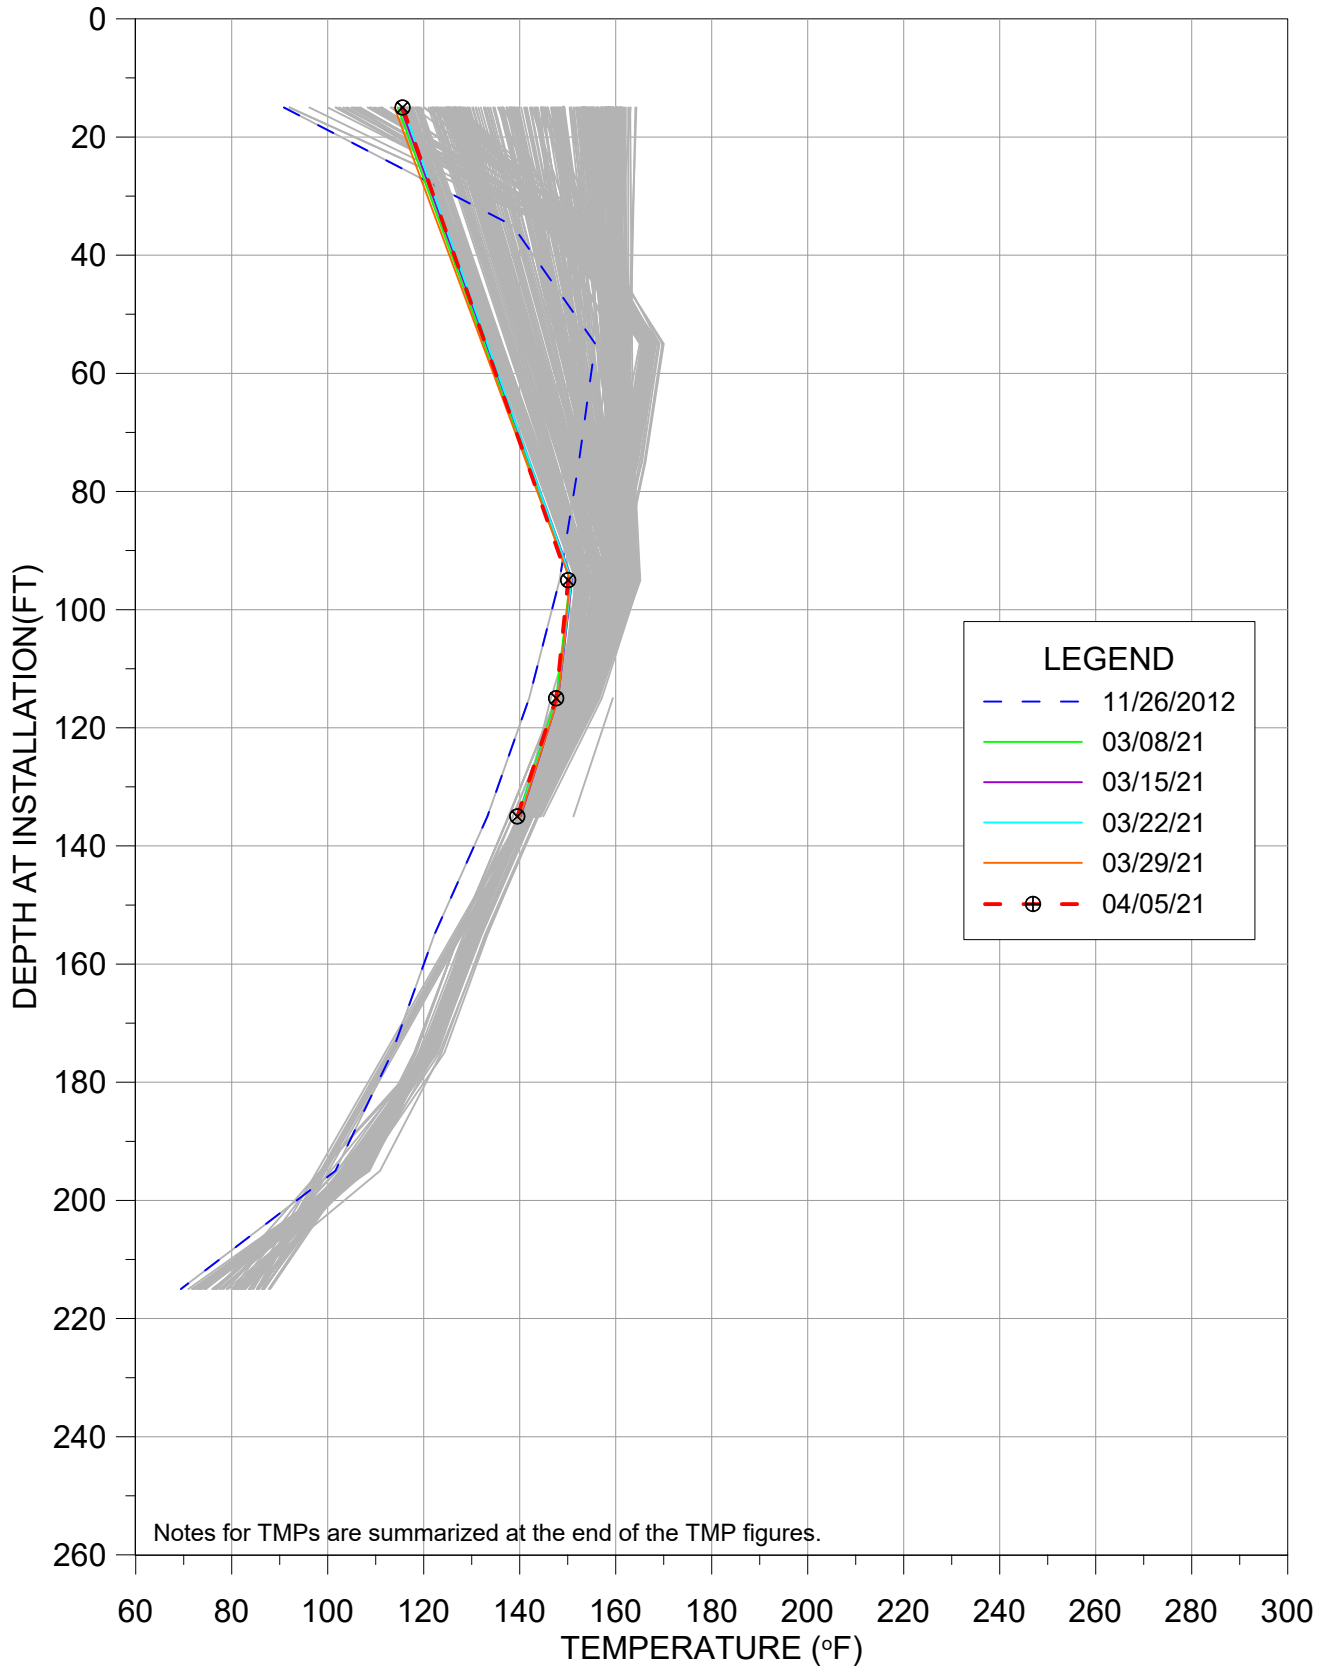
TMP-6

1. The connectivity tests on 4/11/2014 conducted by CEC showed that units at 35, 55, 75, 155, 175, and 195 ft depths are no longer reliable.
2. No reliable temperature readings have been obtained at the unit at 215 ft depth since 6/13/2014.

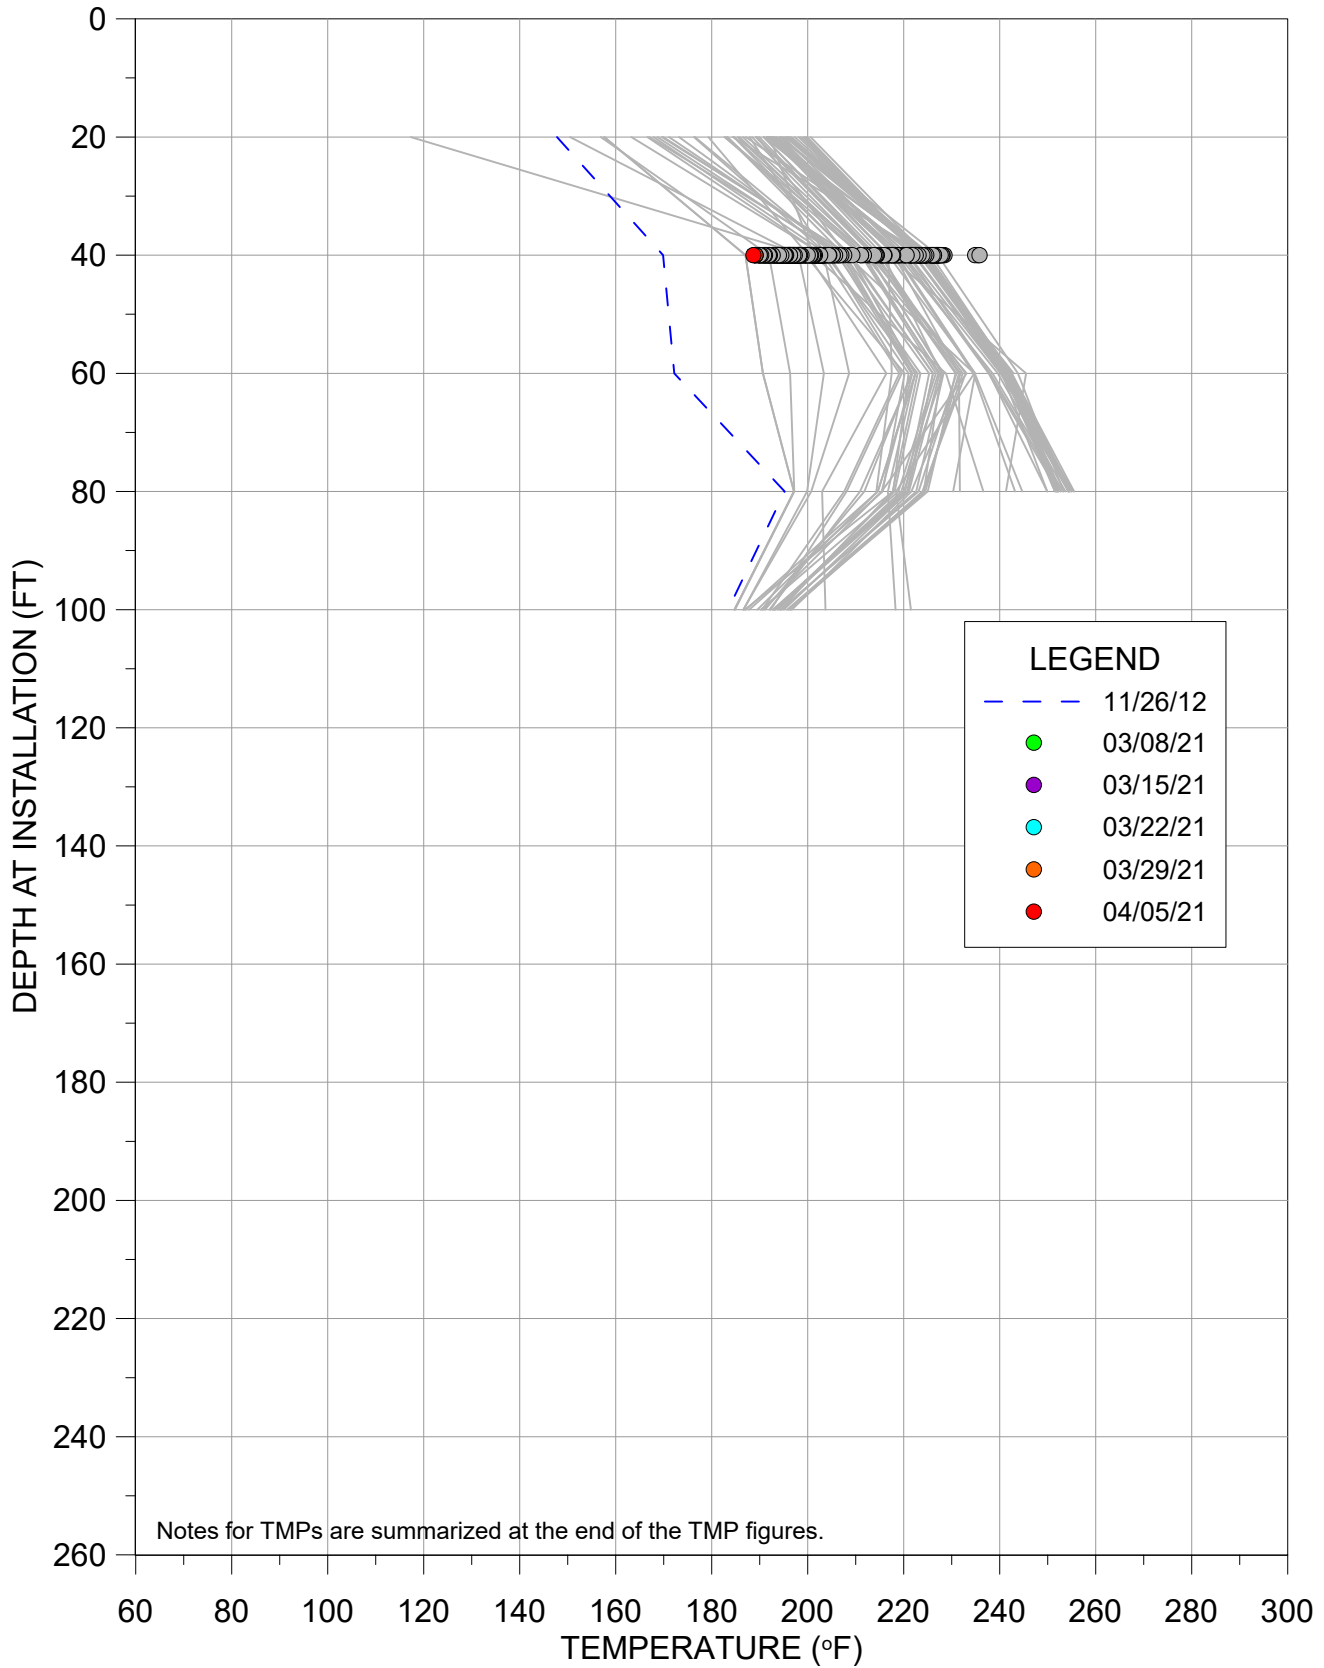
TMP-9

1. Unit at 100 ft depth had an inaccurate temperature reading on 8/1/2013 and no reading since 8/6/2013.
2. The connectivity tests on 4/11/2014 conducted by CEC showed that units at 20, 60, 80, and 100 ft depths are no longer reliable.

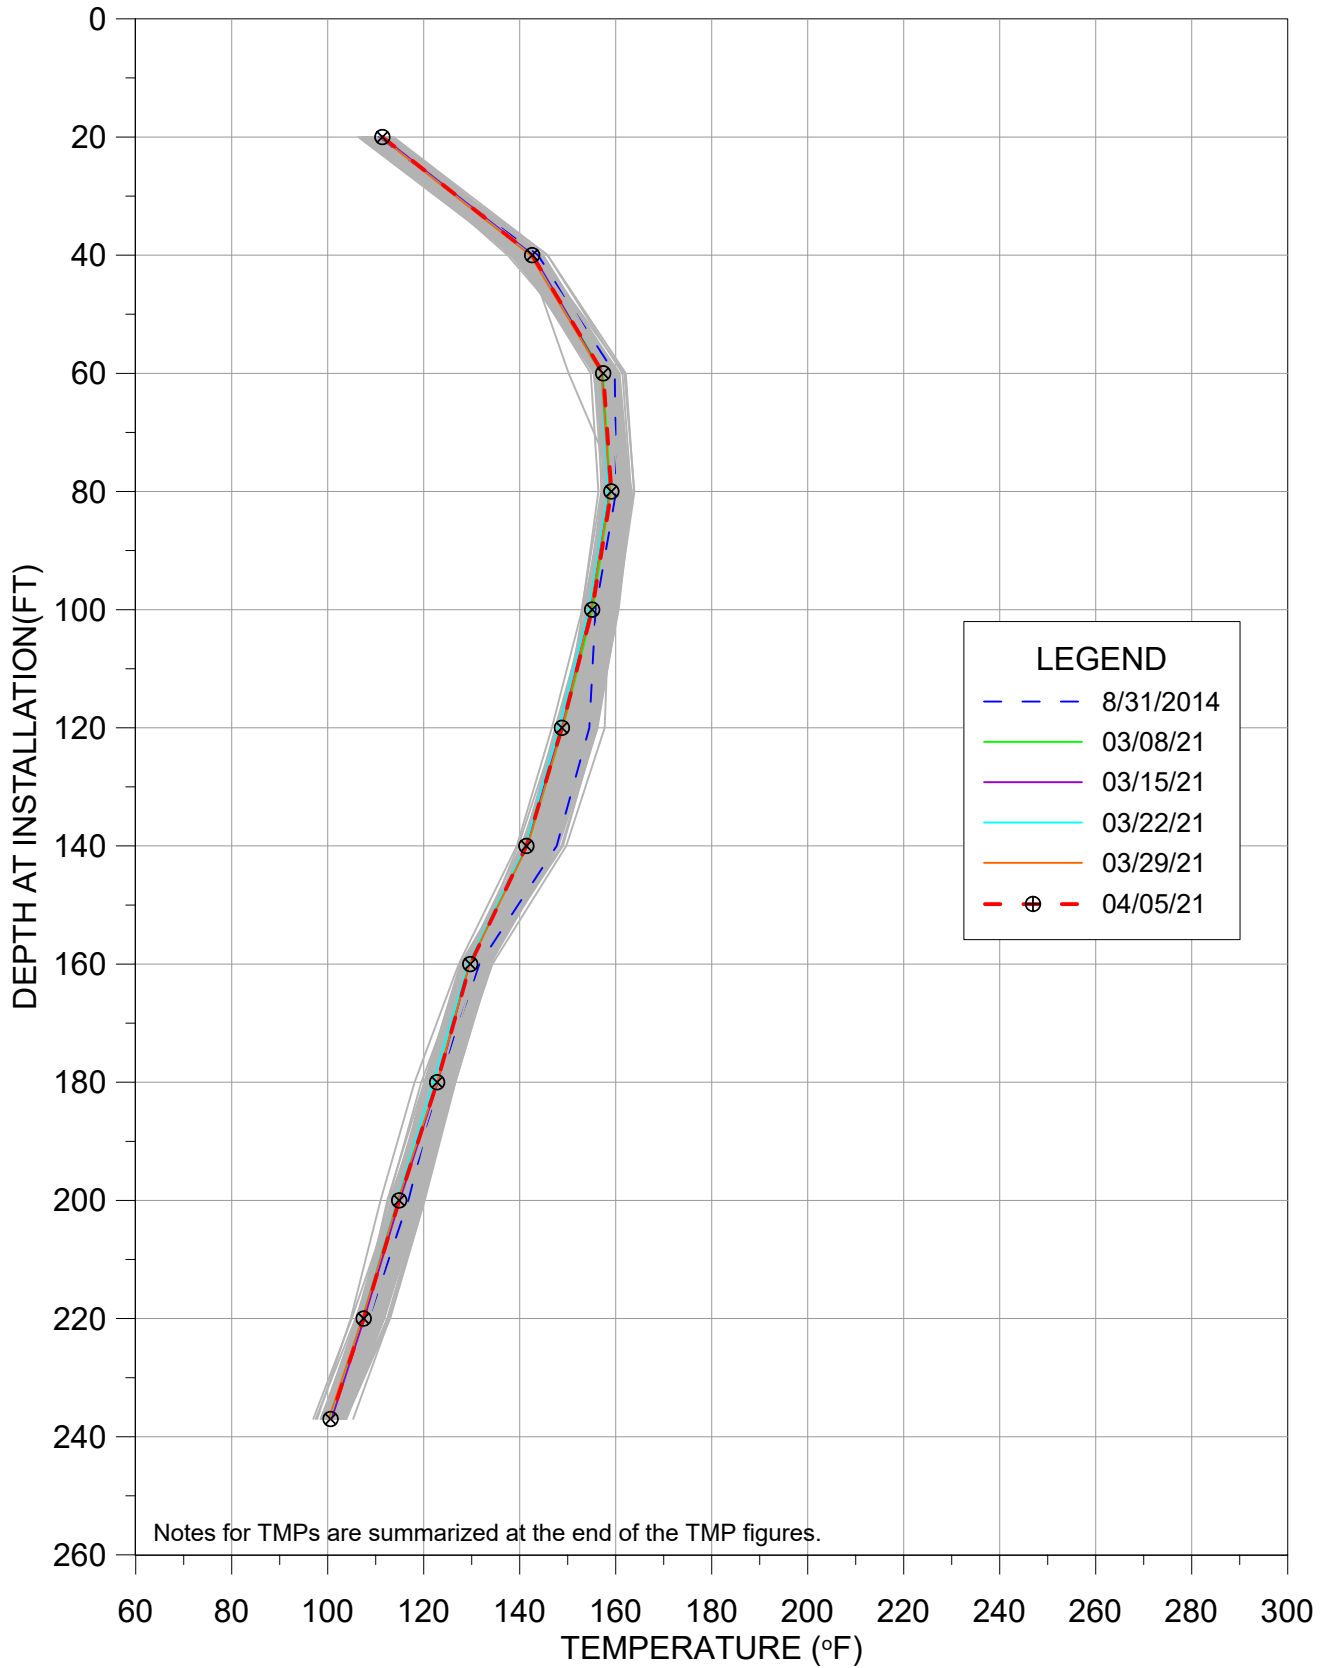
TMP-17

1. Thermocouple at 20' higher resistance than allowable on 9/21. Ongoing maintenance is being performed since it may be a surface corrosion issue at the switchbox.

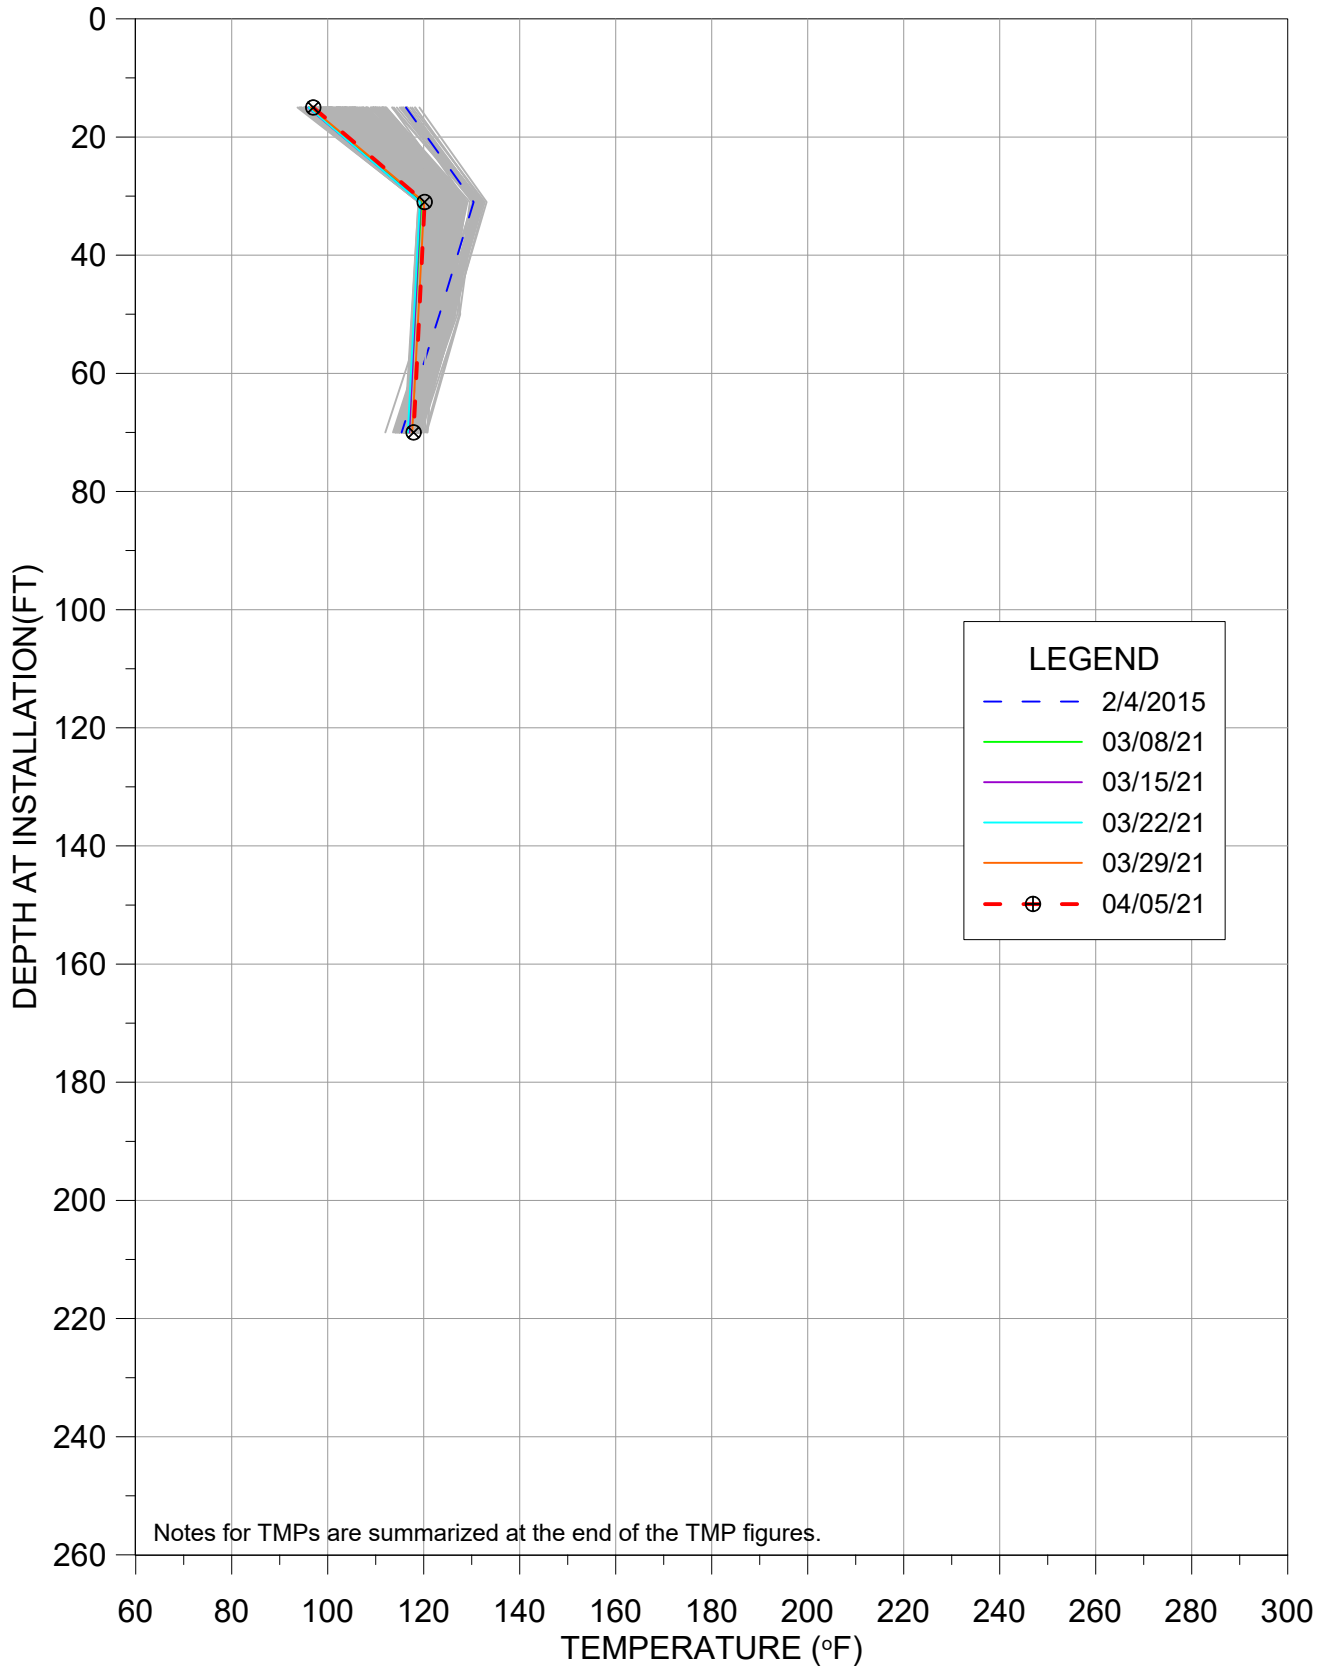
TMP-22

1. No temperature reading could be obtained and resistivity was fluctuating at the unit at 50 ft depth since 4/2/2018.
