Bridgeton Landfill, LLC

Weekly Data Submittal

Week of April 04, 2021 – April 10, 2021

**Required by Section IX.33.g of Final Consent Judgment, Case No. 13SL-
CC01088-01
Effective June 29, 2018**

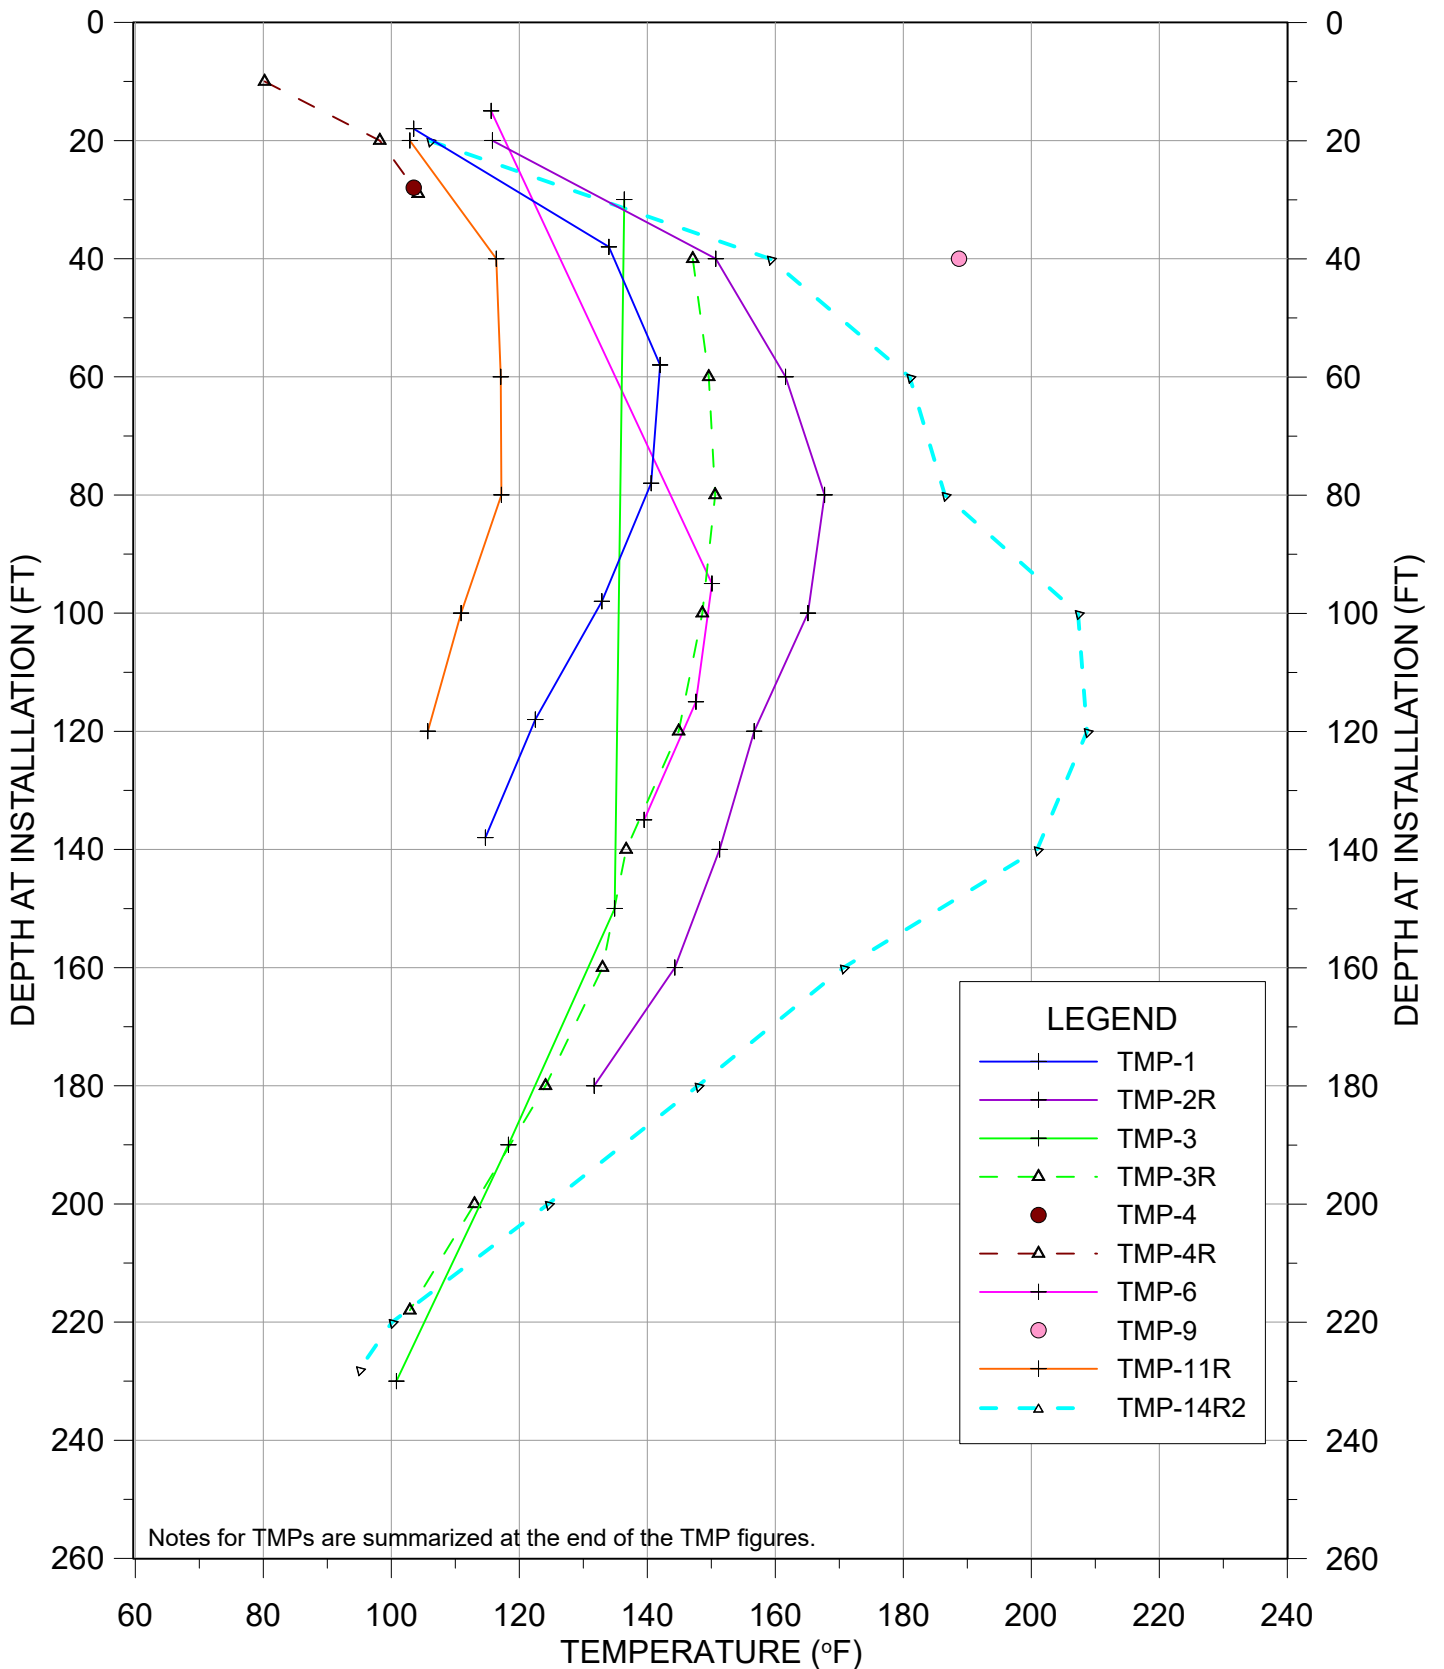
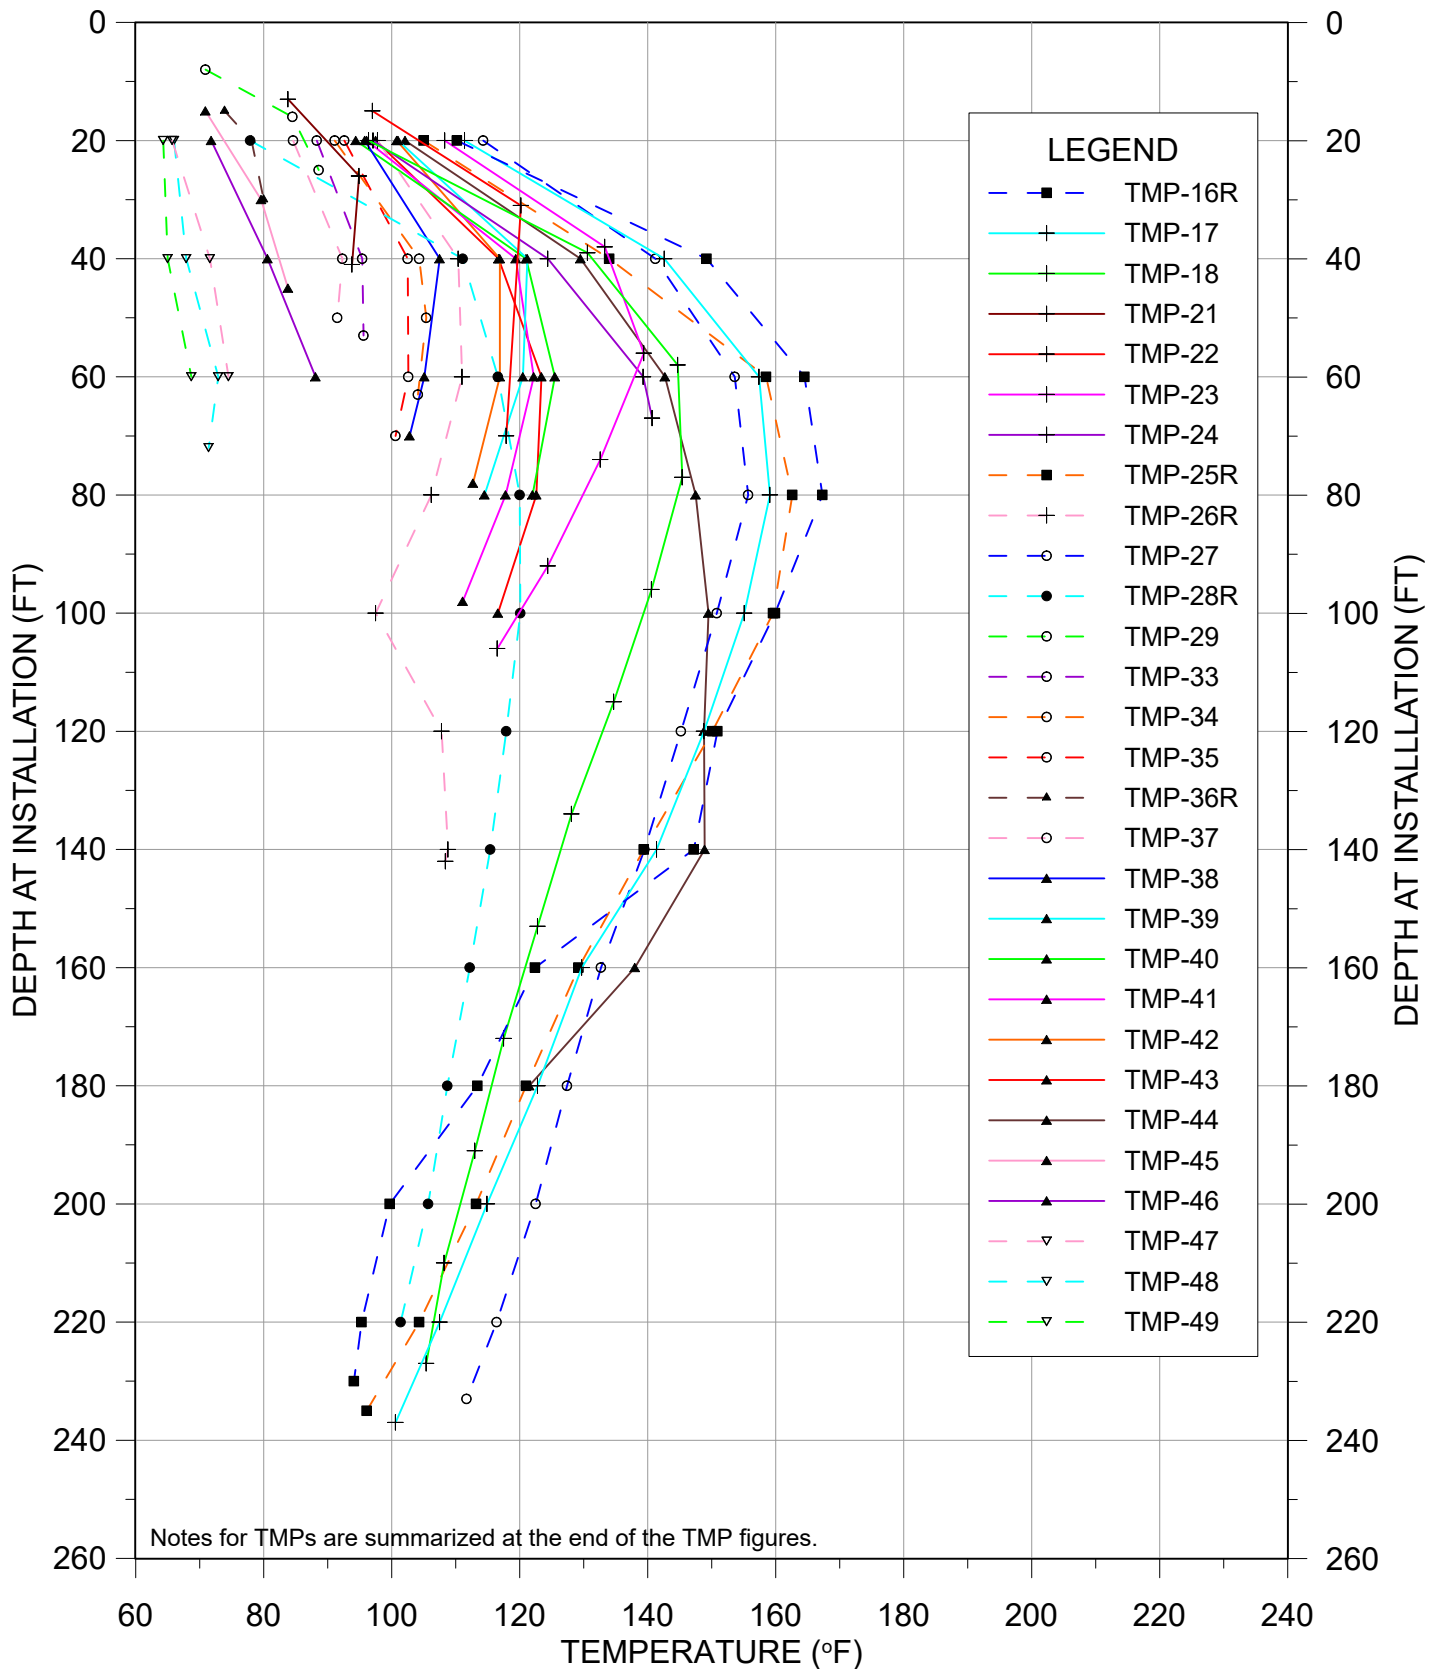
TEMPERATURE VS DEPTH
BRIDGETON LANDFILL

The following Temperature Monitoring Probes (TMPs) indicated profiles that were generally consistent with previous observations: TMP-1, -2R, -3, -3R, -4, -4R, -6, -9, -11R, -14R2, -16R, -17, -18, -21, -22, -23, -24, -25R, -26R, -27, -28R, -29, -33, -34, -35, -36R, -37, -38, -39, -40, -41, -42, -43, -44, -45, -46, -47, -48, and -49.

The TMPs listed above (and associated replacement TMPs) except TMP-6, -9, -11R, and -14R2 constitute the North Quarry TMPs as defined in the August 2017 *North Quarry Subsurface Temperature Monitoring Probes Work Plan*. No temperature in the individual thermocouples of the North Quarry TMPs exceeds the temperature threshold established in this workplan.

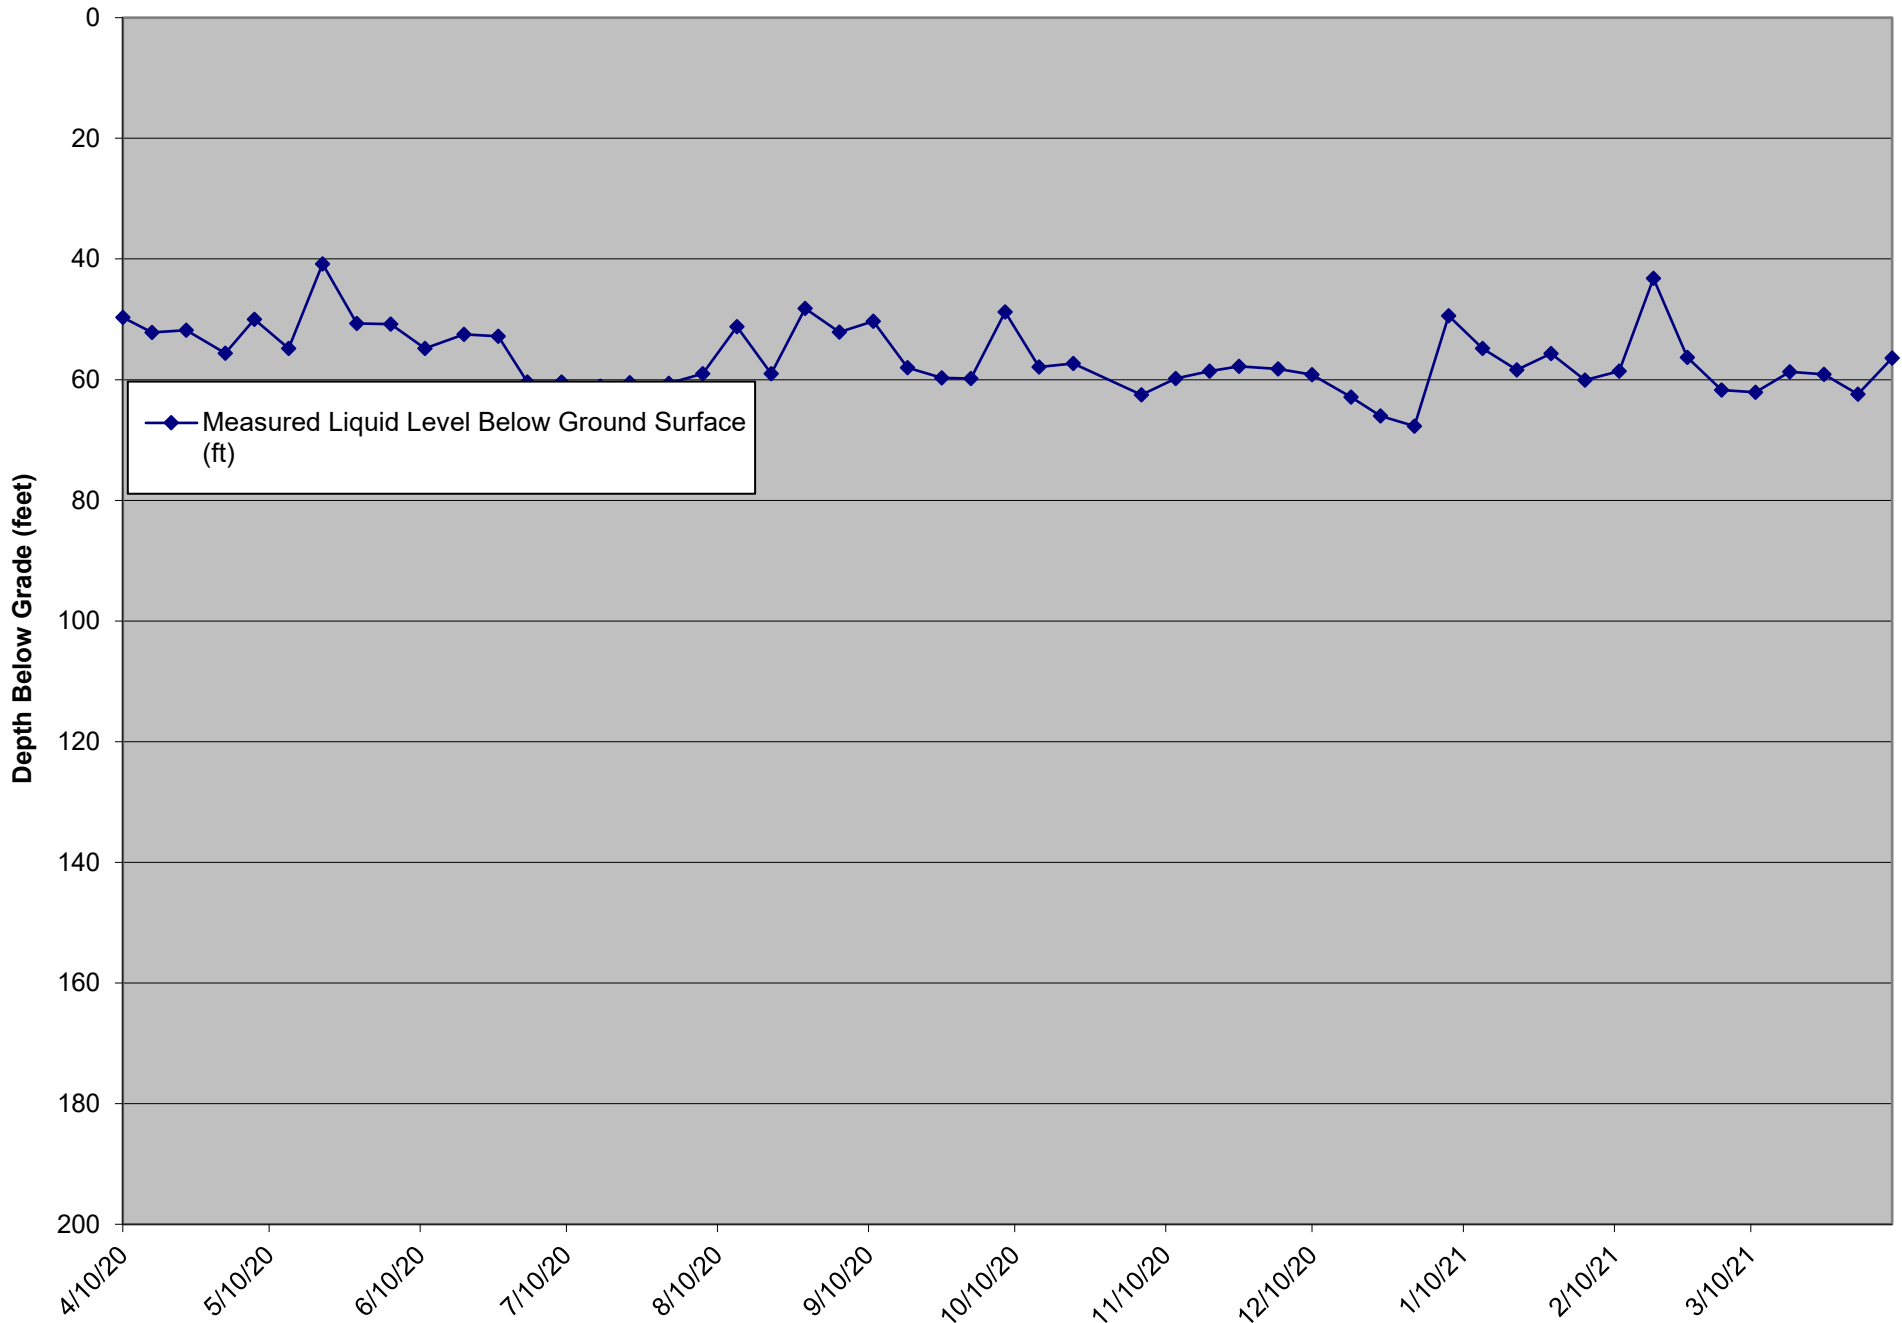
LCS-3D Liquid Level Below Ground Surface

The pump in LCS-3D was fully operational during the weekly reporting period.

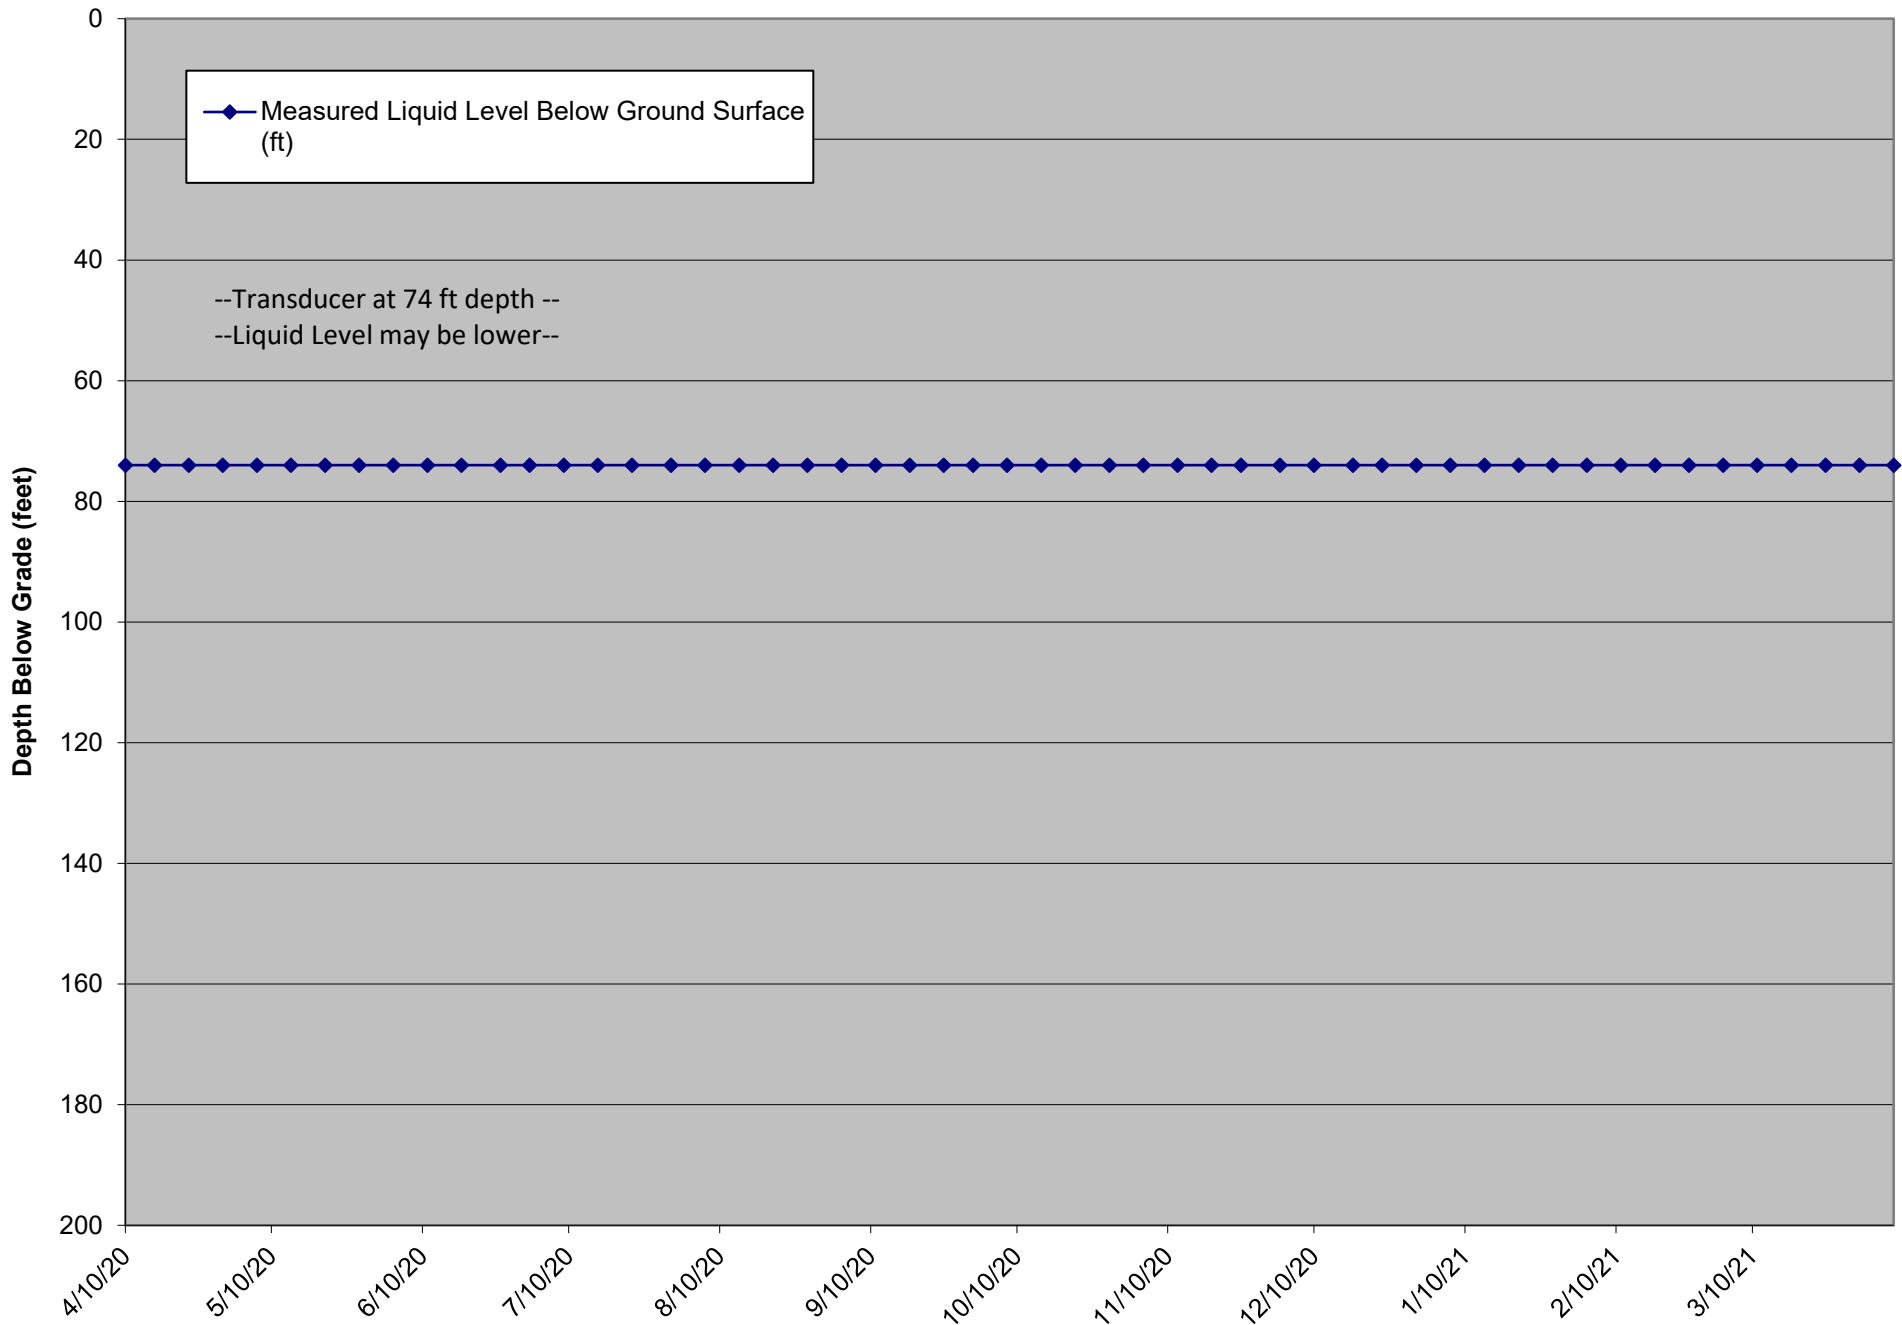
LCS-4B Liquid Level Below Ground Surface

The level sensor in LCS-4B is currently operational and responsive. Liquid level was not recorded by the level sensor during the weekly reporting period. LCS-4B is equipped with a flow meter that displayed no flow during the weekly reporting period. Therefore, it can be concluded that the liquid level was below the bottom of the pump and level sensor in LCS-4B.

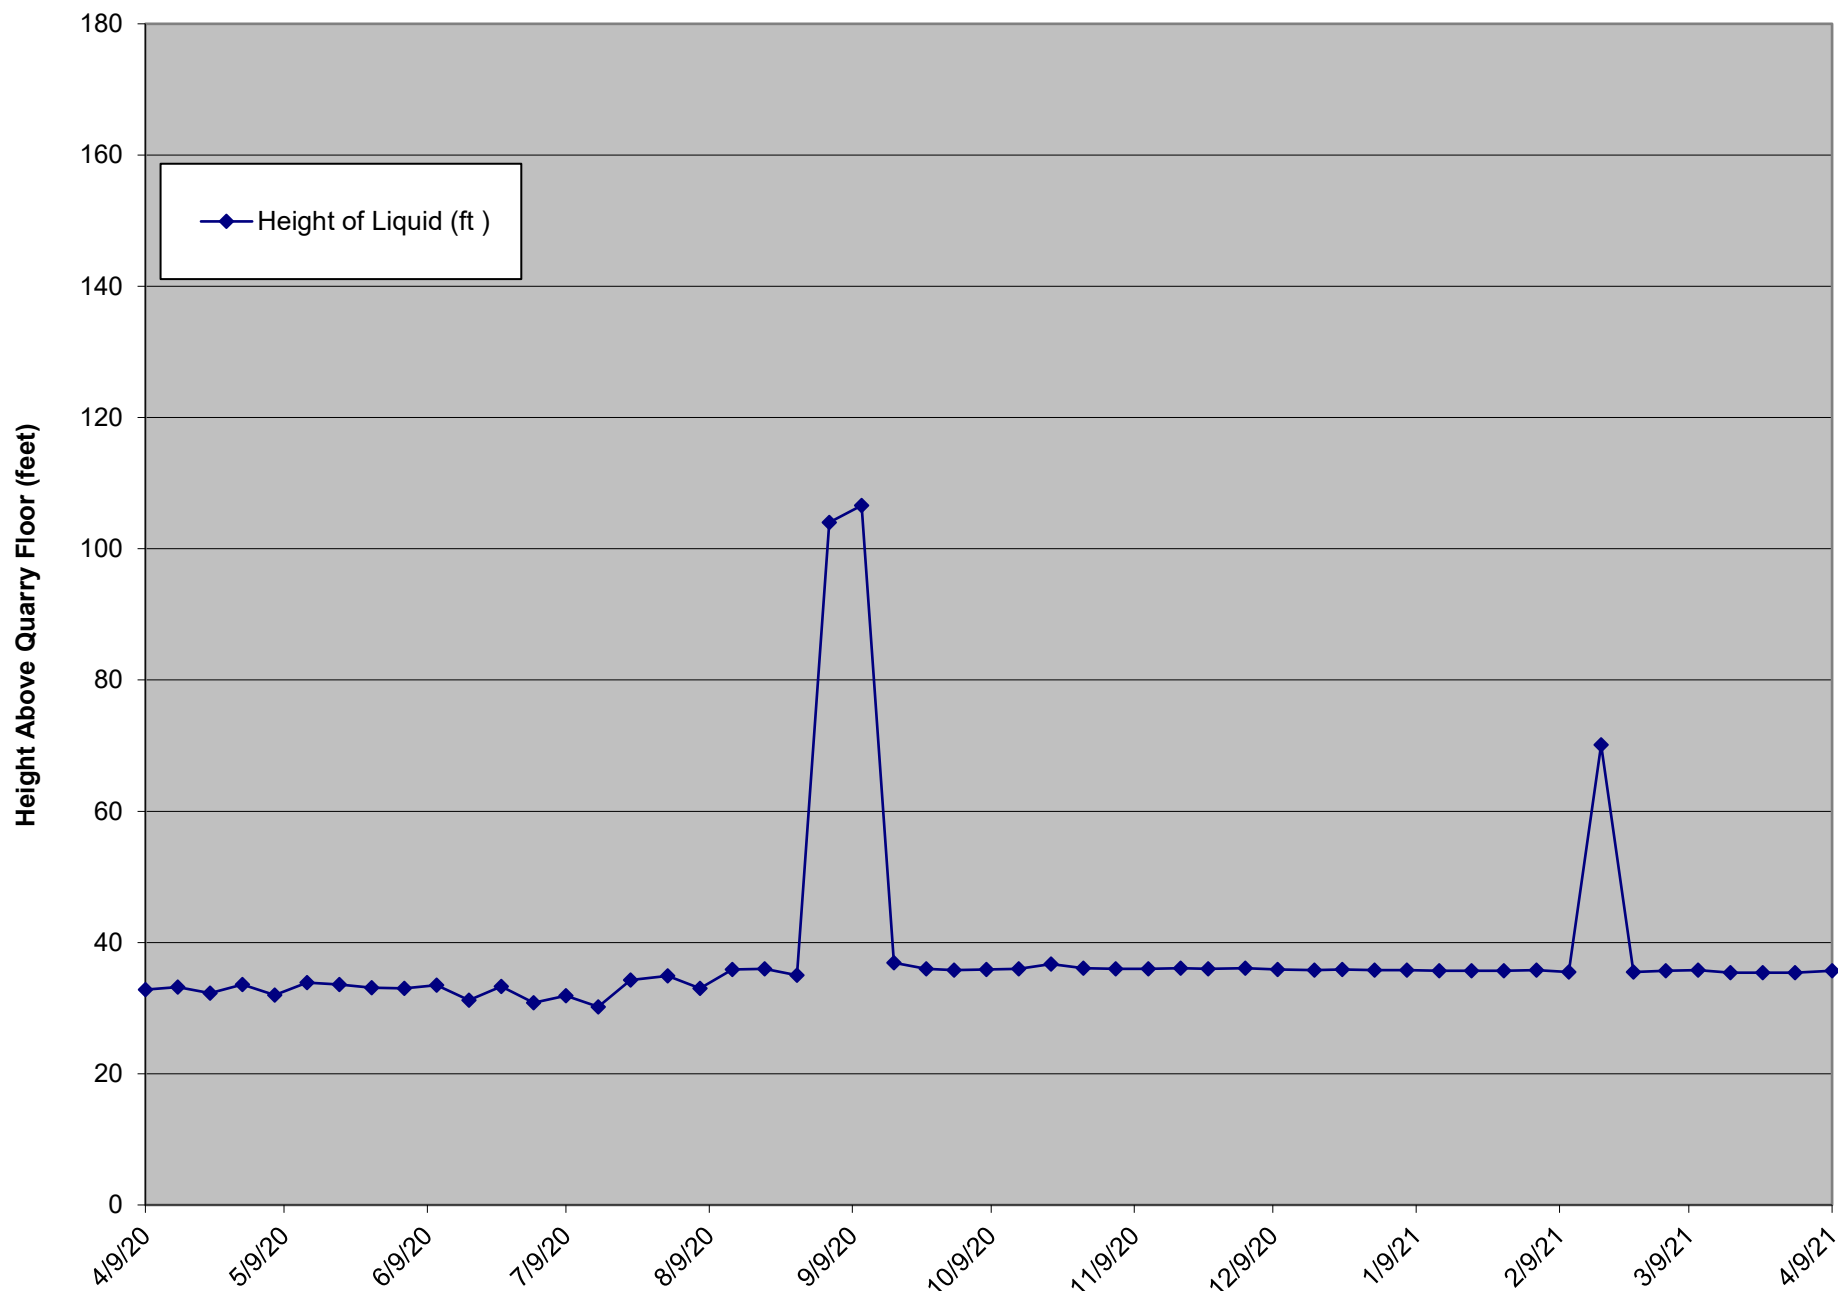
LCS-5B Liquid Level Above Quarry Floor

The pump in LCS-5B and LCS-6B were fully operational during the weekly reporting period.

*The LCS-5B pump was turned off on 8/31/20 for foremain repairs leading to an increase in liquid level. The pump was replaced on 9/17/20.
