# **Bridgeton Landfill, LLC**

## **Weekly Data Submittal**

**Week of February 12, 2017 – February 18, 2017**

**Required by Section 52.F of Agreed Order, Case No. 13SL-CC01088  
Effective May 13, 2013**

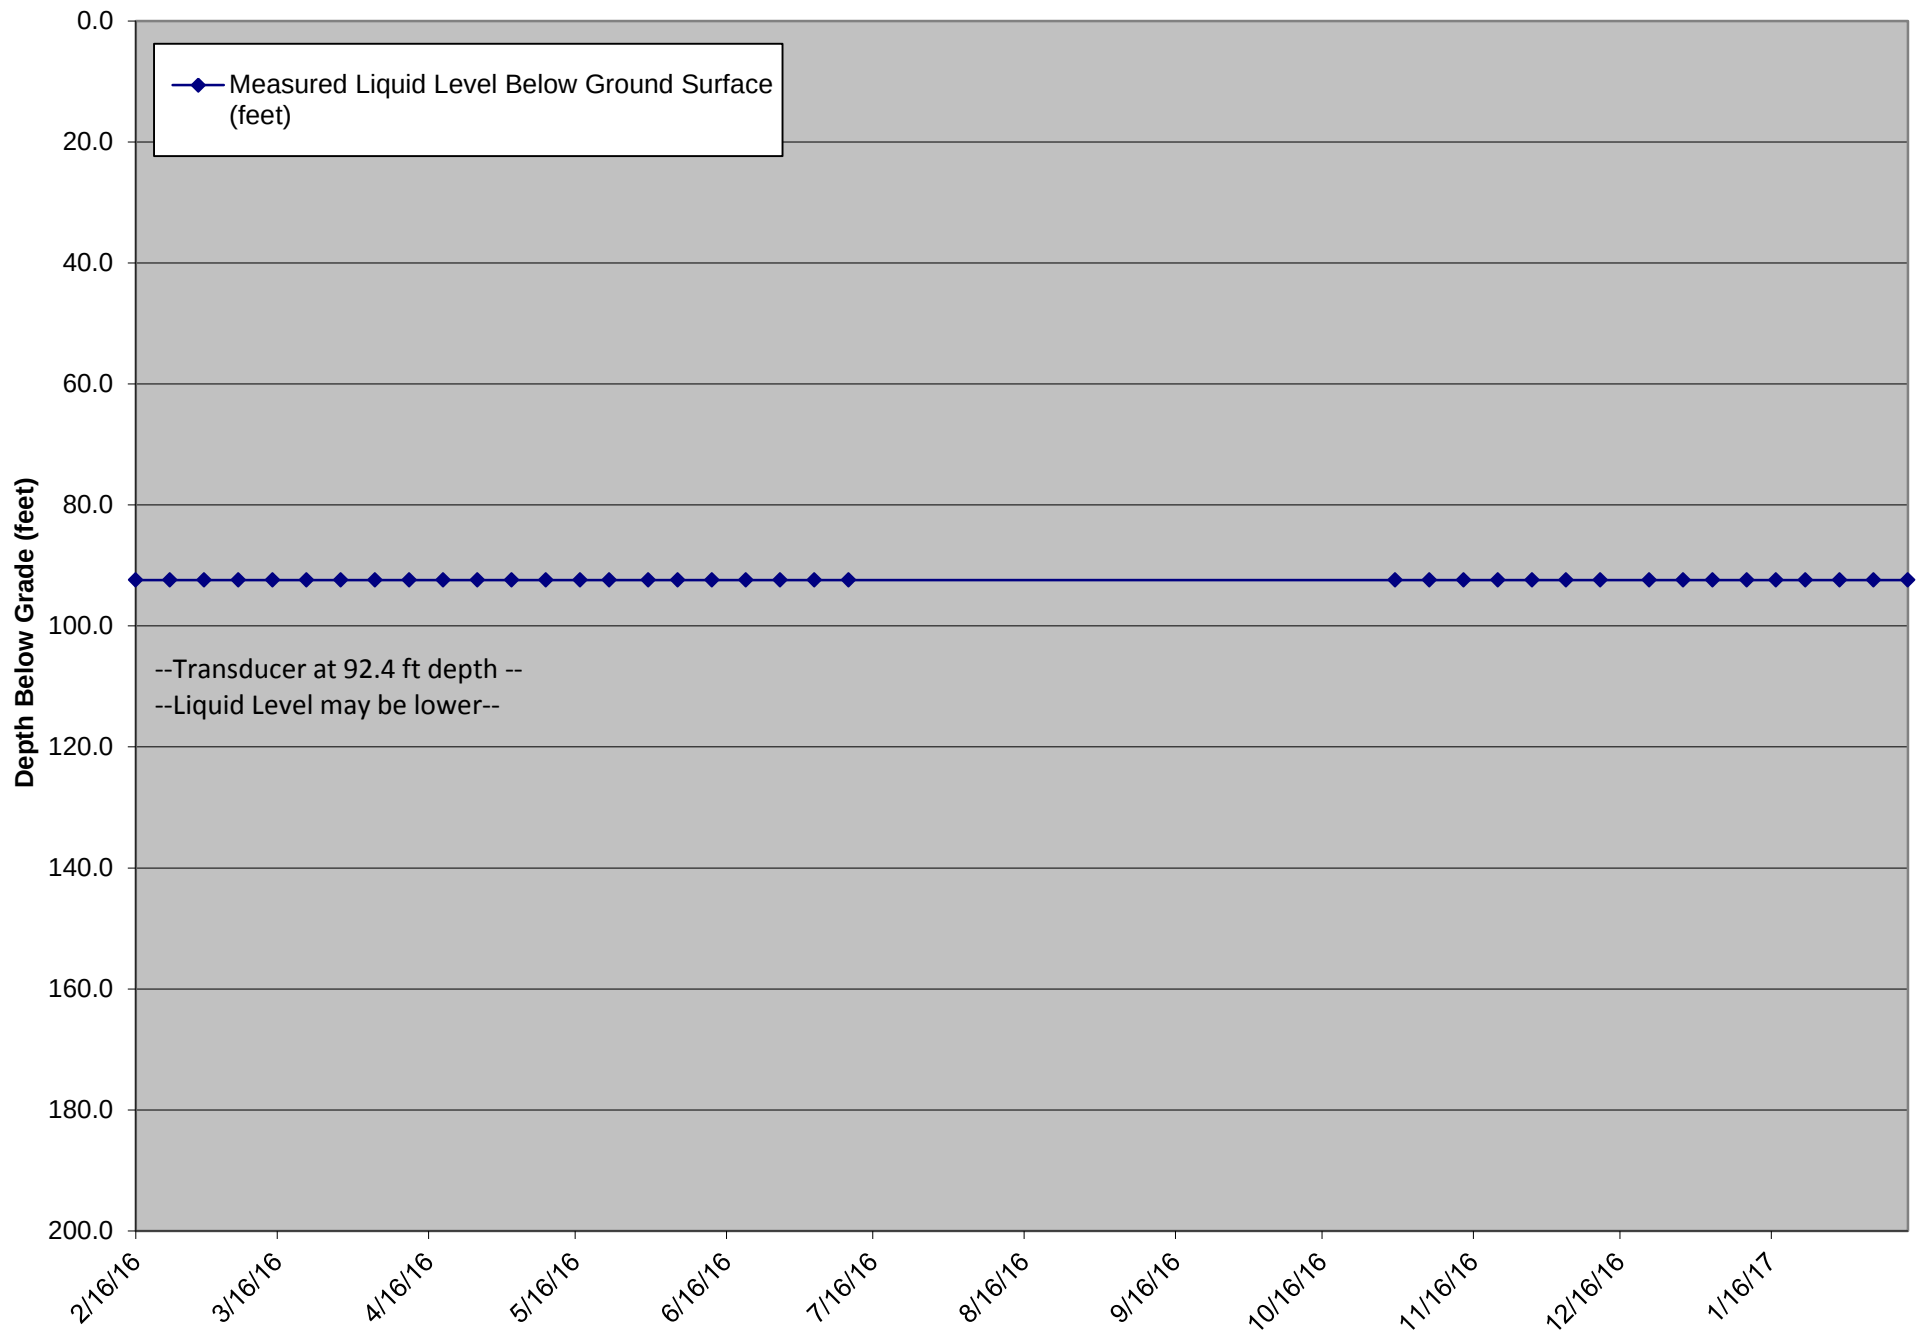
# LCS-1D Liquid Level Below Ground Surface

LCS-1D is equipped with a level sensor and a flow meter. Liquid level was not recorded by the level sensor during the weekly reporting period. The flow meter on LCS-1D displayed flow during the weekly reporting period. Bridgeton Landfill is currently evaluating the level sensor and flow meter to determine if both are currently operational.

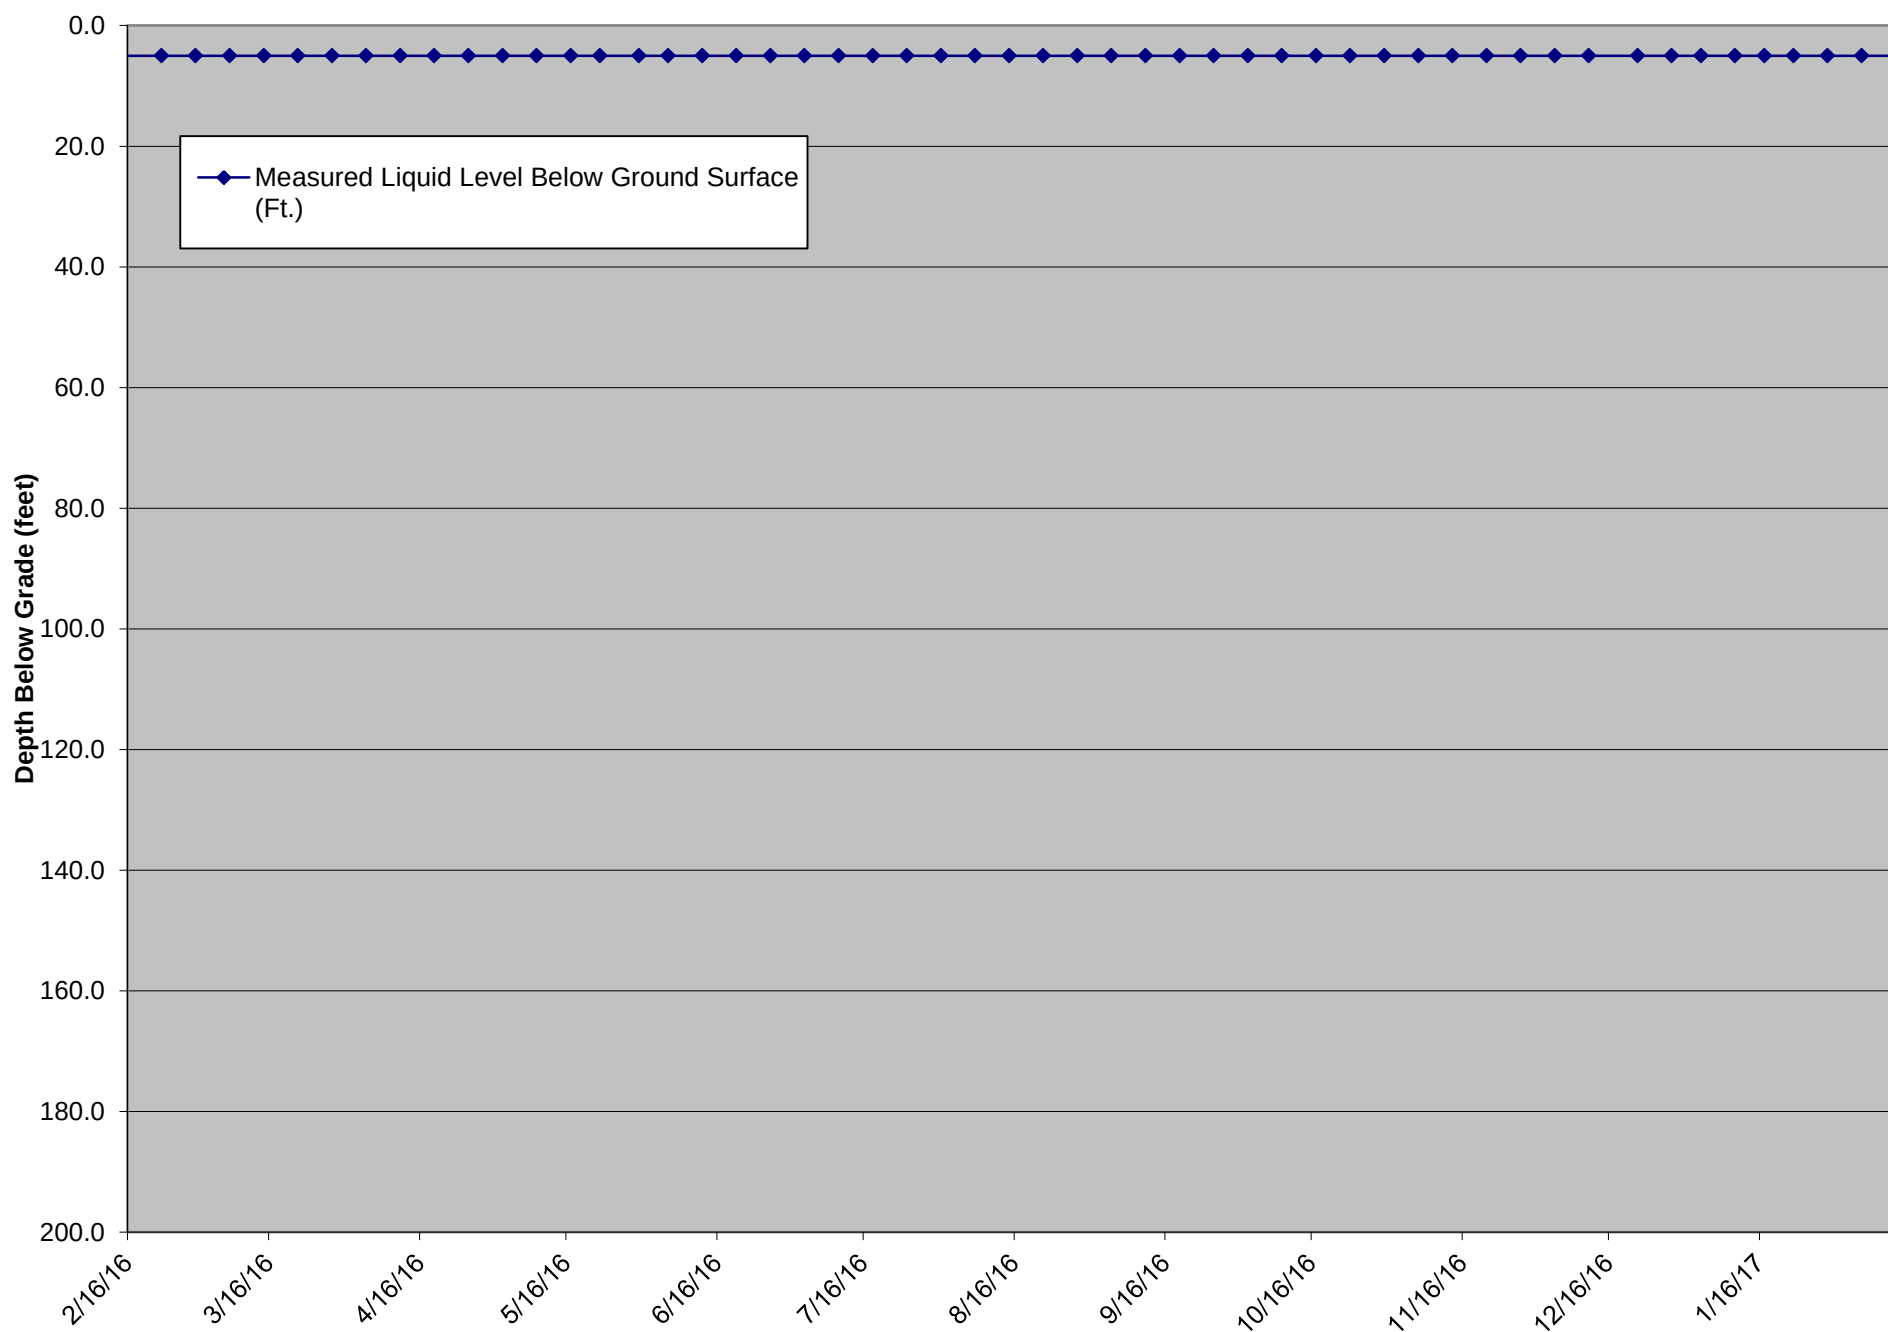
# LCS-3D Liquid Level Below Ground Surface

The pump in LCS-3D was non-operational during the weekly reporting period. The transducer in LCS-3D continued to report liquid levels.

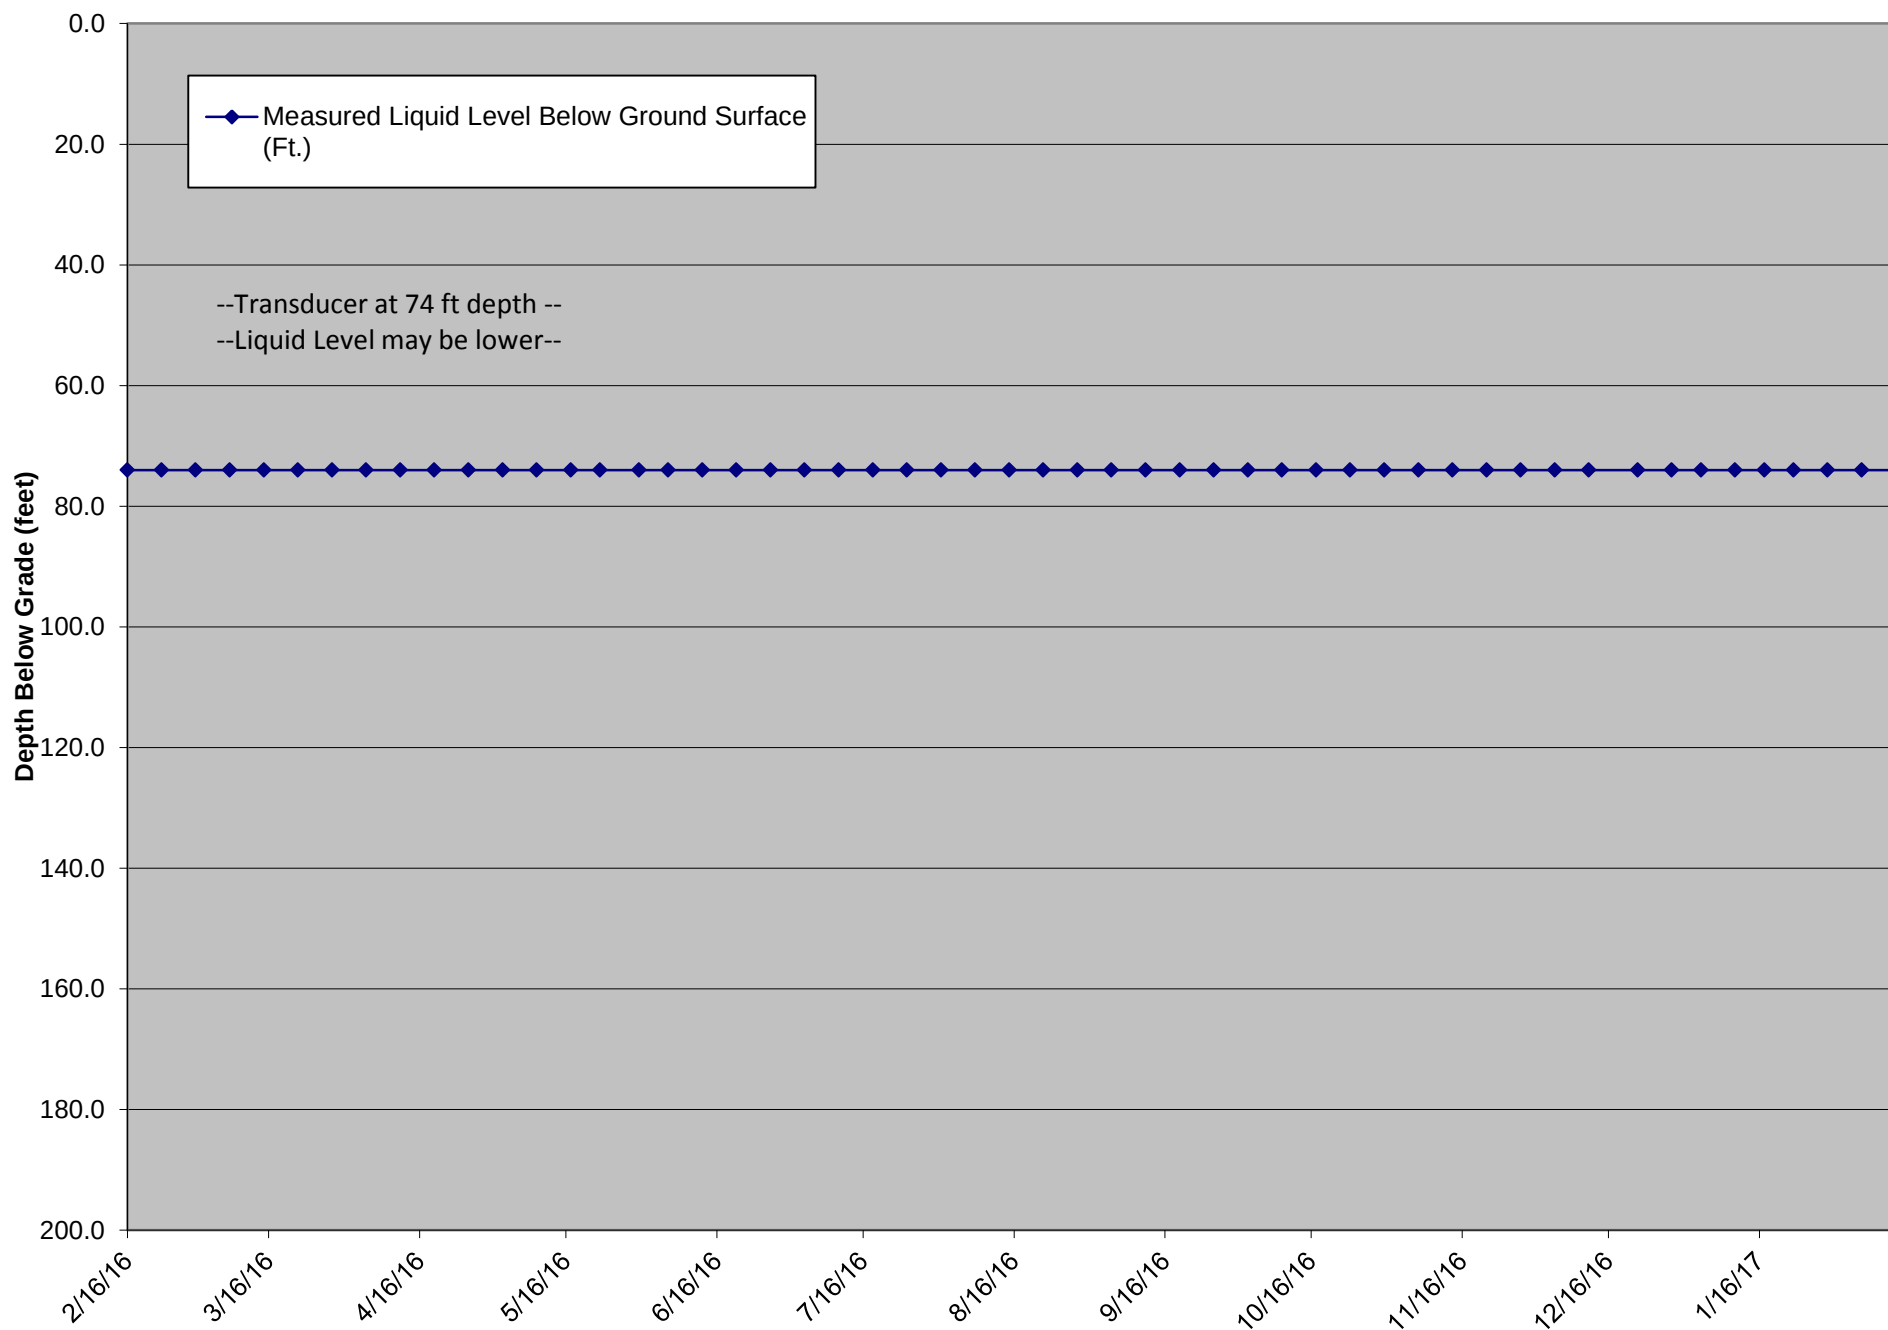
# LCS-4B Liquid Level Below Ground Surface

The level sensor in LCS-4B is currently operational and responsive. Liquid level was not recorded by the level sensor during the weekly reporting period. LCS-4B is equipped with a flow meter that displayed no flow during the weekly reporting period. Therefore, it can be concluded that the liquid level was below the bottom of the pump and level sensor in LCS-4B.

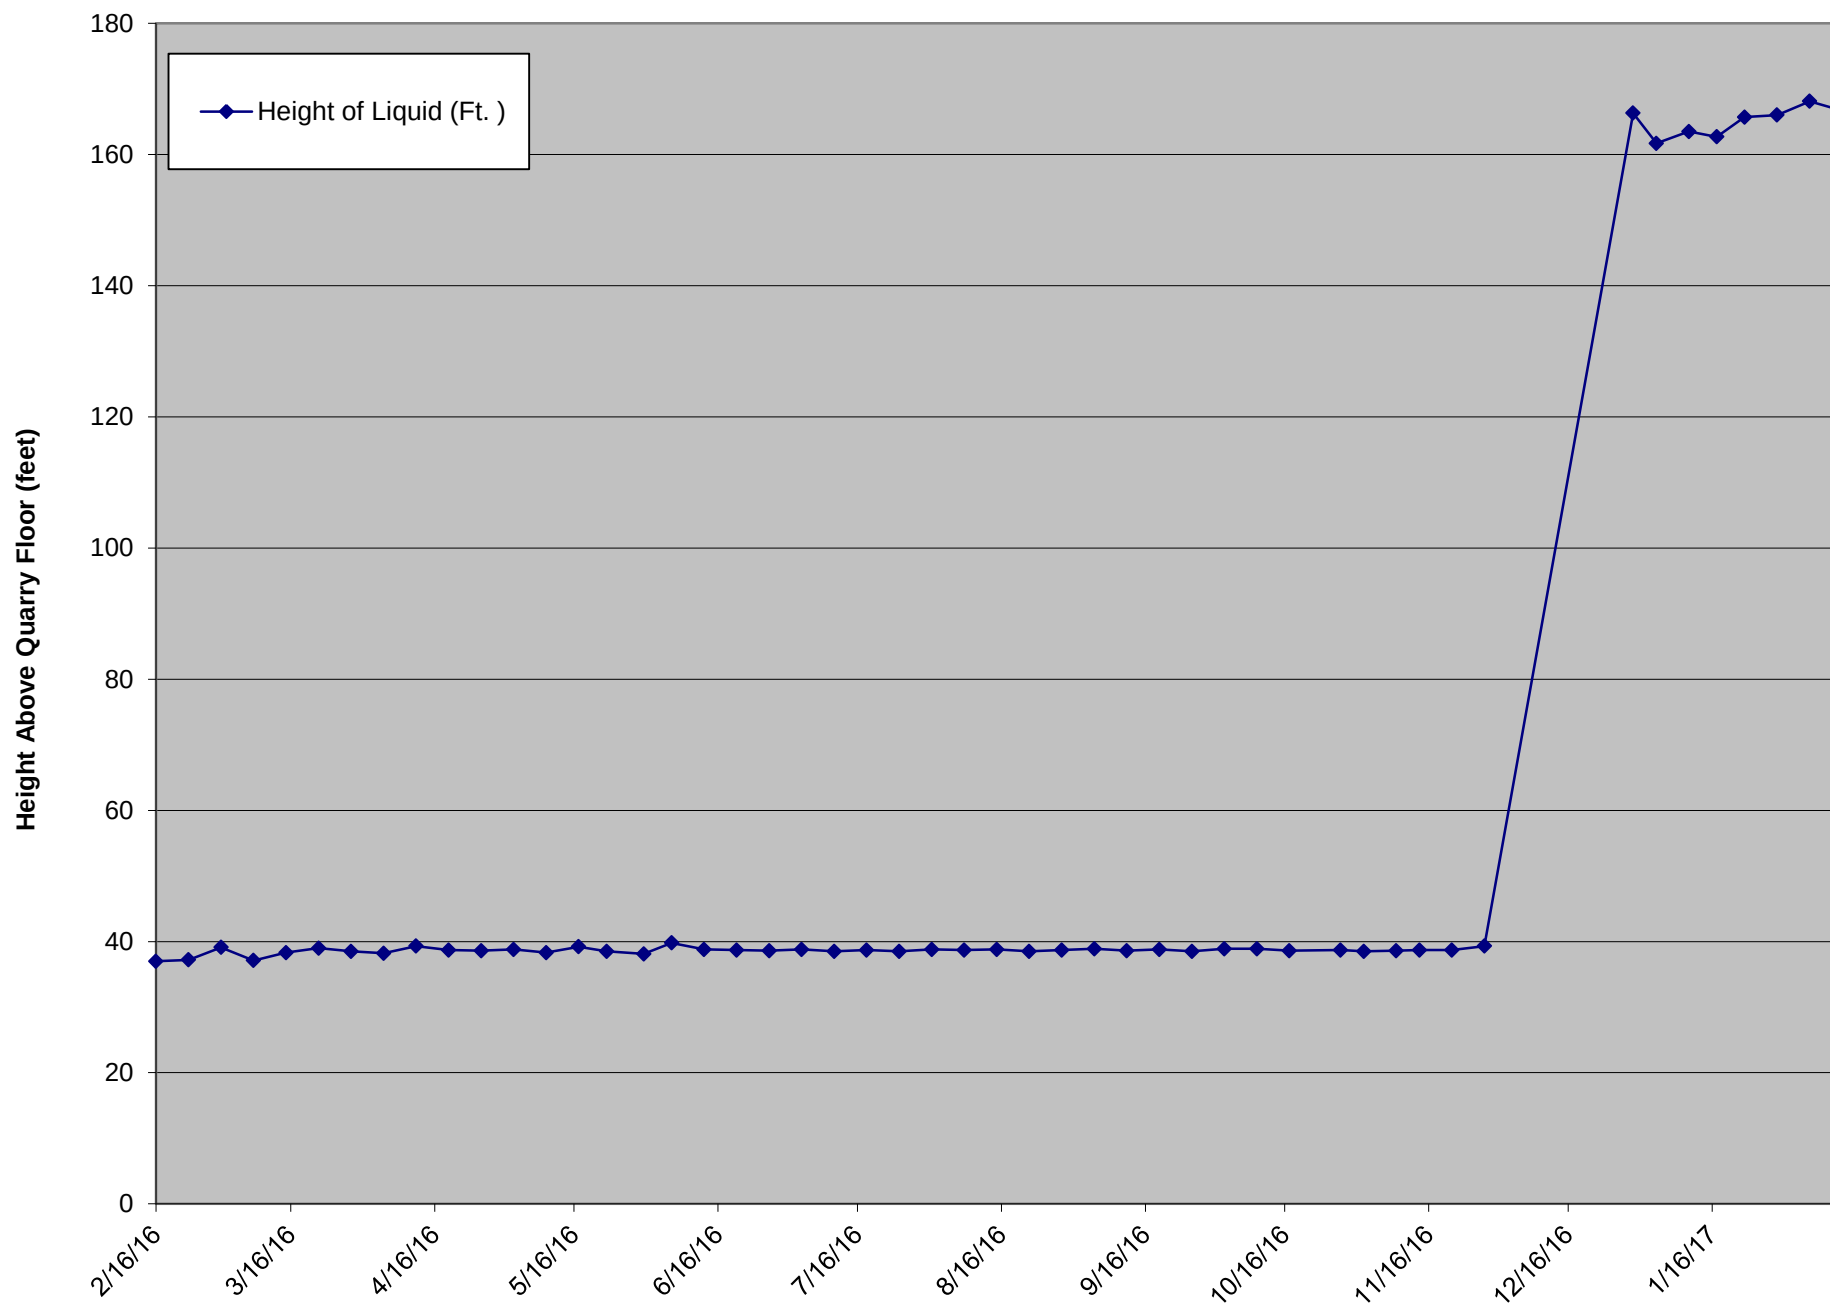
LCS-5A Liquid Level Above Quarry Floor

The pump and level sensor in LCS-5A was replaced and reinstalled the week of 12/26/16. A partial collapse of the sump casing prevented reinstallation of pump and level sensor to the bottom of the sump. The pump and level sensor were set above the partial collapse and are fully operational.

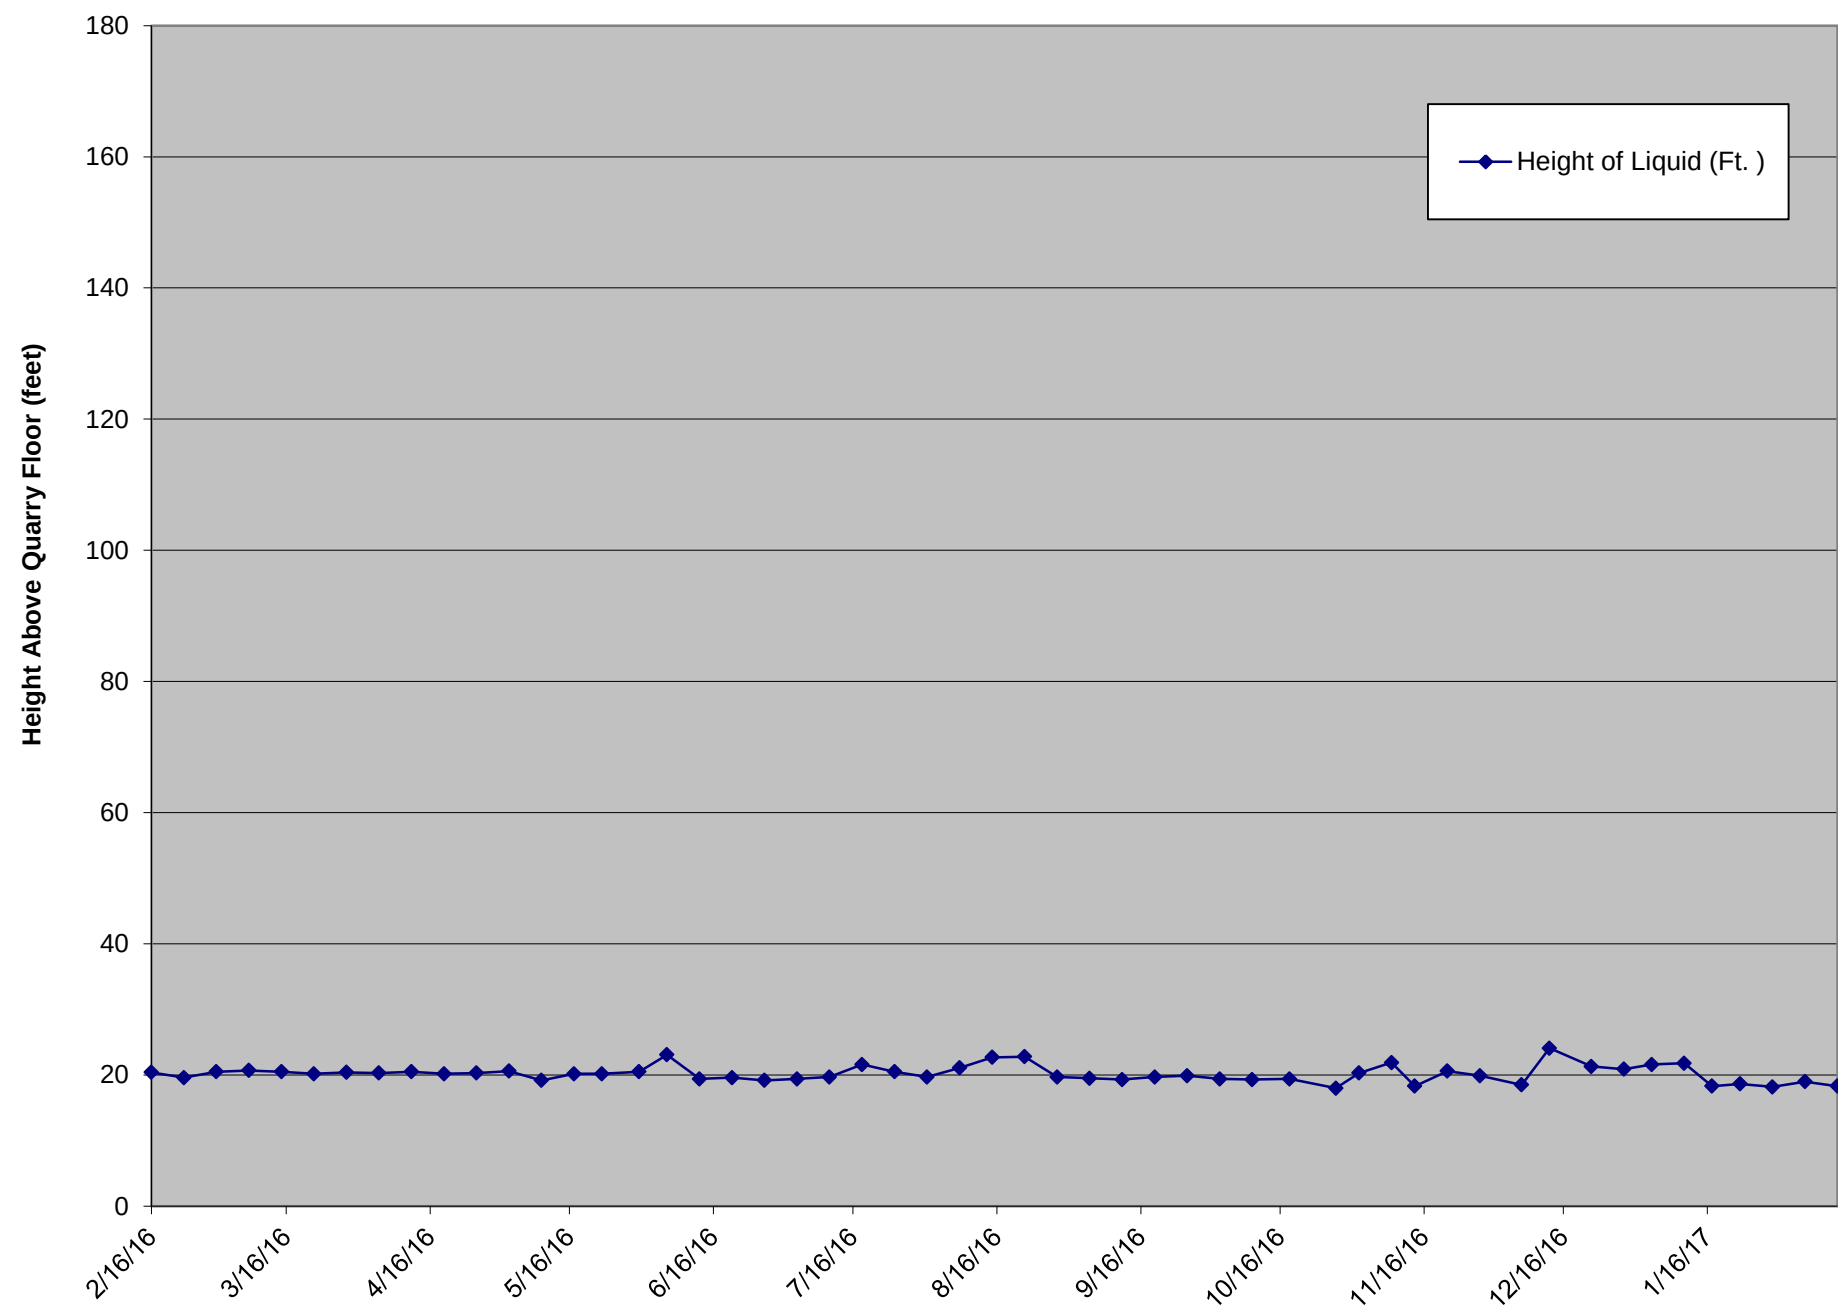
LCS-6B Liquid Level Above Quarry Floor

LCS-6B was fully operational during the weekly reporting period.

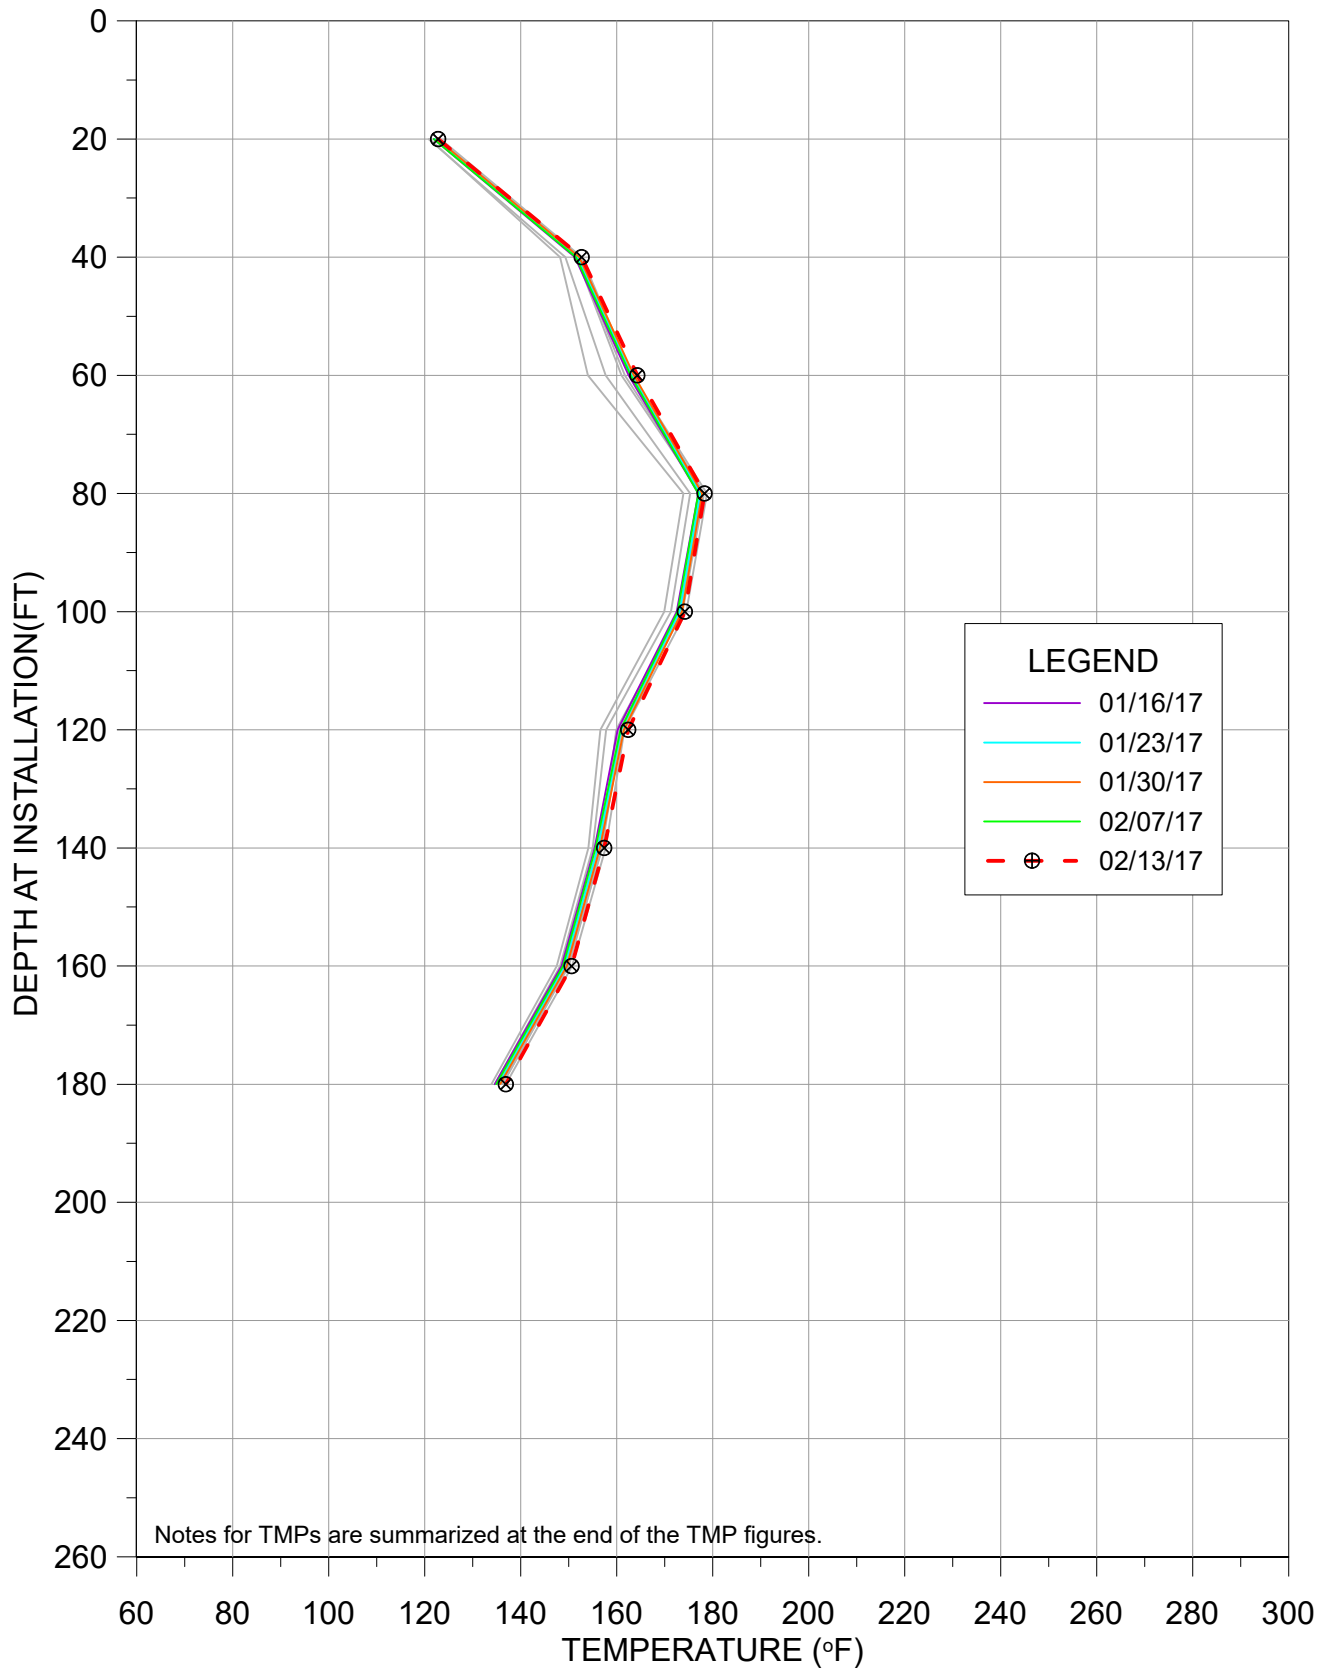
# TMP-2R

1. Data reported on 11/29/2016 was inadvertently left as the 11/22/2016 data. This was corrected on 12/5/2016 reading submittal.

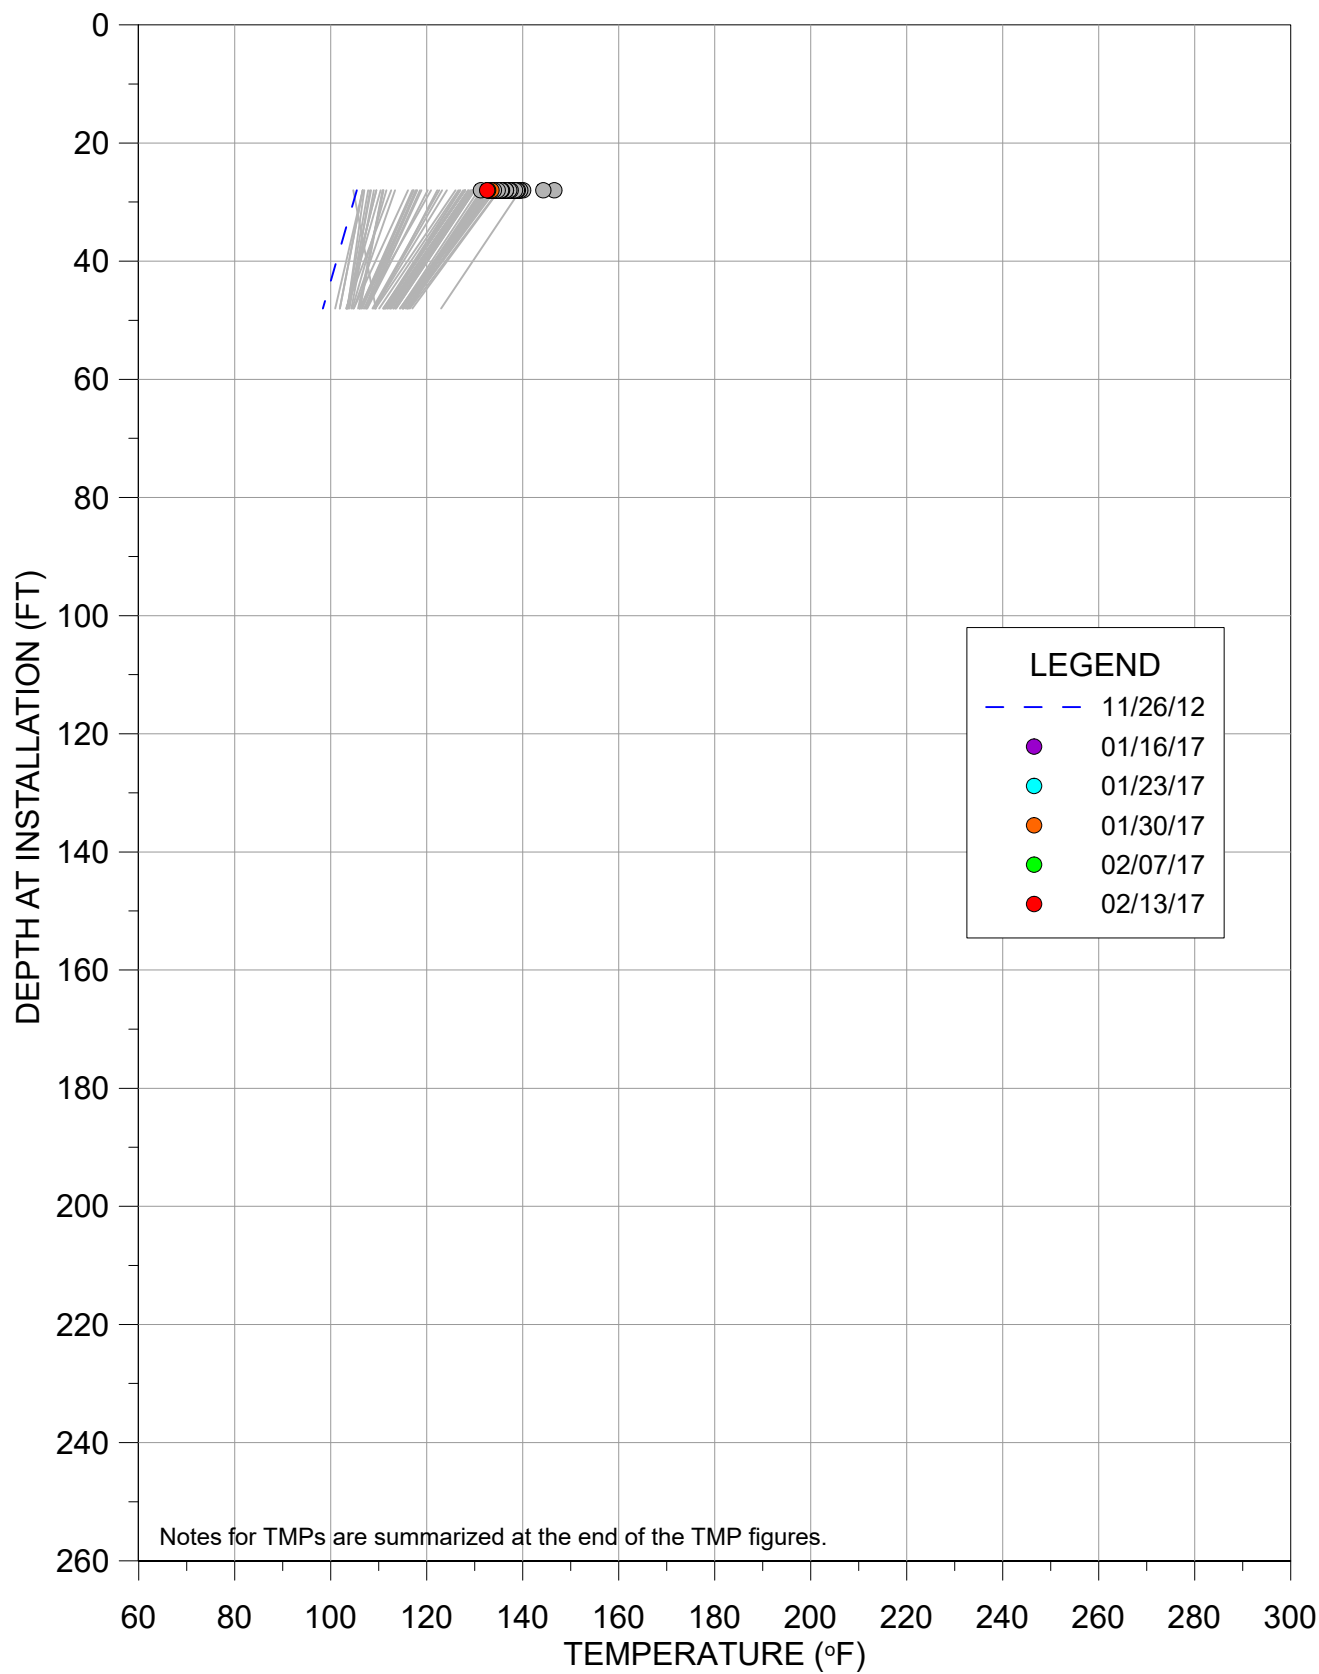
# TMP-4

1. The connectivity tests on 4/11/2014 conducted by CEC showed that the unit at 48 ft depth is no longer reliable.

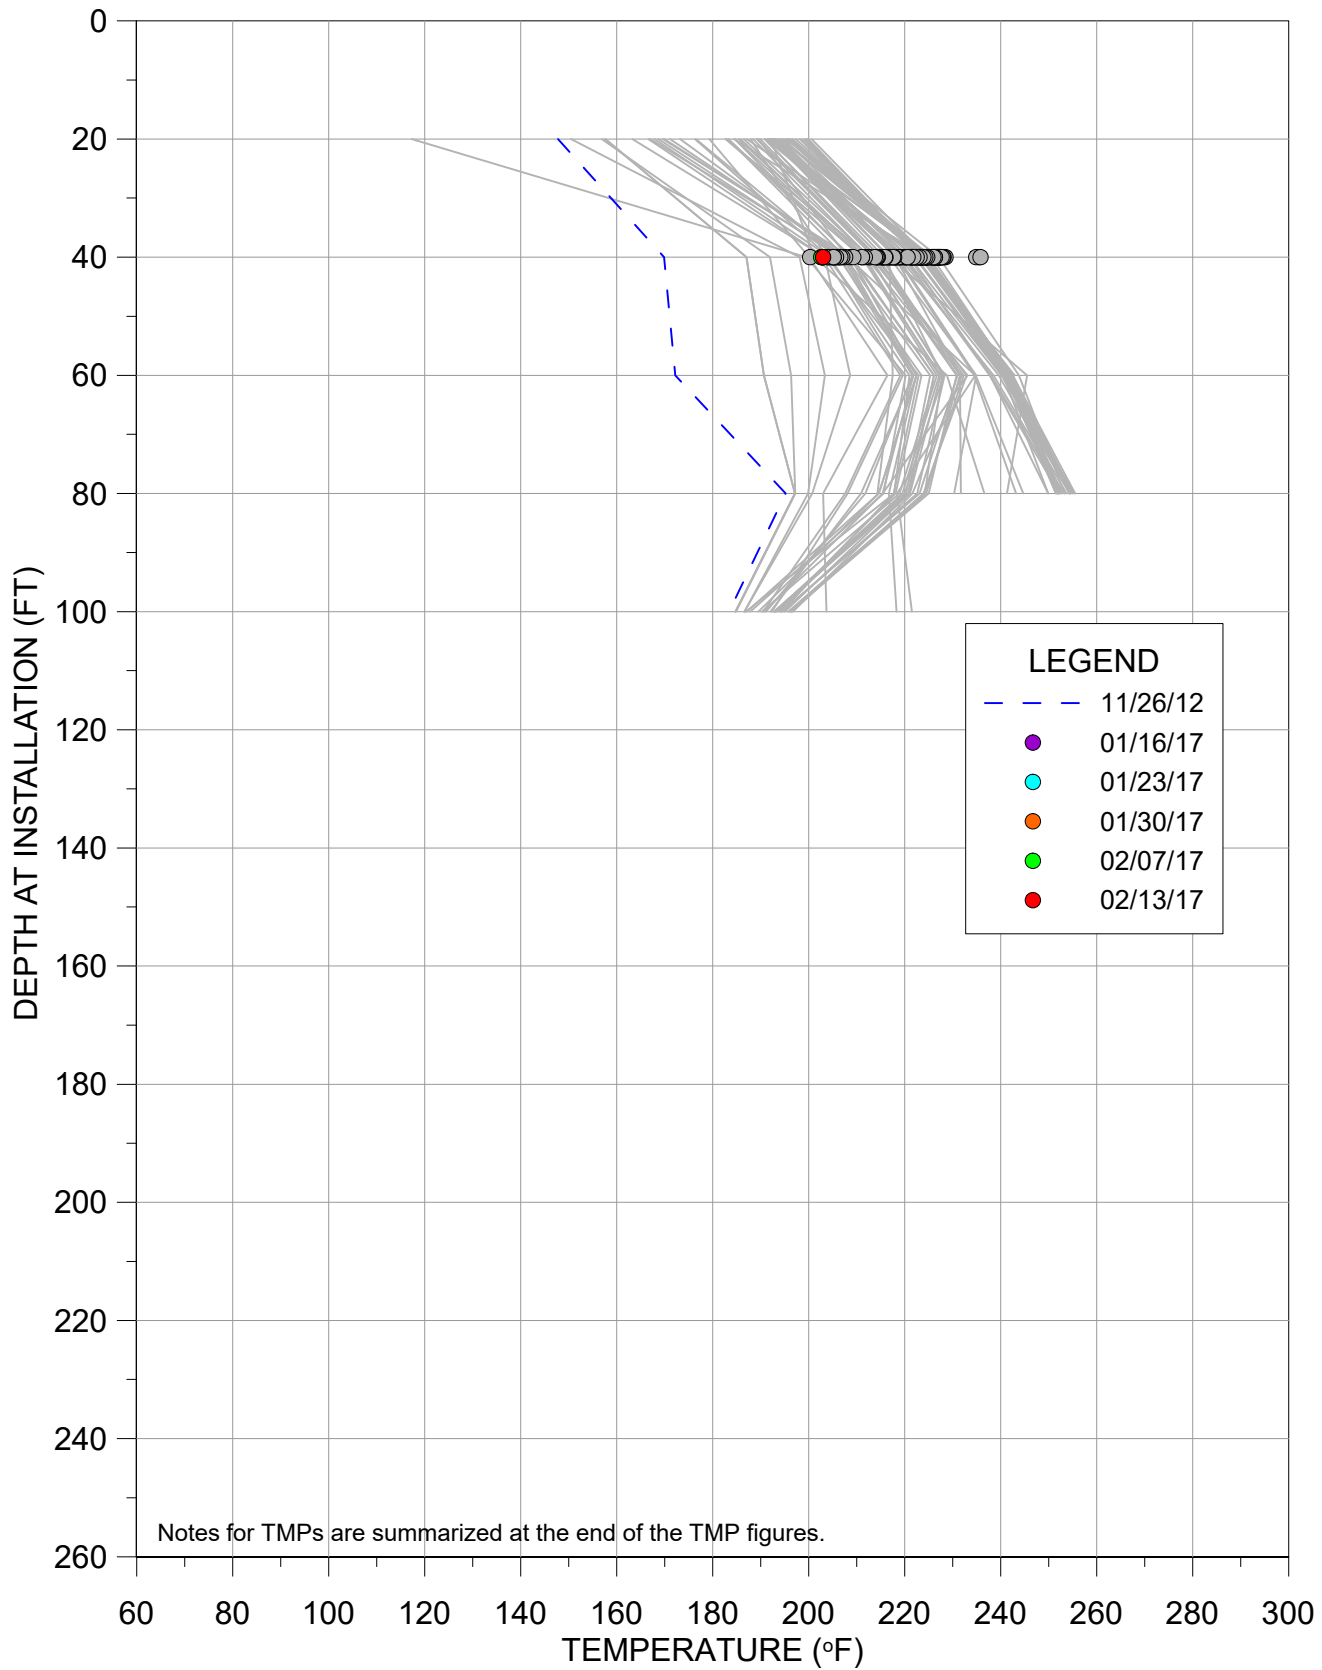
# TMP-9

1. Unit at 100 ft depth had an inaccurate temperature reading on 8/1/2013 and no reading since 8/6/2013.
2. The connectivity tests on 4/11/2014 conducted by CEC showed that units at 20, 60, 80, and 100 ft depths are no longer reliable.

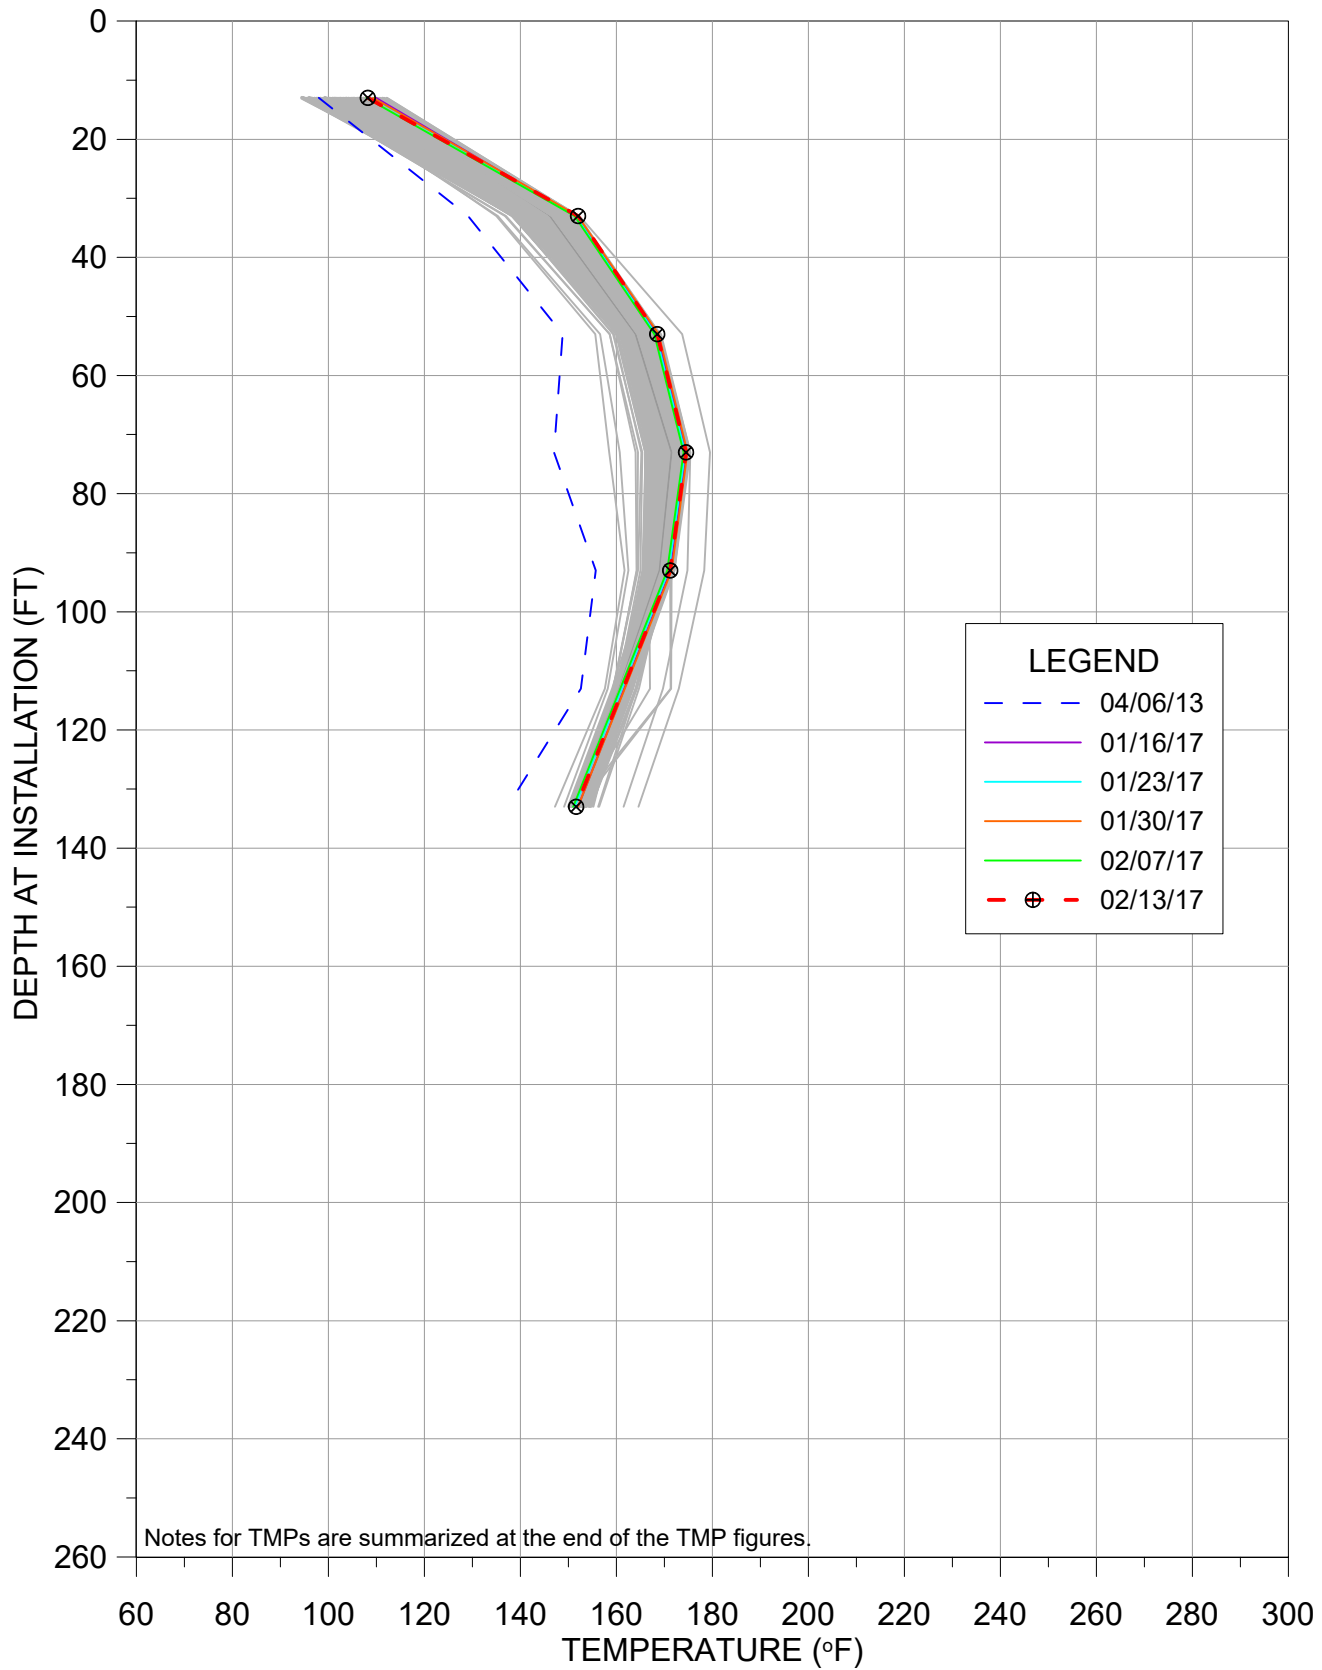
# TMP-10

1. Unit at 113 ft had resistance below the minimum level, change in resistance occurred as of 11/08/16 and has remained below acceptable level.
