# **Bridgeton Landfill, LLC**

## **Weekly Data Submittal**

**Week of February 12, 2017 – February 18, 2017**

**Required by Section 52.F of Agreed Order, Case No. 13SL-CC01088  
Effective May 13, 2013**

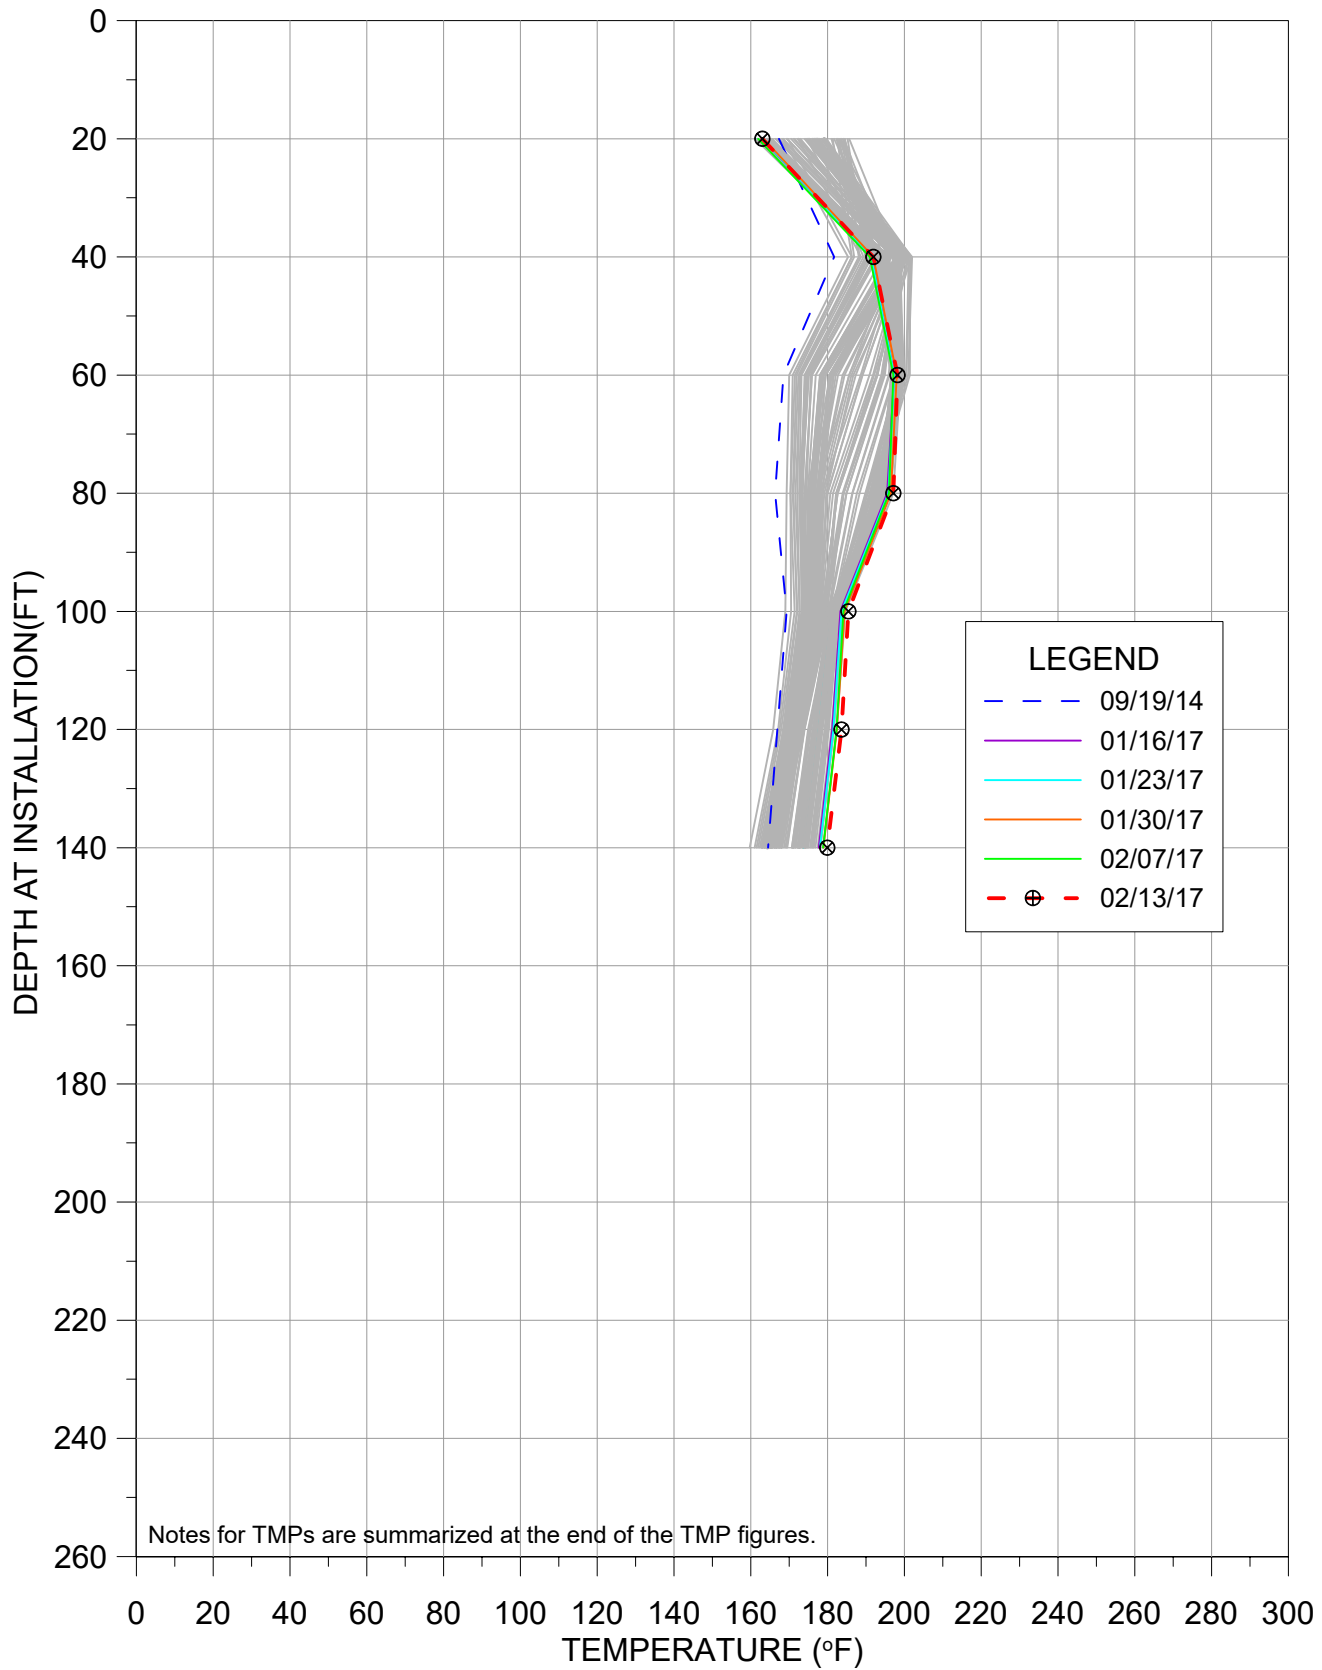
# TMP-14R

1. Due to the connectivity test results by Feezor Engineering on TMP-14 (see note above), TMP-14R is added to this reporting data set as of 3/7/2016.

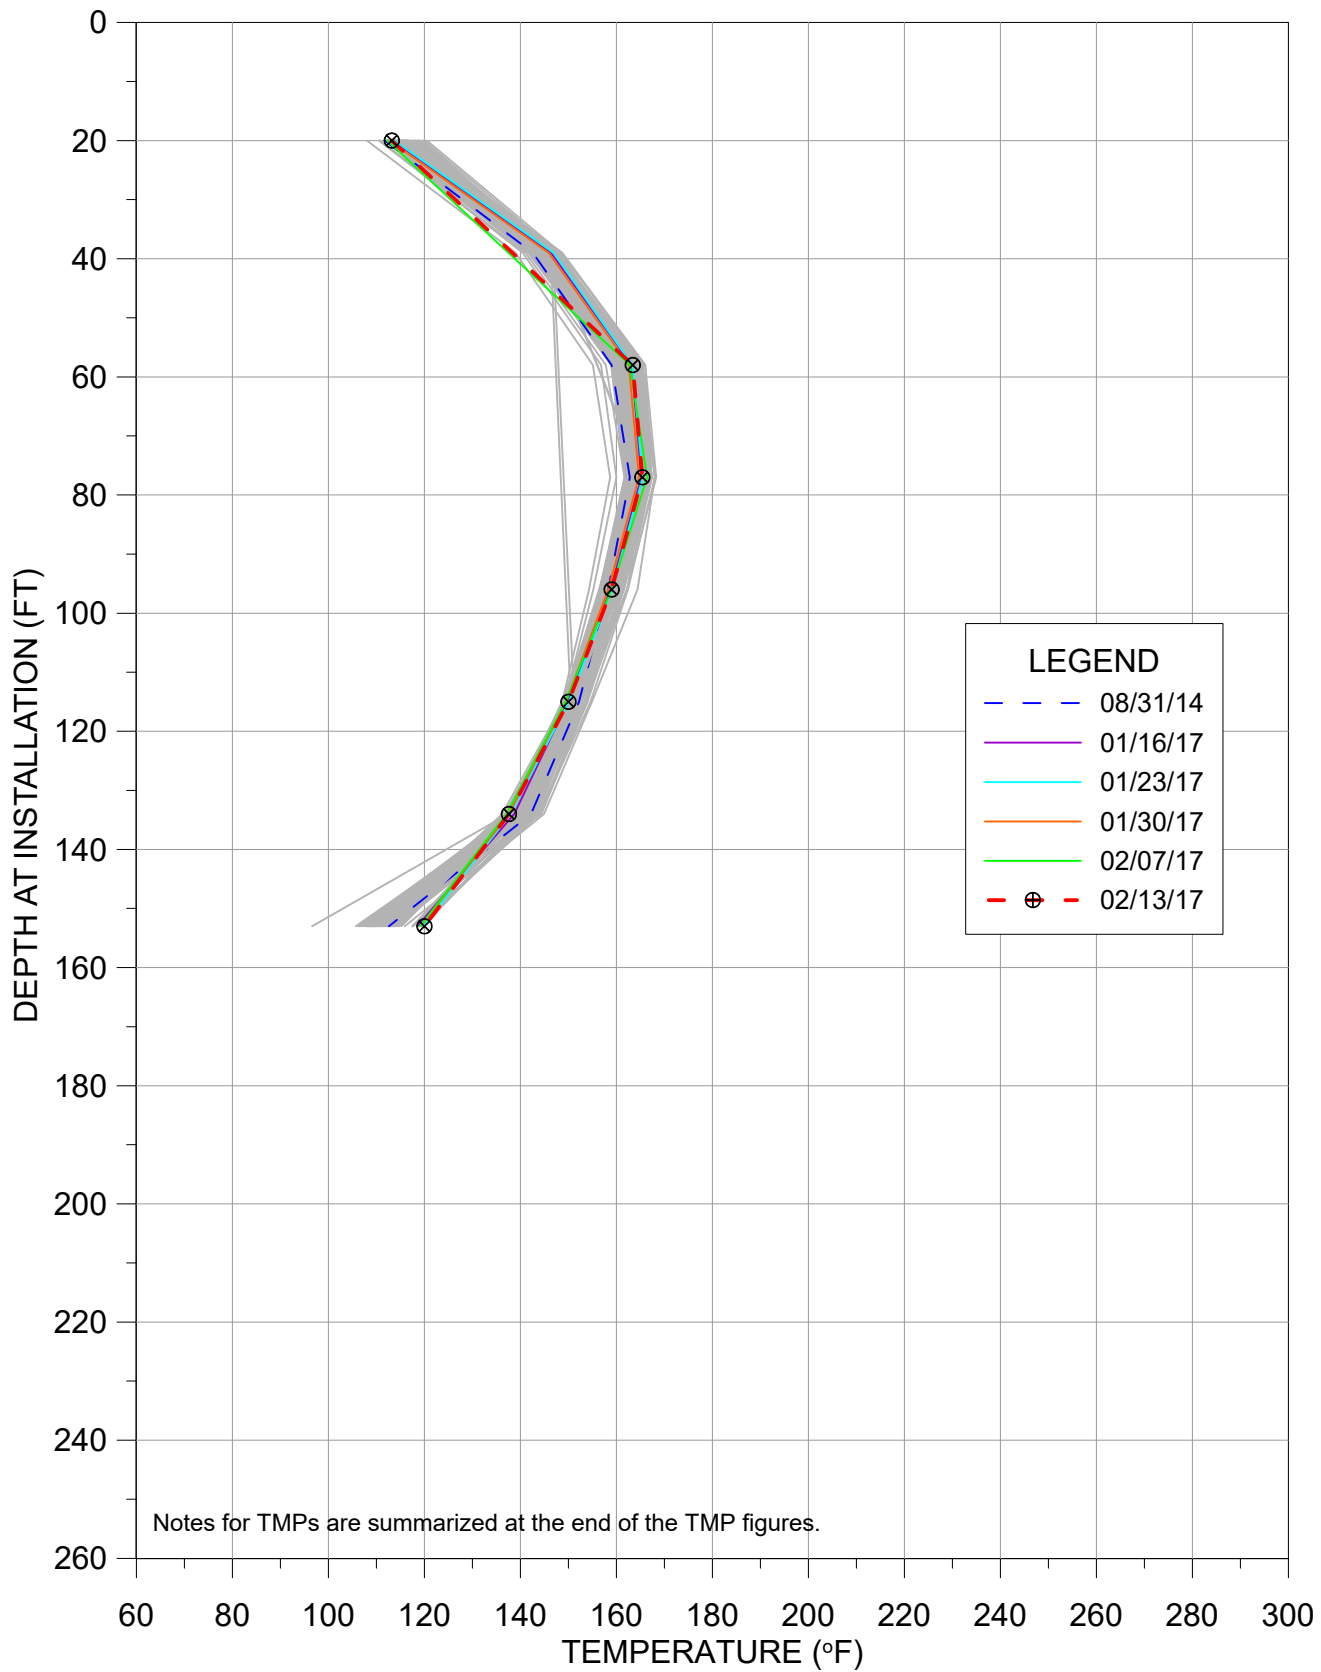
# TMP-16

1. A connectivity test conducted by Feezor Engineering showed that the units on TMP-16 may not be reliable since 9/9/2015. Further testing at the end of September 2015 showed possible connectivity on some of the units.
2. The unit at 153 ft depth had a low resistance reading and unreliable temperature since 12/21/2015.

3. The unit at 39 ft depth had a higher than acceptable resistance reading and unreliable temperature since 2/7/2017.

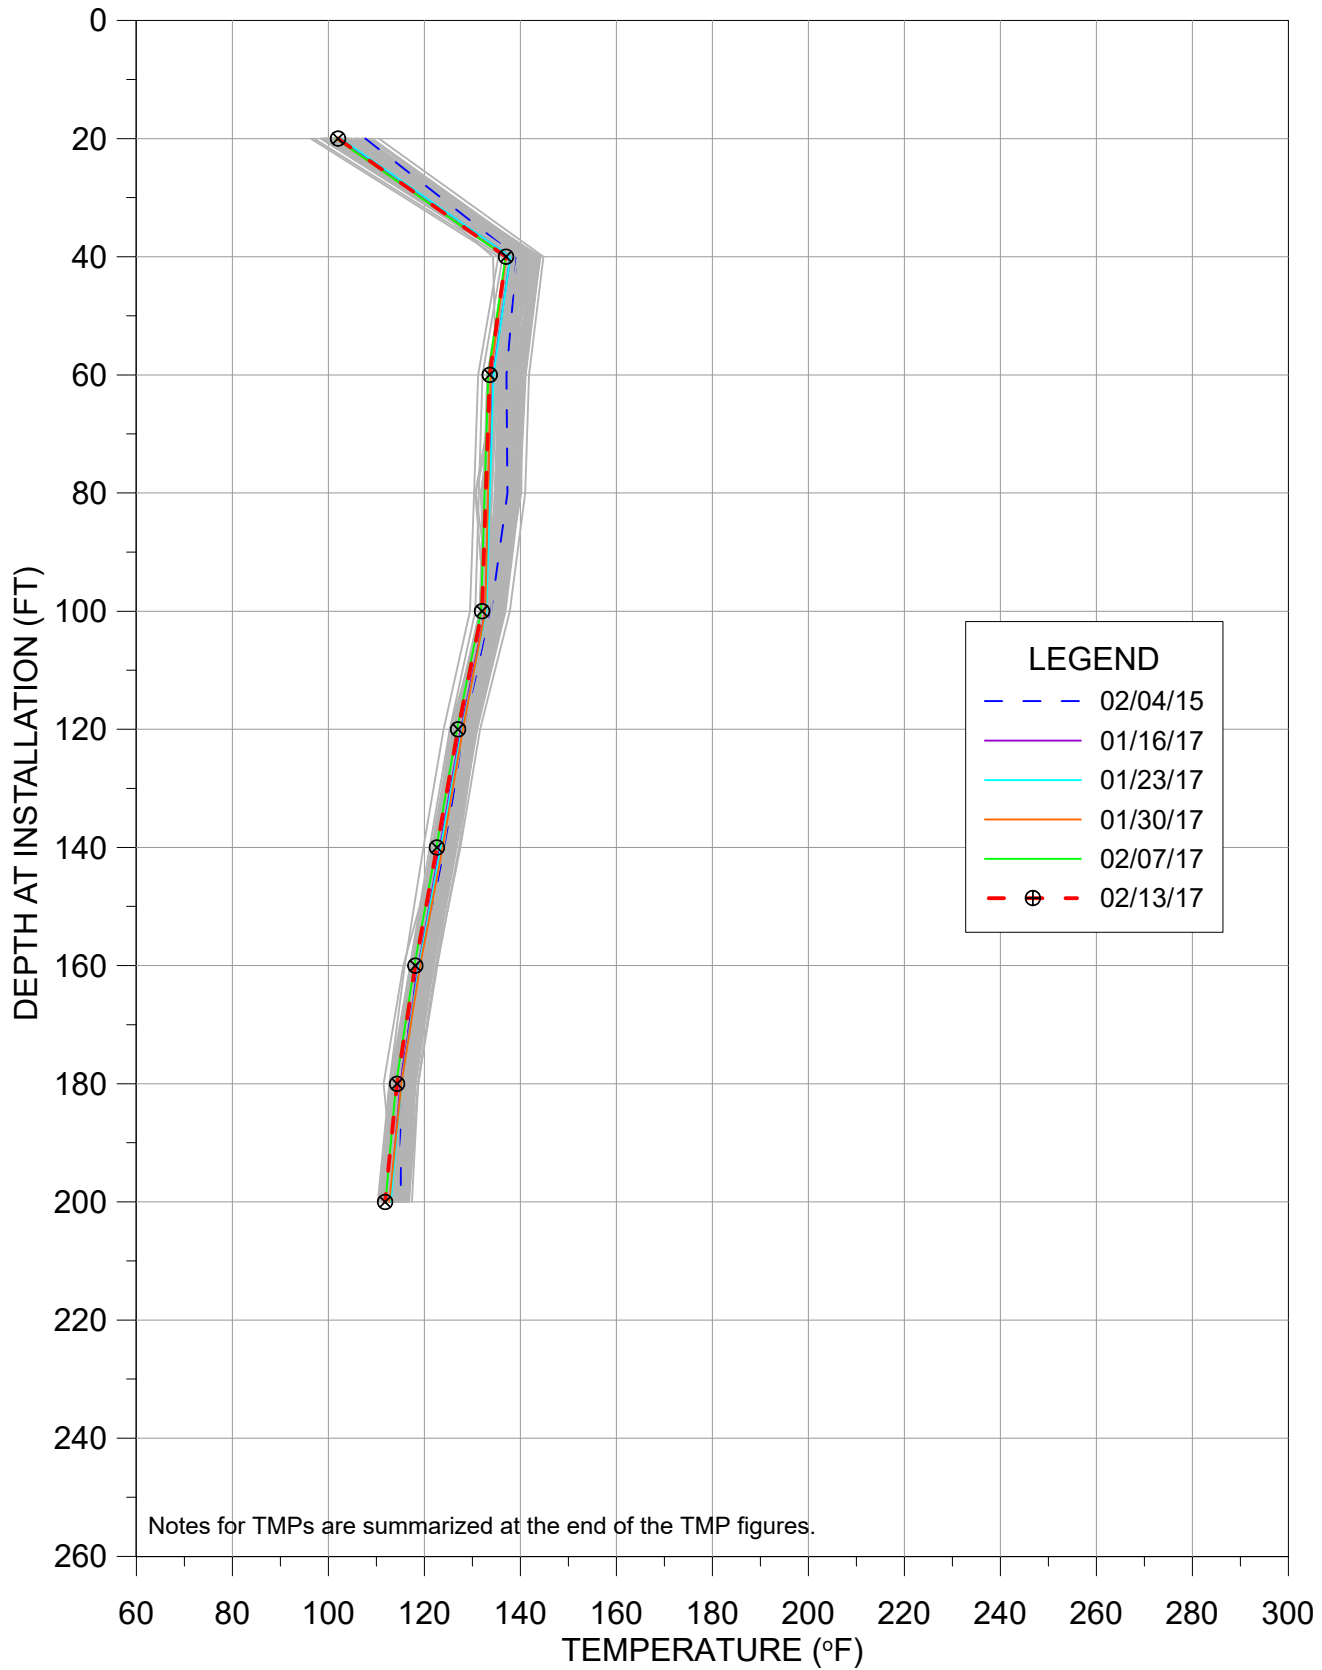
# TMP-28

1. The unit at 217 ft depth has had no resistance or temperature readings since installation.
2. The unit at 80 ft depth had a resistance drop and an unreasonable temperature decrease on 6/1/2016. The temperature has since fluctuated and is determined to be unreliable.

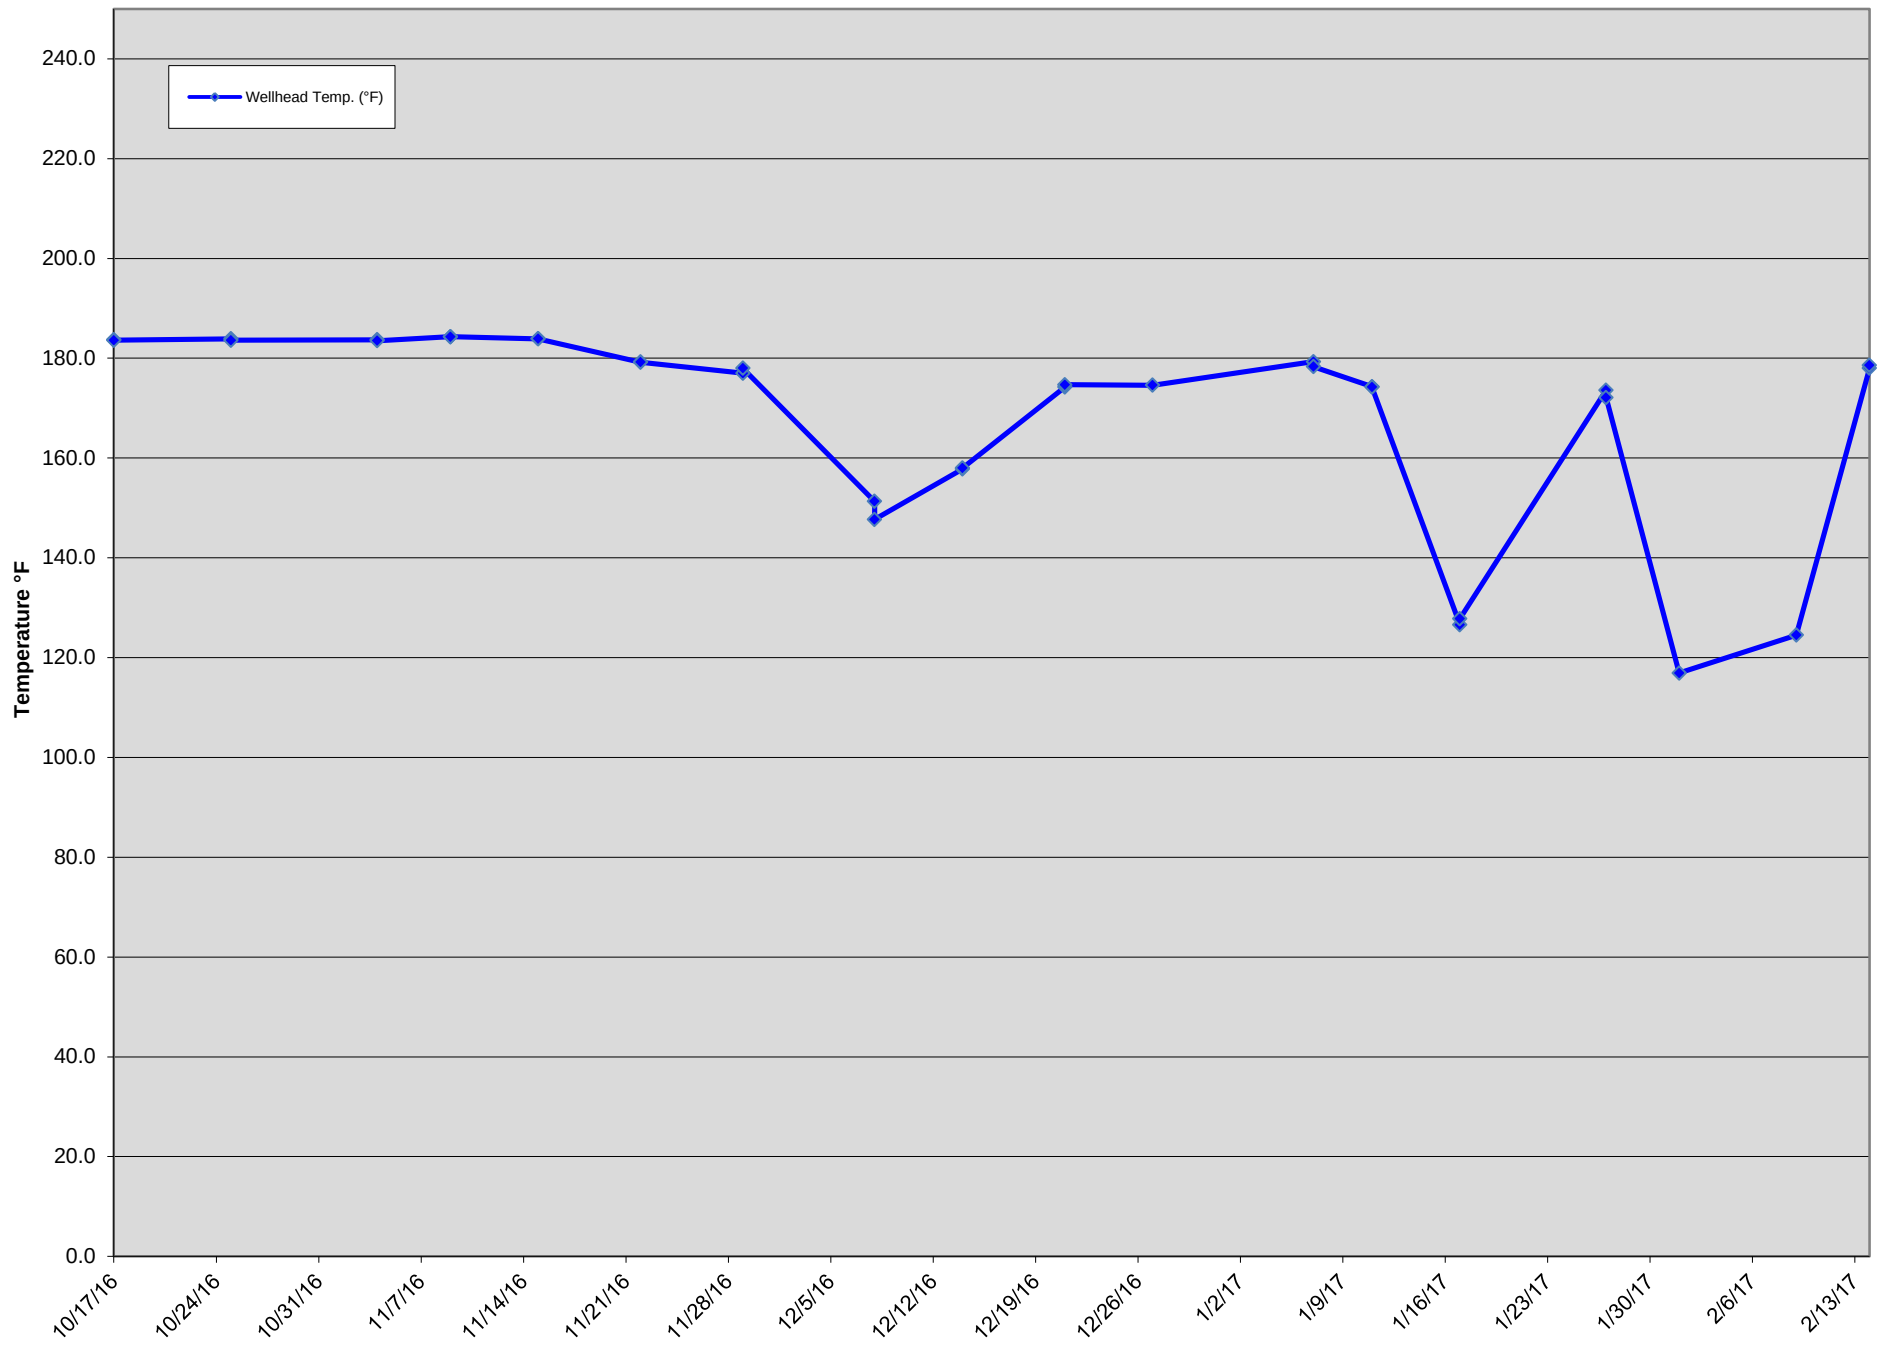
## GIW-1 Wellhead Temperatures

As part of the HES, there are currently cooling water circulation loops installed in twelve Gas Interceptor Wells (GIWs) (GIW-02 through GIW-13). The remaining well (GIW-01) had a measured gas temperature within its historical operating limits.
