# Bridgeton Landfill, LLC

# **Weekly Data Submittal**

Week of March 13, 2016 - March 19, 2016

Required by Section 52.F of Agreed Order, Case No. 13SL-CC01088 Effective May 13, 2013

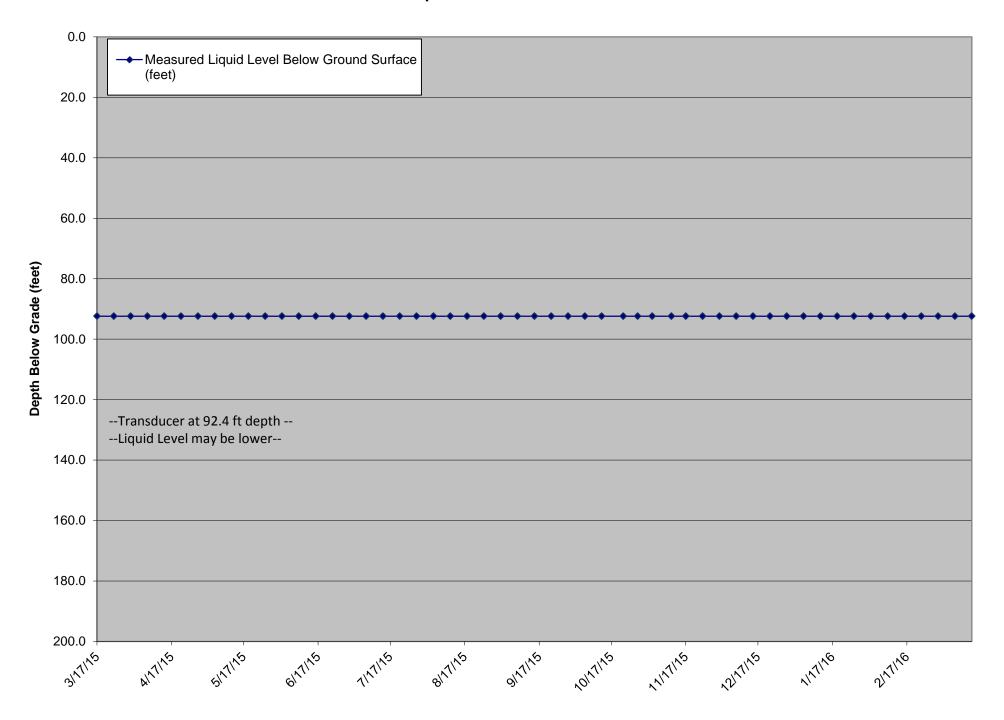
#### **LCS-1D Liquid Level Below Ground Surface**

The level sensors in LCS-1D and LCS-4B are currently operational and responsive. No liquid level was recorded by either level sensor during the weekly reporting period. Both sumps are equipped with flow meters and displayed no flow during the weekly reporting period. Therefore it can be concluded that the liquid level in these sumps is below the bottom of the pump and level sensor in each sump.

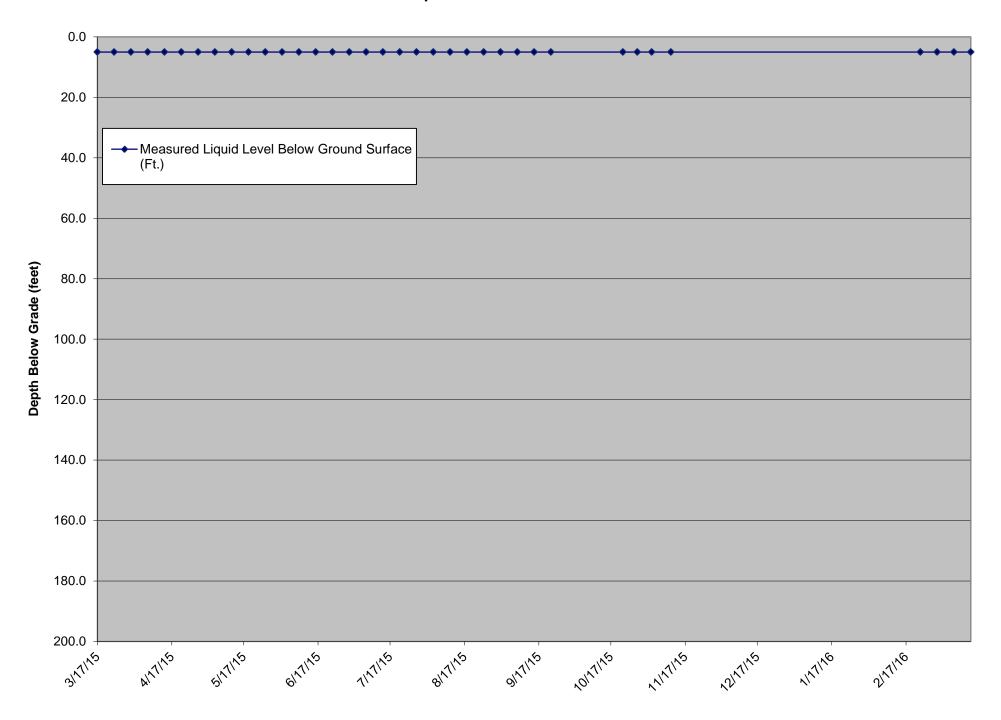
#### **LCS-3D Liquid Level Below Ground Surface**

Leachate Collection Sumps (LCS)-3D was partially operational during the weekly reporting period.

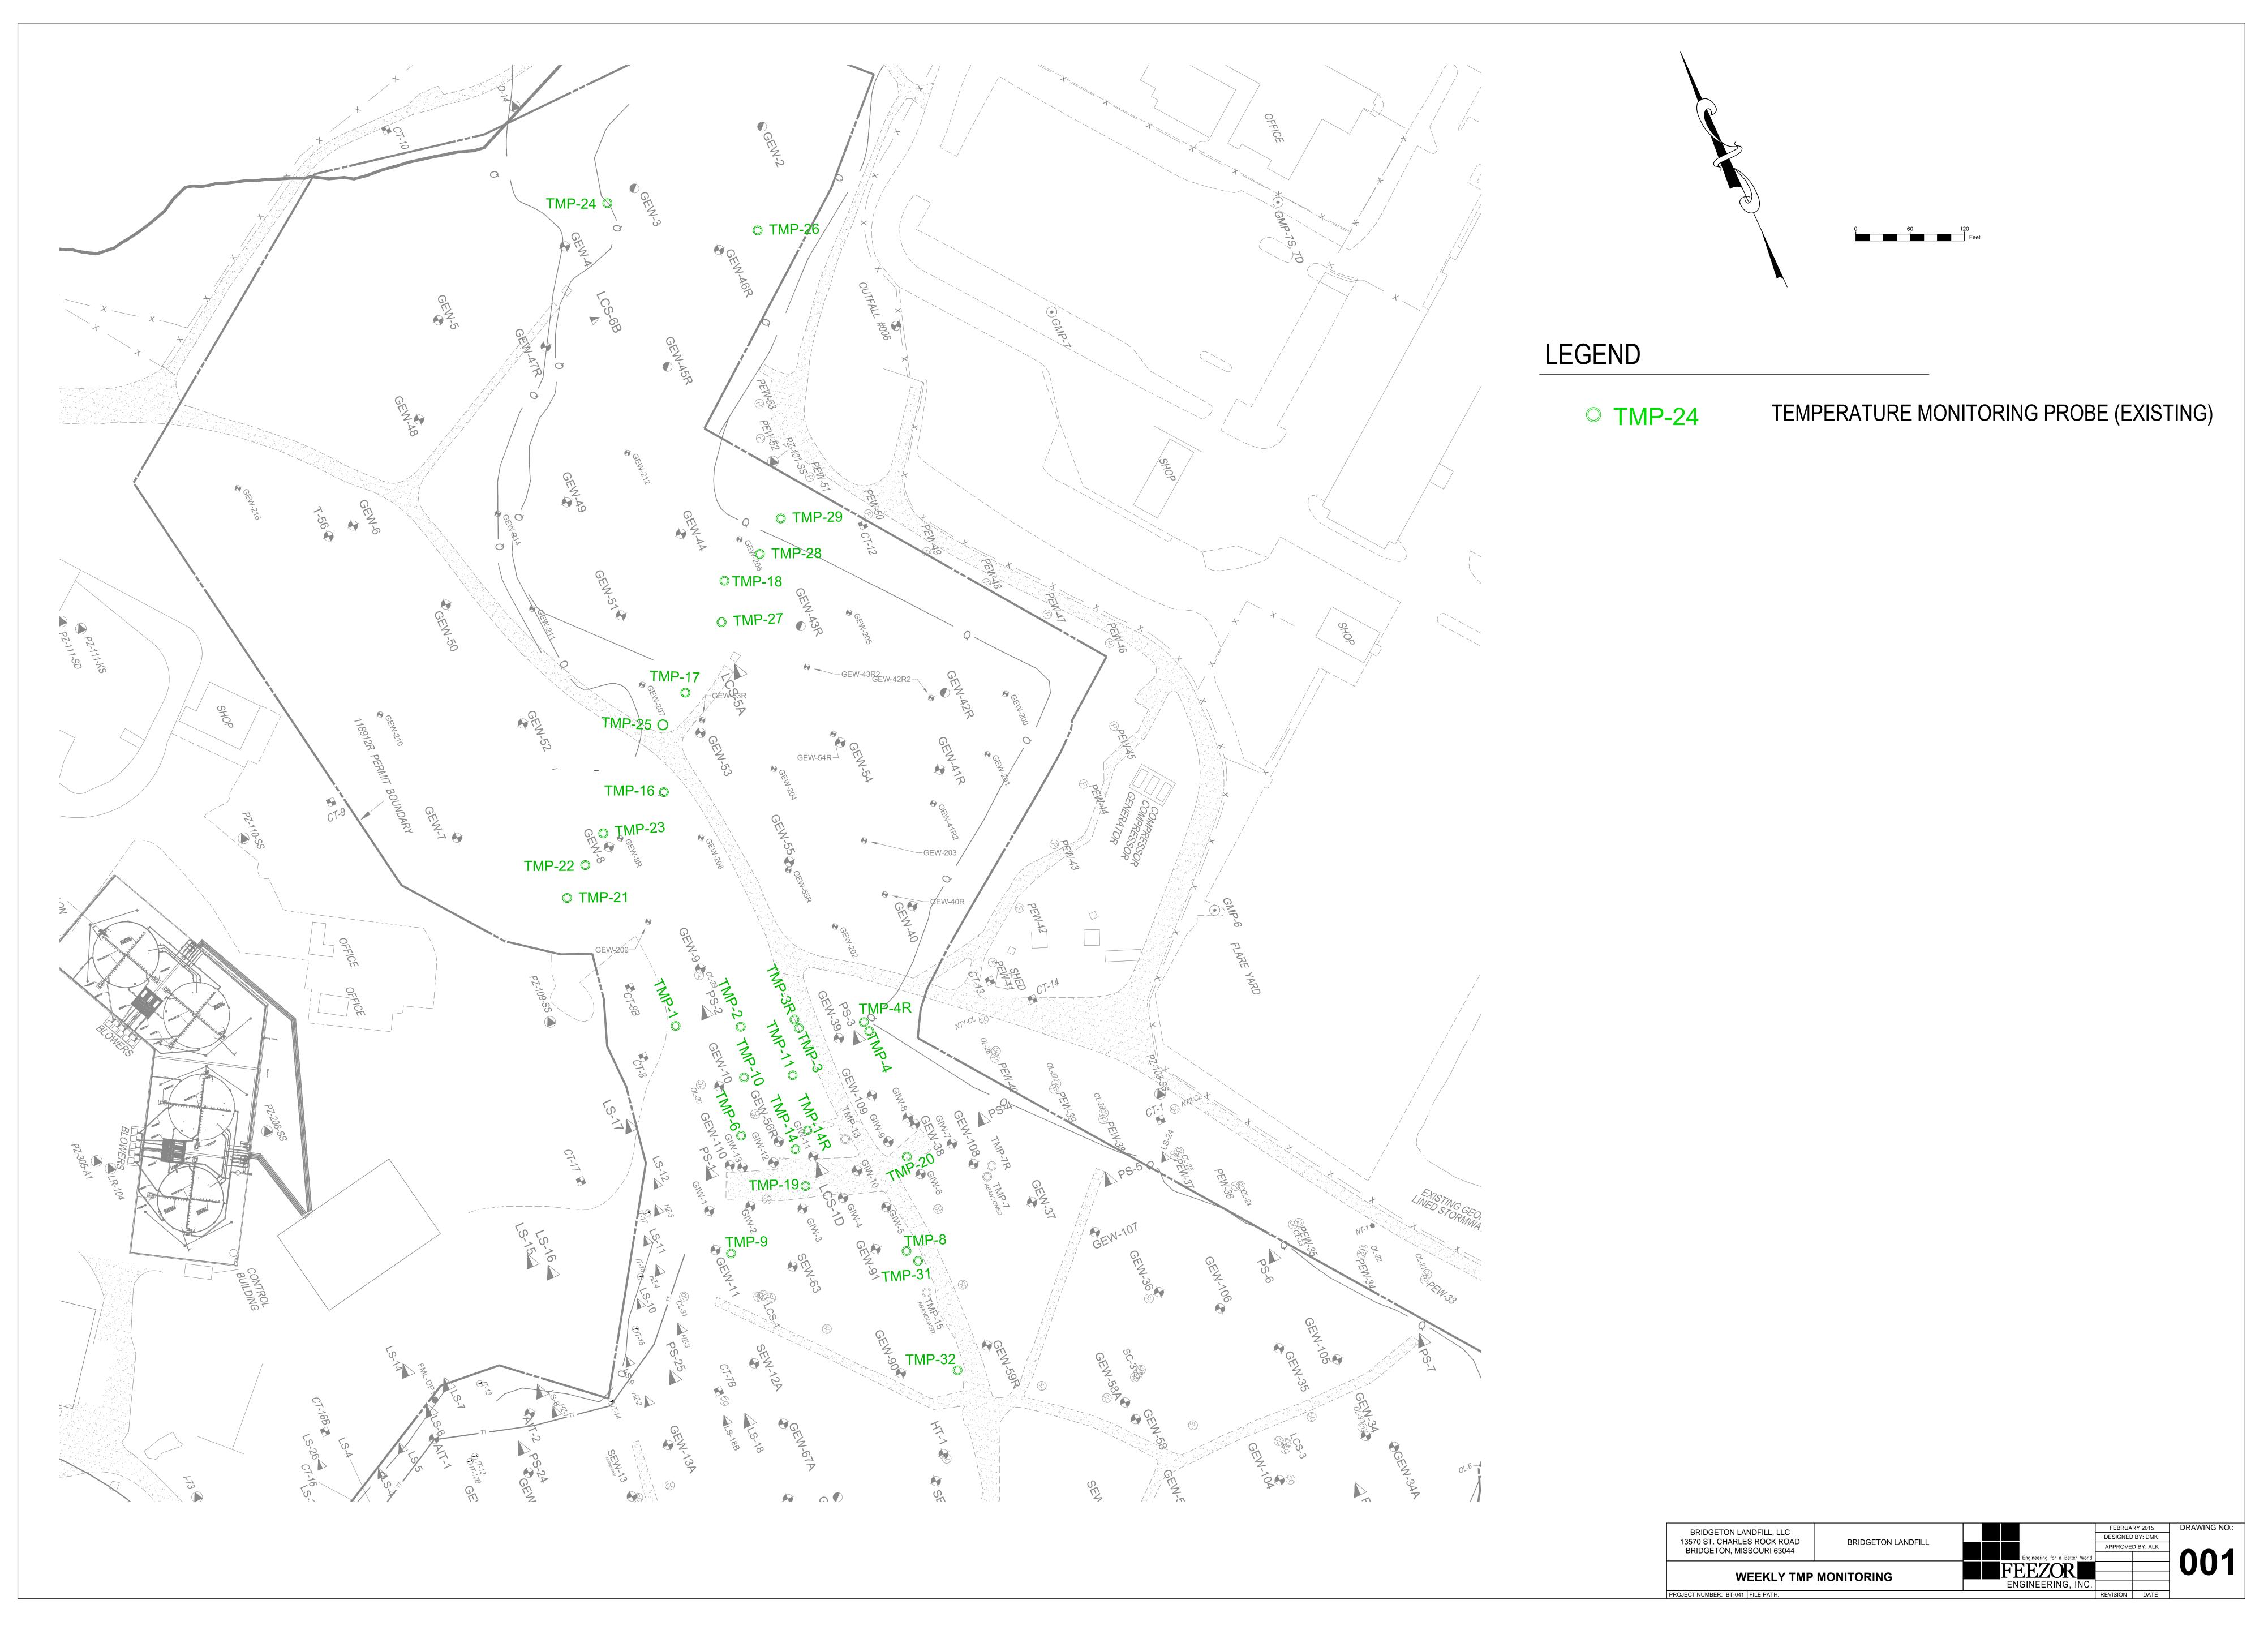
**TMP-1**

- 1. No reliable temperature readings at 138 ft depth from 8/1/2014 to 3/24/2015.
- 2. No reliable temperature readings at 78 ft depth from 8/13/2014 to 3/24/2015.
- 3. No reliable temperature readings at 38 ft depth from 8/2/2014 to 3/24/2015.

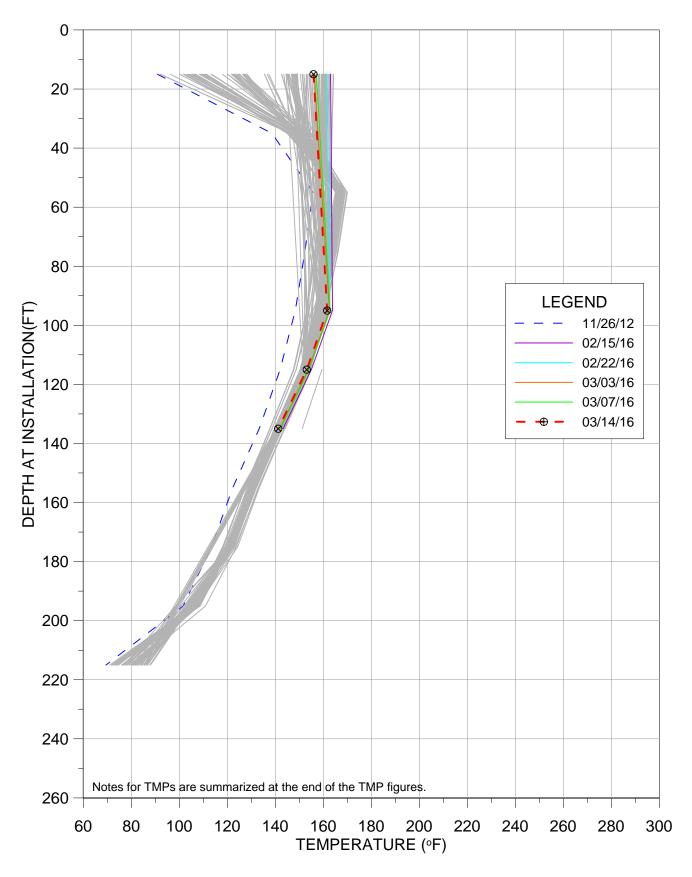
**TMP-9**

1. All units had resistivity readings higher than acceptable levels on 7/3, 7/18, 7/25, 8/14, 8/20, 8/27, and 9/3/2013. Values shown on and between those dates are for informational purposes and should not be considered reliable. Resistivity readings since 9/11/2013 were acceptable for all units except 100'.

- 2. Unit at 100' depth had an inaccurate temperature reading on 8/1/2013 and no reading since 8/6/2013.
- 3. Unit at 80' depth had a high resistivity and no temperature readings on 4/1/2014.
- 4. The conductivity tests on 4/11/14 conducted by CEC showed that units at 20', 60', 80', and 100' depths are no longer reliable.
- 5. Unit at 40' depth had a resistance lower than credible on 11/12/14. The unit requires assessment.
- 6. Unit at 40' depth had a resistance which is fluctuating from week to week between 11/19 & 11/26/14. The readings are considered unreliable during that time.

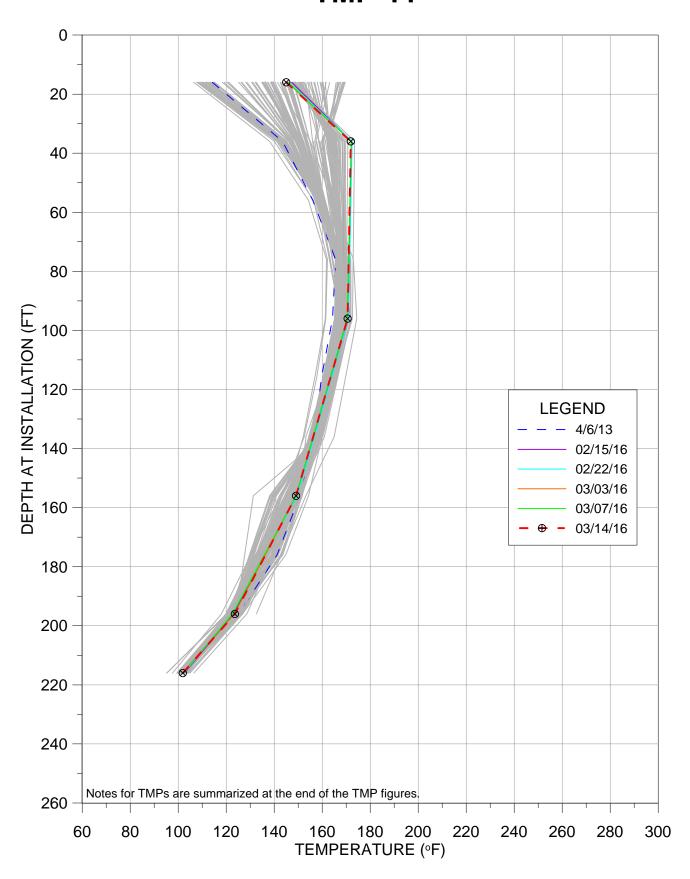
# **TMP-14R**

1. Due to the Conductivity test results by Feezor Engineering on TMP-14 (see note above), TMP-14R is added to this reporting data set as of 3/7/16.

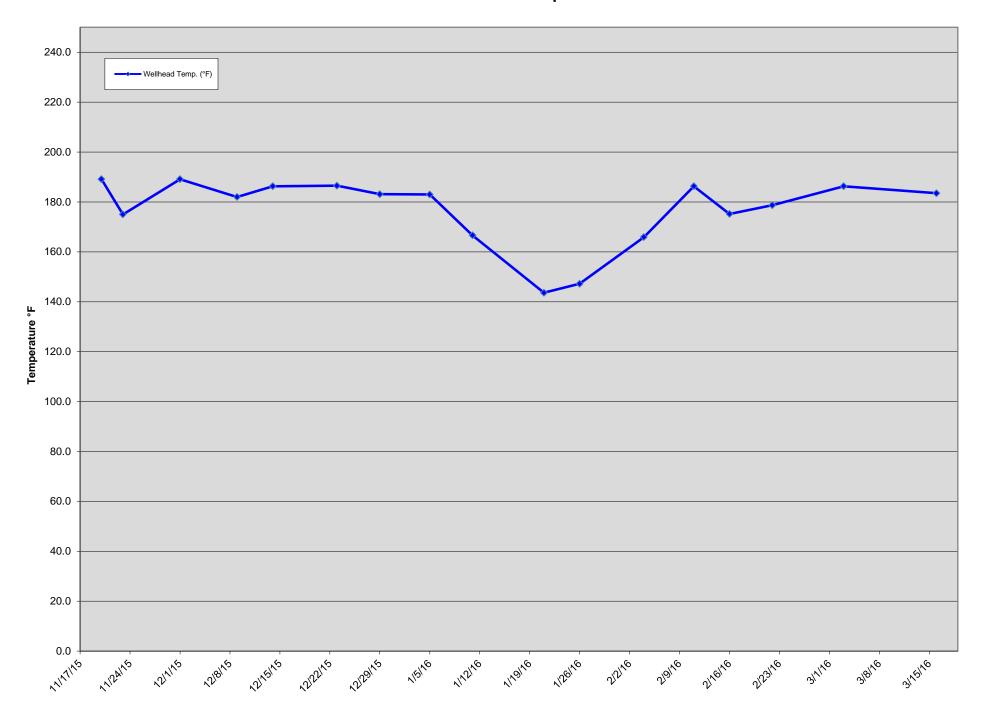
### **GIW-1 Wellhead Temperatures**

As part of the HES, there are currently cooling water circulation loops installed in twelve Gas Interceptor Wells (GIWs) (GIW-02 through GIW-13). The remaining well without a HES installed (GIW-01), gas temperatures are operating within historical limits.

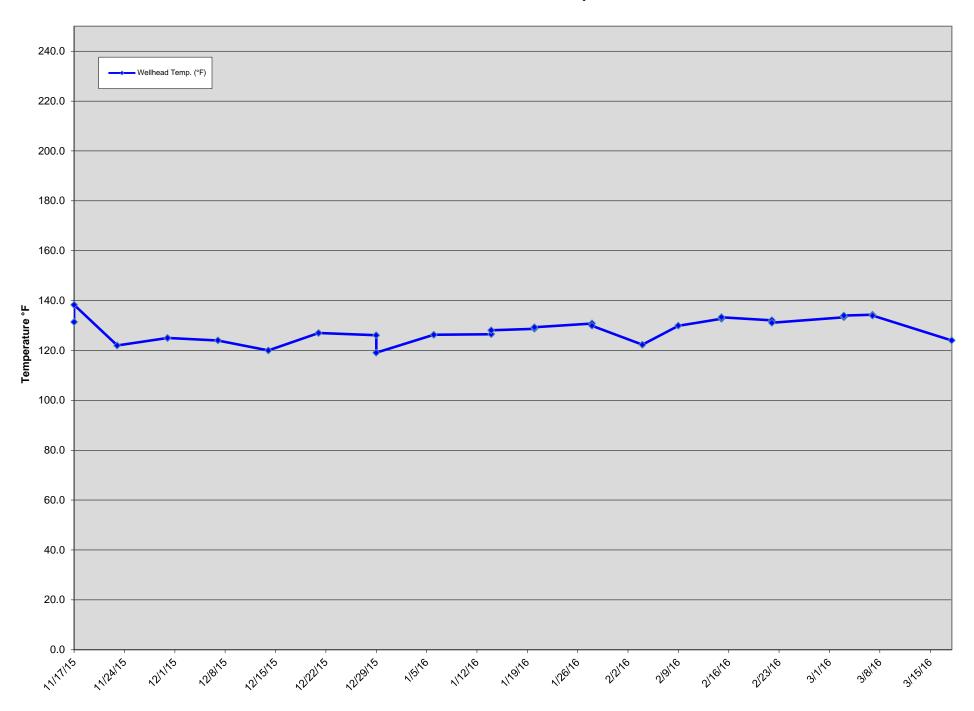
### **GEW-053 Wellhead Temperatures**

Weekly gas temperature data is being collected for select gas extraction wells (GEWs) located in the neck area of the landfill. These wells include GEW-008, -009, -010, -038, -039, -040, 041R, -043R, -053, -054 -055, -056R, -109, and -110. During this reporting period, landfill gas well GEW-053 well head temperature has trended down due to limited gas flow most likely due to obstructed well screens from liquid levels within the gas well. This well has a downhole pump which will be inspected and if necessary serviced in the near future. All other wells are showing temperatures within historic limits.
