# **Bridgeton Landfill, LLC**

## **Weekly Data Submittal**

**Week of July 23, 2017 – July 29, 2017**

**Required by Section 52.F of Agreed Order, Case No. 13SL-CC01088  
Effective May 13, 2013**

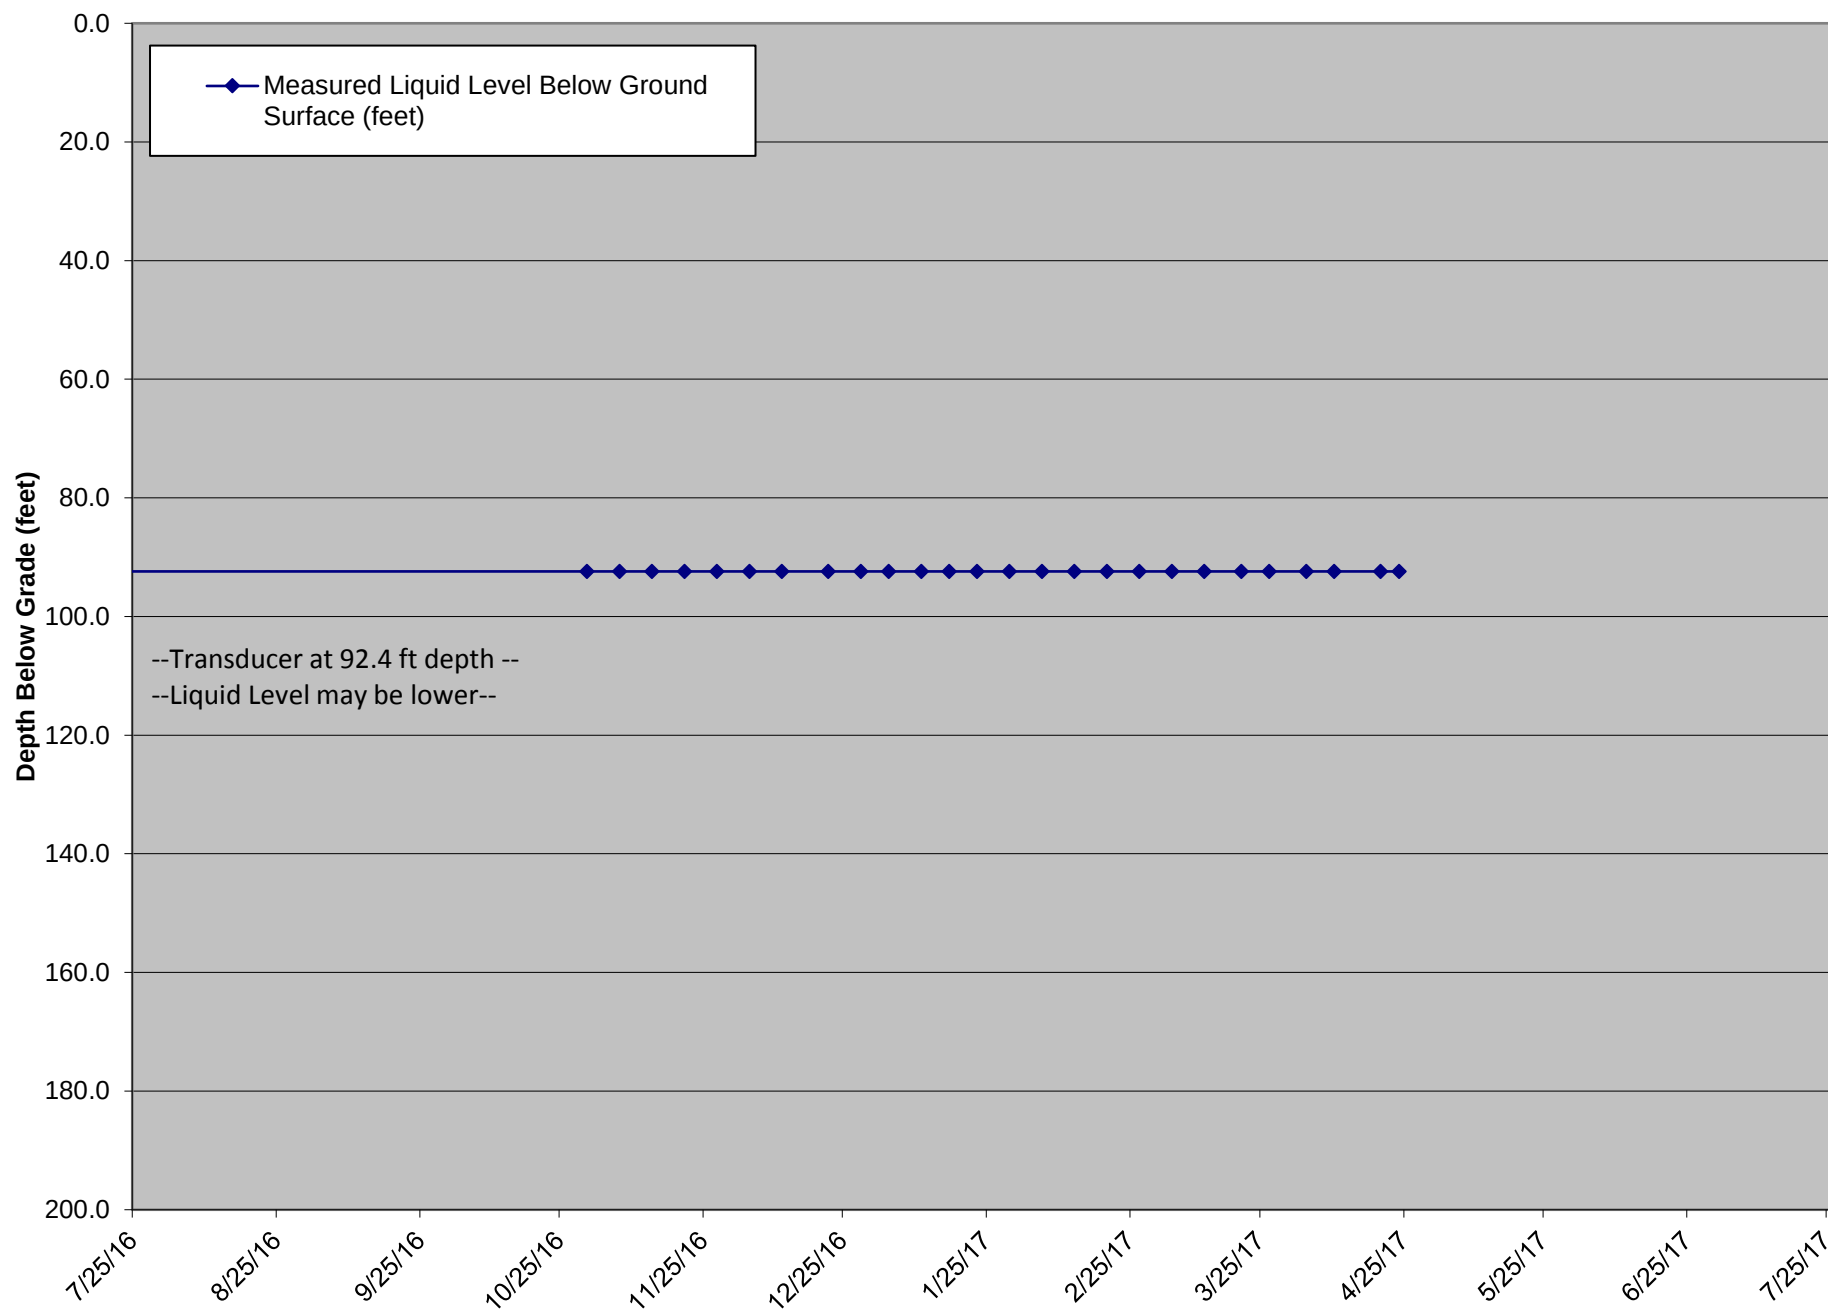
# LCS-1D Liquid Level Below Ground Surface

Bridgeton Landfill is currently troubleshooting the pump in LCS-1D. Level sensor replacement is pending while awaiting parts arrival.

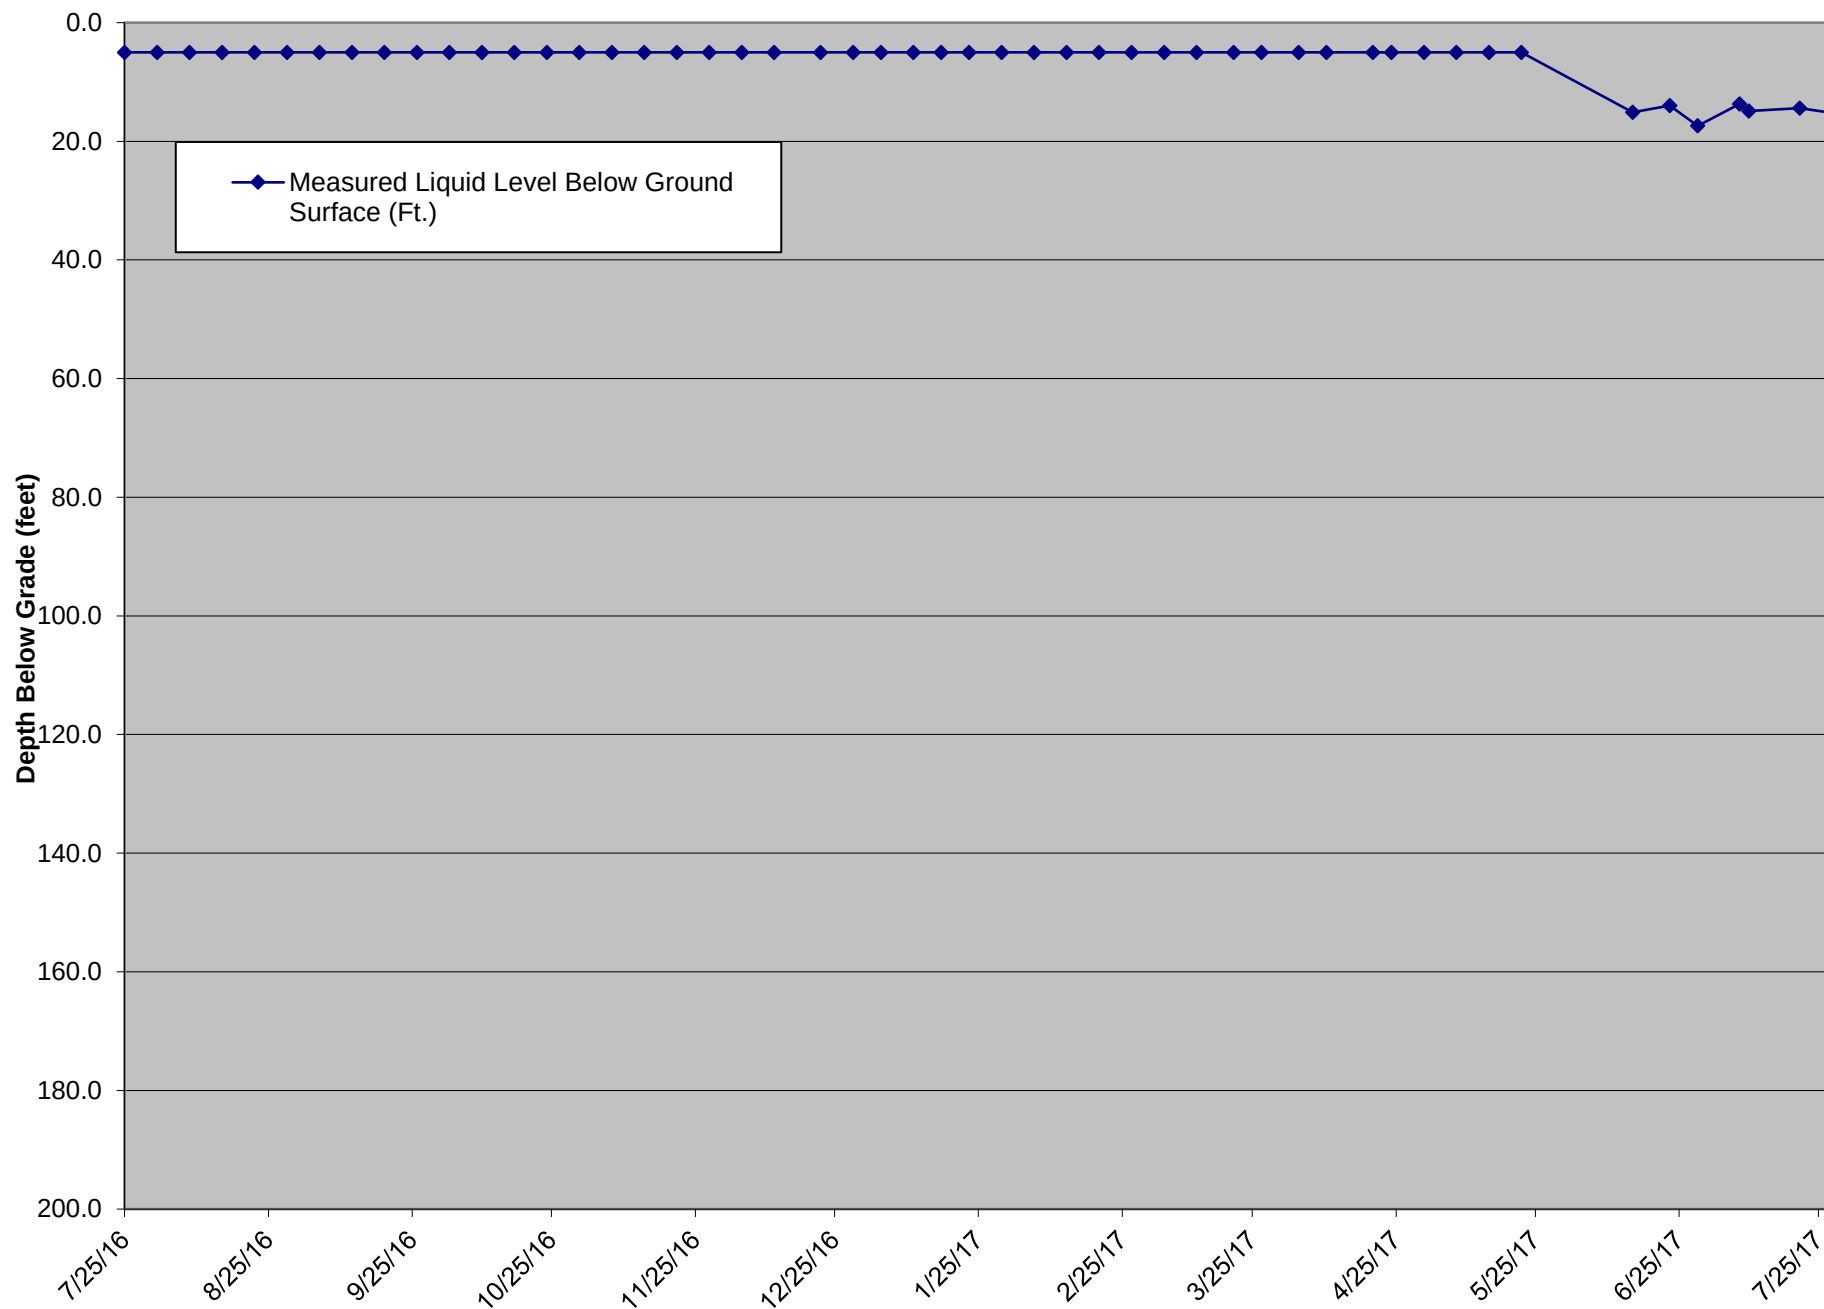
### LCS-3D Liquid Level Below Ground Surface

Two Blackhawk pneumatic pumps were installed in LCS-3D on 6/13/2017. Blackhawk pumps do not require a level sensor. Liquid level was measured manually.

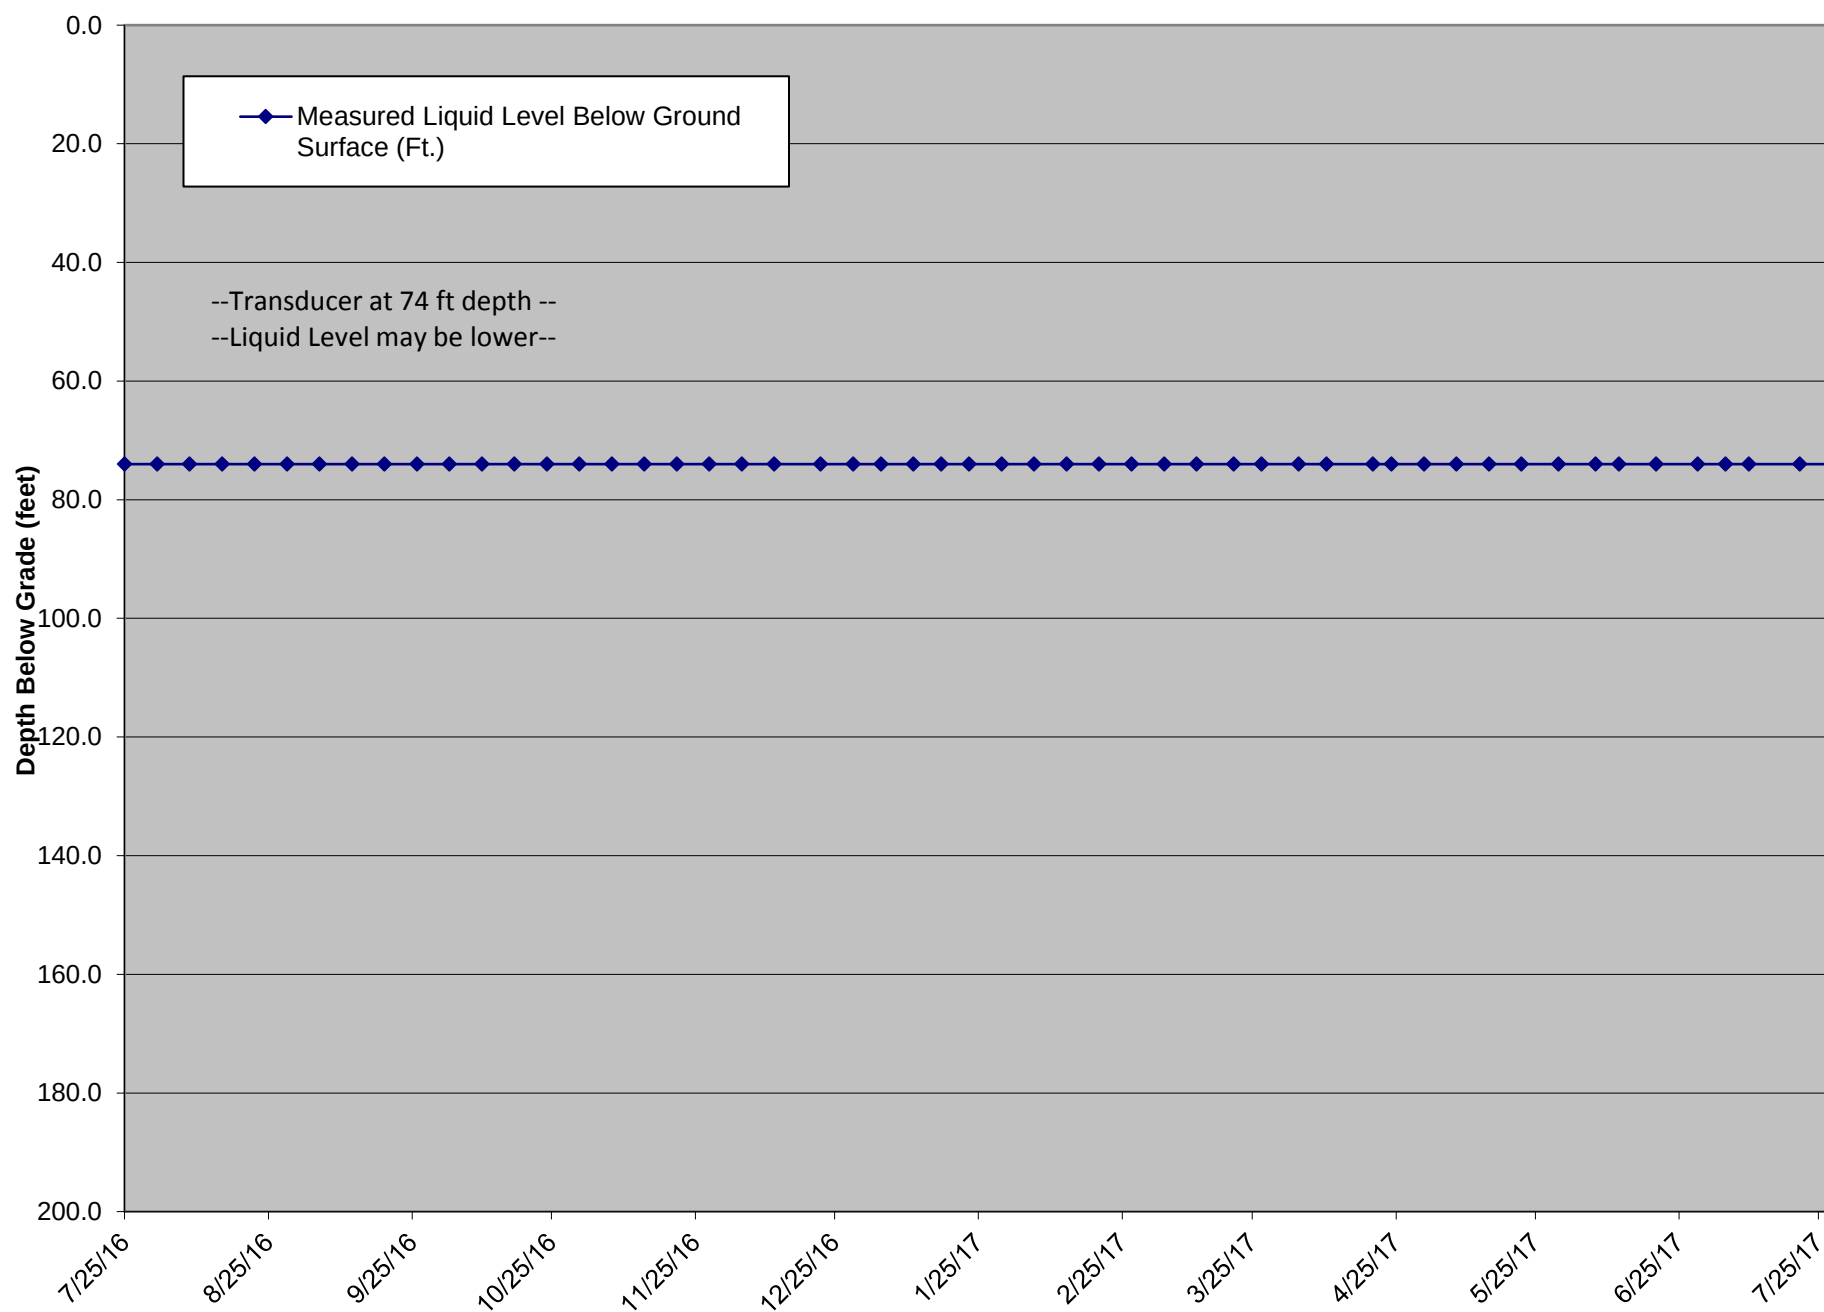
# LCS-4B Liquid Level Below Ground Surface

The level sensor in LCS-4B is currently operational and responsive. Liquid level was not recorded by the level sensor during the weekly reporting period. LCS-4B is equipped with a flow meter that displayed no flow during the weekly reporting period. Therefore, it can be concluded that the liquid level was below the bottom of the pump and level sensor in LCS-4B.

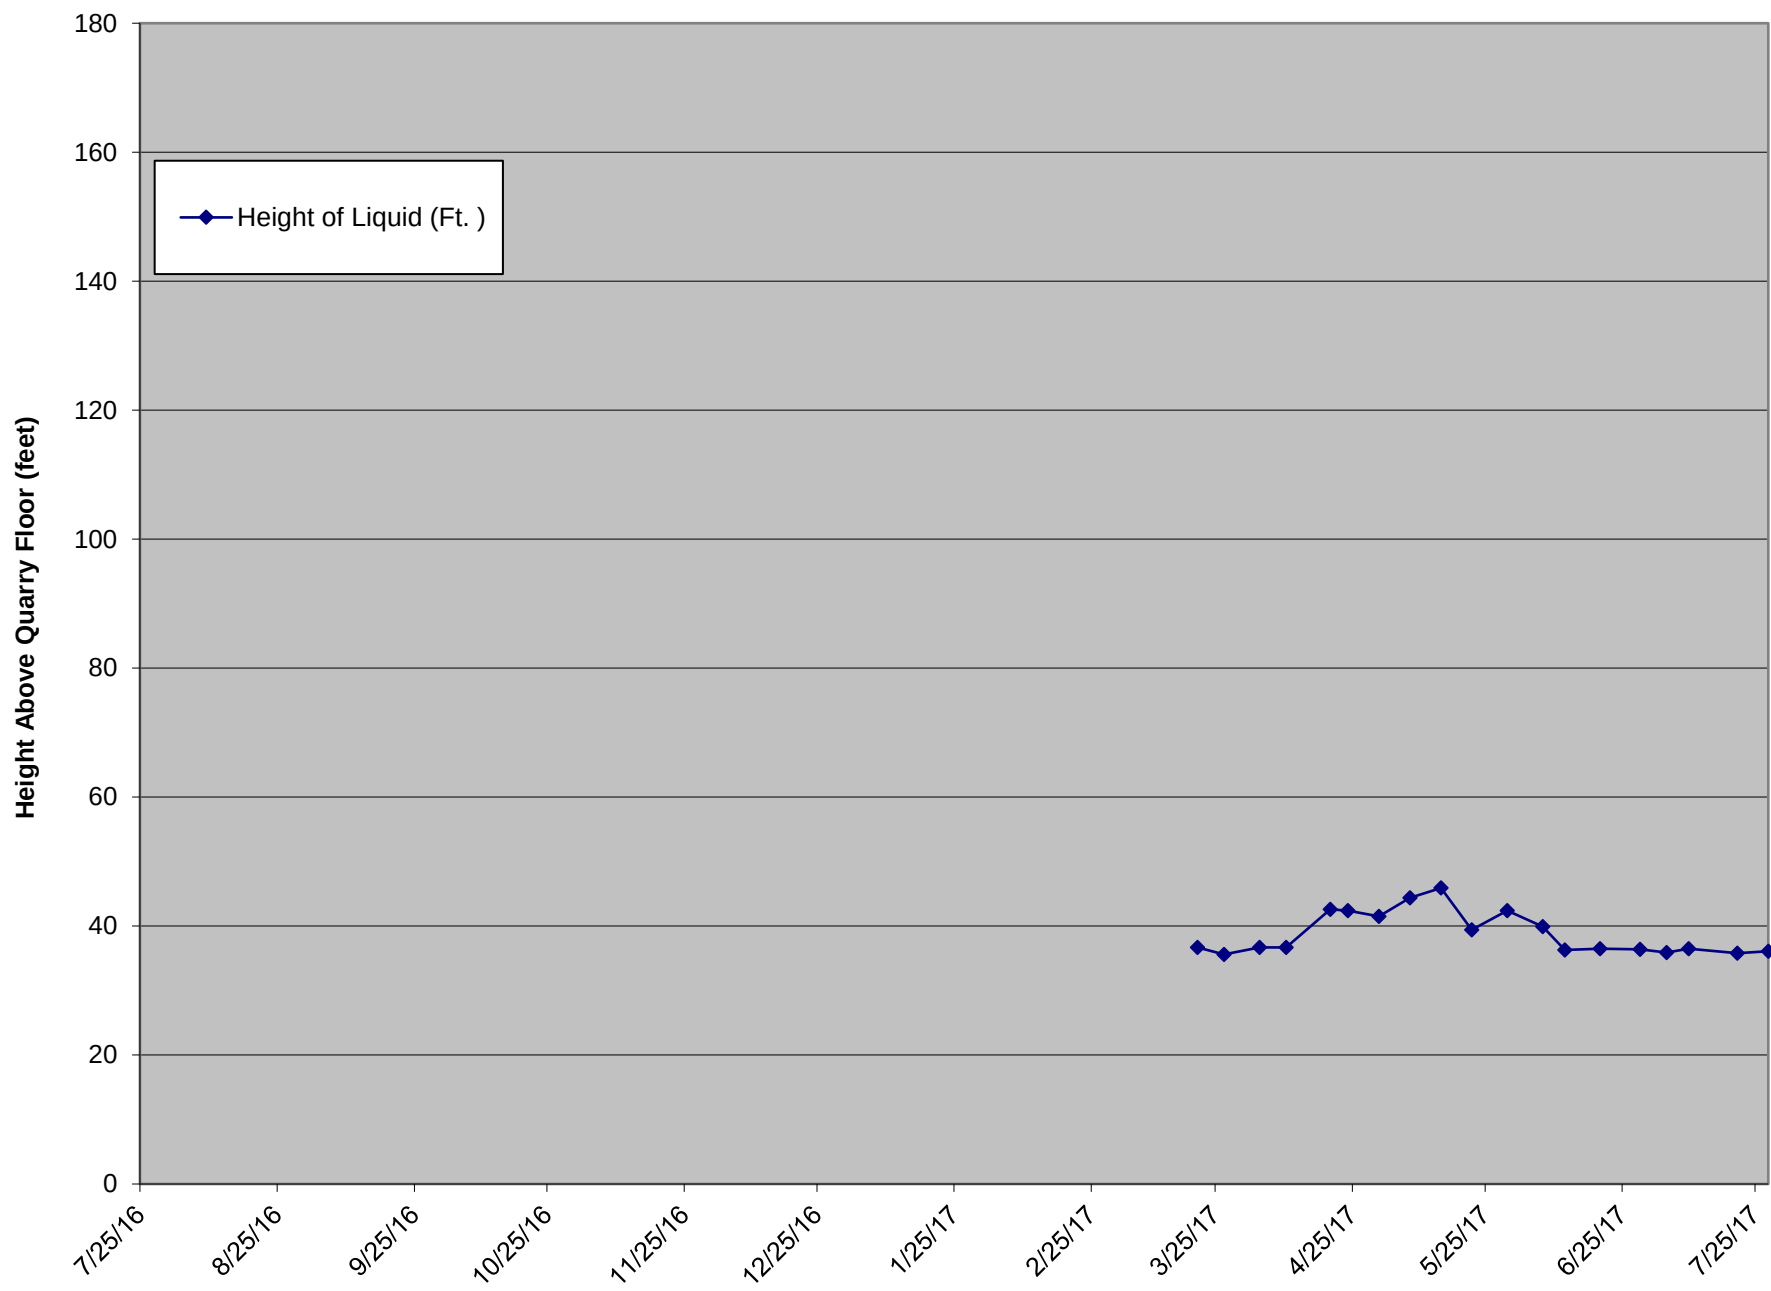
LCS-5B Liquid Level Above Quarry Floor

LCS-5B and LCS-6B were fully operational during the weekly reporting period.

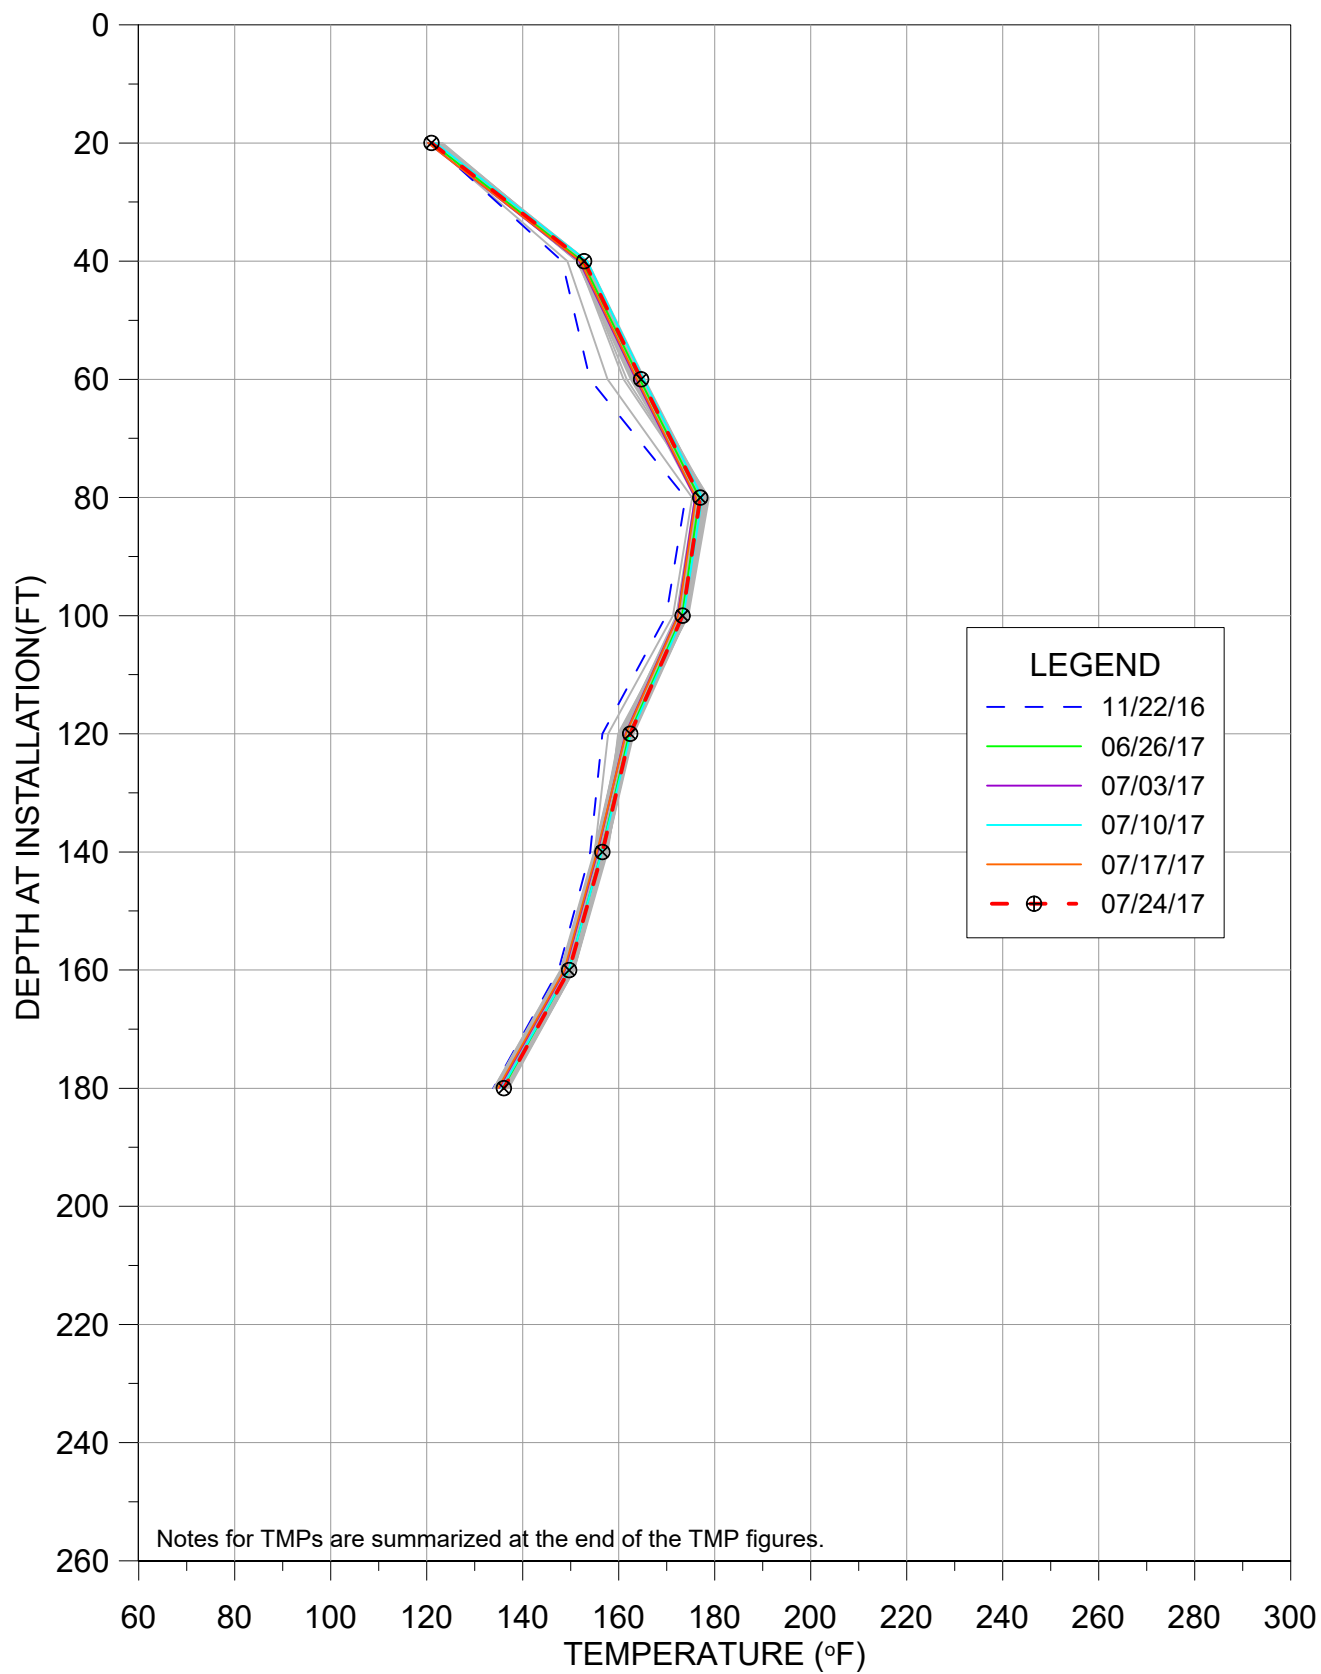
# TMP-2R

1. Data reported on 11/29/2016 was inadvertently left as the 11/22/2016 data. This was corrected on 12/5/2016 reading submittal.

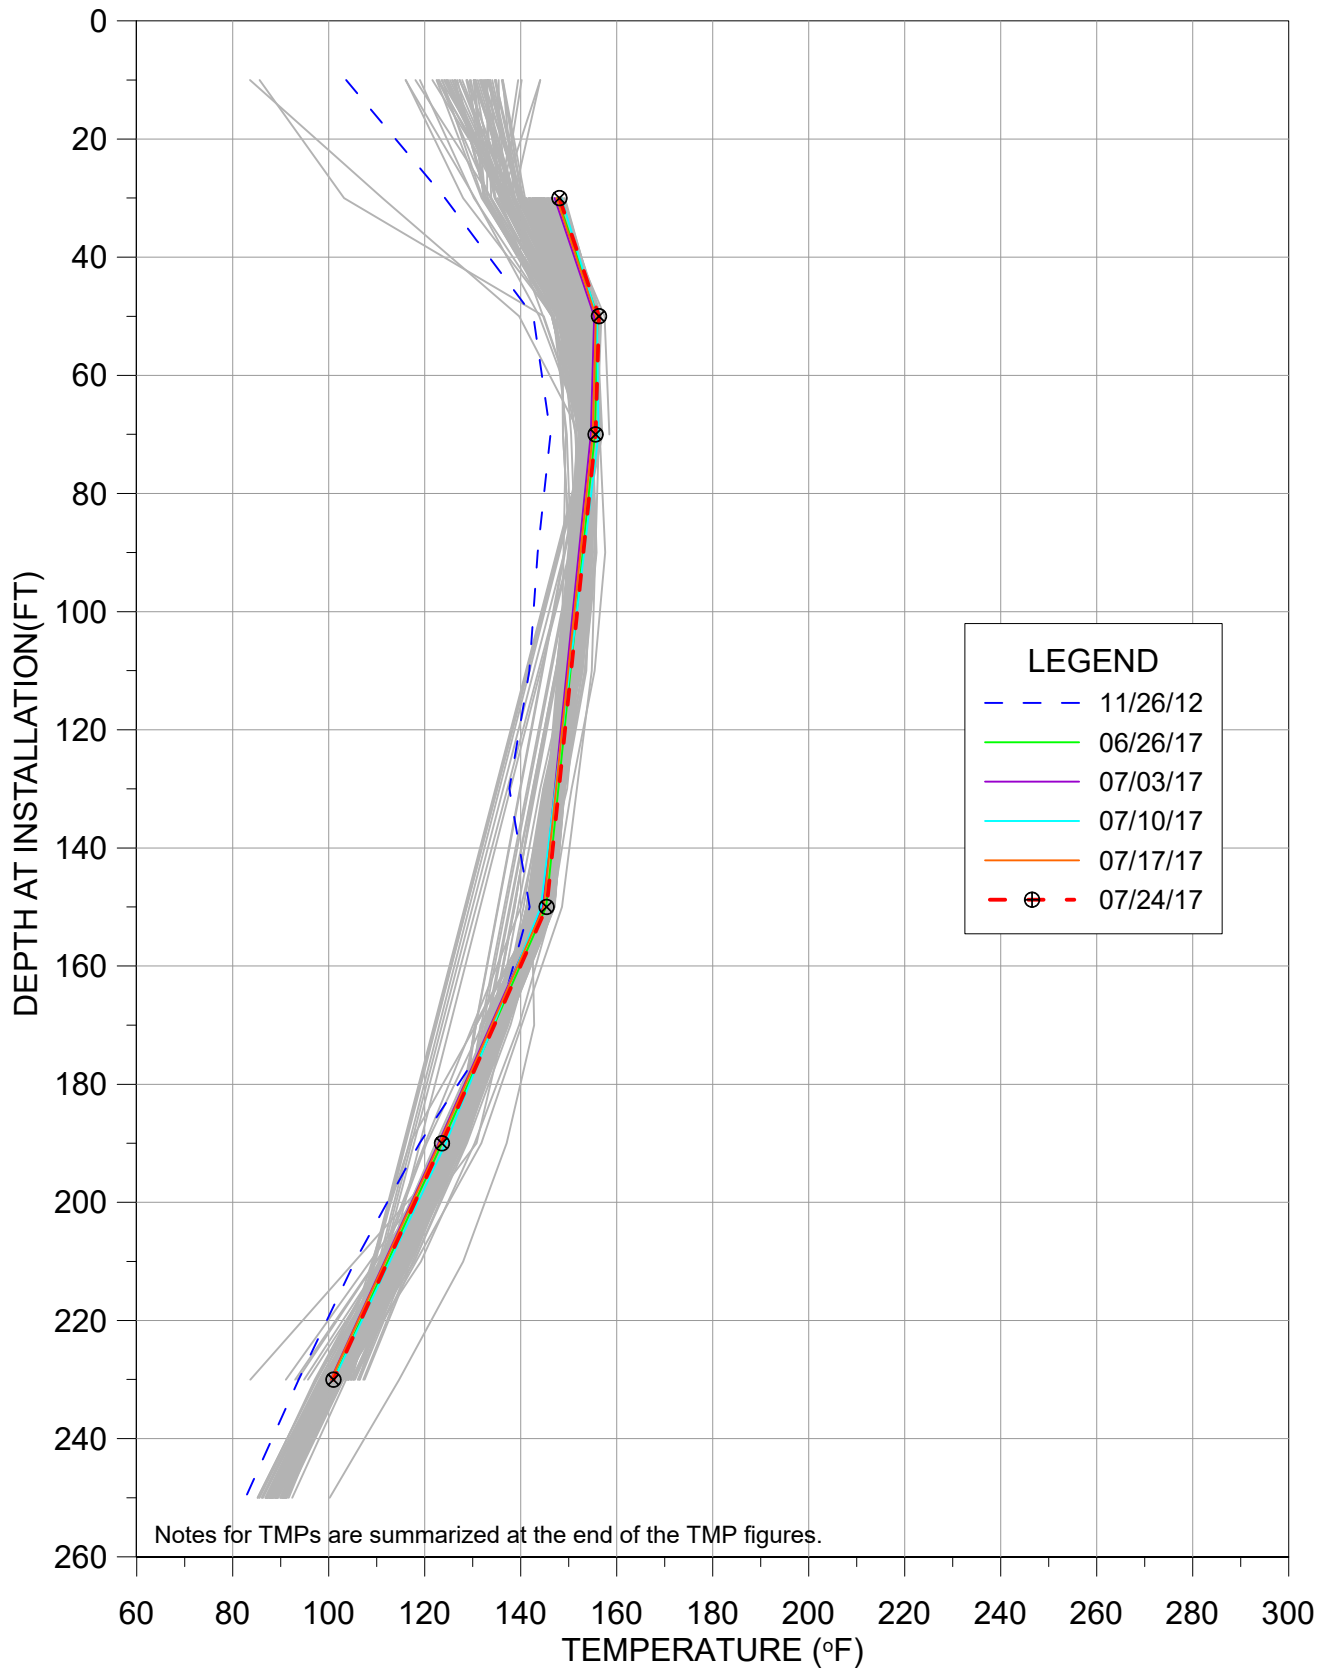
# TMP-3

1. No reliable temperature readings have been obtained at 170 ft depth since 1/29/2014, except on 3/13/2014.
2. The connectivity tests on 4/11/2014 conducted by CEC showed that units at 10, 90, 130, 210 and 250 ft depths are no longer reliable.
3. The connectivity tests on 10/28/2014 conducted by Feezor Engineering showed that units at 10, 90, 110, 130, 210 and 250 ft depths are not reliable.

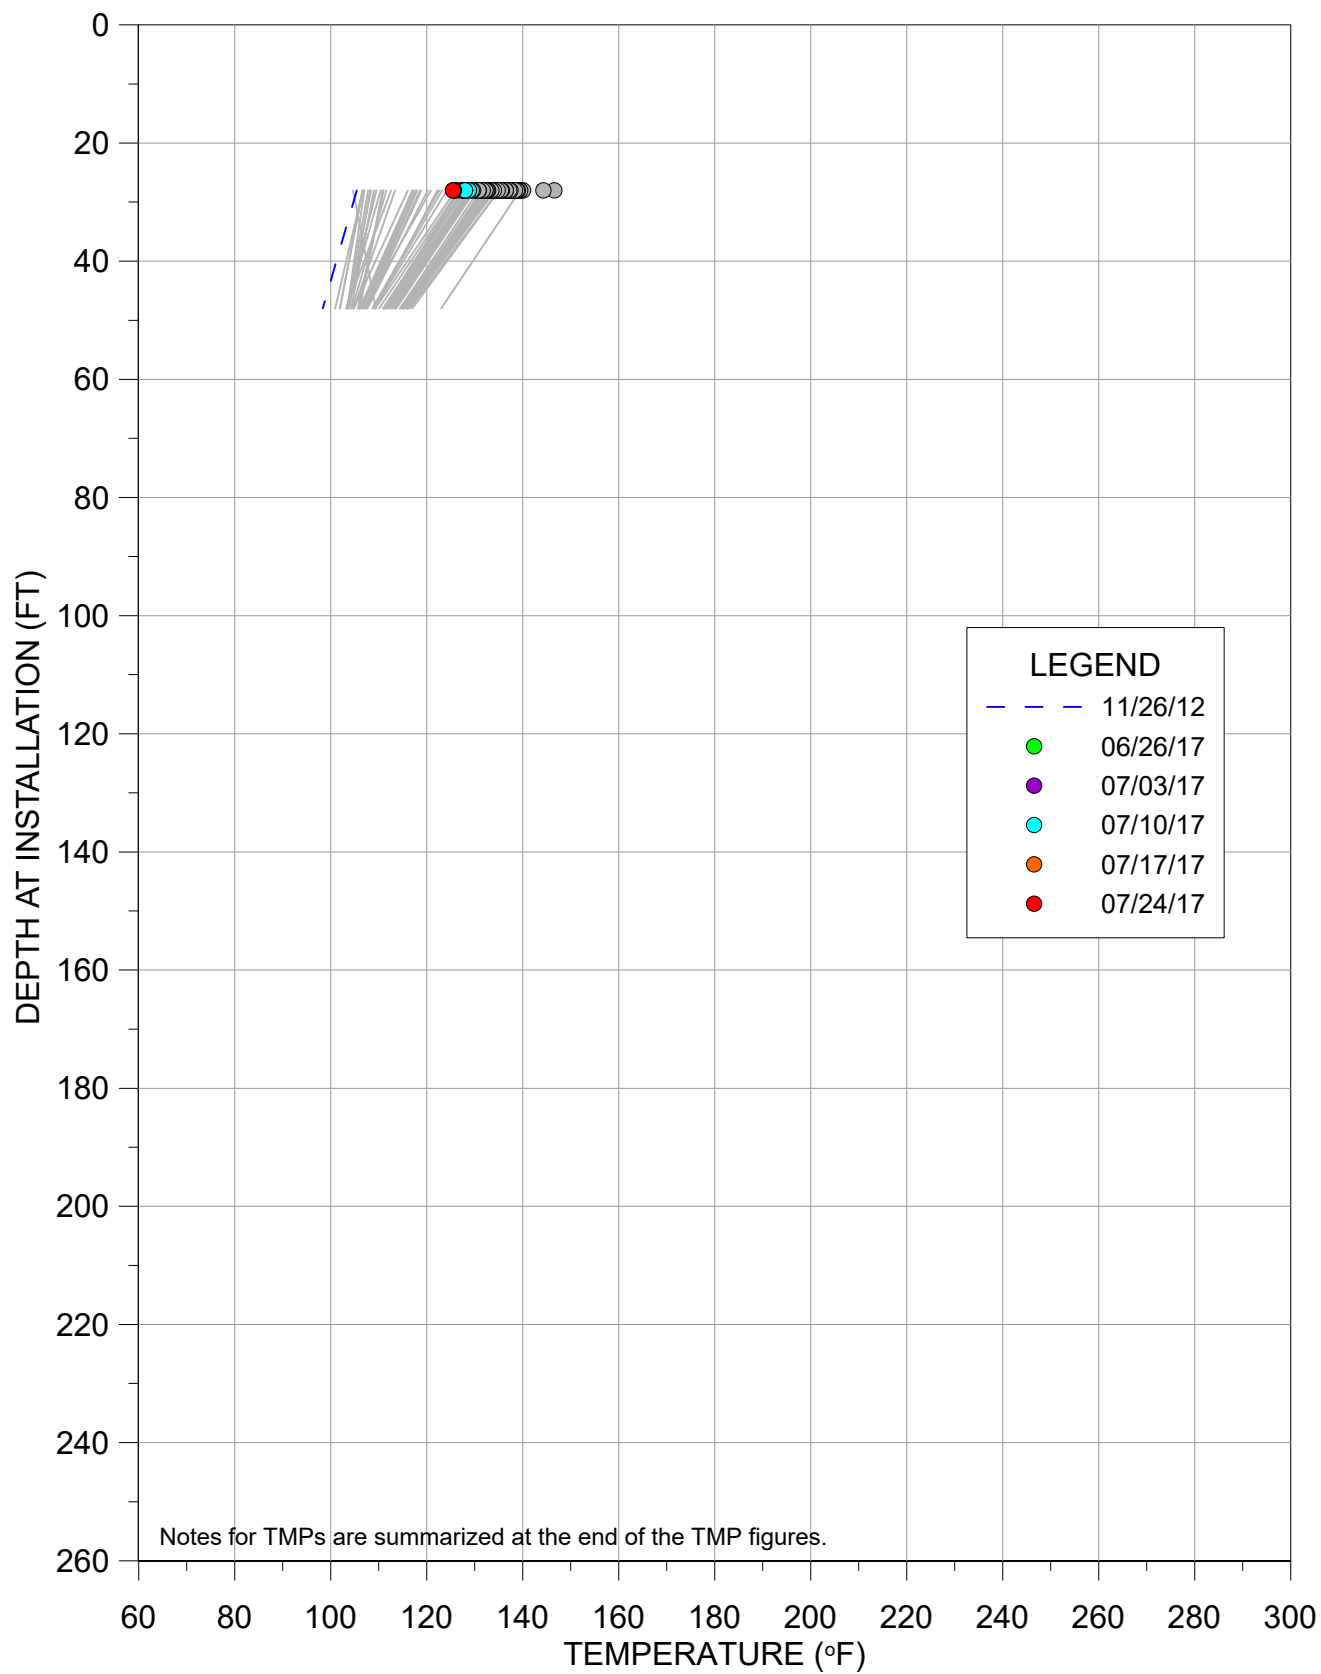
# TMP-4

1. The connectivity tests on 4/11/2014 conducted by CEC showed that the unit at 48 ft depth is no longer reliable.

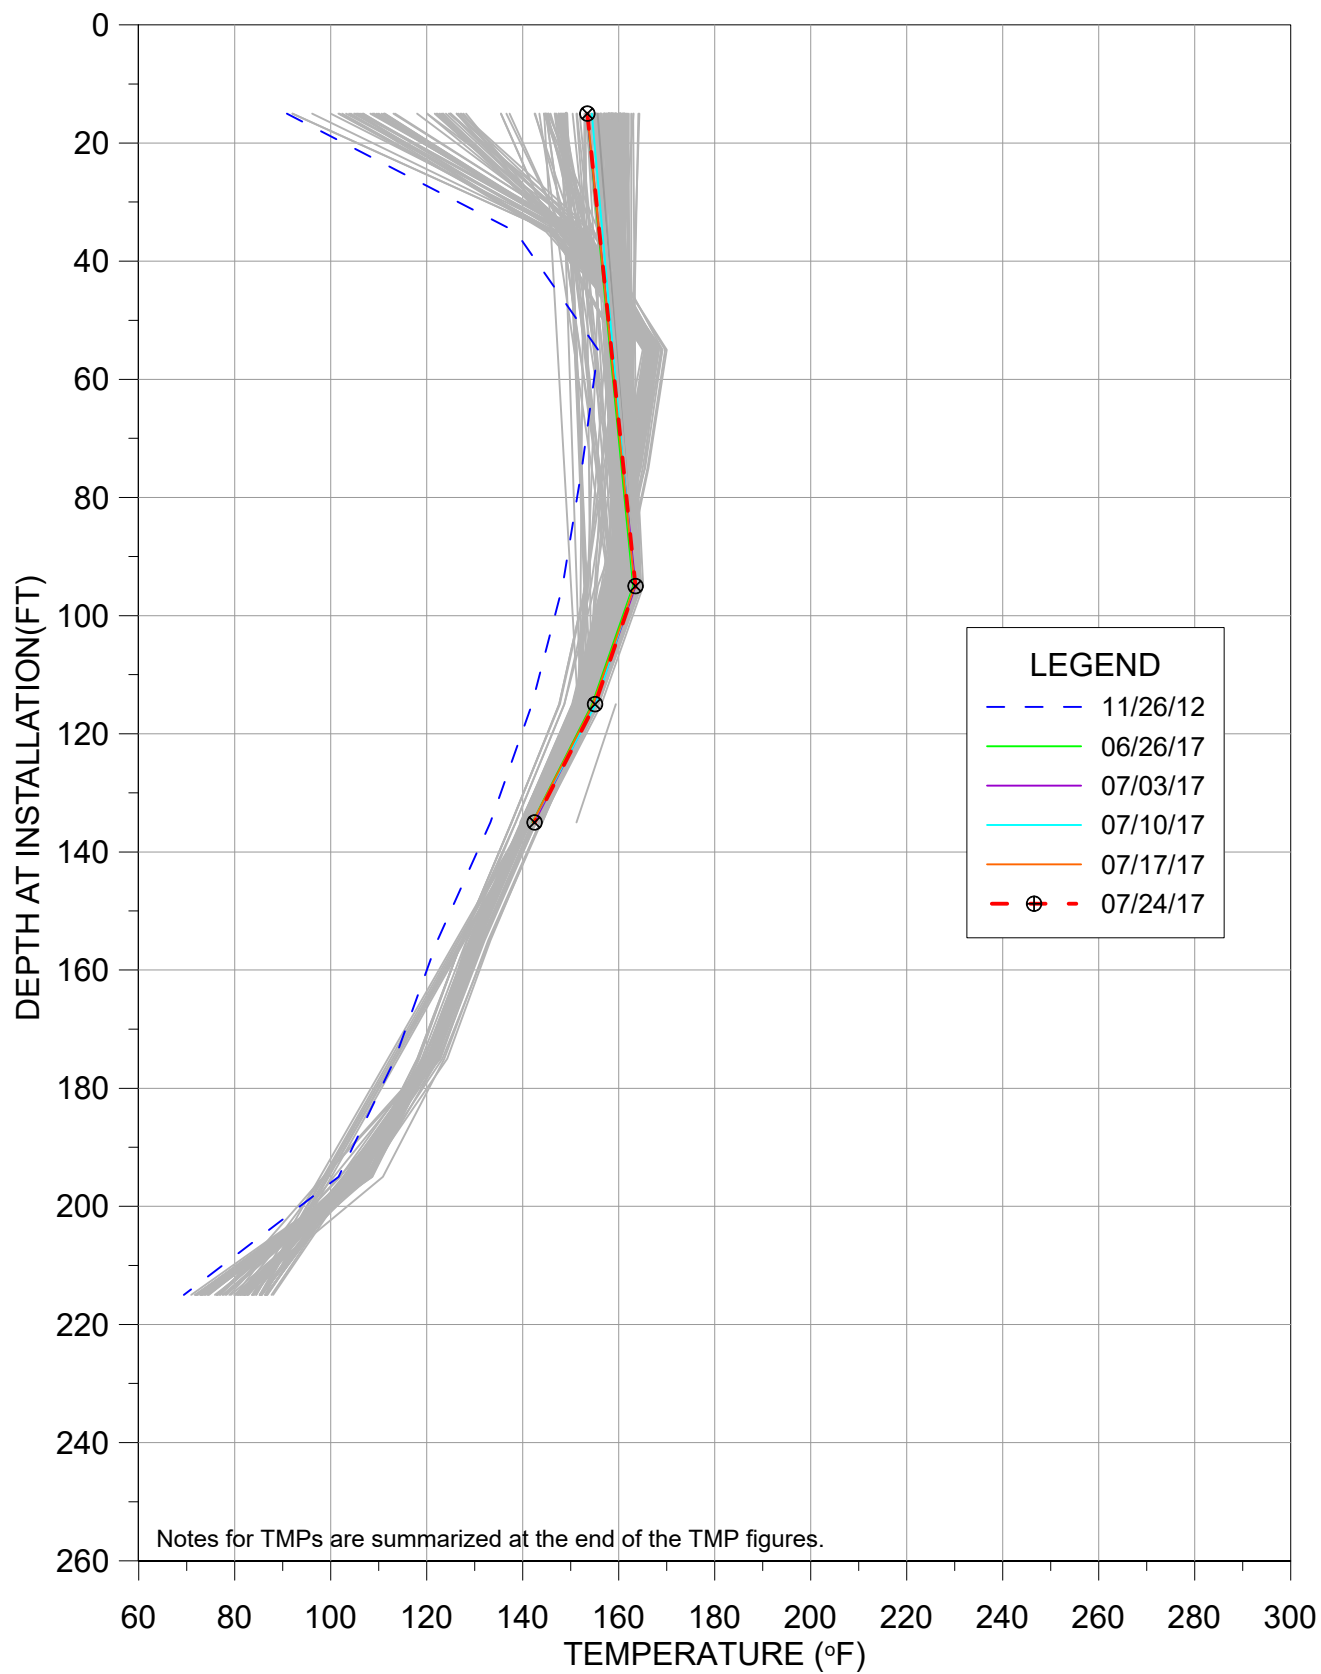
# TMP-6

1. The connectivity tests on 4/11/2014 conducted by CEC showed that units at 35, 55, 75, 155, 175, and 195 ft depths are no longer reliable.
2. No reliable temperature readings have been obtained at the unit at 215 ft depth since 6/13/2014.

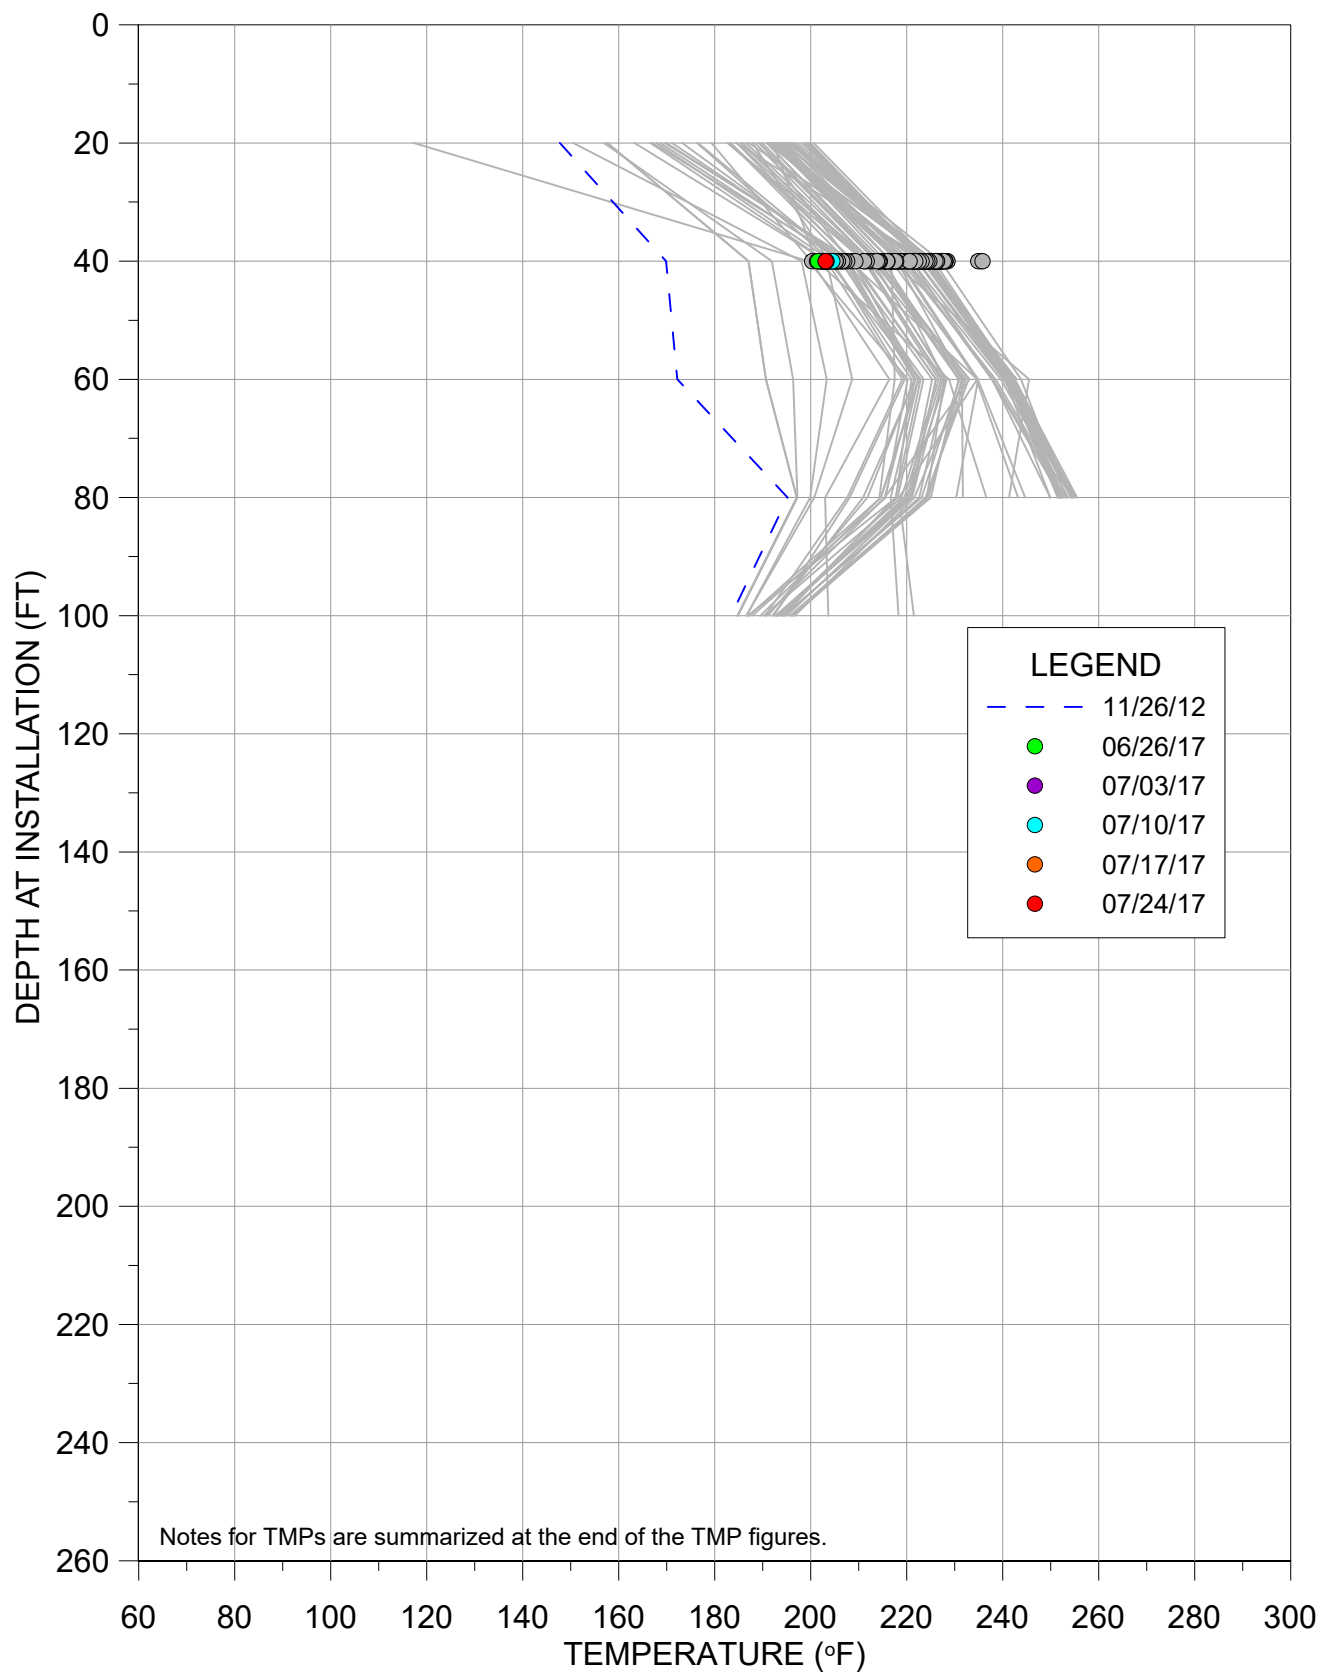
# TMP-9

1. Unit at 100 ft depth had an inaccurate temperature reading on 8/1/2013 and no reading since 8/6/2013.
2. The connectivity tests on 4/11/2014 conducted by CEC showed that units at 20, 60, 80, and 100 ft depths are no longer reliable.

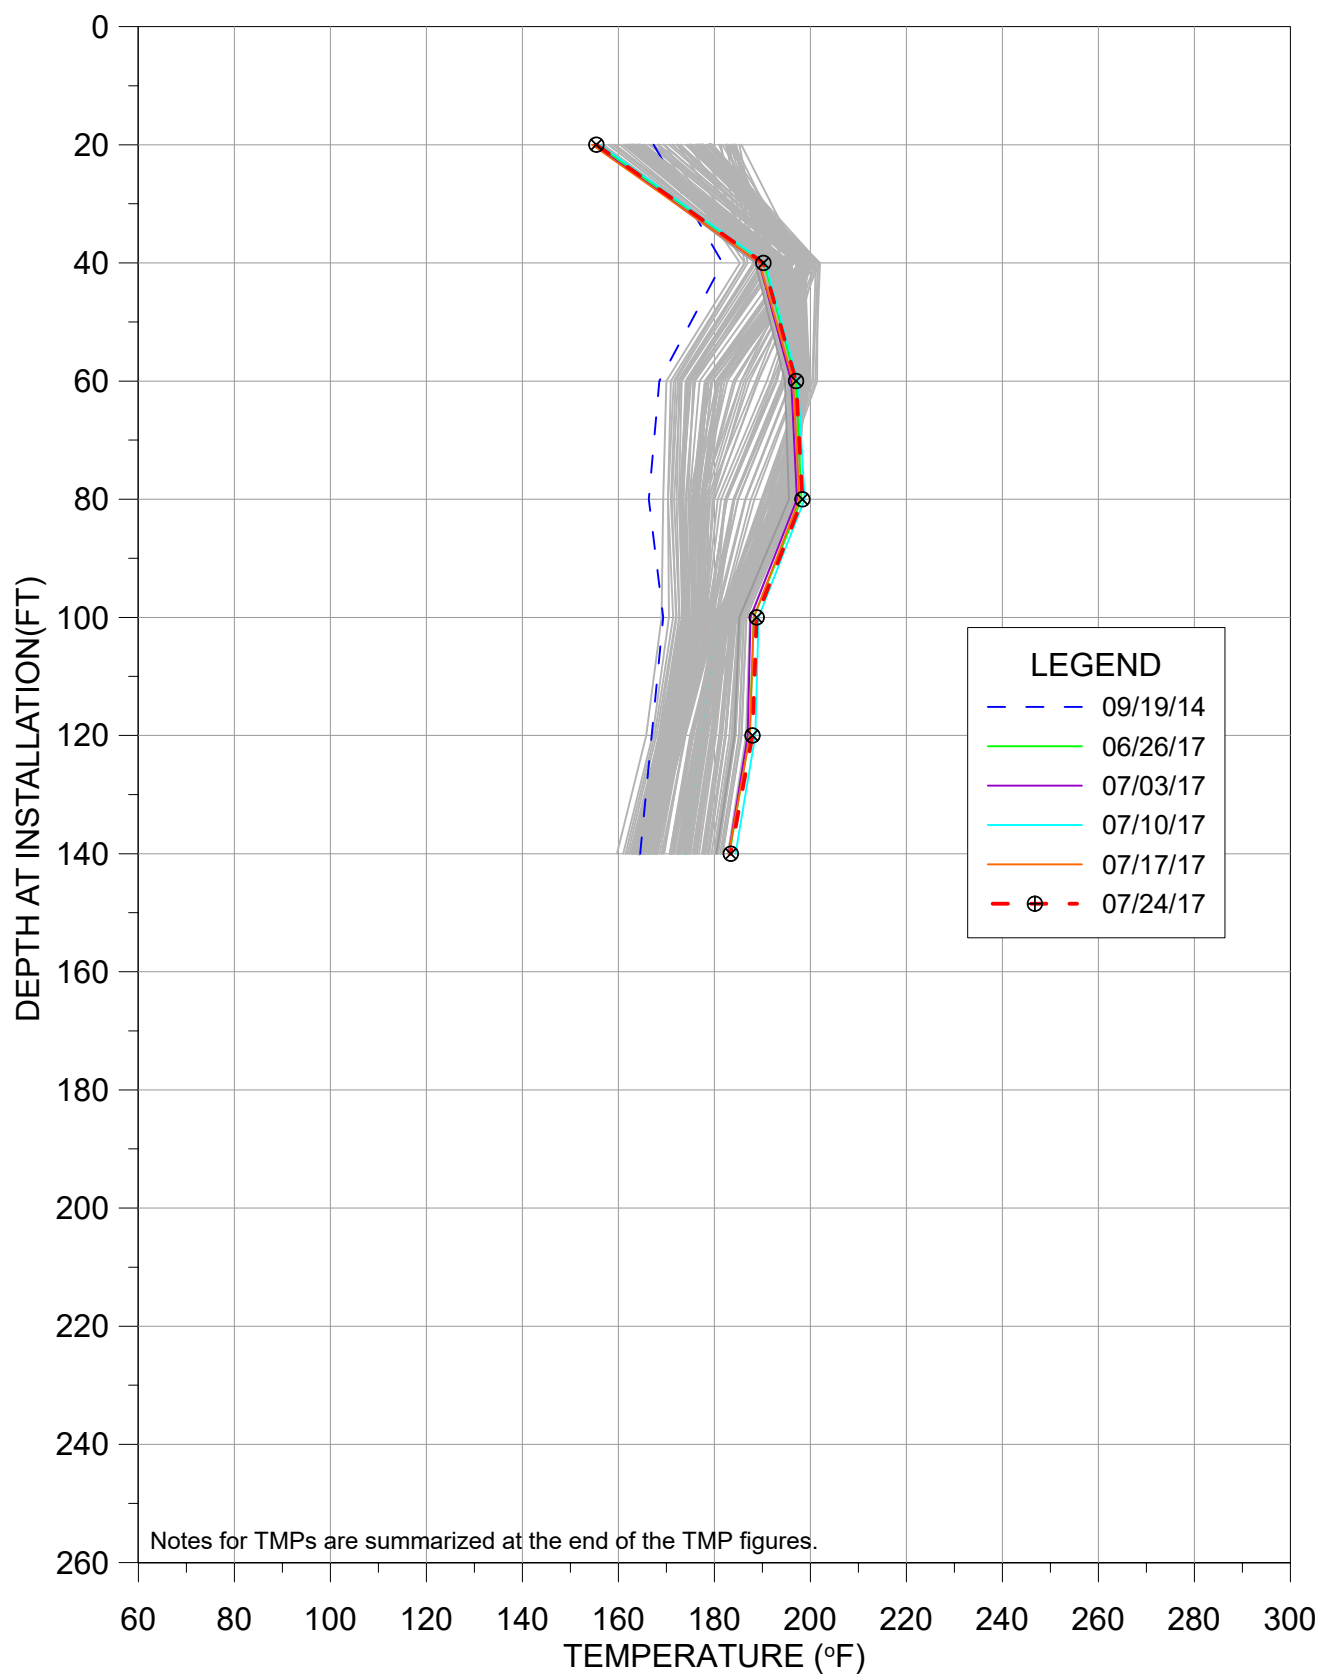
# TMP-14R

1. Due to the connectivity test results by Feezor Engineering on TMP-14 (see note above), TMP-14R is added to this reporting data set as of 3/7/2016.
