# **Bridgeton Landfill, LLC**

## **Weekly Data Submittal**

**Week of July 23, 2017 – July 29, 2017**

**Required by Section 52.F of Agreed Order, Case No. 13SL-CC01088  
Effective May 13, 2013**

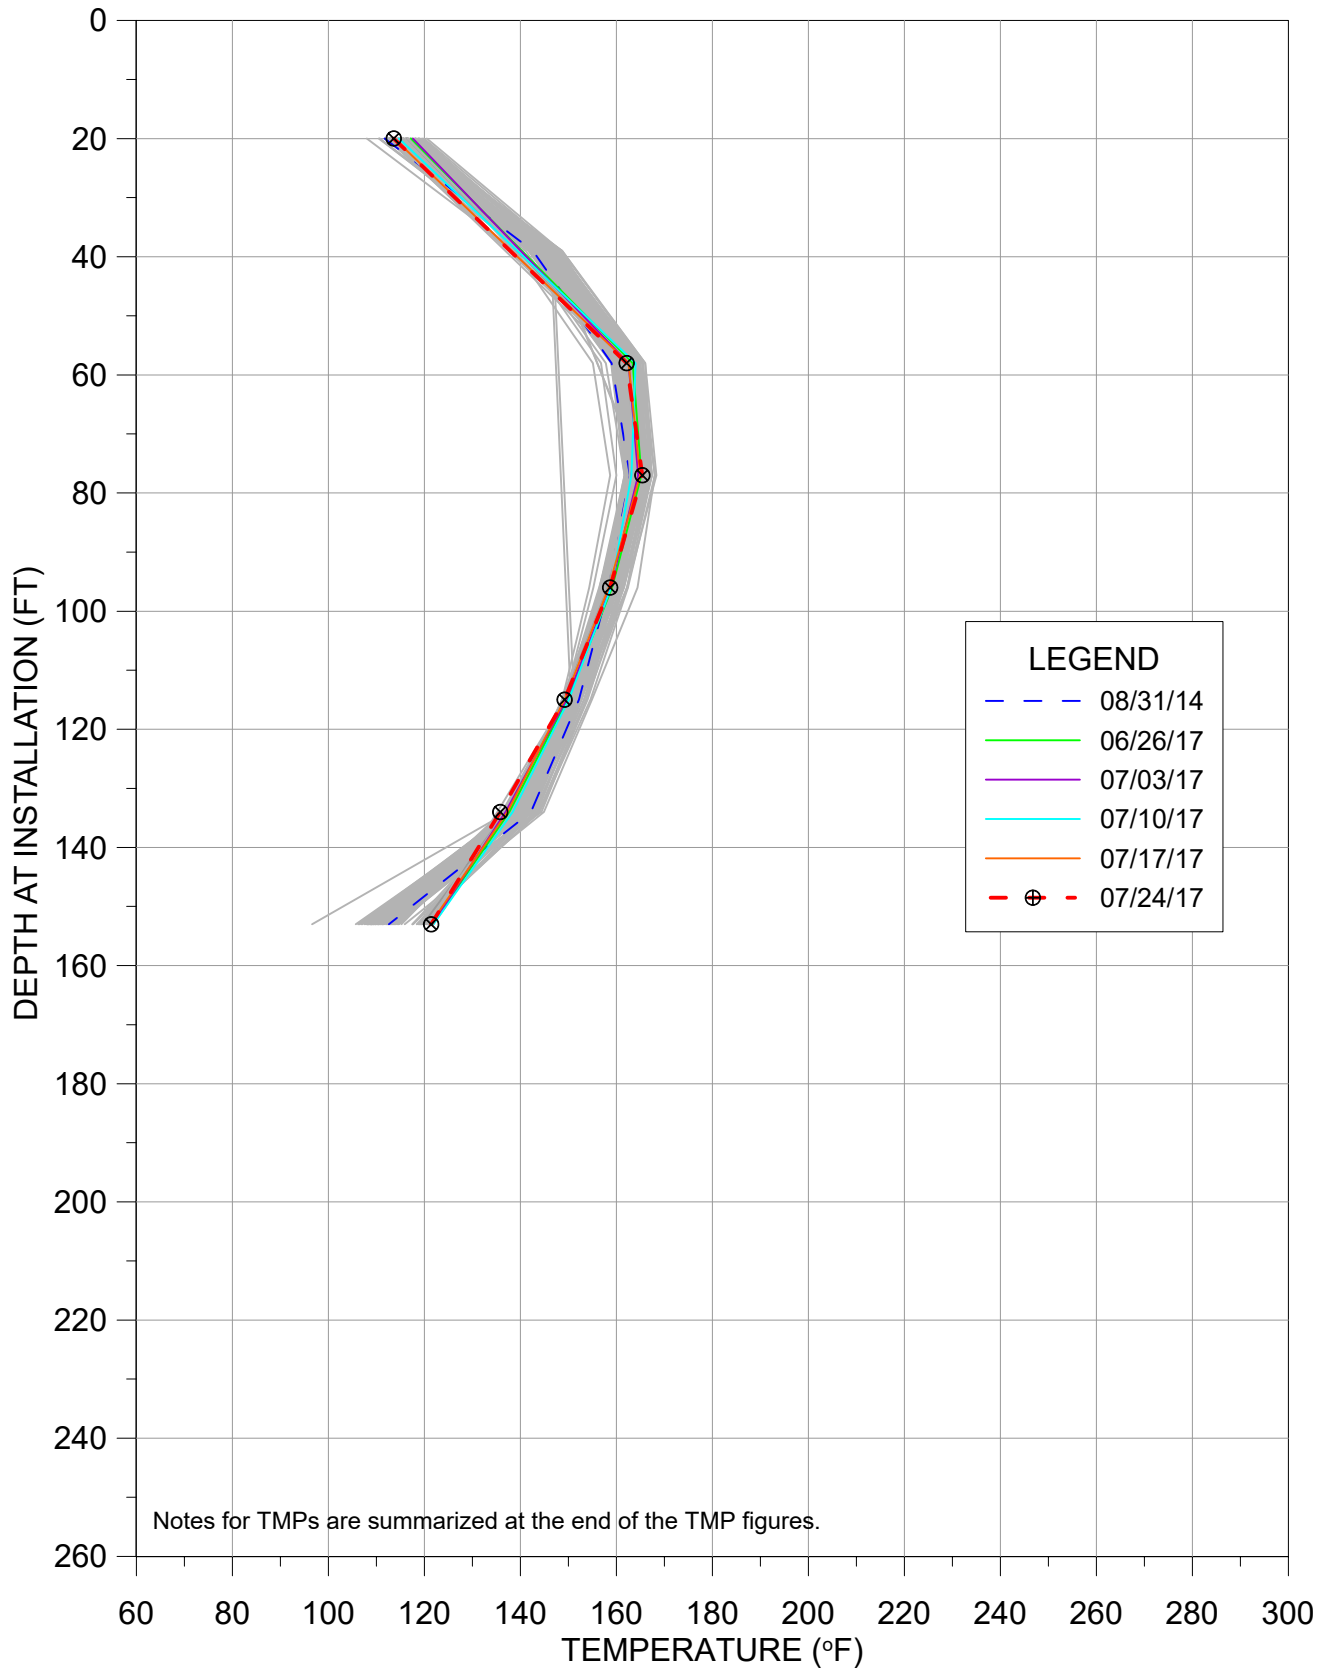
# TMP-16

1. A connectivity test conducted by Feezor Engineering showed that the units on TMP-16 may not be reliable since 9/9/2015. Further testing at the end of September 2015 showed possible connectivity on some of the units.
2. The unit at 153 ft depth had a low resistance reading and unreliable temperature since 12/21/2015.

3. The unit at 39 ft depth had a higher than acceptable resistance reading and unreliable temperature since 2/7/2017.

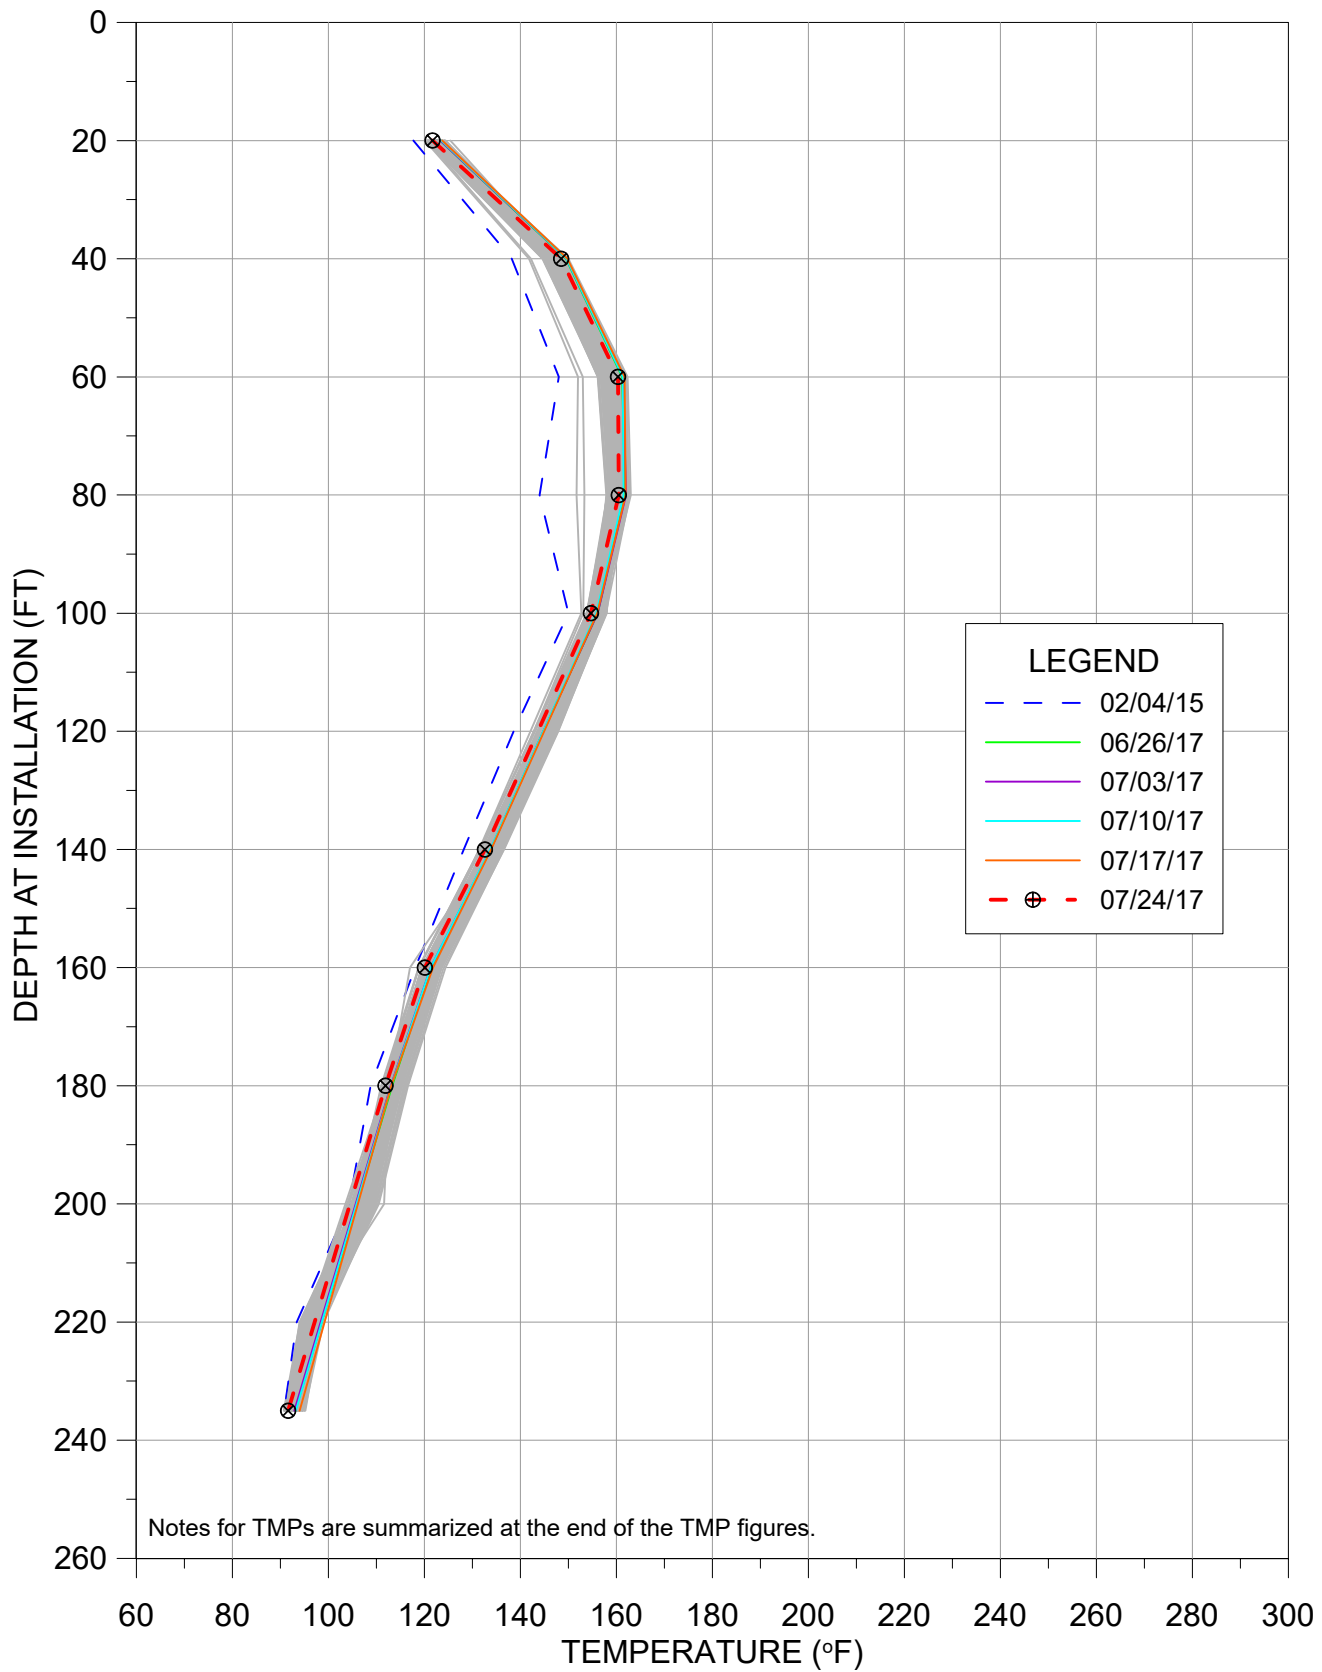
# TMP-25

1. The unit at 200 ft provided an apparent anomalous reading on 3/28/2017. Subsequent readings on 4/4/2017 showed the unit to have failed (see below). The unit is no longer working and the reading of 3/28/2017 was likely unreliable.

2. The unit at 200 ft depth had a resistance reading greater 4000 ohms on 4/4/2017. A connectivity test conducted by Feezor Engineering on 4/7/2017 showed that this unit also had cross-connectivity. The unit is therefore determined to be no longer working as of the 4/4/2017 reading.

3. The unit at 120 feet had a higher than acceptable limit on 7/10/2017. Also, a connectivity test conducted by Feezor Engineering on 4/7/2017 showed that this unit may be unreliable. Therefore, this unit is determined to be unreliable.

4. The unit at 220 ft has been reported as unable to attain a reading of any kind since June 19, 2017. The unit is considered to be on no longer working as of that date.

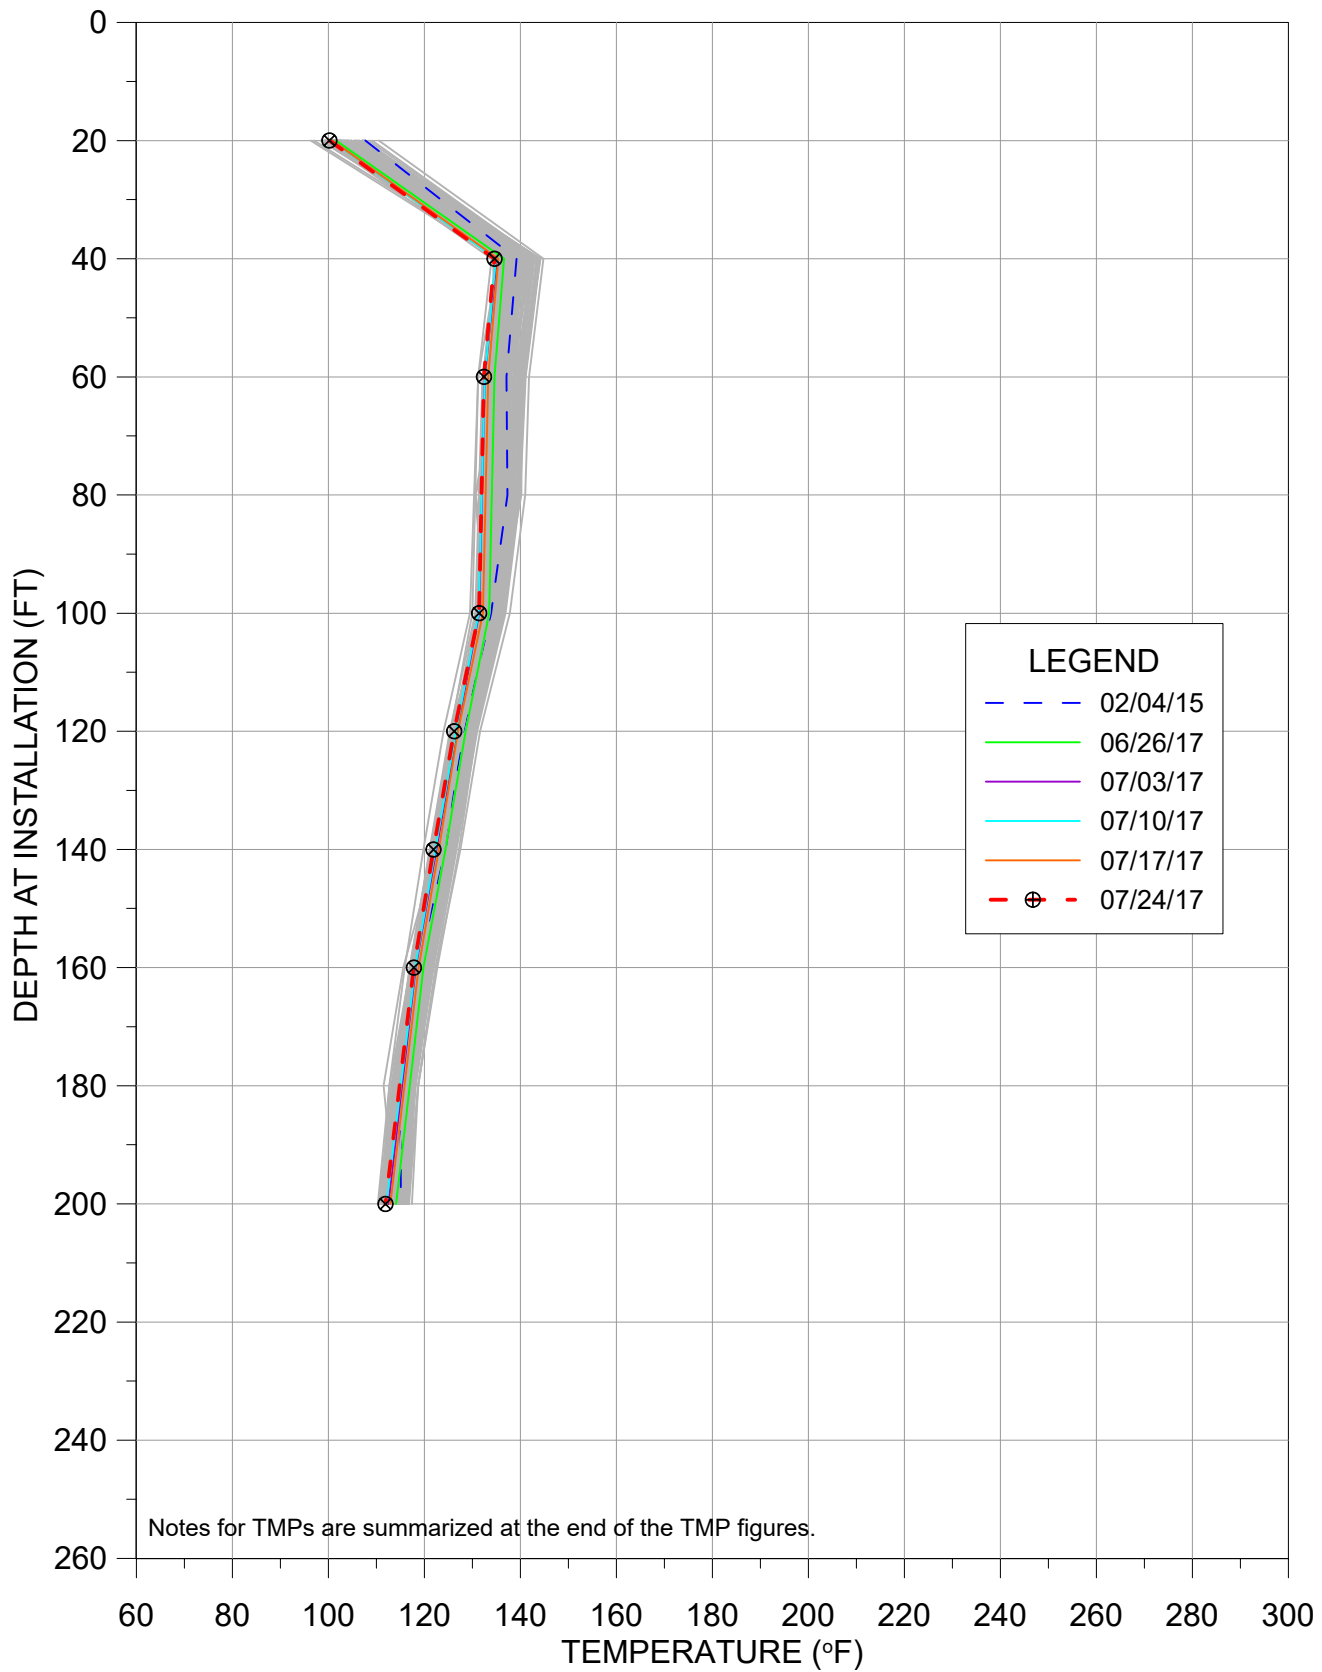
# TMP-28

1. The unit at 217 ft depth has had no resistance or temperature readings since installation.
2. The unit at 80 ft depth had a resistance drop and an unreasonable temperature decrease on 6/1/2016. The temperature has since fluctuated and is determined to be unreliable.
3. The unit at 180 feet has had a higher than acceptable limit since 3/28/2017 and is therefore determined to be unreliable as of the 4/4/2017 reading.

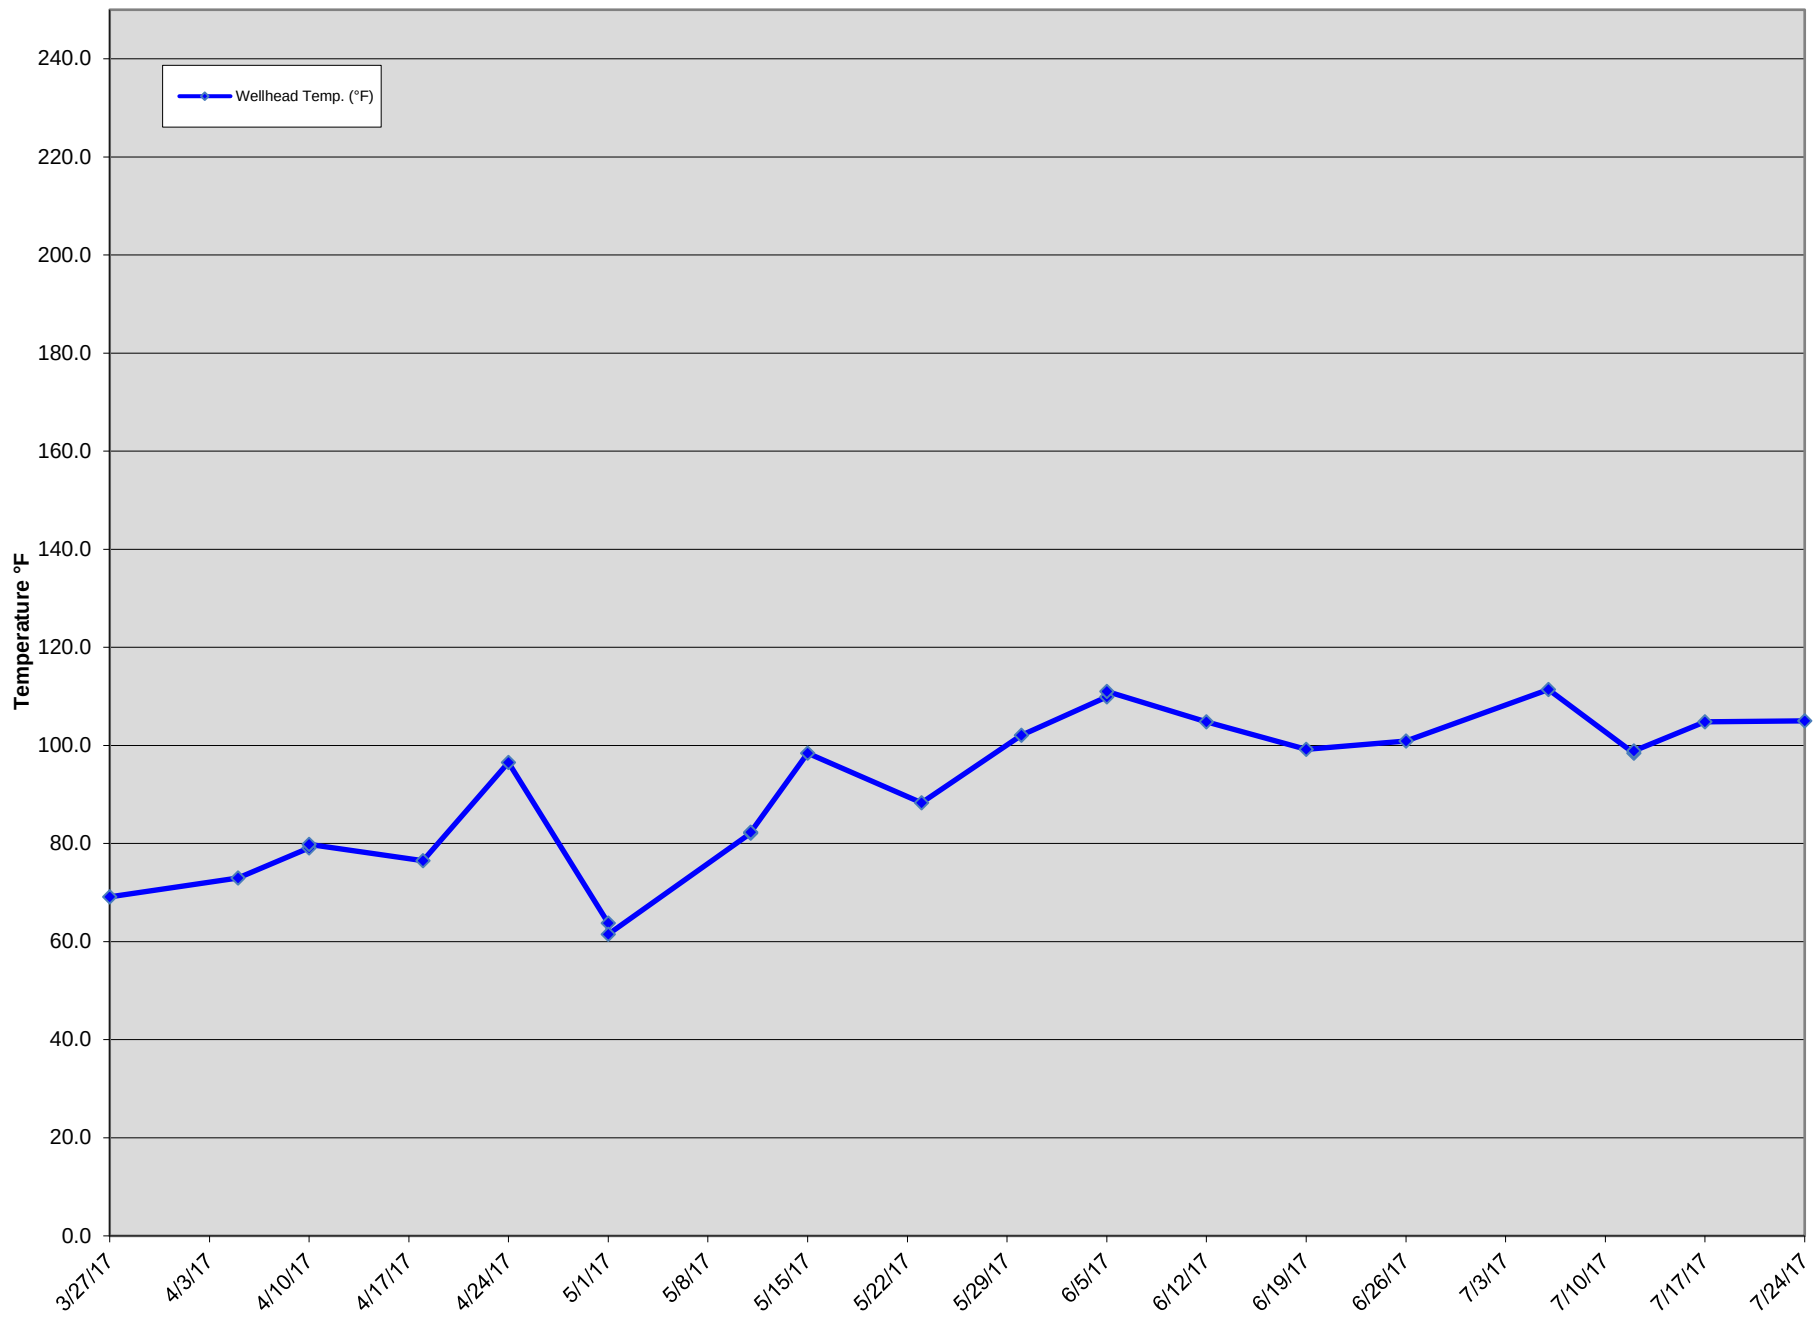
## GIW-1 Wellhead Temperatures

As part of the HES, there are currently cooling water circulation loops installed in twelve Gas Interceptor Wells (GIWs) (GIW-02 through GIW-13). The remaining well (GIW-01) had a measured gas temperature within its historical operating limits.
