BRIDGETON LANDFILL, LLC 13570 SAINT CHARLES ROCK RD BRIDGETON, MO 63044	BRIDGETON LANDFILL SETTLEMENT MONITORING	 	APRIL 2020 DESIGNED BY: IN APPROVED BY: DRF	DRAWING NO.: 003
SETTLEMENT MAP - N. QUARRY 1/15/2020 - 4/20/2020				
PROJECT NUMBER: BT-145 FILE PATH: C:\Users\jplm\OneDrive (Fezor Engineering)\Bridgeton\100-149\BT-145 (Agreed Order Reporting)\Quarterly Settlement\2020-04\Quarterly NQ Settlement 4-20-2020.dwg		REVISION DATE

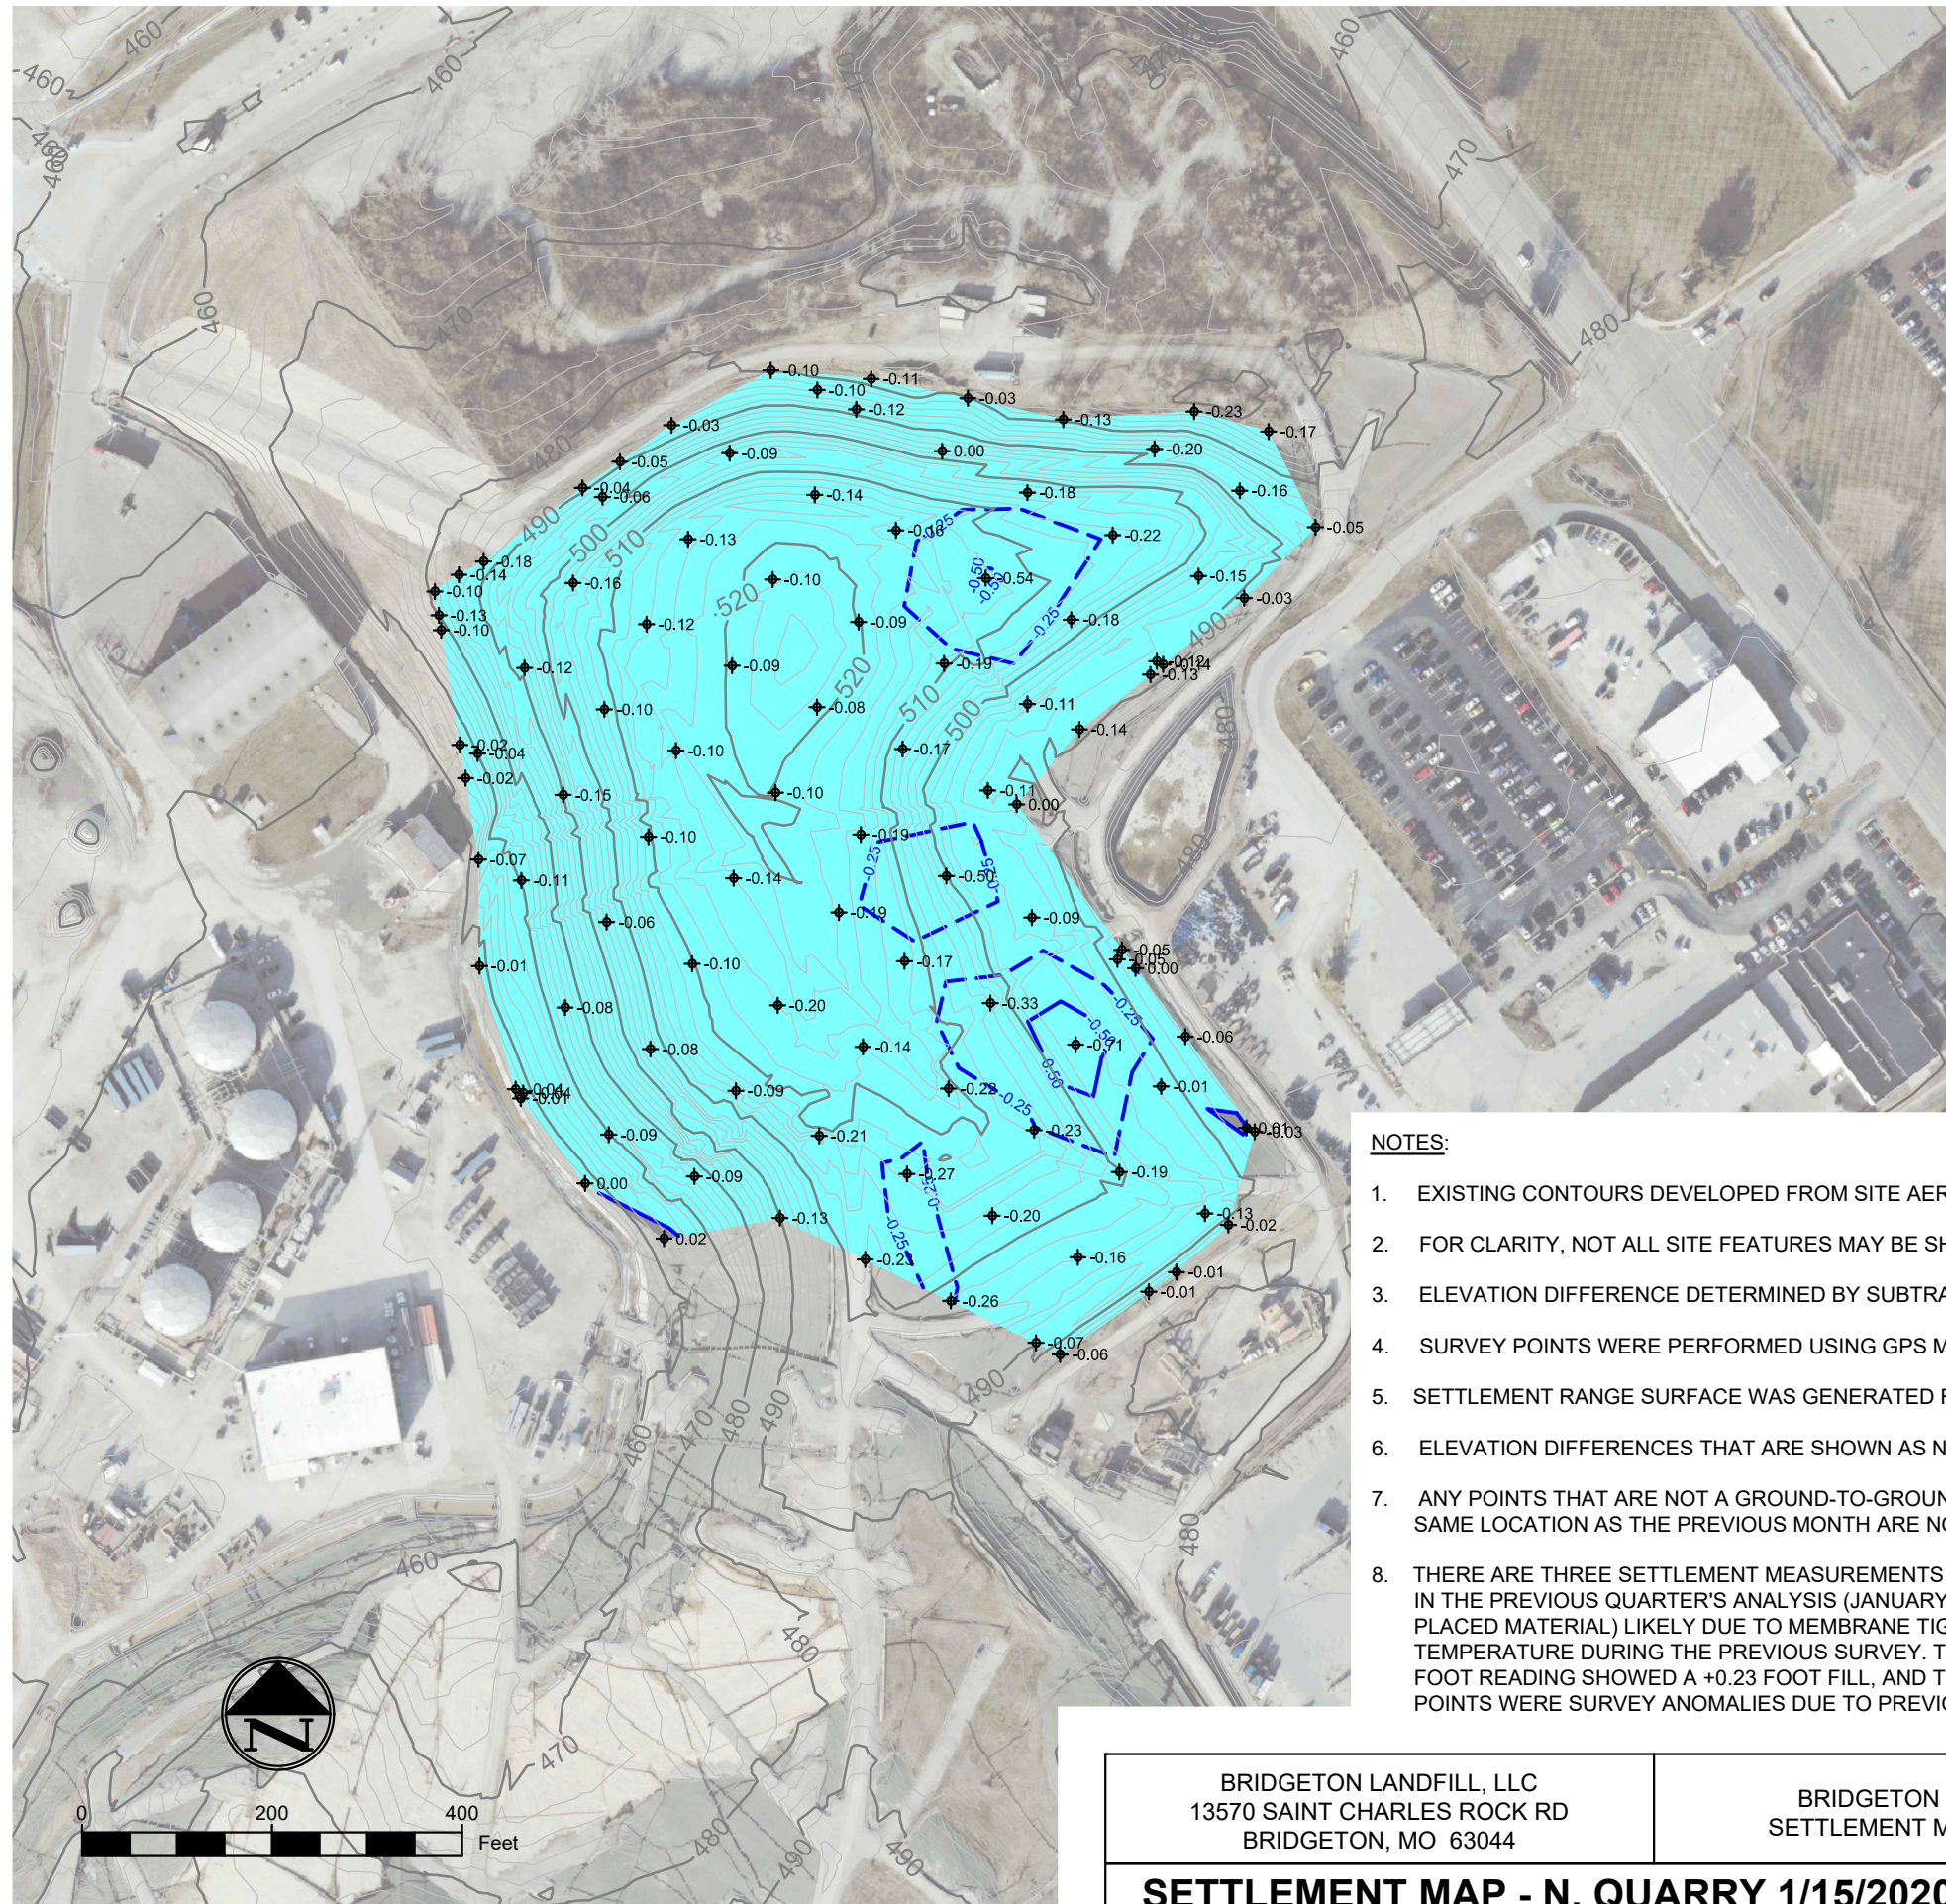
Thickness Map				
Range	Minimum Depth	Maximum Depth	2D Area (Sq. Ft.)	Color
1	-5.00	-4.00	0.00	Dark Blue
2	-4.00	-3.00	0.00	Blue
3	-3.00	-2.00	0.00	Light Blue
4	-2.00	-1.00	0.00	Very Light Blue
5	-1.00	0.00	641,186.20	Cyan
6	0.00	1.00	1,011.36	Grey

3. ELEVATION DIFFERENCE DETERMINED BY SUBTRACTING SPOT ELEVATIONS SURVEYED ON 1-15-20 FROM SPOT ELEVATIONS SURVEYED ON 4-20-20.
4. SURVEY POINTS WERE PERFORMED USING GPS METHODS.

5. SETTLEMENT RANGE SURFACE WAS GENERATED FROM THE SPOT ELEVATION DIFFERENCES.
6. ELEVATION DIFFERENCES THAT ARE SHOWN AS NEGATIVE INDICATE SPOTS OF SETTLEMENT.

8. THERE ARE THREE SETTLEMENT MEASUREMENTS FOR THIS QUARTER WHICH ARE 0.5 FEET OR GREATER(-0.50 FOOT, -0.54 FOOT, AND -0.71 FOOT). IN THE PREVIOUS QUARTER'S ANALYSIS (JANUARY 5, 2020), ALL THREE OF THESE POINTS INDICATED AN ARTIFICIAL "FILL" (RISE IN ELEVATION WITHOUT ANY PLACED MATERIAL) LIKELY DUE TO MEMBRANE TIGHTNESS CAUSED BY COLD AMBIENT TEMPERATURE IN JANUARY AS COMPARED TO THE WARMER TEMPERATURE DURING THE PREVIOUS SURVEY. THE LOCATION OF THE CURRENT -0.50 FOOT READING SHOWED A +0.33 FOOT FILL IN JANUARY, THE -0.54 FOOT READING SHOWED A +0.23 FOOT FILL, AND THE -0.71 FOOT READING SHOWED A +0.38 FOOT FILL. THEREFORE, IT IS BELIEVED THAT THESE THREE POINTS WERE SURVEY ANOMALIES DUE TO PREVIOUS LINER TIGHTNESS AND DO NOT REPRESENT ACTUAL SETTLEMENTS IN THE AMOUNTS PRESENTED.
