Bridgeton Landfill, LLC

Weekly Data Submittal

Week of March 4, 2018 – March 10, 2018

**Required by Section 52.F of Agreed Order, Case No. 13SL-CC01088
Effective May 13, 2013**

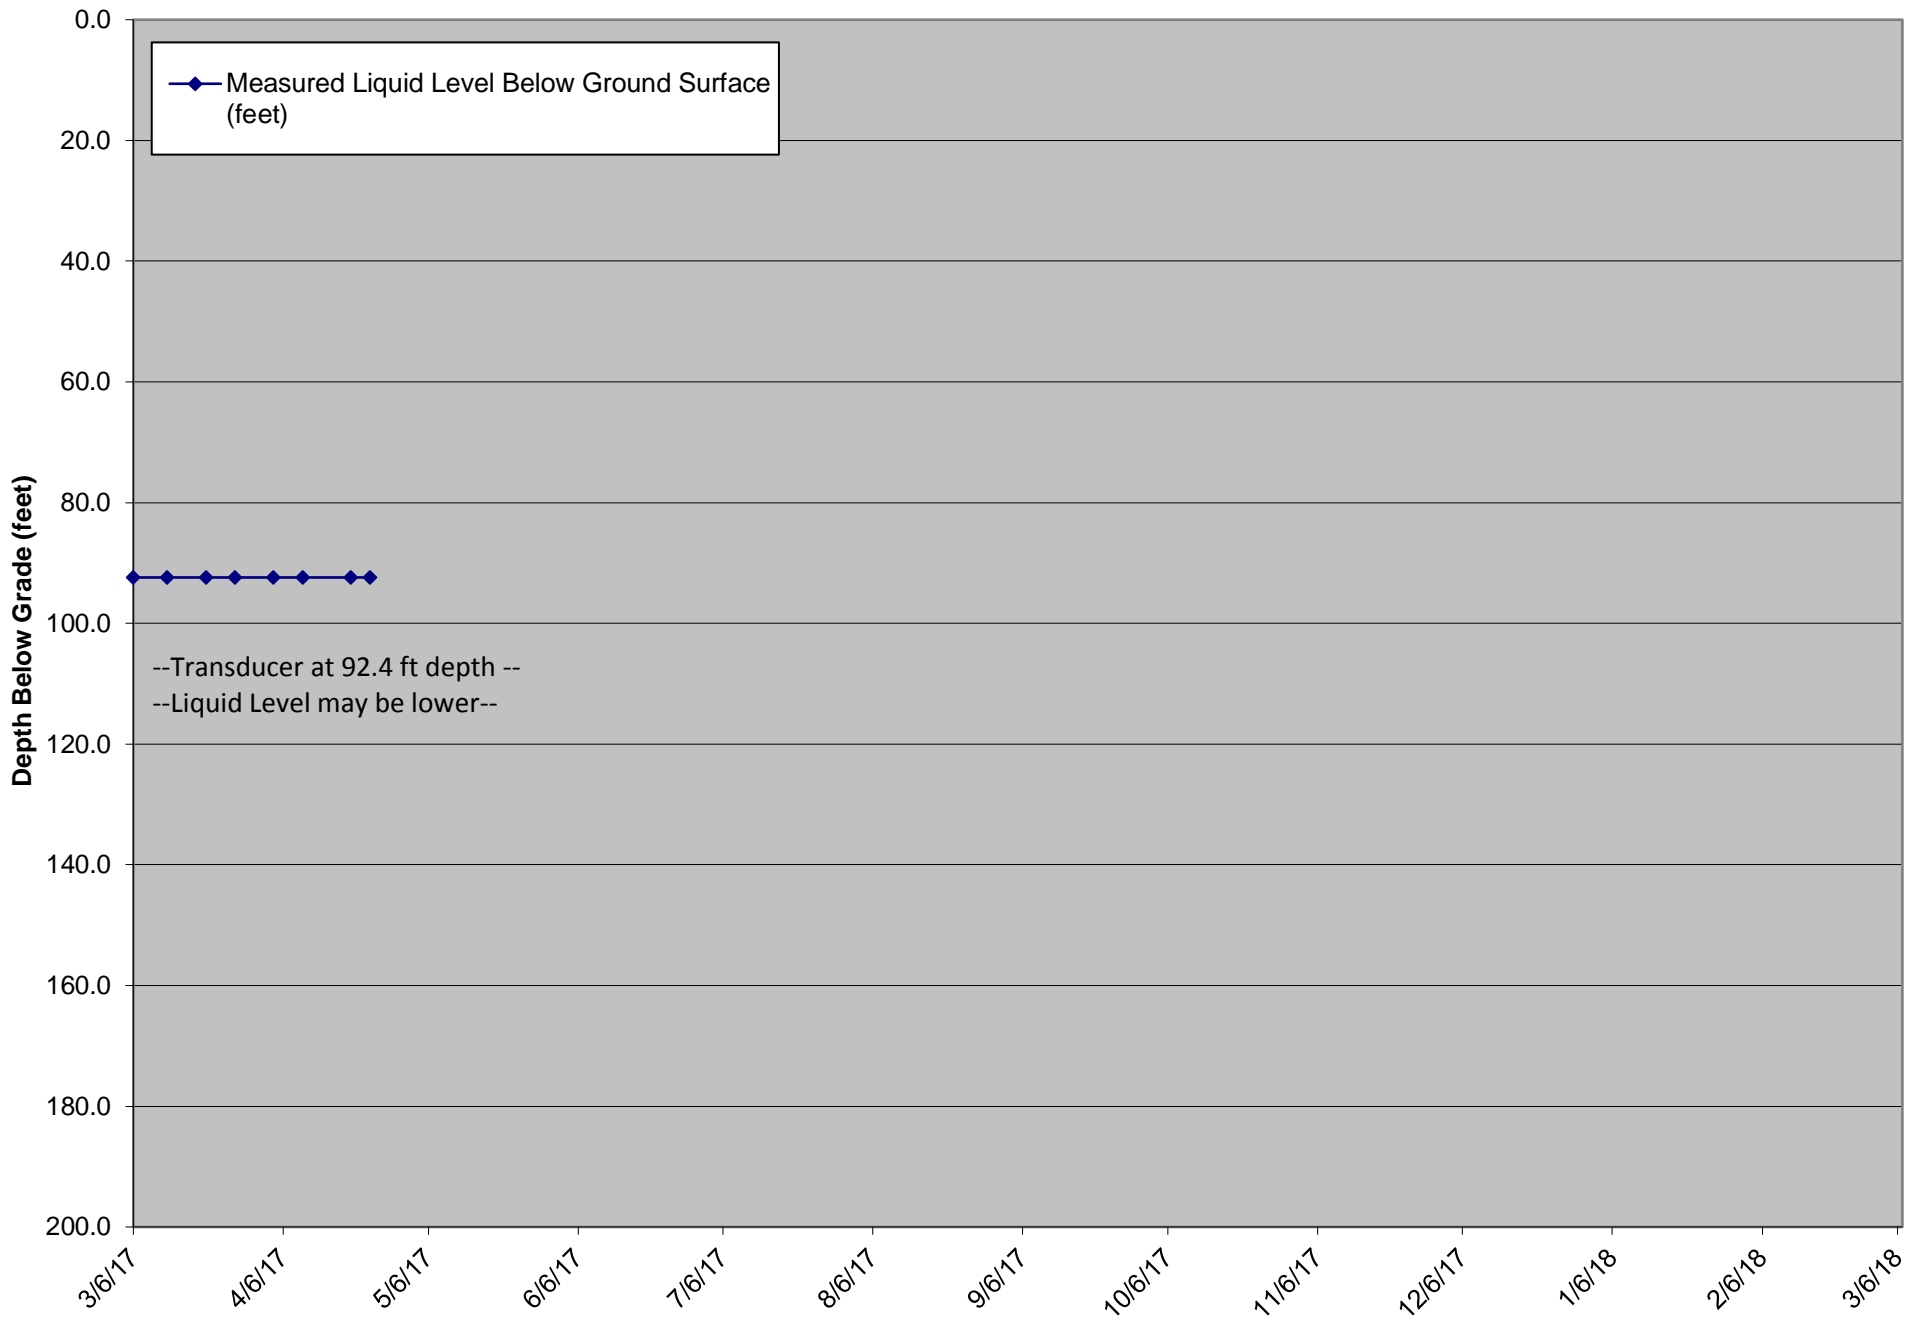
LCS-1D Liquid Level Below Ground Surface

Downhole discharge piping and the pump for LCS-1D was replaced the week of 2/5/18. Pump was non-operational after startup activities. Pump replacement is pending parts arrival.

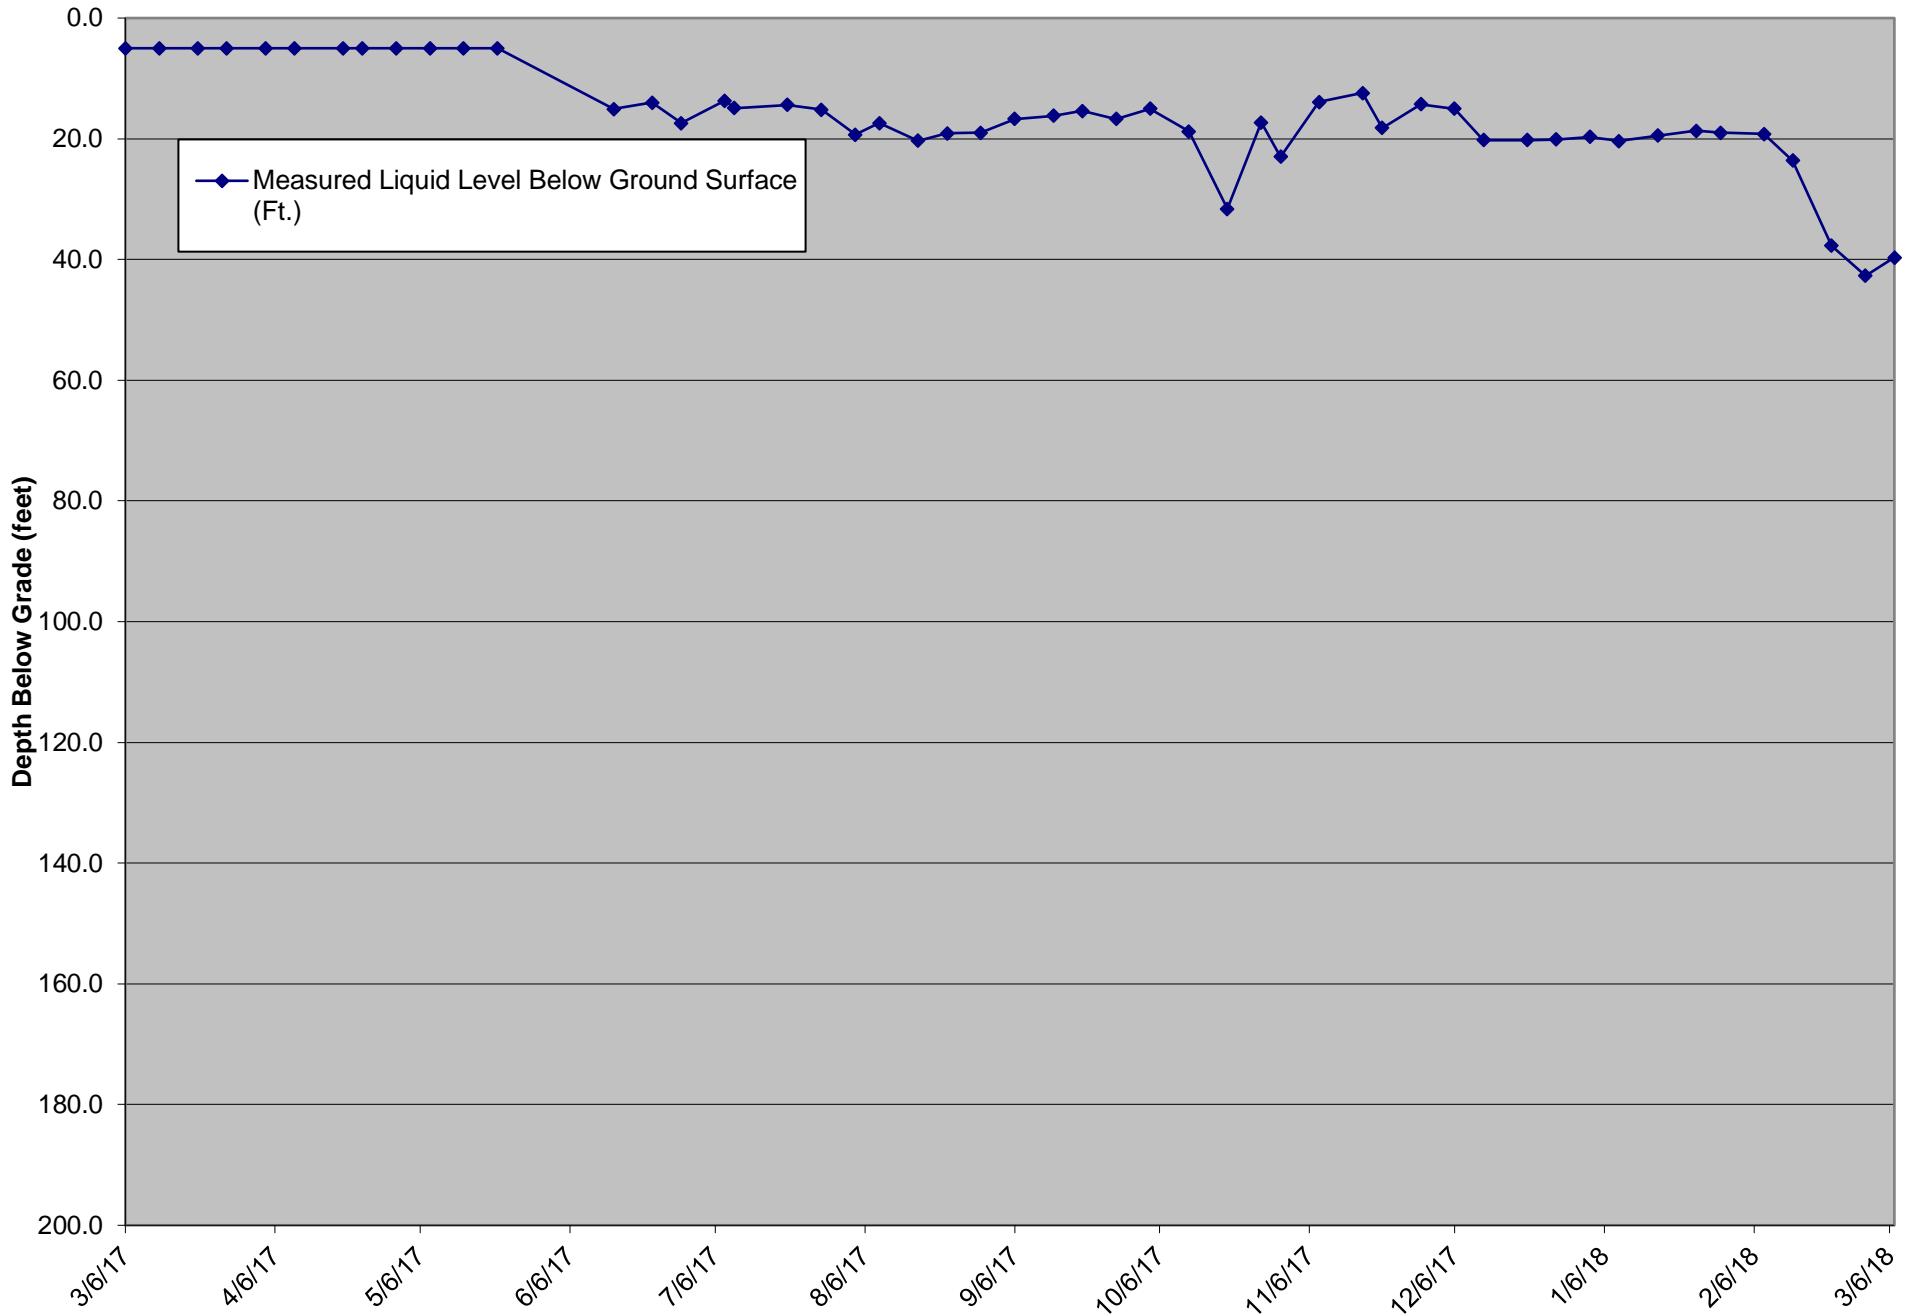
LCS-3D Liquid Level Below Ground Surface

The Blackhawk pneumatic pumps in LCS-3D were replaced with a QED AP-4 pneumatic pump on 2/15/18. Liquid level was measured manually.

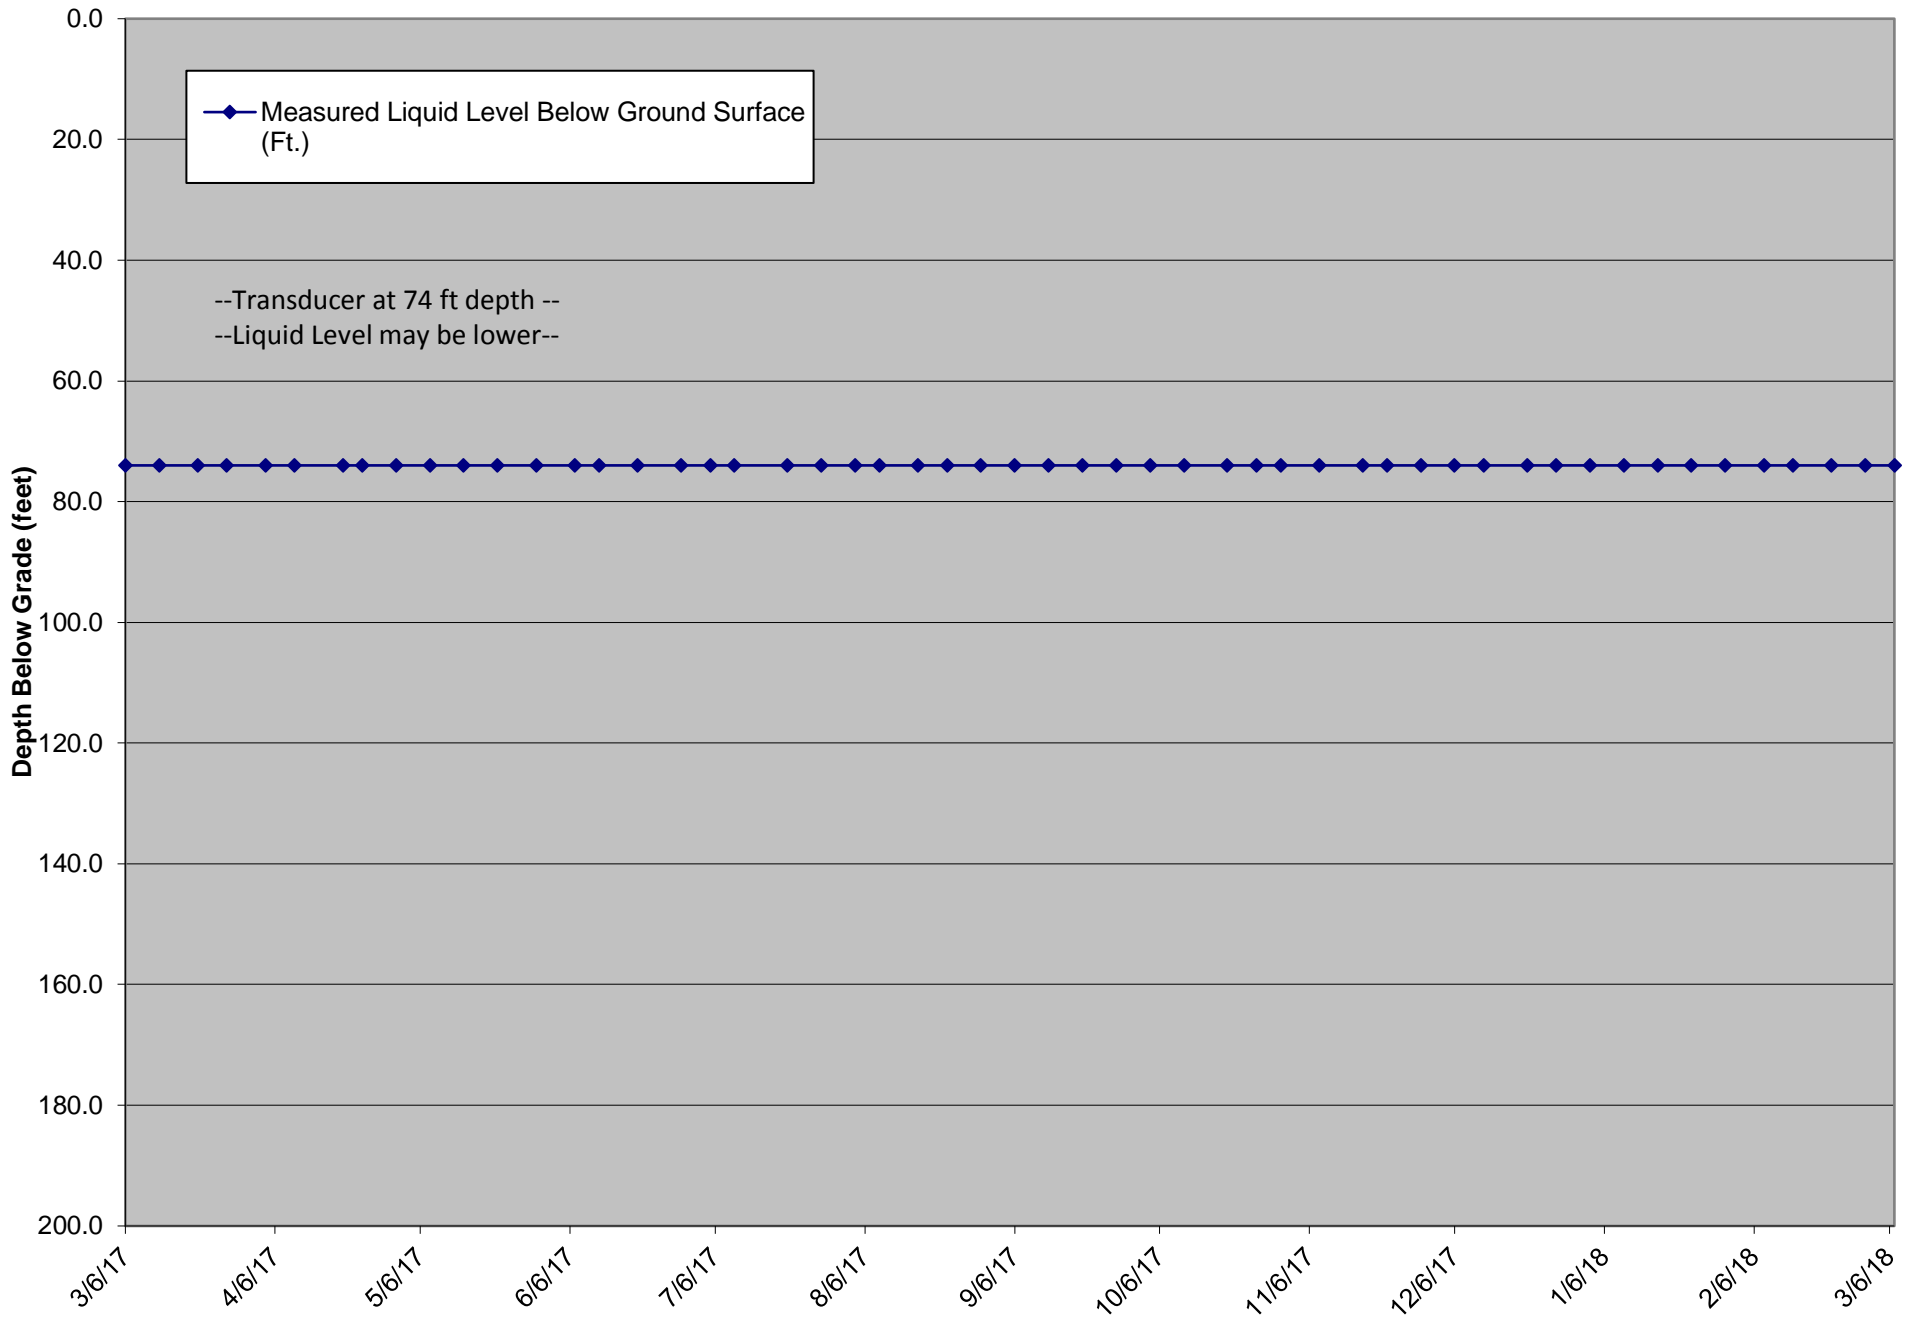
LCS-4B Liquid Level Below Ground Surface

The level sensor in LCS-4B is currently operational and responsive. Liquid level was not recorded by the level sensor during the weekly reporting period. LCS-4B is equipped with a flow meter that displayed no flow during the weekly reporting period. Therefore, it can be concluded that the liquid level was below the bottom of the pump and level sensor in LCS-4B.

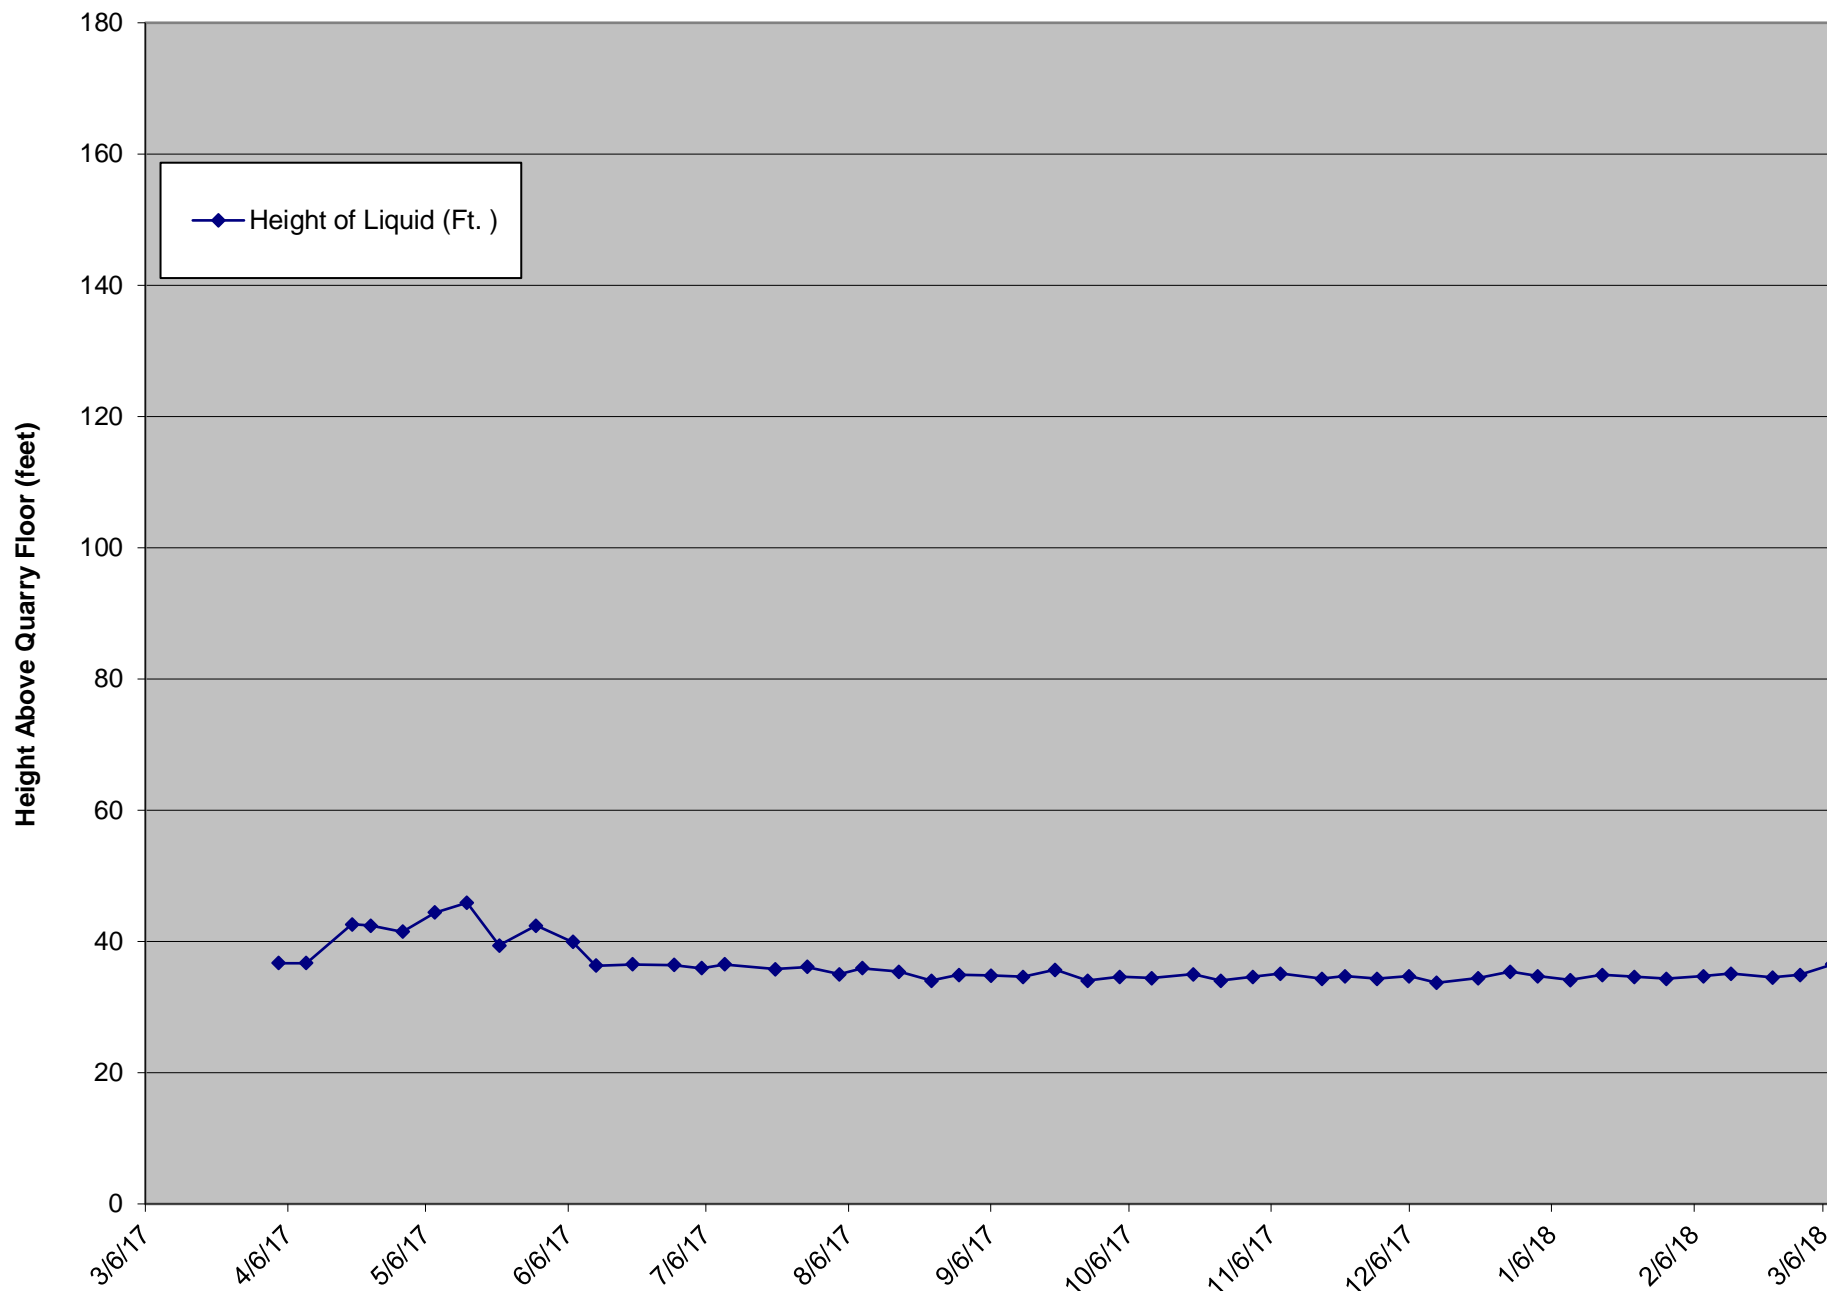
LCS-5B Liquid Level Above Quarry Floor

LCS-5B was fully operational during the weekly reporting period.

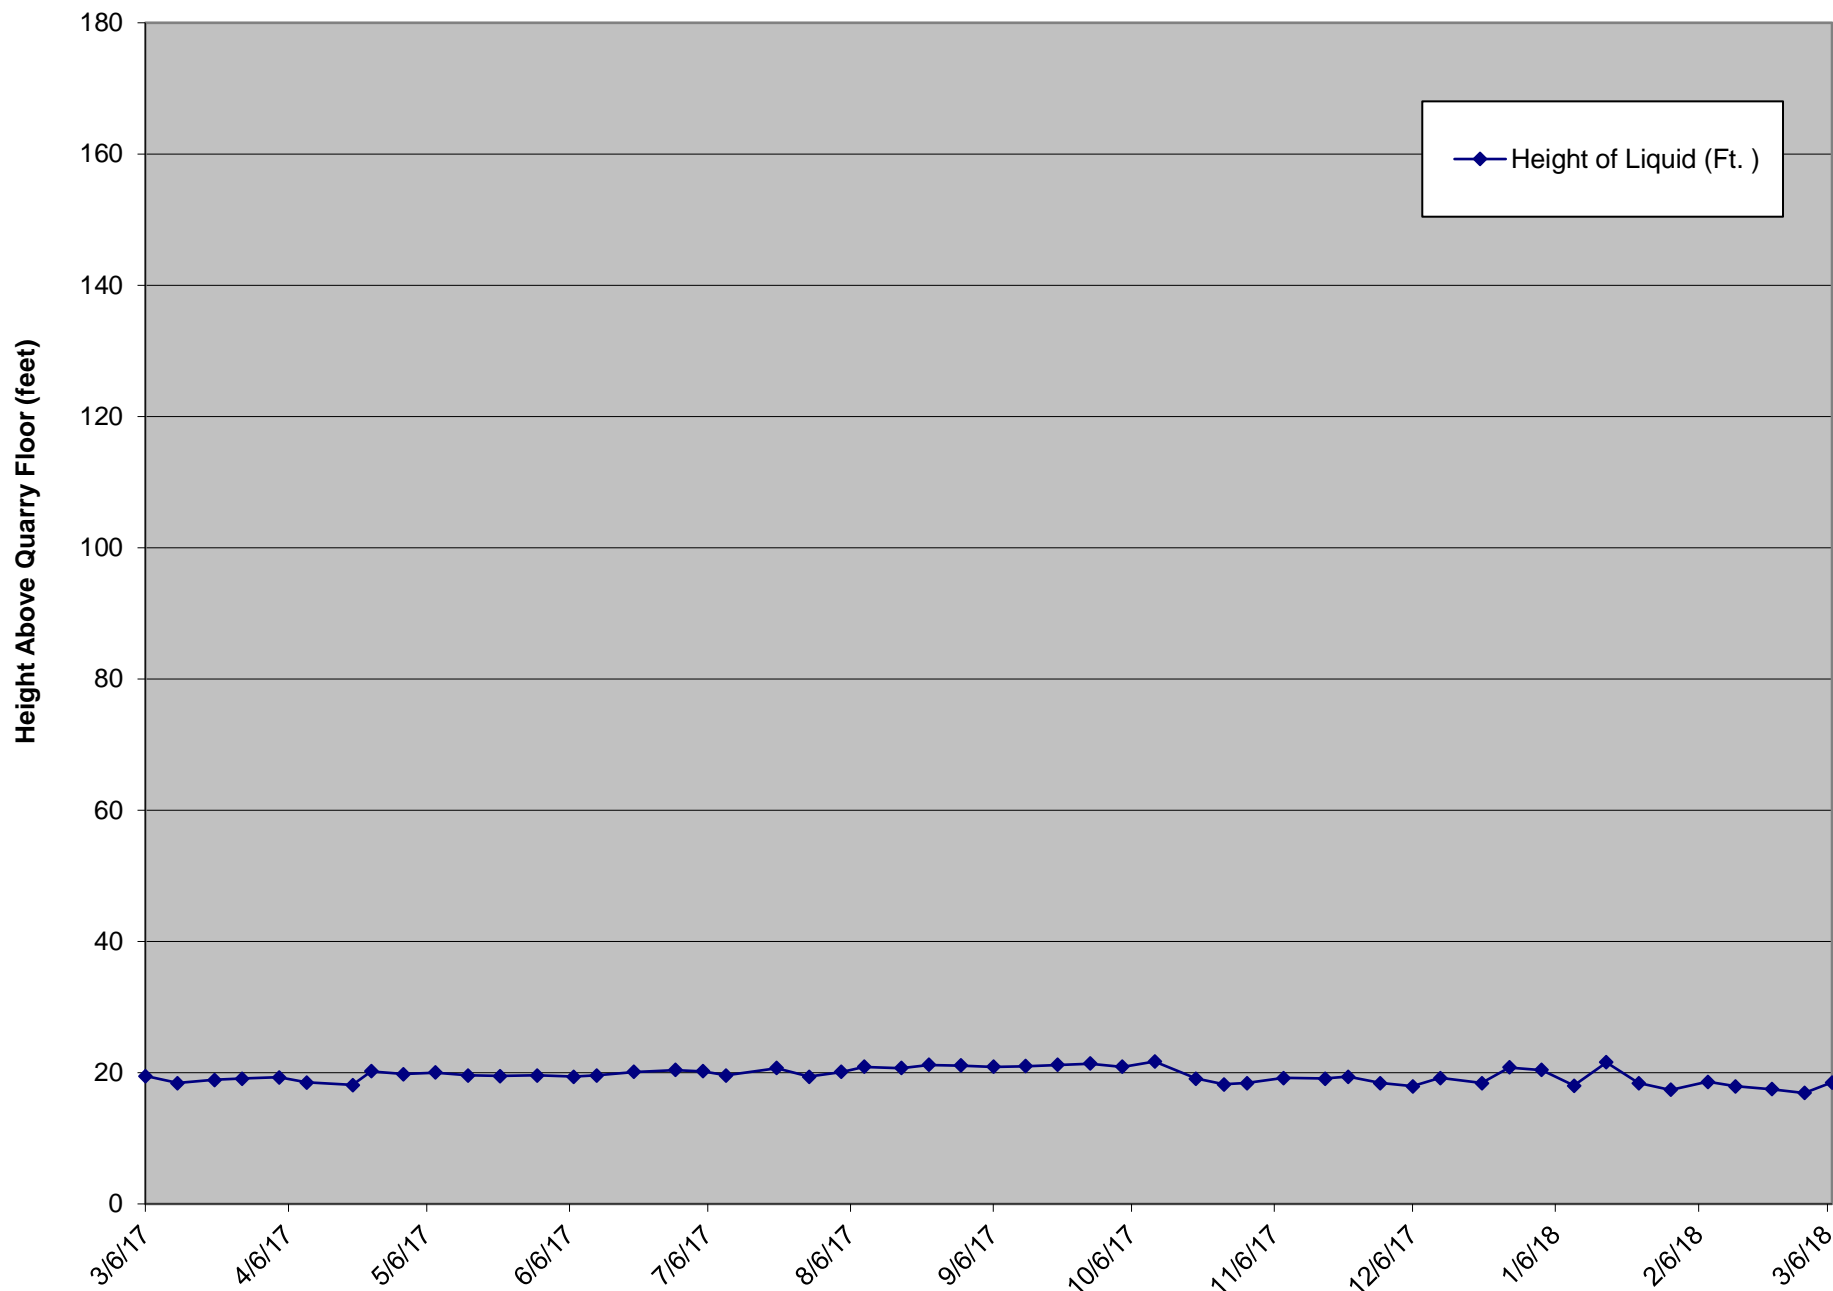
LCS-6B Liquid Level Above Quarry Floor

The liquid level in LCS-6B was measured on 3/7/18. The pump in LCS-6B was observed to be non-operational on 3/9/18. The liquid level in LCS-6B is still in compliance with the pump non-operational. Pump replacement is pending parts arrival.

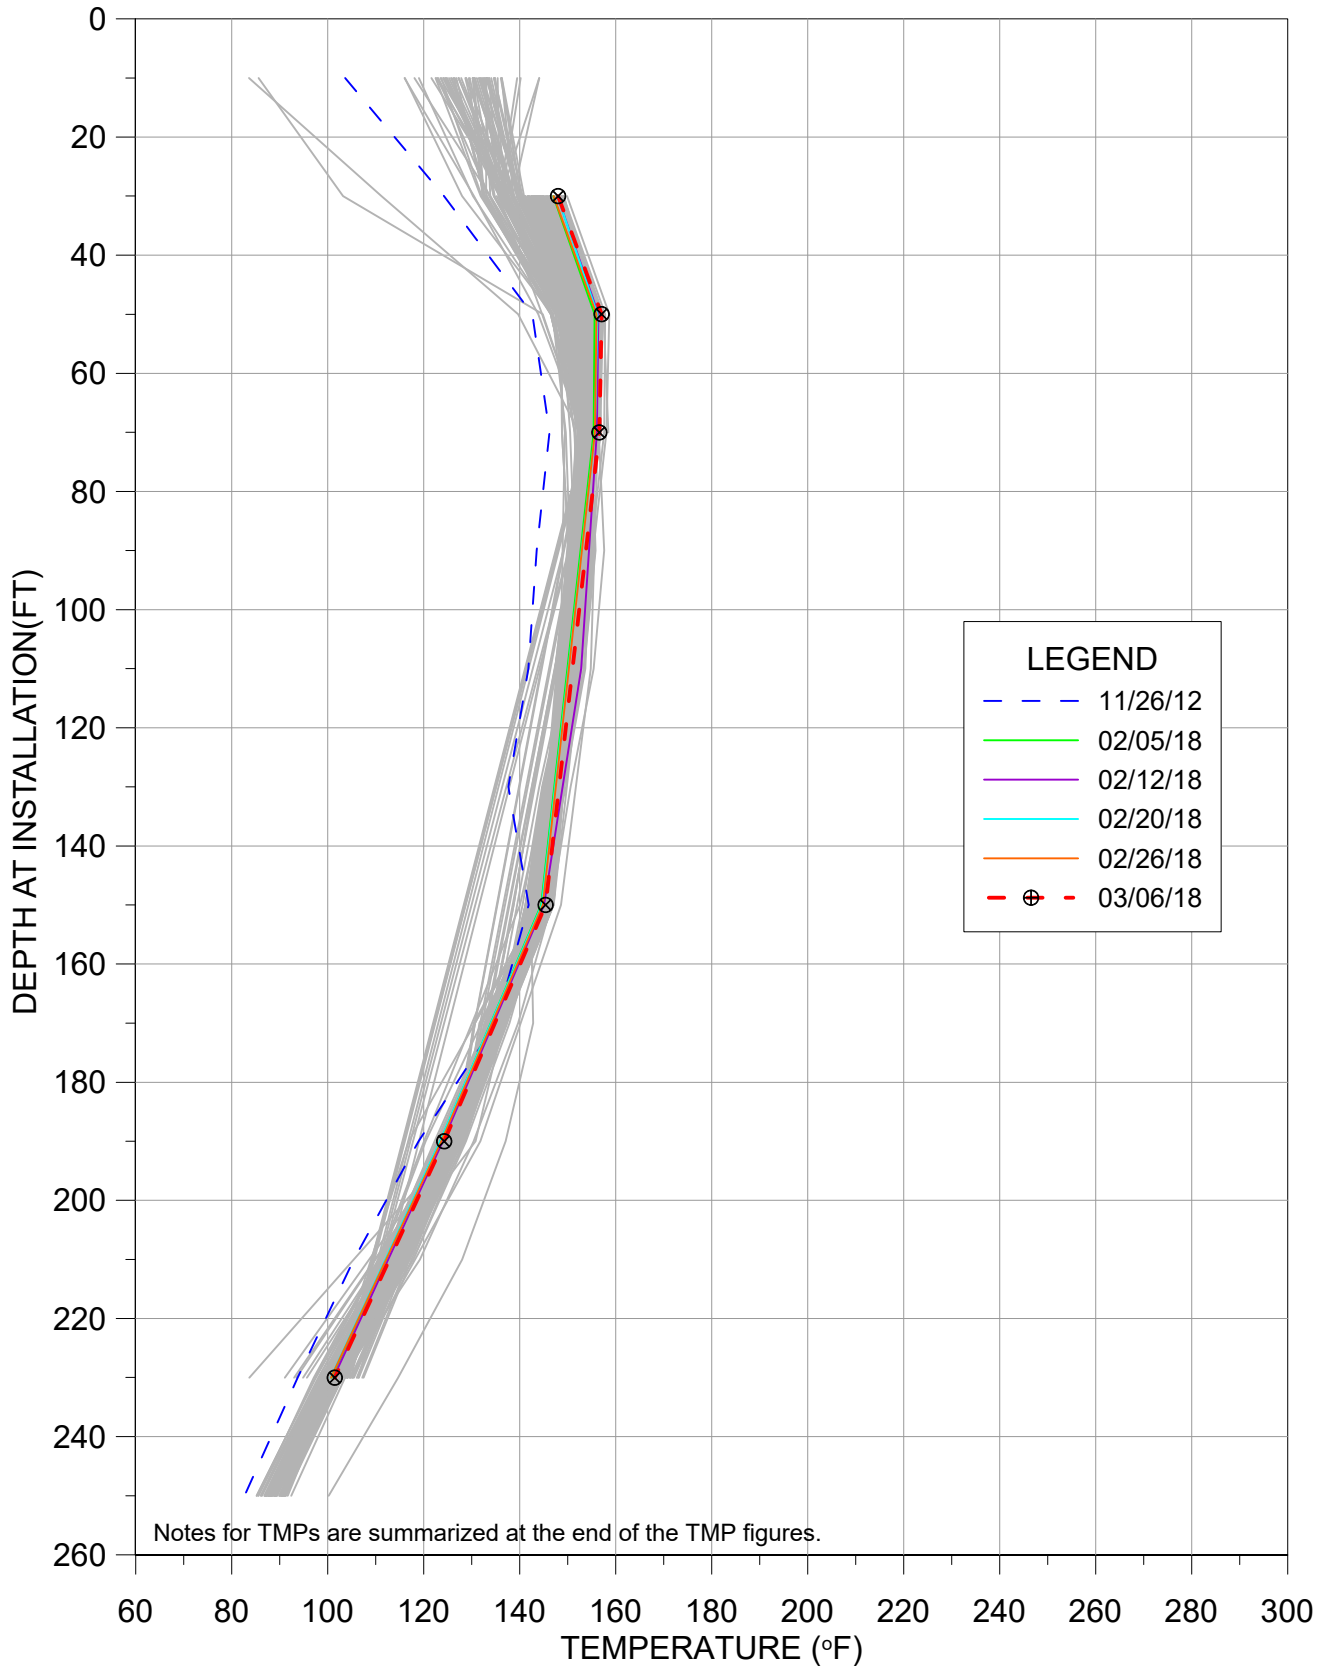
TMP-3

1. No reliable temperature readings have been obtained at 170 ft depth since 1/29/2014, except on 3/13/2014.
2. The connectivity tests on 4/11/2014 conducted by CEC showed that units at 10, 90, 130, 210 and 250 ft depths are no longer reliable.
3. The connectivity tests on 10/28/2014 conducted by Feezor Engineering showed that units at 10, 90, 110, 130, 210 and 250 ft depths are not reliable.

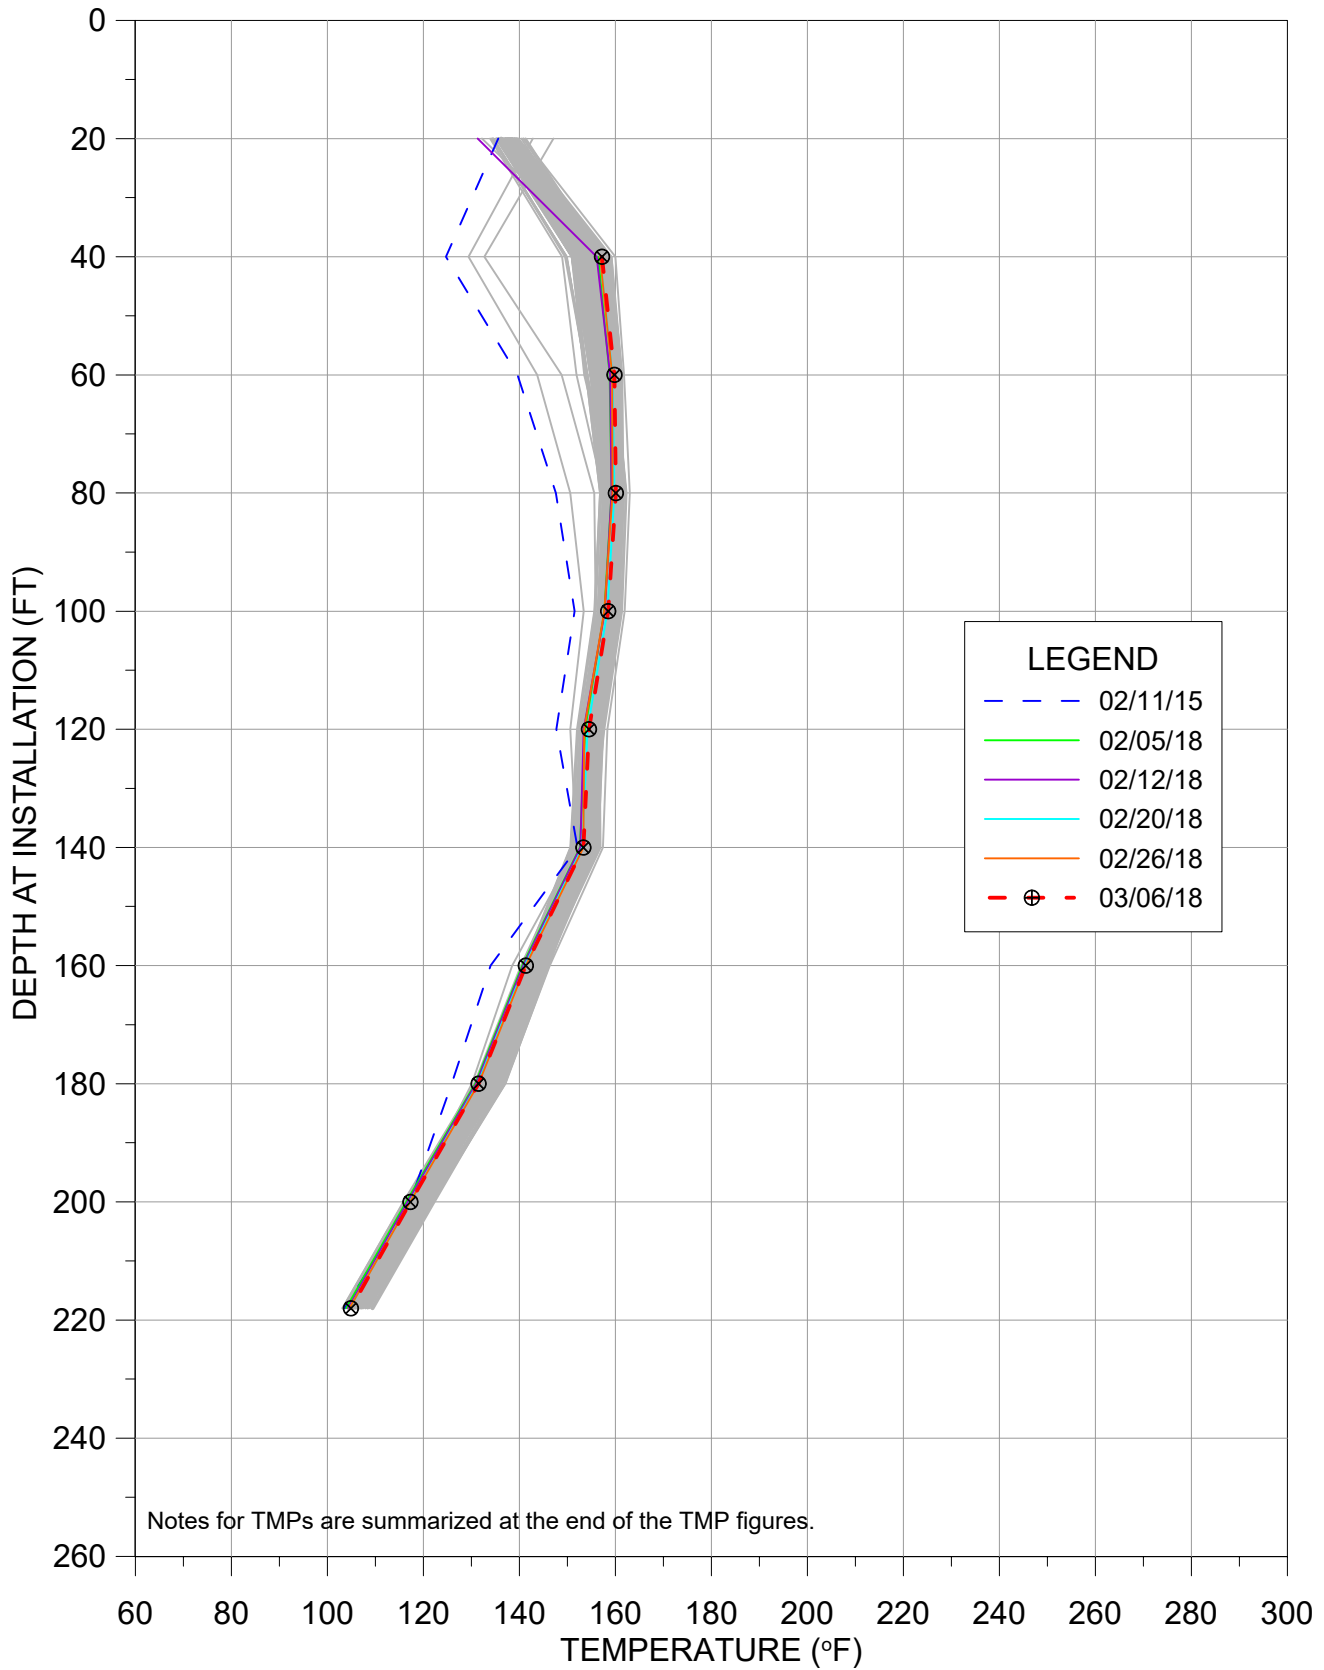
TMP-3R

1. The unit at 20 ft depth had a fluctuating resistance since 9/25/2017. Therefore the temperature is determined to be unreliable.

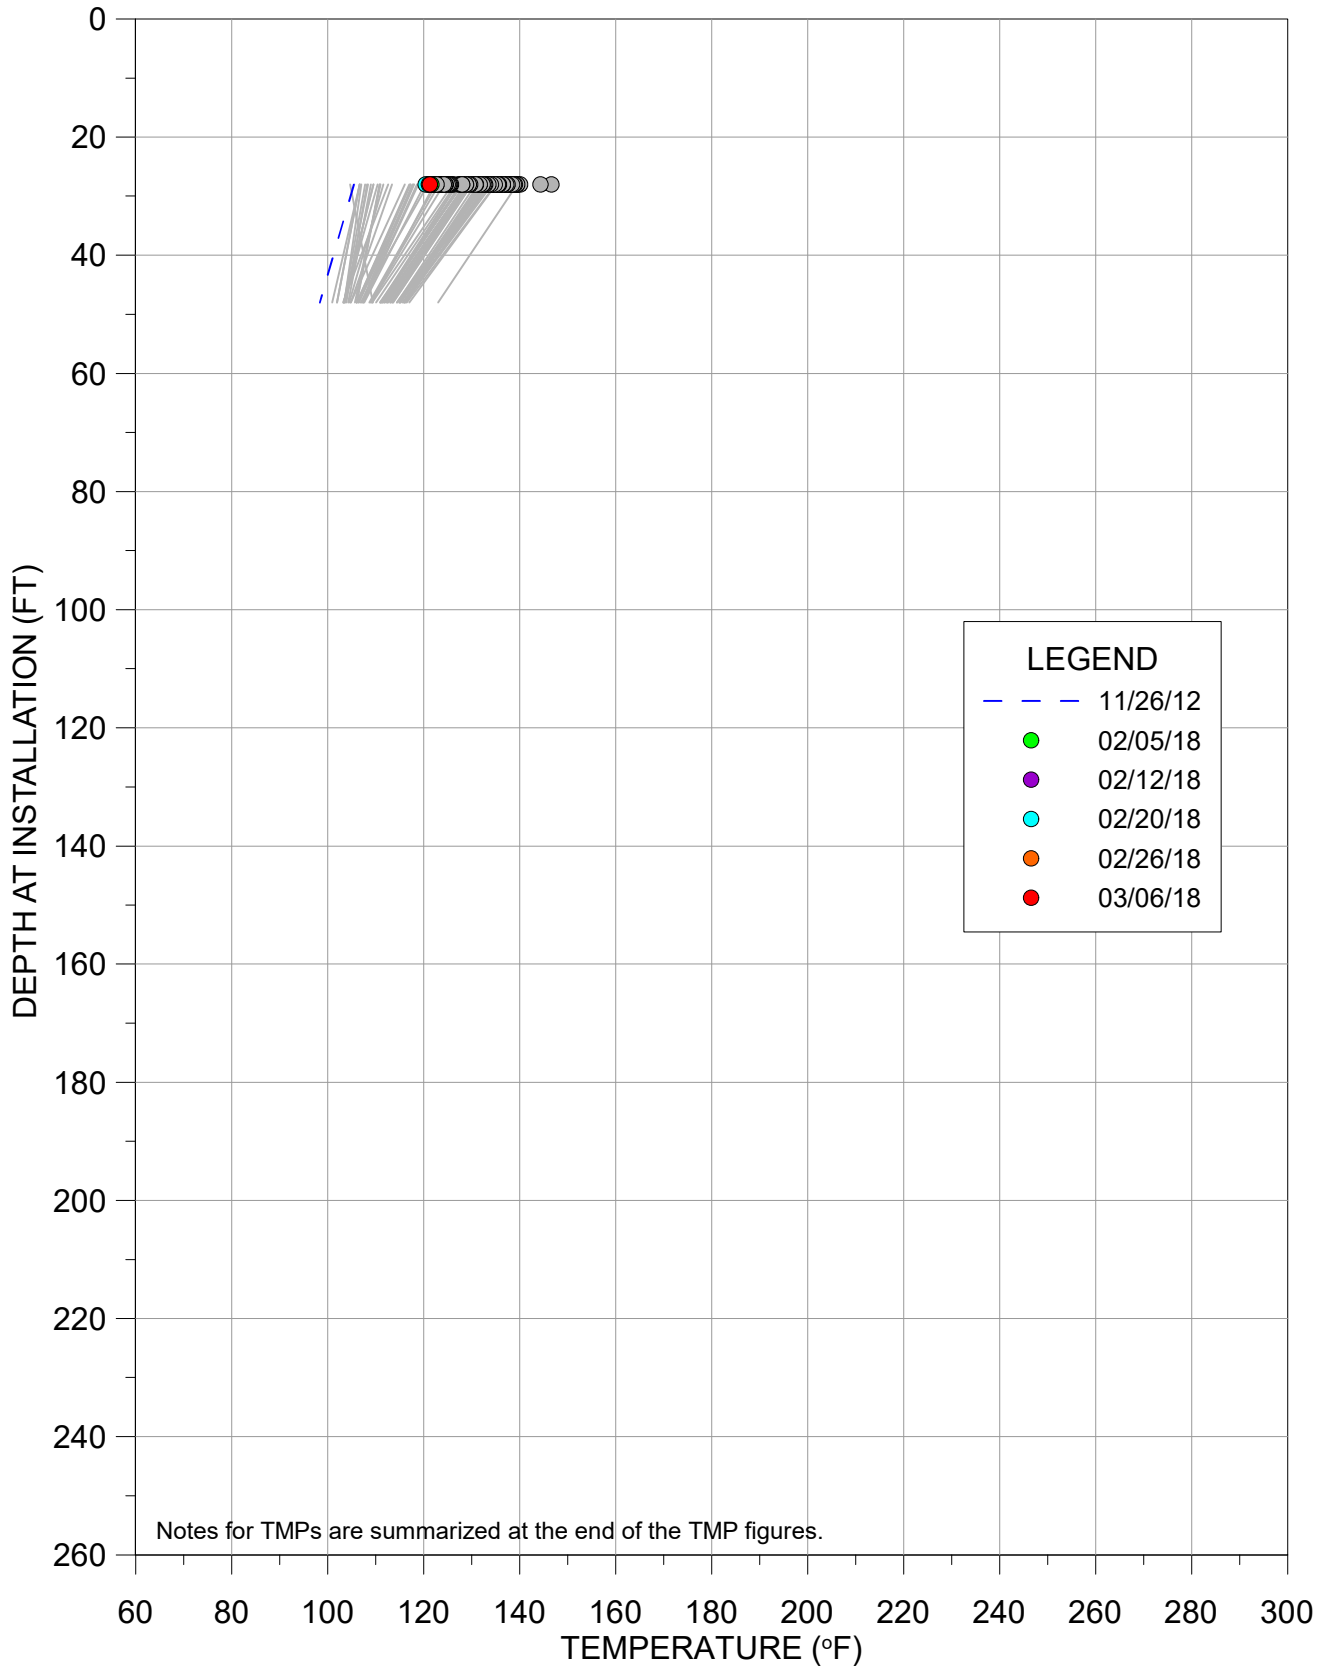
TMP-4

1. The connectivity tests on 4/11/2014 conducted by CEC showed that the unit at 48 ft depth is no longer reliable.

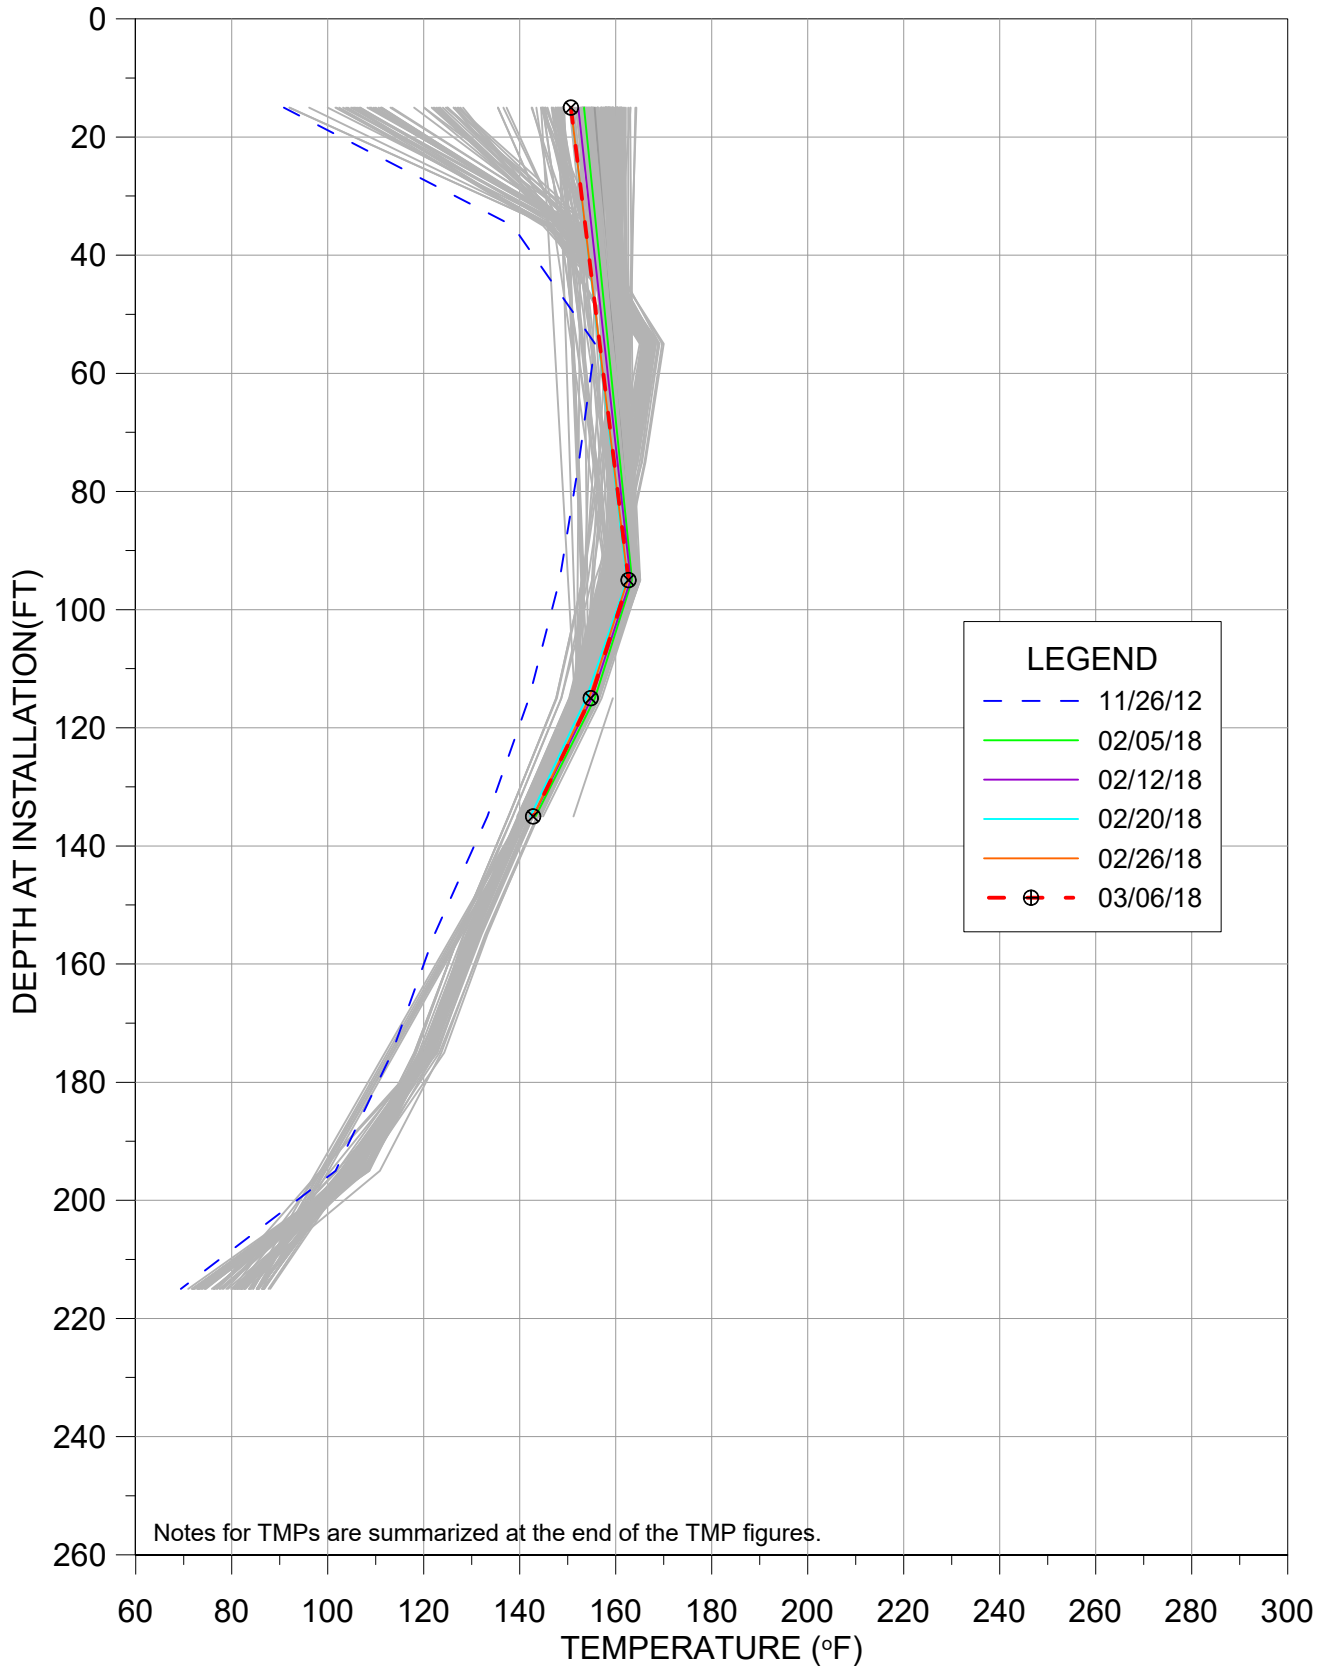
TMP-6

1. The connectivity tests on 4/11/2014 conducted by CEC showed that units at 35, 55, 75, 155, 175, and 195 ft depths are no longer reliable.
2. No reliable temperature readings have been obtained at the unit at 215 ft depth since 6/13/2014.
