Bridgeton Landfill, LLC

Weekly Data Submittal

Week of March 4, 2018 – March 10, 2018

**Required by Section 52.F of Agreed Order, Case No. 13SL-CC01088
Effective May 13, 2013**

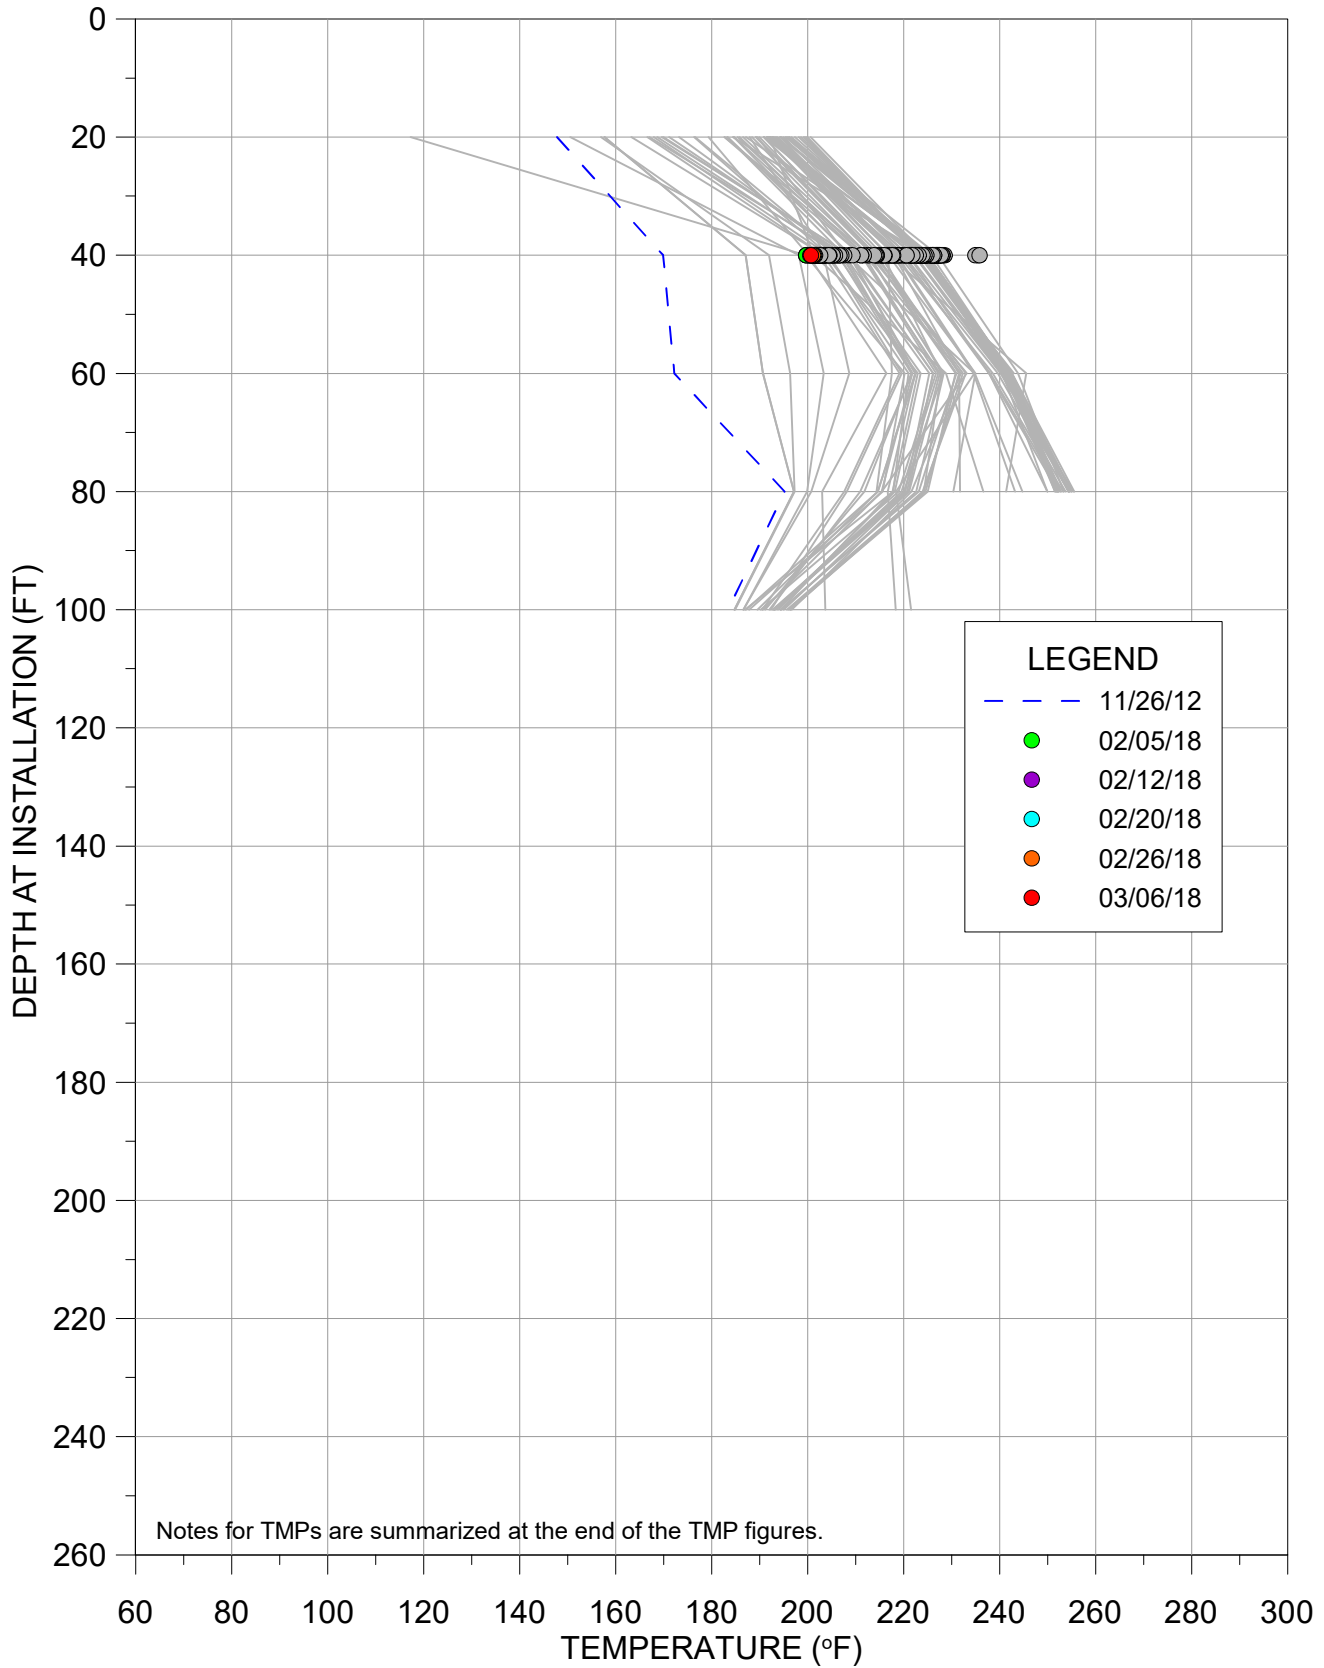
TMP-9

1. Unit at 100 ft depth had an inaccurate temperature reading on 8/1/2013 and no reading since 8/6/2013.
2. The connectivity tests on 4/11/2014 conducted by CEC showed that units at 20, 60, 80, and 100 ft depths are no longer reliable.

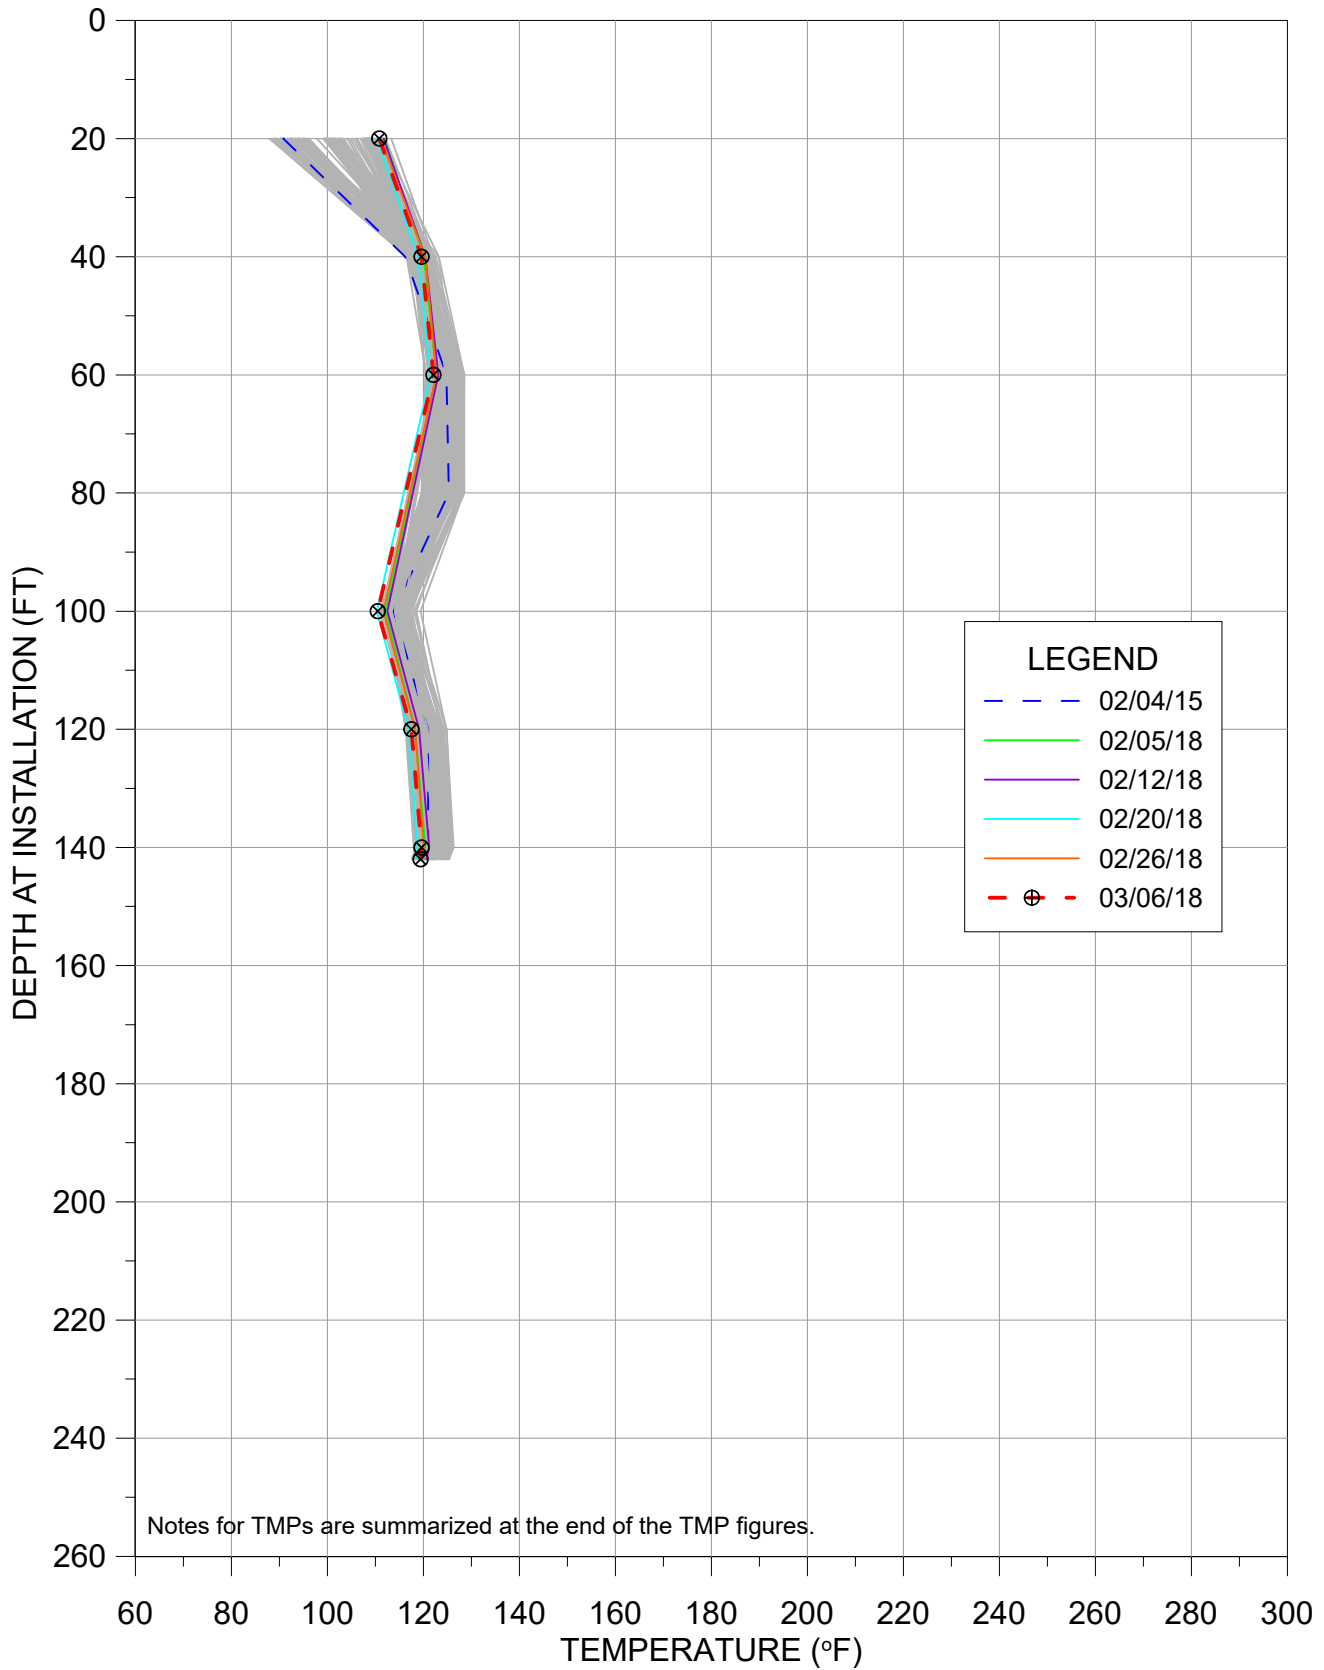
TMP-26

1. Resistance on unit at 80 ft dropped 12.9 ohms (11/06/2017) and subsequent resistance reading continue to be low. Upon further investigation by Feezor Engineering, this unit is determined to be unreliable.

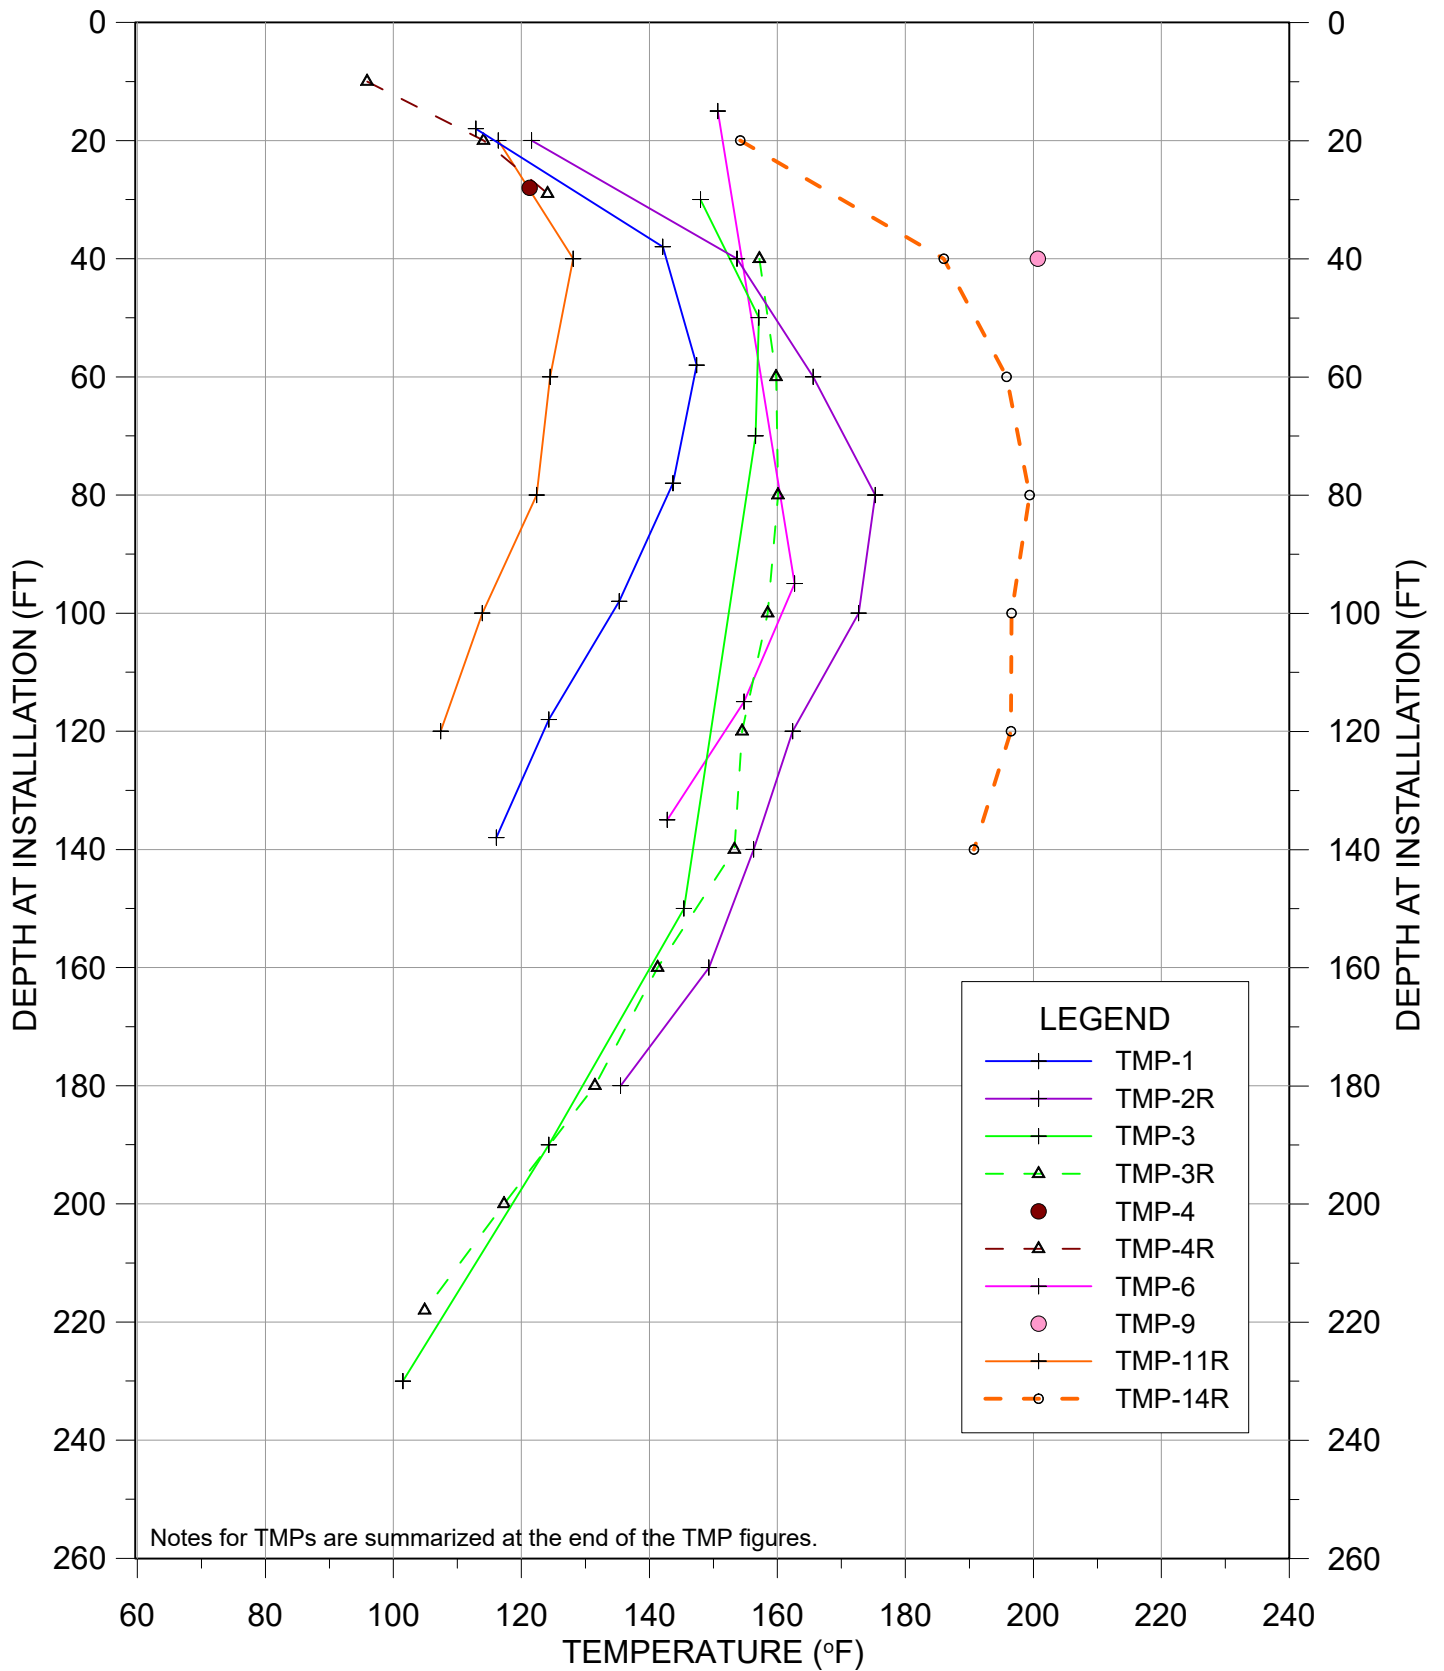
TEMPERATURE VS DEPTH
BRIDGETON LANDFILL

TMP vs DEPTH and TMP vs ELEVATION (for **03/06/18**):

1. There were no reliable temperature readings for TMP-13 since 3/19/2014.
2. There were no reliable temperature readings for TMP-7R, as determined by the connectivity test on 4/11/2014.

3. There were no reliable temperature readings for TMP-5 since 11/5/2014.
4. There were no reliable temperature readings for TMP-12 since 9/28/2015.
5. There were no reliable temperature readings for TMP-8 since 9/9/2015.

6. There were no reliable temperature readings for TMP-14, confirmed since 3/7/2016.
7. There were no reliable temperature readings for TMP-11 as determined by the connectivity test on 11/23/2016.

8. TMP-2 has been replaced by TMP-2R and will no longer be monitored.
9. TMP-11 is no longer in service and will not be included in the presentation.
10. There were no reliable temperature readings for TMP-10 since 5/30/2017.

11. TMP-16, 25, and 28 have been replaced by TMP-16R, 25R, and 28R and will be no longer reported since 1/15/2018.

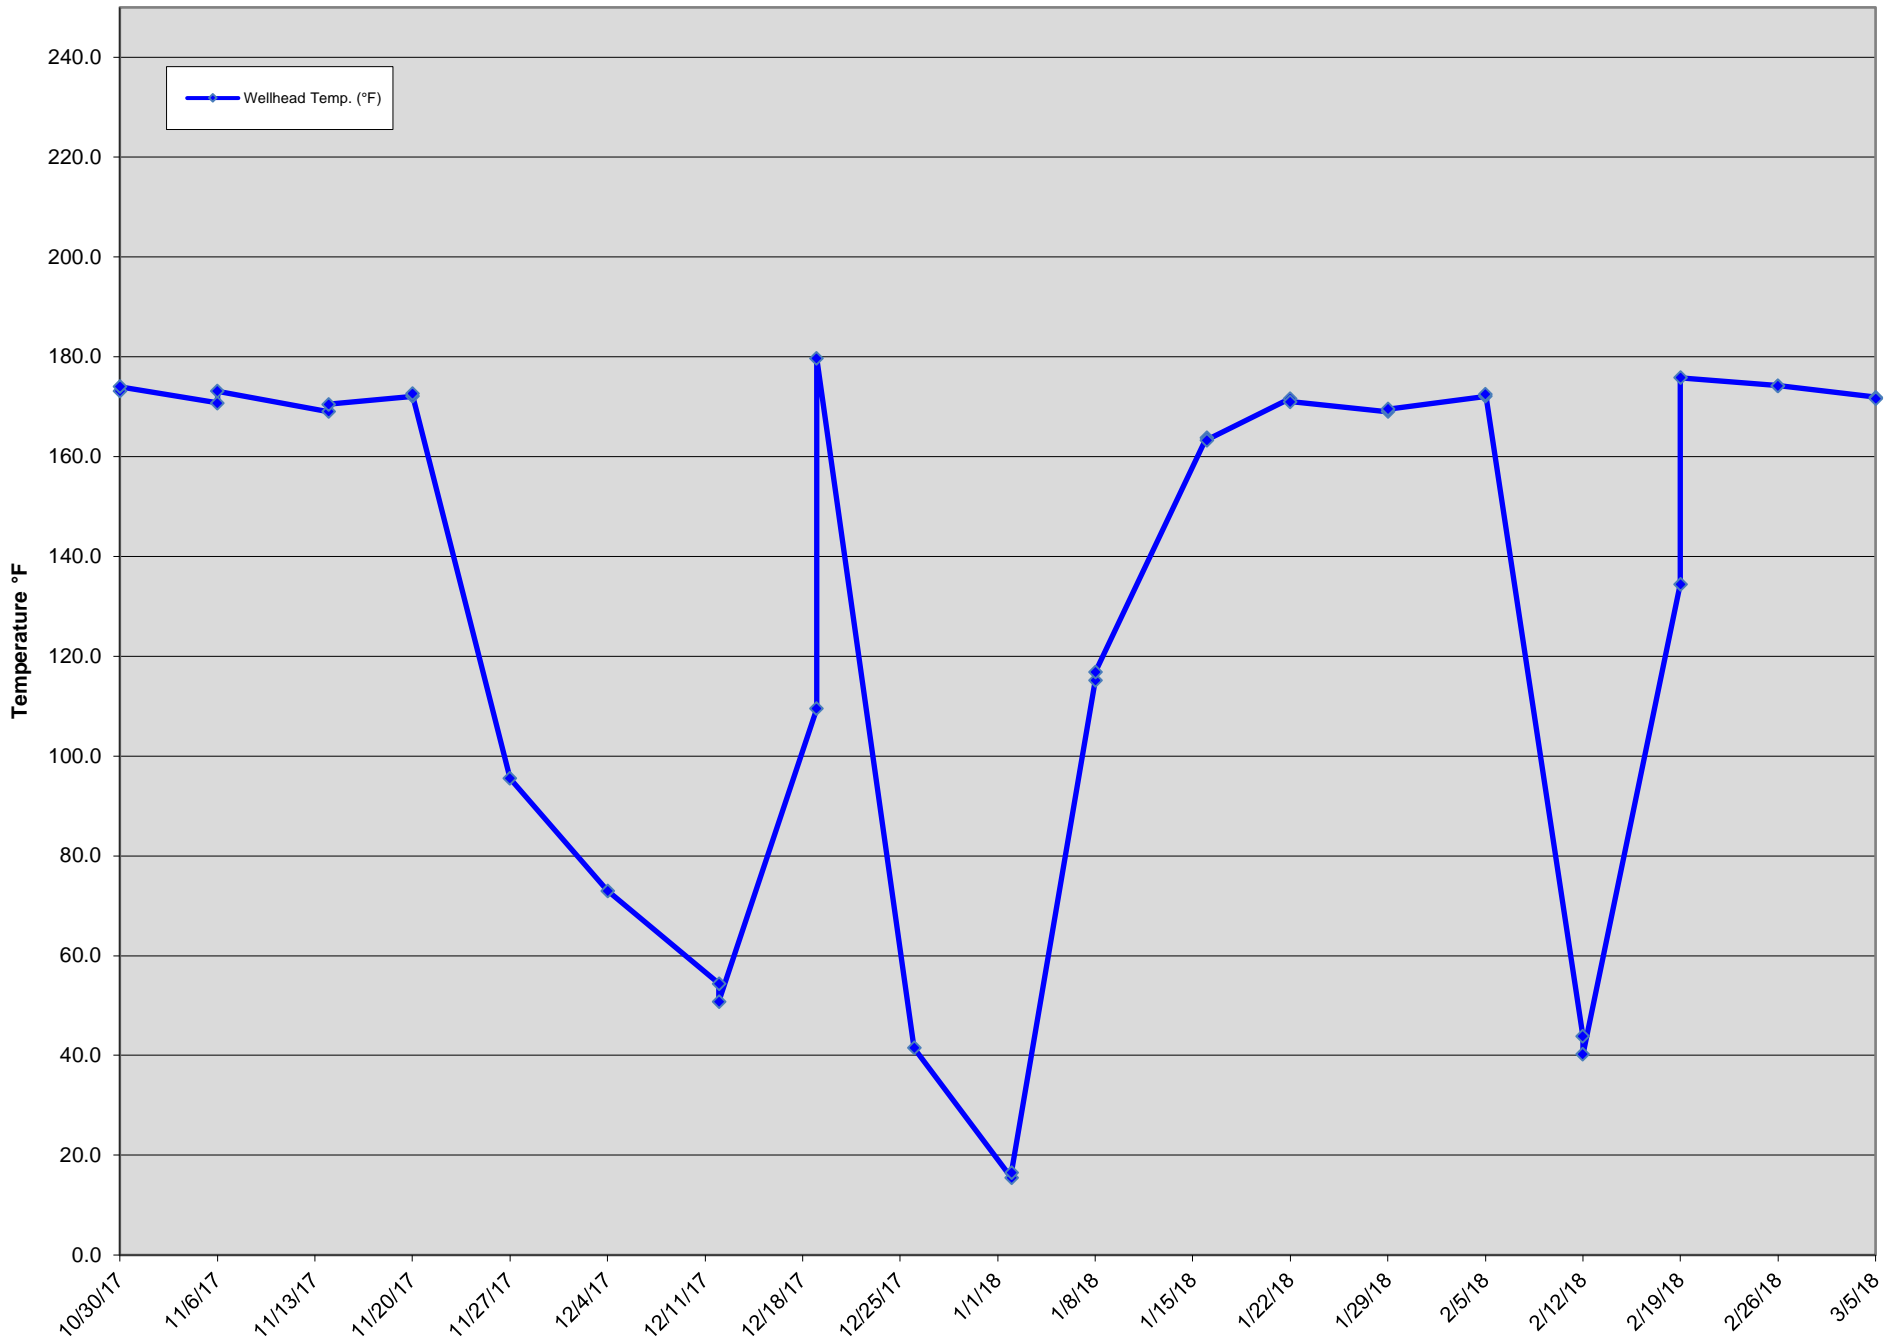
GIW-1 Wellhead Temperatures

As part of the HES, there are currently cooling water circulation loops installed in twelve Gas Interceptor Wells (GIWs) (GIW-02 through GIW-13). The remaining well (GIW-01) had a measured gas temperature within its historical operating limits.
