Bridgeton Landfill, LLC

Weekly Data Submittal

Week of March 11, 2018 – March 17, 2018

**Required by Section 52.F of Agreed Order, Case No. 13SL-CC01088
Effective May 13, 2013**

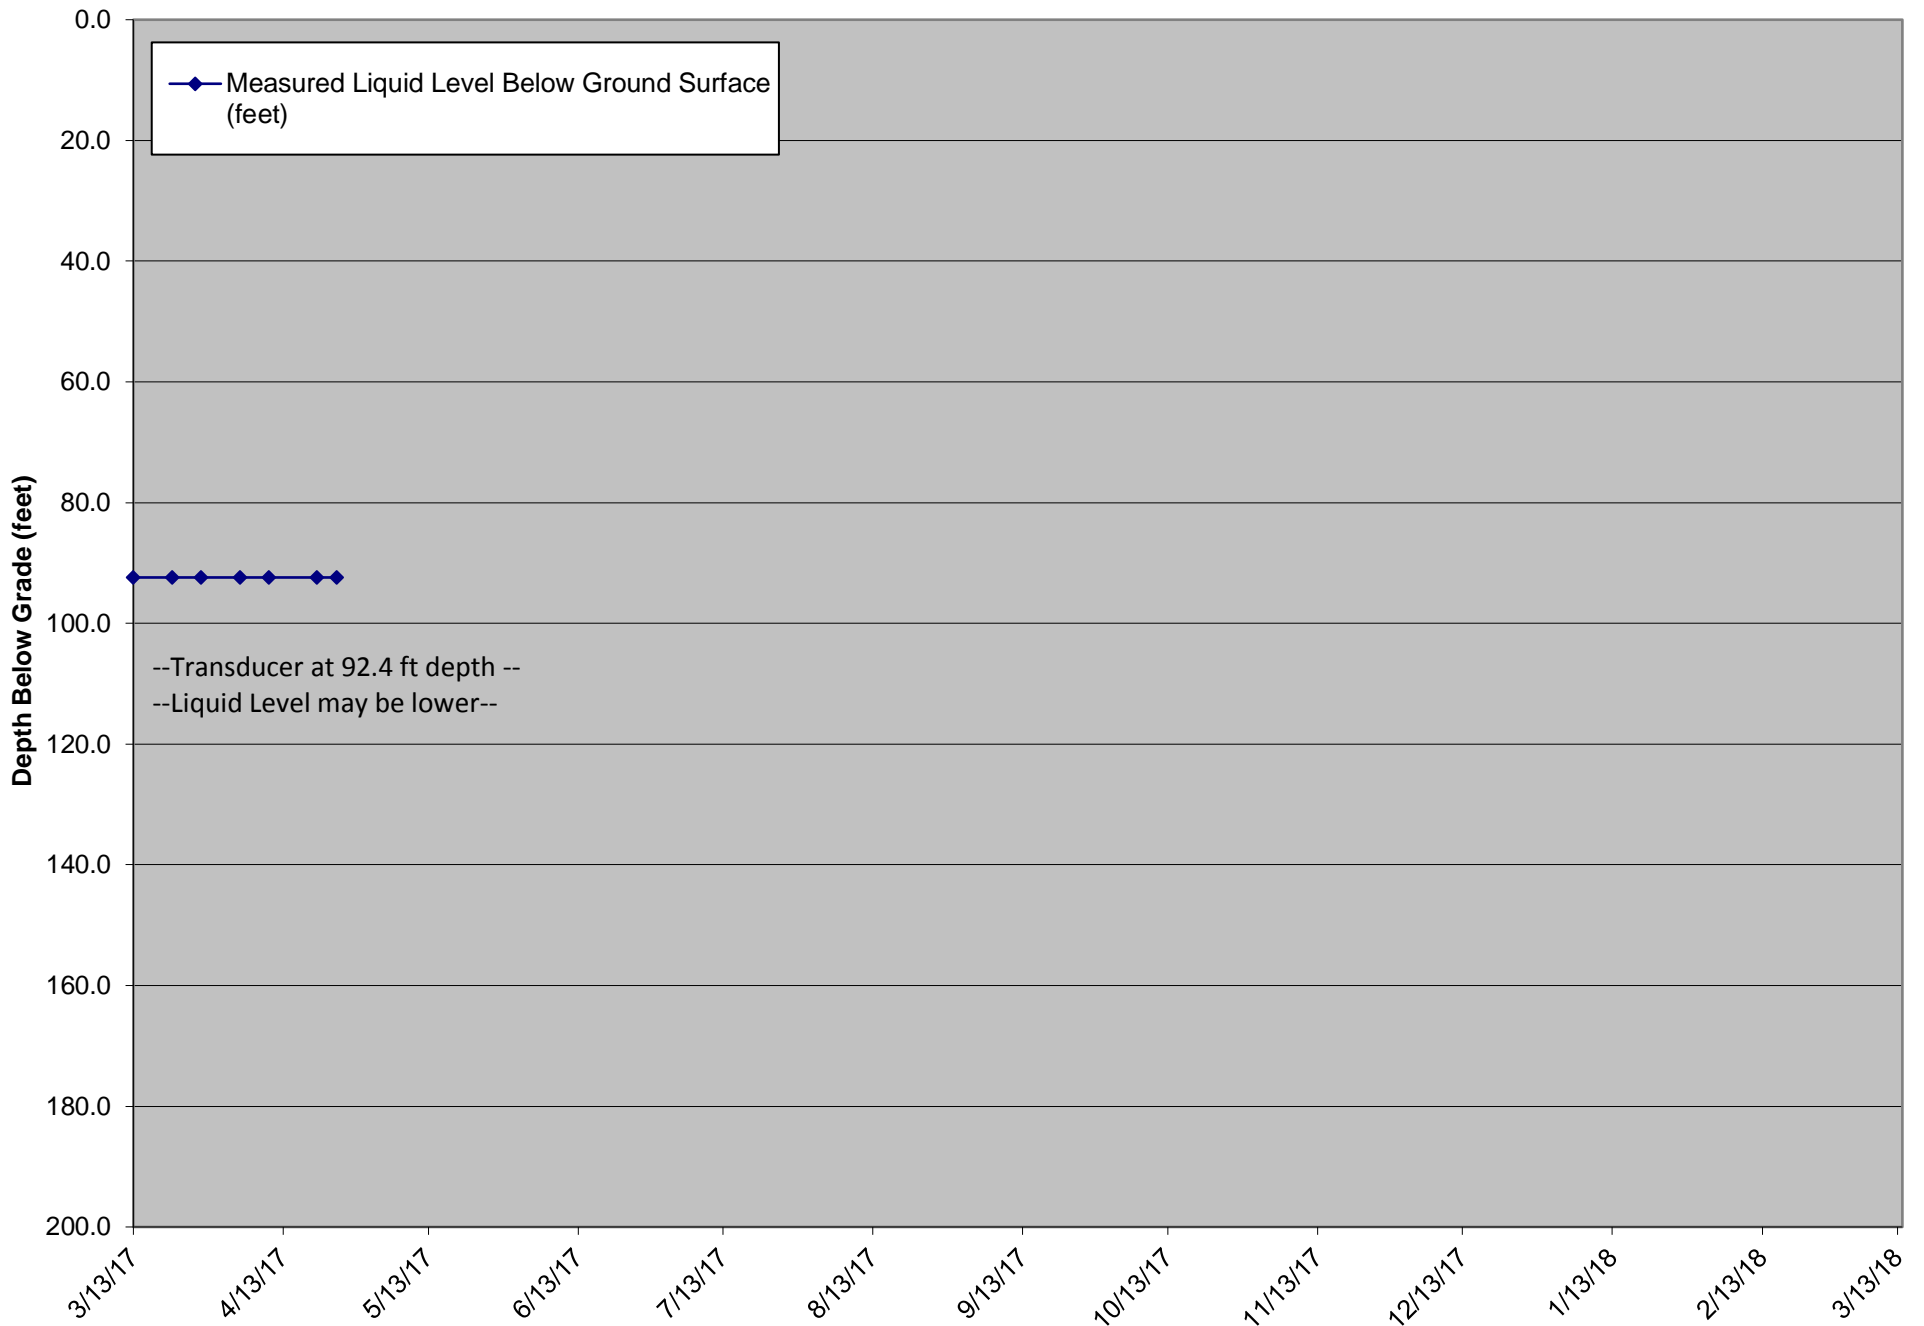
LCS-1D Liquid Level Below Ground Surface

Downhole discharge piping and the pump for LCS-1D was replaced the week of 2/5/18. Pump was non-operational after startup activities. Pump replacement is pending parts arrival.

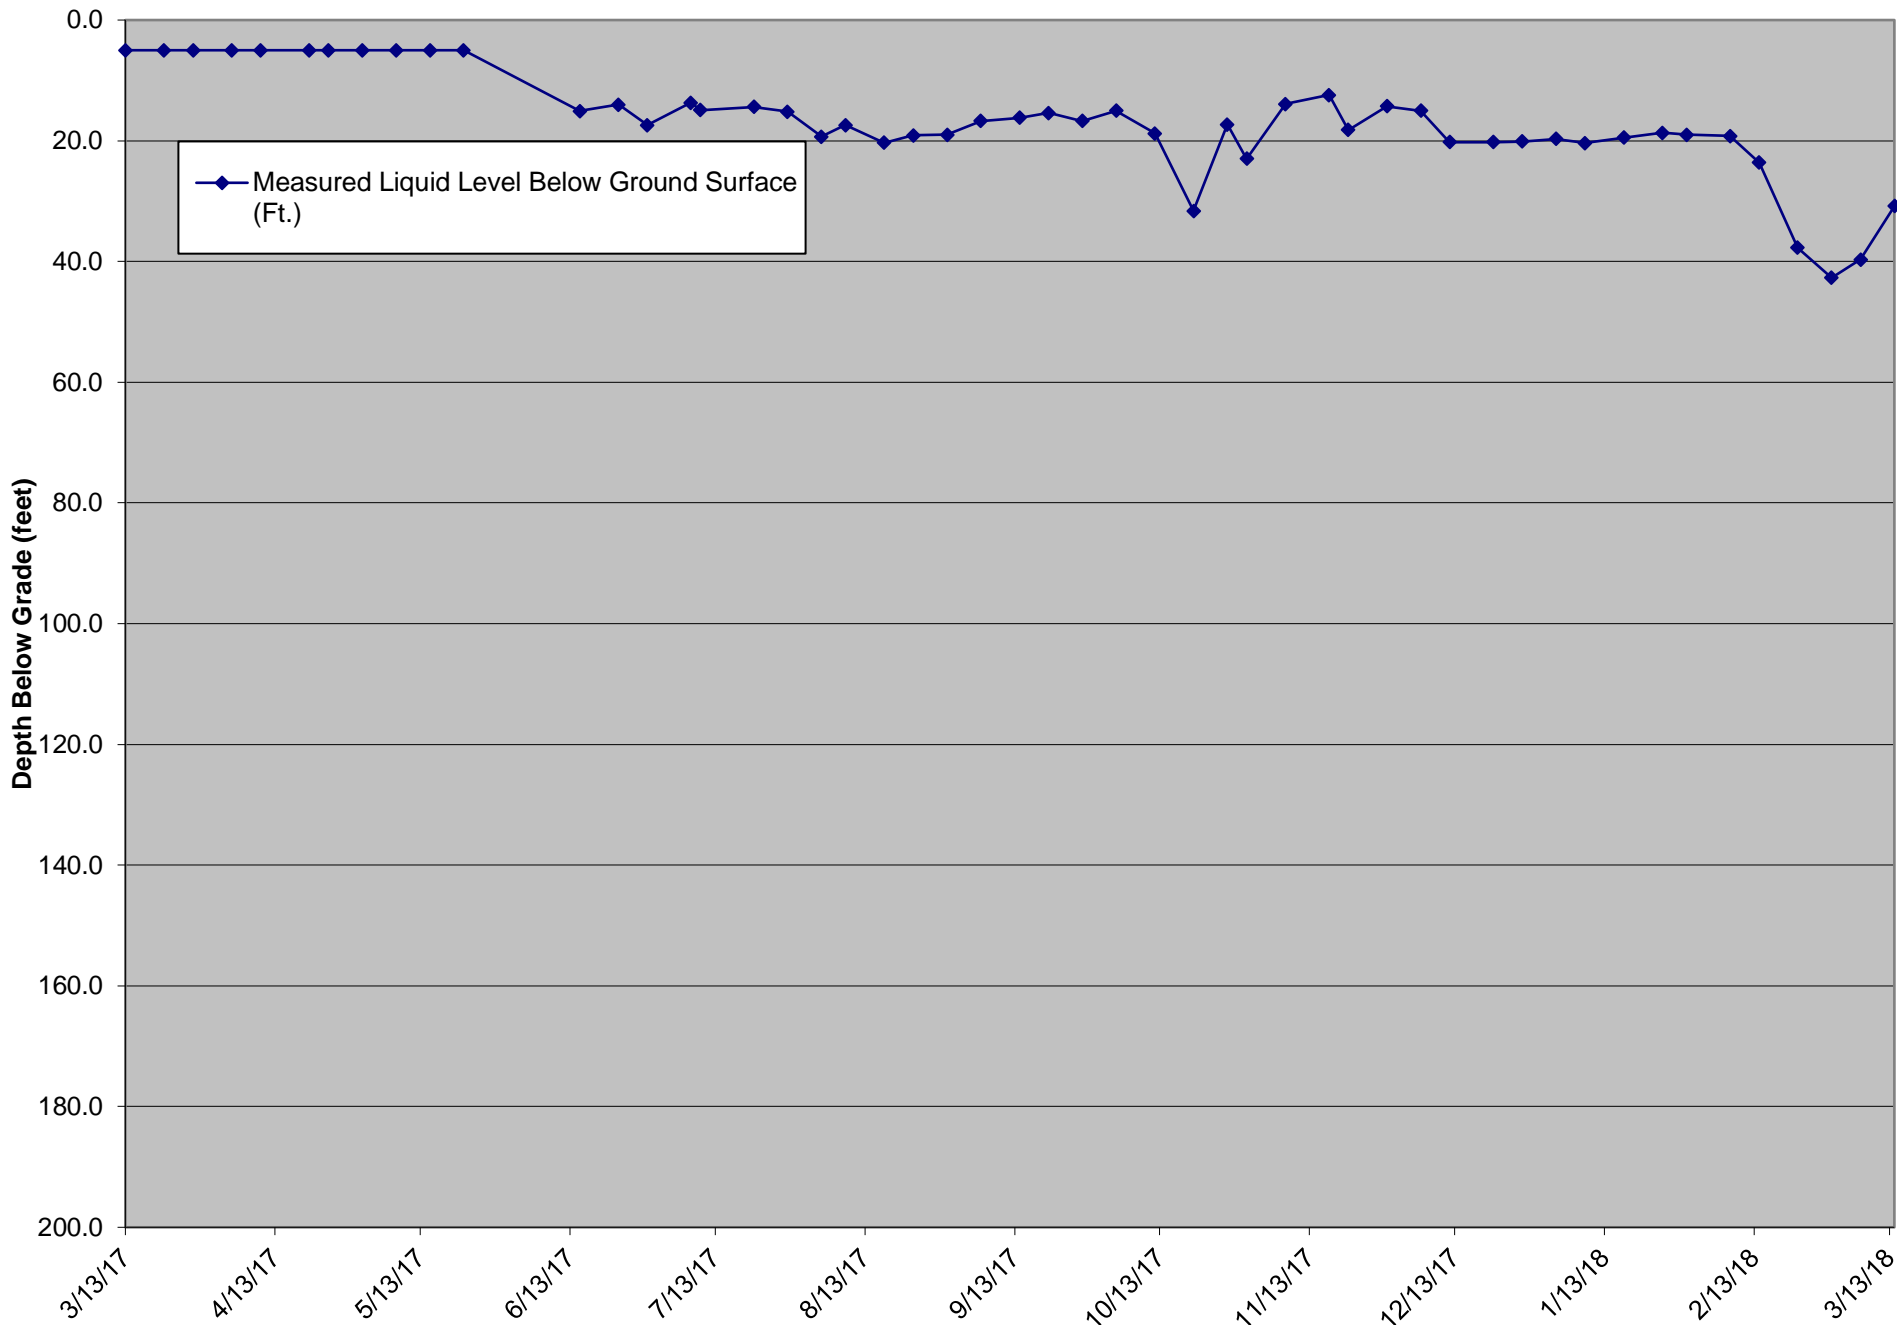
LCS-3D Liquid Level Below Ground Surface

The Blackhawk pneumatic pumps in LCS-3D were replaced with a QED AP-4 pneumatic pump on 2/15/18. Liquid level was measured manually.

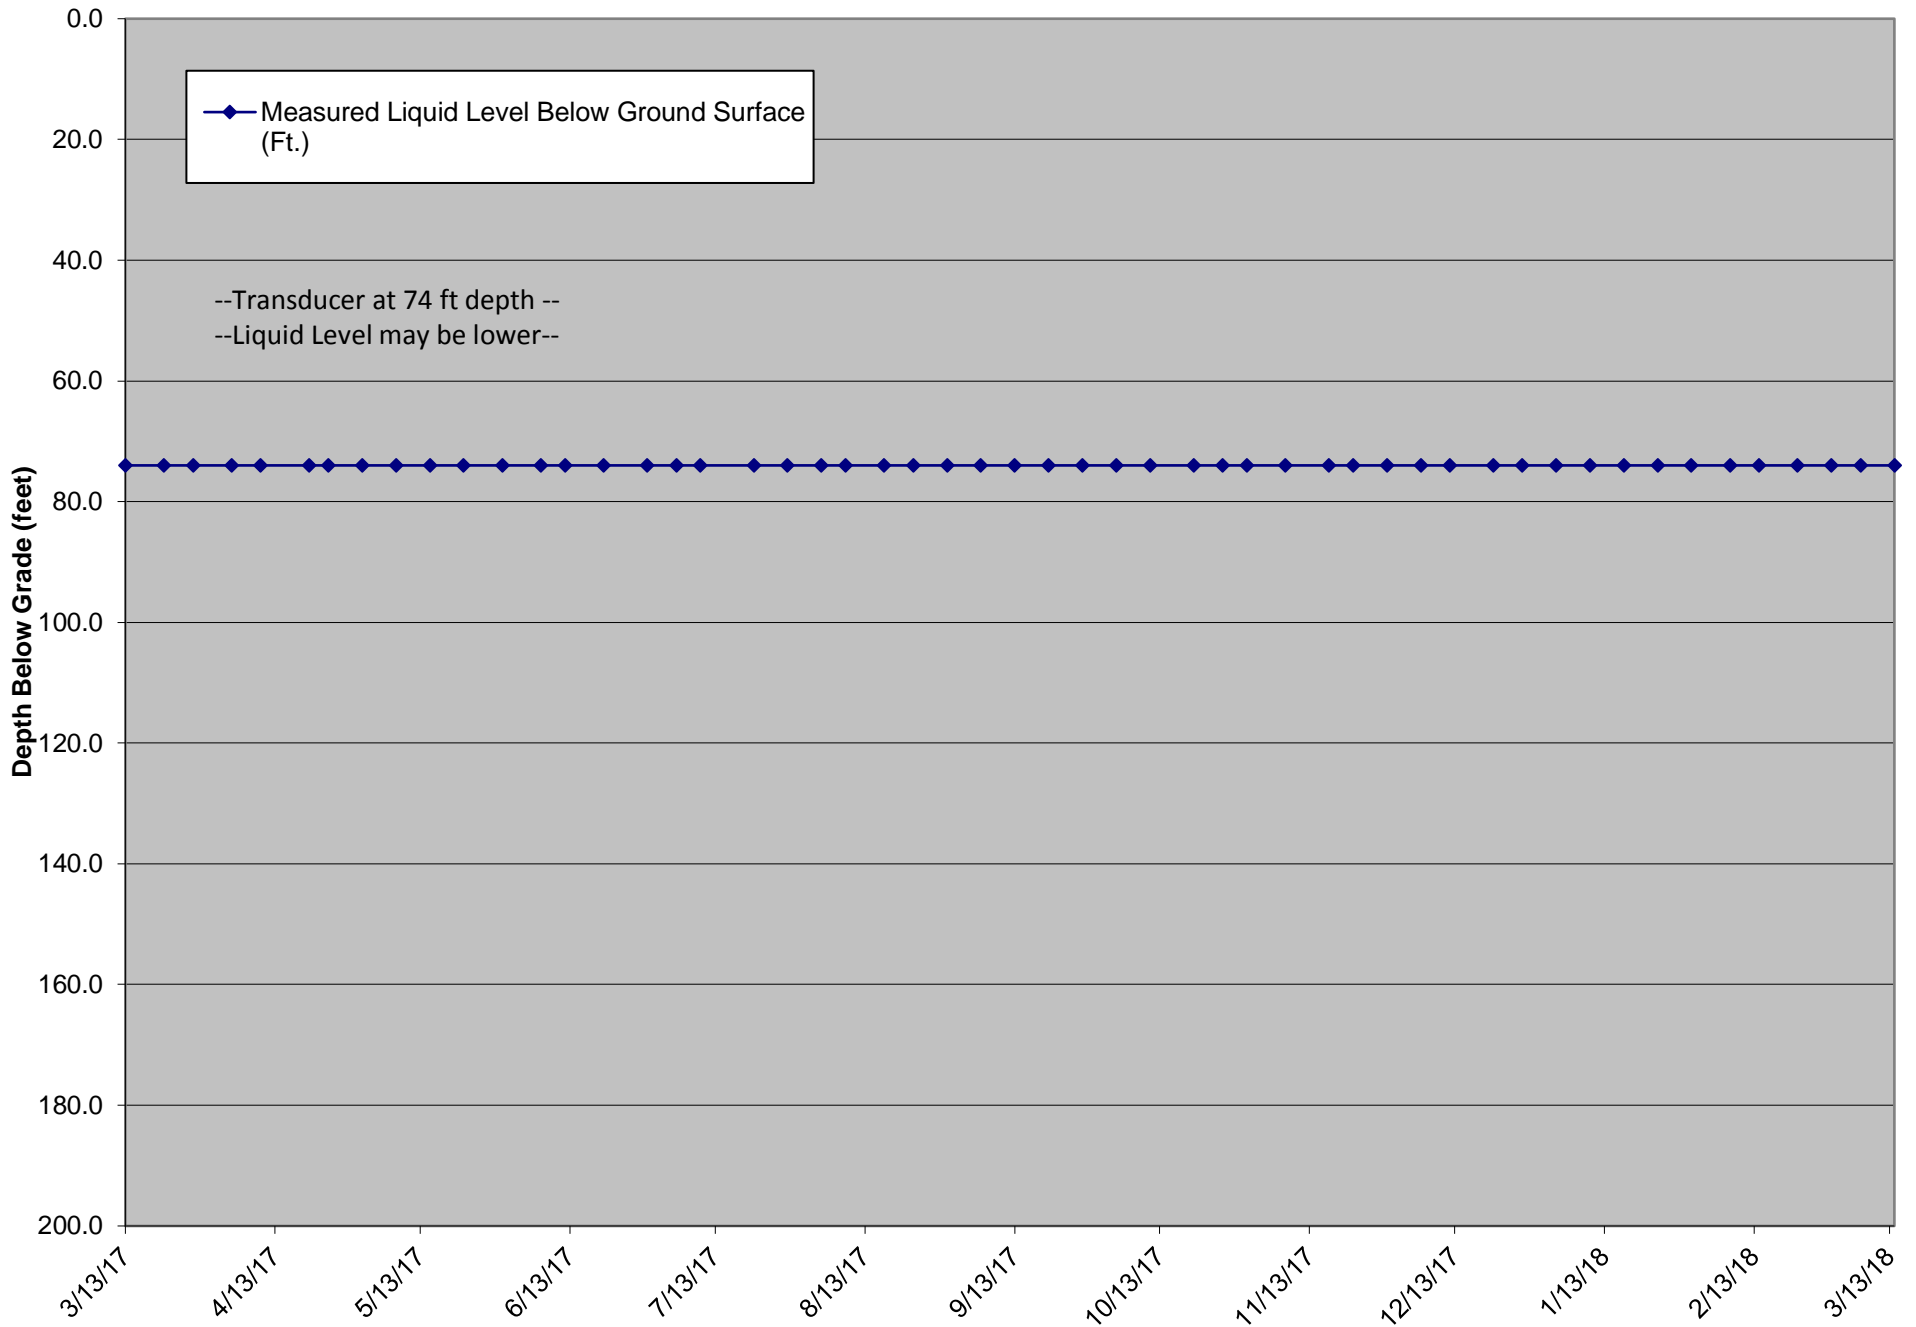
LCS-4B Liquid Level Below Ground Surface

The level sensor in LCS-4B is currently operational and responsive. Liquid level was not recorded by the level sensor during the weekly reporting period. LCS-4B is equipped with a flow meter that displayed no flow during the weekly reporting period. Therefore, it can be concluded that the liquid level was below the bottom of the pump and level sensor in LCS-4B.

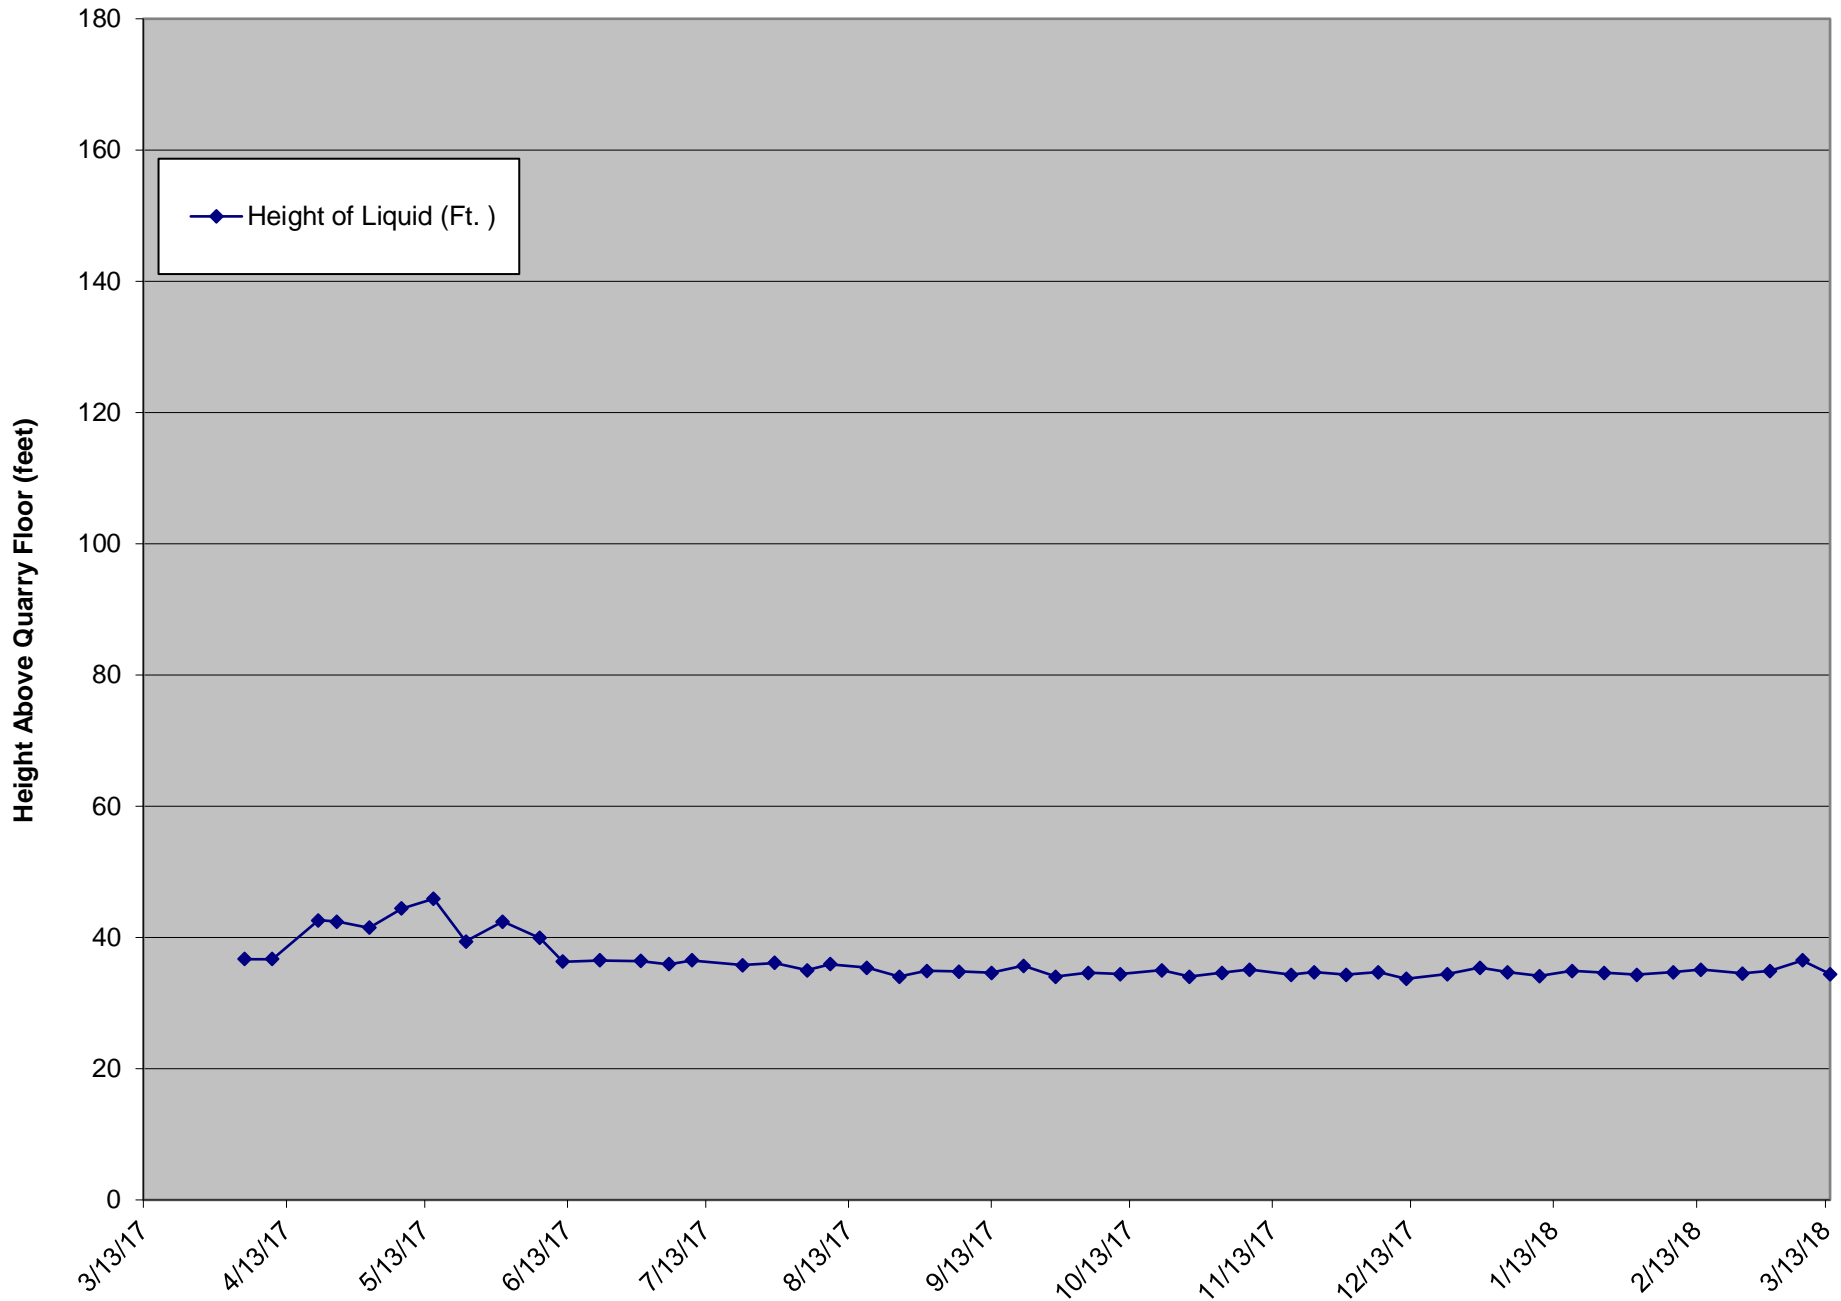
LCS-5B Liquid Level Above Quarry Floor

LCS-5B was fully operational during the weekly reporting period.

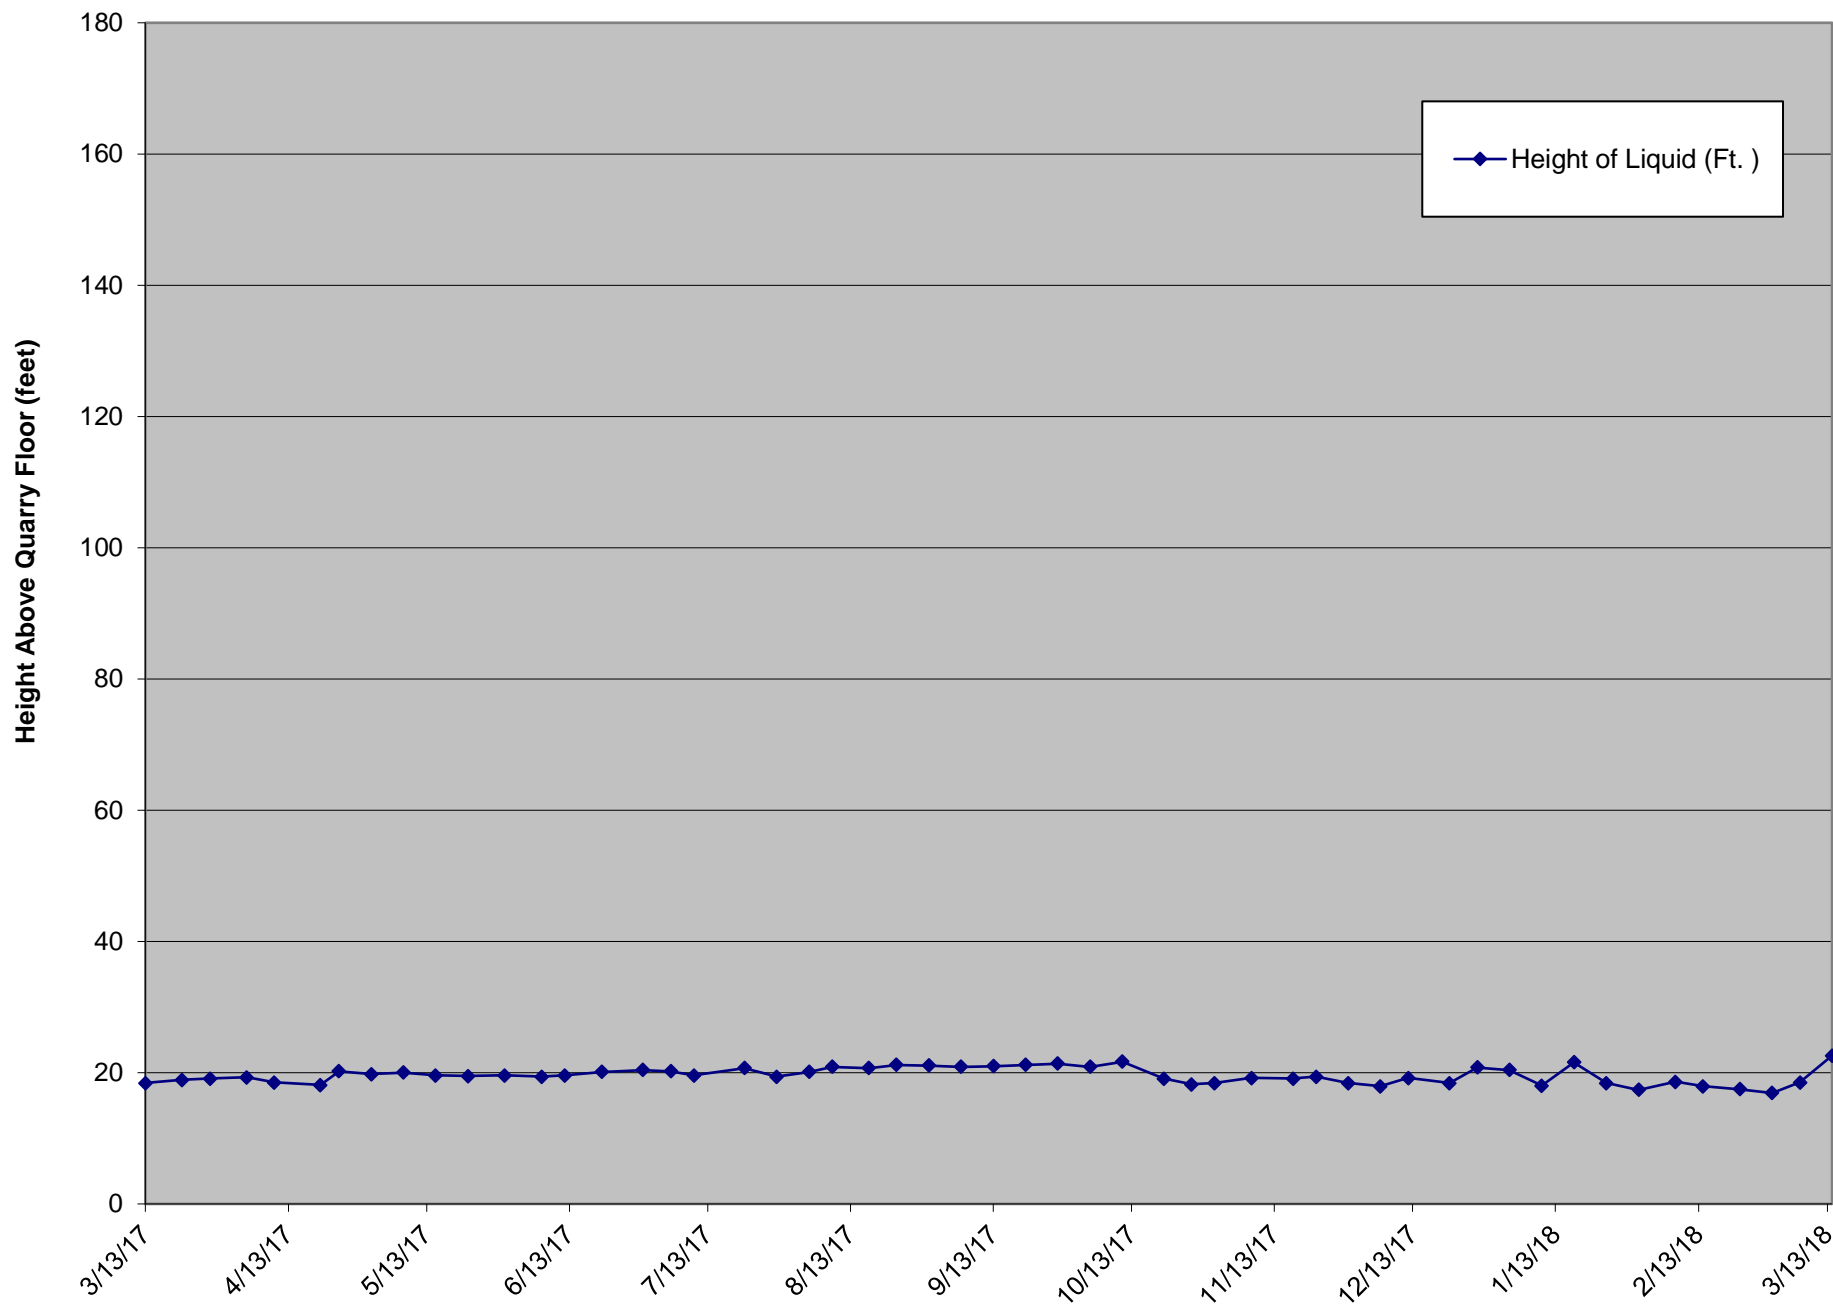
LCS-6B Liquid Level Above Quarry Floor

The pump in LCS-6B was observed to be non-operational on 3/9/18. The liquid level in LCS-6B measured on 3/14/18 is still in compliance with the pump non-operational. Pump replacement is pending parts arrival.

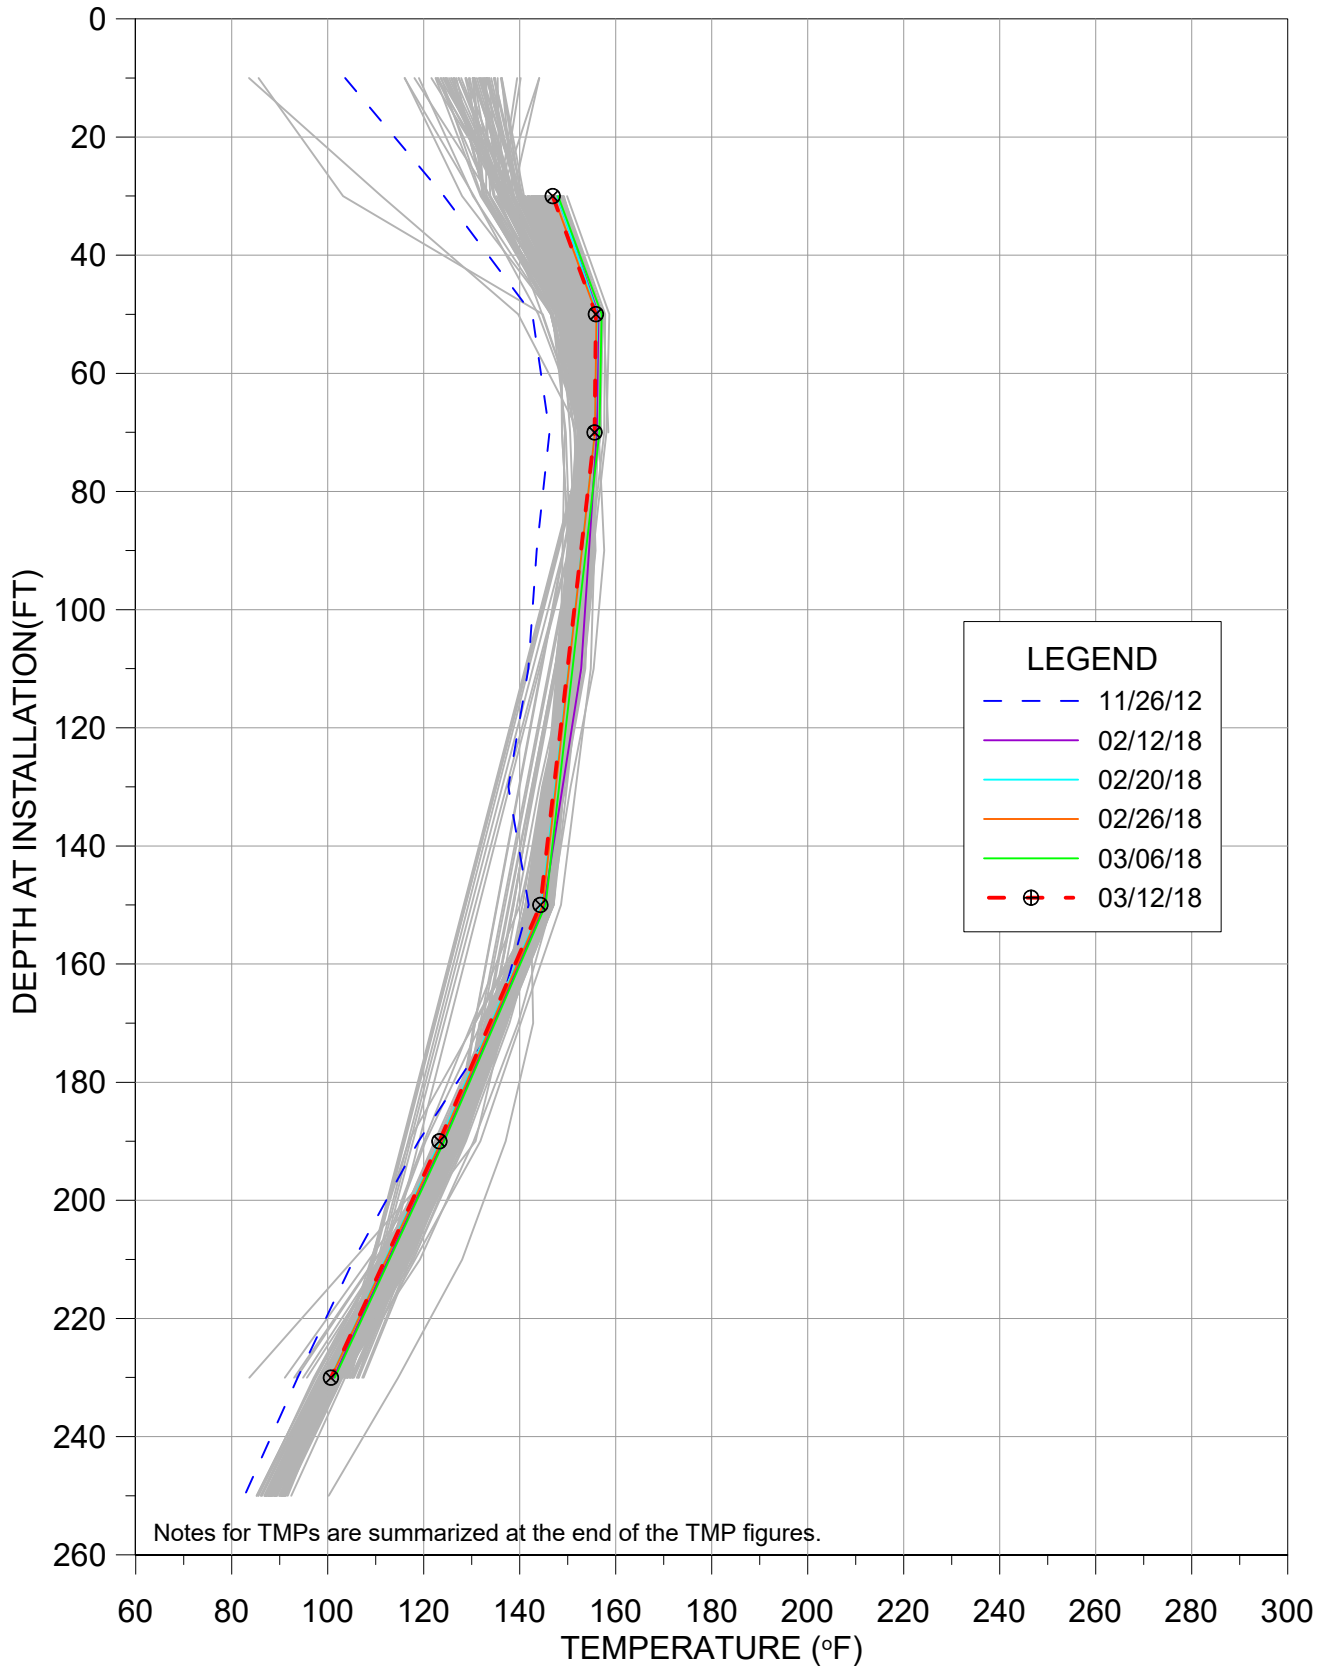
TMP-3

1. No reliable temperature readings have been obtained at 170 ft depth since 1/29/2014, except on 3/13/2014.
2. The connectivity tests on 4/11/2014 conducted by CEC showed that units at 10, 90, 130, 210 and 250 ft depths are no longer reliable.
3. The connectivity tests on 10/28/2014 conducted by Feezor Engineering showed that units at 10, 90, 110, 130, 210 and 250 ft depths are not reliable.

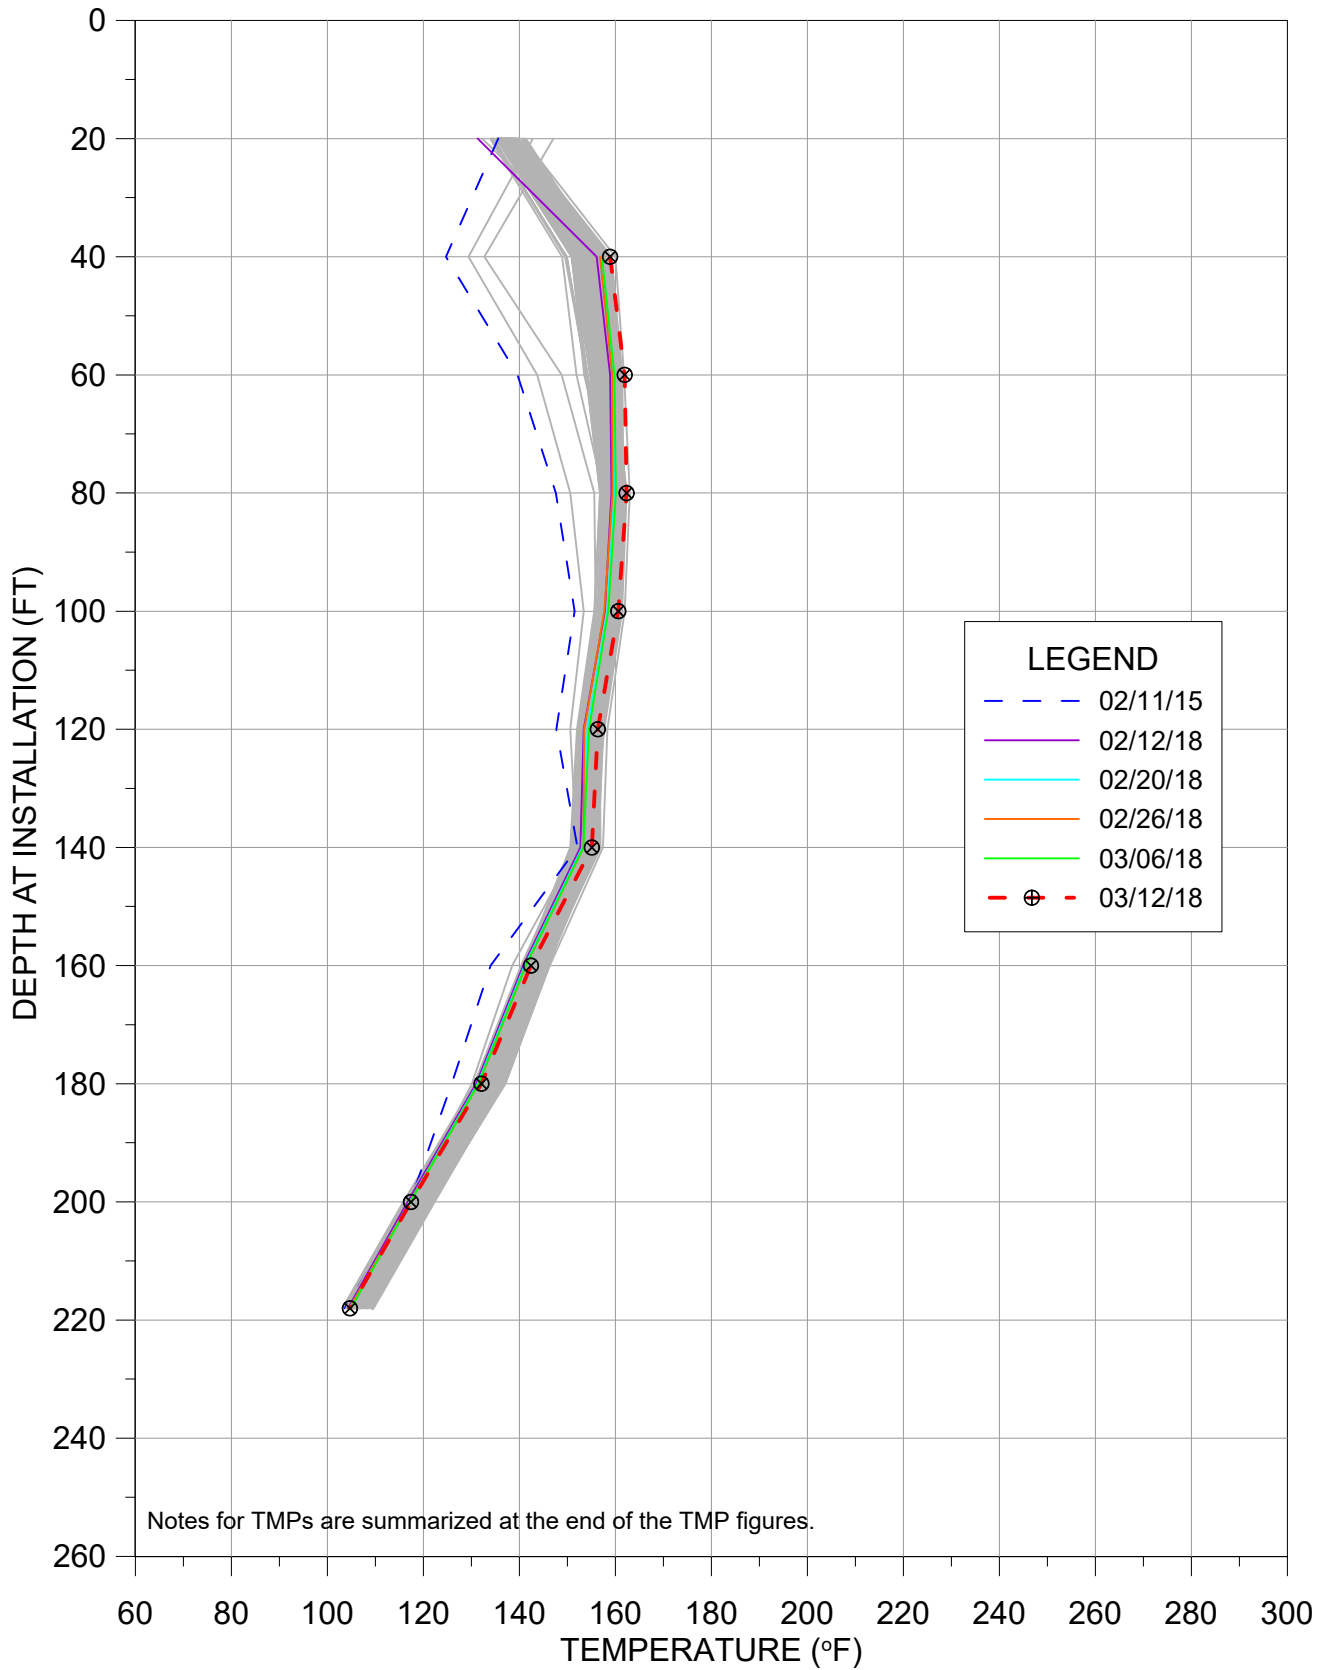
TMP-3R

1. The unit at 20 ft depth had a fluctuating resistance since 9/25/2017. Therefore the temperature is determined to be unreliable.

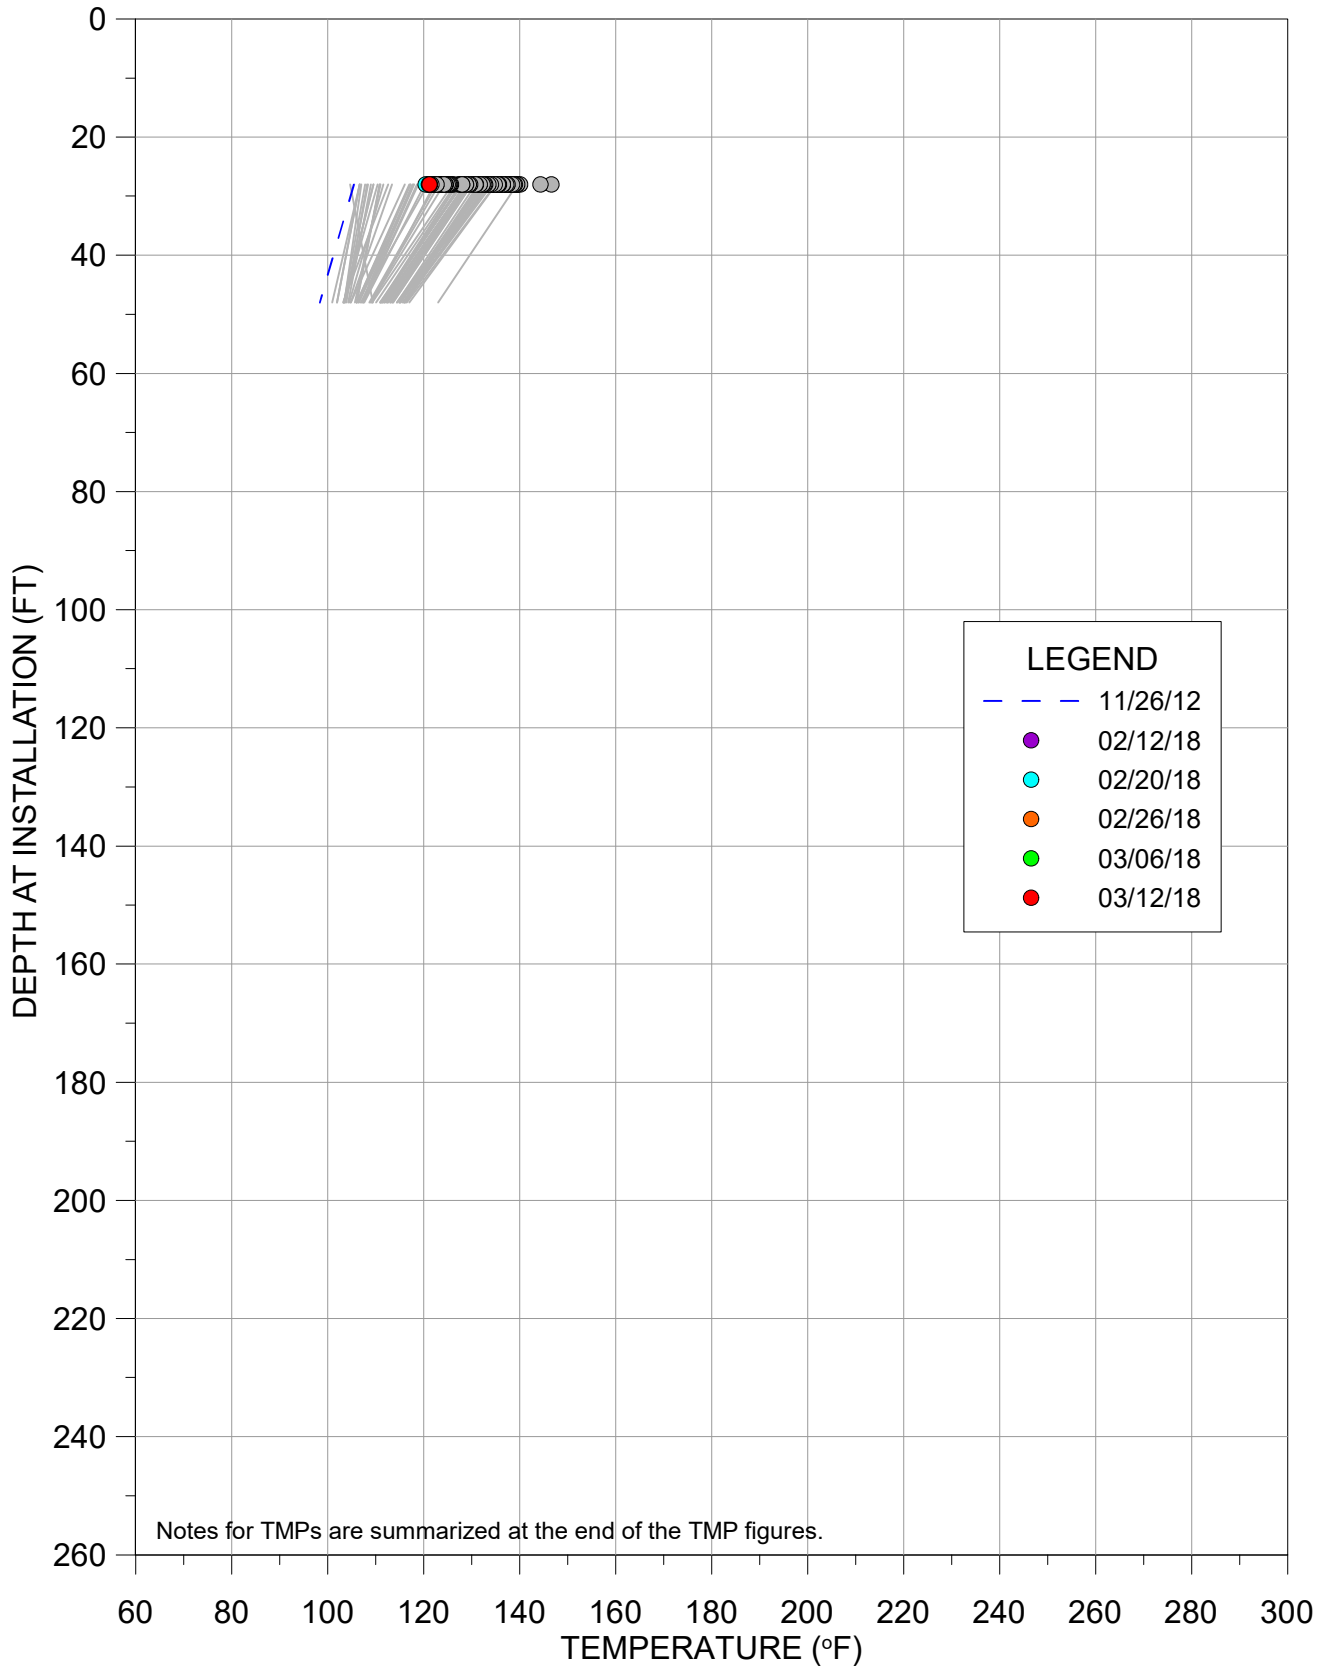
TMP-4

1. The connectivity tests on 4/11/2014 conducted by CEC showed that the unit at 48 ft depth is no longer reliable.

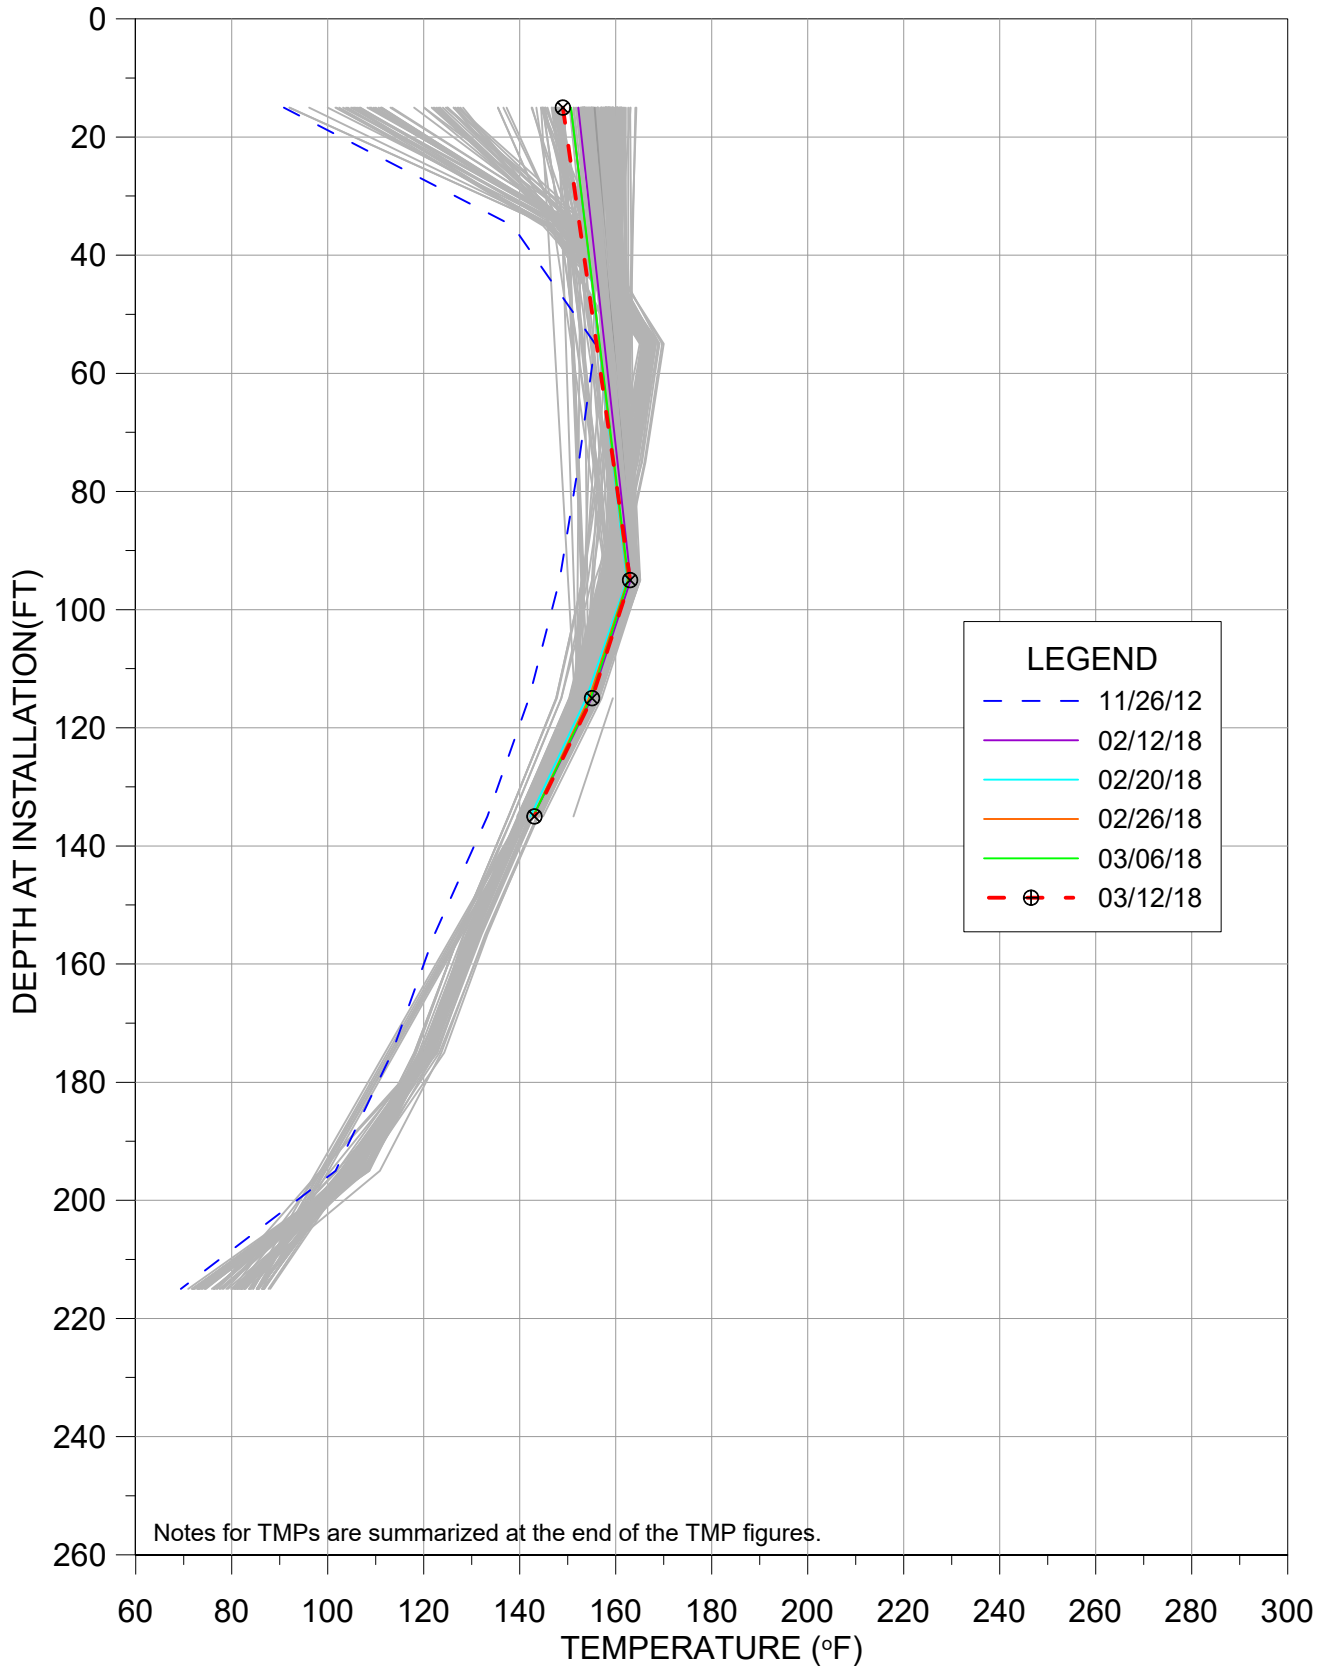
TMP-6

1. The connectivity tests on 4/11/2014 conducted by CEC showed that units at 35, 55, 75, 155, 175, and 195 ft depths are no longer reliable.
2. No reliable temperature readings have been obtained at the unit at 215 ft depth since 6/13/2014.
