Bridgeton Landfill, LLC

Weekly Data Submittal

Week of March 11, 2018 – March 17, 2018

**Required by Section 52.F of Agreed Order, Case No. 13SL-CC01088
Effective May 13, 2013**

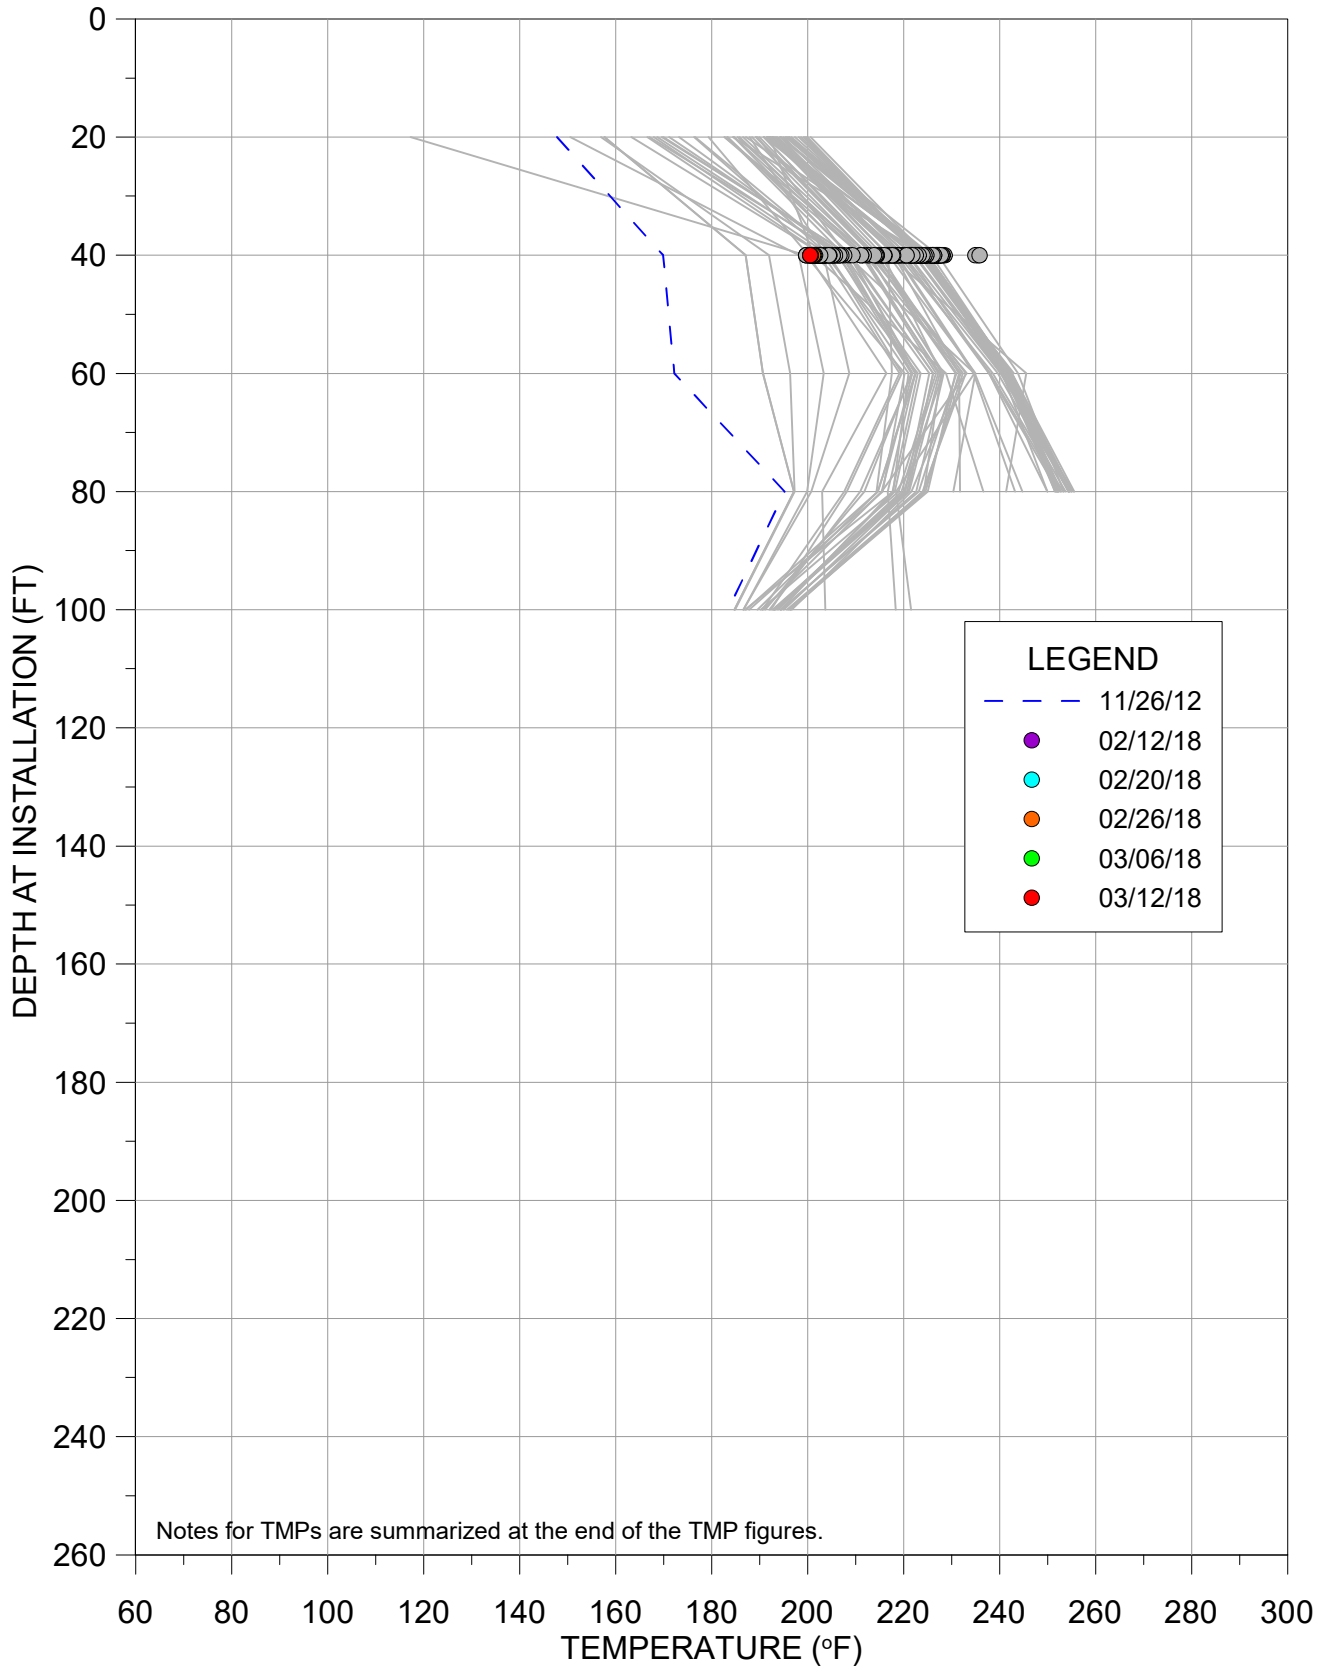
TMP-9

1. Unit at 100 ft depth had an inaccurate temperature reading on 8/1/2013 and no reading since 8/6/2013.
2. The connectivity tests on 4/11/2014 conducted by CEC showed that units at 20, 60, 80, and 100 ft depths are no longer reliable.

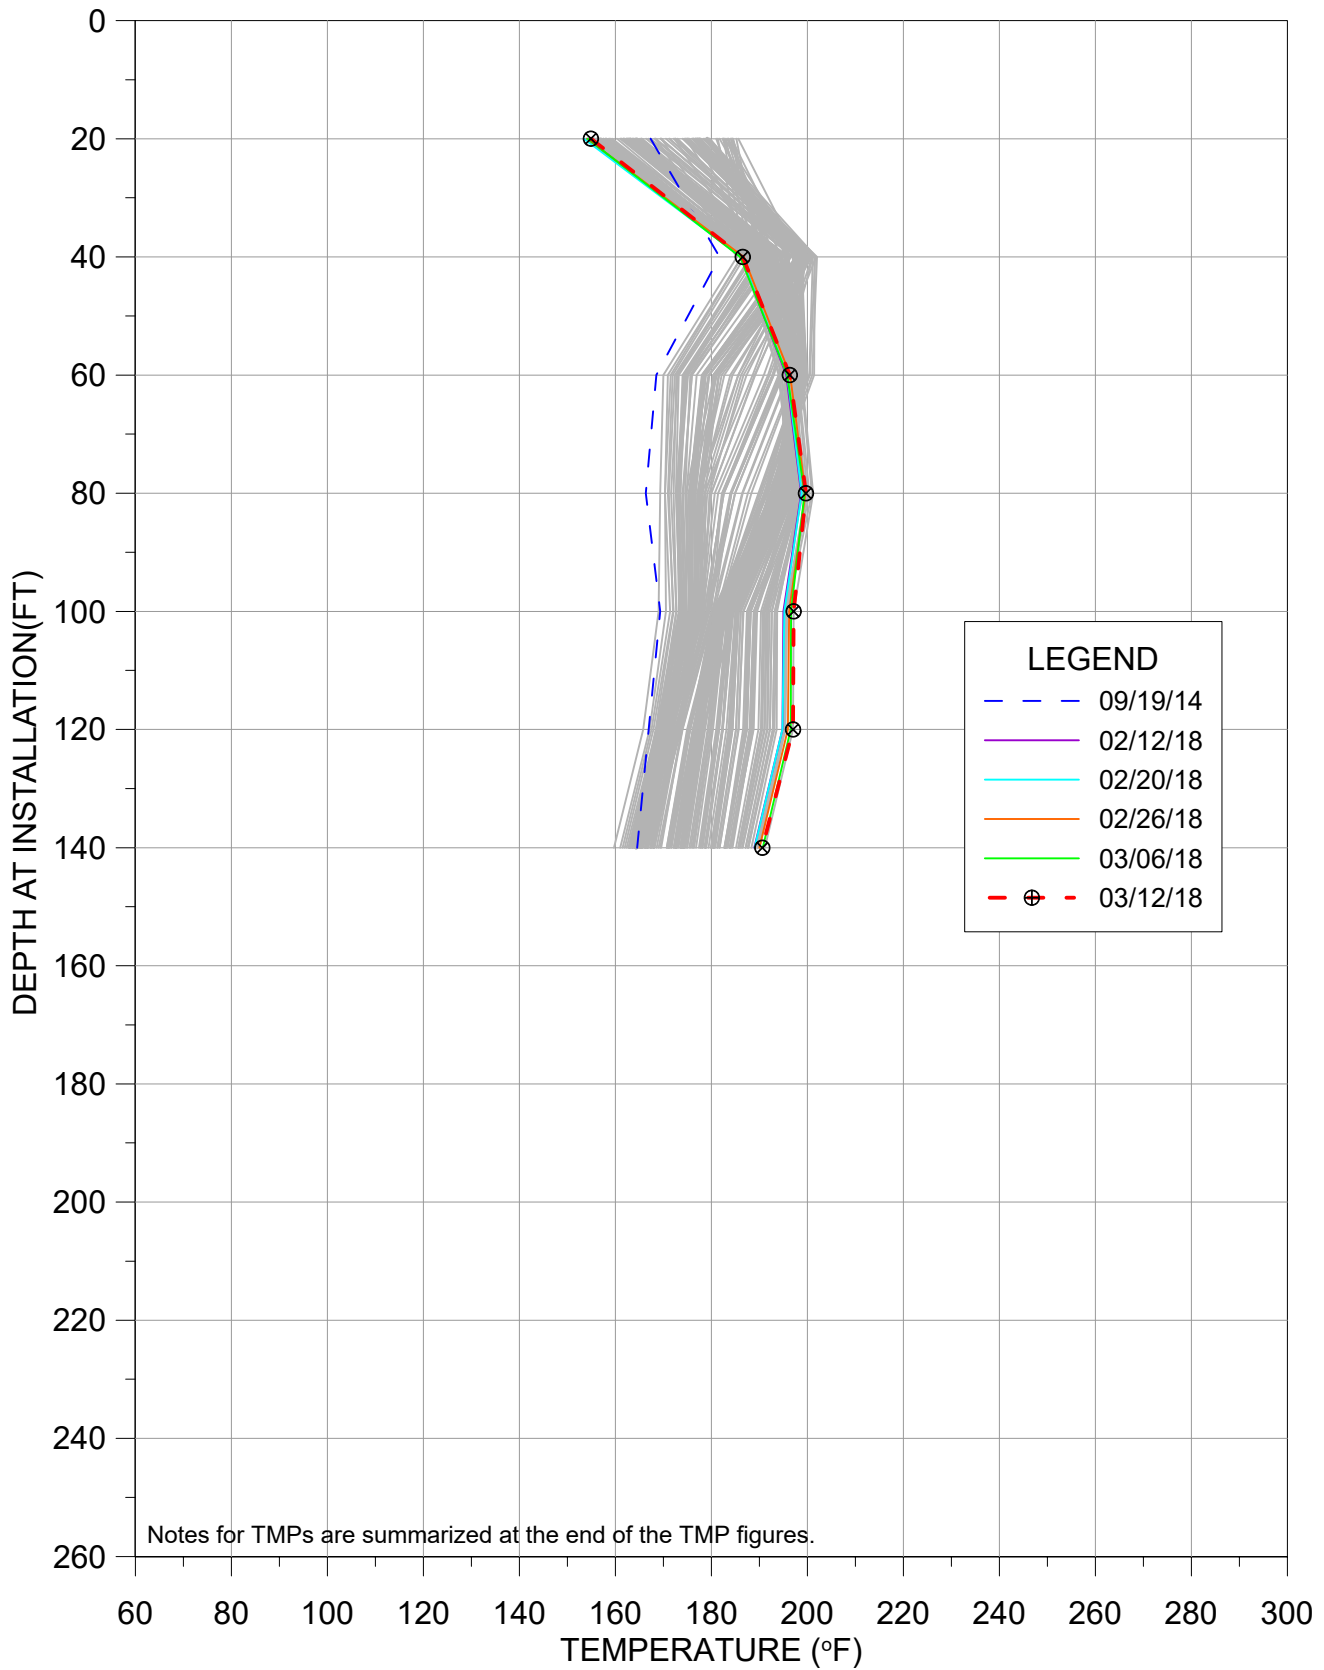
1. Due to the connectivity test results by Feezor Engineering on TMP-14 (see note above), TMP-14R is added to this reporting data set as of 3/7/2016.

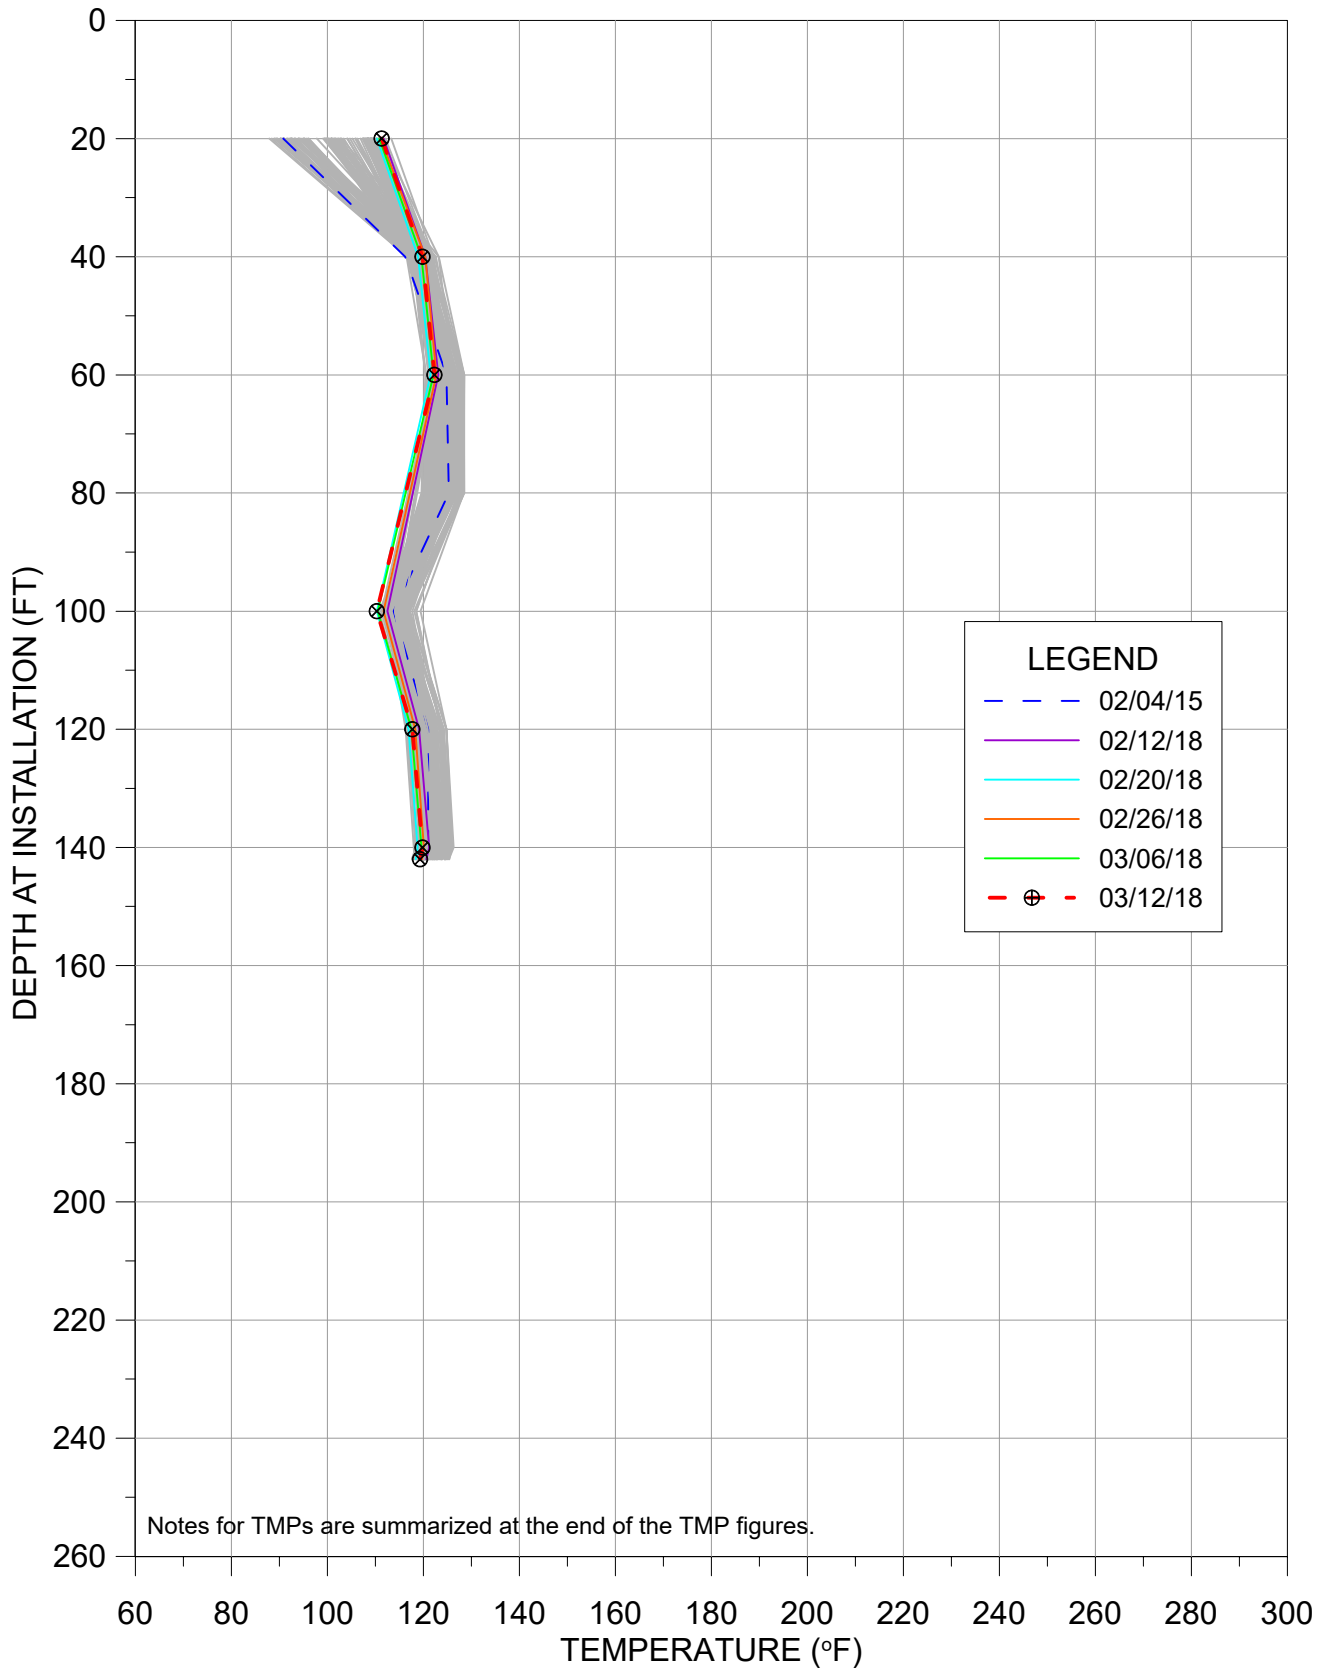
TMP-26

1. Resistance on unit at 80 ft dropped 12.9 ohms (11/06/2017) and subsequent resistance reading continue to be low. Upon further investigation by Feezor Engineering, this unit is determined to be unreliable.

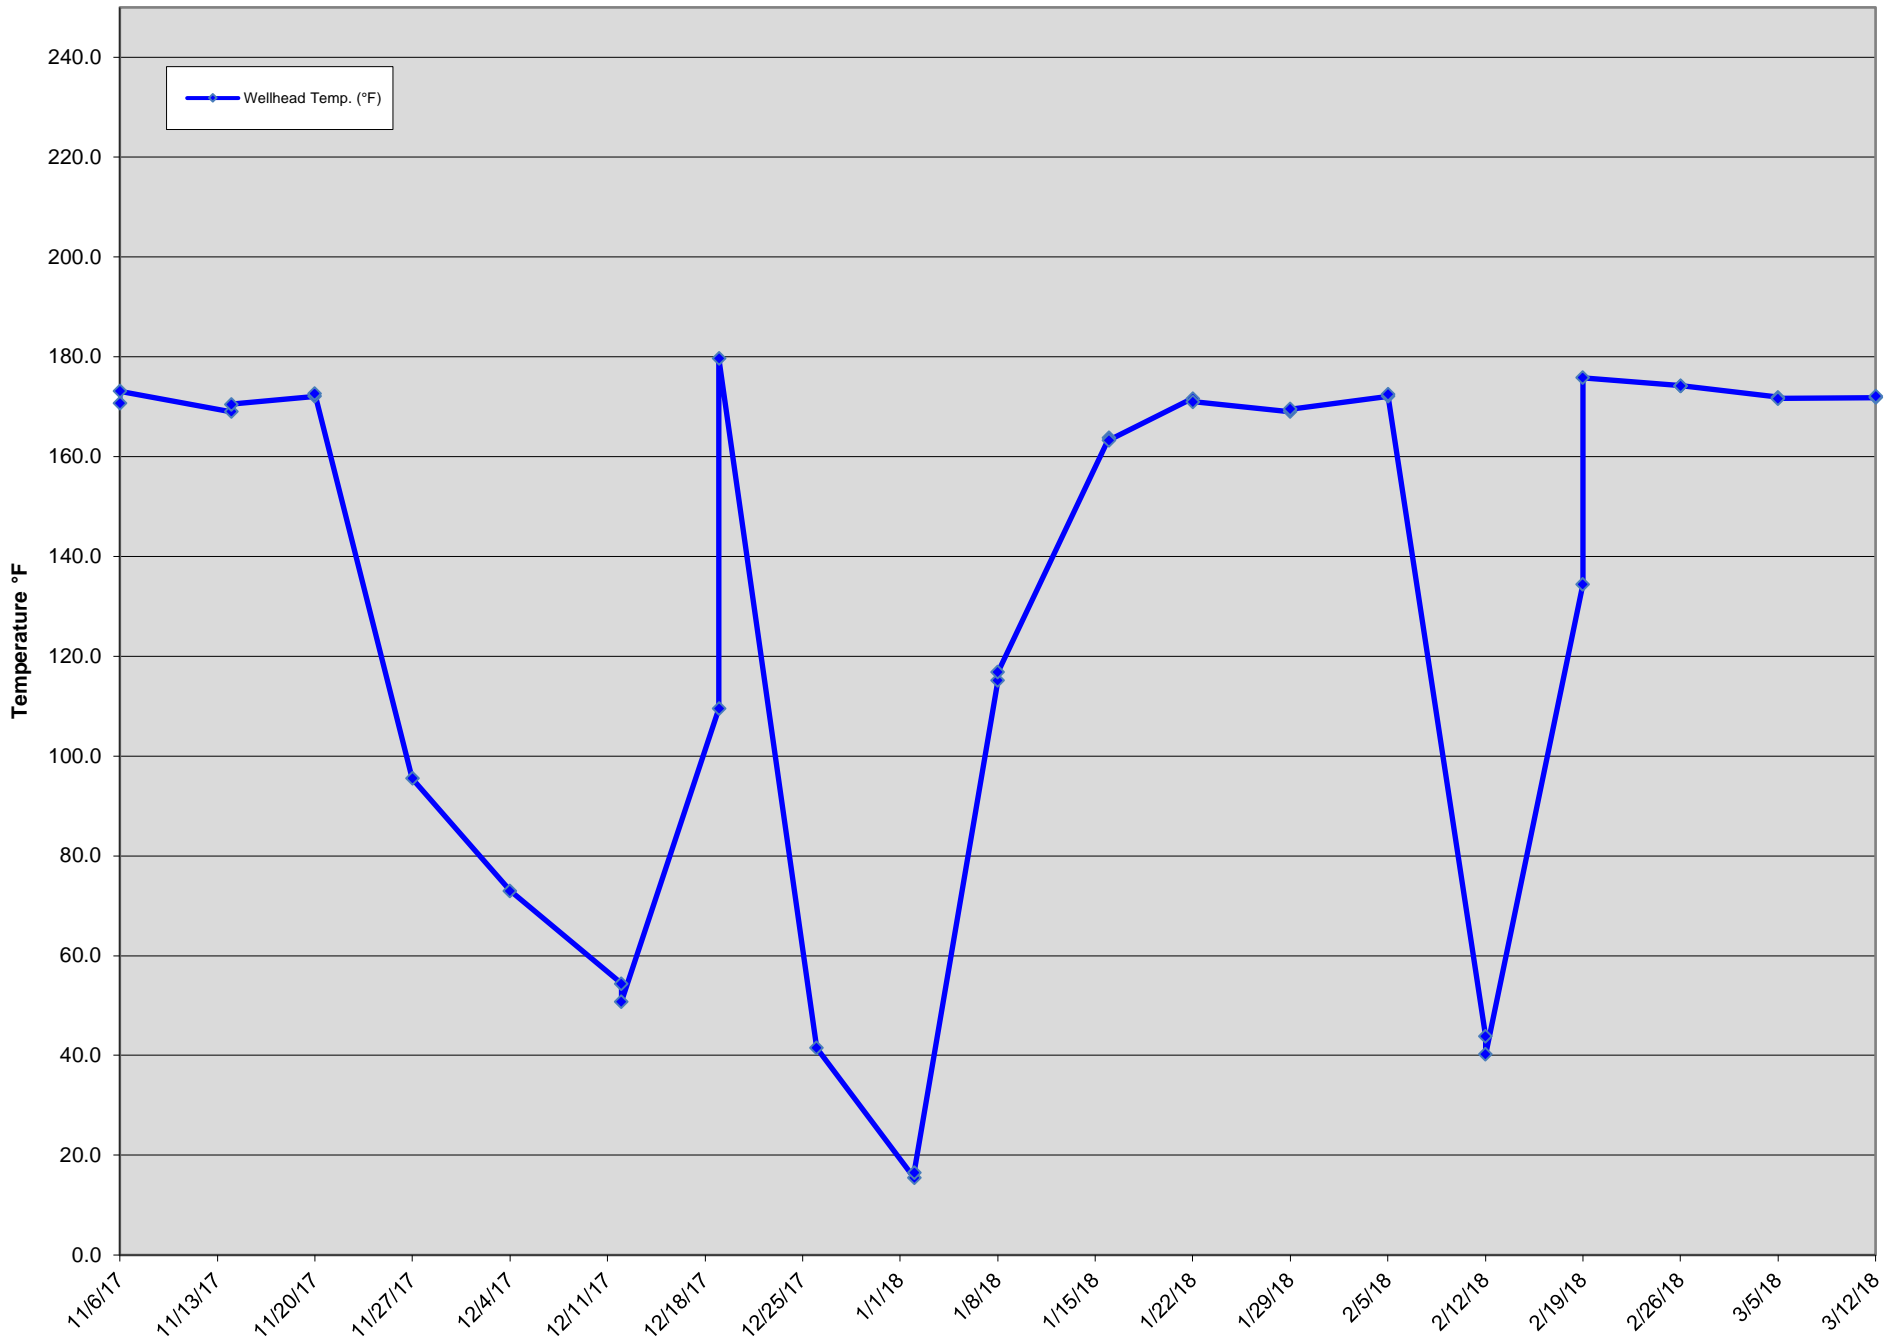
GIW-1 Wellhead Temperatures

As part of the HES, there are currently cooling water circulation loops installed in twelve Gas Interceptor Wells (GIWs) (GIW-02 through GIW-13). The remaining well (GIW-01) had a measured gas temperature within its historical operating limits.
